# BRIDGE INSPECTION REPORT

INSPECTION TYPE: Routine Inspection

COUNTY ROBESON BRIDGE NUMBER 770223 INSPECTION CYCLE 2 YRS  
ROUTE SR1303 ACROSS GUM SWAMP M.P. 0

INSPECTION DATE 02/25/2014

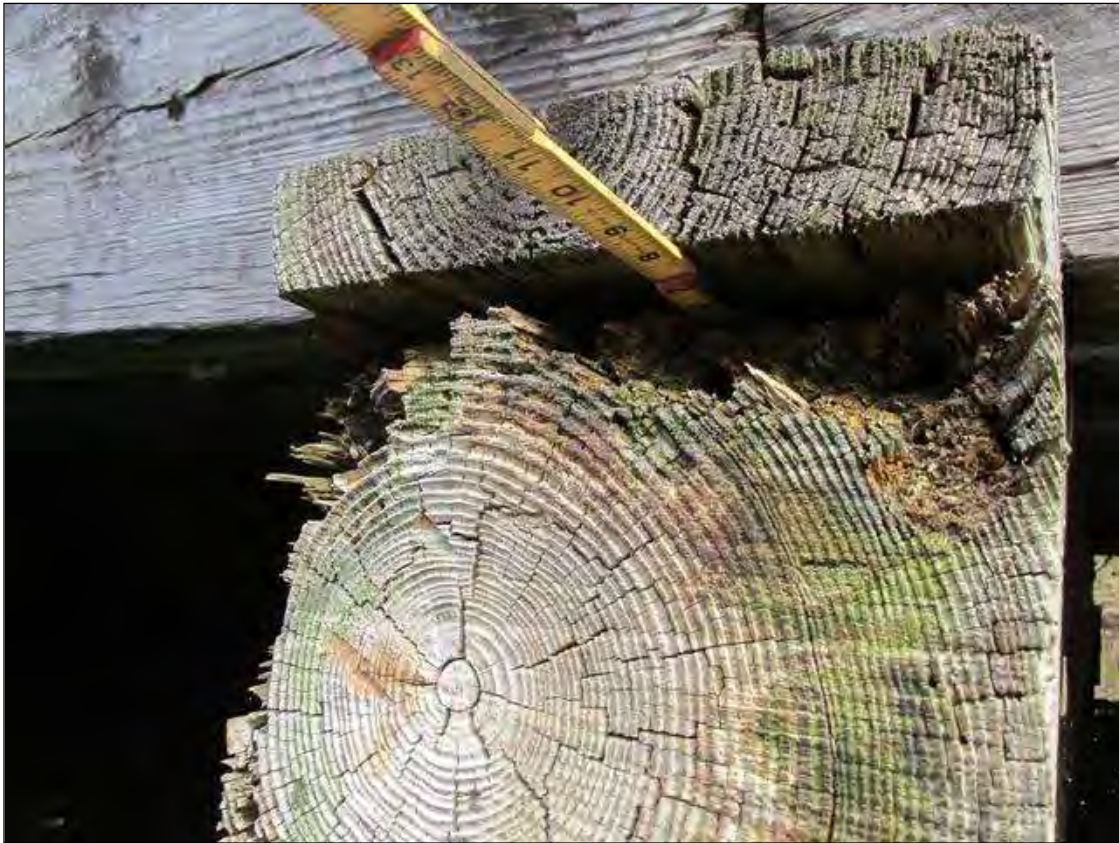
BENT 1 CAP RIGHT END TOP PORTION DECAYED FULL WIDTH X 5" HIGH X 8" DEEP

| MMS Code | Description of Function | Unit | Quantity | Remarks | Est. Cost |
|---|---|---|---|---|---|
| 3344 | Repair / Replace Timber Substructure Components | LF | <del>3</del> TSE | BENT 1 CAP RIGHT END TOP PORTION DECAYED FULL WIDTH X 5" HIGH X 8" DEEP | |

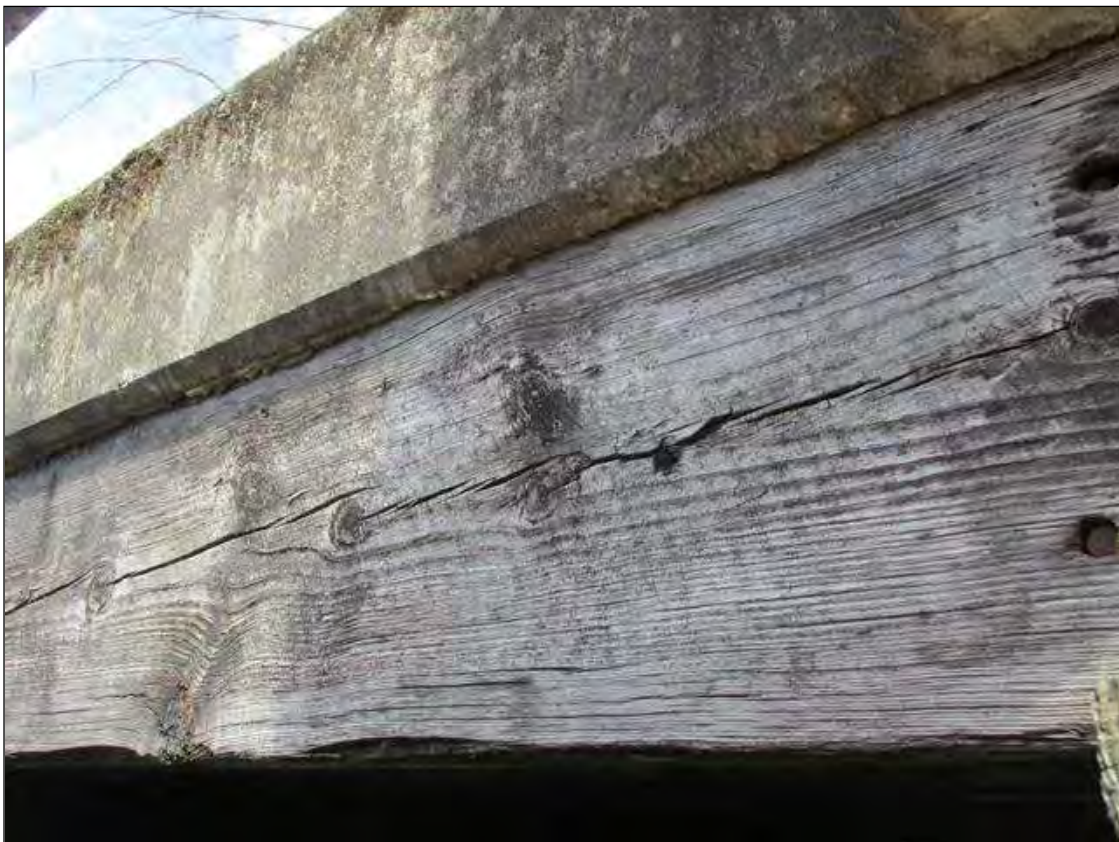
CHECKING UP TO 1/8" WIDE IN JOIST 19 IN SPAN 1

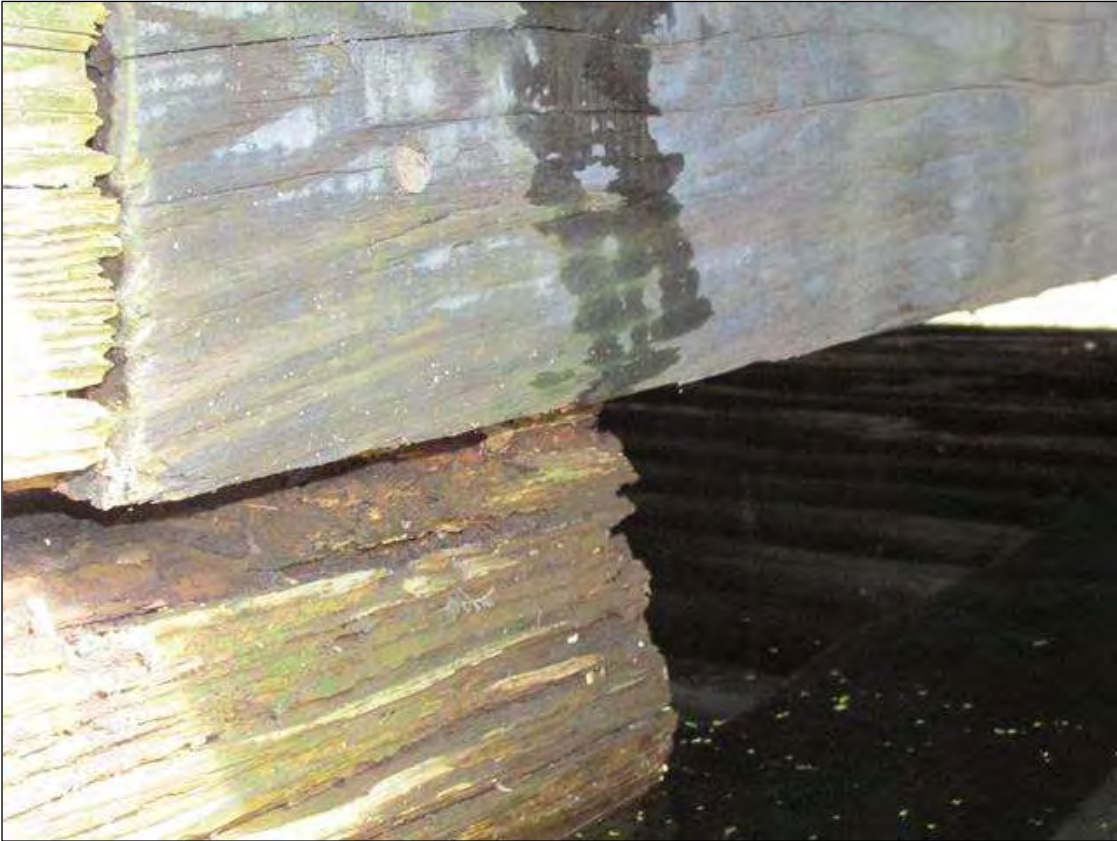
BENT 1 SUB CAP RIGHT END SPAN 2 FACE IS DECAYED 20" L X 2" H X 5" D

| MMS Code | Description of Function | Unit | Quantity | Remarks | Est. Cost |
|---|---|---|---|---|---|
| 3344 | Repair / Replace Timber Substructure Components | LF | 3 | BENT 1 SUB CAP RIGHT END SPAN 2 FACE IS DECAYED 20" L X 2" H X 5" D | |

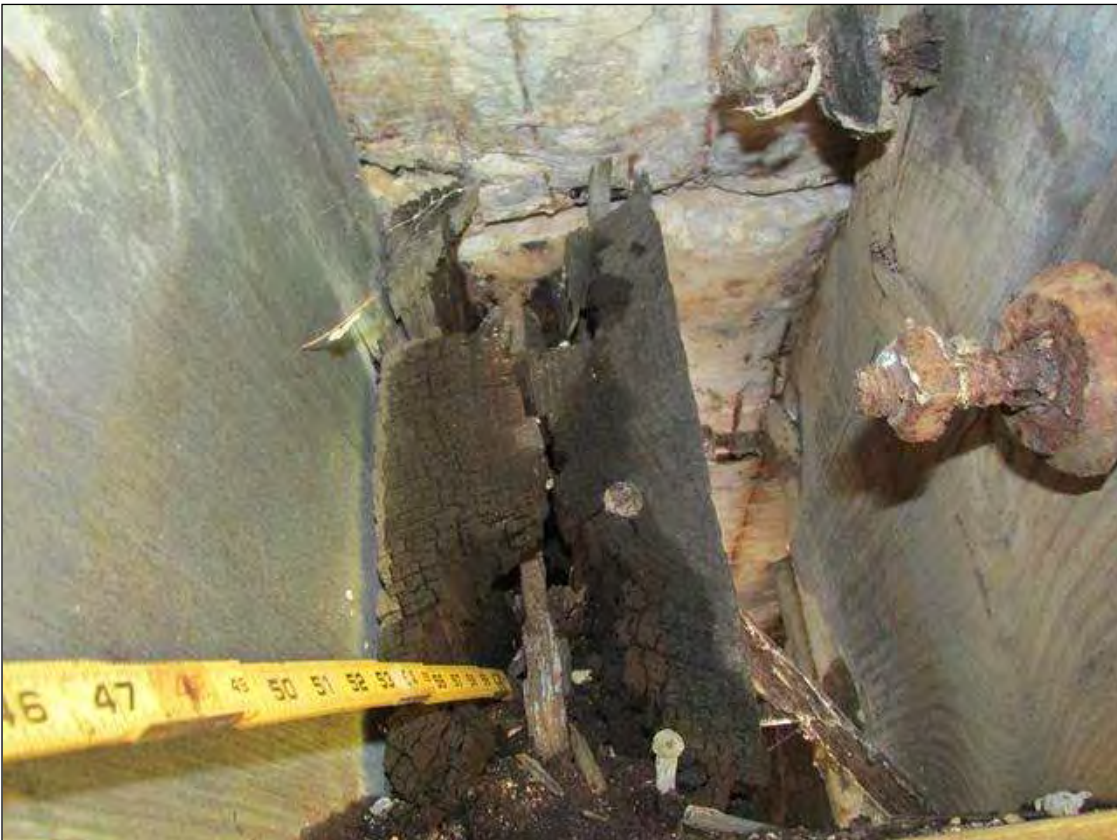
JOIST 18 IN SPAN 2 AT BENT 1 IS END DECAYED TOP, 6" HIGH X 5" WIDE X 15" DEEP, BOTTOM IS 6" HIGH X 4" WIDE X 15" DEEP PM ISSUED

| MMS Code | Description of Function | Unit | Quantity | Remarks | Est. Cost |
|---|---|---|---|---|---|
| 3304 | Maintain/Replace Timber Superstructure Components | LF | <del>17</del> | JOIST 18 IN SPAN 2 AT BENT 1 IS END DECAYED TOP, 6" HIGH X 5" WIDE X 15" DEEP, BOTTOM IS 6" HIGH X 4" WIDE X 15" DEEP PM ISSUED | |

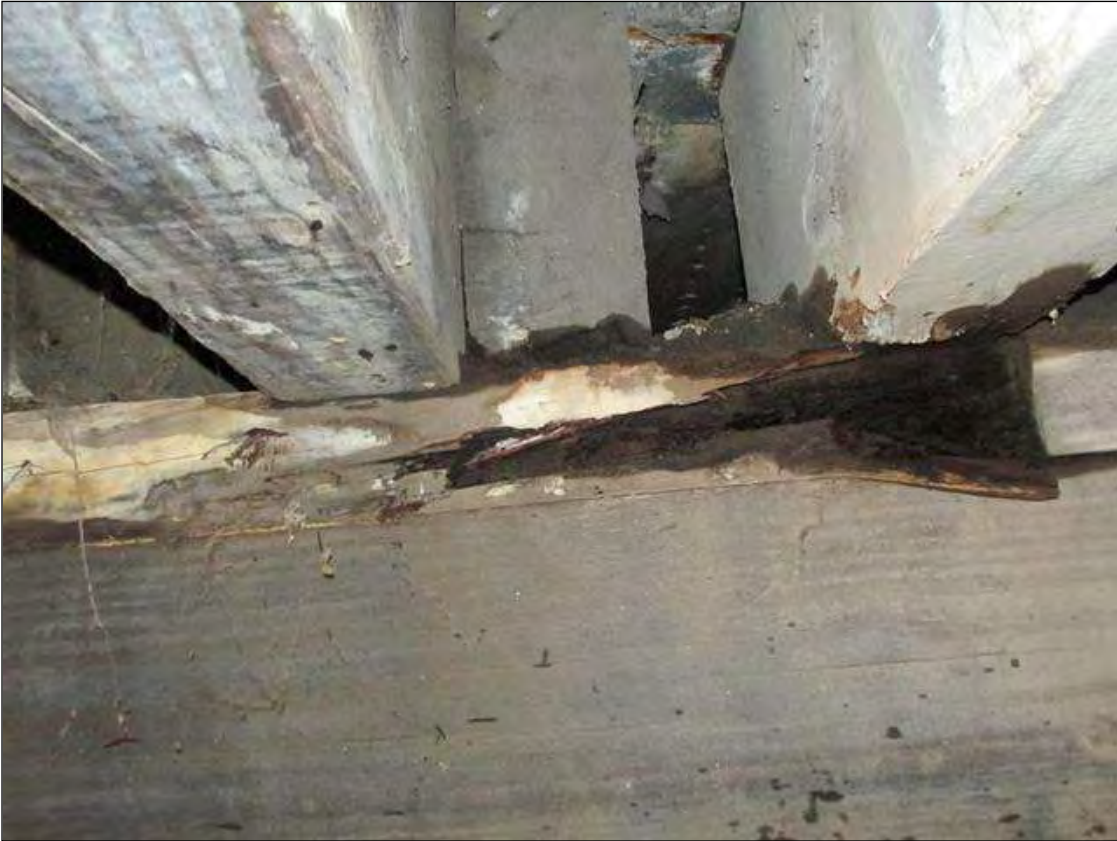
BENT 1 CROWN STRIP DECAYED FROM JOIST 4 THRU JOIST 10 WITH UP TO 1/4" CRUSHING PM ISSUED

| MMS Code | Description of Function | Unit | Quantity | Remarks | Est. Cost |
|---|---|---|---|---|---|
| 3344 | Repair / Replace Timber Substructure Components | LF | <del>8</del> | BENT 1 CROWN STRIP DECAYED FROM JOIST 4 THRU JOIST 10 WITH UP TO 1/4" CRUSHING PM ISSUED | |

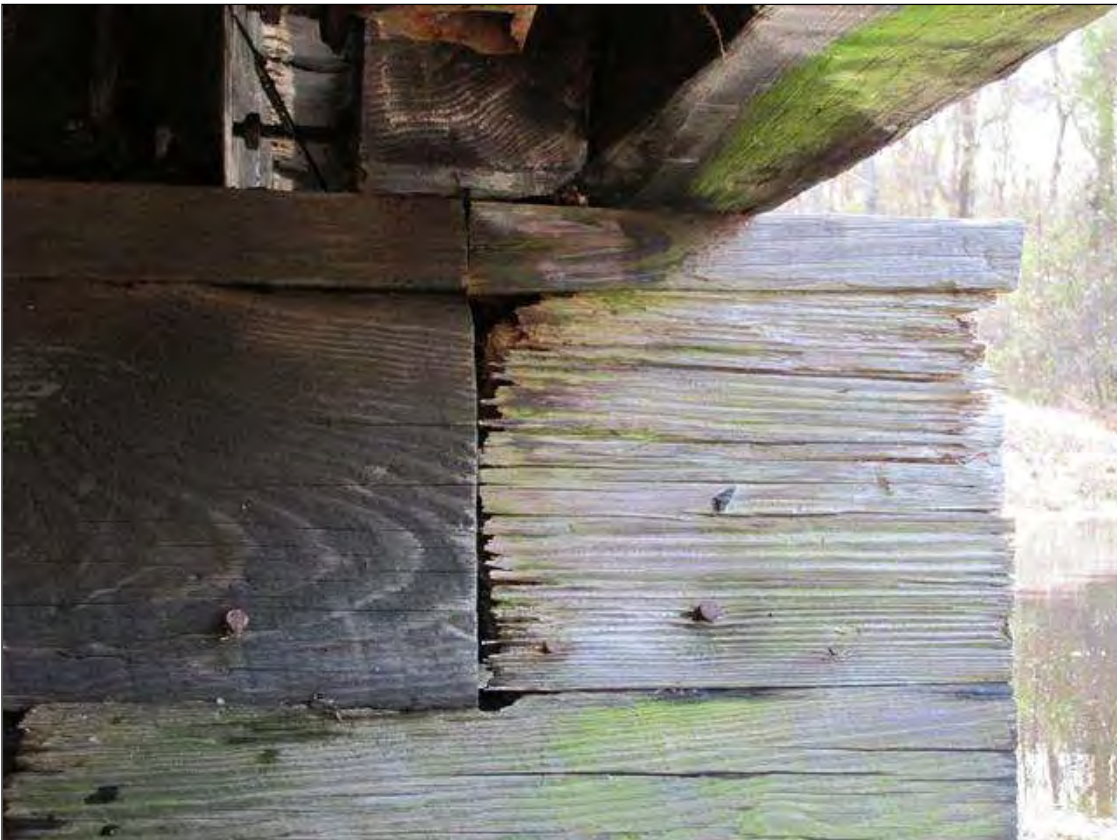
BENT 1 CAP RIGHT END SPAN 1 FACE IS DECAYED AT SPLICE X FULL WIDTH

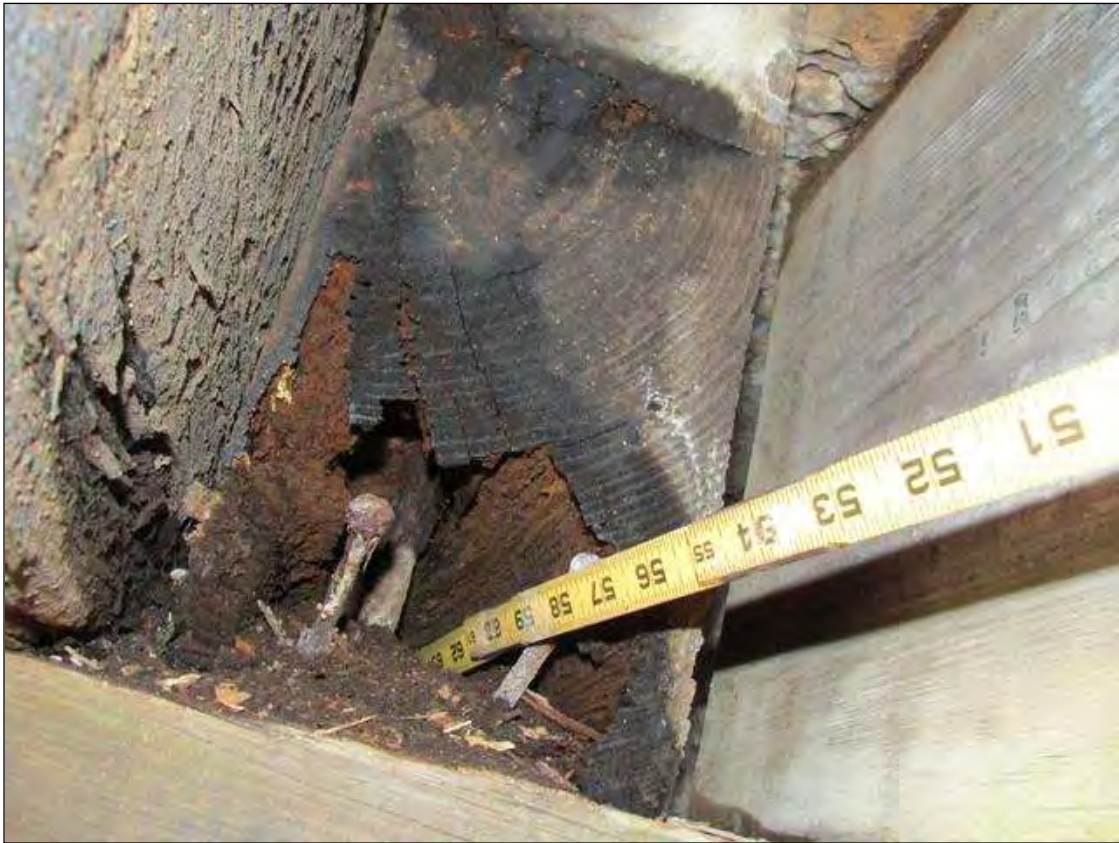
JOIST 18 IN SPAN 1 AT BENT 1 IS END DECAYED 5" WIDE X 4" HIGH X 14" DEEP PM ISSUED.

| MMS Code | Description of Function | Unit | Quantity | Remarks | Est. Cost |
|---|---|---|---|---|---|
| 3304 | Maintain/Replace Timber Superstructure Components | LF | <del>17</del> | JOIST 18 IN SPAN 1 AT BENT 1 IS END DECAYED 5" WIDE X 4" HIGH X 14" DEEP PM ISSUED. | |

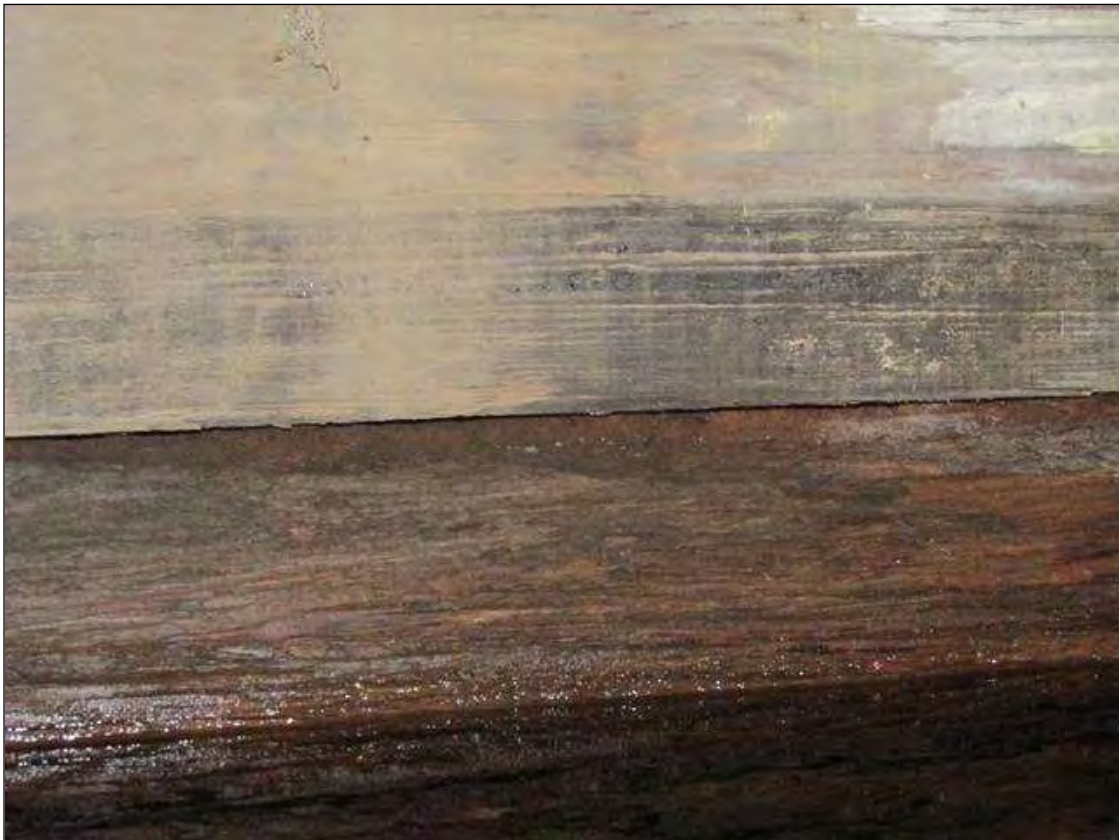
BENT 2 SUB CAP IS SURFACE DECAYED AT LEFT END ON SPAN 2 FACE

| MMS Code | Description of Function | Unit | Quantity | Remarks | Est. Cost |
|---|---|---|---|---|---|
| 3344 | Repair / Replace Timber Substructure Components | LF | 5 | BENT 2 SUB CAP IS SURFACE DECAYED AT LEFT END ON SPAN 2 FACE | |

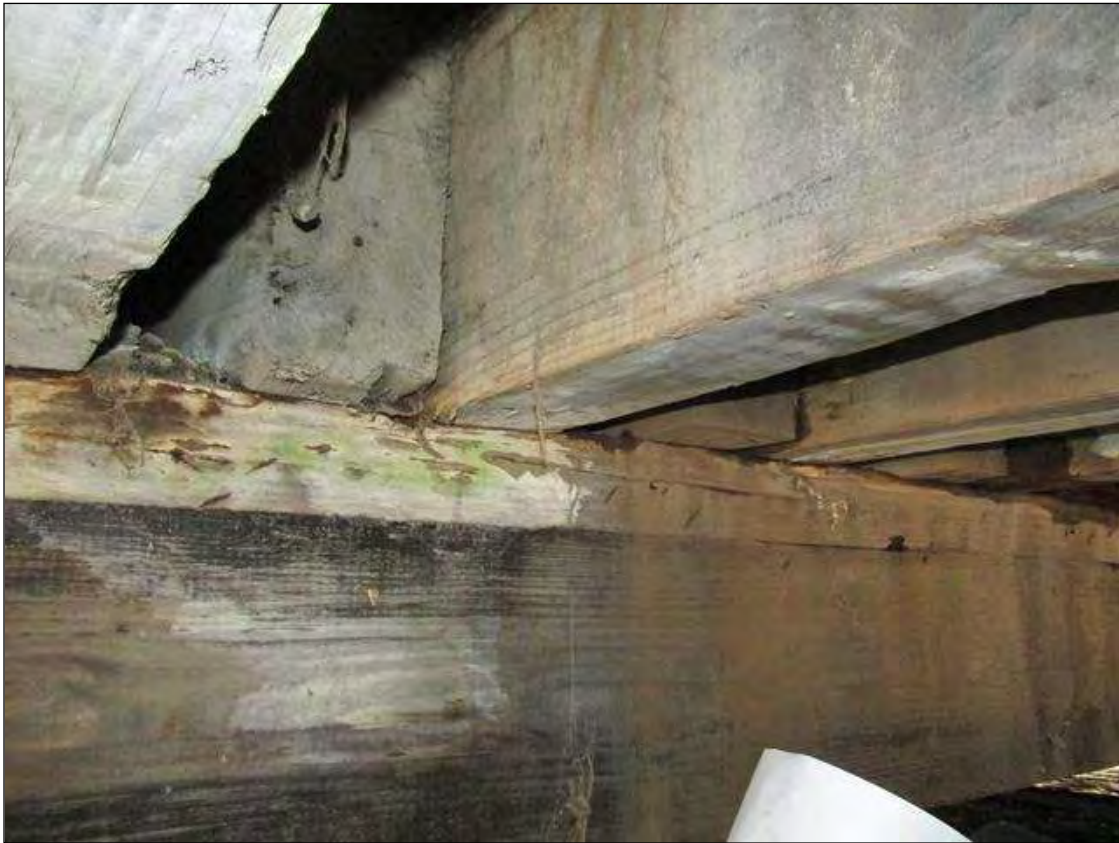
BENT 2 CROWN STRIP IS DECAYED FROM JOIST 5 THRU JOIST 9

| MMS Code | Description of Function | Unit | Quantity | Remarks | Est. Cost |
|---|---|---|---|---|---|
| 3344 | Repair / Replace Timber Substructure Components | LF | 6 | BENT 2 CROWN STRIP IS DECAYED FROM JOIST 5 THRU JOIST 9 | |

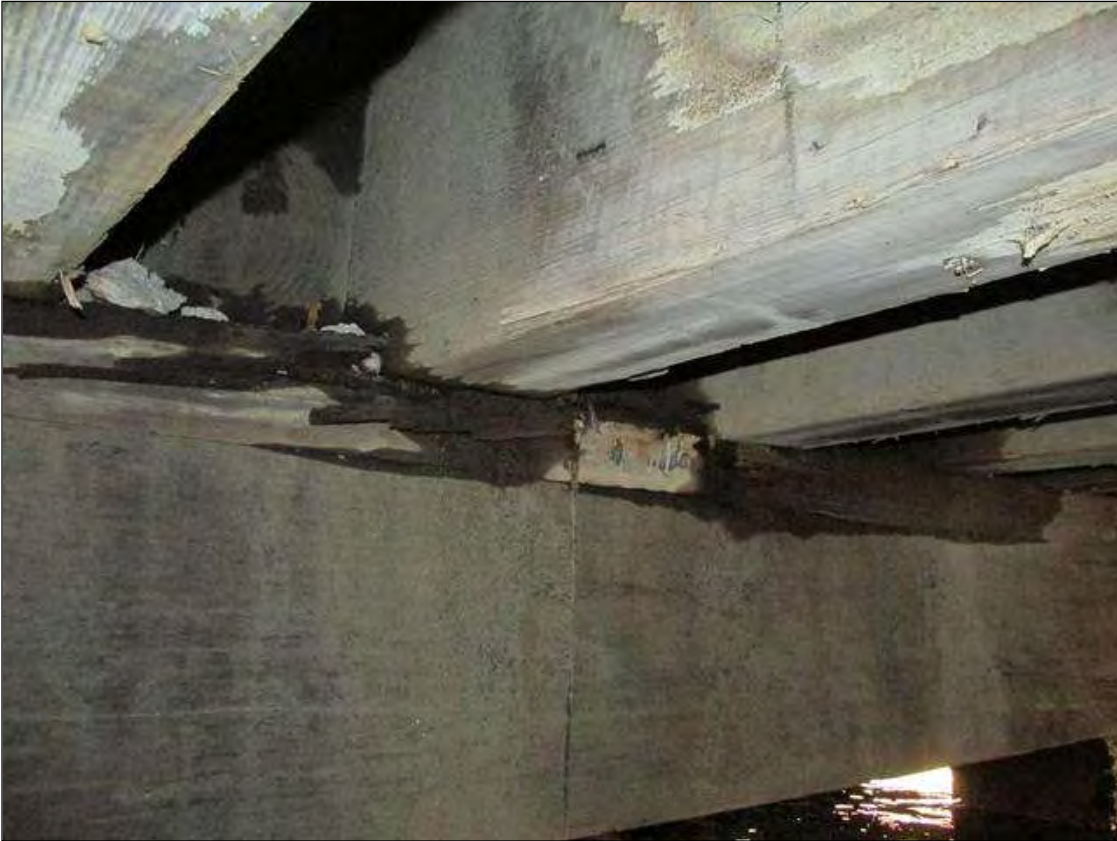
BENT 2 CROWN STRIP IN SPAN 3 IS DECAYED FROM JOIST 8 THRU JOIST 14 WITH UP TO 1/2" CRUSHING  
PM ISSUED

| MMS Code | Description of Function | Unit | Quantity | Remarks | Est. Cost |
|---|---|---|---|---|---|
| 3344 | Repair / Replace Timber Substructure Components | LF | <del>10</del> 12/9/14 | BENT 2 CROWN STRIP IN SPAN 3 IS DECAYED FROM JOIST 8 THRU JOIST 14 WITH UP TO 1/2" CRUSHING PM ISSUED | |

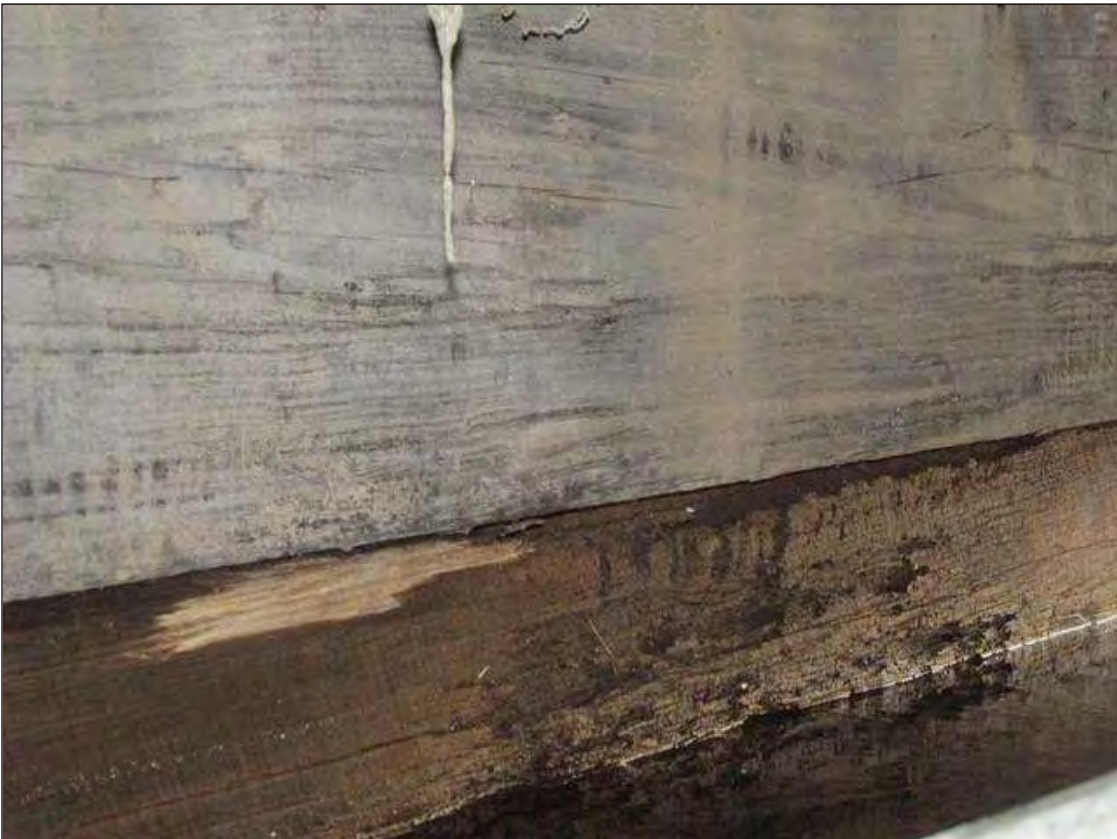
BENT 2 SUB CAP IS SURFACE DECAYED AT LEFT END

| MMS Code | Description of Function | Unit | Quantity | Remarks | Est. Cost |
|---|---|---|---|---|---|
| 3344 | Repair / Replace Timber Substructure Components | LF | 5 | BENT 2 SUB CAP IS SURFACE DECAYED AT LEFT END | |

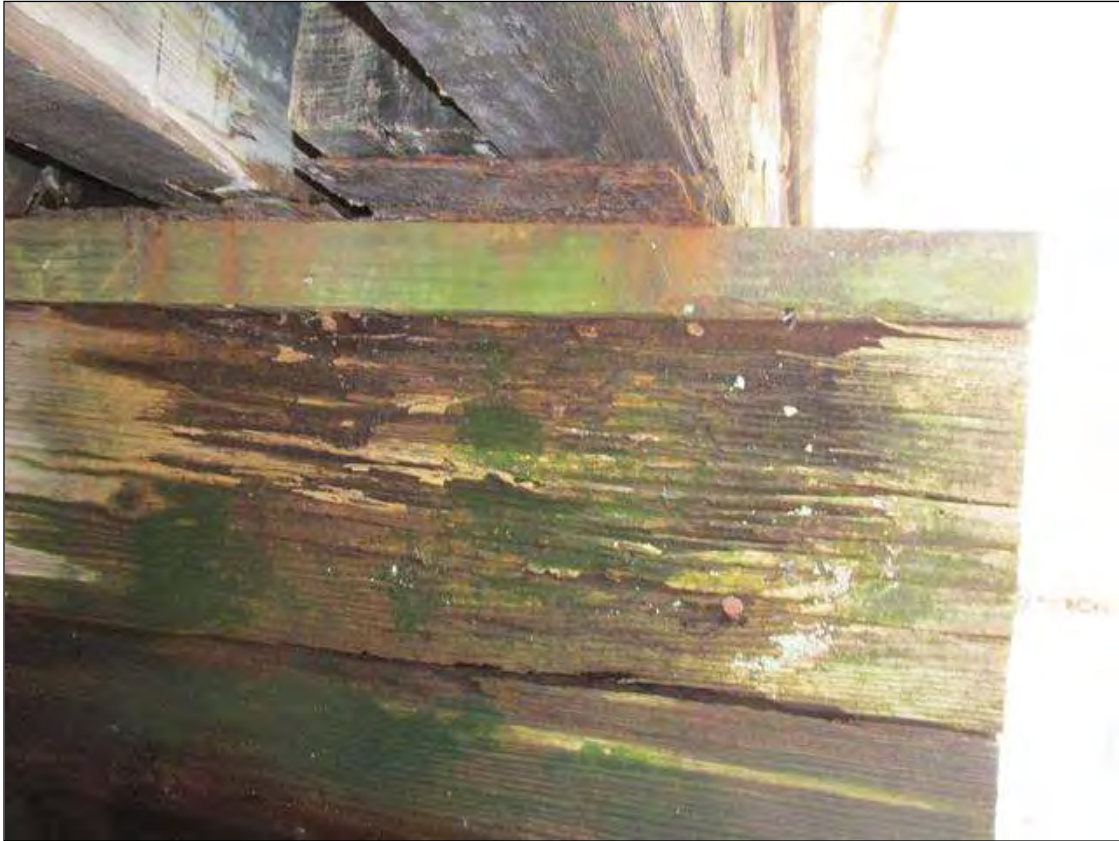
BENT 2 CAP, LEFT END IS SURFACE DECAYED 3' WIDE X 6" TO 10" HIGH X UP TO 1 1/2" DEEP

| MMS Code | Description of Function | Unit | Quantity | Remarks | Est. Cost |
|---|---|---|---|---|---|
| 3344 | Repair / Replace Timber Substructure Components | LF | 3 | BENT 2 CAP, LEFT END IS SURFACE DECAYED 3' WIDE X 6" TO 10" HIGH X UP TO 1 1/2" DEEP | |

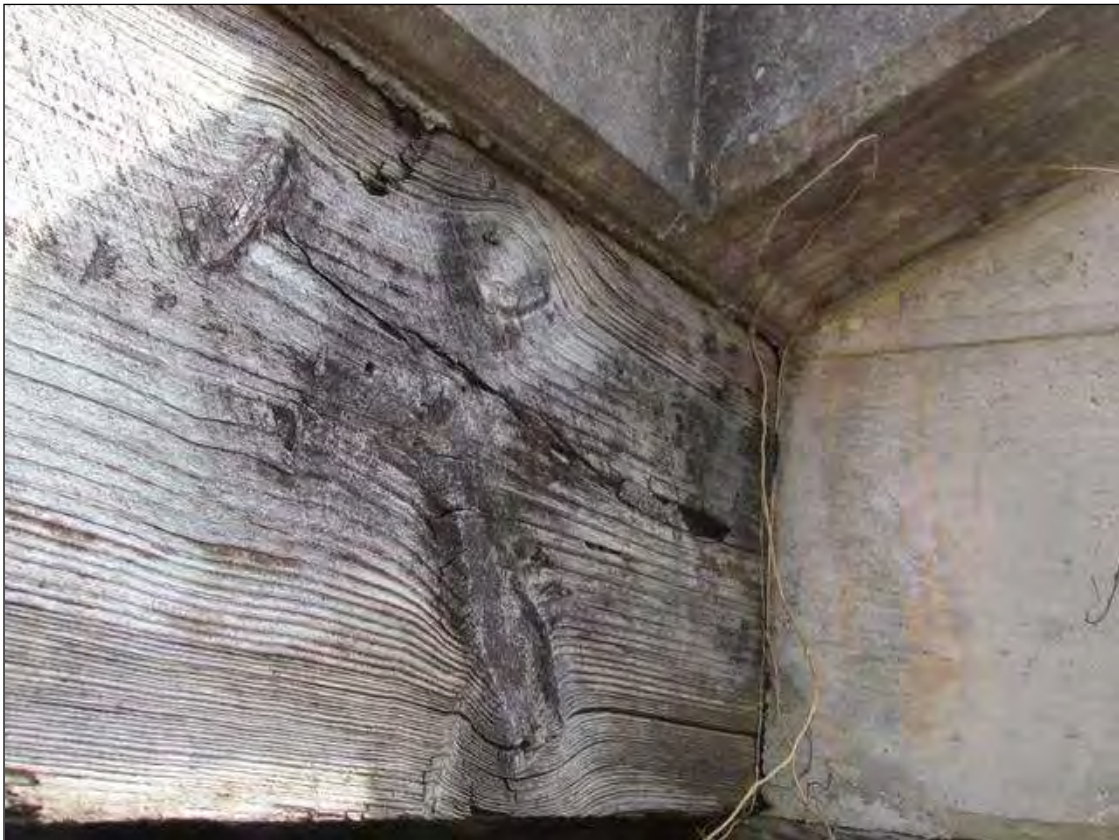
JOIST 19 IN SPAN 3 AT END BENT 2 IS DELAMINATED TOP PORTION 5" WIDE X 6" HIGH

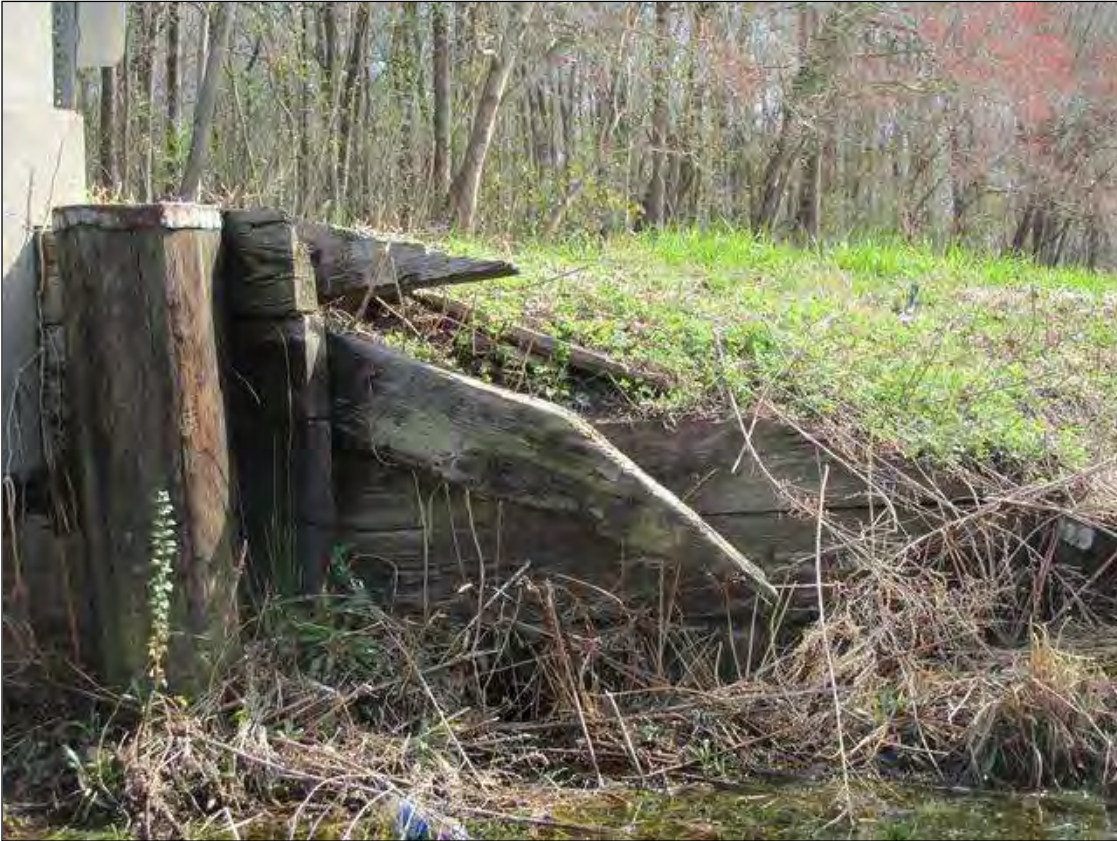
THERE ARE DECAYED WINGWALL BOARDS AT SOUTHEAST CORNER

| MMS Code | Description of Function | Unit | Quantity | Remarks | Est. Cost |
|---|---|---|---|---|---|
| 3346 | Repair / Maintain Timber Wings & Blkhds | SF | 5 | THERE ARE DECAYED WINGWALL BOARDS AT SOUTHEAST CORNER | |

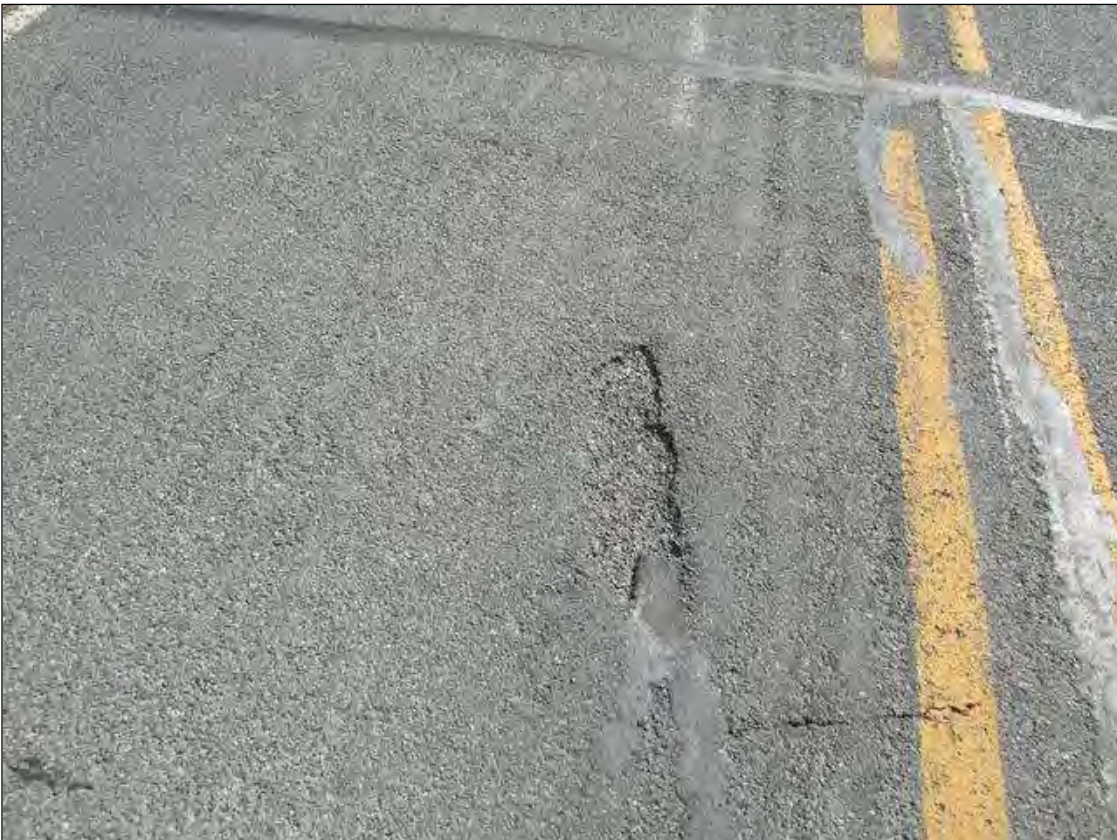
| 50 | F | ( APPROACH ROADWAY )      THE WEST APPROACH ASPHALT WEARING SURFACE IS SPALLED 16" L X 7" W X UP TO 1 1/4" D IN THE WEST BOUND LANE. (PHOTO) | |

WEST APPROACH ASPHALT WEARING SURFACE IS SPALLED 16" L X 7" W X UP TO 1 1/4" D IN THE WEST BOUND LANE

| MMS Code | Description of Function | Unit | Quantity | Remarks | Est. Cost |
|---|---|---|---|---|---|
| 2816 | Asphalt Surface Repair or Replacement | SY | 1 | WEST APPROACH ASPHALT WEARING SURFACE IS SPALLED 16" L X 7" W X UP TO 1 1/4" D IN THE WEST BOUND LANE | |

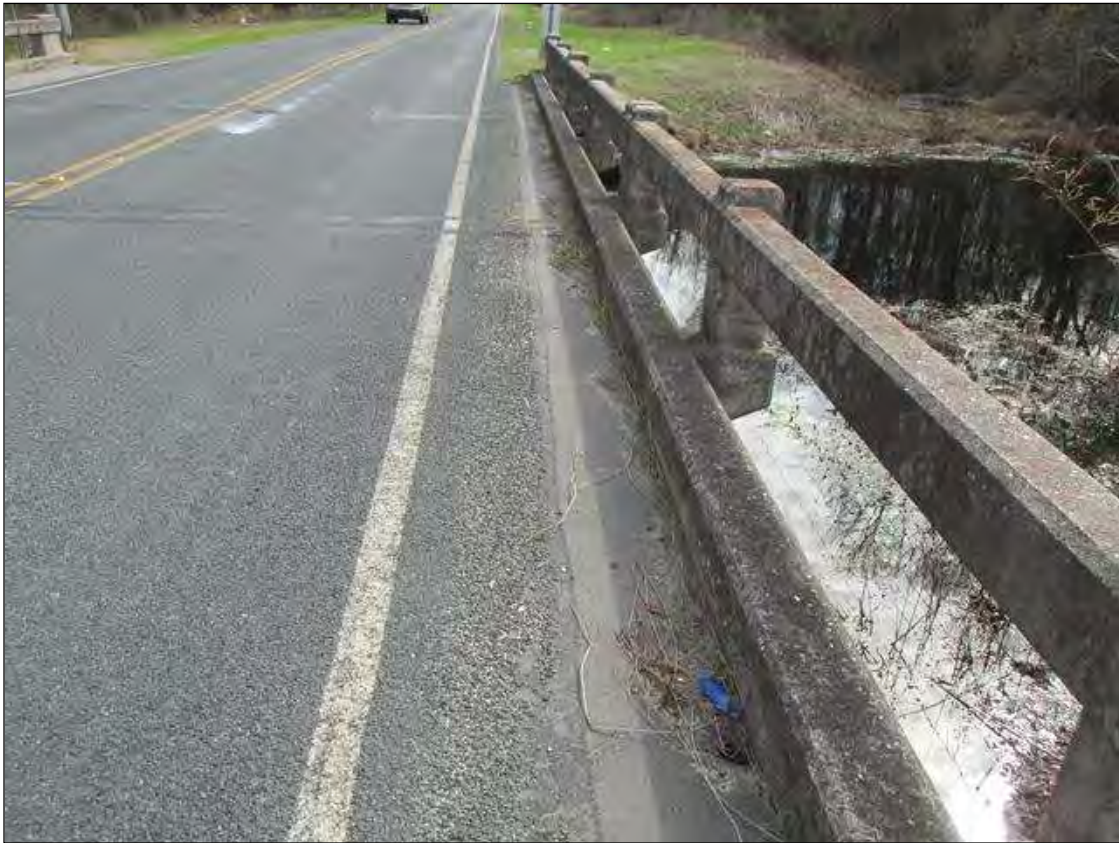
THERE IS DEBRIS AND VEGETATION ALONG RIGHT CURB

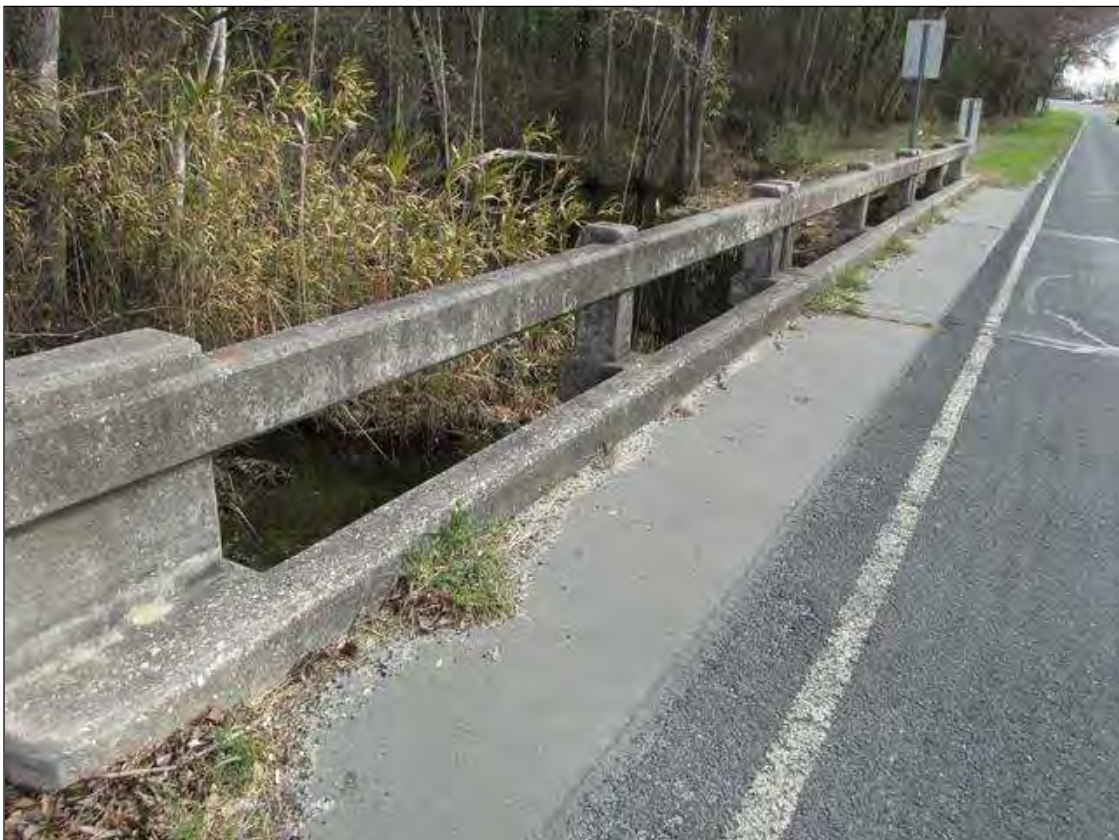
THERE IS DEBRIS AND VEGETATION ALONG LEFT CURB

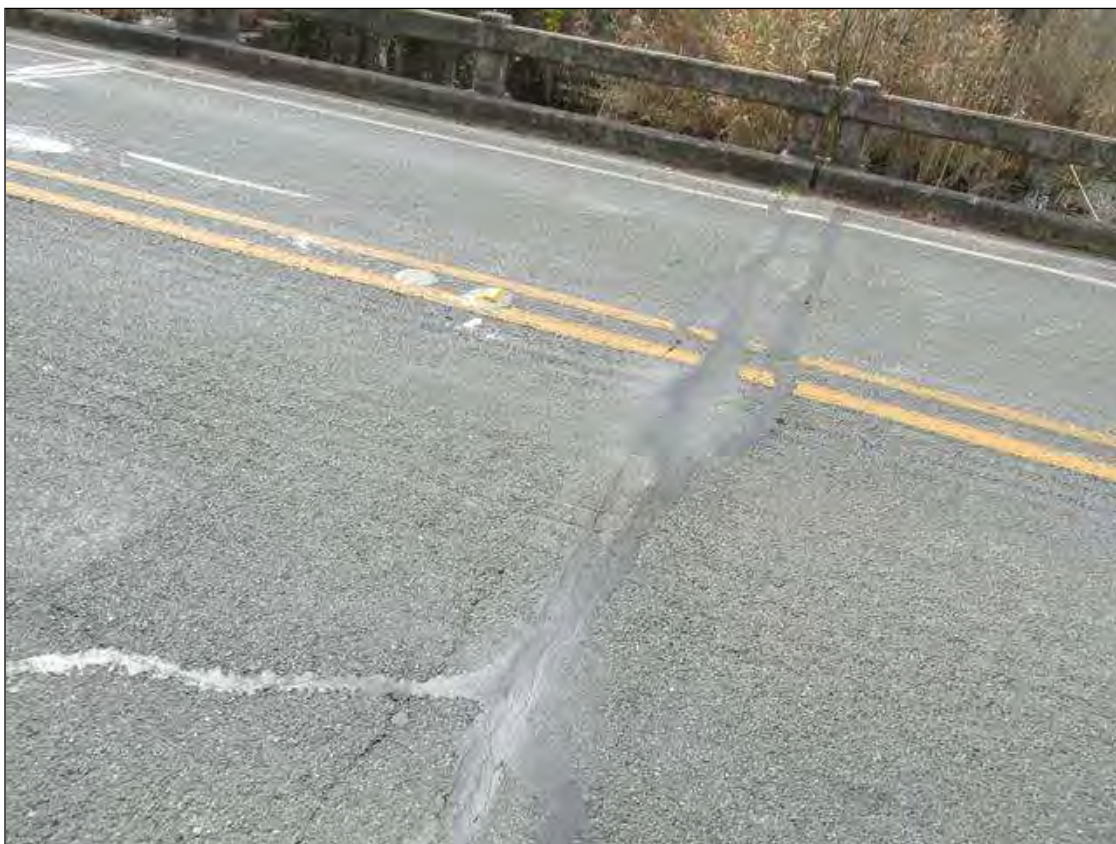
| 6d | G | ( STANDARD JOINTS )    THERE ARE SEALED TRANSVERSE CRACKS IN ASPHALT WEARING SURFACE OVER BENT 1 JOINT. (PHOTO) | |

THERE ARE SEALED TRANSVERSE CRACKS IN ASPHALT WEARING SURFACE OVER BENT 1 JOINT

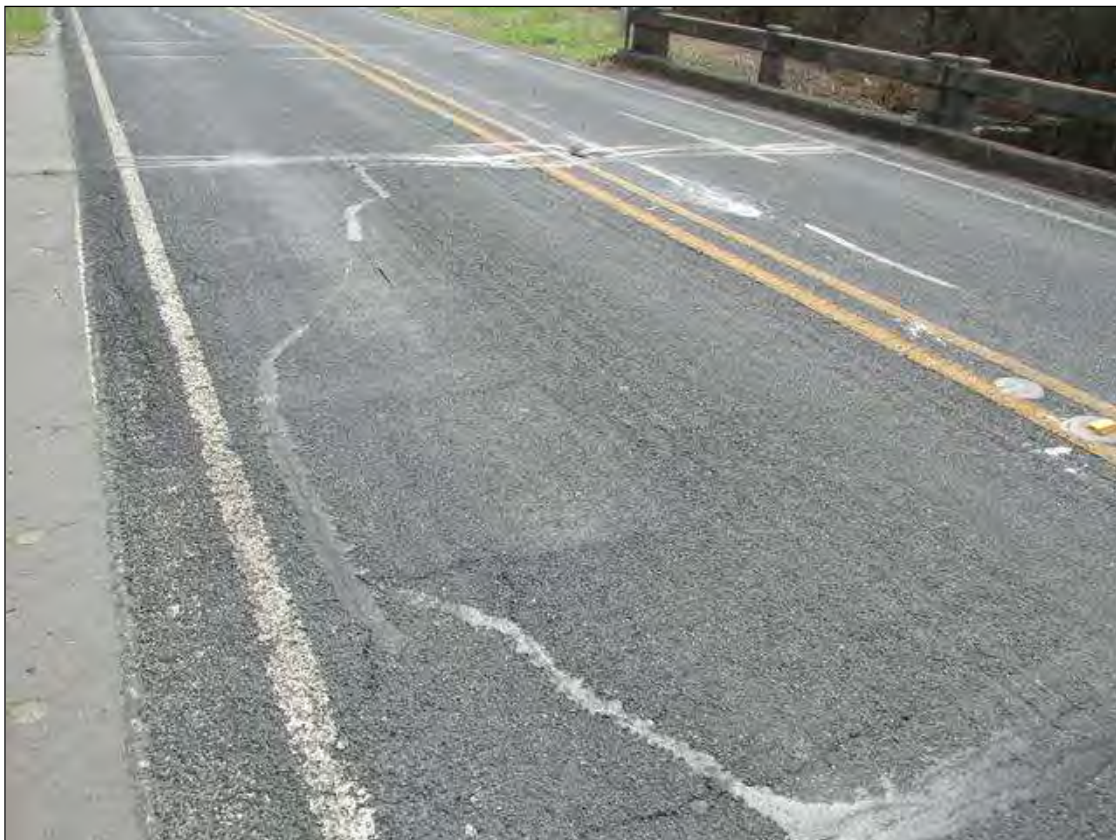
SPAN 2 ASPHALT WEARING SURFACE IN WEST BOUND LANE IS UNEVEN UP TO 2"

| MMS Code | Description of Function | Unit | Quantity | Remarks | Est. Cost |
|---|---|---|---|---|---|
| 2816 | Asphalt Surface Repair or Replacement | SY | 3 | SPAN 2 ASPHALT WEARING SURFACE IN WEST BOUND LANE IS UNEVEN UP TO 2" | |

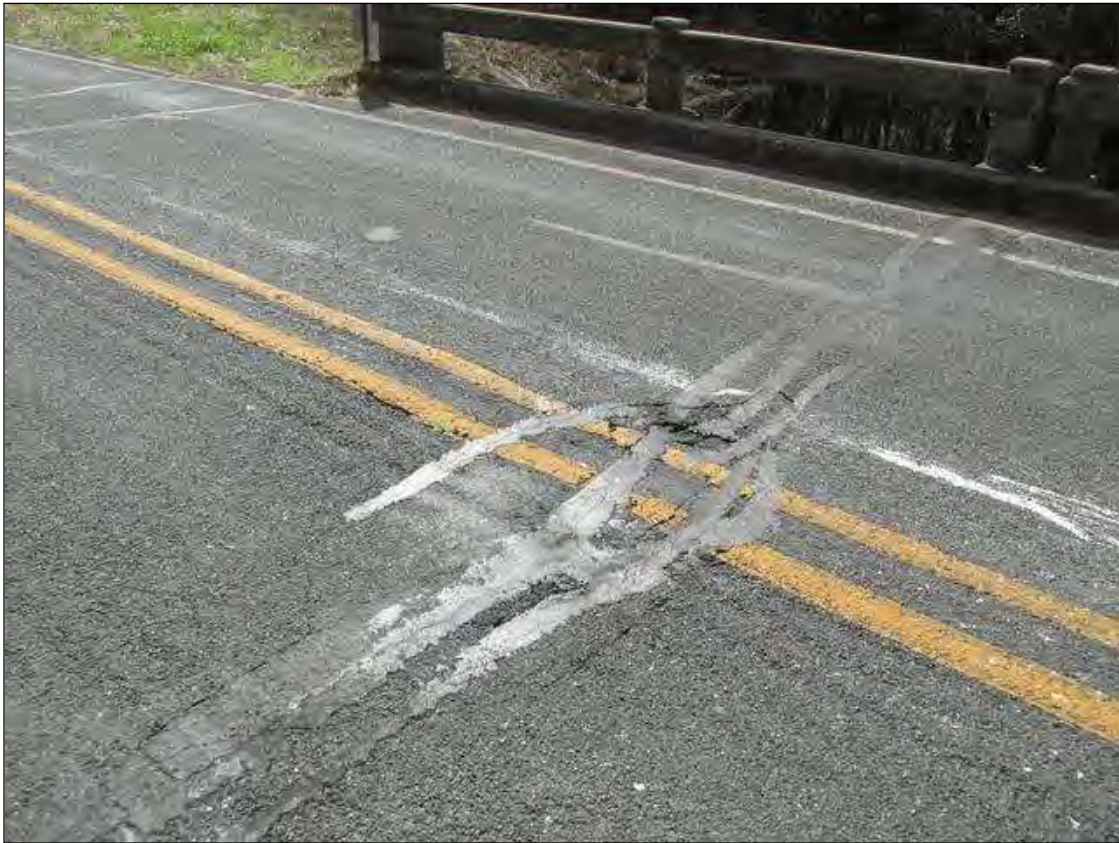
ASPHALT WEARING SURFACE OVER BENT 2 IS UNEVEN WITH SPALL IN EAST BOUND LANE 12" DIAMETER X 2" DEEP

| MMS Code | Description of Function | Unit | Quantity | Remarks | Est. Cost |
|---|---|---|---|---|---|
| 2816 | Asphalt Surface Repair or Replacement | SY | 2 | ASPHALT WEARING SURFACE OVER BENT 2 IS UNEVEN WITH SPALL IN EAST BOUND LANE 12" DIAMETER X 2" DEEP | |

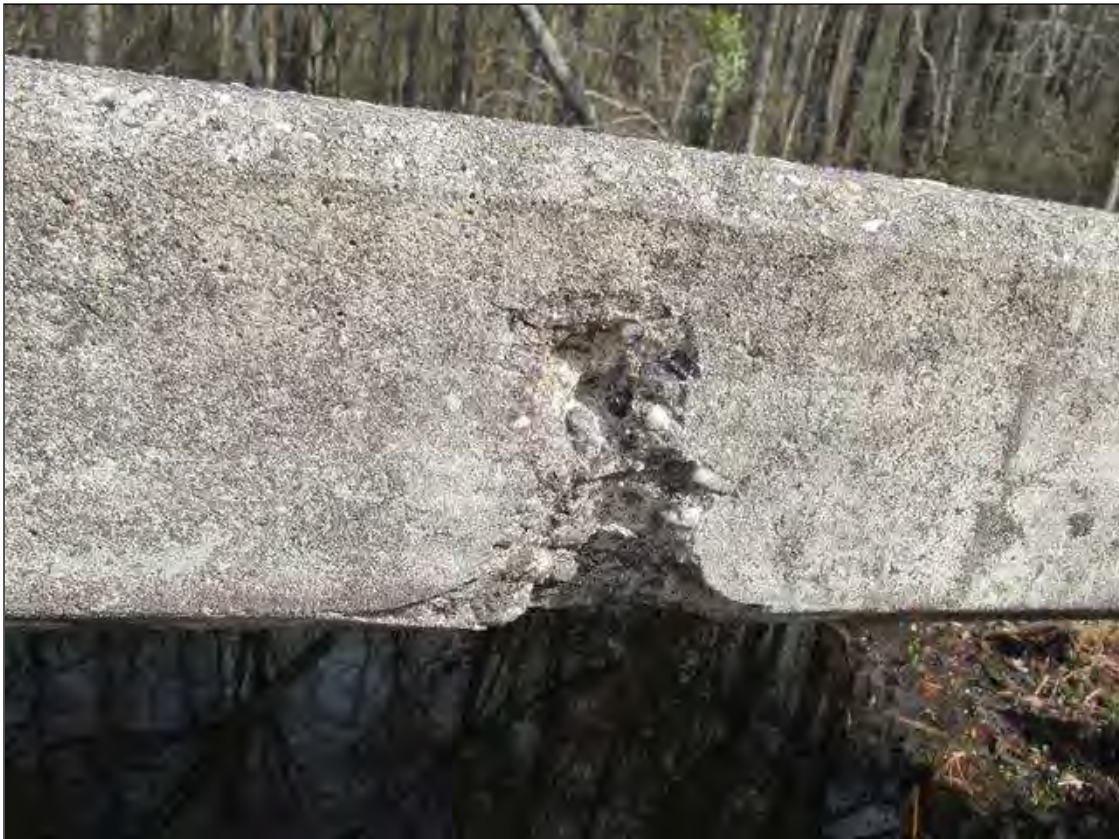
| 3a | F | ( RC RAILS )    THE CONCRETE RAILS EXHIBITS AREAS OF EXPOSED AGGREGATE AND SCALING.<br><br>THERE IS A 3" W X 4" H X 1 1/2" D SPALL ON THE NORTH RAIL BAR IN SPAN 3. (PHOTO) | |

LEFT RAIL BAR IN SPAN 3 IS SPALLED 3" W X 4" H X 1 1/2" D

| MMS Code | Description of Function | Unit | Quantity | Remarks | Est. Cost |
|---|---|---|---|---|---|
| 3318 | Maint to Concrete Handrail | LF | 1 | LEFT RAIL BAR IN SPAN 3 IS SPALLED 3" W X 4" H X 1 1/2" D | |

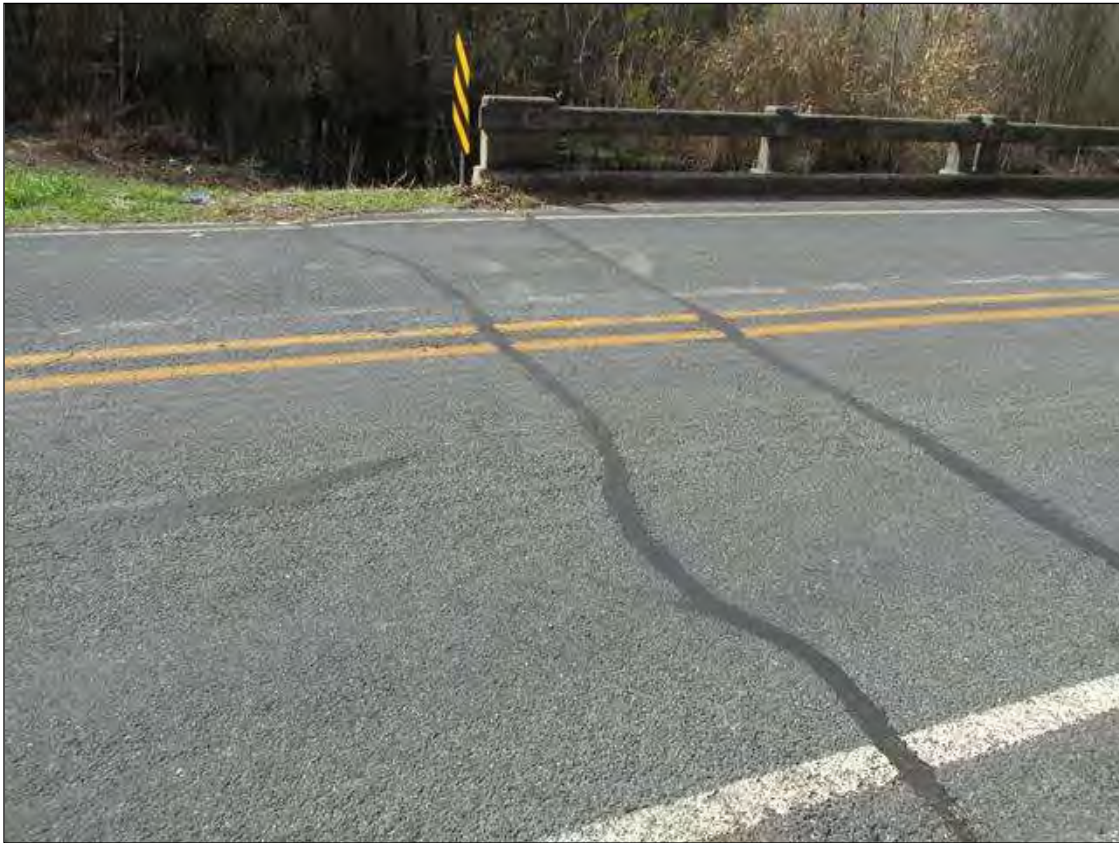
EAST APPROACH ASPHALT WEARING SURFACE CRACKING SEALED
