# BRIDGE INSPECTION REPORT

INSPECTION TYPE: Routine Inspection

COUNTY ROBESON BRIDGE NUMBER 770223 INSPECTION CYCLE 2 YRS  
ROUTE SR1303 ACROSS GUM SWAMP M.P. 0

INSPECTION DATE 02/25/2014

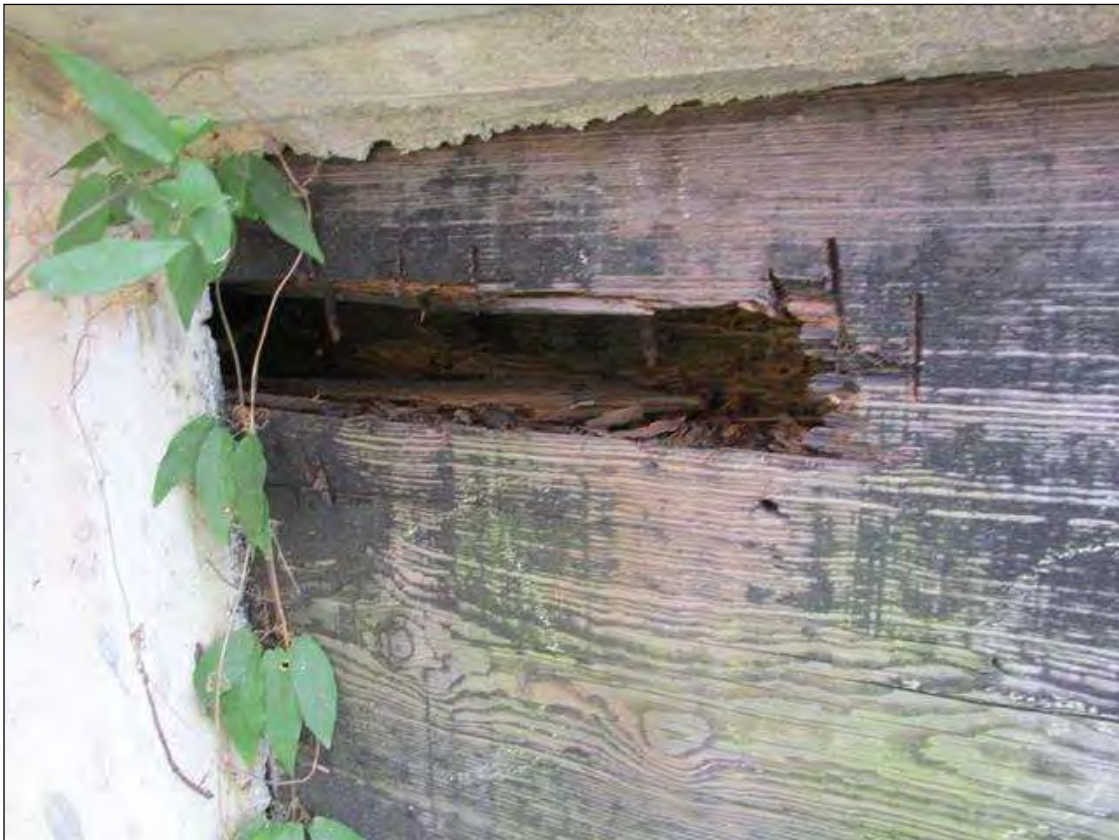
JOIST 1 IN SPAN 3 AT END BENT 2 IS DECAYED 22" L X 4" WIDE X 2" H , SEE SKETCH

| MMS Code | Description of Function | Unit | Quantity | Remarks | Est. Cost |
|---|---|---|---|---|---|
| 3304 | Maintain/Replace Timber Superstructure Components | LF | 17 | JOIST 1 IN SPAN 3 AT END BENT 2 IS DECAYED 22" L X 4" WIDE X 2" H , SEE SKETCH | |

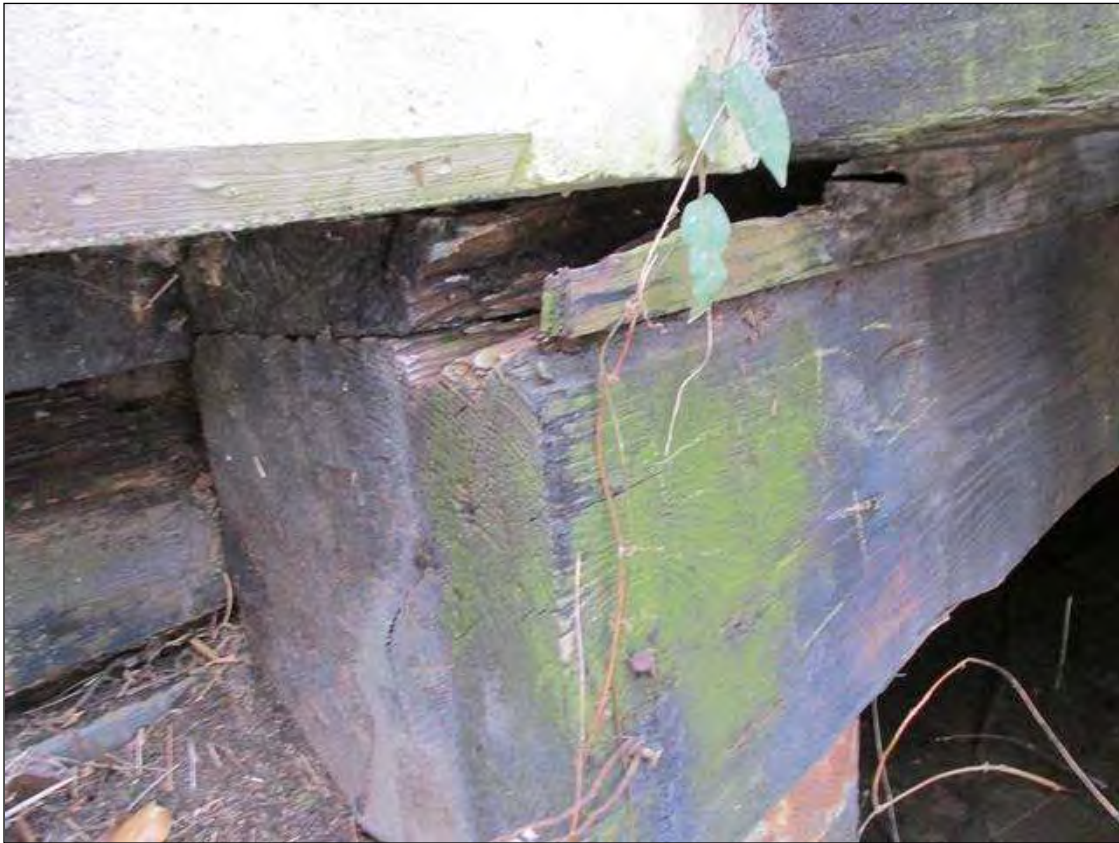
END BENT 2 LEFT END CROWN STRIP IS DECAYED 62" L X 2" H X 4" W

| MMS Code | Description of Function | Unit | Quantity | Remarks | Est. Cost |
|---|---|---|---|---|---|
| 3344 | Repair / Replace Timber Substructure Components | LF | 5 | END BENT 2 LEFT END CROWN STRIP IS DECAYED 62" L X 2" H X 4" W | |

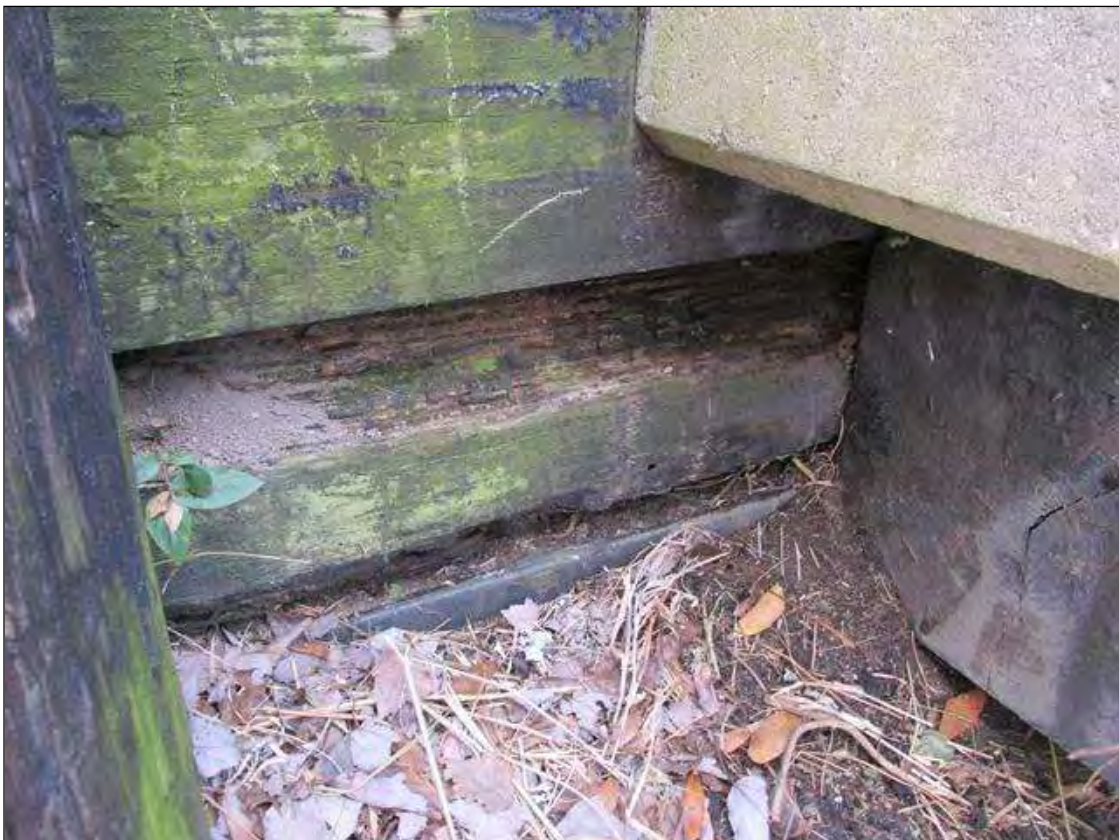
THERE ARE DECAYED BULKHEAD BOARDS AT NORTHEAST CORNER

| MMS Code | Description of Function | Unit | Quantity | Remarks | Est. Cost |
|---|---|---|---|---|---|
| 3346 | Repair / Maintain Timber Wings & Blkhds | SF | 5 | THERE ARE DECAYED BULKHEAD BOARDS AT NORTHEAST CORNER | |

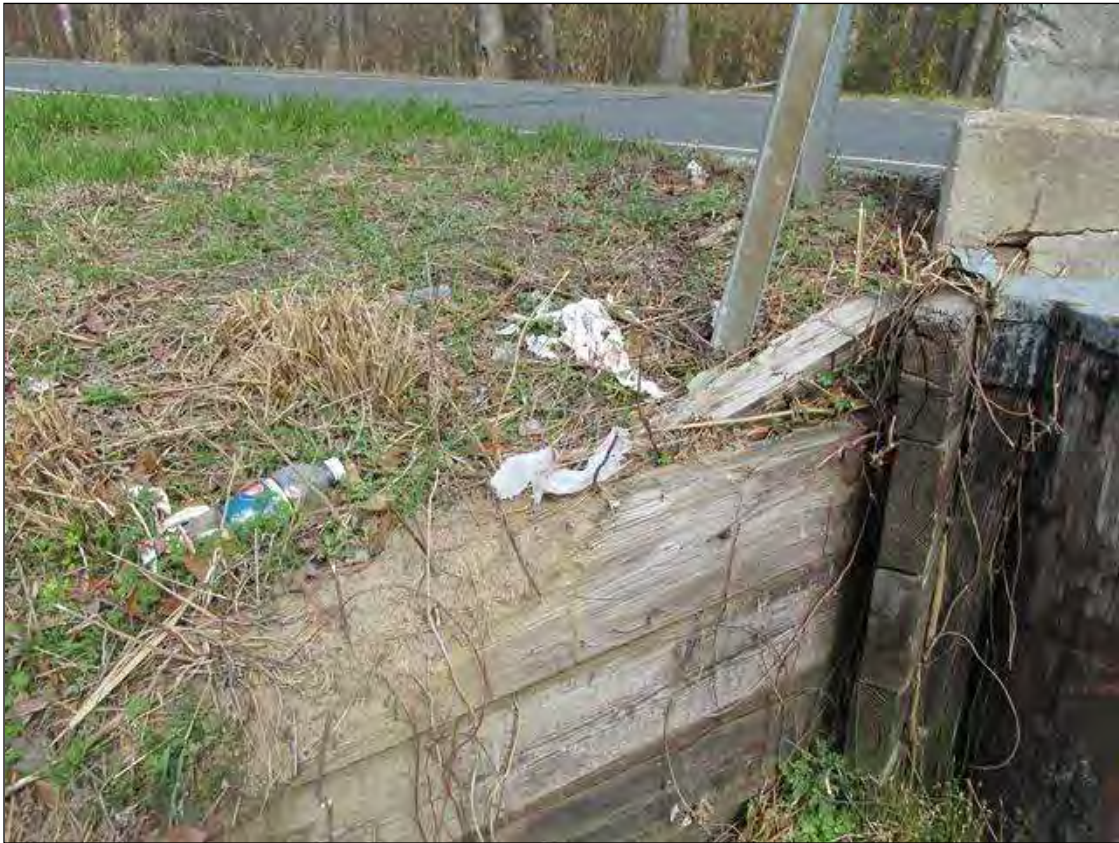
TOP WINGWALL BOARDS ARE DECAYED AT SOUTHWEST CORNER

| MMS Code | Description of Function | Unit | Quantity | Remarks | Est. Cost |
|---|---|---|---|---|---|
| 3346 | Repair / Maintain Timber Wings & Blkhds | SF | 4 | TOP WINGWALL BOARDS ARE DECAYED AT SOUTHWEST CORNER | |
