# BRIDGE INSPECTION REPORT

INSPECTION TYPE: Routine Inspection

COUNTY ROBESON BRIDGE NUMBER 770413 INSPECTION CYCLE 2 YRS

ROUTE SR1323 ACROSS WATSONS POND M.P. 0

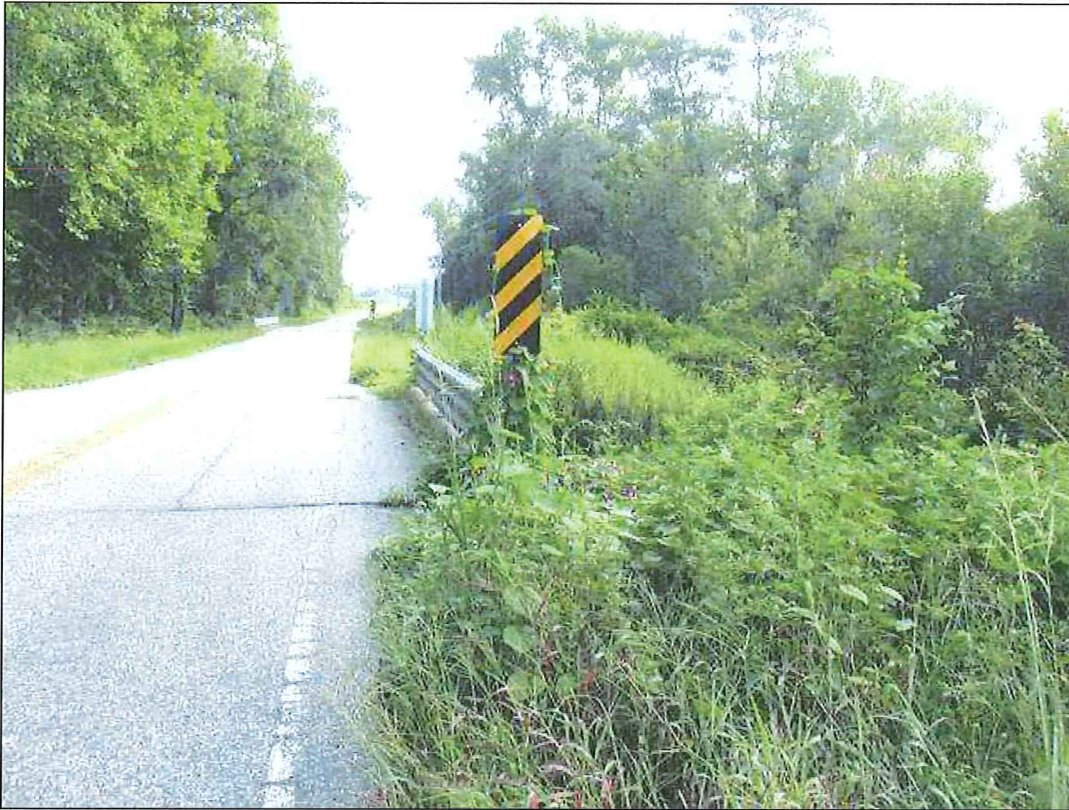
THERE IS VEGETATION OVER RAIL AT SOUTHWEST CORNER

| MMS Code | Description of Function | Unit | Quantity | Remarks | Est. Cost |
|---|---|---|---|---|---|
| 2910 | Manual Brush and Tree Control | LF | 10 | THERE IS VEGETATION OVER RAIL AT SOUTHWEST CORNER | |

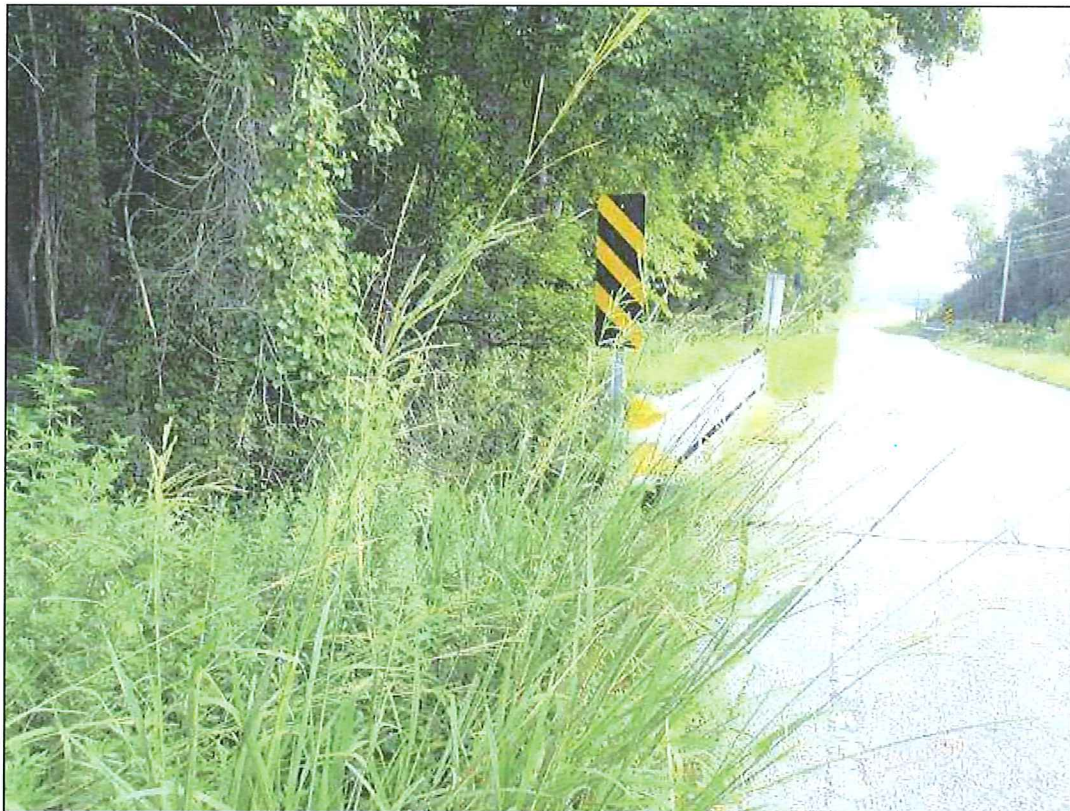
THERE IS VEGETATION OVER RAIL AT NORTHWEST CORNER

| MMS Code | Description of Function | Unit | Quantity | Remarks | Est. Cost |
|---|---|---|---|---|---|
| 2910 | Manual Brush and Tree Control | LF | 10 | THERE IS VEGETATION OVER RAIL AT NORTHWEST CORNER | |

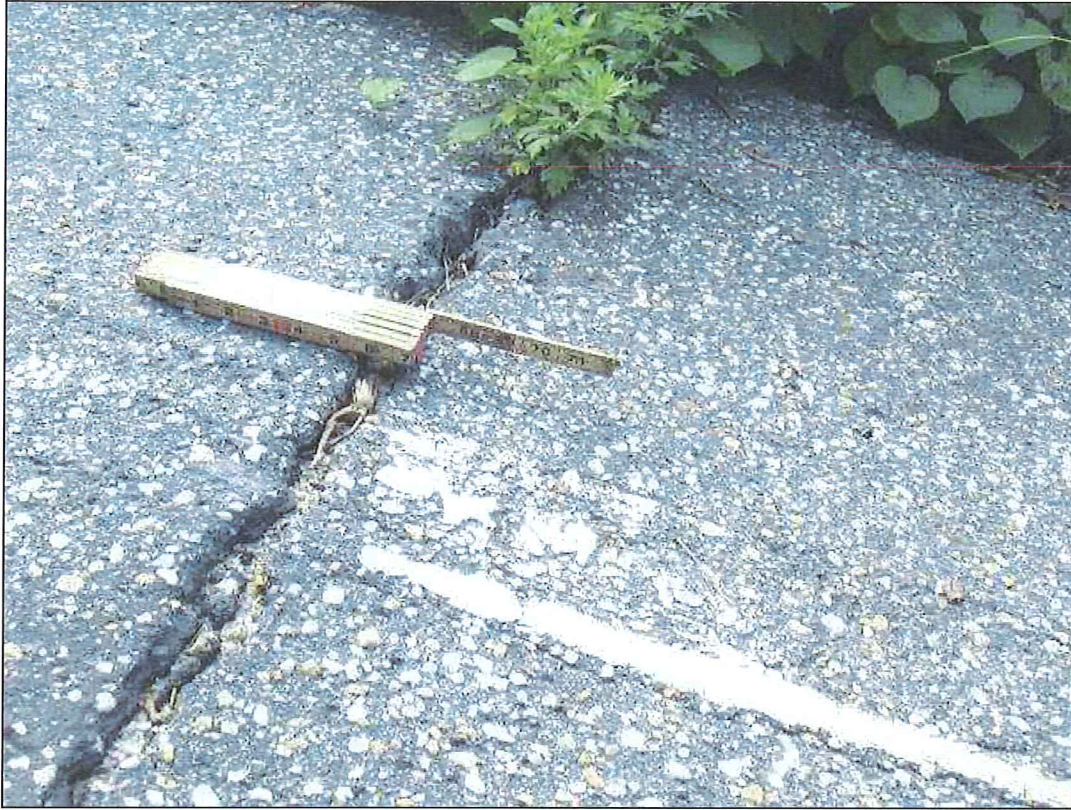
THE WEST APPROACH ASPHALT WEARING SURFACE IS SETTLED UP TO 1"

| MMS Code | Description of Function | Unit | Quantity | Remarks | Est. Cost |
|---|---|---|---|---|---|
| 2816 | Asphalt Surface Repair or Replacement | SY | 1 | THE WEST APPROACH ASPHALT WEARING SURFACE IS SETTLED UP TO 1" | |

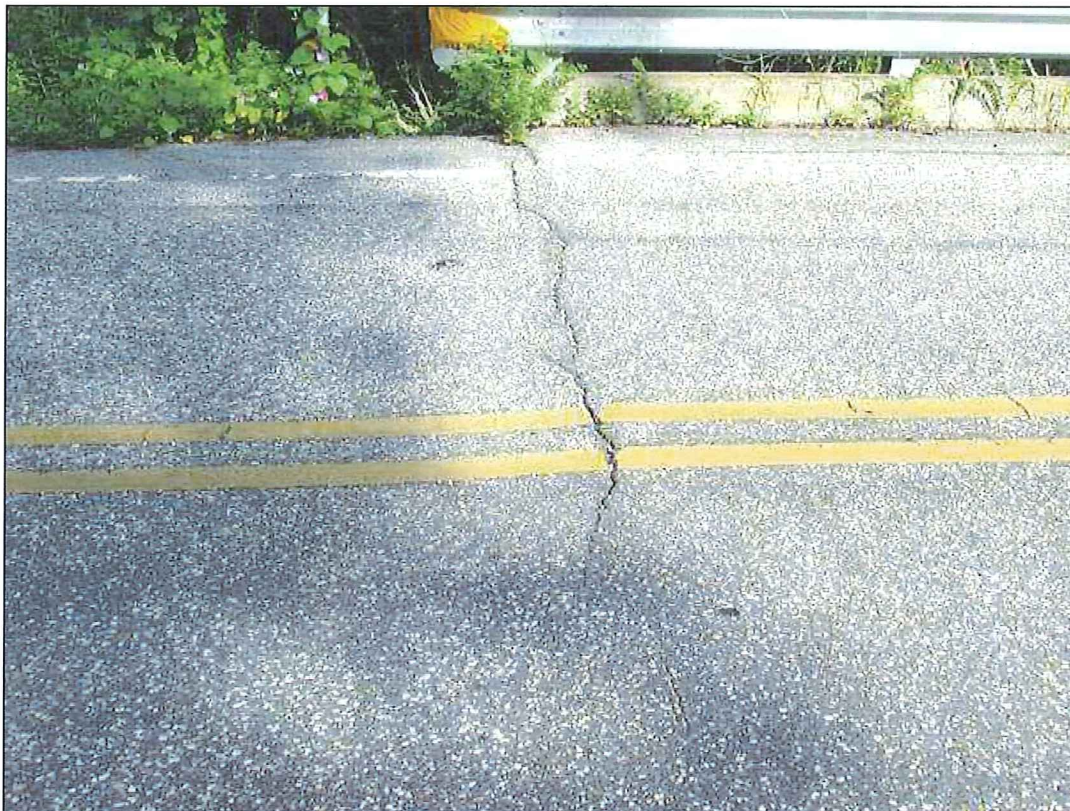
THERE IS A TRANSVERSE CRACK UP TO 1/2" WIDE IN WEST APPROACH OVER END BENT 1

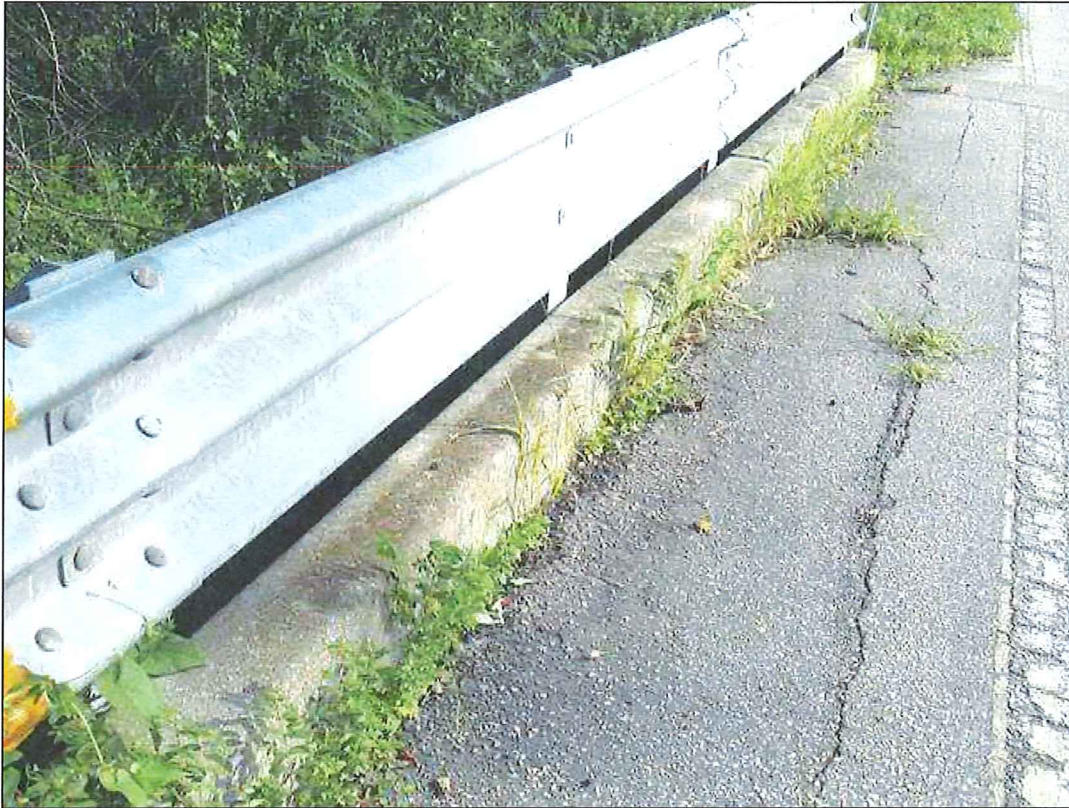
THERE IS VEGETATION ALONG LEFT CURB

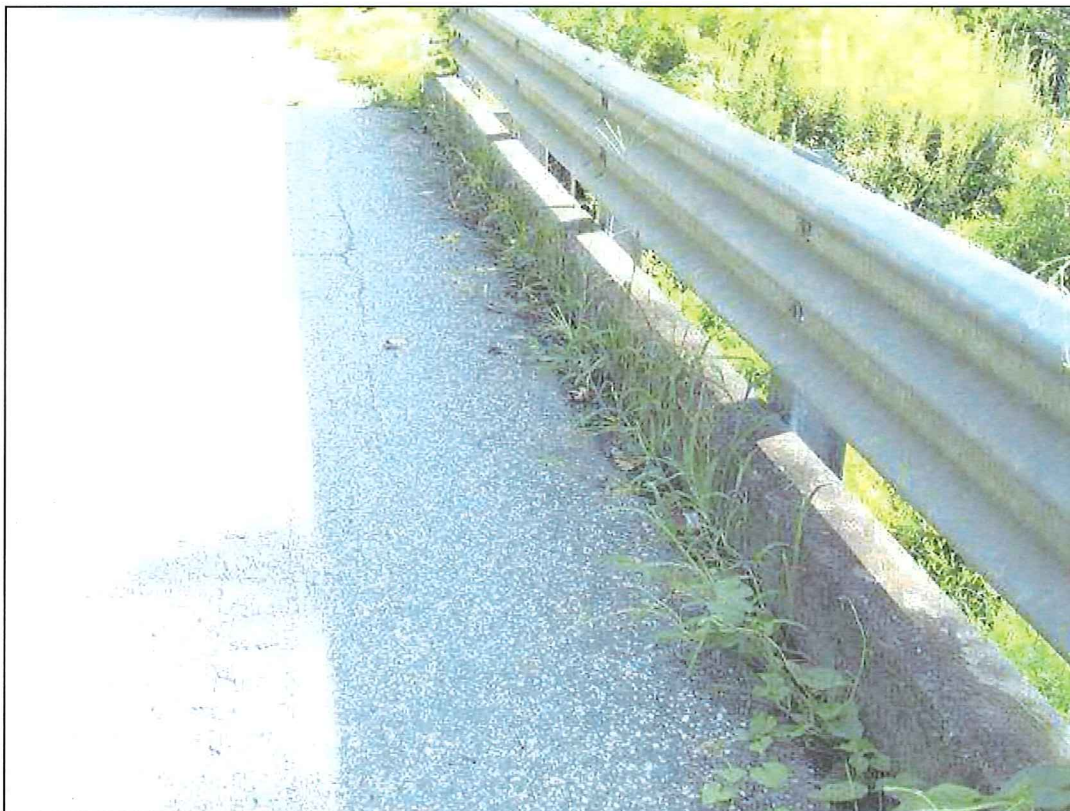
THERE IS VEGETATION ALONG RIGHT CURB

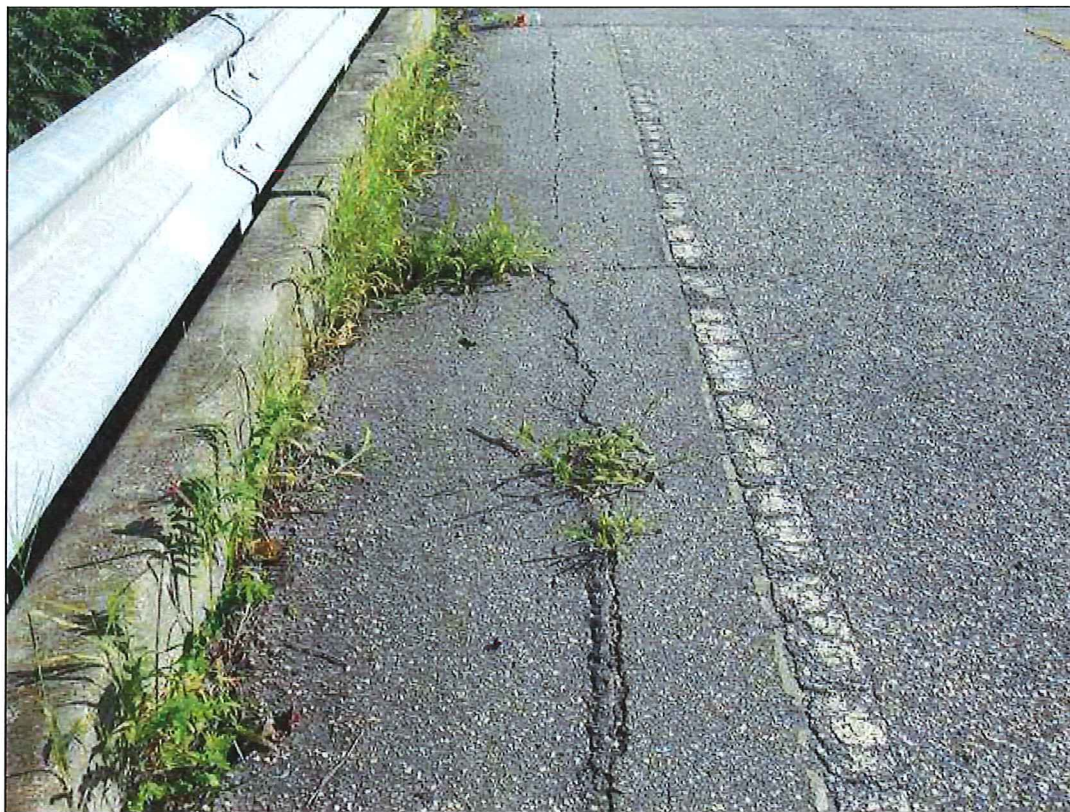
THERE IS A 1/8" TO 3/16" LONGITUDINAL CRACK IN ASPHALT WEARING SURFACE AT SPANS 1 AND 2 LEFT SHOULDER

| MMS Code | Description of Function | Unit | Quantity | Remarks | Est. Cost |
|---|---|---|---|---|---|
| 2816 | Asphalt Surface Repair or Replacement | SY | 1 | THERE IS A 1/8" TO 3/16" LONGITUDINAL CRACK IN ASPHALT WEARING SURFACE AT SPANS 1 AND 2 LEFT SHOULDER | |

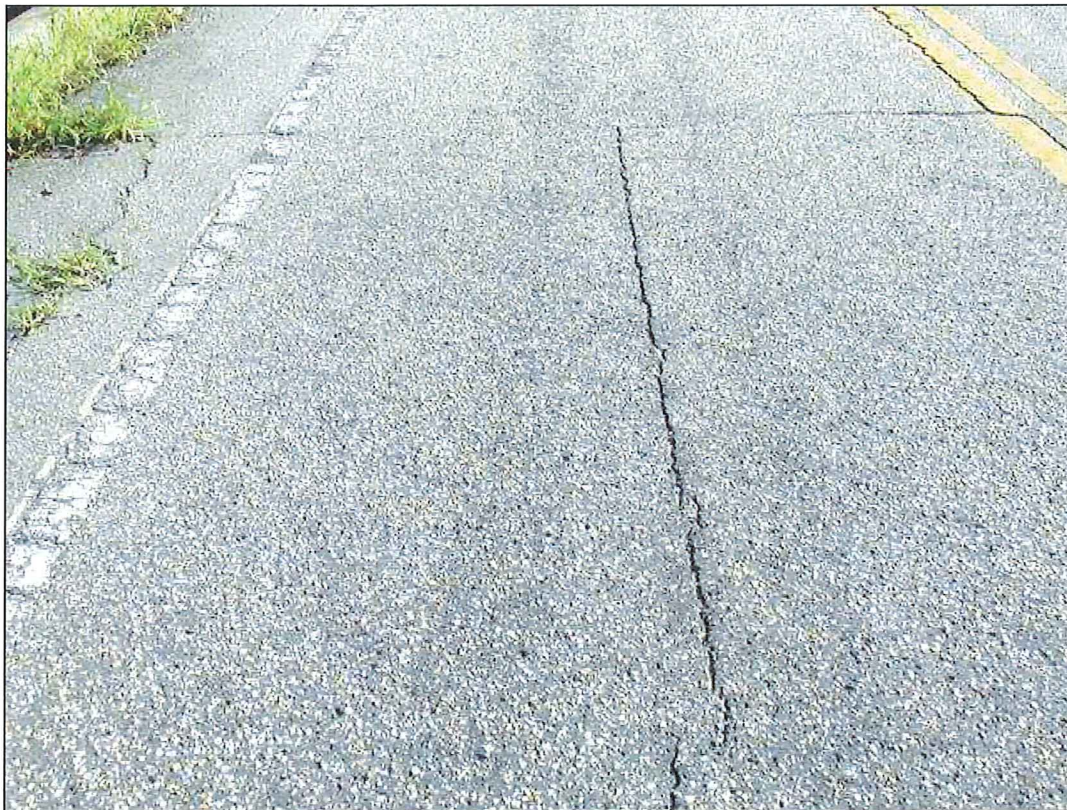
THERE ARE LONGITUDINAL CRACKS UP TO 1/4" WIDE IN SPAN 1 ASPHALT WEARING SURFACE, OVER SLAB JOINTS

| MMS Code | Description of Function | Unit | Quantity | Remarks | Est. Cost |
|---|---|---|---|---|---|
| 2816 | Asphalt Surface Repair or Replacement | SY | 1 | THERE ARE LONGITUDINAL CRACKS UP TO 1/4" WIDE IN SPAN 1 ASPHALT WEARING SURFACE, OVER SLAB JOINTS | |

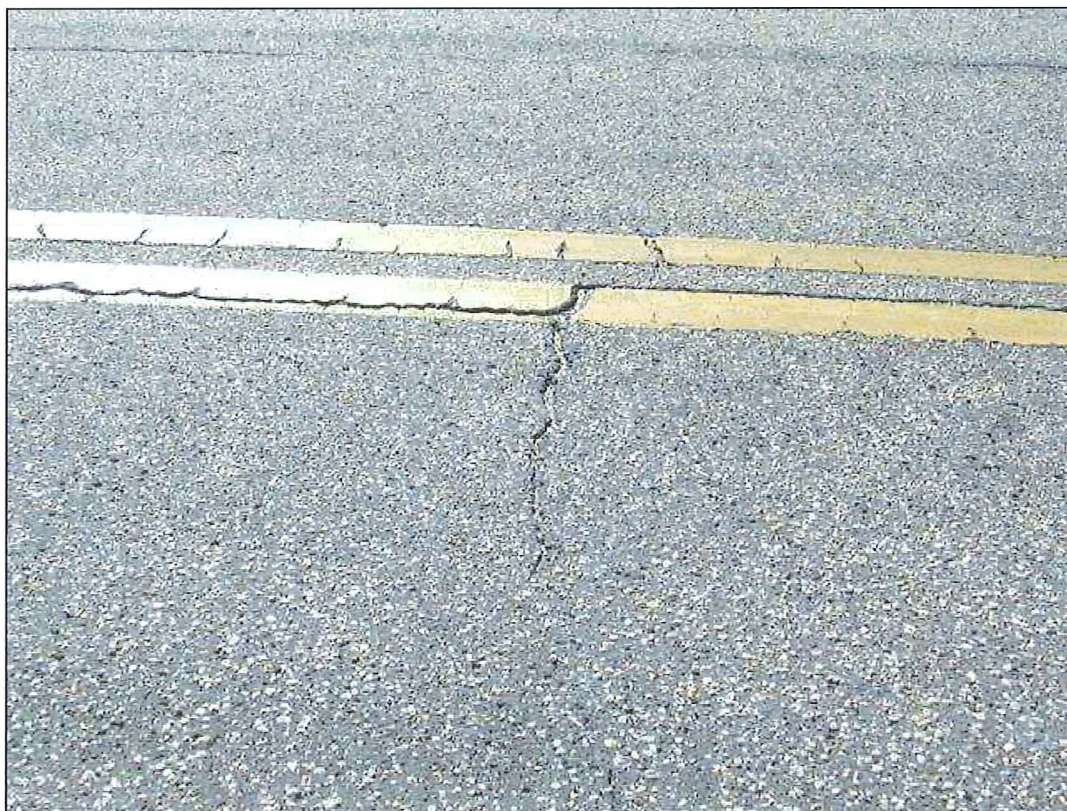
THERE IS A 1/4" TRANSVERSE CRACK IN ASPHALT WEARING SURFACE OVER BENT 1 JOINT

| MMS Code | Description of Function | Unit | Quantity | Remarks | Est. Cost |
|---|---|---|---|---|---|
| 2816 | Asphalt Surface Repair or Replacement | SY | 1 | THERE IS A 1/4" TRANSVERSE CRACK IN ASPHALT WEARING SURFACE OVER BENT 1 JOINT | |

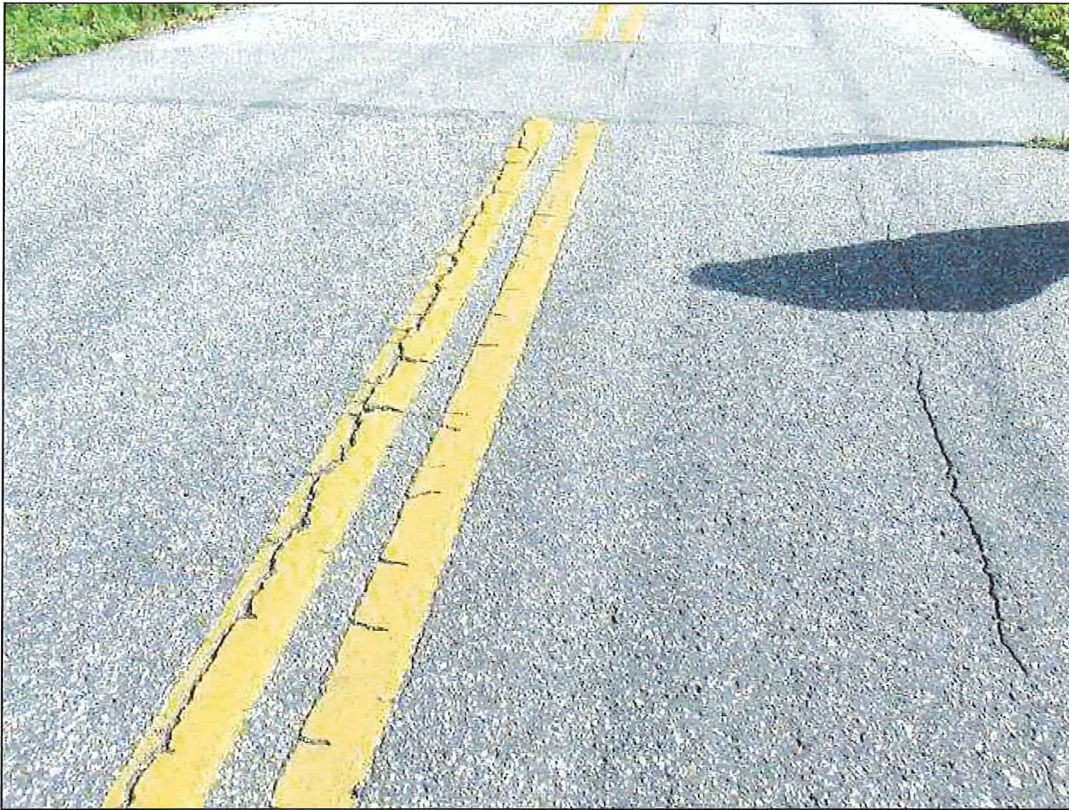
THERE ARE 1/4" WIDE LONGITUDINAL CRACKS IN SPAN 2 ASPHALT WEARING SURFACE, OVER SLAB JOINTS

| MMS Code | Description of Function | Unit | Quantity | Remarks | Est. Cost |
|---|---|---|---|---|---|
| 2816 | Asphalt Surface Repair or Replacement | SY | 1 | THERE ARE 1/4" WIDE LONGITUDINAL CRACKS IN SPAN 2 ASPHALT WEARING SURFACE, OVER SLAB JOINTS | |

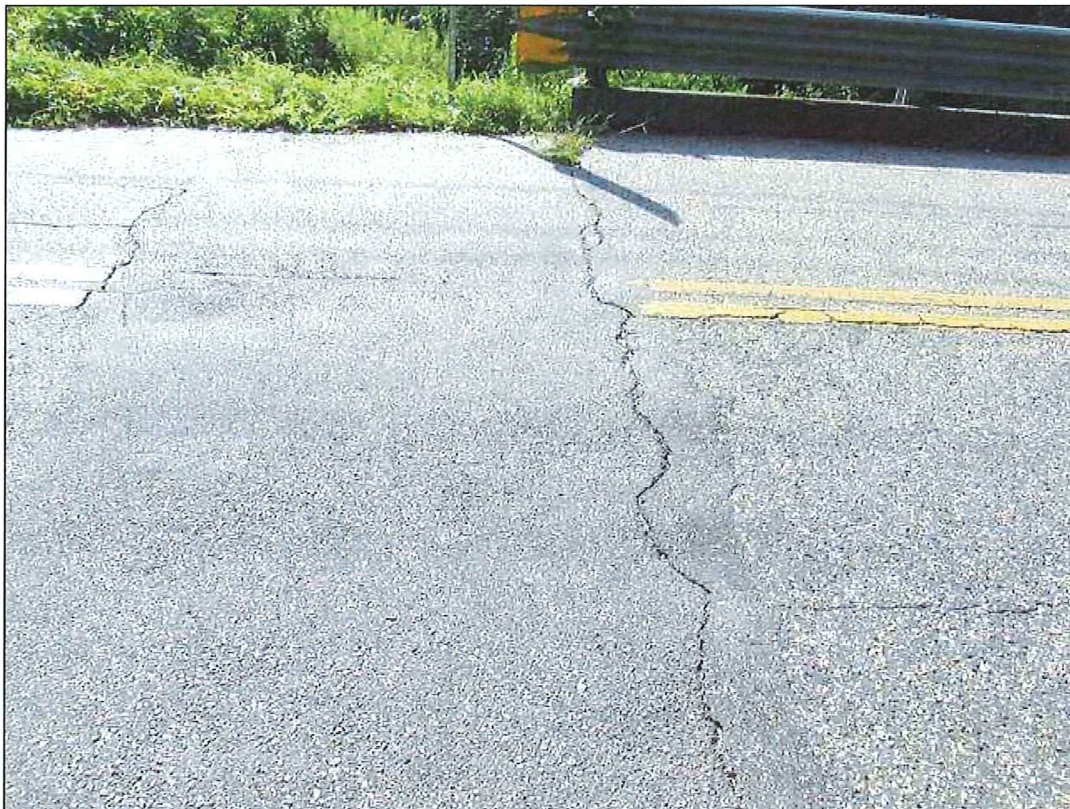
THERE IS A 1/4" TO 3/8" WIDE TRANSVERSE CRACK IN EAST APPROACH ASPHALT WEARING SURFACE  
OVER END BENT 2

| MMS Code | Description of Function | Unit | Quantity | Remarks | Est. Cost |
|---|---|---|---|---|---|
| 2816 | Asphalt Surface Repair or Replacement | SY | 1 | THERE IS A 1/4" TO 3/8" WIDE TRANSVERSE CRACK IN EAST APPROACH ASPHALT WEARING SURFACE OVER END BENT 2 | |

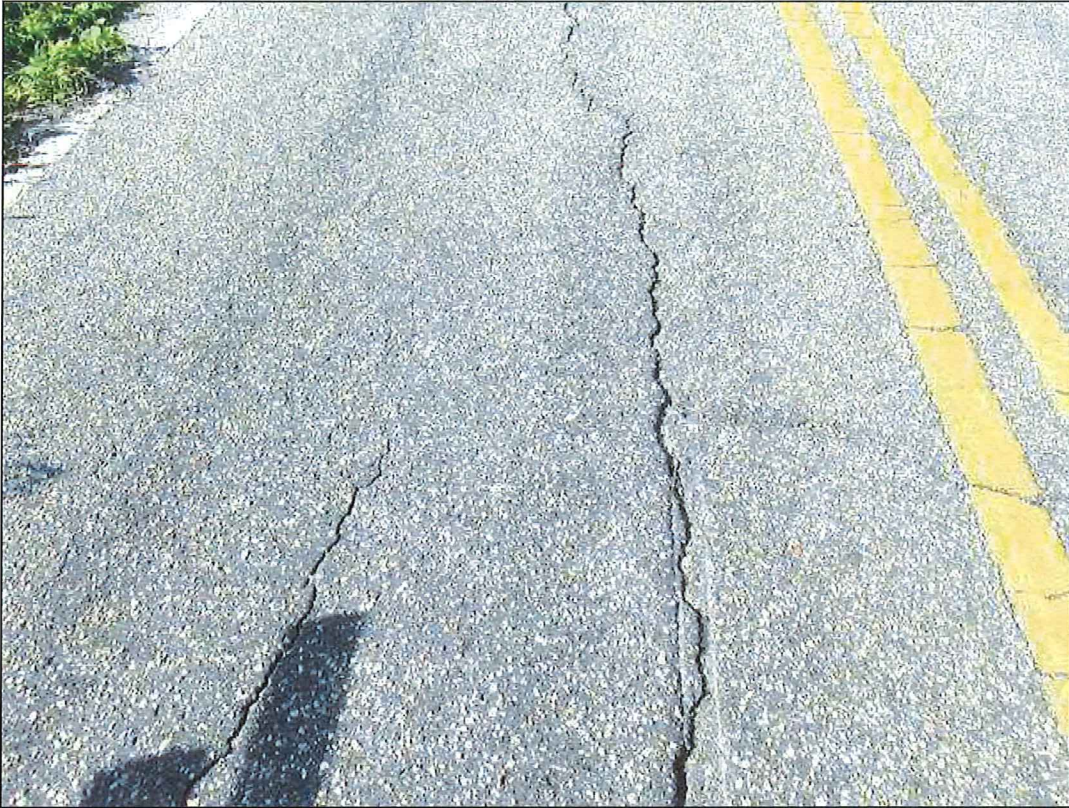
THERE IS A 1/2" WIDE LONGITUDINAL CRACK IN EAST APPROACH EAST BOUND LANE

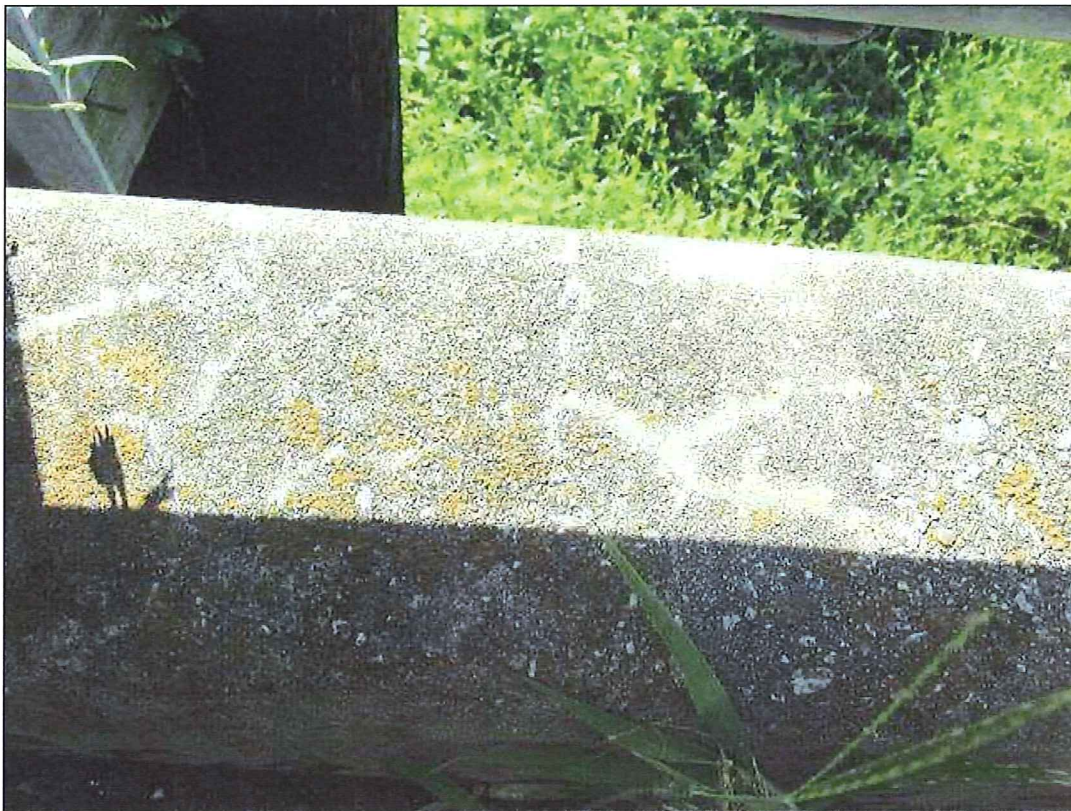
THE SOUTH CURB HAS HAIRLINE MAP CRACKING IN BOTH SPANS

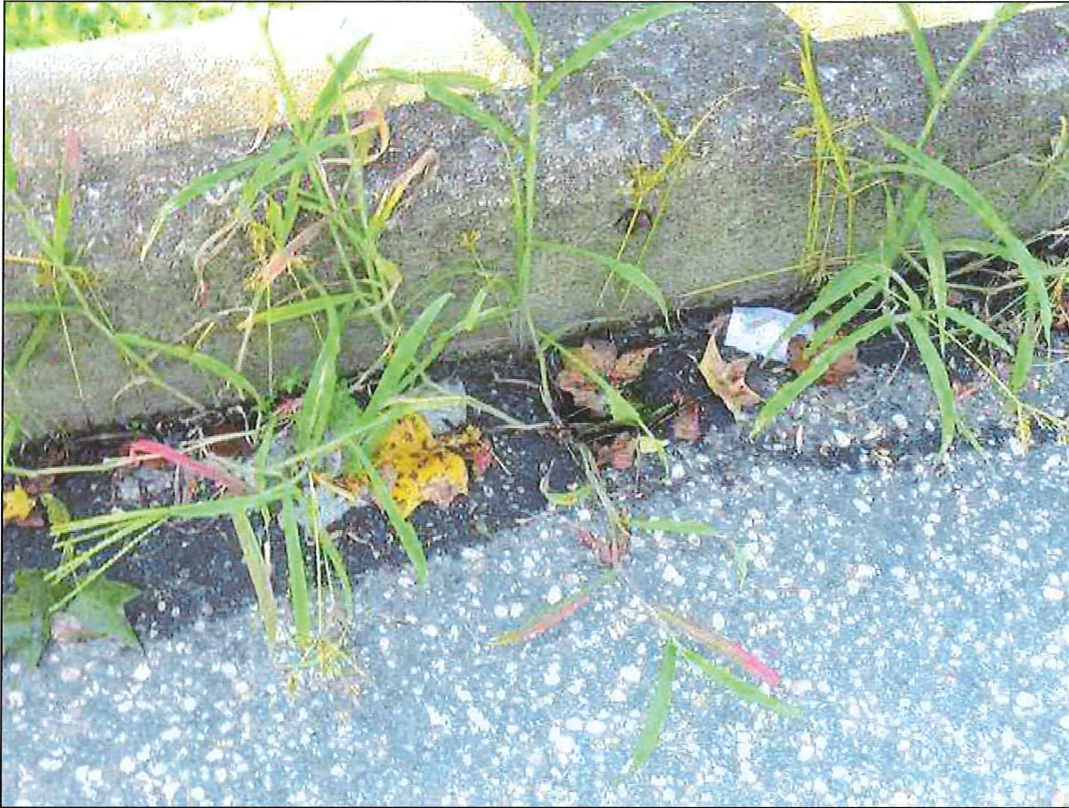
ALL RIGHT CURB DRAINS ARE BLOCKED BY DEBRIS AND VEGETATION

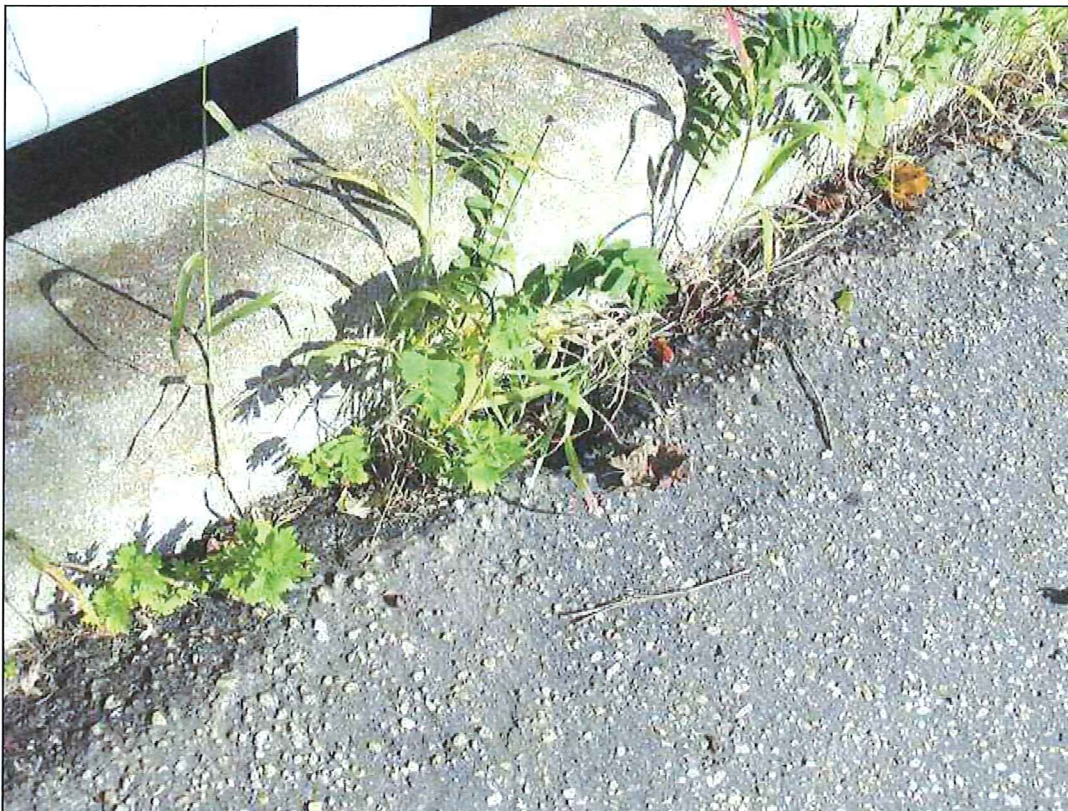
ALL LEFT CURB DRAINS ARE BLOCKED BY DEBRIS AND VEGETATION

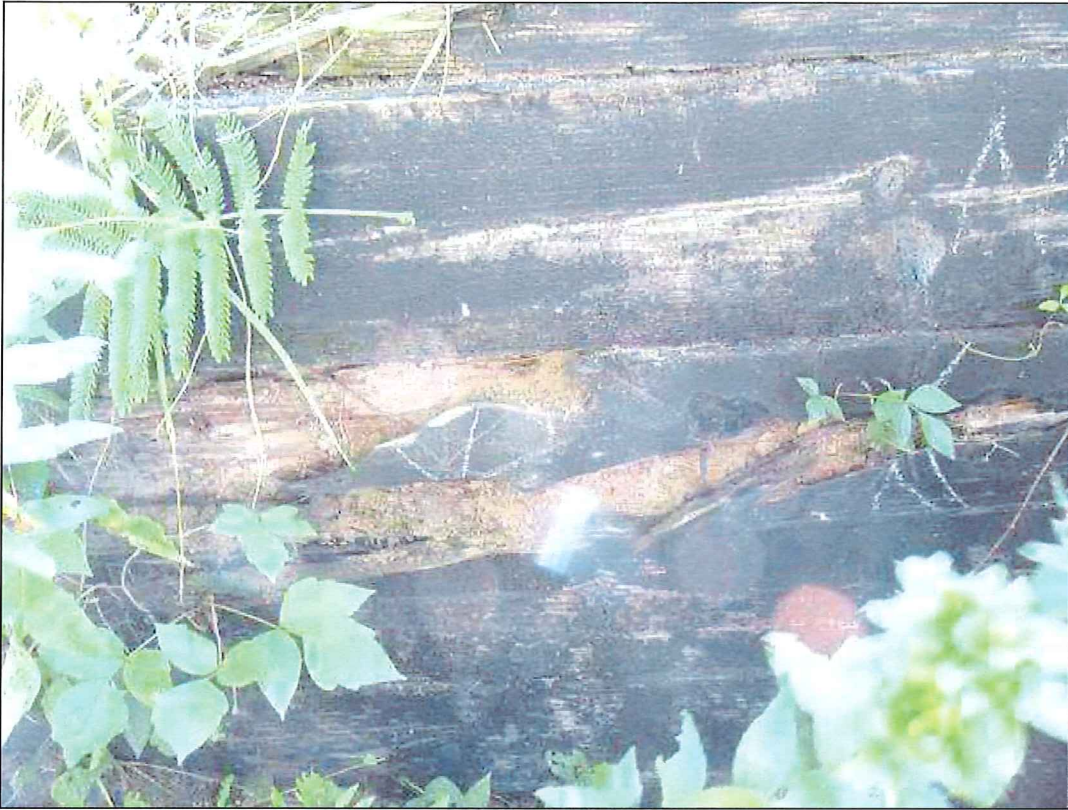
THERE ARE DECAYED WINGWALL BOARDS AT NORTHEAST CORNER

| MMS Code | Description of Function | Unit | Quantity | Remarks | Est. Cost |
|---|---|---|---|---|---|
| 3346 | Repair / Maintain Timber Wings & Blkhds | SF | 4 | THERE ARE DECAYED WINGWALL BOARDS AT NORTHEAST CORNER | |

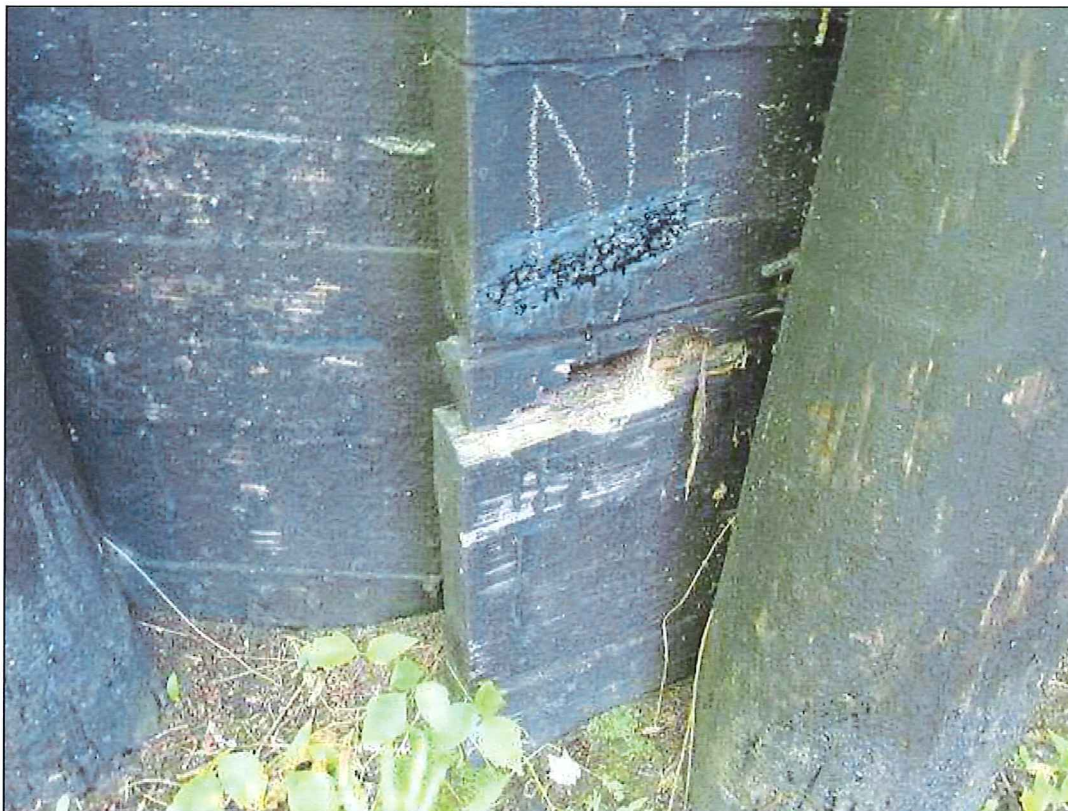
THERE ARE DECAYED EXTERIOR BULKHEAD BOARDS AT NORTHEAST CORNER

| MMS Code | Description of Function | Unit | Quantity | Remarks | Est. Cost |
|---|---|---|---|---|---|
| 3346 | Repair / Maintain Timber Wings & Blkhds | SF | 2 | THERE ARE DECAYED EXTERIOR BULKHEAD BOARDS AT NORTHEAST CORNER | |

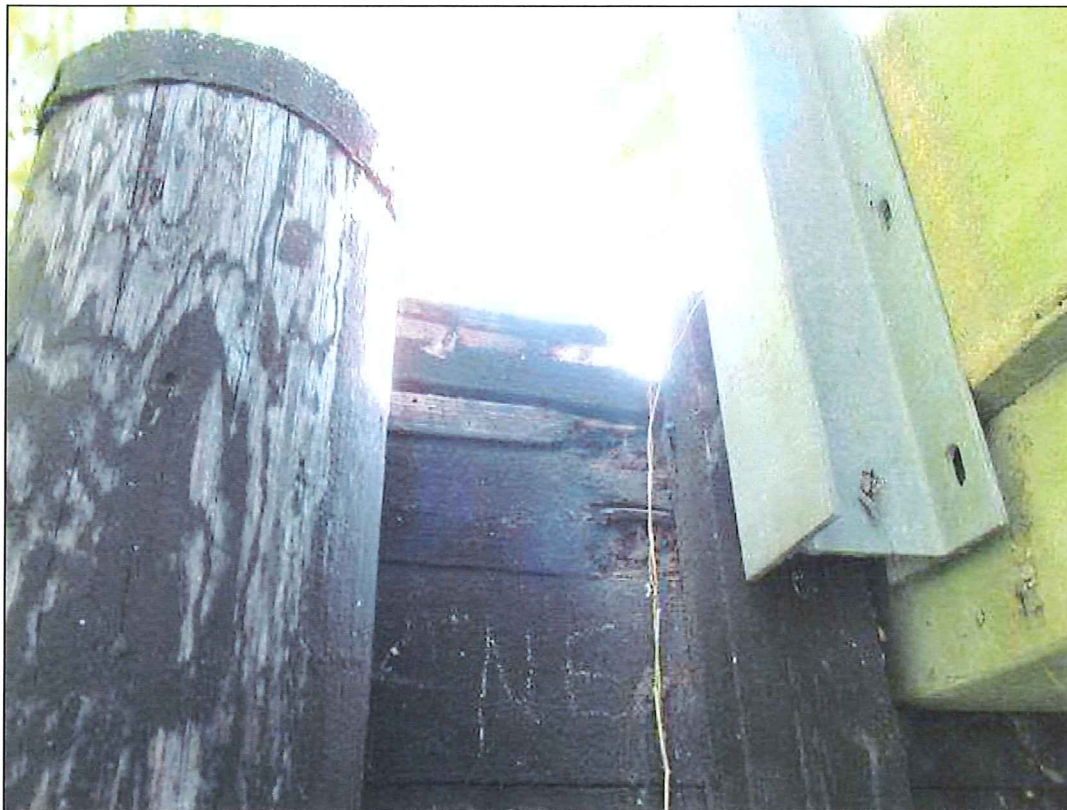
THE NORTHEAST CORNER EXTERIOR BULKHEAD HAS DECAYED BOARDS AT TOP PORTION

| MMS Code | Description of Function | Unit | Quantity | Remarks | Est. Cost |
|---|---|---|---|---|---|
| 3346 | Repair / Maintain Timber Wings & Blkhds | SF | 2 | THE NORTHEAST CORNER EXTERIOR BULKHEAD HAS DECAYED BOARDS AT TOP PORTION | |

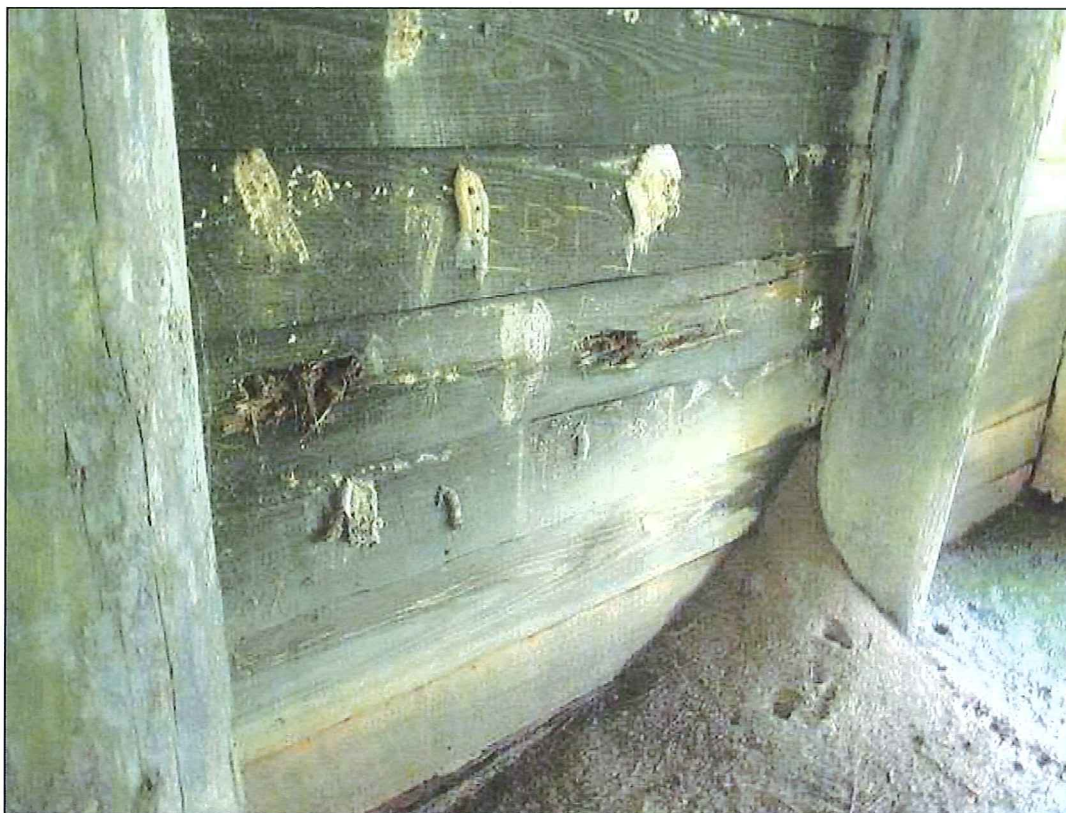
| <b>61</b> | <b>YES</b> | ( PM ISSUED ) ON END BENT 2 BULKHEAD DECAY WITH FILL LEAKAGE | |

THE END BENT 2 BULKHEAD IS DECAYED WITH FILL LEAKAGE BETWEEN PILES 2 AND 3 PM ISSUED

| MMS Code | Description of Function | Unit | Quantity | Remarks | Est. Cost |
|---|---|---|---|---|---|
| 3346 | Repair / Maintain Timber Wings & Blkhds | SF | <del>5</del> <b>TSE</b> | THE END BENT 2 BULKHEAD IS DECAYED WITH FILL LEAKAGE BETWEEN PILES 2 AND 3 | |

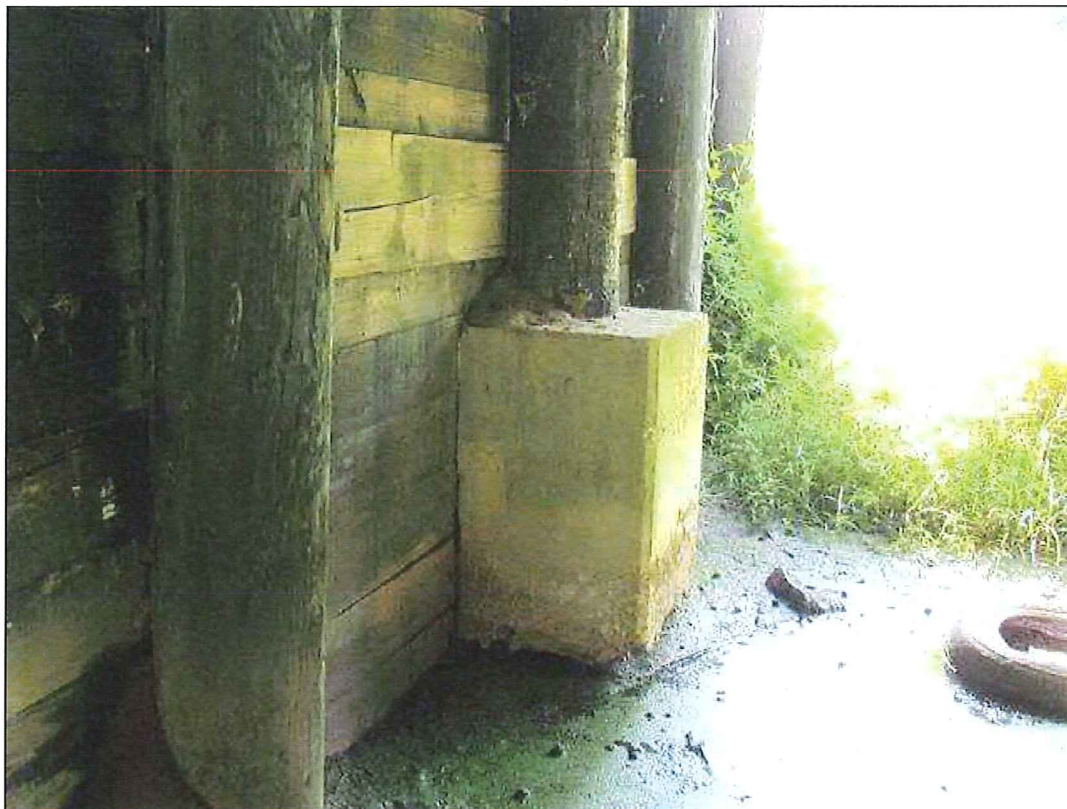
PILE 4 AT END BENT 2 IS ENCASED, TEMPORARY REPAIR

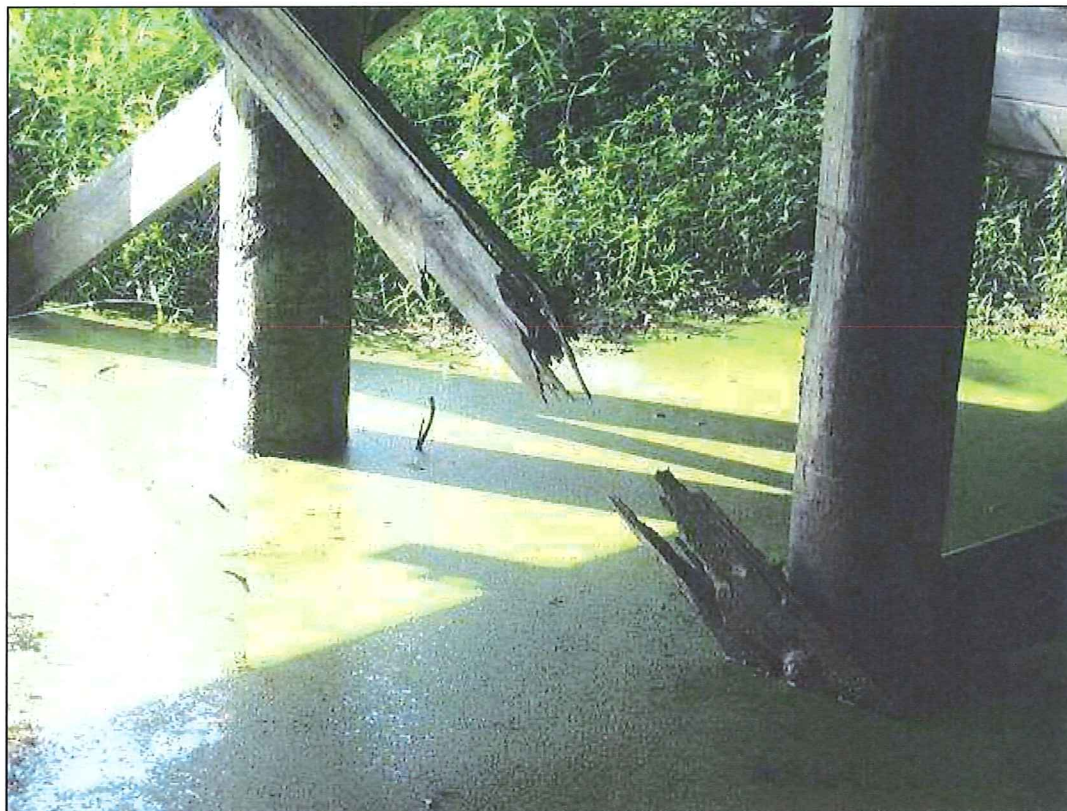
BENT 1 SPAN 2 TIMBER CROSSBRACING IS DECAYED AT PILES 3 AND 4

| MMS Code | Description of Function | Unit | Quantity | Remarks | Est. Cost |
|---|---|---|---|---|---|
| 3344 | Repair / Replace Timber Substructure Components | LF | 20 | BENT 1 SPAN 2 TIMBER CROSSBRACING IS DECAYED AT PILES 3 AND 4 | |

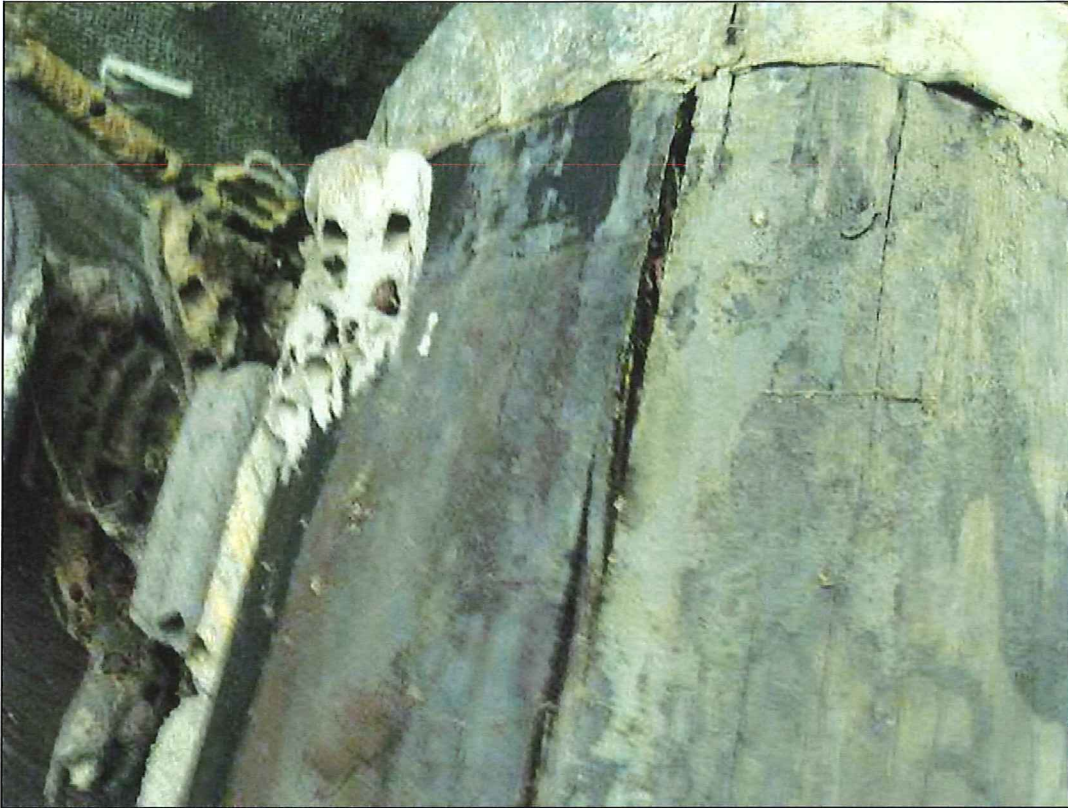
END BENT 2 PILE 2 HAS A 1/4" WIDE X UP TO 1" DEEP VERTICAL CRACK

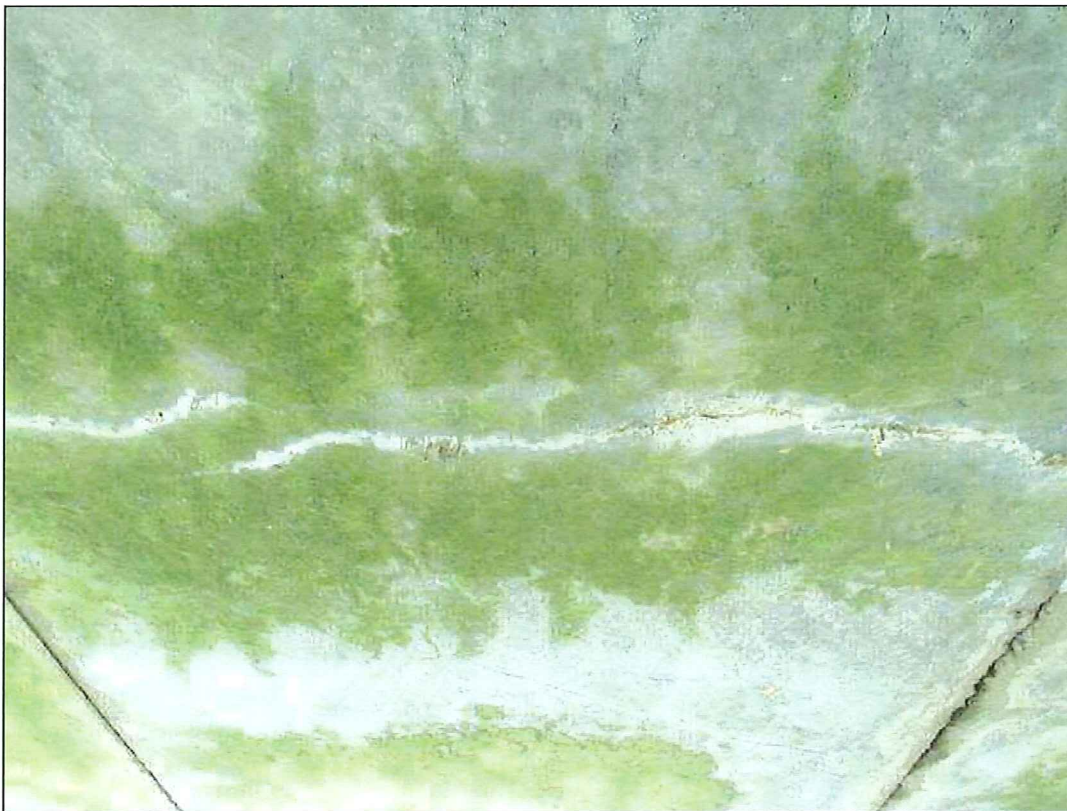
| 10 | F | ( PRE CAST SLABS ) THERE IS A HAIRLINE TRANSVERSE CRACK WITH EFFLORESCENCE IN SLAB 2 UNDERSIDE AT SPAN 2. (PHOTO) | |

THERE IS A HAIRLINE TRANSVERSE CRACK WITH EFFLORESCENCE IN SPAN 2 , SLAB 2 UNDERSIDE

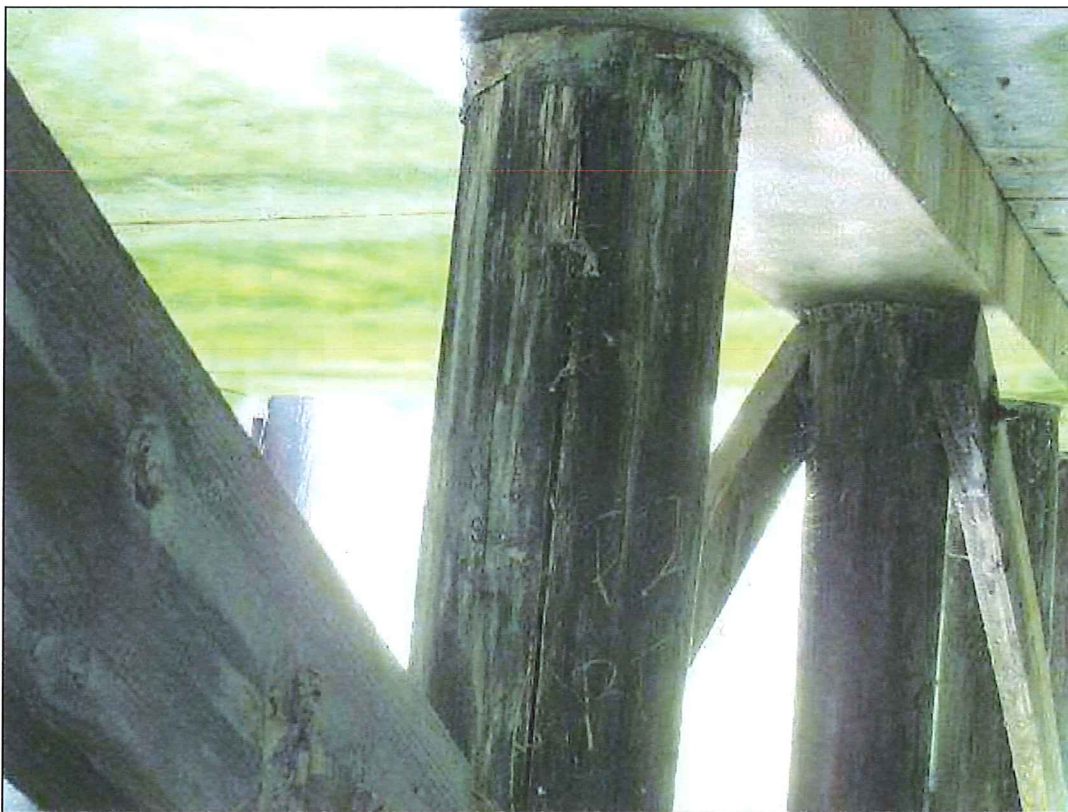
PILE 2 AT BENT 1, NORTH FACE HAS A 1/4" WIDE X FULL HEIGHT X UP TO 2 1/2" DEEP VERTICAL CRACK

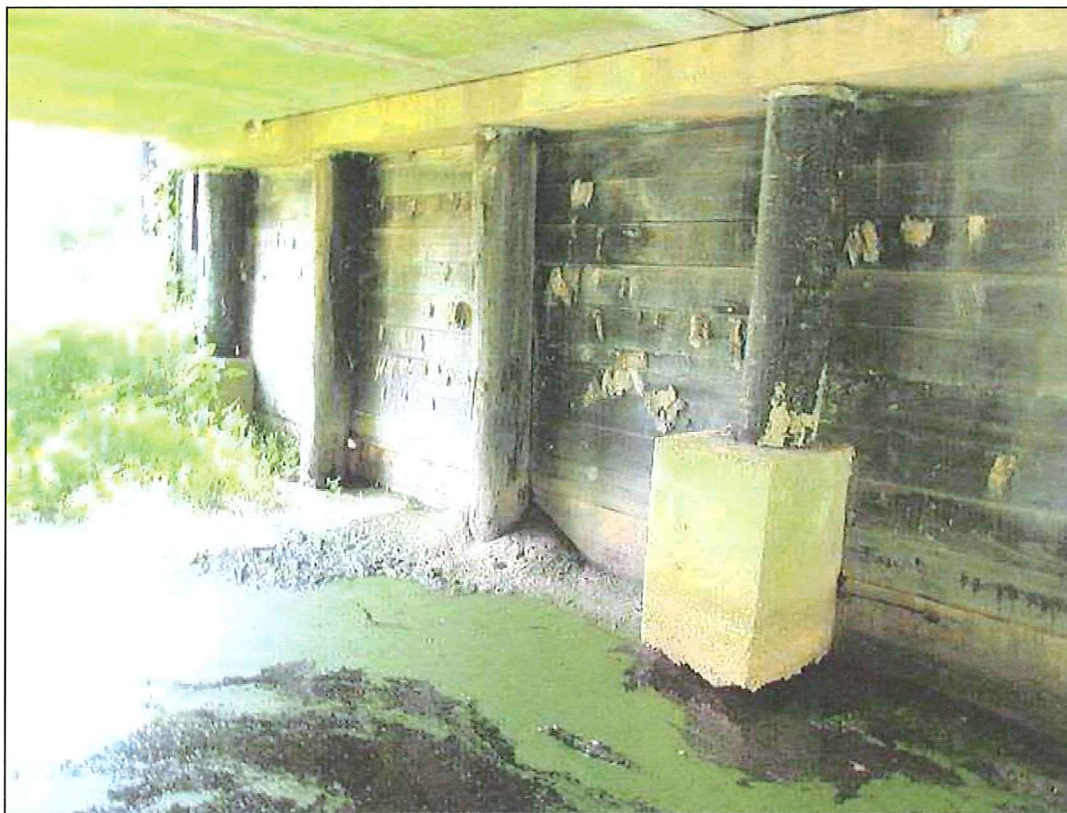
PILES 2 AND 5 AT END BENT 1 ARE ENCASED, TEMPORARY REPAIRS
