# BRIDGE INSPECTION REPORT

INSPECTION TYPE: Routine Inspection

COUNTY ROBESON BRIDGE NUMBER 770413 INSPECTION CYCLE 2 YRS

ROUTE SR1323 ACROSS WATSONS POND M.P. 0

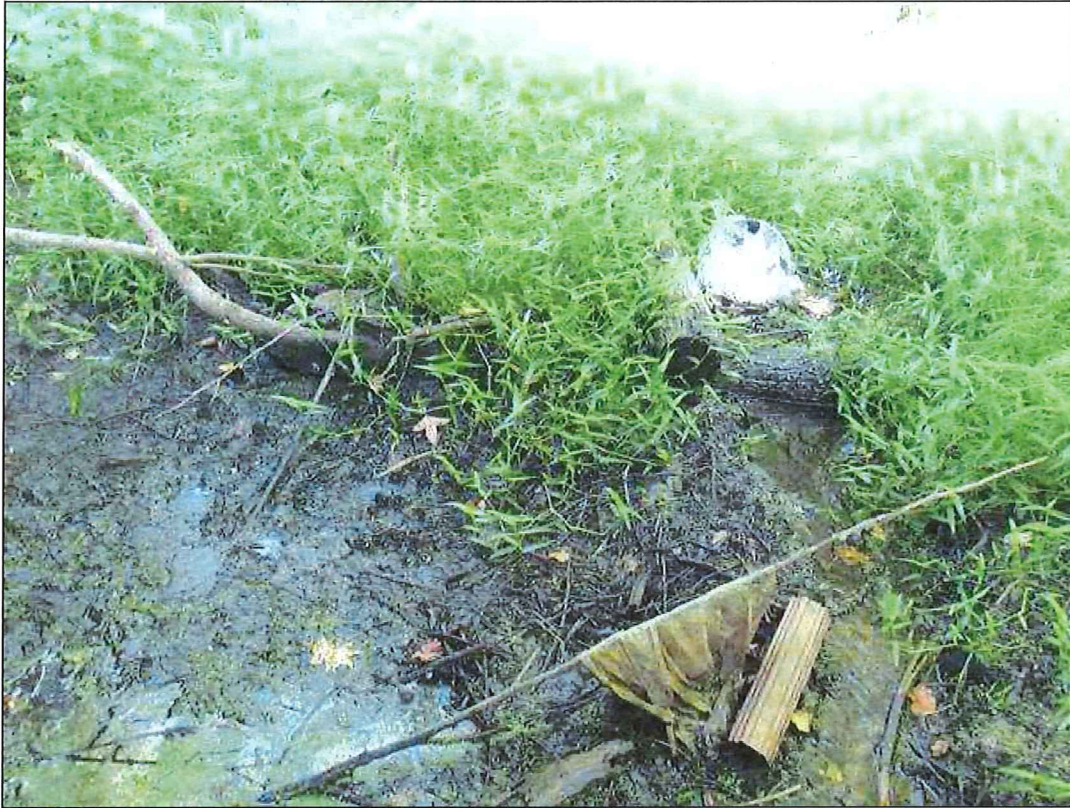
| 41 | G | ( DRIFT ) THERE IS DRIFT 6" DIAMETER X 10' LONG LOG UPSTREAM NORTH AT SPAN 1. (PHOTO) | |

THERE IS DRIFT 6" DIAMETER X 10' LONG LOG UPSTREAM NORTH AT SPAN 1

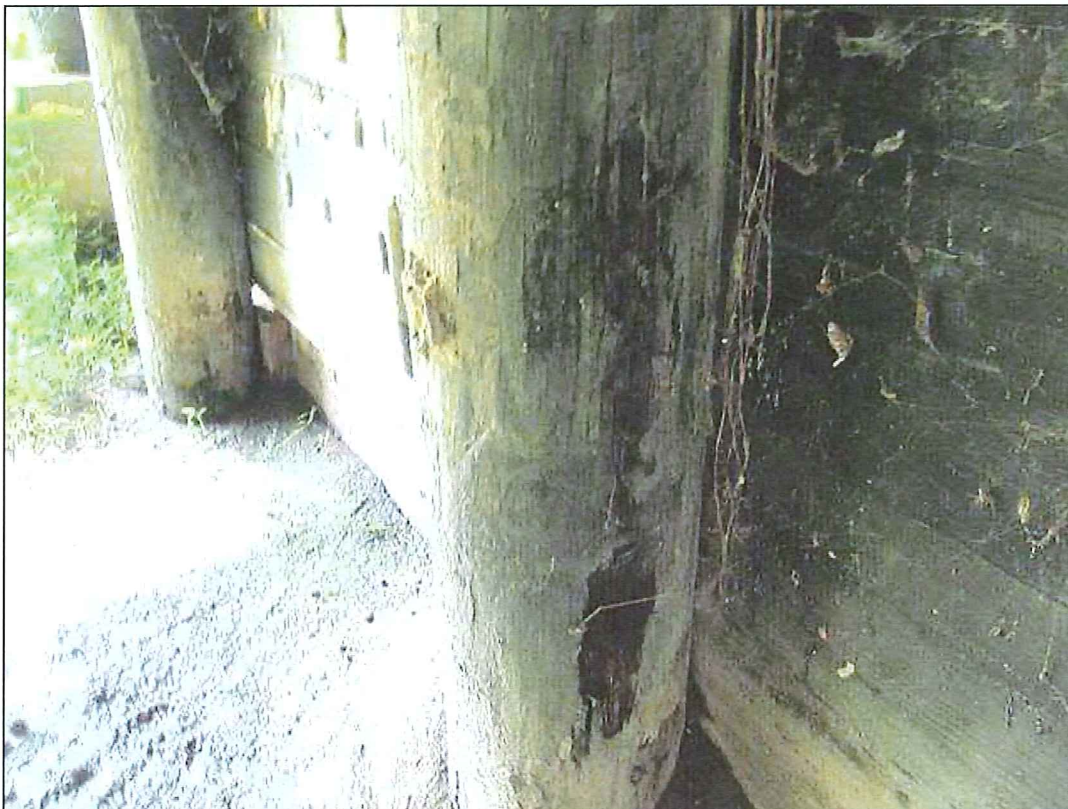
PILE 3 AT END BENT 1 NORTH FACE IS SURFACE DECAYED 2' HIGH X 6" WIDE X 1" DEEP

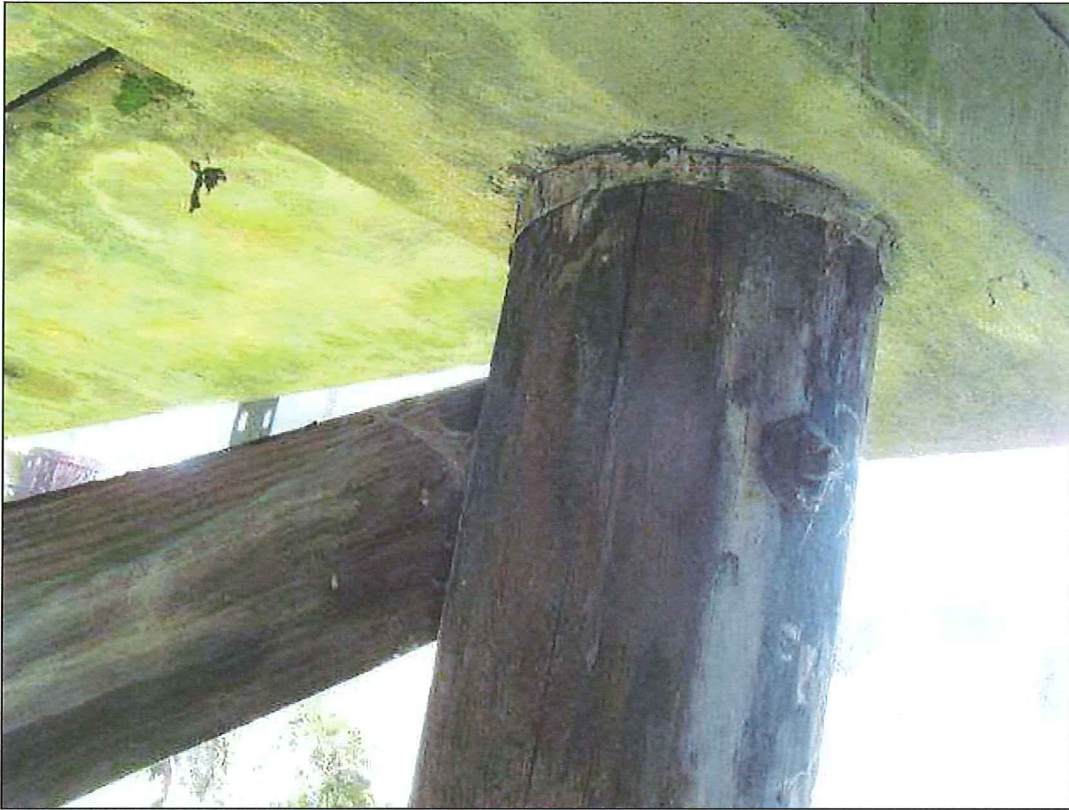
PILE 5 AT BENT 1, NORTHWEST FACE HAS A 1/8" WIDE X 3' HIGH X 1" DEEP VERTICAL CRACK

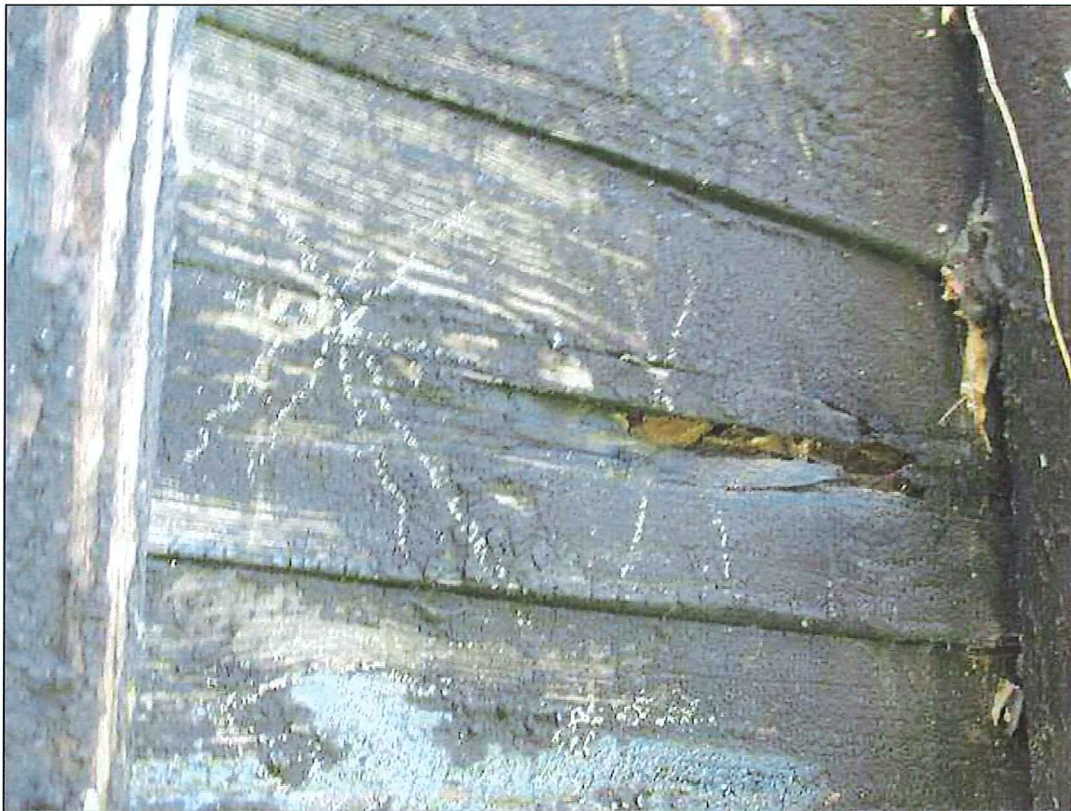
SOUTHEAST CORNER EXTERIOR BULKHEAD BOARD IS DECAYED AT END PORTION

| MMS Code | Description of Function | Unit | Quantity | Remarks | Est. Cost |
|---|---|---|---|---|---|
| 3346 | Repair / Maintain Timber Wings & Blkhds | SF | 3 | SOUTHEAST CORNER EXTERIOR BULKHEAD BOARD IS DECAYED AT END PORTION | |

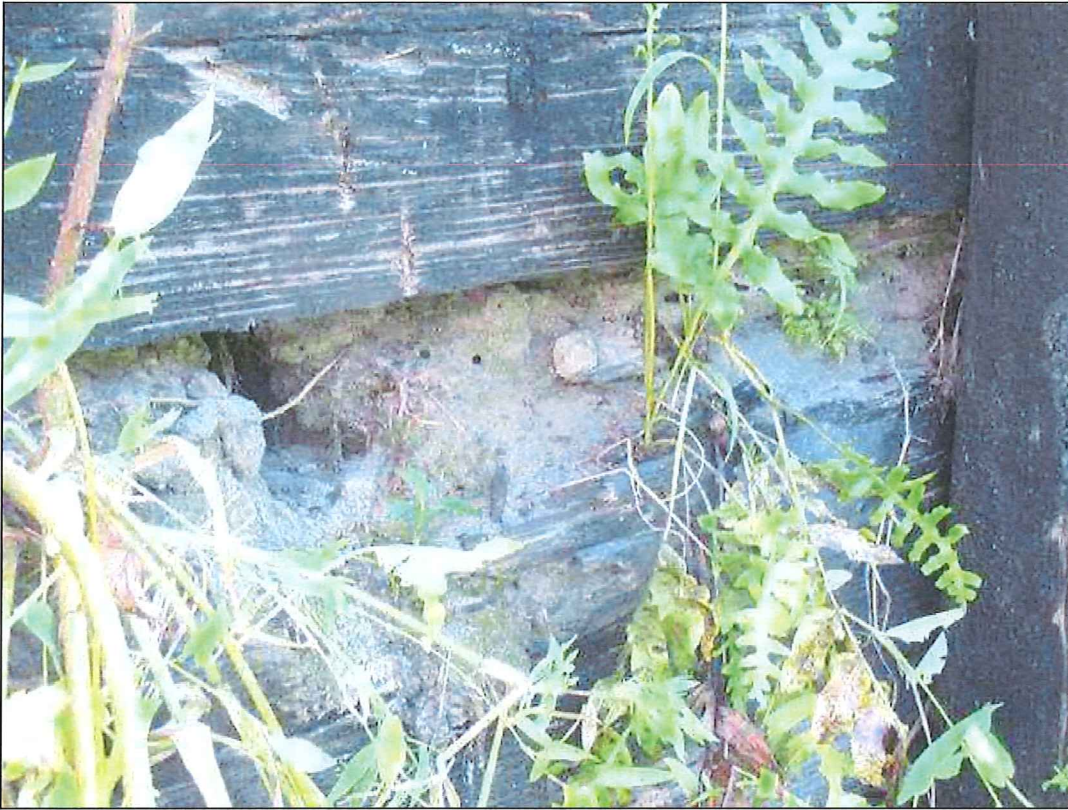
THERE ARE DECAYED WINGWALL BOARDS WITH FILL EXPOSED AT SOUTHEAST CORNER

| MMS Code | Description of Function | Unit | Quantity | Remarks | Est. Cost |
|---|---|---|---|---|---|
| 3346 | Repair / Maintain Timber Wings & Blkhds | SF | 4 | THERE ARE DECAYED WINGWALL BOARDS WITH FILL EXPOSED AT SOUTHEAST CORNER | |

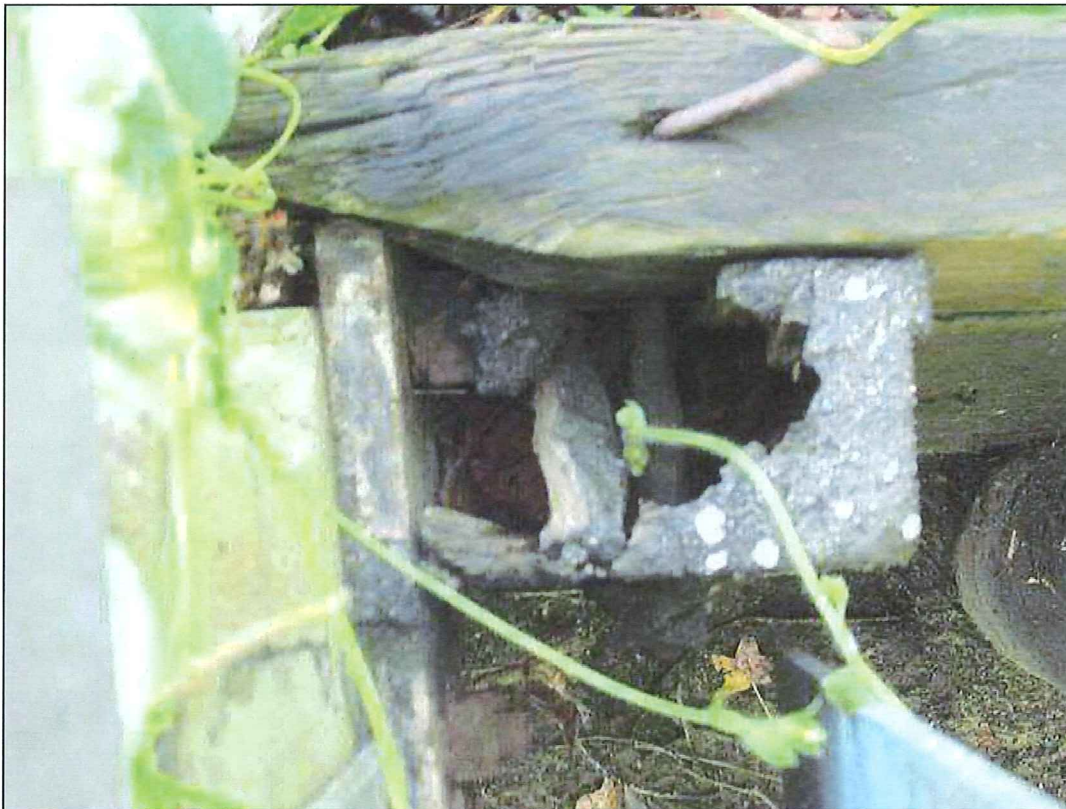
NORTHWEST CORNER EXTERIOR BULKHEAD CLEAT IS DECAYED AT TOP PORTION

| MMS Code | Description of Function | Unit | Quantity | Remarks | Est. Cost |
|---|---|---|---|---|---|
| 3346 | Repair / Maintain Timber Wings & Blkhds | SF | 2 | NORTHWEST CORNER EXTERIOR BULKHEAD CLEAT IS DECAYED AT TOP PORTION | |
