NC DEPARTMENT OF TRANSPORTATION  
DIVISION OF HIGHWAYS  
BRIDGE MANAGEMENT UNIT

# BRIDGE INSPECTION REPORT

INSPECTION TYPE: Routine Inspection

COUNTY ROBESON BRIDGE NUMBER 770414 INSPECTION CYCLE 2 YRS  
ROUTE SR1323 ACROSS WATSONS POND M.P. 0

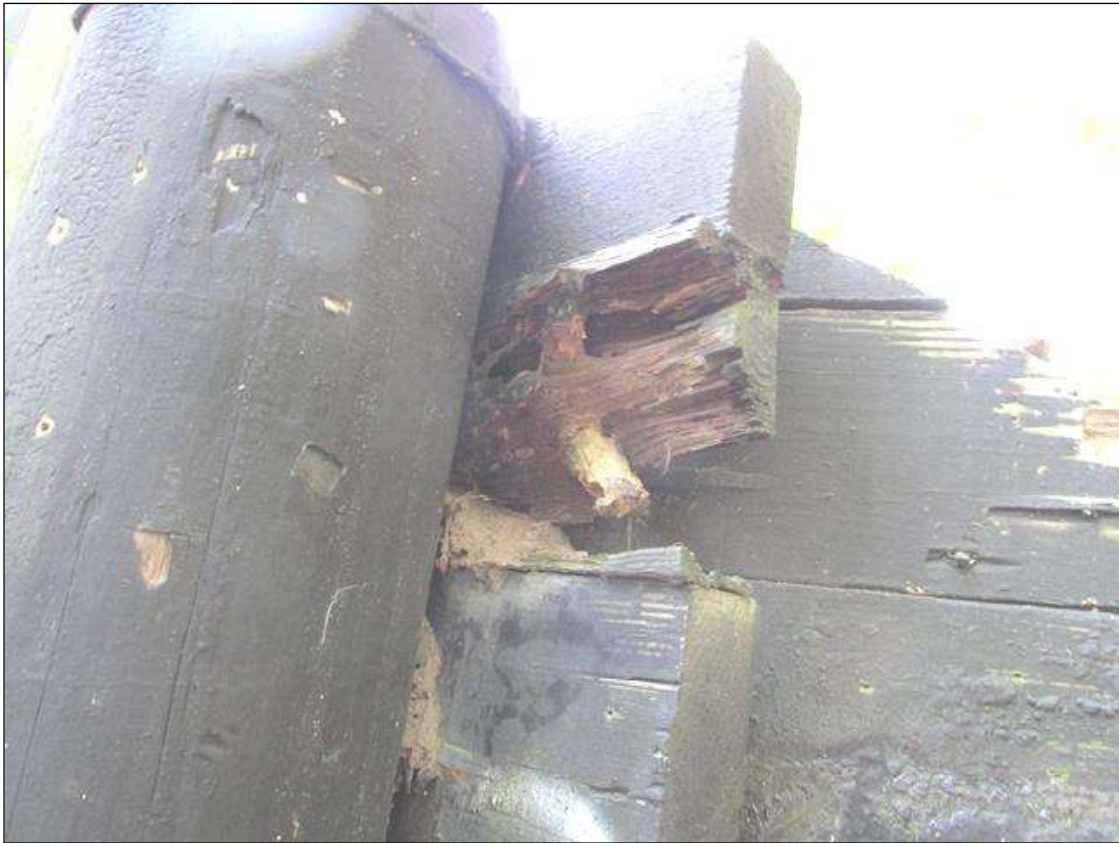
THERE IS A DECAYED EXTERIOR BULKHEAD BOARD AT NORTHWEST CORNER

| MMS Code | Description of Function | Unit | Quantity | Remarks | Est. Cost |
|---|---|---|---|---|---|
| 3346 | Repair / Maintain Timber Wings & Blkhds | SF | 2 | THERE IS A DECAYED EXTERIOR BULKHEAD BOARD AT NORTHWEST CORNER | |

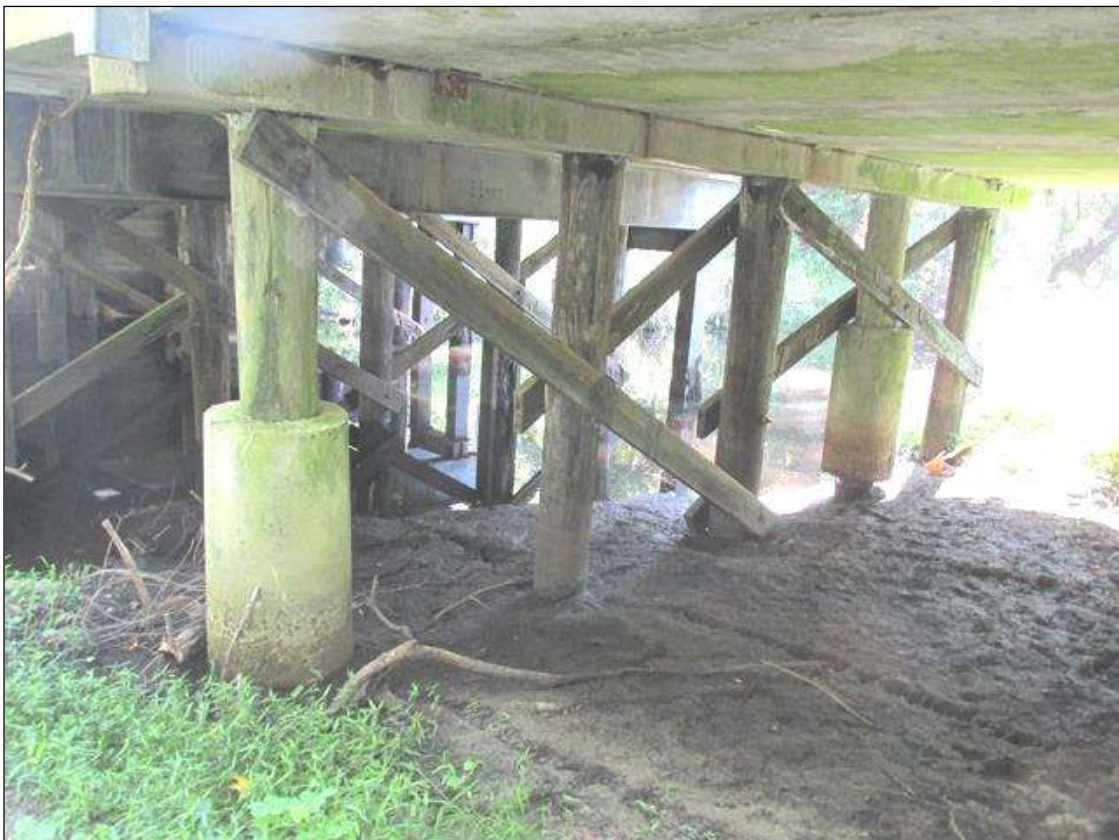
PILES 1 AND 4 AT BENT 1 ARE ENCASED, TEMPORARY REPAIRS

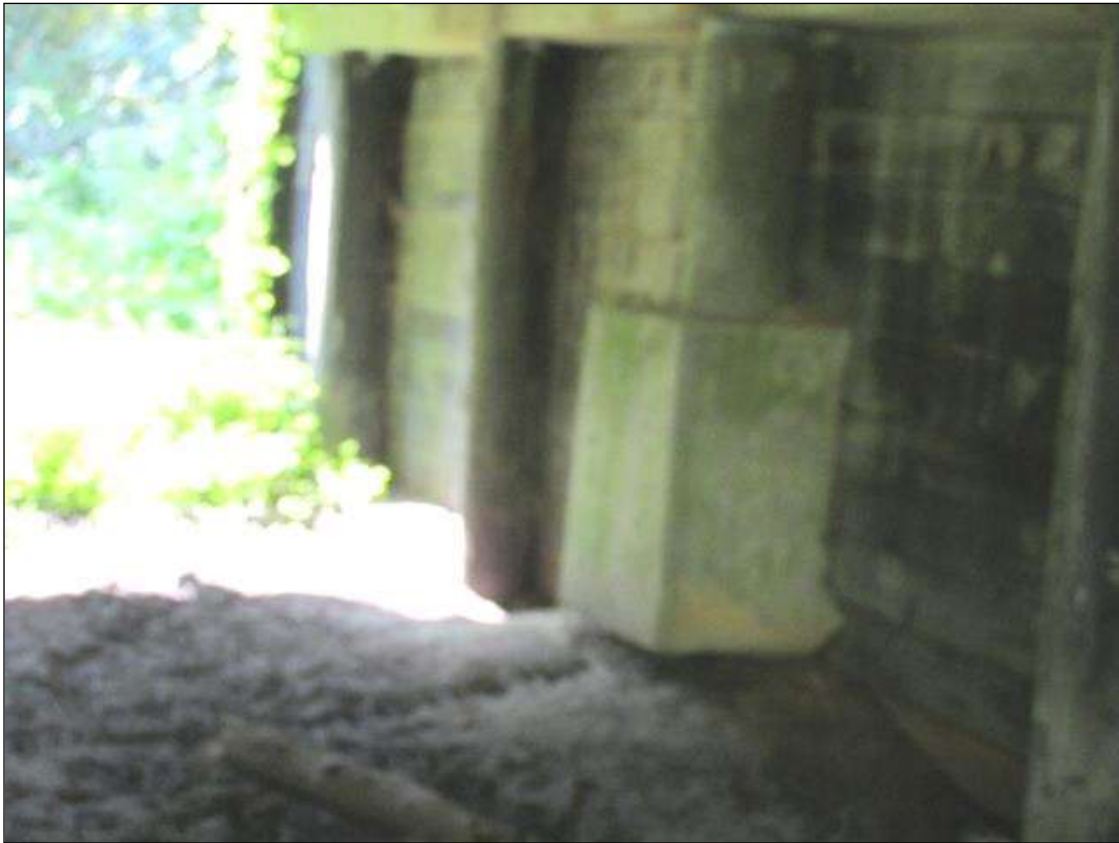
PILE 3 AT END BENT 1 IS ENCASED, TEMPORARY REPAIR

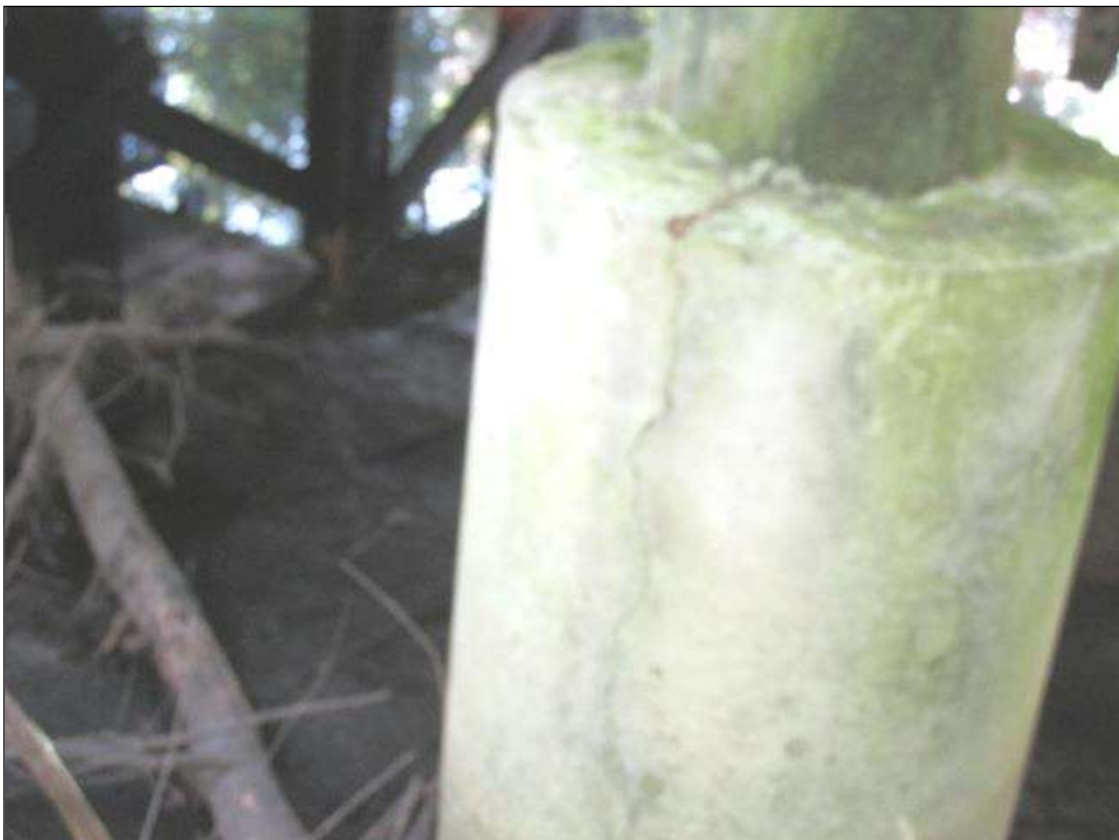
BENT 1 PILE 1 ENCASEMENT HAS A 1/16" VERTICAL CRACK ON NORTH FACE

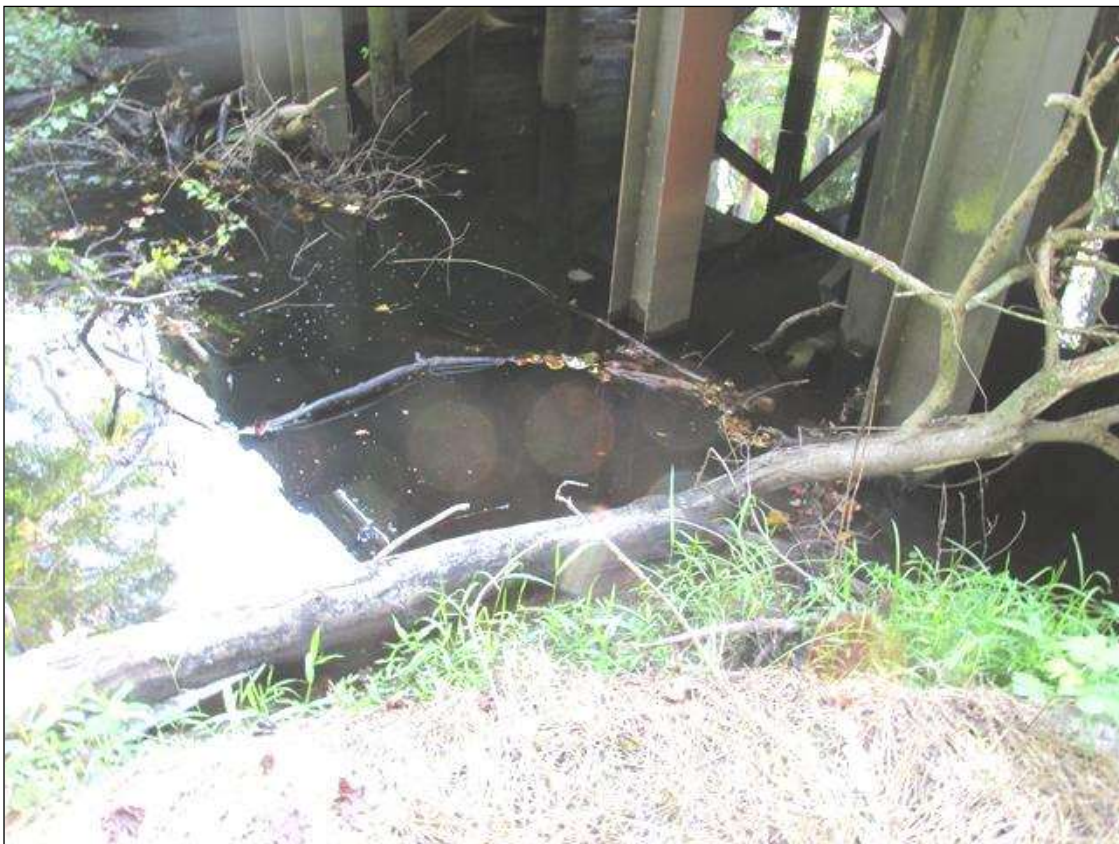
THERE IS DRIFT 8" DIAMETER X 20' LONG TREE NORTH OF BENT 2

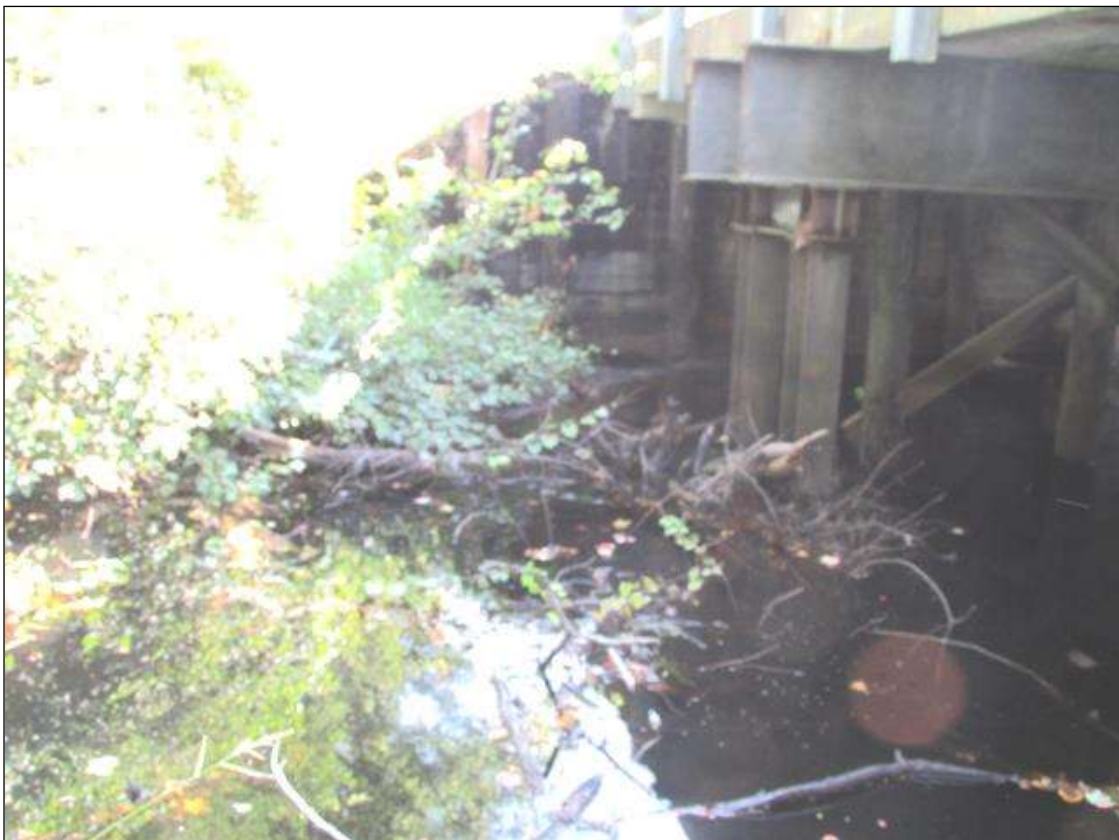
THERE IS DRIFT NORTH OF BENT 3

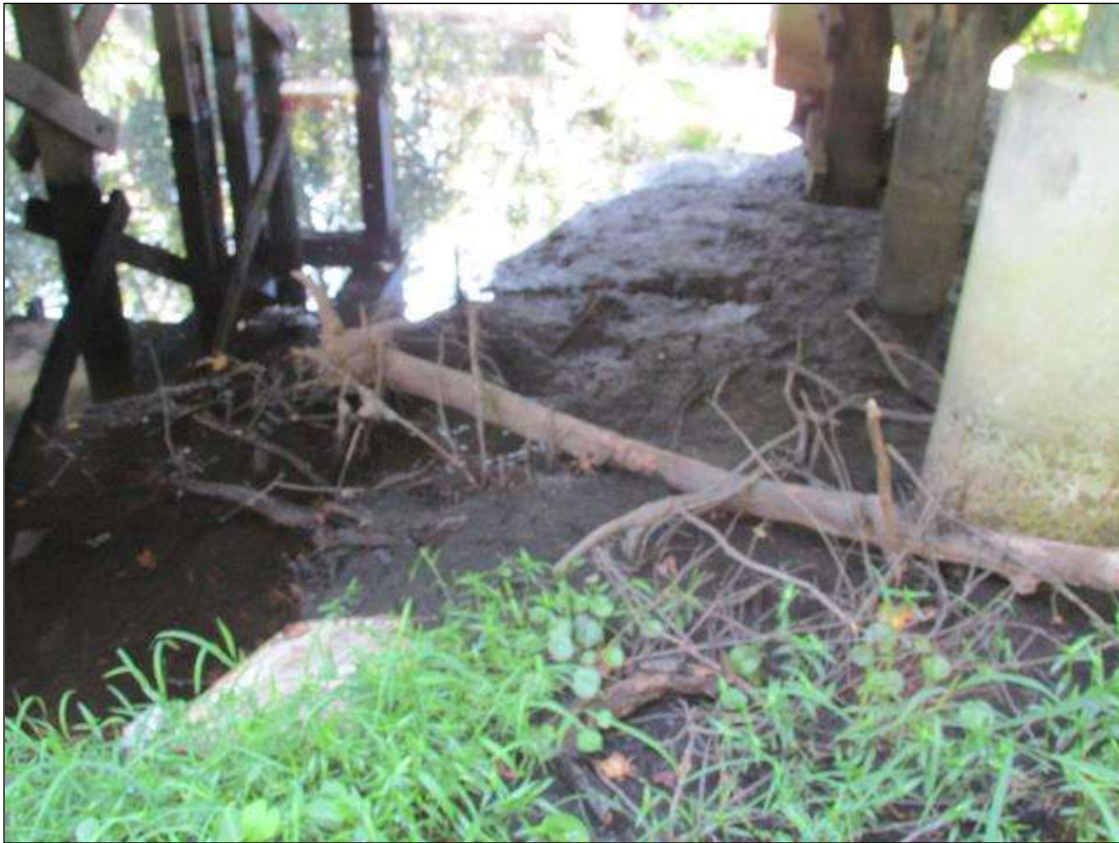
THERE IS DRIFT IN SPAN 2 AT BENT 1 PILE 1

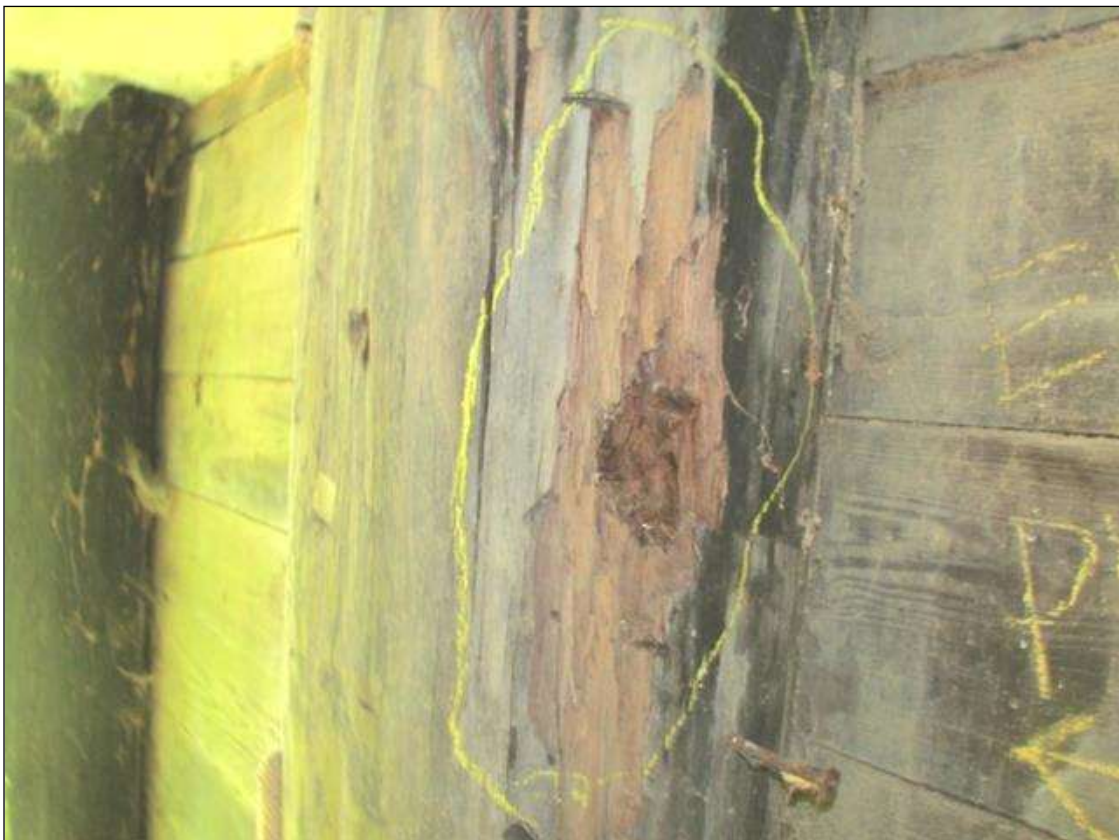
PILE 4 AT END BENT 1 IS DECAYED 12" HIGH X 6" WIDE X 1 1/2" DEEP

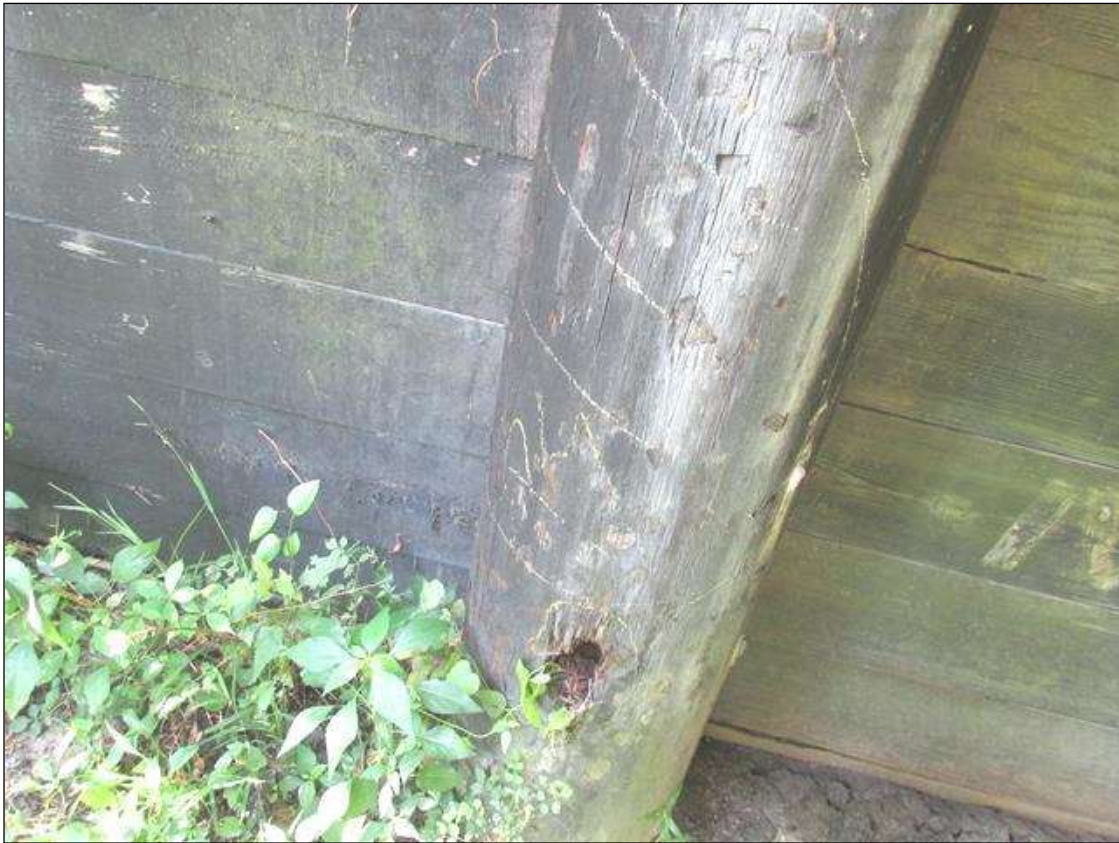
PILE 5 AT END BENT 1 IS DELAMINATED AND DECAYED WITH 1/2" SHELL WITH 2" DEEP DECAY X160 DEGREE CIRCUMFERENCE SEE SKETCH

| MMS Code | Description of Function | Unit | Quantity | Remarks | Est. Cost |
|---|---|---|---|---|---|
| 3344 | Repair / Replace Timber Substructure Components | LF | 5 | PILE 5 AT END BENT 1 IS DELAMINATED AND DECAYED WITH 1/2" SHELL WITH 2" DEEP DECAY X160 DEGREE CIRCUMFERENCE SEE SKETCH | |

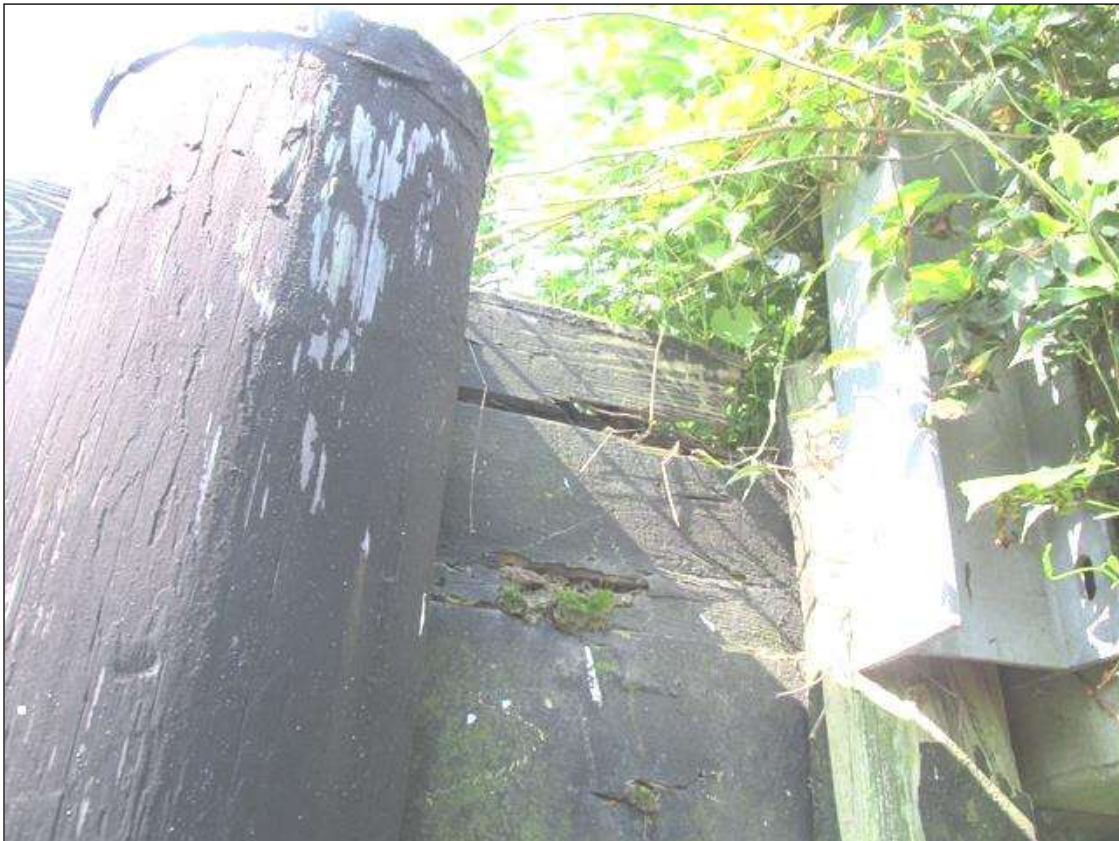
THERE IS A DECAYED BULKHEAD BOARD AT SOUTHWEST CORNER

| MMS Code | Description of Function | Unit | Quantity | Remarks | Est. Cost |
|---|---|---|---|---|---|
| 3346 | Repair / Maintain Timber Wings & Blkhds | SF | 2 | THERE IS A DECAYED BULKHEAD BOARD AT SOUTHWEST CORNER | |

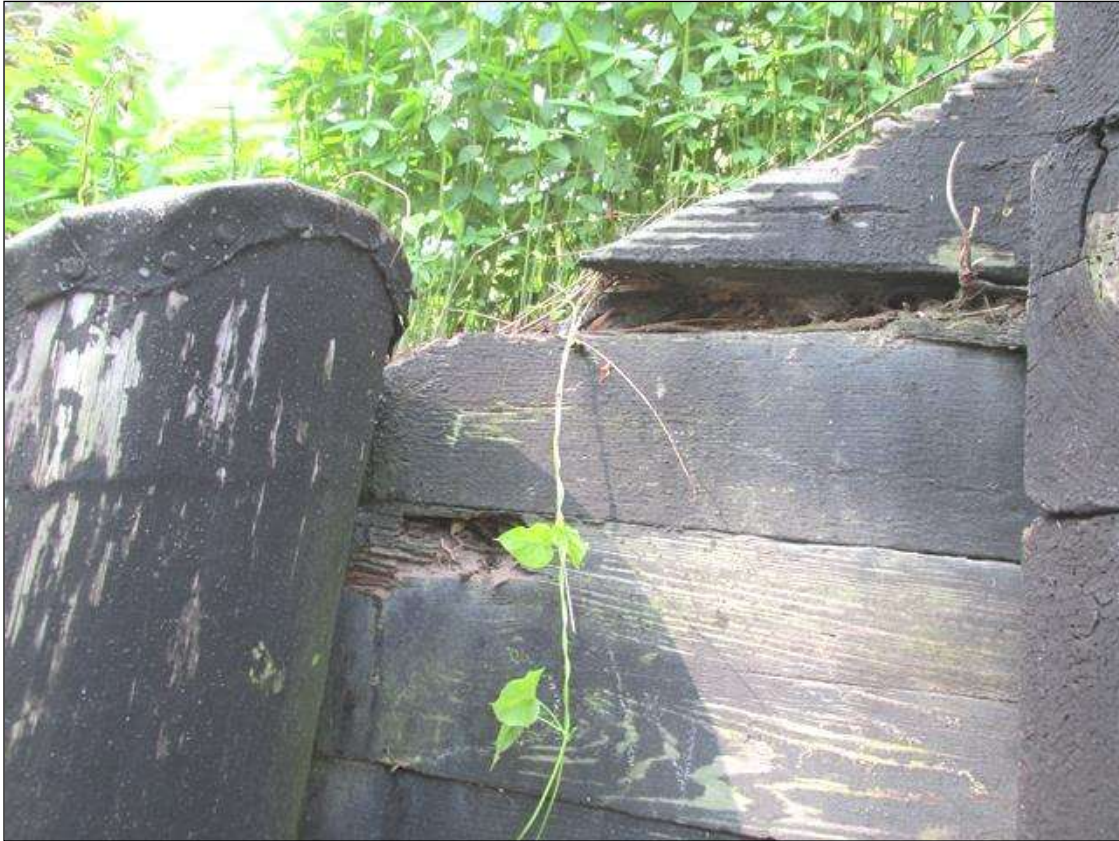
THERE ARE DECAYED WINGWALL BOARDS AT SOUTHWEST CORNER

| MMS Code | Description of Function | Unit | Quantity | Remarks | Est. Cost |
|---|---|---|---|---|---|
| 3346 | Repair / Maintain Timber Wings & Blkhds | SF | 3 | THERE ARE DECAYED WINGWALL BOARDS AT SOUTHWEST CORNER | |

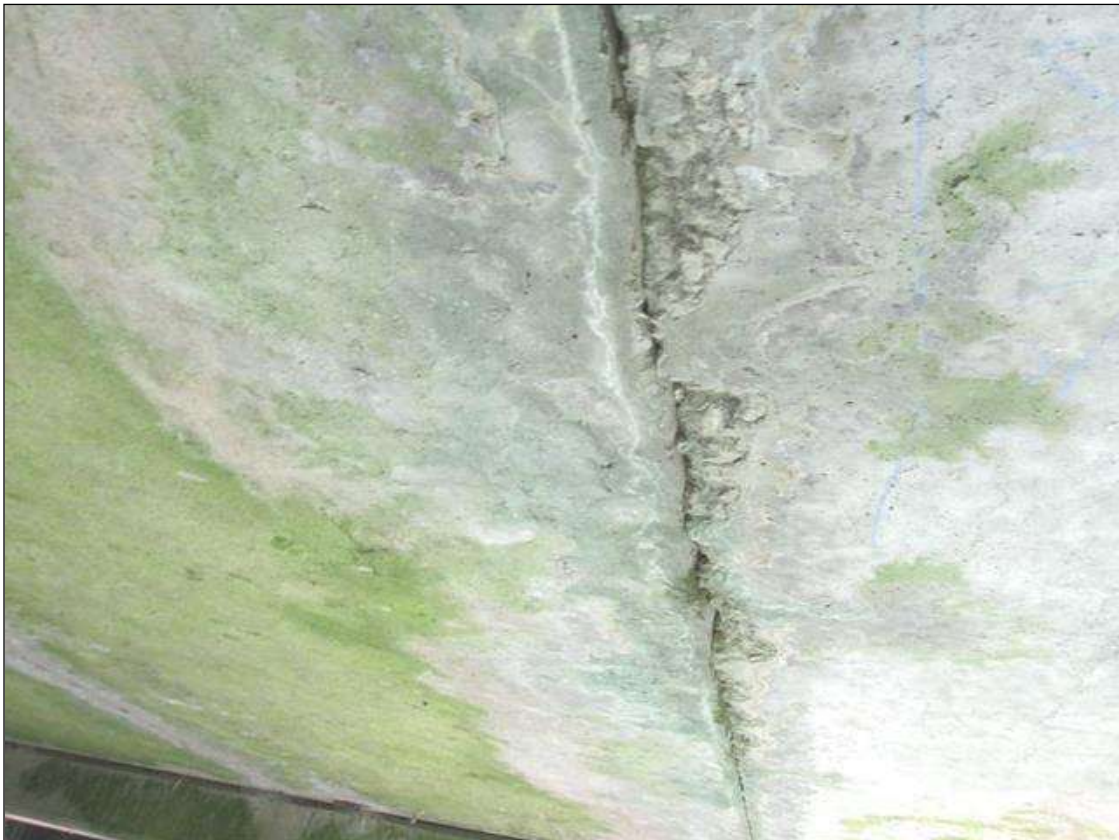
PRECAST SLAB 6 IN SPAN 1 HAS SURFACE SPALLING ALONG SLAB 5 CONNECTION 5' LONG X UP TO 1" WIDE X UP TO 1" DEEP

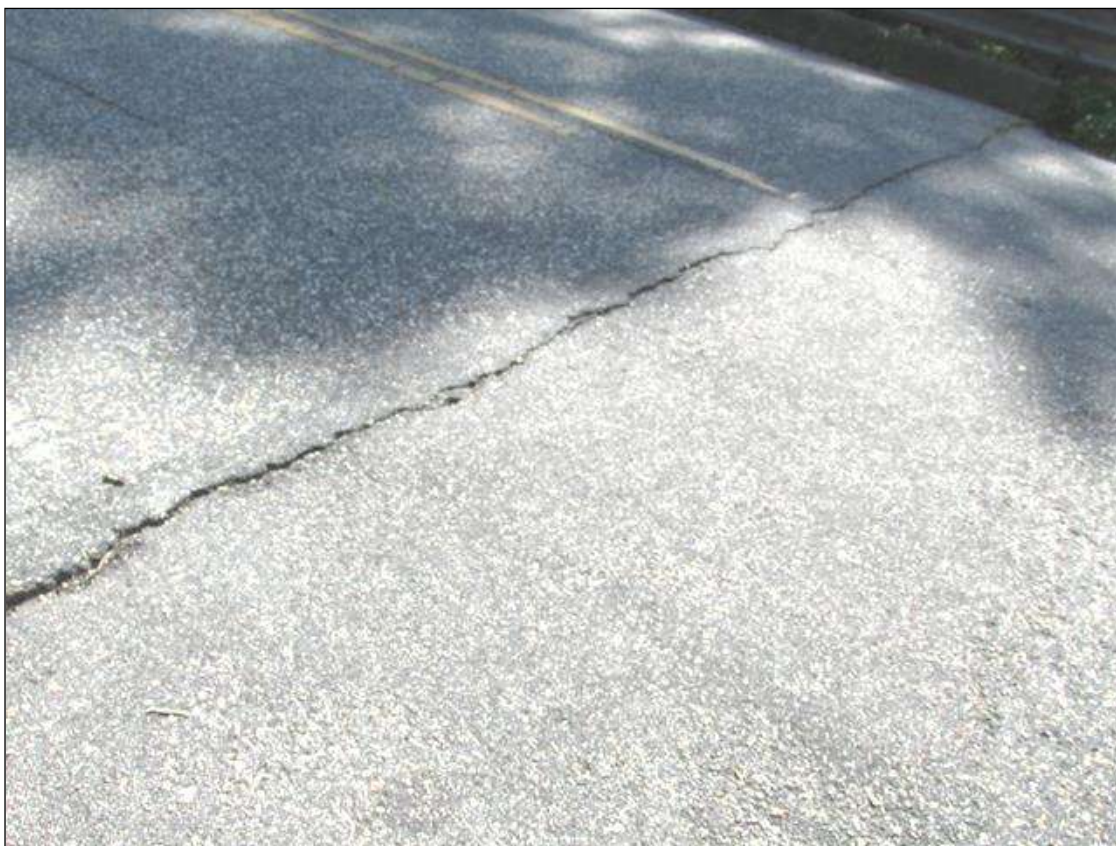
THERE IS A 1/4" TRANSVERSE CRACK AND UP TO 1/2" SETTLEMENT IN THE WEST APPROACH ASPHALT WEARING SURFACE

| MMS Code | Description of Function | Unit | Quantity | Remarks | Est. Cost |
|---|---|---|---|---|---|
| 2816 | Asphalt Surface Repair or Replacement | SY | 1 | THERE IS A 1/4" TRANSVERSE CRACK AND UP TO 1/2" SETTLEMENT IN THE WEST APPROACH ASPHALT WEARING SURFACE | |

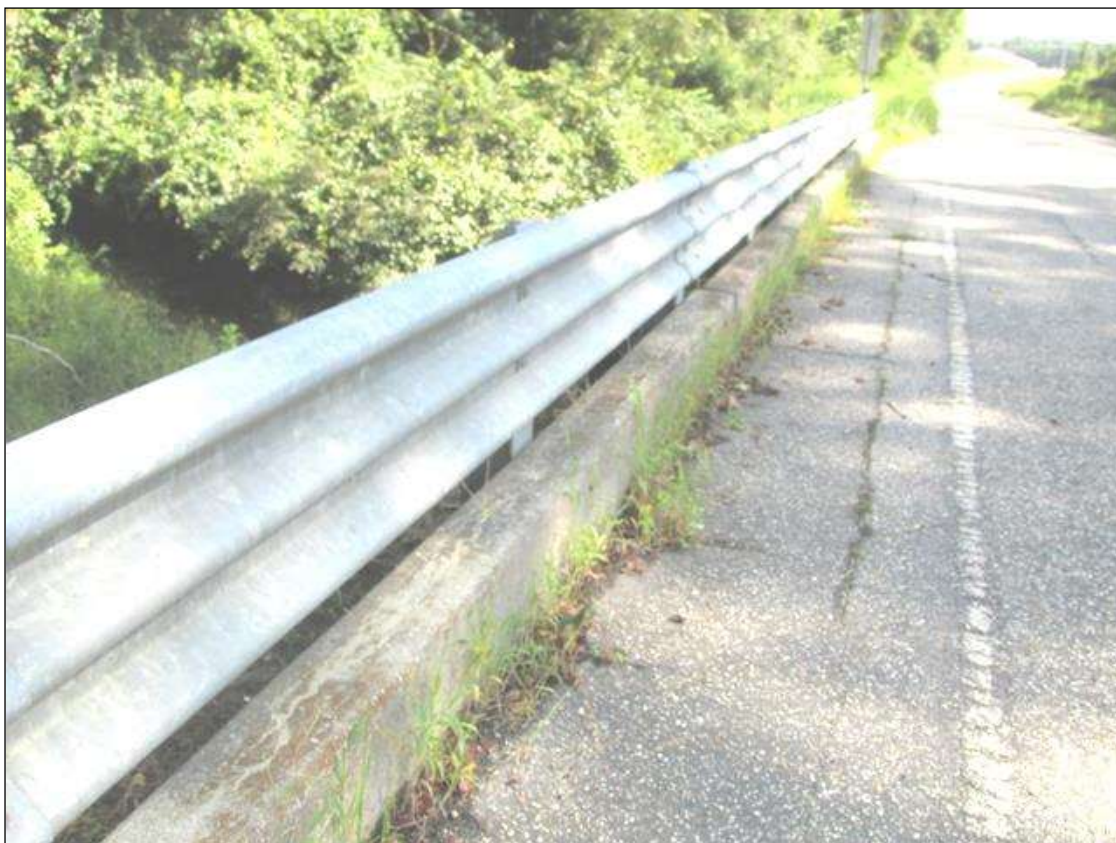
THERE IS VEGETATION ALONG LEFT CURB

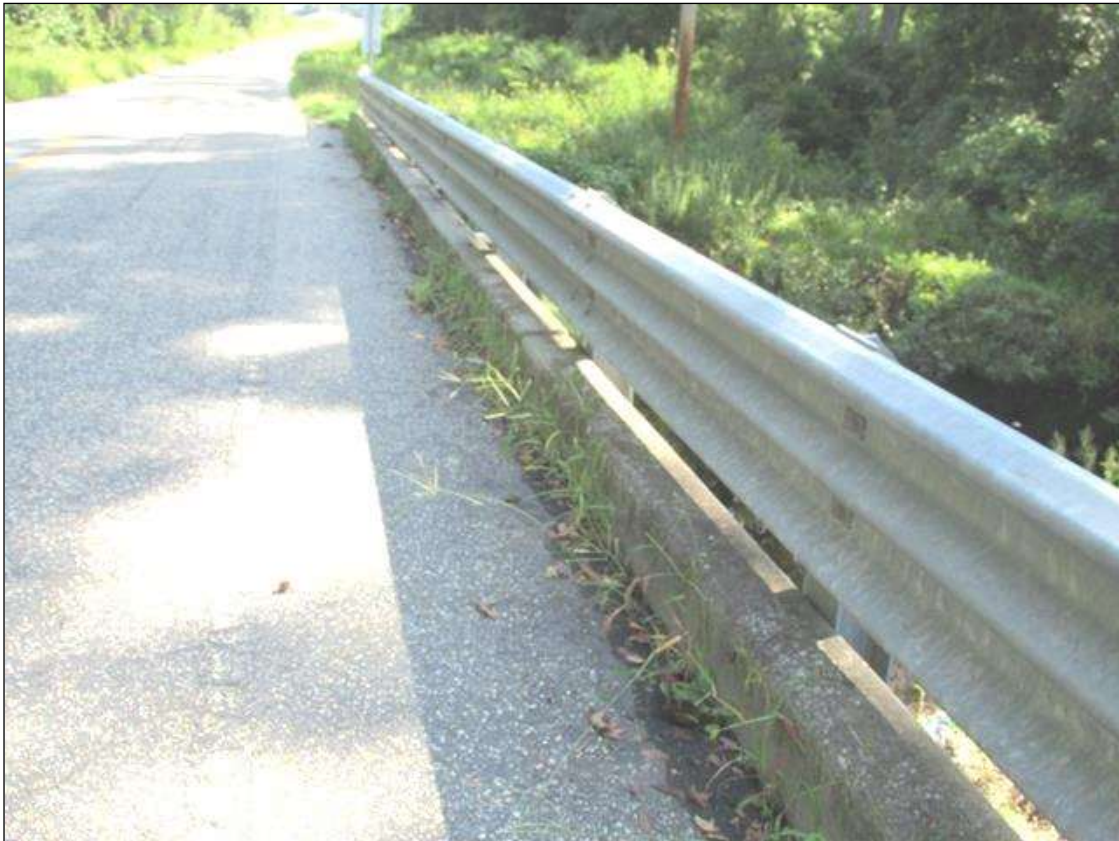
THERE IS VEGETATION ALONG RIGHT CURB

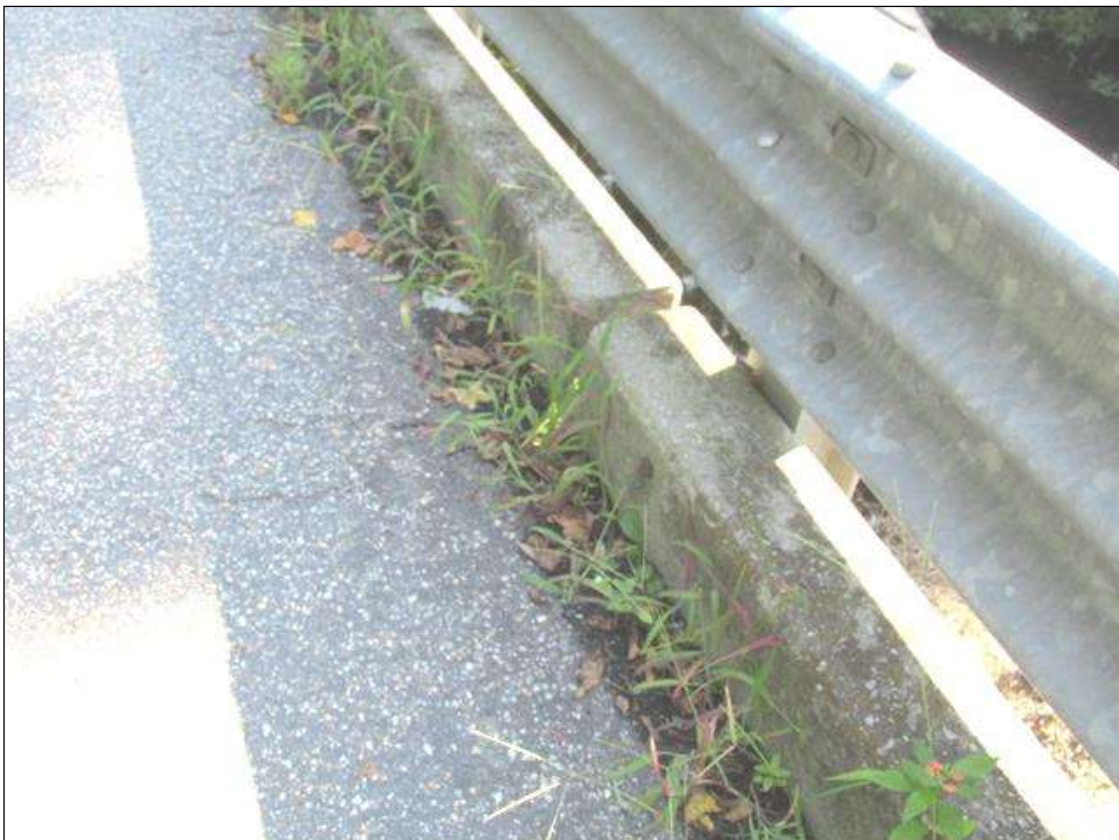
ALL DRAINS ARE BLOCKED BY VEGETATION ALONG RIGHT CURB

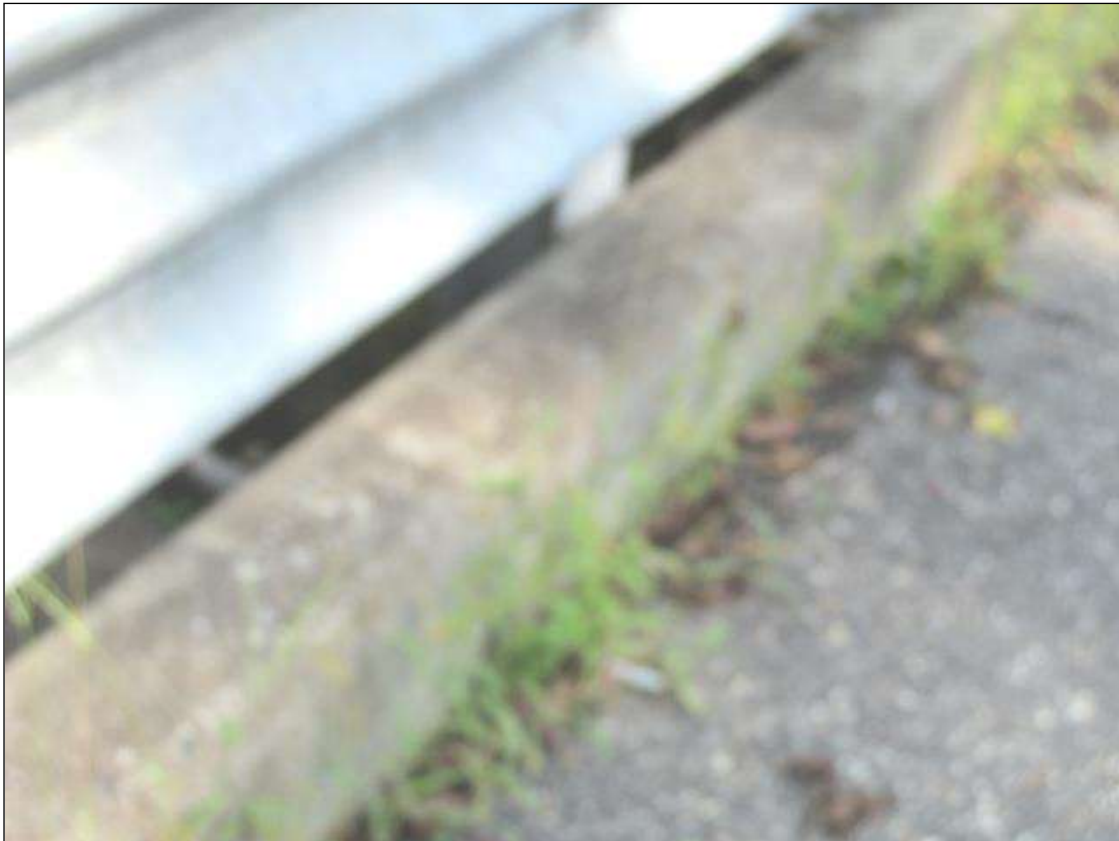
ALL LEFT CURB DRAINS ARE BLOCKED BY VEGETATION

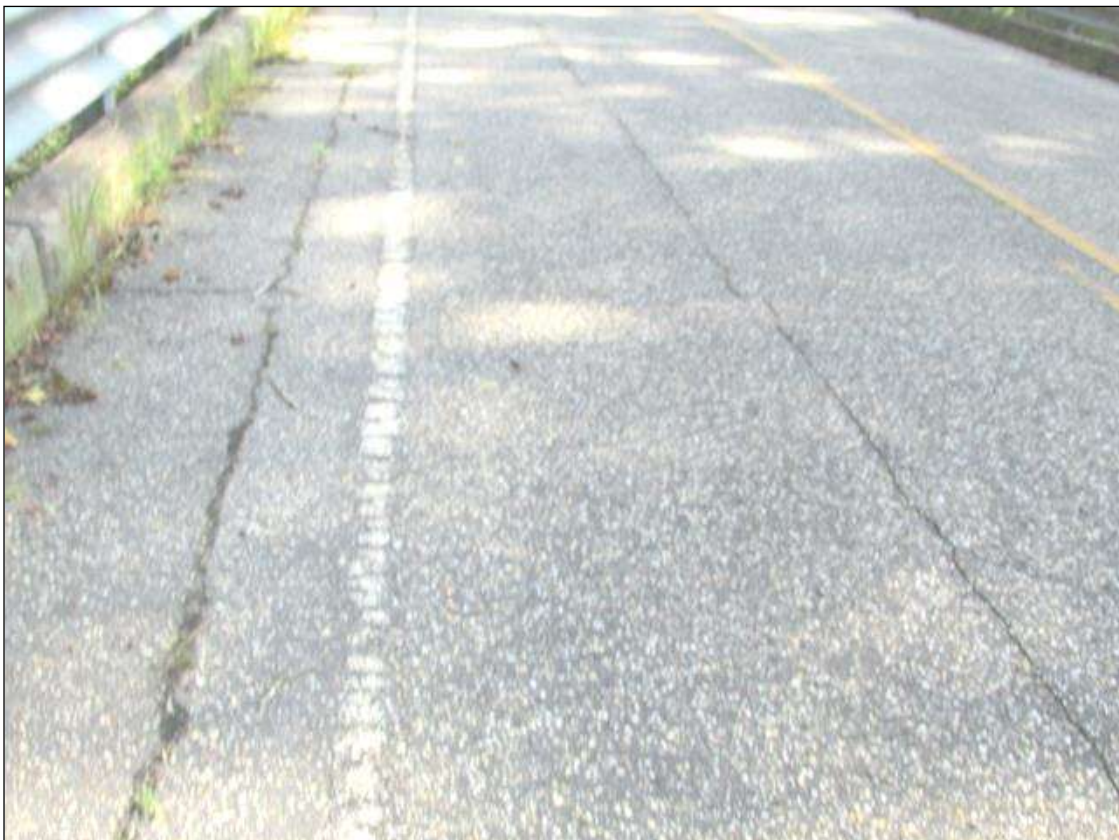
THERE ARE LONGITUDINAL CRACKS IN SPAN 1 OVER PRECAST SLABS

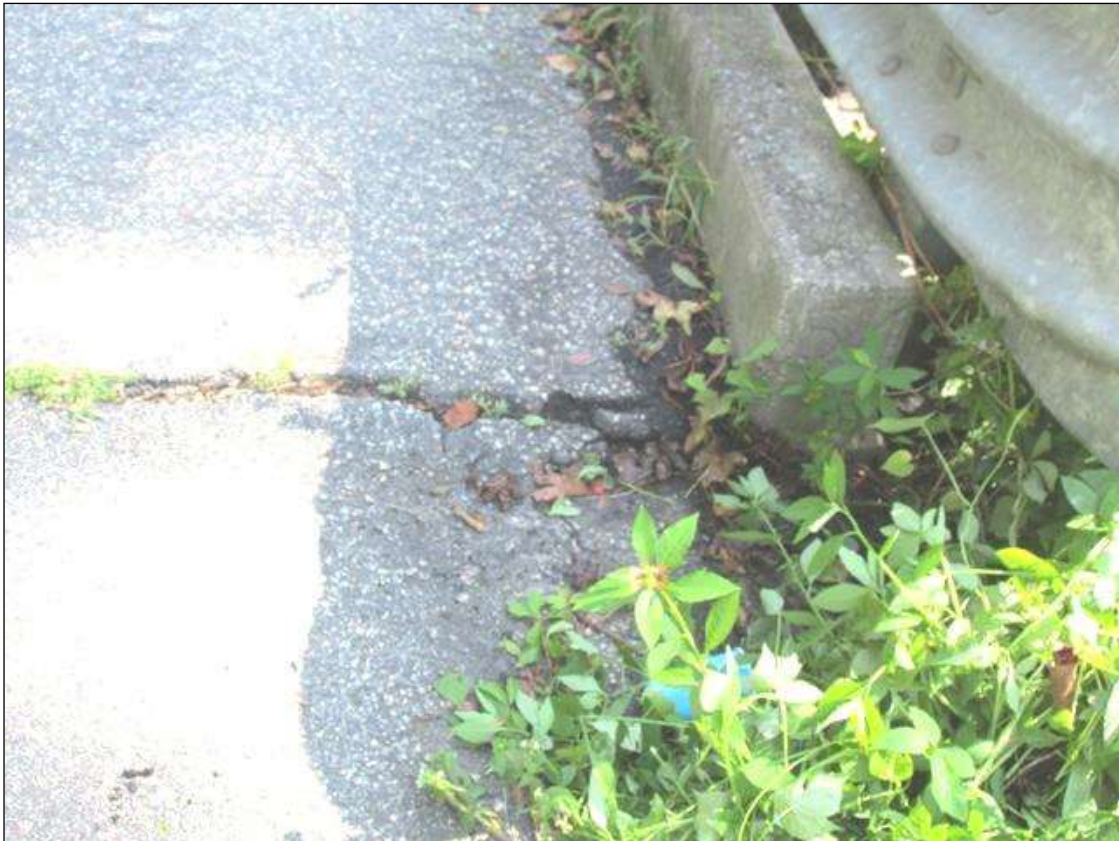
THE WEST APPROACH ASPHALT WEARING SURFACE IS SETTLED 2" AT SOUTHWEST CORNER

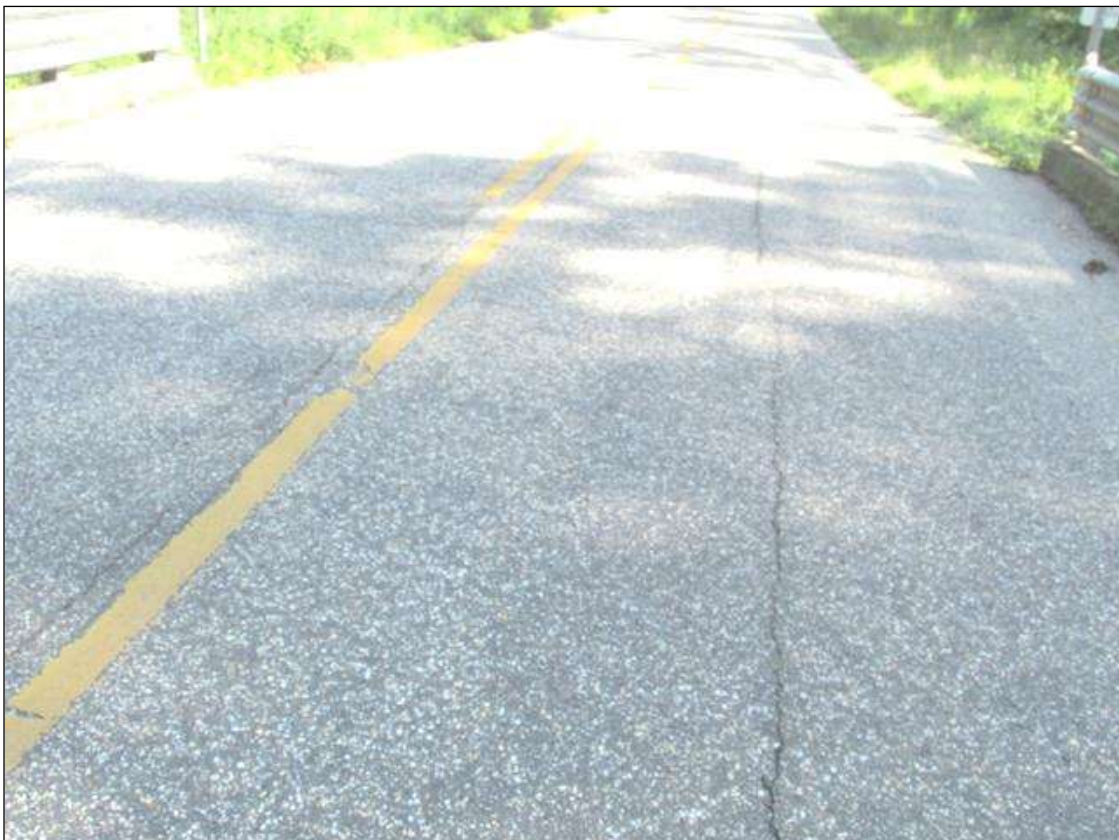
THERE ARE LONGITUDINAL CRACKS OVER SLABS IN SPANS 2 AND 3

| MMS Code | Description of Function | Unit | Quantity | Remarks | Est. Cost |
|---|---|---|---|---|---|
| 2816 | Asphalt Surface Repair or Replacement | SY | 2 | THERE ARE LONGITUDINAL CRACKS OVER SLABS IN SPANS 2 AND 3 | |

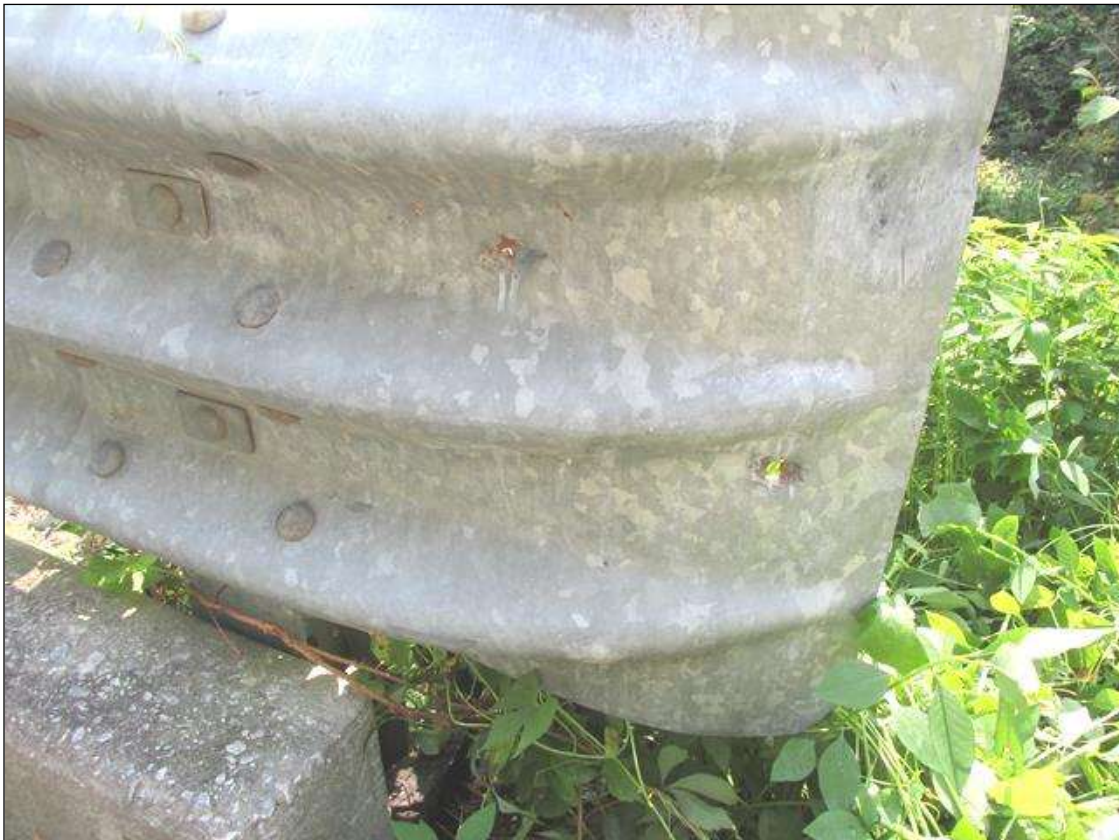
THERE ARE TWO BULLET HOLES IN RIGHT RAIL END AT SOUTHWEST CORNER

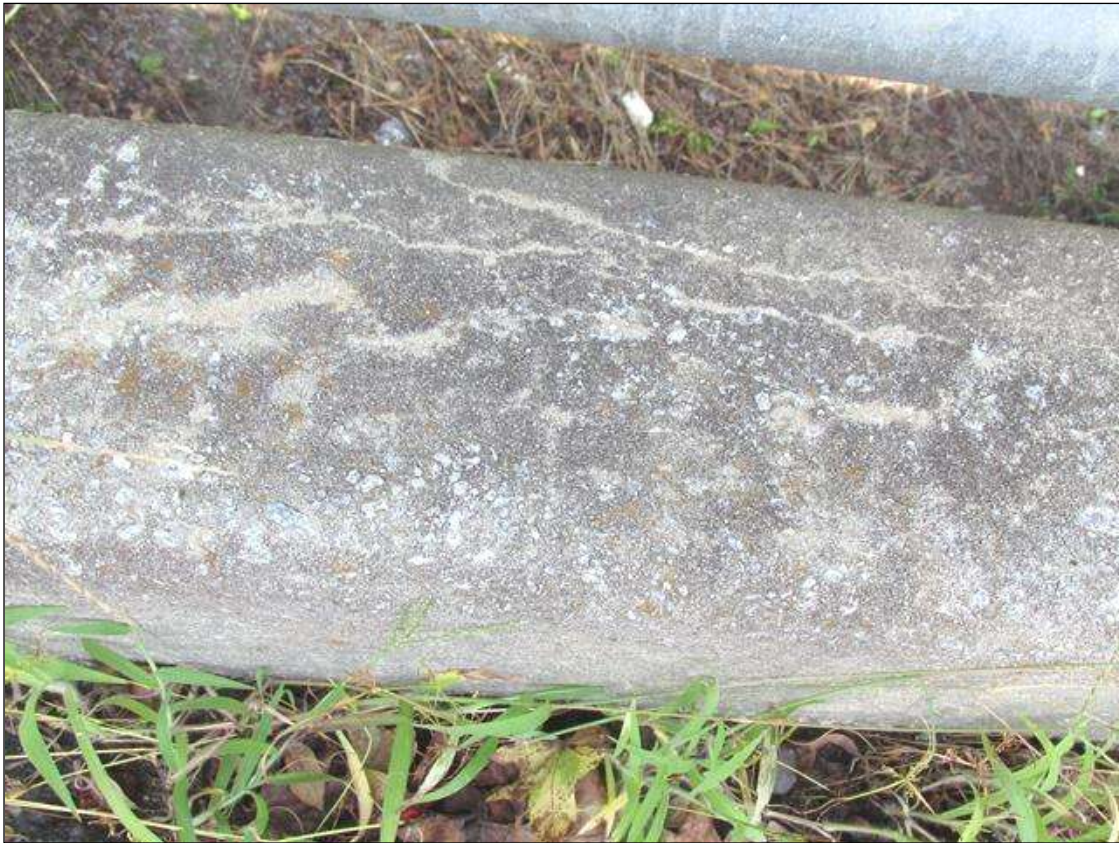
THERE IS HAIRLINE MAP CRACKING IN LEFT CURB IN ALL SPANS

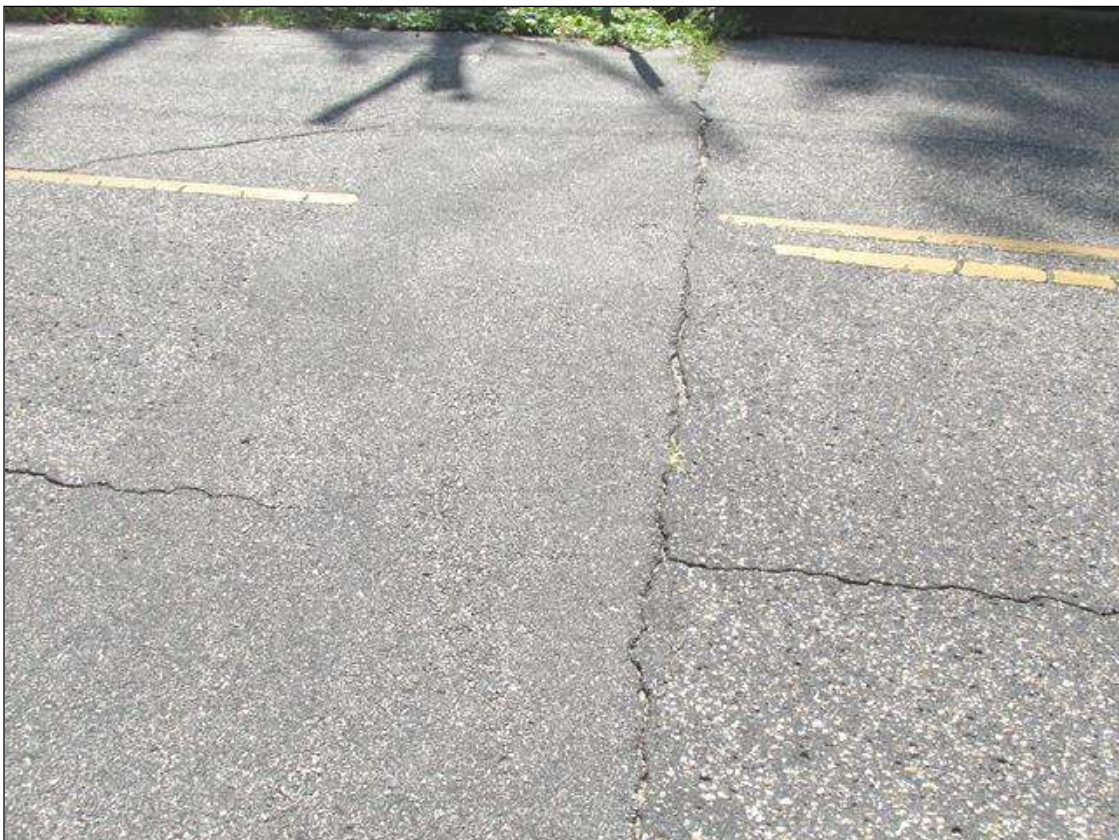
THERE IS A 3/16" TRANSVERSE CRACK IN EAST APPROACH OVER END BENT 2

| MMS Code | Description of Function | Unit | Quantity | Remarks | Est. Cost |
|---|---|---|---|---|---|
| 2816 | Asphalt Surface Repair or Replacement | SY | 1 | THERE IS A 3/16" TRANSVERSE CRACK IN EAST APPROACH OVER END BENT 2 | |
