NC DEPARTMENT OF TRANSPORTATION  
DIVISION OF HIGHWAYS  
BRIDGE MANAGEMENT UNIT

# BRIDGE INSPECTION REPORT

INSPECTION TYPE: Routine Inspection

COUNTY ROBESON BRIDGE NUMBER 770414 INSPECTION CYCLE 2 YRS  
ROUTE SR1323 ACROSS WATSONS POND M.P. 0

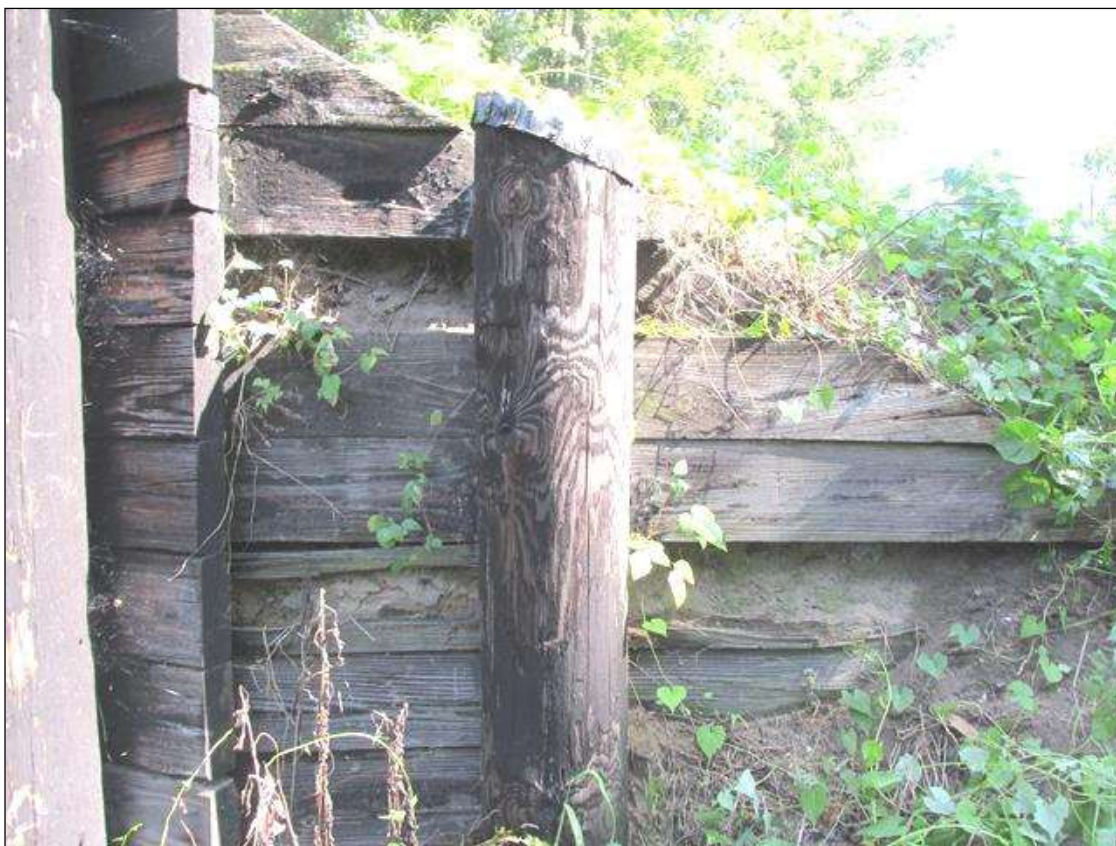
THERE ARE DECAYED AND MISSING WINGWALL BOARDS WITH EXPOSED FILL AT SOUTHEAST CORNER

| MMS Code | Description of Function | Unit | Quantity | Remarks | Est. Cost |
|---|---|---|---|---|---|
| 3346 | Repair / Maintain Timber Wings & Blkhds | SF | 7 | THERE ARE DECAYED AND MISSING WINGWALL BOARDS WITH EXPOSED FILL AT SOUTHEAST CORNER | |

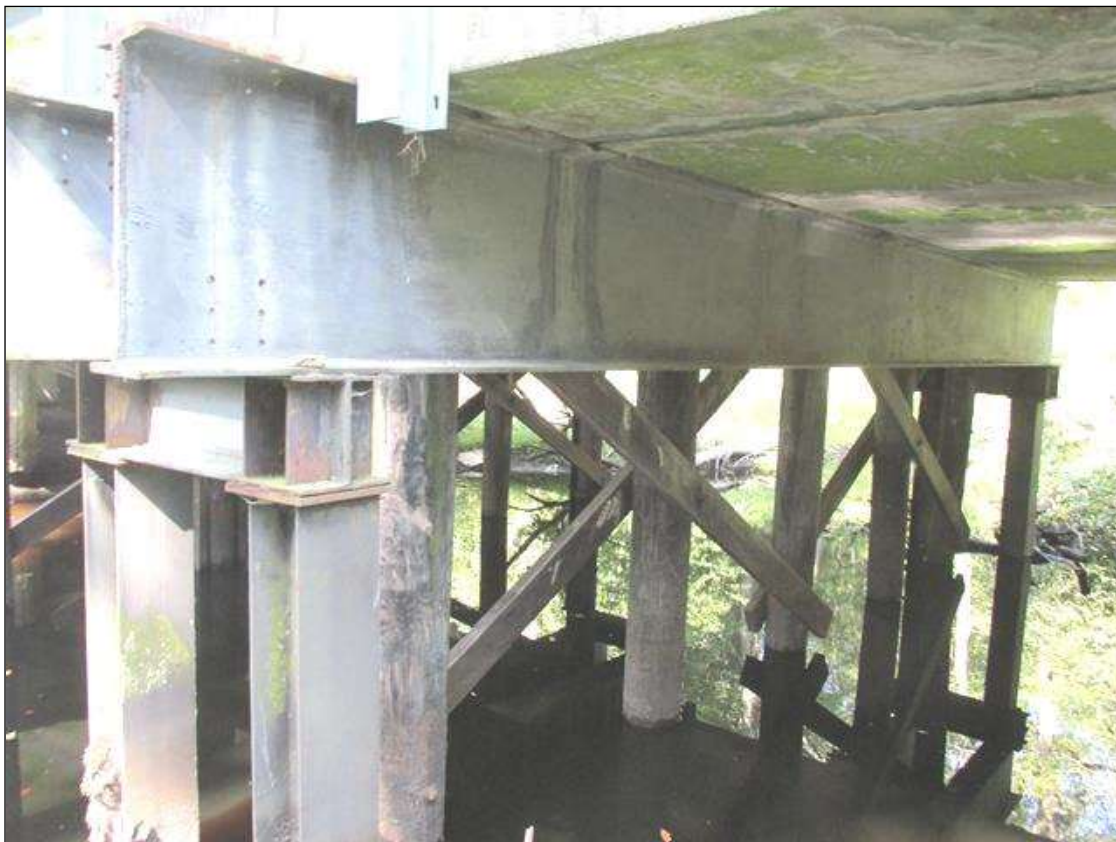
BENT 3 SPAN 4 SIDE STEEL CRUTCH BENT, SIMILAR IN SPAN 3 SIDE

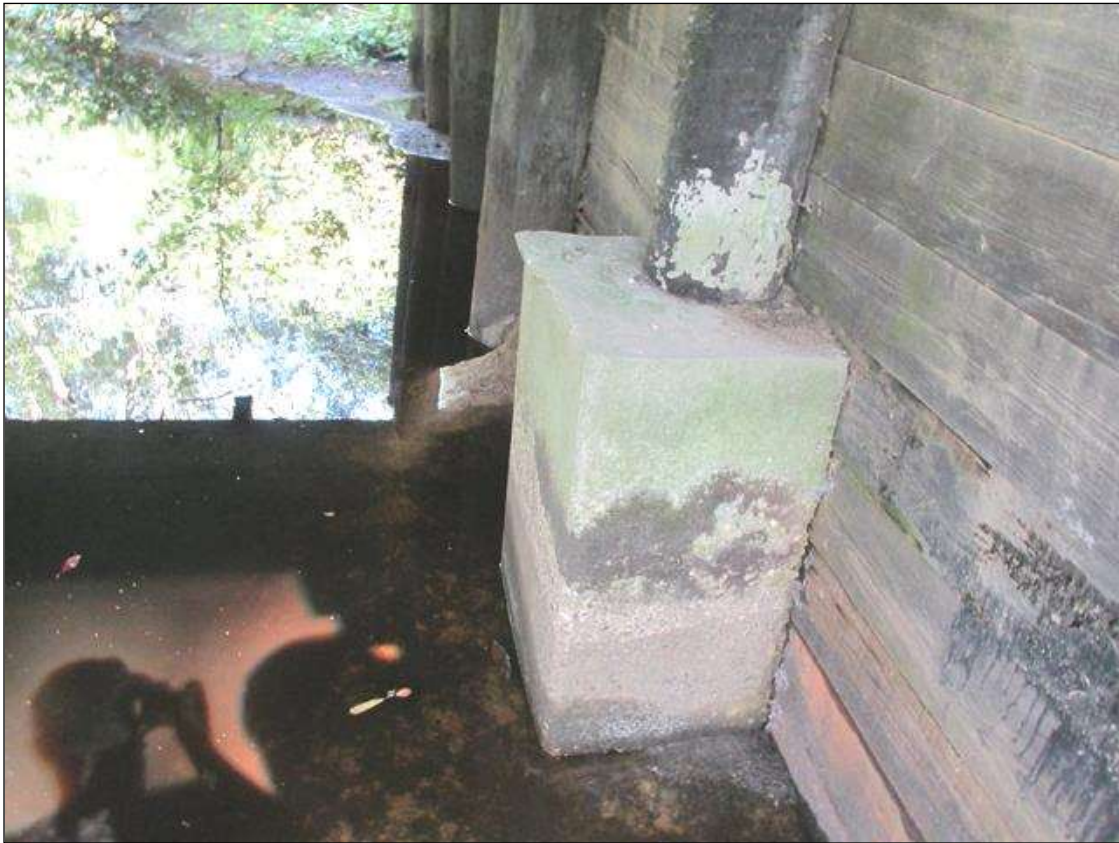
PILE 4 AT END BENT 2 IS ENCASED, TEMPORARY REPAIR

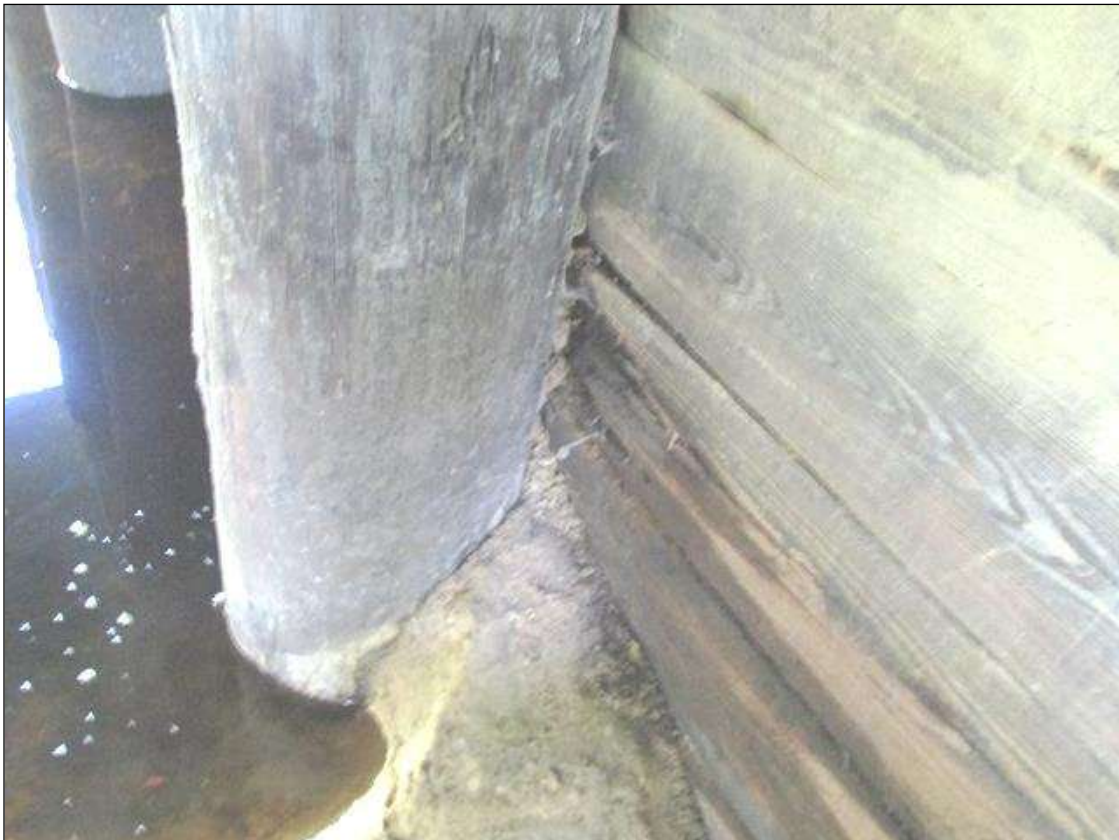
THERE IS A DECAYED BULKHEAD BOARD AT END BENT 2 PILE 3 WITH FILL LEAKAGE PM ISSUED

| MMS Code | Description of Function | Unit | Quantity | Remarks | Est. Cost |
|---|---|---|---|---|---|
| 3346 | Repair / Maintain Timber Wings & Blkhds | SF | 3 | THERE IS A DECAYED BULKHEAD BOARD AT END BENT 2 PILE 3 WITH FILL LEAKAGE | |

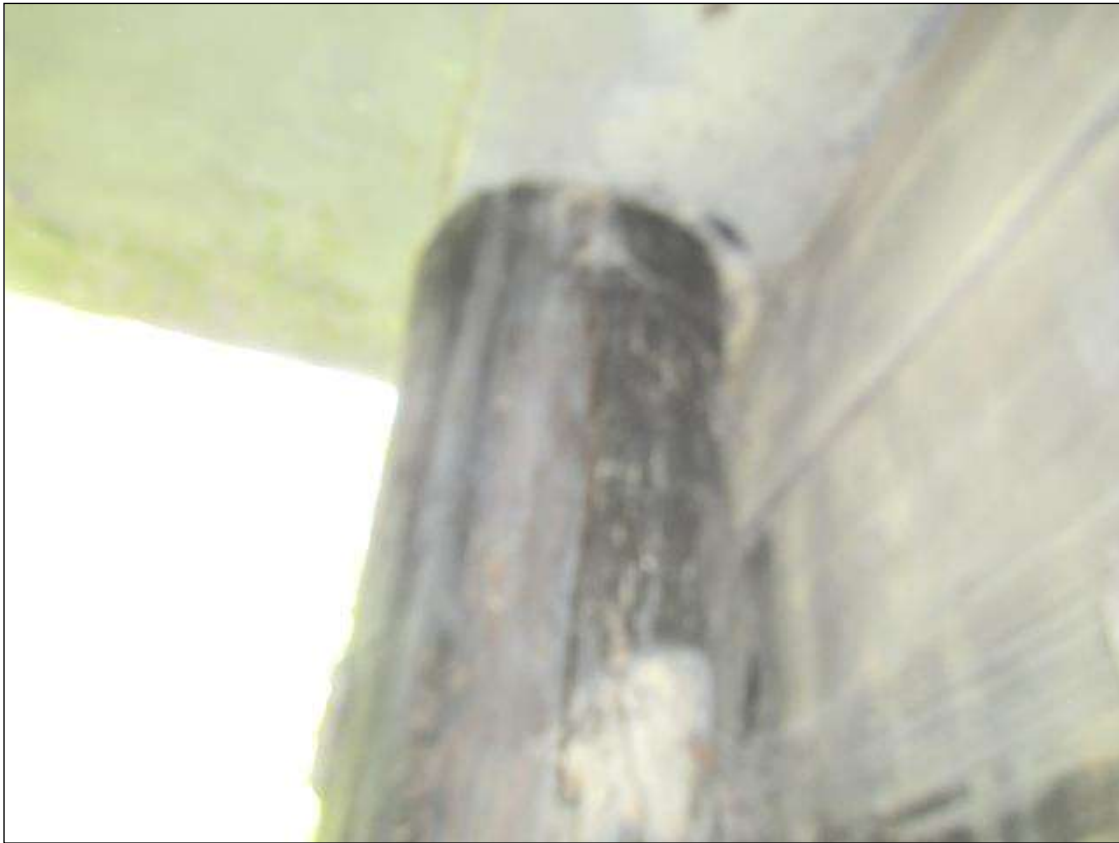
PILE 1 AT END BENT 2 SOUTH FACE HAS A 3/8" VERTICAL CRACK 2' HIGH X 1 1/2" D

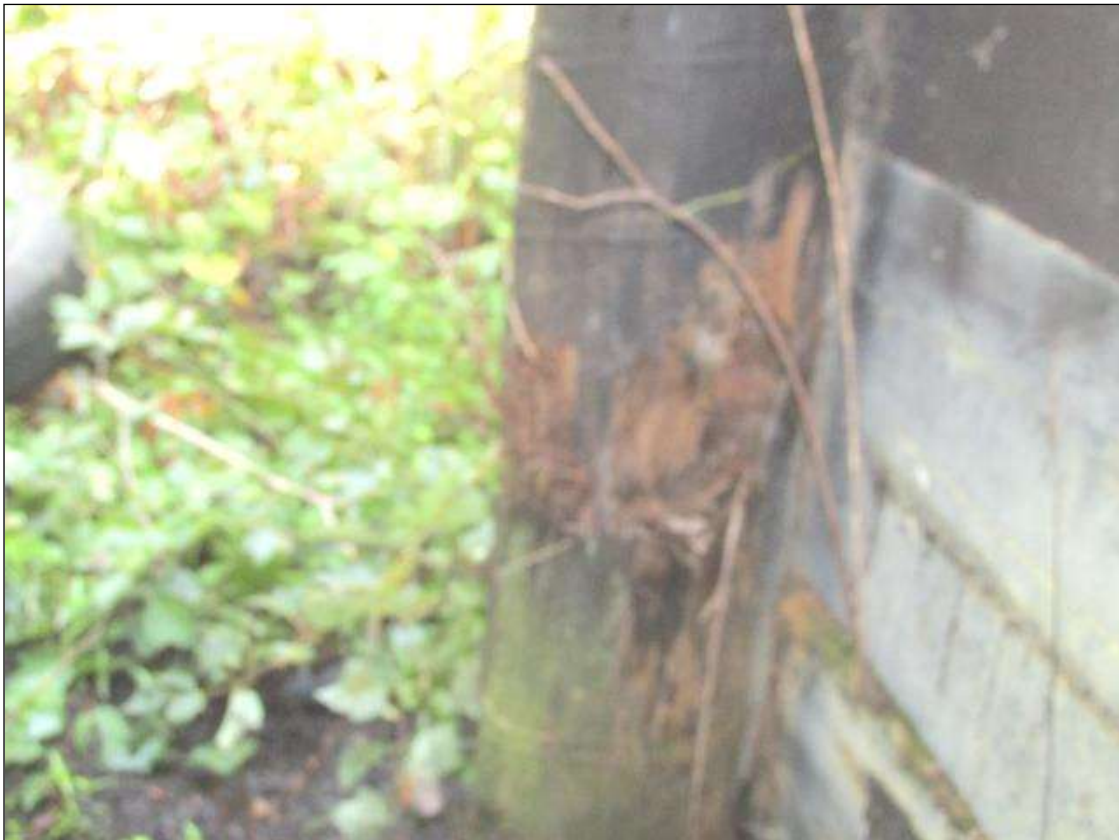
THE NORTHEAST CORNER TURNPILE IS DECAYED 16" HIGH X FULL CIRCUMFERENCE X 4" DEEP, WITH 5" CORE REMAINING

| MMS Code | Description of Function | Unit | Quantity | Remarks | Est. Cost |
|---|---|---|---|---|---|
| 3346 | Repair / Maintain Timber Wings & Blkhds | SF | 5 | THE NORTHEAST CORNER TURNPILE IS DECAYED 16" HIGH X FULL CIRCUMFERENCE X 4" DEEP, WITH 5" CORE REMAINING | |

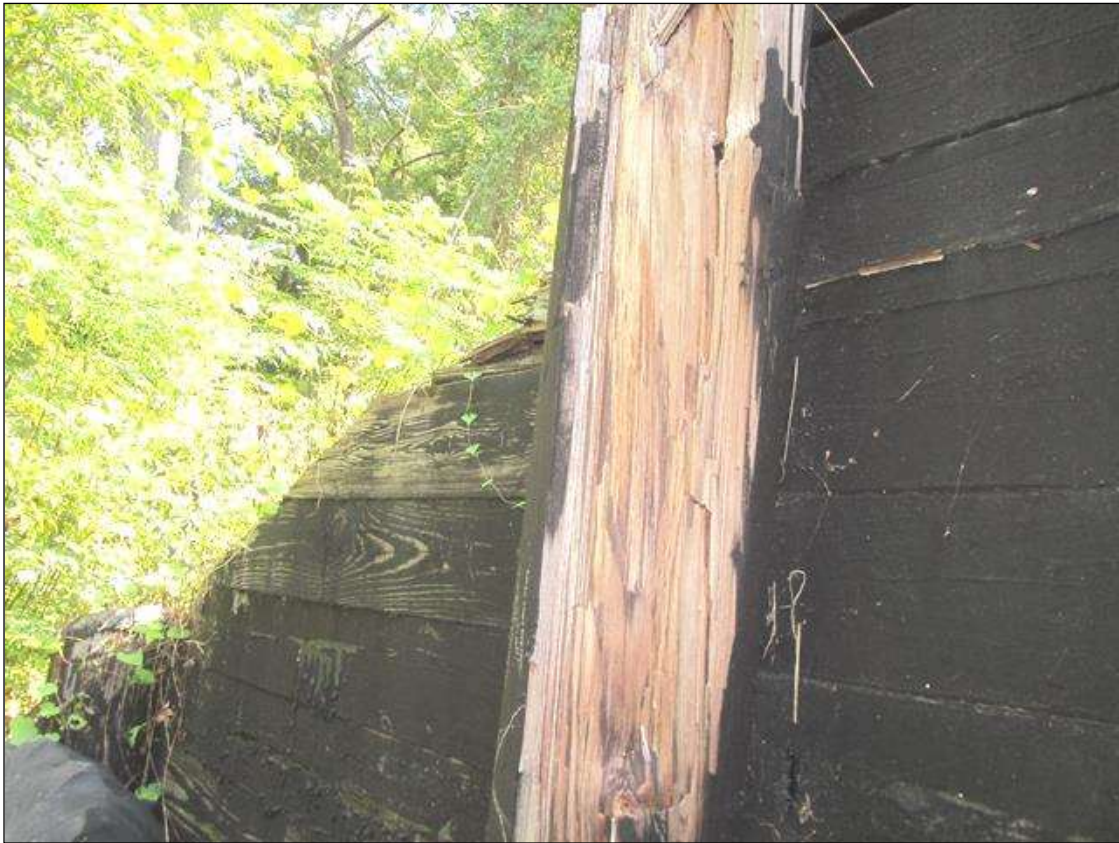
THERE IS A DAMAGED WINGWALL PILE AT NORTHEAST CORNER

| MMS Code | Description of Function | Unit | Quantity | Remarks | Est. Cost |
|---|---|---|---|---|---|
| 3346 | Repair / Maintain Timber Wings & Blkhds | SF | 5 | THERE IS A DAMAGED WINGWALL PILE AT NORTHEAST CORNER | |

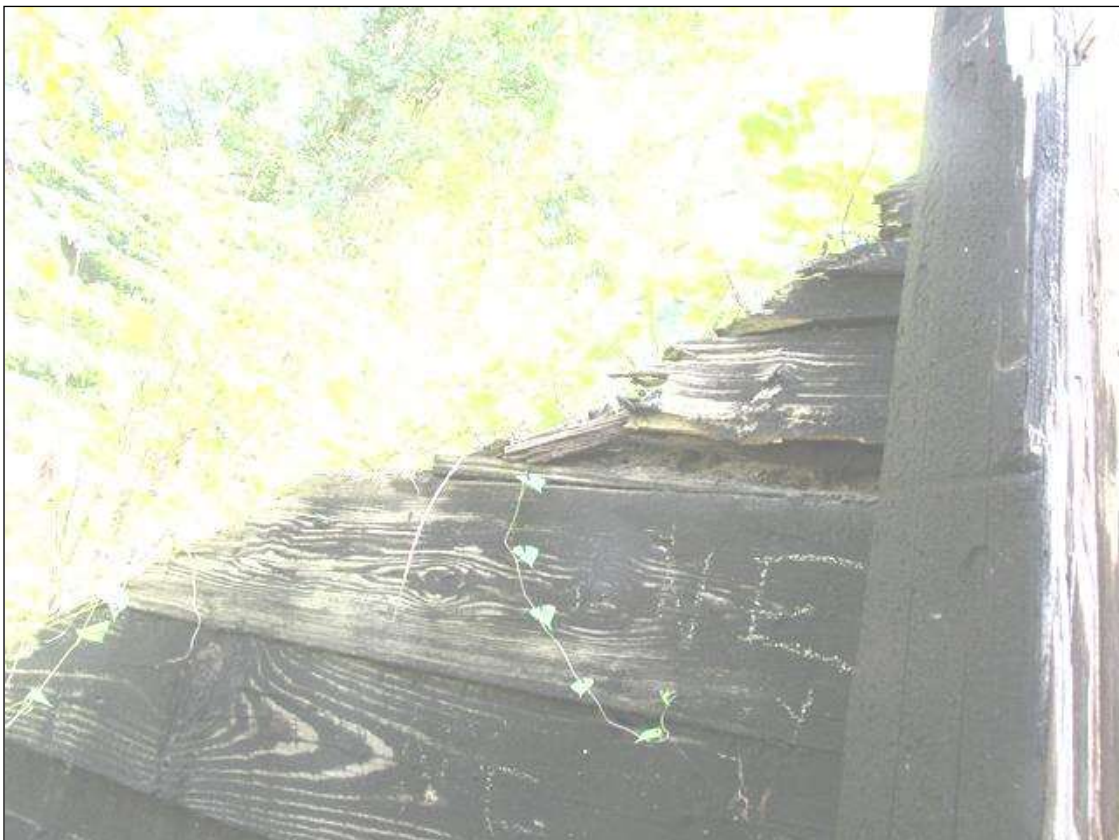
THERE ARE DECAYED WINGWALL BOARDS AT NORTHEAST CORNER

| MMS Code | Description of Function | Unit | Quantity | Remarks | Est. Cost |
|---|---|---|---|---|---|
| 3346 | Repair / Maintain Timber Wings & Blkhds | SF | 3 | THERE ARE DECAYED WINGWALL BOARDS AT NORTHEAST CORNER | |

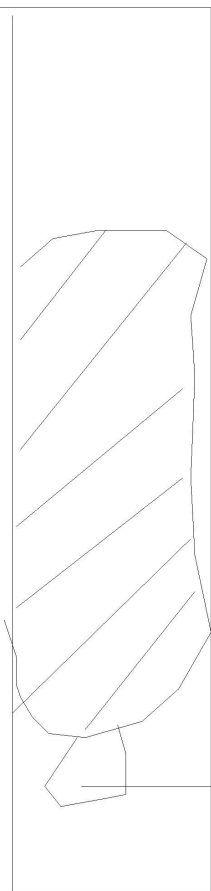
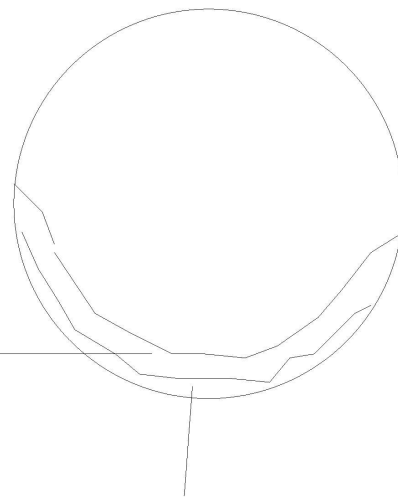
PILE 5 DECAY

2" DEEP DECAY

1/2" SHELL

3" DIAMETER X 2" DEEP HOLE

DECAY AND DELAMINATION IS 160 DEGREE WIDE

| MMS Code | Description of Function | Unit | Quantity | Remarks | Est. Cost |
|---|---|---|---|---|---|
| 3344 | Repair / Replace Timber Substructure Components | LF | 5 | PILE 5 AT END BENT 1 IS DELAMINATED AND DECAYED WITH 1/2" SHELL WITH 2" DEEP DECAY X160 DEGREE CIRCUMFERENCE SEE SKETCH | |

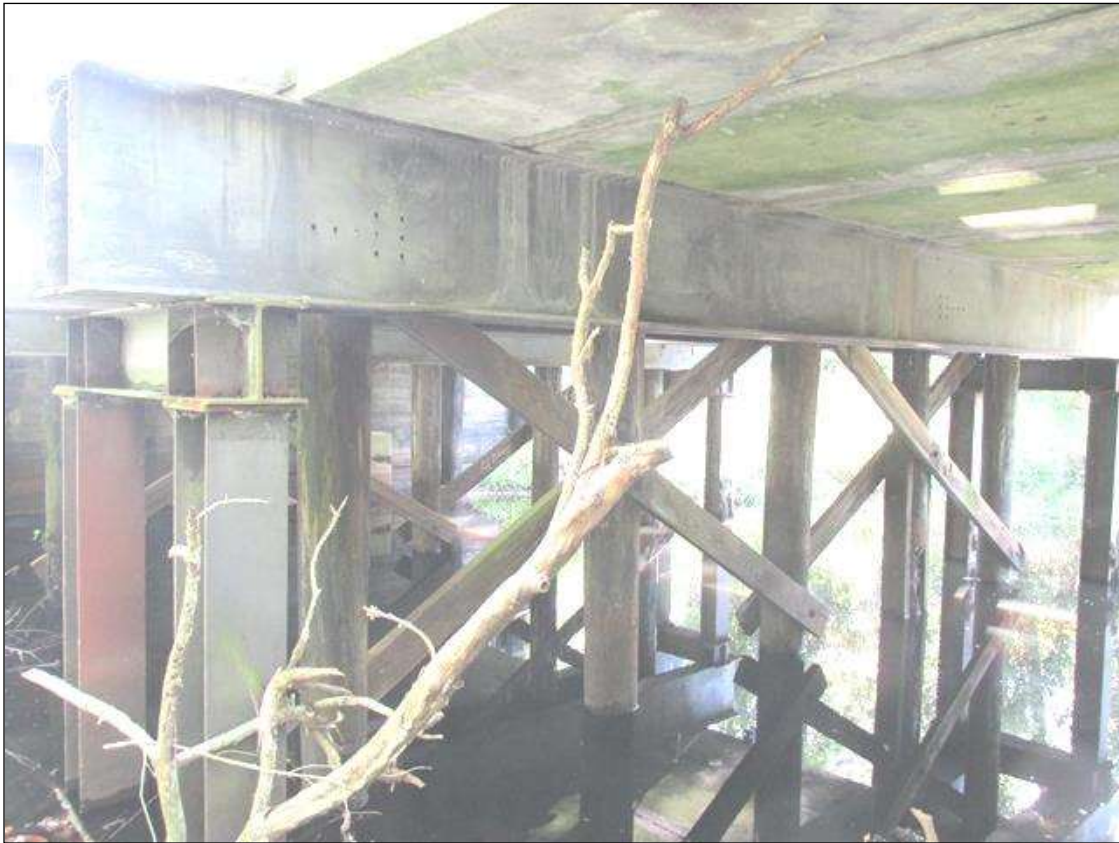
BENT 2, WITH STEEL CRUTCH BENT SPAN 2 SIDE, SIMILAR ON SPAN 3 SIDE, SHORED STRUCTURE
