NC DEPARTMENT OF TRANSPORTATION  
DIVISION OF HIGHWAYS  
BRIDGE MANAGEMENT UNIT

# BRIDGE INSPECTION REPORT

COUNTY ROBESON BRIDGE NUMBER 770432 INSPECTION CYCLE 2 YRS  
ROUTE SR1157 ACROSS BACK SWAMP CANAL M.P. 0

INSPECTION DATE 04/08/2014

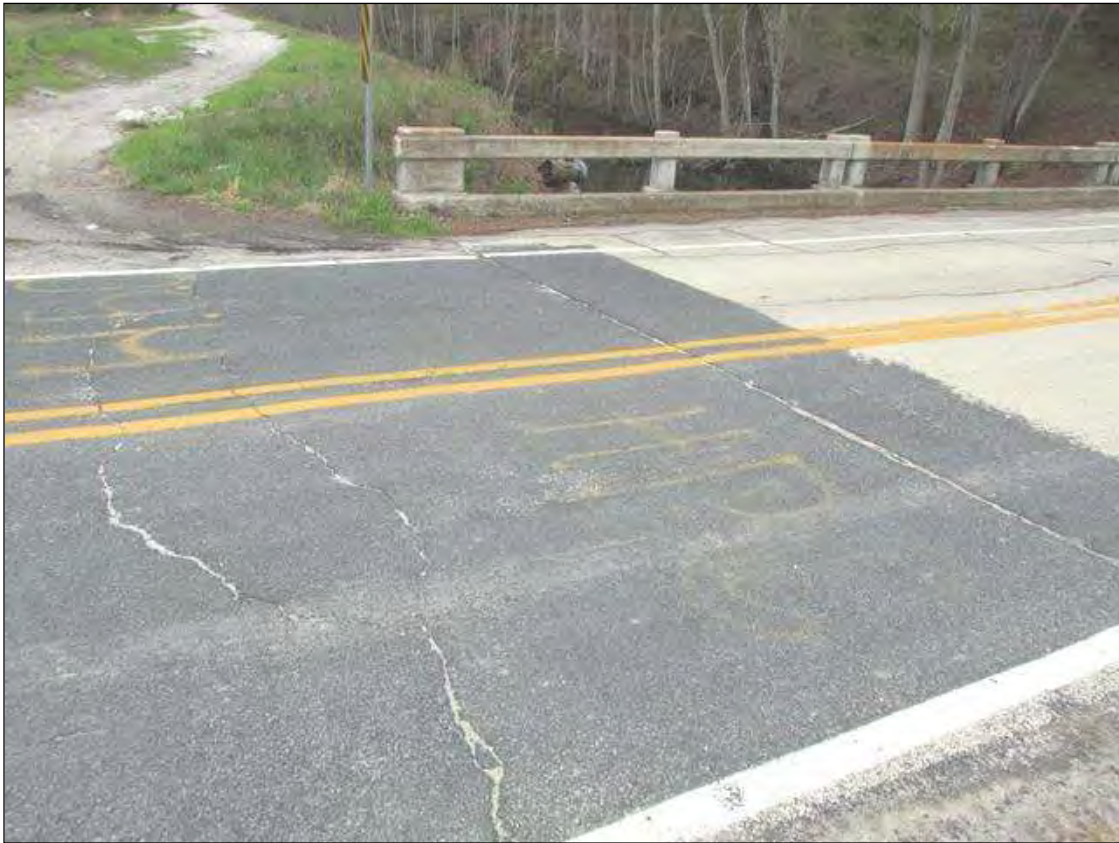
| 50 | F | ( APPROACH ROADWAYS ) THE SOUTH APPROACH ASPHALT WEARING SURFACE IS CRACKED UP TO 1/4" AND SETTLED UP TO 1/2". (PHOTO)<br><br>THE NORTH APPROACH ASPHALT WEARING SURFACE IS CRACKED AND SETTLED UP TO 3/4". (PHOTO)<br><br>THERE IS A 1/2" WIDE TRANSVERSE CRACK IN NORTH APPROACH ASPHALT WEARING SURFACE 10' FROM END BENT 2. (PHOTO) | |

SOUTH APPROACH ASPHALT WEARING SURFACE IS CRACKED UP TO 1/4" AND SETTLED UP TO 1/2"

| MMS Code | Description of Function | Unit | Quantity | Remarks | Est. Cost |
|---|---|---|---|---|---|
| 2816 | Asphalt Surface Repair or Replacement | SY | 2 | SOUTH APPROACH ASPHALT WEARING SURFACE IS CRACKED UP TO 1/4" AND SETTLED UP TO 1/2" | |

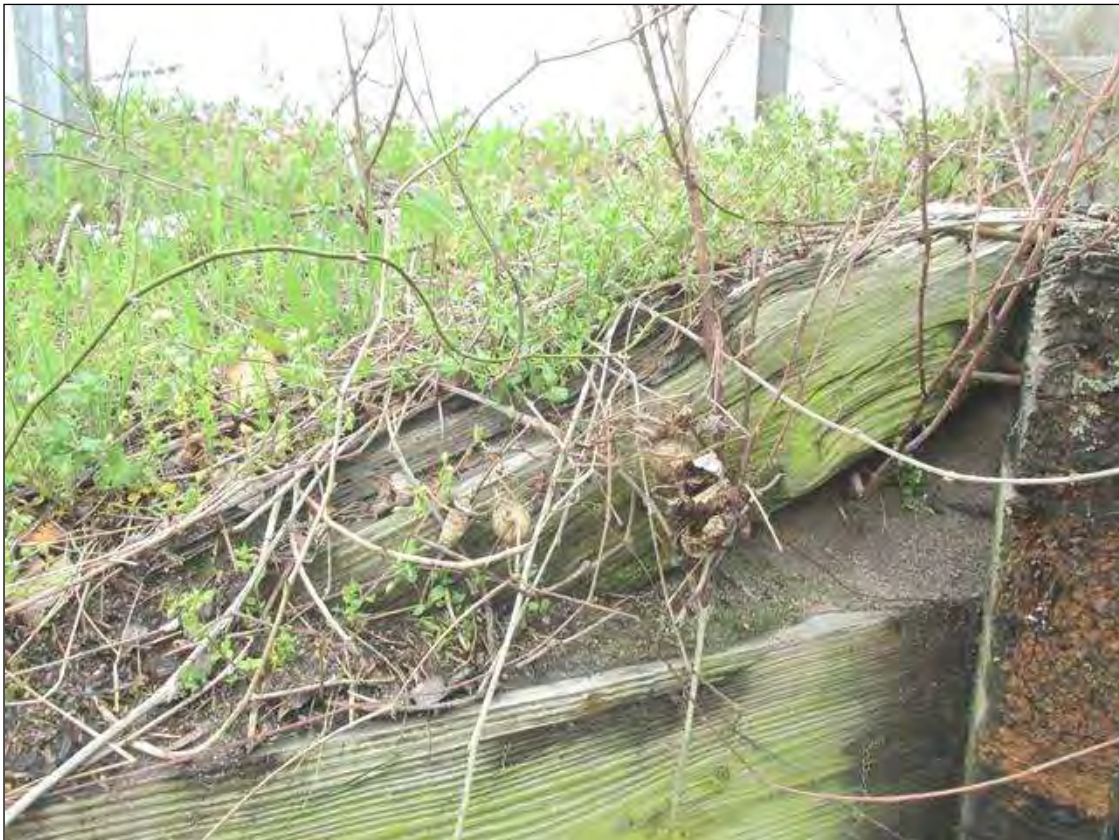
| Bridge I&A Form 1(82)H<br>State of North Carolina<br>Dept. of Transportation<br>Division of Highways | | <h1 style="text-align: center;">FIELD INSPECTION REPORT</h1> <p style="text-align: center;"><u>Bridge Inspeccion &amp; Analysis</u></p> | |
|---|---|---|--|
| 35c | F | ( TIMBER BULKHEAD AND WINGWALLS ) THE TOP WINGWALL BOARDS AT SOUTHEAST CORNER IS MISSING. (PHOTO)<br><br>THERE IS A DECAYED BULKHEAD BOARD AT END BENT 1 RIGHT OF PILE 3. (PHOTO)<br><br>END BENT 1 BULKHEAD BOARDS ARE LEAKING WATER BETWEEN PILES 1 AND 2. (PHOTO)<br><br>END BENT 1 BULKHEAD BOARDS ARE DECAYED AT SOUTHWEST CORNER. (PHOTO)<br><br>END BENT 1 WINGWALL AT SOUTHWEST CORNER IS DECAYED. (PHOTO)<br><br>END BENT 2 BULKHEAD IS DECAYED BETWEEN PILES 2 AND 3. (PHOTO)<br><br>THERE ARE DECAYED BULKHEAD BOARDS AT NORTHWEST CORNER. (PHOTO)<br><br>THERE ARE DECAYED BULKHEAD BOARDS AT NORTHEAST CORNER. (PHOTO)<br><br>END BENT 2 TURNPILE IS DECAYED AT GROUND LINE IN NORTHEAST CORNER. (PHOTO) | |

TOP WINGWALL BOARD AT SOUTHEAST CORNER IS MISSING

| MMS Code | Description of Function | Unit | Quantity | Remarks | Est. Cost |
|---|---|---|---|---|---|
| 3346 | Repair / Maintain Timber Wings & Blkhds | SF | 2 | TOP WINGWALL BOARD AT SOUTHEAST CORNER IS MISSING | |

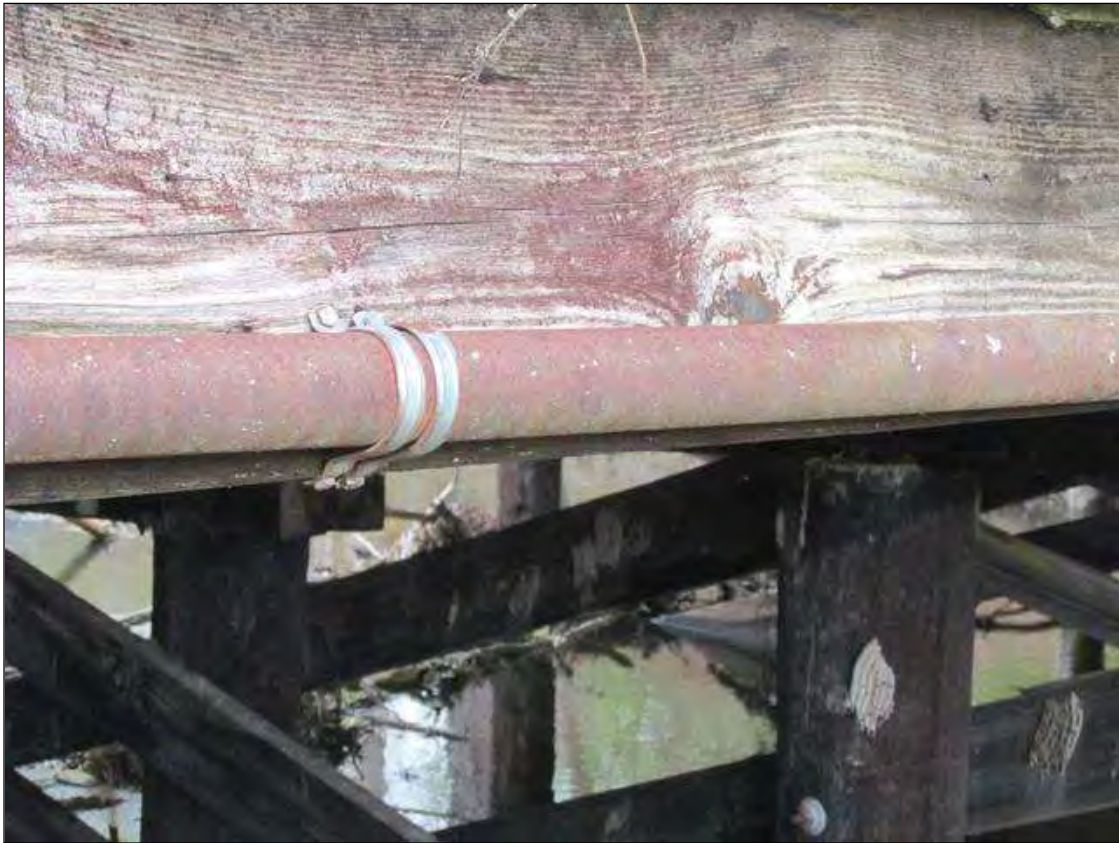
THERE IS A 2" STEEL PIPE ALONG RIGHT SIDE

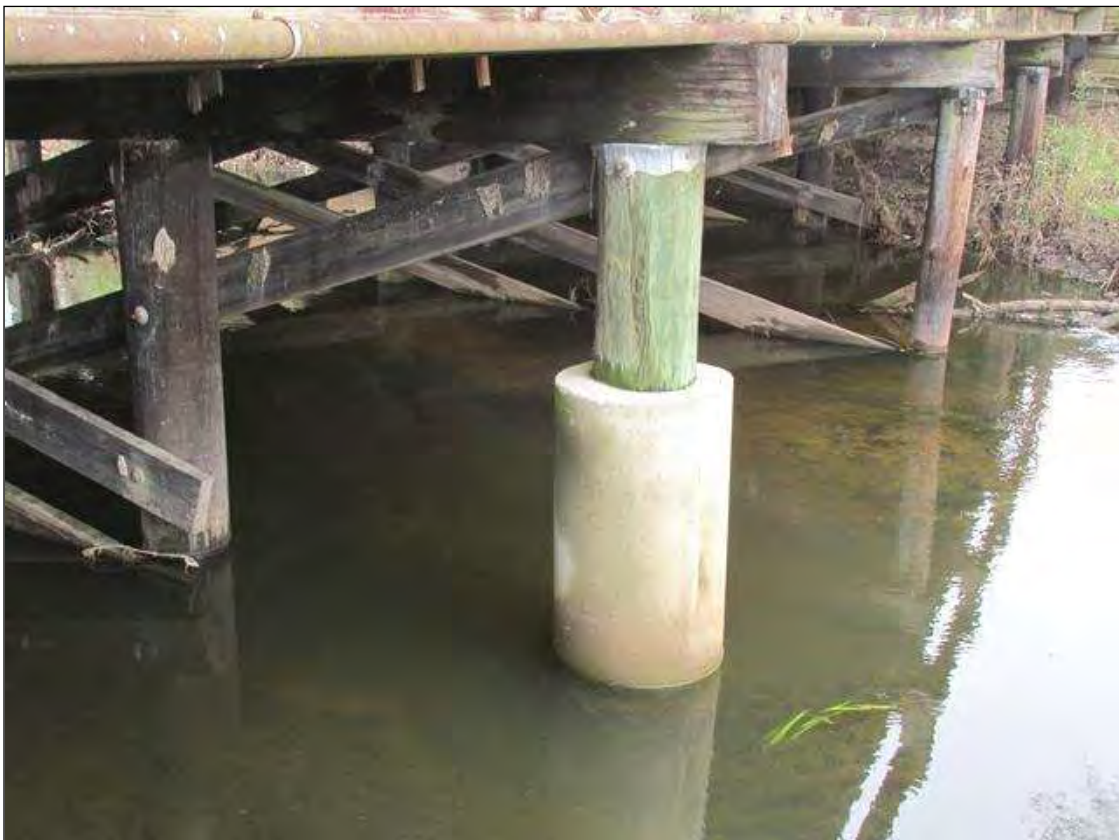
| Bridge I&A Form 1(82)H<br>State of North Carolina<br>Dept. of Transportation<br>Division of Highways | | <h1 style="text-align: center;">FIELD INSPECTION REPORT</h1> <p style="text-align: center;"><u>Bridge Inspeccion &amp; Analysis</u></p> | |
|---|---|---|--|
| 35b | F | THERE IS 1/4" CRACKING IN EAST END OF BENT 3 CAP. (PHOTO)<br>( TIMBER PILES ) PILE 5 AT BENT 1 IS ENCASED. (PHOTO)<br><br>PILE 3 AT END BENT 1 IS DELAMINATED GROUND UP 3' WITH 3/8" WIDE VERTICAL CHECK 2" DEEP. (PHOTO)<br><br>PILE 2 AT END BENT 2 IS ENCASED. (PHOTO)<br><br>PILE 1 AT BENT 3, SPAN 4 FACE IS DECAYED 18" HIGH X 4" WIDE X 2" DEEP. (PHOTO) | |

PILE 5 AT BENT 1 IS ENCASED

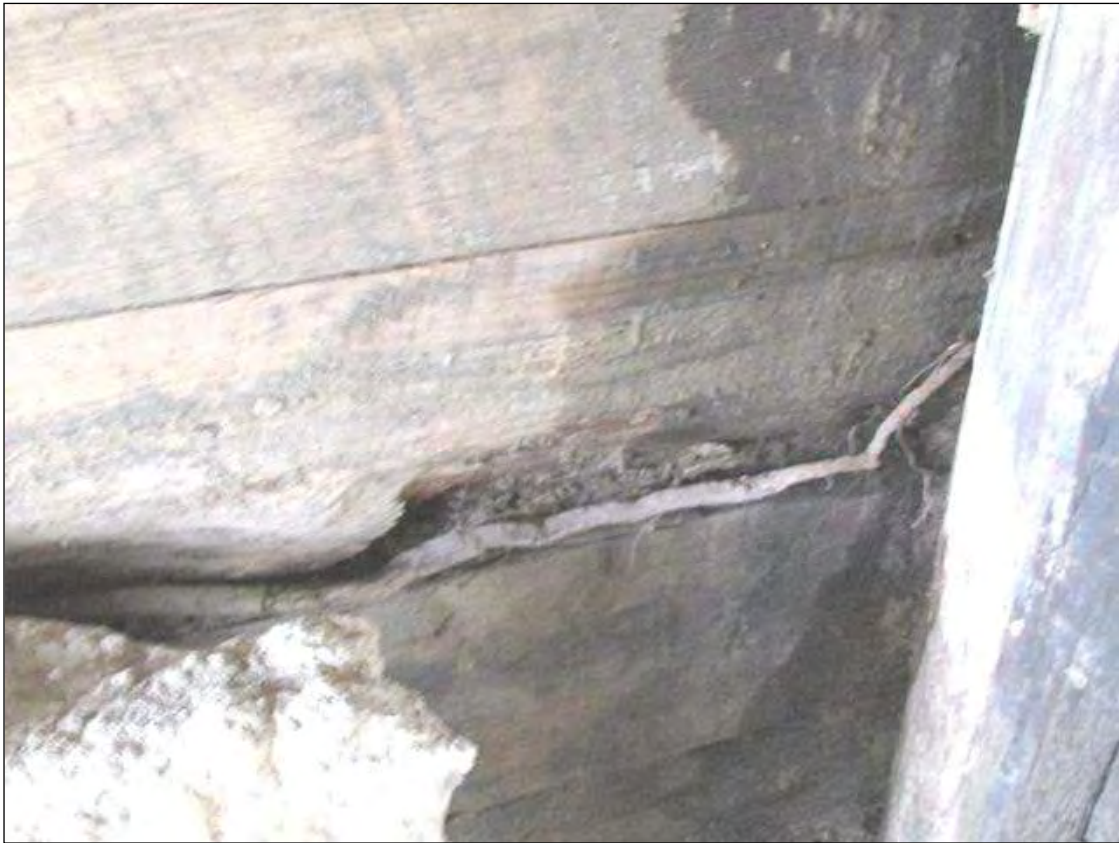
DECAYED BULKHEAD BOARD AT END BENT 1 RIGHT OF PILE 3

| MMS Code | Description of Function | Unit | Quantity | Remarks | Est. Cost |
|---|---|---|---|---|---|
| 3346 | Repair / Maintain Timber Wings & Blkhds | SF | 5 | DECAYED BULKHEAD BOARD AT END BENT 1 RIGHT OF PILE 3 | |

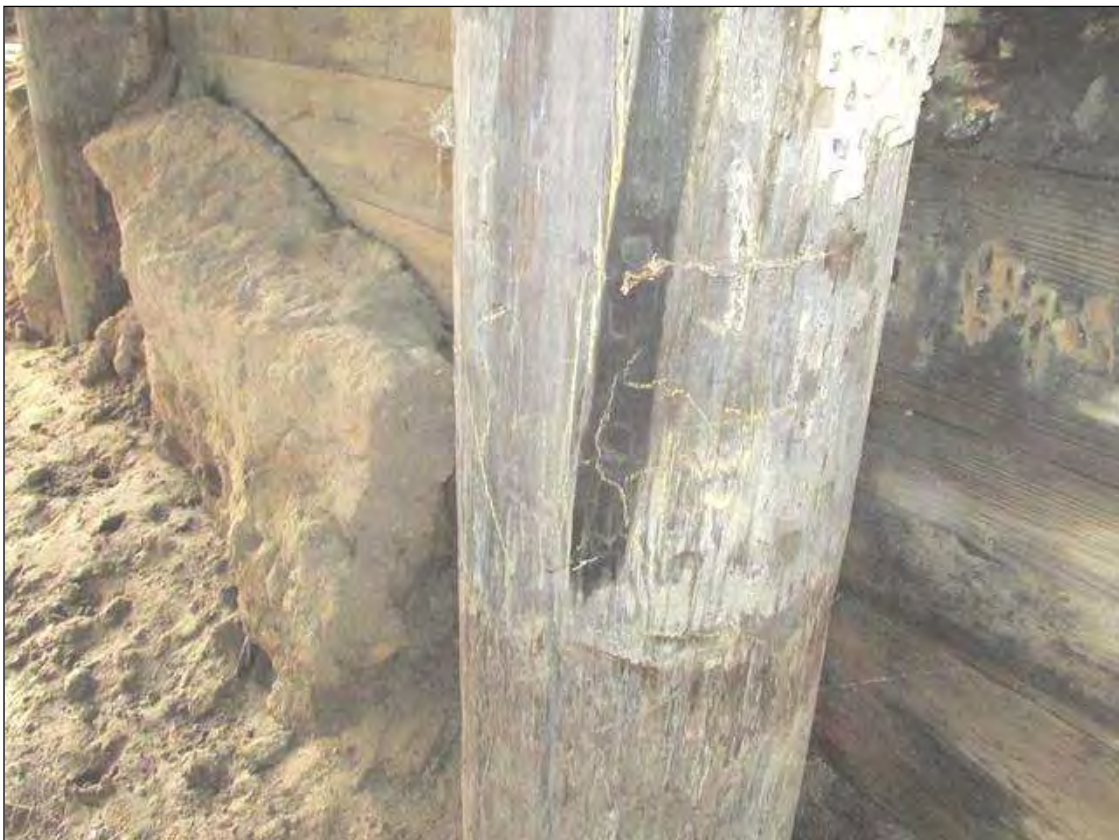
PILE 3 AT END BENT 1 IS DELAMINATED GROUND UP 3' WITH 3/8" WIDE VERTICAL CHECK 2" DEEP

| MMS Code | Description of Function | Unit | Quantity | Remarks | Est. Cost |
|---|---|---|---|---|---|
| 3344 | Repair / Replace Timber Substructure Components | LF | 5 | PILE 3 AT END BENT 1 IS DELAMINATED GROUND UP 3' WITH 3/8" WIDE VERTICAL CHECK 2" DEEP | |

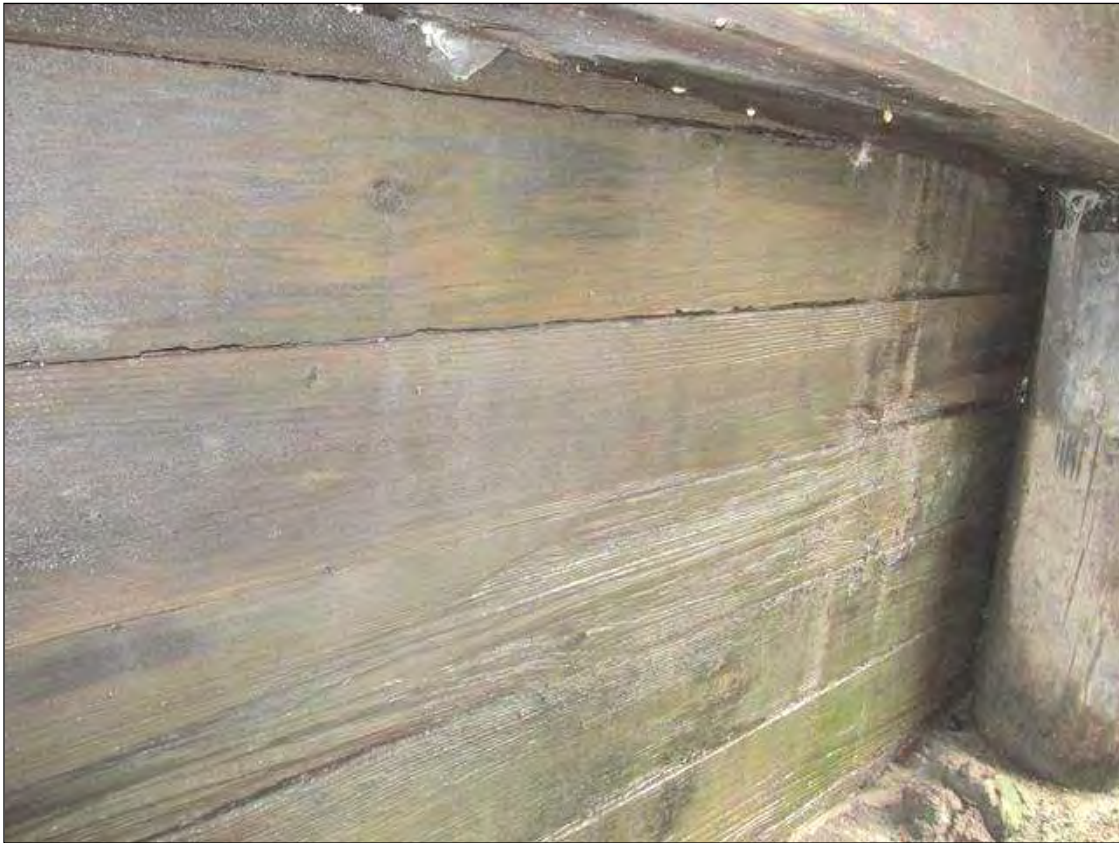
END BENT 1 BULKHEAD BOARDS ARE LEAKING WATER BETWEEN PILES 1 AND 2

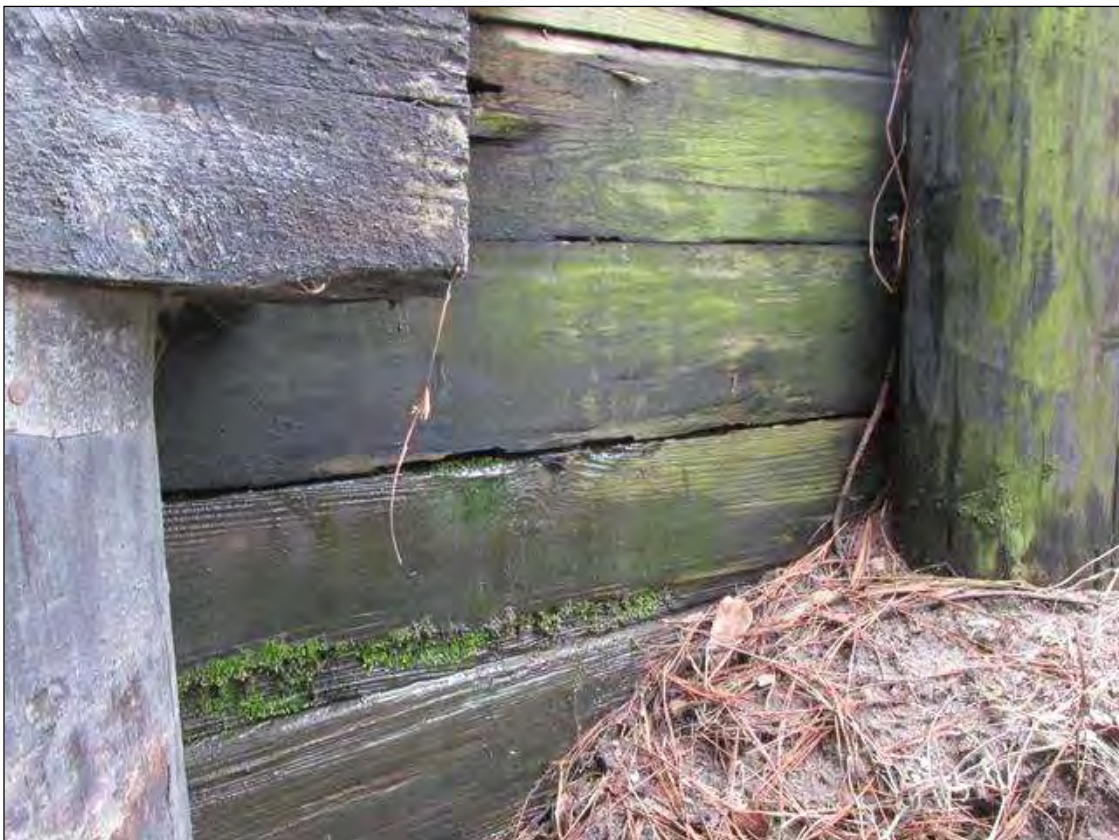
END BENT 1 BULKHEAD BOARDS DECAYED AT SOUTHWEST CORNER

| MMS Code | Description of Function | Unit | Quantity | Remarks | Est. Cost |
|---|---|---|---|---|---|
| 3346 | Repair / Maintain Timber Wings & Blkhds | SF | 4 | END BENT 1 BULKHEAD BOARDS DECAYED AT SOUTHWEST CORNER | |

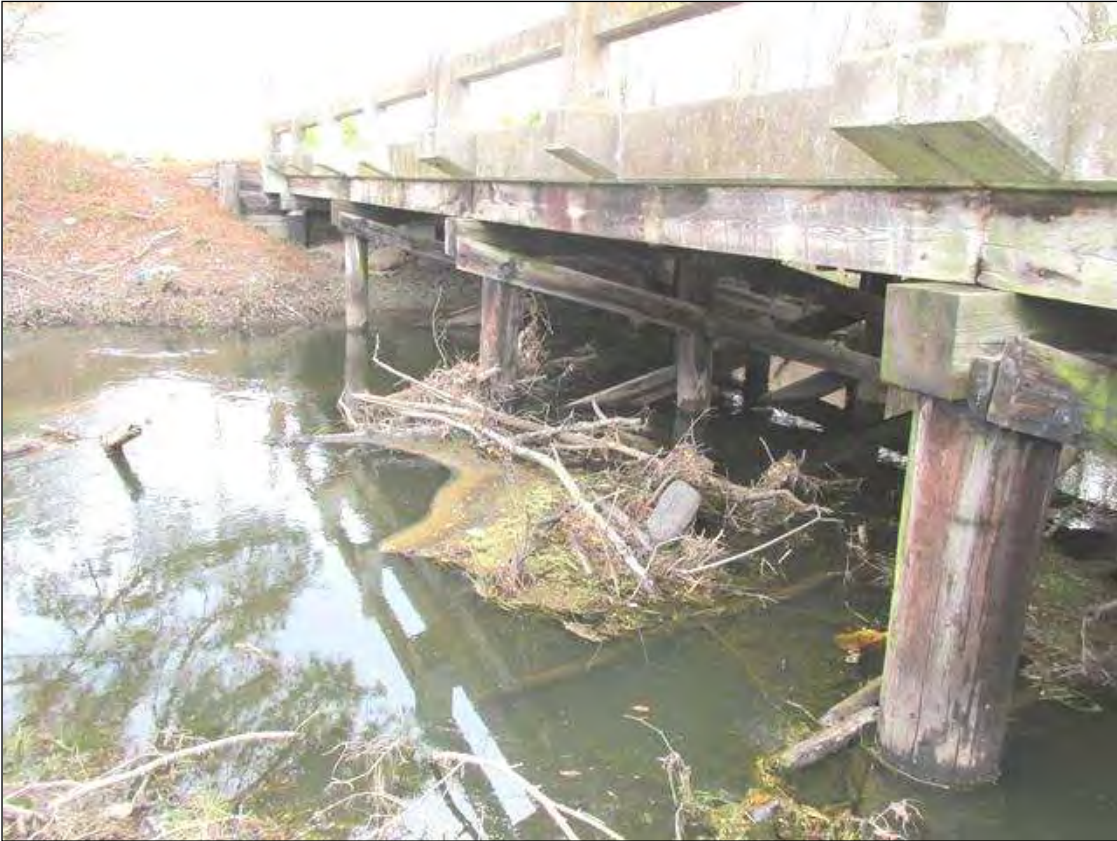
| Bridge I&A Form 1(82)H<br>State of North Carolina<br>Dept. of Transportation<br>Division of Highways | | <h1 style="text-align: center;">FIELD INSPECTION REPORT</h1> <p style="text-align: center;"><u>Bridge Inspeccion &amp; Analysis</u></p> | |
|---|---|---|--|
| 41 | P | ( DRIFT ) THERE IS DRIFT IN SPANS 2 AND 3 UP TO 10' LONG X 3' HIGH AT BENT 2 PILE 1. (PHOTO) | |

THERE IS DRIFT IN SPANS 2 AND 3 UP TO 10' LONG X 3' HIGH AT BENT 2 PILE 1

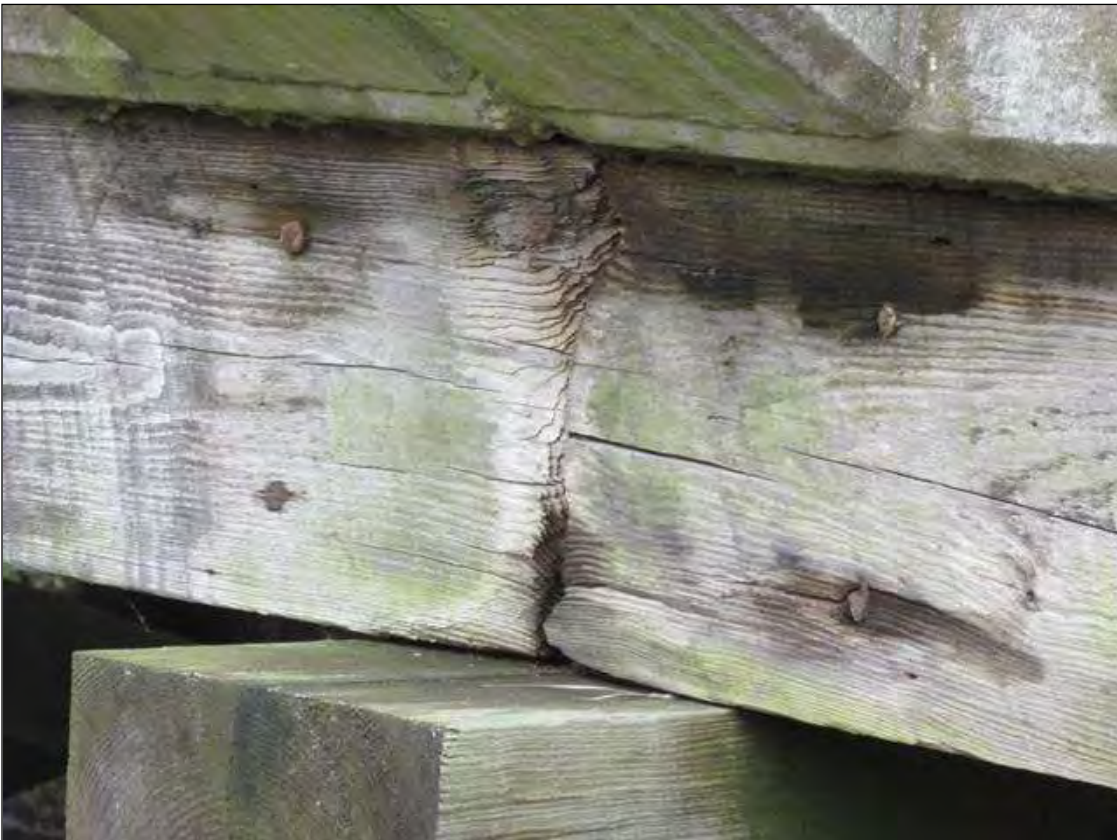
| Bridge I&A Form 1(82)H<br>State of North Carolina<br>Dept. of Transportation<br>Division of Highways | | <h1 style="text-align: center;">FIELD INSPECTION REPORT</h1> <p style="text-align: center;"><u>Bridge Inspection &amp; Analysis</u></p> | |
|---|---|---|--|
| 11 | F | ( TIMBER JOISTS ) JOIST 1 IN SPAN 1 AT BENT 1 IS DECAY ON THE EXTERIOR FACE 3" WIDE ALONG BOTTOM EDGE AND 1" DEEP. (PHOTO)<br><br>SEVERAL JOISTS EXHIBITS CHECKS TO 1/4" WIDE.<br><br>THERE ARE 1/16" VERTICAL CHECKS IN JOIST 1 AT SPAN 1 EXTERIOR FACE. (PHOTO)<br><br>JOIST 22 IN SPAN 4 HAS 1/4" WIDE CHECKS, SIMILAR IN ALL SPANS. (PHOTO) | |

JOIST 1 IN SPAN 1 AT BENT 1 IS SURFACE DECAYED ON EXTERIOR FACE 3" WIDE X 1" DEEP ALONG  
BOTTOM EDGE

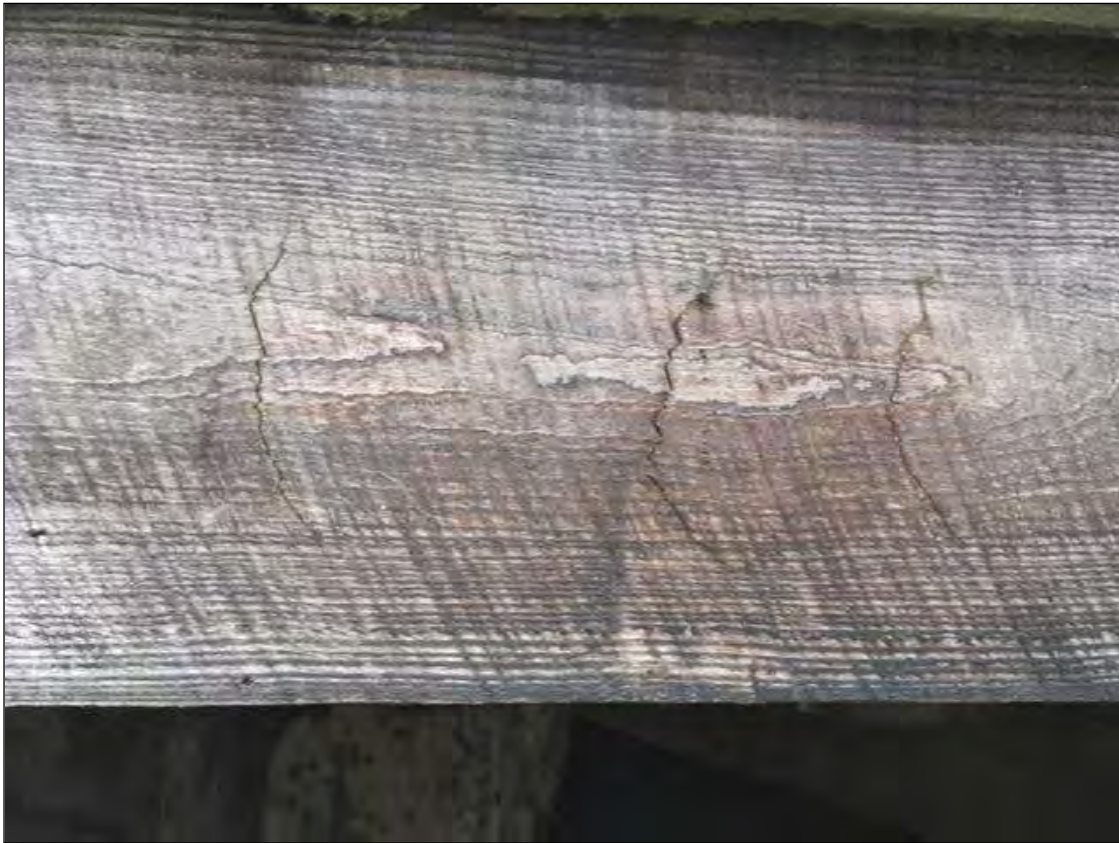
THERE ARE VERTICAL CHECKS IN JOIST 1 AT SPAN 1

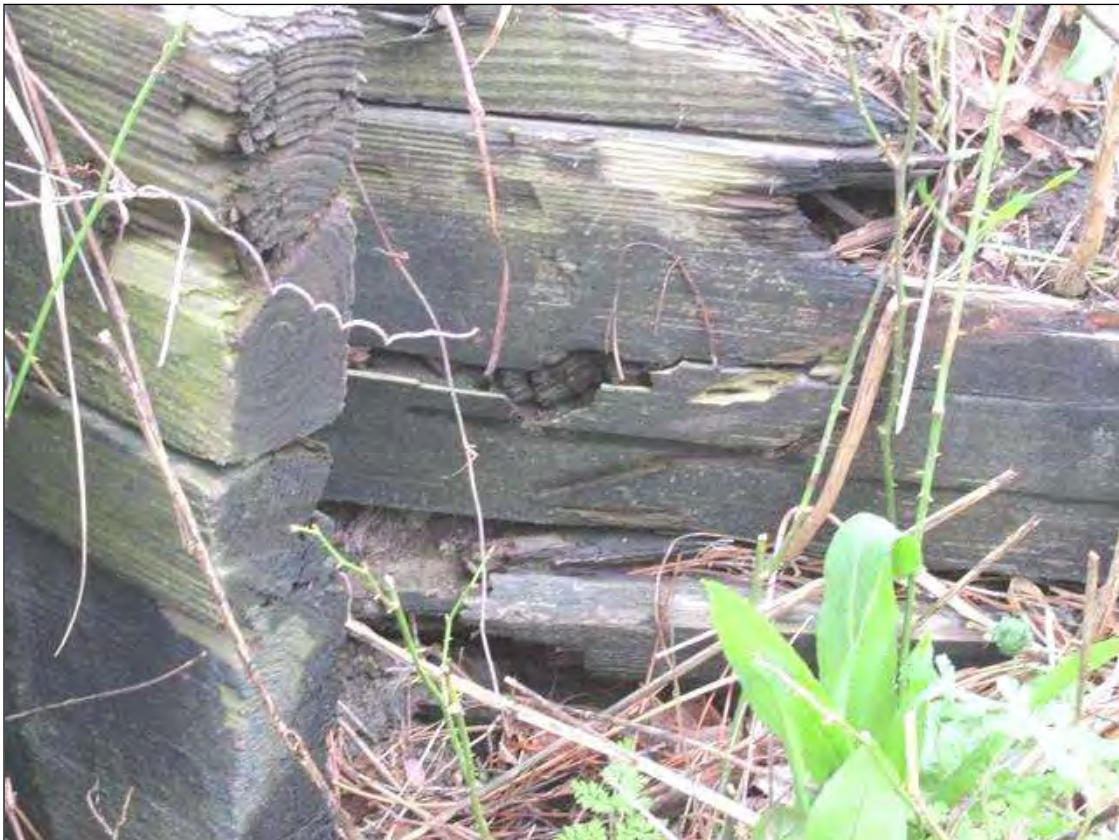
END BENT 1 WINGWALL AT SOUTHWEST CORNER IS DECAYED

| MMS Code | Description of Function | Unit | Quantity | Remarks | Est. Cost |
|---|---|---|---|---|---|
| 3346 | Repair / Maintain Timber Wings & Blkhds | SF | 4 | END BENT 1 WINGWALL AT SOUTHWEST CORNER IS DECAYED | |

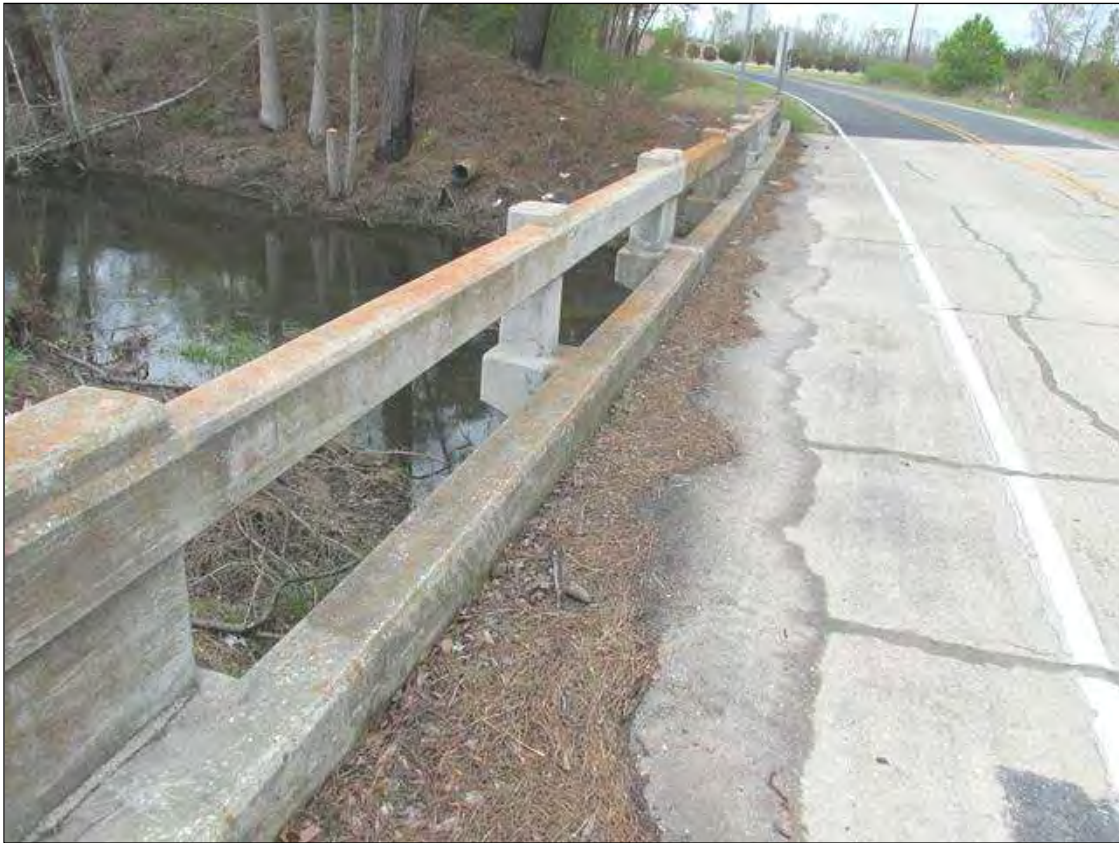
| Bridge I&A Form 1(82)H<br>State of North Carolina<br>Dept. of Transportation<br>Division of Highways | | <h1 style="text-align: center;">FIELD INSPECTION REPORT</h1> <p style="text-align: center;"><u>Bridge Inspection &amp; Analysis</u></p> | |
|---|---|---|--|
| 7 | F | ( DECK DEBRIS ) THERE IS DEBRIS ALONG LEFT CURB. (PHOTO)<br><br>THERE IS SCATTERED DEBRIS ALONG RIGHT CURB. (PHOTO) | |

DEBRIS ALONG LEFT CURB

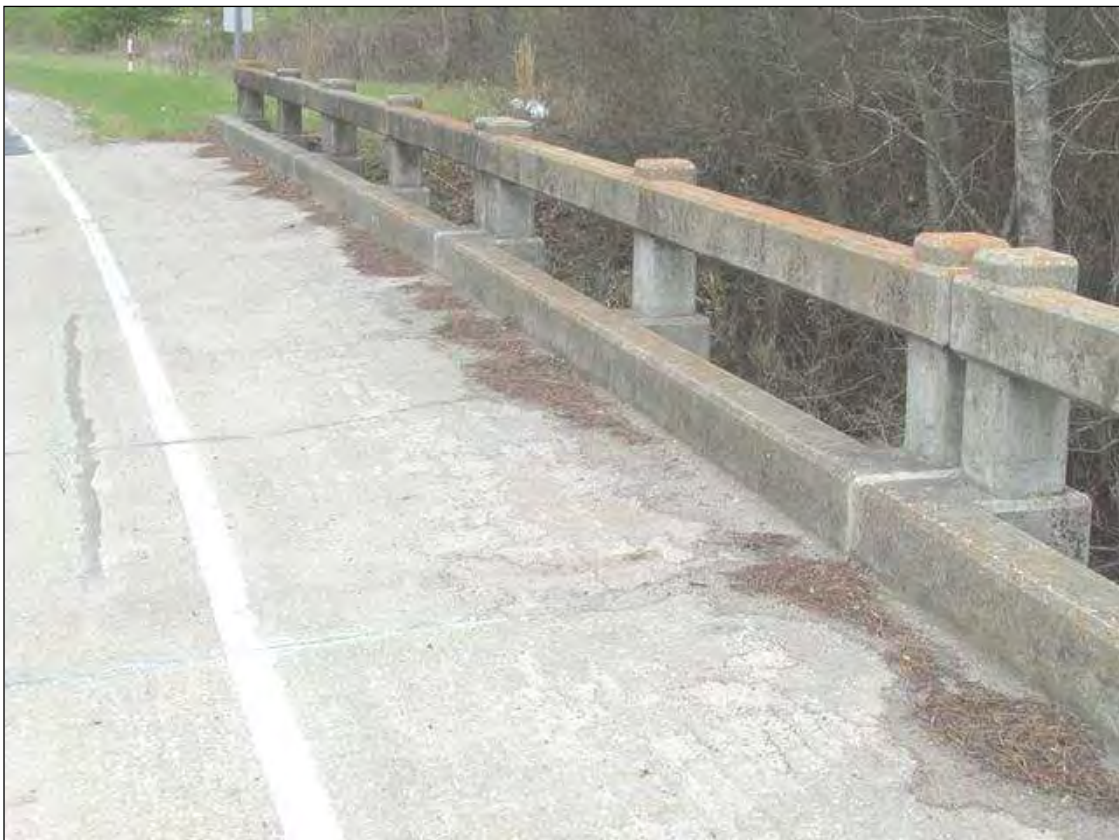
THERE IS SCATTERED DEBRIS ALONG RIGHT CURB

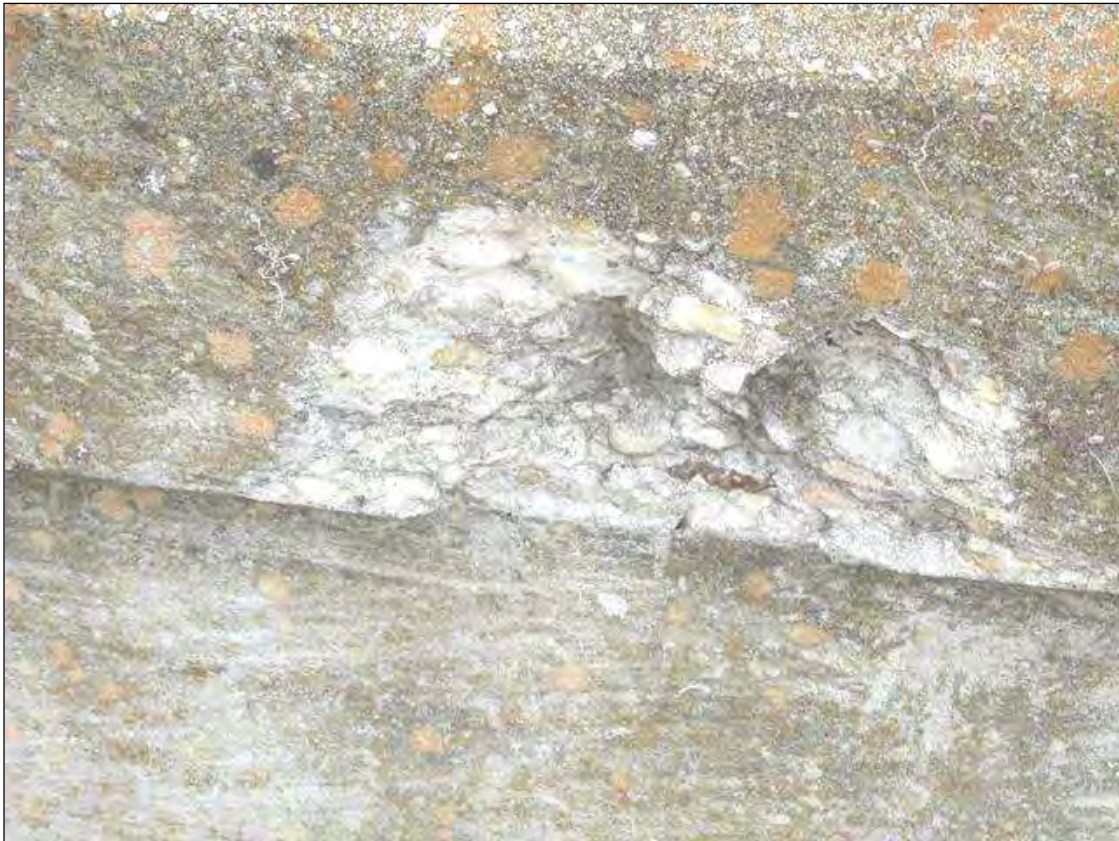
| Bridge I&A Form 1(82)H<br>State of North Carolina<br>Dept. of Transportation<br>Division of Highways | | <h1 style="text-align: center;">FIELD INSPECTION REPORT</h1> <p style="text-align: center;"><u>Bridge Inspection &amp; Analysis</u></p> | |
|---|---|---|--|
| 3a | G | ( RC RAILS ) THE RIGHT RAIL END POST IS SPALLED 10" LONG X 7" HIGH X 1 1/2" DEEP. (PHOTO)<br><br>THERE IS HAIRLINE MAP CRACKING IN LEFT RAIL REPAIRED AREA IN SPANS 1 AND 2. (PHOTO)<br><br>THE LEFT RAIL END POST IS SPALLED 6" DIAMETER X 1 1/2" DEEP AT NORTHWEST CORNER. (PHOTO) | |

RIGHT RAIL END POST IS SPALLED 10" LONG X 7" HIGH X 1 1/2" DEEP

| MMS Code | Description of Function | Unit | Quantity | Remarks | Est. Cost |
|---|---|---|---|---|---|
| 3318 | Maint to Concrete Handrail | LF | 1 | RIGHT RAIL END POST IS SPALLED 10" LONG X 7" HIGH X 1 1/2" DEEP | |

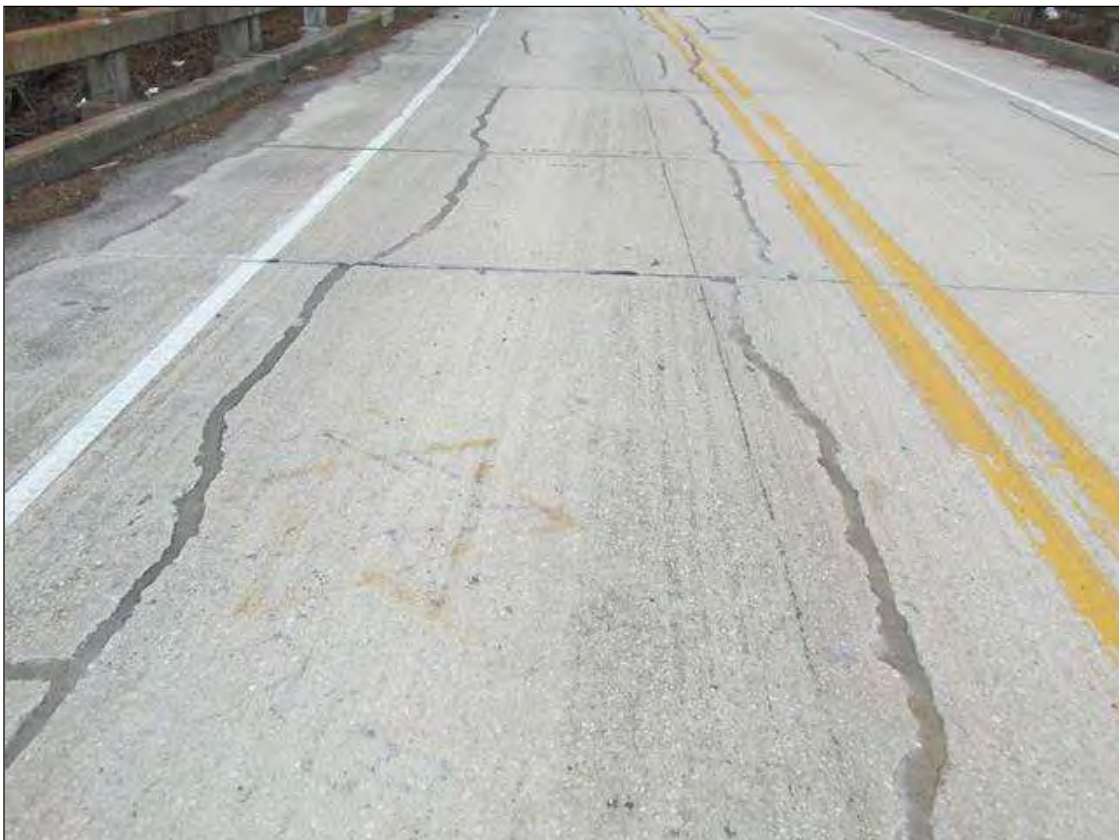
| Bridge I&A Form 1(82)H<br>State of North Carolina<br>Dept. of Transportation<br>Division of Highways | | <h1 style="text-align: center;">FIELD INSPECTION REPORT</h1> <p style="text-align: center;"><u>Bridge Inspection &amp; Analysis</u></p> | |
|---|---|---|--|
| 2a | F | ( RC DECK ) THERE IS PATCHED CRACKING IN SPANS 1 AND 2. ALL SPANS ARE SIMILAR. (PHOTO)<br><br>THERE ARE PATCHED LONGITUDINAL CRACKS AND MAP CRACKING IN DECK. (PHOTO)<br><br>THERE ARE TWO DECK PATCHES AT BENT 3 IN SPANS 3 AND 4, OVER CRUTCH PILES. (PHOTO)<br><br>THERE ARE HAIRLINE TRANSVERSE AND LONGITUDINAL CRACKS IN SPAN 4 DECK. (PHOTO)<br><br>THERE IS A 1/16" TRANSVERSE CRACK IN SPAN 4 DECK OVER END BENT 2 CURTAIN WALL. (PHOTO) | |

PATCHED CRACKING IN SPANS 1 AND 2

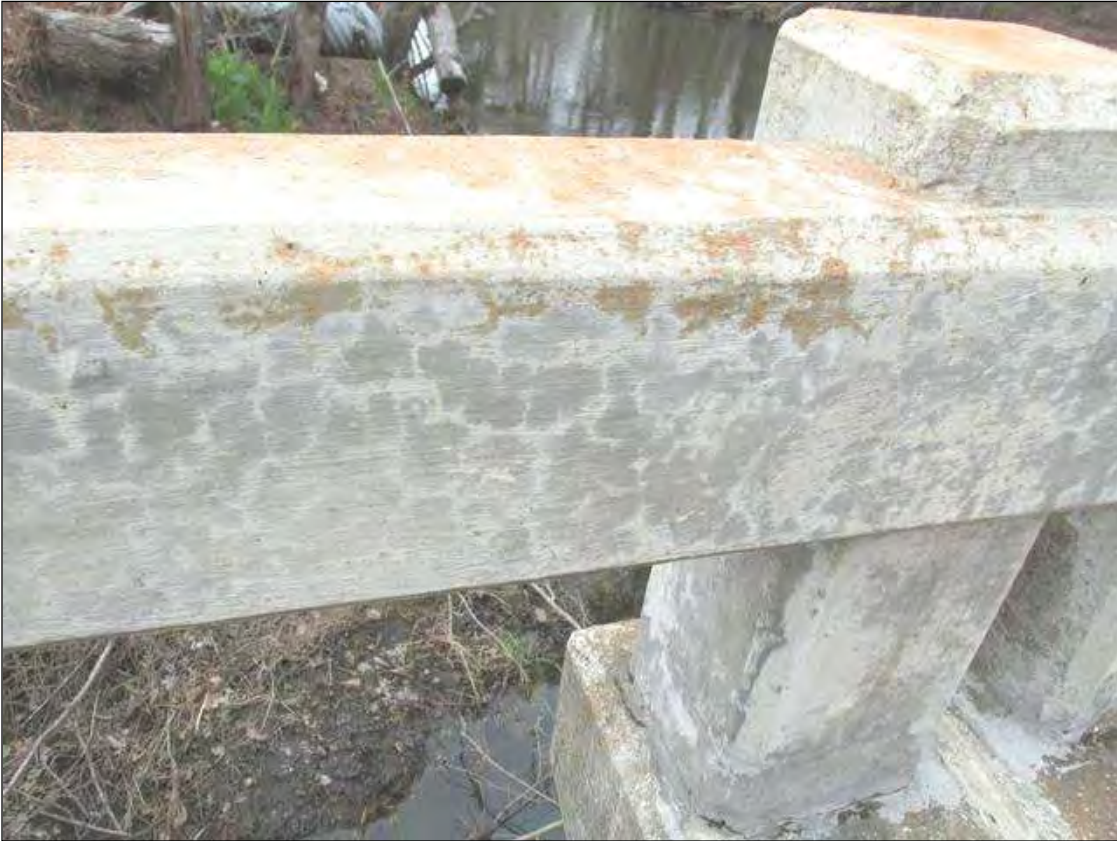
HAIRLINE MAP CRACKING IN LEFT RAIL REPAIRED AREA IN SPANS 1 AND 2

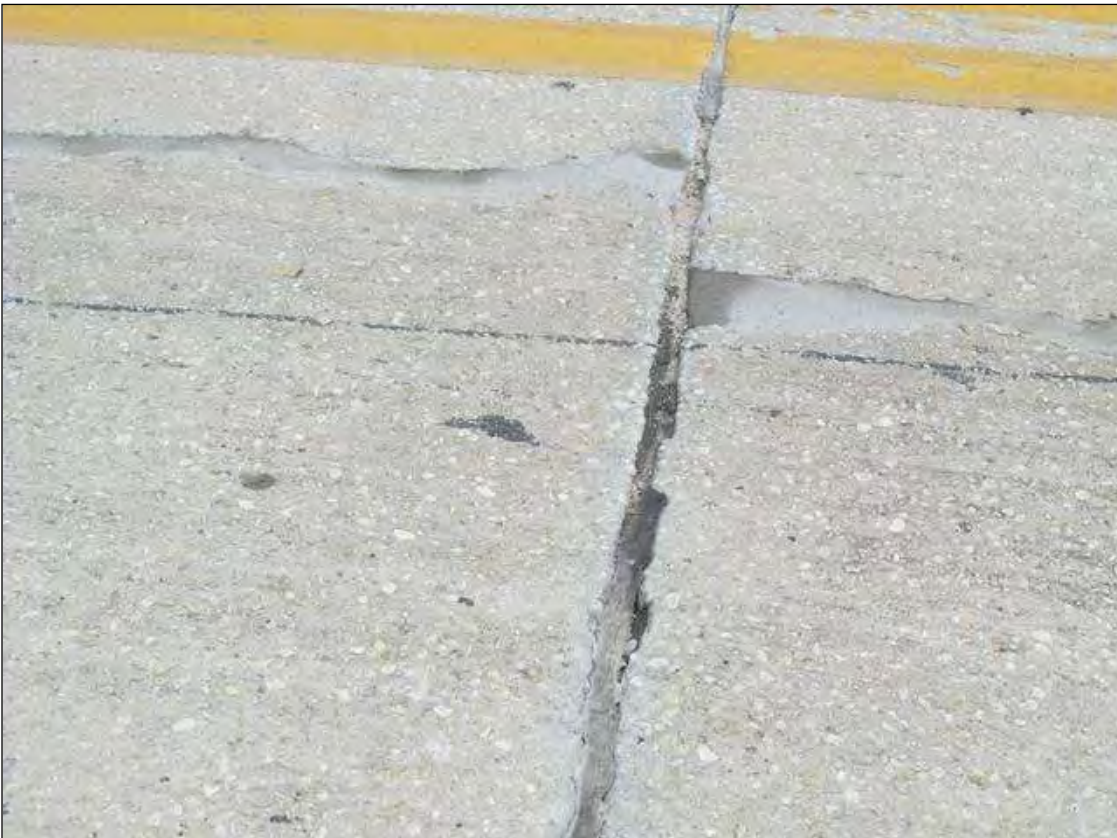
| Bridge I&A Form 1(82)H<br>State of North Carolina<br>Dept. of Transportation<br>Division of Highways | | <h1 style="text-align: center;">FIELD INSPECTION REPORT</h1> <p style="text-align: center;"><u>Bridge Inspection &amp; Analysis</u></p> | |
|---|---|---|--|
| 6d | P | ( STANDARD JOINTS ) BENT 1 STANDARD JOINT HAS MISSING MATERIAL IN NORTH BOUND LANE AND SOUTH BOUND LANE. (PHOTO)<br><br>THERE IS MISSING JOINT MATERIAL AT BENT 3 STANDARD JOINT. (PHOTO)<br><br>BENT 3 STANDARD JOINT IS DETERIORATED IN SOUTH BOUND LANE. (PHOTO) | |

BENT 1 STANDARD JOINT HAS MISSING MATERIAL IN NORTH BOUND LANE AND SOUTH BOUND LANE

| MMS Code | Description of Function | Unit | Quantity | Remarks | Est. Cost |
|---|---|---|---|---|---|
| 3310 | Maintenance/Repair/Replacement of Standard Bridge Expansion Joints | LF | 28 | BENT 1 STANDARD JOINT HAS MISSING MATERIAL IN NORTH BOUND LANE AND SOUTH BOUND LANE | |

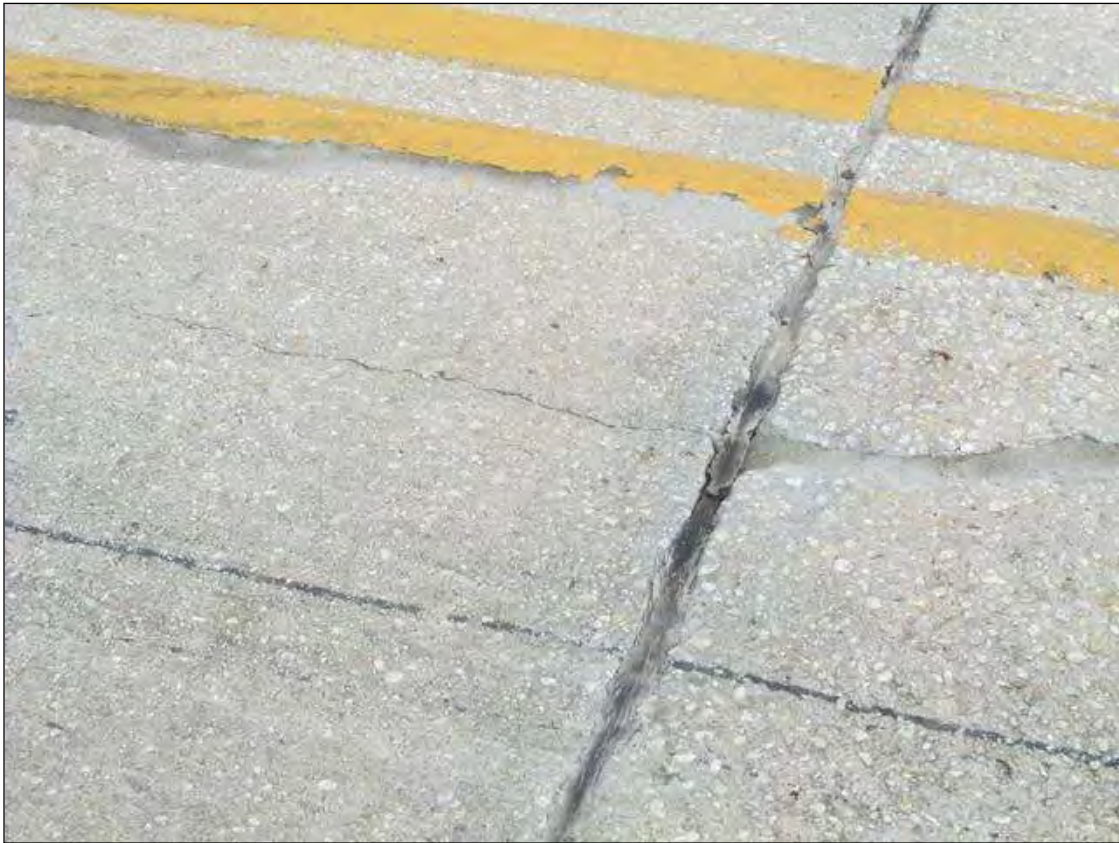
MISSING JOINT MATERIAL AT BENT 3 STANDARD JOINT

| MMS Code | Description of Function | Unit | Quantity | Remarks | Est. Cost |
|---|---|---|---|---|---|
| 3310 | Maintenance/Repair/Replacement of Standard Bridge Expansion Joints | LF | 28 | MISSING JOINT MATERIAL AT BENT 3 STANDARD JOINT | |

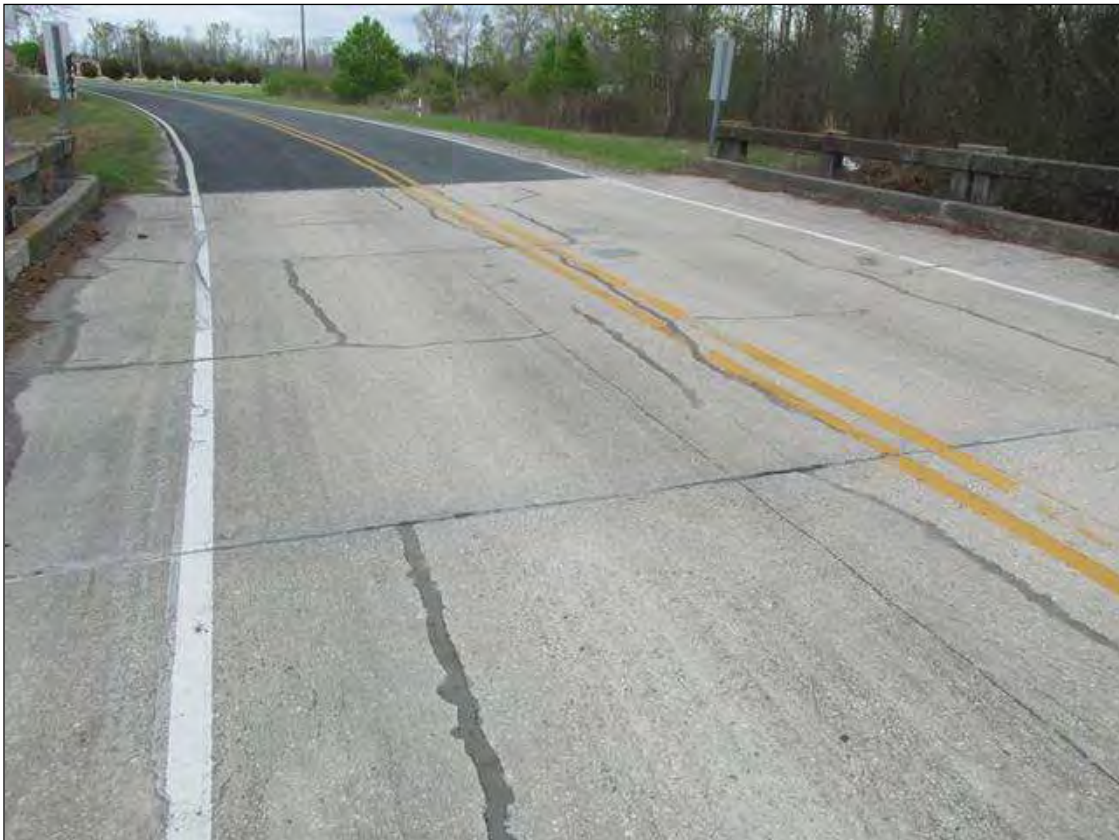
PATCHED LONGITUDINAL CRACKS AND MAP CRACKING IN DECK

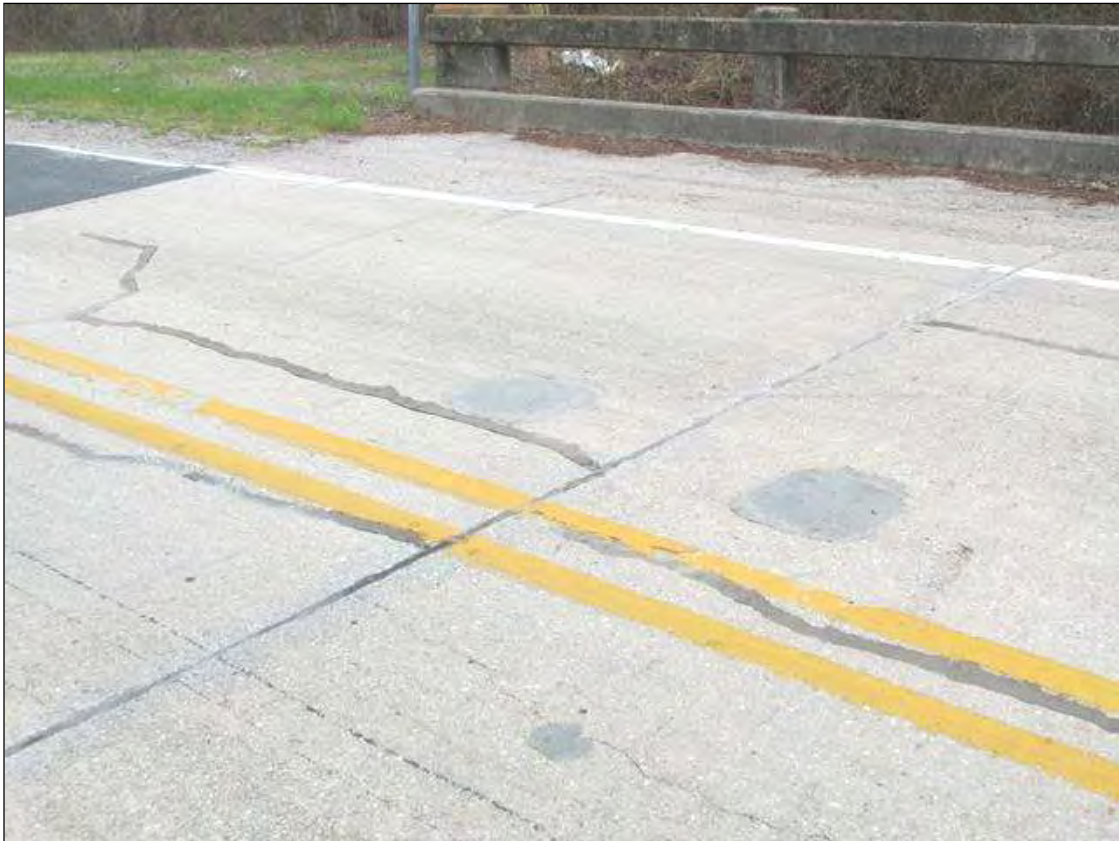
TWO DECK PATCHES AT BENT 3 IN SPANS 3 AND 4, OVER CRUTCH PILES

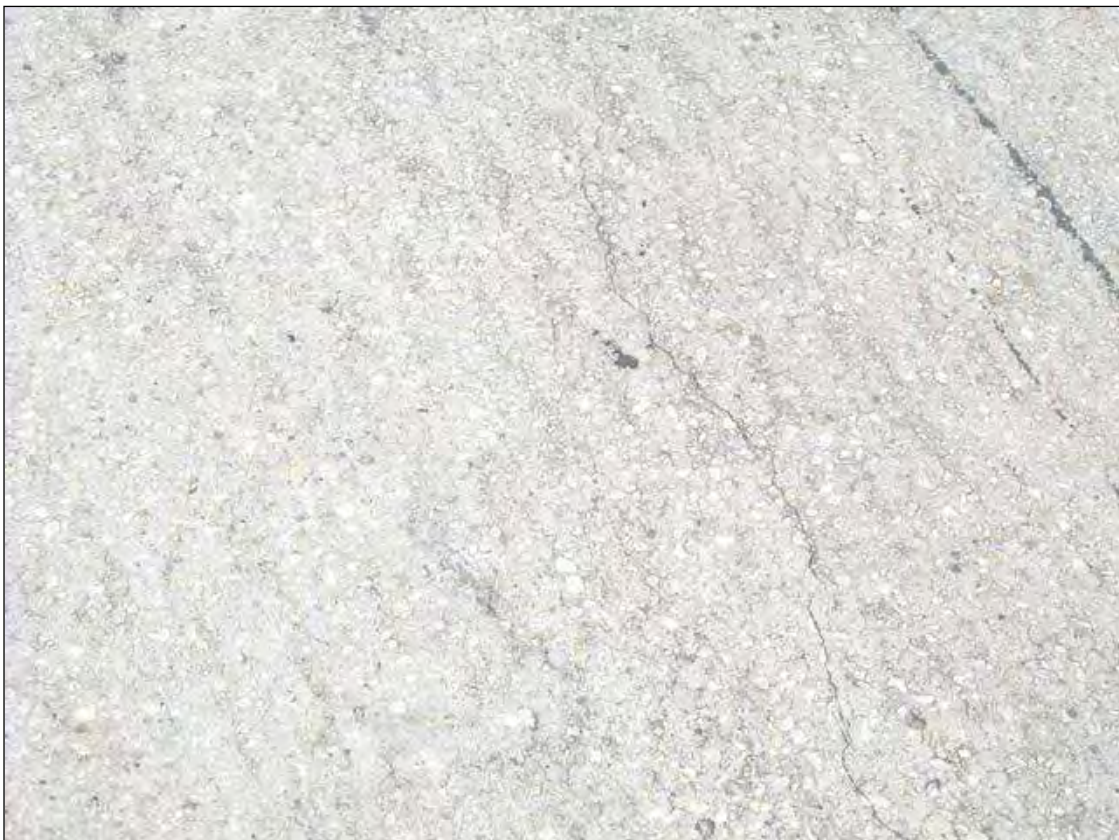
HAIRLINE TRANSVERSE AND LONGITUDINAL CRACKS IN SPAN 4 DECK
