NC DEPARTMENT OF TRANSPORTATION  
DIVISION OF HIGHWAYS  
BRIDGE MANAGEMENT UNIT

# BRIDGE INSPECTION REPORT

COUNTY ROBESON BRIDGE NUMBER 770432 INSPECTION CYCLE 2 YRS  
ROUTE SR1157 ACROSS BACK SWAMP CANAL M.P. 0

INSPECTION DATE 04/08/2014

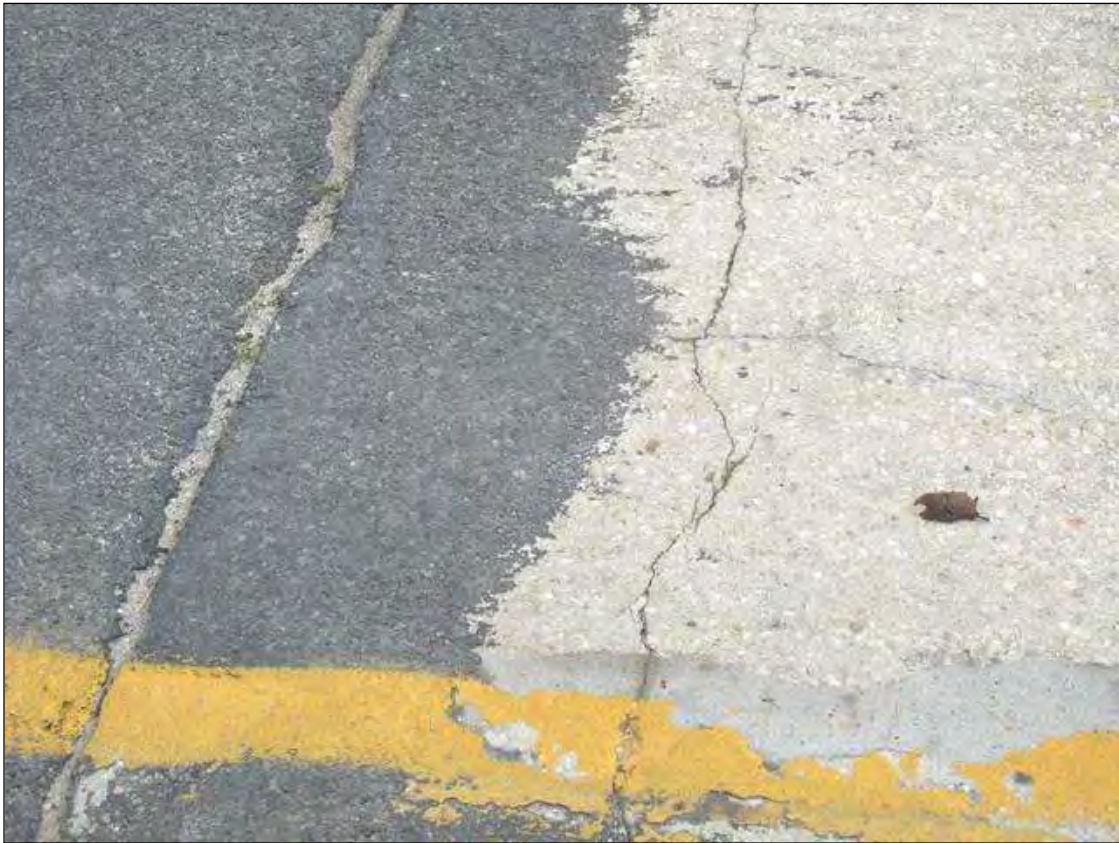
| Bridge I&A Form 1(82)H<br>State of North Carolina<br>Dept. of Transportation<br>Division of Highways | | <h1 style="text-align: center;">FIELD INSPECTION REPORT</h1> <p style="text-align: center;"><u>Bridge Inspection &amp; Analysis</u></p> | |
|---|---|---|--|
| 2a | F | ( RC DECK ) THERE IS PATCHED CRACKING IN SPANS 1 AND 2. ALL SPANS ARE SIMILAR. (PHOTO)<br><br>THERE ARE PATCHED LONGITUDINAL CRACKS AND MAP CRACKING IN DECK. (PHOTO)<br><br>THERE ARE TWO DECK PATCHES AT BENT 3 IN SPANS 3 AND 4, OVER CRUTCH PILES. (PHOTO)<br><br>THERE ARE HAIRLINE TRANSVERSE AND LONGITUDINAL CRACKS IN SPAN 4 DECK. (PHOTO)<br><br>THERE IS A 1/16" TRANSVERSE CRACK IN SPAN 4 DECK OVER END BENT 2 CURTAIN WALL. (PHOTO) | |

1/16" TRANSVERSE CRACK IN SPAN 4 DECK OVER END BENT 2 CURTAIN WALL

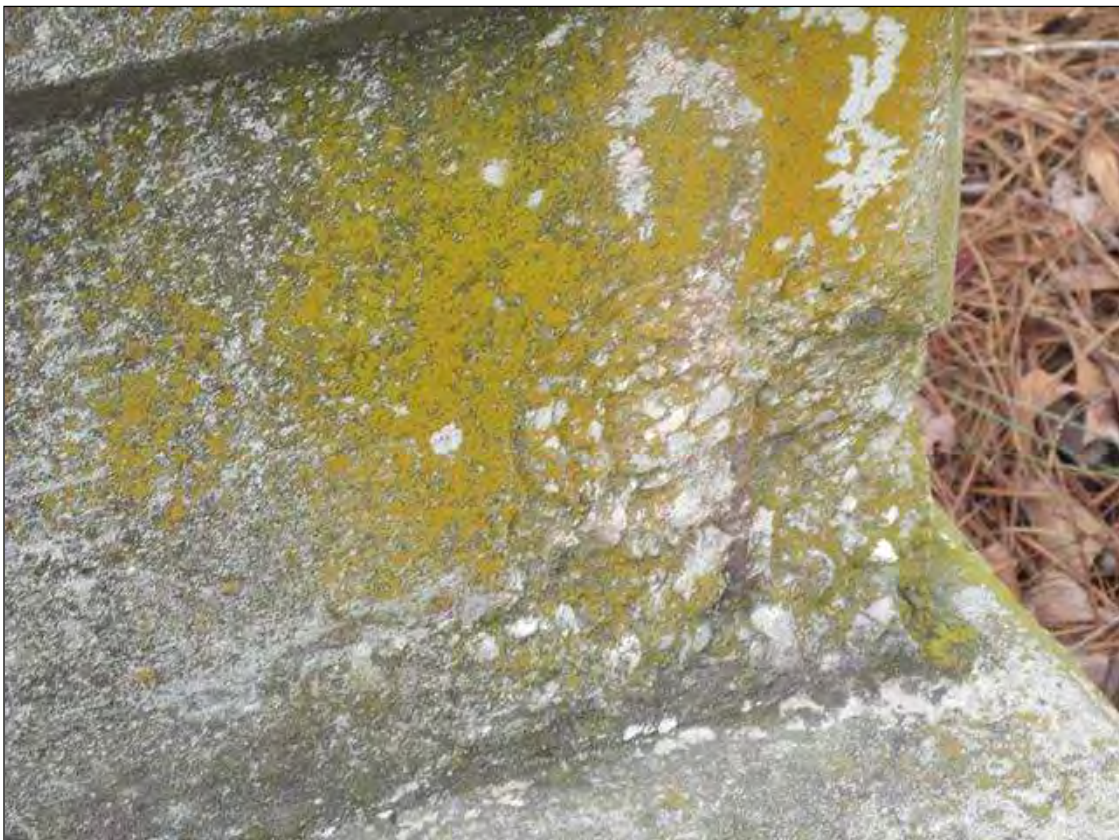
| Bridge I&A Form 1(82)H<br>State of North Carolina<br>Dept. of Transportation<br>Division of Highways | | <h1 style="text-align: center;">FIELD INSPECTION REPORT</h1> <p style="text-align: center;"><u>Bridge Inspection &amp; Analysis</u></p> | |
|---|---|---|--|
| 3a | G | ( RC RAILS ) THE RIGHT RAIL END POST IS SPALLED 10" LONG X 7" HIGH X 1 1/2" DEEP. (PHOTO)<br><br>THERE IS HAIRLINE MAP CRACKING IN LEFT RAIL REPAIRED AREA IN SPANS 1 AND 2. (PHOTO)<br><br>THE LEFT RAIL END POST IS SPALLED 6" DIAMETER X 1 1/2" DEEP AT NORTHWEST CORNER. (PHOTO) | |

LEFT RAIL END POST IS SPALLED 6" DIAMETER X 1 1/2" DEEP AT NORTHWEST CORNER

| MMS Code | Description of Function | Unit | Quantity | Remarks | Est. Cost |
|---|---|---|---|---|---|
| 3318 | Maint to Concrete Handrail | LF | 1 | LEFT RAIL END POST IS SPALLED 6" DIAMETER X 1 1/2" DEEP AT NORTHWEST CORNER | |

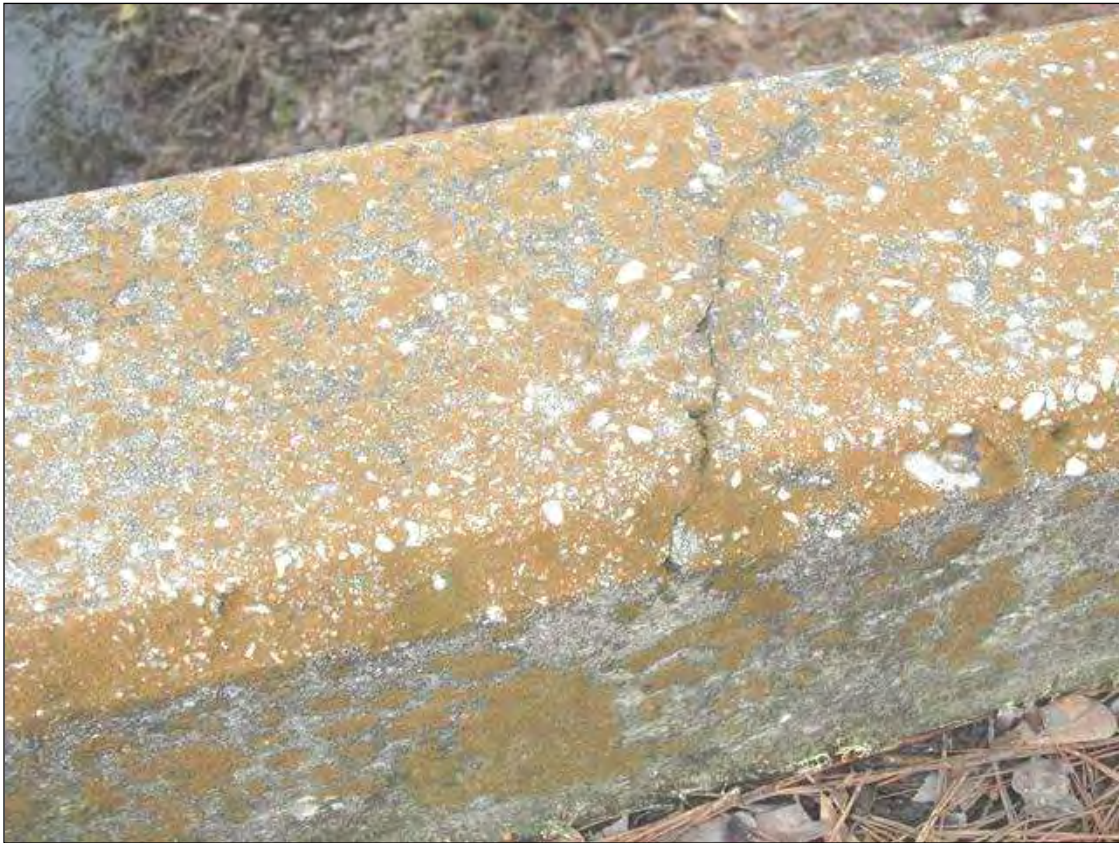
| Bridge I&A Form 1(82)H<br>State of North Carolina<br>Dept. of Transportation<br>Division of Highways | | <h1 style="text-align: center;">FIELD INSPECTION REPORT</h1> <p style="text-align: center;"><u>Bridge Inspection &amp; Analysis</u></p> | |
|---|---|---|--|
| 4 | G | ( CONC CURBS ) THE LEFT CURB IS CRACKED AT BENT 3. (PHOTO) | |

LEFT CURB IS CRACKED AT BENT 3

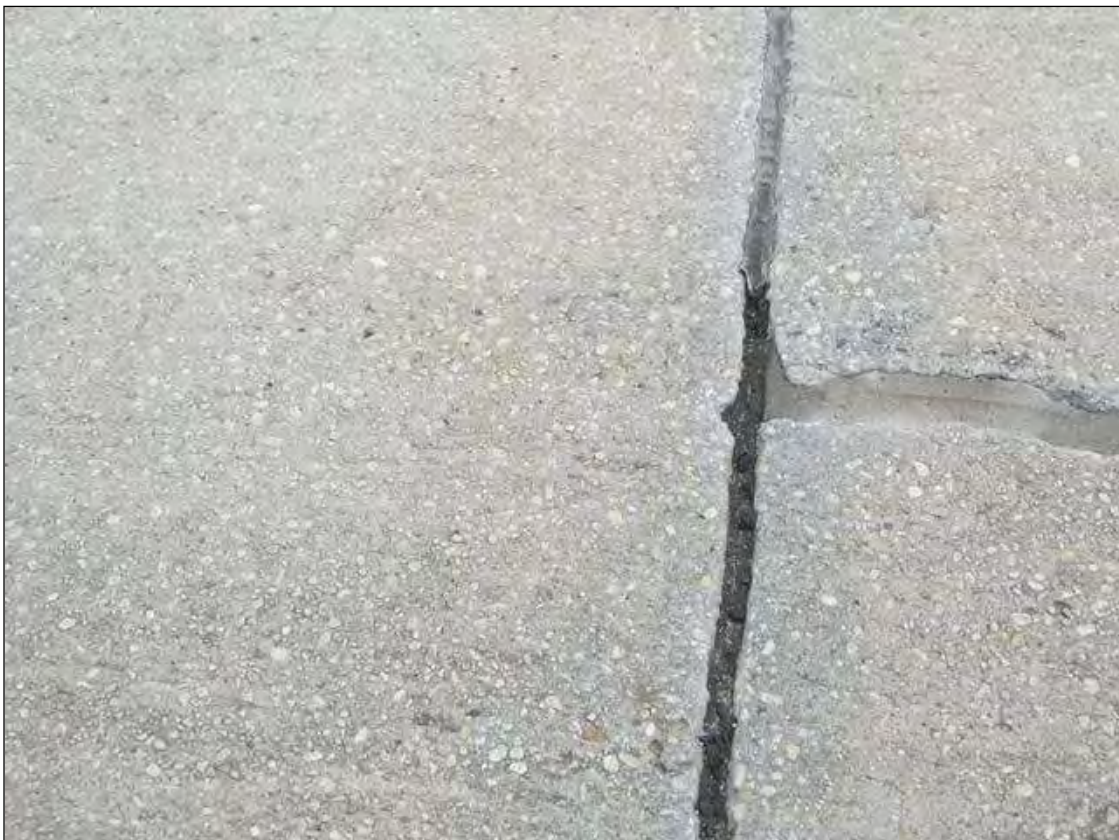
| Bridge I&A Form 1(82)H<br>State of North Carolina<br>Dept. of Transportation<br>Division of Highways | | <h1 style="text-align: center;">FIELD INSPECTION REPORT</h1> <p style="text-align: center;"><u>Bridge Inspection &amp; Analysis</u></p> | |
|---|---|---|--|
| 6d | P | ( STANDARD JOINTS ) BENT 1 STANDARD JOINT HAS MISSING MATERIAL IN NORTH BOUND LANE AND SOUTH BOUND LANE. (PHOTO)<br><br>THERE IS MISSING JOINT MATERIAL AT BENT 3 STANDARD JOINT. (PHOTO)<br><br>BENT 3 STANDARD JOINT IS DETERIORATED IN SOUTH BOUND LANE. (PHOTO) | |

BENT 3 STANDARD JOINT IS DETERIORATED IN SOUTH BOUND LANE

| MMS Code | Description of Function | Unit | Quantity | Remarks | Est. Cost |
|---|---|---|---|---|---|
| 3310 | Maintenance/Repair/Replacement of Standard Bridge Expansion Joints | LF | 28 | BENT 3 STANDARD JOINT IS DETERIORATED IN SOUTH BOUND LANE | |

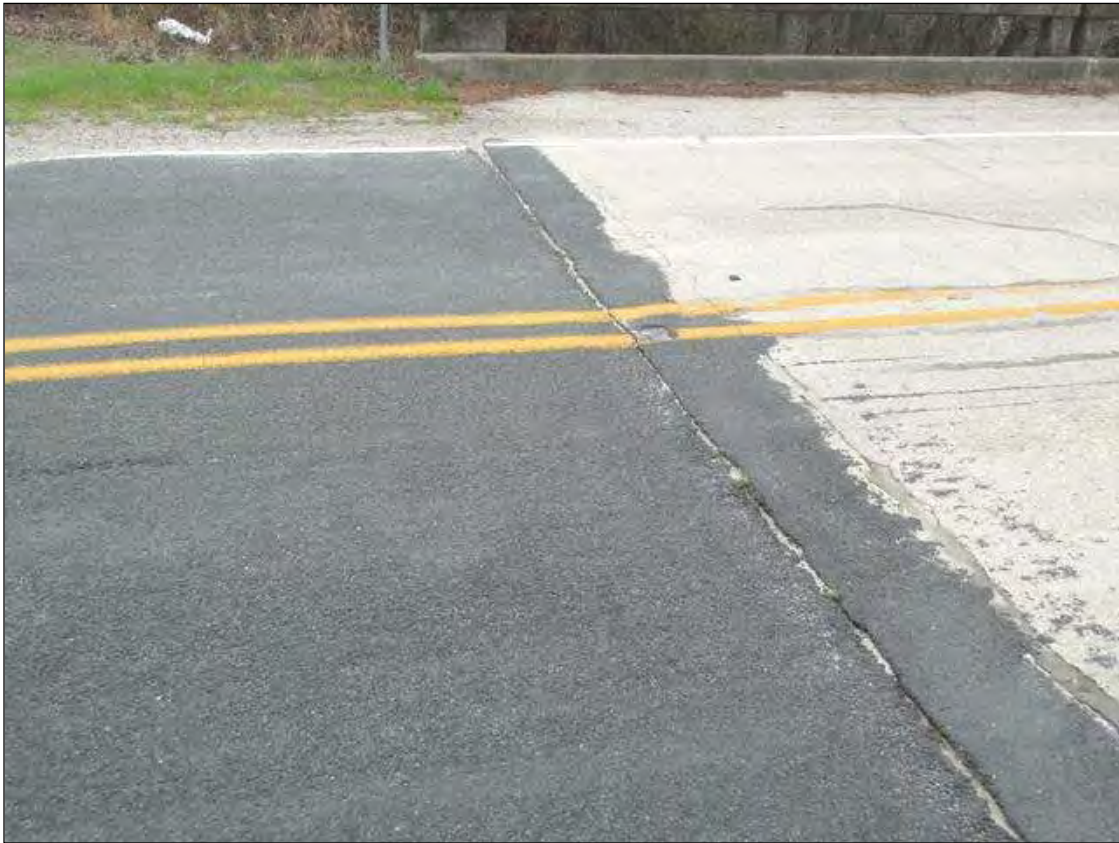
| 50 | F | ( APPROACH ROADWAYS ) THE SOUTH APPROACH ASPHALT WEARING SURFACE IS CRACKED UP TO 1/4" AND SETTLED UP TO 1/2". (PHOTO)<br><br>THE NORTH APPROACH ASPHALT WEARING SURFACE IS CRACKED AND SETTLED UP TO 3/4". (PHOTO)<br><br>THERE IS A 1/2" WIDE TRANSVERSE CRACK IN NORTH APPROACH ASPHALT WEARING SURFACE 10' FROM END BENT 2. (PHOTO) | |

NORTH APPROACH ASPHALT WEARING SURFACE IS CRACKED AND SETTLED UP TO 3/4'

| MMS Code | Description of Function | Unit | Quantity | Remarks | Est. Cost |
|---|---|---|---|---|---|
| 2816 | Asphalt Surface Repair or Replacement | SY | 2 | NORTH APPROACH ASPHALT WEARING SURFACE IS CRACKED AND SETTLED UP TO 3/4' | |

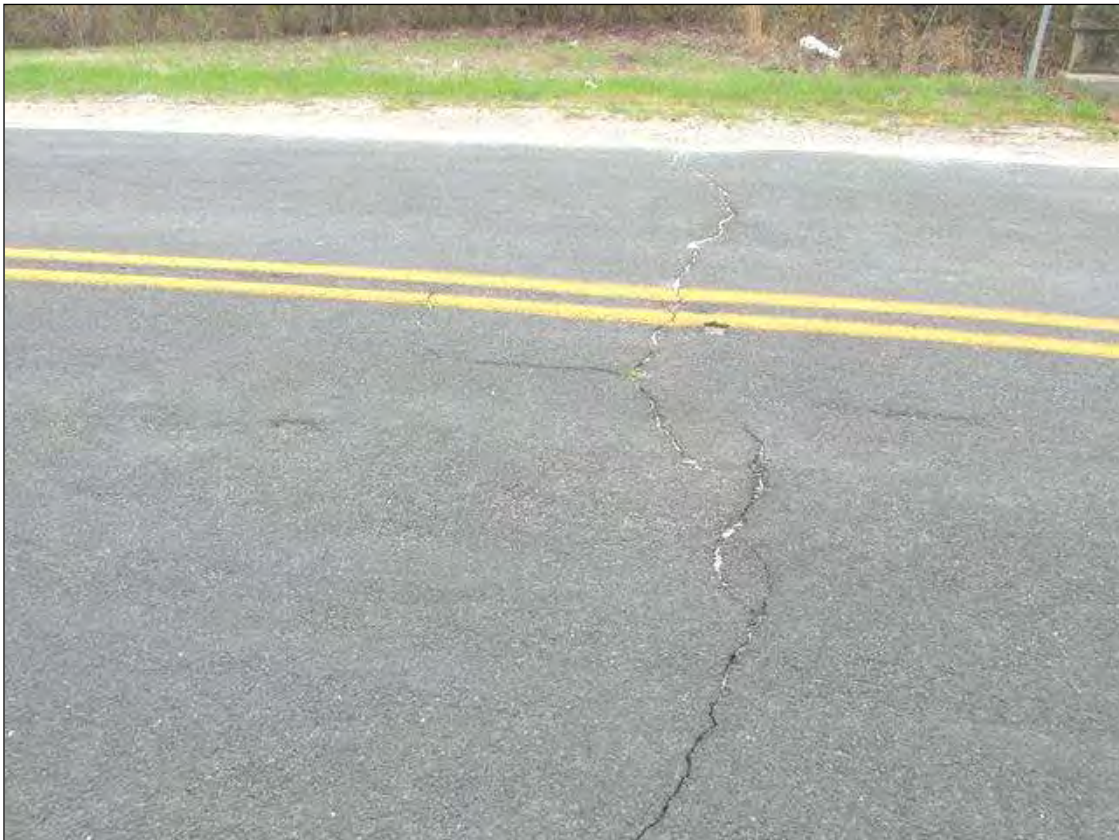
1/2" WIDE TRANSVERSE CRACK IN NORTH APPROACH ASPHALT WEARING SURFACE 10' FROM END BENT 2

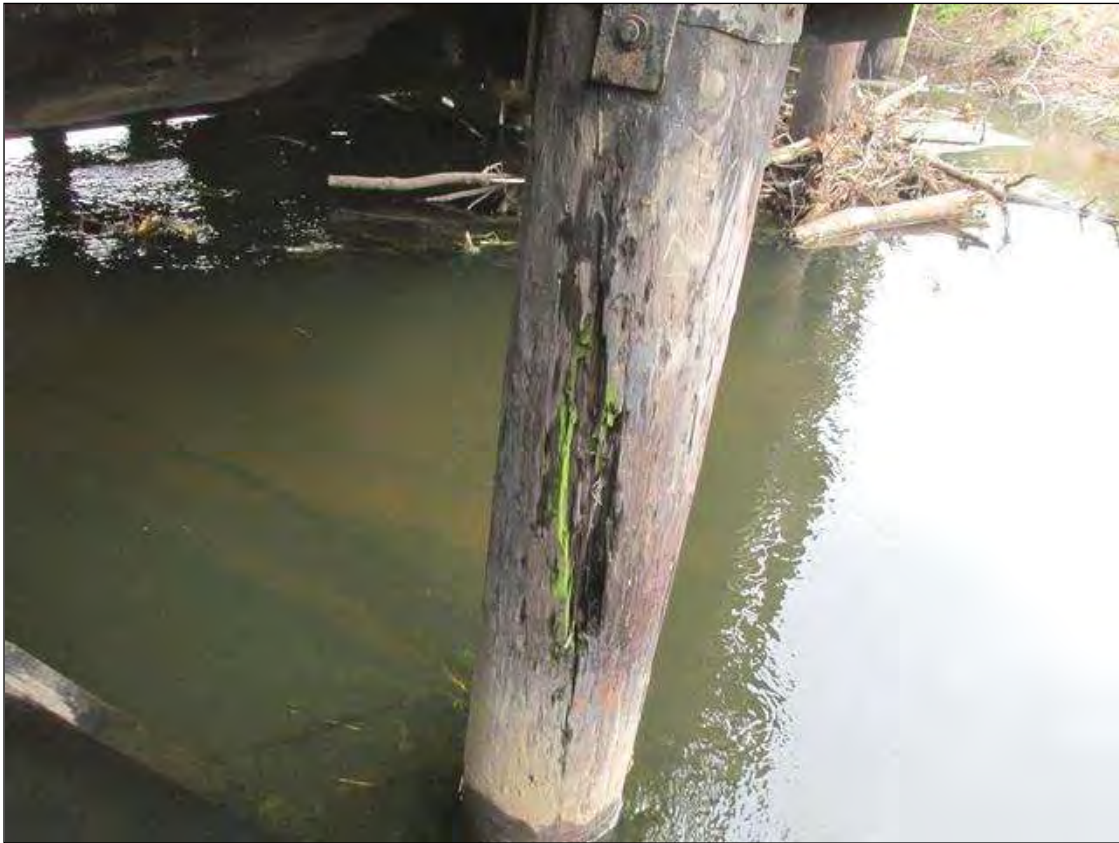
| Bridge I&A Form 1(82)H<br>State of North Carolina<br>Dept. of Transportation<br>Division of Highways | | <h1 style="text-align: center;">FIELD INSPECTION REPORT</h1> <p style="text-align: center;"><u>Bridge Inspeccion &amp; Analysis</u></p> | |
|---|---|---|--|
| 35b | F | THERE IS 1/4" CRACKING IN EAST END OF BENT 3 CAP. (PHOTO)<br>( TIMBER PILES ) PILE 5 AT BENT 1 IS ENCASED. (PHOTO)<br><br>PILE 3 AT END BENT 1 IS DELAMINATED GROUND UP 3' WITH 3/8" WIDE VERTICAL CHECK 2" DEEP. (PHOTO)<br><br>PILE 2 AT END BENT 2 IS ENCASED. (PHOTO)<br><br>PILE 1 AT BENT 3, SPAN 4 FACE IS DECAYED 18" HIGH X 4" WIDE X 2" DEEP. (PHOTO) | |

PILE 1 AT BENT 3, SPAN 4 FACE IS DECAYED 18" HIGH X 4" WIDE X 2" DEEP

| MMS Code | Description of Function | Unit | Quantity | Remarks | Est. Cost |
|---|---|---|---|---|---|
| 3344 | Repair / Replace Timber Substructure Components | LF | 5 | PILE 1 AT BENT 3, SPAN 4 FACE IS DECAYED 18" HIGH X 4" WIDE X 2" DEEP | |

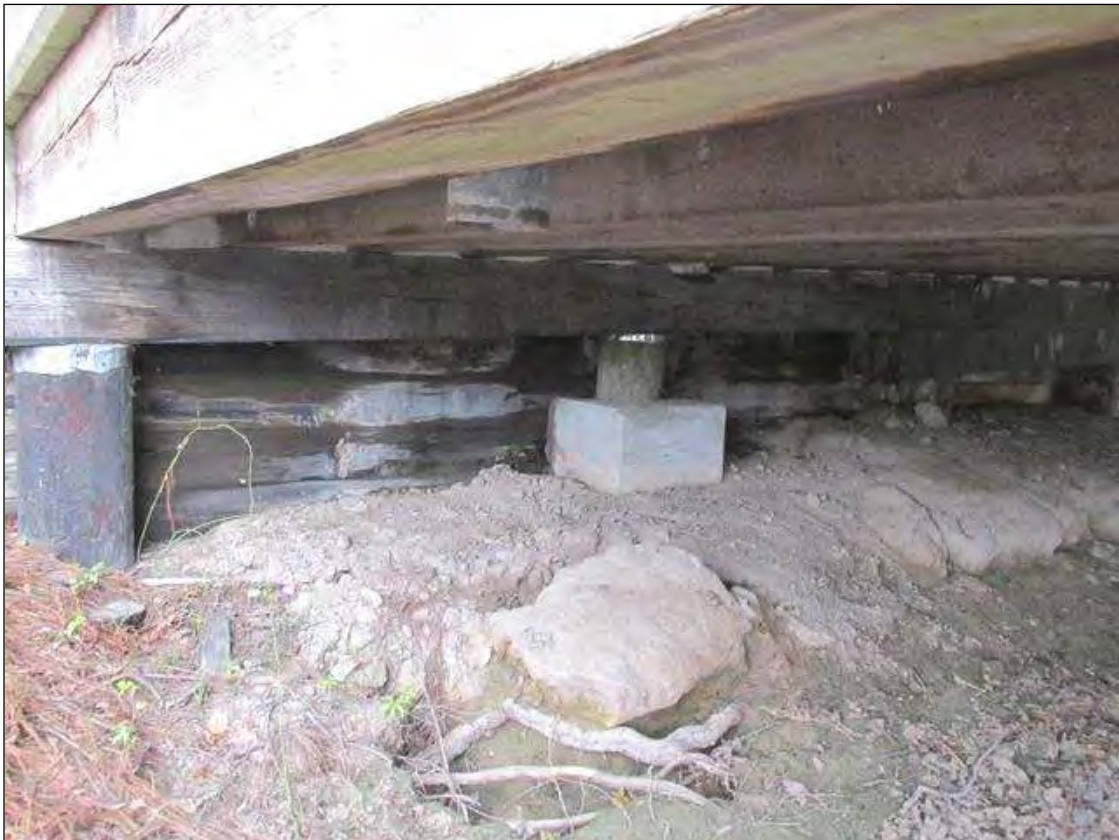
PILE 2 AT END BENT 2 IS ENCASED

NOTE: PILE 2 AT EBT2 IS ENCASED IN CONCRETE

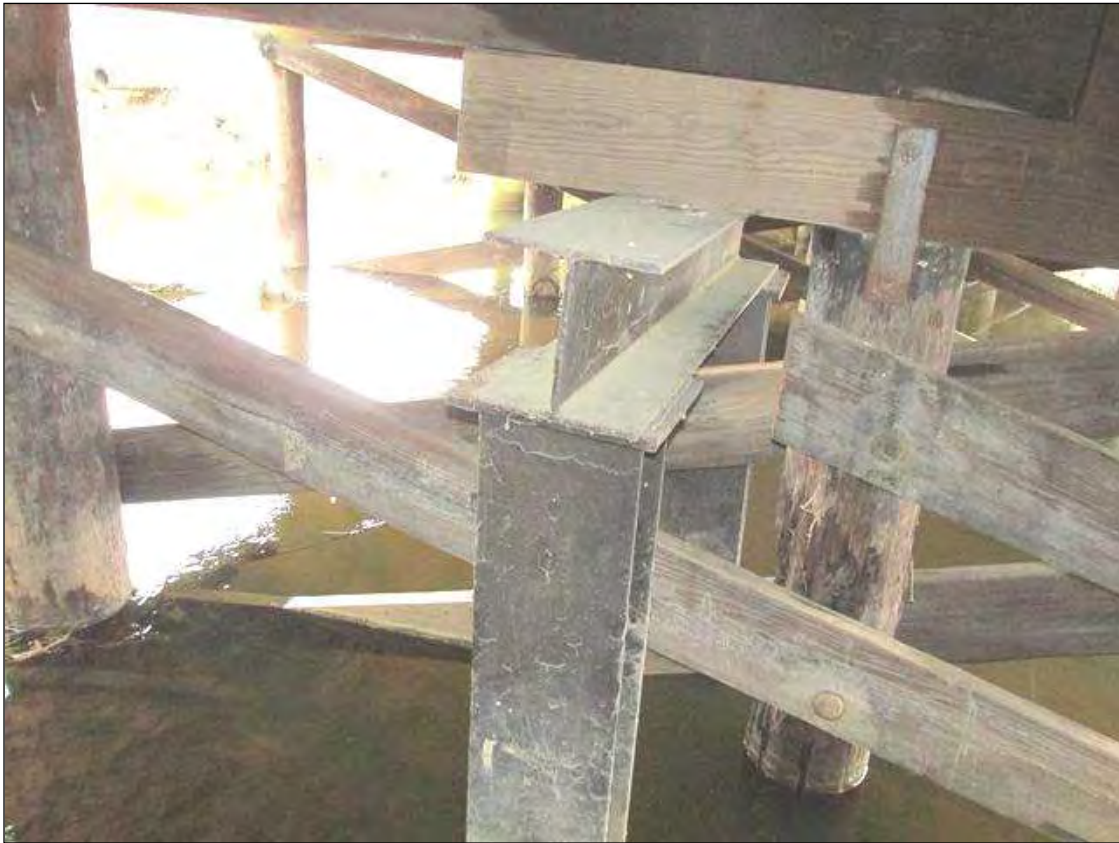
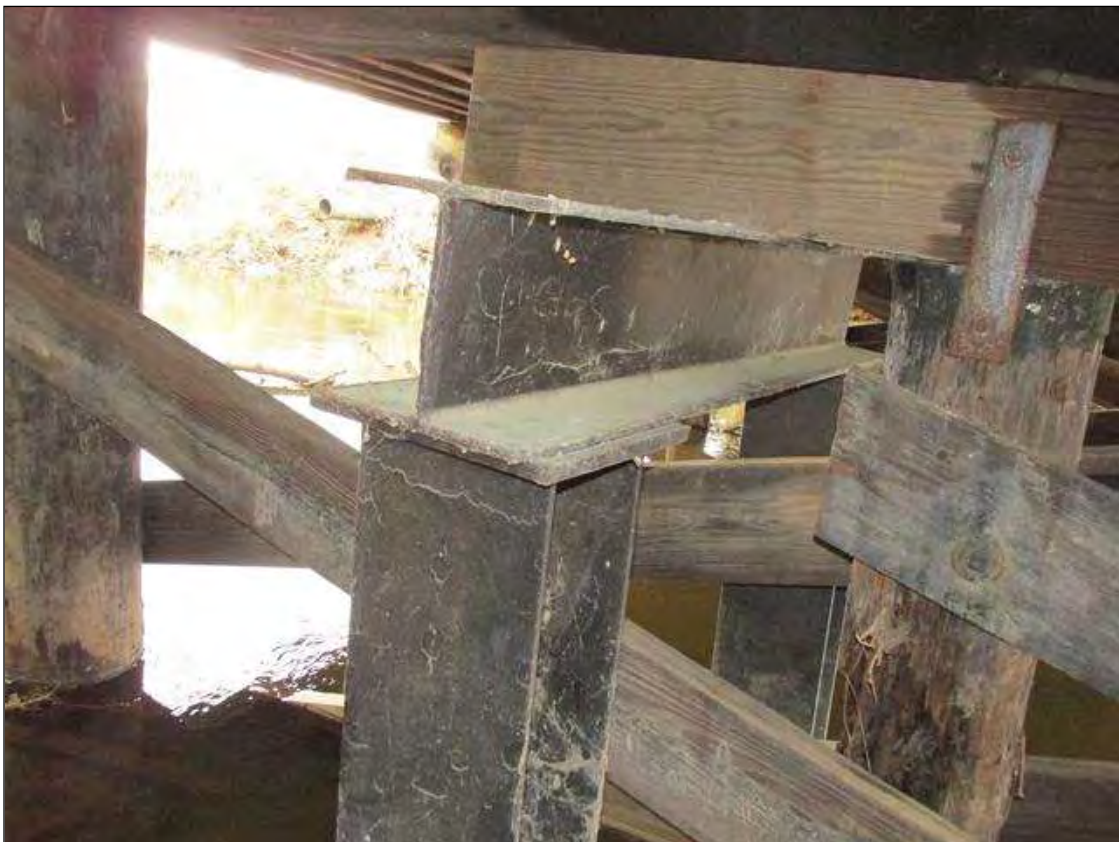
**COMMENTS****Crutch bent at Pile 3 bent 3.**

| Bridge I&A Form 1(82)H<br>State of North Carolina<br>Dept. of Transportation<br>Division of Highways | | <h1 style="text-align: center;">FIELD INSPECTION REPORT</h1> <p style="text-align: center;"><u>Bridge Inspeccion &amp; Analysis</u></p> | |
|---|---|---|--|
| 37a | G | THE TOP WINGWALL BOARDS ARE DECAYED AT NORTHEAST CORNER. (PHOTO)<br>( STEEL CAP ) THERE IS A STEEL CRUTCHBENT NOTED AT BENT 3 17" RIGHT OF ORIGINAL PILE 3. (PHOTO) | |
| 37b | G | ( STEEL PILES ) THERE IS A STEEL CRUTCHBENT NOTED AT BENT 3 17" RIGHT OF ORIGINAL PILE 3. (PHOTO) | |

STEEL CRUTCH BENT AT BENT 3 17" RIGHT OF PILE 3

STEEL CRUTCH BENT 17" RIGHT OF PILE 3 AT BENT 3

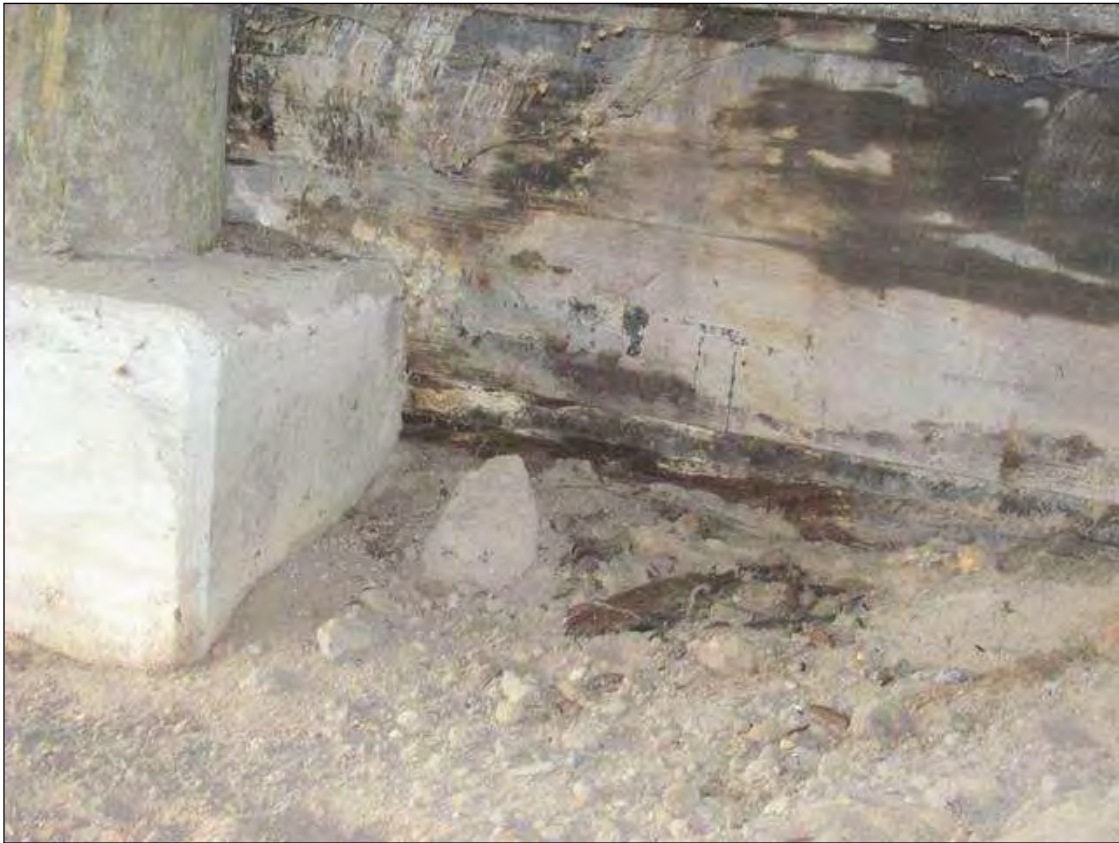
END BENT 2 BULKHEAD DECAYED BETWEEN PILES 2 AND 3

| MMS Code | Description of Function | Unit | Quantity | Remarks | Est. Cost |
|---|---|---|---|---|---|
| 3346 | Repair / Maintain Timber Wings & Blkhds | SF | 4 | END BENT 2 BULKHEAD DECAYED BETWEEN PILES 2 AND 3 | |

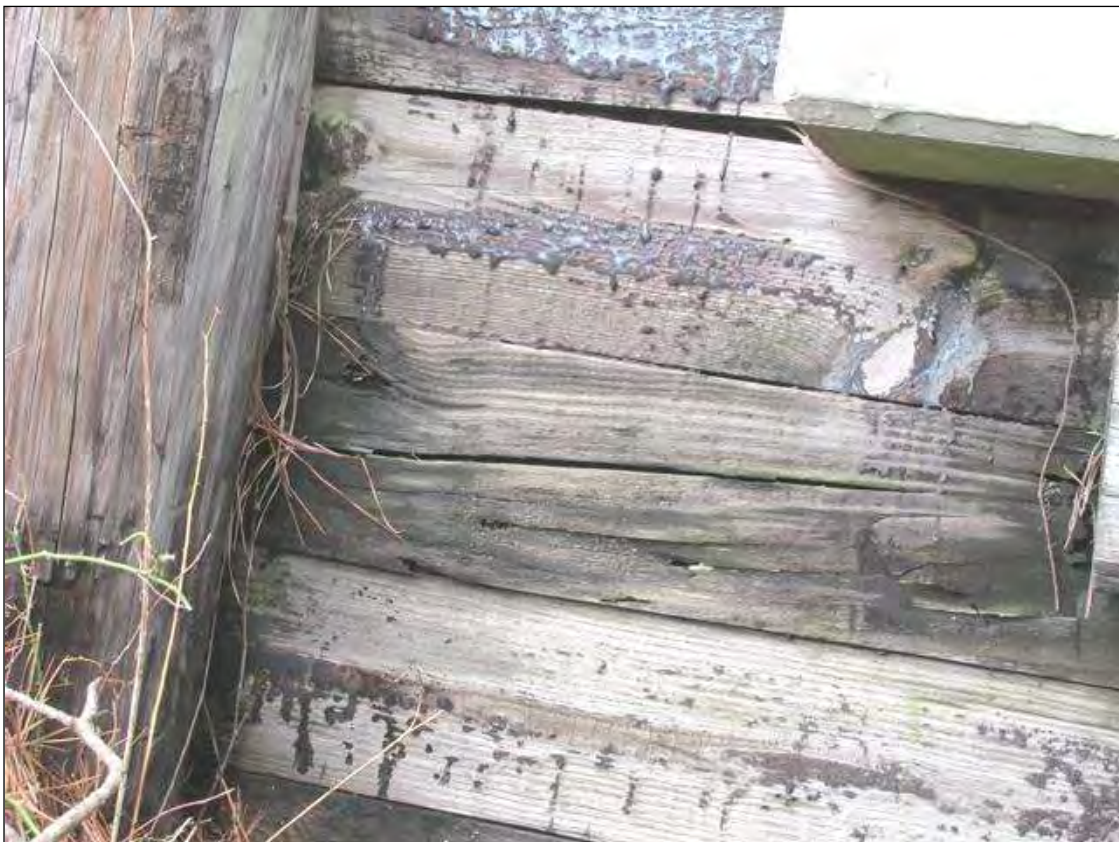
DECAYED BULKHEAD BOARDS AT NORTHWEST CORNER

| MMS Code | Description of Function | Unit | Quantity | Remarks | Est. Cost |
|---|---|---|---|---|---|
| 3346 | Repair / Maintain Timber Wings & Blkhds | SF | 2 | DECAYED BULKHEAD BOARDS AT NORTHWEST CORNER | |

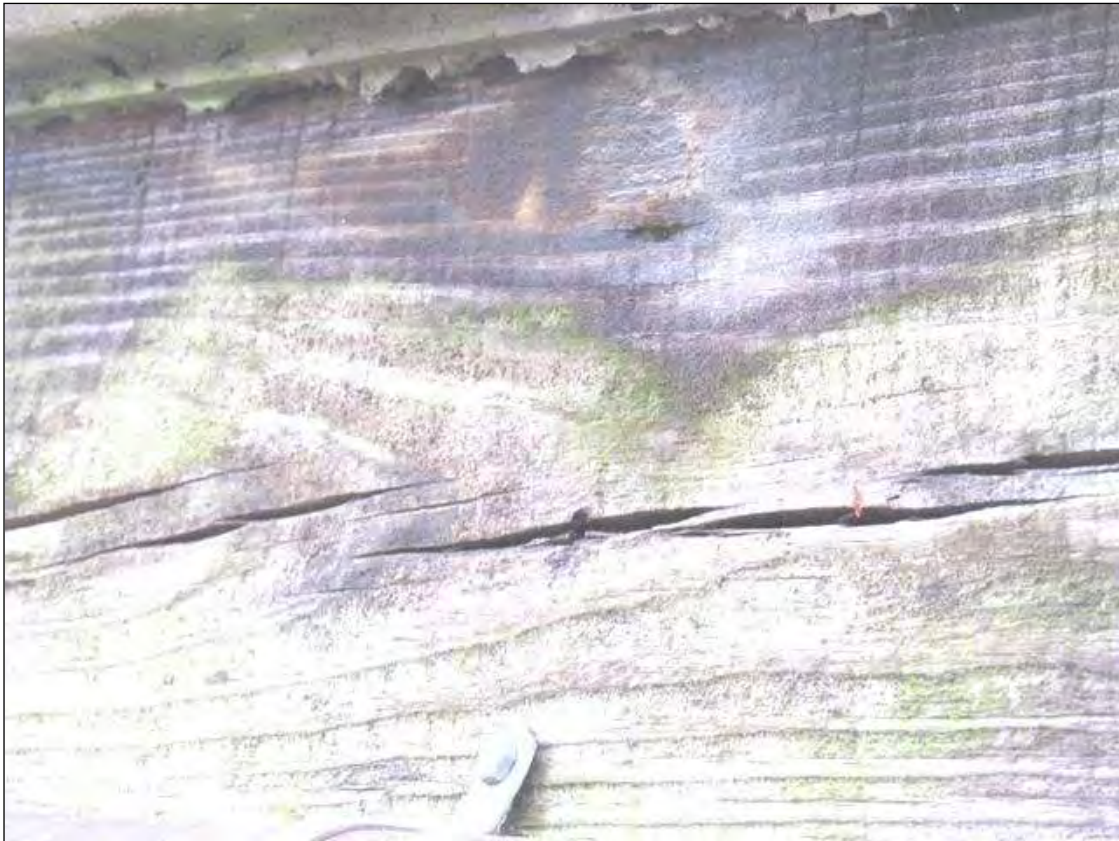
| Bridge I&A Form 1(82)H<br>State of North Carolina<br>Dept. of Transportation<br>Division of Highways | | <h1 style="text-align: center;">FIELD INSPECTION REPORT</h1> <p style="text-align: center;"><u>Bridge Inspection &amp; Analysis</u></p> | |
|---|---|---|--|
| 11 | F | ( TIMBER JOISTS ) JOIST 1 IN SPAN 1 AT BENT 1 IS DECAY ON THE EXTERIOR FACE 3" WIDE ALONG BOTTOM EDGE AND 1" DEEP. (PHOTO)<br><br>SEVERAL JOISTS EXHIBITS CHECKS TO 1/4" WIDE.<br><br>THERE ARE 1/16" VERTICAL CHECKS IN JOIST 1 AT SPAN 1 EXTERIOR FACE. (PHOTO)<br><br>JOIST 22 IN SPAN 4 HAS 1/4" WIDE CHECKS, SIMILAR IN ALL SPANS. (PHOTO) | |

JOIST 22 IN SPAN 4 HAS 1/4" WIDE CHECKS, SIMILAR IN ALL SPANS

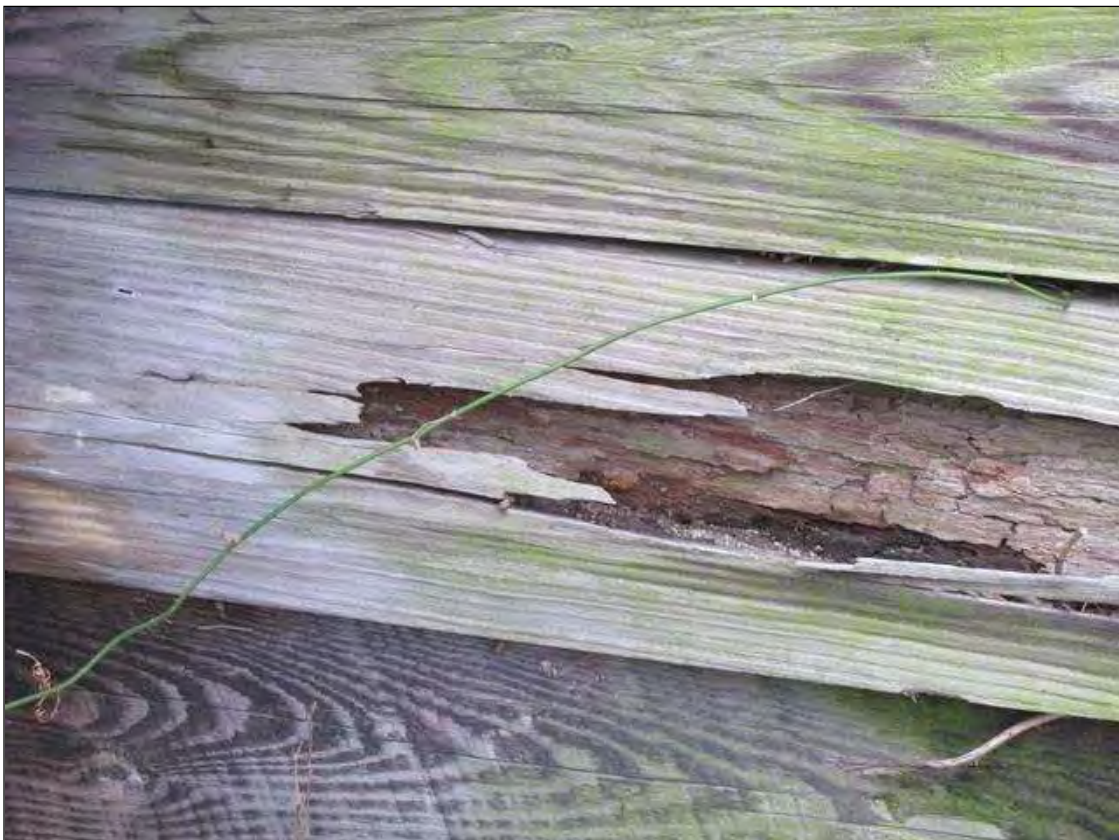
THERE ARE DECAYED BULKHEAD BOARDS AT NORTHEAST CORNER

| MMS Code | Description of Function | Unit | Quantity | Remarks | Est. Cost |
|---|---|---|---|---|---|
| 3346 | Repair / Maintain Timber Wings & Blkhds | SF | 4 | THERE ARE DECAYED BULKHEAD BOARDS AT NORTHEAST CORNER | |

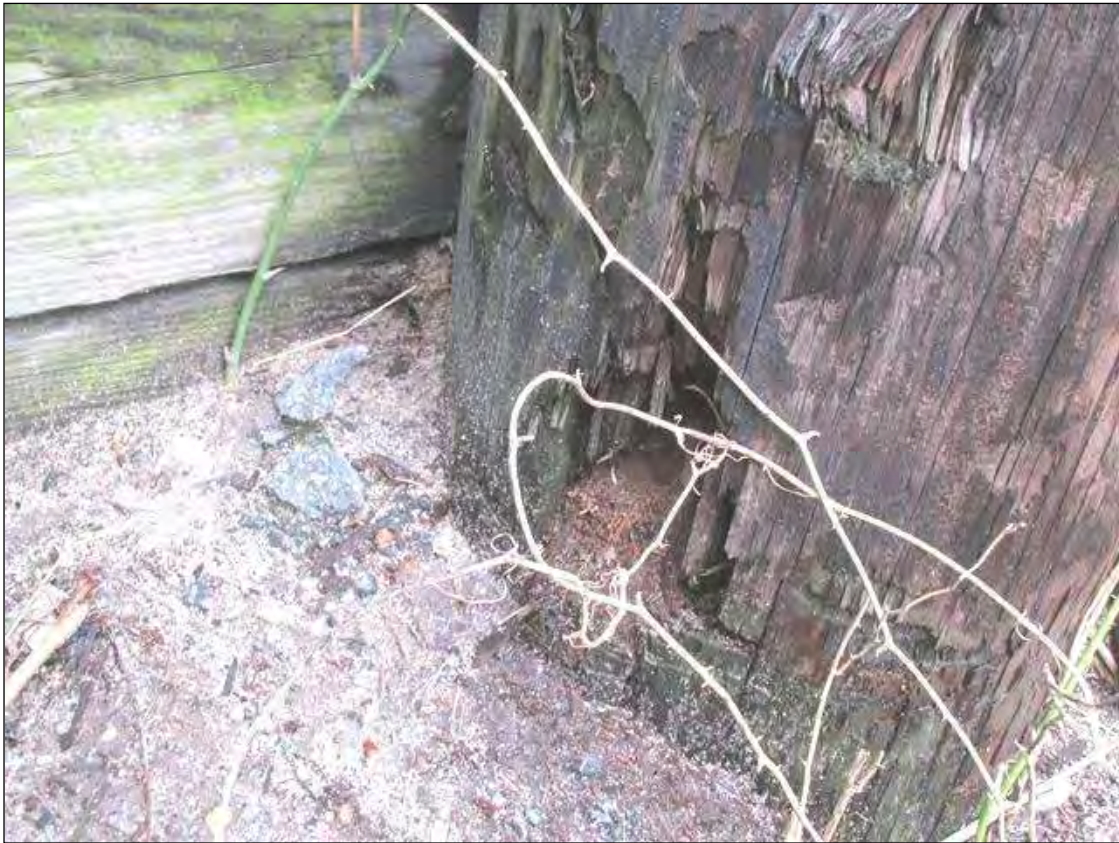
| Bridge I&A Form 1(82)H<br>State of North Carolina<br>Dept. of Transportation<br>Division of Highways | | <h1 style="text-align: center;">FIELD INSPECTION REPORT</h1> <p style="text-align: center;"><u>Bridge Inspeccion &amp; Analysis</u></p> | |
|---|---|---|--|
| 35c | F | ( TIMBER BULKHEAD AND WINGWALLS ) THE TOP WINGWALL BOARDS AT SOUTHEAST CORNER IS MISSING. (PHOTO)<br><br>THERE IS A DECAYED BULKHEAD BOARD AT END BENT 1 RIGHT OF PILE 3. (PHOTO)<br><br>END BENT 1 BULKHEAD BOARDS ARE LEAKING WATER BETWEEN PILES 1 AND 2. (PHOTO)<br><br>END BENT 1 BULKHEAD BOARDS ARE DECAYED AT SOUTHWEST CORNER. (PHOTO)<br><br>END BENT 1 WINGWALL AT SOUTHWEST CORNER IS DECAYED. (PHOTO)<br><br>END BENT 2 BULKHEAD IS DECAYED BETWEEN PILES 2 AND 3. (PHOTO)<br><br>THERE ARE DECAYED BULKHEAD BOARDS AT NORTHWEST CORNER. (PHOTO)<br><br>THERE ARE DECAYED BULKHEAD BOARDS AT NORTHEAST CORNER. (PHOTO)<br><br>END BENT 2 TURNPILE IS DECAYED AT GROUND LINE IN NORTHEAST CORNER. (PHOTO) | |

END BENT 2 TURNPILE IS DECAYED AT NORTHEAST CORNER

| MMS Code | Description of Function | Unit | Quantity | Remarks | Est. Cost |
|---|---|---|---|---|---|
| 3346 | Repair / Maintain Timber Wings & Blkhds | SF | 5 | END BENT 2 TURNPILE IS DECAYED AT NORTHEAST CORNER | |

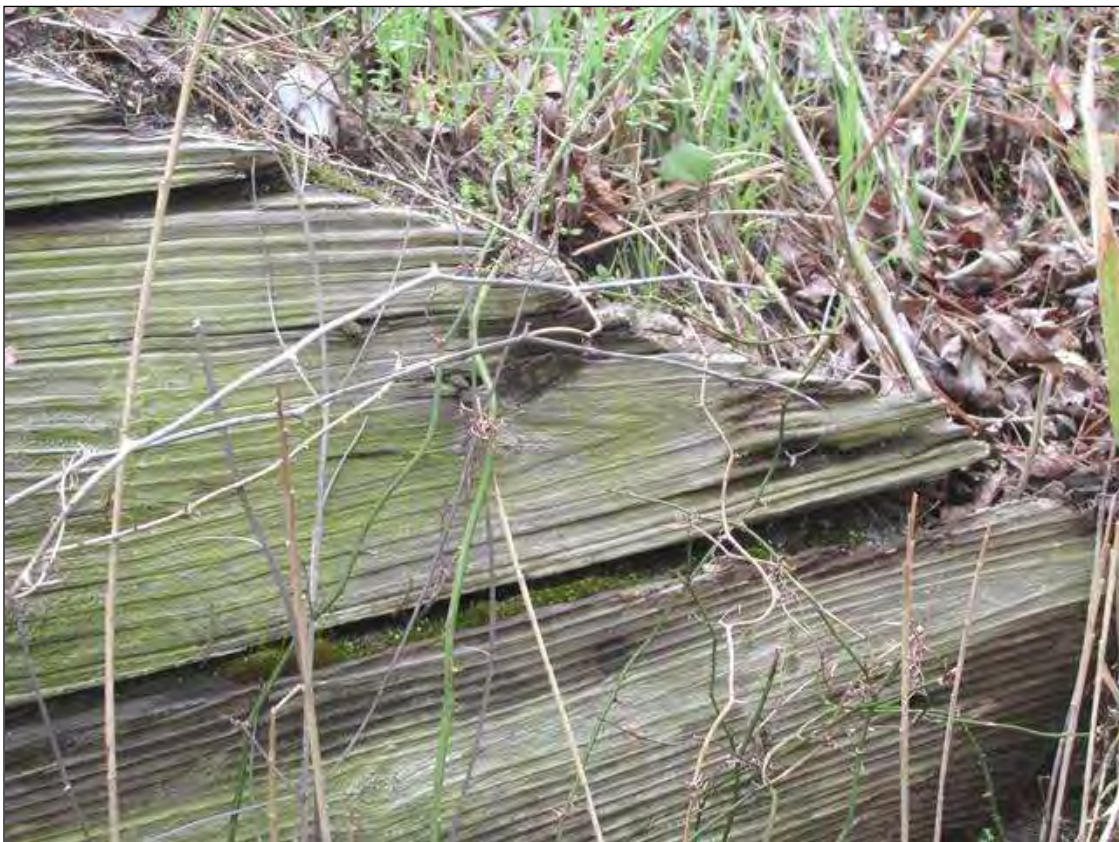
TOP WINGWALL BOARDS ARE DECAYED AT NORTHEAST CORNER

| MMS Code | Description of Function | Unit | Quantity | Remarks | Est. Cost |
|---|---|---|---|---|---|
| 3346 | Repair / Maintain Timber Wings & Blkhds | SF | 3 | TOP WINGWALL BOARDS ARE DECAYED AT NORTHEAST CORNER | |

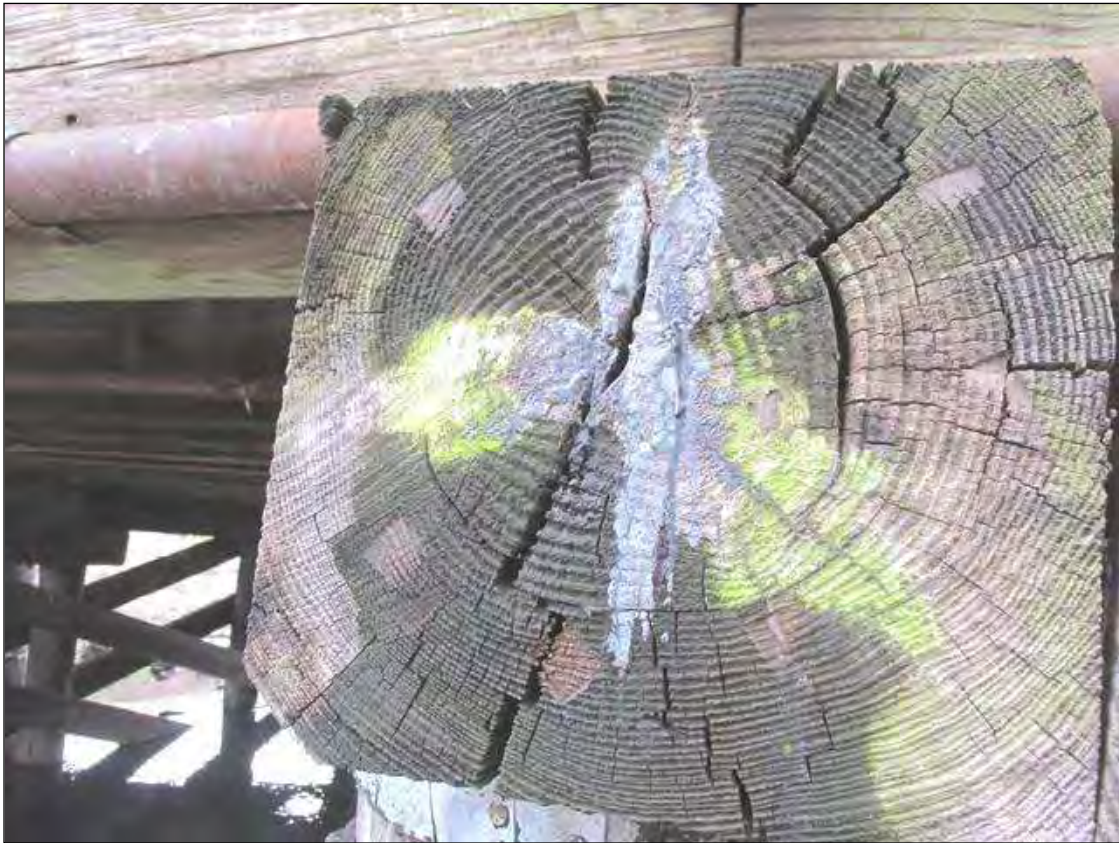
THERE IS 1/4" CRACKING IN EAST END OF BENT 3 CAP

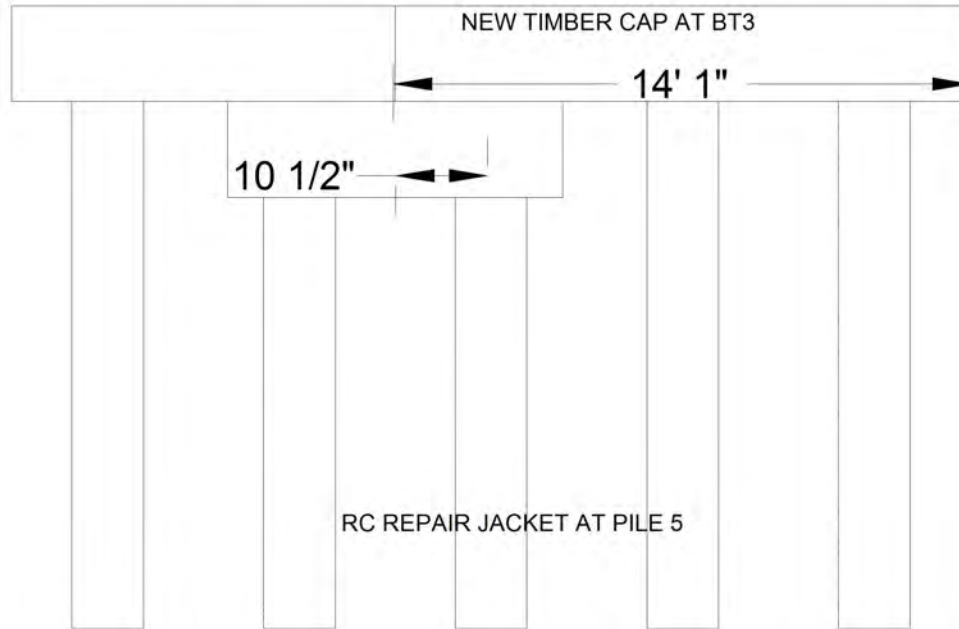
STEEL H-PILE CRUTCH BENT AT BT3 17" RT OF PILE 3 ( SEE SKETCH )
