# BRIDGE INSPECTION REPORT

INSPECTION TYPE: Routine Inspection

COUNTY ROBESON BRIDGE NUMBER 770433 INSPECTION CYCLE 2 YRS  
ROUTE SR1160 ACROSS BACK SWAMP M.P. 0

INSPECTION DATE 04/08/2014

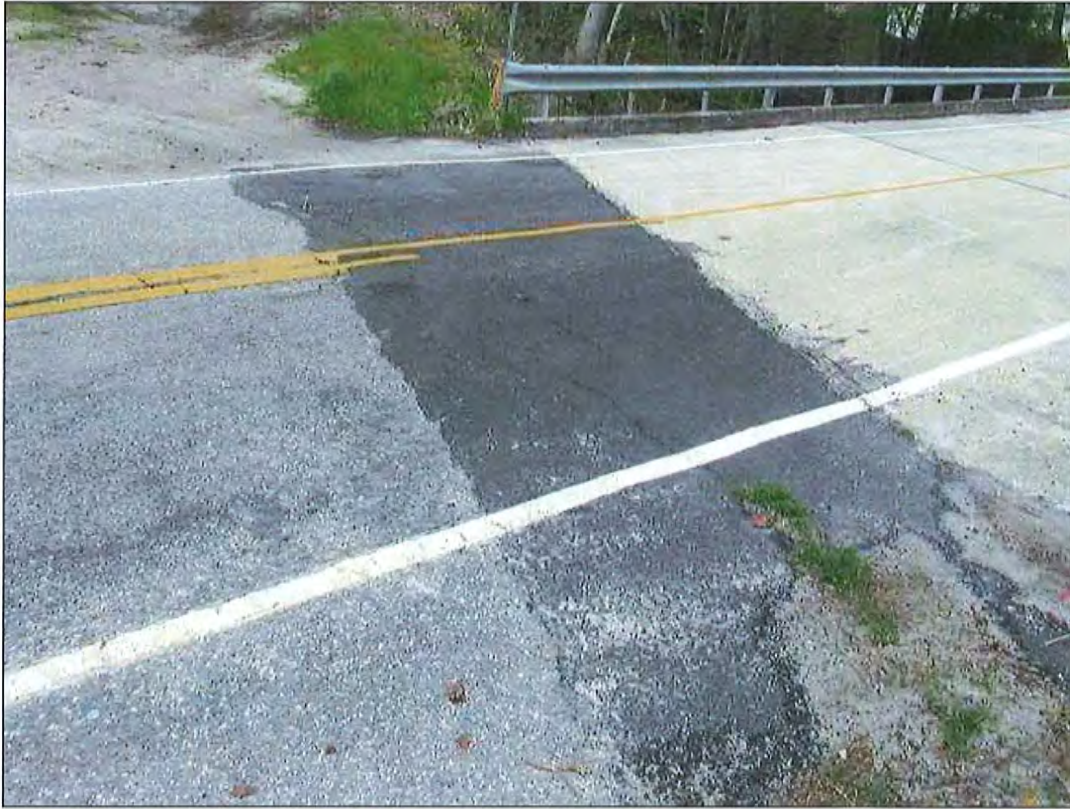
| 50 | F | ( APPROACH ROADWAY ) THE SOUTH APPROACH PATCH IS UNEVEN. (PHOTO)<br><br>NORTH APPROACH ASPHALT WEARING SURFACE HAS BEEN PATCHED. (PHOTO) | |

SOUTH APPROACH PATCH IS UNEVEN

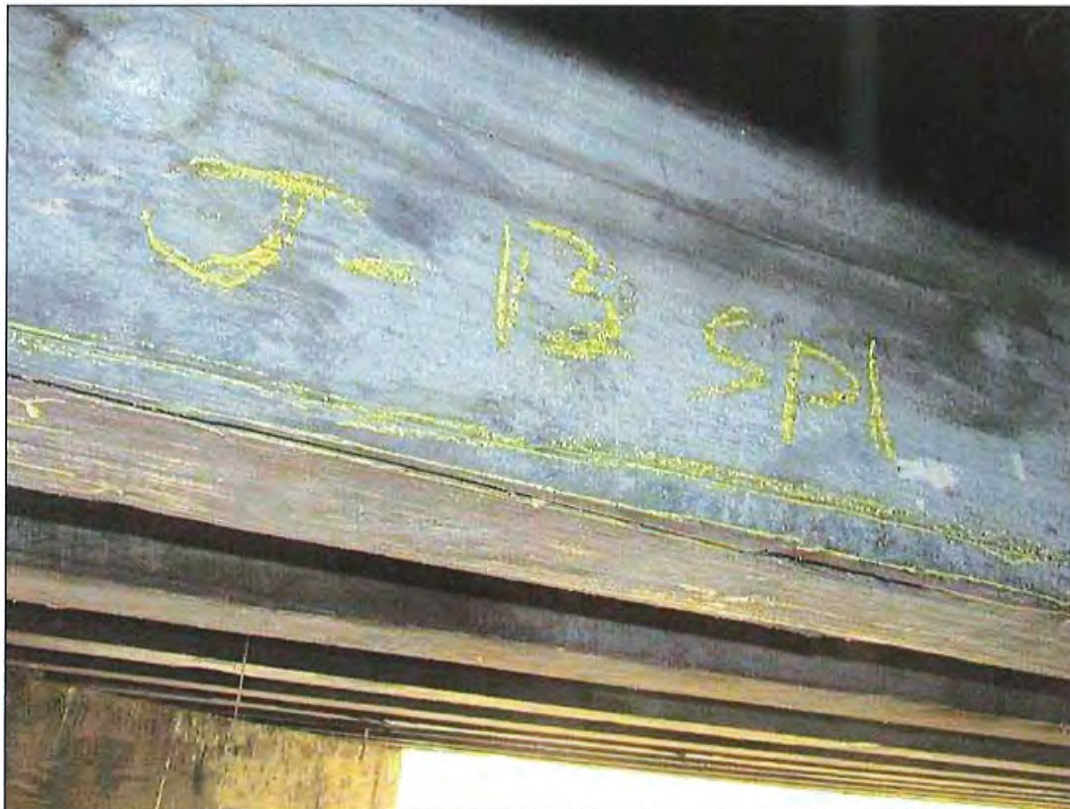
| Item No. | Grade | |
|---|---|---|
| 11 | G | <p>( TIMBER JOISTS ) JOIST 13 IN SPAN 1 HAS A 2' LONG X 0" TO 1/2" HIGH X 0" TO 1/2" WIDE SHAKE. (PHOTO)</p> <p>JOIST 1 EXTERIOR AT SPAN 1 HAS 3/16" WIDE CHECKS. A FEW OTHER JOISTS ARE SIMILAR. (PHOTO)</p> |

JOIST 13 IN SPAN 1 HAS A 2' LONG X 0" TO 1/2" HIGH X 0" TO 1/2" WIDE SHAKE

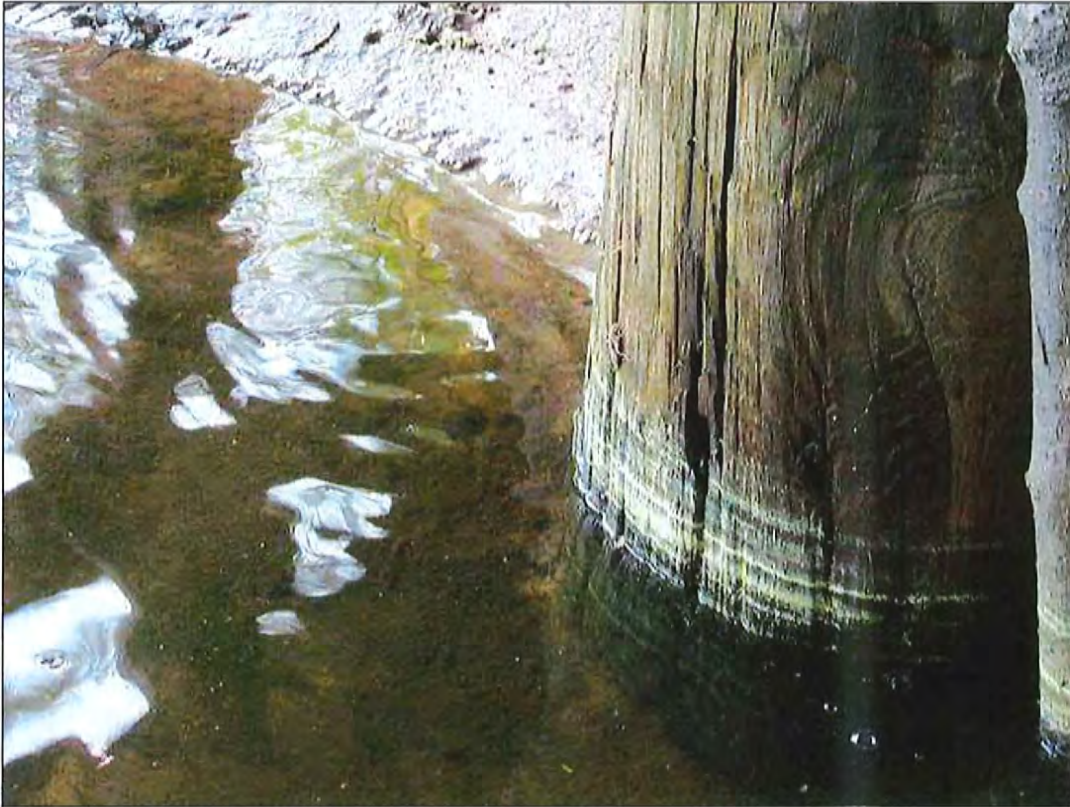
| 35b | F | ( TIMBER PILES ) THERE IS LOCAL SCOUR UP TO 2' DEEP AROUND PILE 1 AT BENTS 2 AND 3 DUE TO DRIFT. PM ISSUED ON DRIFT.<br><br>PILE 4 AT BENT 1 SPAN 2 SIDE SURFACE DECAY UP TO 1" DEEP AT THE WATERLINE. (PHOTO)<br><br>PILE 1 AT BENT 3 HAS SPOT DECAYED.<br><br>THERE ARE ENCASED PILES NOTED AT: (PHOTOS)<br>PILES 2, AND 5 AT BENT 2.<br>PILES 2, AND 3 AT BENT 3<br>PILES 1, AND 3 AT END BENT 2. | |

PILE 4 AT BENT 1, SPAN 2 SIDE IS SURFACE DECAYED UP TO 1" DEEP

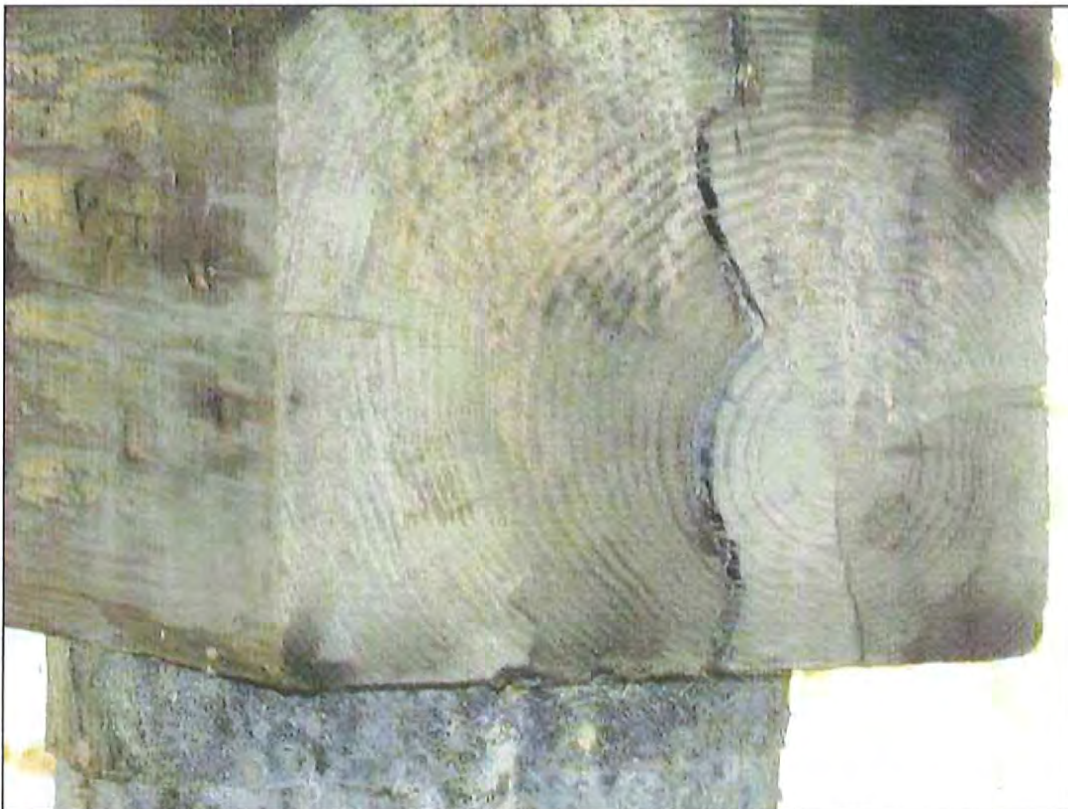
| Item No. | Grade | |
|---|---|---|
| 35a | F | <p>( TIMBER CAPS ) THE END BENT 1 HAS NEW SUBCAP OVER PILE 4 AND PILE 5.</p> <p>BENT 1 SUB CAP EAST END HAS 1/4" WIDE VERTICAL CHECK 2" DEEP. (PHOTO)</p> <p>A NEW CAP HAD BEEN ADDED AT BENT 1 OVER PILE 1 AND PILE 2 PREVIOUS TO LAST INSPECTION.</p> |

BENT 1 SUB CAP EAST END HAS 1/4" WIDE VERTICAL CHECK 2" DEEP

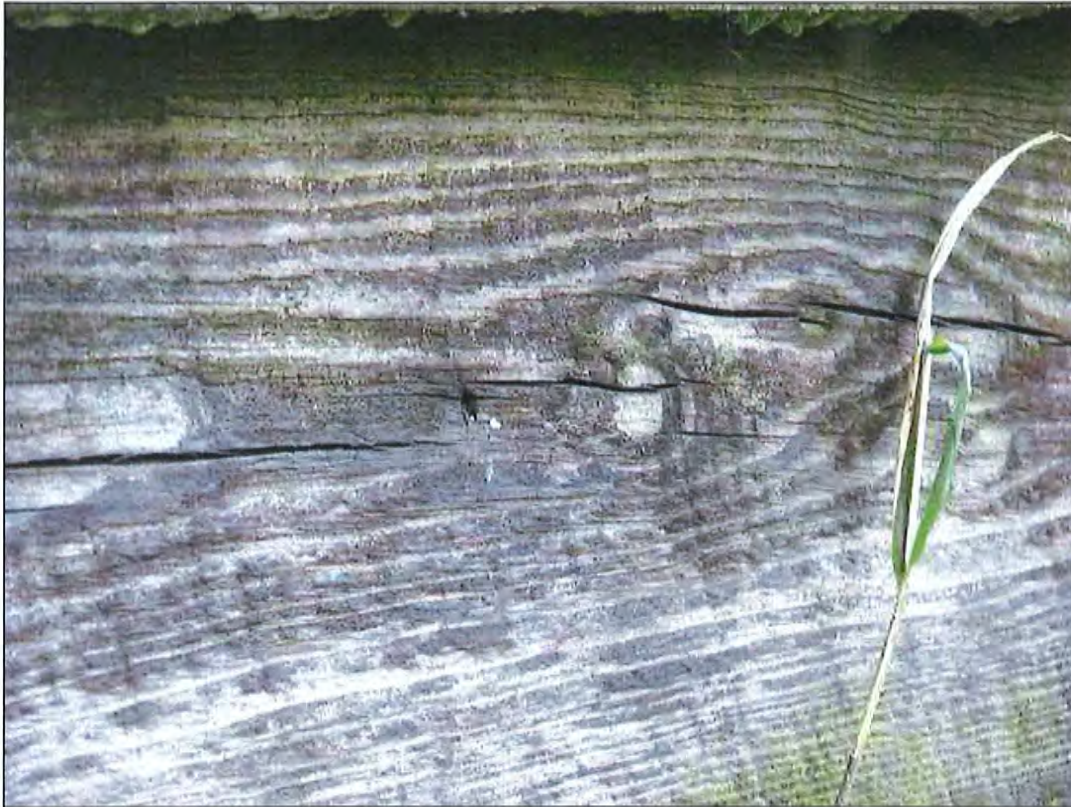
JOIST 1 EXTERIOR AT SPAN 1 HAS 3/16" WIDE CHECKS, OTHER JOISTS ARE SIMILAR

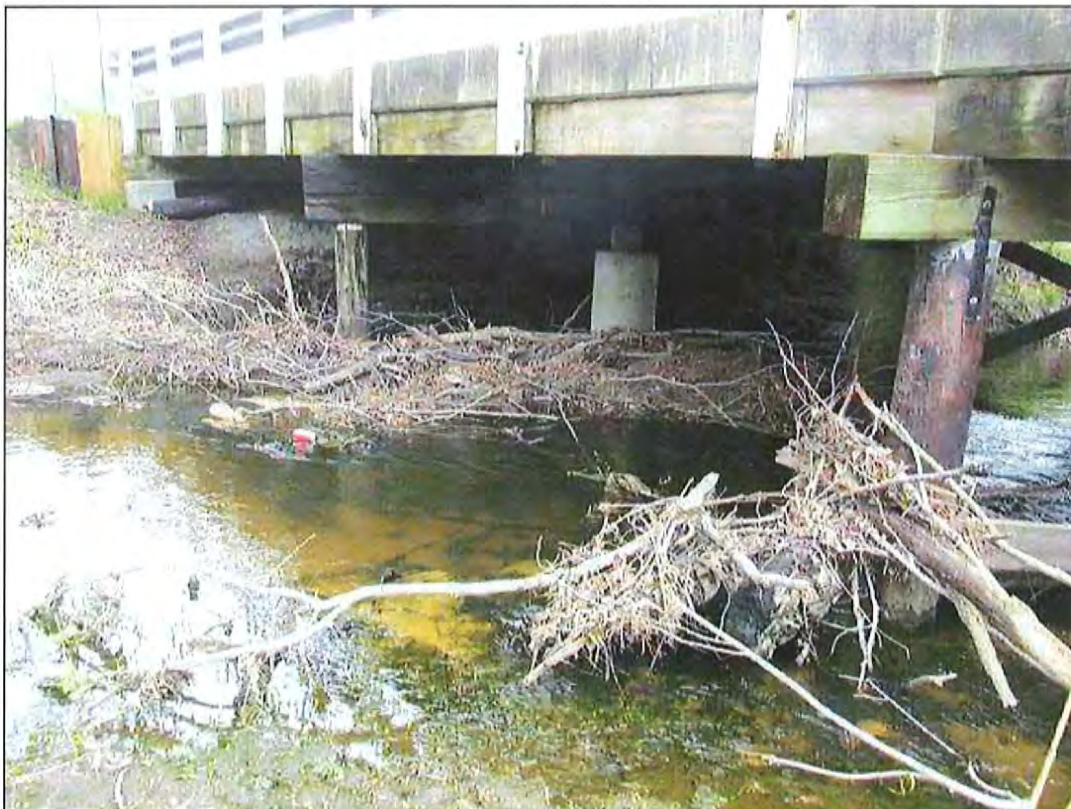
| 41 | P | ( DRIFT ) THERE IS DRIFT UP TO 4' HIGH AT WEST END OF BENTS 2 AND 3 CAUSING LOCAL SCOUR AT PILES. (PHOTO) PM ISSUED<br><br>THERE IS DRIFT AND DEBRIS UP TO 4' HIGH AGAINST WEST END OF PILES 1 AND 2 AT BENT3. (PHOTO) | |

DRIFT UP TO 4' HIGH AT WEST END OF BENTS 2 AND 3 CAUSING LOCAL SCOUR AT PILES. PM ISSUED

| MMS Code | Description of Function | Unit | Quantity | Remarks | Est. Cost |
|---|---|---|---|---|---|
| 3366 | Drift and Debris Removal | HR | <del>28</del> TSE | DRIFT UP TO 4' HIGH AT WEST END OF BENTS 2 AND 3 | |

| MMS Code | MMS Description | Quantity |
|---|---|---|
| DRIFT UP TO 4' HIGH AT WEST END OF BENTS 2 AND 3 | | |

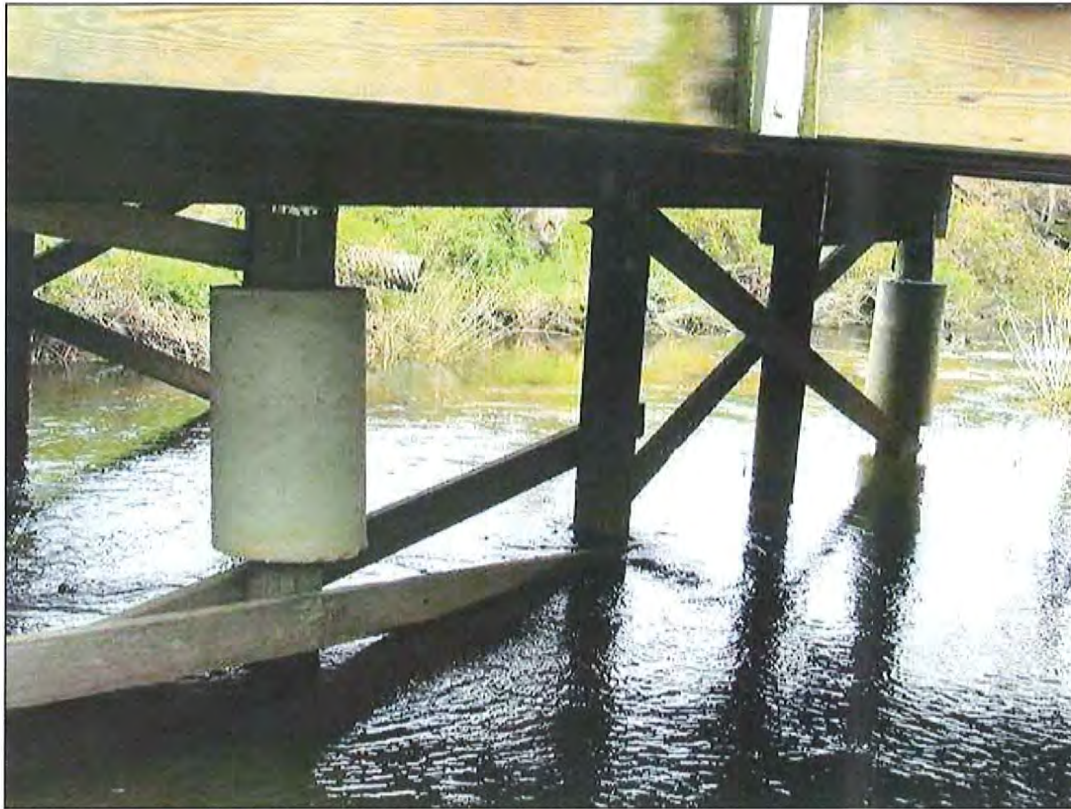
Piles 2 & 5 @ Bt. 2 encased in concrete.  
Piles 2 & 3 @ Bt. 3 encased in concrete.  
Piles 1 & 3 @ End Bt. 2 encased in concrete.

PILES 2 AND 5 ARE ENCASED AT BENT 2

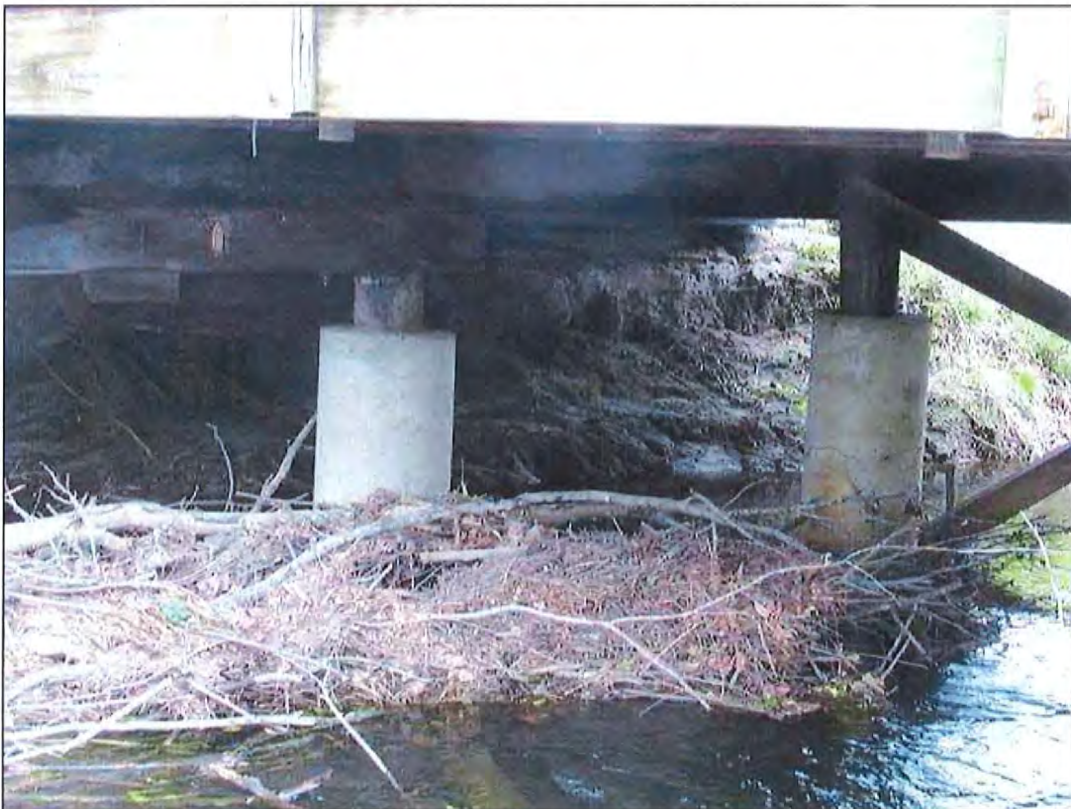
PILES 2 AND 3 ARE ENCASED AT BENT 3

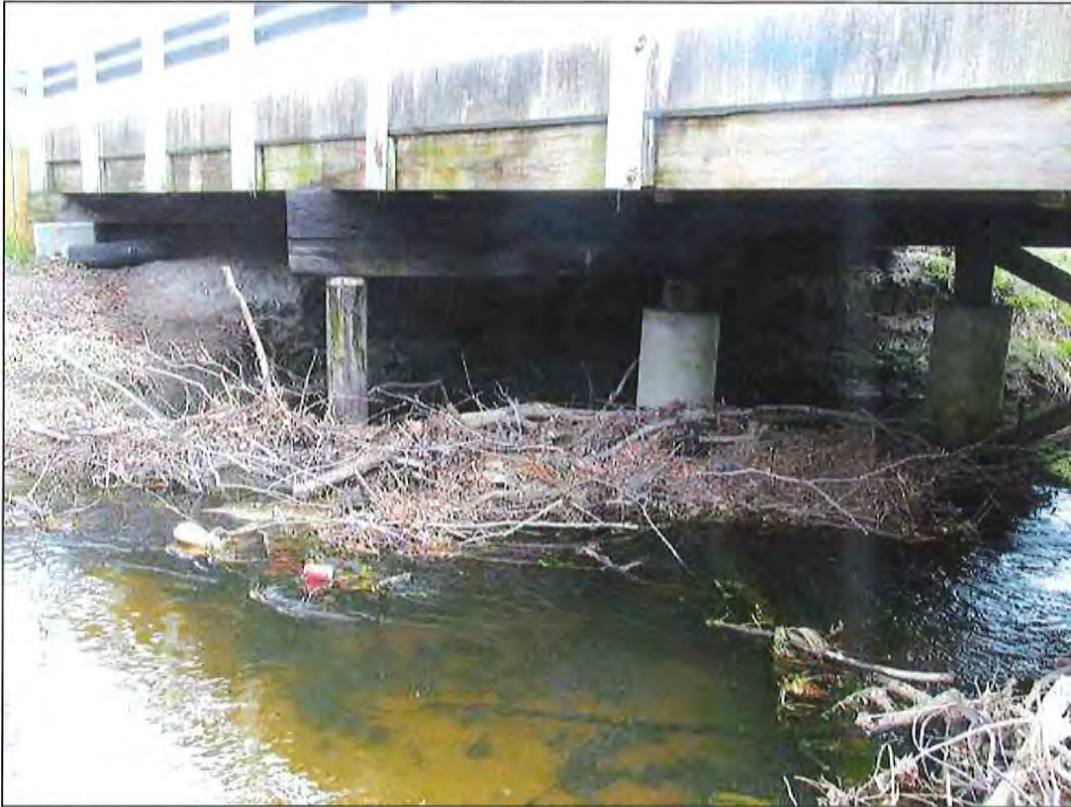
THERE IS DRIFT AND DEBRIS UP TO 4' HIGH AGAINST WEST END OF PILES 1 AND 2 AT BENT3

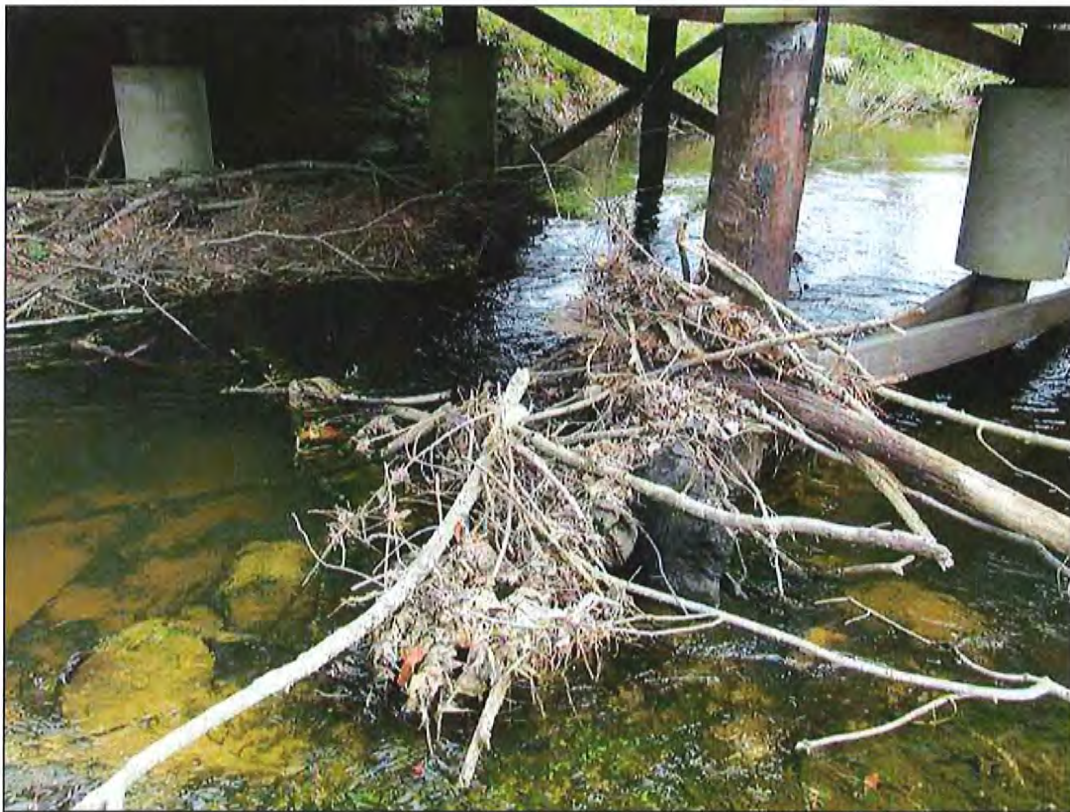
THERE IS DRIFT IN SPAN 3 AT BENT 2

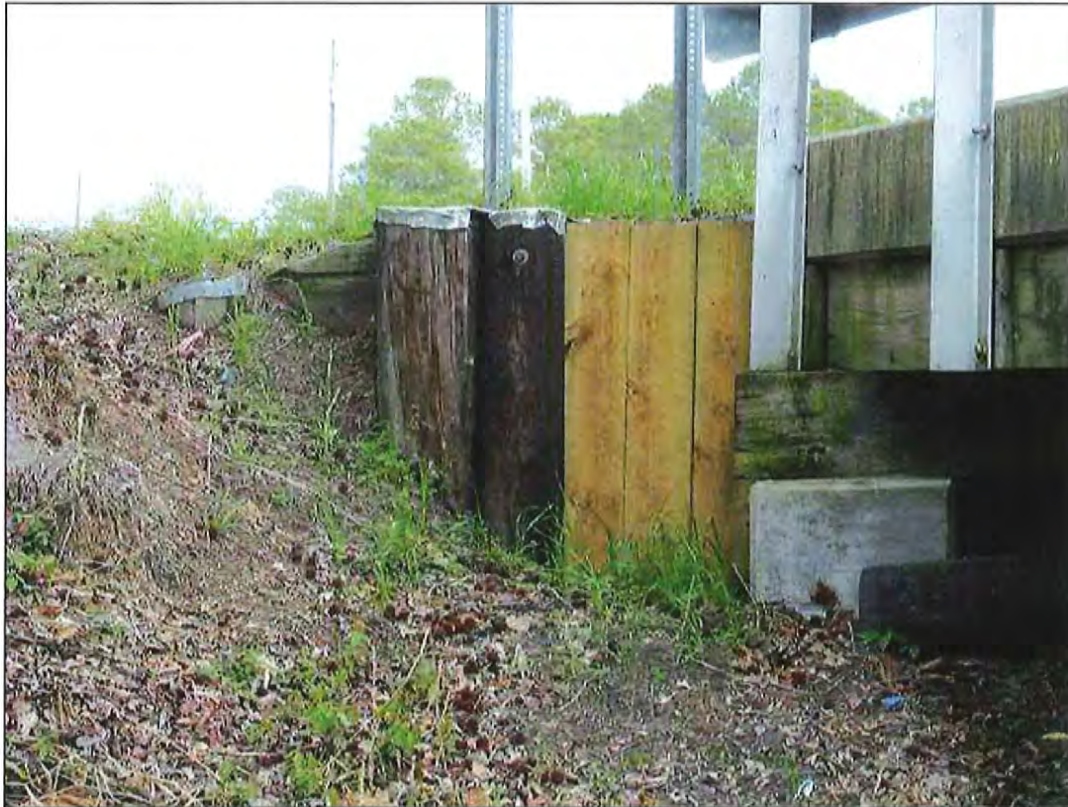
THERE ARE REPAIRED EXTERIOR BULKHEAD BOARDS AT NORTHWEST CORNER

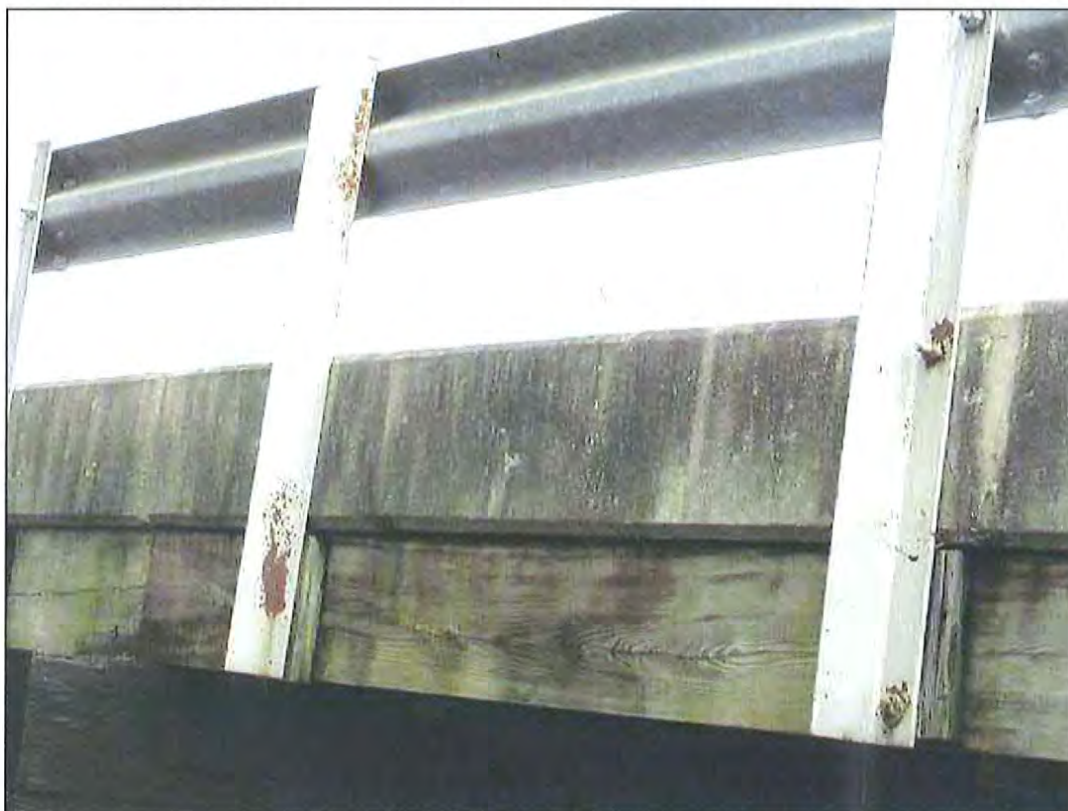
| Item No. | Grade | |
|---|---|---|
| 3d | G | <p>( STEEL RAILS ) POST 3 AT RIGHT RAIL HAS A BOLT MISSING IN SPAN 2.</p> <p>THE LEFT RAIL POSTS 2 AND 3 IN SPAN 3 EXHIBITS SURFACE RUST. OTHERS ARE SIMILAR. (PHOTO)</p> |

LEFT RAIL POSTS 2 AND 3 HAS SURFACE RUST

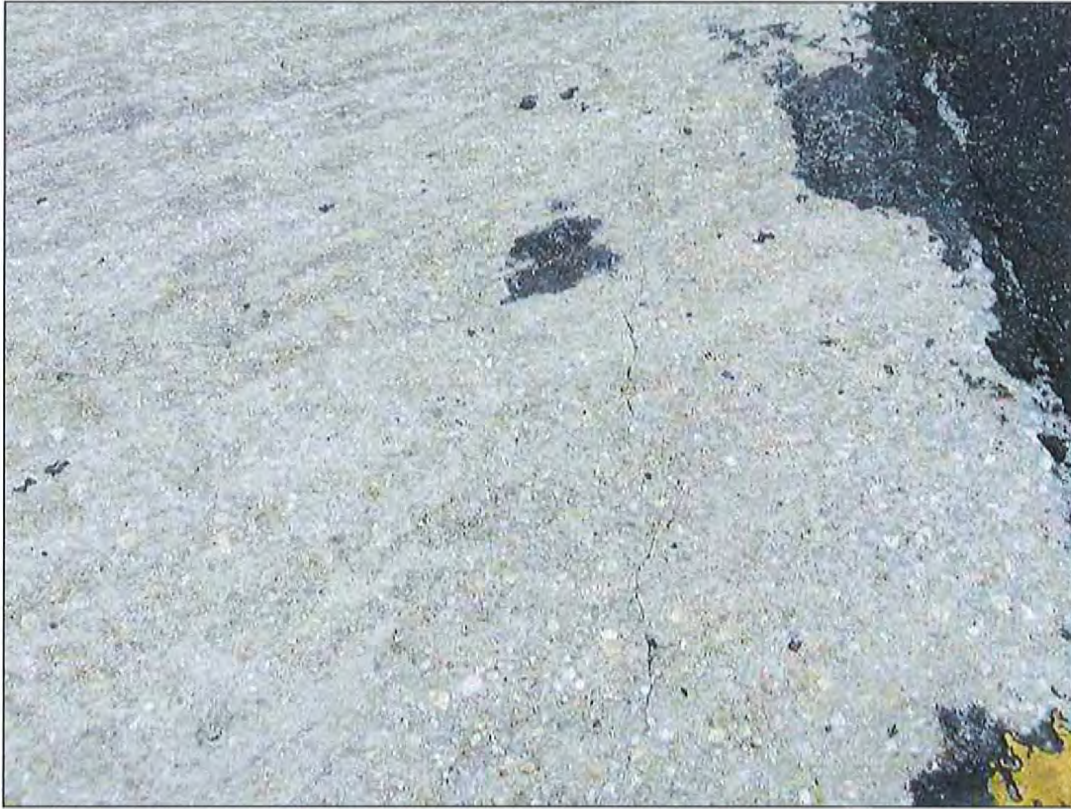
1/16" TRANSVERSE CRACK IN SPAN 1 DECK OVER END BENT 1 CURTAIN WALL

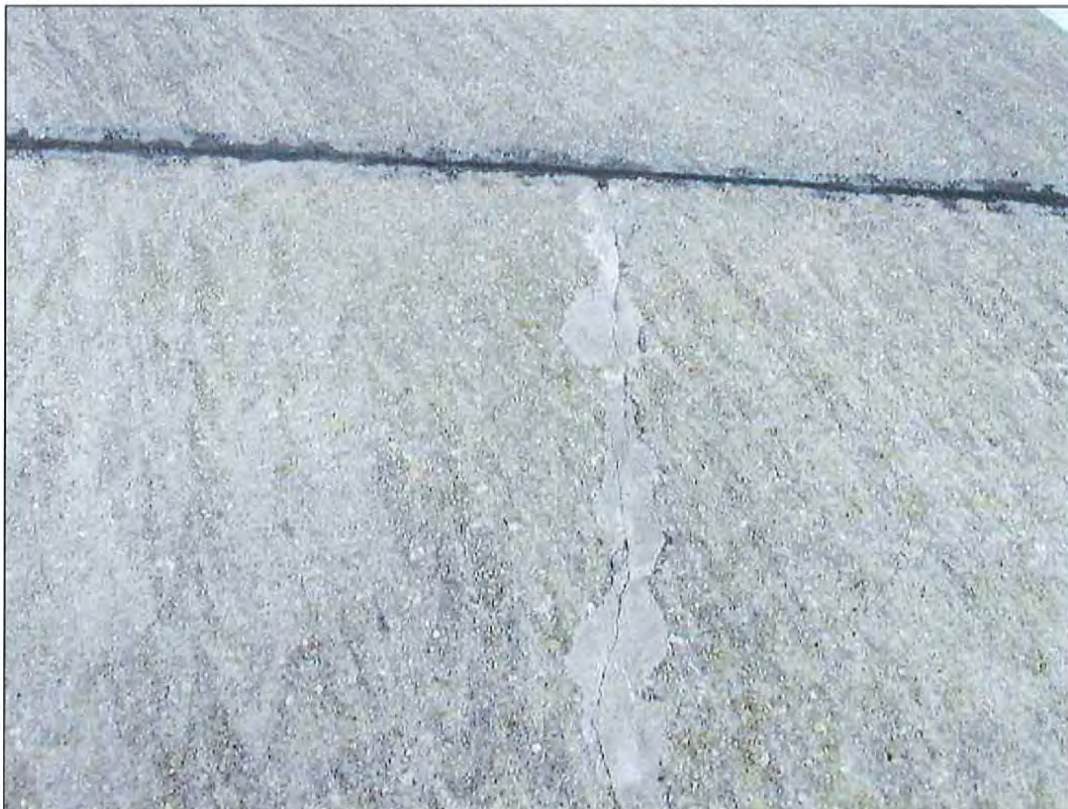
1/16" LONGITUDINAL CRACK IN SPAN 1 AT BENT 1 JOINT IN NORTH BOUND LANE

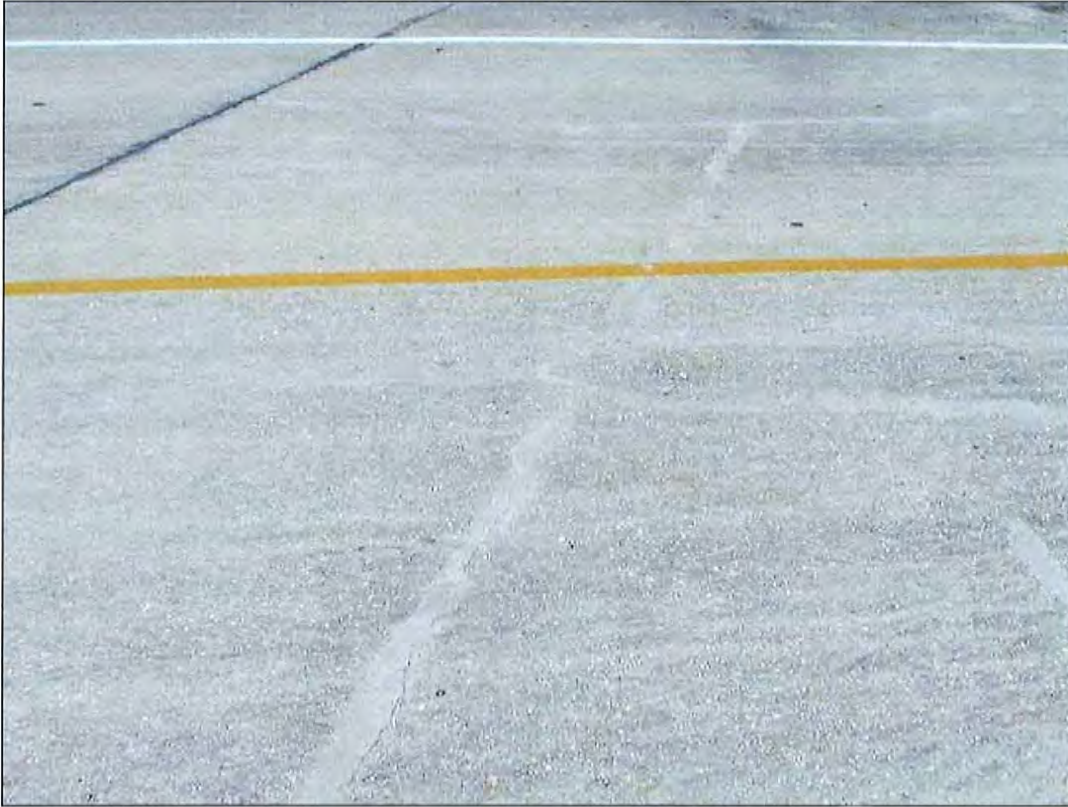
SEALED CRACKING IN SPAN 1 DECK

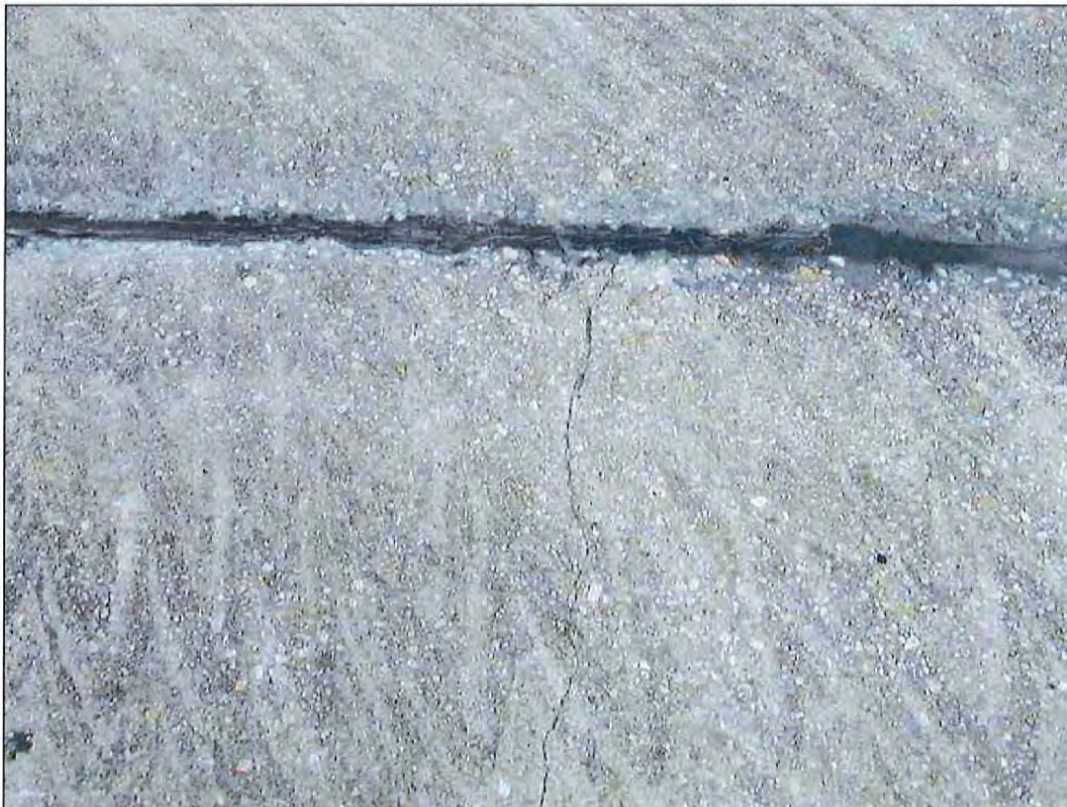
1/16" LONGITUDINAL CRACK IN SPAN 1 DECK IN THE SOUTH BOUND LANE

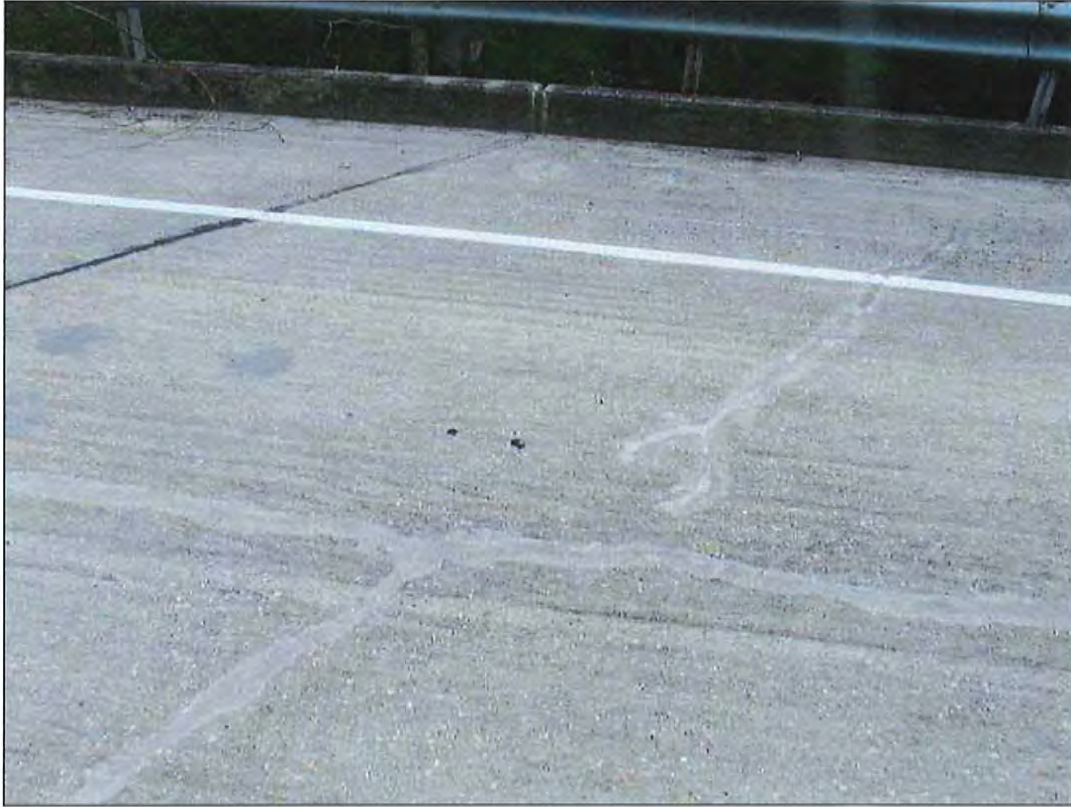
SEALED CRACKING IN SPAN 2 DECK

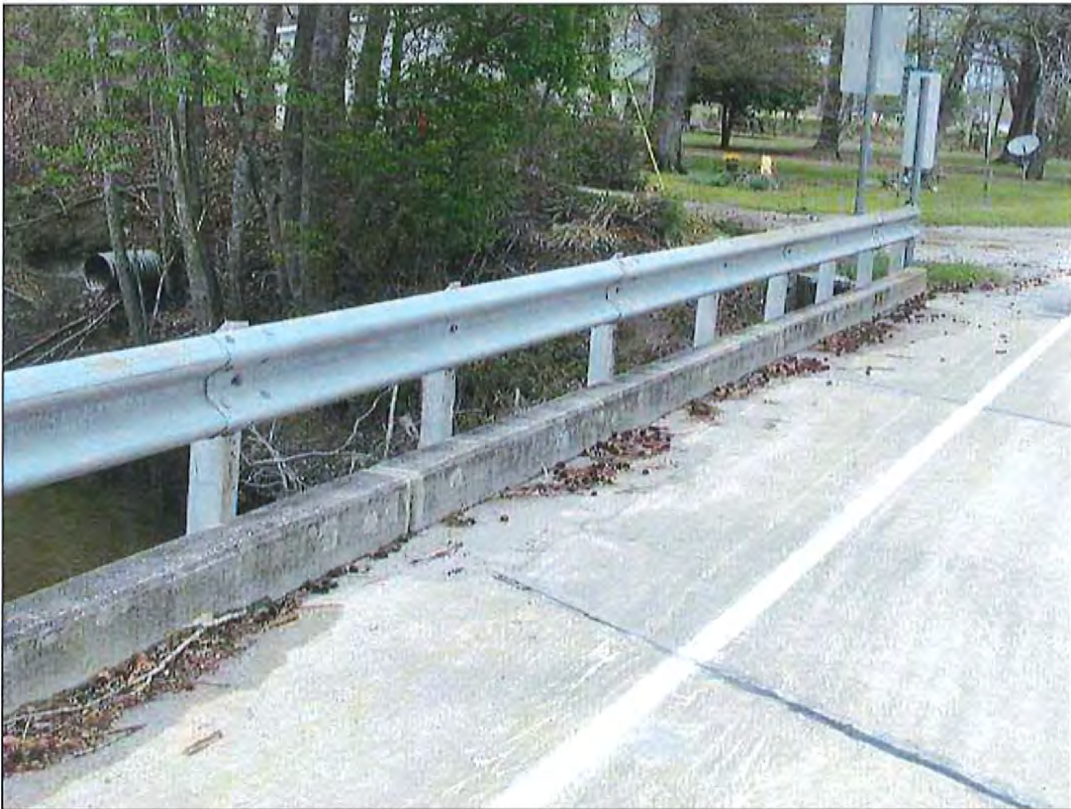
| Item No. | Grade | |
|---|---|---|
| 7 | G | <p>( DECK DEBRIS ) SCATTERED DEBRIS ALONG THE LEFT CURB. (PHOTO)</p> |

SCATTERED DEBRIS ALONG LEFT CURB

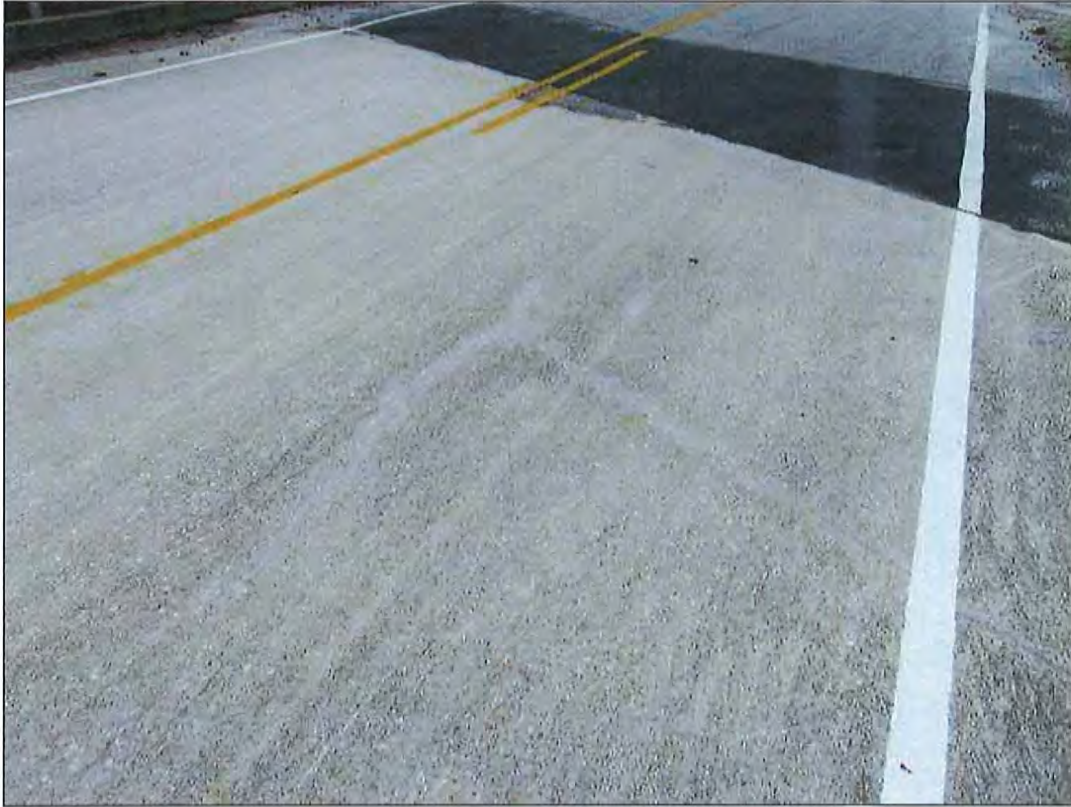
SEALED CRACKING IN SPAN 4 DECK

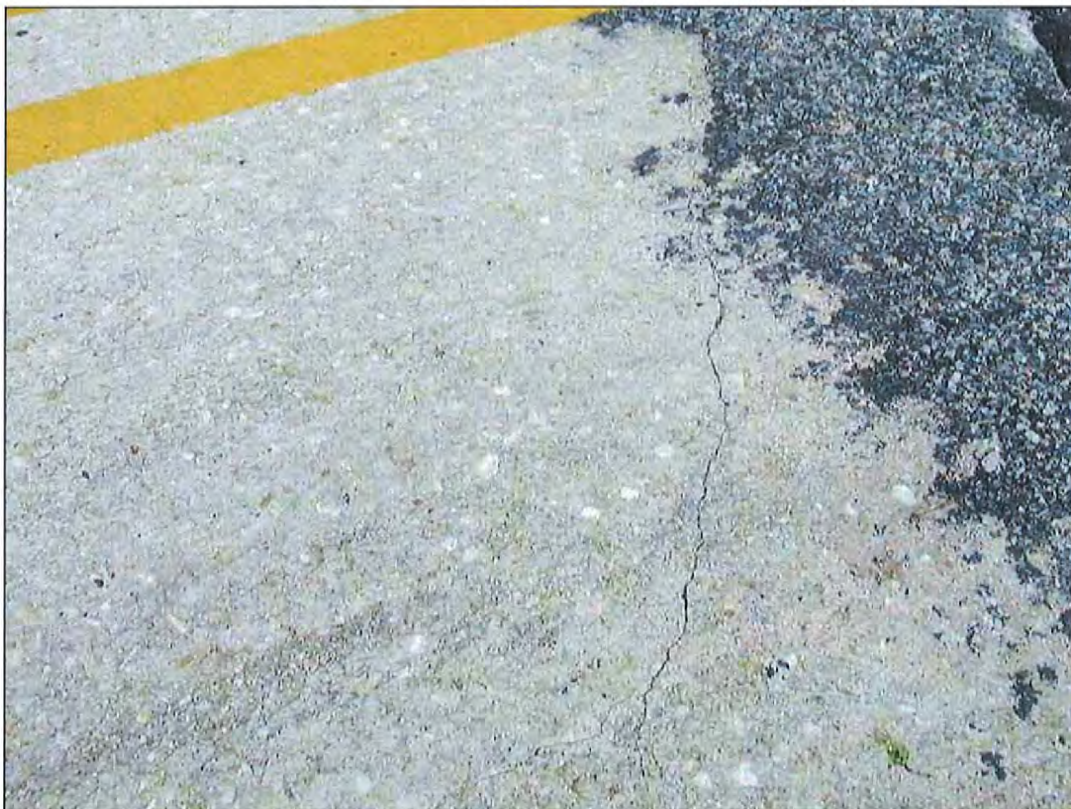
HAIRLINE TRANSVERSE CRACK IN SPAN 4 DECK OVER END BENT 2 CURTAIN WALL

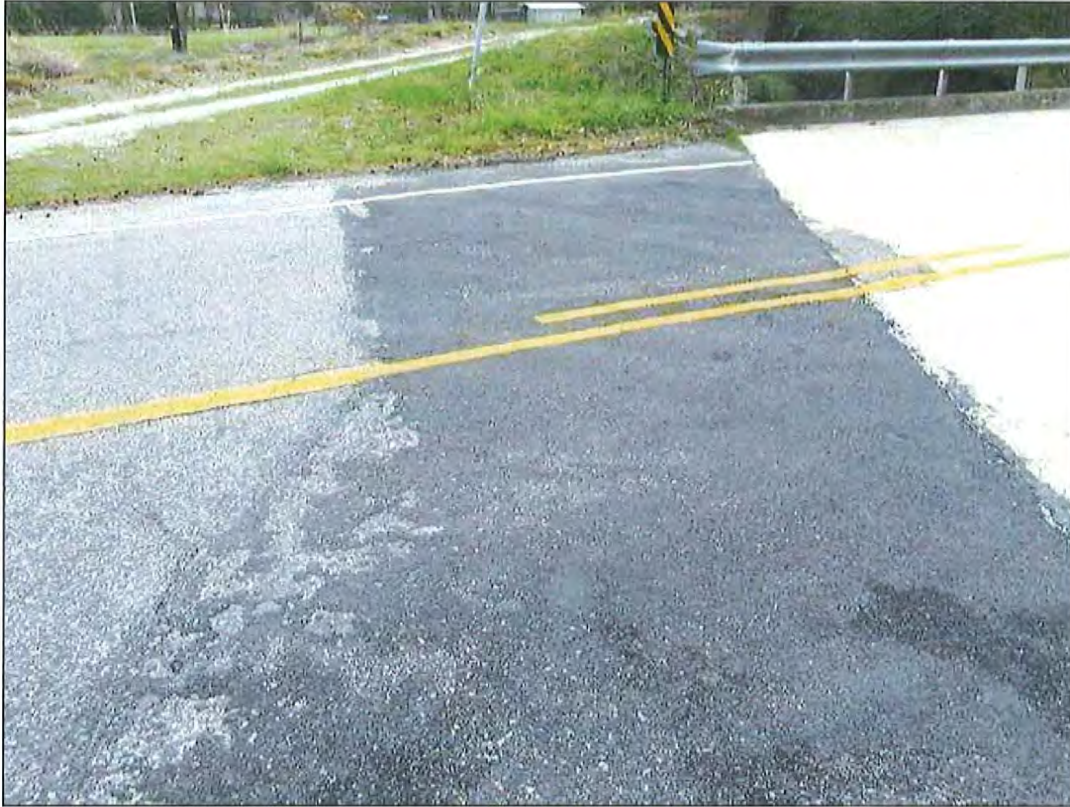
NORTH APPROACH ASPHALT WEARING SURFACE HAS BEEN PATCHED

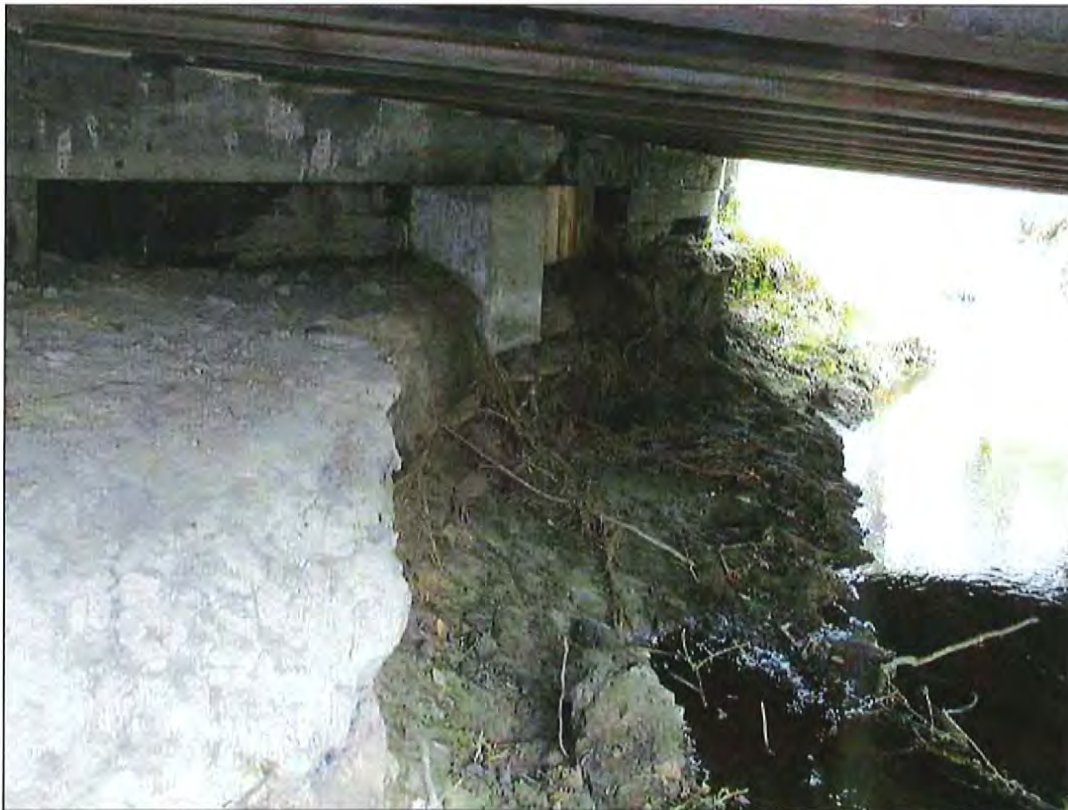
| 45c | P | THERE IS DRIFT IN SPAN 3 AT BENT 2. (PHOTO)<br>( SCOUR ) THERE IS LATERAL BANK EROSION 5' DEEP X 4' WIDE X 20' LONG IN SPAN 4 AT END BENT 2 EXPOSING PILES 3, 4, AND 5. (PHOTO) PM ISSUED.<br><br>THERE IS LOCAL SCOUR AT BENTS 2 AND 3 UPSTREAM PILES DUE TO DRIFT.<br><br>SEE SCOUR REPORT DATED 6/24/2010. | |

THERE IS LATERAL BANK EROSION 5' DEEP X 4' WIDE X 20' LONG IN SPAN 4 AT END BENT 2 EXPOSING PILES 3, 4, AND 5 PM ISSUED.

| MMS Code | Description of Function | Unit | Quantity | Remarks | Est. Cost |
|---|---|---|---|---|---|
| 3352 | Maint Slope Protection | SF | <del>400</del> TSE<br>9/25/14 | THERE IS LATERAL BANK EROSION 5' DEEP X 4' WIDE X 20' LONG IN SPAN 4 AT END BENT 2 EXPOSING PILES 3, 4, AND 5 | |

| MMS Code | MMS Description | Quantity |
|---|---|---|
| THERE IS LATERAL BANK EROSION 5' DEEP X 4' WIDE X 20' LONG IN SPAN 4 AT END BENT 2 EXPOSING PILES 3, 4, AND 5 | | |

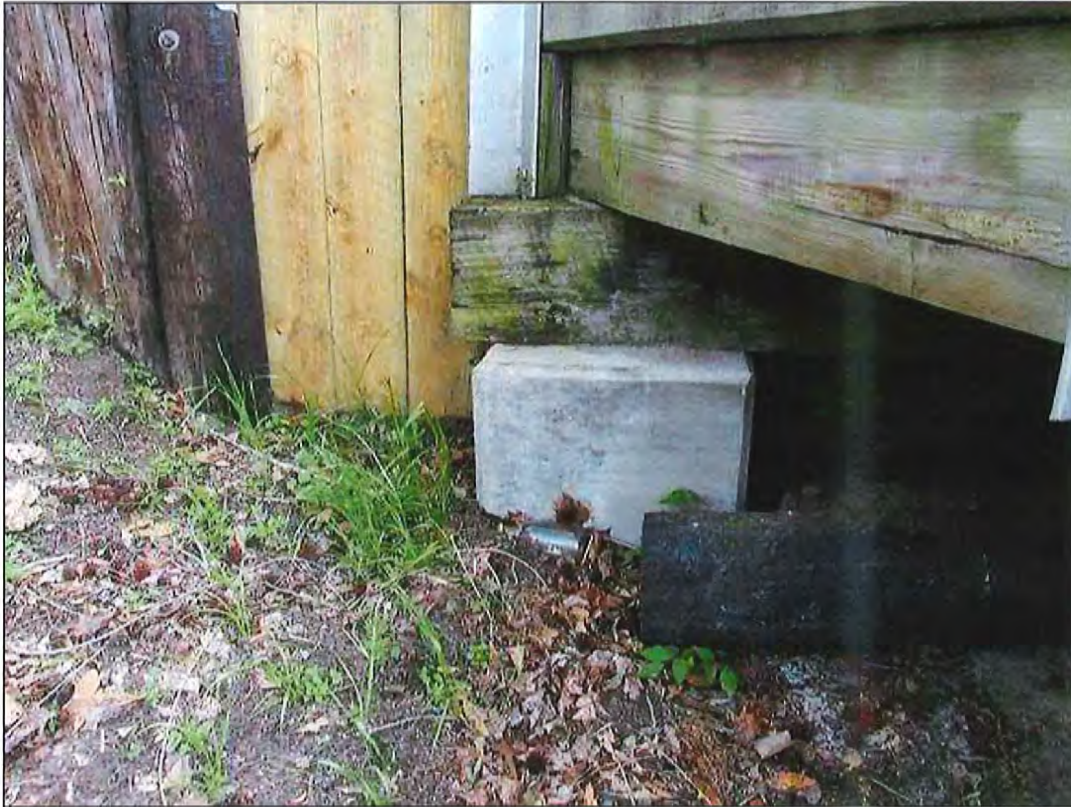
PILE 1 AT END BENT 2 IS ENCASED

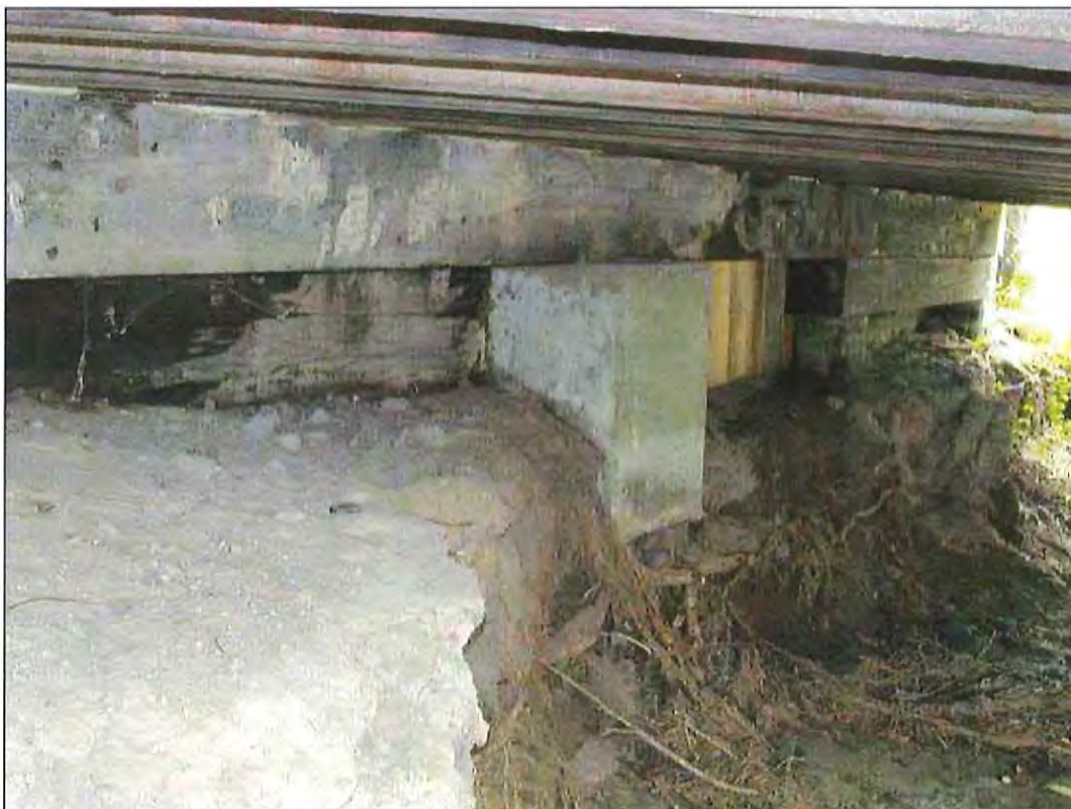
PILE 3 AT END BENT 2 IS ENCASED

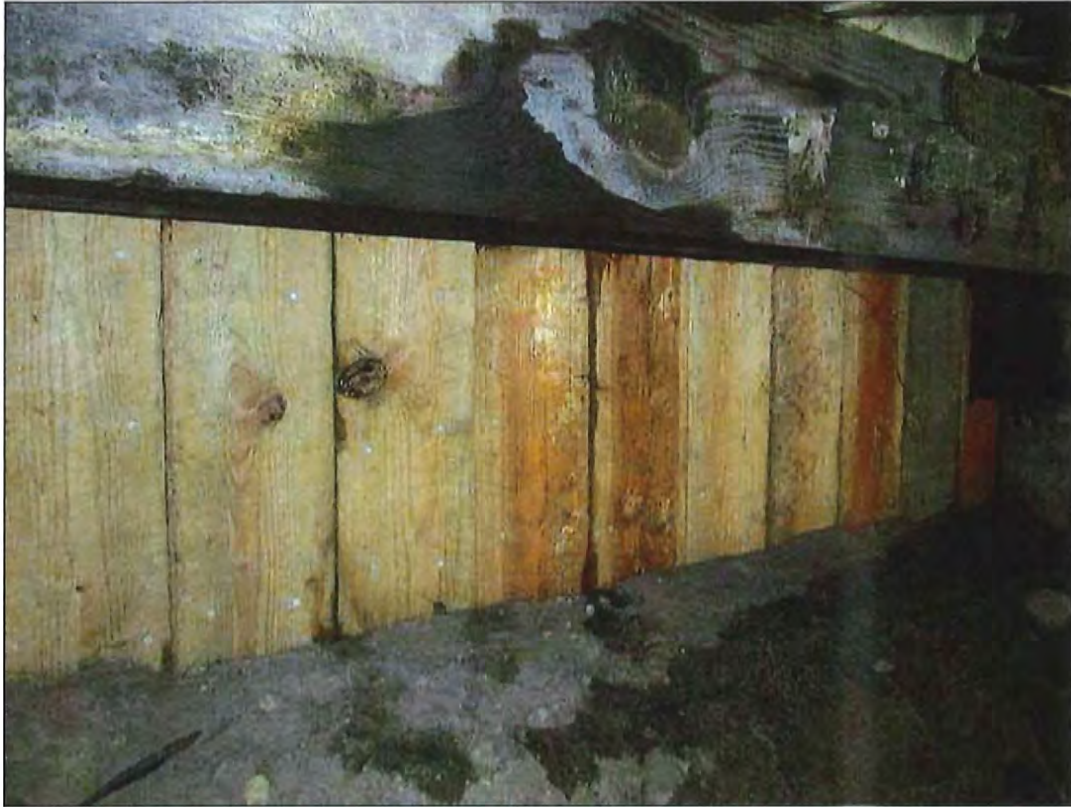
END BENT 2 BULKHEAD REPAIR BETWEEN PILES 3 AND 4
