# BRIDGE INSPECTION REPORT

INSPECTION TYPE: Routine Inspection

COUNTY ROBESON BRIDGE NUMBER 770433 INSPECTION CYCLE 2 YRS  
ROUTE SR1160 ACROSS BACK SWAMP M.P. 0

INSPECTION DATE 04/08/2014

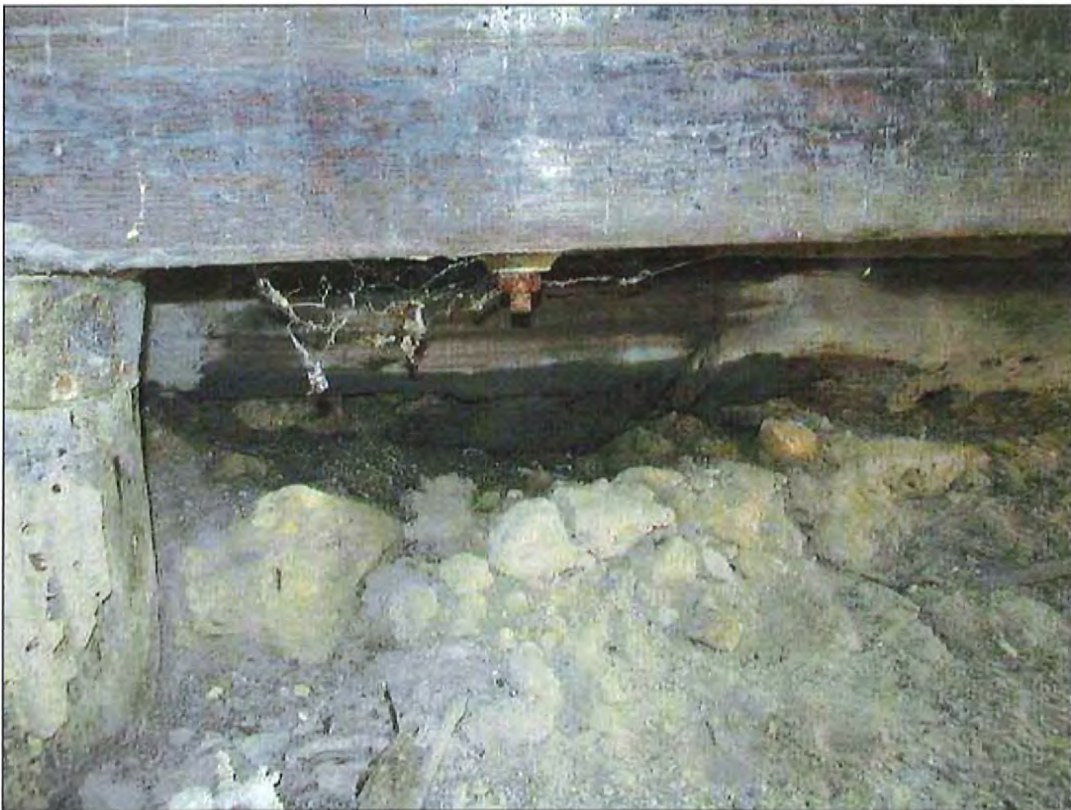
DECAYED BOTTOM BULKHEAD BOARD AT END BENT 2 BETWEEN PILES 4 AND 5

| MMS Code | Description of Function | Unit | Quantity | Remarks | Est. Cost |
|---|---|---|---|---|---|
| 3346 | Repair / Maintain Timber Wings & Blkhds | SF | 5 | DECAYED BOTTOM BULKHEAD BOARD AT END BENT 2 BETWEEN PILES 4 AND 5 | |

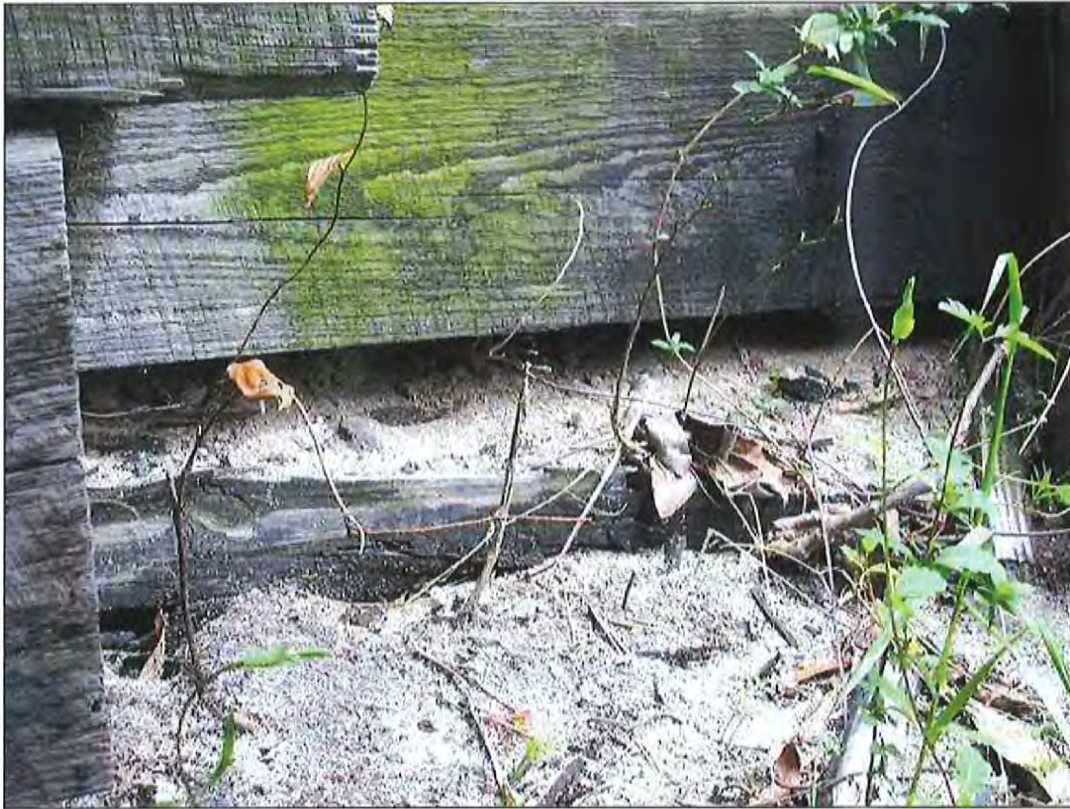
| 35c | F | ( TIMBER BULKHEAD AND WINGWALLS ) THERE ARE REPAIRED EXTERIOR BULKHEAD BOARDS AT NORTHWEST CORNER. (PHOTO)<br><br>END BENT 2 BULKHEAD REPAIR BETWEEN PILES 3 AND 4. (PHOTO)<br><br>DECAYED BOTTOM BULKHEAD BOARD AT END BENT 2 BETWEEN PILES 4 AND 5. (PHOTO)<br><br>DECAYED BOTTOM EXTERIOR BULKHEAD BOARD AT NORTHEAST CORNER WITH FILL LEAKAGE. (PHOTO) | |

DECAYED BOTTOM EXTERIOR BULKHEAD BOARD AT NORTHEAST CORNER WITH FILL LEAKAGE

| MMS Code | Description of Function | Unit | Quantity | Remarks | Est. Cost |
|---|---|---|---|---|---|
| 3346 | Repair / Maintain Timber Wings & Blkhds | SF | 3 | DECAYED BOTTOM EXTERIOR BULKHEAD BOARD AT NORTHEAST CORNER WITH FILL LEAKAGE | |
