NC DEPARTMENT OF TRANSPORTATION  
DIVISION OF HIGHWAYS  
STRUCTURE MANAGEMENT UNIT

## Structure Safety Report

### Routine Element Inspection

COUNTY: HALIFAX STRUCTURE NUMBER: 410127 FREQUENCY: 24 MONTHS  
FACILITY CARRIED: SR1002 MILE POST: \_\_\_\_\_  
LOCATION: 0.4 MI.E.JCT.SR1210  
FEATURE INTERSECTED: JACKET SWAMP  
LATITUDE: 36° 12' 24.34" LONGITUDE: 77° 43' 48.15"  
SUPERSTRUCTURE: PPC CHANNELS  
SUBSTRUCTURE: EBTS&IBTS:PPC CAPS/TIMBER PILES @ 5"9 CTS.  
SPANS: 2@25.5'  
2@25"6  
☐ FRACTURE CRITICAL ☒ TEMPORARY SHORING ☐ SCOUR CRITICAL ☒ SCOUR PLAN OF ACTION  
PRESENT CONDITION: Fair INSPECTION DATE: 07/15/2015  
POSTED SV: 25 POSTED TTST: 29  
OTHER SIGNS PRESENT: 4 DELINEATORS

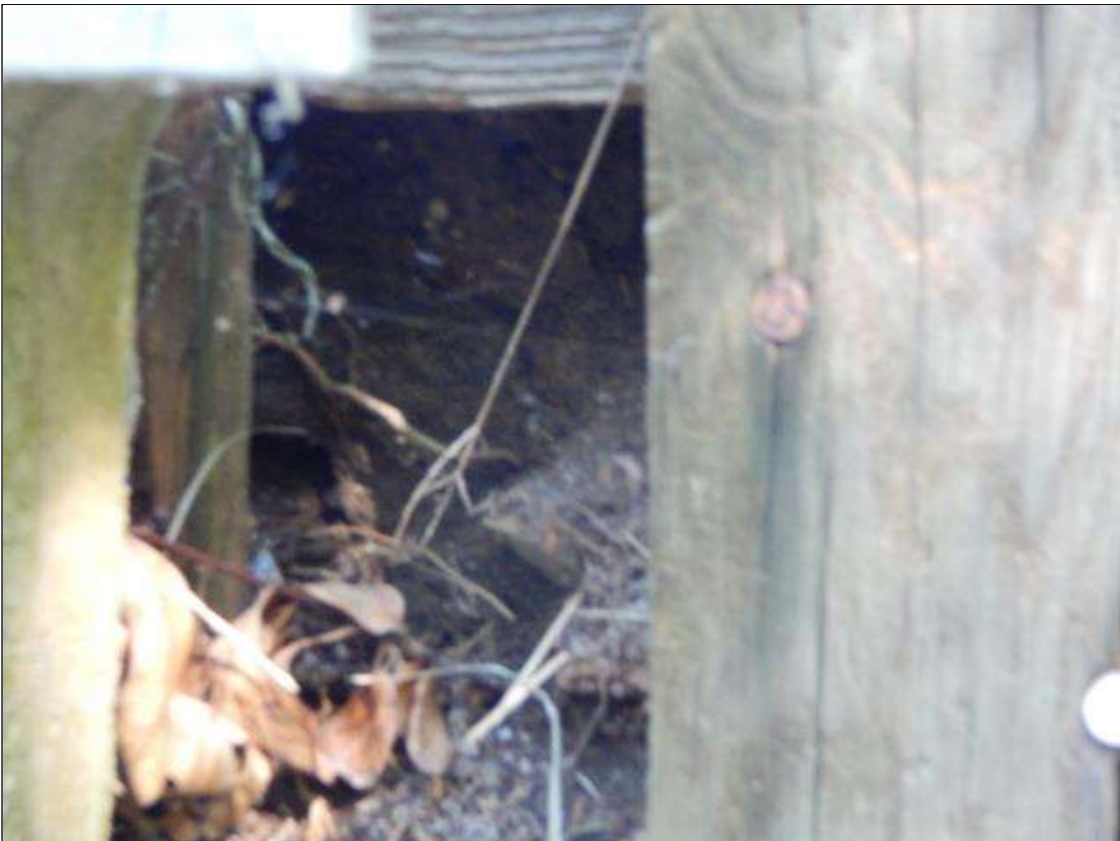
End Bent 1 Abutment/Backwall : 4 Feet of Decay/Section Loss ON LEFT SIDE AT END BENT 1: Affects 10% or more of the member but does not warrant structural review.

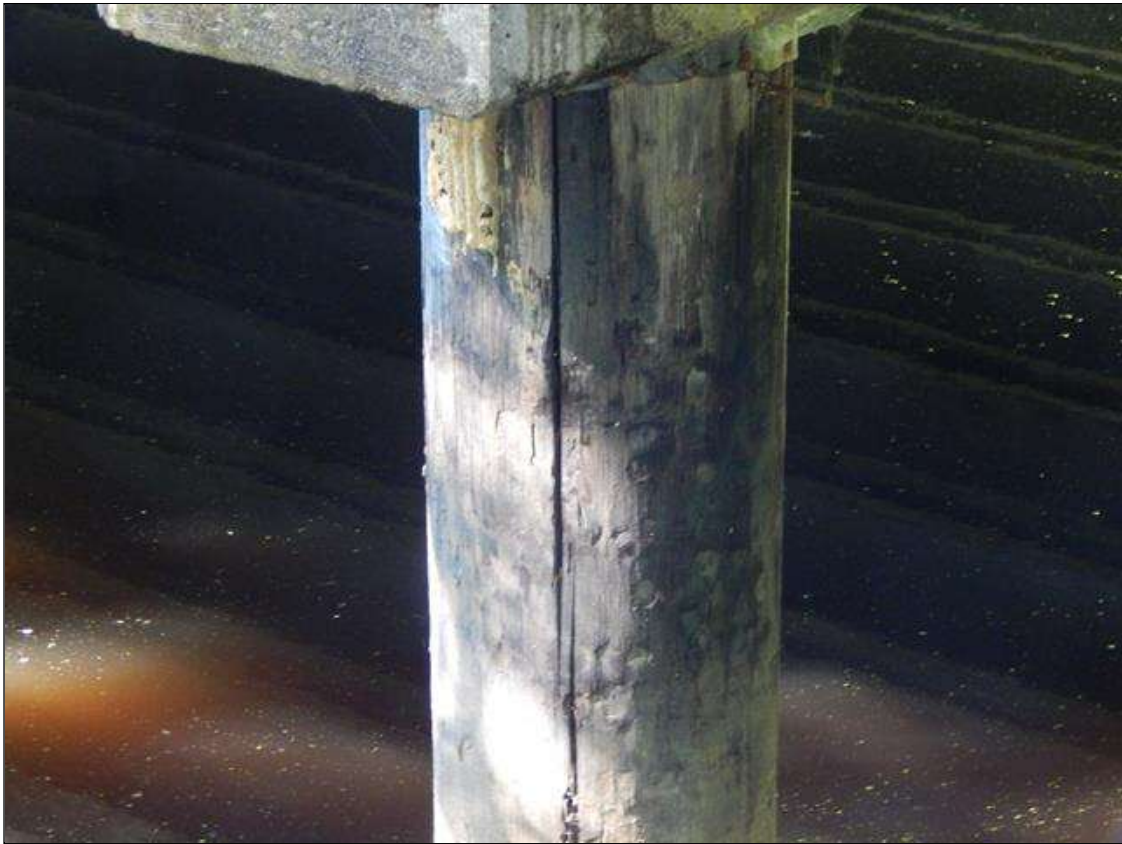
Bent 1 Pile 1: 1 Each of Split/Delamination (Timber) FROM CAP DOWN 3': Length equal to or greater than the member depth but does not require structural review.

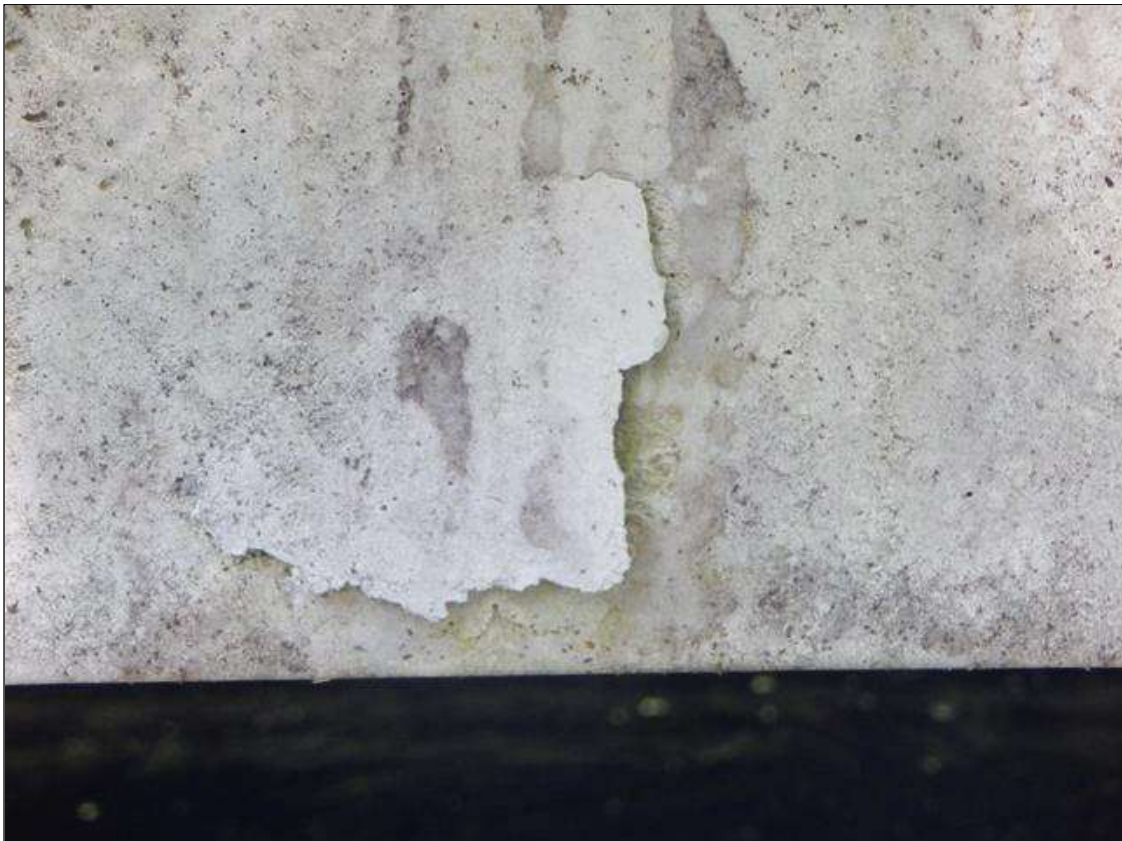
Span 1 Channel/Slab 1: 9 Feet of Delamination/Spall/Patched Area: 4' OF Delaminated AREAS. Spall 1 in. or less deep or 6 in. or less in diameter. 5' OF Patched area that is sound.

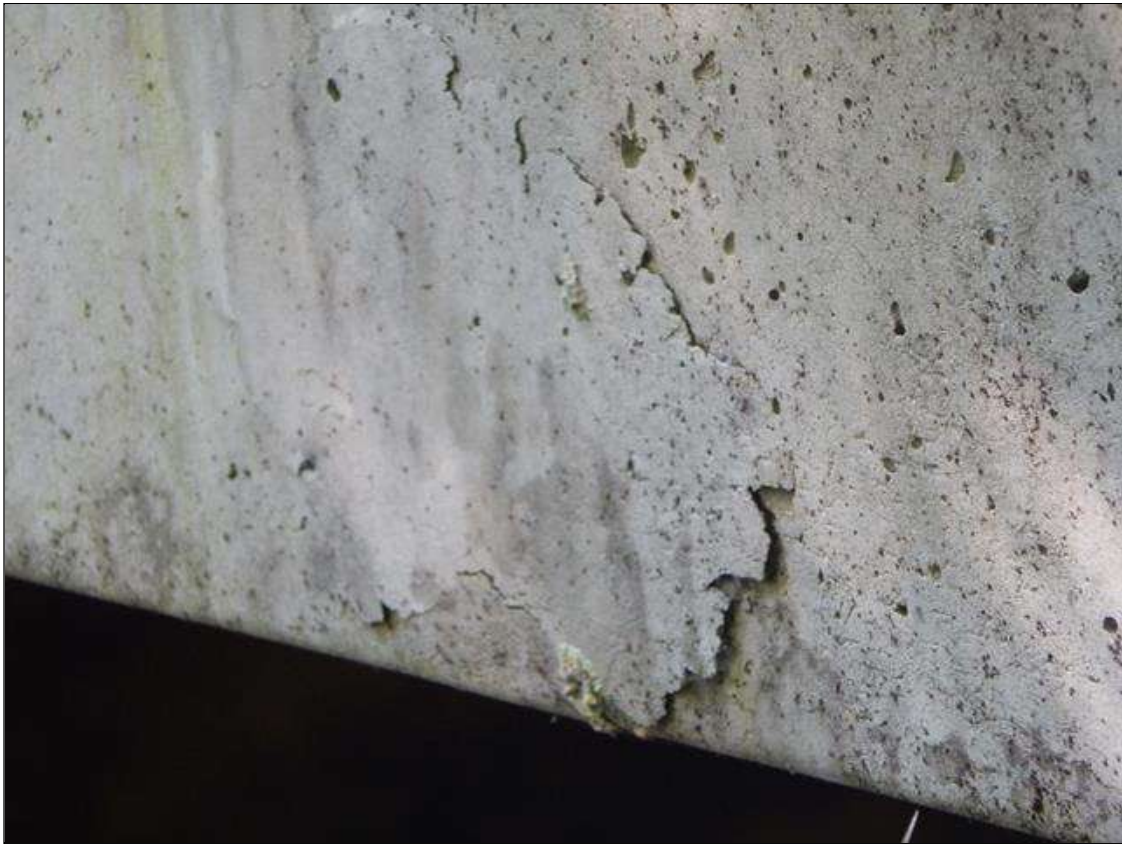
Span 2 Channel/Slab 1: 4 Feet of Delaminated Area: Delaminated.

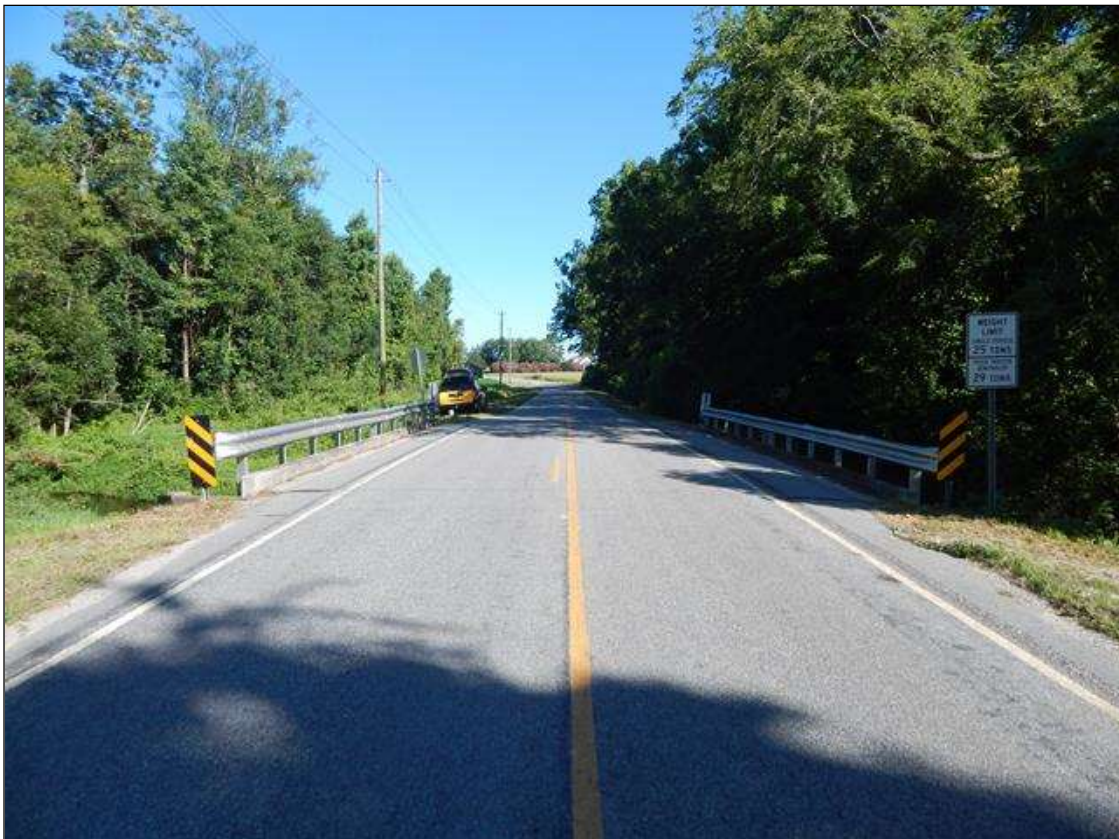
LOOKING WEST WEIGHT LIMIT SV 25 TONS, TTST 29 TONS

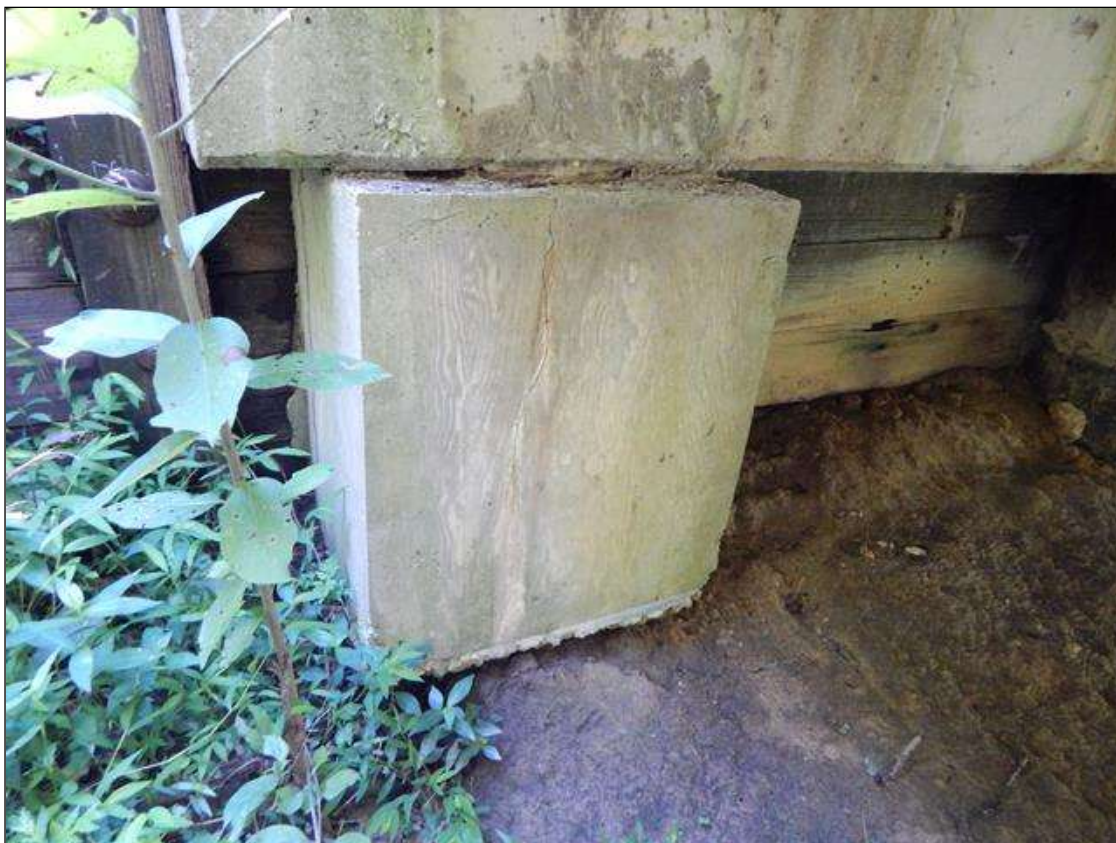
PILE 1 AT END BENT 2 ENCASED.

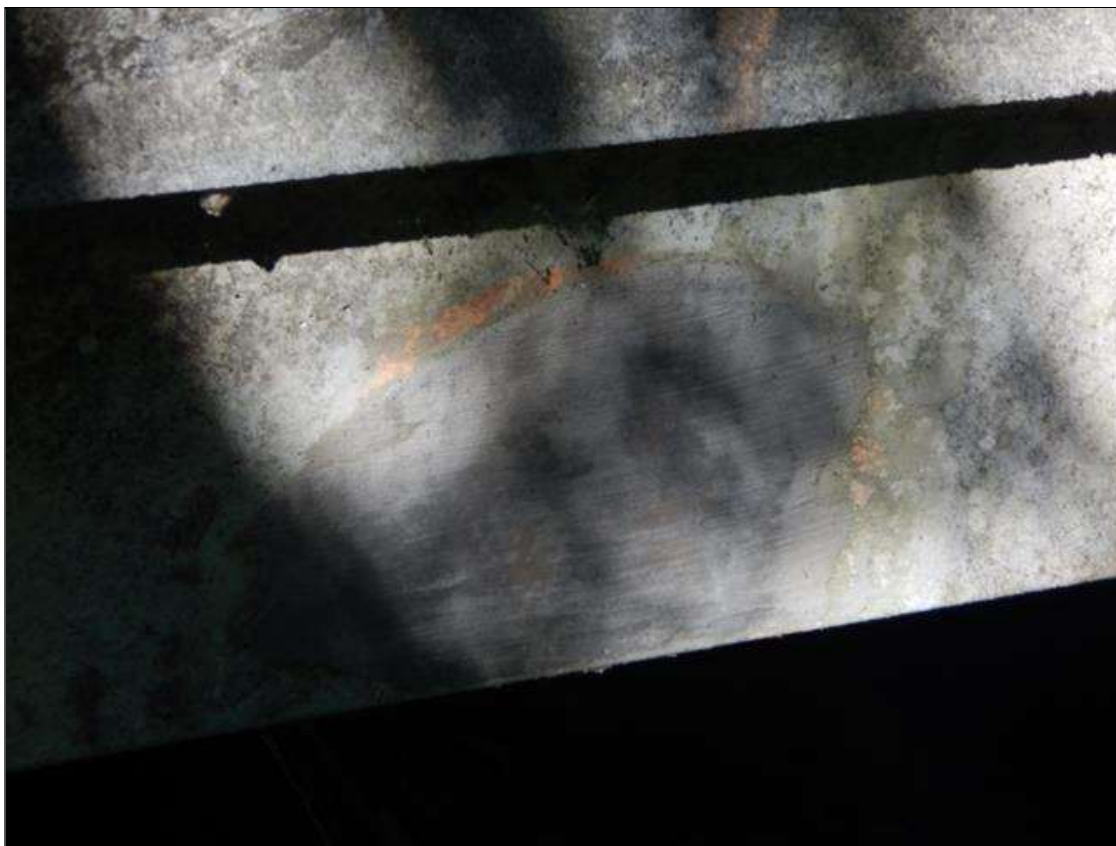
5 REPAIR AREAS IN CHANNEL 1, LEG 1 IN SPAN 1.
