# BRIDGE INSPECTION REPORT

INSPECTION TYPE: Routine Inspection

COUNTY NASH BRIDGE NUMBER 630103 INSPECTION CYCLE 2 YRS  
ROUTE SR1105 ACROSS TRIB OF TURKEY CR M.P. 0

INSPECTION DATE 05/20/2014

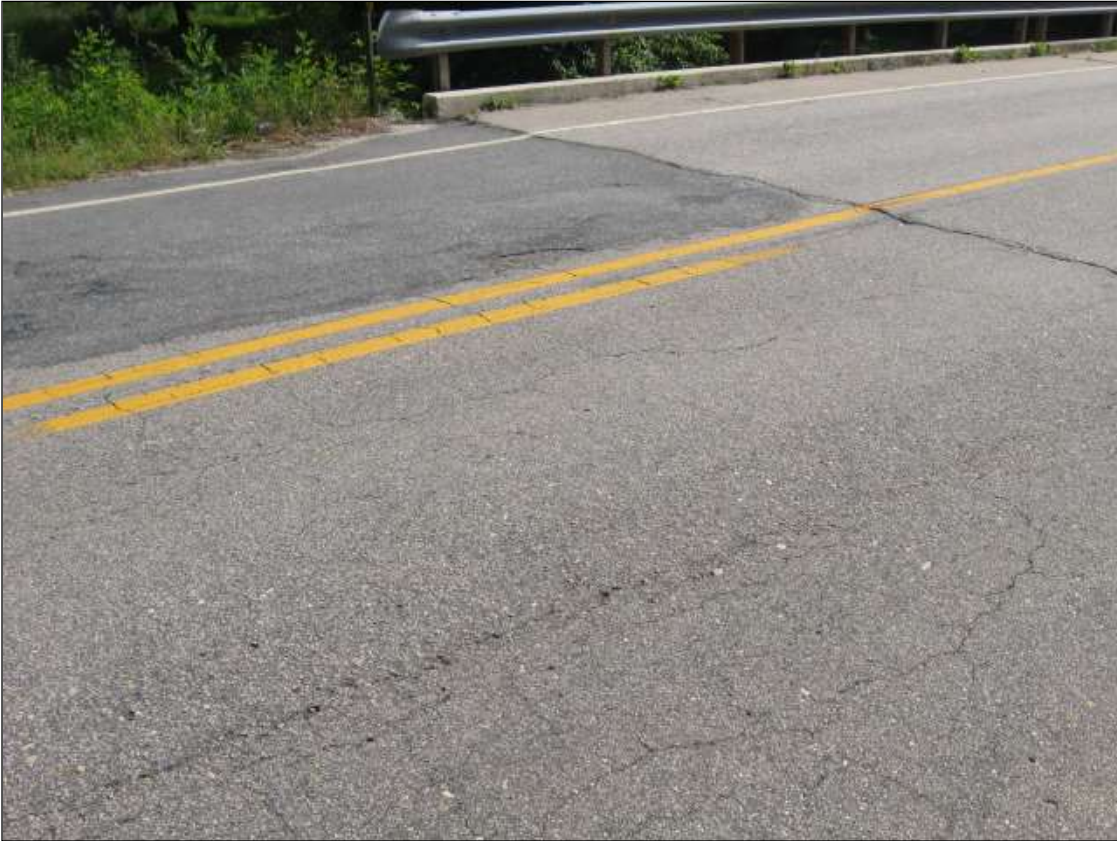
| <b>50</b> | <b>F</b> | APPROACH ROADWAY<br>LONGITUDINAL AND MAP CRACKS IN BOTH APPROACHES.<br>SEE PHOTOS. | |

LONGITUDINAL AND MAP CRACKING IN ASPHALT WEARING SURFACE APPROACH ROADWAY @ WEST END

| MMS Code | Description of Function | Unit | Quantity | Remarks | Est. Cost |
|---|---|---|---|---|---|
| 2816 | Asphalt Surface Repair or Replacement | SY | 2 | WEARING SURFACE<br>TRANSVERSE, MAP, AND<br>LONGITUDINAL CRACKS IN ASPHALT<br>WEARING SURFACE IN ALL SPANS.<br>TRANSVERSE CRACKS IN WEARING<br>SURFACE OVER BOTH END BENTS<br>AND INTERIOR BENTS.<br>APPROACH ROADWAY<br>LONGITUDINAL AND MAP CRACKS IN<br>BOTH APPROACHES. | |

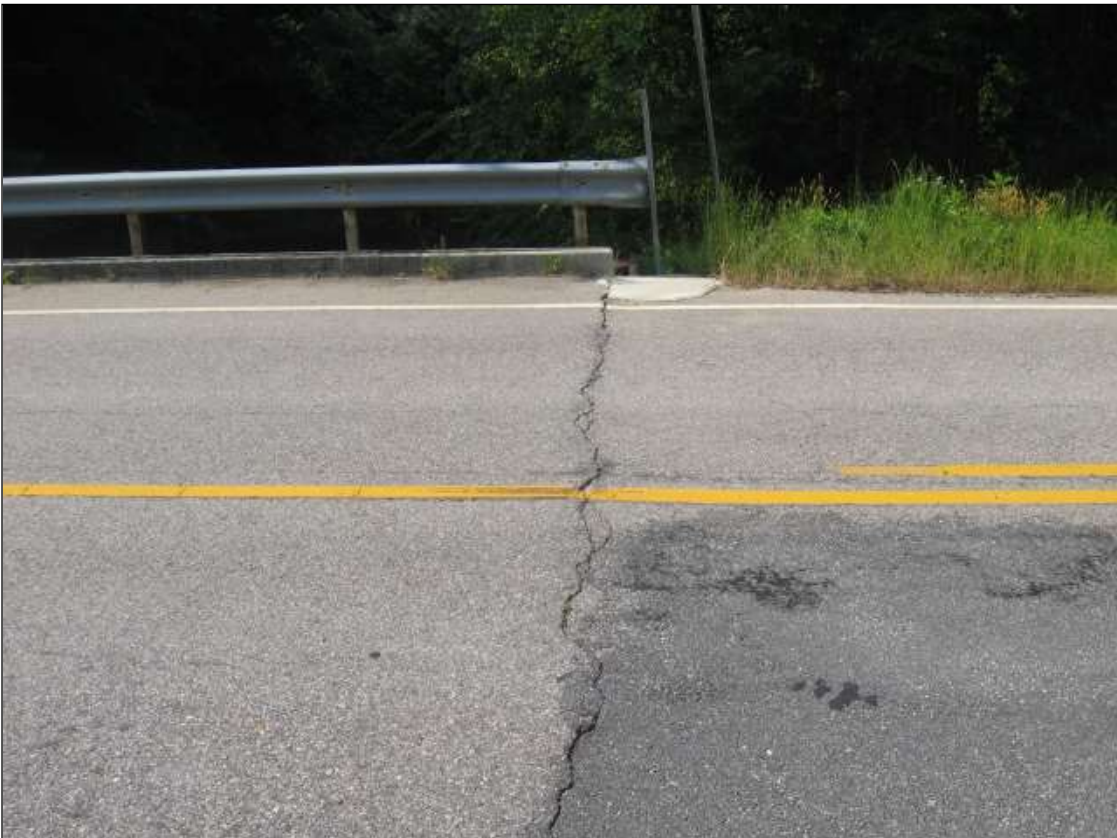
| Bridge I&A Form 1(82)H<br>State of North Carolina<br>Dept. of Transportation<br>Division of Highways | | <b>FIELD INSPECTION REPORT</b><br><u>Bridge Inspection &amp; Analysis</u> | |
|---|---|---|--|
| <b>1</b> | <b>F</b> | WEARING SURFACE<br>TRANSVERSE, MAP, AND LONGITUDINAL CRACKS IN ASPHALT WEARING SURFACE IN ALL SPANS.<br>TRANSVERSE CRACKS IN WEARING SURFACE OVER BOTH END BENTS AND INTERIOR BENTS.<br>SEE PHOTOS. | |

TRANSVERSE CRACK IN ASPHALT WEARING SURFACE OVER END BENT 1

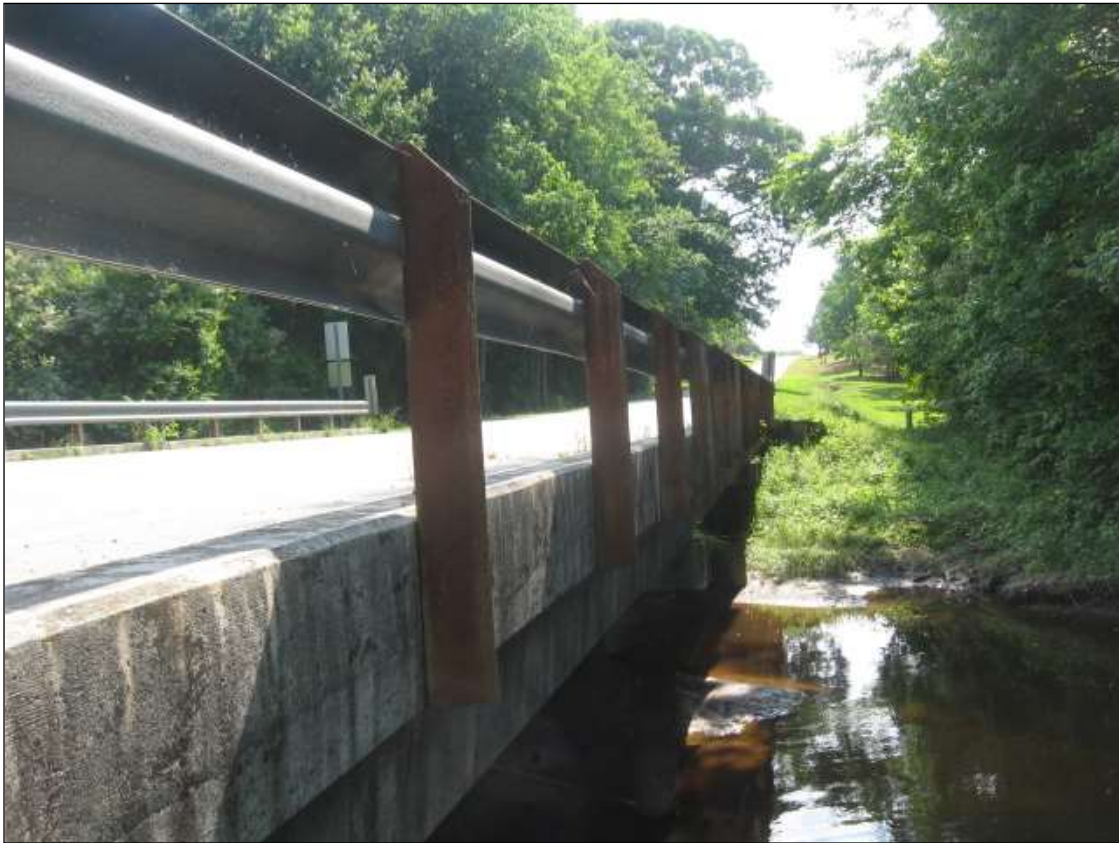
SURFACE RUST ON BACKSIDE OF GUARDRAIL POST RIGHT SIDE AND LEFT SIDE

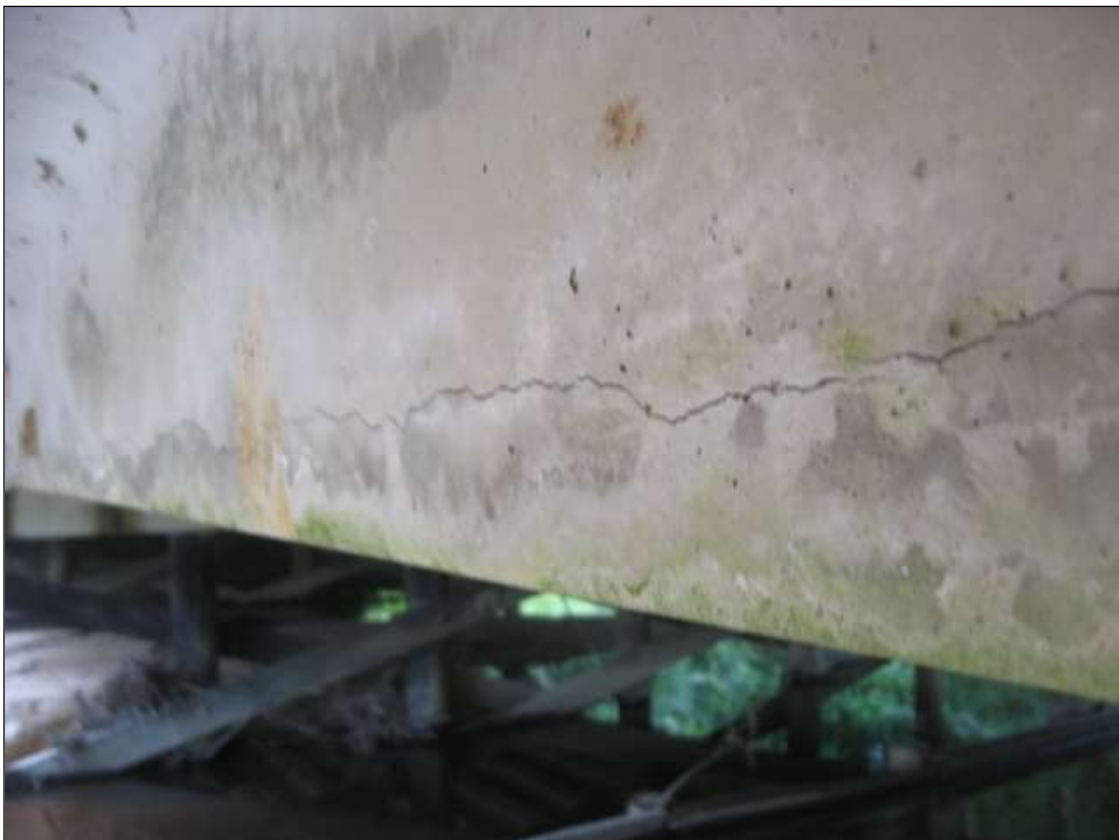
| Bridge I&A Form 1(82)H<br>State of North Carolina<br>Dept. of Transportation<br>Division of Highways | | <b>FIELD INSPECTION REPORT</b><br><u>Bridge Inspection &amp; Analysis</u> | |
|---|---|---|--|
| <b>10</b> | <b>F</b> | LONGITUDINAL PPC CHANNELS<br>SMALL SURFACE SPALLS IN THE ENDS OF CHANNELS OVER INTERIOR BENT CAPS.<br><br>SPAN 1<br>RIGHT LEG OF CHANNEL 1 HAS 1/16 IN X 8 FT. LONG CRACK WITH DELAMINATION IN BOTTOM.<br>RIGHT LEG OF CHANNEL 11 HAS 1/16 IN X 4 FT. LONG CRACK 2 FT. OUT FROM INTERIOR BENT 1.<br>RIGHT LEG OF CHANNEL 10 HAS SMALL SURFACE SPALL.<br><br>SPAN 2<br>LEFT LEG OF CHANNEL 3 HAS 3/16 IN X 3 FT. LONG CRACK 2 1/2 FT. OUT FROM INTERIOR BENT 2.<br>RIGHT LEG OF CHANNEL 9 HAS 1/8 IN X 3 FT. LONG CRACK 10 FT. OUT FROM INTERIOR BENT 2. | |

LONGITUDINAL CRACK IN CHANNEL 1 RIGHT LEG @ SPAN 1

| MMS Code | Description of Function | Unit | Quantity | Remarks | Est. Cost |
|---|---|---|---|---|---|
| 3306 | Maintain Concrete Superstructure Components | SF | 64 | LONGITUDINAL PPC CHANNELS<br>SMALL SURFACE SPALLS IN THE ENDS<br>OF CHANNELS OVER INTERIOR BENT<br>CAPS.<br><br>SPAN 1<br>RIGHT LEG OF CHANNEL 1 HAS 1/16 IN<br>X 8 FT. LONG CRACK WITH<br>DELAMINATION IN BOTTOM.<br>RIGHT LEG OF CHANNEL 11 HAS 1/16<br>IN X 4 FT. LONG CRACK 2 FT. OUT<br>FROM INTERIOR BENT 1.<br>RIGHT LEG OF CHANNEL 10 HAS<br>SMALL SURFACE SPALL.<br><br>SPAN 2<br>LEFT LEG OF CHANNEL 3 HAS 3/16 IN X<br>3 FT. LONG CRACK 2 1/2 FT. OUT FROM<br>INTERIOR BENT 2.<br>RIGHT LEG OF CHANNEL 9 HAS 1/8 IN<br>X 3 FT. LONG CRACK 10 FT. OUT FROM<br>INTERIOR BENT 2. | |

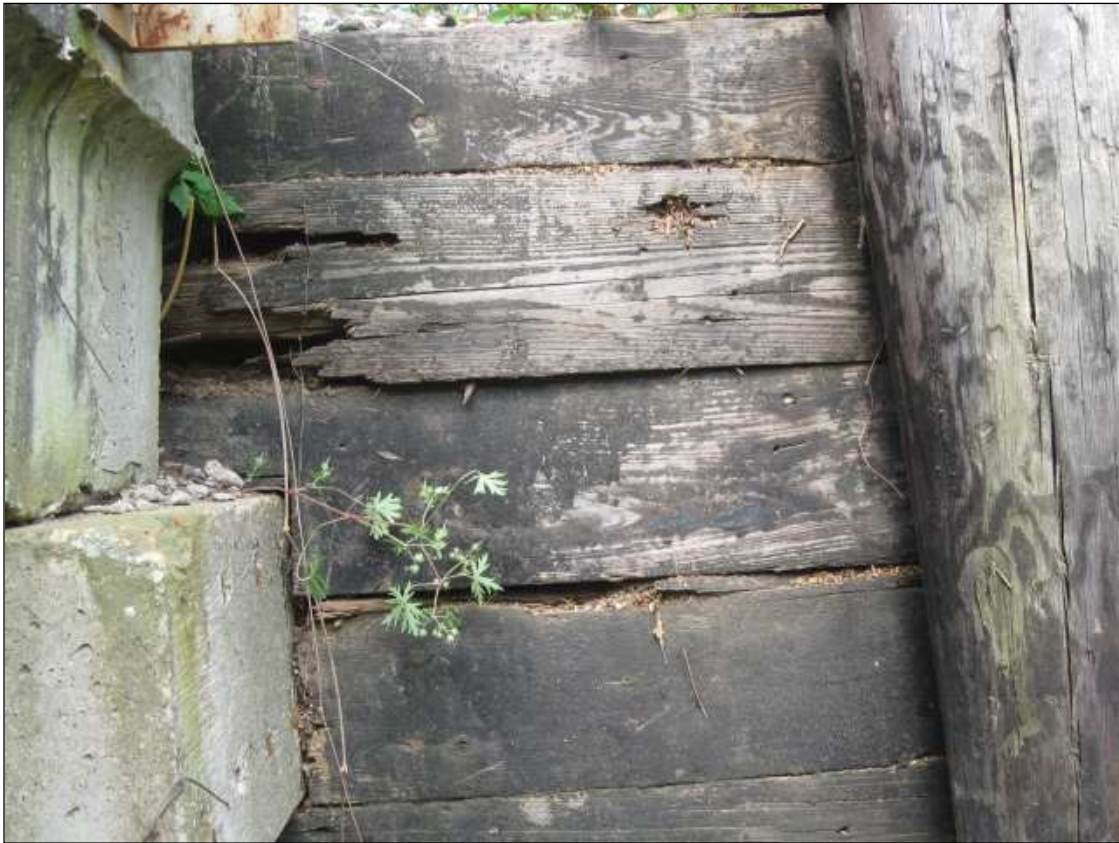
| Bridge I&A Form 1(82)H<br>State of North Carolina<br>Dept. of Transportation<br>Division of Highways | | <b>FIELD INSPECTION REPORT</b><br><u>Bridge Inspection &amp; Analysis</u> | |
|---|---|---|--|
| <b>35c</b> | <b>F</b> | TIMBER BULKHEADS<br>RANDOM AREAS OF DECAY W/ EXPOSED FILL IN BOARDS. PILES ARE DECAYED IN THE TOPS | |

DECAYED BULKHEAD BOARDS @ NORTH WEST CORNER WINGWALL

| MMS Code | Description of Function | Unit | Quantity | Remarks | Est. Cost |
|---|---|---|---|---|---|
| 3346 | Repair / Maintain Timber Wings & Blkhds | SF | 64 | TIMBER BULKHEADS -- RANDOM<br>AREAS OF DECAY WIDE/ EXPOSED<br>FILL IN BOARDS. PILES ARE DECAYED<br>IN THE TOPS. | |

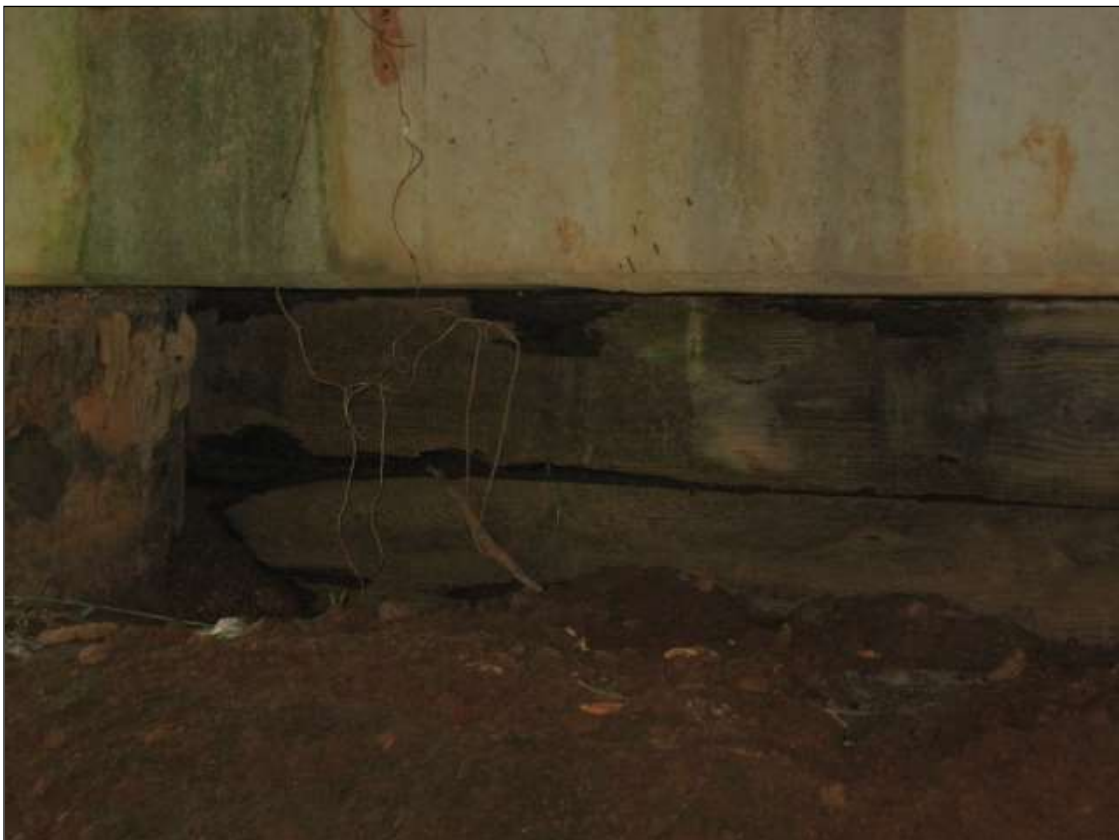
DECAYED BULKHEAD BOARDS @ END BENT 1

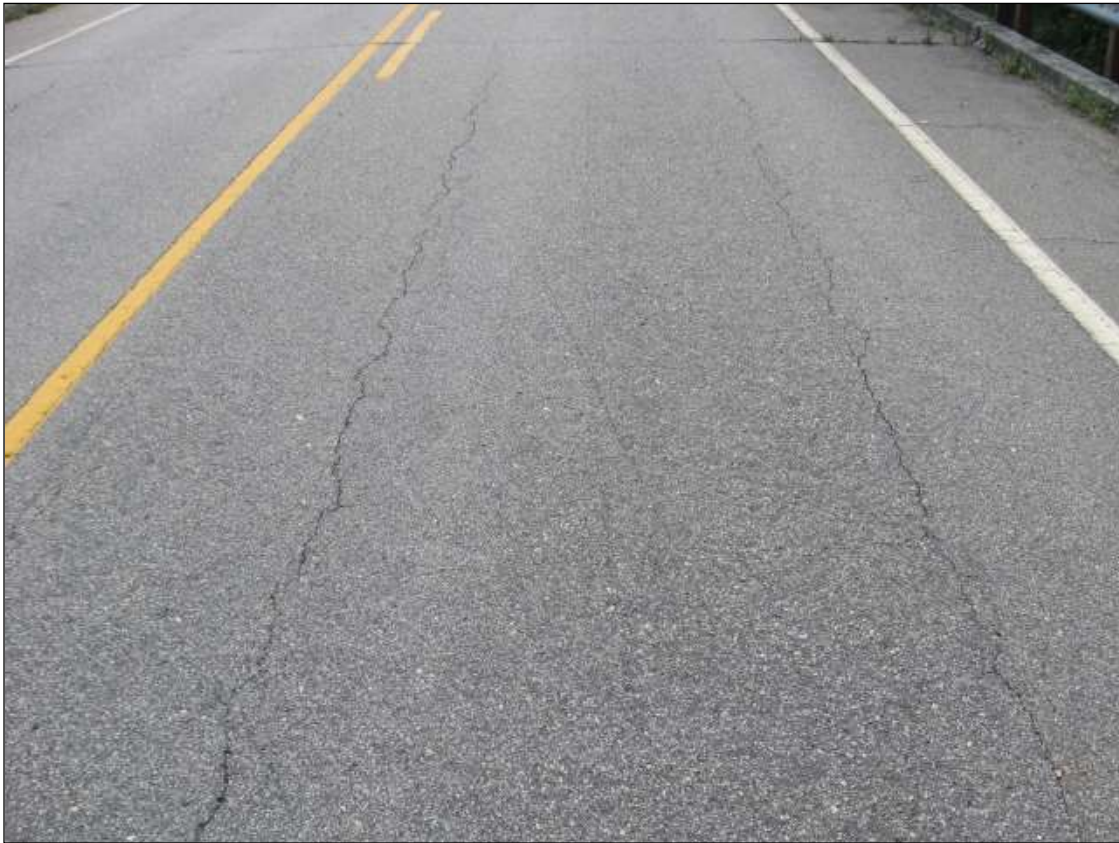
LONGITUDINAL CRACK IN ASPHALT WEARING SURFACE TOP OF DECK @ WHEELINES SPAN 1 ( ALL OTHER SPANS SIMILAR )

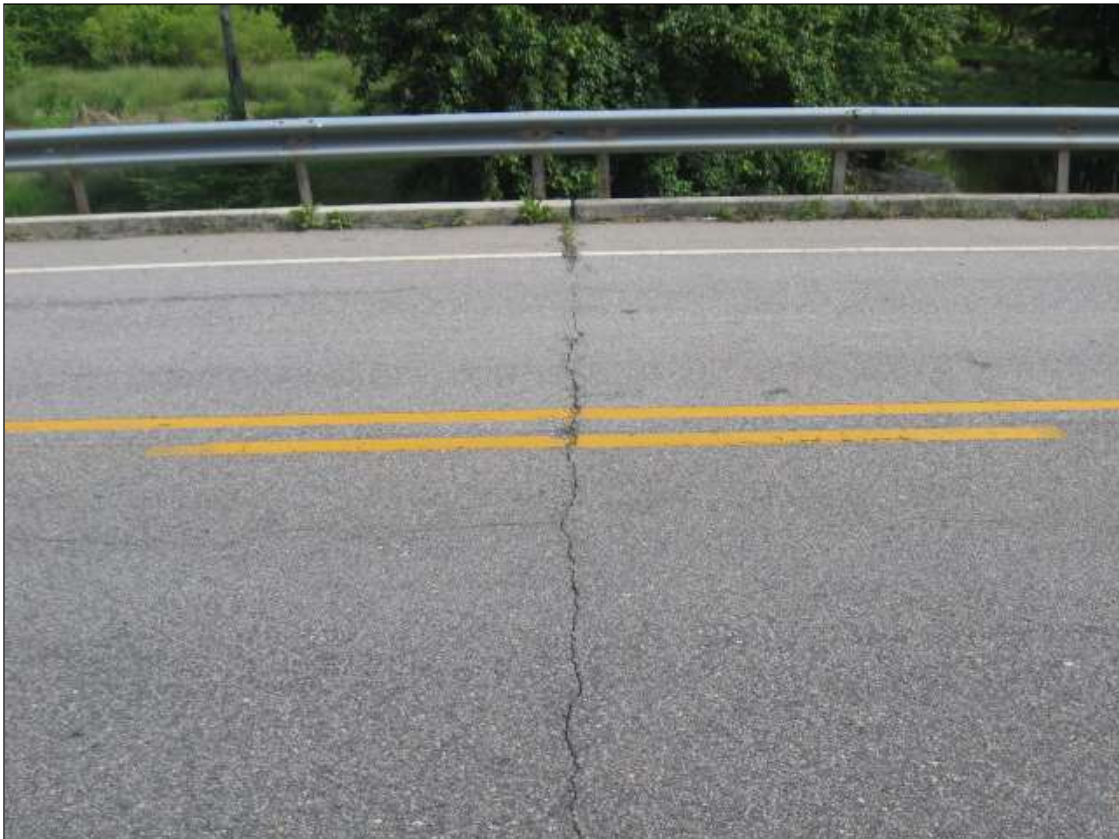
TRANSVERSE CRACK IN ASPHALT WEARING SURFACE OVER INTERIOR BENT 1

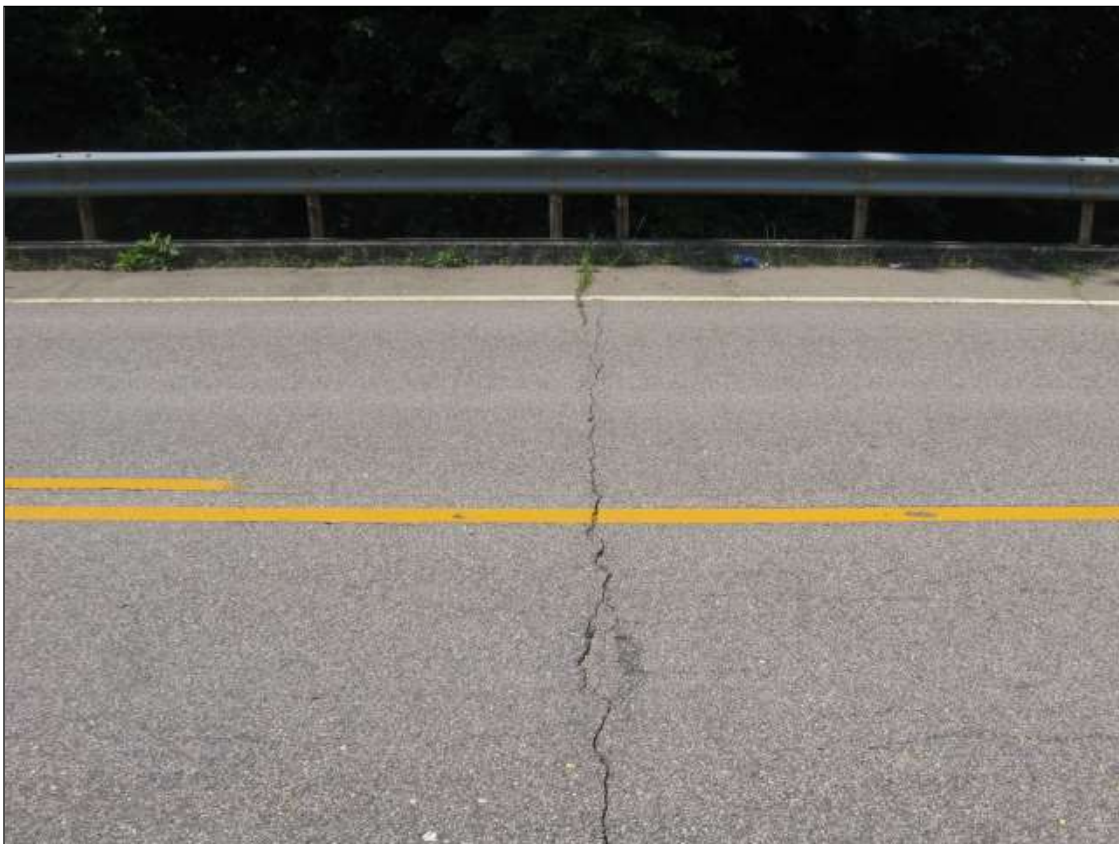
TRANSVERSE CRACK IN ASPHALT WEARING SURFACE OVER INTERIOR BENT 2

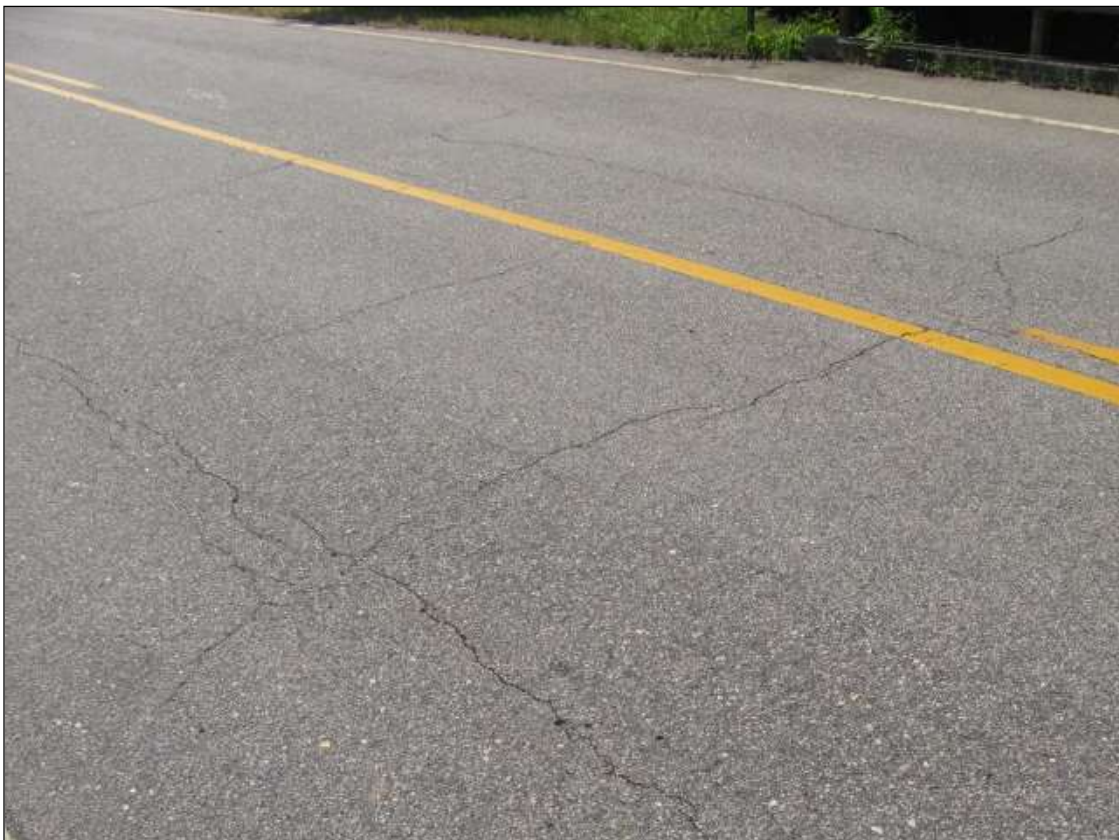
TRANSVERSE AND LONGITUDINAL CRACKS IN ASPHALT WEARING SURFACE TOP OF DECK SPAN 3

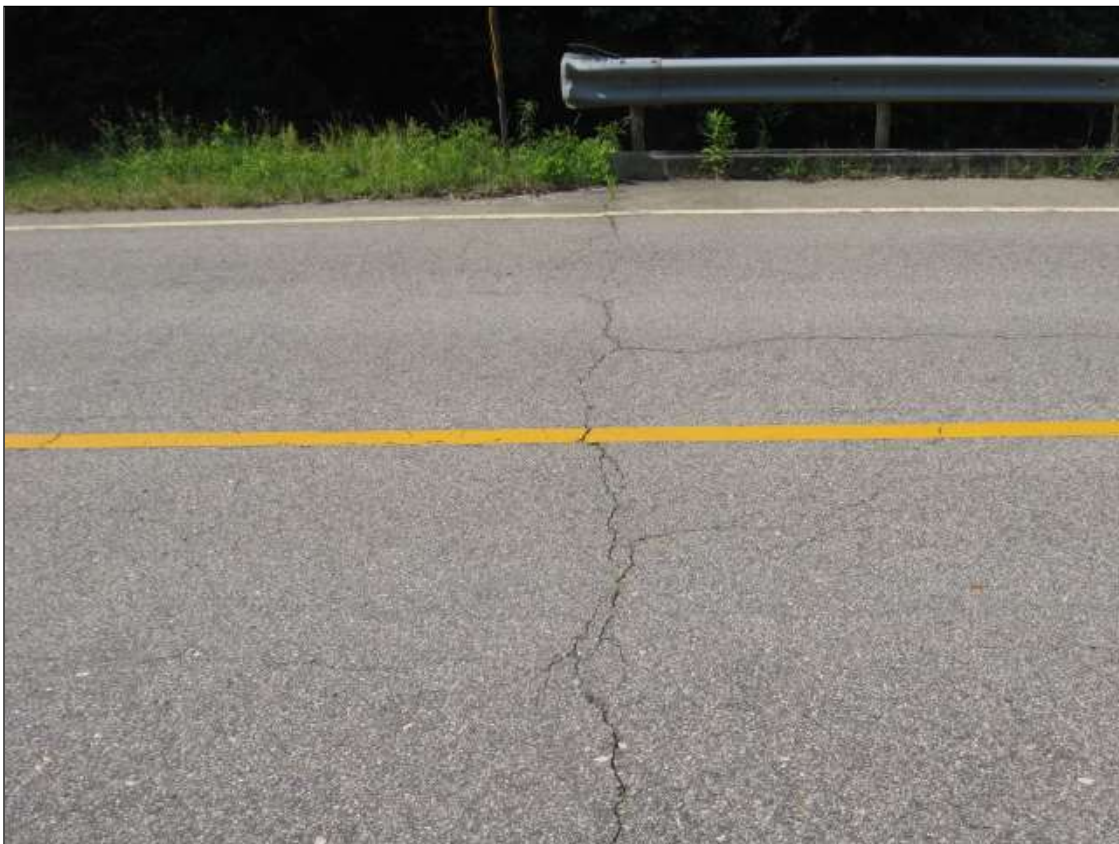
TRANSVERSE CRACK IN ASPHALT WEARING SURFACE OVER END BENT 2

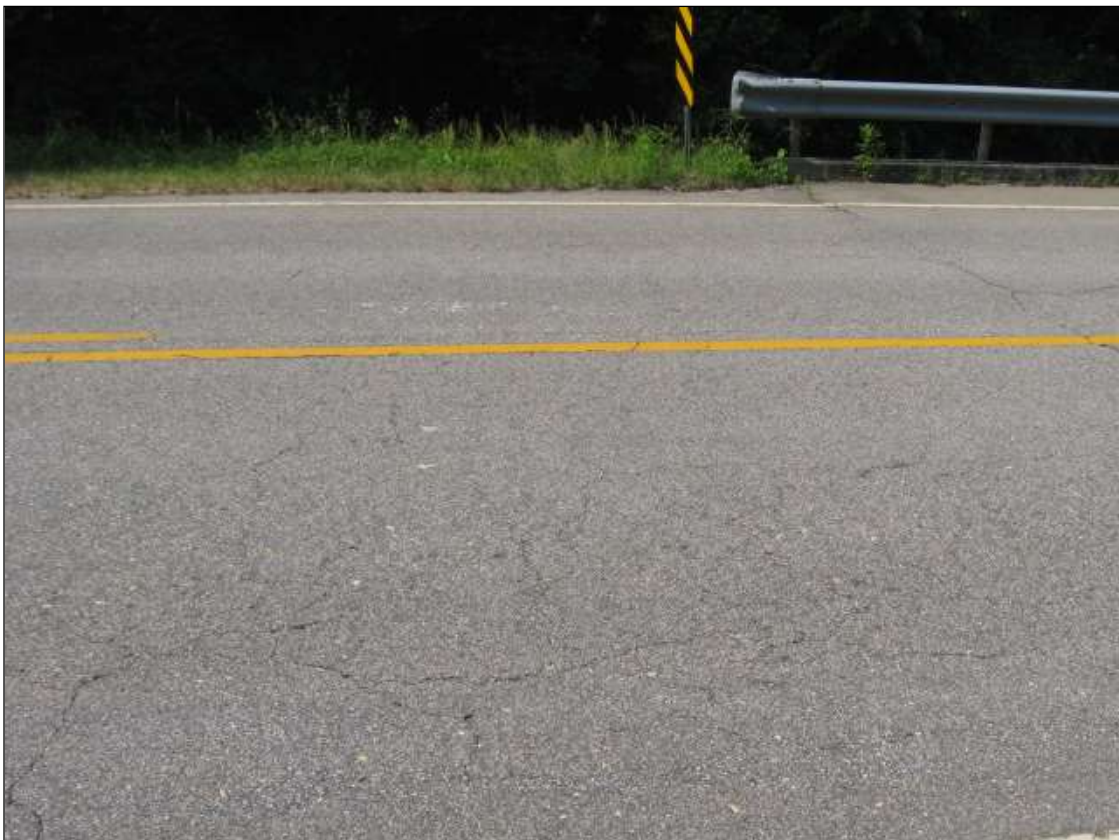
MAP CRACKING IN ASPHALT WEARING SURFACE APPROACH ROADWAY @ EAST END

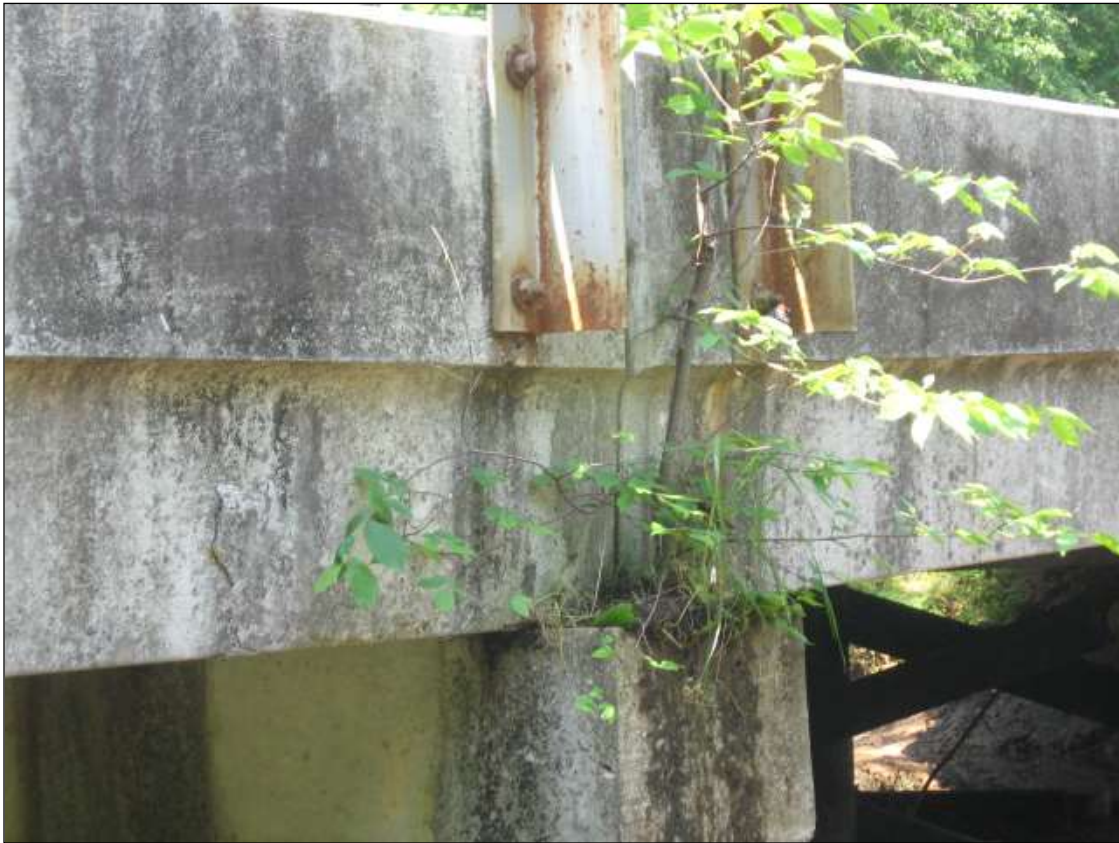
| Bridge I&A Form 1(82)H<br>State of North Carolina<br>Dept. of Transportation<br>Division of Highways | | <b>FIELD INSPECTION REPORT</b><br><u>Bridge Inspection &amp; Analysis</u> | |
|---|---|---|--|
| <b>36a</b> | <b>G</b> | CONCRETE CAPS<br>HAIRLINE TO 1/16 IN. WIDE MAP CRACKS IN RT END OF INTERIOR BENT 1 CAP.<br><br>16 FT. HAIRLINE LONGITUDINAL CRACK IN THE FACE OF END BENT 2 CAP EXTENDING FROM LT END OVER TO CHANNEL 6.<br><br>HAIRLINE LONGITUDINAL AND MAP CRACKS IN TOPS AND FACES. VEGETATION GROWING IN TOPS OF CAPS. | |

VEGETATION ON TOP OF CAP @ INTERIOR BENT 2 LEFT SIDE

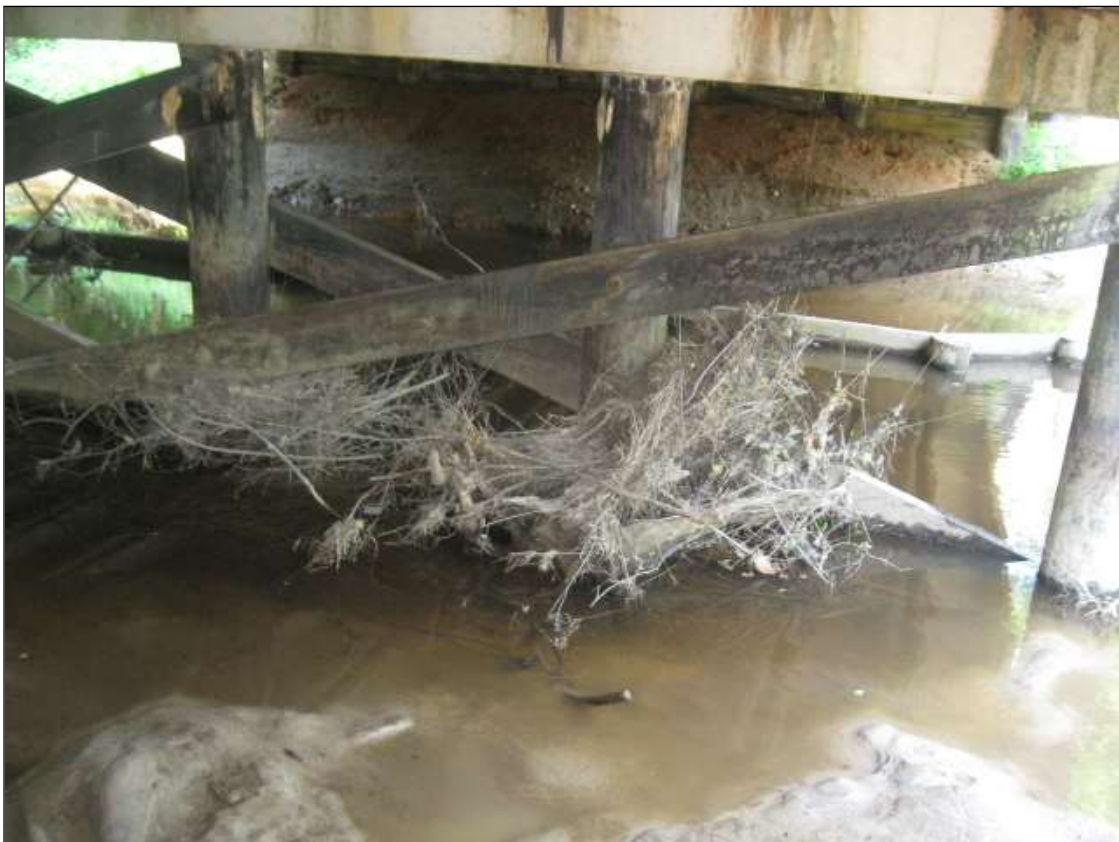
| <b>41</b> | <b>F</b> | DRIFT<br>3 FT WIDE X 8 FT LONG DRIFT AT SPAN 2 AT BASE OF INTERIOR BENT 1. | |

DRIFT @ BASE OF INTERIOR BENT 1 SPAN 2 SIDE

| MMS Code | Description of Function | Unit | Quantity | Remarks | Est. Cost |
|---|---|---|---|---|---|
| 3366 | Drift and Debris Removal | HR | 2 | DRIFT<br>3 FT WIDE X 8 FT LONG DRIFT AT SPAN<br>2 AT BASE OF INTERIOR BENT 1. | |

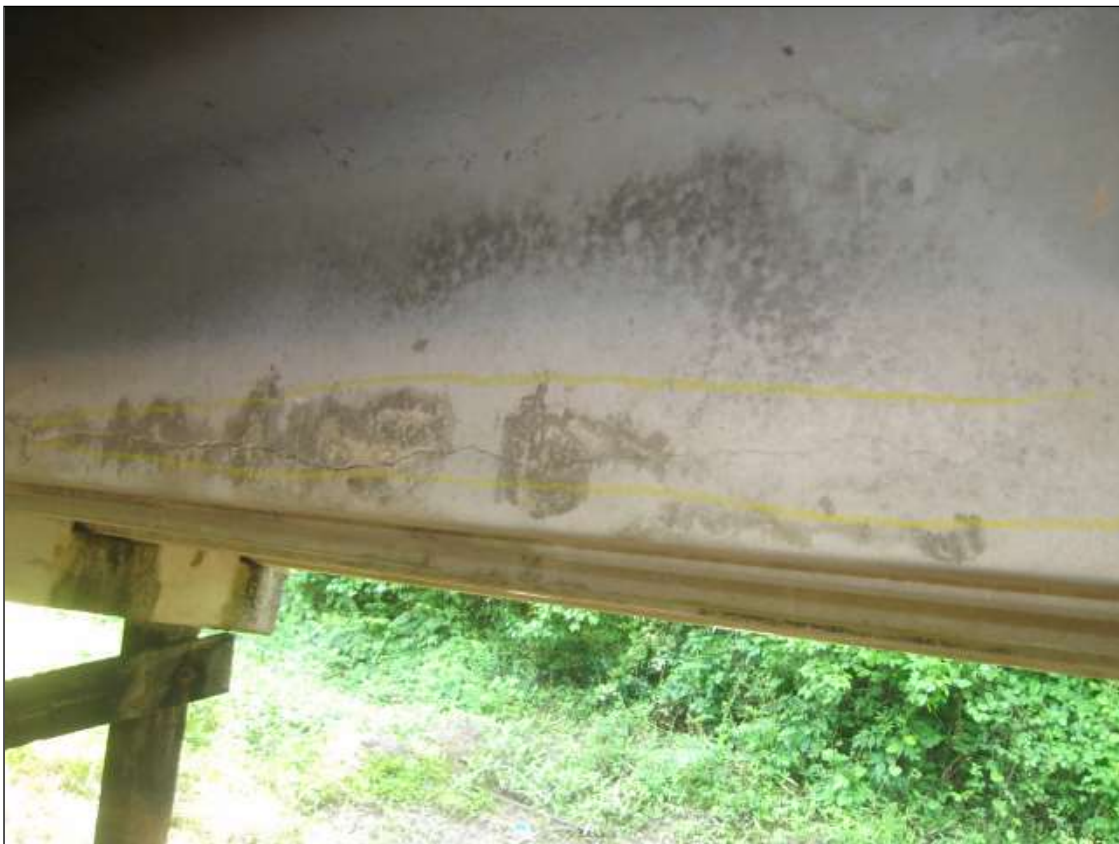
LONGITUDINAL CRACK IN CHANNEL 9 RIGHT LEG @ SPAN 2

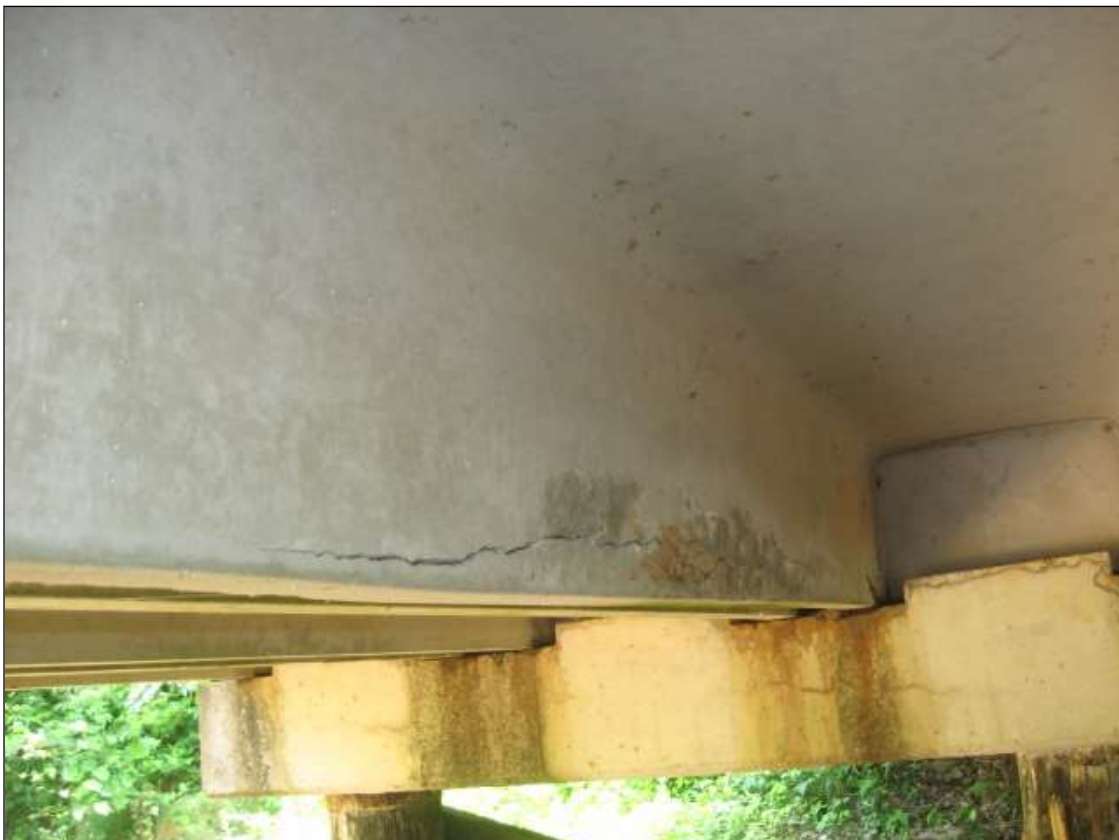
LONGITUDINAL CRACK IN CHANNEL 3 LEFT LEG @ SPAN 2

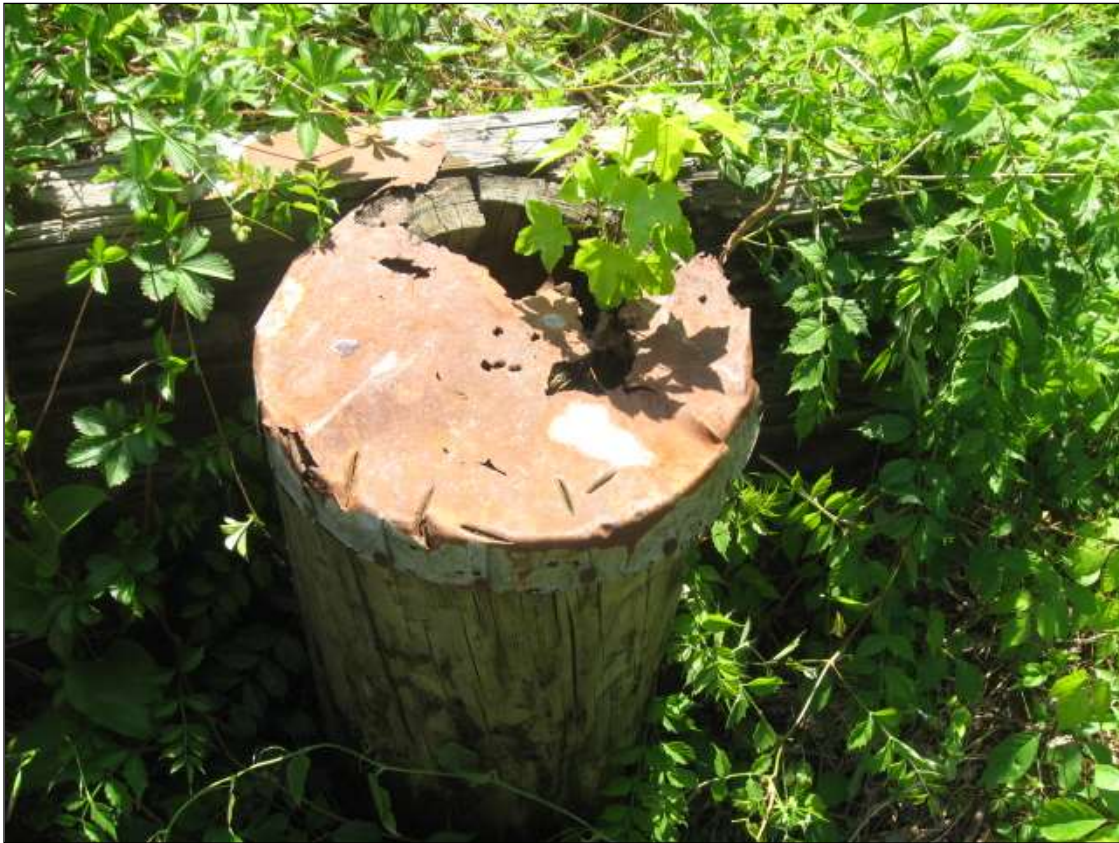
DECAYED BULKHEAD PILE @ SOUTH EAST CORNER WINGWALL
