NC DEPARTMENT OF TRANSPORTATION  
DIVISION OF HIGHWAYS  
BRIDGE MANAGEMENT UNIT

# BRIDGE INSPECTION REPORT

COUNTY NASH BRIDGE NUMBER 630143 INSPECTION CYCLE 0 YRS

ROUTE SR1302 ACROSS STONEY CREEK M.P. 0

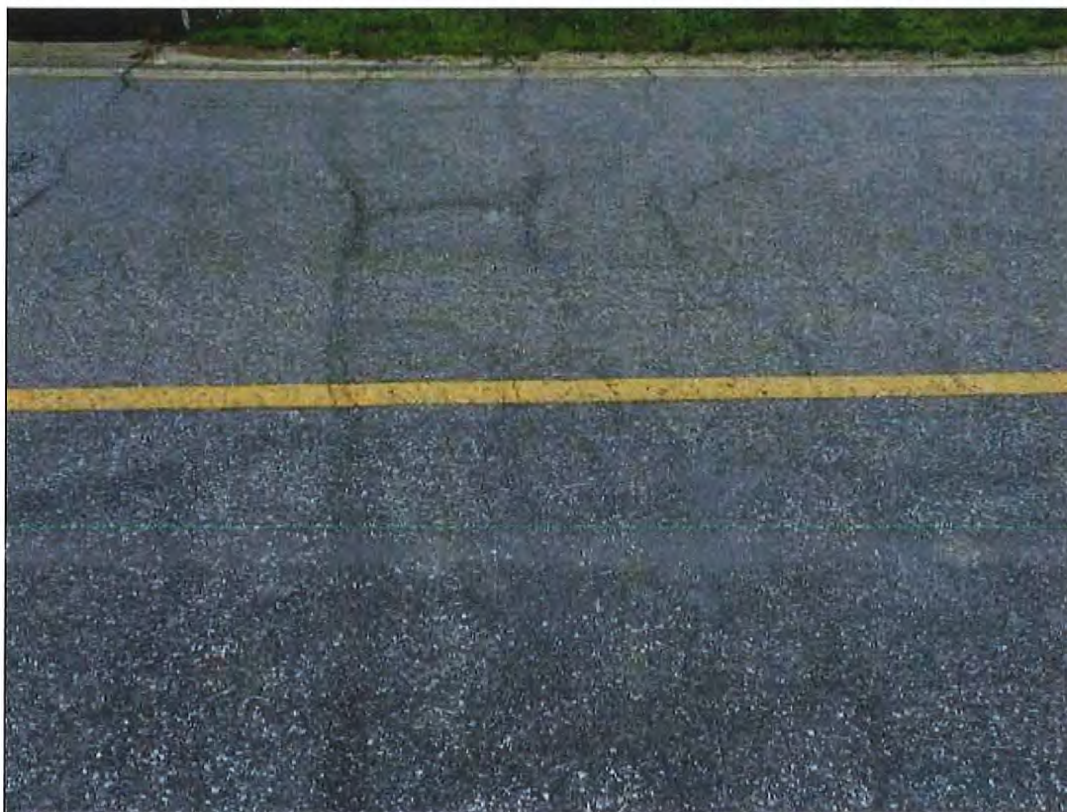
| <b>50</b> | <b>F</b> | ALLIGATOR CRACKS IN THE ASPHALT WEARING SURFACE AT THE SOUTH APPROACH (SEE PHOTO).<br><br>TRANSVERSE CRACKS IN THE ASPHALT WEARING SURFACE ALONG BOTH END BENT FILL FACES. SEE PHOTO OF THE CRACK ALONG END BENT 1 FILL FACE.<br><br>TRANSVERSE CRACKS IN THE ASPHALT WEARING SURFACE AT THE NORTH APPROACH (SEE PHOTO). | |

ALLIGATOR CRACKS IN ASPHALT WEARING SURFACE AT SOUTH APPROACH

| MMS Code | Description of Function | Unit | Quantity | Remarks | Est. Cost |
|---|---|---|---|---|---|
| 2816 | Asphalt Surface Repair or Replacement | SY | 50 | CRACKS IN THE ASPHALT WEARING SURFACE AT BOTH APPROACHES, ALONG BOTH END BENT FILL FACES AND ALONG THE BENT JOINTS. | |

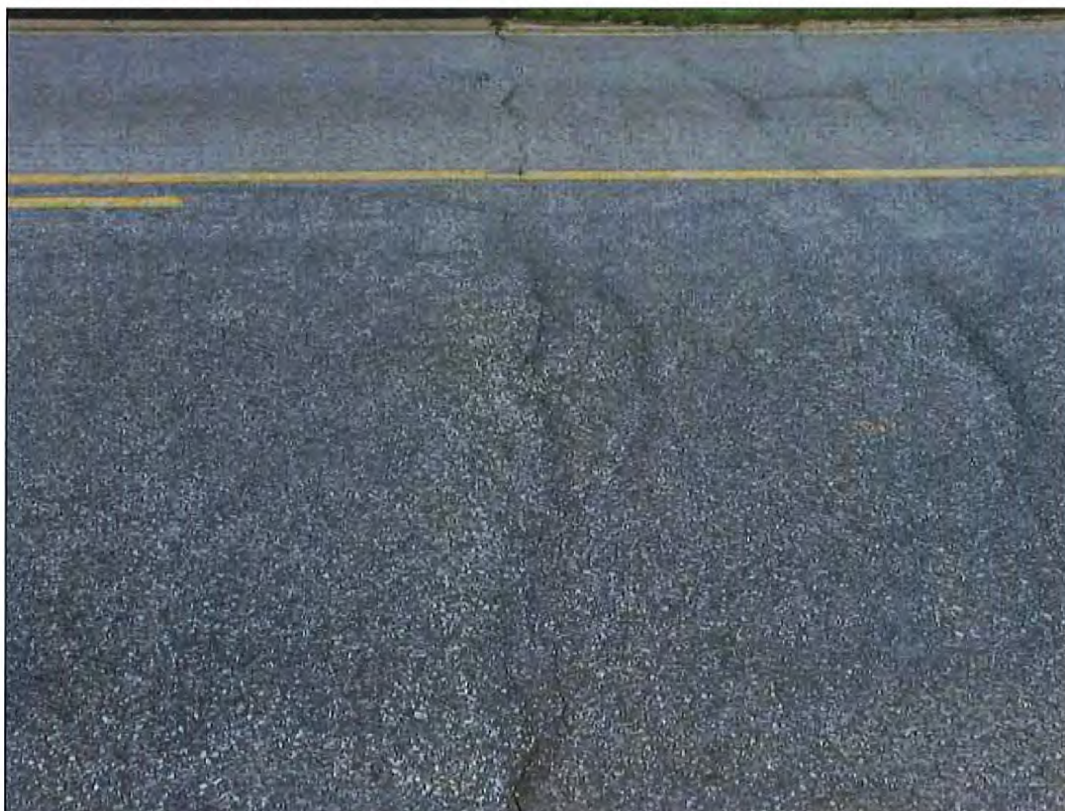
TRANSVERSE CRACK IN ASPHALT WEARING SURFACE ALONG END BENT 1 FILL FACE

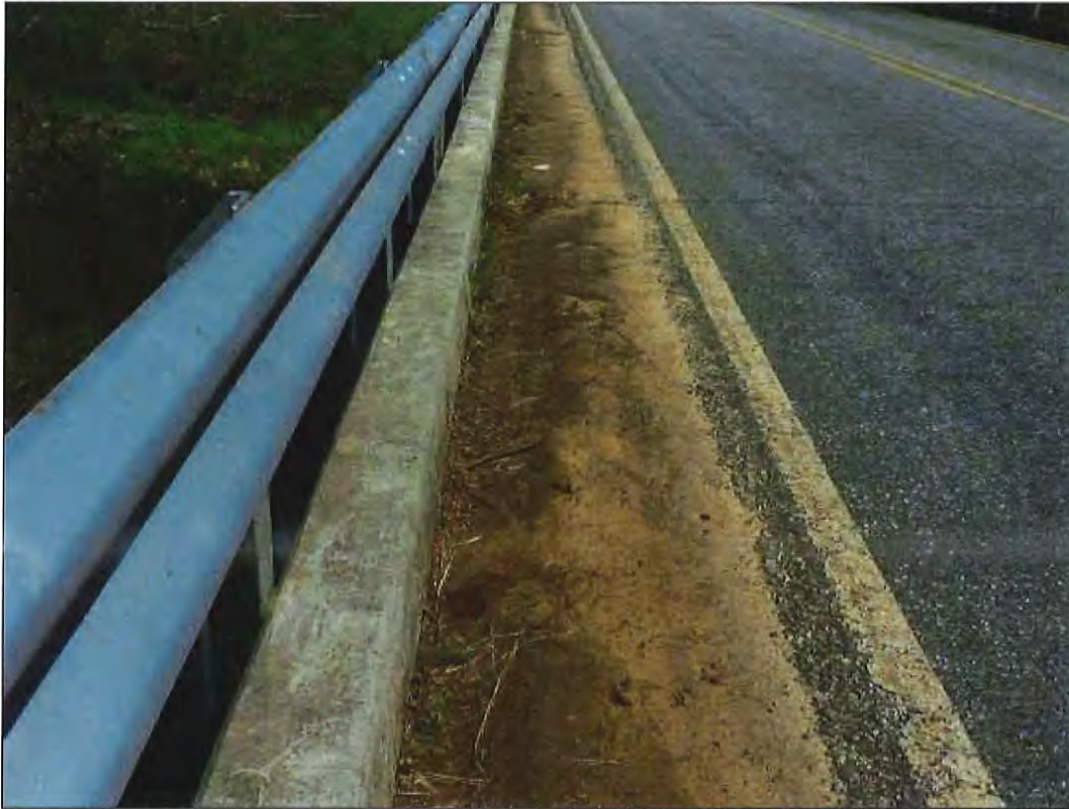
| 7 | G | SILT ACCUMULATION ALONG BOTH SHOULDERS. SEE PHOTO OF THE ACCUMULATION ALONG THE UPSTREAM SHOULDER. | |

SILT ACCUMULATION ALONG UPSTREAM SHOULDER

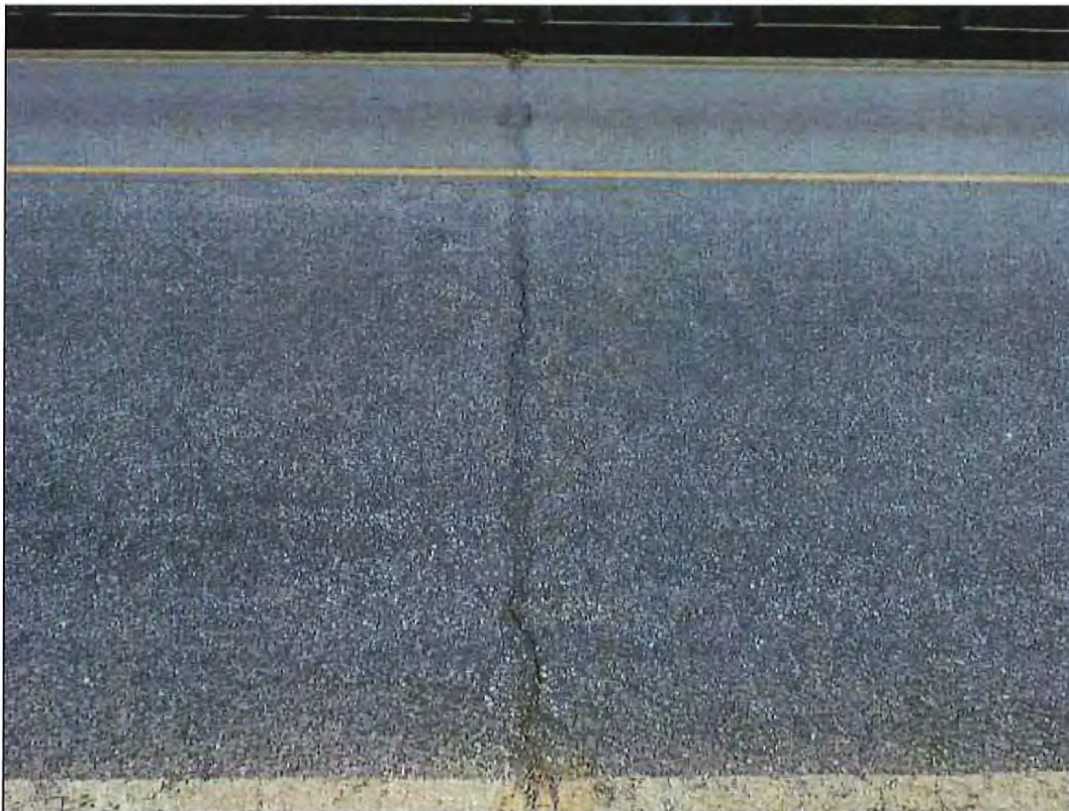
| 1 | G | TRANSVERSE CRACKS IN THE ASPHALT WEARING SURFACE ALONG THE BENT JOINTS. SEE PHOTO OF THE CRACK IN THE ASPHALT WEARING SURFACE ALONG BENT 1. | |

TRANSVERSE CRACK IN ASPHALT WEARING SURFACE ALONG BENT 1

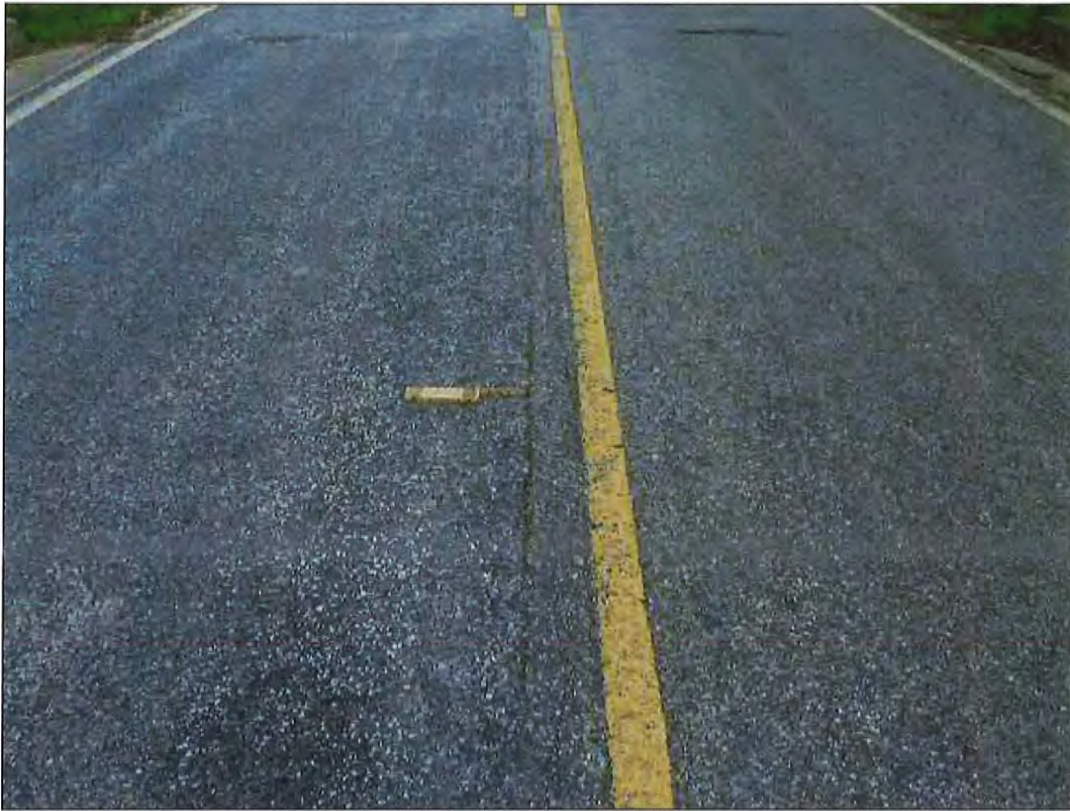
| 6d | F | LONGITUDINAL CRACK IN THE ASPHALT WEARING SURFACE IN THE NORTHBOUND LANE OF SPAN 4 (SEE PHOTO). SIMILAR CRACKS IN SPANS 2 AND 3.<br>TRANSVERSE CRACKS IN THE ASPHALT WEARING SURFACE ALONG THE BENT JOINTS AND WATER STAINS ON THE FACES OF THE CAPS INDICATIVE OF LEAKING JOINTS. | |

LONGITUDINAL CRACK IN ASPHALT WEARING SURFACE IN NORTHBOUND LANE OF SPAN 4

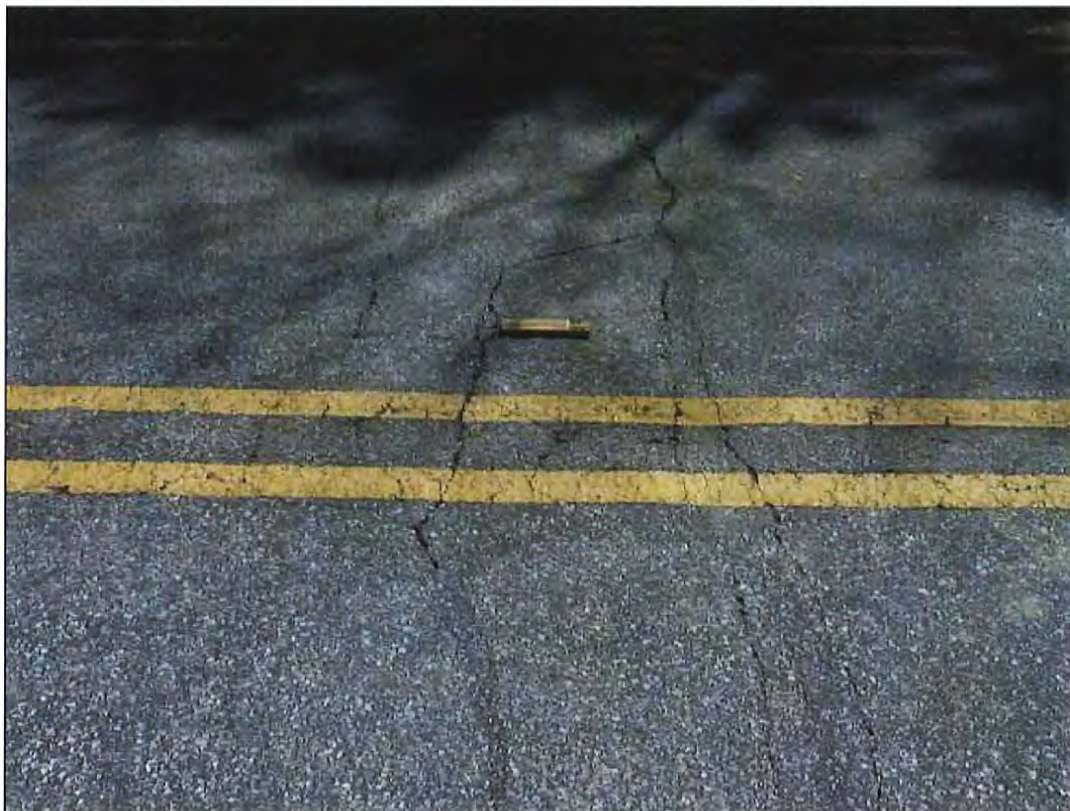
TRANSVERSE CRACKS IN ASPHALT WEARING SURFACE AT NORTH APPROACH

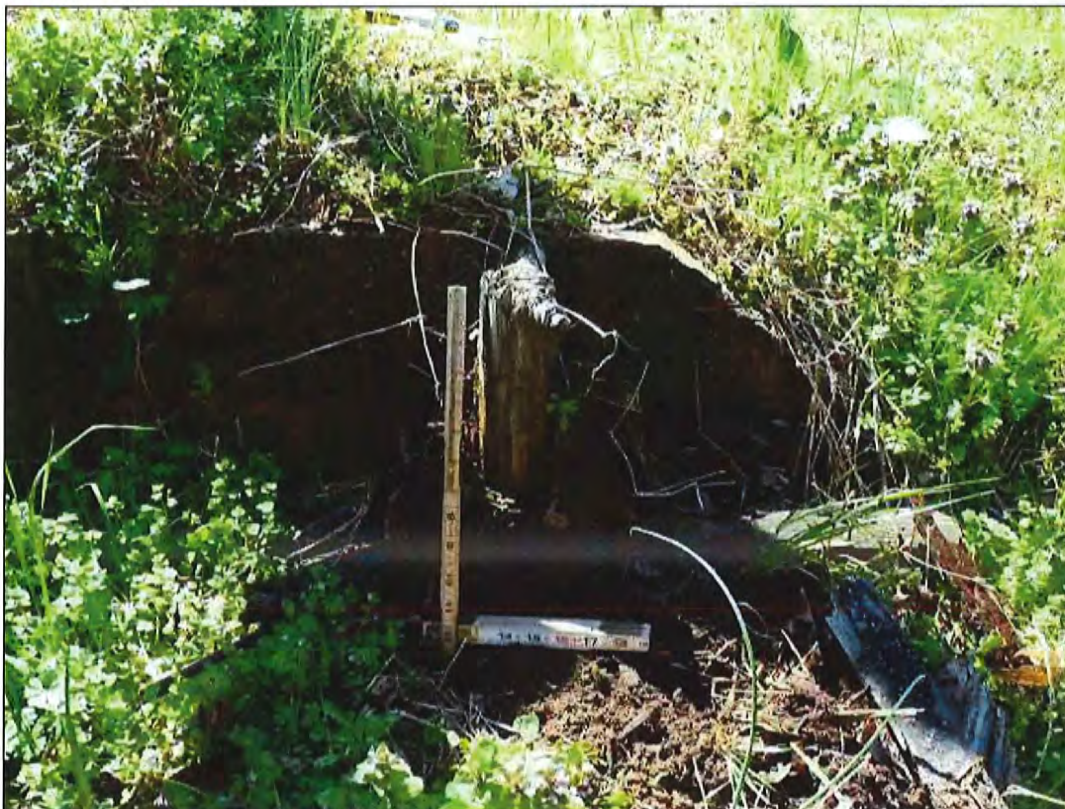
| 35b | F | PRIORITY MAINTENANCE: 40" X 6" X 4" DEEP AREA OF DECAY IN THE UPSTREAM FACE OF PILE 5 AT BENT 1 (SEE PHOTO).<br><br>100% DECAY OF THE PILE AT THE UPSTREAM END OF END BENT 1 BULKHEAD (SEE PHOTO).<br><br>UP TO 1/8" SPLIT IN SPAN 1 FACE OF PILE 4 AT BENT 1 (SEE PHOTO). SIMILAR SPLITS IN THE PILES AT VARIOUS LOCATIONS THROUGHOUT THE STRUCTURE.<br><br>PILE 3 AT BENT 3 SOUNDS HOLLOW AT MID-HEIGHT. (NUMBERING INCLUDES NEW PILE)<br><br>20" X 3" X 1" DEEP AREA OF DECAY IN SPAN 3 FACE OF PILE 5 AT BENT 3 (SEE PHOTO). (NUMBERING INCLUDES NEW PILE)<br>24" X 14" X 1 1/2" DEEP AREA OF DECAY IN THE UPSTREAM END OF END BENT 1 BULKHEAD. | |

100% DECAY OF PILE AT UPSTREAM END OF END BENT 1 BULKHEAD

| MMS Code | Description of Function | Unit | Quantity | Remarks | Est. Cost |
|---|---|---|---|---|---|
| 3344 | Repair / Replace Timber Substructure Components | LF | 1 | 100% DECAY OF THE PILE AT THE UPSTREAM END OF END BENT 1 BULKHEAD. | |

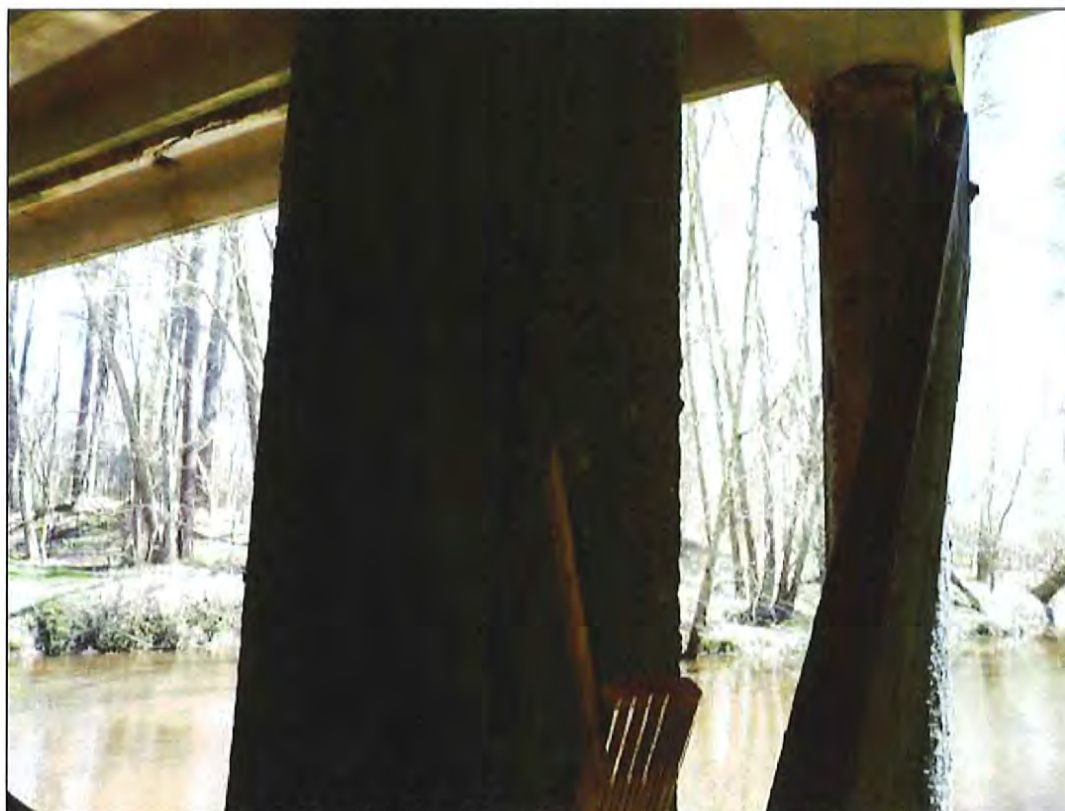
UP TO 1/8" SPLIT IN SPAN 1 FACE OF PILE 4 AT BENT 1

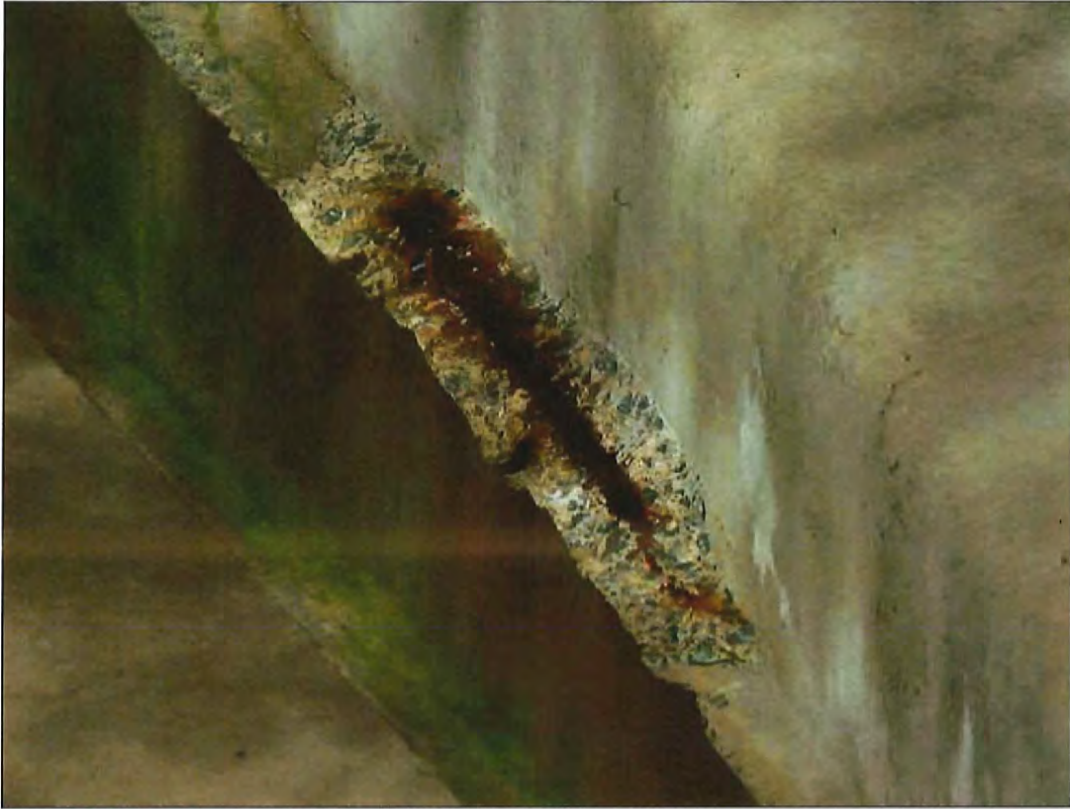
| <b>10</b> | <b>F</b> | <p>PRIORITY MAINTENANCE: 10" X 1" X 1" DEEP SPALL WITH EXPOSED STRAND IN THE BOTTOM OF LEG 2 IN CHANNEL 1 OF SPAN 2, APPROXIMATELY 10' FROM BENT 2 (SEE PHOTO).</p> <p>PRIORITY MAINTENANCE: 30" X 2 1/2" X 3" DEEP SPALL WITH EXPOSED STRAND IN THE BOTTOM OF LEG 1 IN CHANNEL 10 OF SPAN 2, APPROXIMATELY 10' FROM BENT 1 (SEE PHOTO).</p> <p>PRIORITY MAINTENANCE: 6" X 1" X 1/2" DEEP SPALL WITH EXPOSED STRAND IN THE UPSTREAM FACE OF LEG 2 IN CHANNEL 10 OF SPAN 2, APPROXIMATELY 3' FROM BENT 1 (SEE PHOTO).</p> <p>24" X 3" AREA OF DELAMINATION AND 14" X 1" X 1/4" DEEP SPALL WITH EXPOSED REBAR IN THE BOTTOM AND DOWNSTREAM FACE OF LEG 1 IN CHANNEL 4 OF SPAN 2 AT BENT 1 (SEE PHOTO). SIMILAR CONDITION AT THE FOLLOWING LOCATIONS:</p> <p>1) UP TO 1/8" CRACKS AND AREA OF DELAMINATION IN DOWNSTREAM FACE OF LEG 1 IN CHANNEL 2 OF SPAN 2 AT BENT 1;</p> <p>2) 8" X 3" AREA OF DELAMINATION IN DOWNSTREAM FACE OF LEG 2 IN CHANNEL 8 OF SPAN 2 AT BENT 1;</p> <p>3) UP TO 1/8" CRACKS AND 5" X 1" X 1/2" DEEP SPALL WITH EXPOSED REBAR IN DOWNSTREAM FACE OF LEG 1 IN CHANNEL 10 OF SPAN 2 AT BENT 1;</p> <p>4) AREA OF DELAMINATION IN LEGS 1 AND 2 IN CHANNEL 8 OF SPAN 2 AT BENT 2;</p> <p>5) AREA OF DELAMINATION IN UPSTREAM FACE OF LEG 2 IN CHANNEL 9 OF SPAN 2 AT BENT 2;</p> <p>6) 30" X 2" AREA OF DELAMINATION IN DOWNSTREAM FACE OF LEG 1 IN CHANNEL 10 OF SPAN 2, APPROXIMATELY MIDSPAN;</p> <p>7) AREA OF DELAMINATION IN BOTTOM OF LEG 1 IN CHANNEL 9 OF SPAN 3 AT BENT 3;</p> <p>8) AREA OF DELAMINATION IN UPSTREAM FACE OF LEG 2 IN CHANNEL 9 OF SPAN 3 AT BENT 3;</p> <p>9) AREA OF DELAMINATION IN DOWNSTREAM FACE OF LEG 1 IN CHANNEL 2 OF SPAN 4 AT BENT 3;</p> <p>10) AREA OF DELAMINATION IN DOWNSTREAM AND UPSTREAM FACES OF LEG 1 IN CHANNEL 3 OF SPAN 4 AT BENT 3;</p> <p>11) AREA OF DELAMINATION IN DOWNSTREAM FACE AND BOTTOM OF LEG 1 IN CHANNEL 4 OF SPAN 4 AT BENT 3;</p> <p>12) AREA OF DELAMINATION IN DOWNSTREAM AND UPSTREAM FACES OF LEG 1 IN CHANNEL 5 OF SPAN 4 AT BENT 3;</p> <p>13) AREA OF DELAMINATION IN DOWNSTREAM FACE OF LEG 1 IN CHANNEL 8 OF</p> | |

30" X 2 1/2" X 3" DEEP SPALL WITH EXPOSED STRAND IN BOTTOM OF LEG 1 IN CHANNEL 10 OF SPAN 2, APPROXIMATELY 10' FROM BENT 1 (PRIORITY MAINTENANCE)

| MMS Code | Description of Function | Unit | Quantity | Remarks | Est. Cost |
|---|---|---|---|---|---|
| 3306 | Maintain Concrete Superstructure Components | SF | <del>1</del> TSE | 30" X 2 1/2" X 3" DEEP SPALL WITH EXPOSED STRAND IN THE BOTTOM OF LEG 1 IN CHANNEL 10 OF SPAN 2, APPROXIMATELY 10' FROM BENT 1. | |

| MMS Code | MMS Description | Quantity |
|---|---|---|
| 30" X 2 1/2" X 3" DEEP SPALL WITH EXPOSED STRAND IN THE BOTTOM OF LEG 1 IN CHANNEL 10 OF SPAN 2, APPROXIMATELY 10' FROM BENT 1. | | |

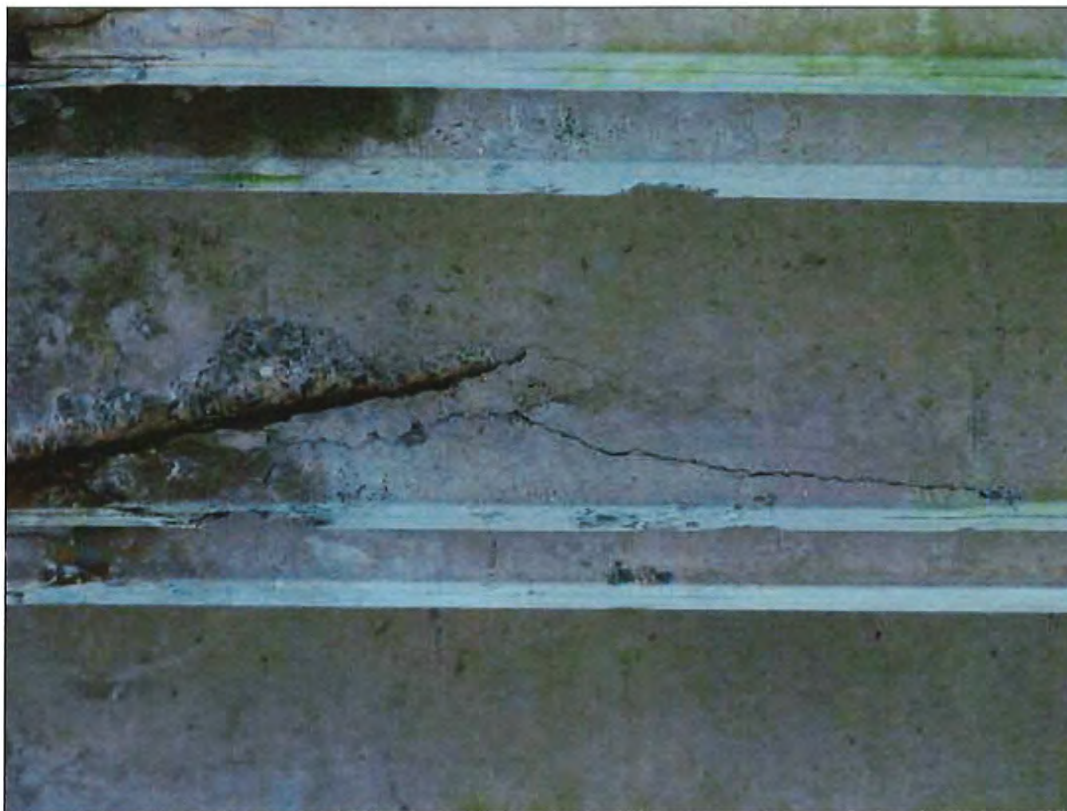
24" X 3" AREA OF DELAMINATION & 14" X 1" X 1/4" DEEP SPALL WITH EXPOSED REBAR IN BOTTOM & DOWNSTREAM FACE OF LEG 1 IN CHANNEL 4 OF SPAN 2 AT BENT 1

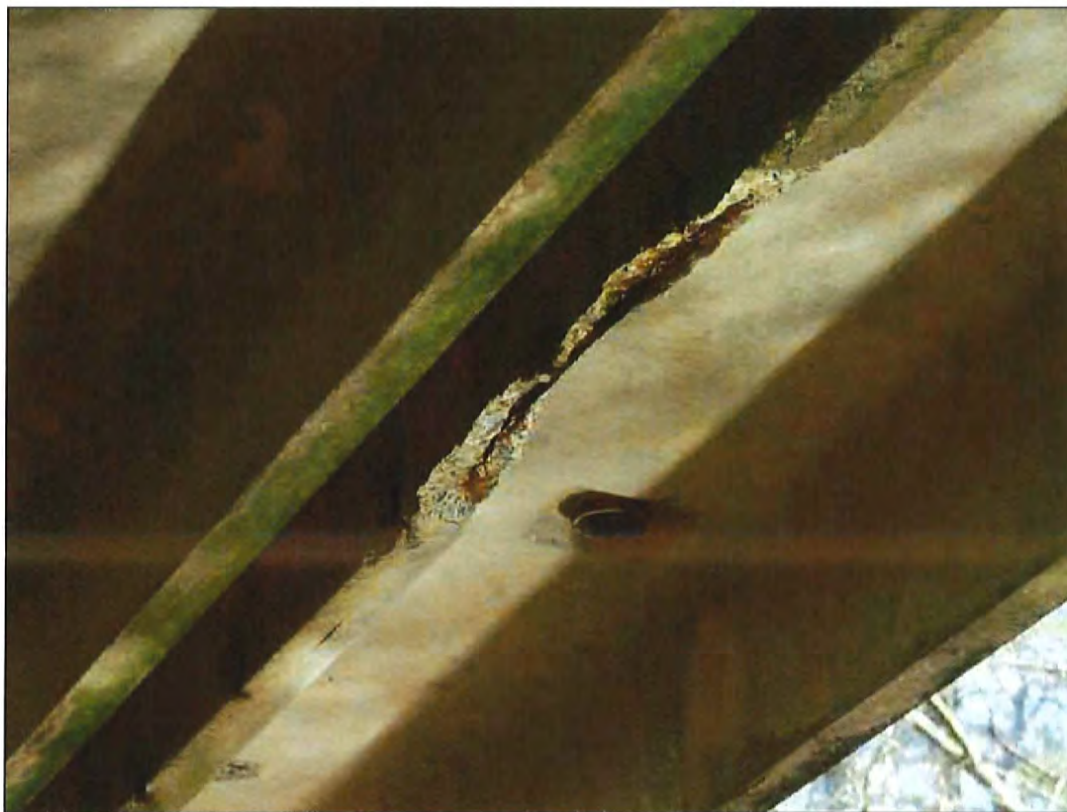
| 10A | NO | SPAN 4 AT BENT 3.<br><br>FIVE (5) SPALLS UP TO 6" X 3" X 1/4" DEEP WITH EXPOSED REBAR IN THE UPSTREAM FACE OF LEG 1 IN CHANNEL 10 OF SPAN 2, APPROXIMATELY 10' FROM BENT 1 (SEE PHOTO). SIMILAR SPALLS IN THE BACK FACES OF THE CHANNEL LEGS THROUGHOUT THE STRUCTURE.<br><br>EFFLORESCENCE SEEPAGE ON THE UPSTREAM FACE OF LEG 1 IN CHANNEL 10 OF SPAN 4 NEAR END BENT 2 (SEE PHOTO).<br><br>HONEYCOMBING AND UP TO 3/16" LONGITUDINAL CRACK IN THE BOTTOM OF LEG 1 IN CHANNEL 10 OF SPAN 4 AT BENT 3, EXTENDING APPROXIMATELY 10' (SEE PHOTO). SIMILAR HONEYCOMBING ALONG LEG 1 OF CHANNEL 10 IN SPAN 3.<br><br>EFFLORESCENCE SEEPAGE IN A REPAIR OF LEG 2 IN CHANNEL 5 OF SPAN 4 NEAR MIDSPAN (SEE PHOTO).<br>NO CURVED GIRDERS. | |

FIVE (5) SPALLS UP TO 6" X 3" X 1/4" DEEP WITH EXPOSED REBAR IN UPSTREAM FACE OF LEG 1 IN CHANNEL 10 OF SPAN 2, APPROXIMATELY 10' FROM BENT 1

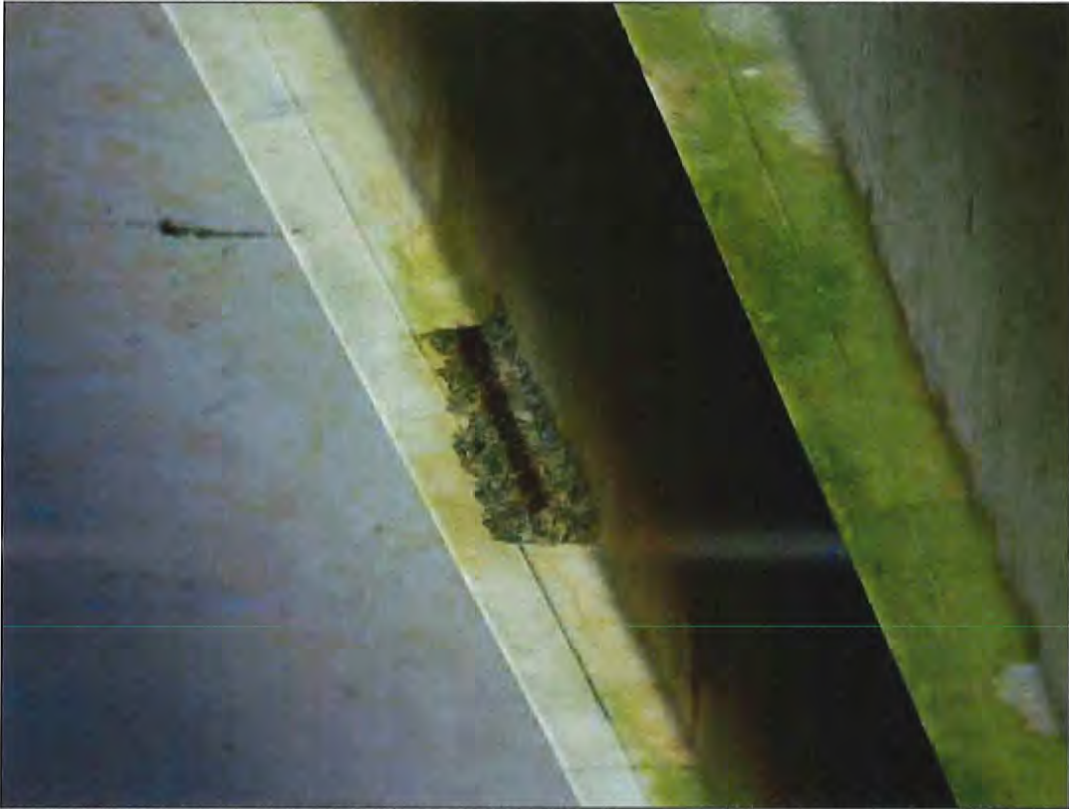
10" X 1" X 1" DEEP SPALL WITH EXPOSED STRAND IN BOTTOM OF LEG 2 IN CHANNEL 1 OF SPAN 2, APPROXIMATELY 10' FROM BENT 2 (PRIORITY MAINTENANCE)

| MMS Code | Description of Function | Unit | Quantity | Remarks | Est. Cost |
|---|---|---|---|---|---|
| 3306 | Maintain Concrete Superstructure Components | SF | <del>1</del><br>9/25/14 | 10" X 1" X 1" DEEP SPALL WITH EXPOSED STRAND IN THE BOTTOM OF LEG 2 IN CHANNEL 1 OF SPAN 2, APPROXIMATELY 10' FROM BENT 2. | |

| MMS Code | MMS Description | Quantity |
|---|---|---|
| 10" X 1" X 1" DEEP SPALL WITH EXPOSED STRAND IN THE BOTTOM OF LEG 2 IN CHANNEL 1 OF SPAN 2, APPROXIMATELY 10' FROM BENT 2. | | |

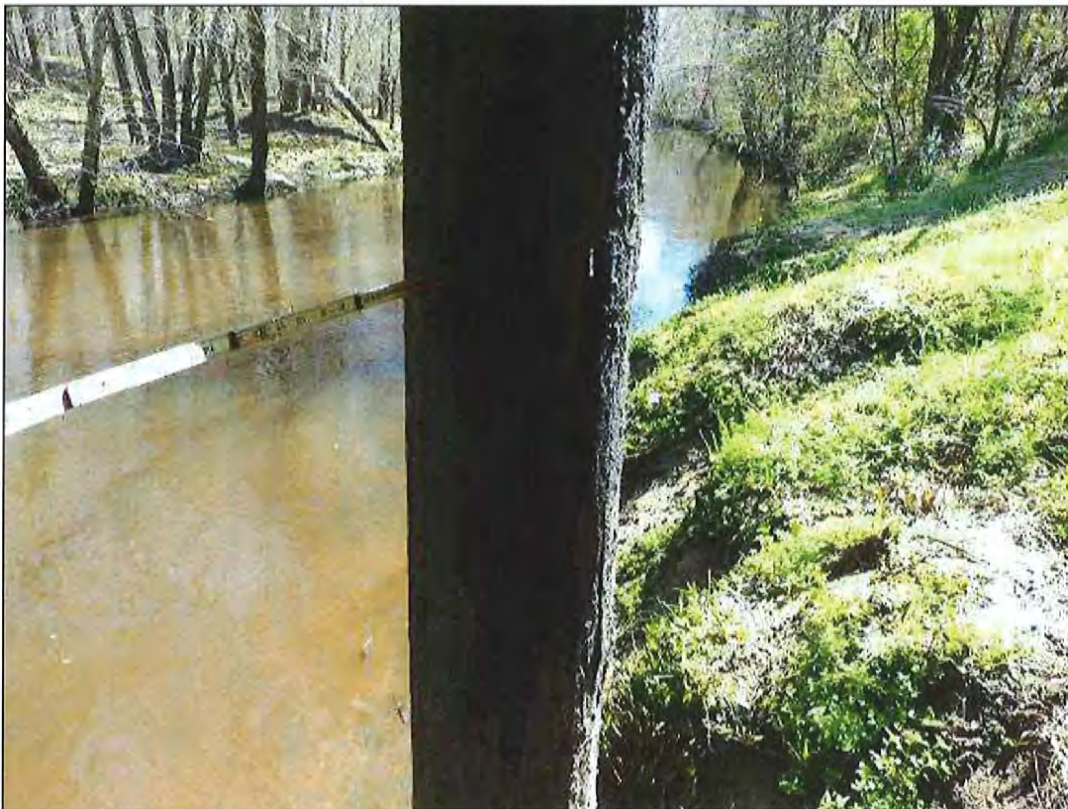
| <b>61</b> | <b>YES</b> | 40" X 6" X 4" DEEP AREA OF DECAY IN THE UPSTREAM FACE OF PILE 5 AT BENT 1 NEAR MID-HEIGHT.<br><br>10" X 1" X 1" DEEP SPALL WITH EXPOSED STRAND IN THE BOTTOM OF LEG 2 IN CHANNEL 1 OF SPAN 2, APPROXIMATELY 10' FROM BENT 2.<br><br>30" X 2 1/2" X 3" DEEP SPALL WITH EXPOSED STRAND IN THE BOTTOM OF LEG 1 IN CHANNEL 10 OF SPAN 2, APPROXIMATELY 10' FROM BENT 1.<br><br>6" X 1" X 1/2" DEEP SPALL WITH EXPOSED STRAND IN THE UPSTREAM FACE OF LEG 2 IN CHANNEL 10 OF SPAN 2, APPROXIMATELY 3' FROM BENT 1. | |

40" X 6" X 4" DEEP AREA OF DECAY IN UPSTREAM FACE OF PILE 5 AT BENT 1 (PRIORITY MAINTENANCE)

| MMS Code | Description of Function | Unit | Quantity | Remarks | Est. Cost |
|---|---|---|---|---|---|
| 3344 | Repair / Replace Timber Substructure Components | LF | <del>1</del> TSE | 40" X 6" X 4" DEEP AREA OF DECAY IN THE UPSTREAM FACE OF PILE 5 AT BENT 1 NEAR MID-HEIGHT. | |

| MMS Code | MMS Description | Quantity |
|---|---|---|
| 40" X 6" X 4" DEEP AREA OF DECAY IN THE UPSTREAM FACE OF PILE 5 AT BENT 1 NEAR MID-HEIGHT. | | |

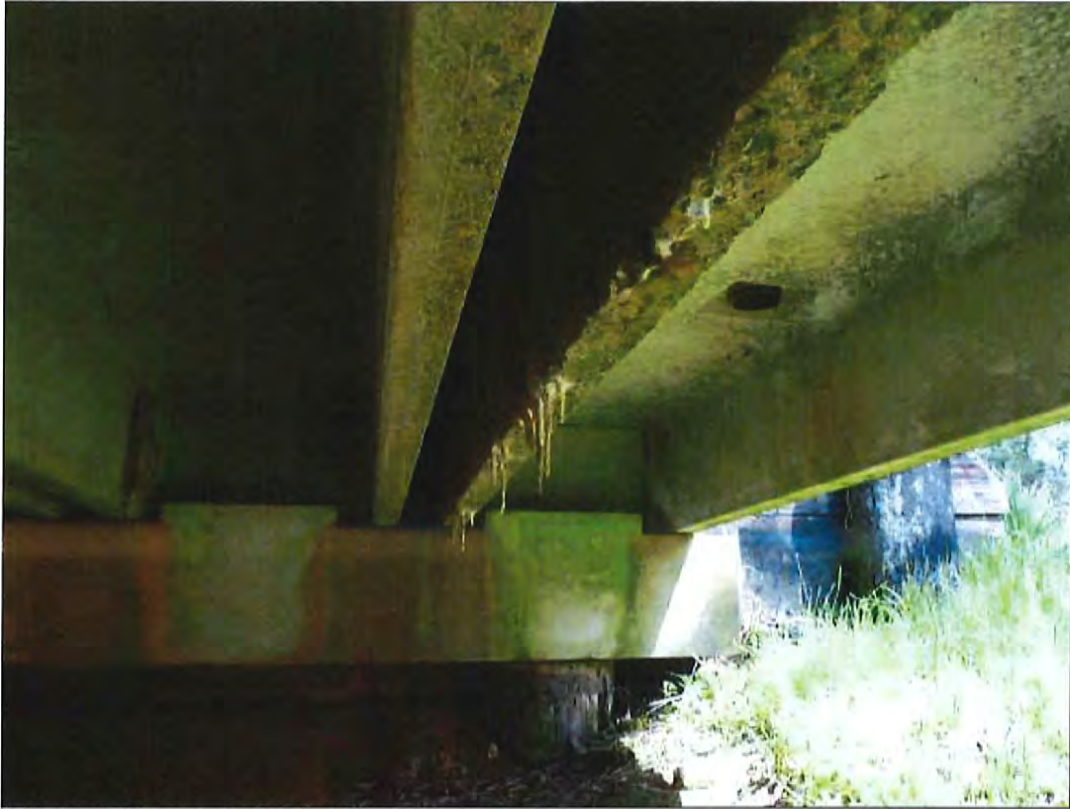
EFFLORESCENCE SEEPAGE ON UPSTREAM FACE OF LEG 1 IN CHANNEL 10 OF SPAN 4 NEAR END BENT 2

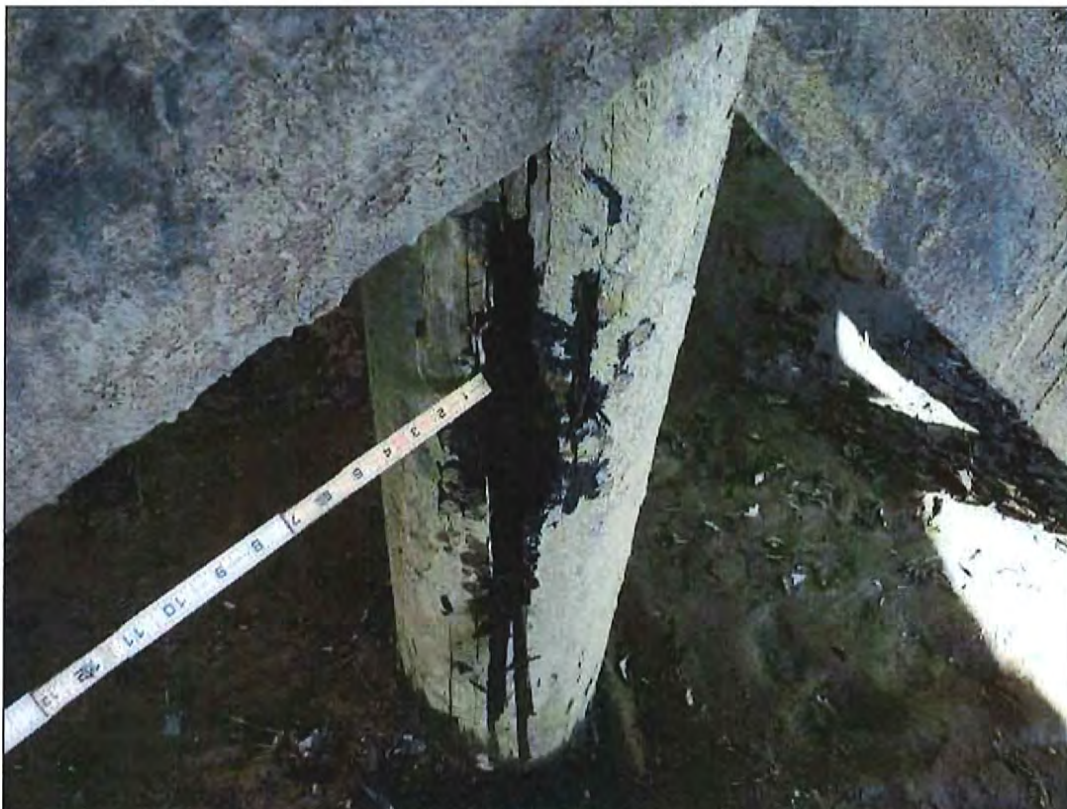
20" X 3" X 1" DEEP AREA OF DECAY IN SPAN 3 FACE OF PILE 5 AT BENT 3

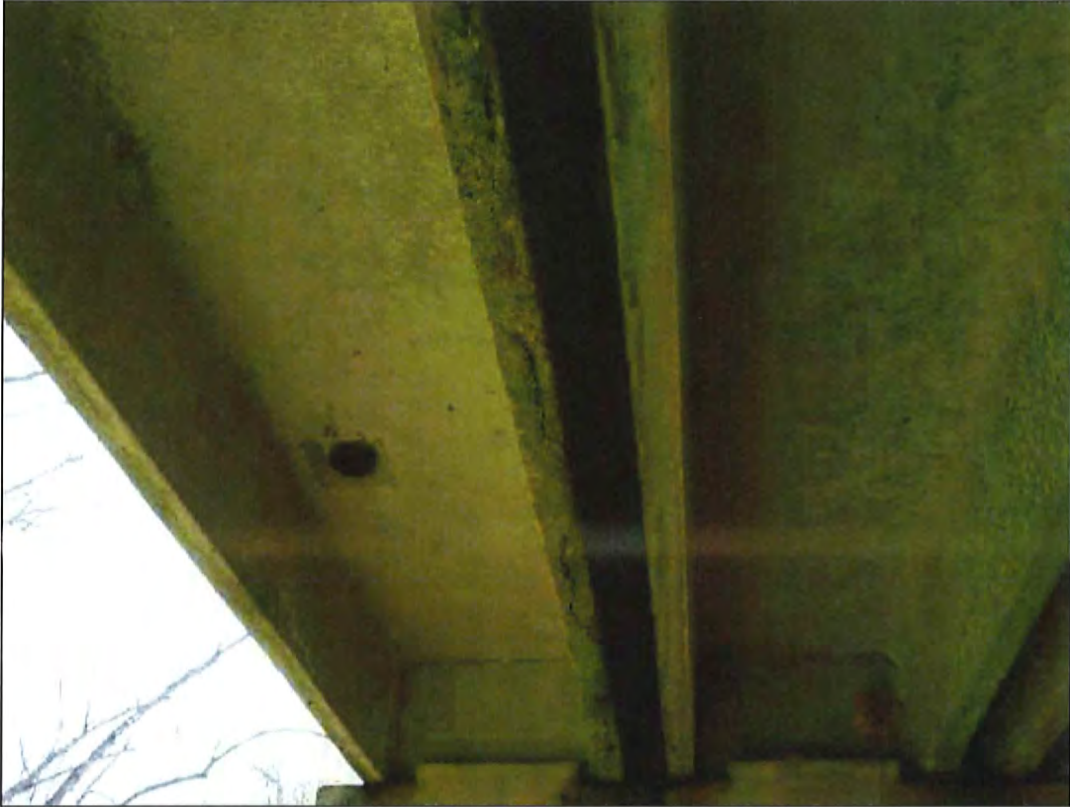
HONEYCOMBING AND UP TO 3/16" LONGITUDINAL CRACK IN BOTTOM OF LEG 1 IN CHANNEL 10 OF SPAN 4 AT BENT 3, EXTENDING APPROXIMATELY 10'

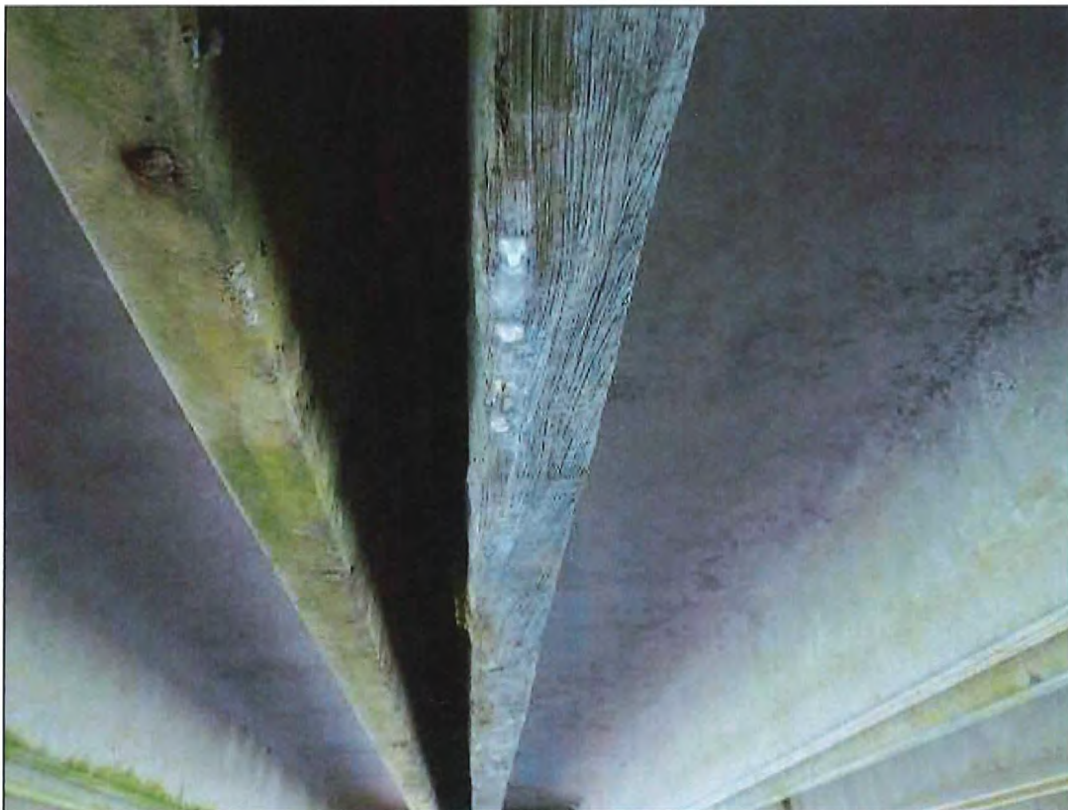
EFFLORESCENCE SEEPAGE IN REPAIR OF LEG 2 IN CHANNEL 5 OF SPAN 4 NEAR MIDSPAN
