NC DEPARTMENT OF TRANSPORTATION  
DIVISION OF HIGHWAYS  
STRUCTURE MANAGEMENT UNIT

## Structure Safety Report

### Routine Element Inspection

COUNTY: ROBESON STRUCTURE NUMBER: 770028 FREQUENCY: 24 MONTHS

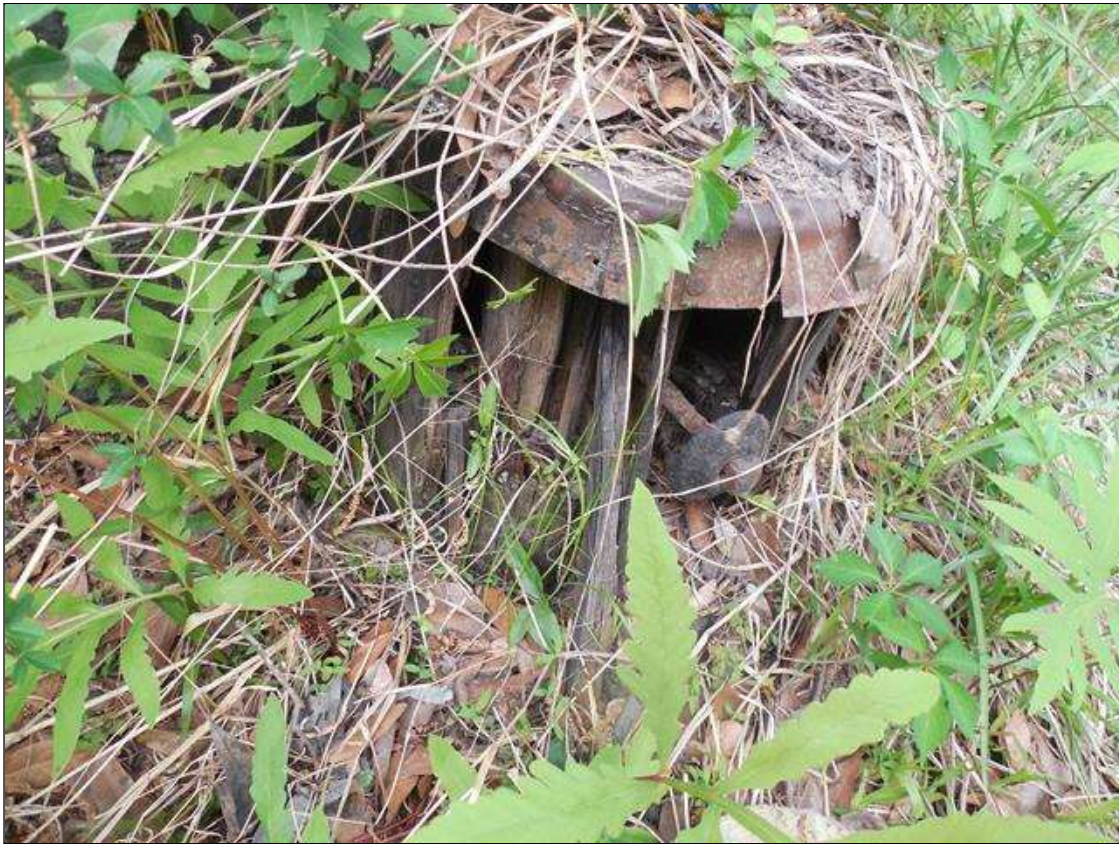
| Details | FULLY DECAYED WINGWALL PILE AT SOUTHWEST CORNER ( PHOTO # 6518 ) | | | | | |

FULLY DECAYED WINGWALL PILE AT SOUTHWEST CORNER ( PHOTO # 6518 )

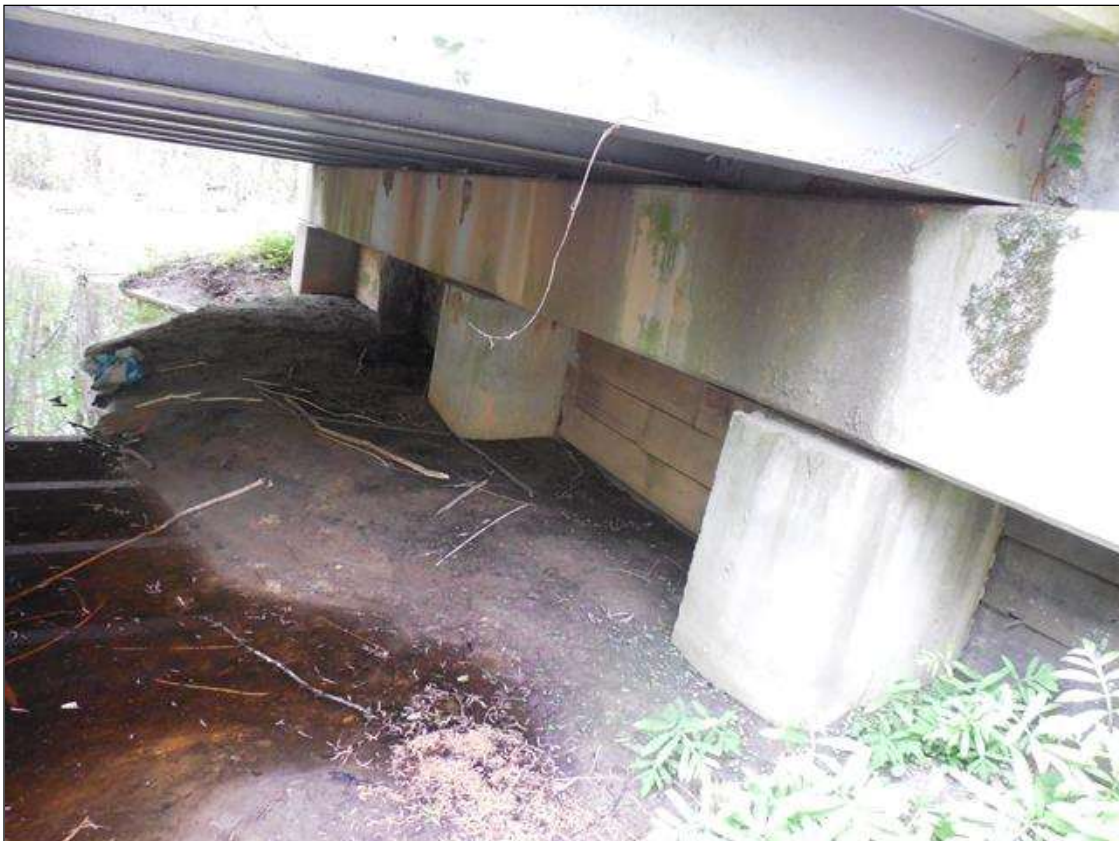
PILES 1, 2, AND 4 ENCASED AT END BENT 1 TEMPORARY REPAIR ( PHOTO # 6520 )

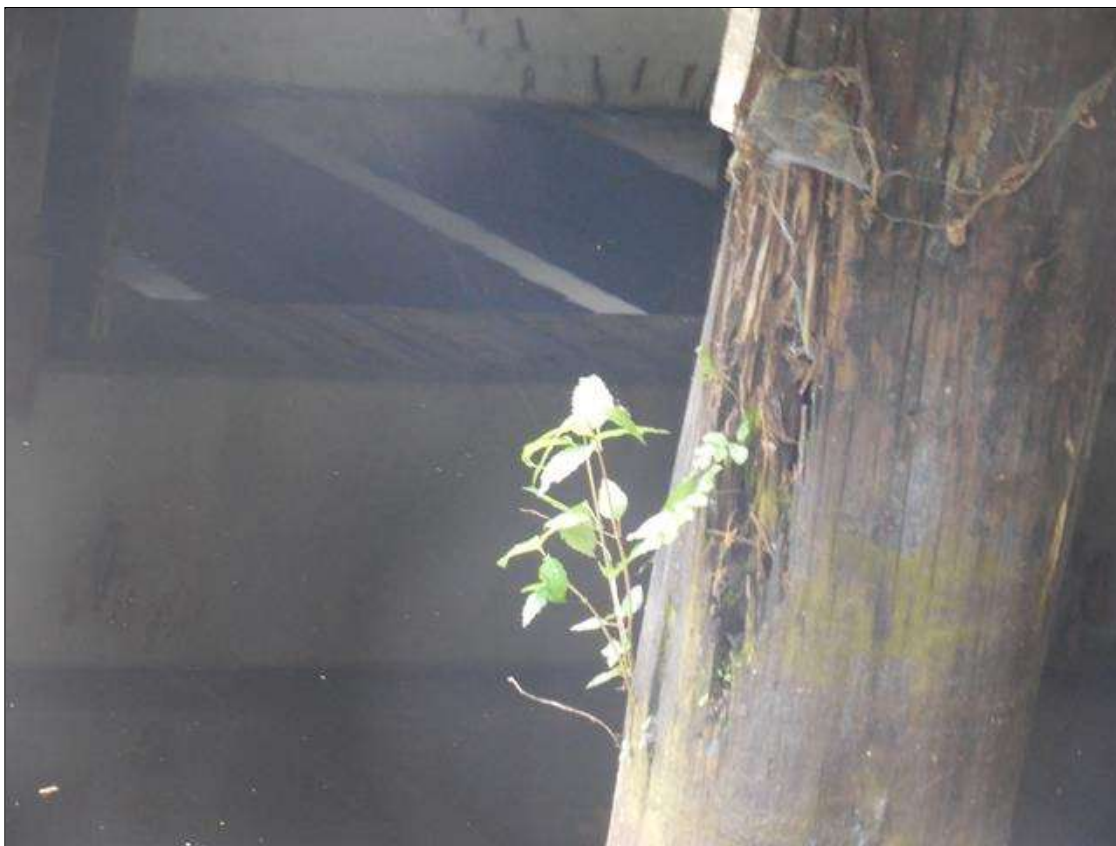
1 Each of Decay/Section Loss: Affects less than 10% of the member section DECAYED 2' HIGH X 10" WIDE X 2" DEEP ON WEST FACE

Bent 1 Pile 1: 1 Each of Decay/Section Loss: Affects less than 10% of the member section DECAYED 2' HIGH X 10" WIDE X 2" DEEP ON WEST FACE

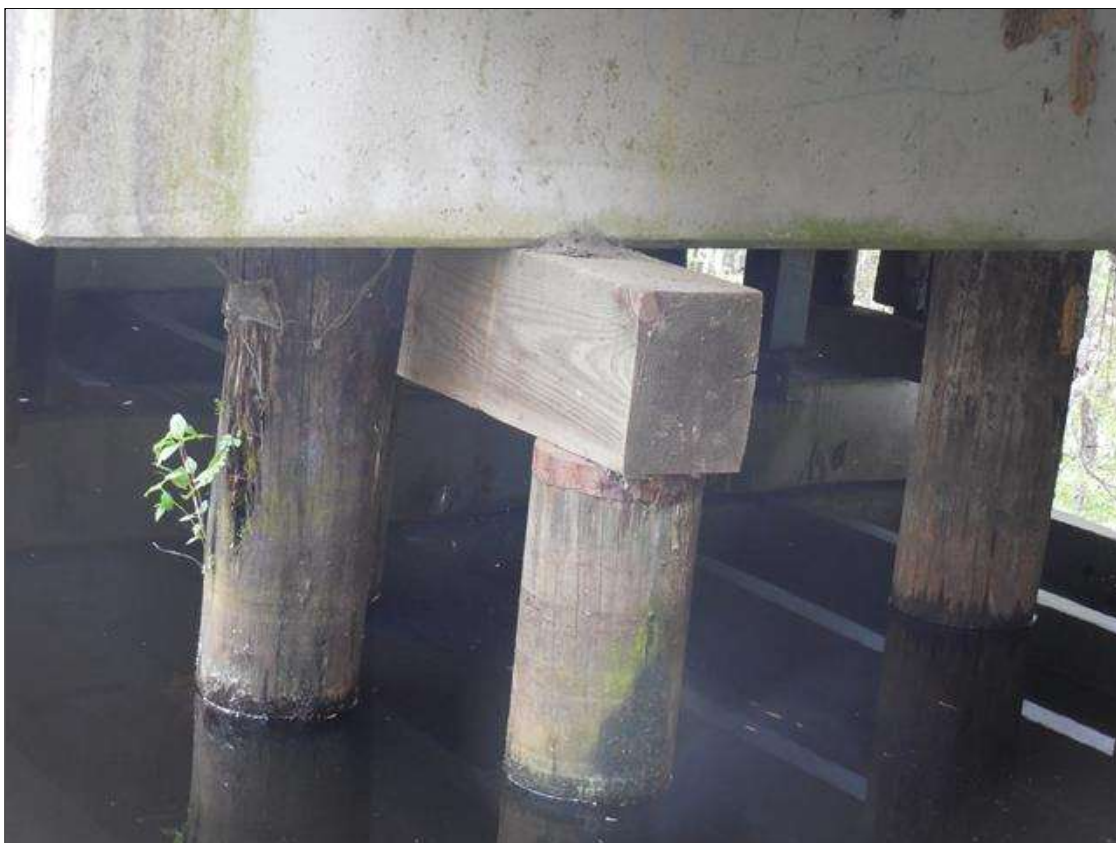
TIMBER CRUTCH EAST OF PILE 1 AT BENT 1 SHORED STRUCTURE ( PHOTO # 6523 )

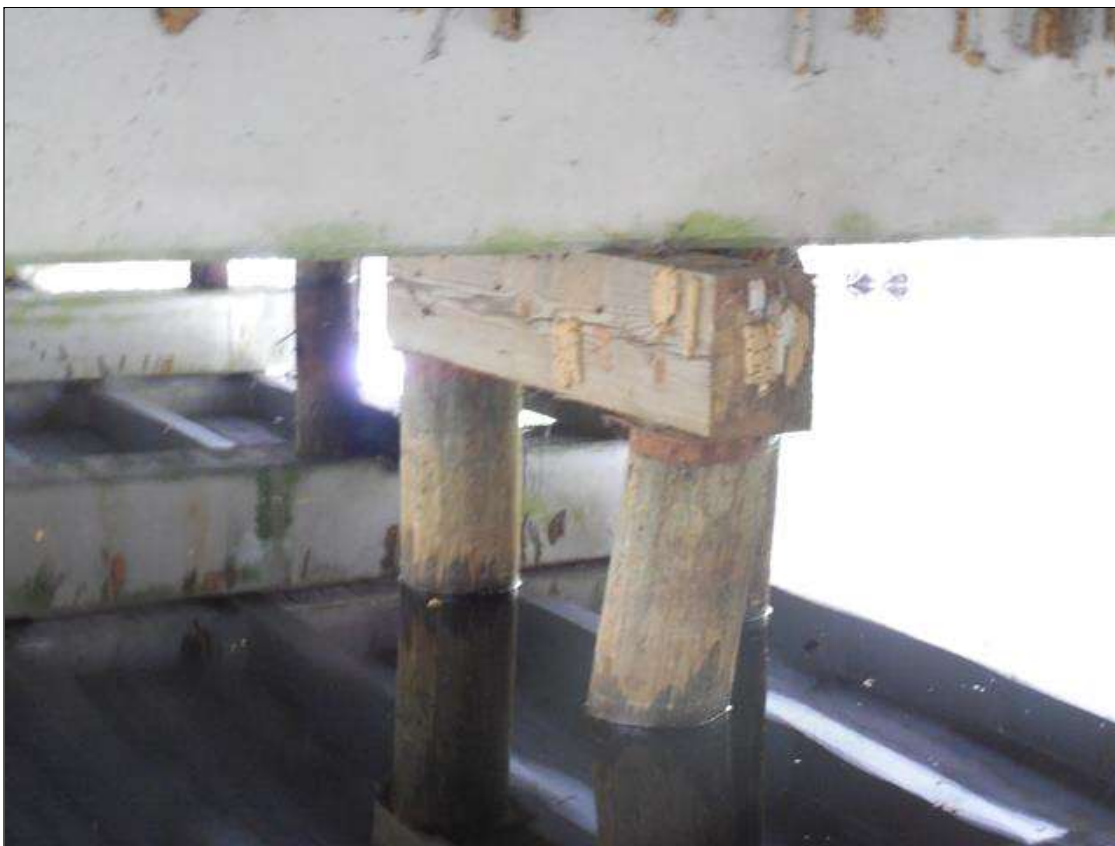
TIMBER CRUTCH WEST OF PILE 3 AT BENT 1 SHORED STRUCTURE ( PHOTO # 6524 )

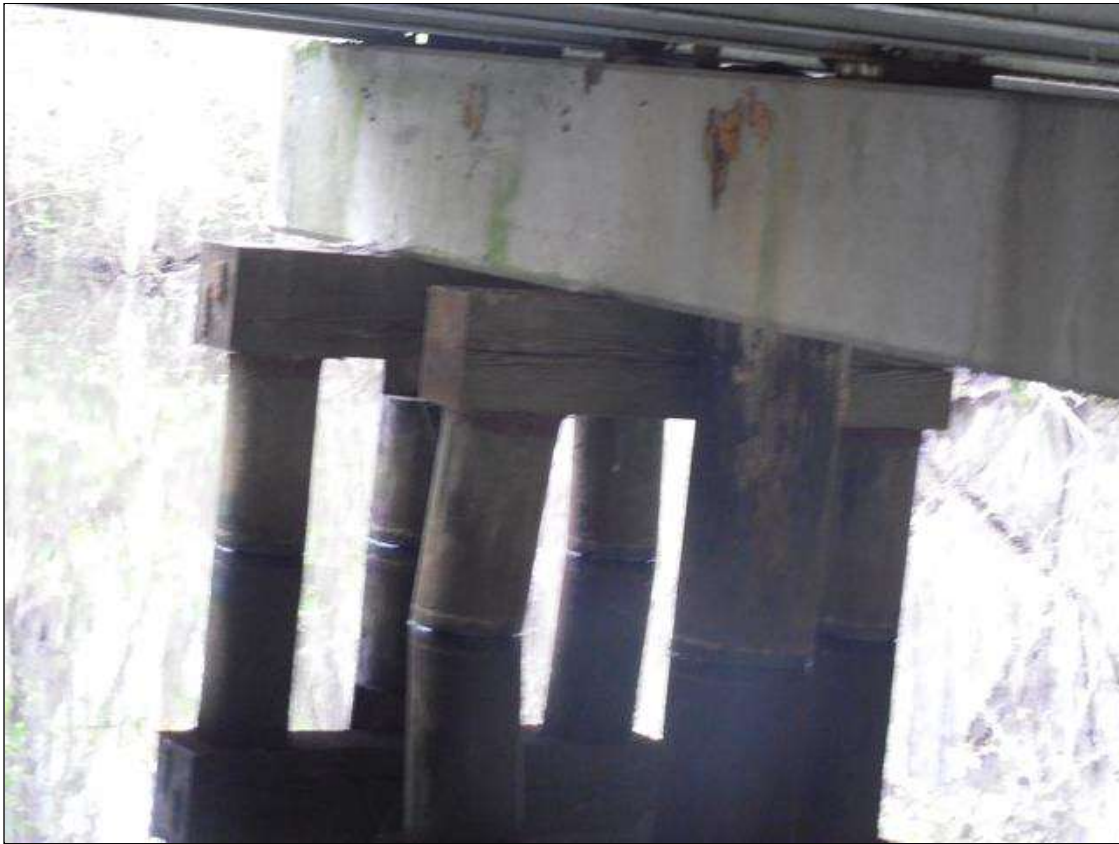
TIMBER CRUTCH WEST OF PILE 2 AT BENT 2 , SHORED STRUCTURE ( PHOTO # 6529 )

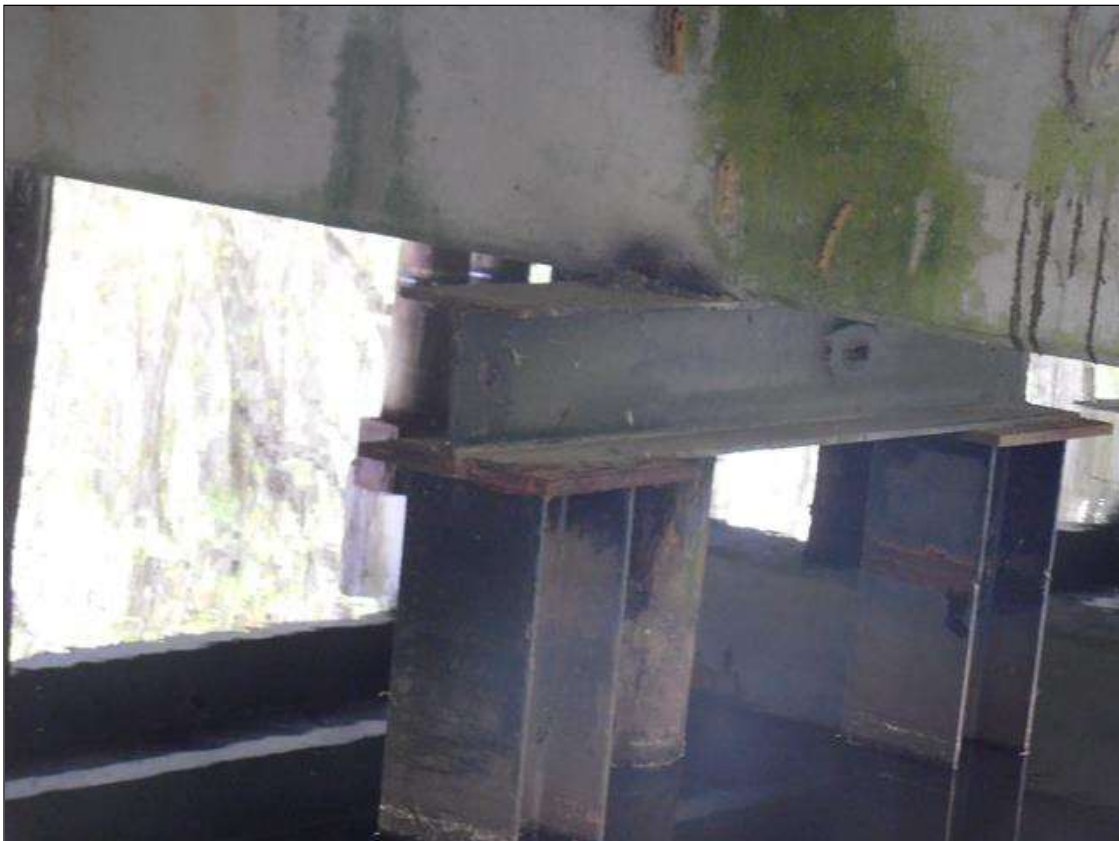
STEEL CRUTCH EAST OF PILE 4 AT BENT 2, SHORED STRUCTURE ( PHOTO # 6530 )

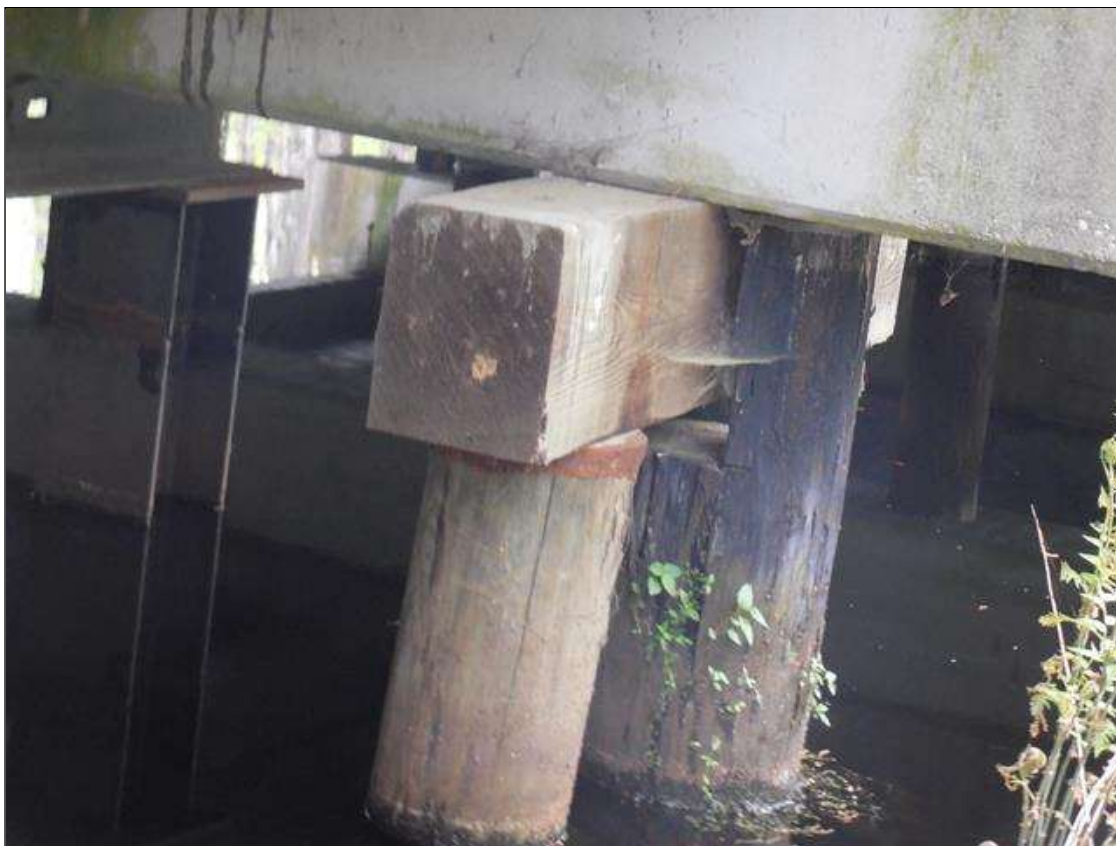
TIMBER CRUTCH WEST OF PILE 4 AT BENT 2, SHORED STRUCTURE ( PHOTO # 6531 )

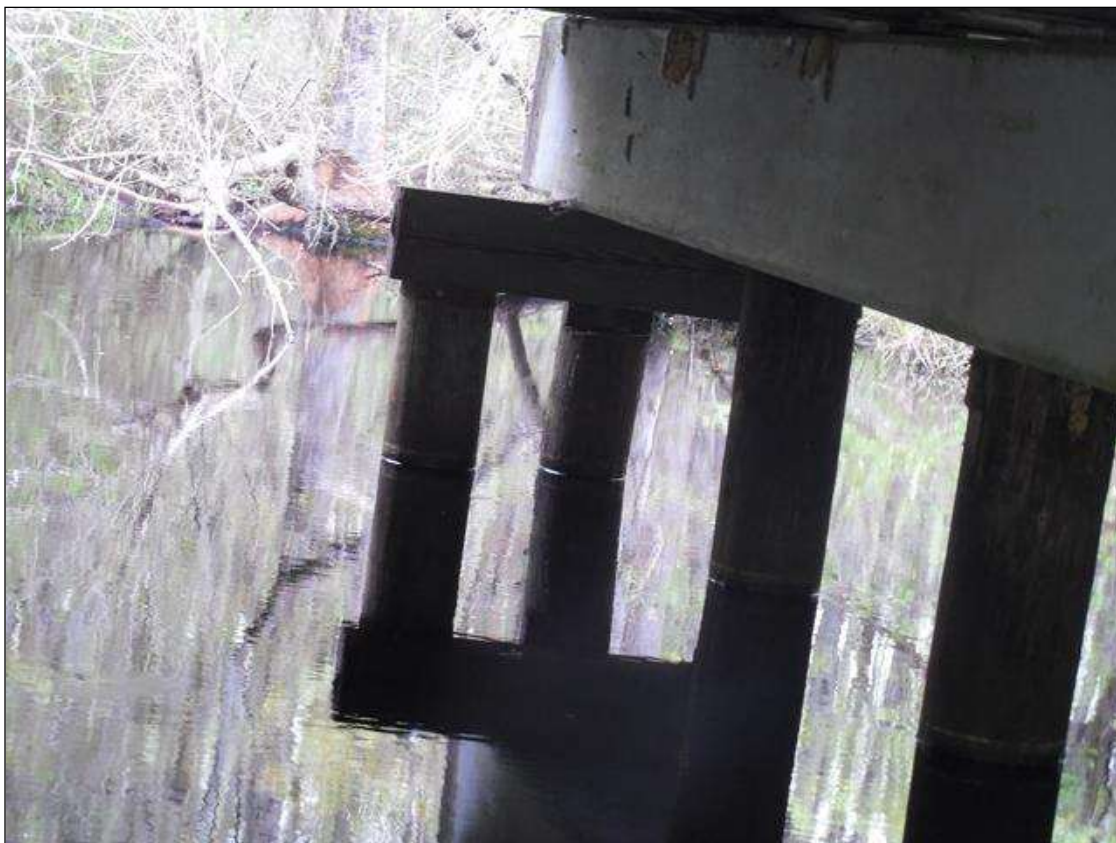
TIMBER CRUTCH EAST OF PILE 1 AT BENT 3, SHORED STRUCTURE ( PHOTO # 6533 )

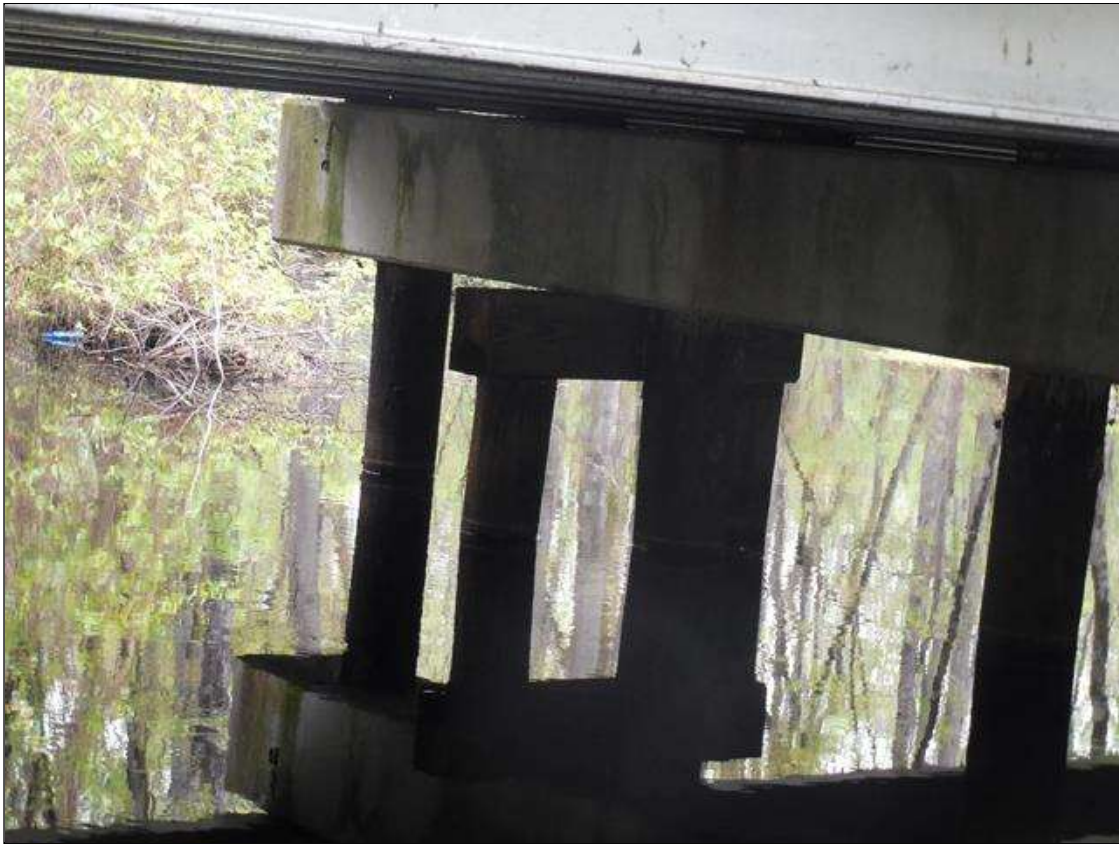
TIMBER CRUTCH WEST OF PILE 2 AT BENT 4 , SHORED STRUCTURE ( PHOTO # 6535 )

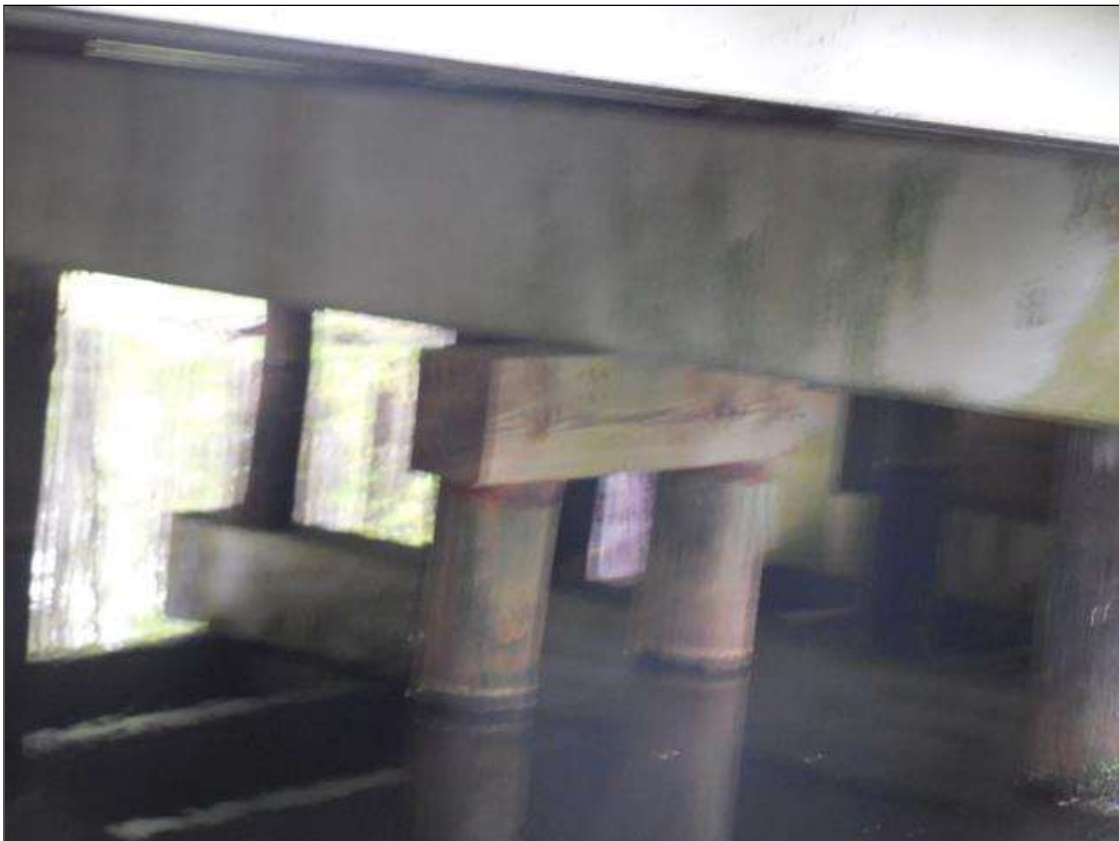
TIMBER CRUTCH EAST OF PILE 4 BENT 4, SHORED STRUCTURE ( PHOTO # 6536 )

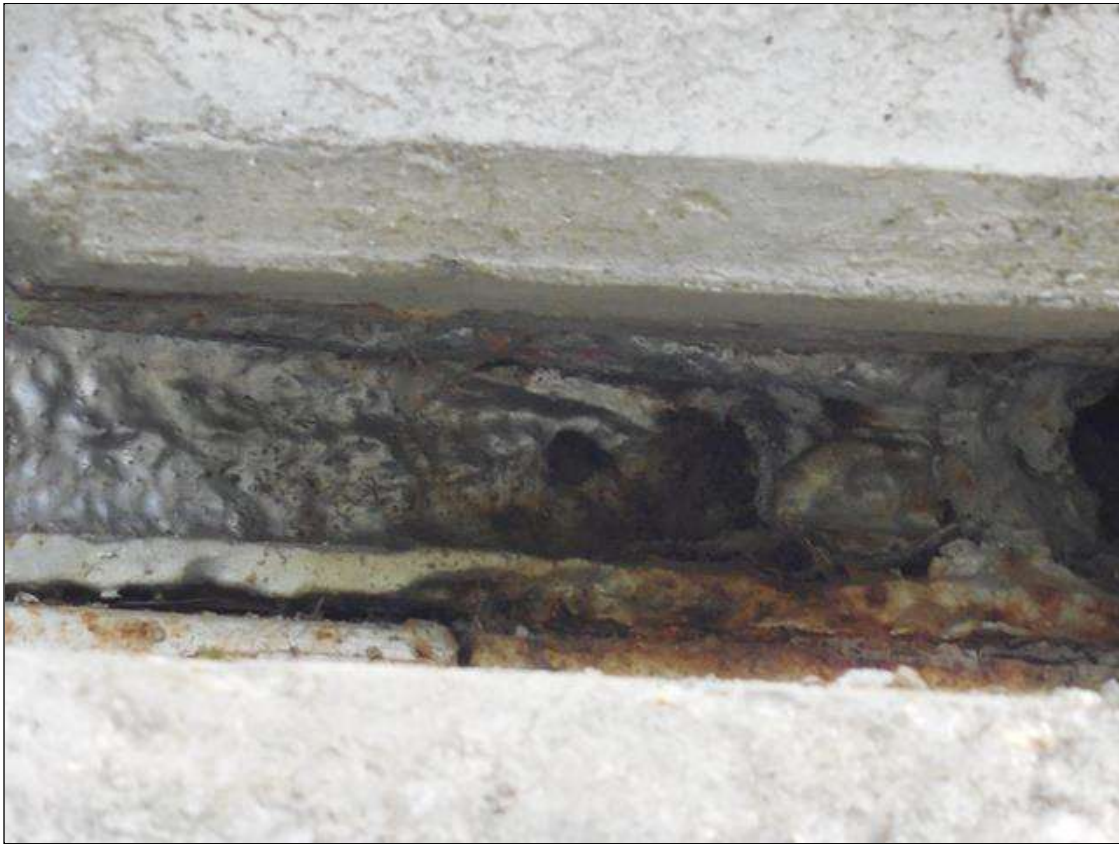
1 Foot of Corrosion: Section loss is evident or pack rust is present but does not warrant structural review. RUST HOLE 1/2" DIAMETER IN WEB 4 1/2" FROM BEAM END AND UP 1" FROM BOTTOM FLANGE OVER BENT 2 CAP

Span 2 Beam 7: 1 Feet of Corrosion: Section loss is evident or pack rust is present but does not warrant structural review. RUST HOLE 1/2" DIAMETER IN WEB 4 1/2" FROM BEAM END AND UP 1" FROM BOTTOM FLANGE OVER BENT 2 CAP

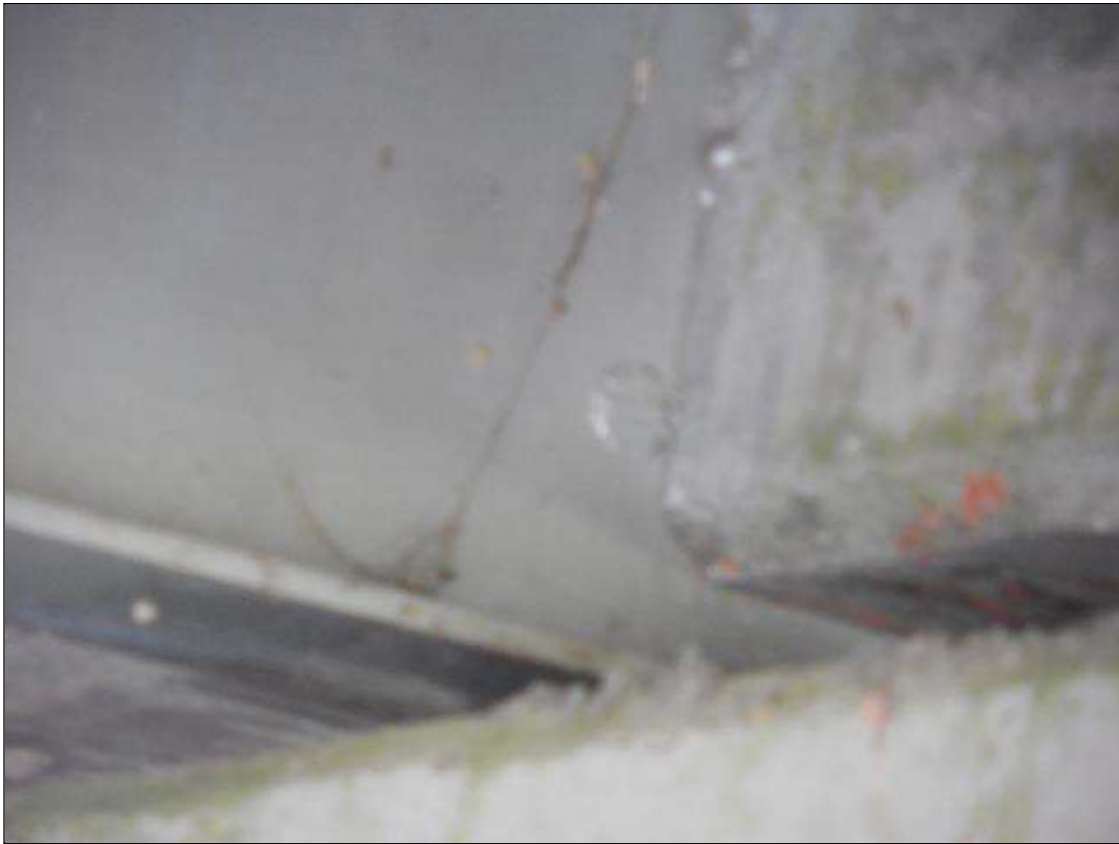
Span 3 Beam 5: 1 Feet of Cracking: Crack that has self-arrested or has been arrested with effective arrest holes, doubling plates, or similar. DRILLED HOLE 1 1/4" DIAMETER IN WEB FILLED WITH CONCRETE AT 5 1/2" FROM BEARING CENTERLINE AND UP 3 1/2" FROM BOTTOM FLANGE AT BENT 3 CAP, ALL BEAMS AT SPAN 3 BENT 3 ARE SIMILAR

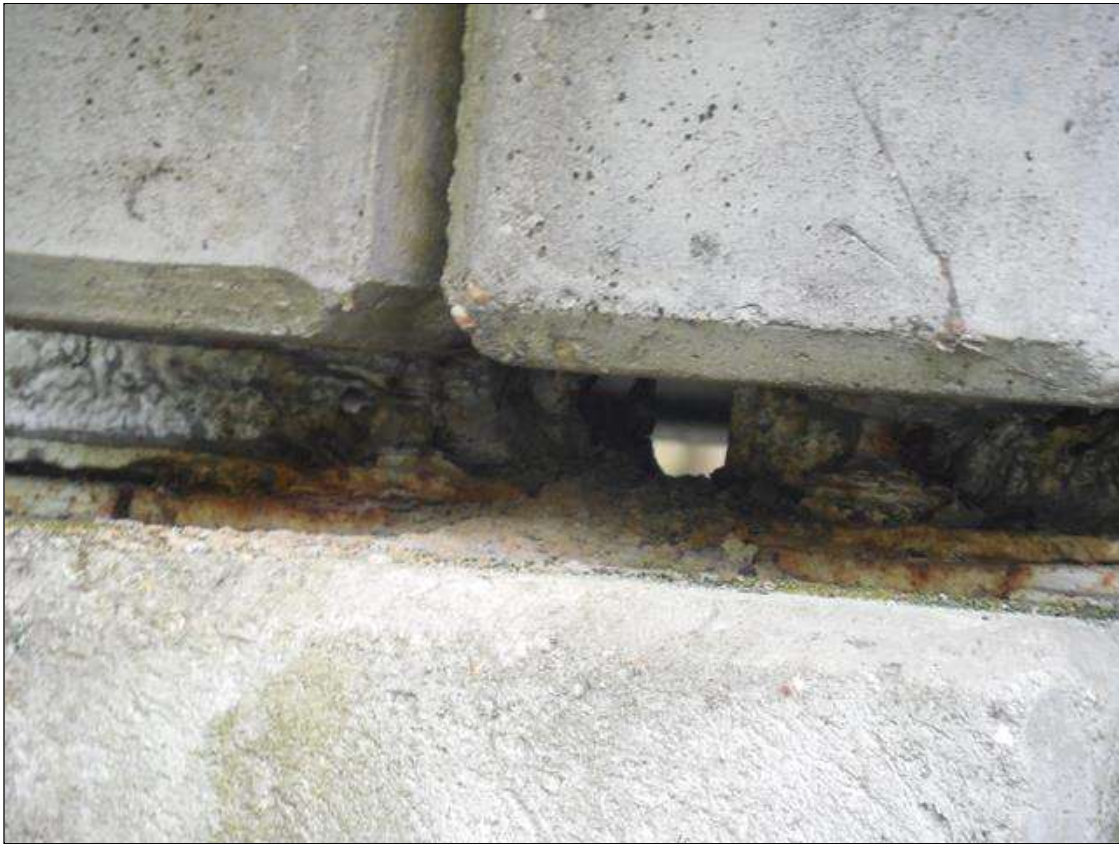
1 Feet of Corrosion: Section loss is evident or pack rust is present but does not warrant structural review. BEAM 7 AT BENT 3 HAS RUST HOLE 2" DIAMETER IN WEB 4" FROM BEAM END UP 1" FROM BOTTOM FLANGE, NOTE: LAST INSPECTION HOLE WAS 1/4" DIAMETER SEE SKETCH

Span 3 Beam 7: 1 Feet of Corrosion: Section loss is evident or pack rust is present but does not warrant structural review. BEAM 7 AT BENT 3 HAS RUST HOLE 2" DIAMETER IN WEB 4" FROM BEAM END UP 1" FROM BOTTOM FLANGE, NOTE: LAST INSPECTION HOLE WAS 1/4" DIAMETER SEE SKETCH

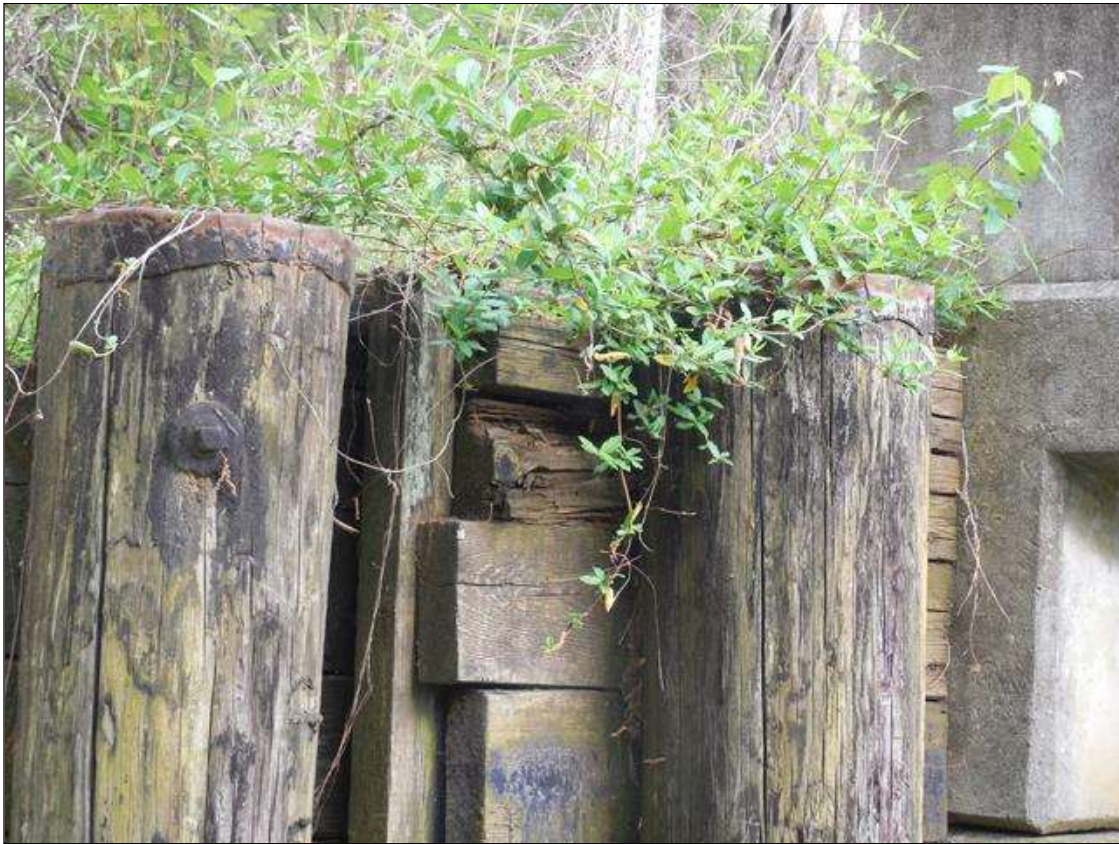
3 Feet of Decay/Section Loss: Affects less than 10% of the member section DECAYED BULKHEAD BOARD AT SOUTHWEST CORNER

End Bent 1 Abutment/Backwall : 3 Feet of Decay/Section Loss: Affects less than 10% of the member section  
DECAYED BULKHEAD BOARD AT SOUTHWEST CORNER

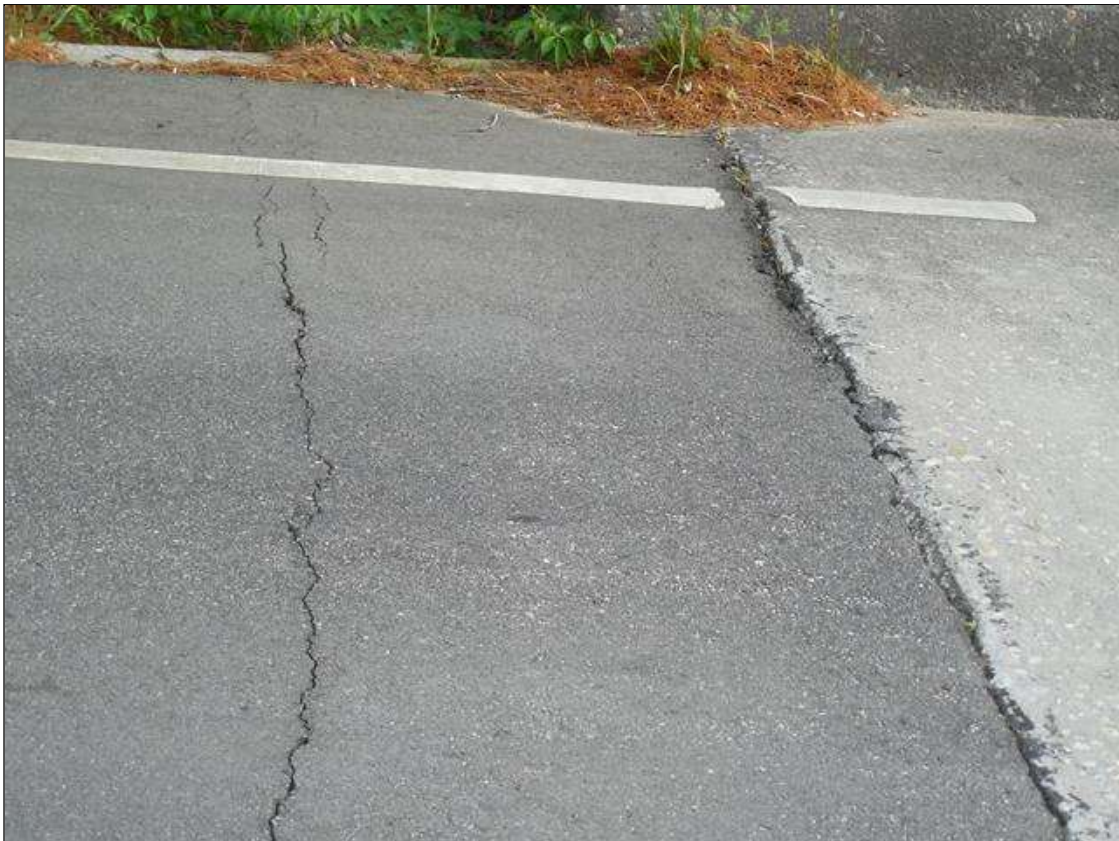
| Details | 1/8" WIDE TRANSVERSE CRACK WITH 1/2" SETTLEMENT IN SOUTH APPROACH IN THE SOUTH BOUND LANE ( PHOTO # 6545 ) | | | | | |

1/8" WIDE TRANSVERSE CRACK WITH 1/2" SETTLEMENT IN SOUTH APPROACH IN THE SOUTH BOUND LANE  
( PHOTO # 6545 )

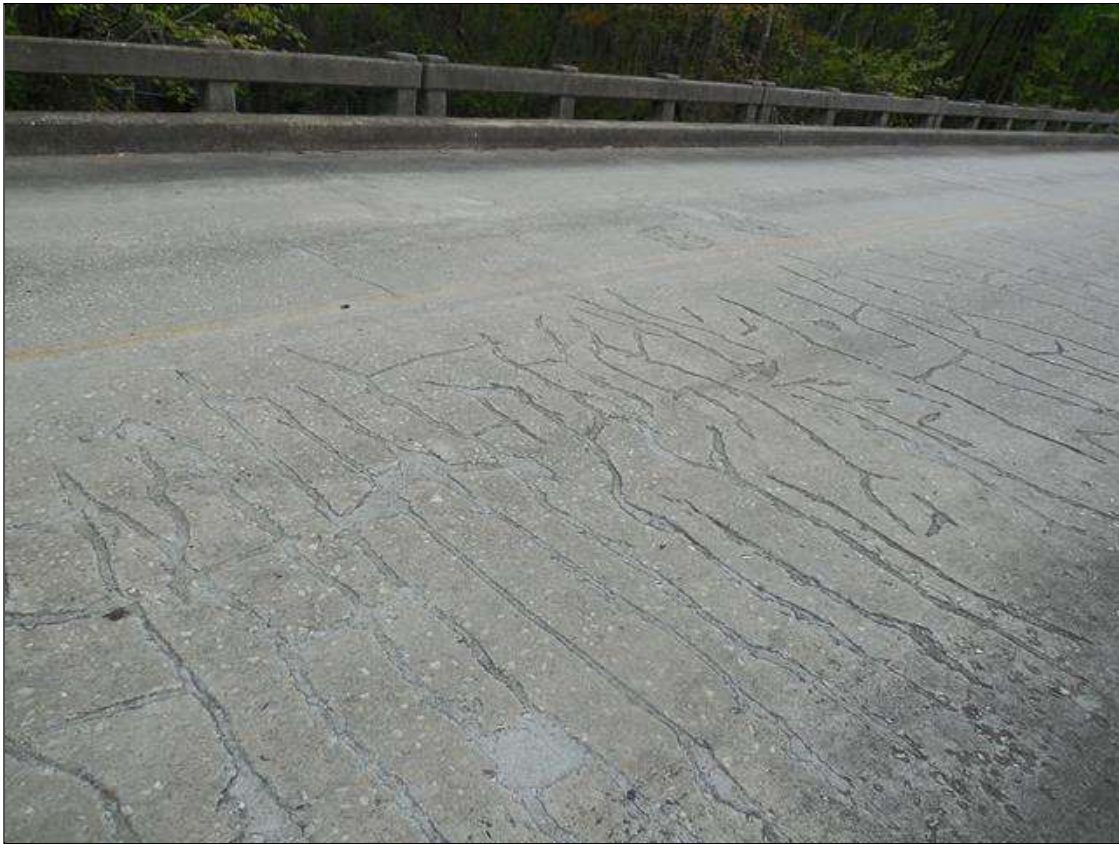
Span 1 Deck: 60 Square Feet of Delamination/Spall/Patched Area: Delaminated. Spall 1 in. or less deep or 6 in. or less in diameter. Patched area that is sound. CRACK PATCHES IN NORTH BOUND LANE

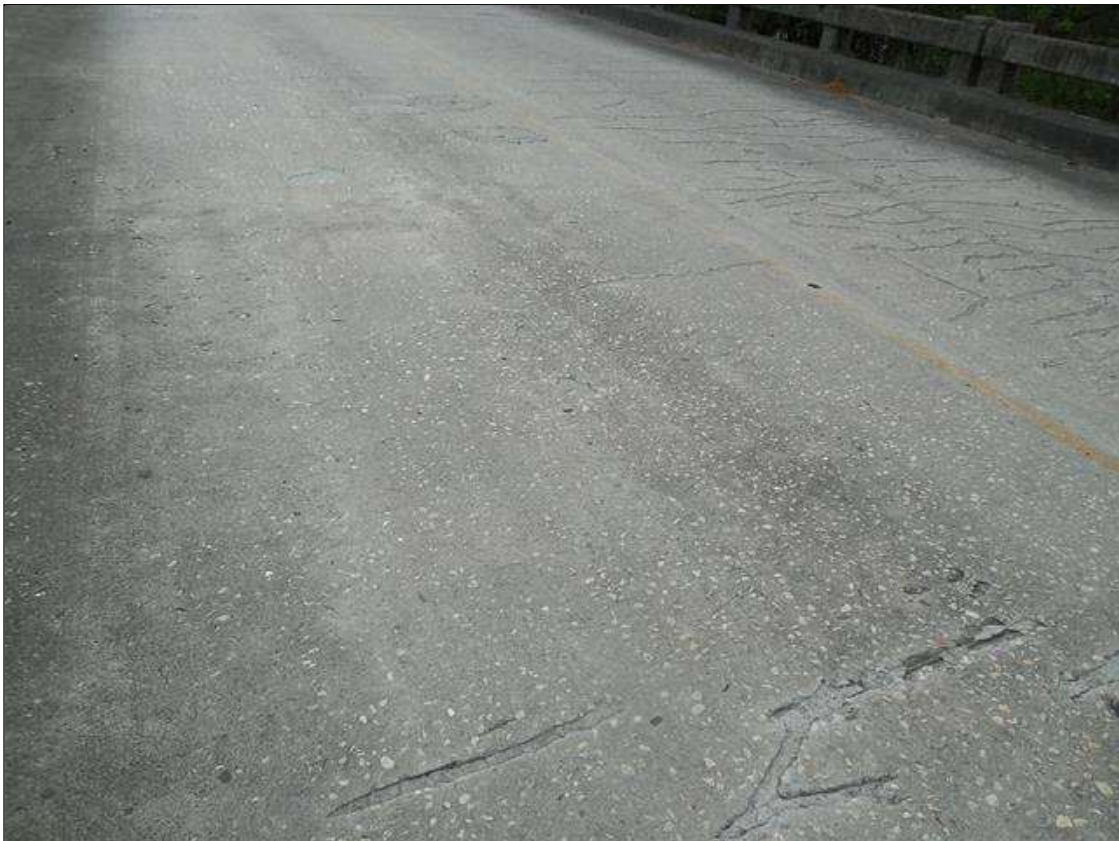
Span 1 Deck: 30 Square Feet of Delamination/Spall/Patched Area: Delaminated. Spall 1 in. or less deep or 6 in. or less in diameter. Patched area that is sound. CRACK PATCHES IN SOUTH BOUND LANE

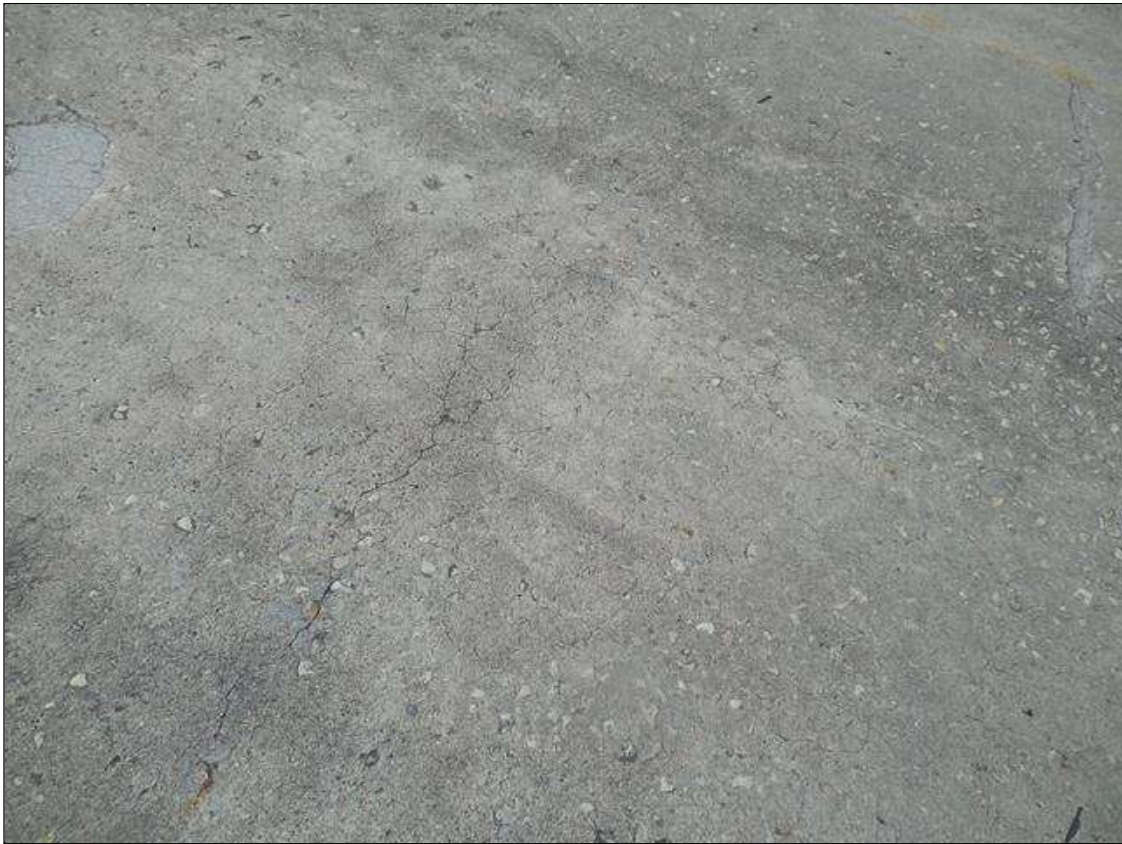
Span 1 Deck: 400 Square Feet of Cracking (RC and Other): Width greater than 0.05 in. or spacing of less than 1 ft.  
HAIRLINE MAP CRACKING

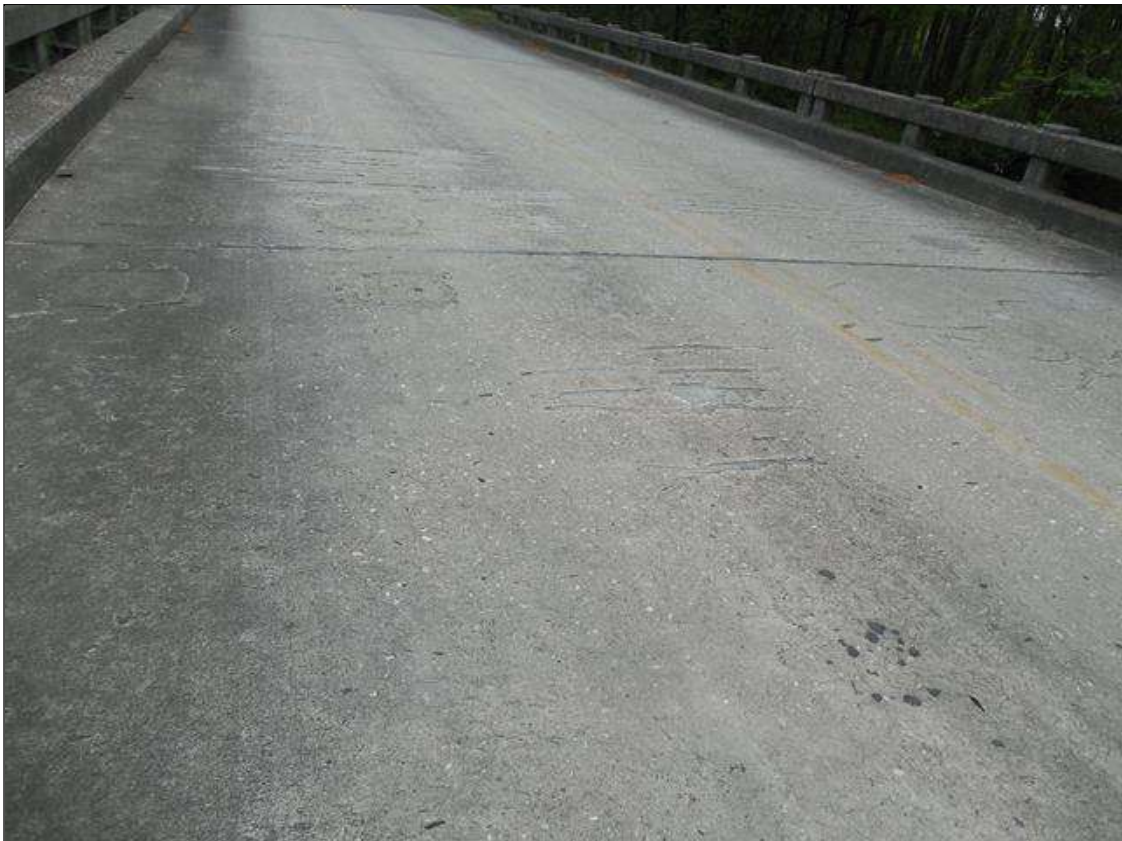
Span 2 Deck: 20 Square Feet of Delamination/Spall/Patched Area: Delaminated. Spall 1 in. or less deep or 6 in. or less in diameter. Patched area that is sound. CRACK PATCHES IN SOUTH BOUND LANE

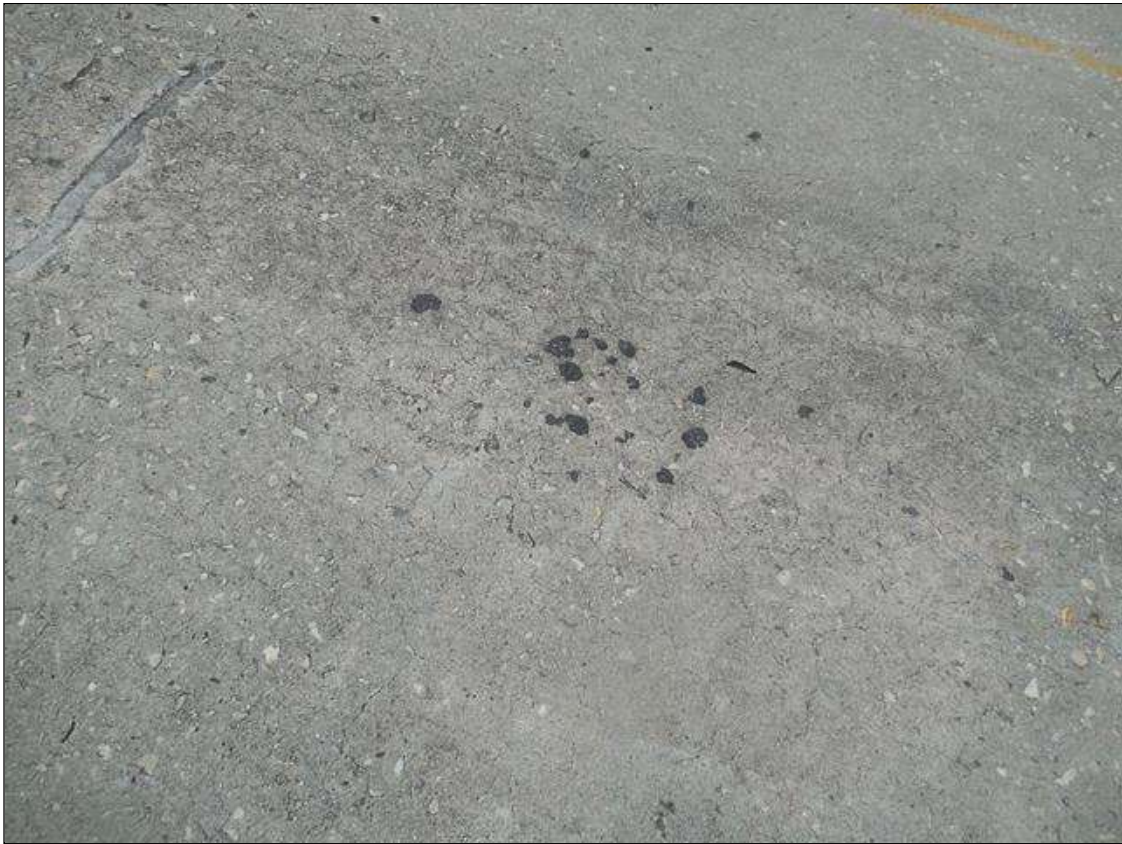
Span 2 Deck: 450 Square Feet of Cracking (RC and Other): Width greater than 0.05 in. or spacing of less than 1 ft.  
HAIRLINE MAP CRACKING IN BOTH LANES

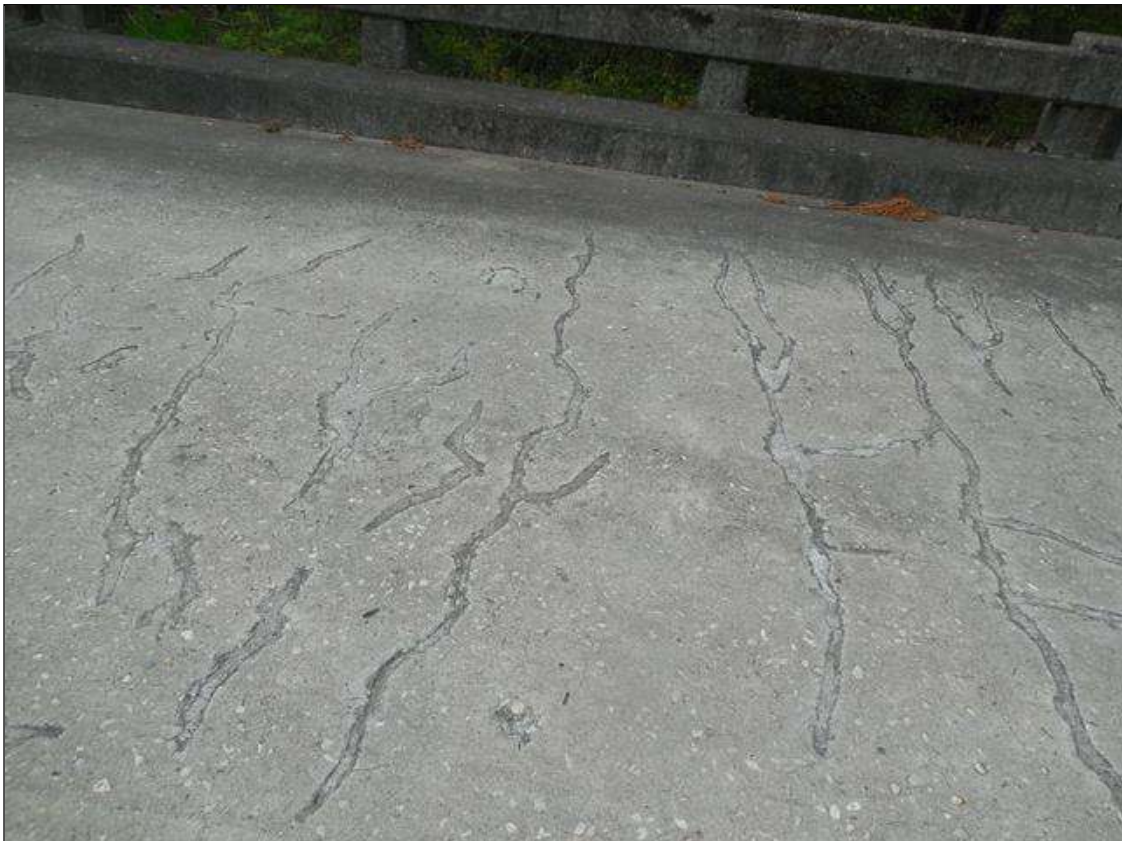
Span 2 Deck: 80 Square Feet of Delamination/Spall/Patched Area: Delaminated. Spall 1 in. or less deep or 6 in. or less in diameter. Patched area that is sound. PATCHED CRACKS IN NORTH BOUND LANE

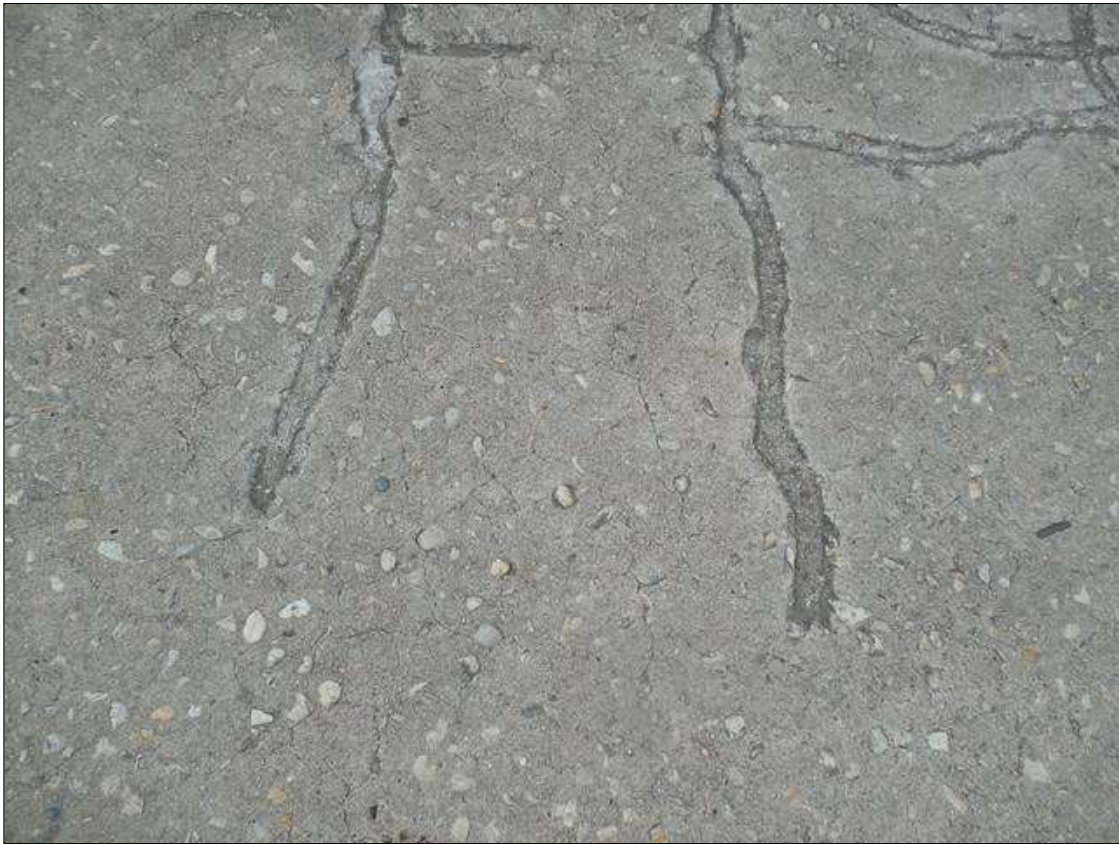
Span 2 Deck: 39 Square Feet of Cracking (RC and Other): Width greater than 0.05 in. or spacing of less than 1 ft.  
HAIRLINE MAP CRACKING IN SOUTH BOUND LANE
