NC DEPARTMENT OF TRANSPORTATION  
DIVISION OF HIGHWAYS  
STRUCTURE MANAGEMENT UNIT

## Structure Safety Report

### Routine Element Inspection

COUNTY: ROBESON STRUCTURE NUMBER: 770028 FREQUENCY: 24 MONTHS

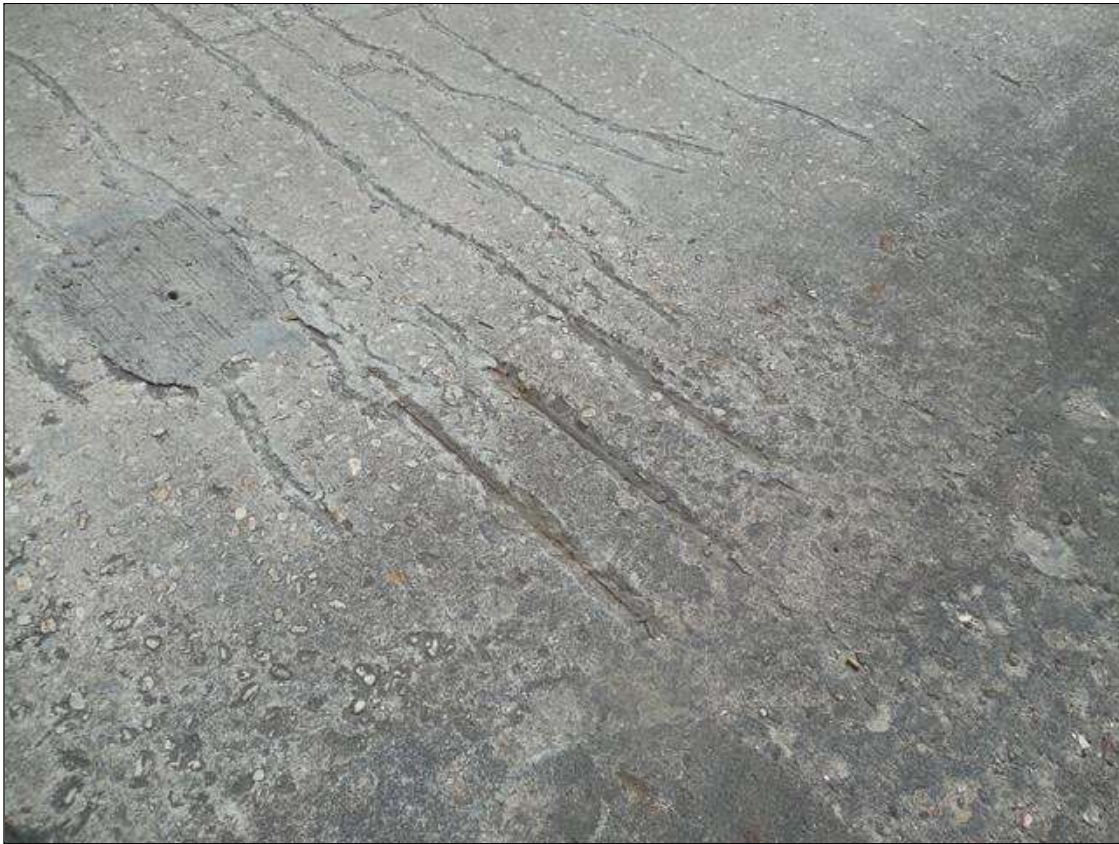
4 Square Feet of Delamination/Spall/Patched Area: Spall greater than 1 in. deep or greater than 6 in. in diameter. Patched area that is unsound or showing distress. Does not warrant structural review. SURFACE SPALL IN NORTH BOUND LANE AT BENT 2

Span 3 Deck: 4 Square Feet of Delamination/Spall/Patched Area: Spall greater than 1 in. deep or greater than 6 in. in diameter. Patched area that is unsound or showing distress. Does not warrant structural review. SURFACE SPALL IN NORTH BOUND LANE AT BENT 2

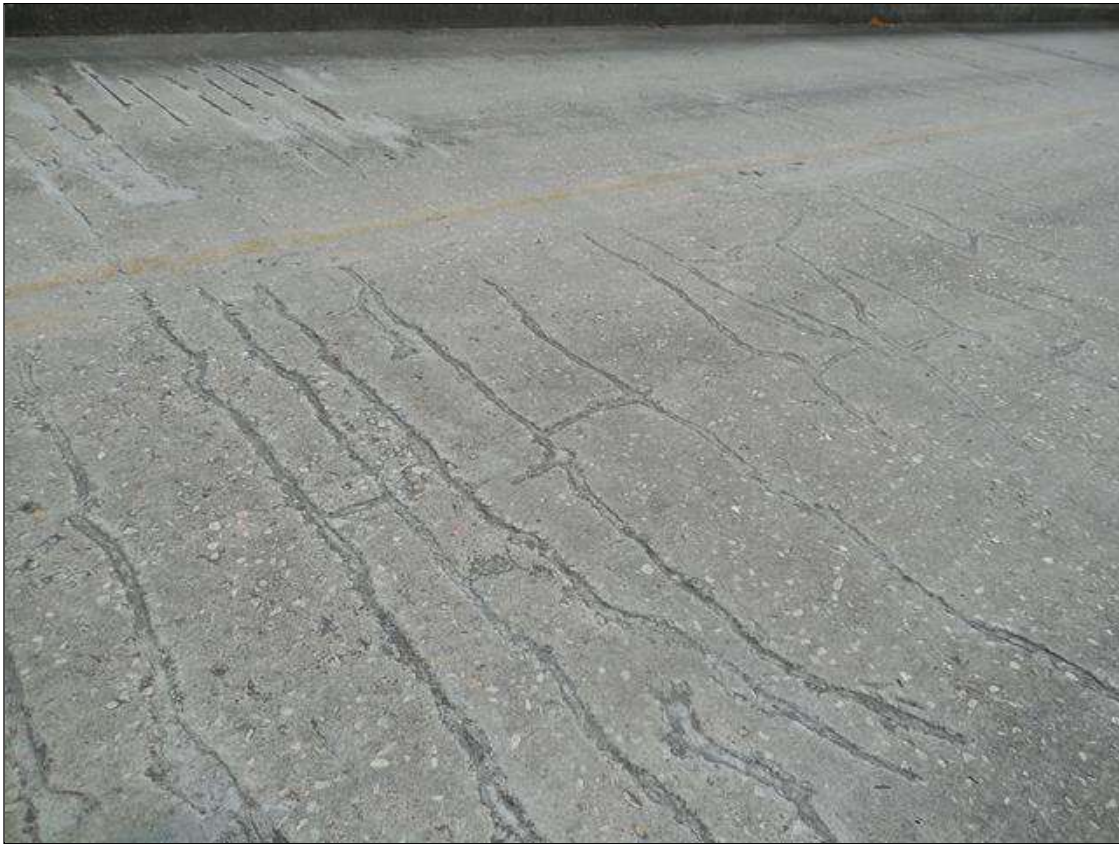
Span 3 Deck: 60 Square Feet of Delamination/Spall/Patched Area: Delaminated. Spall 1 in. or less deep or 6 in. or less in diameter. Patched area that is sound. PATCHED CRACKS IN NORTH BOUND LANE

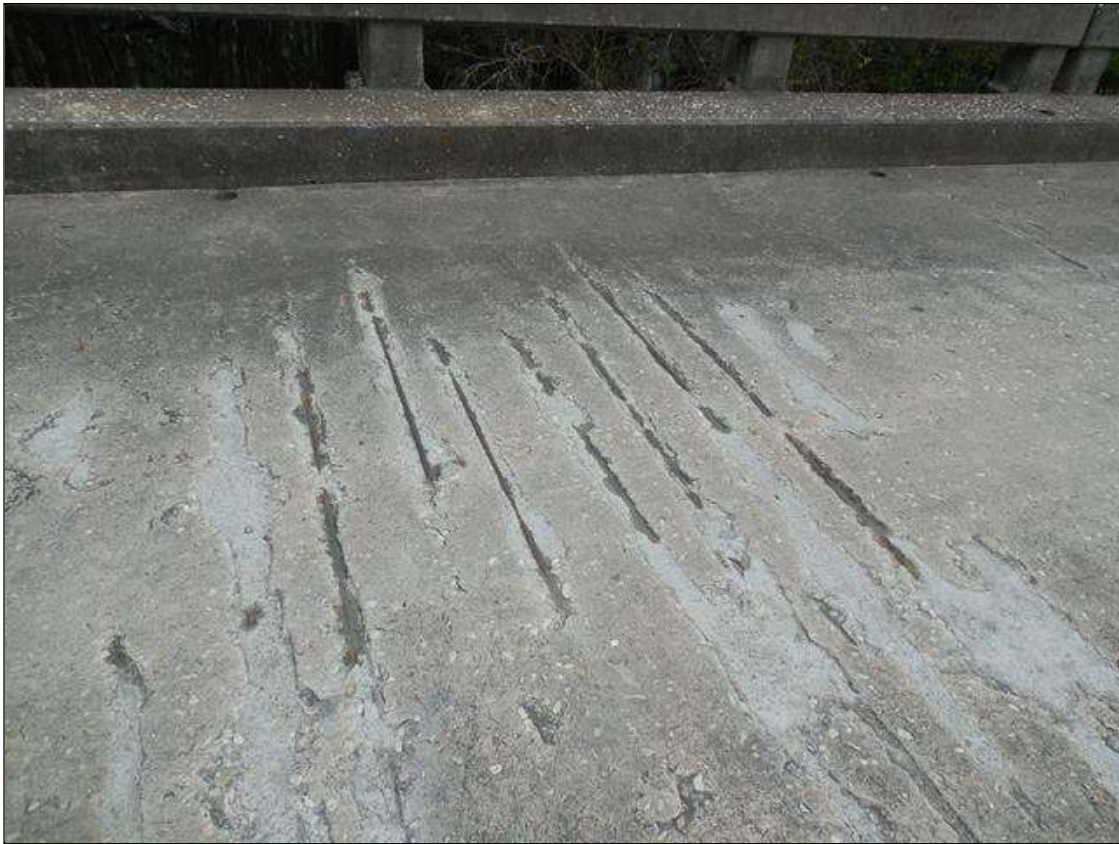
20 Square Feet of Delamination/Spall/Patched Area: Spall greater than 1 in. deep or greater than 6 in. in diameter. Patched area that is unsound or showing distress. Does not warrant structural review. SURFACE SPALL 20 SQ. FT. WITH EXPOSED REBAR IN SOUTH BOUND LANE PM ISSUED

Span 3 Deck: 20 Square Feet of Delamination/Spall/Patched Area: Spall greater than 1 in. deep or greater than 6 in. in diameter. Patched area that is unsound or showing distress. Does not warrant structural review. SURFACE SPALL 20 SQ. FT. WITH EXPOSED REBAR IN SOUTH BOUND LANE PM ISSUED

| MMS Code | Description of Function | Unit | Quantity | Remarks | Est. Cost |
|---|---|---|---|---|---|
| 3326 | Maintain Concrete Deck | SF | 20 | SPAN 3 DECK, SOUTH BOUND LANE HAS 20 SQ. FT. SURFACE SPALL WITH EXPOSED REBAR PM ISSUED | |

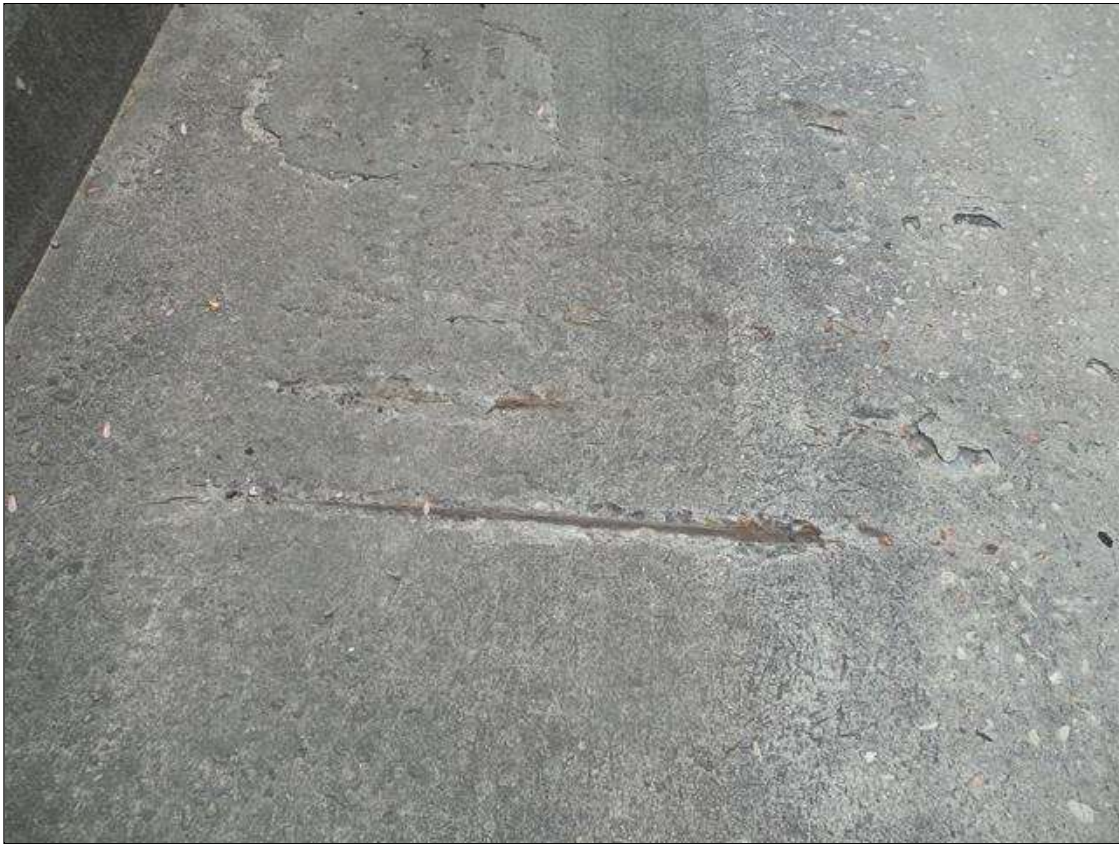
5 Square Feet of Delamination/Spall/Patched Area: Spall greater than 1 in. deep or greater than 6 in. in diameter. Patched area that is unsound or showing distress. Does not warrant structural review. SURFACE SPALL 5 SQ. FT. IN SOUTH BOUND LANE WITH EXPOSED REBAR PM ISSUED

Span 3 Deck: 5 Square Feet of Delamination/Spall/Patched Area: Spall greater than 1 in. deep or greater than 6 in. in diameter. Patched area that is unsound or showing distress. Does not warrant structural review. SURFACE SPALL 5 SQ. FT. IN SOUTH BOUND LANE WITH EXPOSED REBAR PM ISSUED

| MMS Code | Description of Function | Unit | Quantity | Remarks | Est. Cost |
|---|---|---|---|---|---|
| 3326 | Maintain Concrete Deck | SF | 5 | SPAN 3 DECK , SBL HAS 5 SQ. FT. SURFACE SPALL WITH EXPOSED REBAR PM ISSUED | |

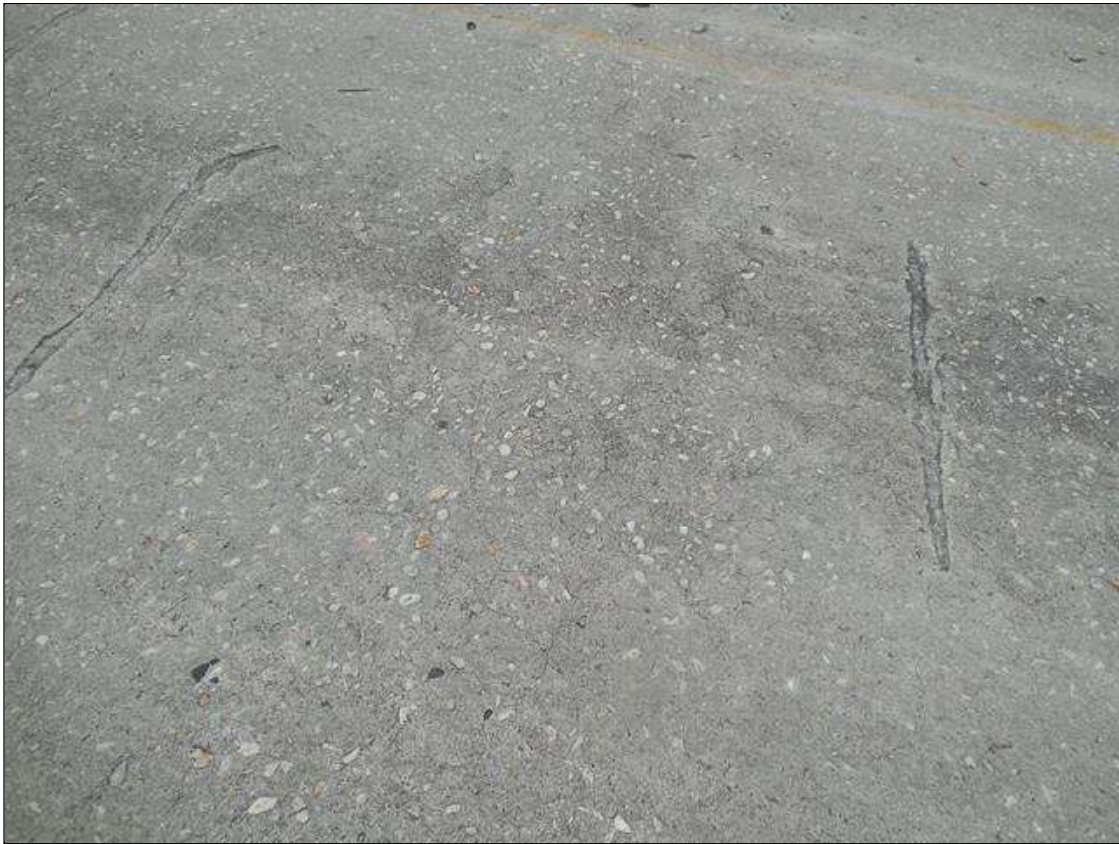
Span 4 Deck: 50 Square Feet of Cracking (RC and Other): Width greater than 0.05 in. or spacing of less than 1 ft.  
HAIRLINE MAP CRACKING IN SOUTH BOUND LANE

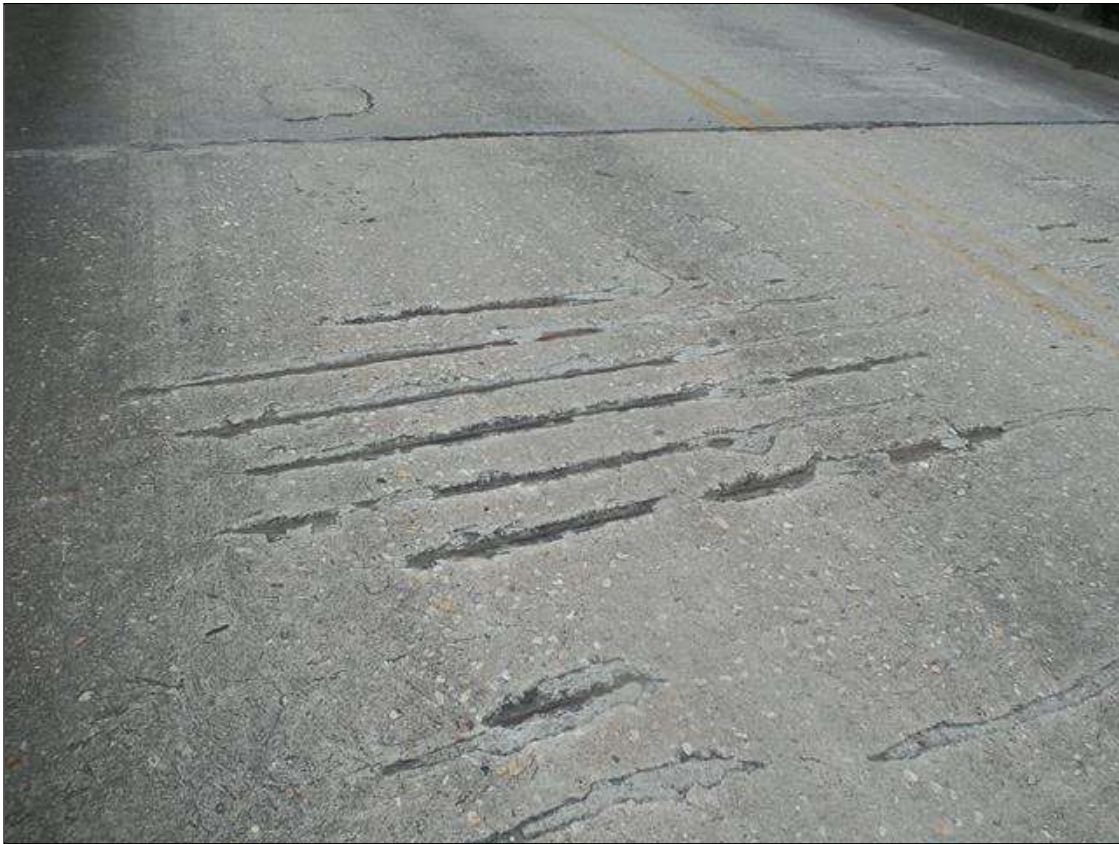
25 Square Feet of Delamination/Spall/Patched Area: Spall greater than 1 in. deep or greater than 6 in. in diameter. Patched area that is unsound or showing distress. Does not warrant structural review. SURFACE SPALL WITH EXPOSED REBAR IN SOUTH BOUND LANE PM ISSUED

Span 4 Deck: 25 Square Feet of Delamination/Spall/Patched Area: Spall greater than 1 in. deep or greater than 6 in. in diameter. Patched area that is unsound or showing distress. Does not warrant structural review. SURFACE SPALL WITH EXPOSED REBAR IN SOUTH BOUND LANE PM ISSUED

| MMS Code | Description of Function | Unit | Quantity | Remarks | Est. Cost |
|---|---|---|---|---|---|
| 3326 | Maintain Concrete Deck | SF | 25 | SPAN 4 DECK, SOUTH BOUND LANE HAS 25 SQ. FT. SURFACE SPALL WITH EXPOSED REBAR PM ISSUED | |

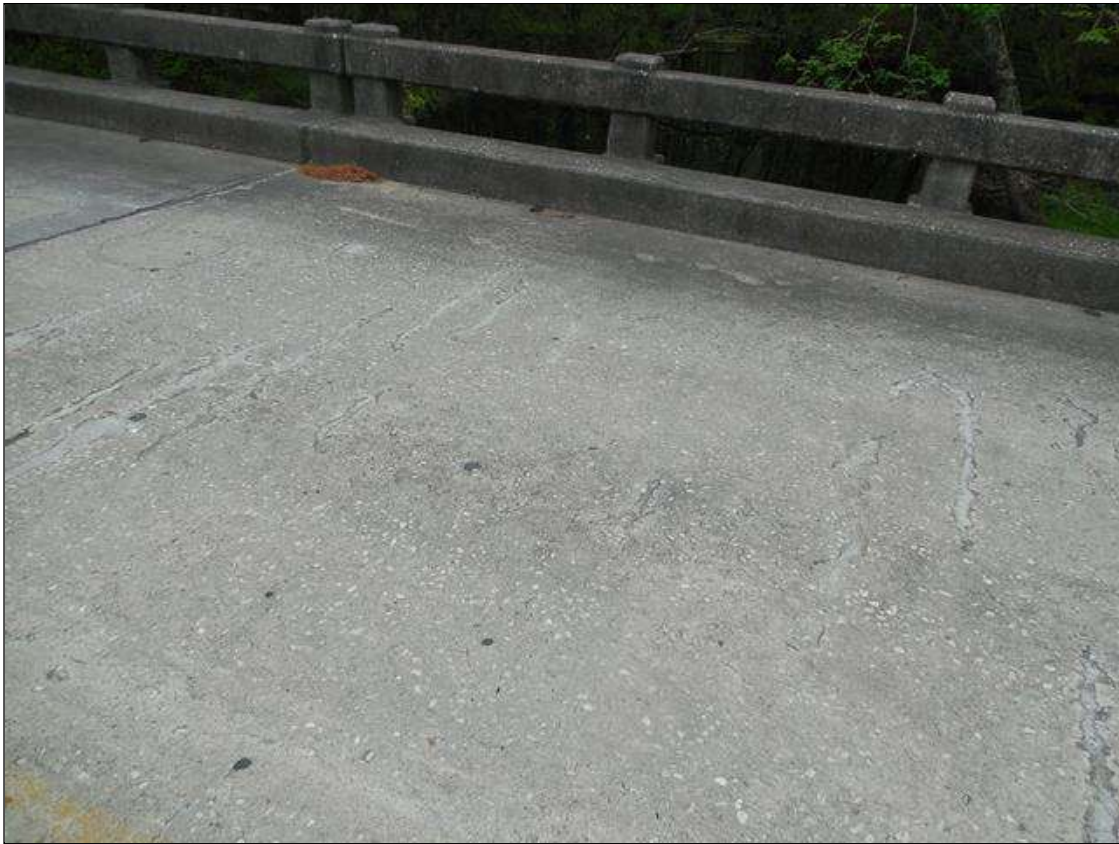
Span 4 Deck: 60 Square Feet of Delamination/Spall/Patched Area: Delaminated. Spall 1 in. or less deep or 6 in. or less in diameter. Patched area that is sound. PATCHED CRACKS IN NORTH BOUND LANE

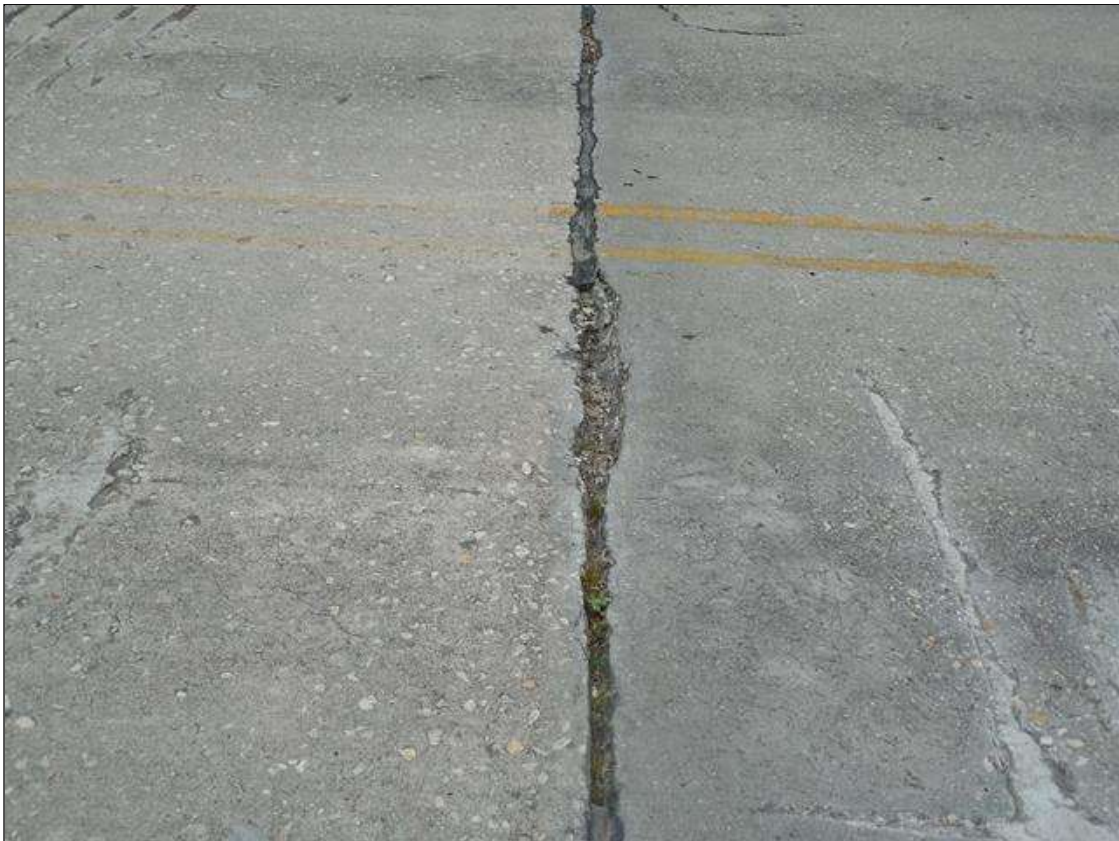
30 Feet of Seal Damage: Punctured or ripped or partially pulled out. JOINT MATERIAL DETERIORATED, MISSING, LEAKING

Expansion Joint 5 : 30 Feet of Seal Damage: Punctured or ripped or partially pulled out. JOINT MATERIAL DETERIORATED, MISSING, LEAKING

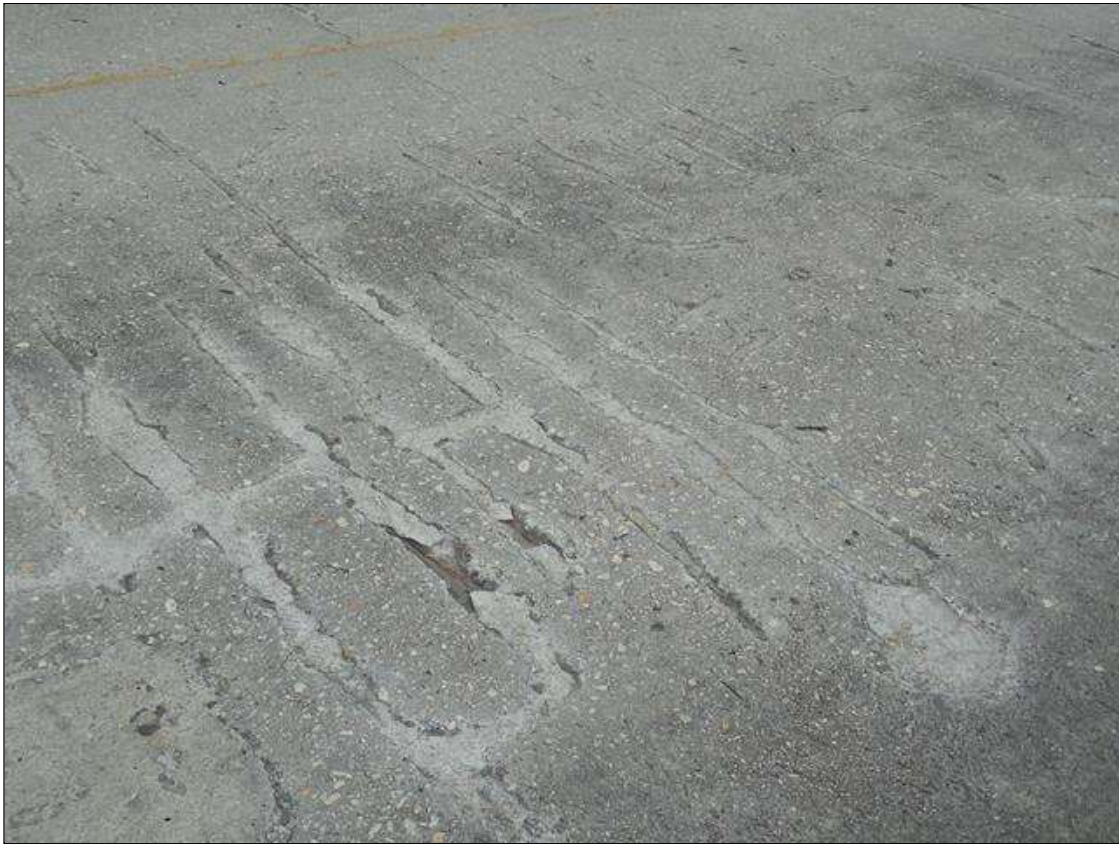
Span 5 Deck: 60 Square Feet of Delamination/Spall/Patched Area: Delaminated. Spall 1 in. or less deep or 6 in. or less in diameter. Patched area that is sound. PATCHED CRACKS IN NORTH BOUND LANE

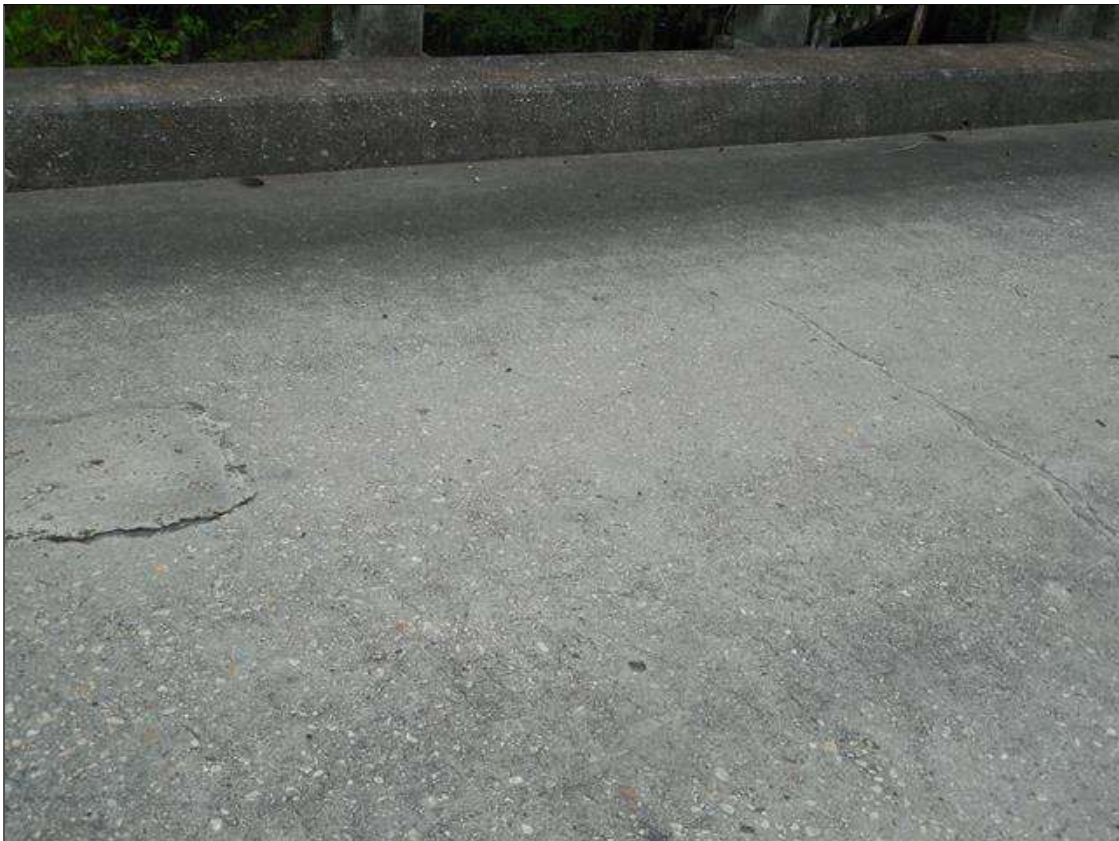
Span 5 Deck: 15 Square Feet of Delamination/Spall/Patched Area: Delaminated. Spall 1 in. or less deep or 6 in. or less in diameter. Patched area that is sound. PATCHES IN SOUTH BOUND LANE

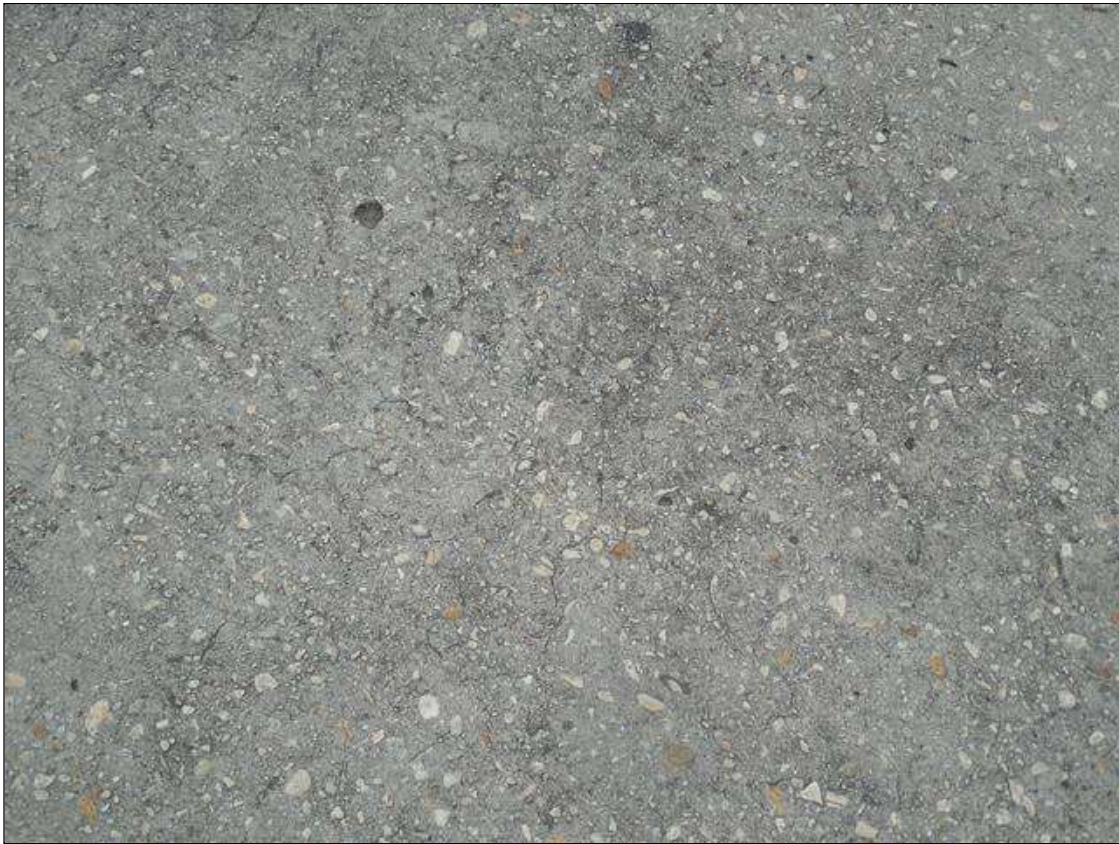
Span 5 Deck: 400 Square Feet of Cracking (RC and Other): Width greater than 0.05 in. or spacing of less than 1 ft.  
HAIRLINE MAP CRACKING IN BOTH LANES

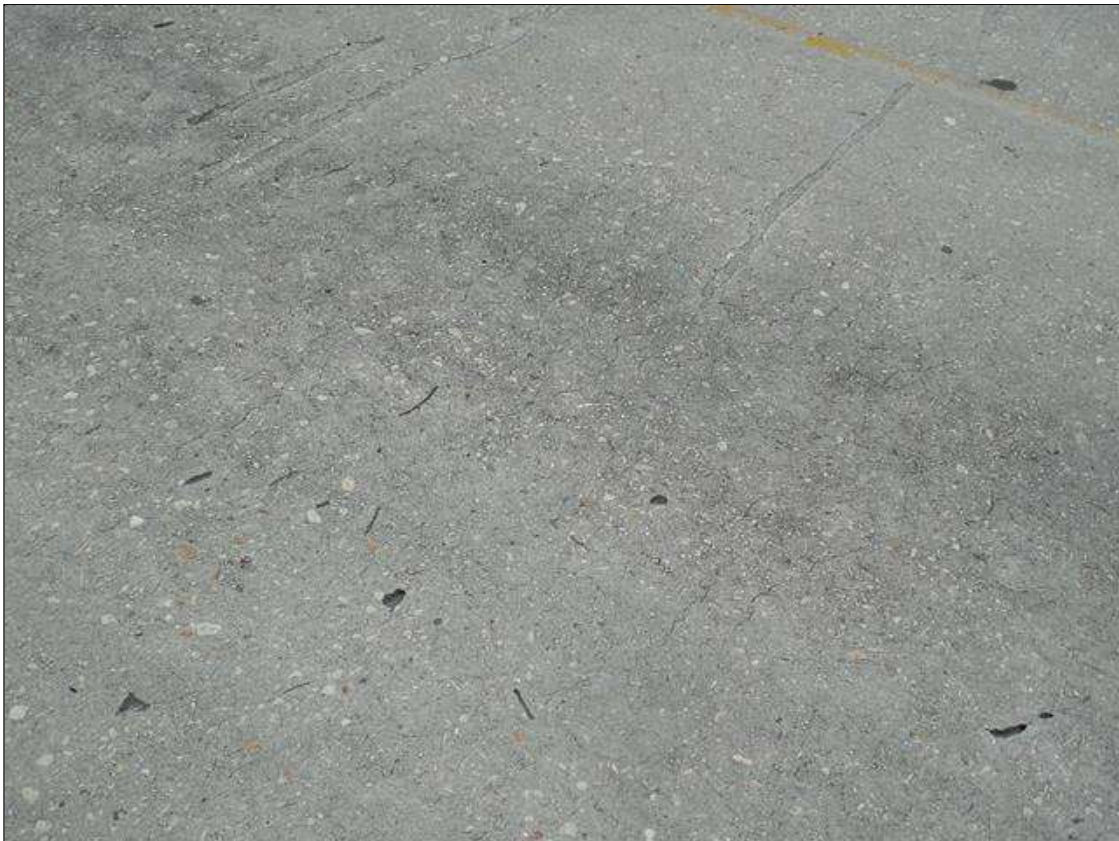
Span 6 Deck: 500 Square Feet of Cracking (RC and Other): Width greater than 0.05 in. or spacing of less than 1 ft.  
HAIRLINE MAP CRACKING IN BOTH LANES

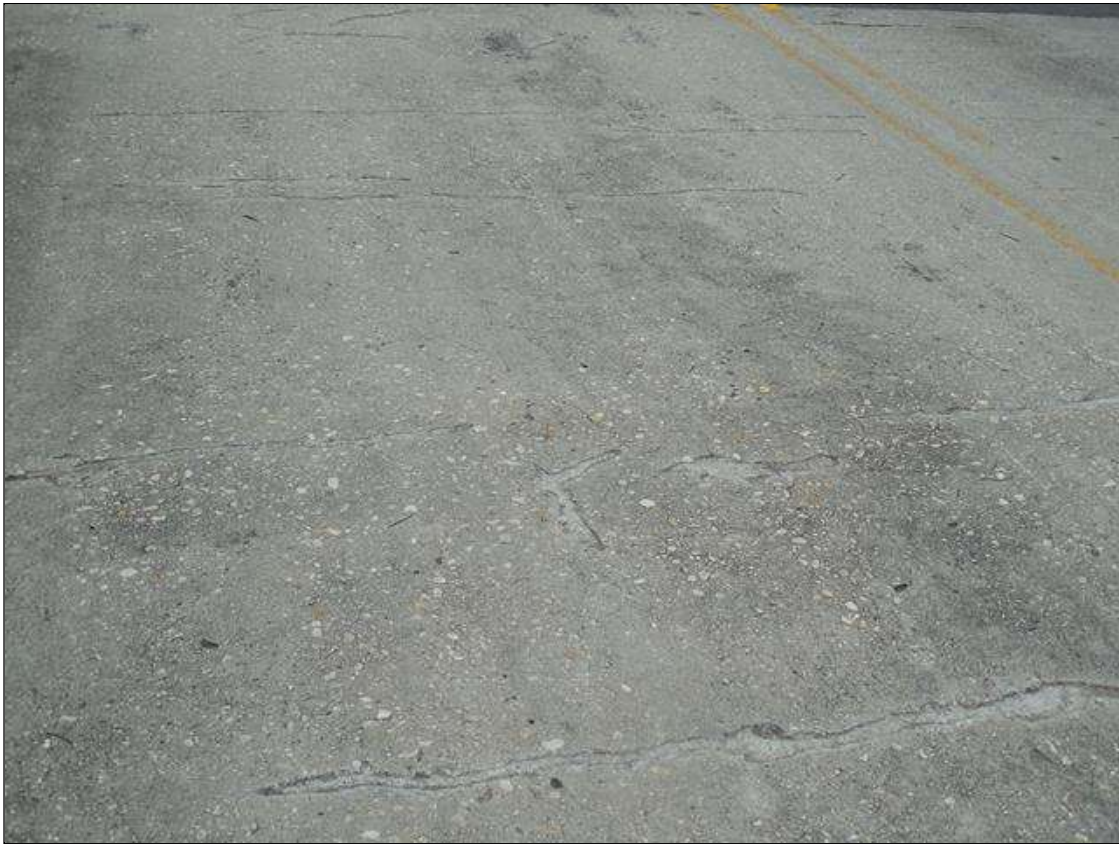
Span 6 Deck: 40 Square Feet of Delamination/Spall/Patched Area: Delaminated. Spall 1 in. or less deep or 6 in. or less in diameter. Patched area that is sound. PATCHED CRACKS IN SOUTH BOUND LANE

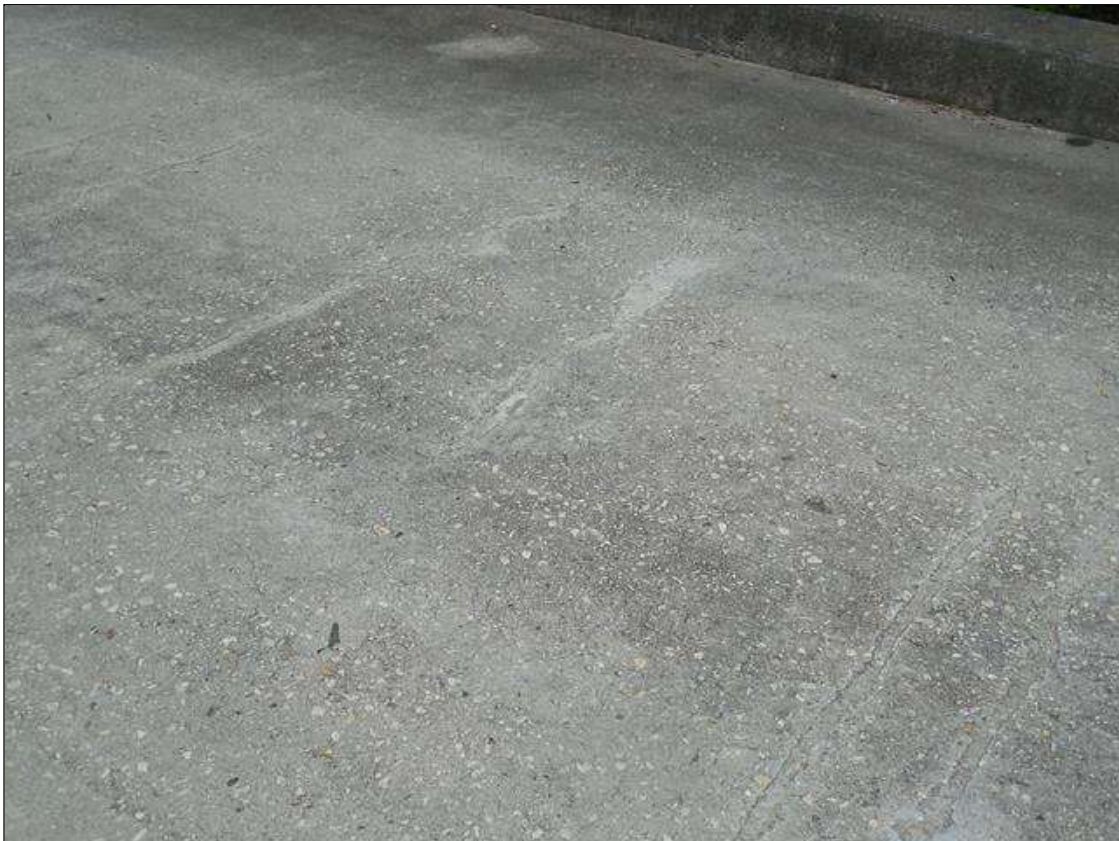
Span 6 Deck: 60 Square Feet of Delamination/Spall/Patched Area: Delaminated. Spall 1 in. or less deep or 6 in. or less in diameter. Patched area that is sound. PATCHED CRACKS IN NORTH BOUND LANE

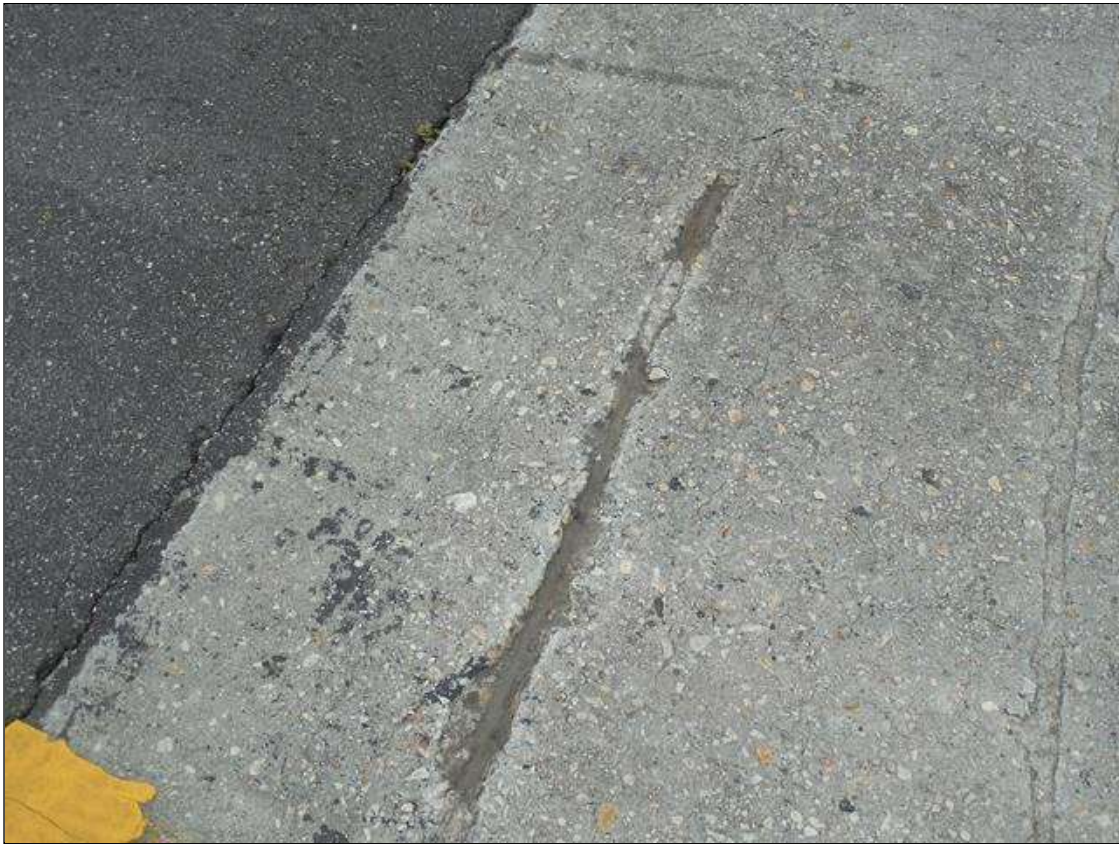
3 Square Feet of Delamination/Spall/Patched Area: Spall greater than 1 in. deep or greater than 6 in. in diameter. Patched area that is unsound or showing distress. Does not warrant structural review. SURFACE SPALL WITH EXPOSED REBAR 3 SQ. FT. AT END BENT 2 IN NORTH BOUND LANE PM ISSUED

Span 6 Deck: 3 Square Feet of Delamination/Spall/Patched Area: Spall greater than 1 in. deep or greater than 6 in. in diameter. Patched area that is unsound or showing distress. Does not warrant structural review. SURFACE SPALL WITH EXPOSED REBAR 3 SQ. FT. AT END BENT 2 IN NORTH BOUND LANE PM ISSUED

| MMS Code | Description of Function | Unit | Quantity | Remarks | Est. Cost |
|---|---|---|---|---|---|
| 3326 | Maintain Concrete Deck | SF | 3 | SPAN 6 DECK, NORTH BOUND LANE AT END BENT 2 HAS 3 SQ. FT. SURFACE SPALL WITH EXPOSED REBAR PM ISSUED | |

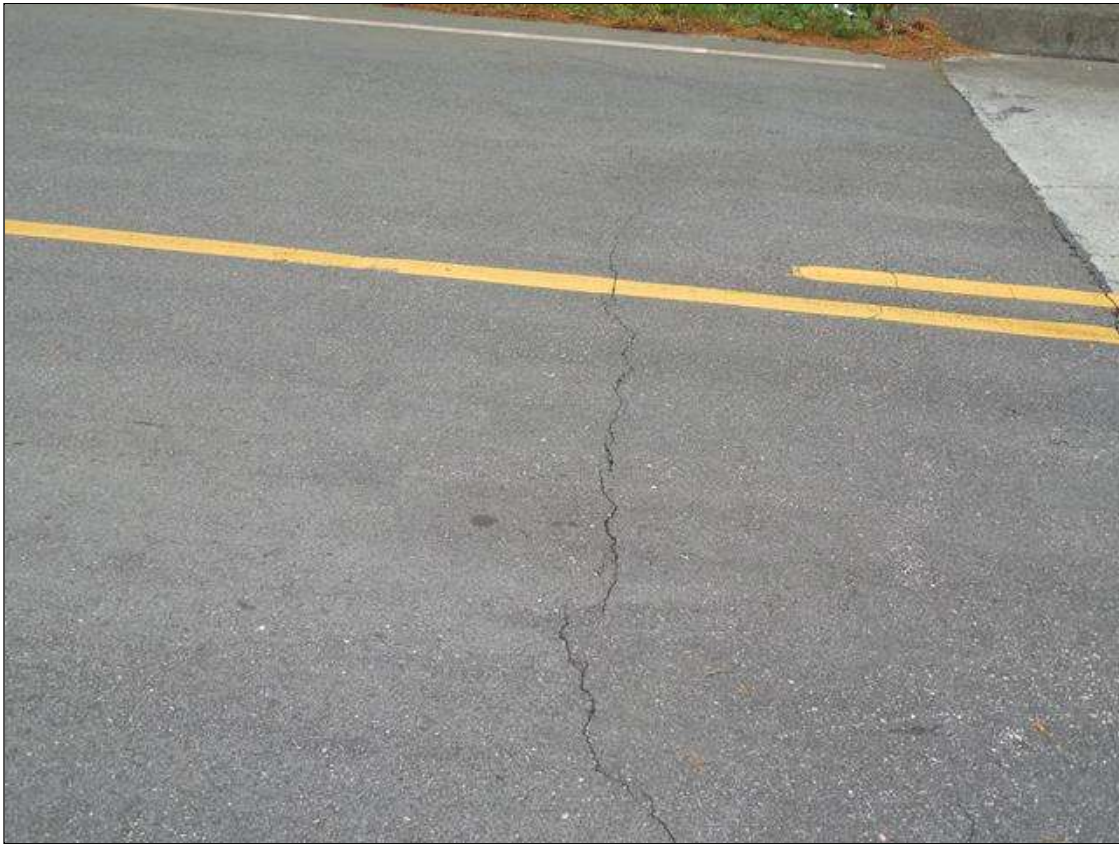
| | NORTH APPROACH ASPHALT WEARING SURFACE 1/8" TRANSVERSE CRACK OVER END BENT 2 | | | | | |

NORTH APPROACH ASPHALT WEARING SURFACE 1/8" TRANSVERSE CRACK OVER END BENT 2

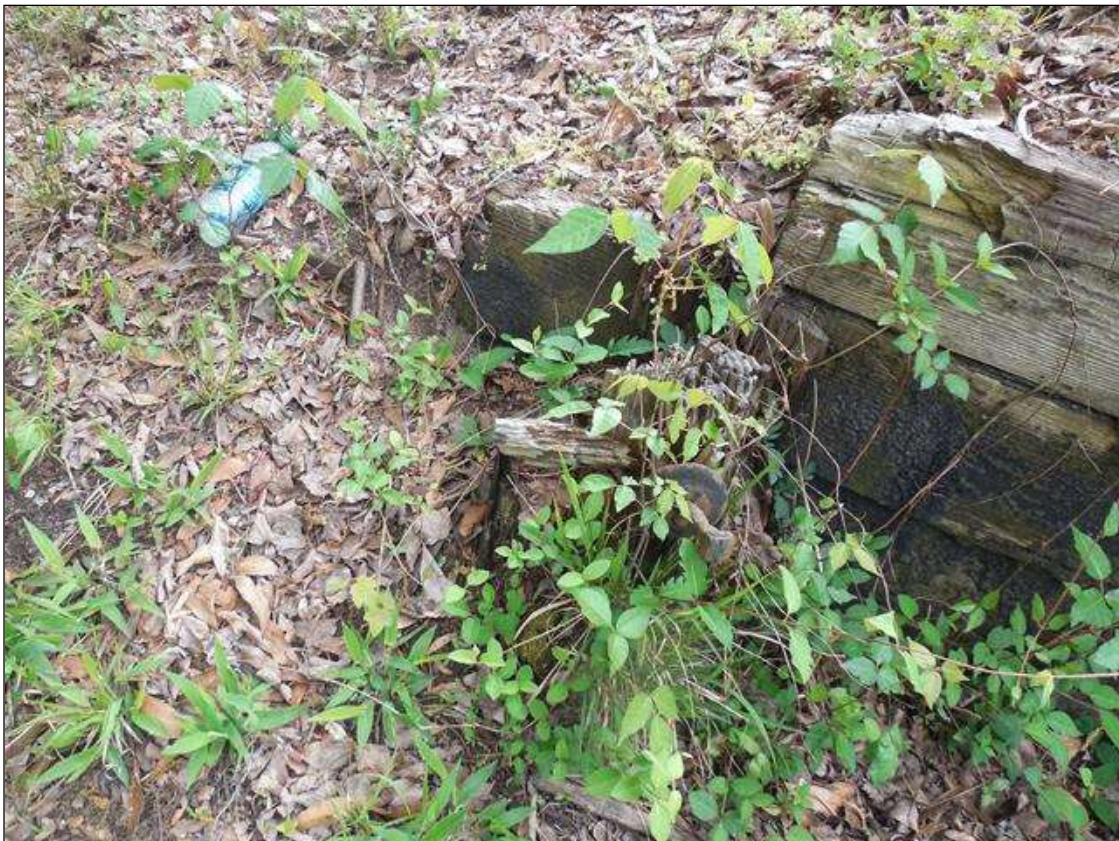
| | DECAYED WINGWALL PILE AT NORTHWEST CORNER, 2 FT. | | | | | |

DECAYED WINGWALL PILE AT NORTHWEST CORNER, 2 FT.

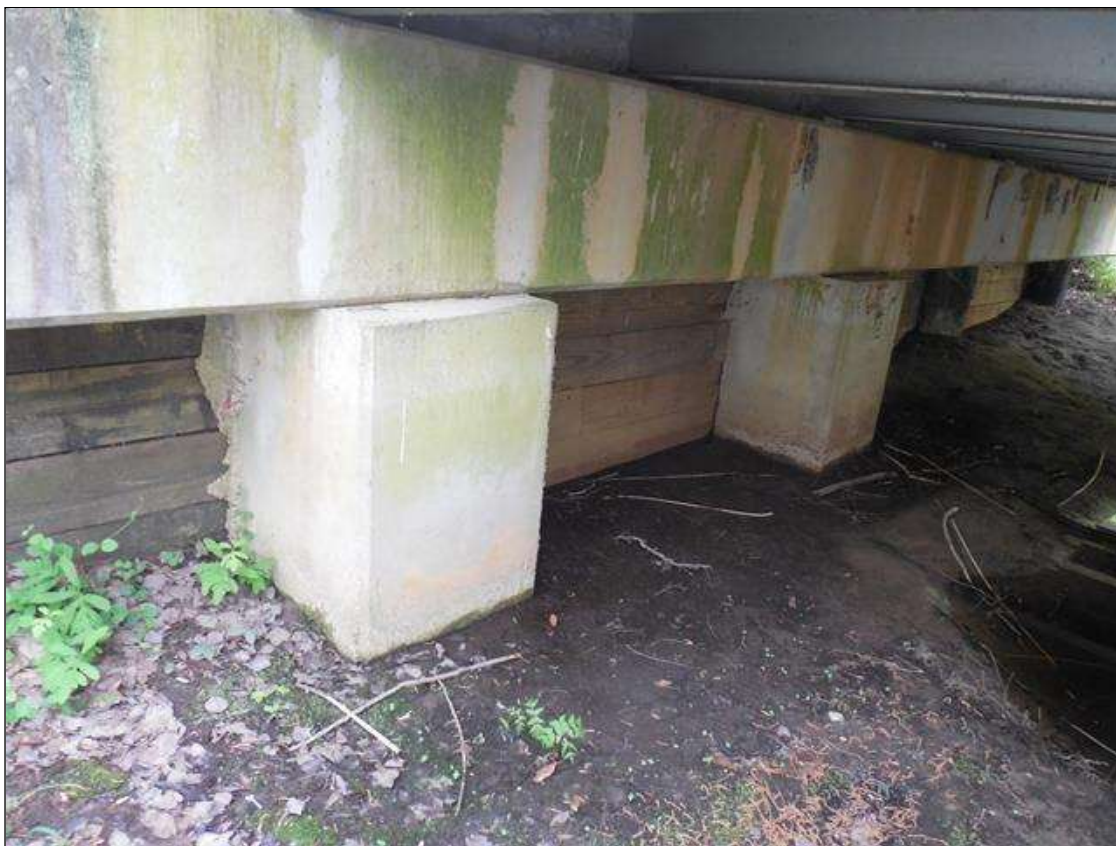
PILES 1 AND 2 ENCASED AT END BENT 2, TEMPORARY REPAIRS ( PHOTO # 6577 )

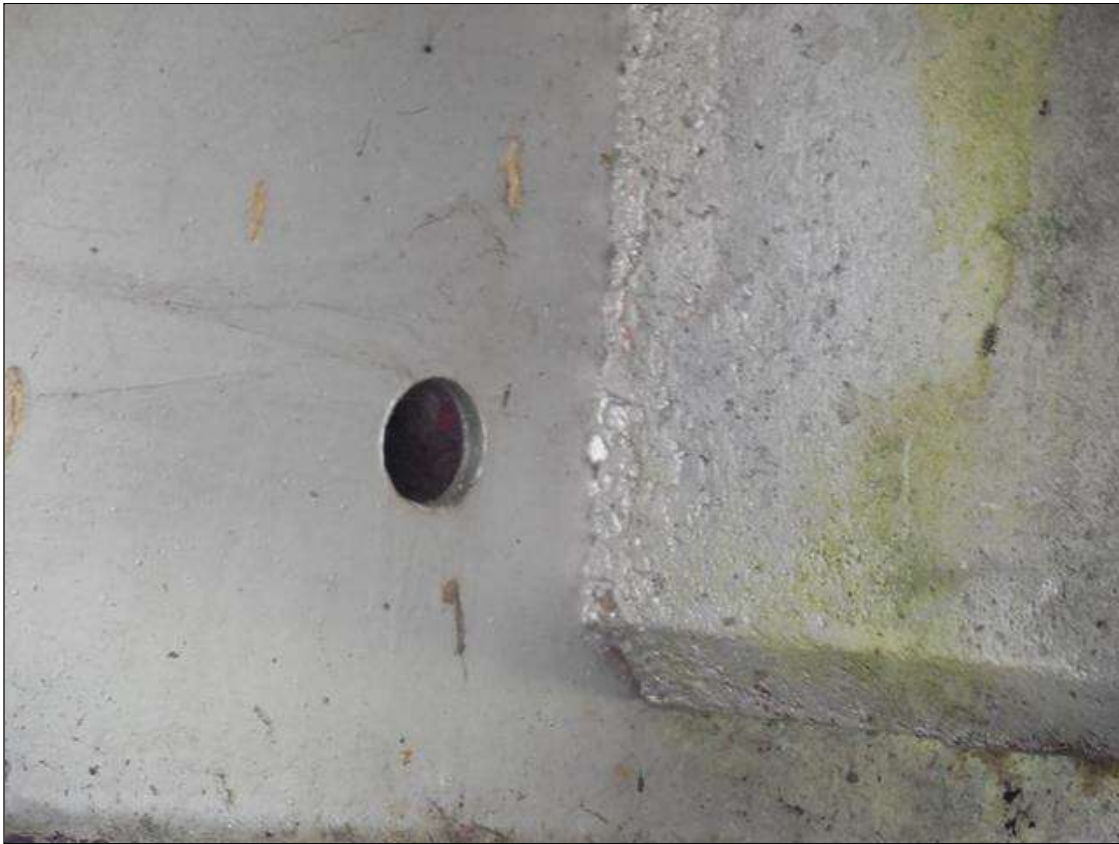
1 Feet of Cracking: Crack that has self-arrested or has been arrested with effective arrest holes, doubling plates, or similar. 1 1/4" DRILLED HOLE IN WEB 7" FROM CENTERLINE OF BEARING AT BENT 5 AND UP 3 1/2" FROM BOTTOM FLANGE, BEAMS 2 AND 3 ARE SIMILAR

Span 6 Beam 1: 1 Feet of Cracking: Crack that has self-arrested or has been arrested with effective arrest holes, doubling plates, or similar. 1 1/4" DRILLED HOLE IN WEB 7" FROM CENTERLINE OF BEARING AT BENT 5 AND UP 3 1/2" FROM BOTTOM FLANGE, BEAMS 2 AND 3 ARE SIMILAR

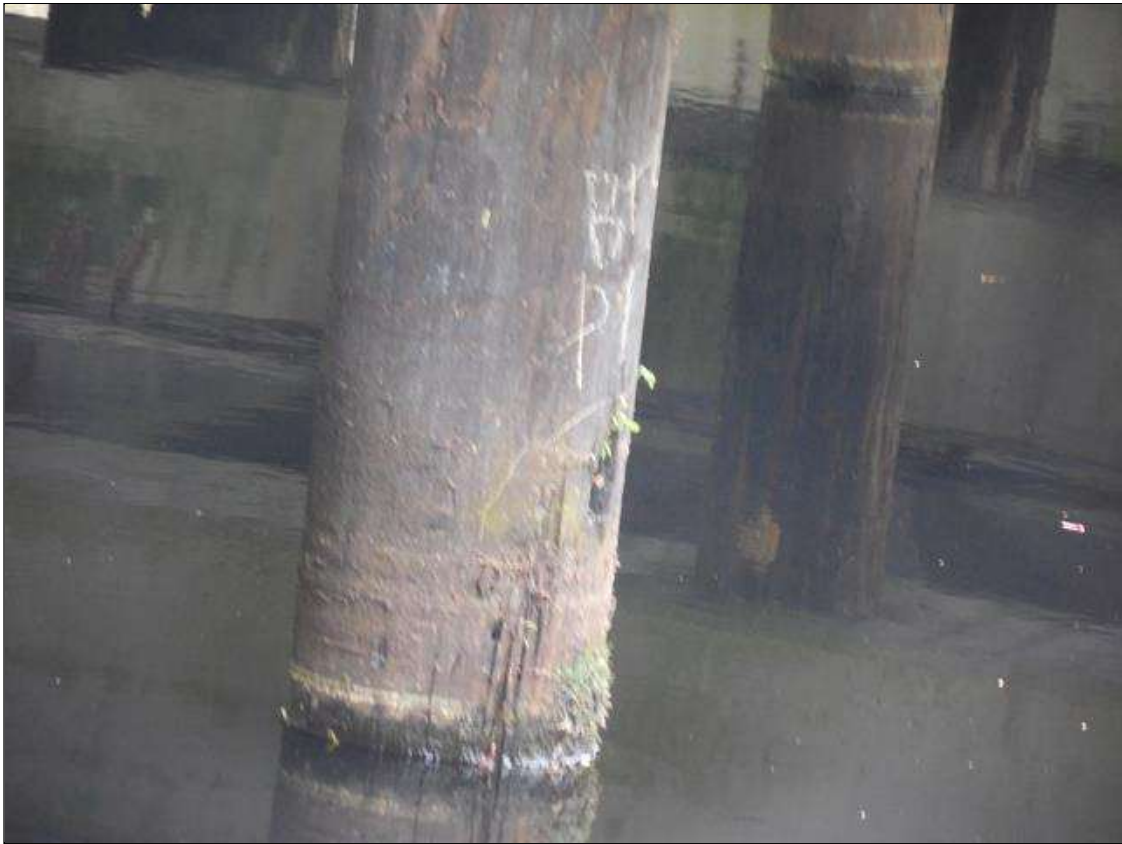
1 Each of Decay/Section Loss: Affects less than 10% of the member section DECAYED 14" HIGH X 8" WIDE X 2" DEEP ON WEST FACE

Bent 4 Pile 1: 1 Each of Decay/Section Loss: Affects less than 10% of the member section DECAYED 14" HIGH X 8" WIDE X 2" DEEP ON WEST FACE

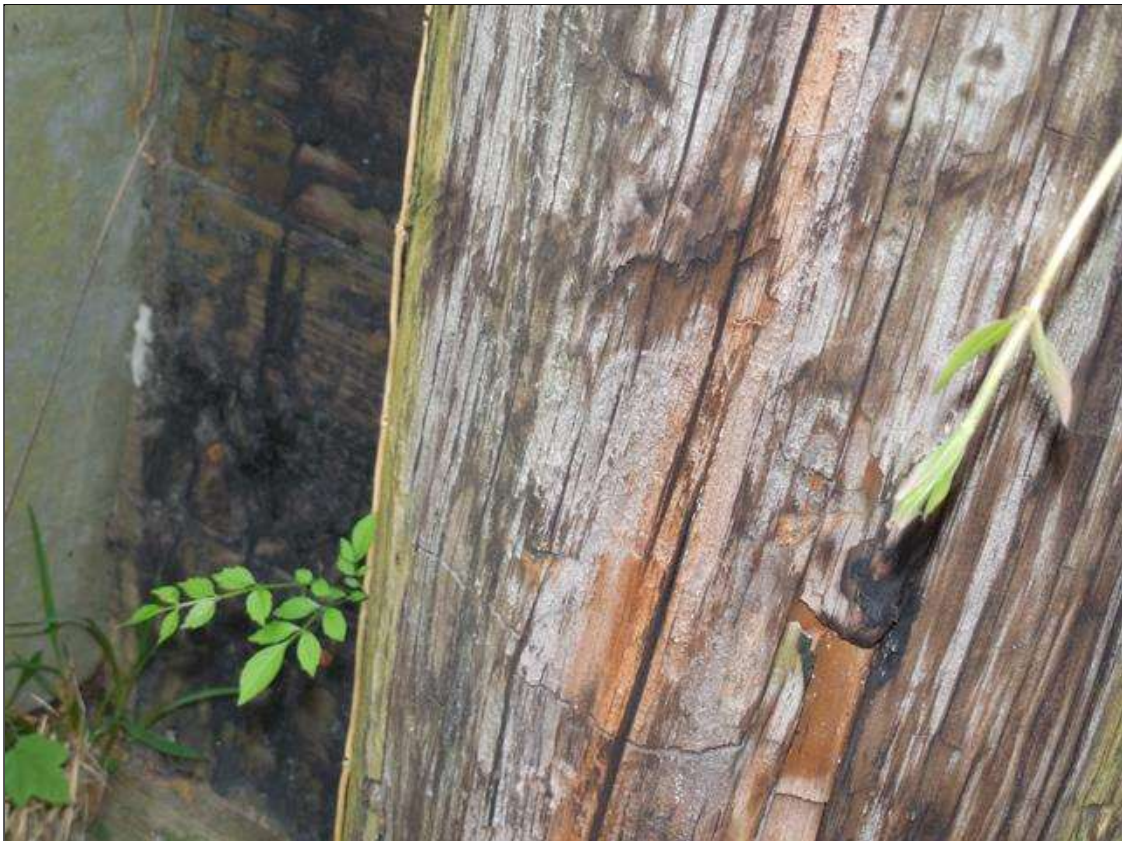
End Bent 2 Abutment/Backwall : 1 Feet of Check/Shake: Penetrates 5%-50% of the thickness of teh member and not in a tension zone. TURNPILE AT NORTHEAST CORNER HAS 1/8" WIDE VERTICAL CHECKS, 1" DEEP

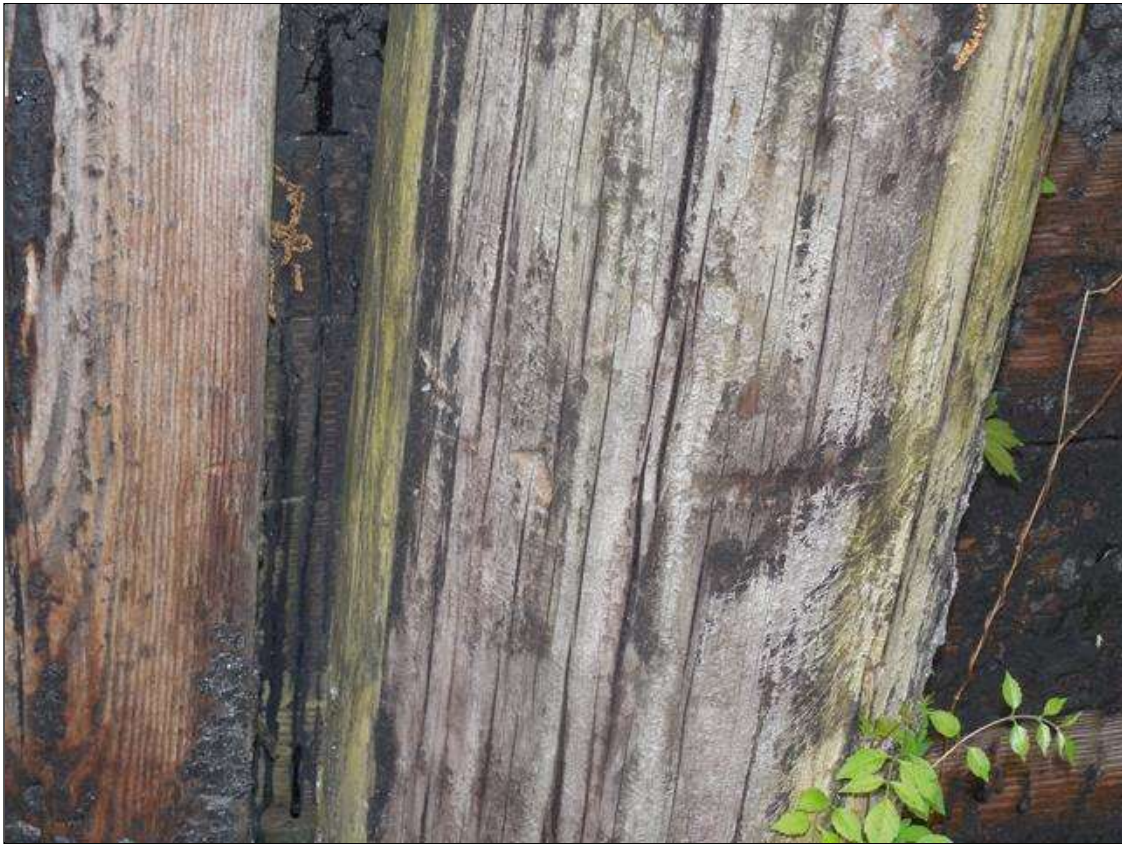
| | 1/4" WIDE VERTICAL CHECKS , 1" DEEP IN WINGWALL PILE AT NORTHEAST CORNER ( PHOTO # 6584 ) | | | | | |

1/4" WIDE VERTICAL CHECKS , 1" DEEP IN WINGWALL PILE AT NORTHEAST CORNER ( PHOTO # 6584 )
