NC DEPARTMENT OF TRANSPORTATION  
DIVISION OF HIGHWAYS  
STRUCTURE MANAGEMENT UNIT

## Structure Safety Report

### Routine Element Inspection

COUNTY: ROBESON STRUCTURE NUMBER: 770028 FREQUENCY: 24 MONTHS

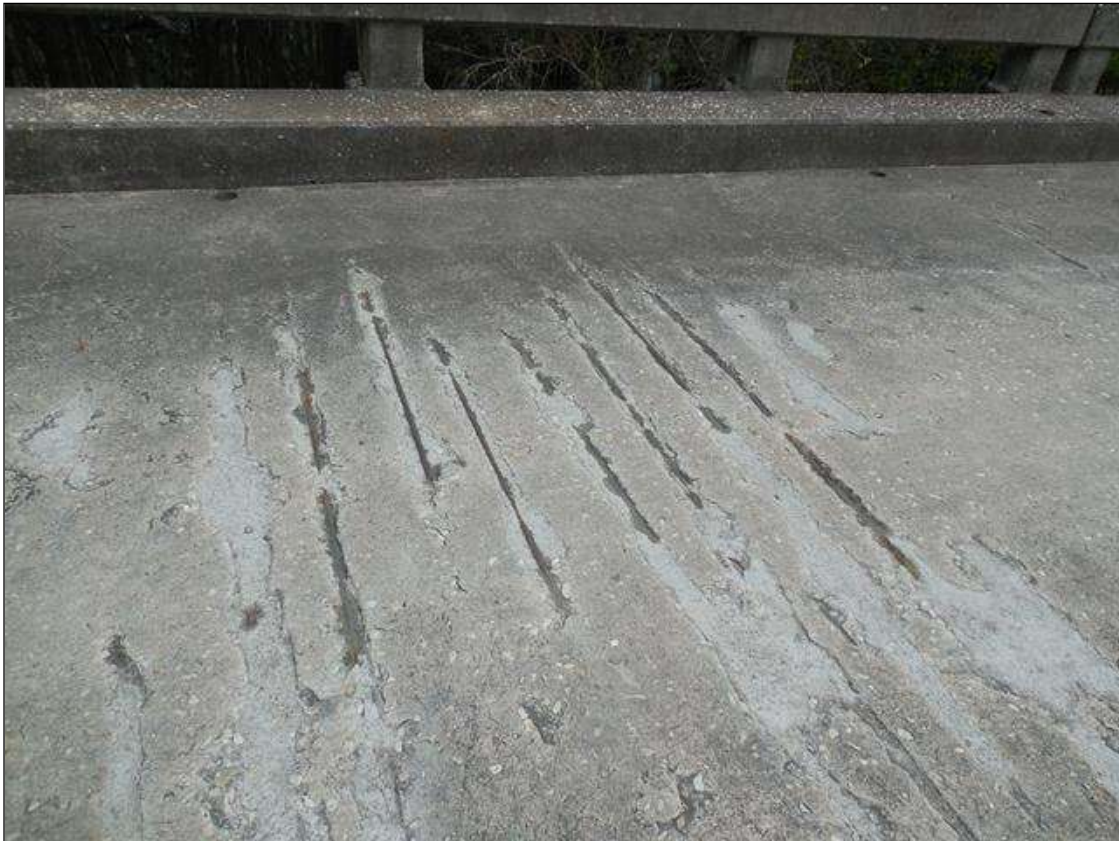
SPAN 3 DECK, SOUTH BOUND LANE HAS 20 SQ. FT. SURFACE SPALL WITH EXPOSED REBAR PM ISSUED

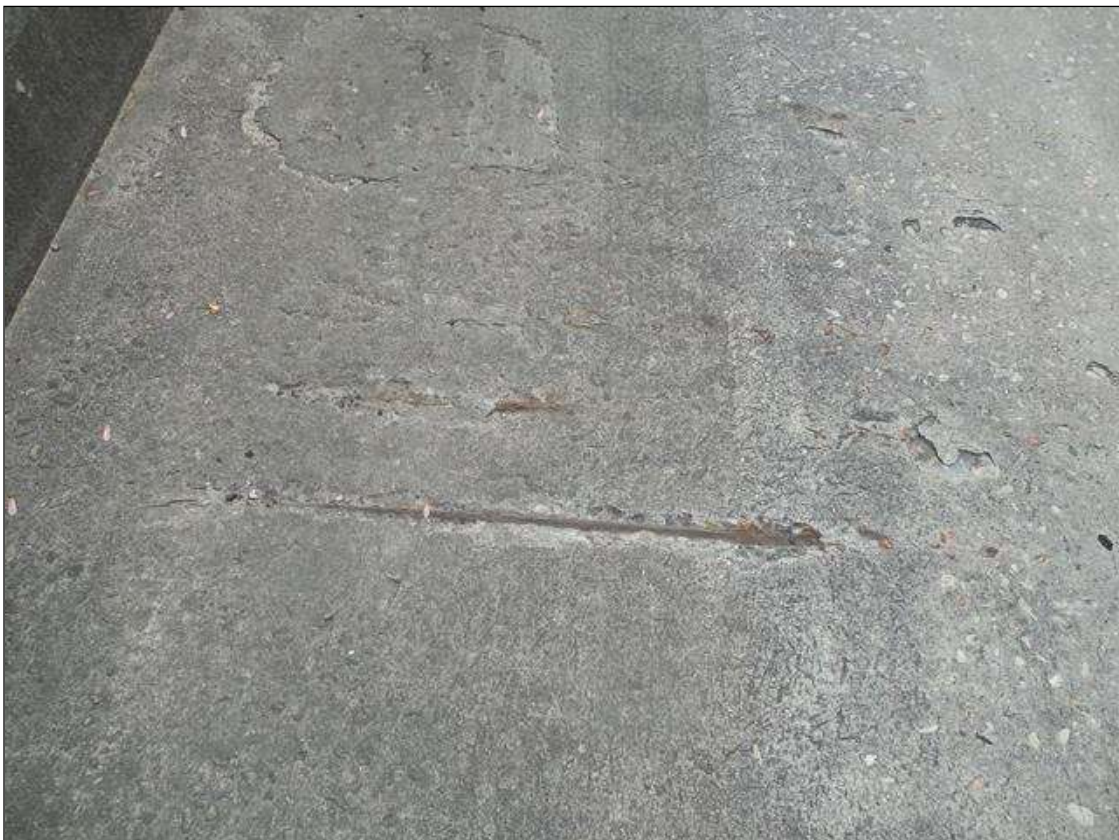
SPAN 3 DECK , SBL HAS 5 SQ. FT. SURFACE SPALL WITH EXPOSED REBAR PM ISSUED

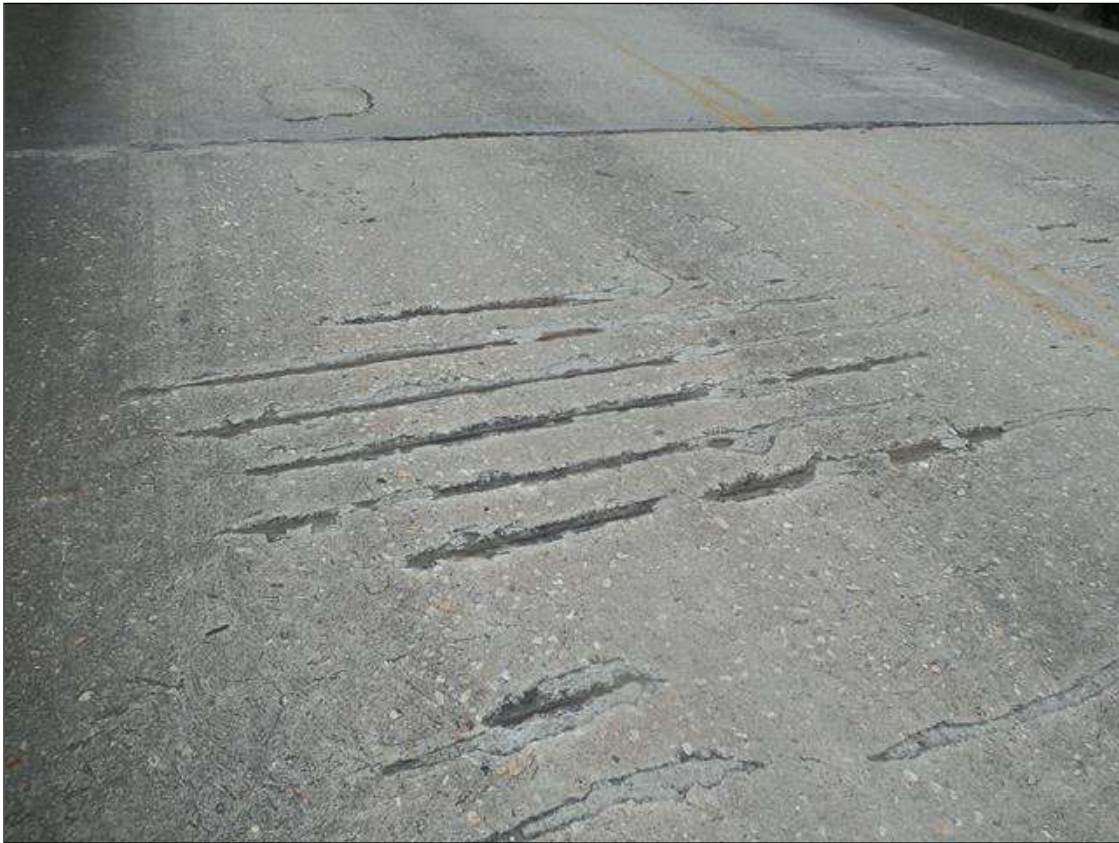
SPAN 4 DECK, SOUTH BOUND LANE HAS 25 SQ. FT. SURFACE SPALL WITH EXPOSED REBAR PM ISSUED

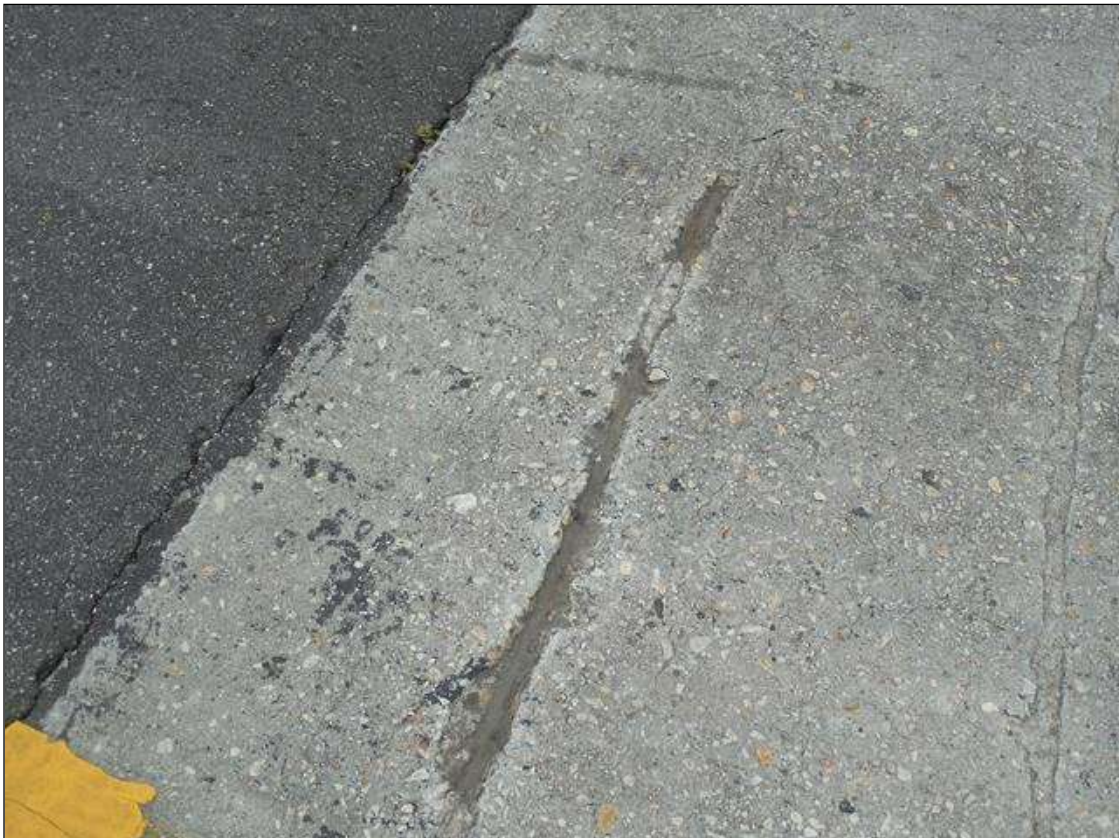
SPAN 6 DECK, NORTH BOUND LANE AT END BENT 2 HAS 3 SQ. FT. SURFACE SPALL WITH EXPOSED REBAR  
PM ISSUED
