NC DEPARTMENT OF TRANSPORTATION  
DIVISION OF HIGHWAYS  
STRUCTURE MANAGEMENT UNIT

## Structure Safety Report

### Routine Element Inspection - Contract

COUNTY: ROBESON STRUCTURE NUMBER: 770149 FREQUENCY: 24 MONTHS  
FACILITY CARRIED: SR1122 MILE POST: \_\_\_\_\_  
LOCATION: 1.0 MI. NE. OF JCT. US501  
FEATURE INTERSECTED: FIRST SWAMP  
LATITUDE: 34° 36' 17.28" LONGITUDE: 79° 19' 7.54"  
SUPERSTRUCTURE: REINFORCED CONCRETE FLOOR ON TIMBER JOISTS  
SUBSTRUCTURE: E.BTS&IBT:TIM.CAPS/TIM.PILES;E.BT1 STL CRUTCH  
SPANS: 2@18'  
☐ FRACTURE CRITICAL ☒ TEMPORARY SHORING ☐ SCOUR CRITICAL ☒ SCOUR PLAN OF ACTION  
PRESENT CONDITION: Fair INSPECTION DATE: 04/13/2016  
POSTED SV: 17 POSTED TTST: 24  
OTHER SIGNS PRESENT: (4) DELINEATORS

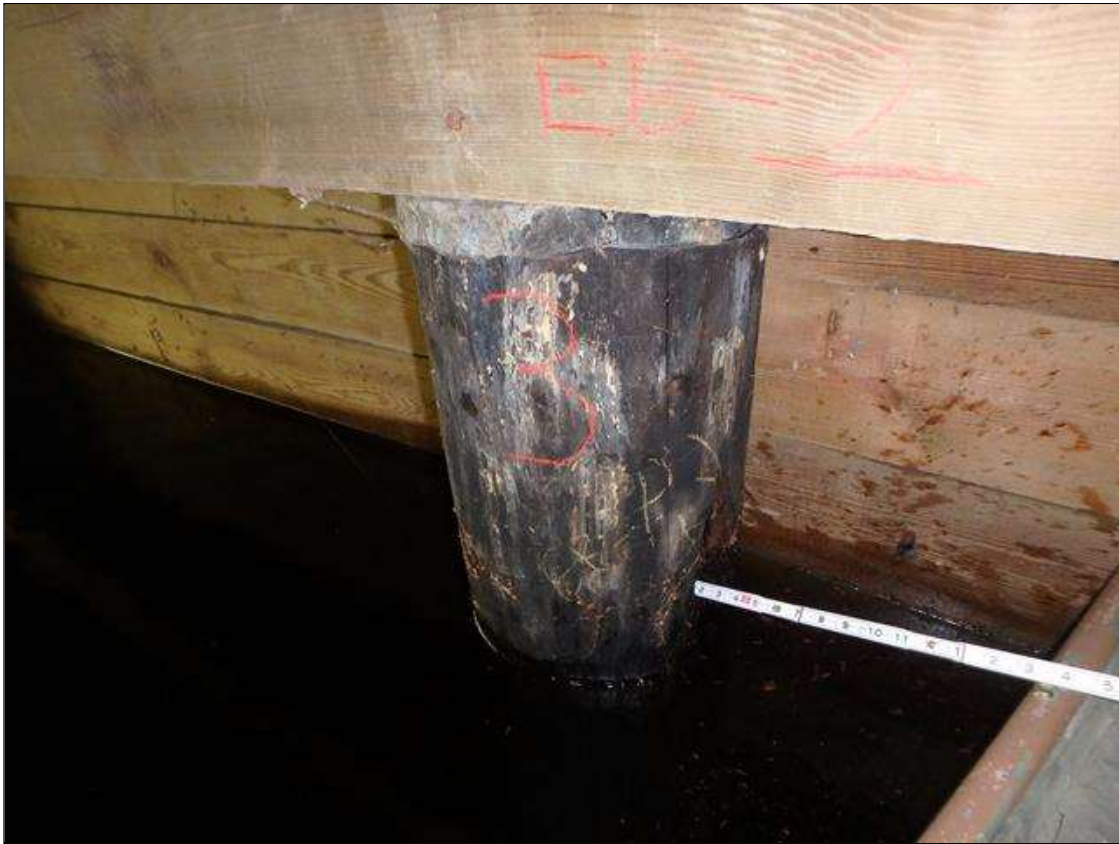
ABUT 2 PILE 3 RT SIDE HAS DECAY 2-1/2IN. DEEP X 5IN. WIDE X 17IN. HIGH. PRIORITY MAINTENANCE  
 1 Each of Decay/Section Loss: Affects 10% or more of the member but does not warrant structural review.

ABUT 2 PILE 3 RT SIDE HAS DECAY 2-1/2IN. DEEP X 5IN. WIDE X 17IN. HIGH. PRIORITY MAINTENANCE

| MMS Code | Description of Function | Unit | Quantity | Remarks | Est. Cost |
|---|---|---|---|---|---|
| 3344 | Repair / Replace Timber Substructure Components | LF | 2 | BRIDGE POSTED SV 17T TTST 24T<br>ABUT 2 PILE 3 RT SIDE HAS DECAY 2-1/2IN. DEEP X 5IN. WIDE X 17IN. HIGH.<br><br>BRIDGE IS POSTED SV 17T TTST 24T | |

| MMS Code | MMS Description | Quantity |
|---|---|---|
| ABUT 2 PILE 3 RT SIDE HAS DECAY 2-1/2IN. DEEP X 5IN. WIDE X 17IN. HIGH.<br><br>BRIDGE IS POSTED SV 17T TTST 24T | | |

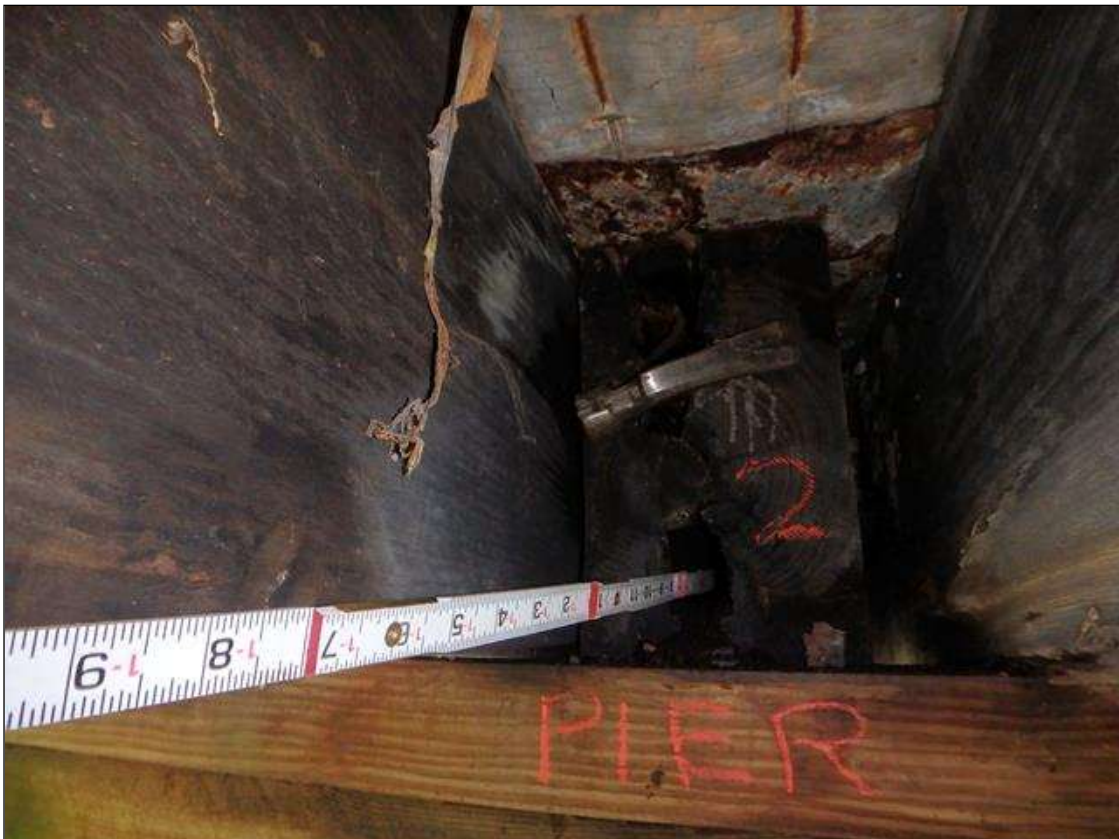
SPAN 2 END OF JOIST 2 AT INT. BENT, VERTICAL C/L SPLIT & DECAY FULL HEIGHT X 2IN. WIDE X 19IN. LONG AT TOP, 9IN. LONG AT BOTTOM. PRIORITY MAINTENANCE

2 Feet of Decay/Section Loss: The condition warrants a structural review to determine the effect on strength or serviceability of the element or bridge; OR a structural review has been completed and the defects impact strength or serviceability of the element or bridge.

| MMS Code | Description of Function | Unit | Quantity | Remarks | Est. Cost |
|---|---|---|---|---|---|
| 3304 | Maintain/Replace Timber Superstructure Components | LF | 2 | SPAN 2 END OF JOIST 2 AT INT. BENT, VERTICAL C/L SPLIT & DECAY FULL HEIGHT X 2IN. WIDE X 19IN. LONG AT TOP, 9IN. LONG AT BOTTOM. | |

| MMS Code | MMS Description | Quantity |
|---|---|---|
| SPAN 2 END OF JOIST 2 AT INT. BENT, VERTICAL C/L SPLIT & DECAY FULL HEIGHT X 2IN. WIDE X 19IN. LONG AT TOP, 9IN. LONG AT BOTTOM.<br><br>BRIDGE POSTED SV 17T TTST 24T | | |

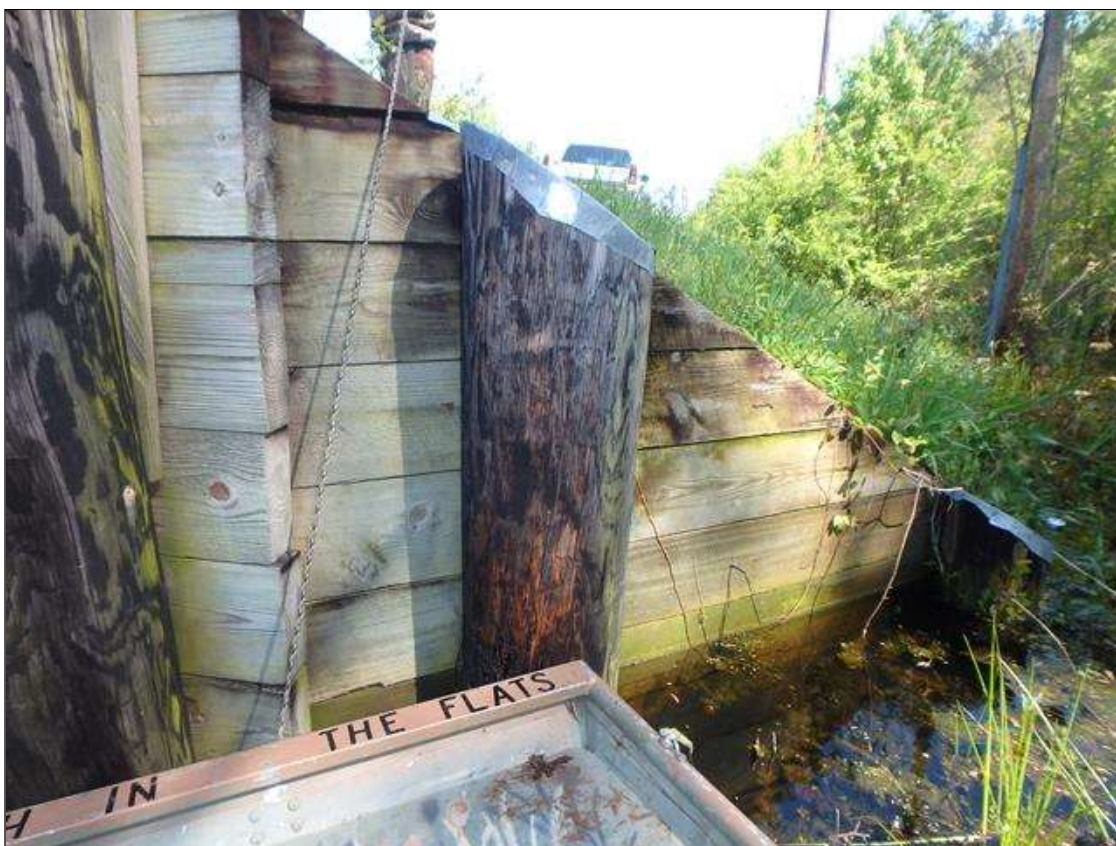
SEVERAL BULKHEAD BOARDS REPLACED AT BOTH ENDS OF ABUTMENT 2. REMAINING BULKHEAD BOARDS ARE 1/8IN. SOFT.

NORTHEAST CORNER WINGWALL BULKHEAD BOARDS REPLACED AND NEW SOLDIER PILE, REPAIR TO BULKHEAD BOARDS TO RT. END OF ABUTMENT 2.

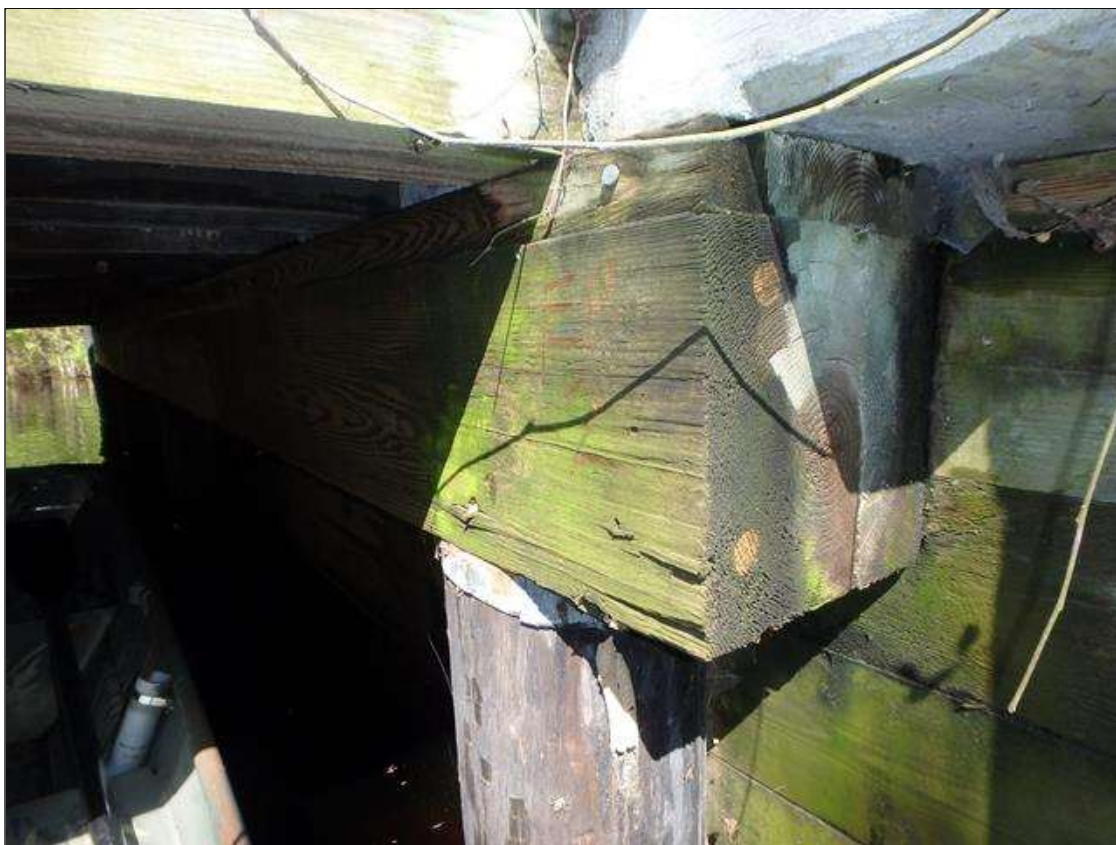
ABUTMENT 2 CAP RT. END 1/4IN. DEEP CHECK FULL HEIGHT

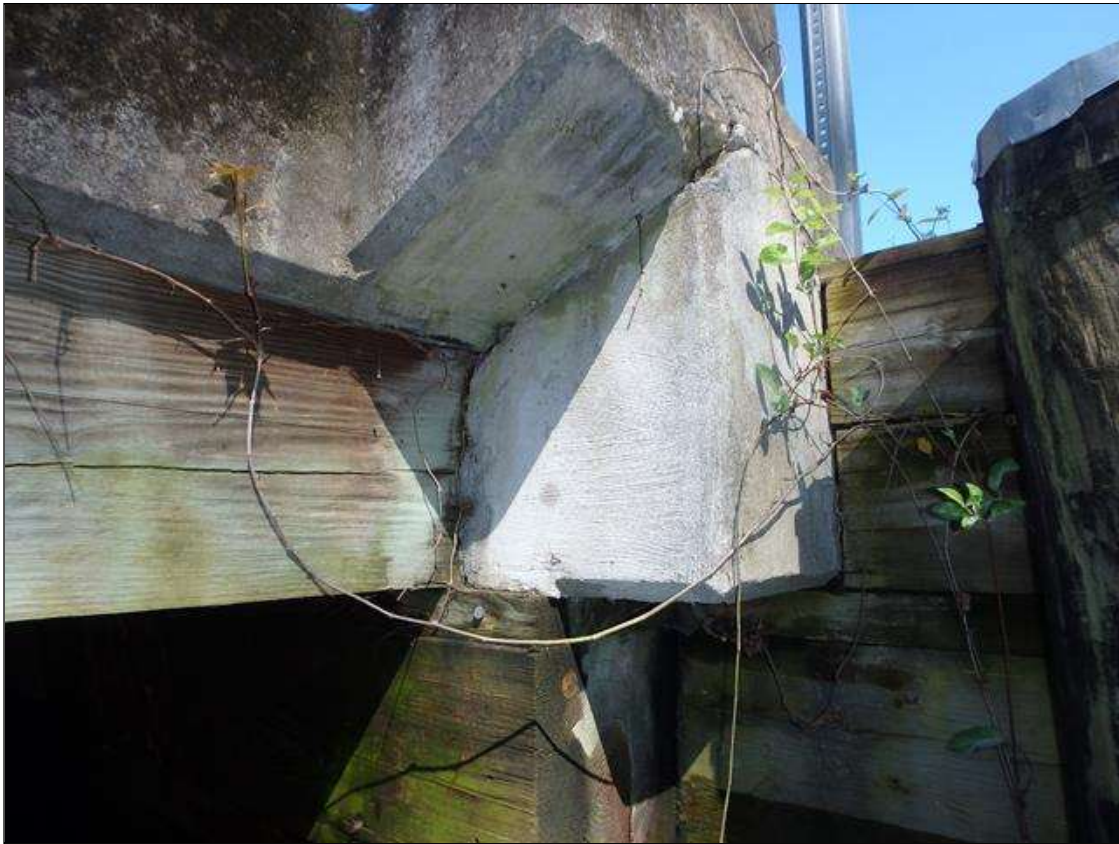
REPAIR TO CONCRETE CURTAIN WALL AT ABUTMENT 2 RT. END W/ 1/8IN. CRACK AT COLD JOINT.  
 2 Square Feet of Patched Areas: Patched area that is unsound or showing distress. Does not warrant structural review.  
 RC DECK PATCH 4FT. L X 10IN. WIDE, WITH FORM IN PLACE, ON UNDERSIDE SPAN 2 BAY 16, BAYS 3 & 5 AT ABUTMENT 2 SIMILAR.  
 12 Square Feet of Patched Areas: Patched area that is sound

REPAIR TO CONCRETE CURTAIN WALL AT ABUTMENT 2 RT. END W/ 1/8IN. CRACK AT COLD JOINT.

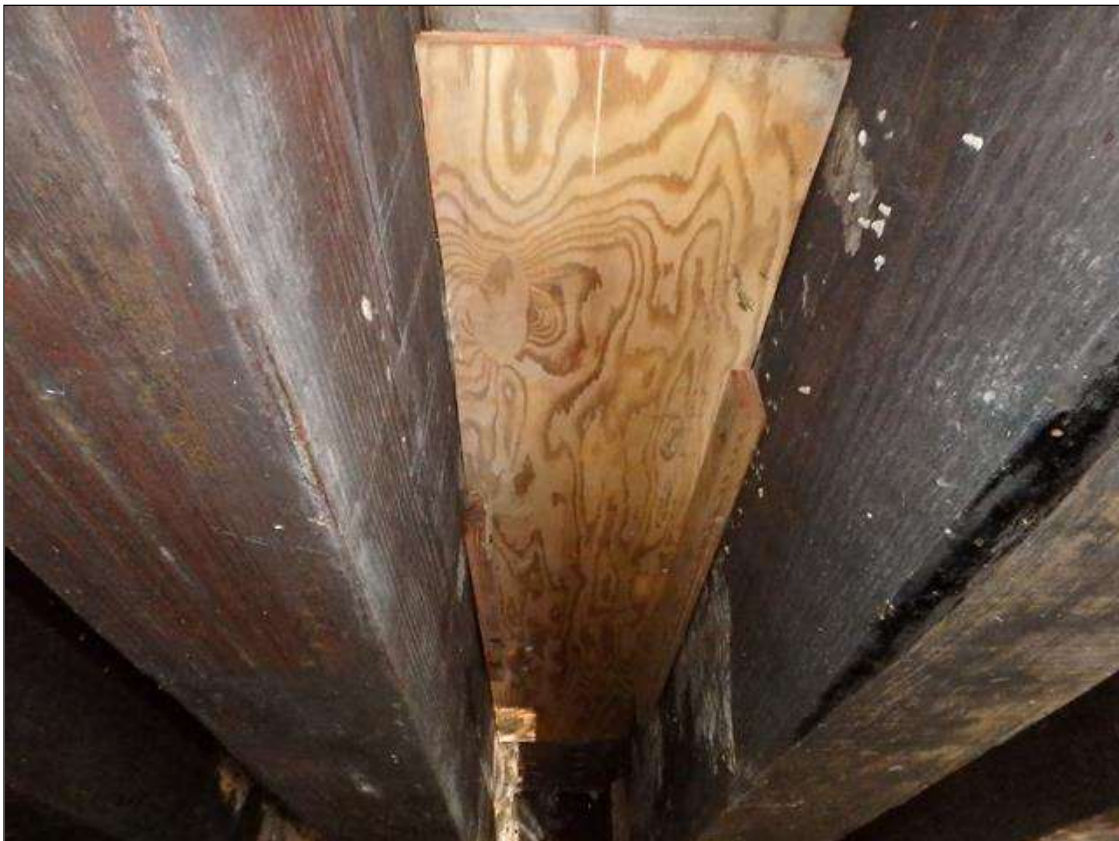
RC DECK PATCH 4FT. L X 10IN. WIDE, WITH FORM IN PLACE, ON UNDERSIDE SPAN 2 BAY 16, BAYS 3 & 5 AT ABUTMENT 2 SIMILAR.

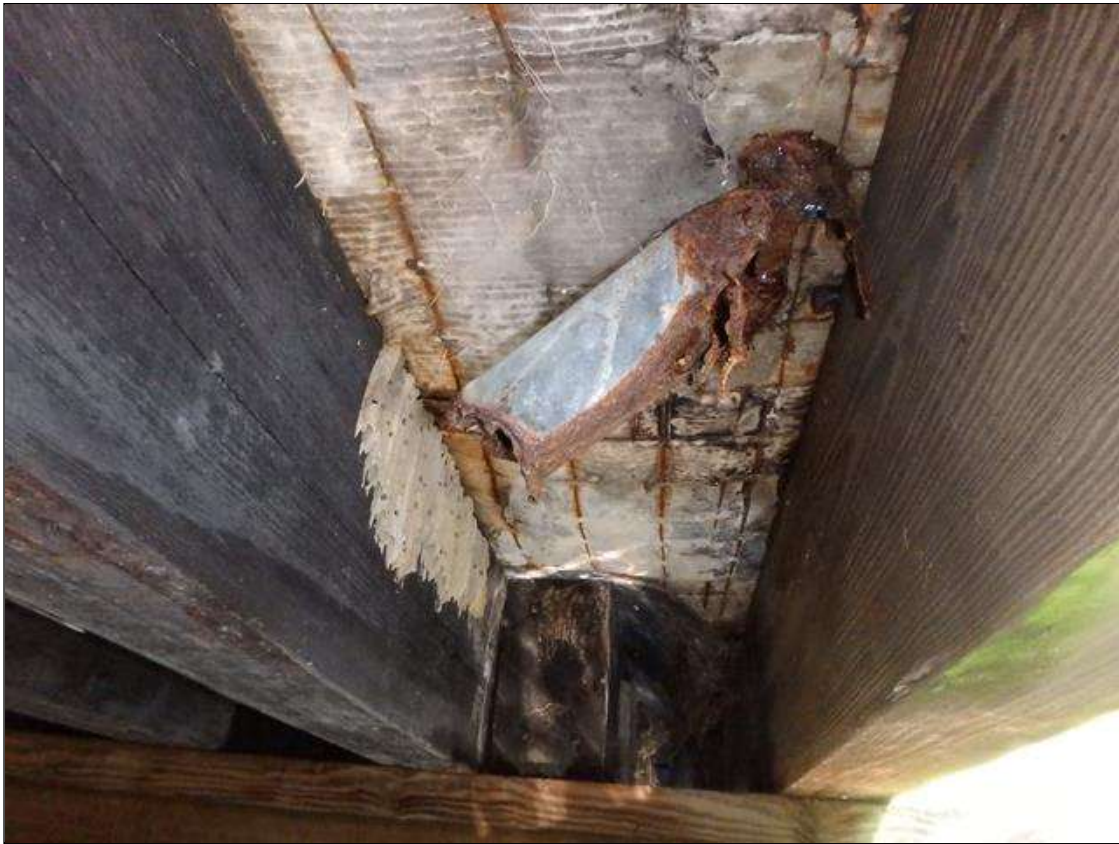
| <b>Details</b> | ALL STEEL DECK DRAIN PIPE EXTENSIONS UNDER DECK HAVE COMPLETE SECTION LOSS OR ARE BROKEN. | | | | | | |

STEEL DECK DRAIN PIPE EXTENSION UNDER DECK IN SPAN 1 COMPLETE SECTION LOSS, ALL SIMILAR OR BROKEN

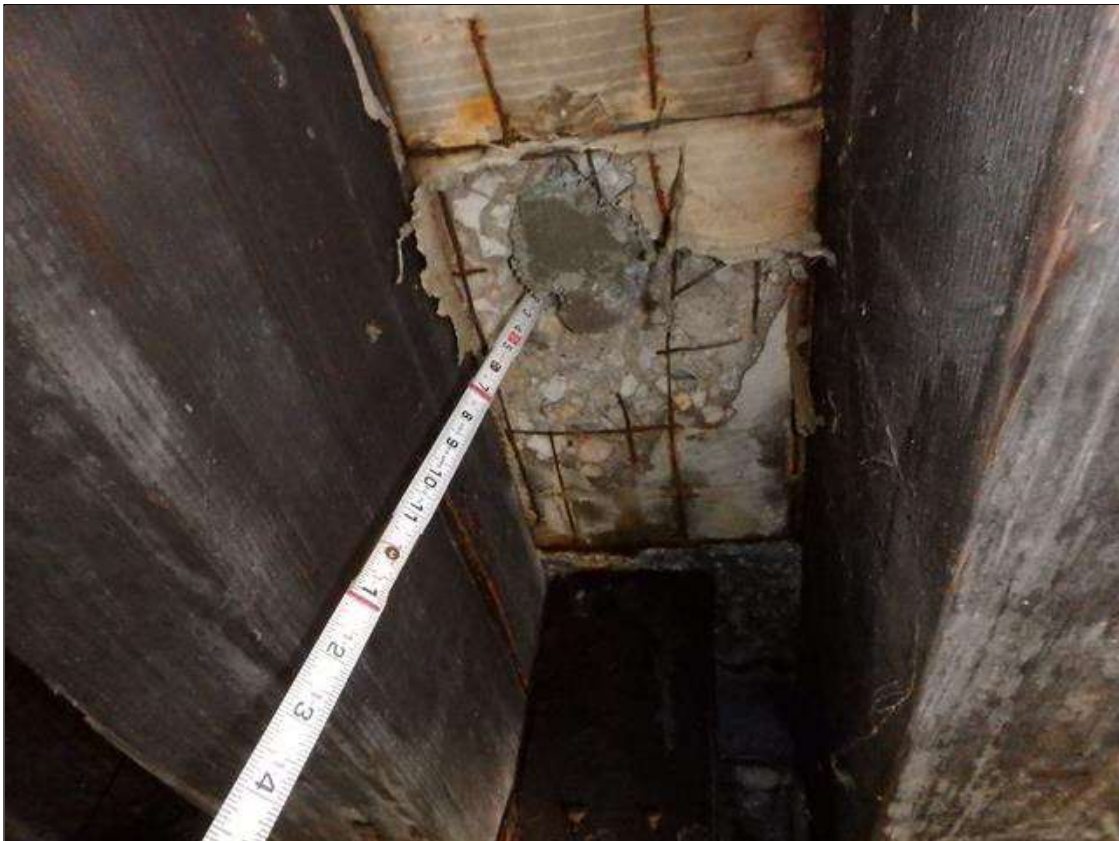
RC DECK HAS PATCH TO UNDERSIDE W/ SPALL 10IN. W X 2IN. D X 8IN. LONG, SPAN 1 BAY 18 NEAR BENT 1  
 1 Square Feet of Patched Areas: Patched area that is unsound or showing distress. Does not warrant structural review  
 RC DECK CONCRETE PATCHES ABOVE END BENT 1 CRUTCH PILES  
 8 Square Feet of Patched Areas: Patched area that is sound

RC DECK HAS PATCH TO UNDERSIDE W/ SPALL 10IN. W X 2IN. D X 8IN. LONG, SPAN 1 BAY 18 NEAR BENT 1

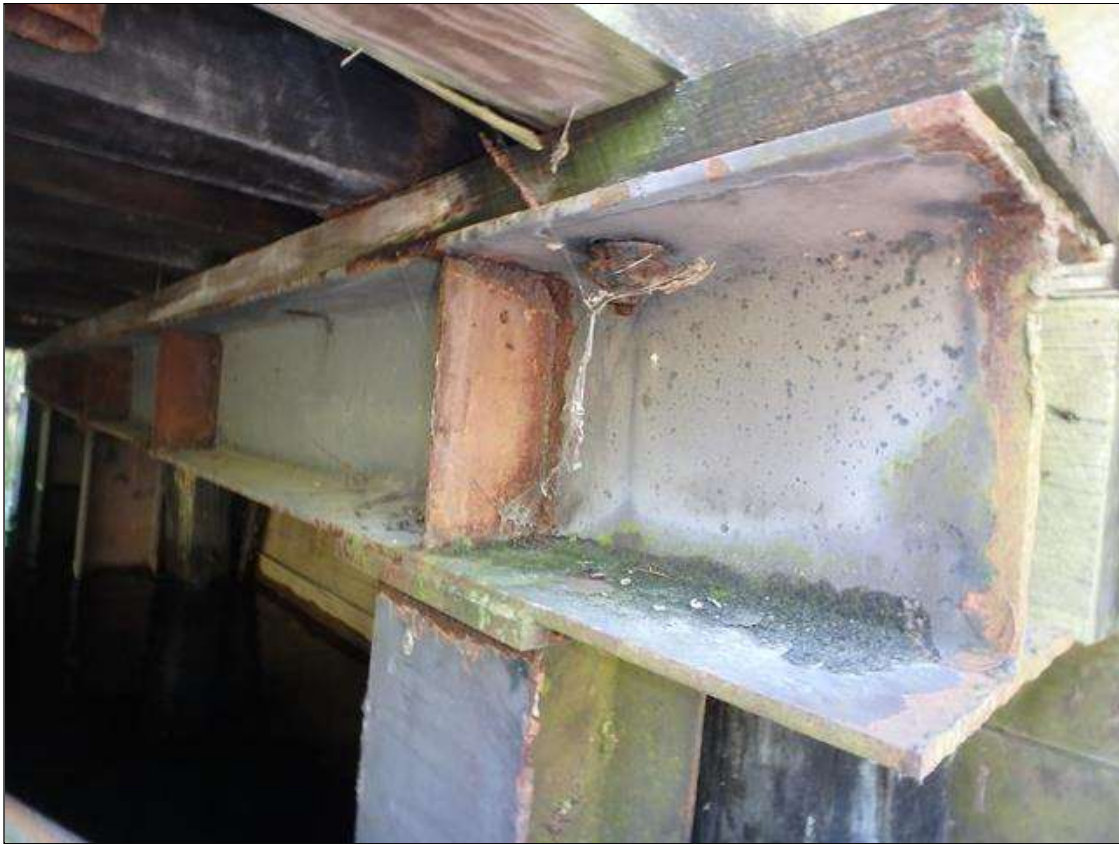
END BENT 1 SHORED: STEEL CRUTCH BENT REPLACED TIMBER END BENT.  
STEEL CRUTCH CAP MISSING WELD IN WEB SPLICE LEFT OF STEEL PILE 3  
STEEL END BENT 1 CRUTCH CAP HAS SURFACE RUST WHERE PAINT MISSING ON EDGES OF WEB AND FLANGES, AT BEARING PLATES, AND SPLICE PLATES. REMAINING PAINT DULL WITH PIGMENT LOSS THROUGHOUT AND SPOTS PEELING EXPOSING PRIMER COAT.

27 Feet of Corrosion: Freckled Rust. Corrosion of the steel has initiated.  
27 Square Feet of Effectiveness (Steel Protective Coatings): Failed; no protection of the underlying metal.  
10 Square Feet of Peeling/Bubbling/Cracking (steel Protective Coatings): Finish and primer coats.  
118 Square Feet of Chalking (Steel Protective Coatings): Loss of pigment.

STEEL END BENT 1 CRUTCH CAP AND PILES HAVE SURFACE RUST WHERE PAINT MISSING ON EDGES OF WEB AND FLANGES, AT BEARING PLATES, AND SPLICE PLATES. REMAINING PAINT DULL WITH PIGMENT LOSS THROUGHOUT.

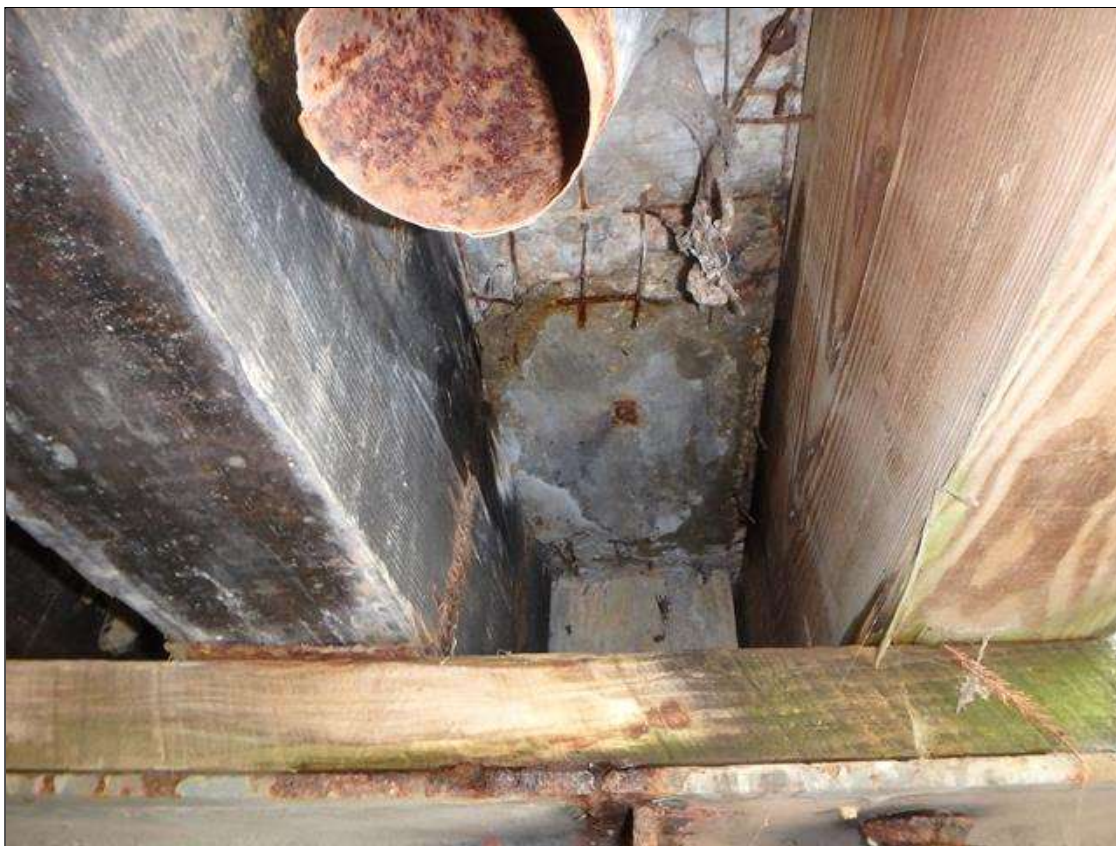
SPAN 1 RC DECK CONCRETE PATCHES ABOVE END BENT 1 CRUTCH PILES

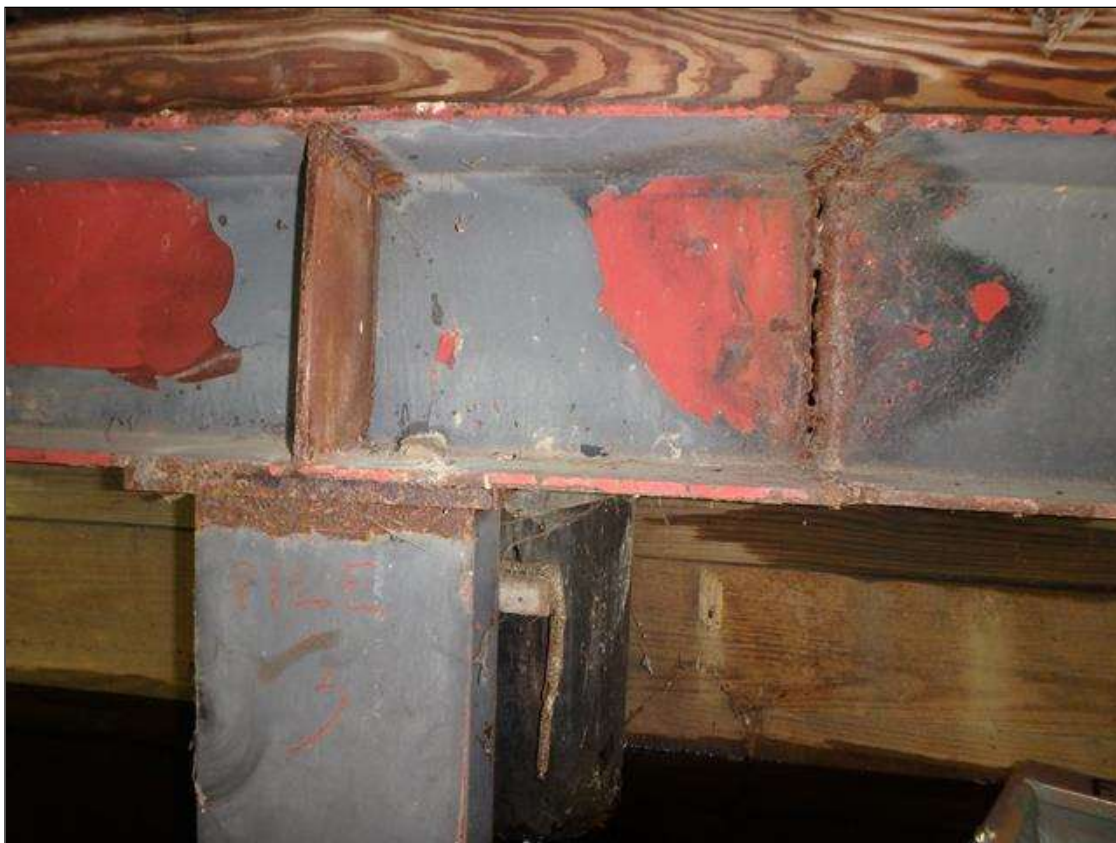
END BENT 1 STEEL CRUTCH CAP SPLICE LEFT OF STEEL PILE 3 MISSING WELD IN WEB

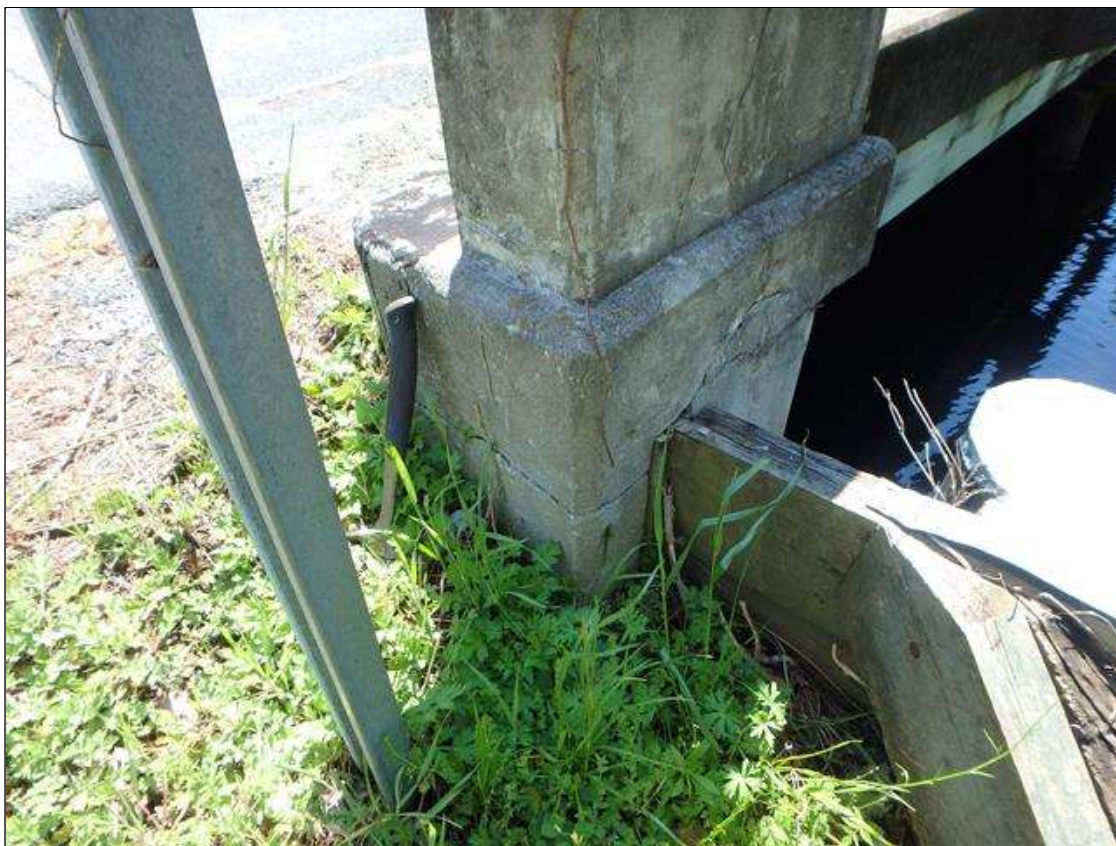
LEFT CONC. RAIL END POST AT ABUTMENT 2 HAS 1/4IN. HORIZONTAL CRACK FULL CIRCUMFERENCE  
 2 Feet of Cracking (RC and Other): Wide cracks or heavy pattern (map) cracking.

LEFT CONC. RAIL END POST AT ABUTMENT 2 HAS 1/4IN. HORIZONTAL CRACK FULL CIRCUMFERENCE

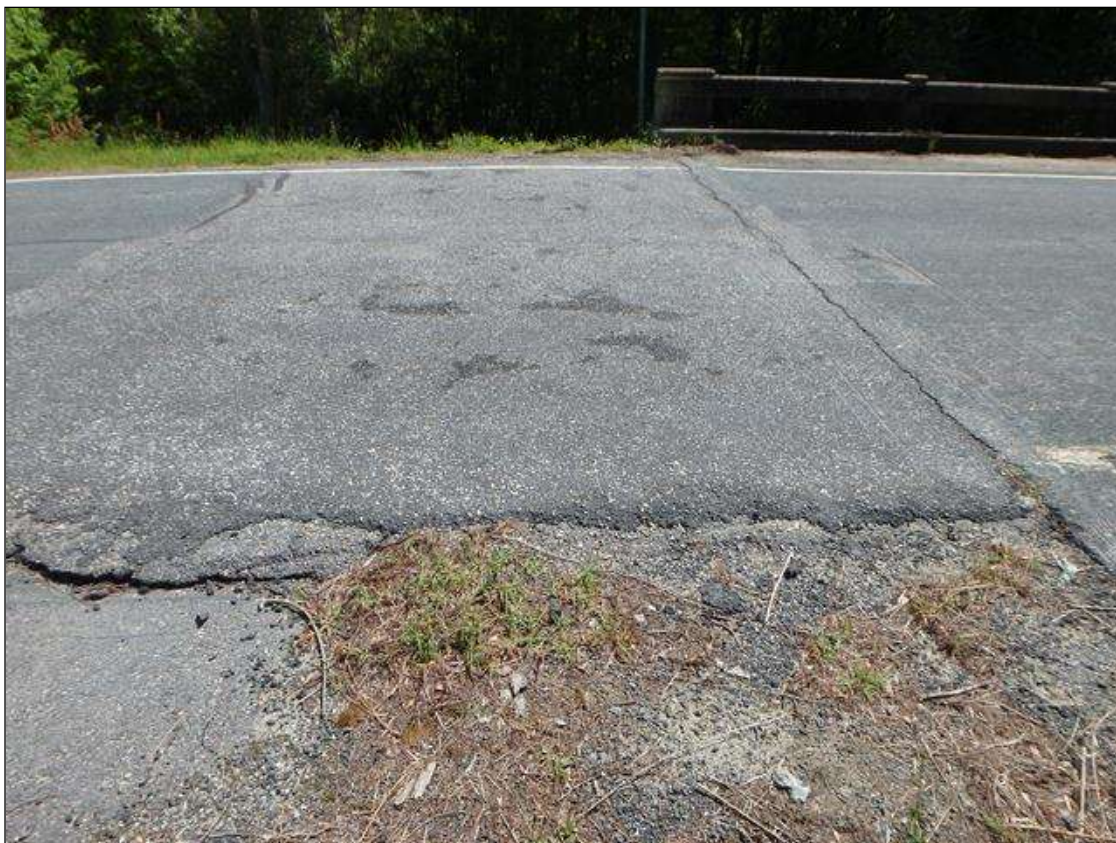
NORTH APPROACH ROADWAY AT BRIDGE REPAVED

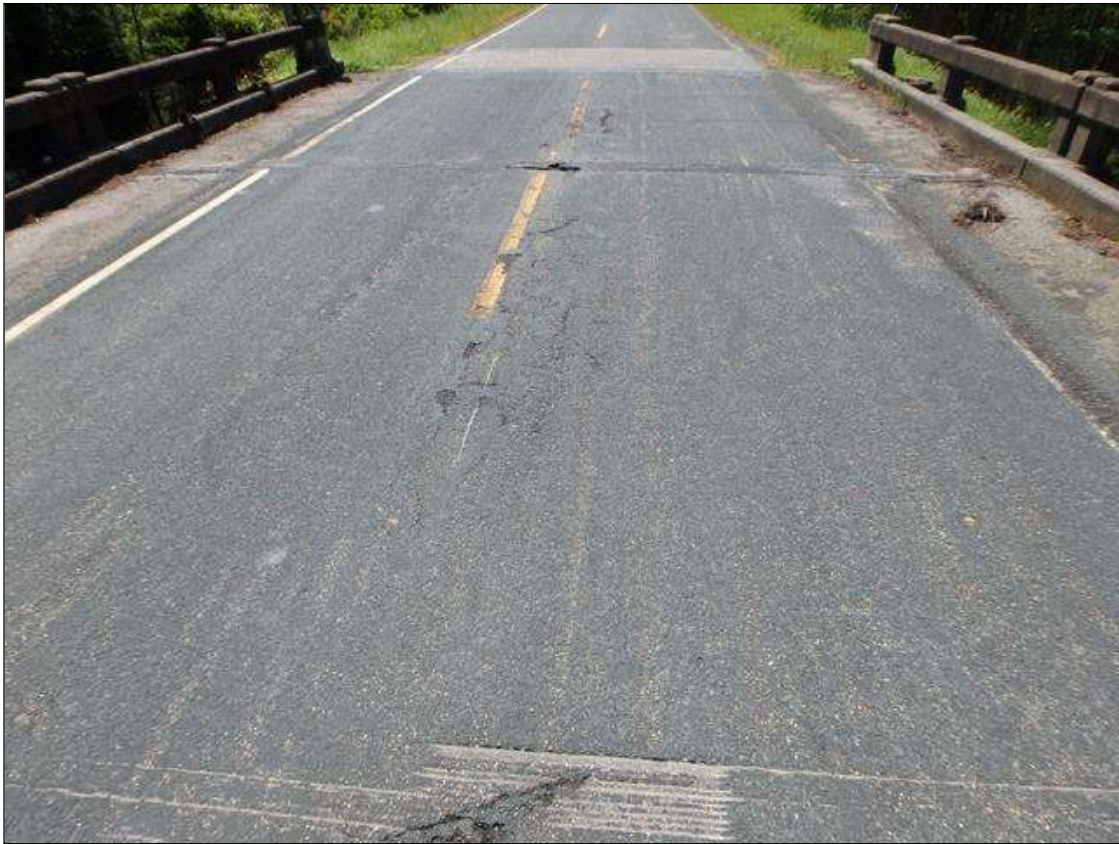
SPAN 2 AWS RAVELING ALONG C/L AND ABOVE BENT WITH MATERIAL MISSING 2IN. D X 2FT. W X 8IN. LONG.  
 2 Square Feet of Delamination/Spall/Patched Area/Pothole (Wearing Surfaces): Spall 1 in. deep or greater or 6 in. diameter or greater. Patched area that is unsound or showing distress. Full depth pothole.  
 18 Square Feet of Delamination/Spall/Patched Area/Pothole (Wearing Surfaces): Delaminated. Spall less than 1 in. deep or less than 6 in. diameter. Patched area that is sound. Partial depth pothole.

SPAN 2 AWS RAVELING ALONG C/L AND ABOVE BENT WITH MATERIAL MISSING 2IN. D X 2FT. W X 8IN. LONG.

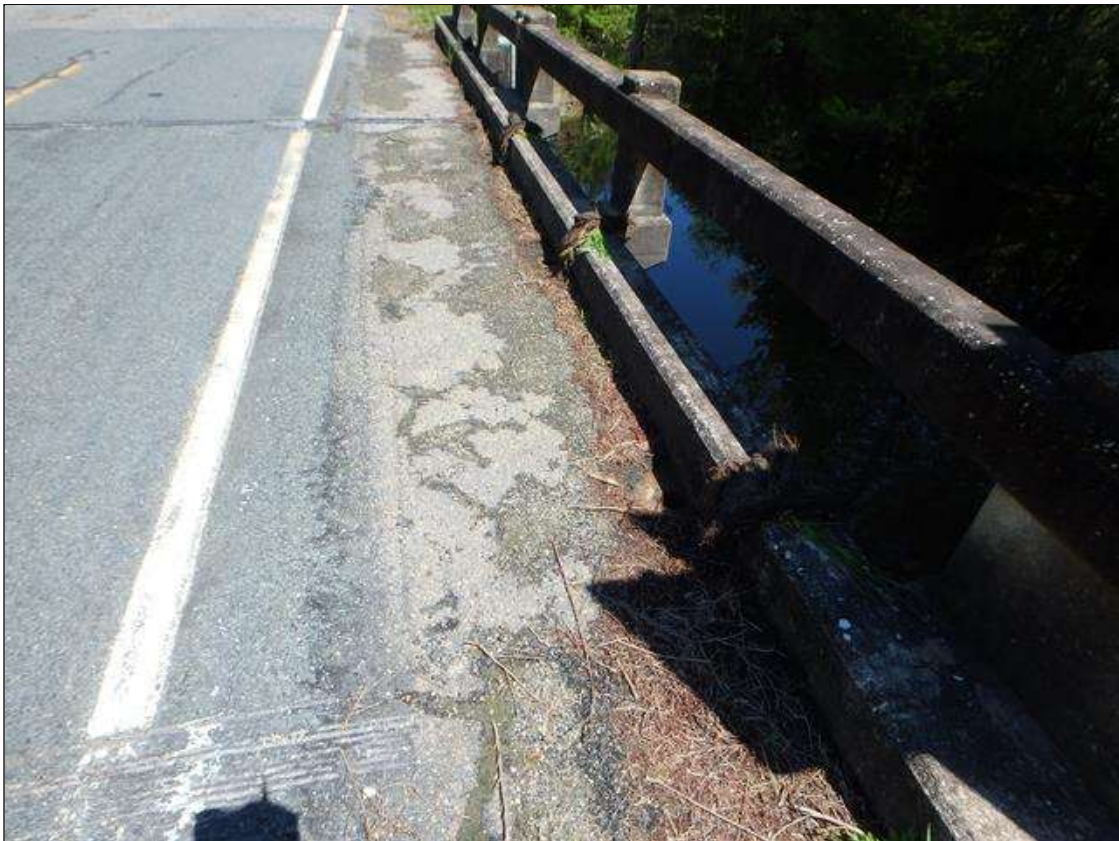
DECK DEBRIS ALONG RT. GUTTERLINE BLOCKING DRAIN HOLES 8IN. W X 2IN. H X BRIDGE LENGTH. LT. SIDE SIMILAR.

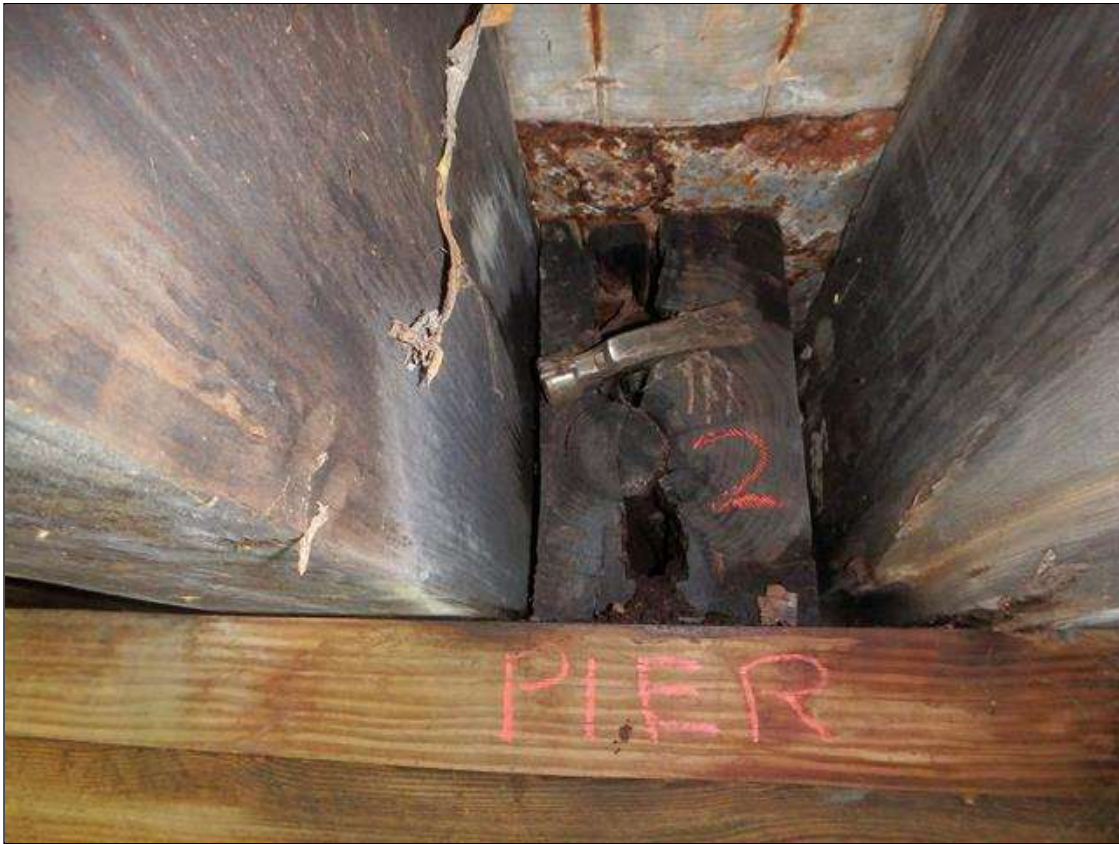
SPAN 2 END OF JOIST 2 AT INT. BENT, VERTICAL C/L SPLIT & DECAY FULL HEIGHT X 2IN. WIDE X 19IN. LONG AT TOP, 9IN. LONG AT BOTTOM. PRIORITY MAINTENANCE

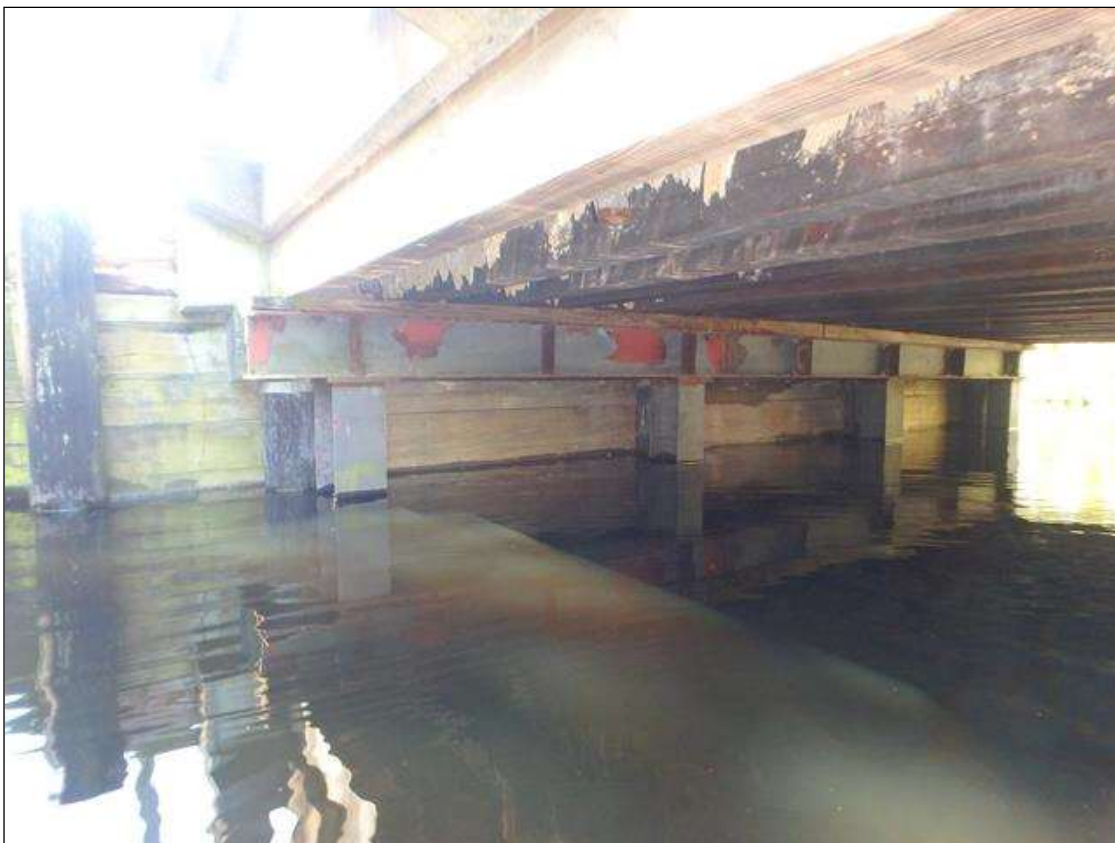
END BENT 1 SHORED: STEEL CRUTCH BENT REPLACED TIMBER END BENT.

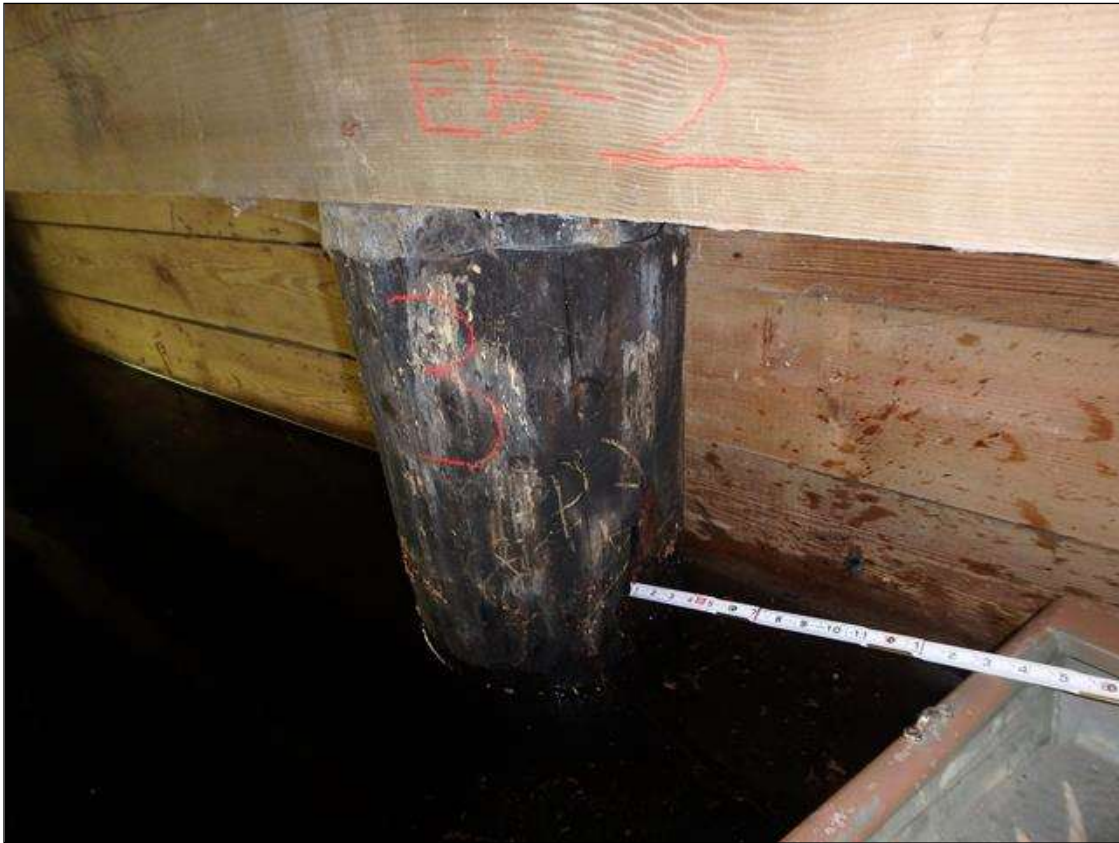
ABUT 2 PILE 3 RT SIDE HAS DECAY 2-1/2IN. DEEP X 5IN. WIDE X 17IN. HIGH. PRIORITY MAINTENANCE

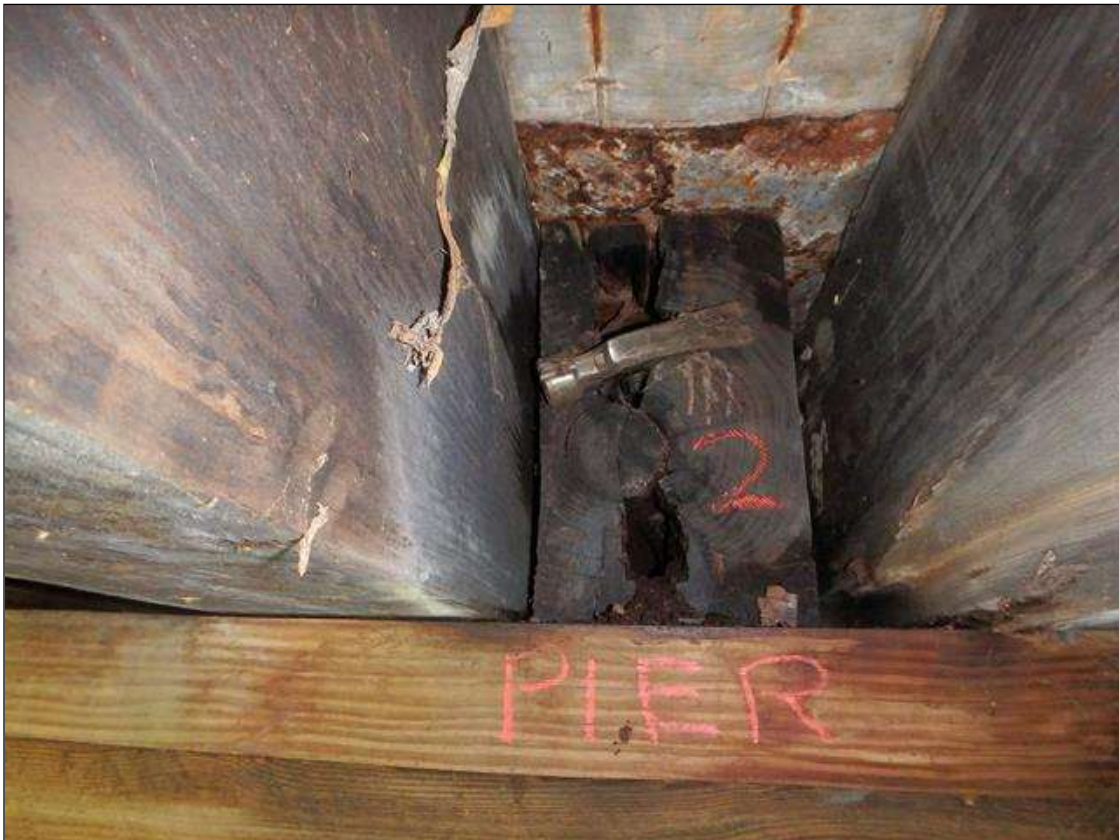
SPAN 2 END OF JOIST 2 AT INT. BENT, VERTICAL C/L SPLIT & DECAY FULL HEIGHT X 2IN. WIDE X 19IN. LONG AT TOP, 9IN. LONG AT BOTTOM. PRIORITY MAINTENANCE

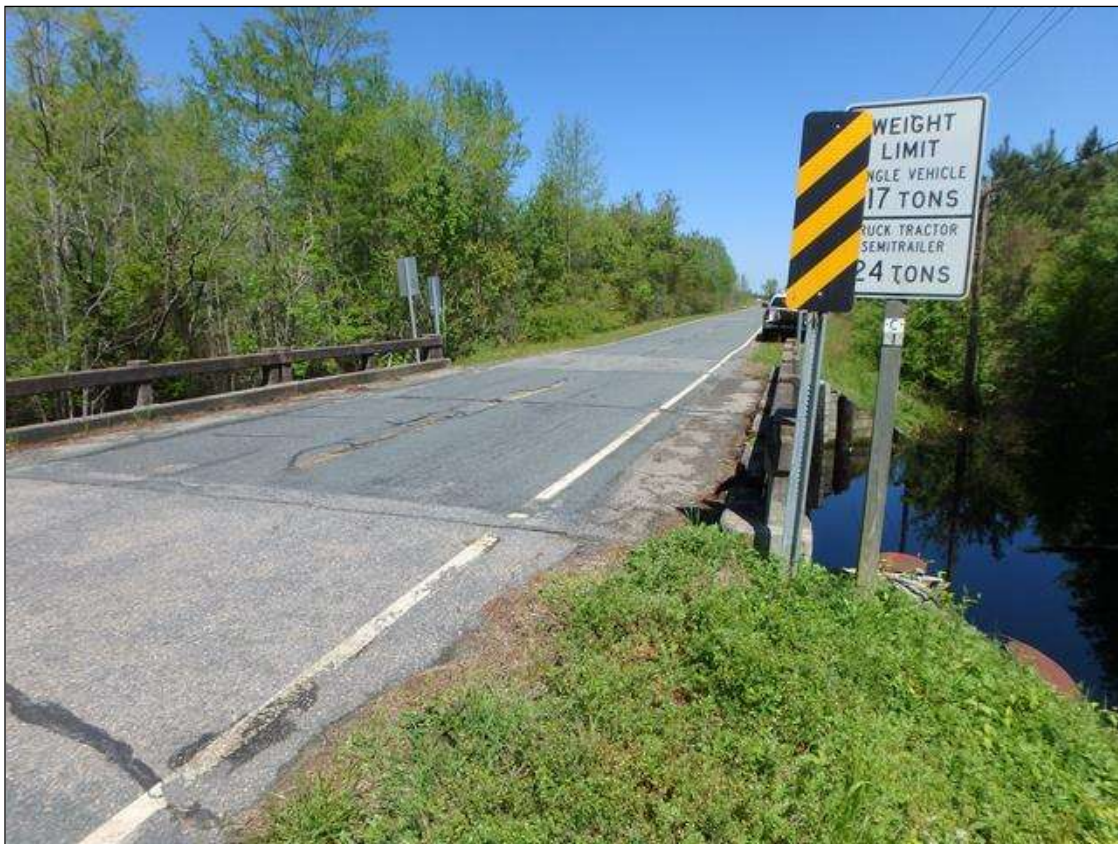
PRESENT POSTING SV 17T TTST 24T
