NC DEPARTMENT OF TRANSPORTATION

# Structure Safety Report

## 2 Year Complete Topside and Underwater Element Inspection

COUNTY: ROBESON STRUCTURE NUMBER: 770228 FREQUENCY: 24 MONTHSFACILITY CARRIED: SR1513 MILE POST: LOCATION: 0.6 MI. SW OF JCT. SR1318FEATURE INTERSECTED: BURNT SWAMPLATITUDE: 34° 43' 29.74" LONGITUDE: 79° 8' 33.3"SUPERSTRUCTURE: RC FLOOR ON TIMBER JOIST,BMD-10SUBSTRUCTURE: E.BTS&INT.BTS:TIMBER CAPS/TIMBER PILES@VAR. CTS.SPANS: 1@17.75'; 1@17'; 1@17.75'☐ FRACTURE CRITICAL ☒ TEMPORARY SHORING ☐ SCOUR CRITICAL ☐ SCOUR PLAN OF ACTIONPRESENT CONDITION: Fair INSPECTION DATE: 12/09/2015POSTED SV: 20 POSTED TTST: 29OTHER SIGNS PRESENT:

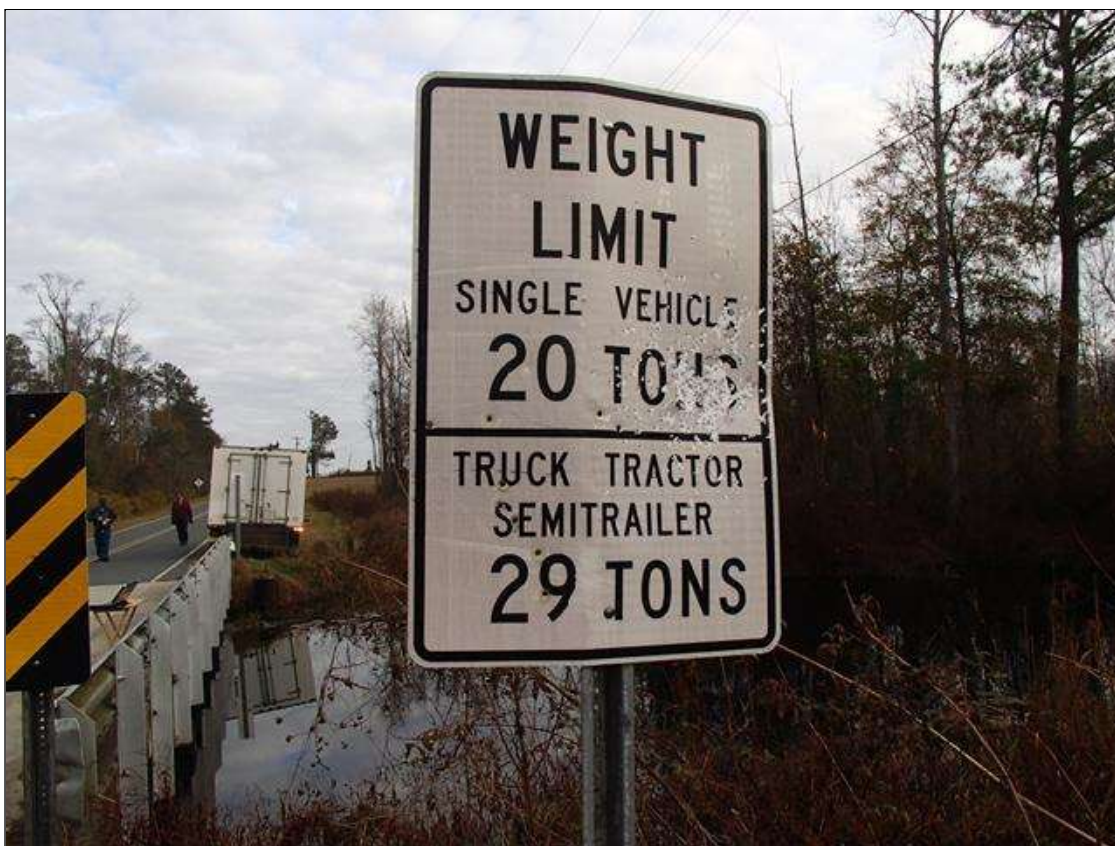
SE POSTING SIGN DEFACED

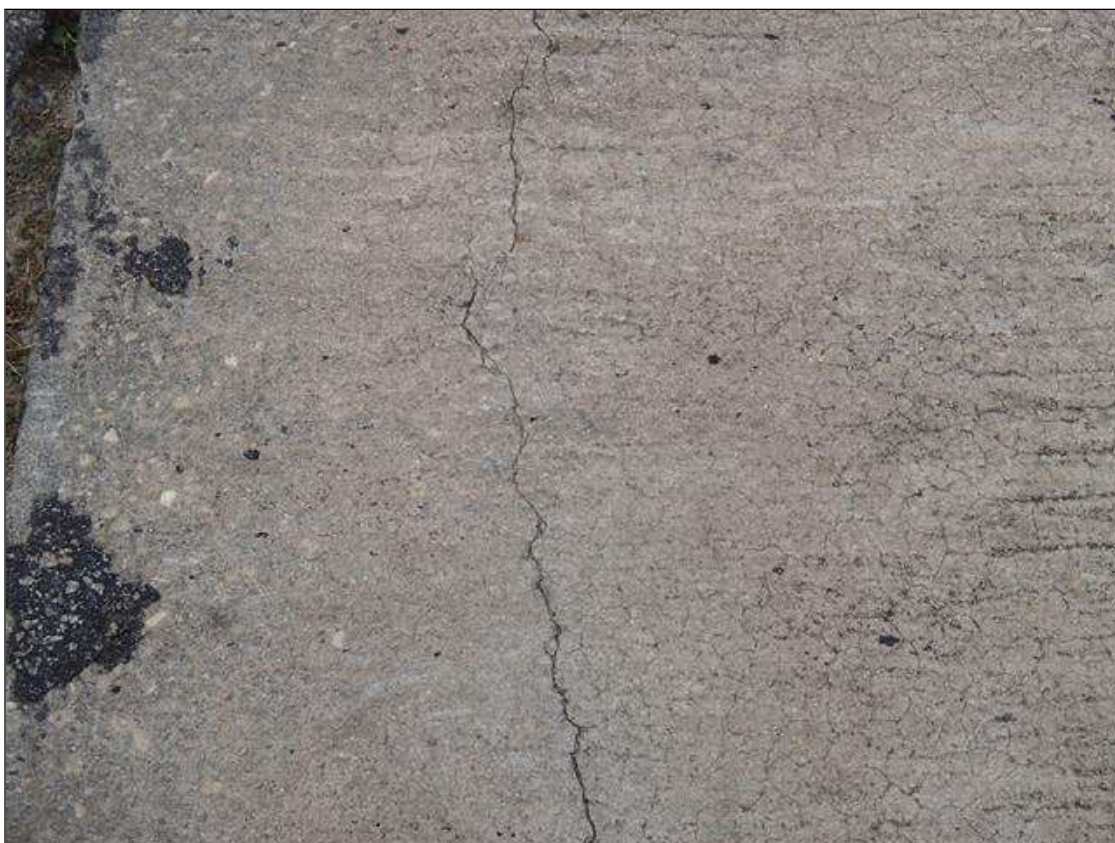
TRANSVERSE CRACK TO 1/8", +/-1' FROM JOINT X FULL WIDTH  
LONGITUDINAL CRACK TO 1/16" NEAR C/L X FULL LENGTH  
H/L MAP CRACKING THROUGHOUT

SPAN 1, TRANVERSE CRACK TO 1/8"

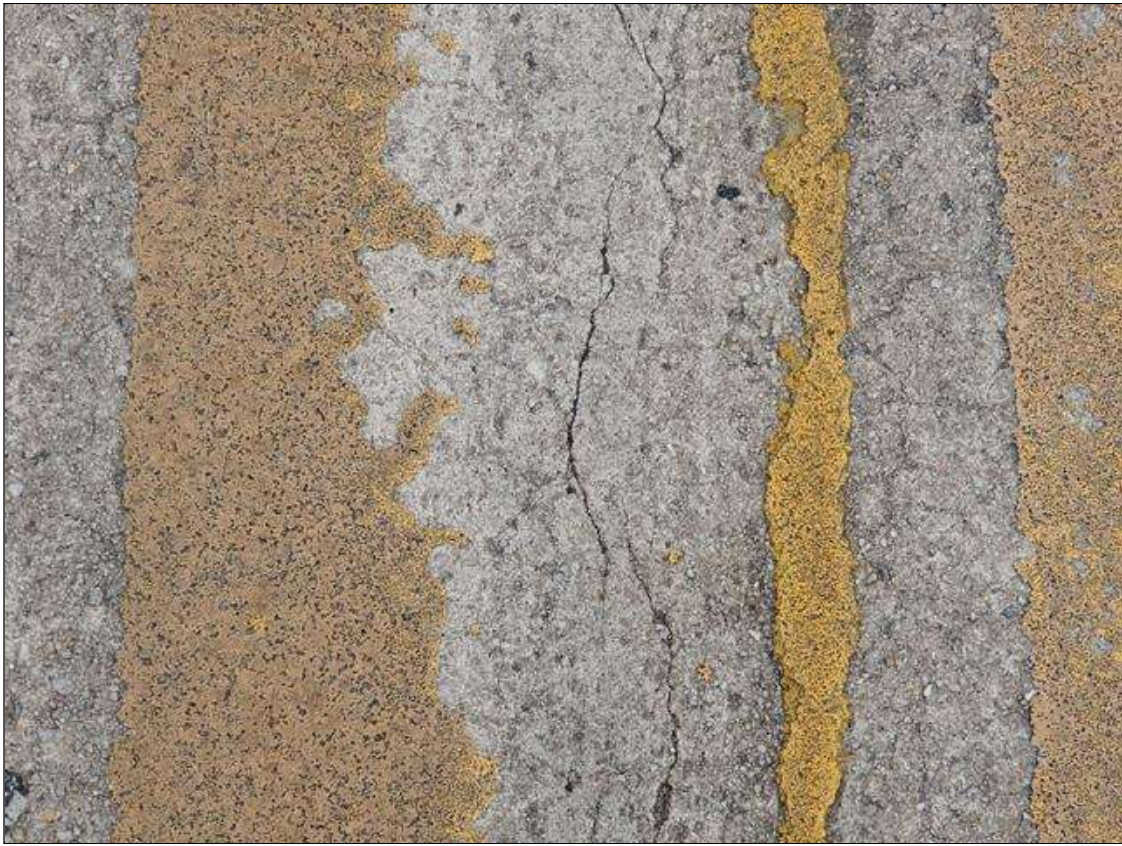
SPAN 1, LONGITUDINAL CRACK TO 1/16"

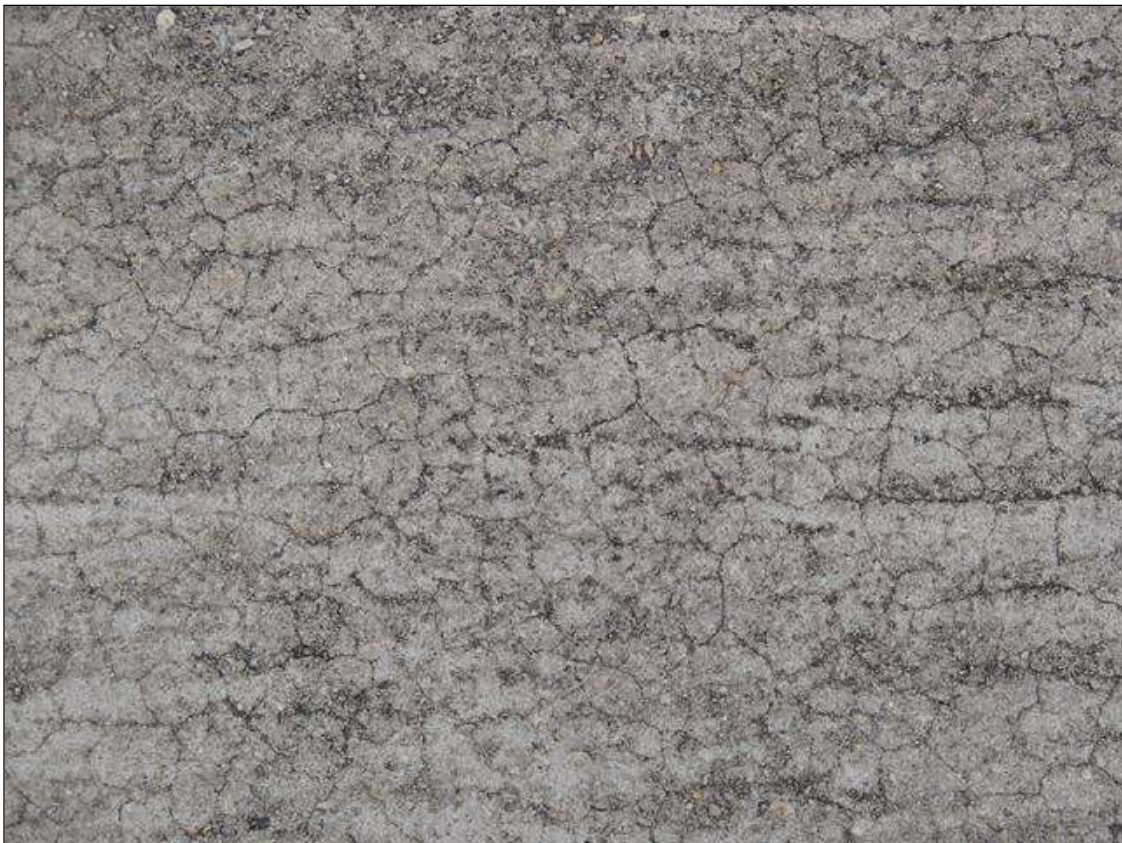
SPAN 1, H/L MAP CRACKING

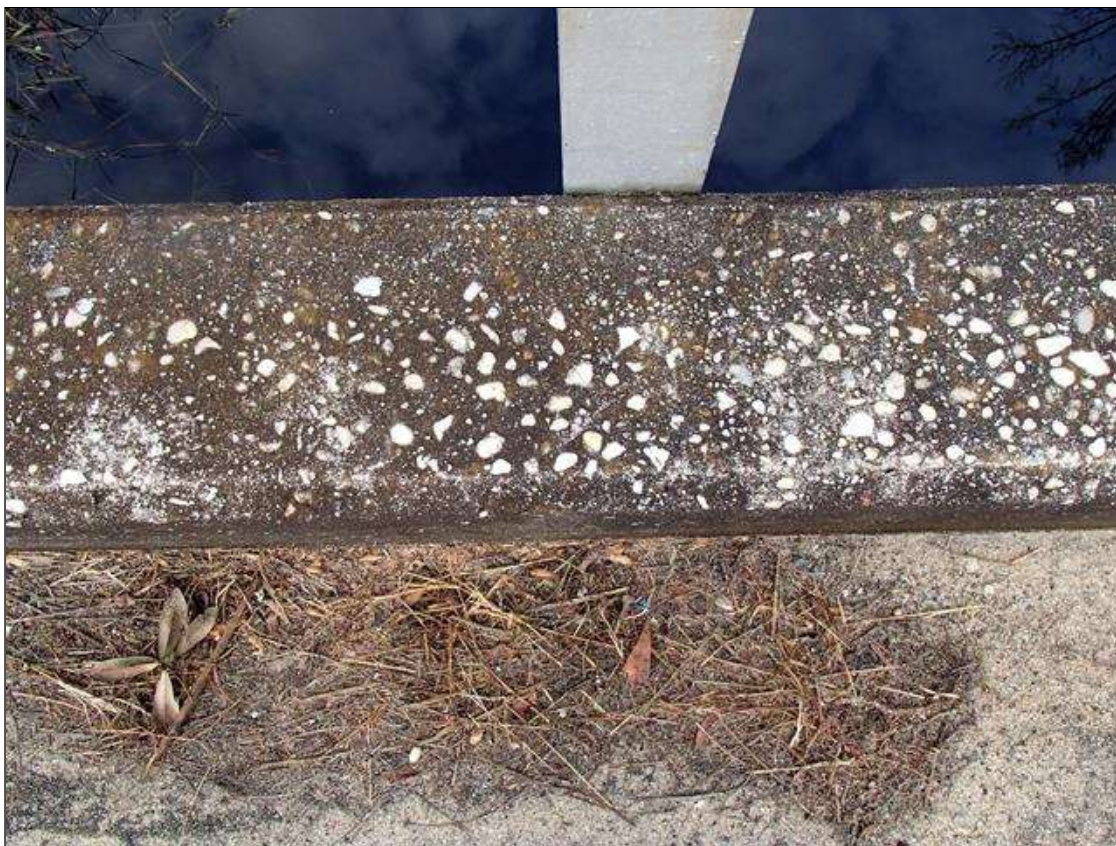
SPAN 1, CURB - COARSE AGGREGATE EXPOSED

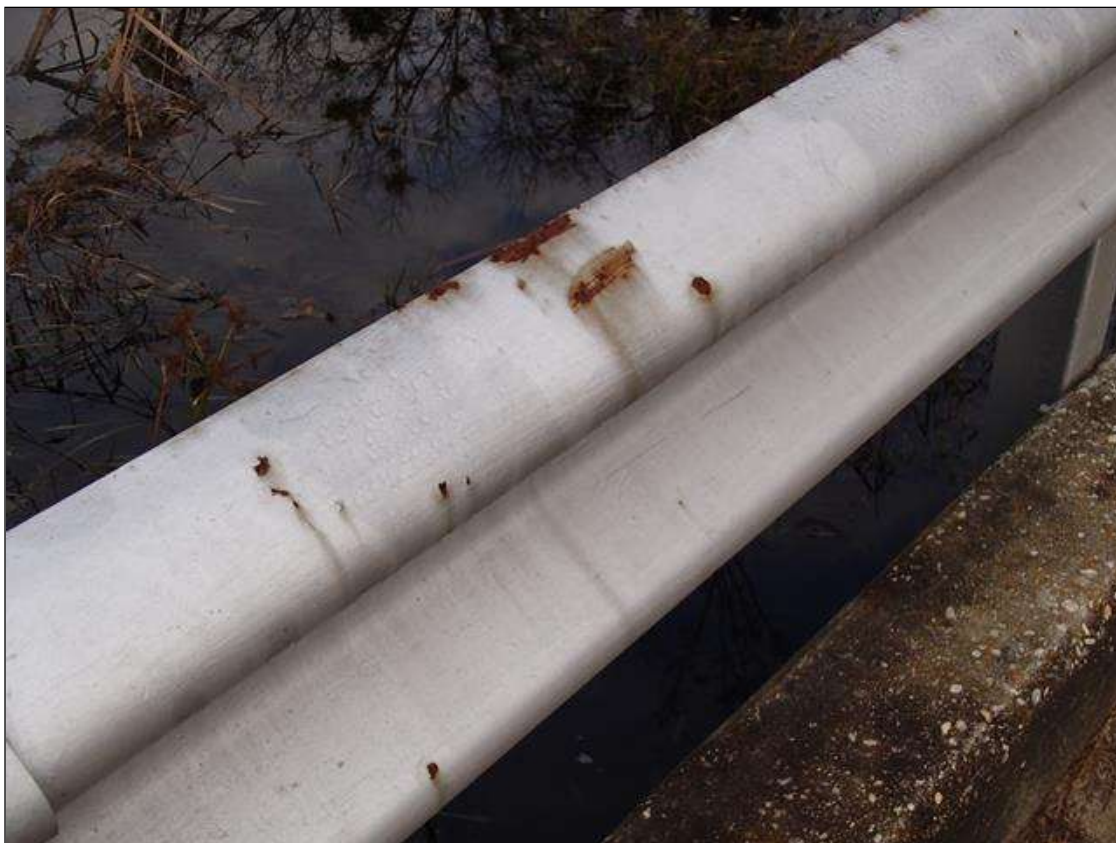
SPAN 1, LEFT RAIL - SPOT RUST

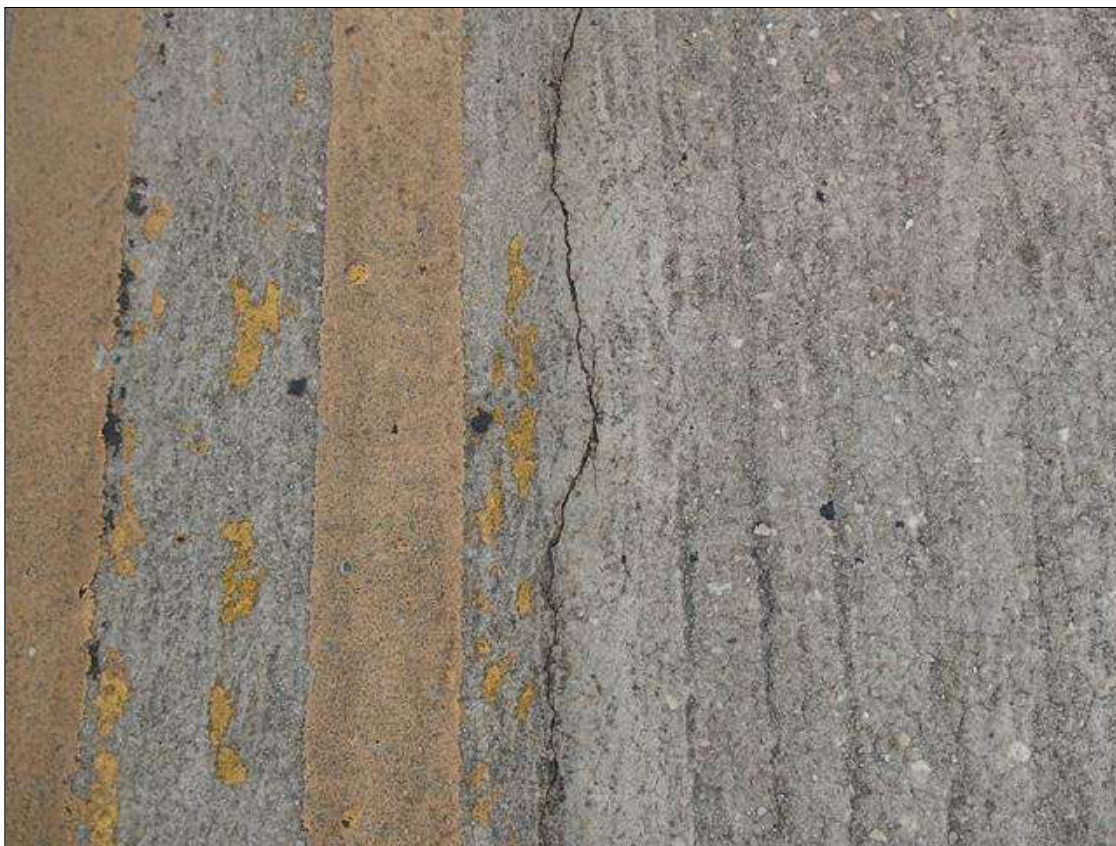
| Span | 2 | Deck | 1 | Component Name: | | Reinforced Concrete Deck | | | | | | | |
|---|---|---|---|---|---|---|---|---|---|---|---|---|---|
| <b>Defect Description:</b><br>LONGITUDINAL CRACK TO 1/8" NEAR C/L<br>H/L MAP CRACKING THROUGHOUT | | | | | | | | | | | | | |

SPAN 2, LONGITUDINAL CRACK TO 1/8"

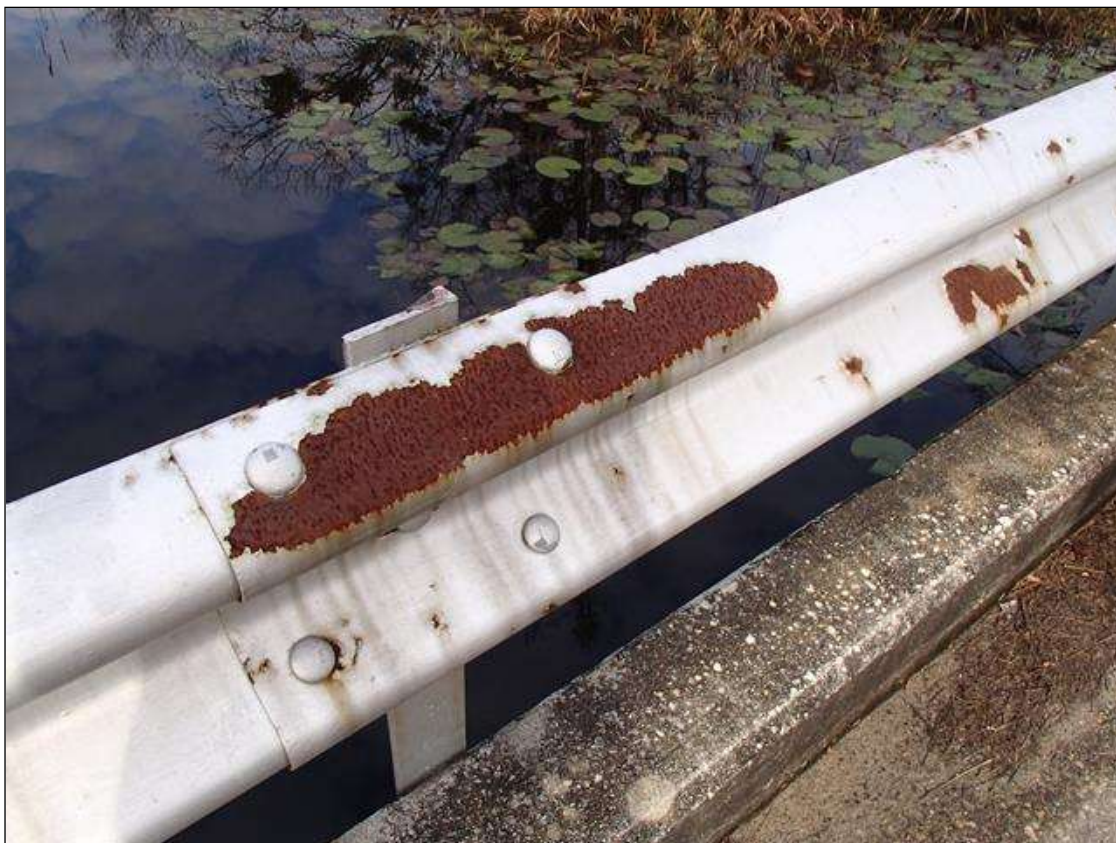
SPAN 2, LEFT RAIL - SURFACE RUST

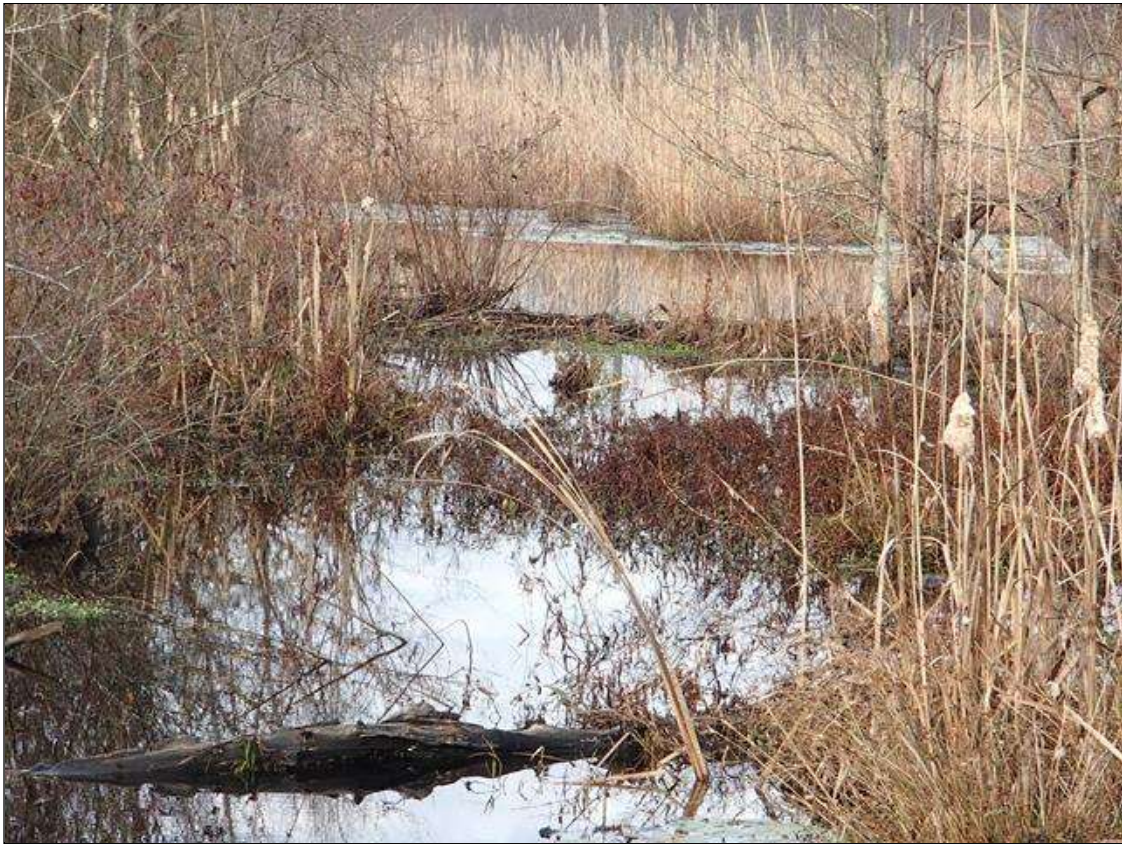
**Details** NO PROBLEMS NOTED AT STRUCTURE  
BEAVER DAMS UP AND DOWNSTREAM

BEAVER DAM UPSTREAM

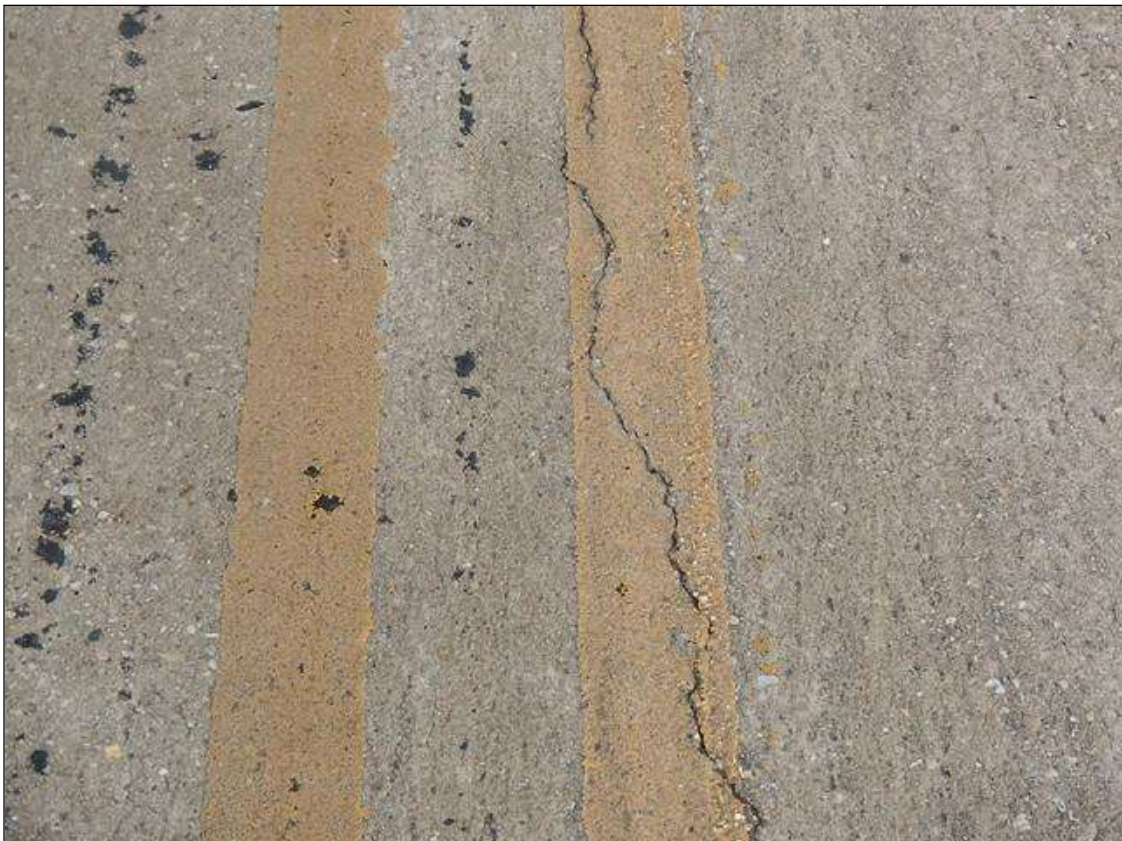
SPAN 3 - LONGITUDINAL TO 1/8" NEAR C/L

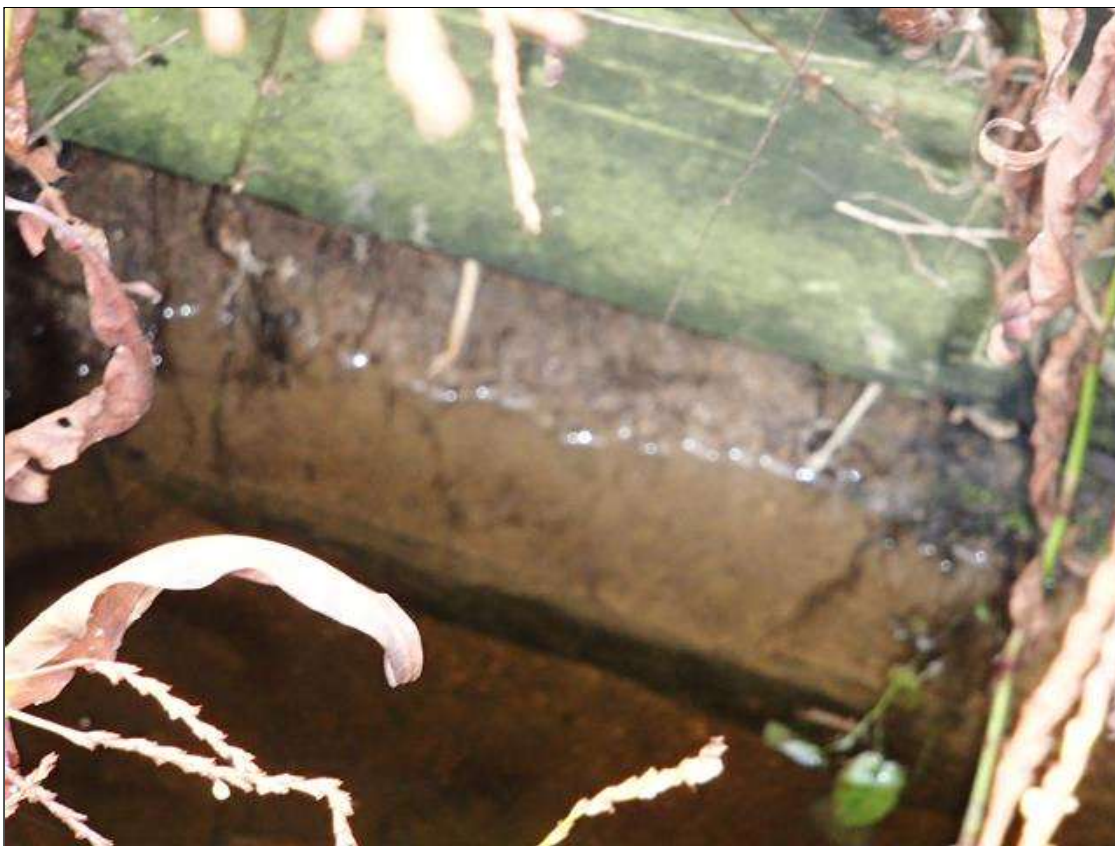
SE EXTERIOR BULKHEAD - BOARD 4 100% DECAYED WITH FILL EXPOSED

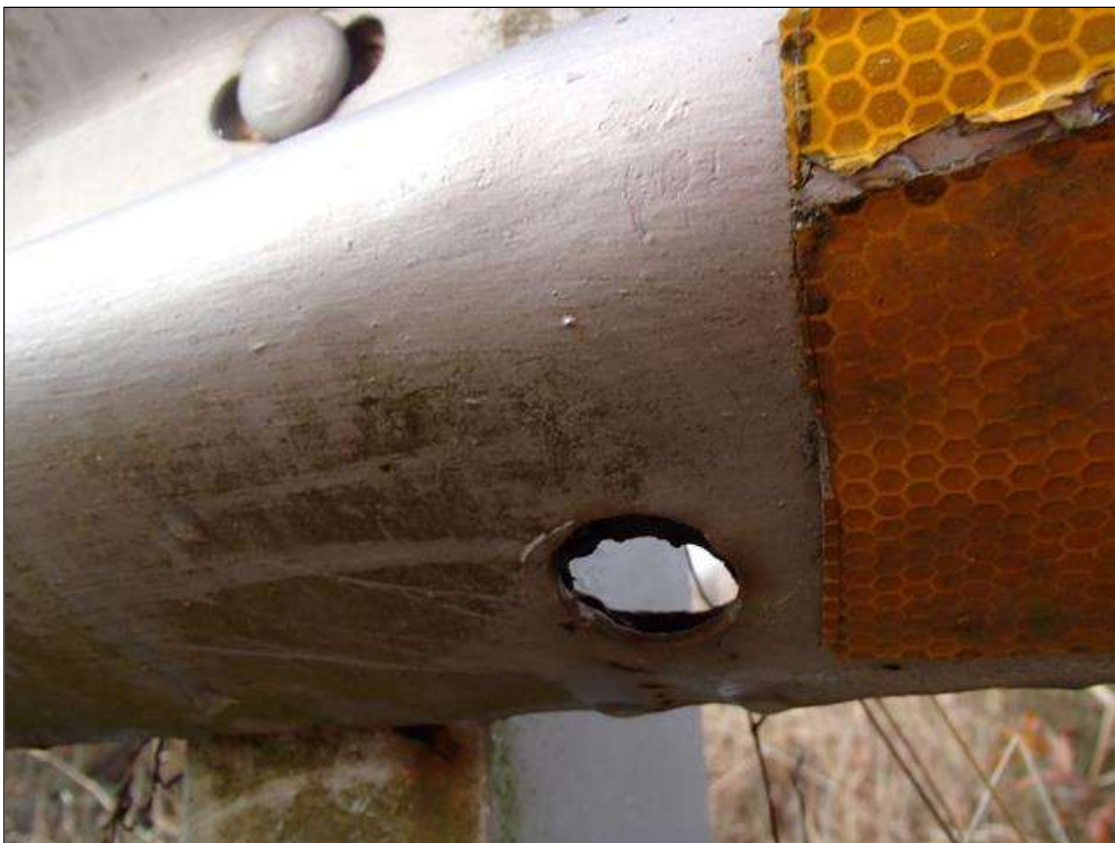
MISSING BOLT NW TERMINAL END

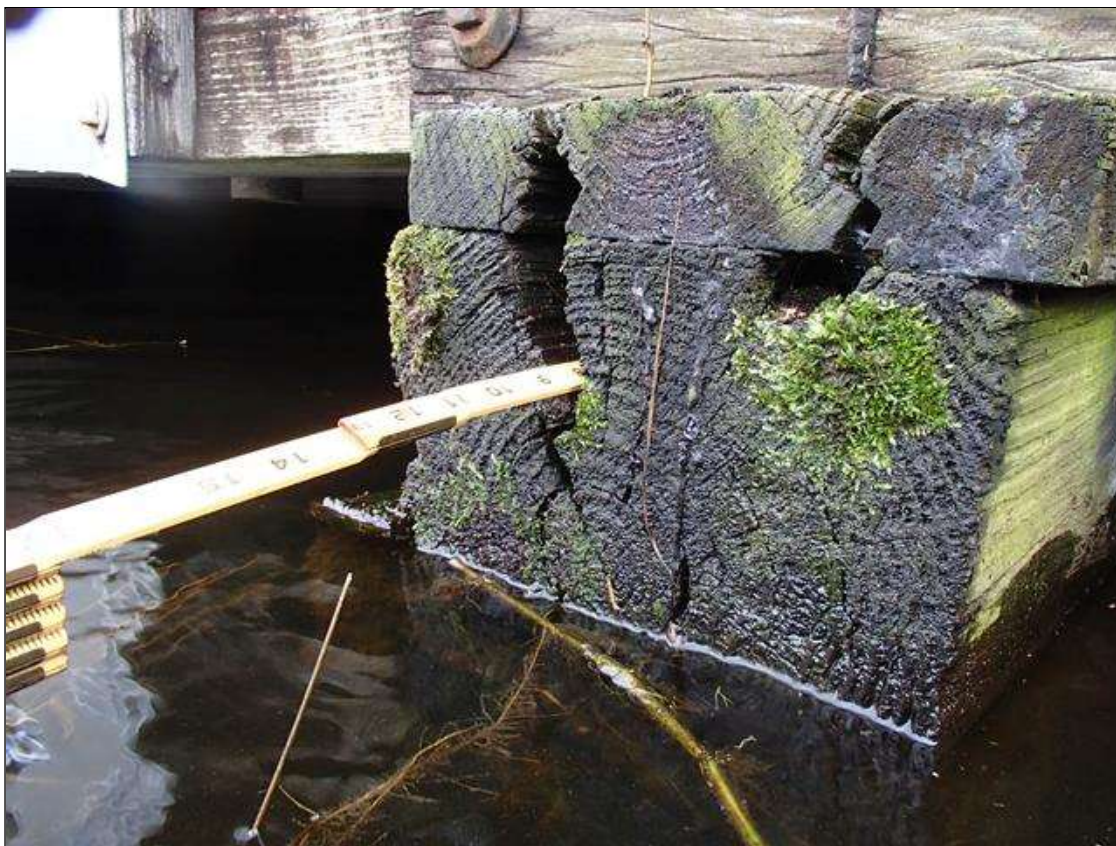
BENT 1 CAP, DECAY AT WEST END

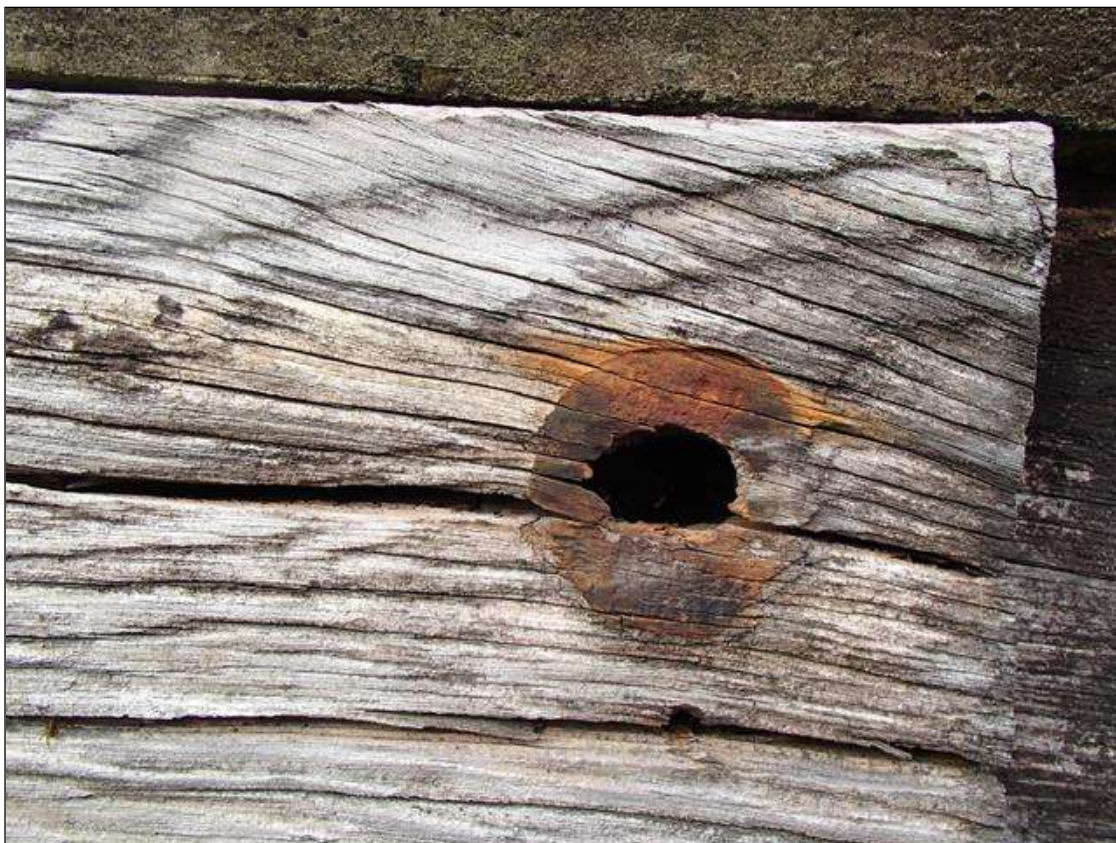
J-1 AT BENT 1 MISSING BOLT IN SPLICE BLOCK

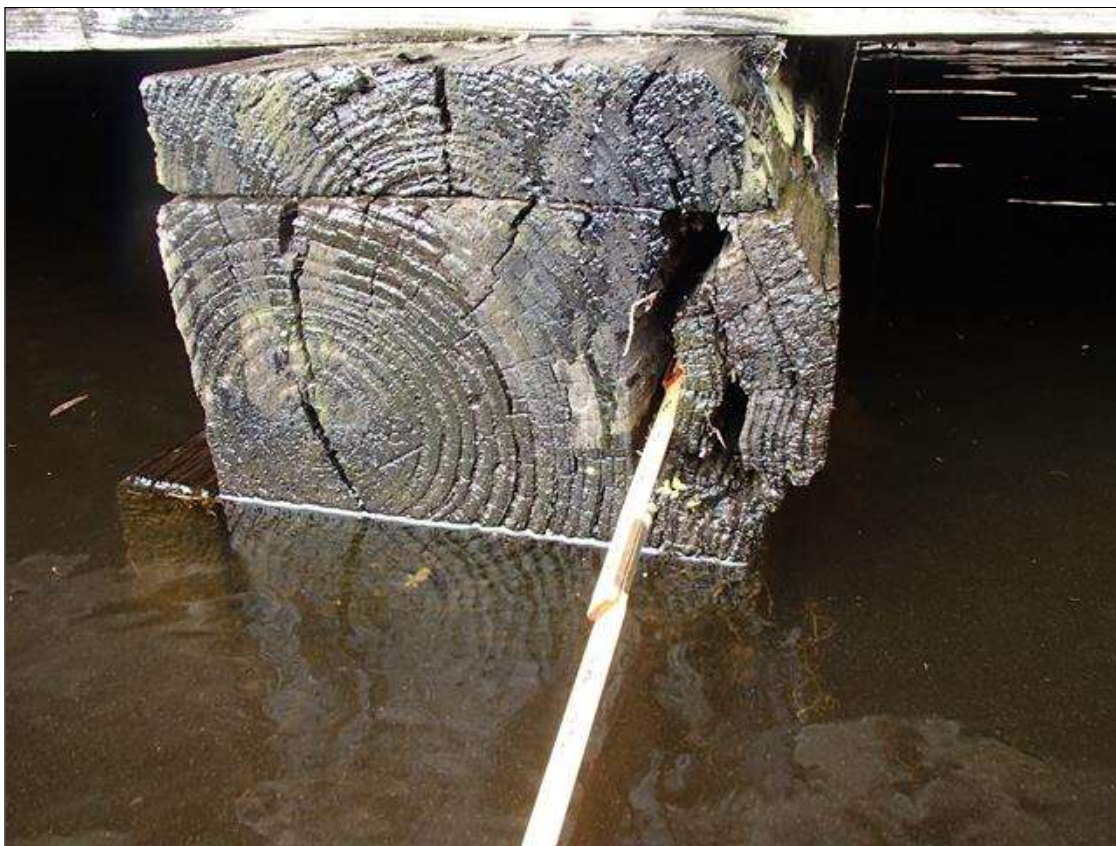
BENT 1 CAP, DECAY AT EAST END

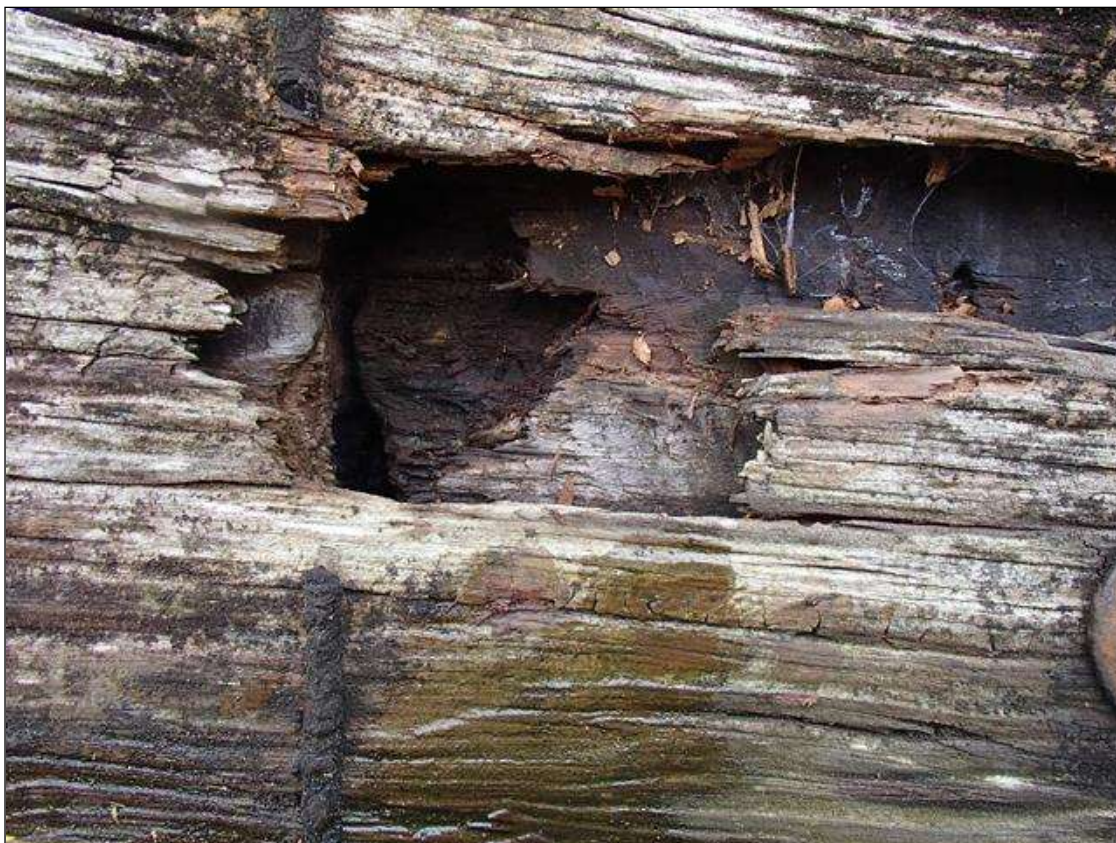
| SPLICE BLOCK AT BENT 2 DECAYED, 12" LONG X 3.5" VERTICAL X FULL WIDTH | | | | | | | | | | | | |

BENT 2 - DECAY IN SPLICE BLOCK AT J-1

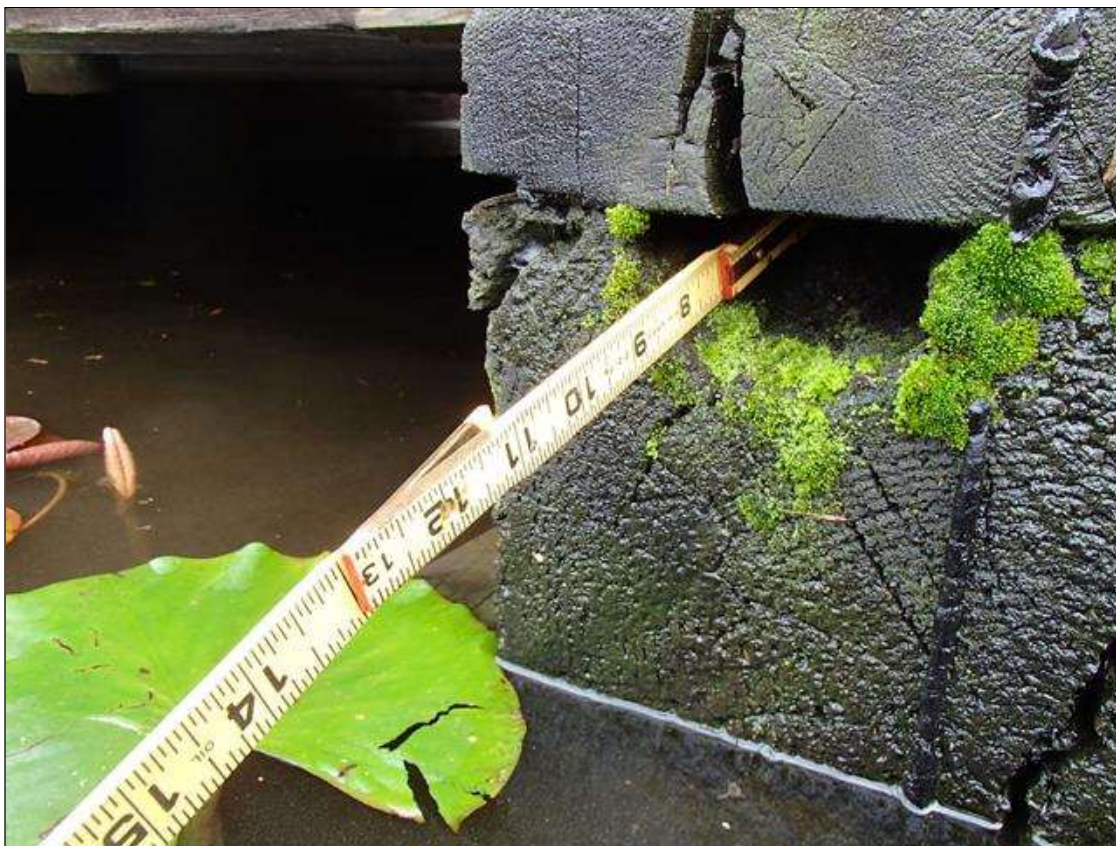
BENT 2 CAP, DECAY AT WEST END

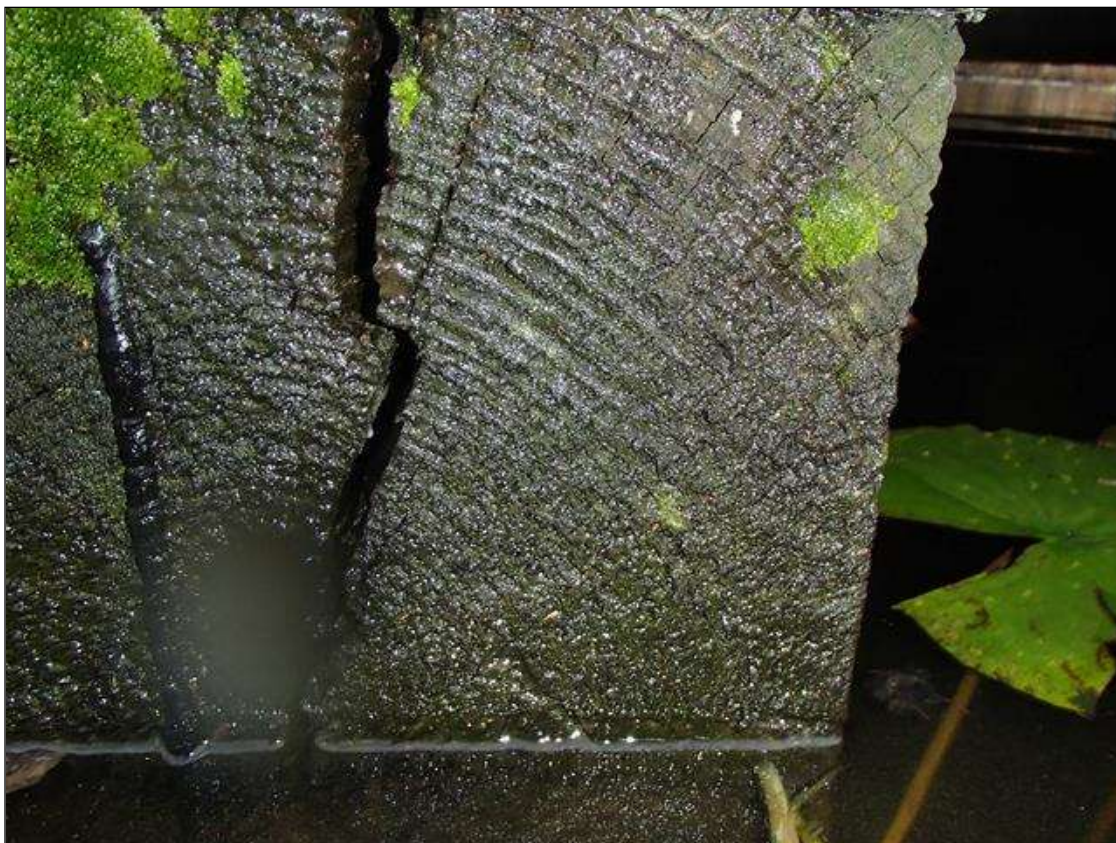
BENT 2 CAP, SPLIT AT WEST END

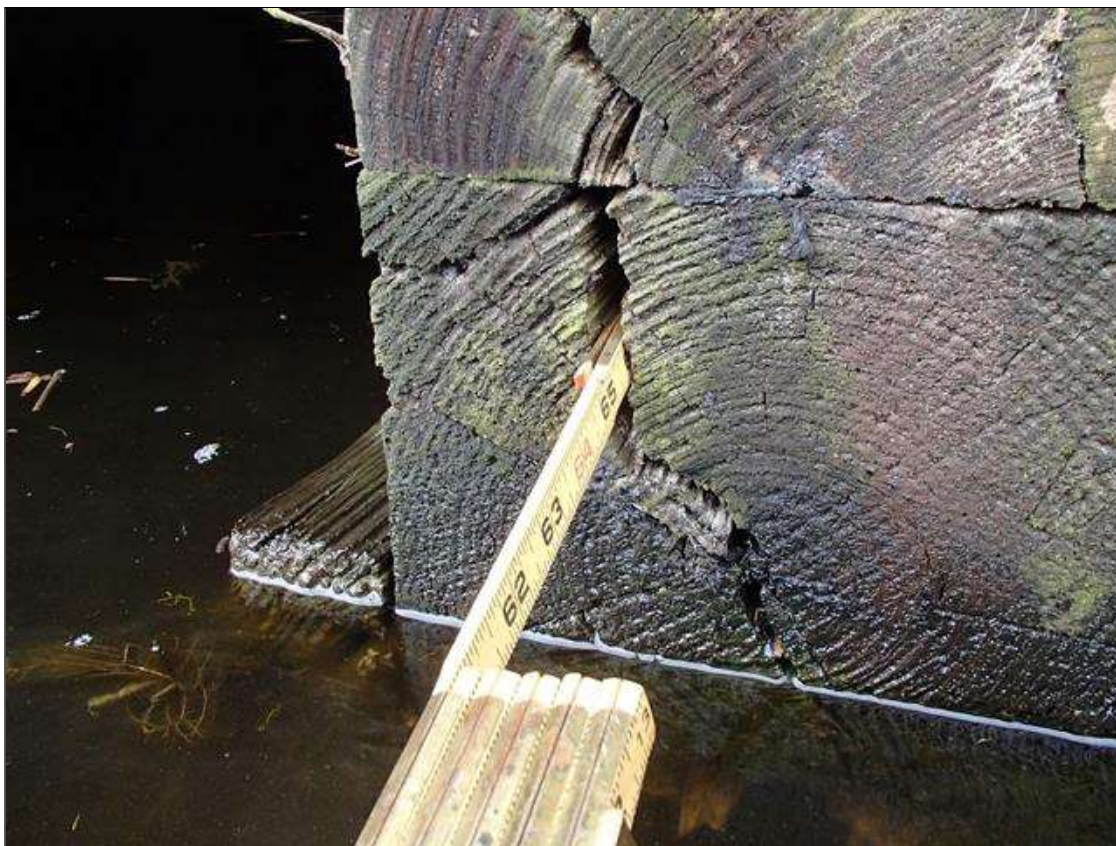
BENT 2 CAP, SPLIT AT EAST END

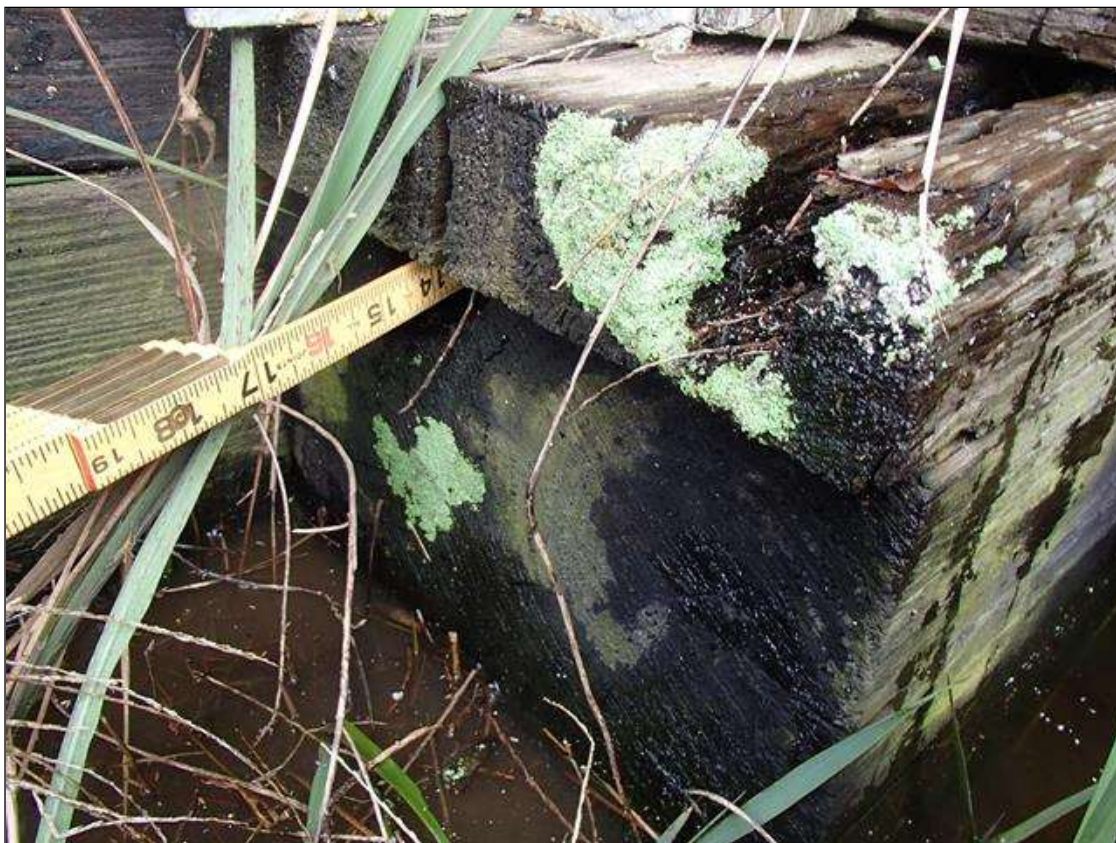
END BENT 2, DECAY AT WEST END
