NC DEPARTMENT OF TRANSPORTATION  
DIVISION OF HIGHWAYS  
STRUCTURE MANAGEMENT UNIT

## Structure Safety Report

### Routine Element Inspection

COUNTY: BLADEN STRUCTURE NUMBER: 080013 FREQUENCY: 24 MONTHS  
FACILITY CARRIED: SR1100 MILE POST: \_\_\_\_\_  
LOCATION: 0.4MI.E. OF JCT. SR1122  
FEATURE INTERSECTED: CRAWLEY SWAMP  
LATITUDE: 34° 37' 6.02" LONGITUDE: 78° 48' 2.78"  
SUPERSTRUCTURE: RC FLOOR ON TIMBER JOISTS  
SUBSTRUCTURE: EBTS&IBTS:TIMBER CAPS ON TIMBER PILES @ VAR.CTS.  
SPANS: 1@18"; 3@16.83"; 1@18"  
☐ FRACTURE CRITICAL ☐ TEMPORARY SHORING ☐ SCOUR CRITICAL ☒ SCOUR PLAN OF ACTION  
PRESENT CONDITION: Poor INSPECTION DATE: 06/09/2015  
POSTED SV: 19 POSTED TTST: 28  
OTHER SIGNS PRESENT: 4 DELINEATORS

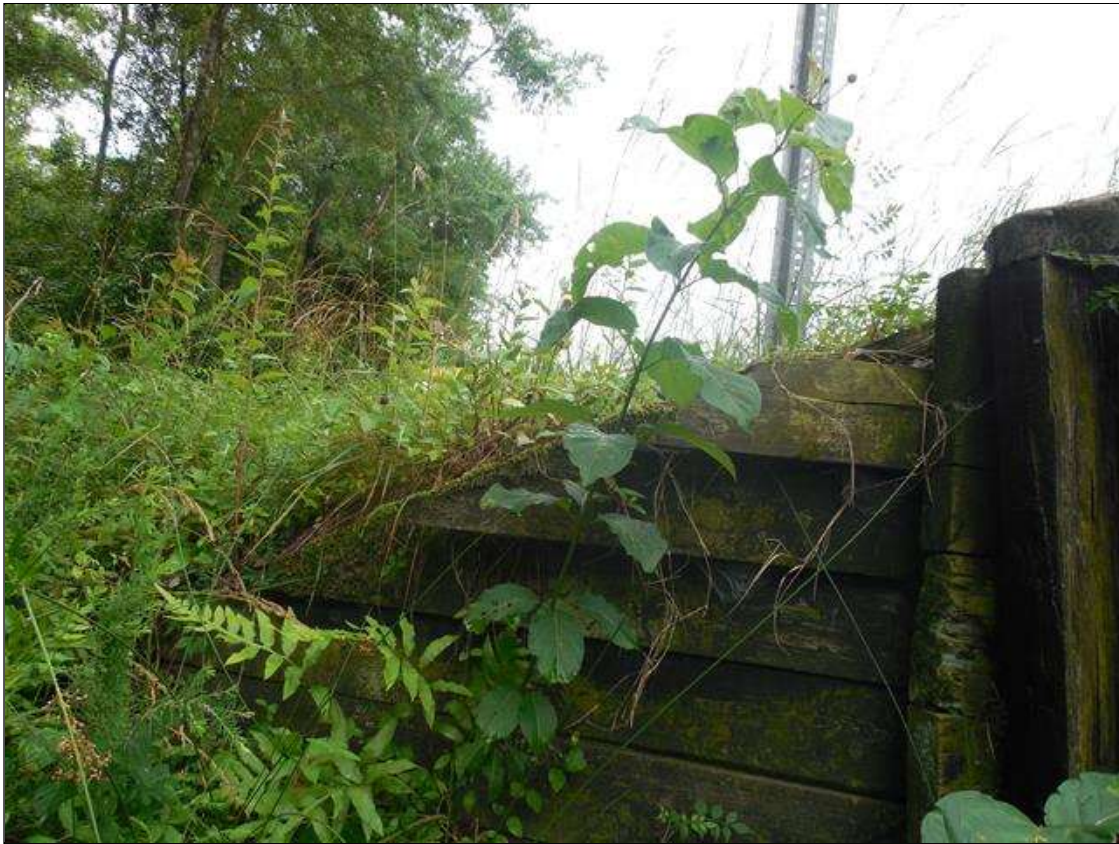
TOP 3 WINGWALL BOARDS DECAYED AT SOUTHWEST CORNER 5 FT. MAINTENANCE

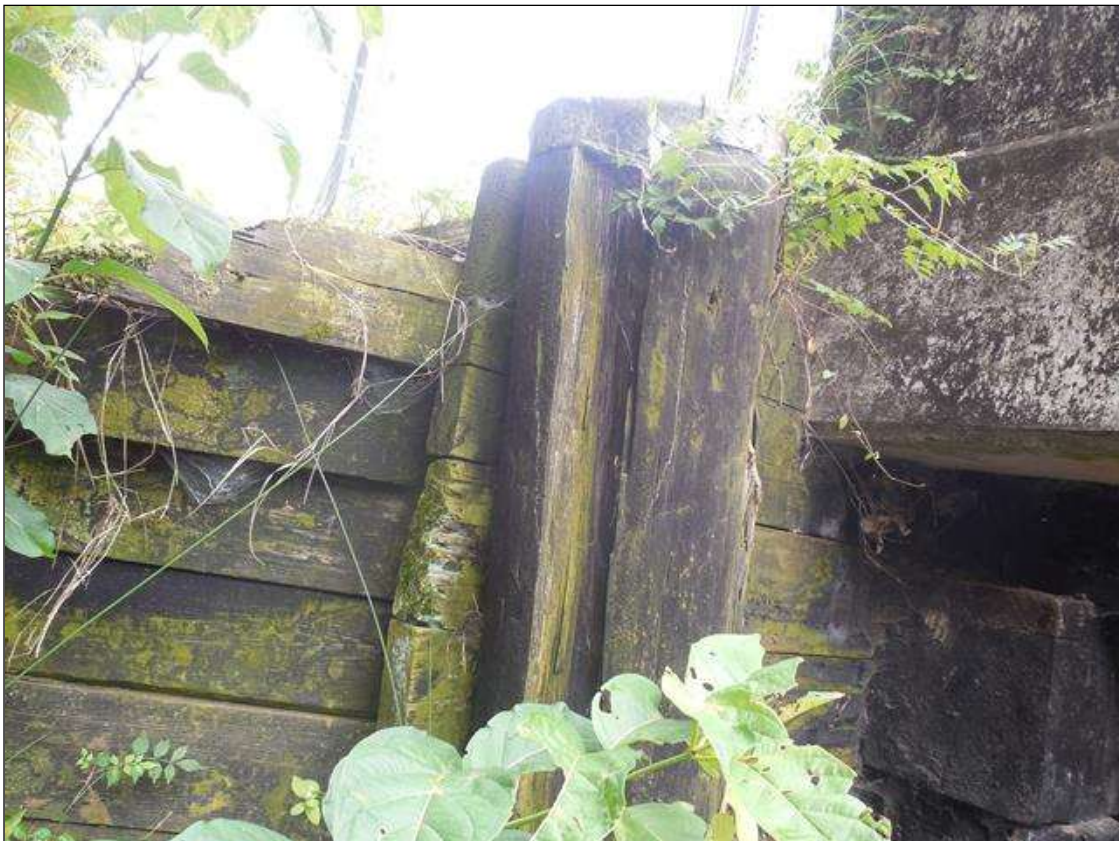
SURFACE SOFT TO 1/8".  
 APROX. MAX. W/D AT ABUTMENT 1- 2.0"  
 1 Feet of Decay/Section Loss: Affects 10% or more of the member but does not warrant structural review. TURNPILE AT  
 SOUTHWEST CORNER DECAYED 4' HIGH X 6" WIDE X 3" DEEP

End Bent 1 Abutment/Backwall : 1 Feet of Decay/Section Loss: Affects 10% or more of the member but does not warrant structural review. TURNPILE AT SOUTHWEST CORNER DECAYED 4' HIGH X 6" WIDE X 3" DEEP

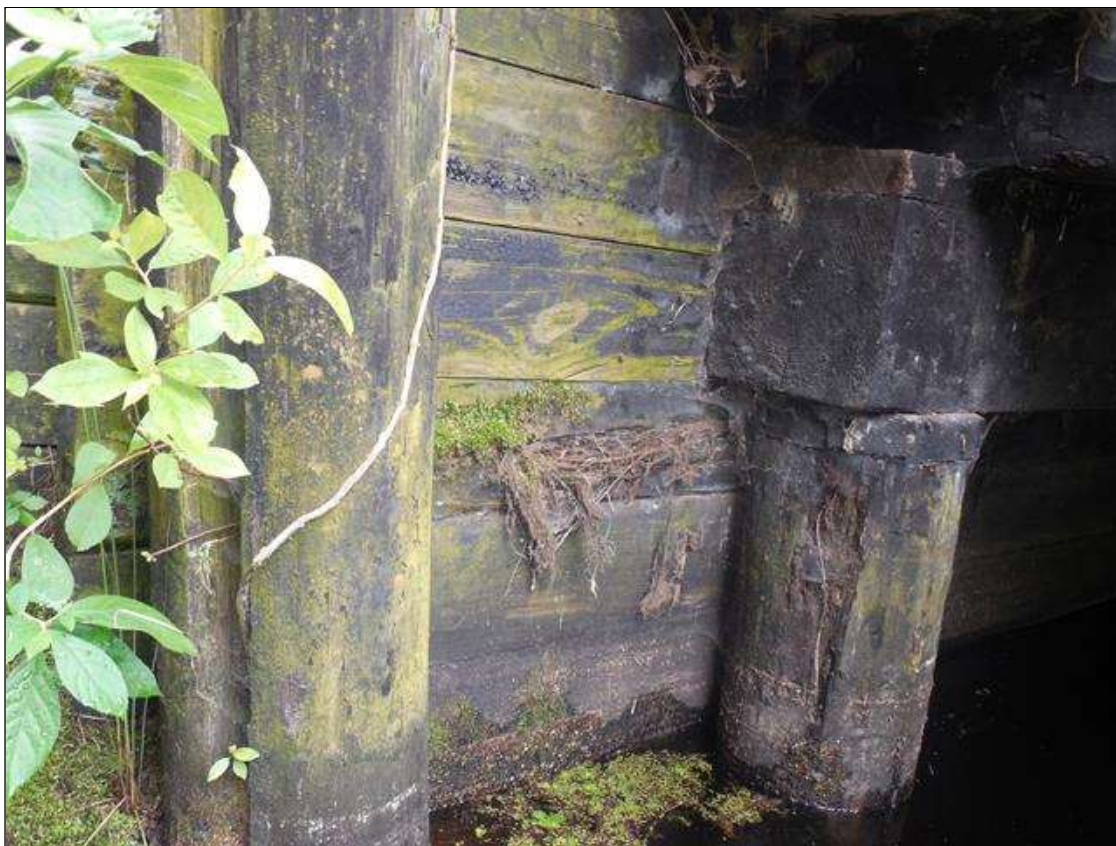
END BENT 1 TIMBER ABUTMENT DECAYED 4' AT SOUTHWEST CORNER

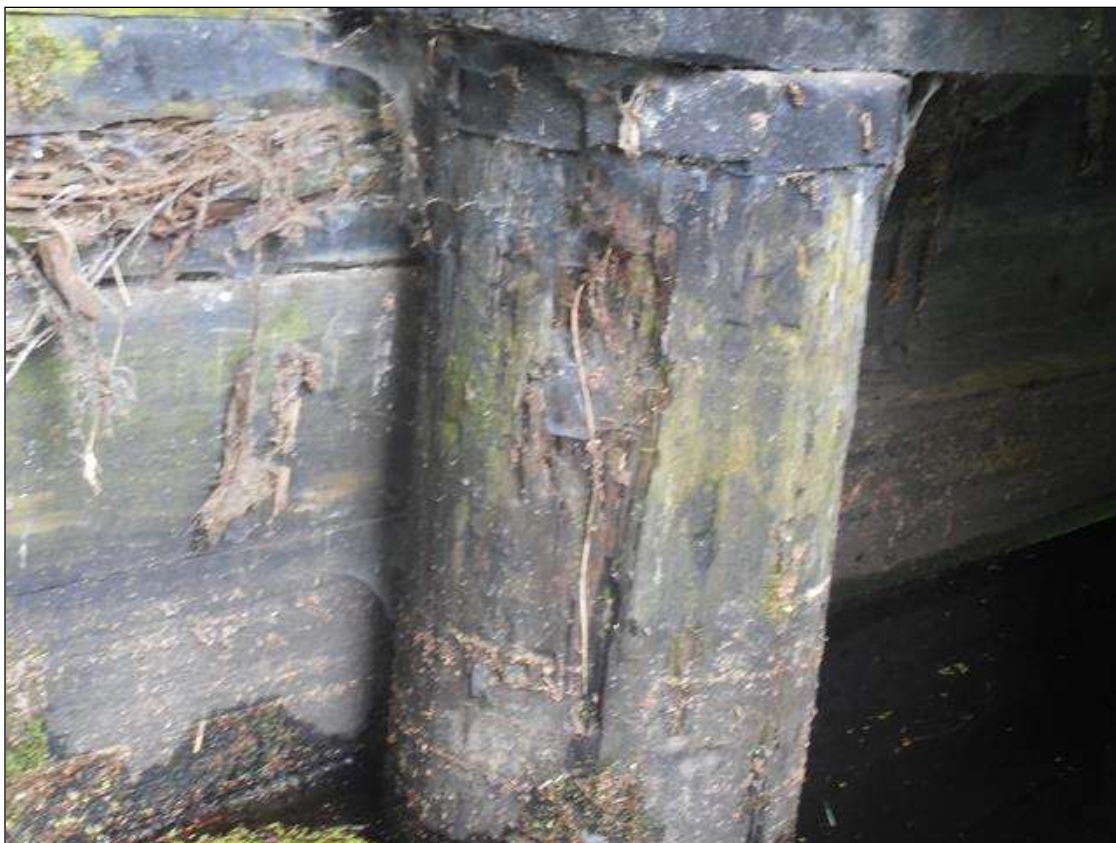
END BENT 1 PILE 4 DECAYED 2' HIGH X 4" WIDE X 1" DEEP

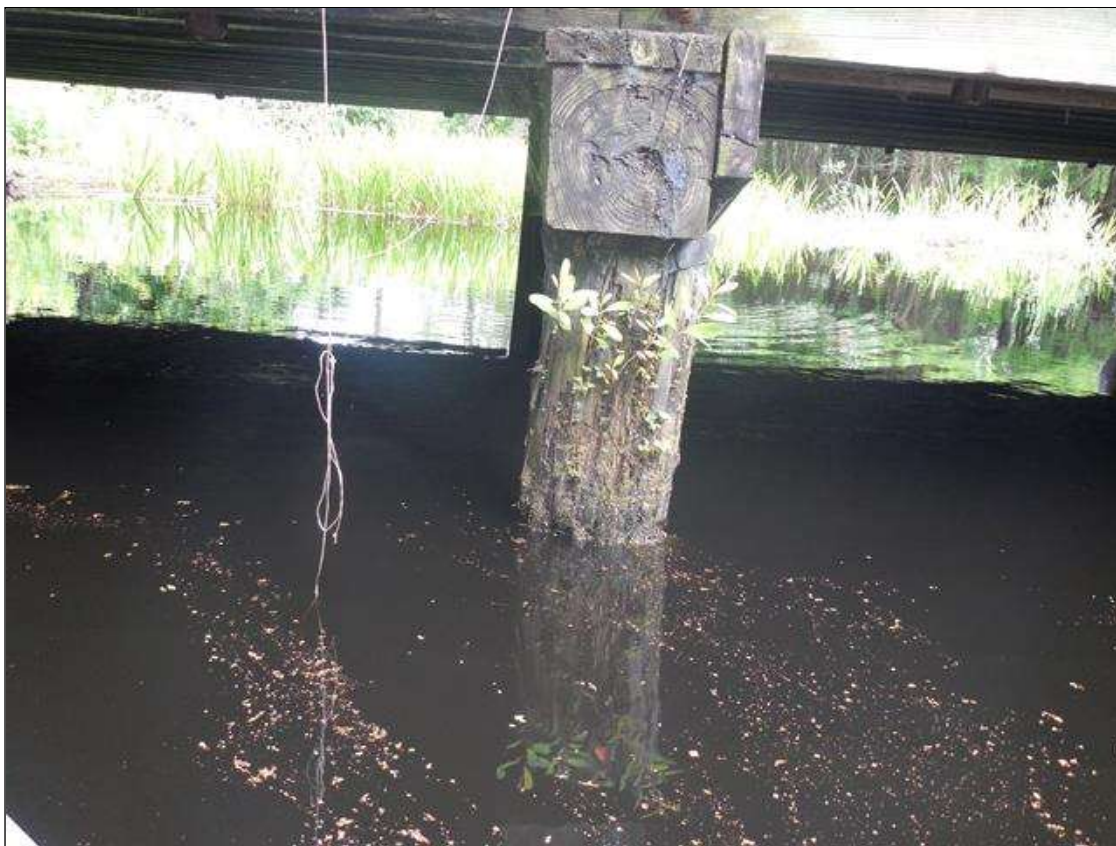
BENT 1 PILE 4 DECAYED 2' HIGH X 14" WIDE X 2" DEEP ON SOUTH FACE

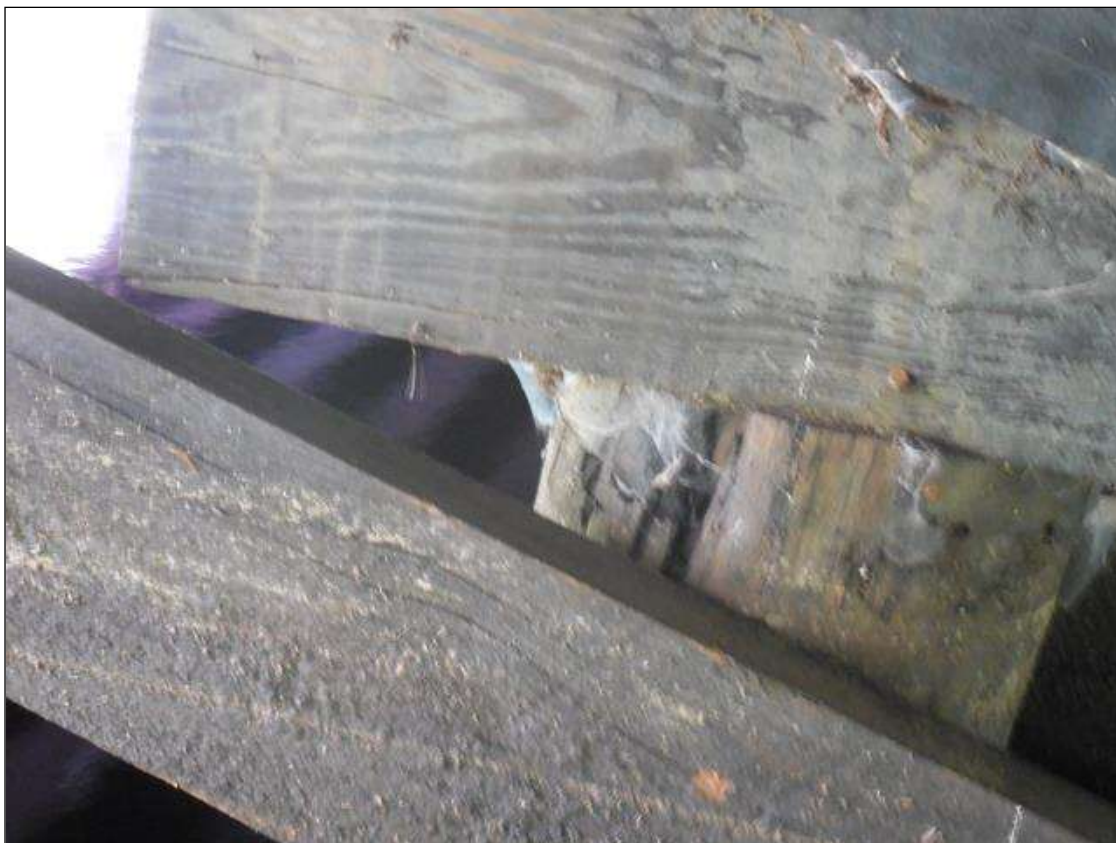
PILE 2 AT BENT 1 DECAYED 1' HIGH X 6" WIDE X 1 1/2" DEEP

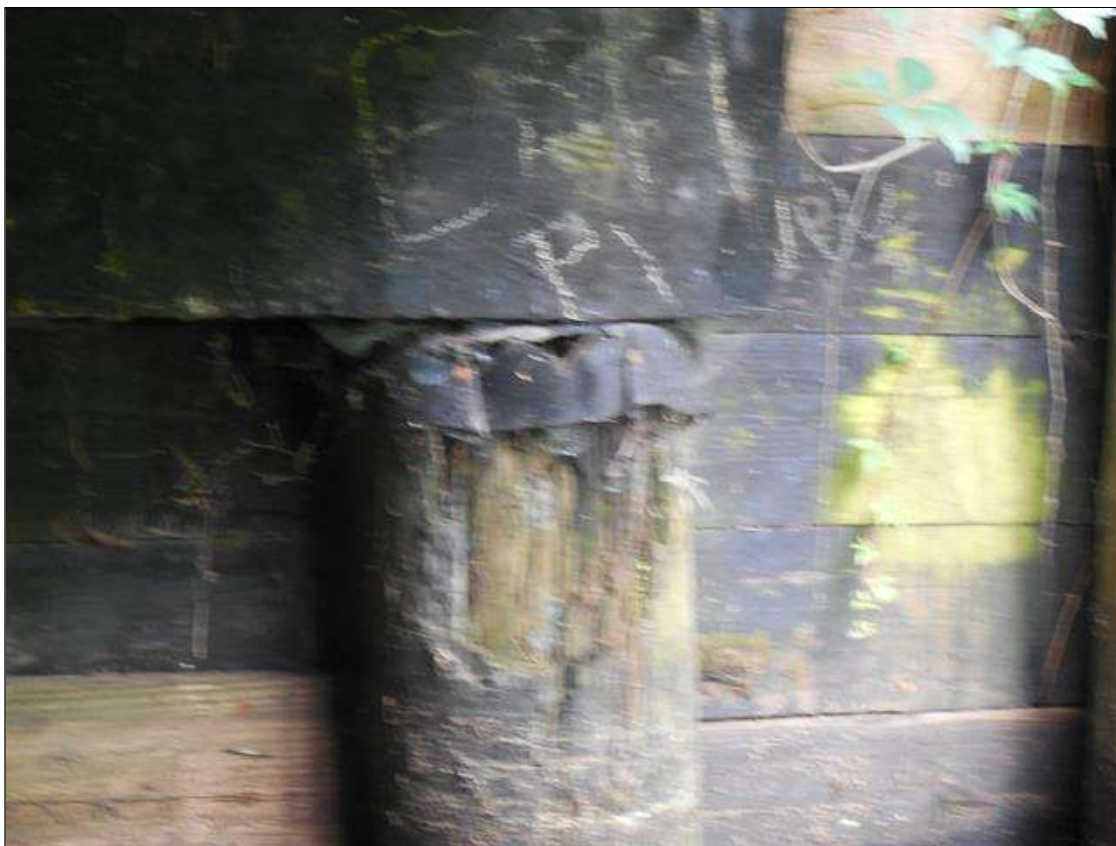
PILE 1 AT END BENT 1 DECAYED 14" HIGH X 10" WIDE X 1" DEEP

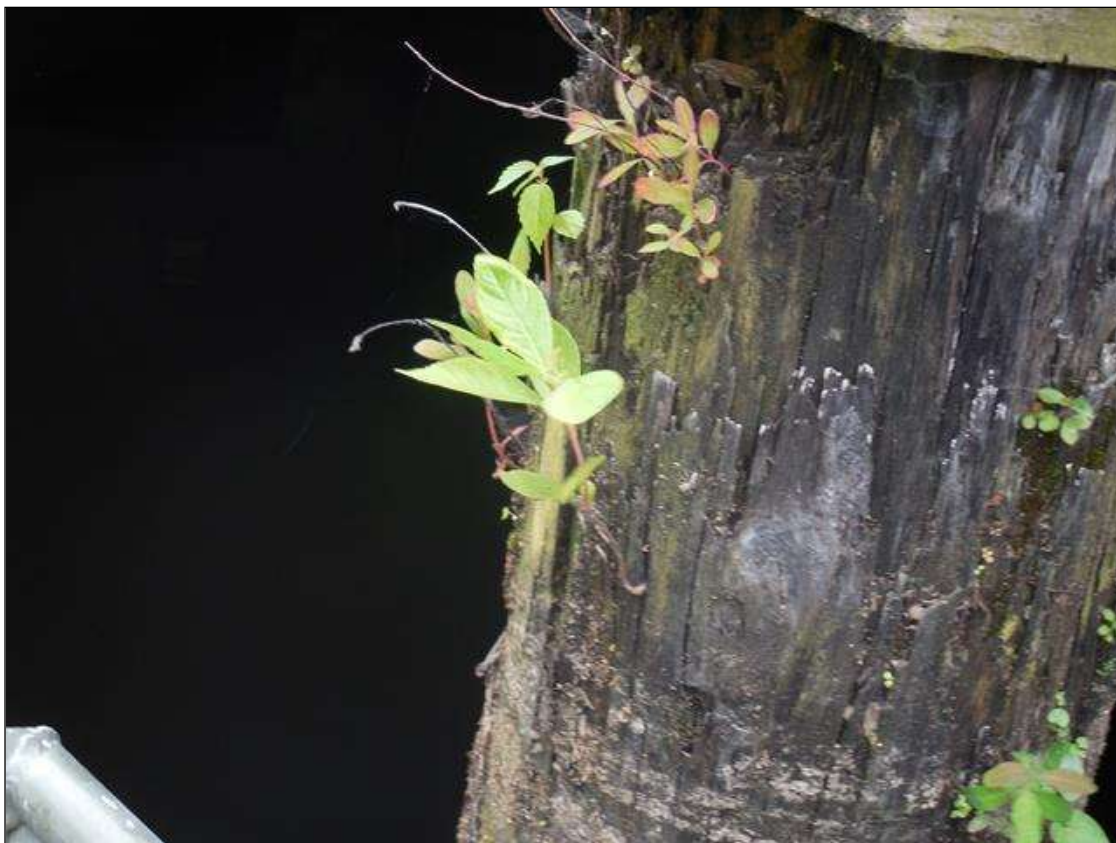
PILE 1 AT BENT 1 DECAYED 2' HIGH X 10" WIDE X 2" DEEP

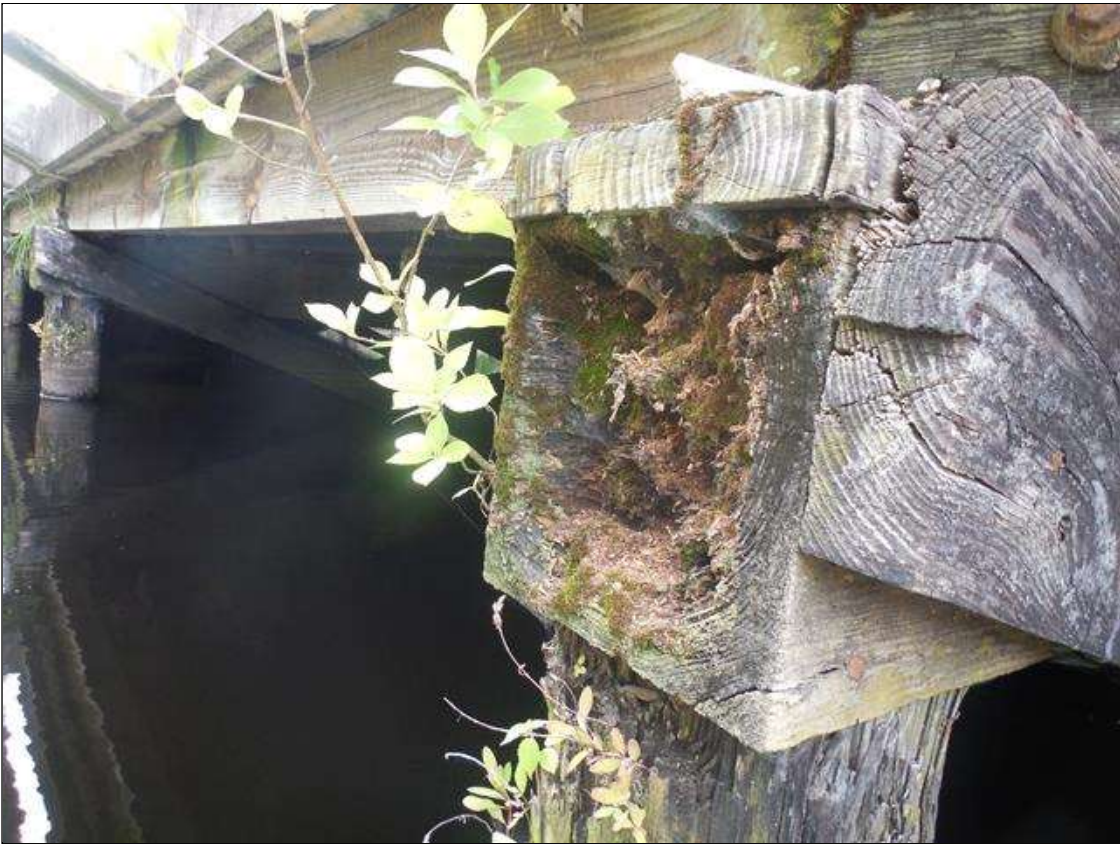
1 Feet of Decay/Section Loss: Affects less than 10% of the member section. DECAYED 11" WIDE X 11" HIGH X 6" DEEP ON NORTH END

Bent 1 Cap : 1 Feet of Decay/Section Loss: Affects less than 10% of the member section. DECAYED 11" WIDE X 11" HIGH X 6" DEEP ON NORTH END

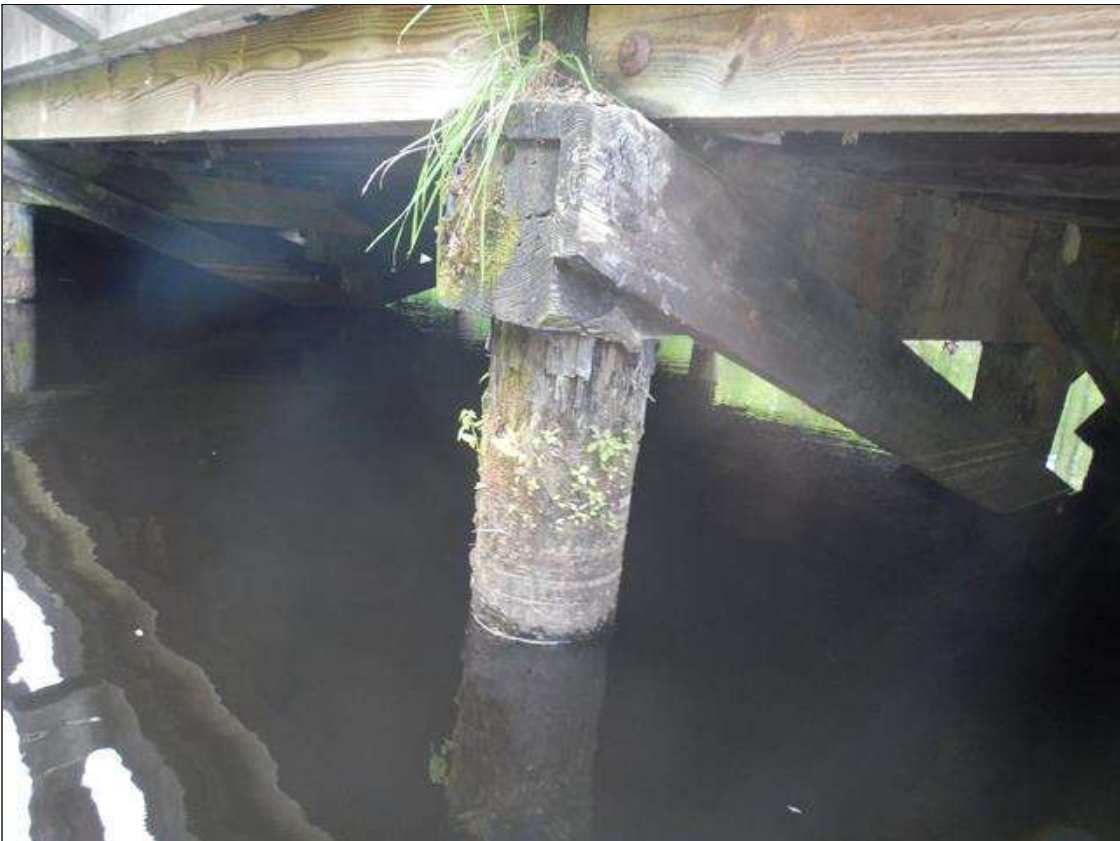
PILE 1 AT BENT 2 DECAYED 14" HIGH X 14" WIDE X 2" DEEP

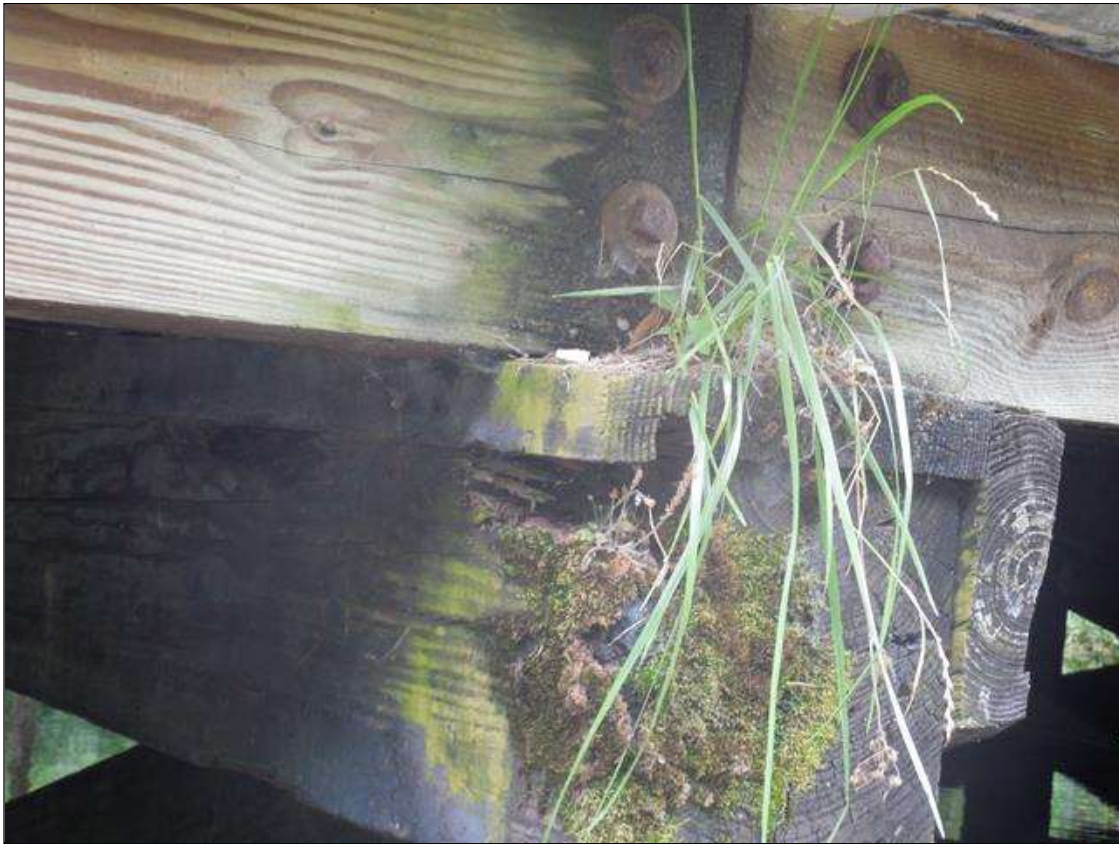
2 Feet of Decay/Section Loss: Affects 10% or more of the member but does not warrant structural review. DECAYED ON SPAN 3 FACE AND NORTH END 2' LONG X 3" HIGH X 3" WIDE

Bent 2 Cap : 2 Feet of Decay/Section Loss: Affects 10% or more of the member but does not warrant structural review.  
DECAYED ON SPAN 3 FACE AND NORTH END 2' LONG X 3" HIGH X 3" WIDE

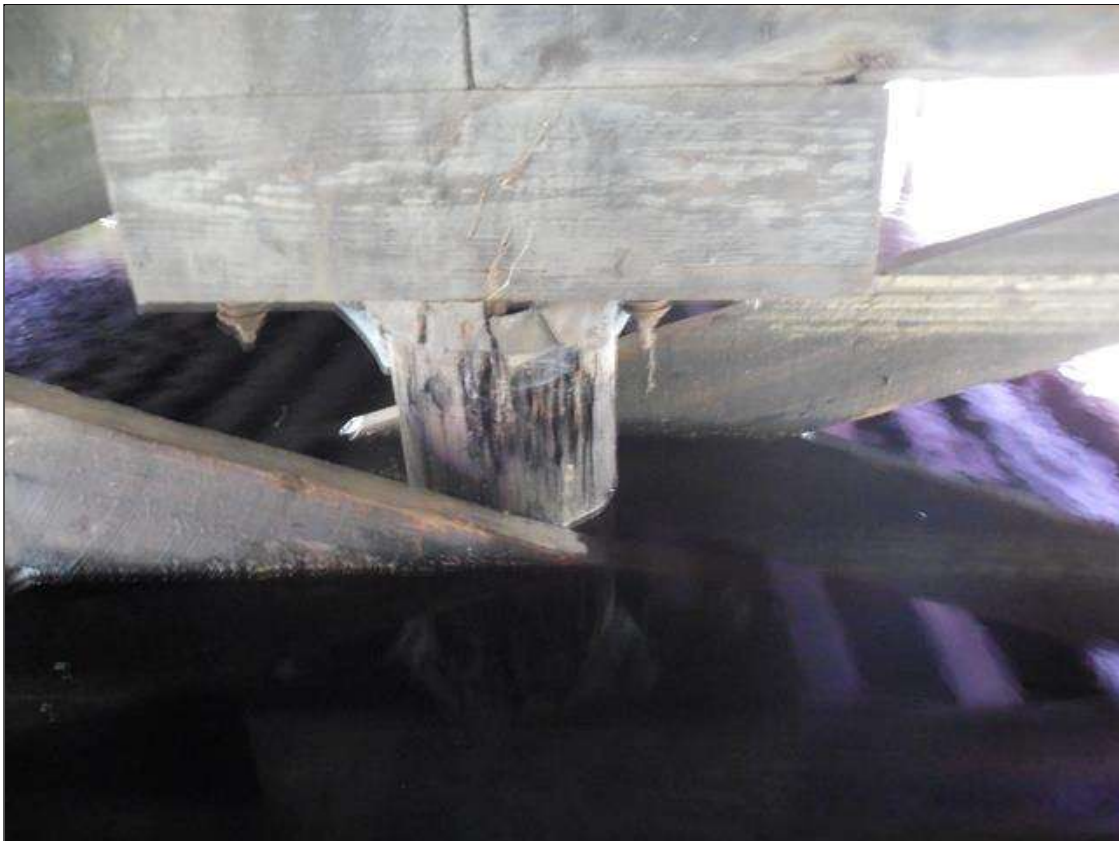
PILE 3 AT BENT 2 DECAYED 1' HIGH X 10" WIDE X 2" DEEP

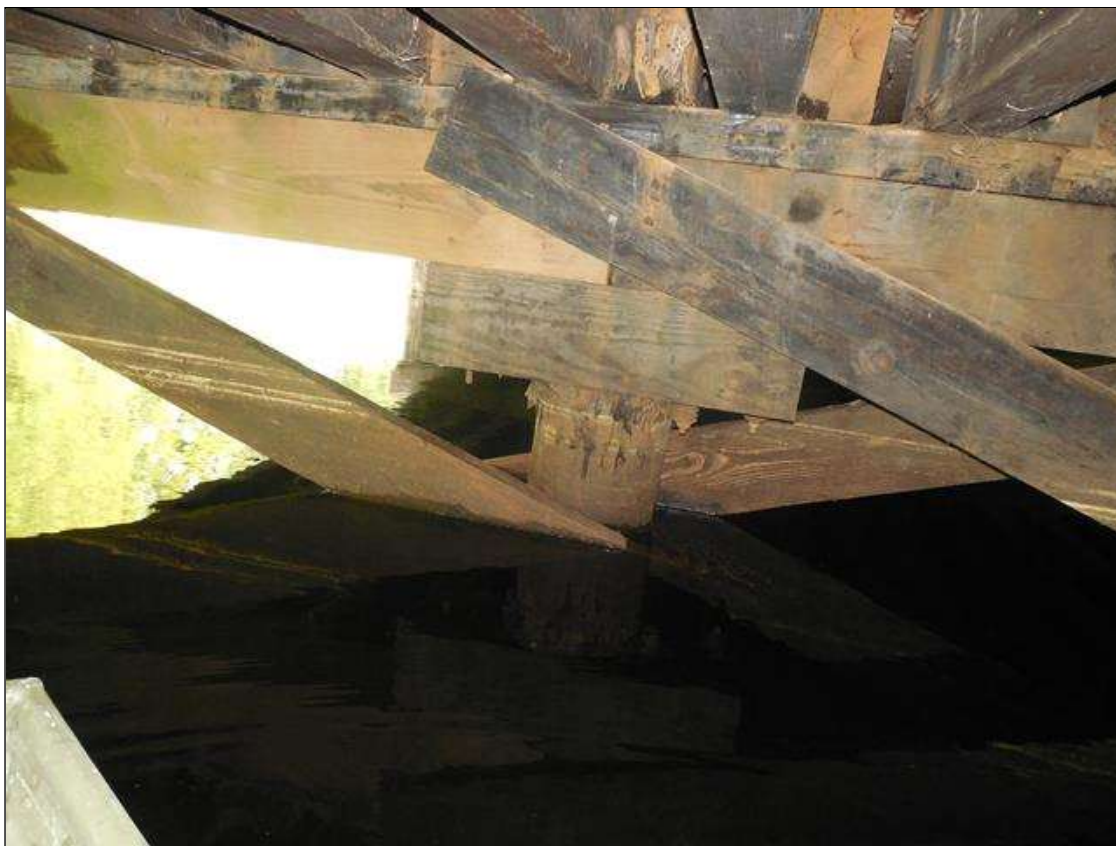
PILE 2 AT BENT 3 DECAYED 1' HIGH X 12" WIDE X 1" DEEP

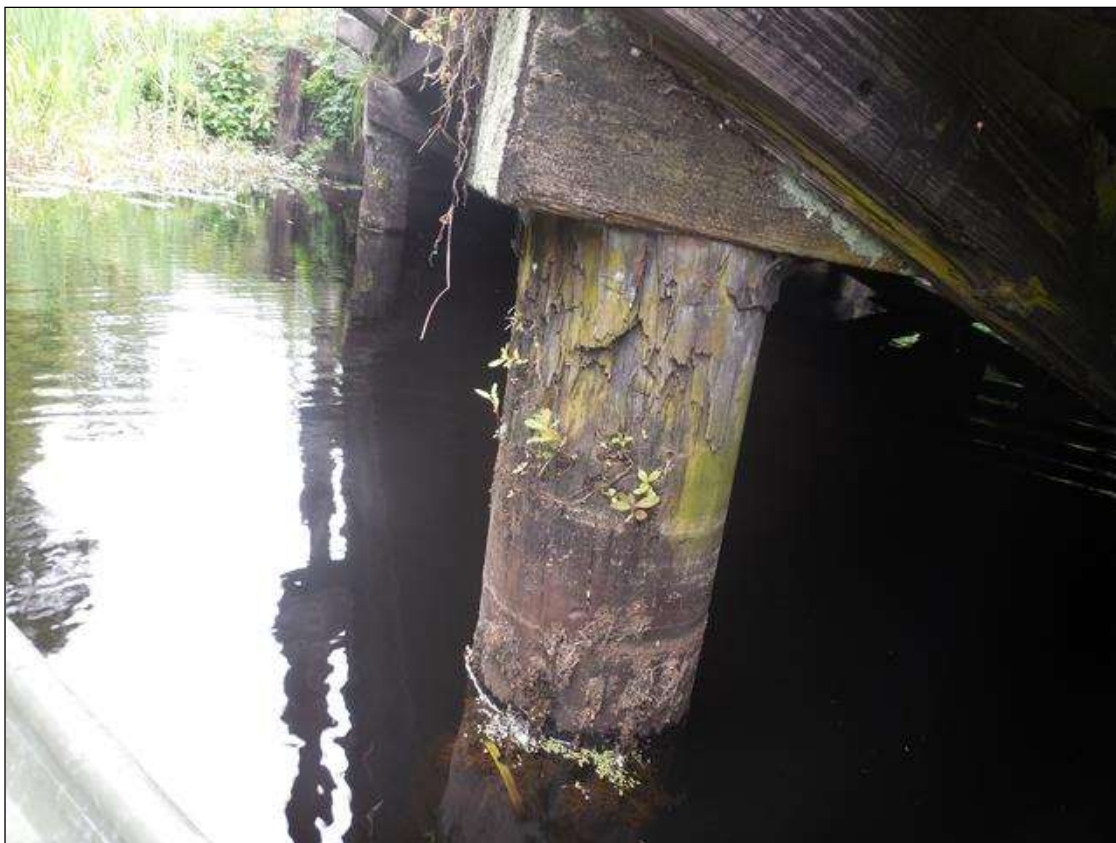
PILE 1 AT BENT 3 DECAYED 14" HIGH X 12" WIDE X 2" DEEP

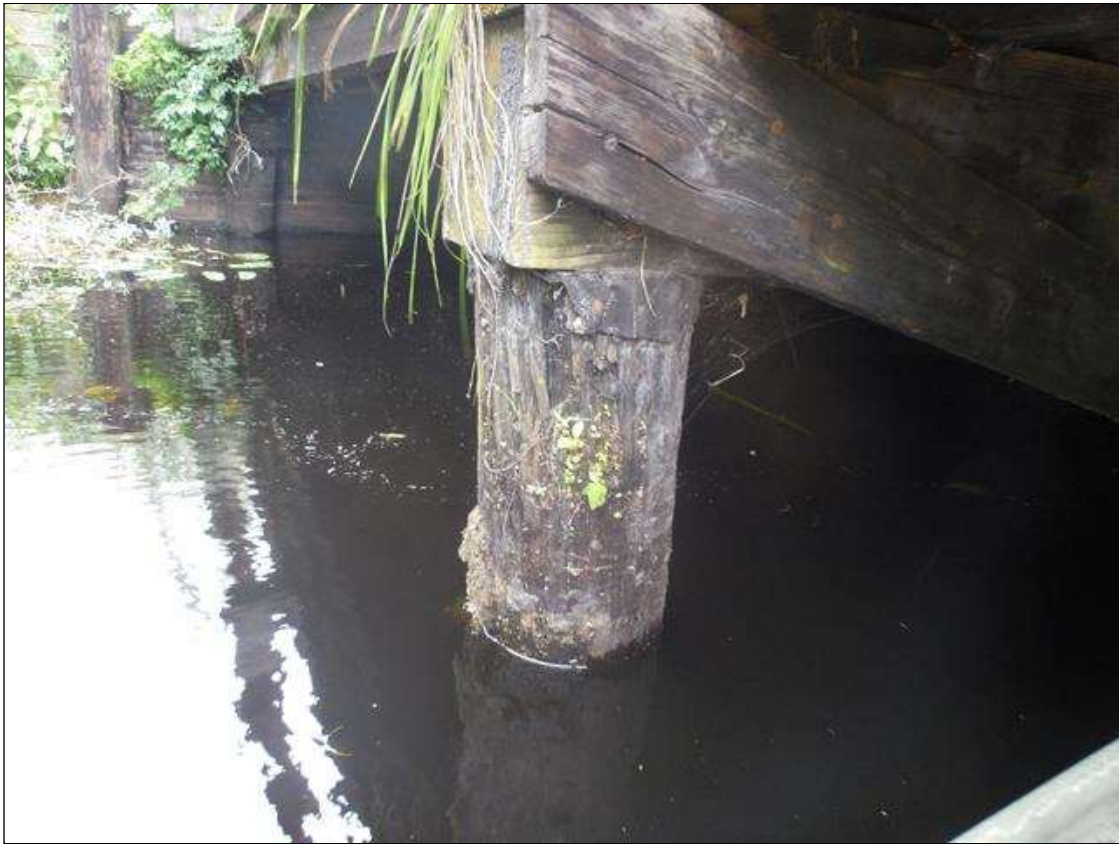
PILE 1 AT BENT 4 SURFACE DECAYED 16" HIGH X 10" WIDE X 1" DEEP

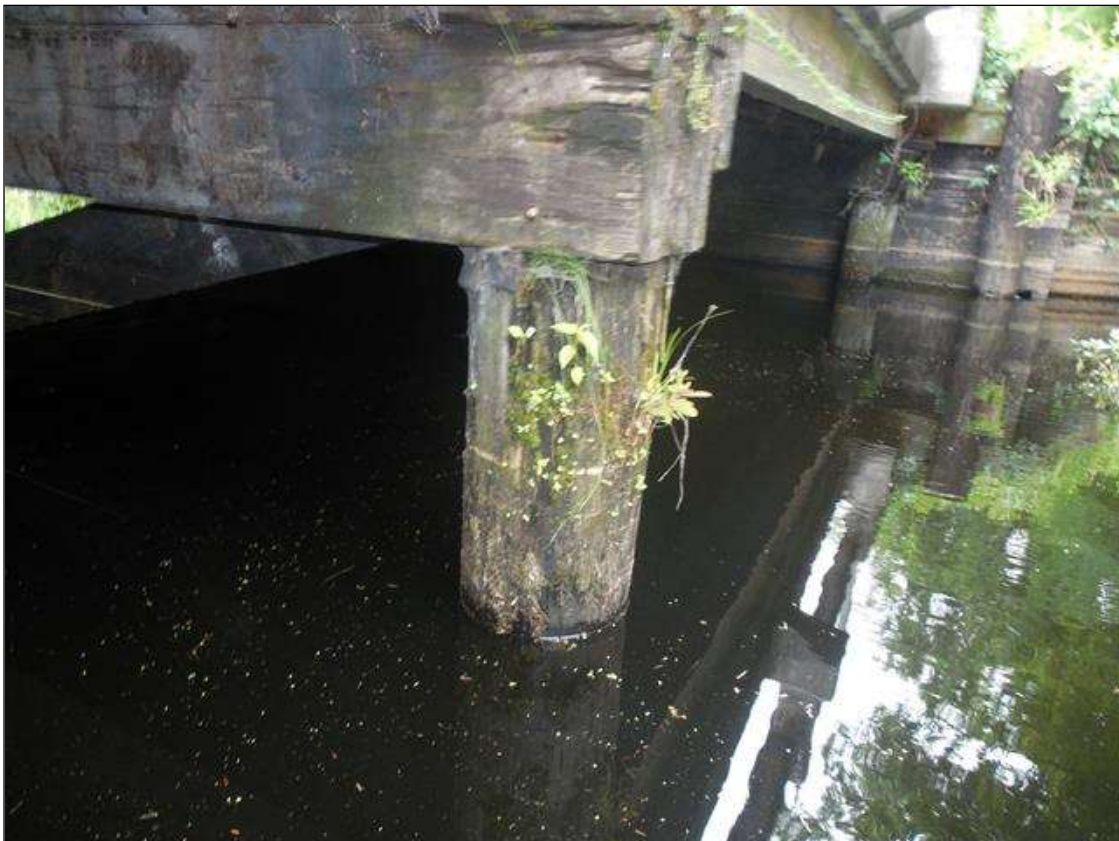
PILE 4 AT BENT 4 DECAYED 2' HIGH X 10" WIDE X 1 1/2" DEEP

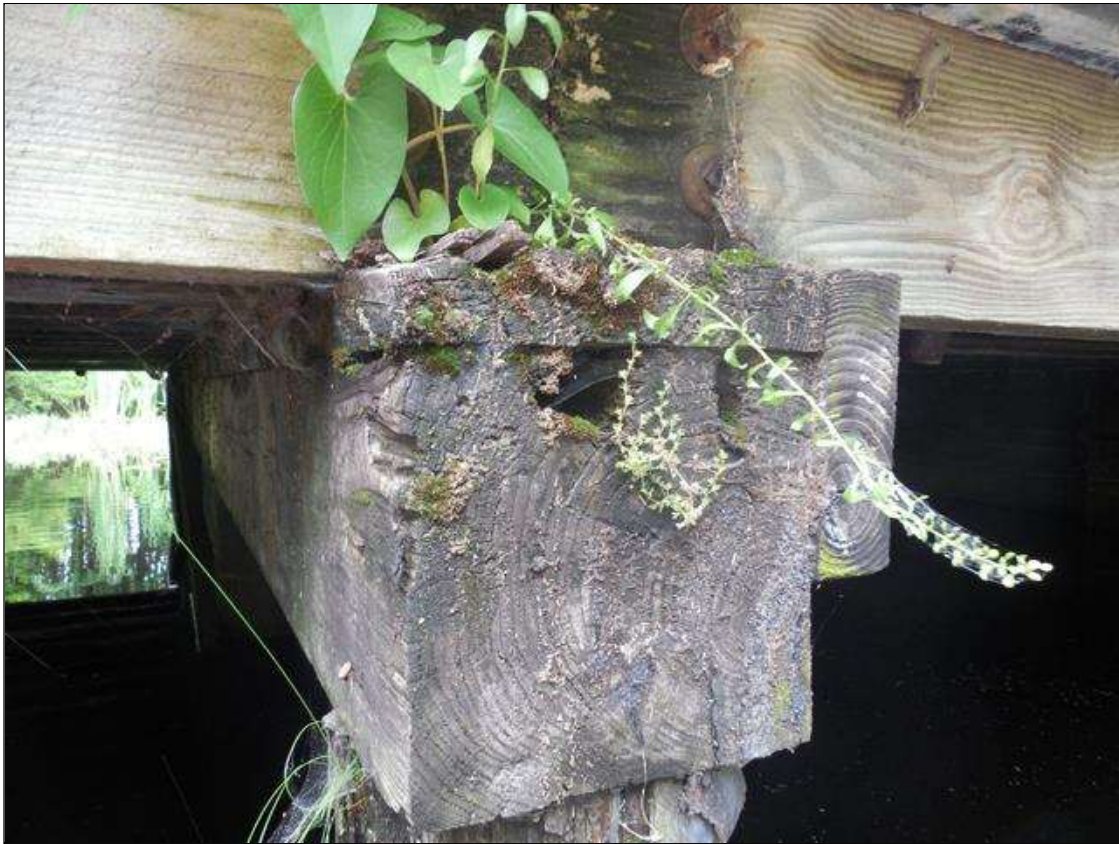
1 Feet of Decay/Section Loss: Affects less than 10% of the member section. SOUTH END OF BENT 4 CAP 2 HOLES 1 @ 3" DIAMETER X 7" DEEP AND 1 @ 2" W X 3" H X 6" DEEP

Bent 4 Cap : 1 Feet of Decay/Section Loss: Affects less than 10% of the member section. SOUTH END OF BENT 4  
CAP 2 HOLES 1 @ 3" DIAMETER X 7" DEEP AND 1 @ 2" W X 3" H X 6" DEEP

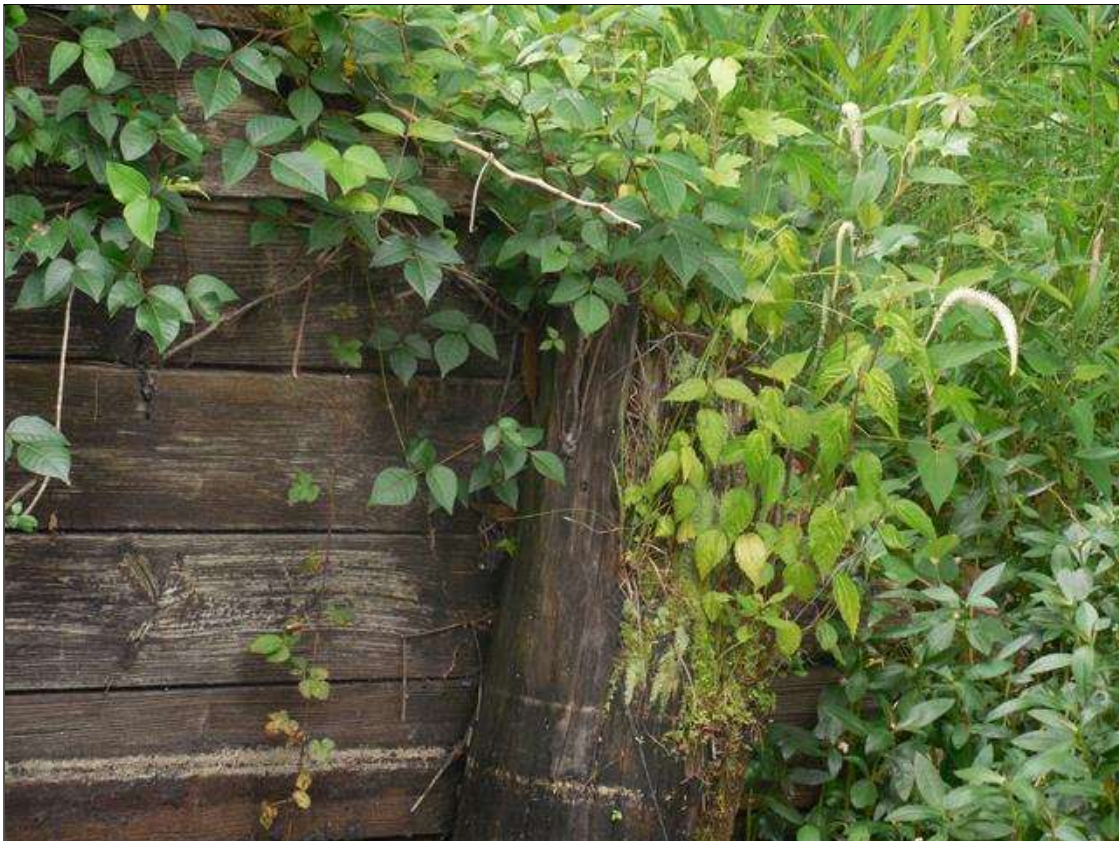
SOUTHWEST CORNER WINGWALL PILE DECAYED 2' HIGH X 14" WIDE X 2" DEEP 1 FT. MAINTENANCE

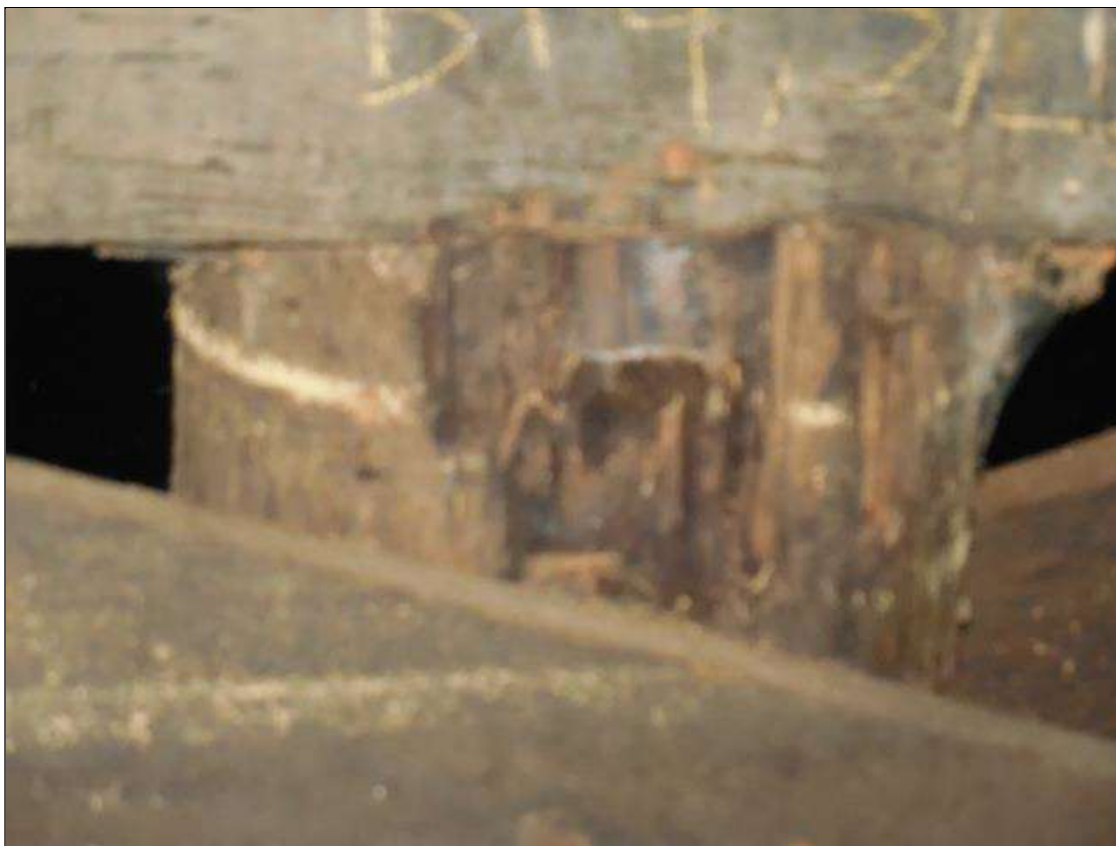
PILE 4 AT BENT 4 SPAN 5 FACE DECAYED 1' HIGH X 8" WIDE X 2" DEEP

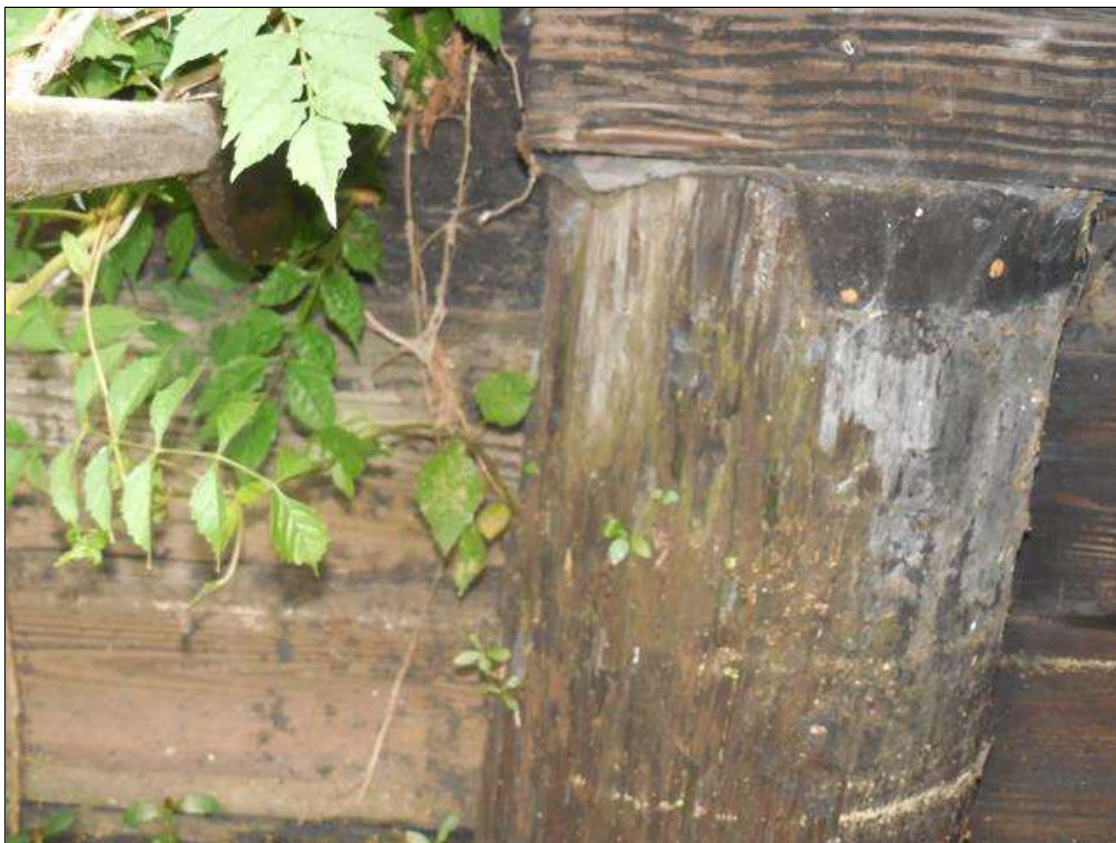
PILE 1 AT END BENT 2 SURFACE DECAYED 16" HIGH X 10" WIDE X 1" DEEP

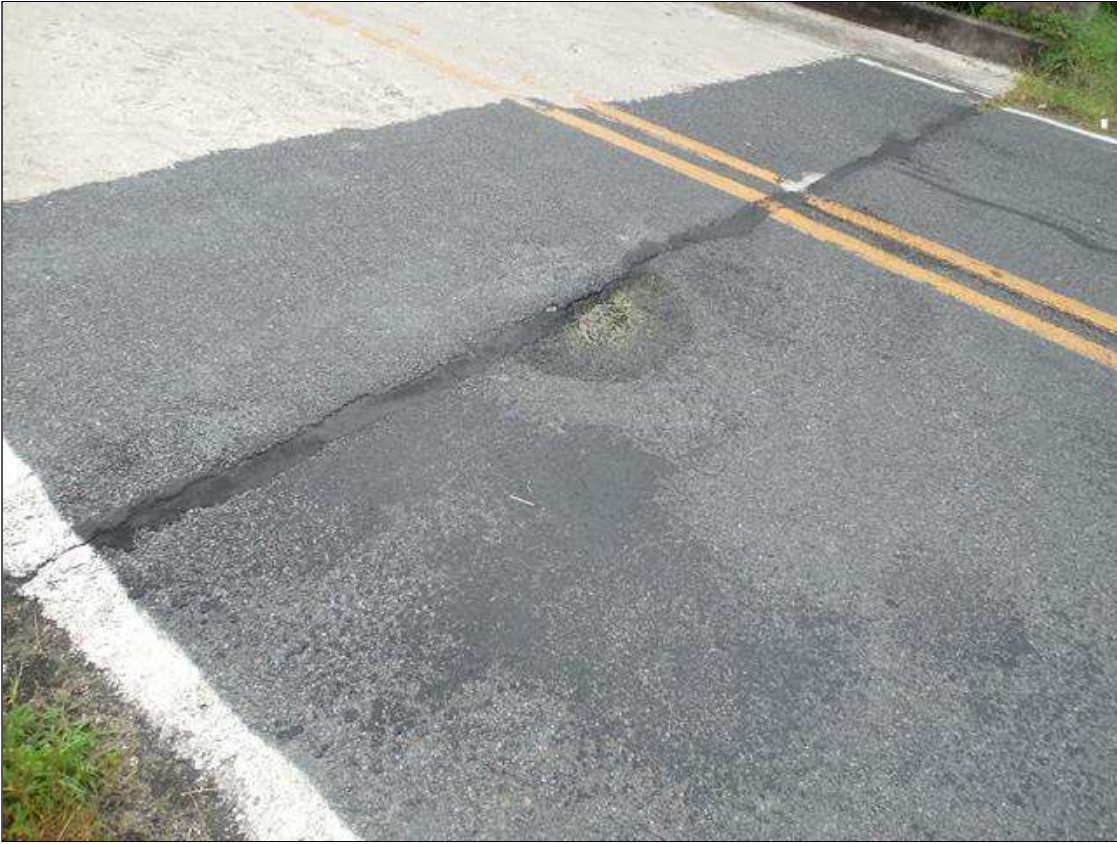
WEST APPROACH ASPHALT WEARING SURFACE SETTLED 2" IN WEST BOUND LANE WITH POT HOLE 16" WIDE X 8" LONG X 2" DEEP 20 SQ. FT. MAINTENANCE

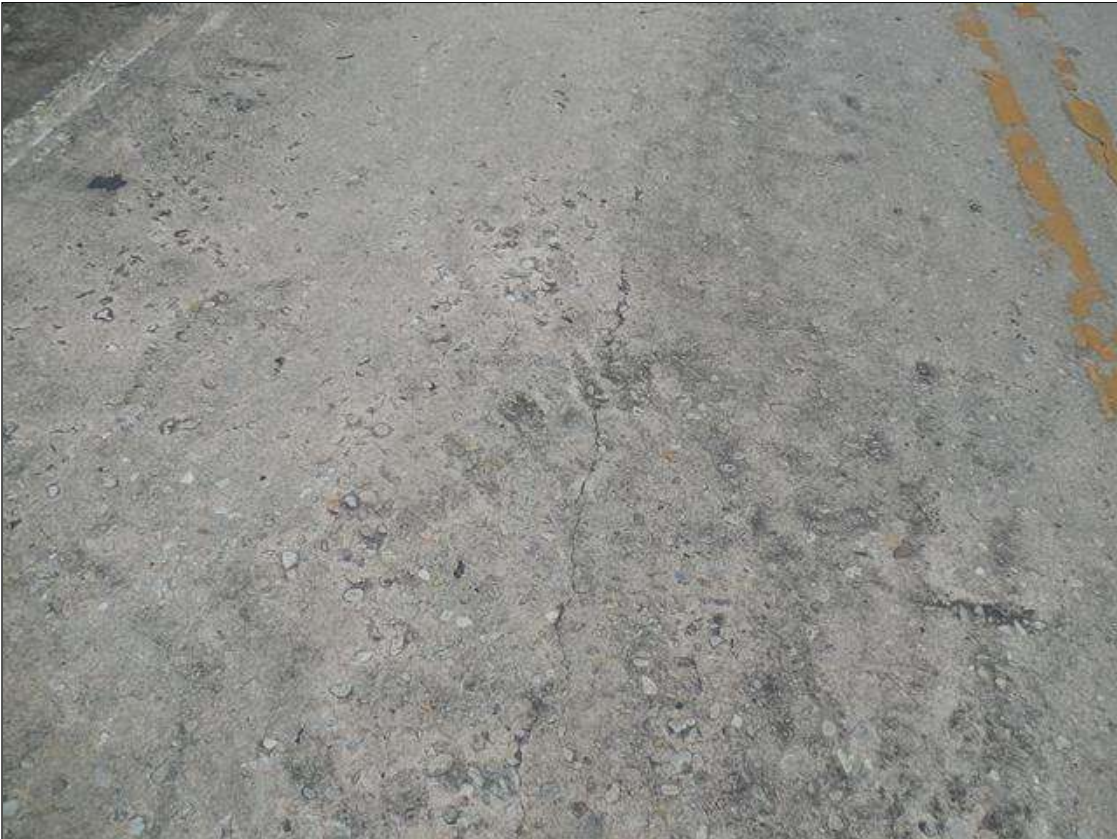
Span 1 Deck: 8 Square Feet of Cracking (RC and Other): Width greater than 0.05 in. or spacing of less than 1 ft. 1/16" LONGITUDINAL CRACK IN WEST BOUND LANE

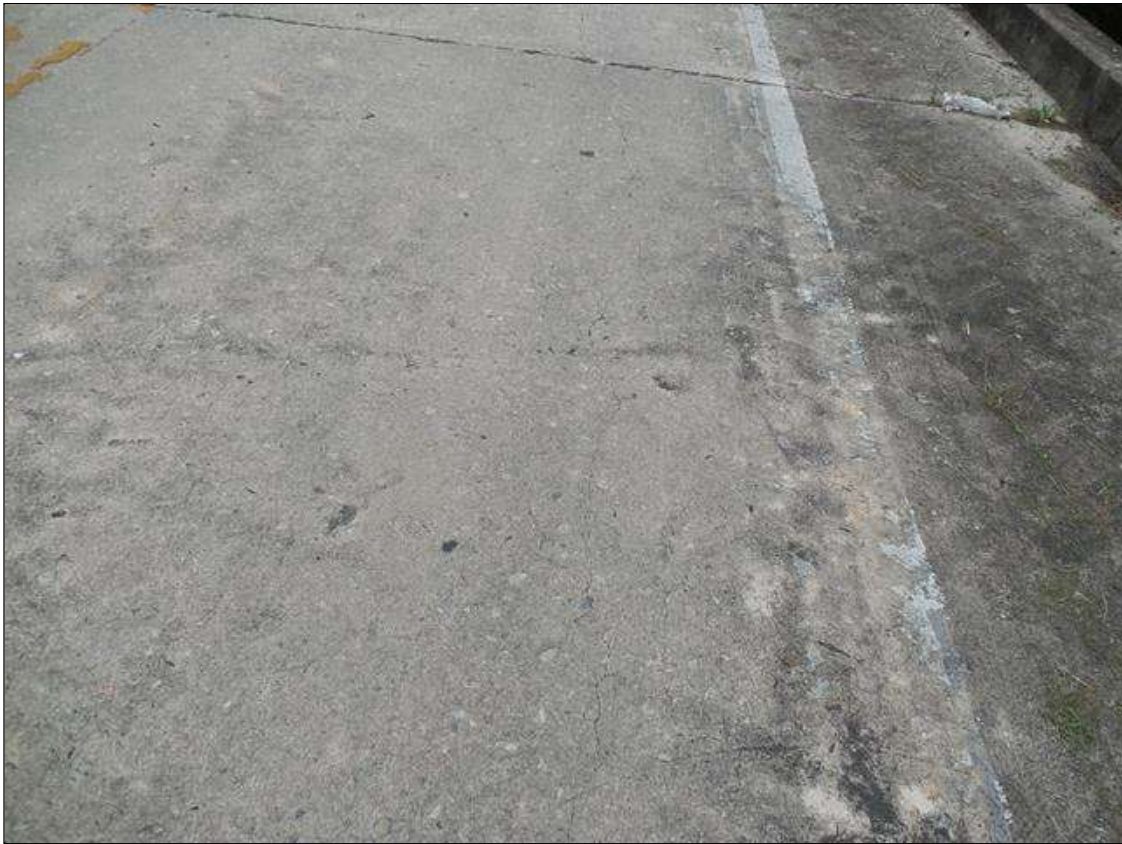
Span 1 Deck: 18 Square Feet of Cracking (RC and Other): Width greater than 0.05 in. or spacing of less than 1 ft.  
1/16" LONGITUDINAL CRACK IN EAST BOUND LANE
