NC DEPARTMENT OF TRANSPORTATION  
DIVISION OF HIGHWAYS  
STRUCTURE MANAGEMENT UNIT

## Structure Safety Report

### Routine Element Inspection

COUNTY: BLADEN STRUCTURE NUMBER: 080013 FREQUENCY: 24 MONTHS  
FACILITY CARRIED: SR1100 MILE POST: \_\_\_\_\_  
LOCATION: 0.4MI.E. OF JCT. SR1122  
FEATURE INTERSECTED: CRAWLEY SWAMP  
LATITUDE: 34° 37' 6.02" LONGITUDE: 78° 48' 2.78"  
SUPERSTRUCTURE: RC FLOOR ON TIMBER JOISTS  
SUBSTRUCTURE: EBTS&IBTS:TIMBER CAPS ON TIMBER PILES @ VAR.CTS.  
SPANS: 1@18"; 3@16.83"; 1@18"  
☐ FRACTURE CRITICAL ☐ TEMPORARY SHORING ☐ SCOUR CRITICAL ☒ SCOUR PLAN OF ACTION  
PRESENT CONDITION: Poor INSPECTION DATE: 06/09/2015  
POSTED SV: 19 POSTED TTST: 28  
OTHER SIGNS PRESENT: 4 DELINEATORS

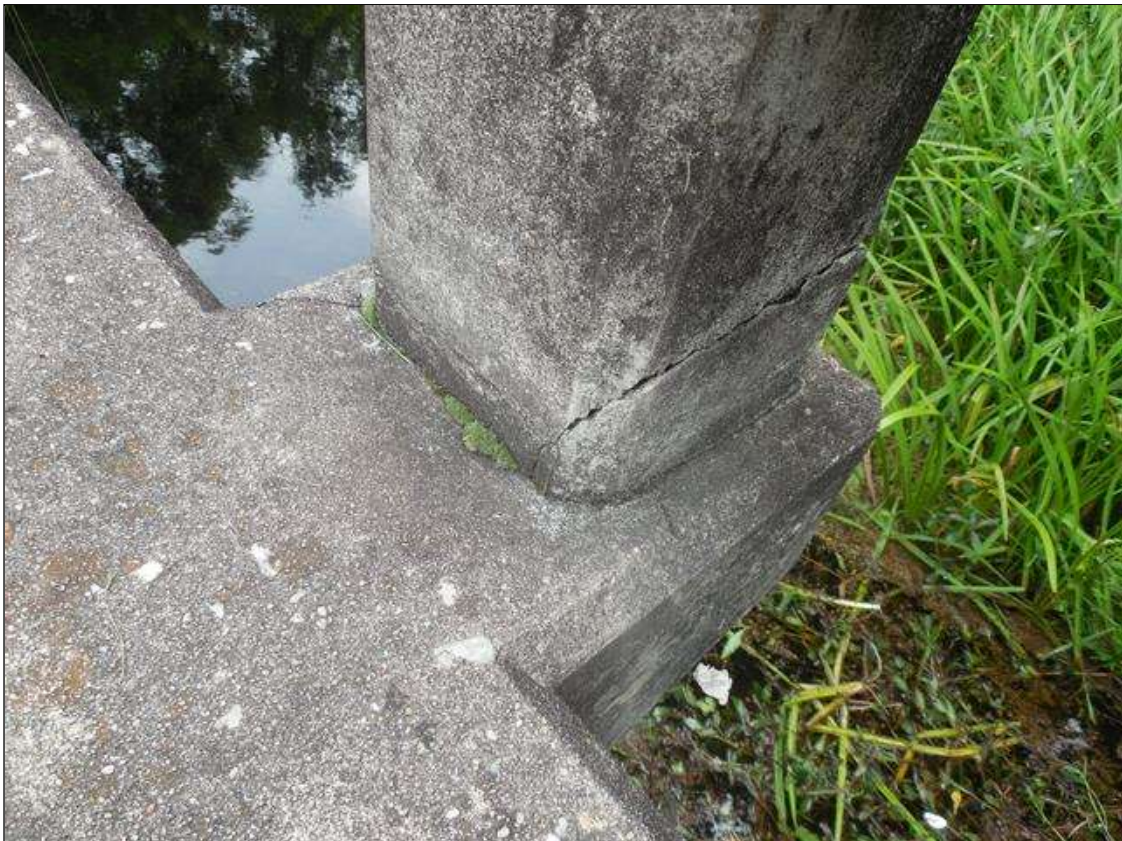
1 Feet of Cracking (RC and Other): Width greater than 0.05 in. or spacing of less than 1 ft. 1/16" CRACK AT RAIL POST 2

Span 1 Right Bridge Rail: 1 Feet of Cracking (RC and Other): Width greater than 0.05 in. or spacing of less than 1 ft.  
1/16" CRACK AT RAIL POST 2

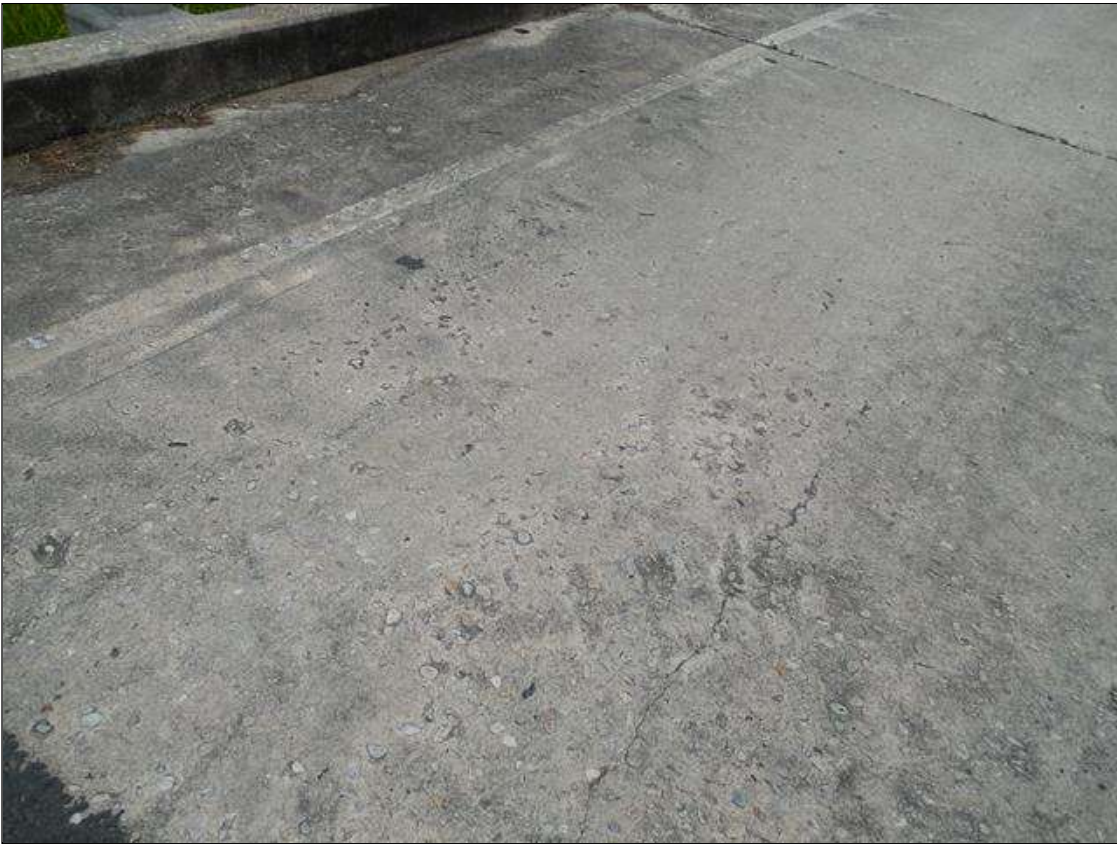
Span 1 Deck: 300 Square Feet of Abrasion/Wear (PSC/RC): Abrasion or wearing has exposed coarse aggregate but the aggregate remains secure in the concrete. SCALING WITH EXPOSED AGGREGATE

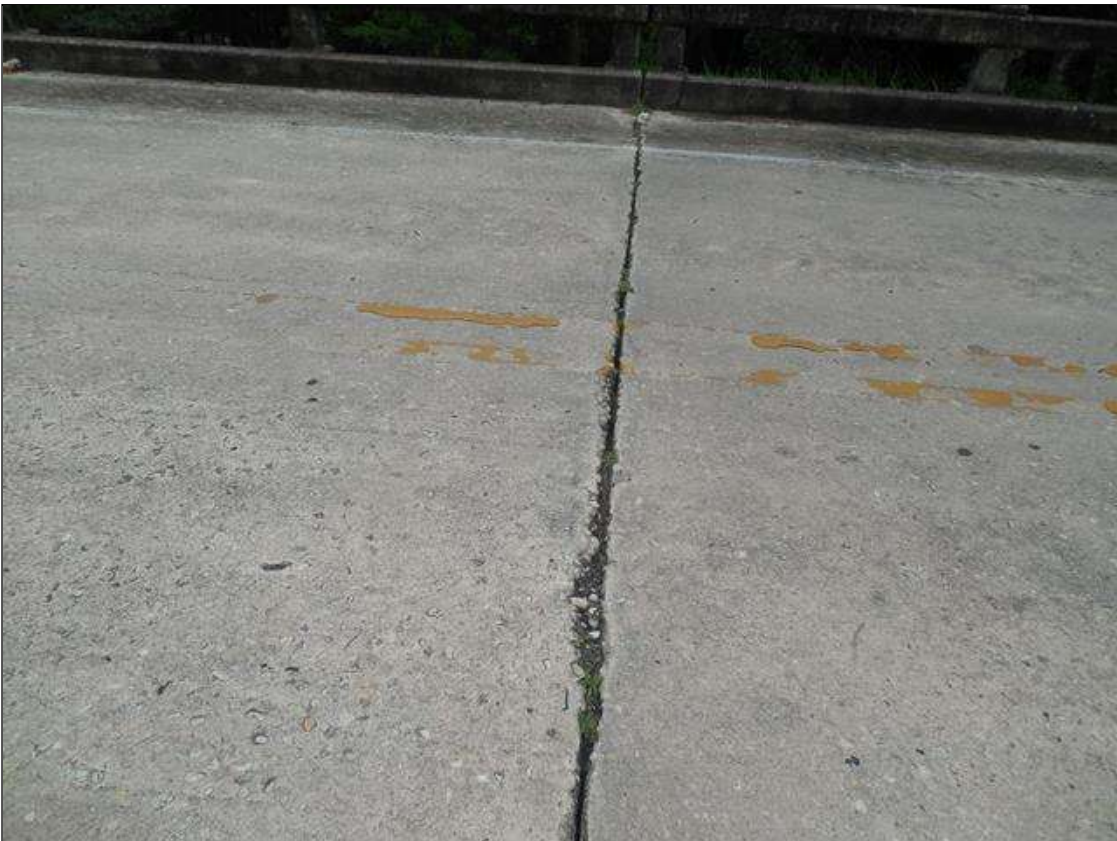
26 Feet of Leakage: Moderate. More than a drip and less than free flow of water. JOINT MATERIAL MISSING , LEAKING

Expansion Joint 2 : 26 Feet of Leakage: Moderate. More than a drip and less than free flow of water. JOINT MATERIAL MISSING , LEAKING

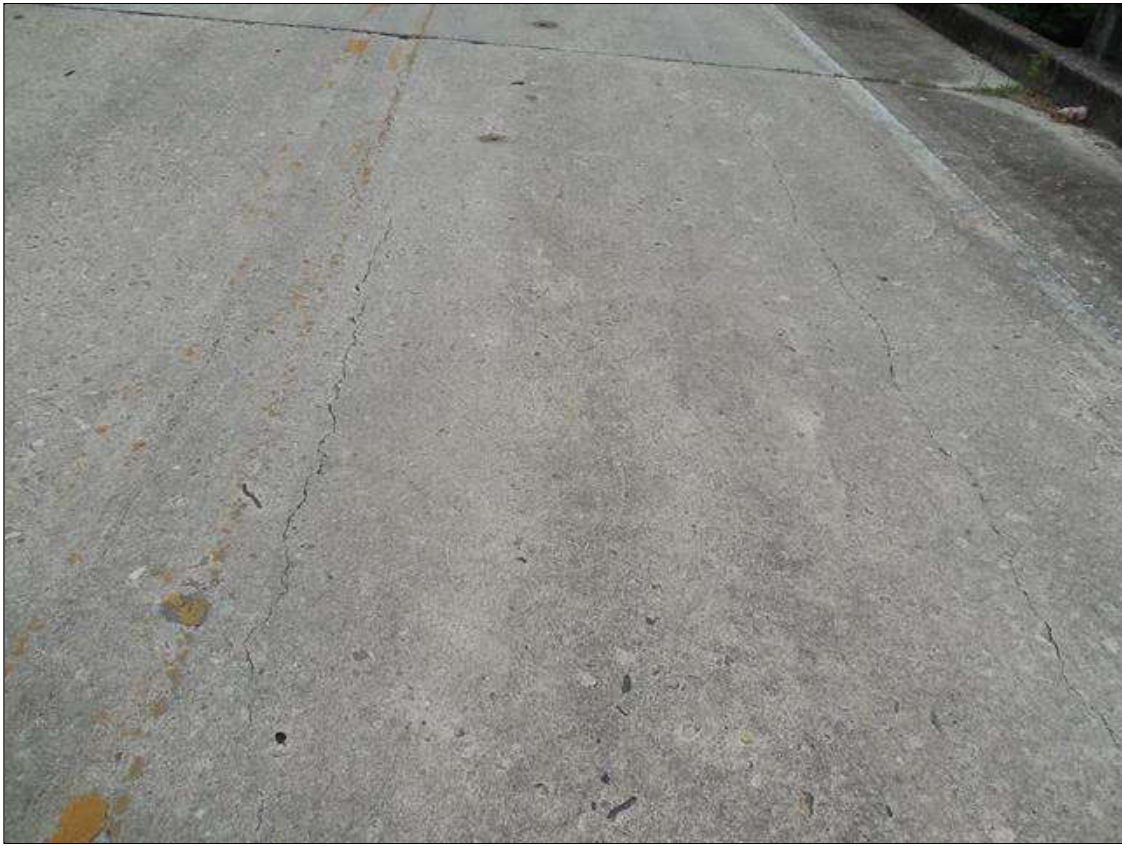
Span 2 Deck: 34 Square Feet of Cracking (RC and Other): Width greater than 0.05 in. or spacing of less than 1 ft. 2  
17' X 1/8" LONGITUDINAL CRACKS IN EAST BOUND LANE

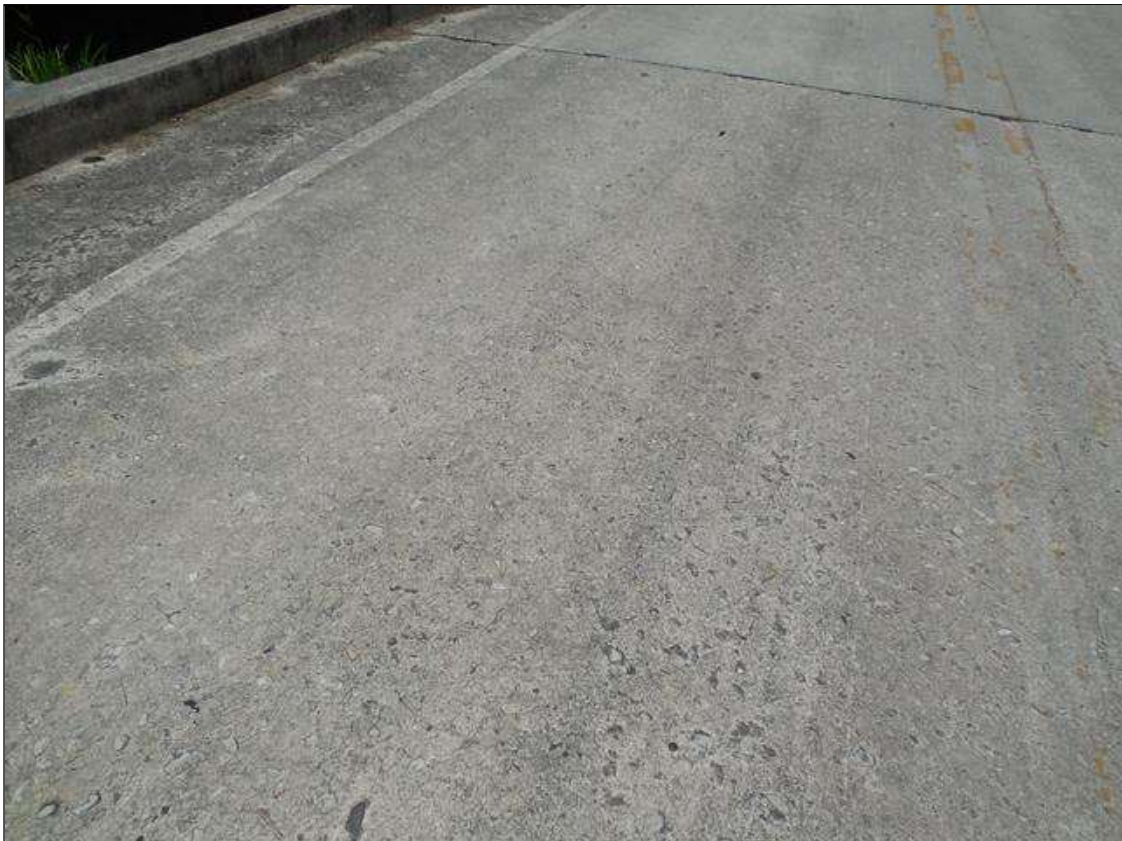
Span 2 Deck: 190 Square Feet of Abrasion/Wear (PSC/RC): Abrasion or wearing has exposed coarse aggregate but  
the aggregate remains secure in the concrete.

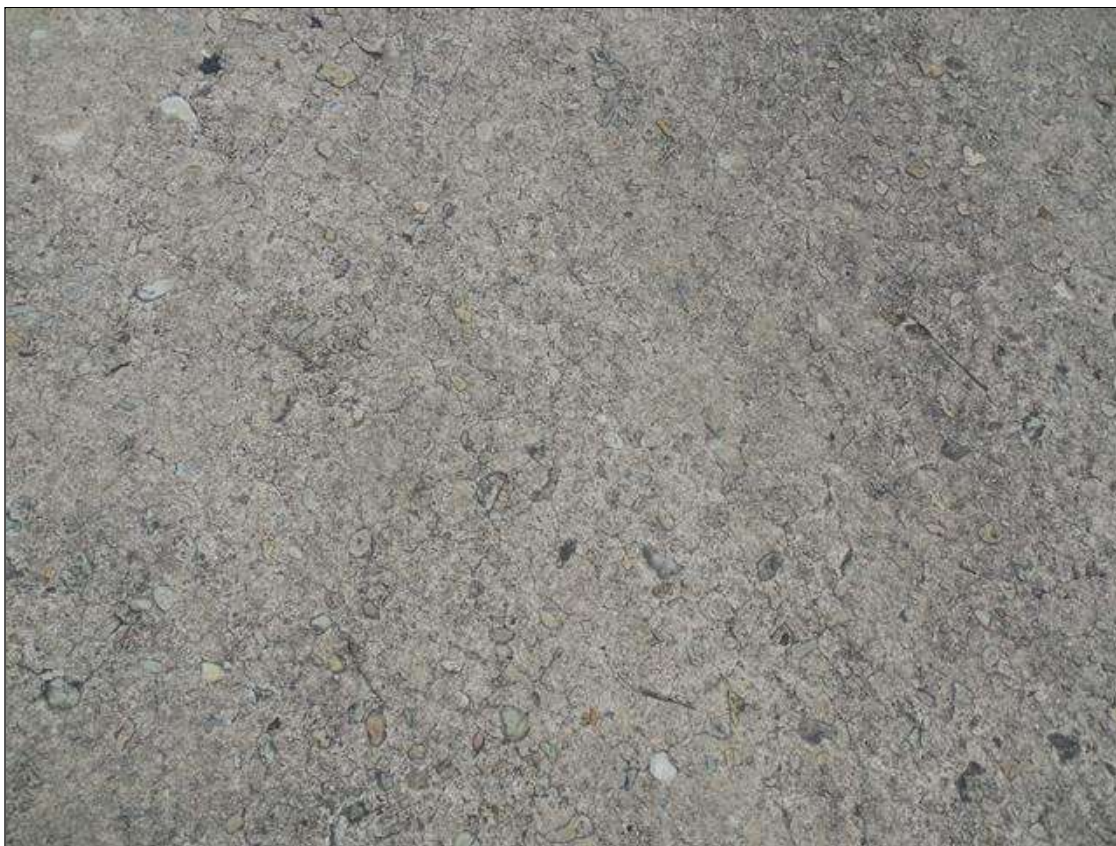
Span 2 Deck: 187 Square Feet of Cracking (RC and Other): Width greater than 0.05 in. or spacing of less than 1 ft.  
HAIRLINE MAP CRACKING

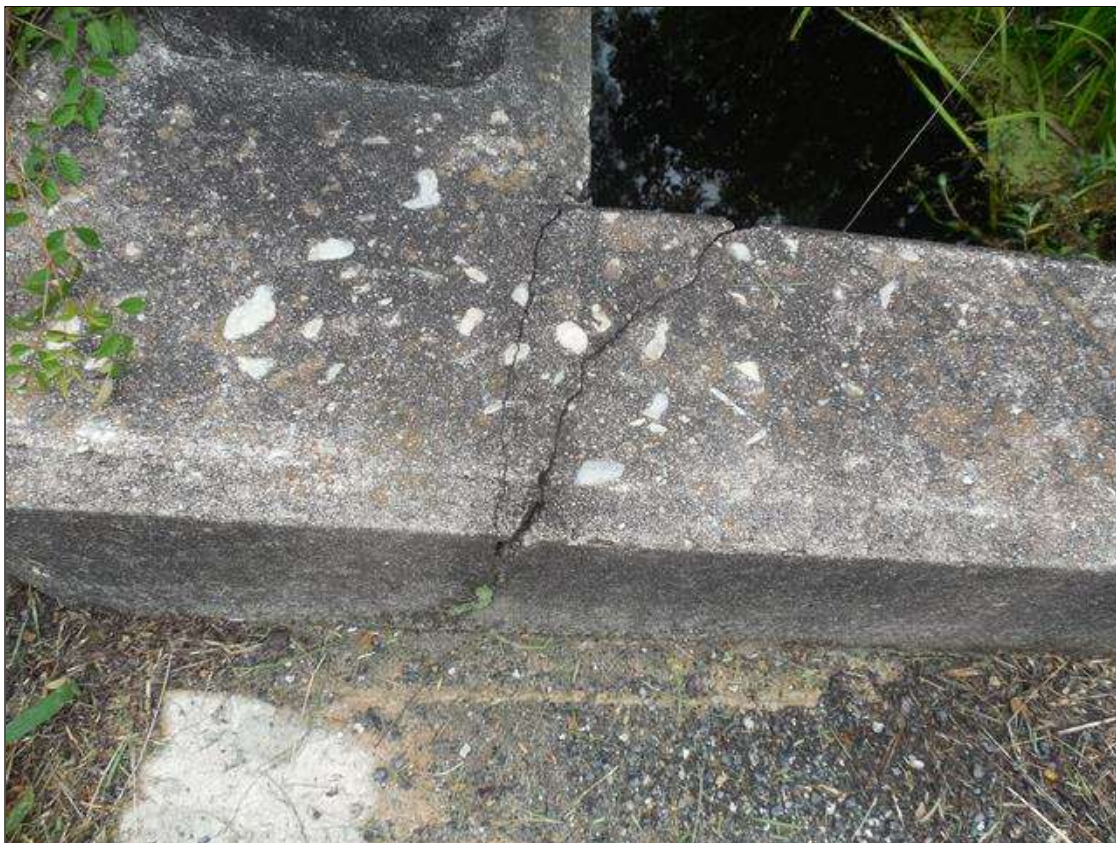
SPAN 1 RIGHT CURB CRACKED AT BENT 1

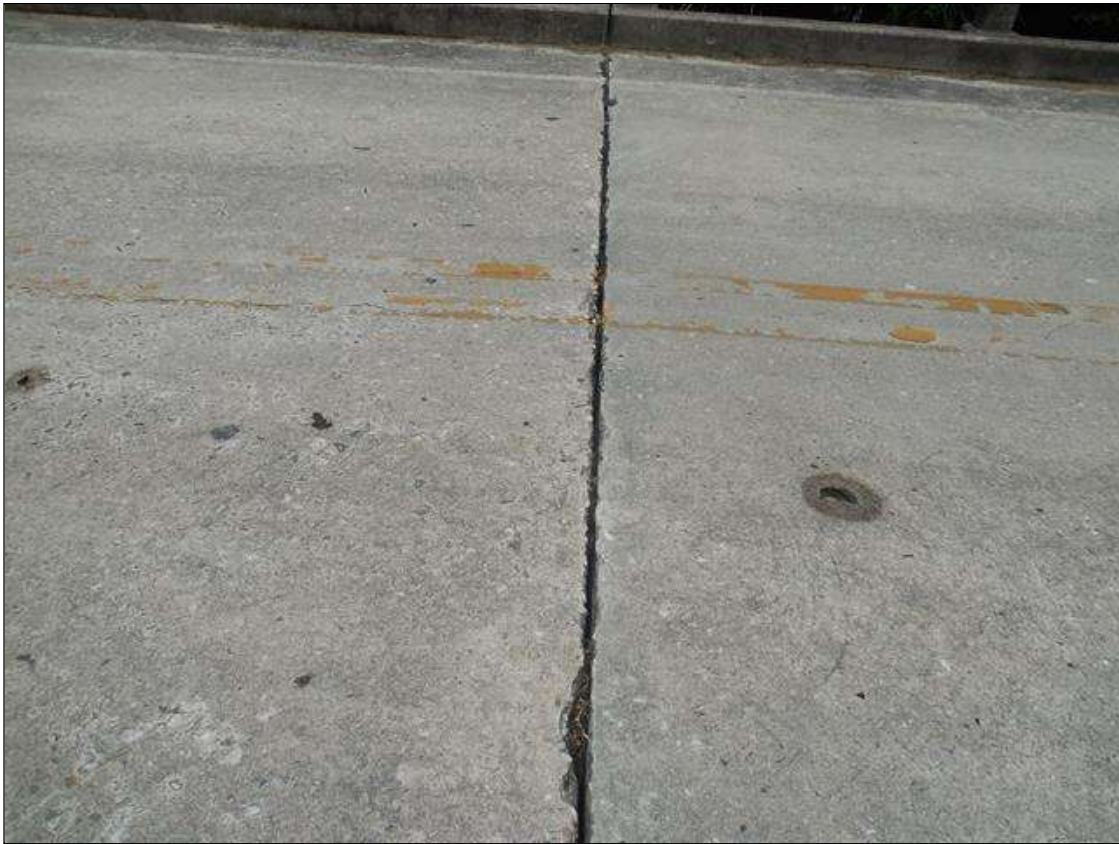
26 Feet of Leakage: Moderate. More than a drip and less than free flow of water. BT 2 JOINT MATERIAL MISSING , LEAKING

Expansion Joint 3 : 26 Feet of Leakage: Moderate. More than a drip and less than free flow of water. BT 2 JOINT MATERIAL MISSING , LEAKING

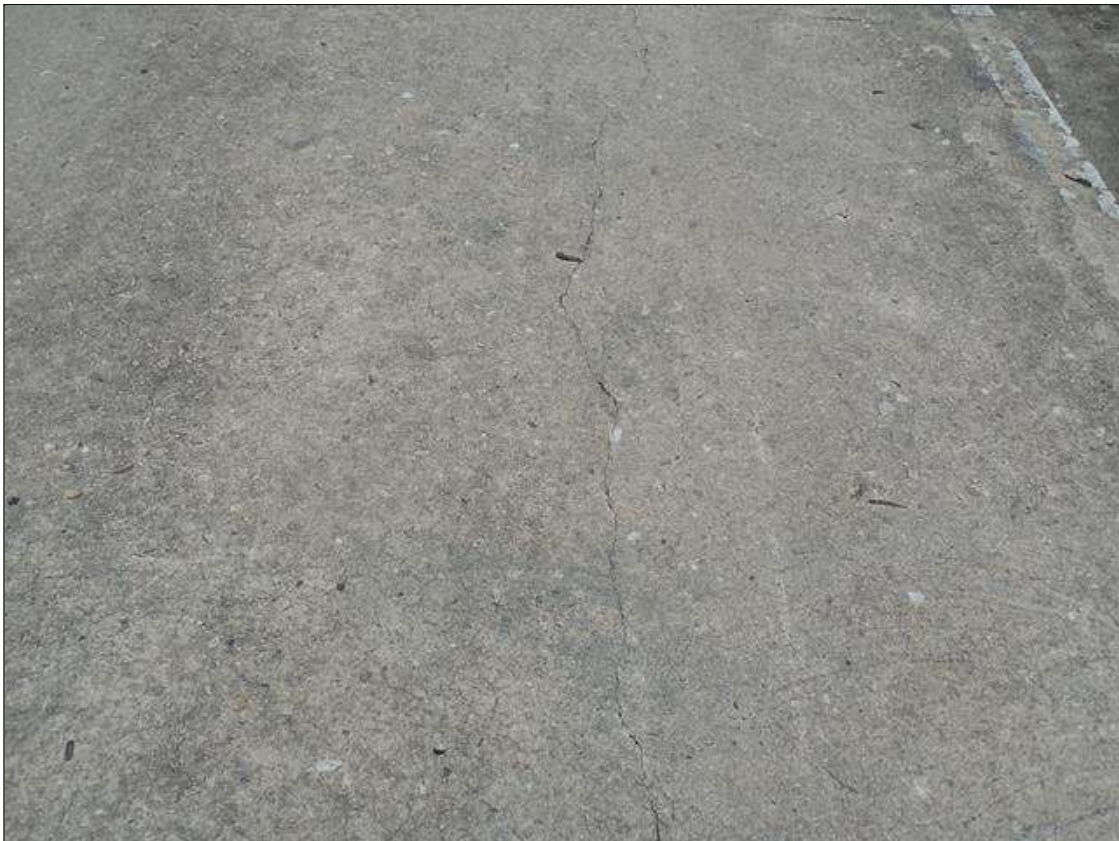
Span 3 Deck: 20 Square Feet of Cracking (RC and Other): Width greater than 0.05 in. or spacing of less than 1 ft. 1/16" LONGITUDINAL CRACK IN EAST BOUND LANE

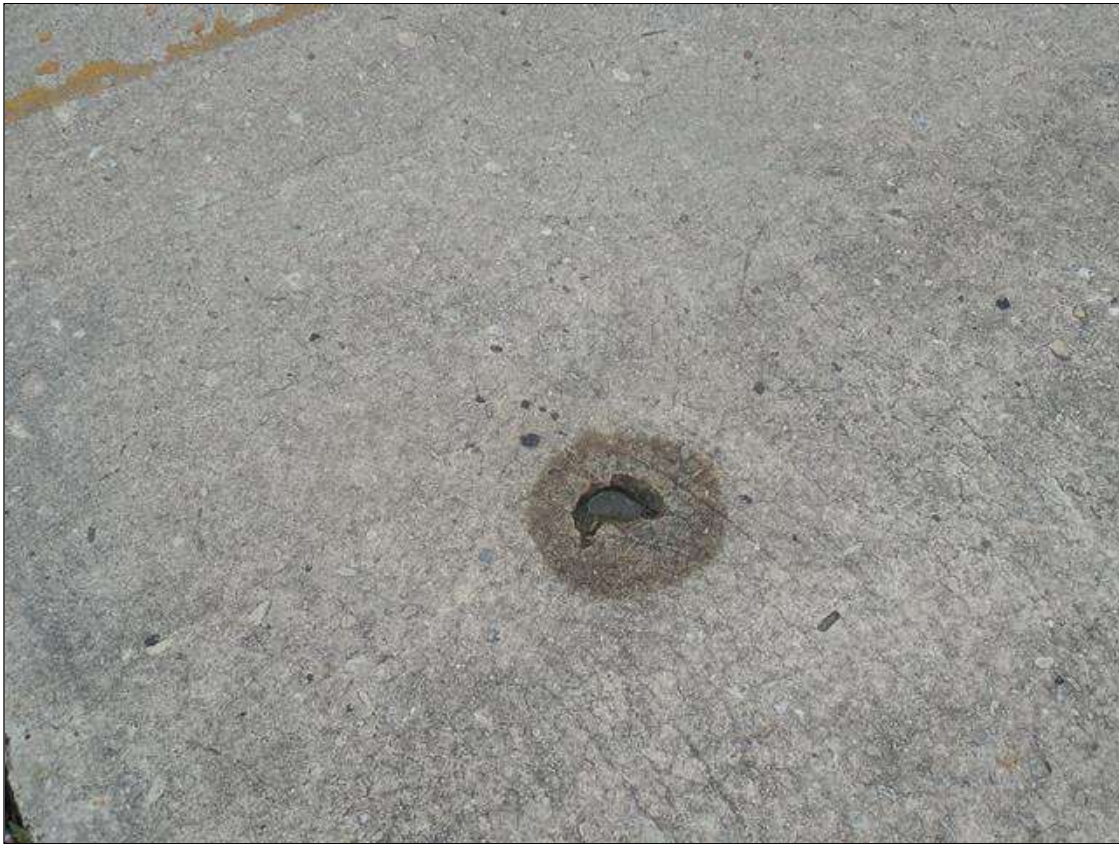
Span 3 Deck: 1 Square Feet of Delamination/Spall/Patched Area: Delaminated. Spall 1 in. or less deep or 6 in. or less in diameter. Patched area that is sound. SURFACE SPALL 3" DIAMETER X 1" DEEP IN EAST BOUND LANE

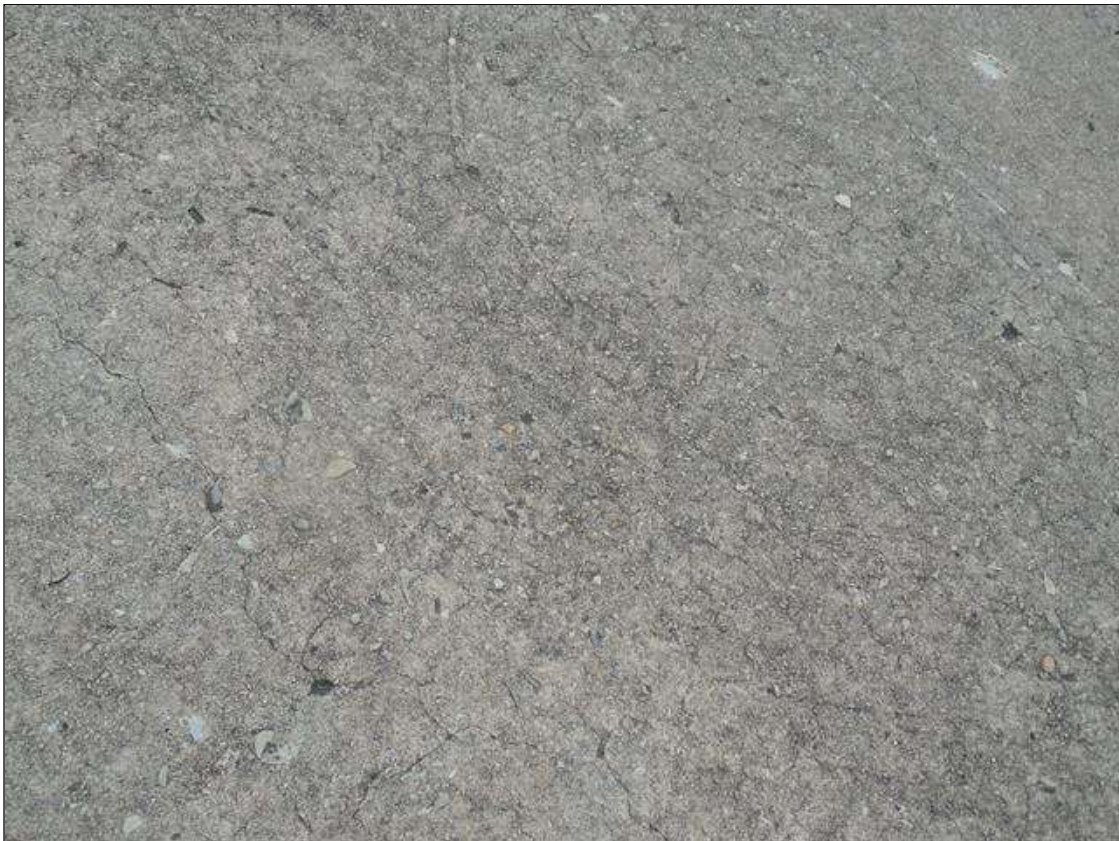
Span 3 Deck: 150 Square Feet of Cracking (RC and Other): Width greater than 0.05 in. or spacing of less than 1 ft.  
HAIRLINE MAP CRACKING

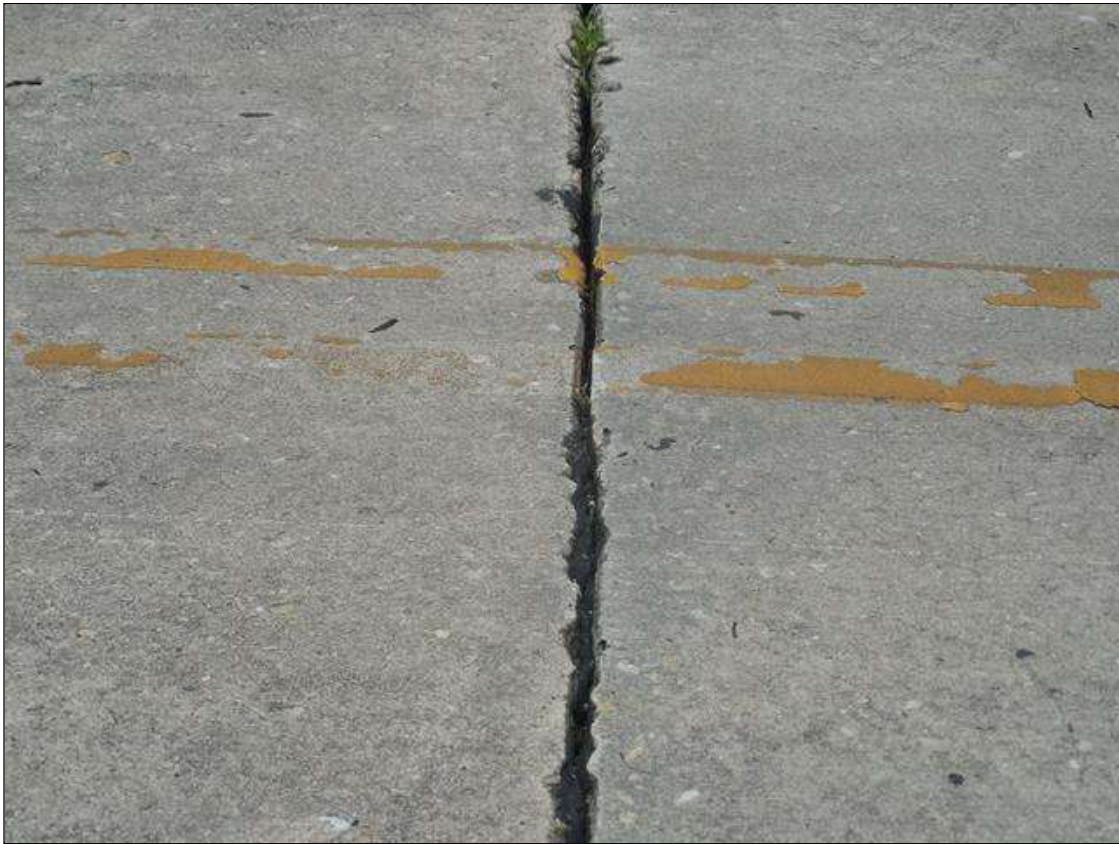
26 Feet of Leakage: Moderate. More than a drip and less than free flow of water. BENT 3 JOINT MATERIAL MISSING , LEAKING

Expansion Joint 4 : 26 Feet of Leakage: Moderate. More than a drip and less than free flow of water. BENT 3 JOINT MATERIAL MISSING , LEAKING

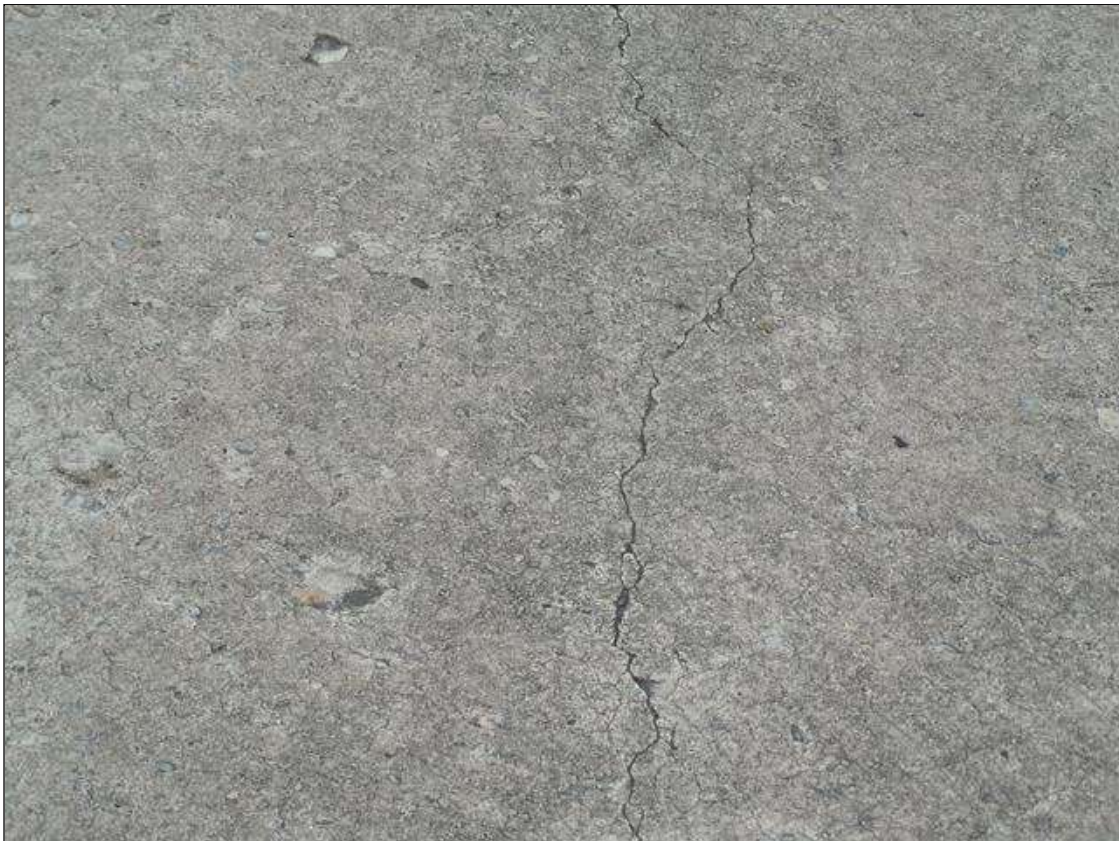
15 Square Feet of Cracking (RC and Other): Width greater than 0.05 in. or spacing of less than 1 ft. 1/8" LONGITUDINAL CRACK IN EAST BOUND LANE

Span 4 Deck: 15 Square Feet of Cracking (RC and Other): Width greater than 0.05 in. or spacing of less than 1 ft. 1/8" LONGITUDINAL CRACK IN EAST BOUND LANE

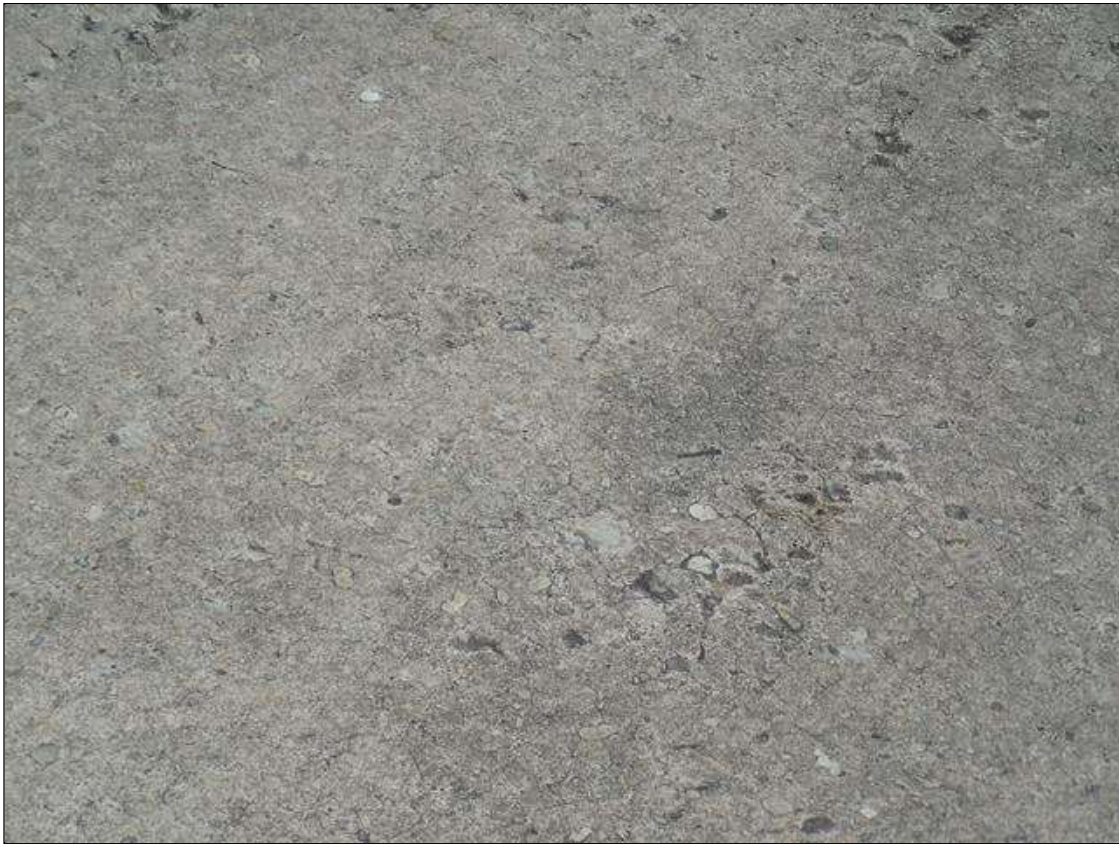
100 Square Feet of Abrasion/Wear (PSC/RC): Abrasion or wearing has exposed coarse aggregate but the aggregate remains secure in the concrete.

Span 4 Deck: 100 Square Feet of Abrasion/Wear (PSC/RC): Abrasion or wearing has exposed coarse aggregate but the aggregate remains secure in the concrete.

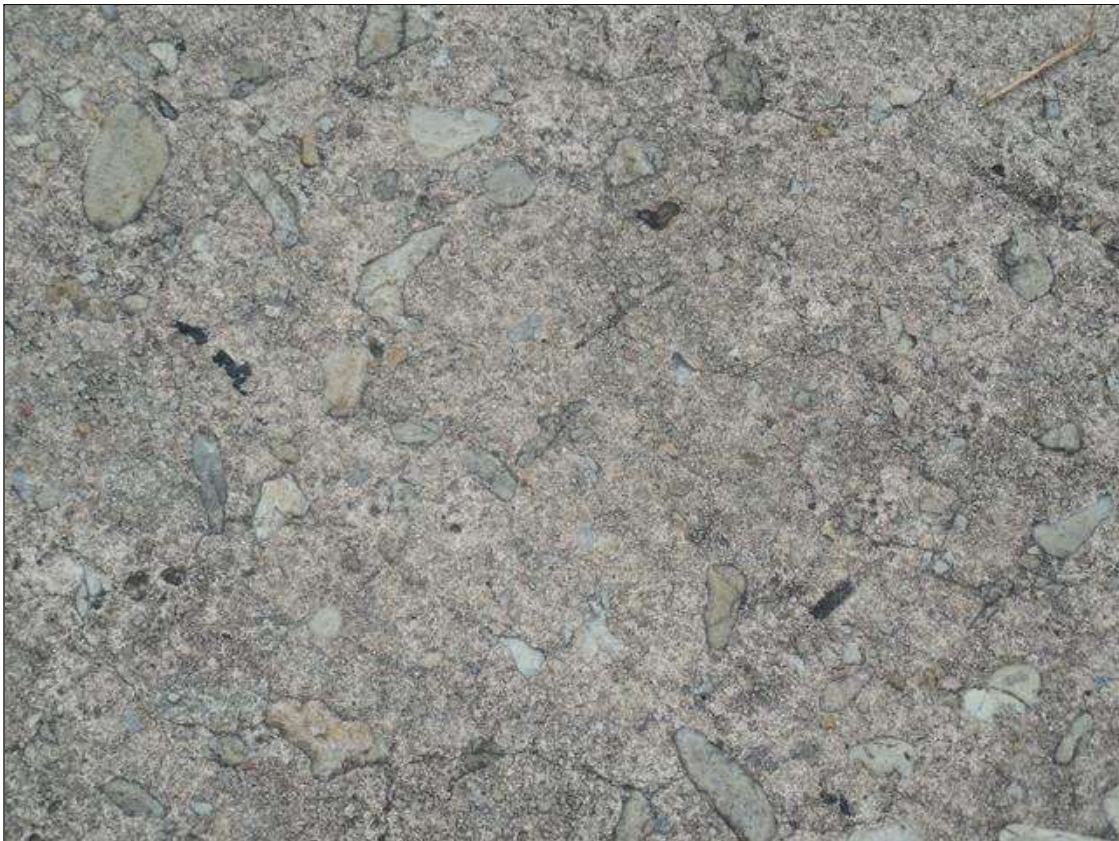
200 Square Feet of Cracking (RC and Other): Width greater than 0.05 in. or spacing of less than 1 ft. HAIRLINE MAP CRACKING

Span 4 Deck: 200 Square Feet of Cracking (RC and Other): Width greater than 0.05 in. or spacing of less than 1 ft.  
HAIRLINE MAP CRACKING

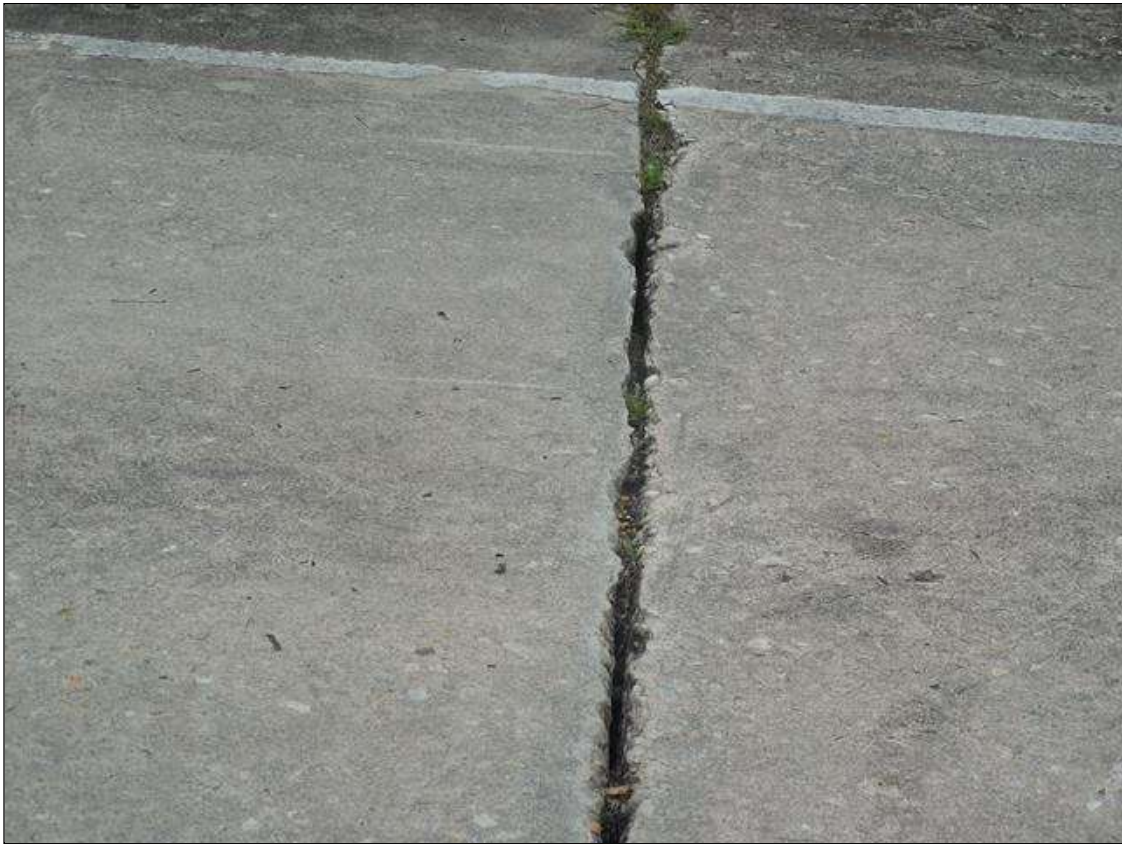
26 Feet of Leakage: Moderate. More than a drip and less than free flow of water. BENT 4 JOINT MATERIAL MISSING , LEAKING

Expansion Joint 5 : 26 Feet of Leakage: Moderate. More than a drip and less than free flow of water. BENT 4 JOINT MATERIAL MISSING , LEAKING

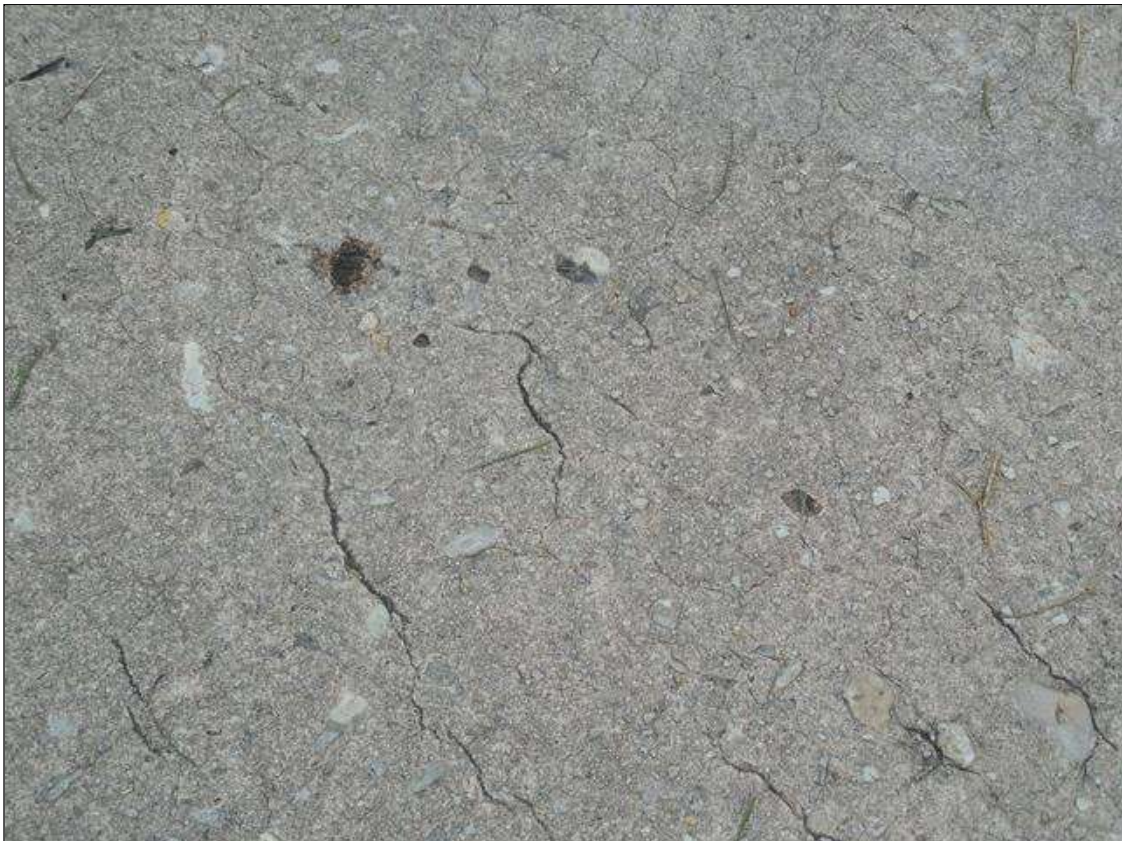
200 Square Feet of Cracking (RC and Other): Width greater than 0.05 in. or spacing of less than 1 ft. 1/16" TO 1/8" MAP CRACKING

Span 5 Deck: 200 Square Feet of Cracking (RC and Other): Width greater than 0.05 in. or spacing of less than 1 ft. 1/16" TO 1/8" MAP CRACKING

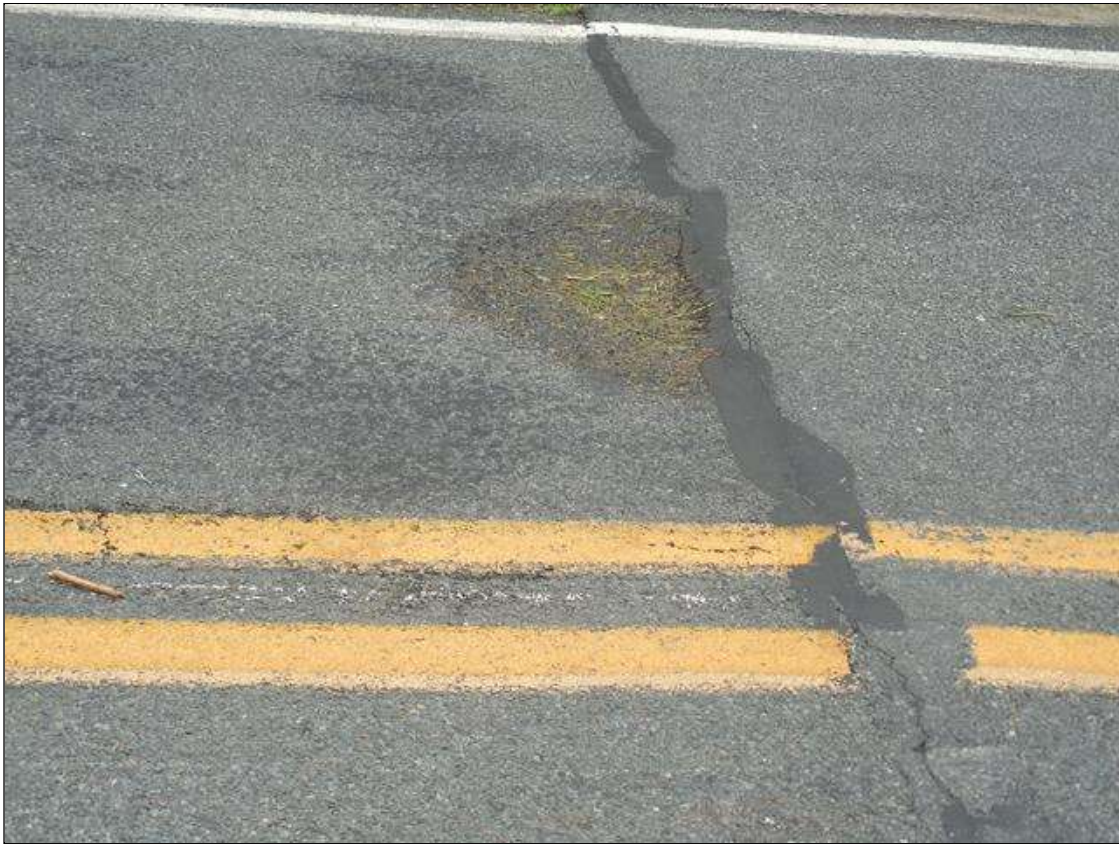
EAST APPROACH ASPHALT WEARING SURFACE SETTLED 1" 20 SQ. FT. MAINTENANCE

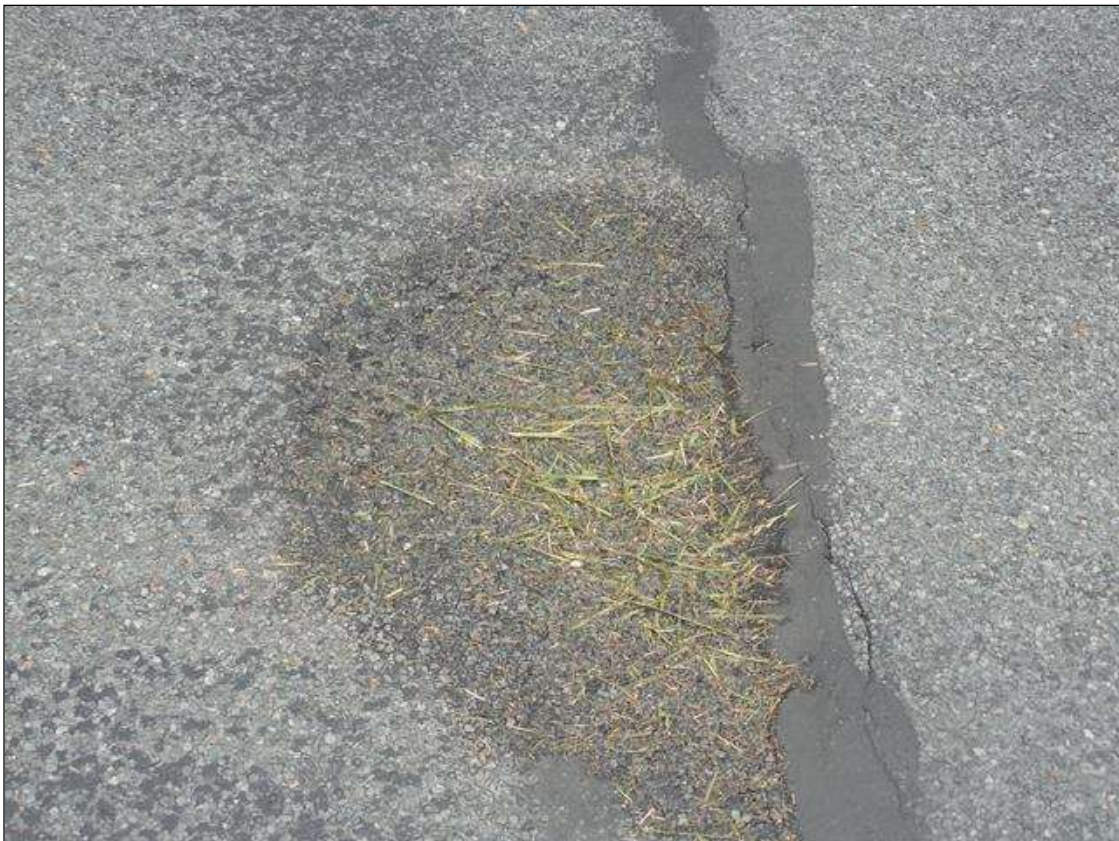
EAST APPROACH ASPHALT WEARING SURFACE POT HOLE 16" WIDE X 10" LONG X 1" DEEP IN EAST BOUND LANE

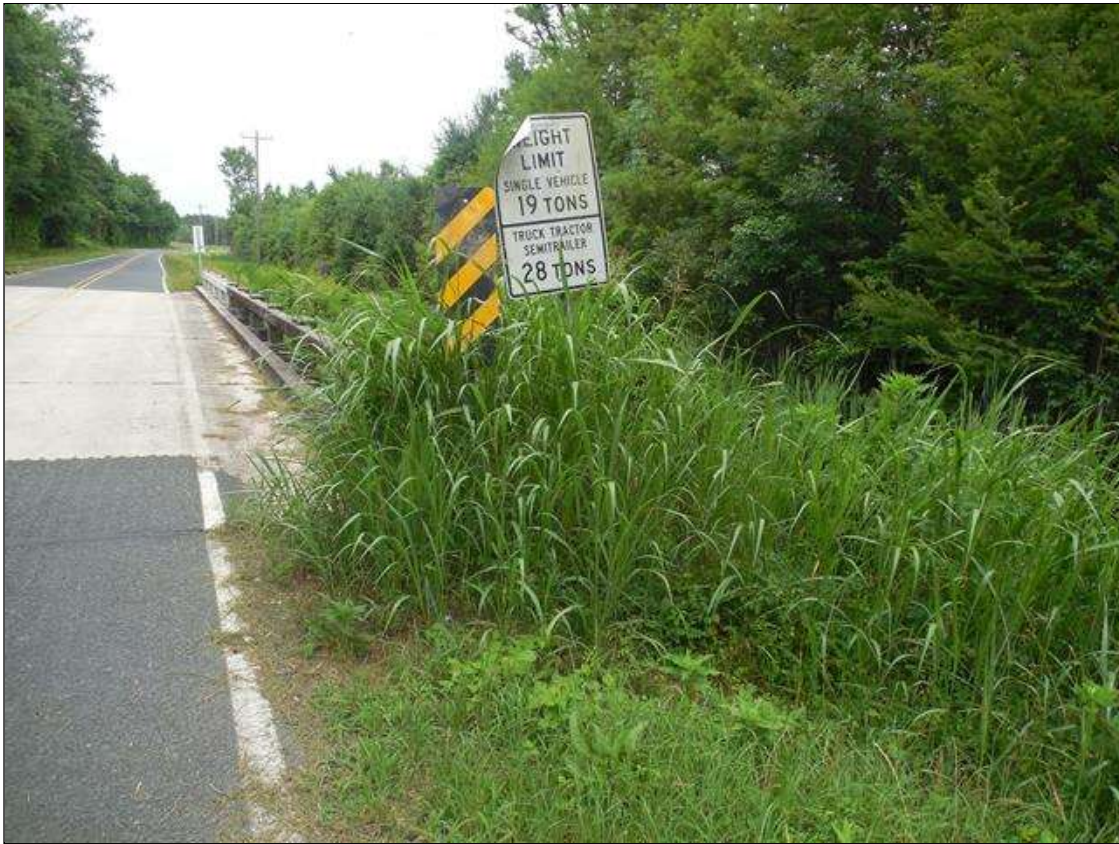
VEGETATION OVER RAIL AT NORTHEAST CORNER 20 SQ. FT. BRUSH CONTROL

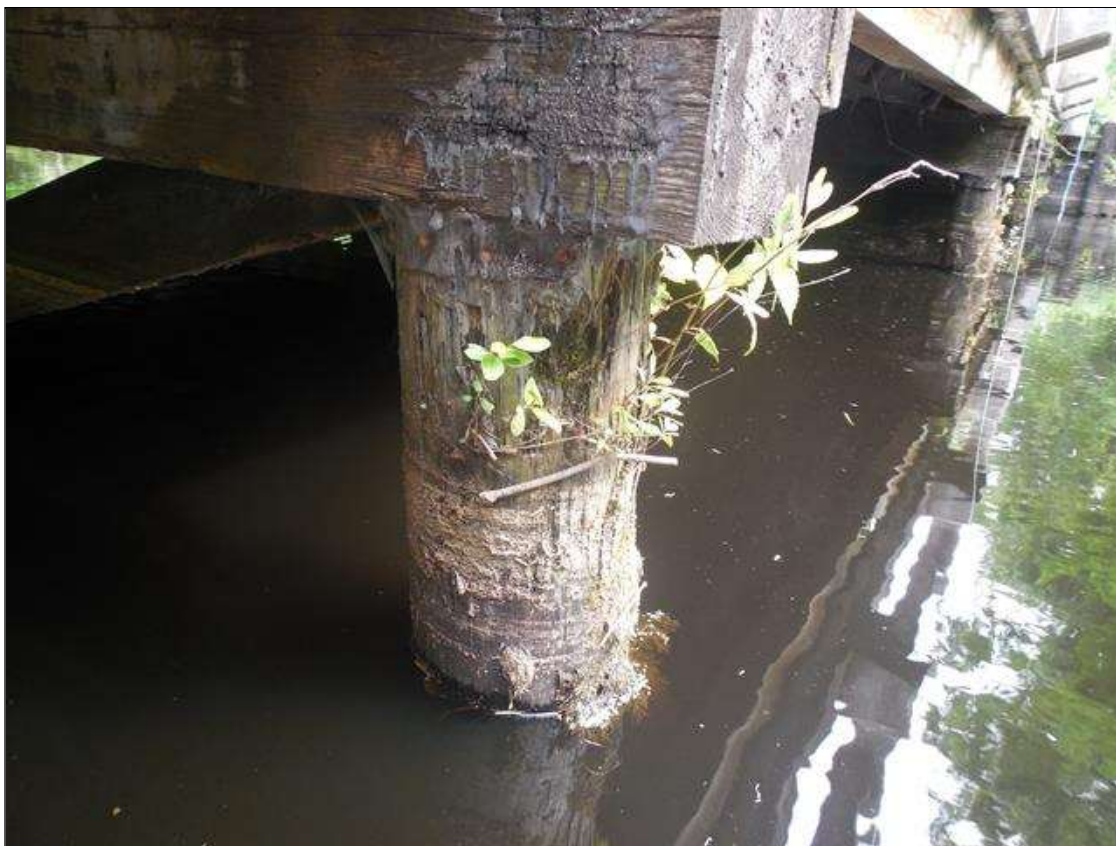
PILE 4 AT BENT 2 DECAYED 1' HIGH X 8" WIDE X 1" DEEP

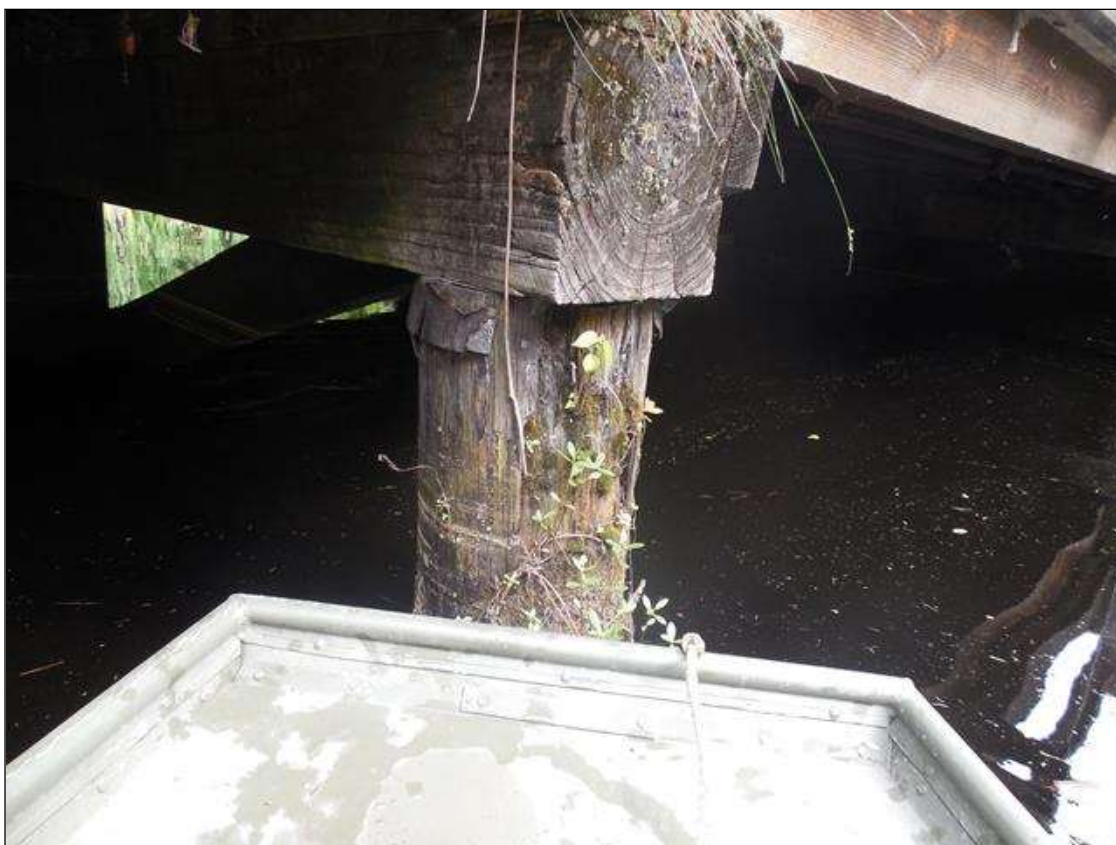
PILE 4 AT BENT 3 DECAYED 14" HIGH X 10" WIDE X 1 1/2" DEEP
