# Structure Safety Report

## 2 Year Complete Topside and Underwater Element Inspection

COUNTY: ROBESON STRUCTURE NUMBER: 770422 FREQUENCY: 24 MONTHS

FEATURE INTERSECTED: JACKSON SWAMP

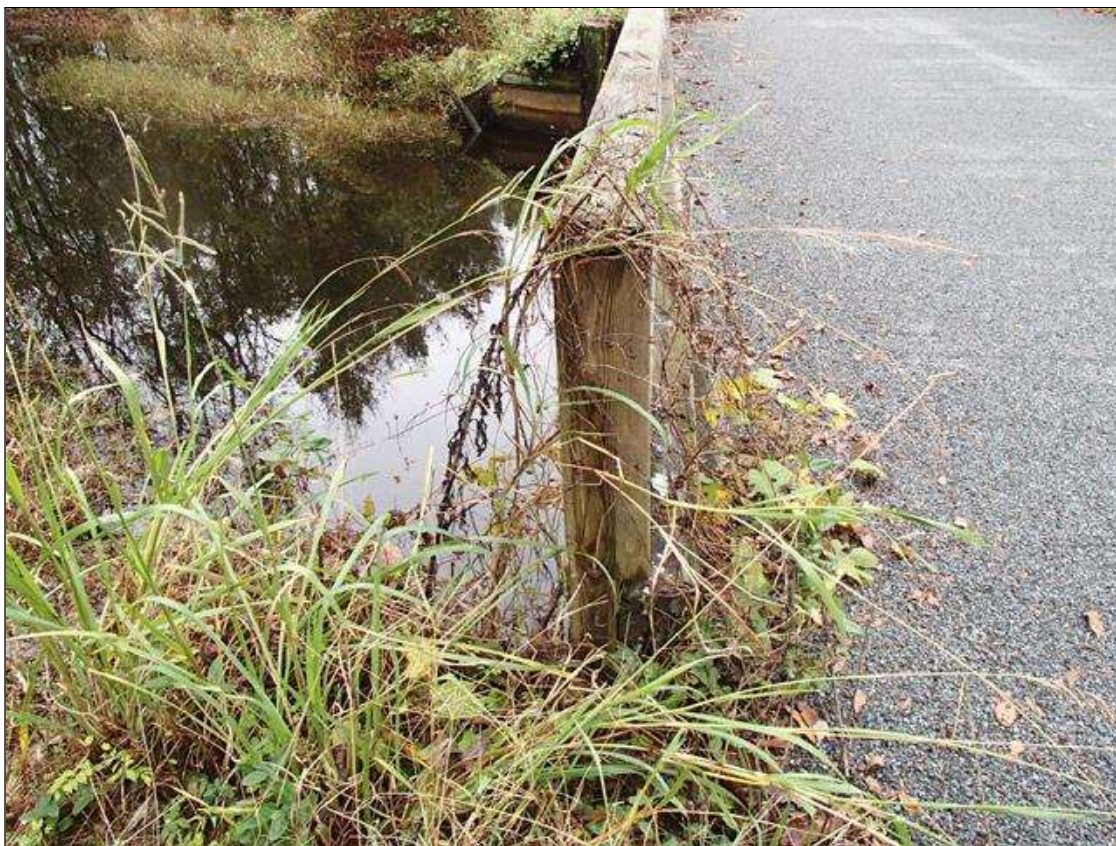
SE CORNER - MISSING DELINEATOR

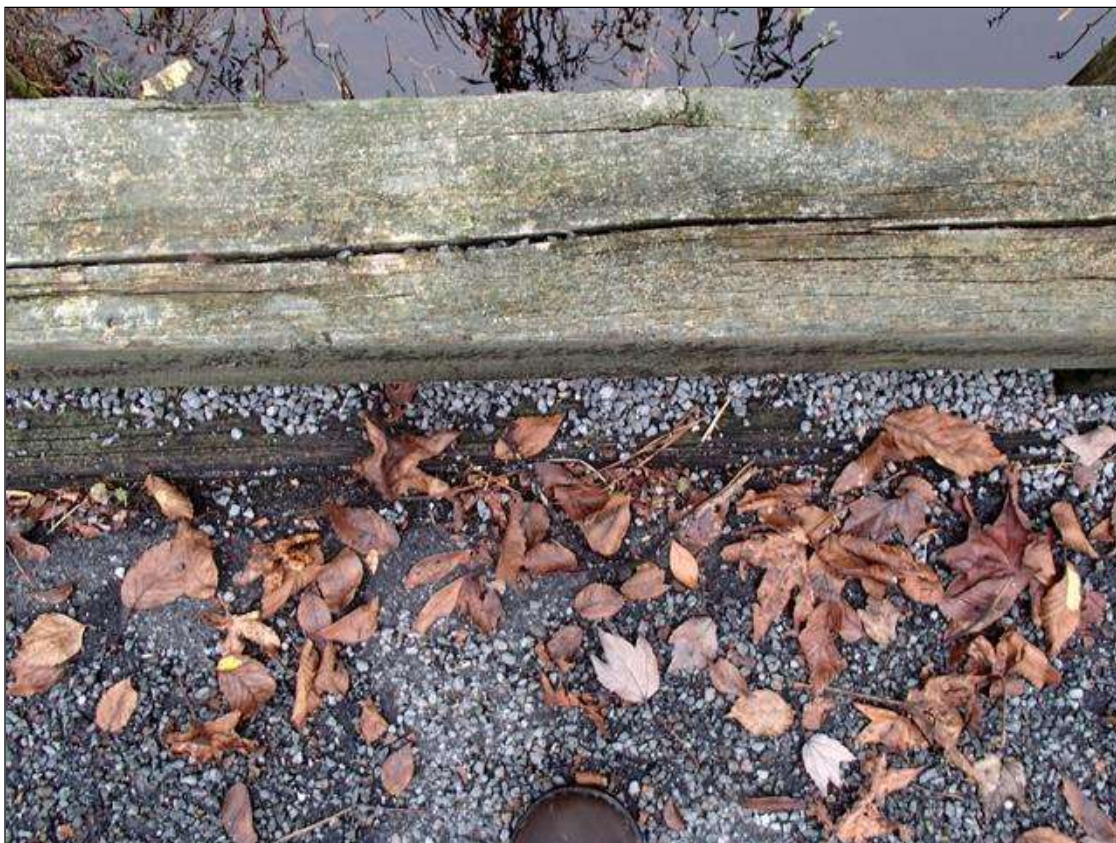
CHECKS TO 1/2"/SURFACE SOFT TO 1/4"

SPAN 1, LEFT RAIL - CHECK IN WHEELGUARD

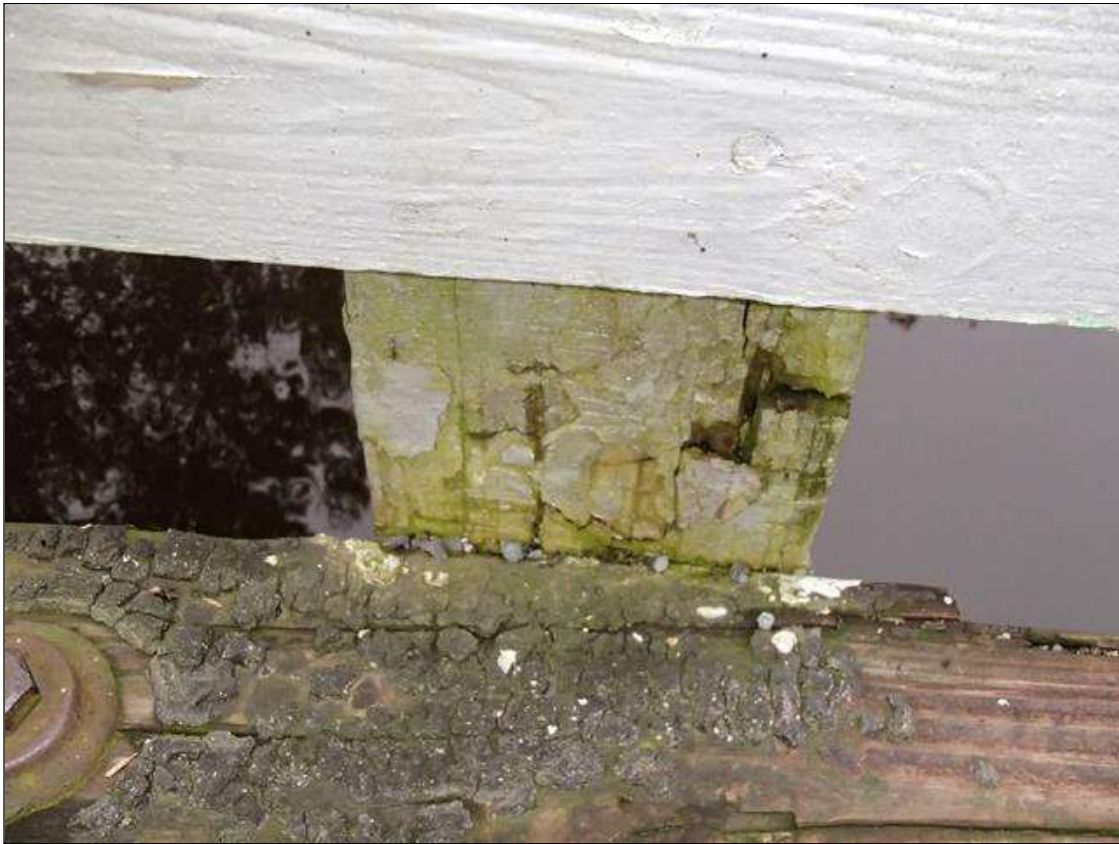
POST 3 - BROKEN  
CHECKS TO 1/2"/ SURFACE SOFT TO 1/4"

SPAN 1, RIGHT RAIL, POST 3 - BROKEN

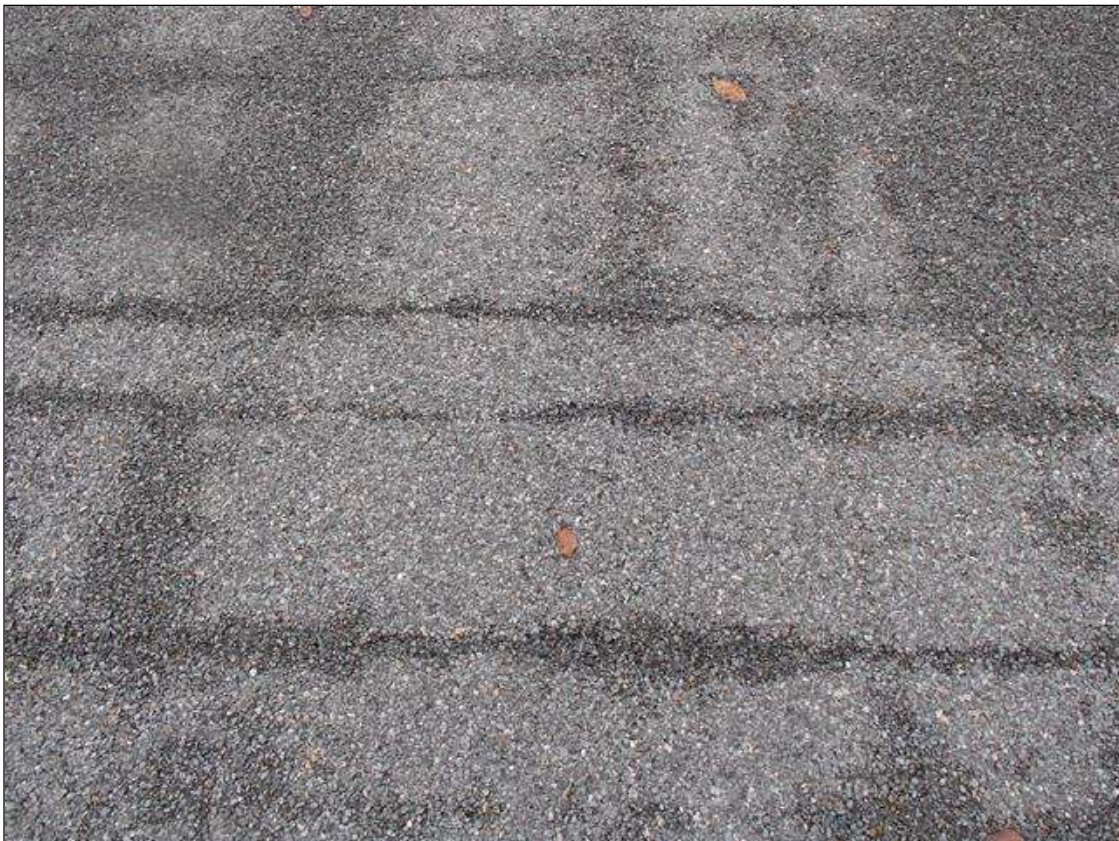
TRANSVERSE CRACKS BETWEEN MOST DECK BOARDS

SPAN 1, CRACKS BETWEEN DECK BOARDS

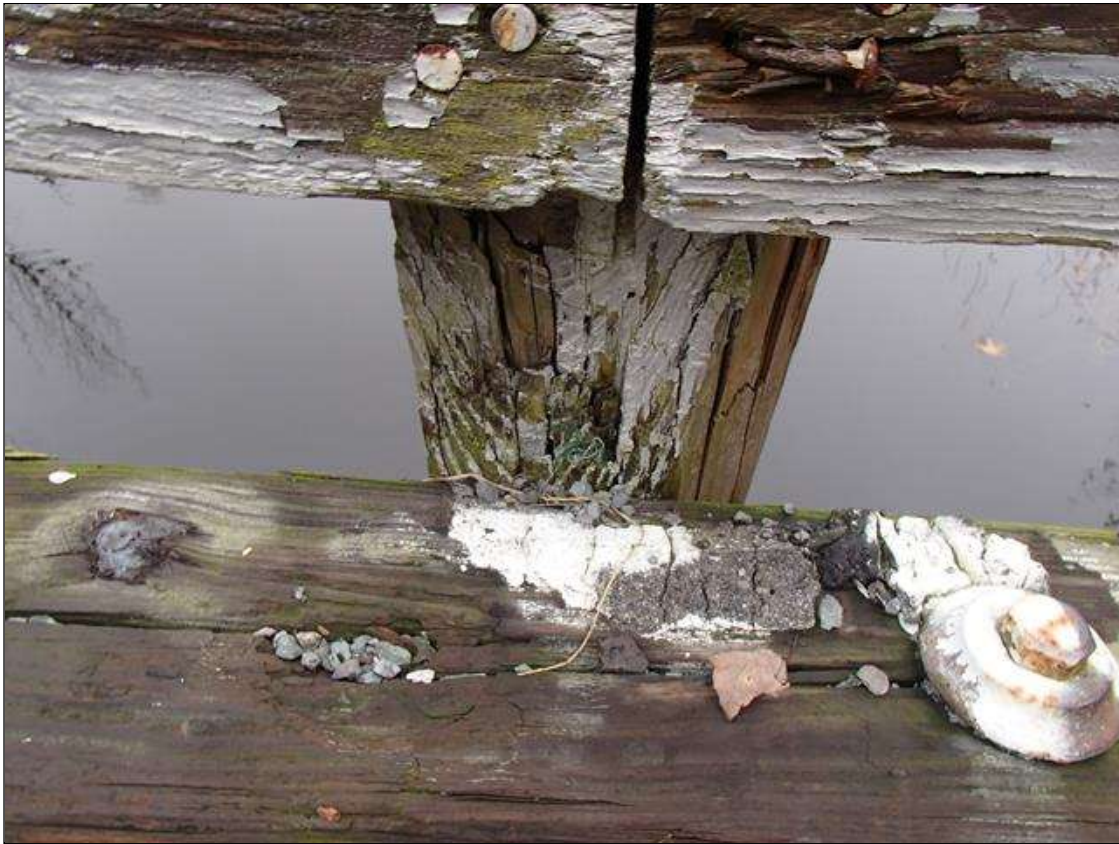
SPAN 2, LEFT RAIL, POST 5 - BROKEN

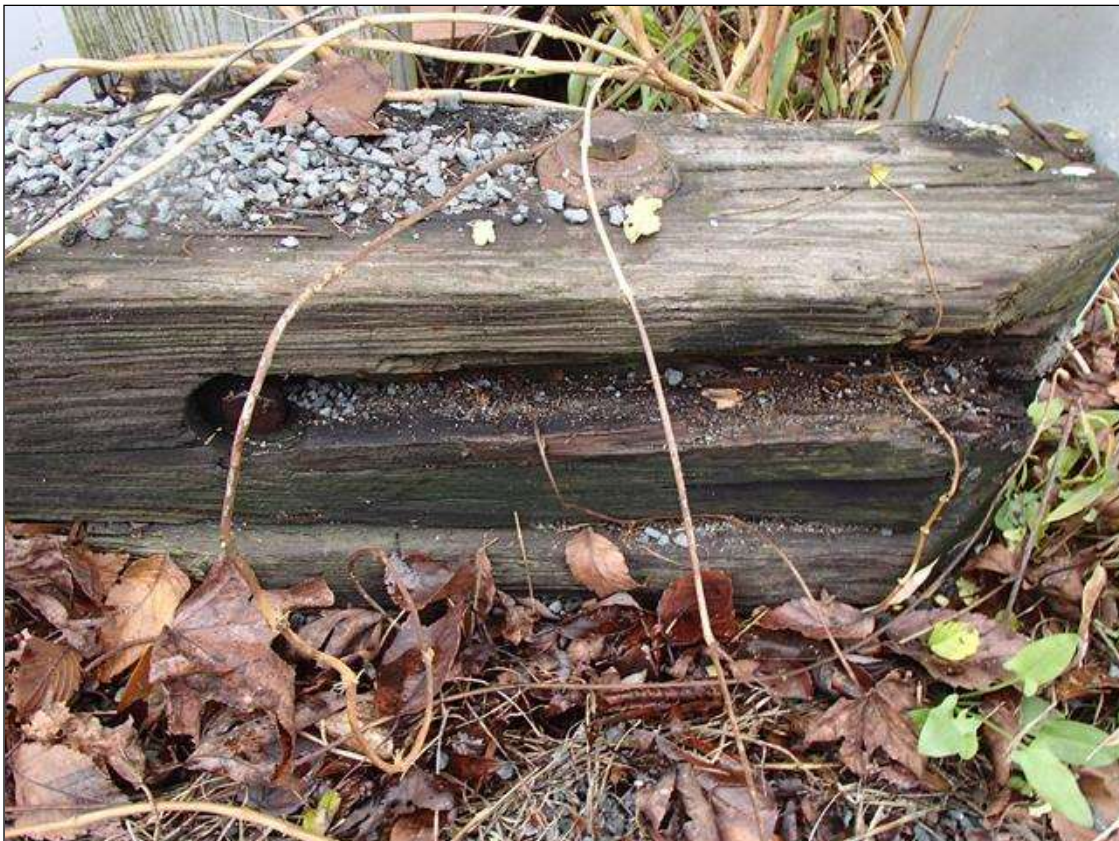
SPAN 2, WHEELGUARD, EAST END - DECAY 2" VERTICAL X 18" LONG X 2" DEEP

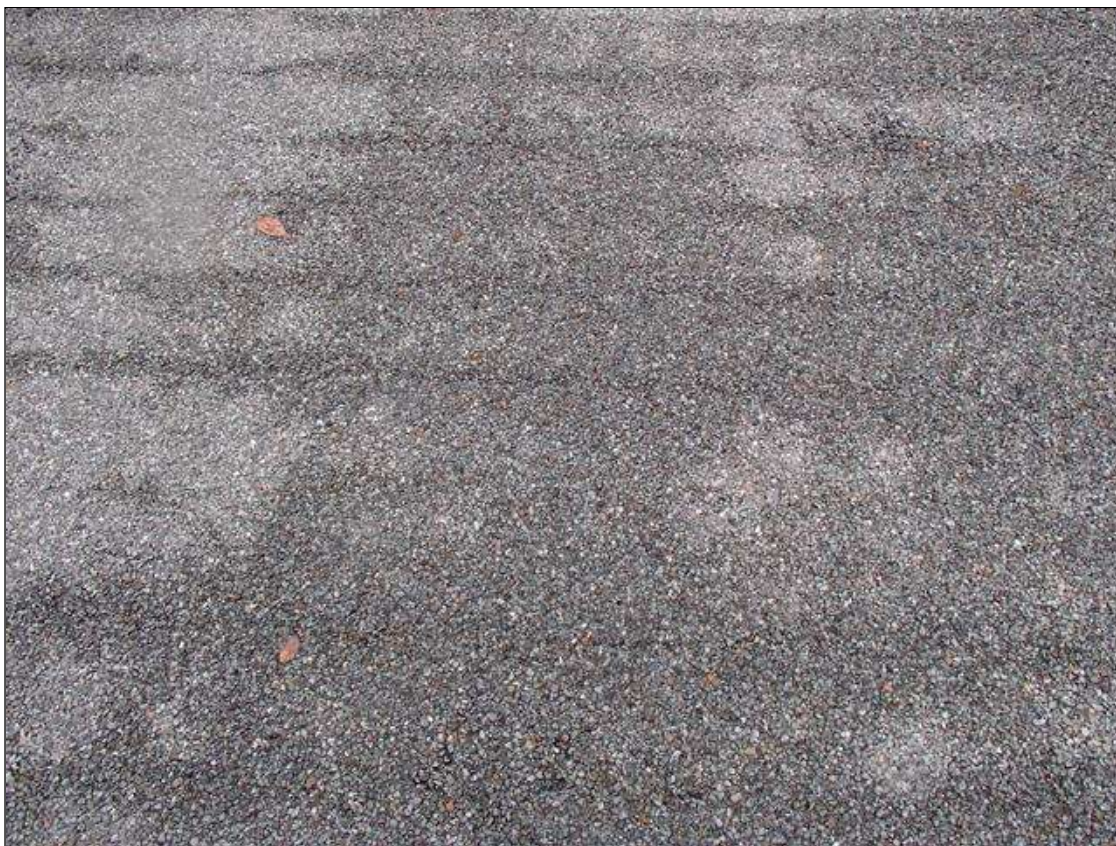
SPAN 2, CRACKS BETWEEN DECK BOARDS

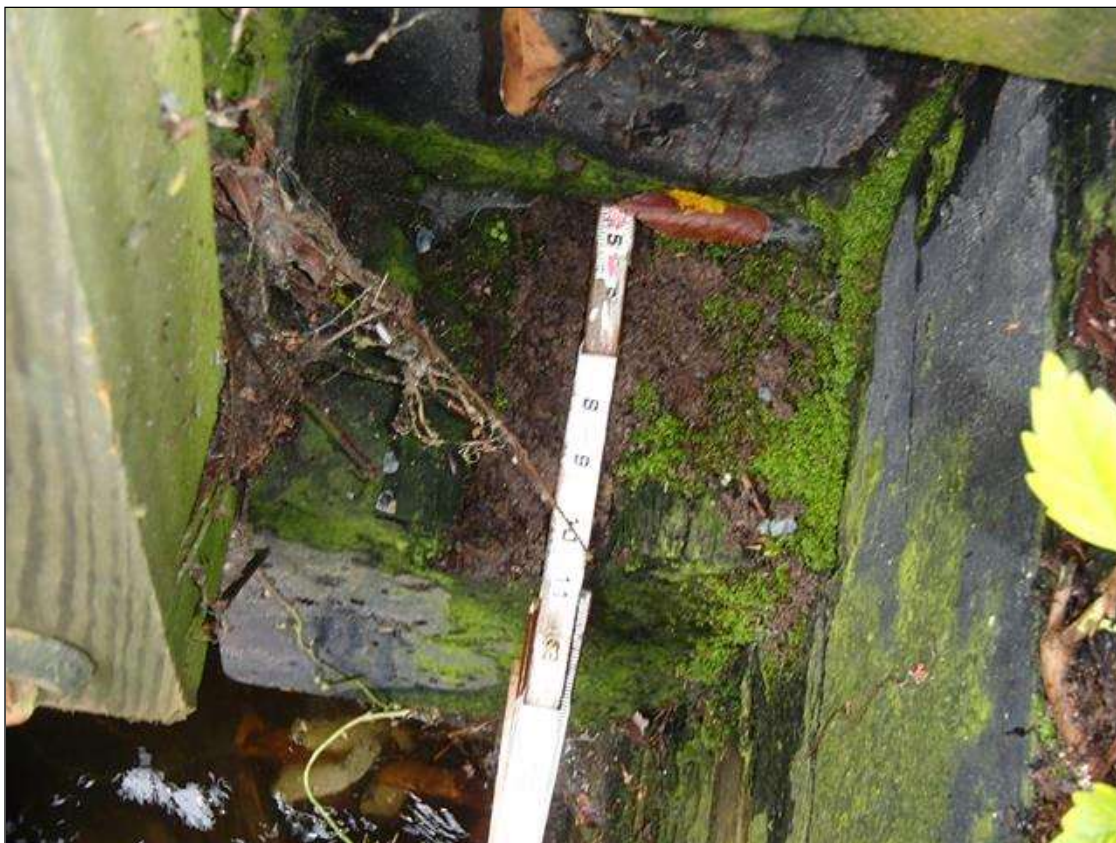
| NORTH END, TOP OF CAP - DECAY 1' LONG X 2" VERTICAL X 3" WIDE | | | | | | | | | | | | |

END BENT 1 CAP - DECAY AT NORTH END

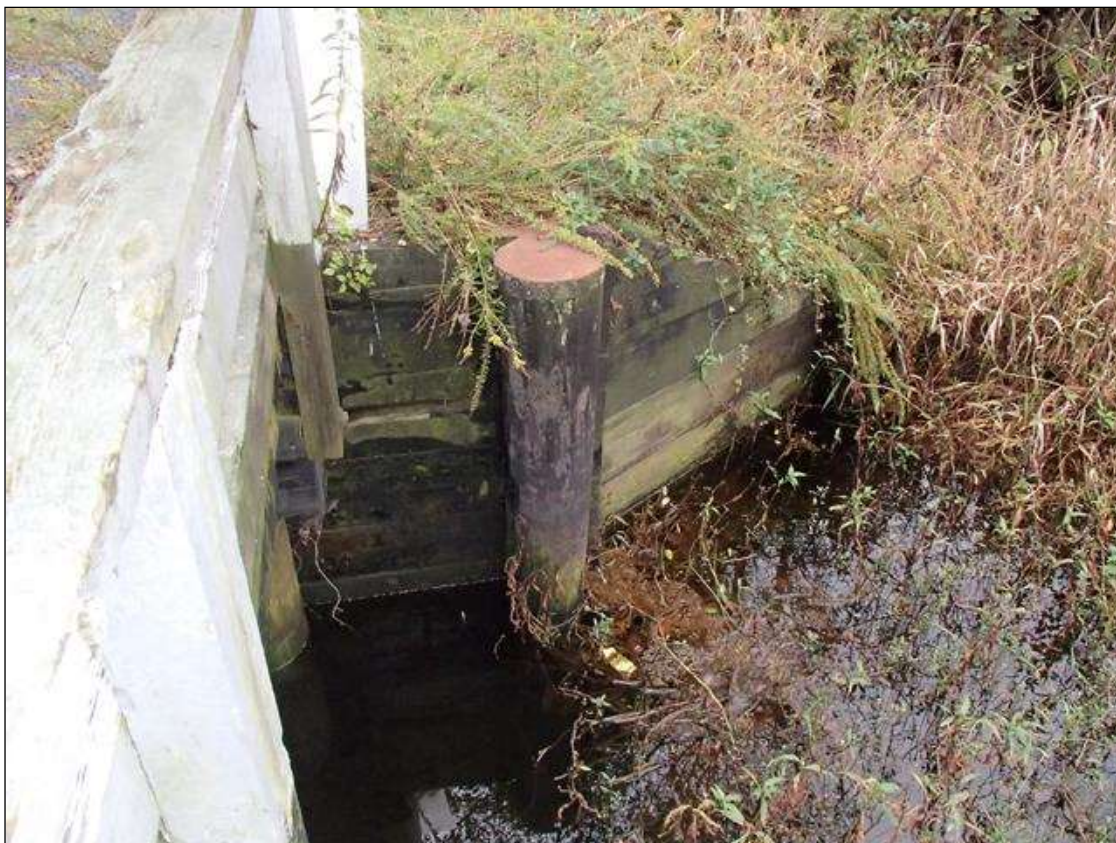
NW WING/EXTERIOR BULKHEAD

Details SURFACE SOFT TO 1/4"  
NW WING - BOARD 3 - DECAY 2' LONG X 3" WIDE X 5" VERTICAL  
NE WING PILE DECAYED TOP DOWN 20" X 5" WIDE X 2" DEEP

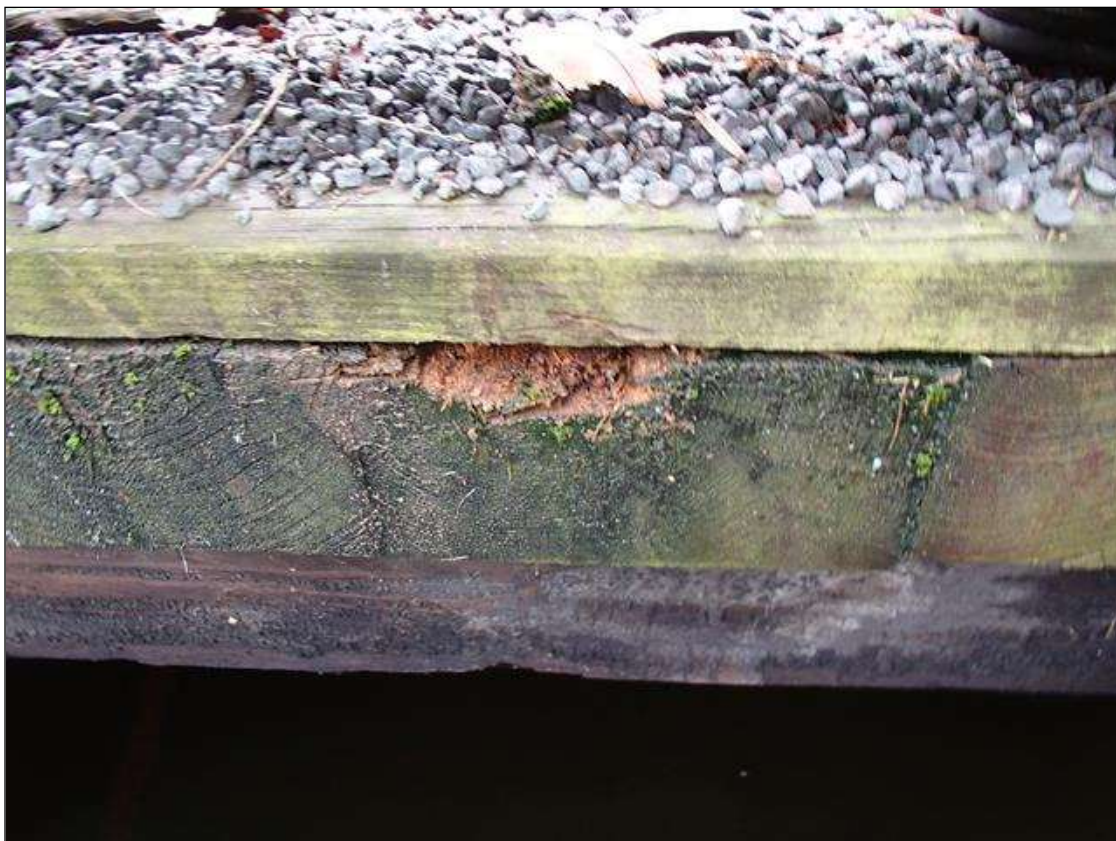
| Span | 2 | Deck | 1 | Component Name: | | Timber Deck | | | | | | | |
|---|---|---|---|---|---|---|---|---|---|---|---|---|---|
| RANDOM AREAS DECAY ON TOP OF ENDS - 1/2" VERTICAL | | | | | | | | | | | | | |

SPAN 2 - DECAY ON DECK BOARD
