NC DEPARTMENT OF TRANSPORTATION  
DIVISION OF HIGHWAYS  
STRUCTURE MANAGEMENT UNIT

## Structure Safety Report

### Routine Element Inspection - Contract

COUNTY: ROBESON STRUCTURE NUMBER: 770434 FREQUENCY: 24 MONTHS

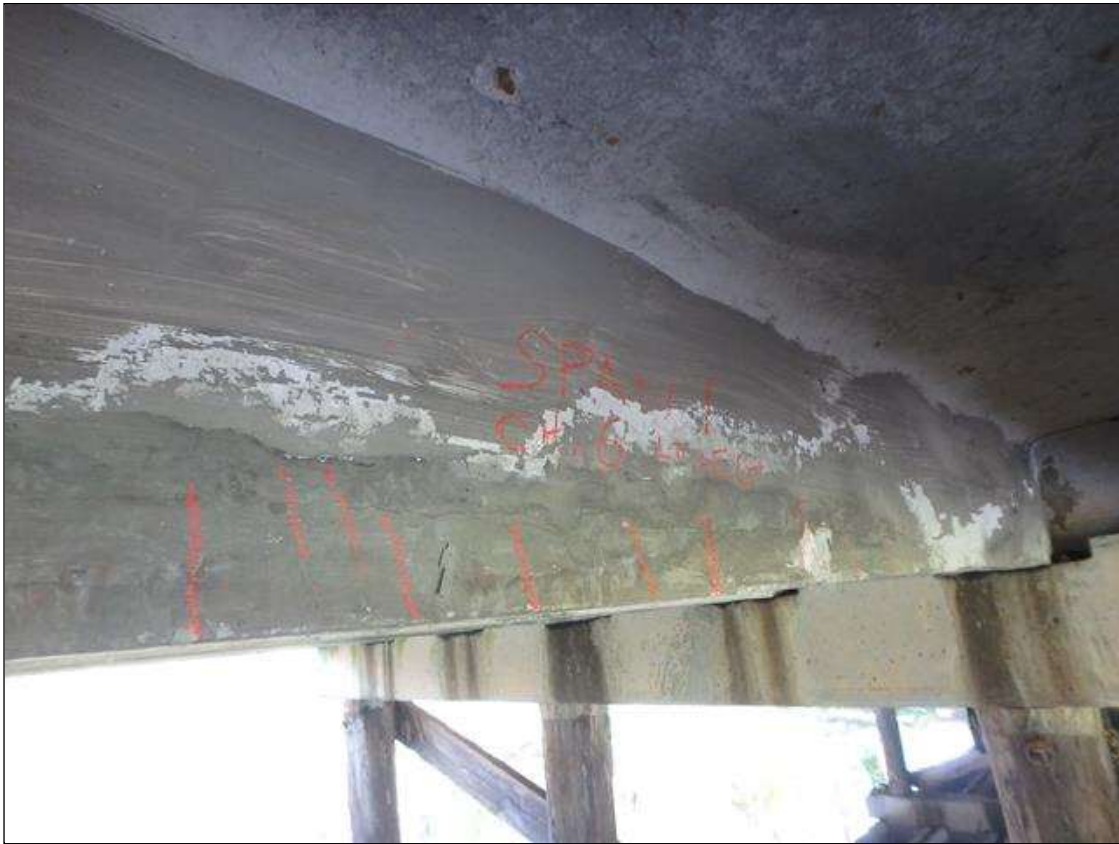
SPAN 1 CHANNEL 6 BEGIN 4FT. FROM BENT 1 BOTTOM OF LT. LEG HAS 1/32IN. CRACKS AND DELAMINATION 3IN. H X 5FT. LONG. PRIORITY MAINTENANCE

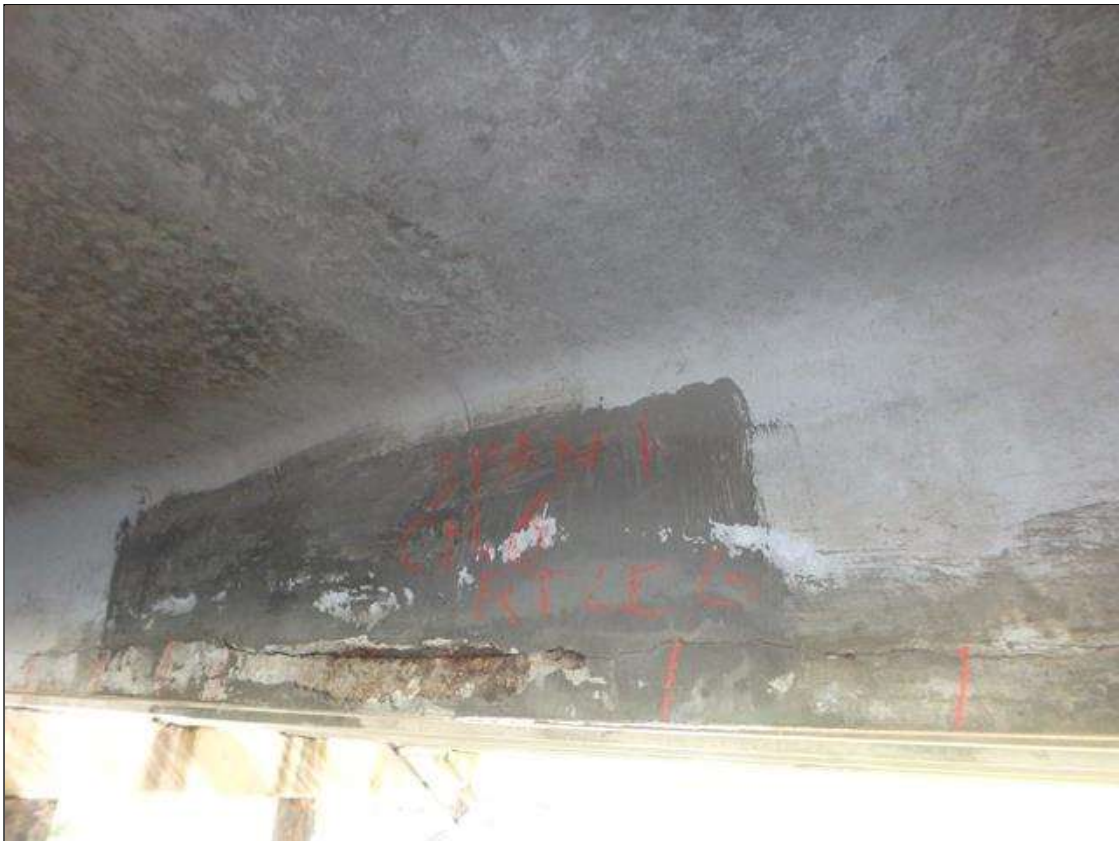
SPAN 1 CHANNEL 6, 8FT. FROM ABUT 1 BOTTOM RT. LEG 1/16" CRACKS/ DELAMINATION 3IN. H X 7FT. LONG W/ SPALL & EXPOSED STEEL 3IN. H X 1FT. L. PRIORITY MAINTENANCE

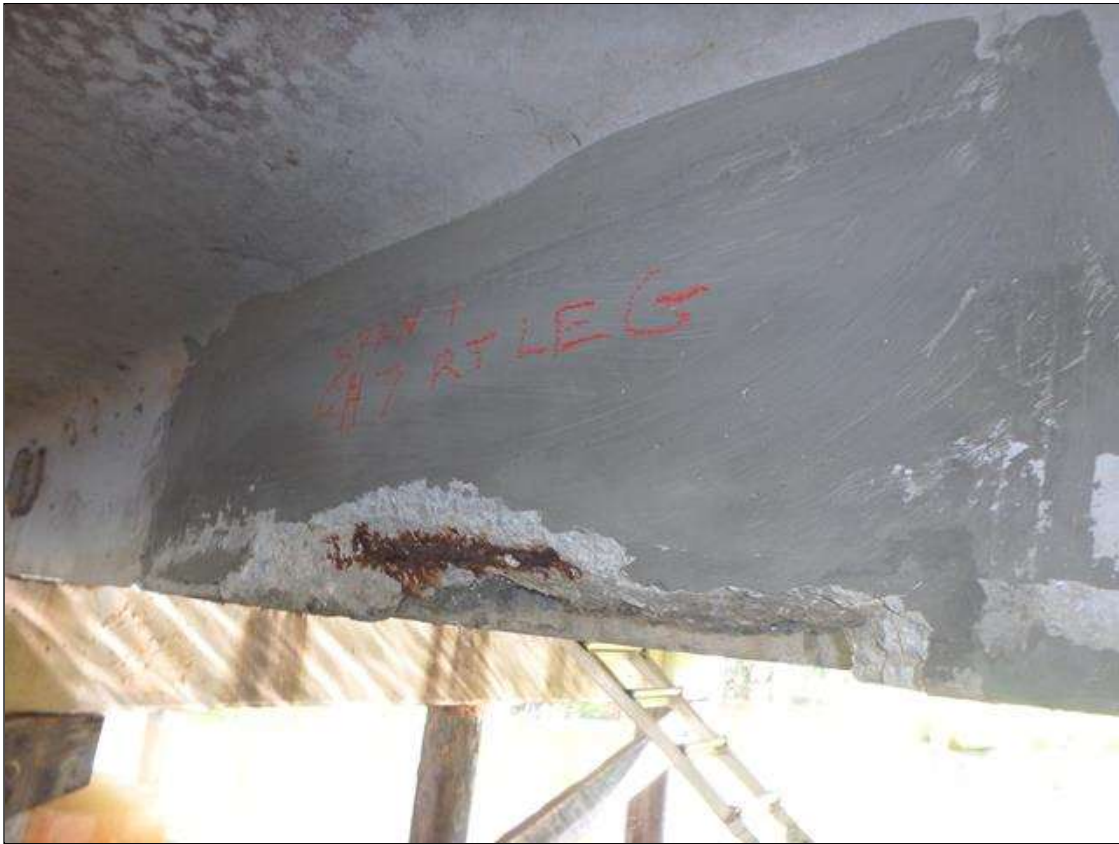
SPAN 1 CHANNEL 7 BEGIN 5FT. FROM BENT 1, BOTTOM RT. LEG HAS CONC. PATCH W/ SPALL & EXPOSED STEEL 4IN. H X 2FT. L, STEEL HAS RUST AND SCALE. PRIORITY MAINTENANCE

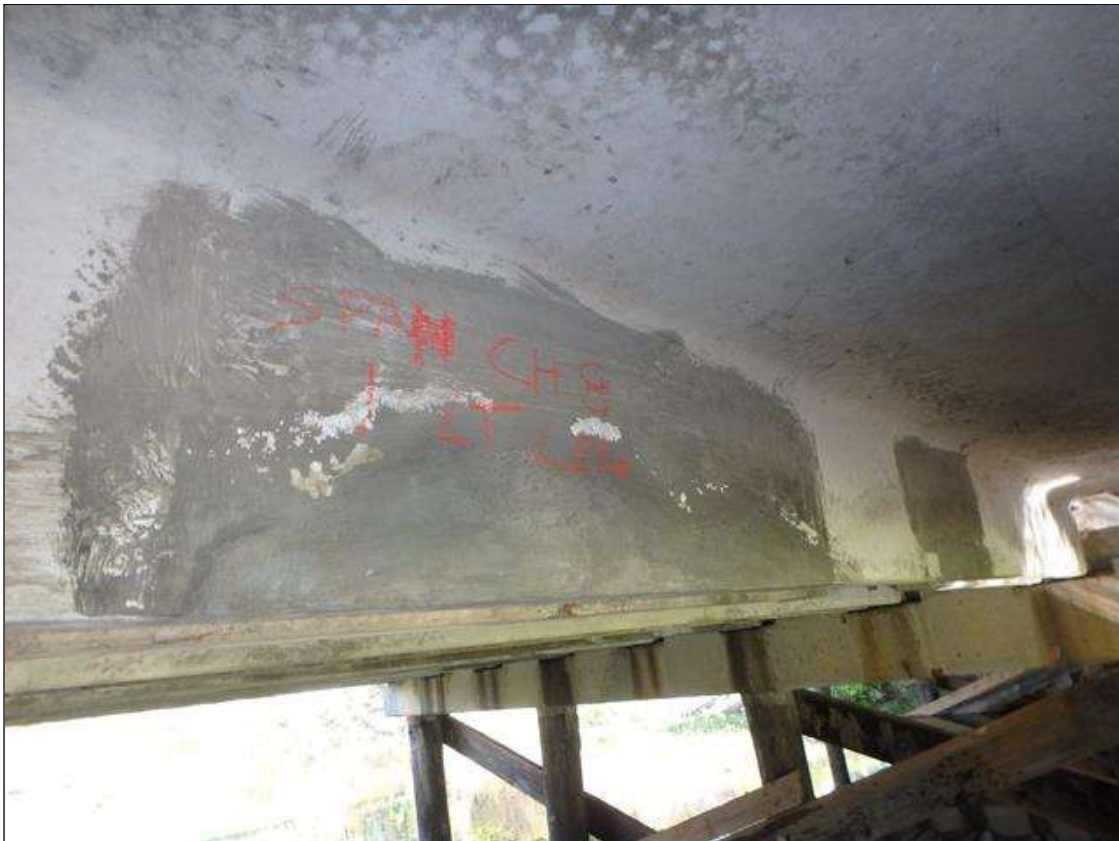
SPAN 1 CHANNEL 8 AT MID-SPAN BOTTOM LT. LEG HAS TEMPORARY REPAIR CONCRETE PATCH 4FT. L

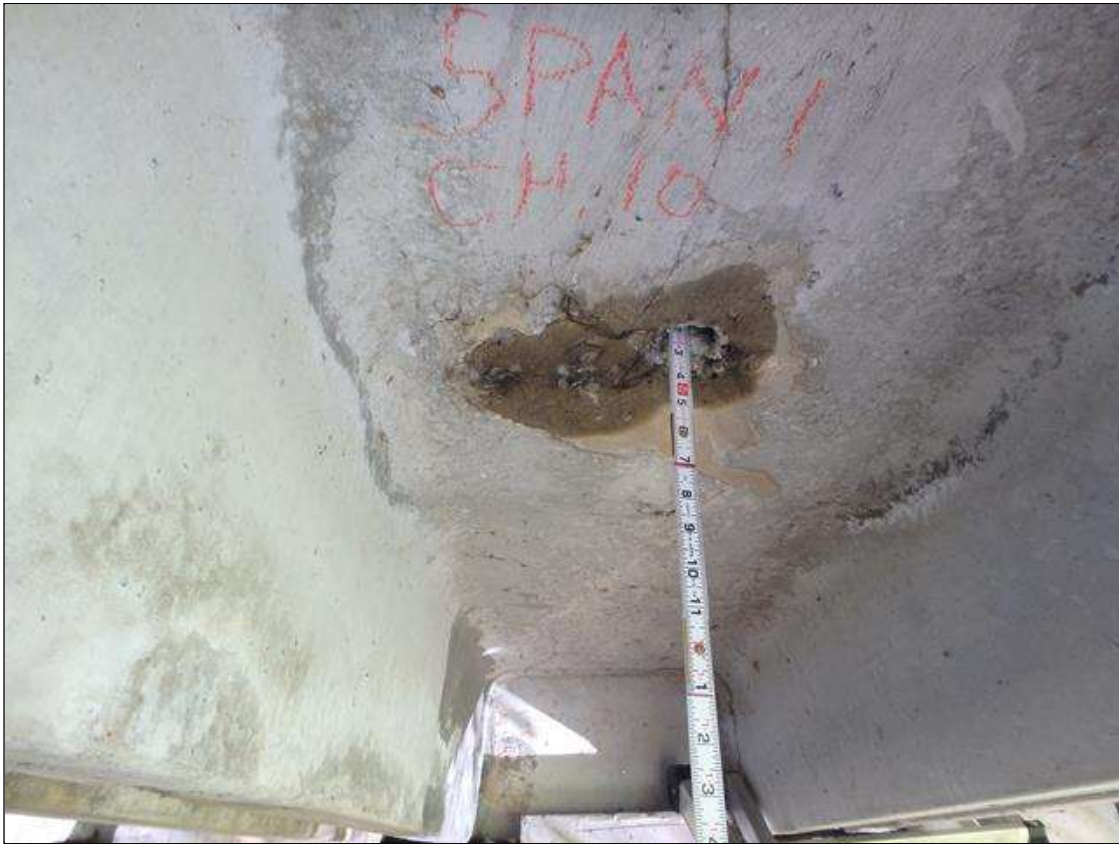
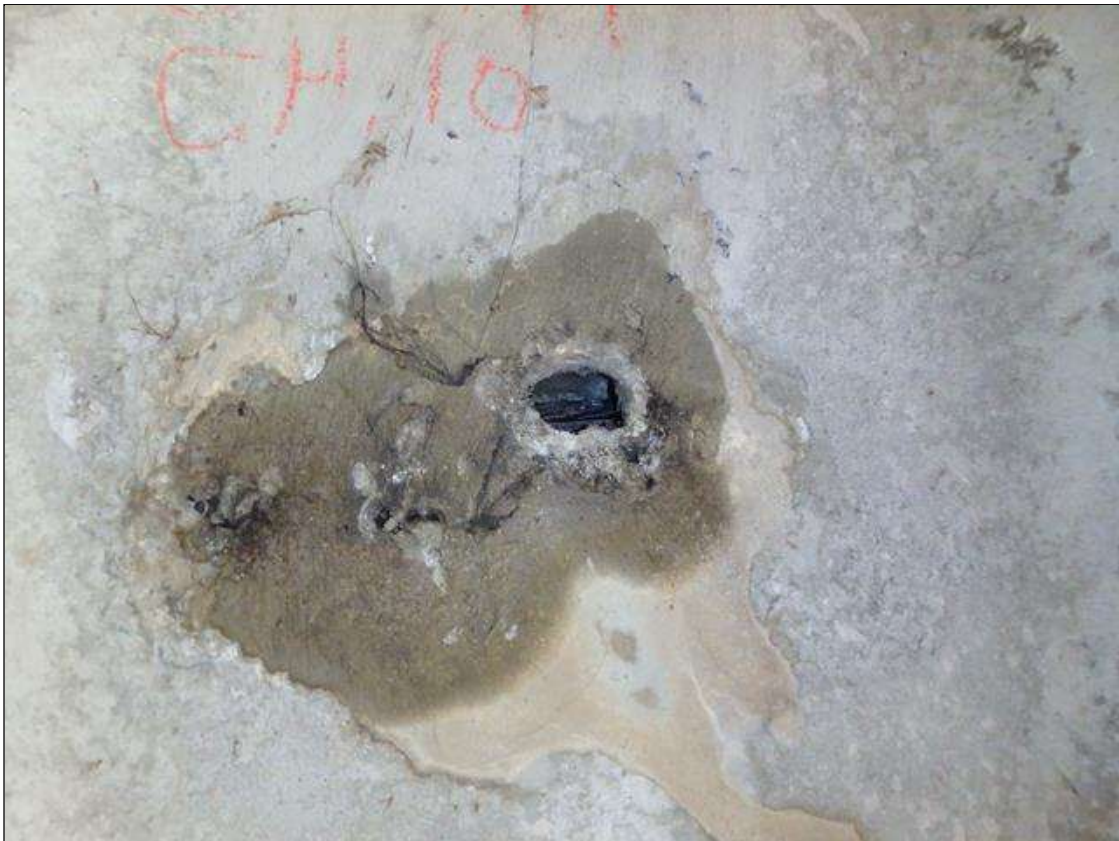
SPAN 1 CHANNEL 10, 3FT. FROM BENT, UNDERSIDE OF TOP SLAB HAS 1-1/2IN. DIA. HOLE X 2IN. DEEP EXPOSING TRANSVERSE CABLE. NO CORROSION VISIBLE. PRIORITY MAINTENANCE

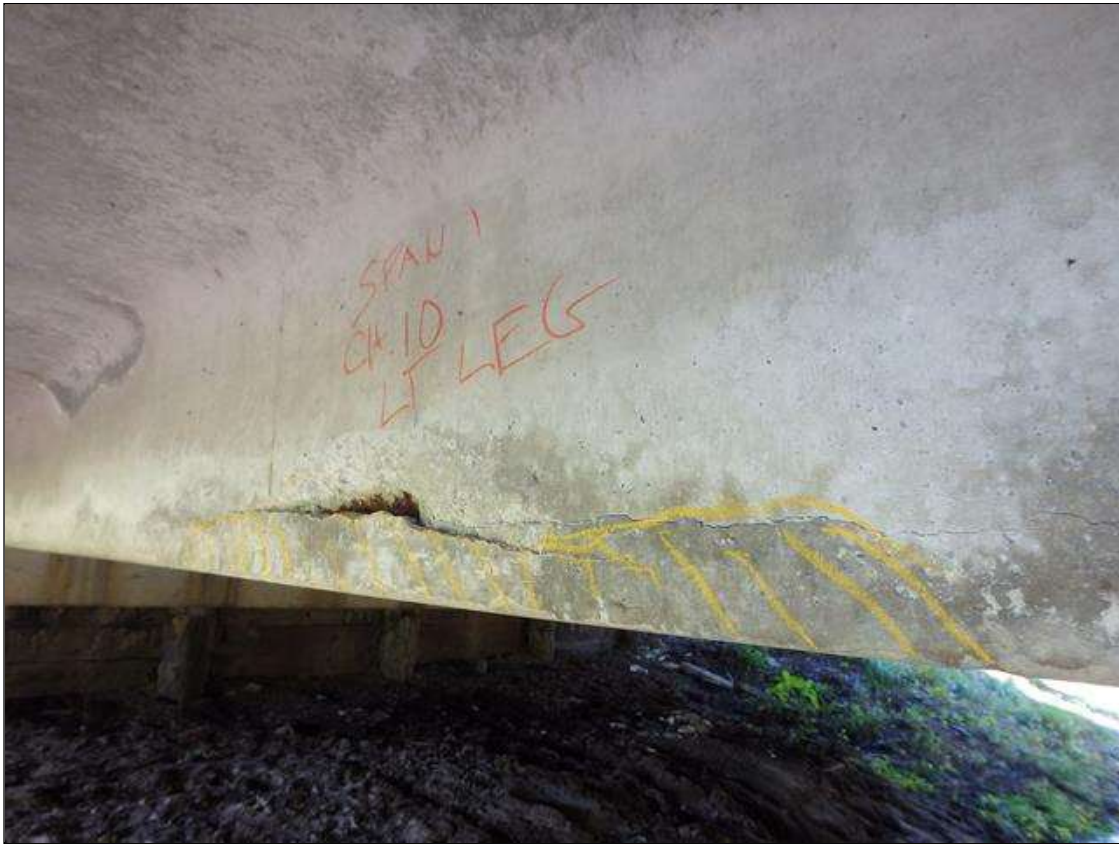
SPAN 1 CHANNEL 10, 9FT. FROM BENT BOTTOM LT. LEG DELAMINATION 3IN. H X 2FT. L & SPALL W/ EXPOSED STEEL 10IN. L X 2IN. H X 1IN. D. PRIORITY MAINTENANCE

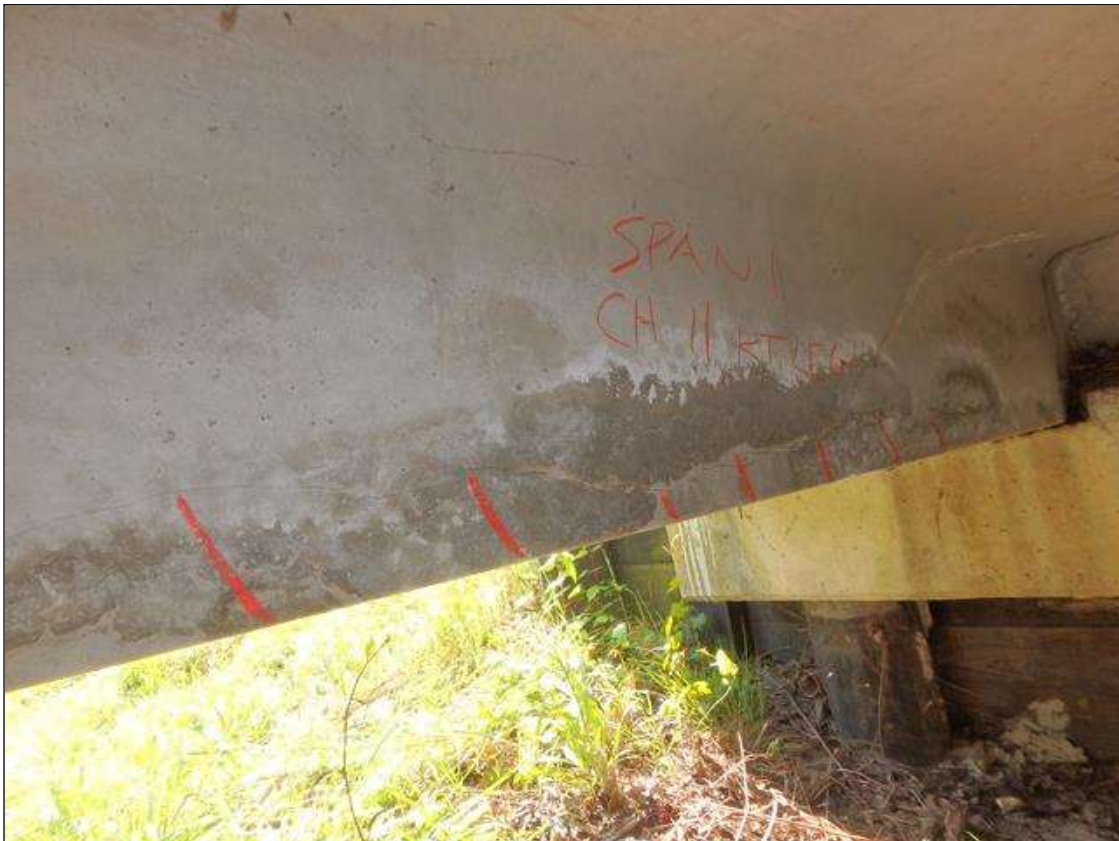
SPAN 1 CHANNEL 11 NEAR ABUT 1, BOTTOM RT. LEG 1/16IN. CRACKS/ DELAMINATION 3IN. HIGH X 30IN. LONG. PRIORITY MAINTENANCE

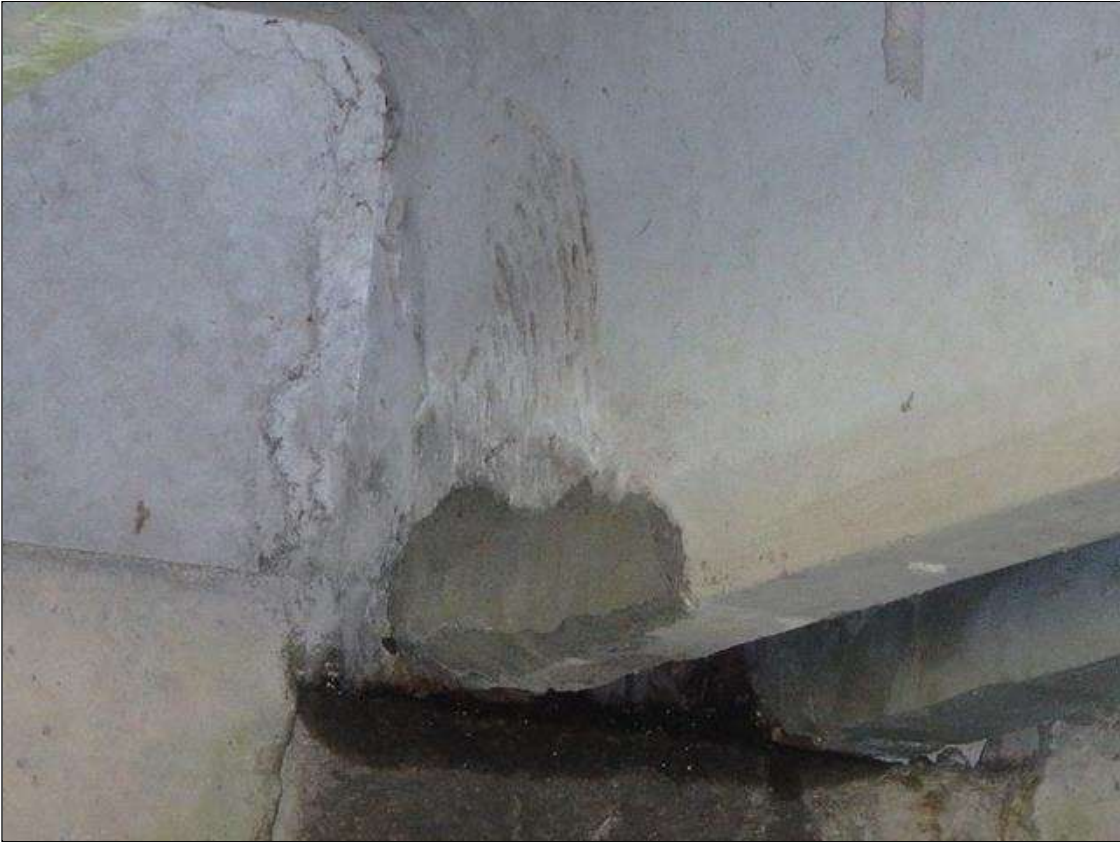
SPAN 1 CHANNEL 3 AT BENT BOTTOM RT. LEG HAS TEMPORARY REPAIR SOUND CONCRETE PATCH 1FT. LONG.

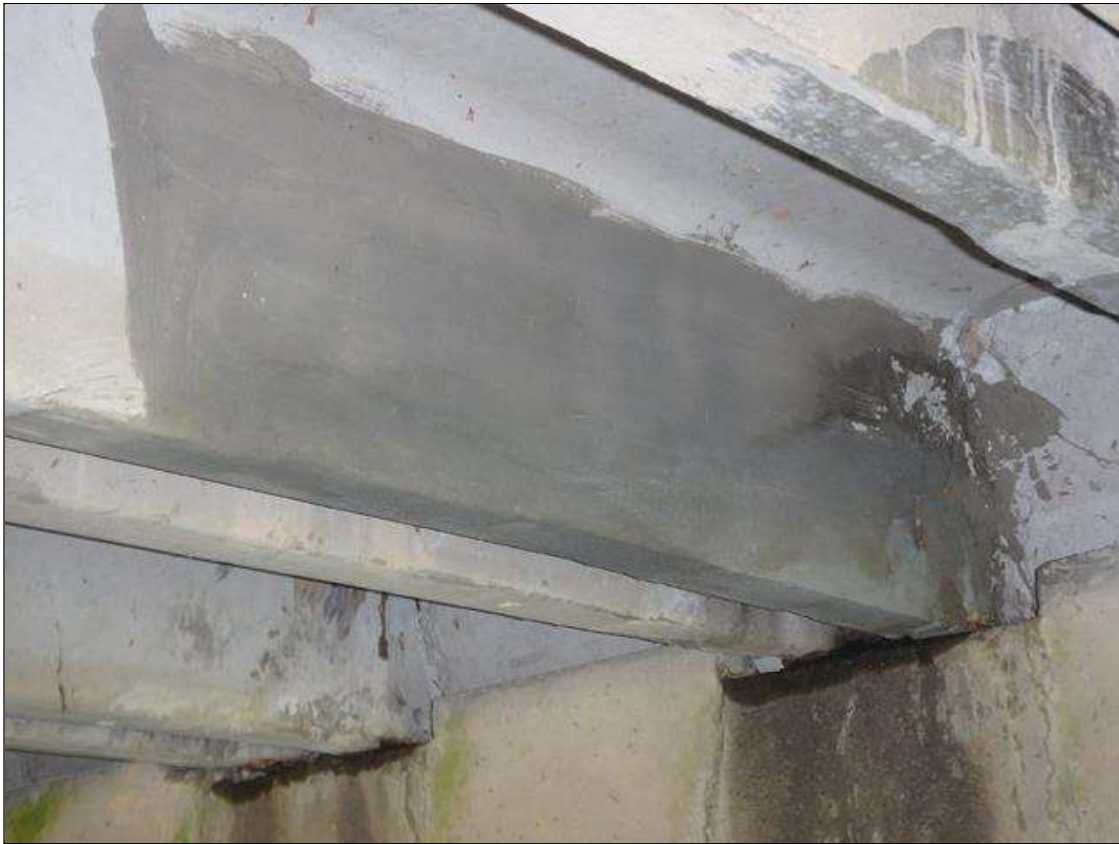
SPAN 1 CHANNEL 4 AT BENT, BOTTOM OF LT LEG HAS TEMPORARY REPAIR SOUND CONC. PATCH 4FT. LONG

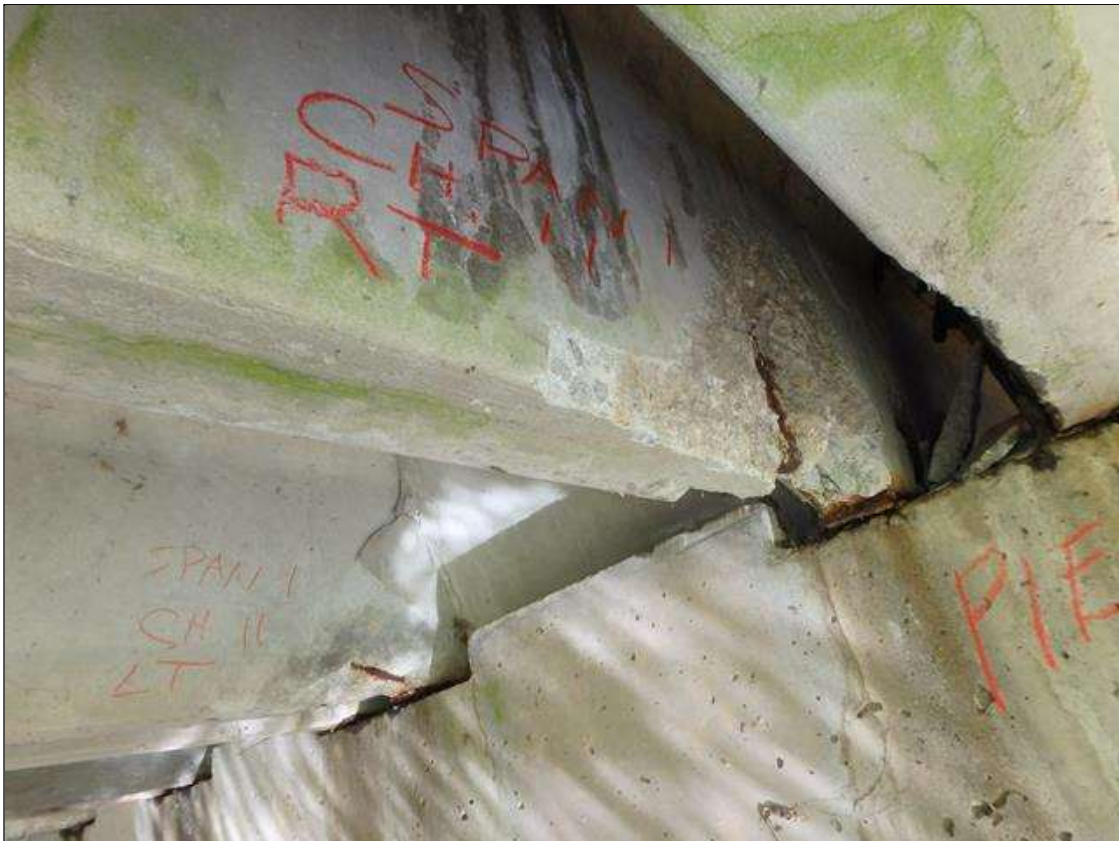
SPAN 1 CHANNEL 11 AT BENT BOTH LEGS HAVE A SPALL WITH EXPOSED STEEL UP TO 1FT. L X UP TO 7IN. H X 2IN. DEEP. PRIORITY MAINTENANCE

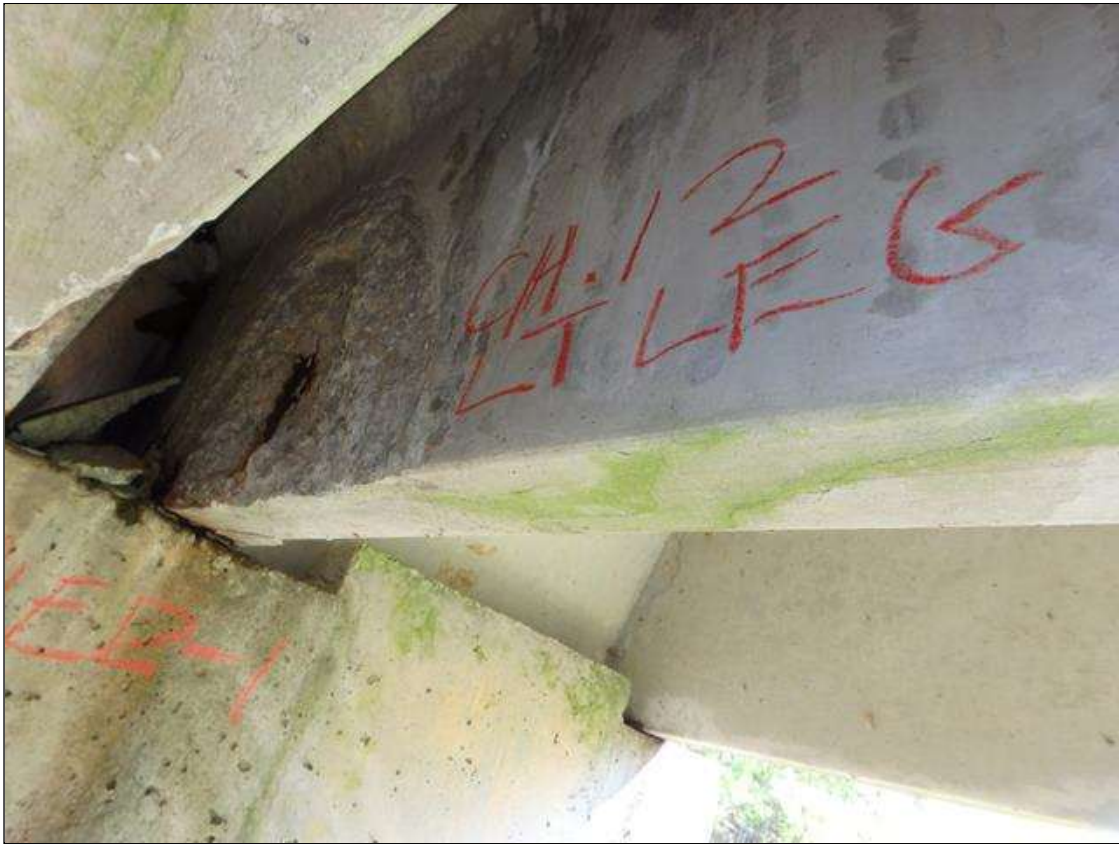
SPAN 1 CHANNEL 12 AT BENT, BOTTOM OF LT. LEG HAS SPALL WITH EXPOSED STEEL 1FT. L X 8IN. H X UP TO 1IN. DEEP. PRIORITY MAINTENANCE

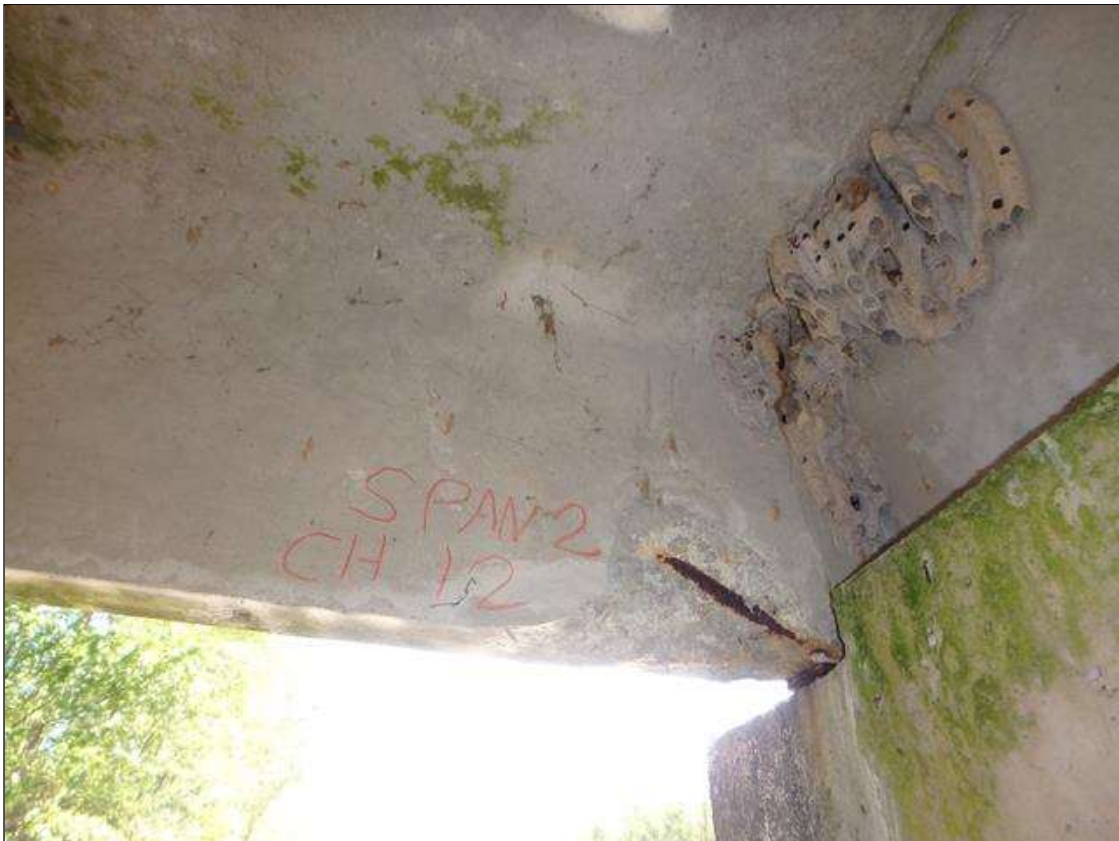
SPAN 2 CHANNEL 12 RT. LEG AT BENT 1 SPALL WITH EXPOSED STEEL 1IN. D X 1FT. L X 6IN. HIGH. PRIORITY MAINTENANCE

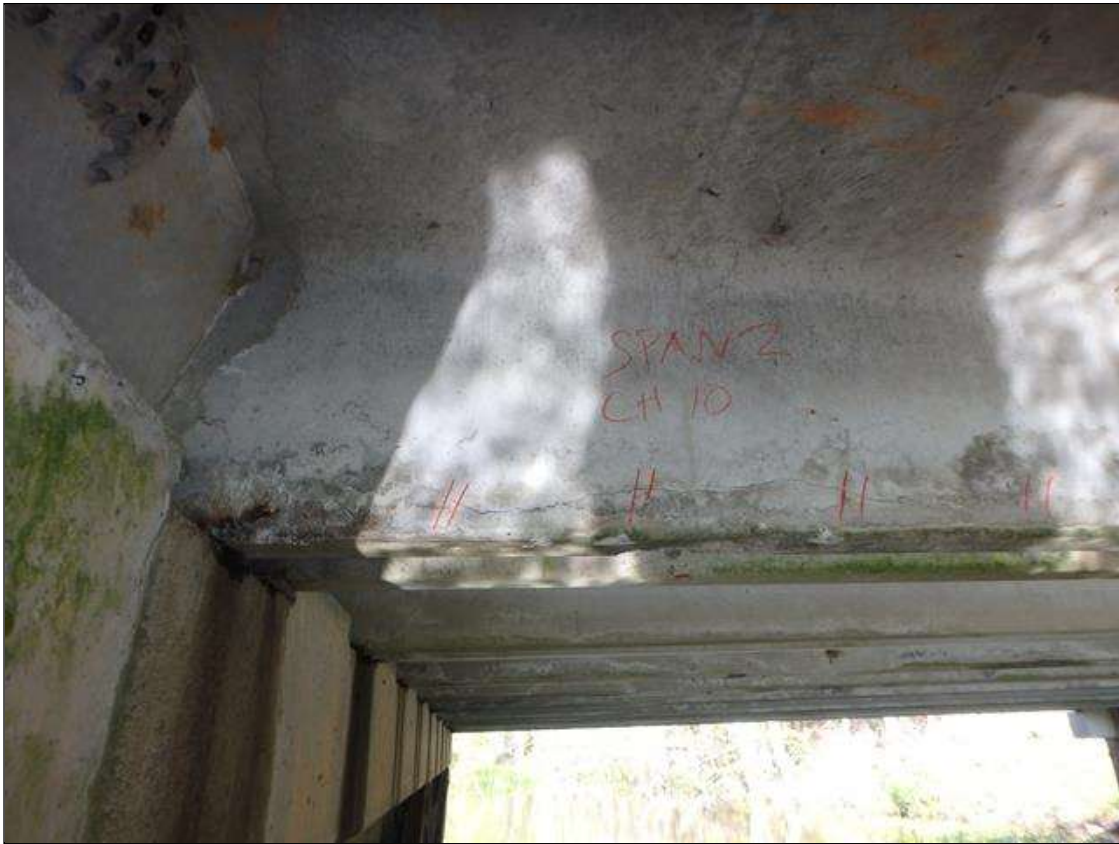
SPAN 2 CHANNEL 10 AT BENT 1 BOTTOM LT. LEG DELAMINATION 3IN. H X 3FT. L & SPALL WITH EXPOSED STEEL 5IN. L X 2IN. H X 1IN. DEEP. PRIORITY MAINTENANCE

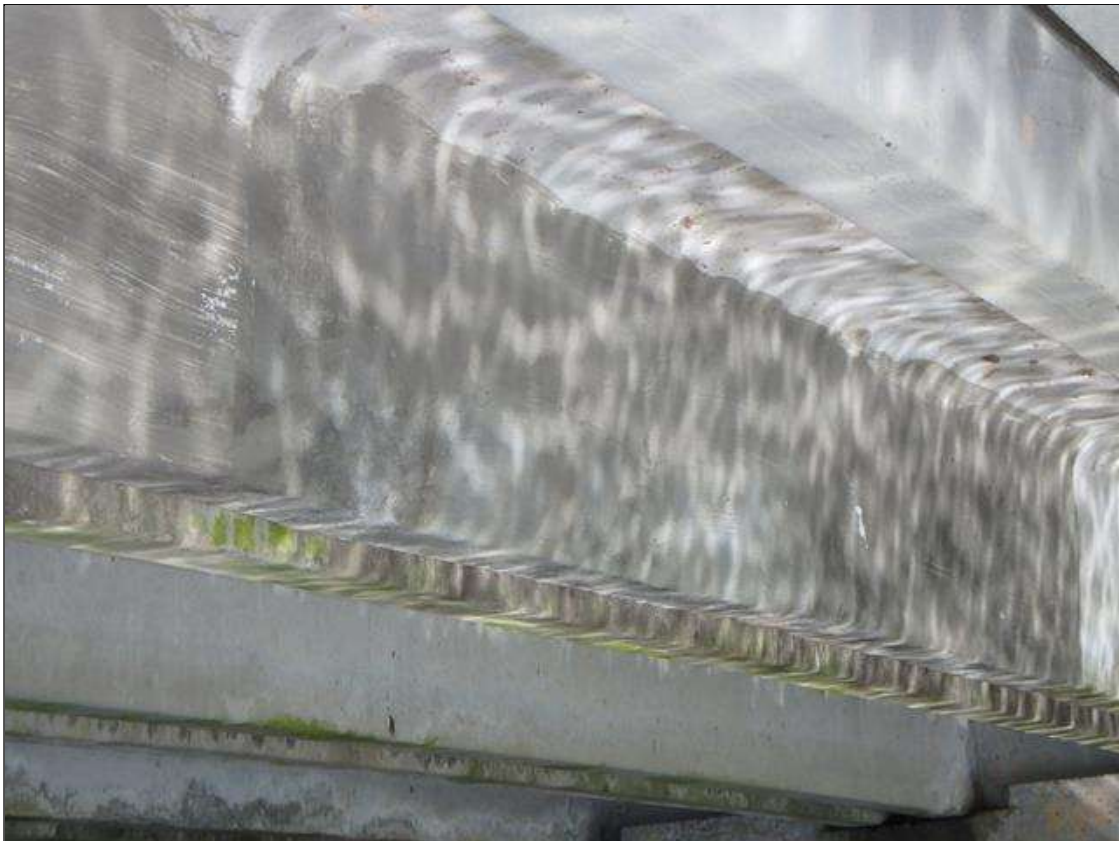
SPAN 2 CHANNEL 10 AT MID-SPAN, LT. LEG HAS TEMPORARY REPAIR, SOUND CONC. PATCH 6FT. LONG.

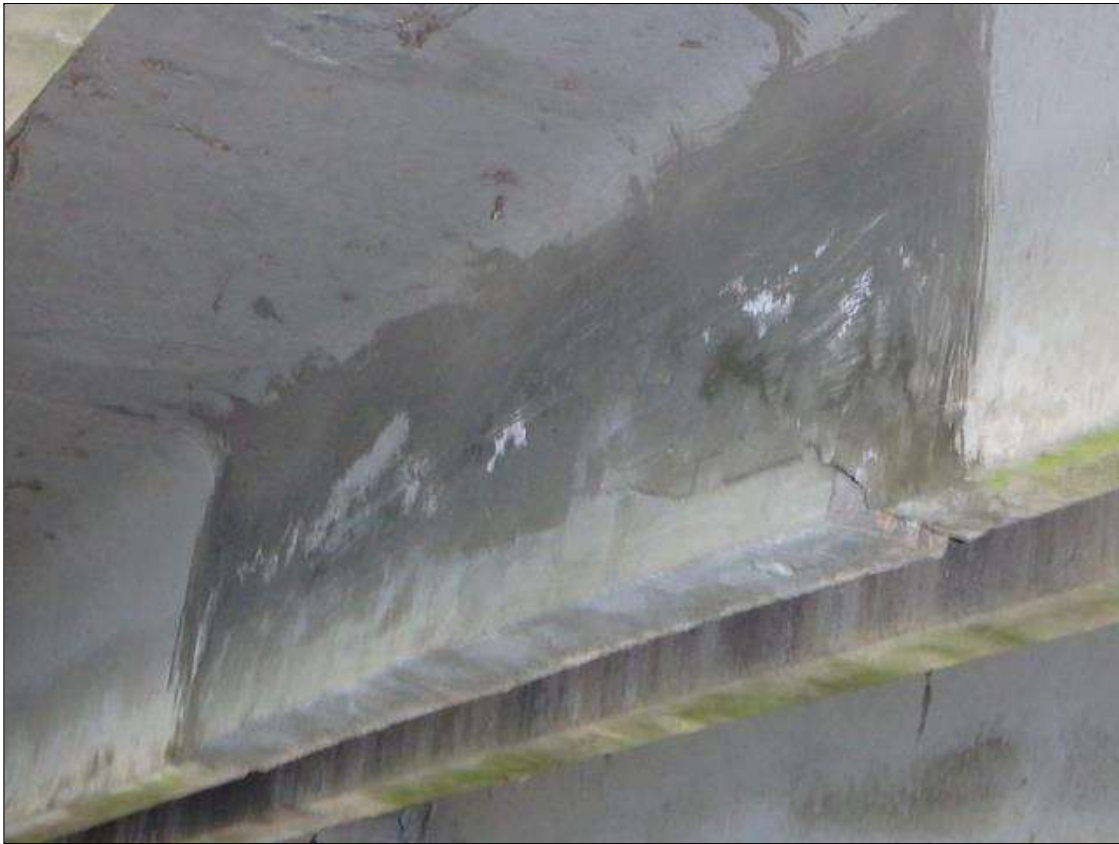
MID-SPAN 2 CHANNEL 7 BOTTOM RT LEG HAS TEMPORARY REPAIR, CONC. PATCH W/ CRACKS/ DELAMINATION 4IN. H X 3FT. LONG. PRIORITY MAINTENANCE

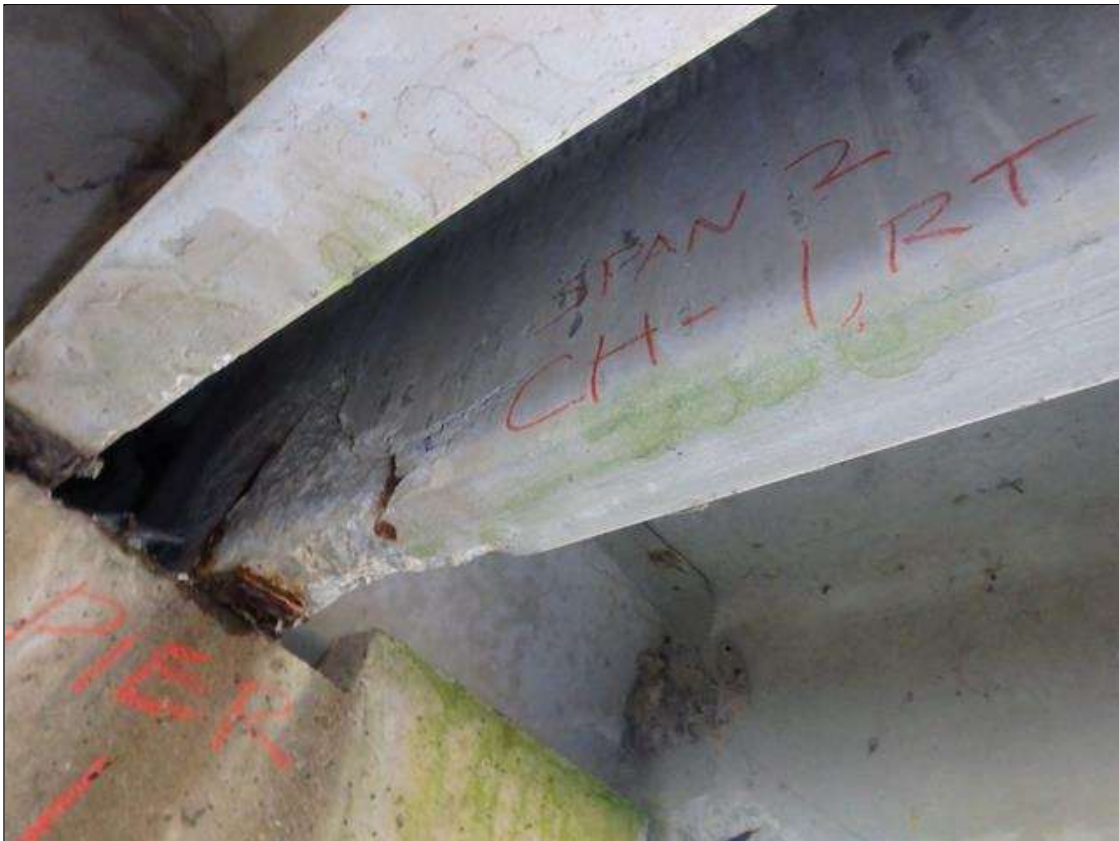
SPAN 2 CHANNEL 1 RT. LEG AT BENT 1 HAS SPALL WITH EXPOSED STEEL UP TO 1IN. D X 1FT. L X 8IN. HIGH. PRIORITY MAINTENANCE

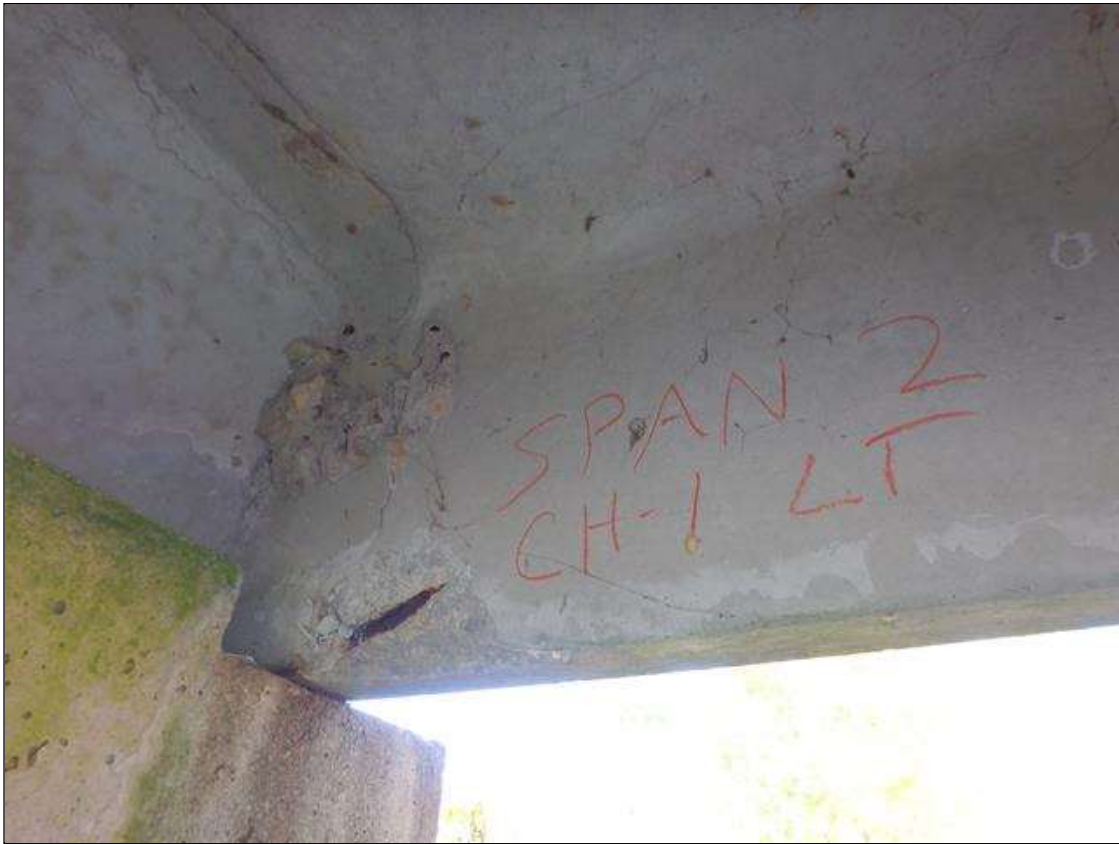
SPAN 2 CHANNEL 1 LT. LEG AT BENT 1 HAS SPALL WITH EXPOSED STEEL UP TO 1IN. D X 8IN. L X 6IN. HIGH.  
PRIORITY MAINTENANCE

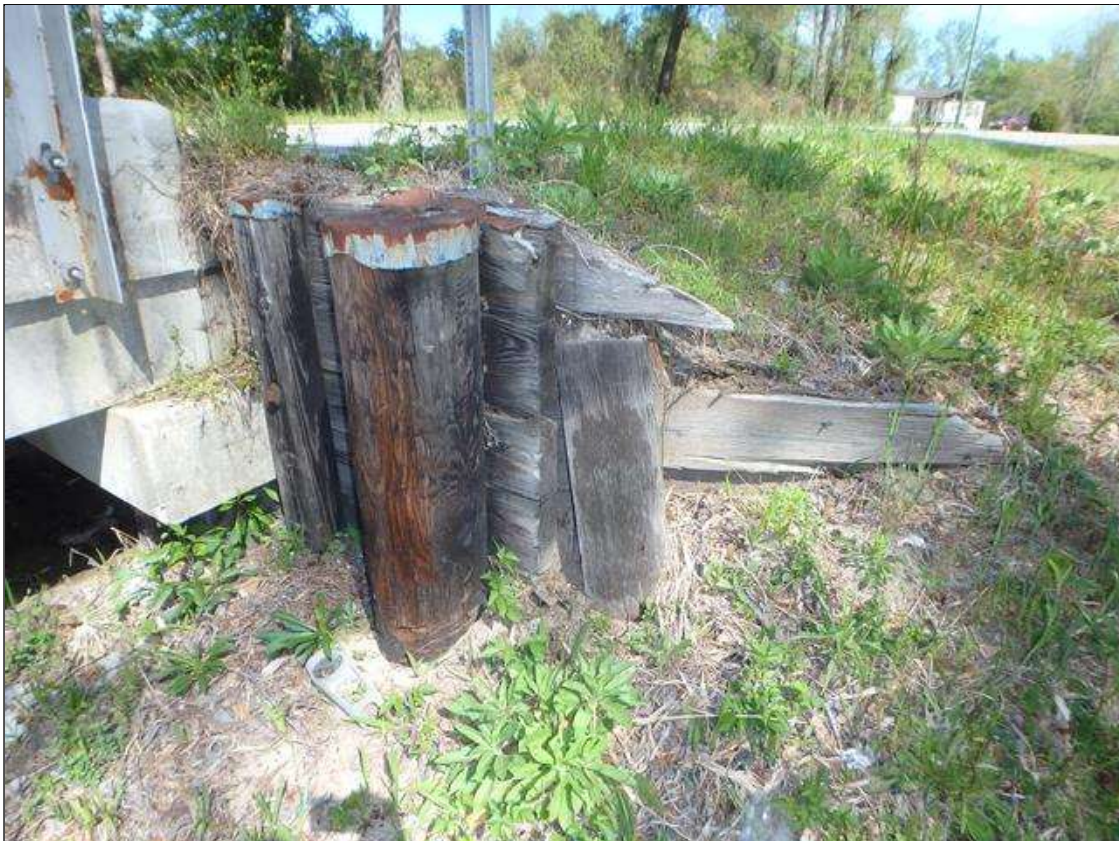
NORTHEAST CORNER WINGWALL TOP TWO BOARDS DECAYED LOOSE AND FALLEN.

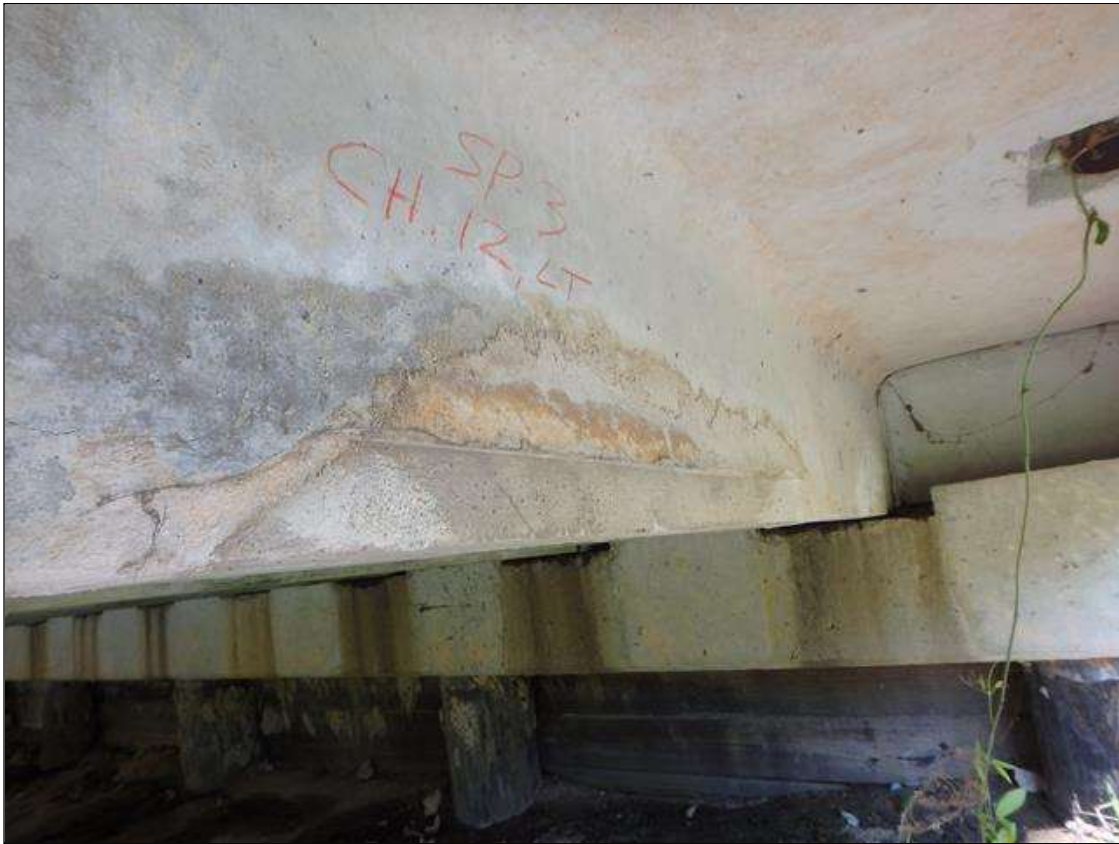
SPAN 3 CHANNEL 12, BEGIN 2FT. FROM ABUTMENT 2, BOTTOM OF LT. LEG HAS TEMPORARY REPAIR, SOUND CONC. PATCH 3IN. H X 3FT. LONG.

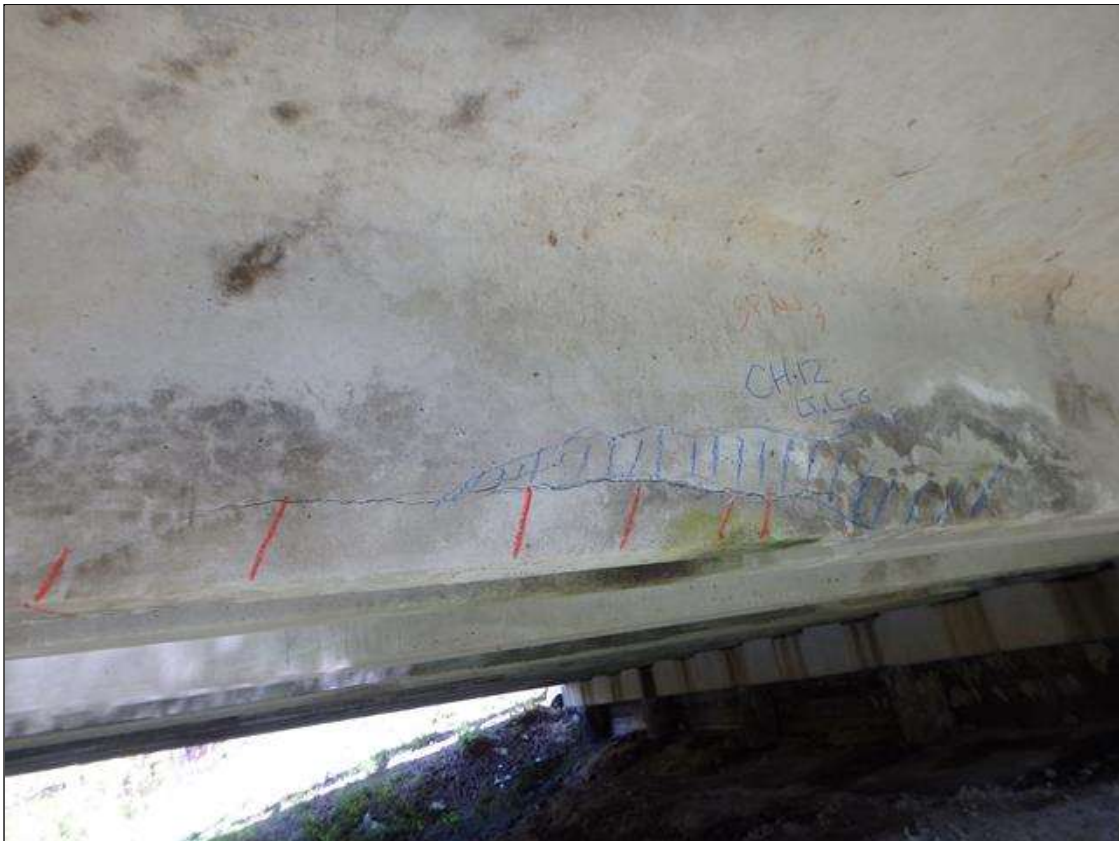
MID-SPAN 3 CHANNEL 12 BOTTOM LT. LEG 1/16IN. CRACKS & DELAMINATION 4IN. H X 3FT. LONG X FULL WIDTH. PRIORITY MAINTENANCE

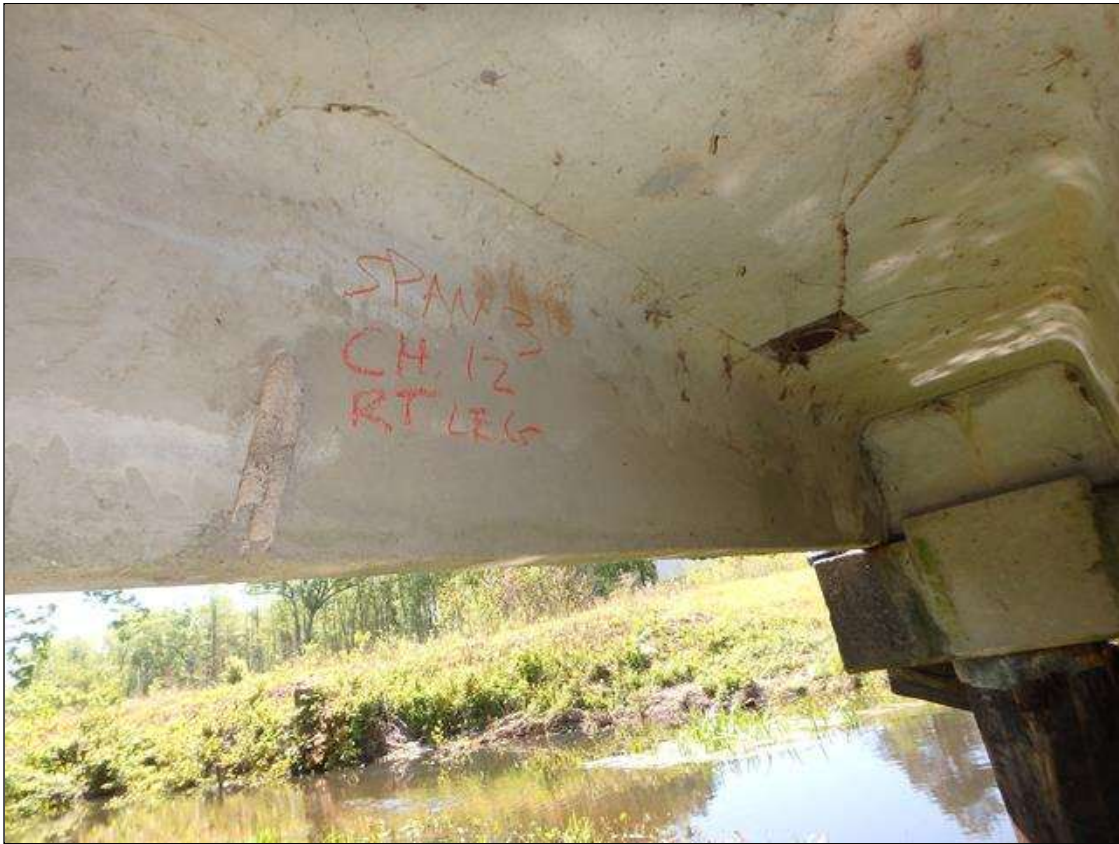
SPAN 3 CHANNEL 12 NEAR BENT 2 BOTTOM RT. LEG HAS TEMPORARY REPAIR, SOUND CONC. PATCH 4IN. H X 4FT. LONG.
