NC DEPARTMENT OF TRANSPORTATION  
DIVISION OF HIGHWAYS  
STRUCTURE MANAGEMENT UNIT

## Structure Safety Report

### Routine Element Inspection - Contract

COUNTY: ROBESON STRUCTURE NUMBER: 770434 FREQUENCY: 24 MONTHS

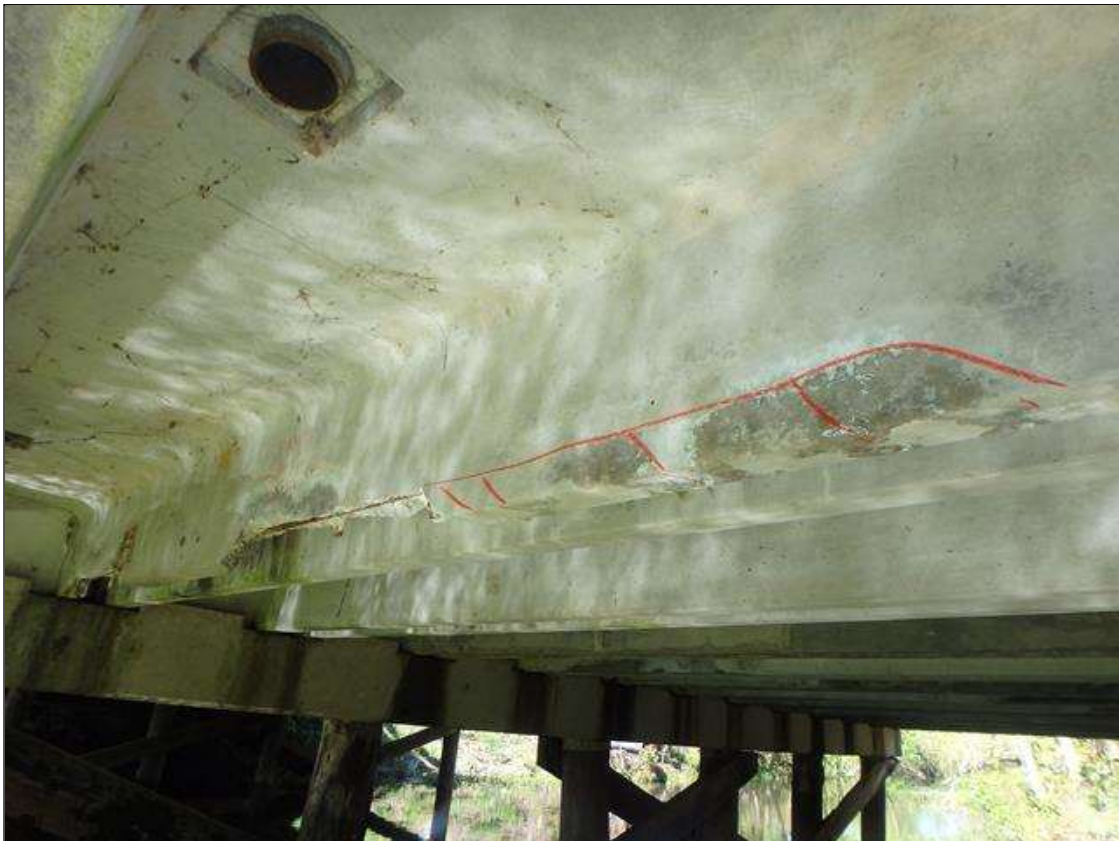
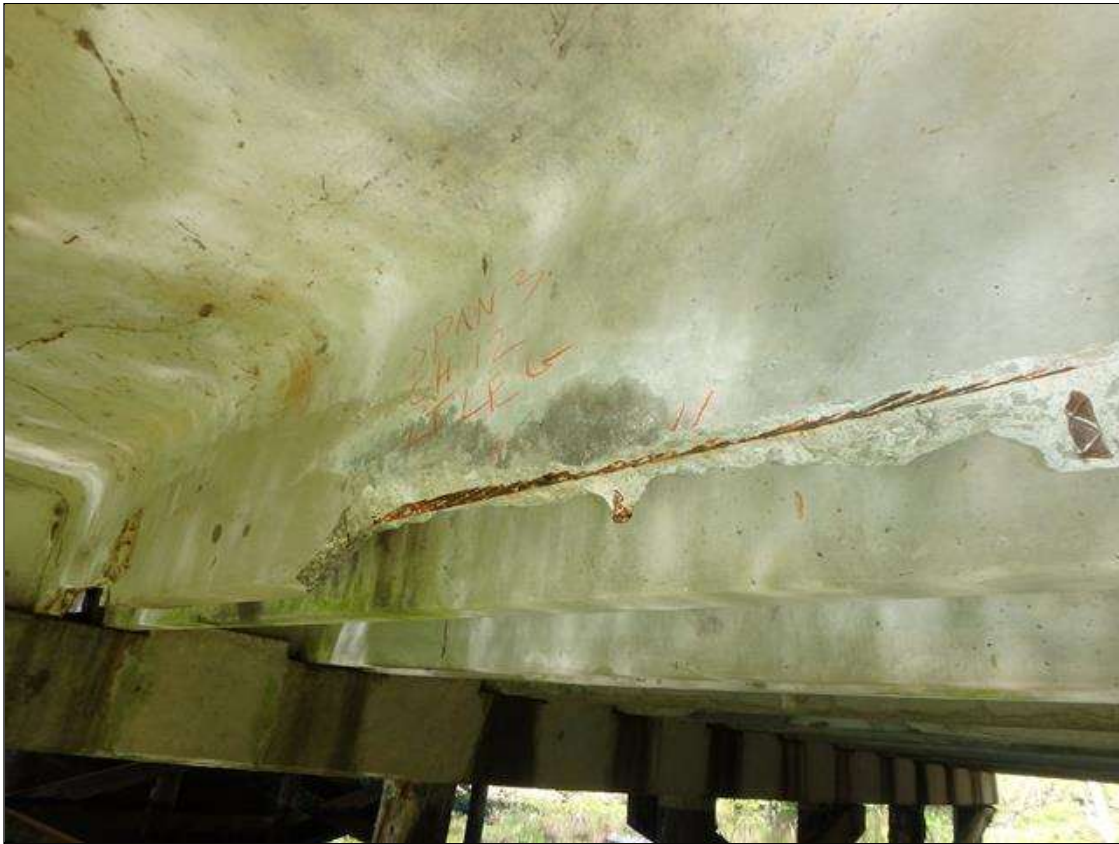
SPAN 3 CHANNEL 12 BEGIN AT BENT 2, BOTTOM LT. LEG 10 FT. OF SPALL WITH EXPOSED STEEL AND DELAMINATION 3-1/2IN. H X FULL WIDTH. PRIORITY MAINTENANCE

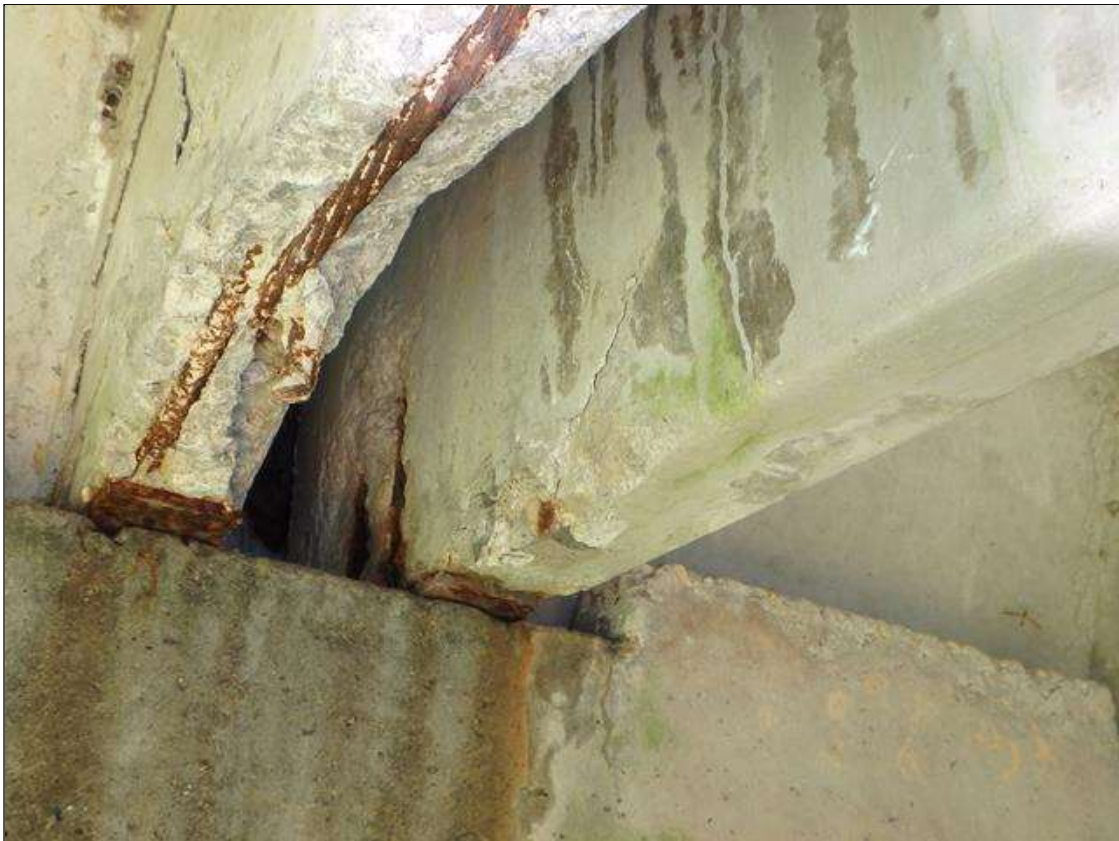
SPAN 3 CHANNEL 11 RT. LEG AT BENT 2 CRACKS/ DELAMINATION 6IN. L X 8IN. H & SPALL W/ EXPOSED STEEL 8IN. H X 6IN. L X 1/2IN. DEEP. PRIORITY MAINTENANCE

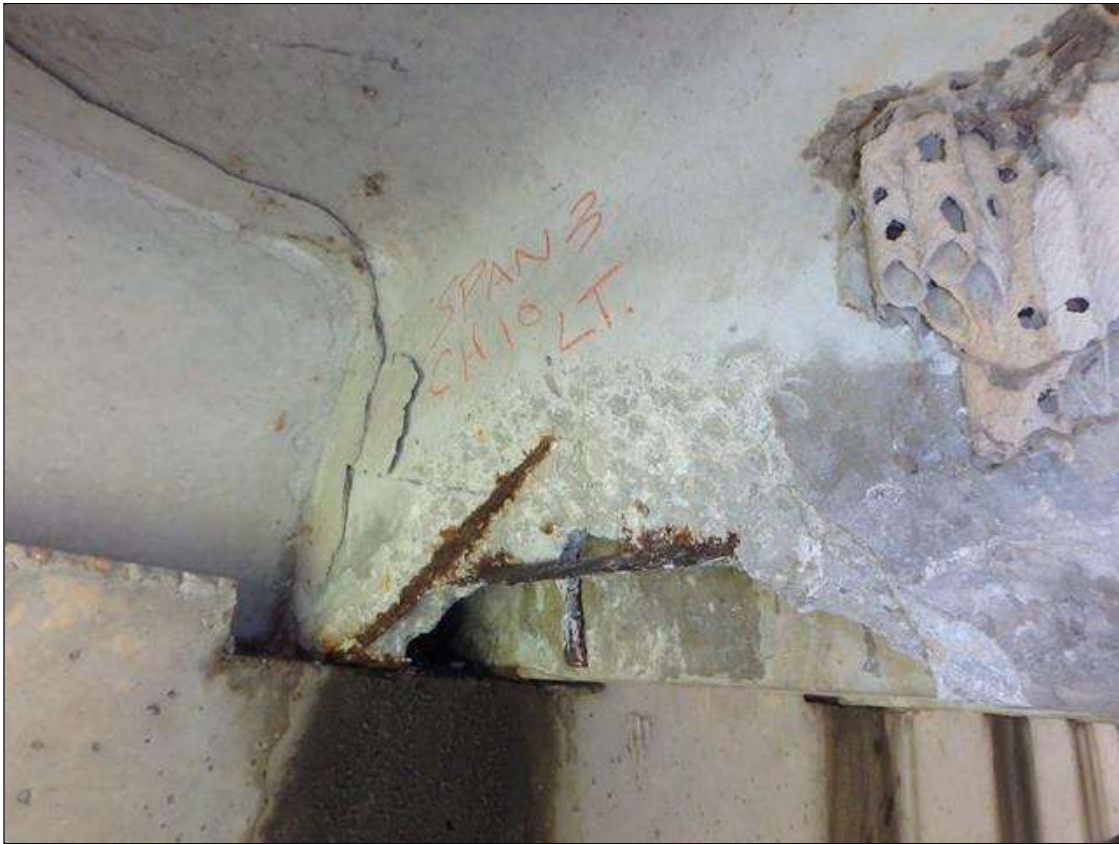
SPAN 3 CHANNEL 10 AT BENT BOTTOM LT. LEG HAS SPALL WITH EXPOSED STEEL 6IN. H X 18IN. LONG. STRANDS HAVE RUST & SCALE. PRIORITY MAINTENANCE

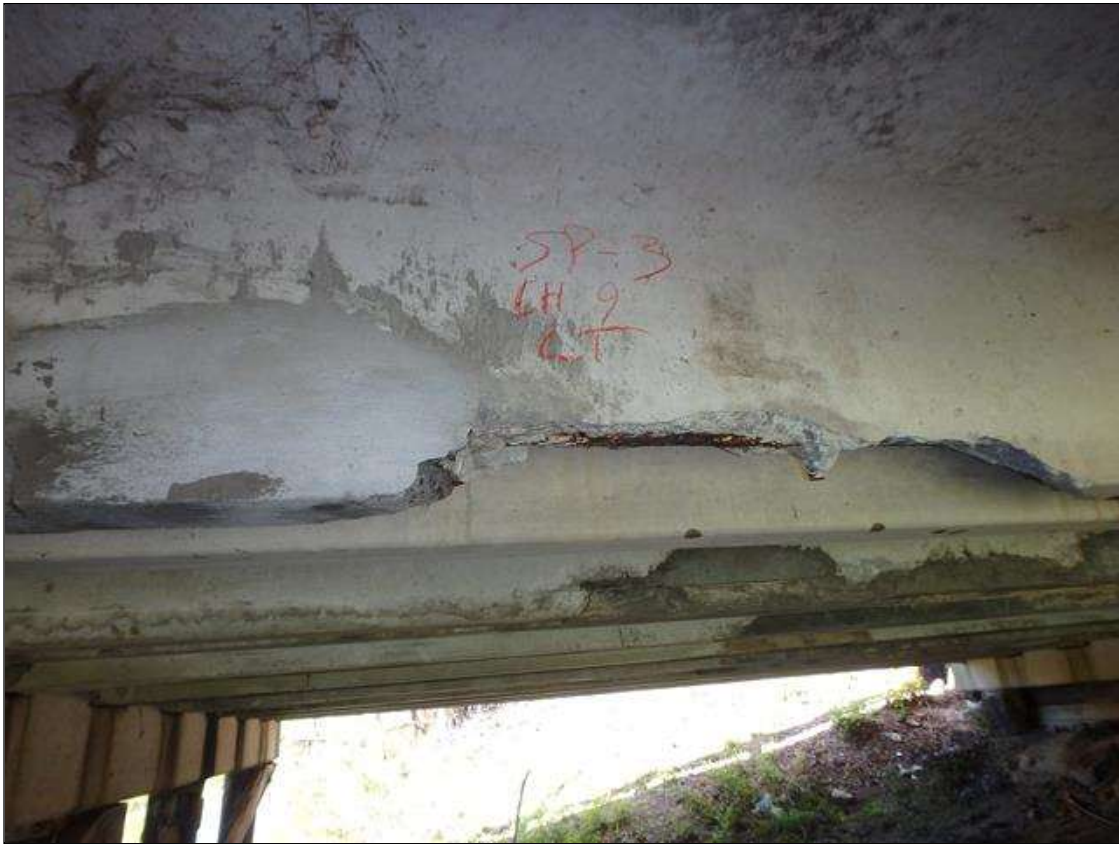
SPAN 3 CHANNEL 9 BOTTOM LT. LEG NEAR BENT PATCH W/ DELAMINATION 3IN. H X 30IN. L & SPALL WITH EXPOSED STEEL 3IN. H X 20IN. LONG. PRIORITY MAINTENANCE

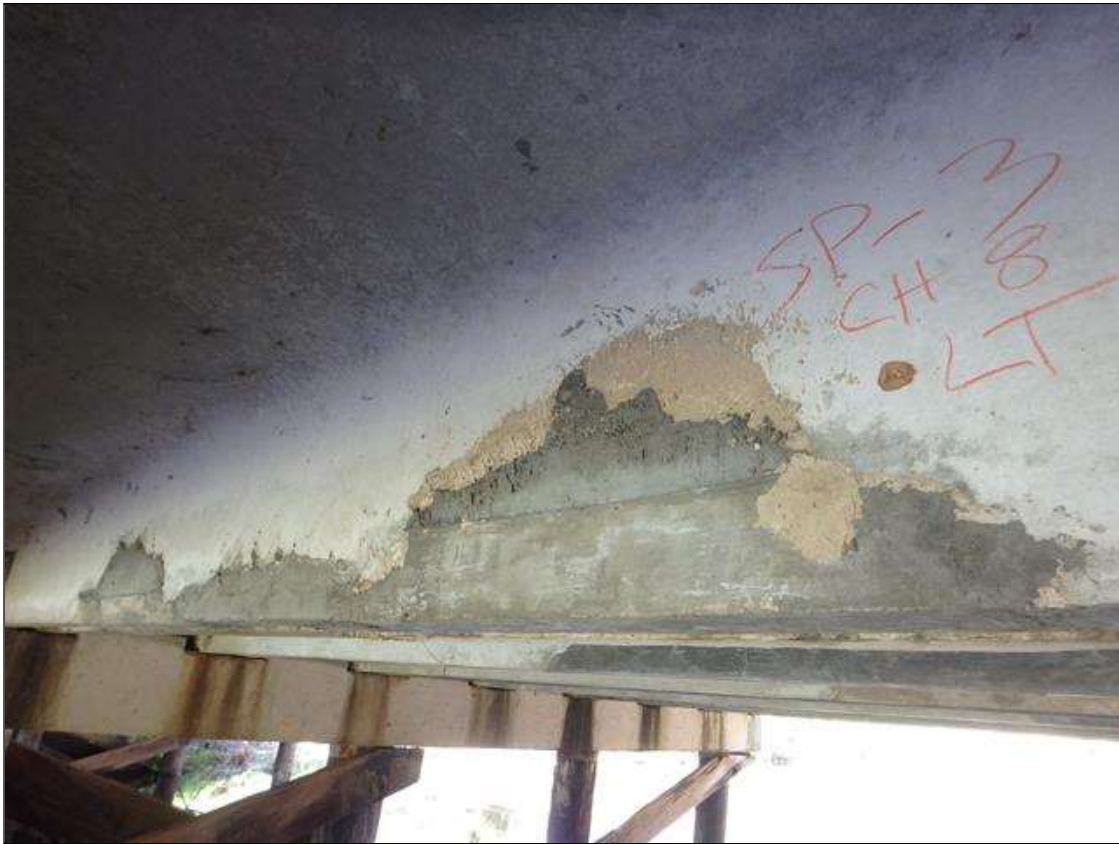
MID-SPAN 3 CHANNEL 8 BOTTOM OF LT. LEG HAS TEMPORARY REPAIR, SOUND CONC. PATCH 3IN. H X 5FT. LONG.

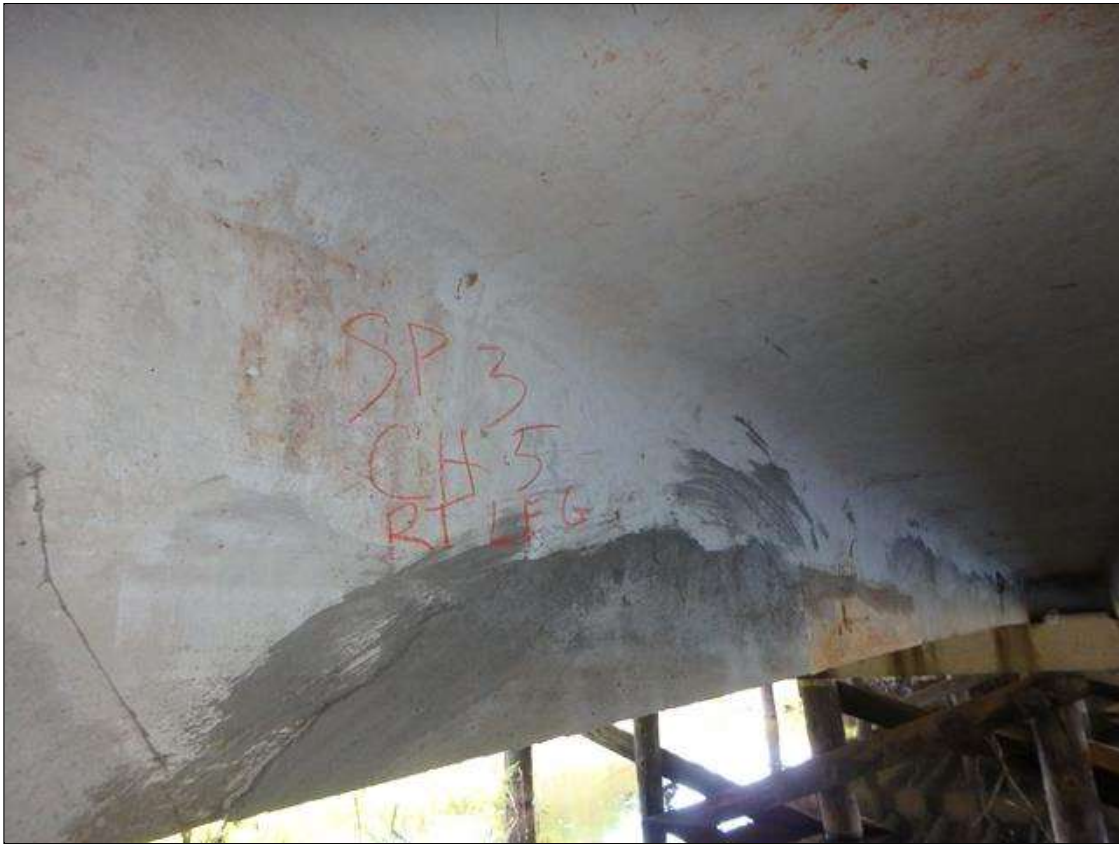
SPAN 3 CHANNEL 5 BOTTOM OF RT. LEG HAS TEMPORARY REPAIR, SOUND CONC. PATCHING 4IN. H X 23FT. LONG.

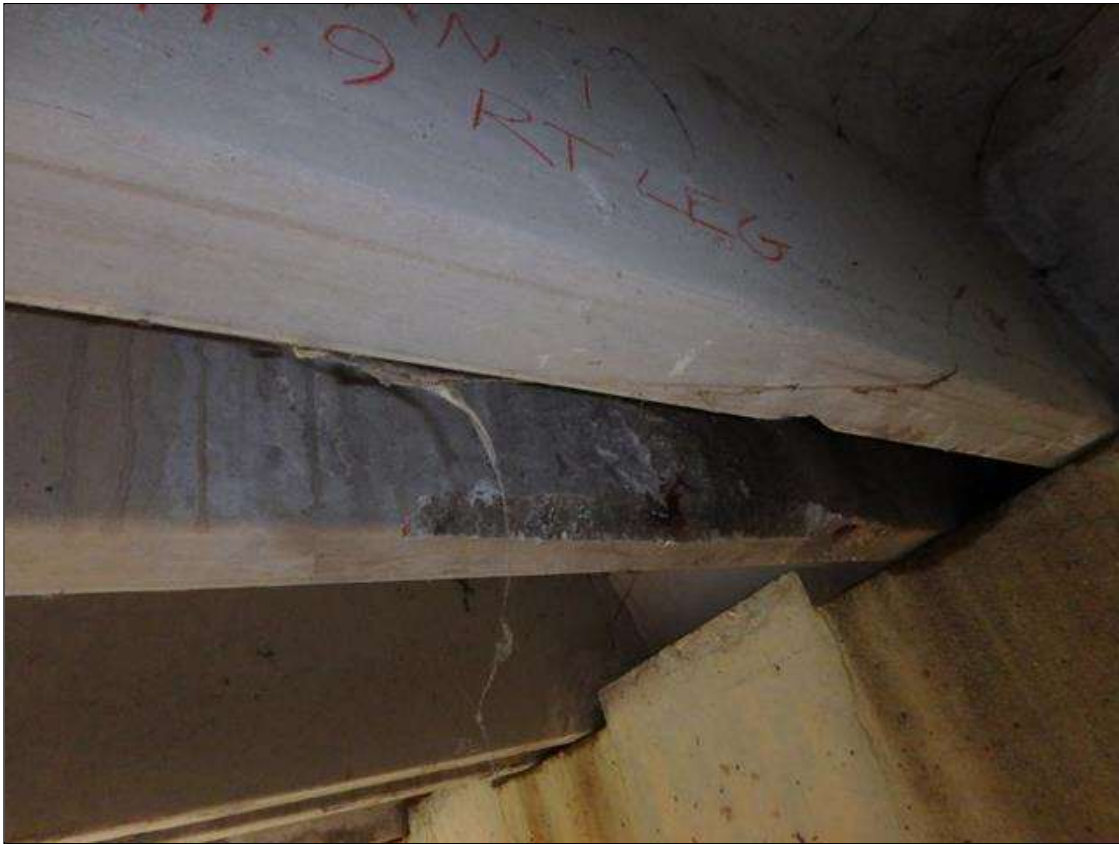
SPAN 1 CHANNEL 10 AT ABUTMENT 1, BOTTOM OF LEFT LEG HAS SPALL WITH EXPOSED VERTICAL STEEL  
1/2IN. D X 16IN. L X 1IN. - 3IN. HIGH.

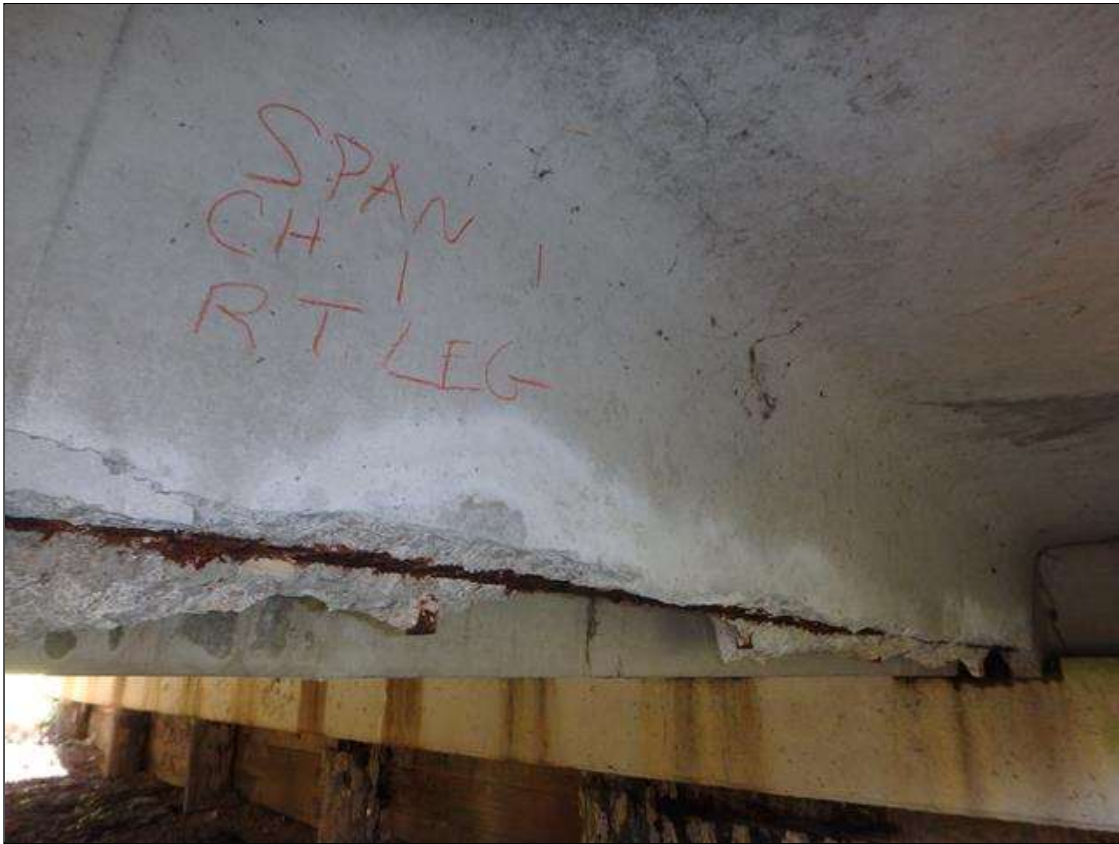
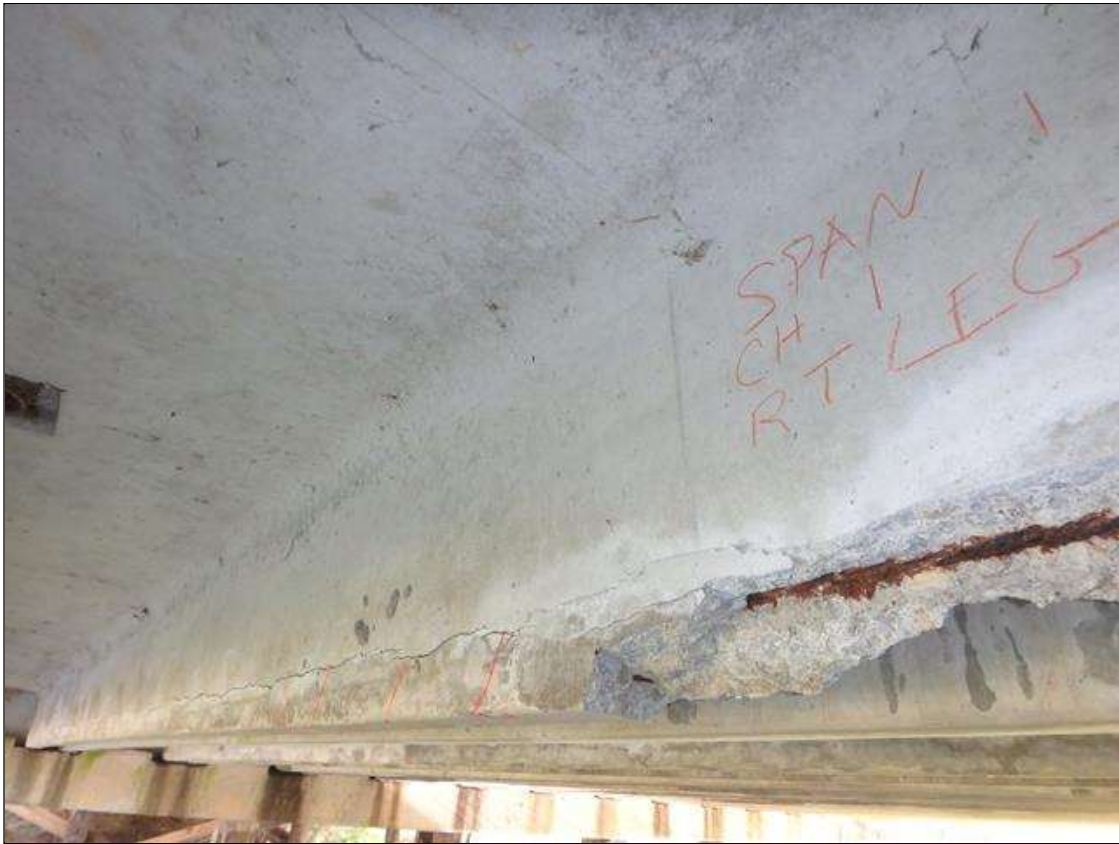
SPAN 1 CHANNEL 1 BOTTOM OF RT. LEG HAS A SPALL WITH EXPOSED STEEL BEGIN AT ABOUT 1, 6FT. L X 3IN. H X FULL WIDTH. BOTTOM 3IN. OF REMAINING CHANNEL LEG LENGTH HAS DELAMINATION. PRIORITY MAINTENANCE.

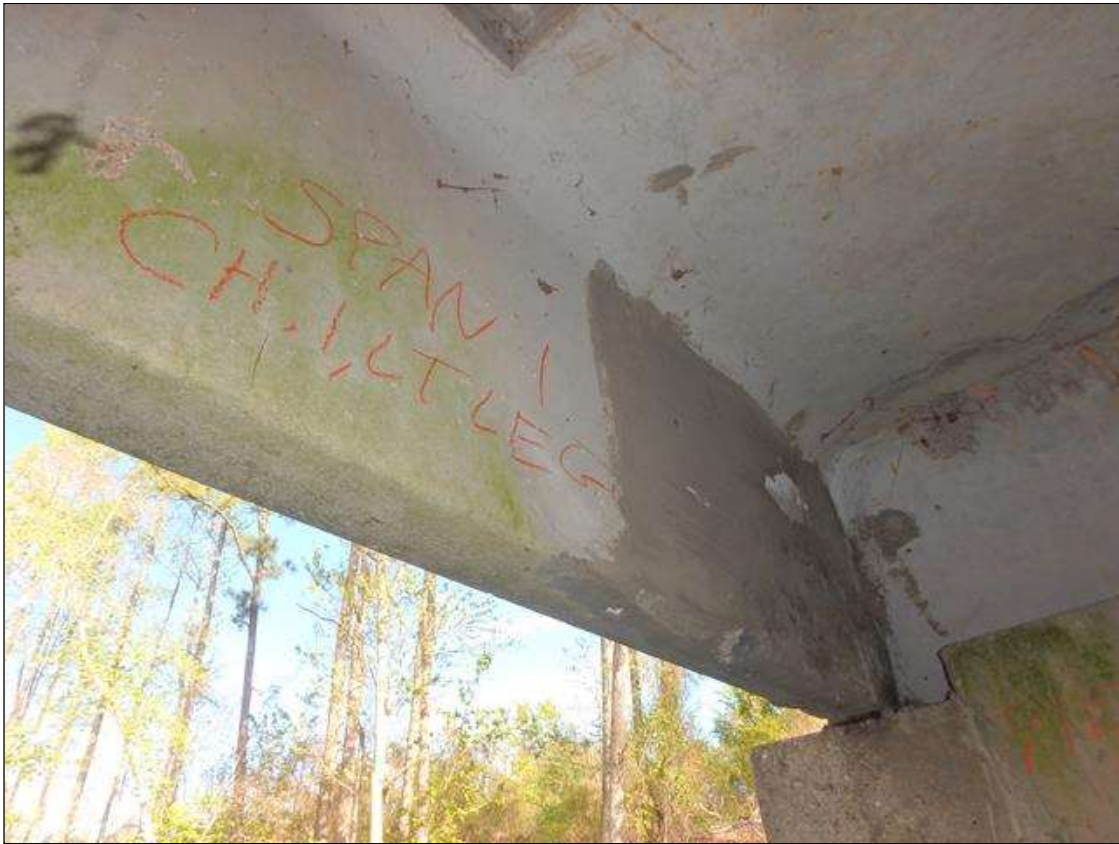
SPAN 1 CHANNEL 1 AT BENT 1 BOTTOM OF LEFT LEG HAS TEMPORARY REPAIR CONC. PATCH WITH 1/16IN. CRACKS.

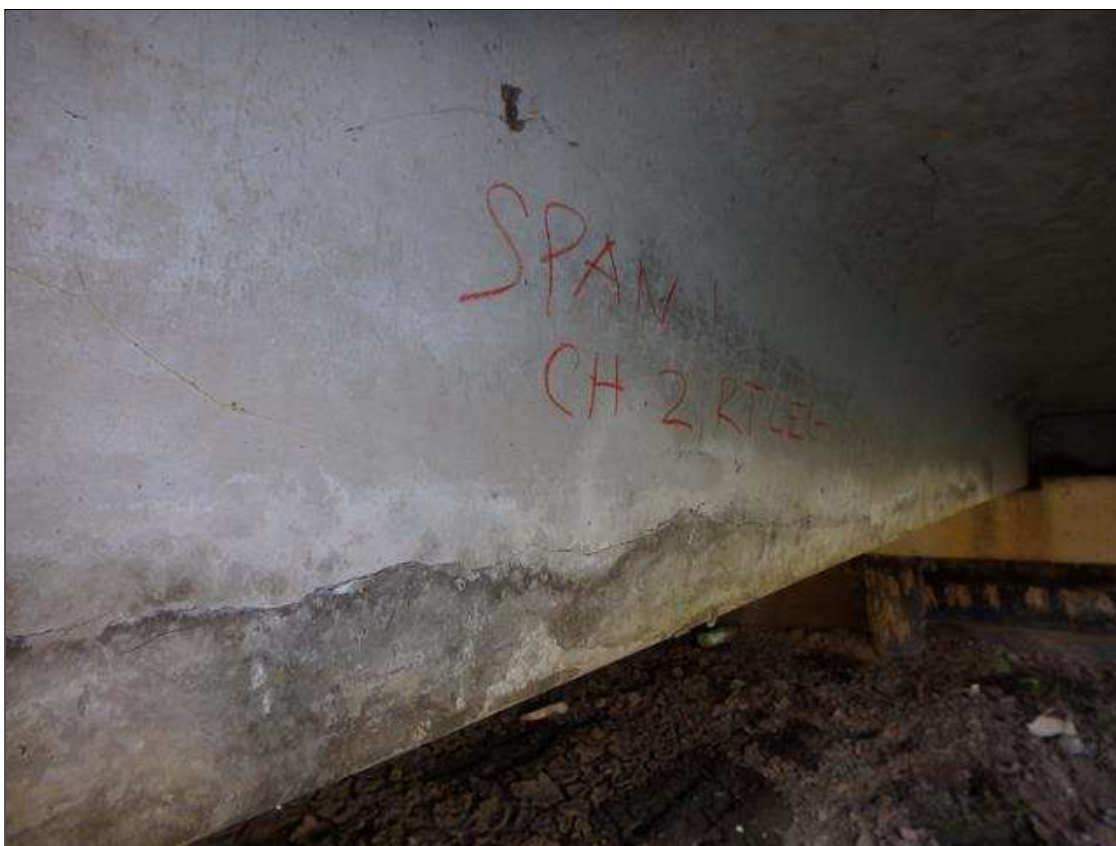
SPAN 1 CHANNEL 2 BEGINNING 7FT. FROM ABUTMENT 1, BOTTOM OF RT. LEG HAS 1/32IN. HORIZONTAL CRACKING 8FT. LONG.

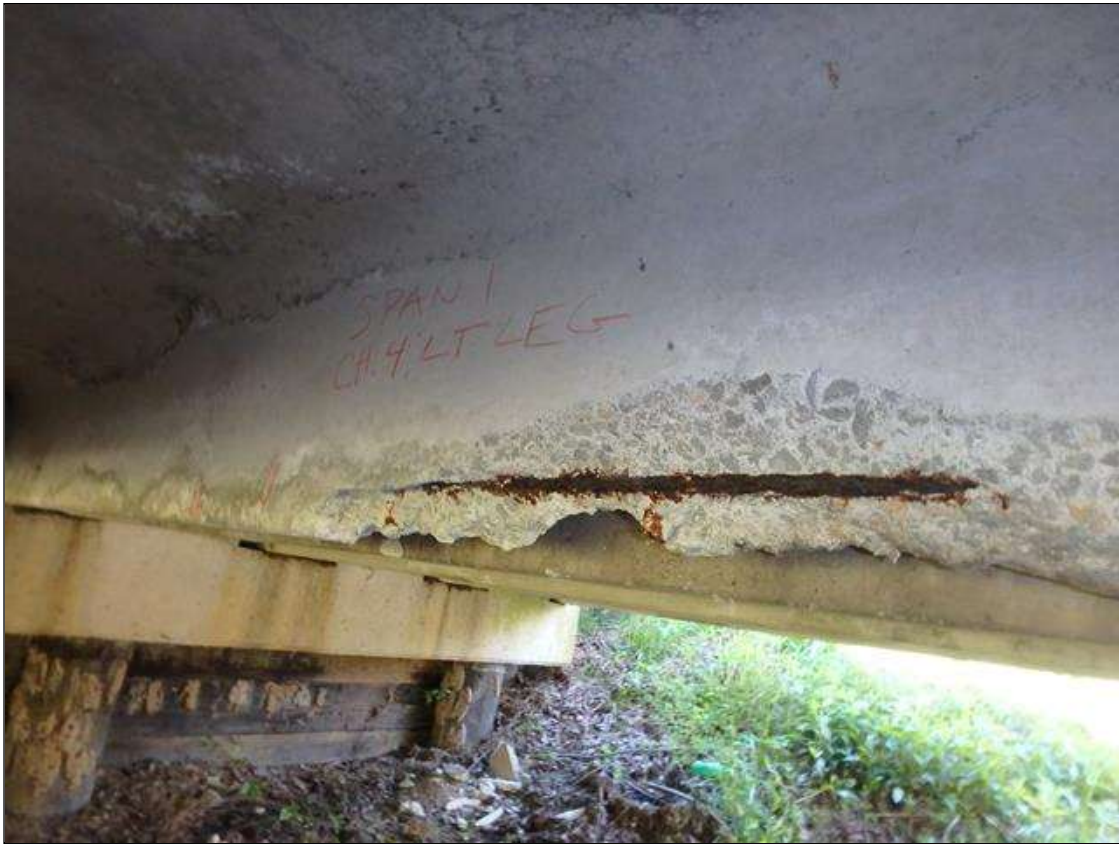
SPAN 1 CHANNEL 4 BEGIN AT ABUT 1 BOTTOM LT. LEG DELAMINATION 3IN. H X 5FT. L THEN SPALL WITH EXPOSED STEEL 3IN. H X 30IN. L. PRIORITY MAINTENANCE

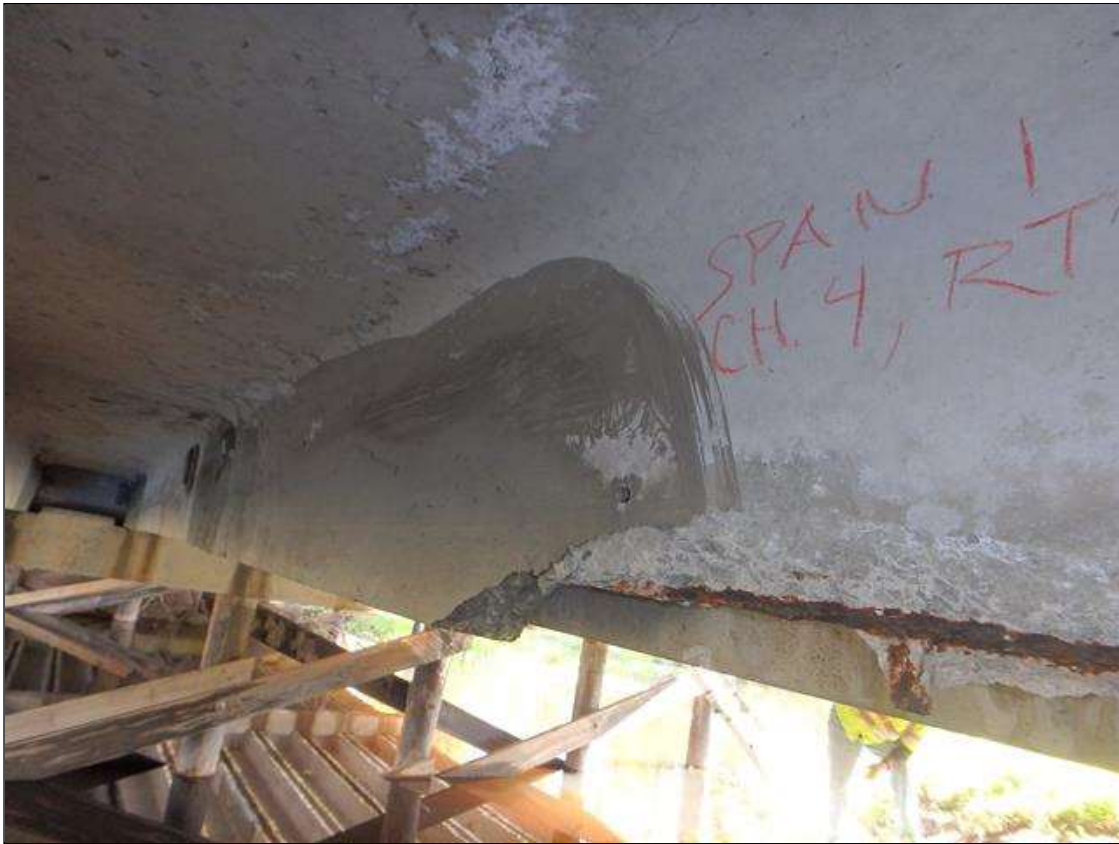
SPAN 1 CHANNEL 4 AT MID-SPAN RT. LEG HAS TEMPORARY REPAIR SOUND CONC. PATCH 4FT. LONG

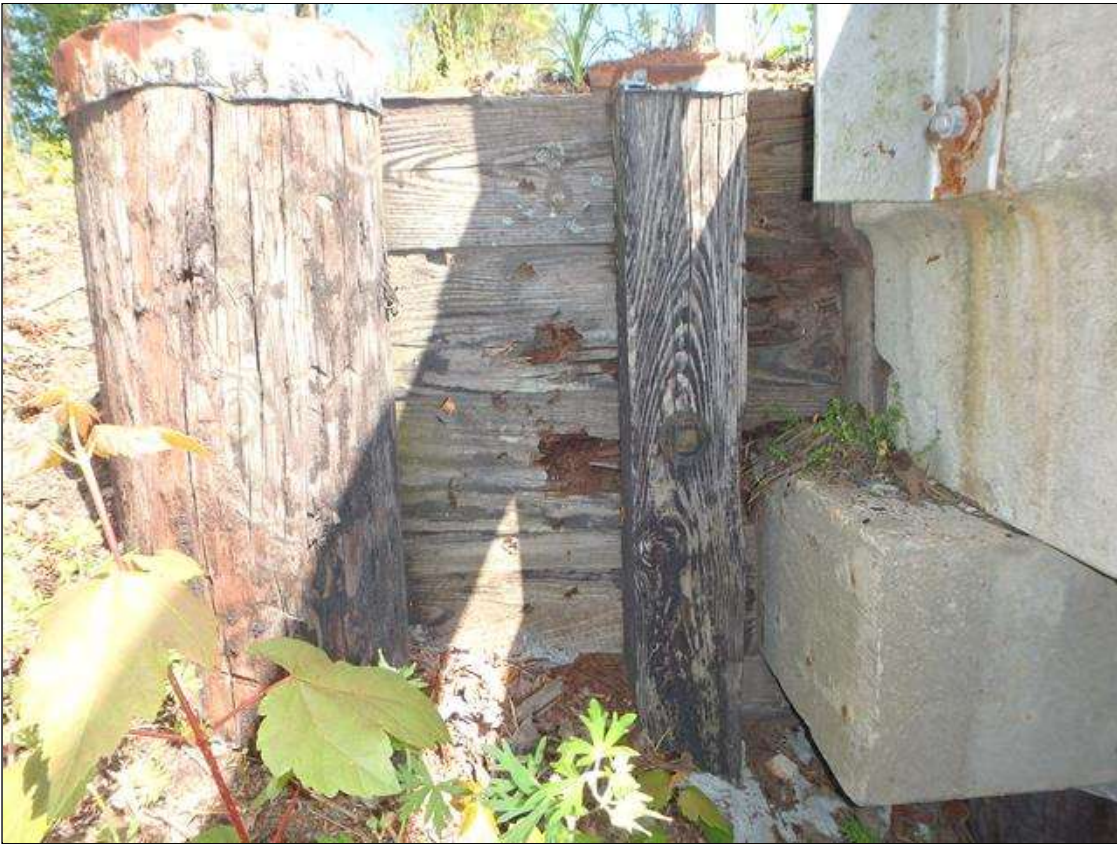
ABUT 2 LT. END BULKHEAD BOARDS HAVE 3 SQUARE FEET OF DECAY EXPOSING FILL. PRIORITY MAINTENANCE

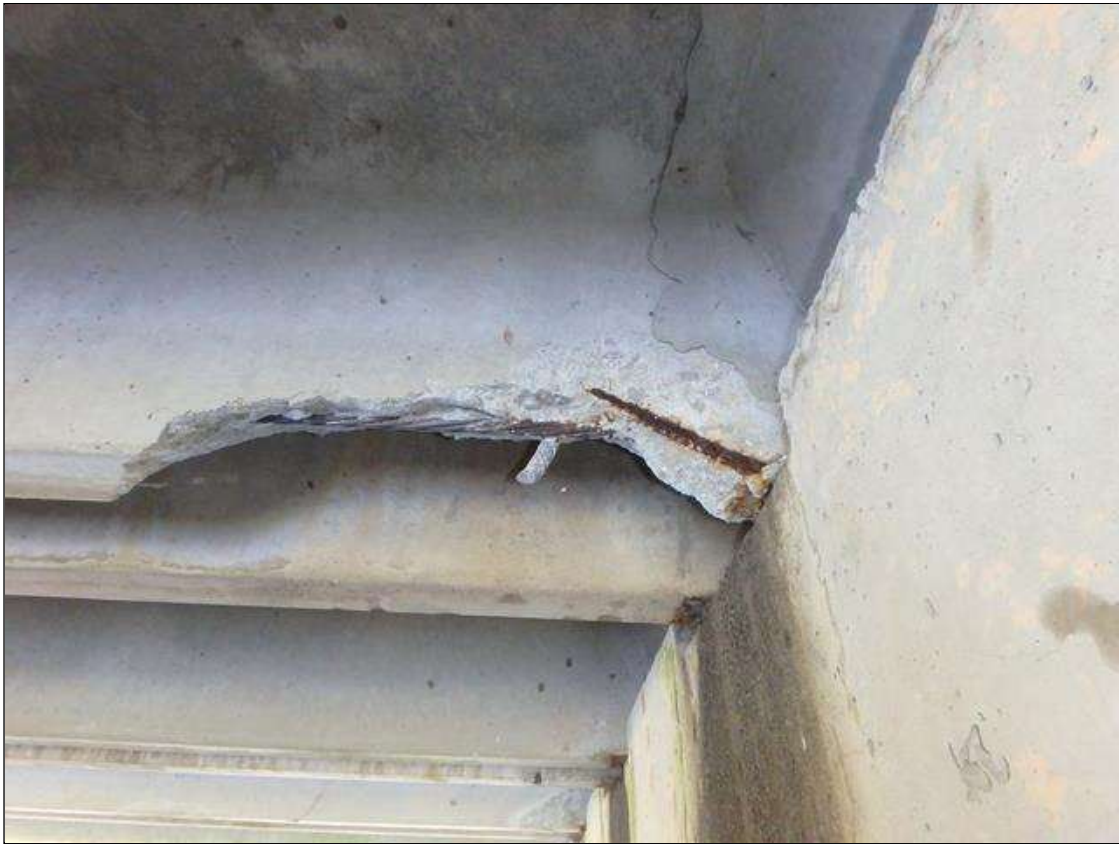
SPAN 2 CHANNEL 4 AT BENT 2 BOTTOM LT. LEG HAS SPALL WITH EXPOSED STEEL 18IN. L X 4IN. HIGH.  
PRIORITY MAINTENANCE

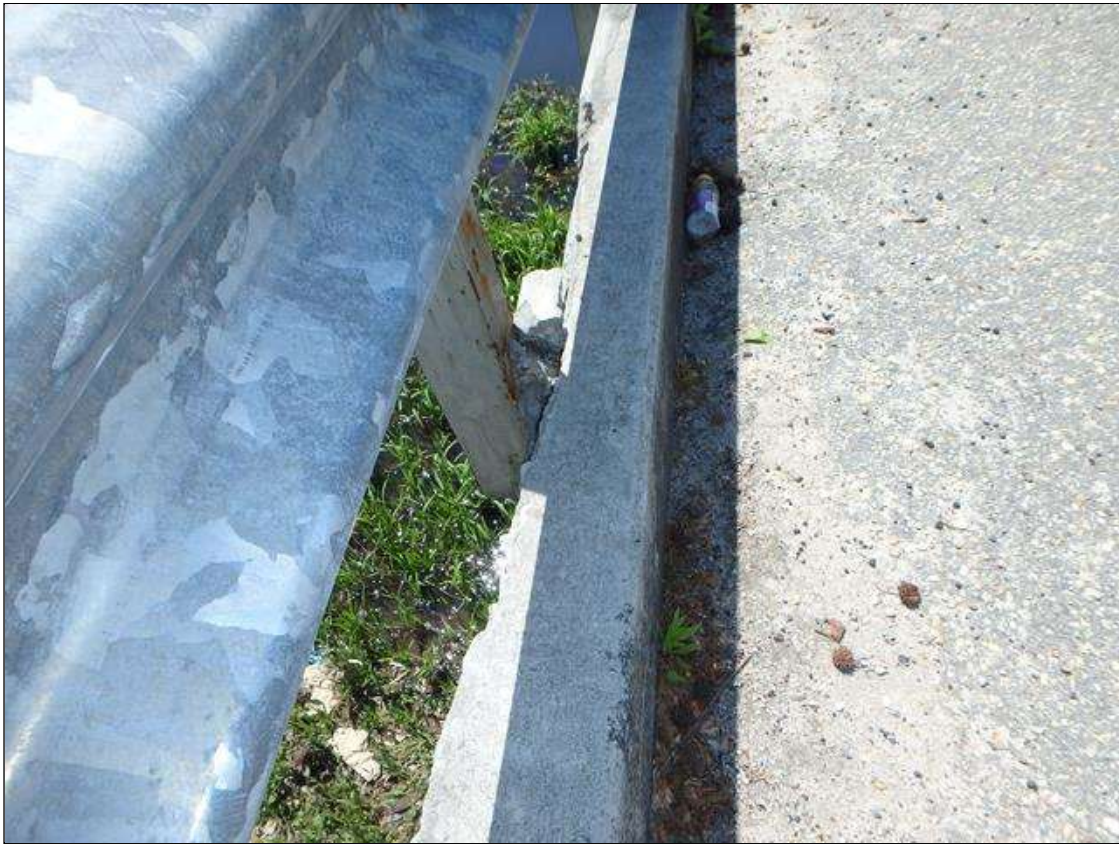
SPAN 3 RT. STEEL RAIL 4TH POST FROM ABUT 2 CONNECTION LOOSE DUE TO SPALL IN CURB 5FT. LONG X 3IN. D X 4IN. HIGH. PRIORITY MAINTENANCE

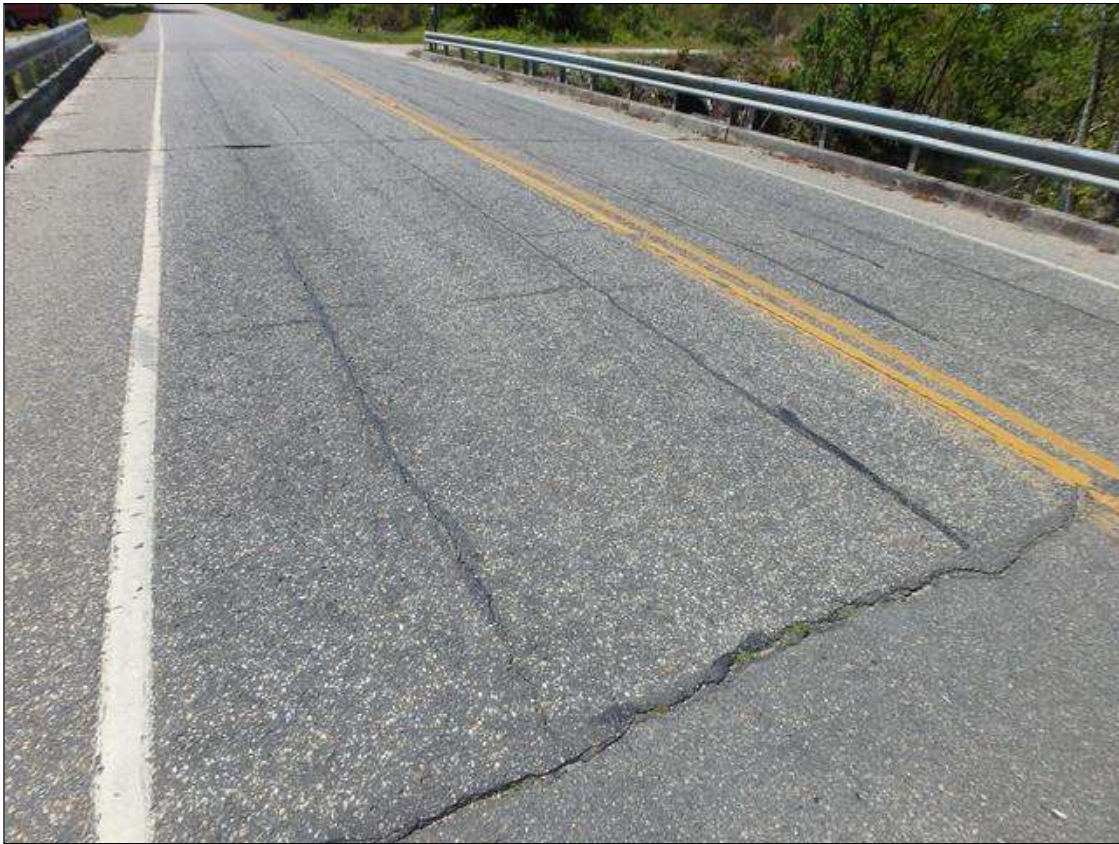
AWS HAS LONGITUDINAL CRACKS SPACED 2-1/2FT. APART IN ALL SPANS

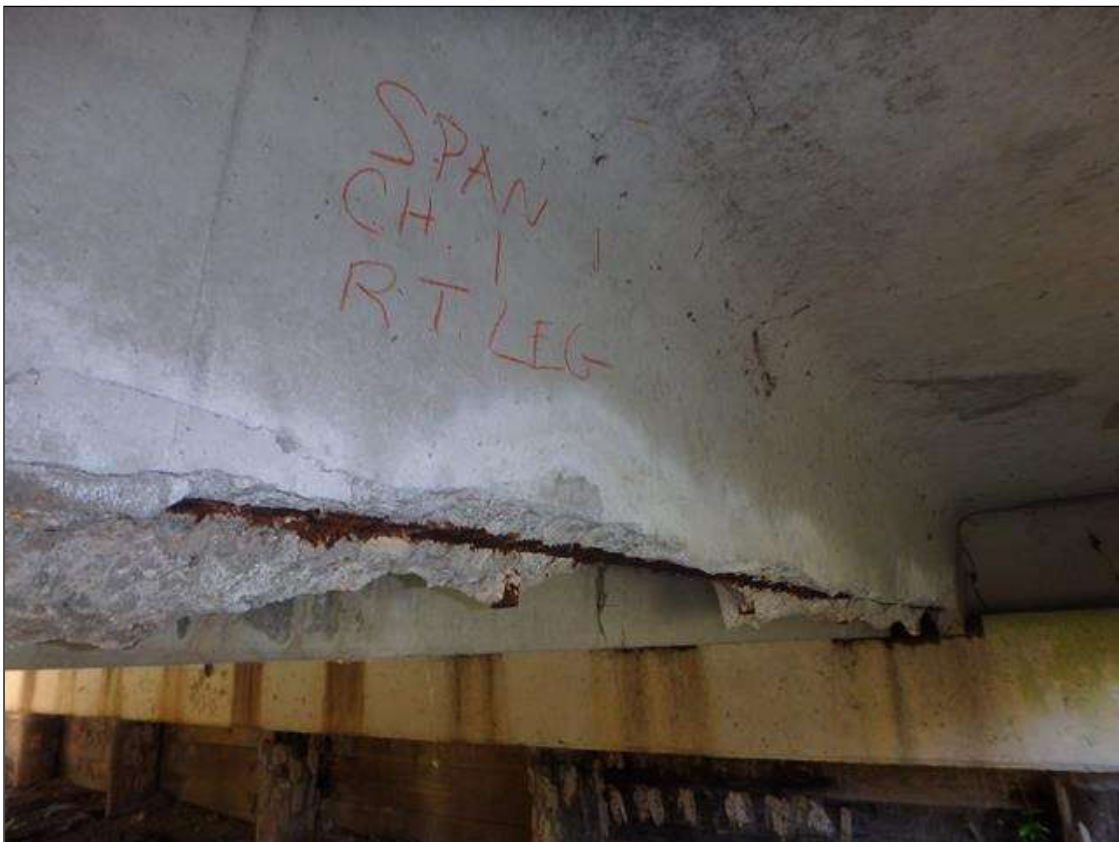
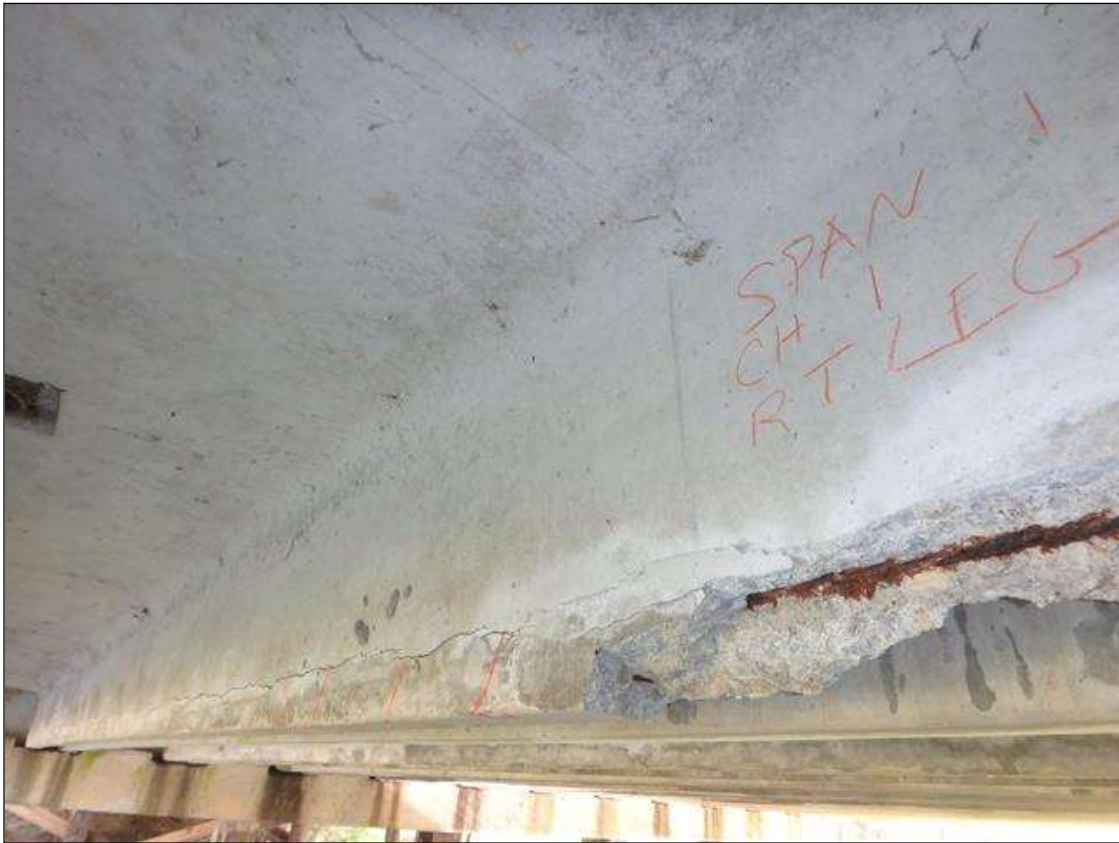
SPAN 1 CHANNEL 1 RT. LEG BOTTOM SPALL WITH EXPOSED STEEL BEGIN AT ABOUT 1, 6FT. L X 3IN. H, DELAMINATION REMAINING CHANNEL LENGTH. PRIORITY MAINTENANCE

SPAN 1 CHANNEL 1 RT. LEG BOTTOM SPALL WITH EXPOSED STEEL BEGIN AT ABUT 1, 6FT. L X 3IN. H, DELAMINATION REMAINING CHANNEL LENGTH. PRIORITY MAINTENANCE

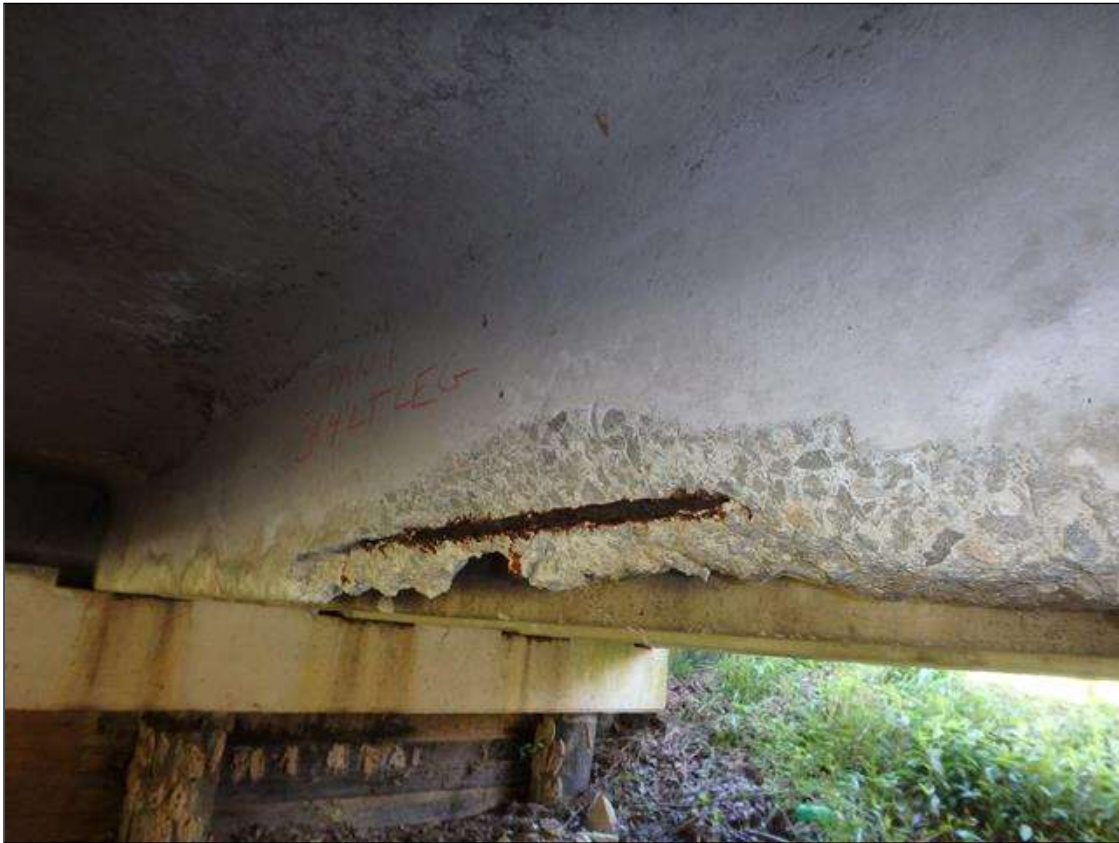
SPAN 1 CHANNEL 4 BOTTOM LT. LEG BEGIN AT ABUT 1 DELAMINATION 3IN. H X 5FT. L THEN SPALL WITH EXPOSED STEEL 3IN. H X 30IN. L. PRIORITY MAINTENANCE

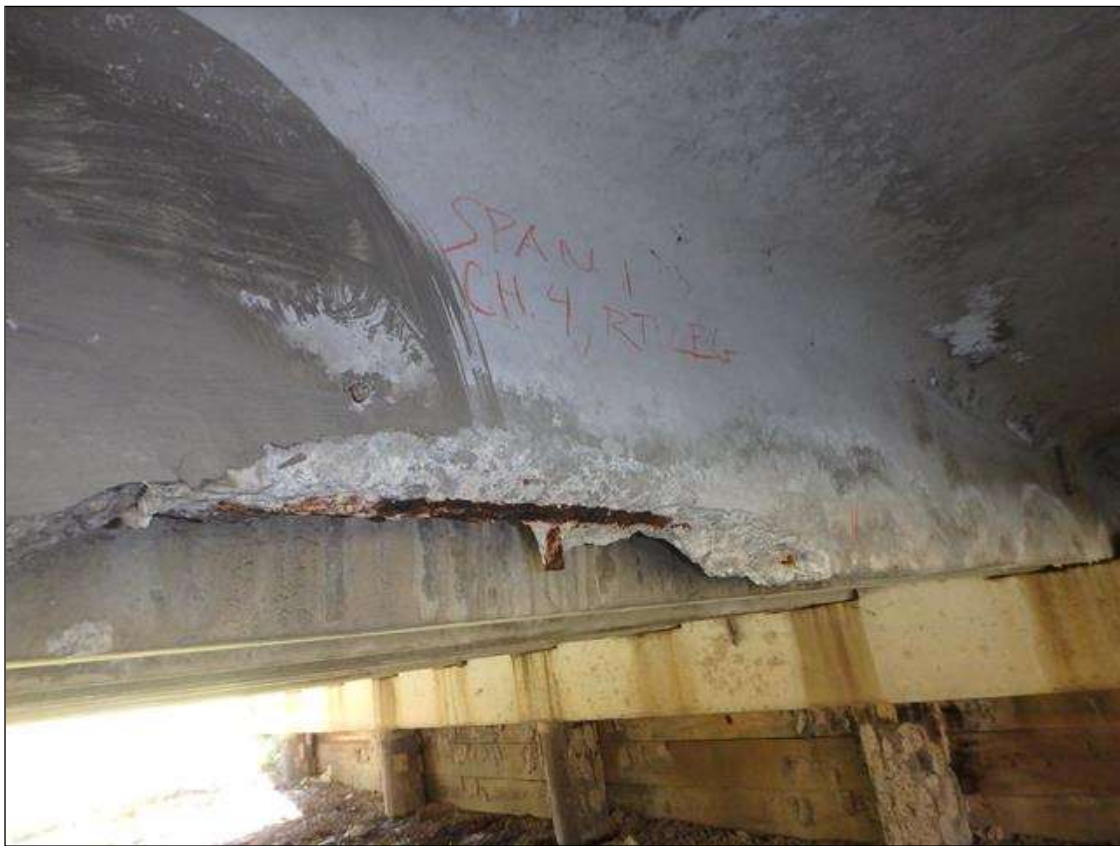
SPAN 1 CHANNEL 4 BOTTOM RT. LEG AT ABOUT 1 1/16" CRACKS/ DELAMINATION 3IN. H X 5FT. L THEN SPALL W/ EXPOSED STEEL 3IN. H X 2FT. L. PRIORITY MAINTENANCE

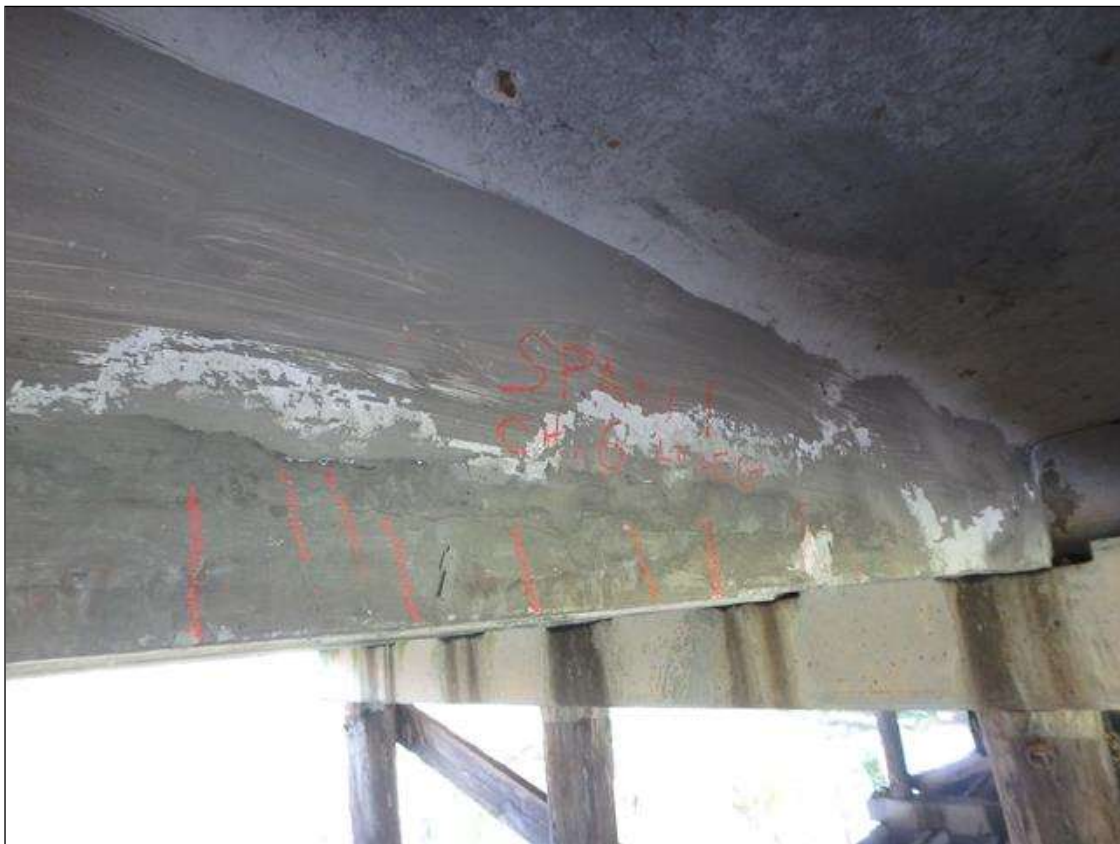
SPAN 1 CHANNEL 6 BOTTOM LT. LEG BEGIN 4FT. FROM BENT 1 CONC. PATCH WITH 1/16" CRACKS/  
DELAMINATION 3IN. H X5FT. L. PRIORITY MAINTENANCE
