NC DEPARTMENT OF TRANSPORTATION  
DIVISION OF HIGHWAYS  
STRUCTURE MANAGEMENT UNIT

## Structure Safety Report

### Routine Element Inspection - Contract

COUNTY: ROBESON STRUCTURE NUMBER: 770434 FREQUENCY: 24 MONTHS

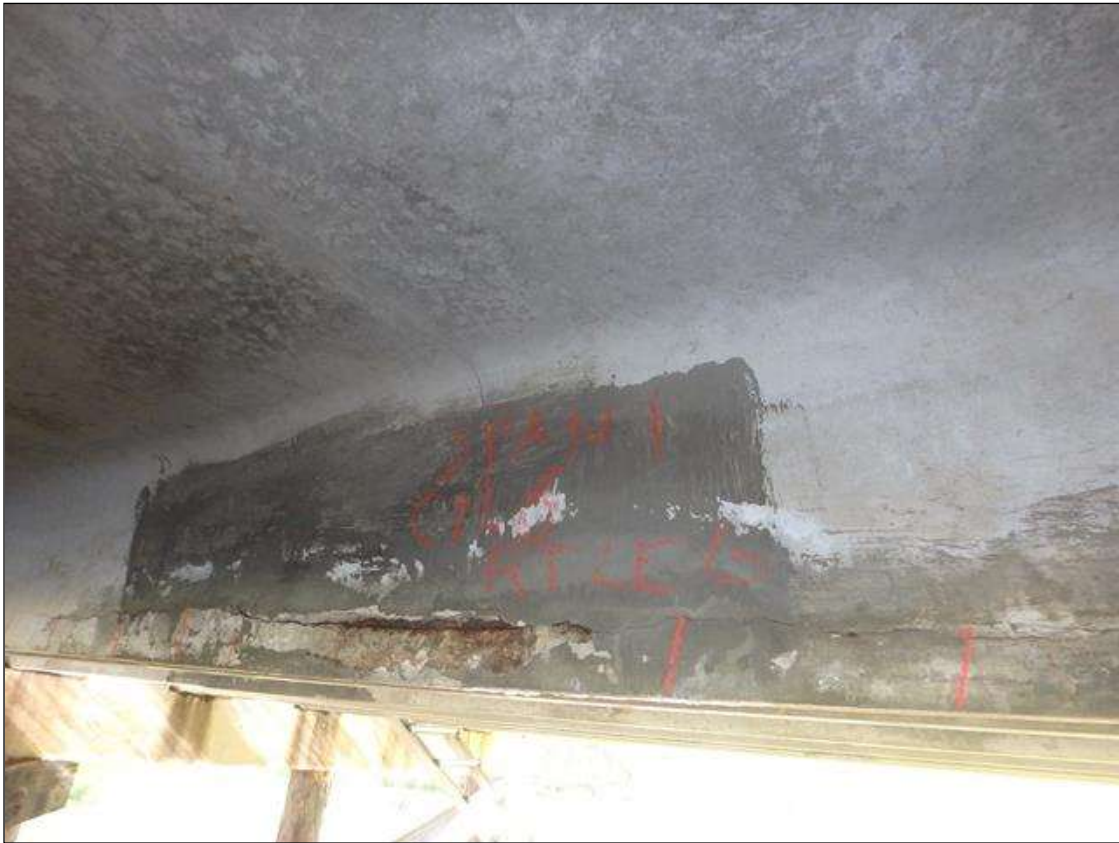
SPAN 1 CHANNEL 6 BOTTOM RT. 8FT. FROM ABUT 1 1/16" CRACKS/ DELAMINATION 3IN. H X 7FT. L W/  
SPALL& EXPOSED STEEL 3IN. H X 1FT. L. PRIORITY MAINTENANCE

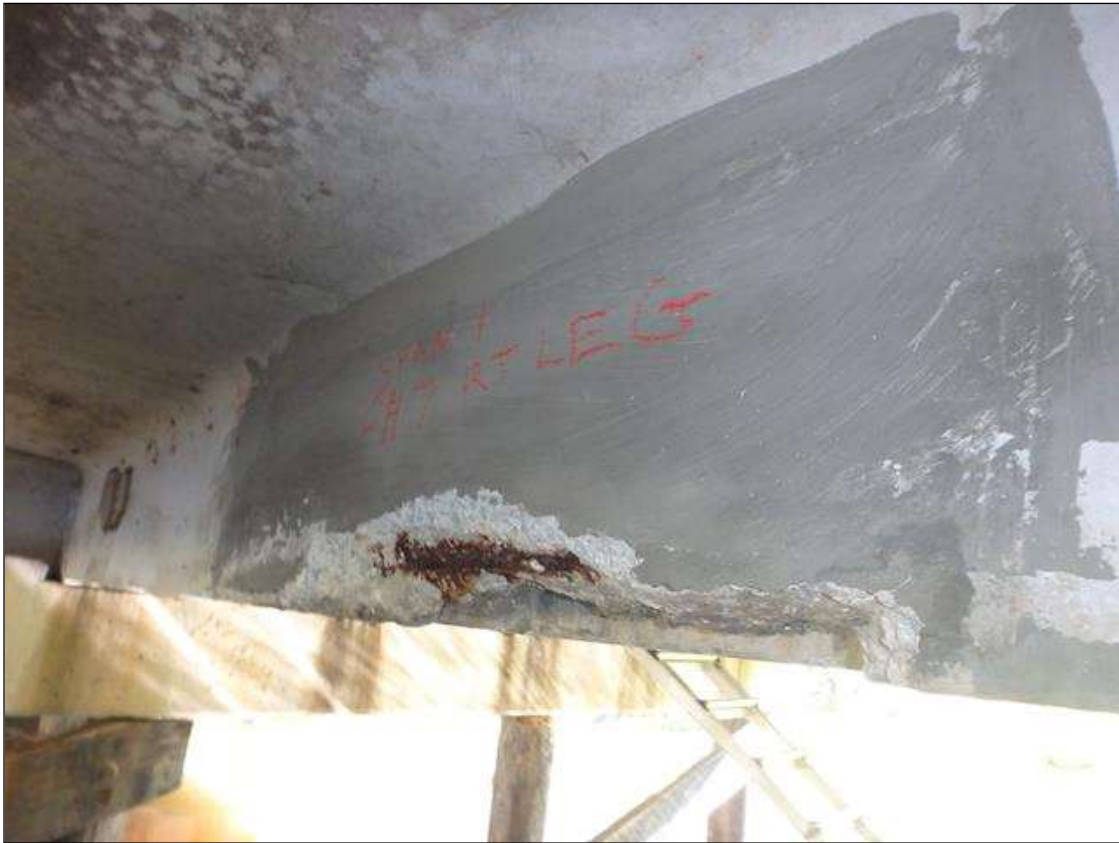
SPAN 1 CHANNEL 7 BOTTOM RT. LEG 5FT. FROM BENT 1 CONC. PATCH W/ SPALL & EXPOSED STEEL 4IN. H X 2FT. L, STEEL HAS RUST AND SCALE. PRIORITY MAINTENANCE

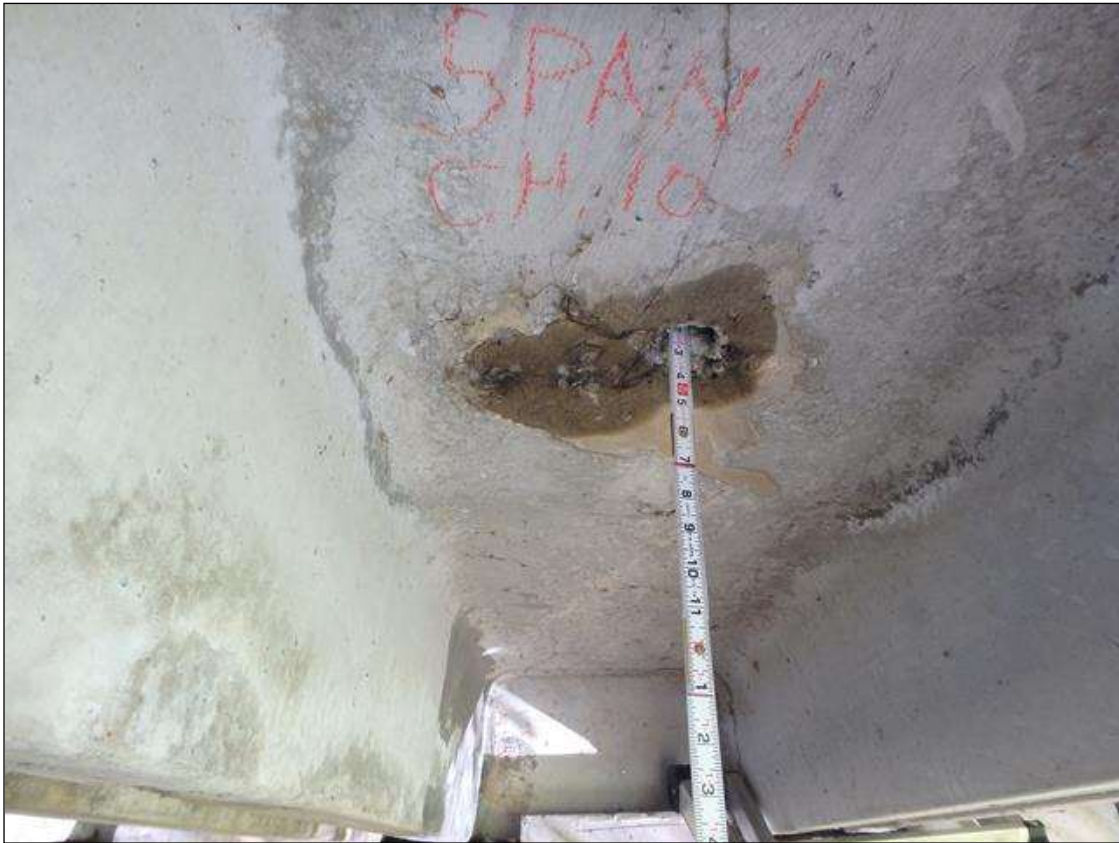
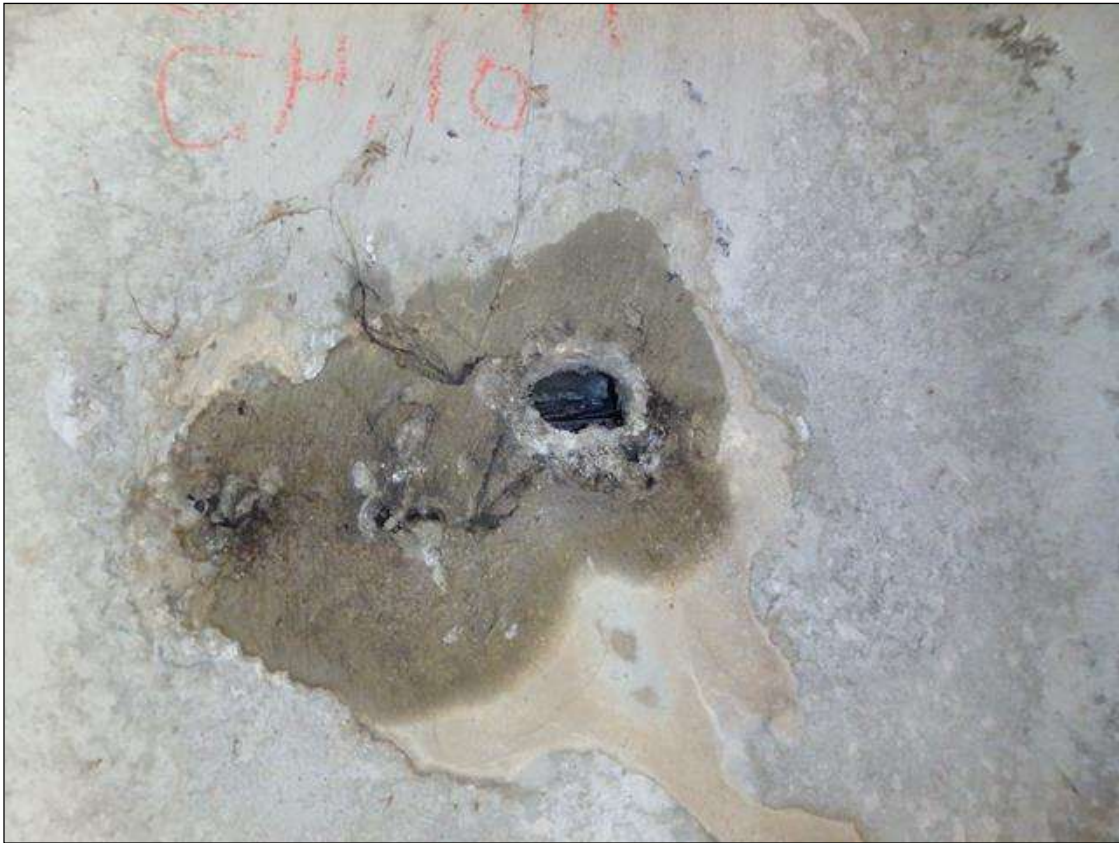
SPAN 1 CHANNEL 10 UNDERSIDE 3FT. FROM BENT, 1-1/2IN. DIA. HOLE X 2IN. DEEP EXPOSING TRANSVERSE CABLE. NO CORROSION VISIBLE. PRIORITY MAINTENANCE

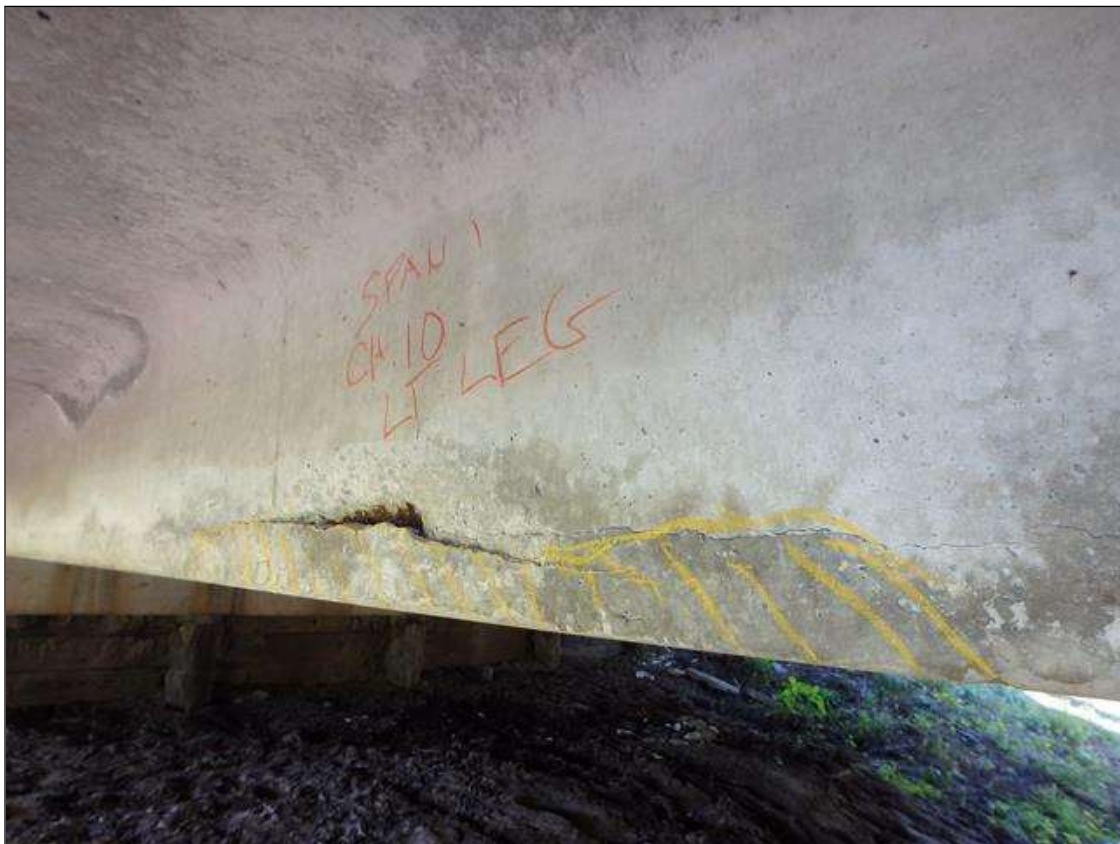
SPAN 1 CHANNEL 10 BOTTOM LT. LEG 9FT. FROM BENT DELAMINATION 3IN. H X 2FT. L & SPALL W/  
EXPOSED STEEL 10IN. L X 2IN. H X 1IN. D. PRIORITY MAINTENANCE

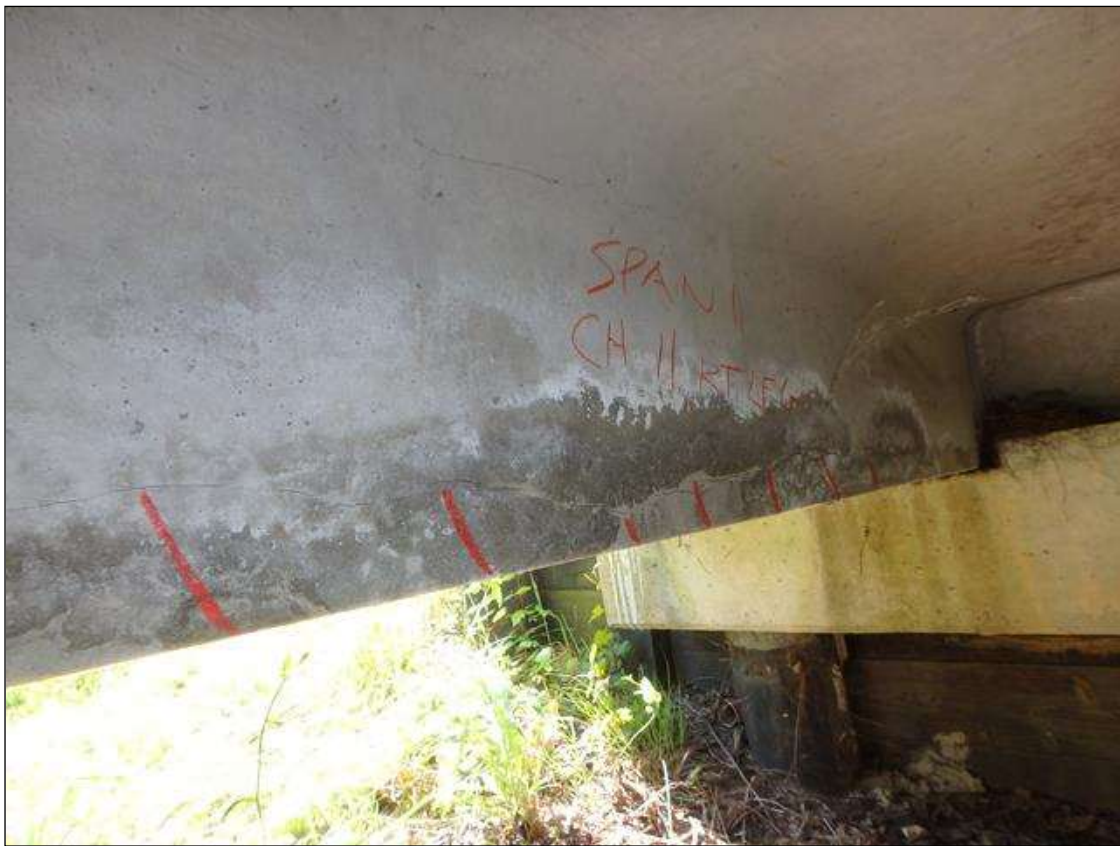
SPAN 1 CHANNEL 11 BOTTOM RT. LEG NEAR ABUT 1 1/16IN. CRACKS/ DELAMINATION 3IN. HIGH X 30IN. LONG. PRIORITY MAINTENANCE

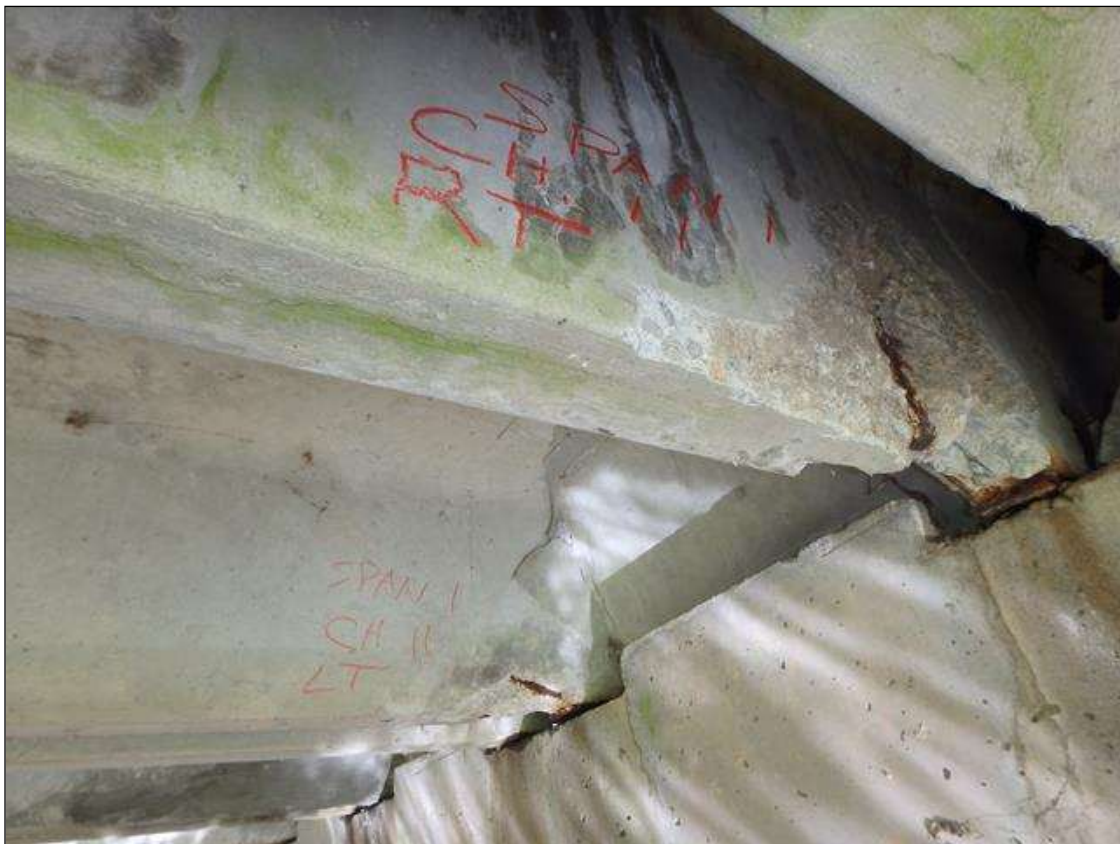
SPAN 1 CHANNEL 11 BOTH LEGS AT BENT HAVE SPALL WITH EXPOSED STEEL UP TO 1FT. L X UP TO 7IN. H X 2IN. DEEP. PRIORITY MAINTENANCE

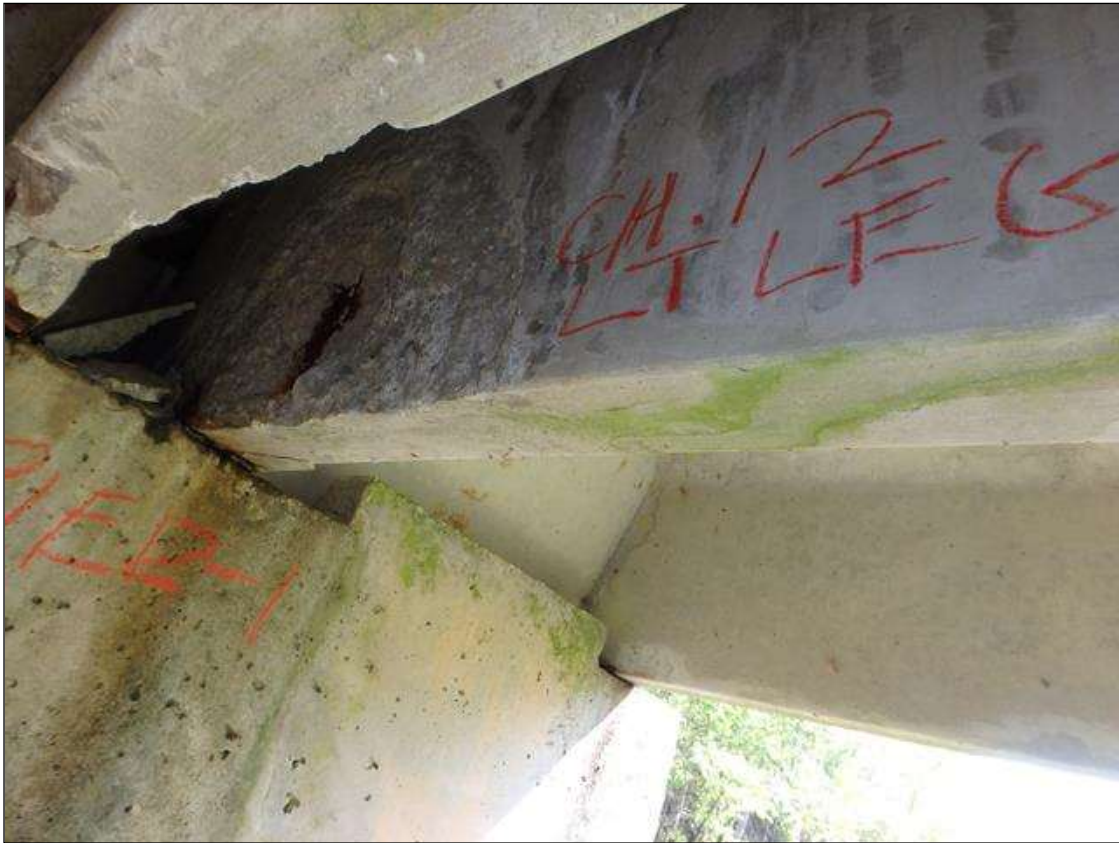
SPAN 1 CHANNEL 12 LT. LEG AT BENT HAS SPALL WITH EXPOSED STEEL 1FT. L X 8IN. H X UP TO 1IN. DEEP.  
PRIORITY MAINTENANCE

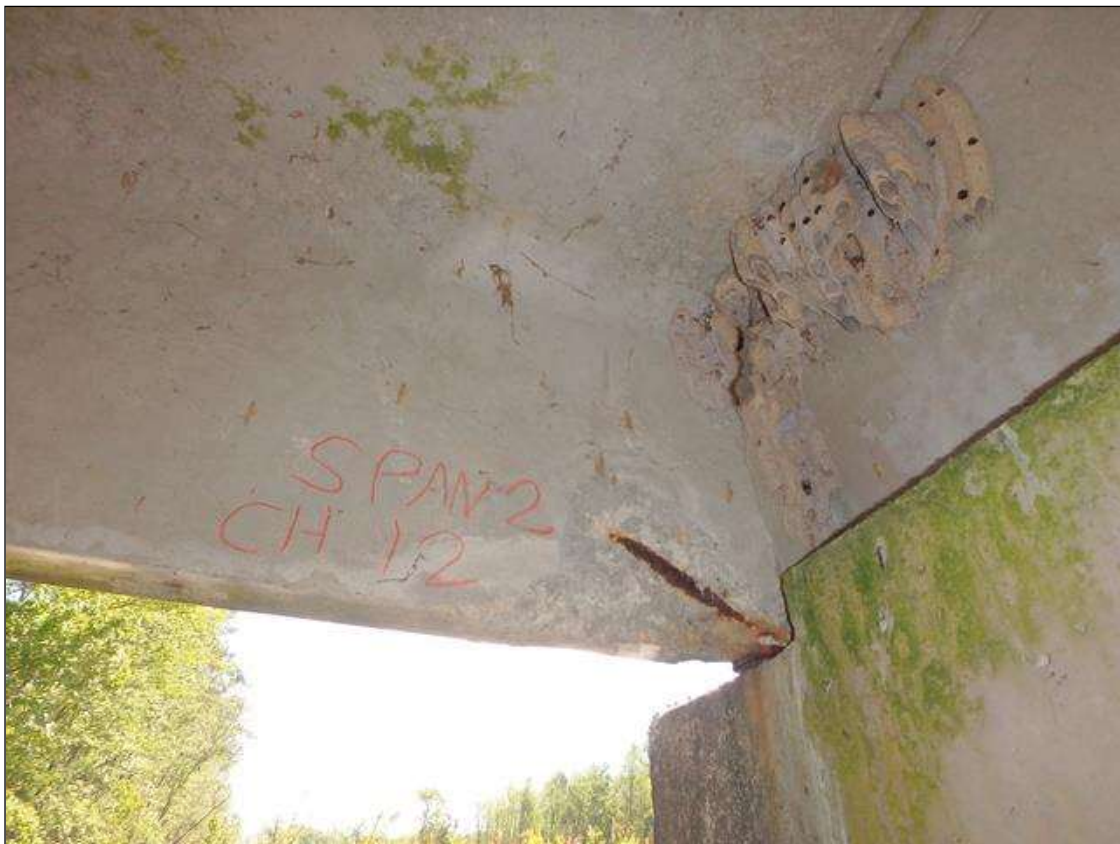
SPAN 2 CHANNEL 12 RT. LEG AT BENT 1 SPALL WITH EXPOSED STEEL 1IN. D X 1FT. L X 6IN. HIGH. PRIORITY MAINTENANCE

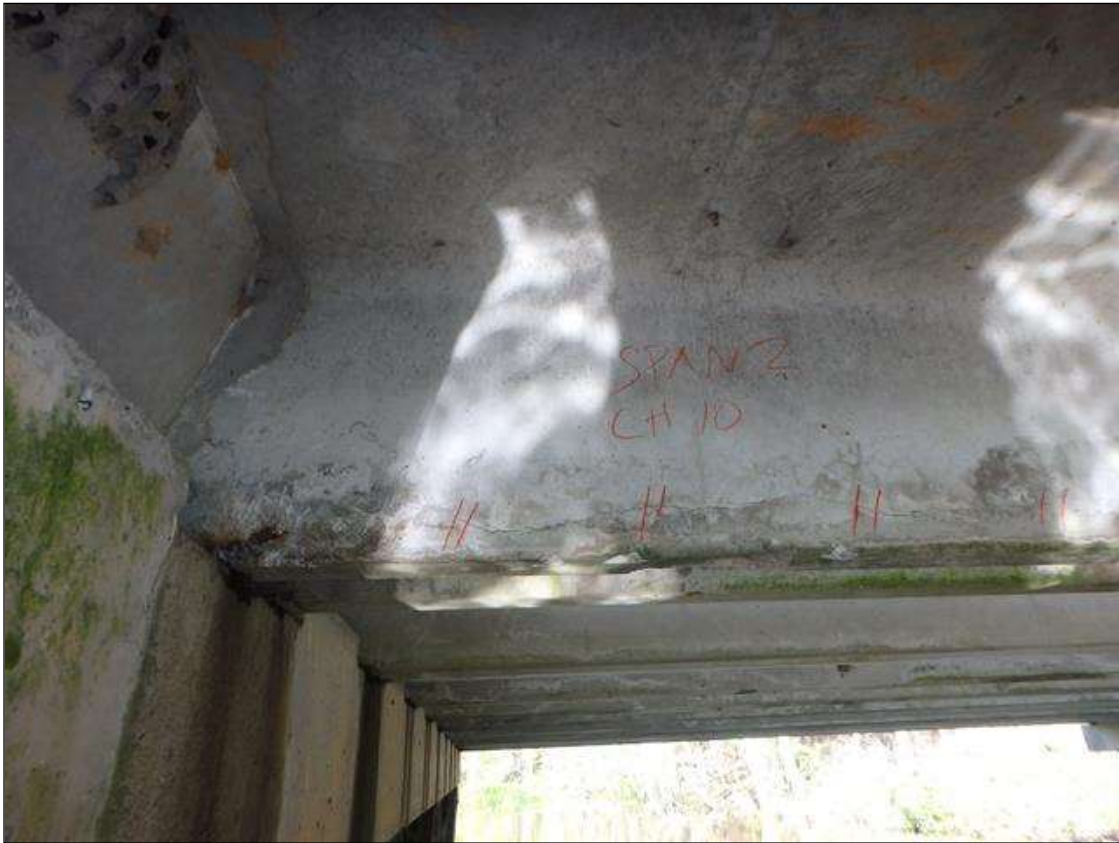
SPAN 2 CHANNEL 10 AT BENT 1 BOTTOM LT. LEG DELAMINATION 3IN. H X 3FT. L & SPALL WITH EXPOSED STEEL 5IN. L X 2IN. H X 1IN. DEEP. PRIORITY MAINTENANCE

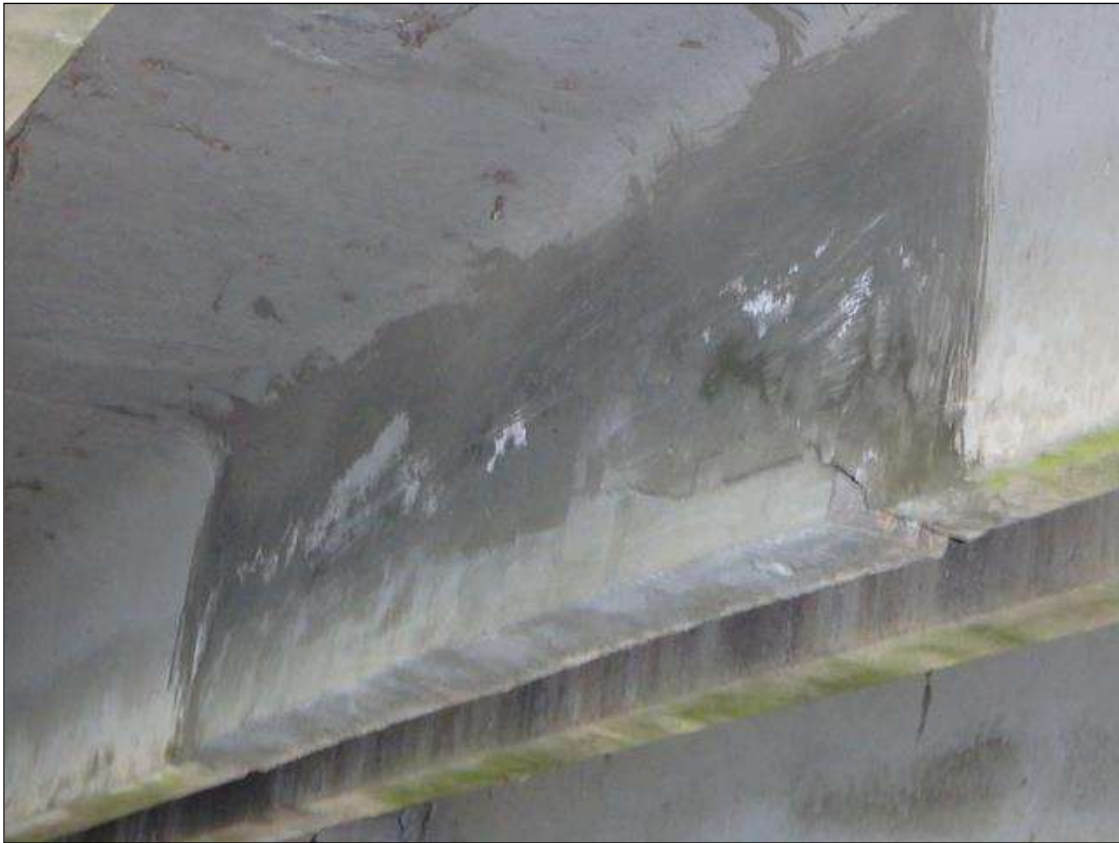
MID-SPAN 2 CHANNEL 7 BOTTOM RT LEG CONC. PATCH W/ CRACKS/ DELAMINATION 4IN. H X 3FT. LONG.  
PRIORITY MAINTENANCE

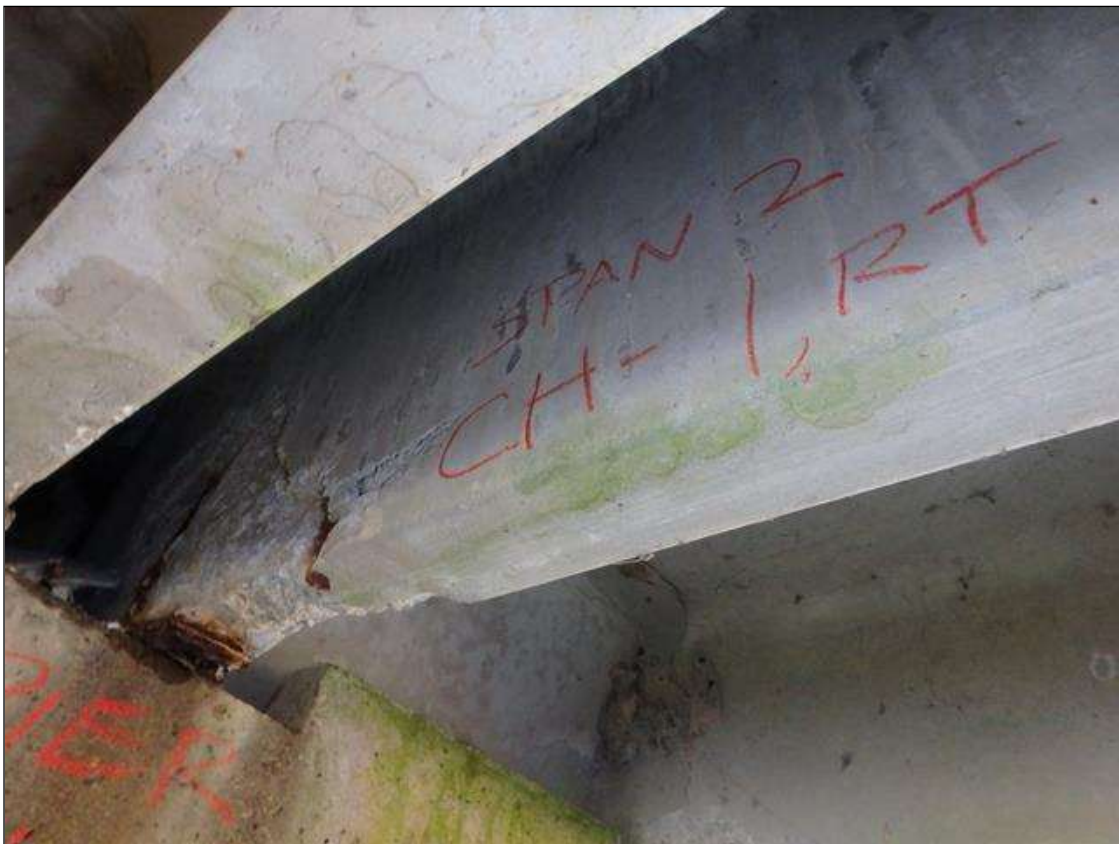
SPAN 2 CHANNEL 1 RT. LEG AT BENT 1 HAS SPALL WITH EXPOSED STEEL UP TO 1IN. D X 1FT. L X 8IN. HIGH.  
PRIORITY MAINTENANCE

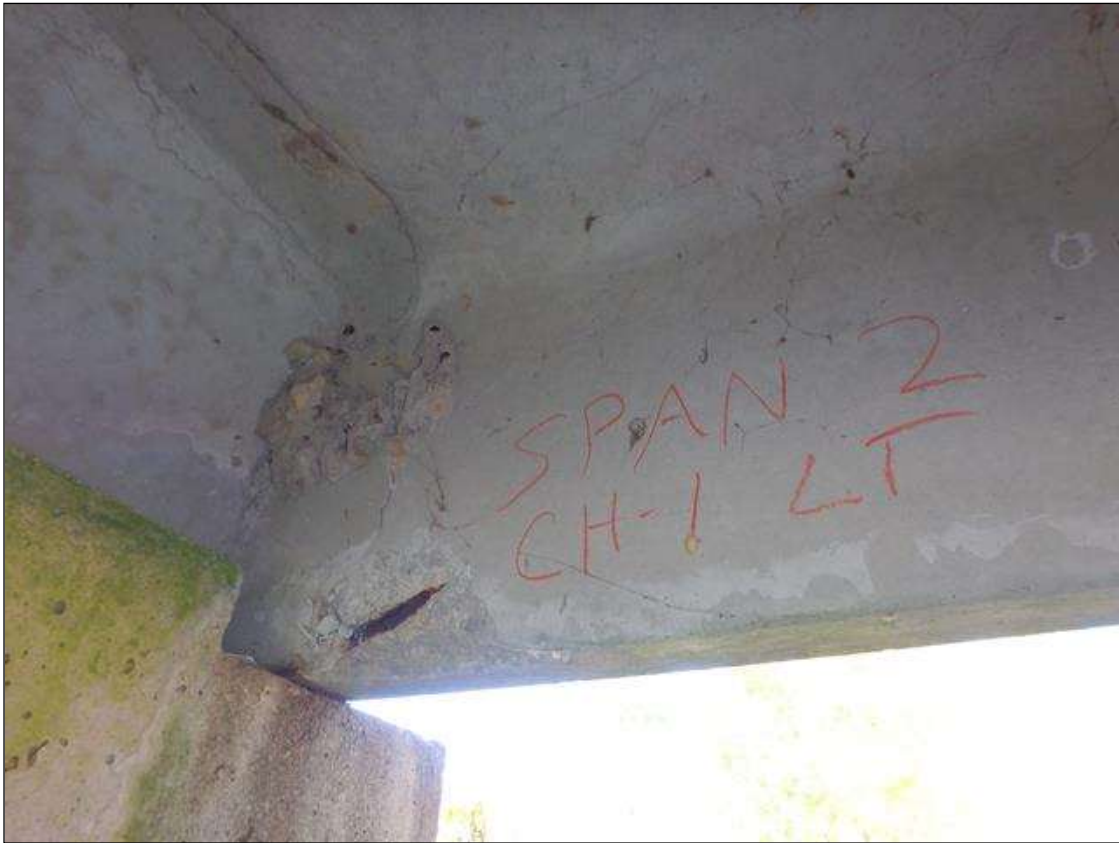
SPAN 2 CHANNEL 1 LT. LEG AT BENT 1 HAS SPALL WITH EXPOSED STEEL UP TO 1IN. D X 8IN. L X 6IN. HIGH.  
PRIORITY MAINTENANCE

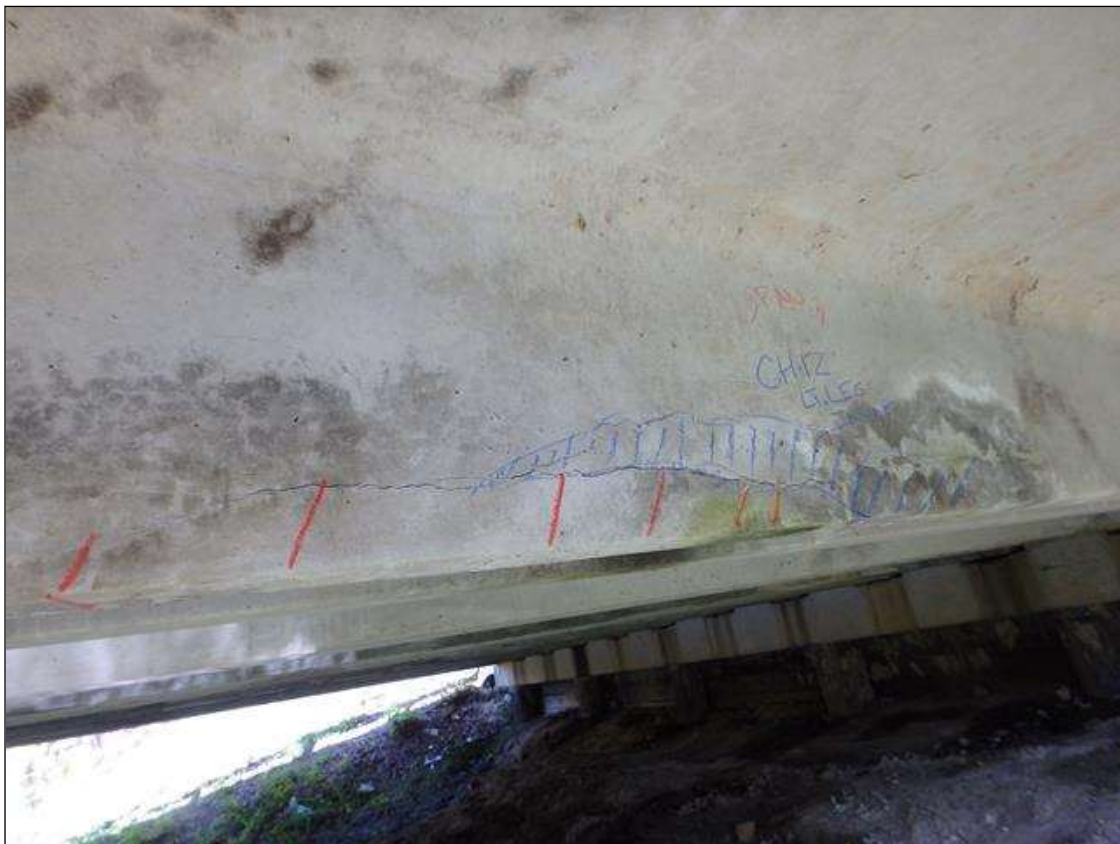
MID-SPAN 3 CHANNEL 12 BOTTOM LT. LEG 1/16IN. CRACKS & DELAMINATION 4IN. H X 3FT. LONG X FULL WIDTH. PRIORITY MAINTENANCE

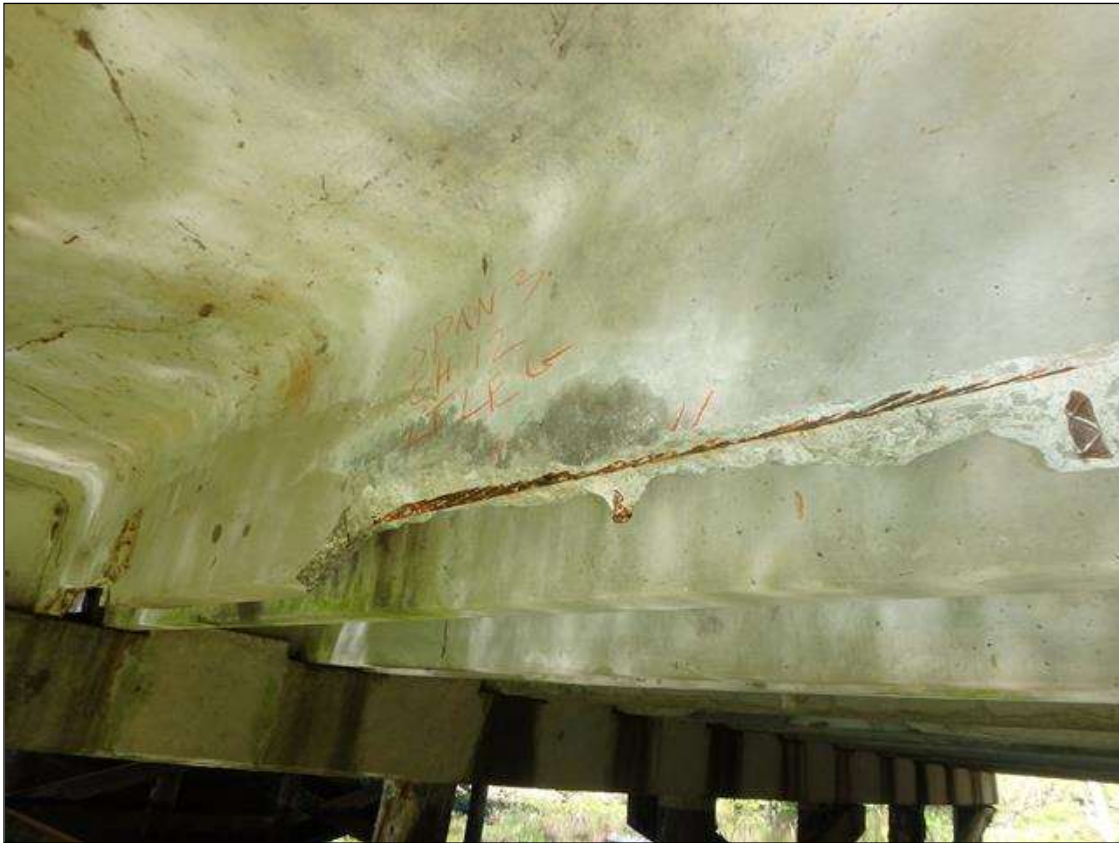
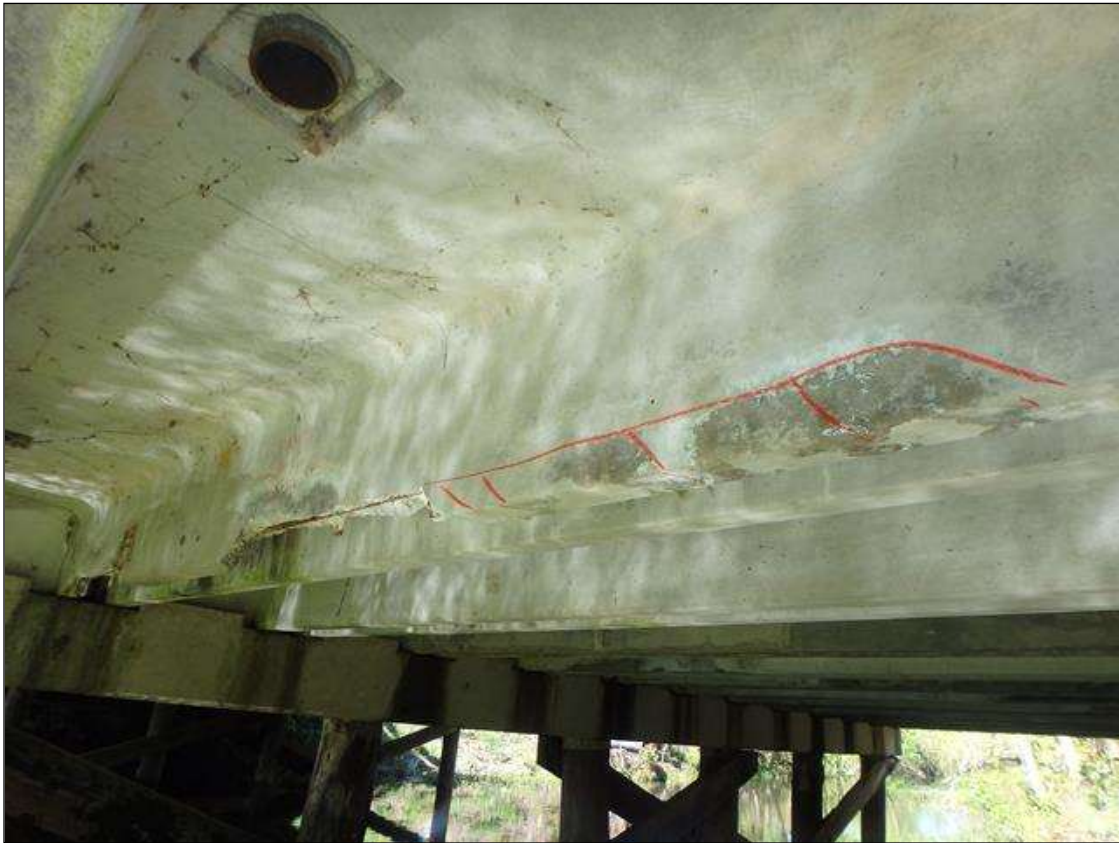
SPAN 3 CHANNEL 12 BOTTOM LT. LEG BEGIN AT BENT 2, 10 FT. OF SPALL WITH EXPOSED STEEL AND DELAMINATION 3-1/2IN. H X FULL WIDTH. PRIORITY MAINTENANCE

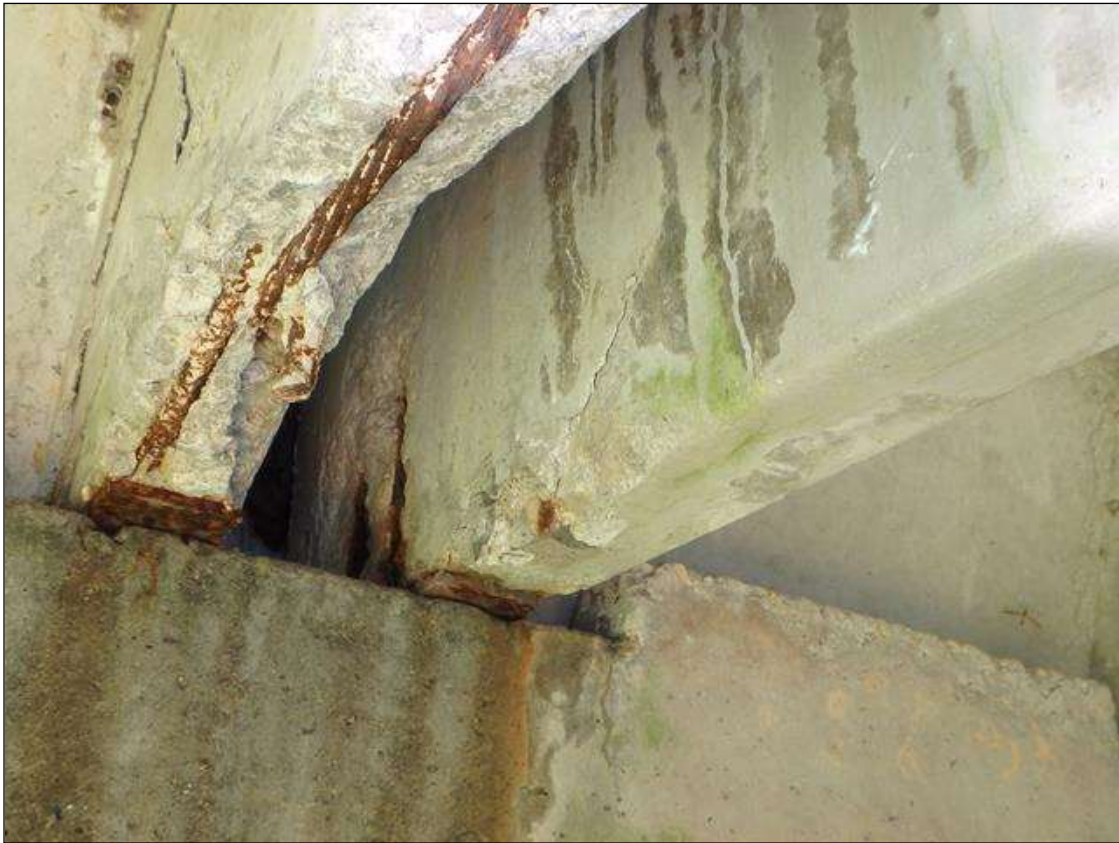
SPAN 3 CHANNEL 11 RT. LEG AT BENT 2 CRACKS/ DELAMINATION 6IN. L X 8IN. H & SPALL W/ EXPOSED STEEL 8IN. H X 6IN. L X 1/2IN. DEEP. PRIORITY MAINTENANCE

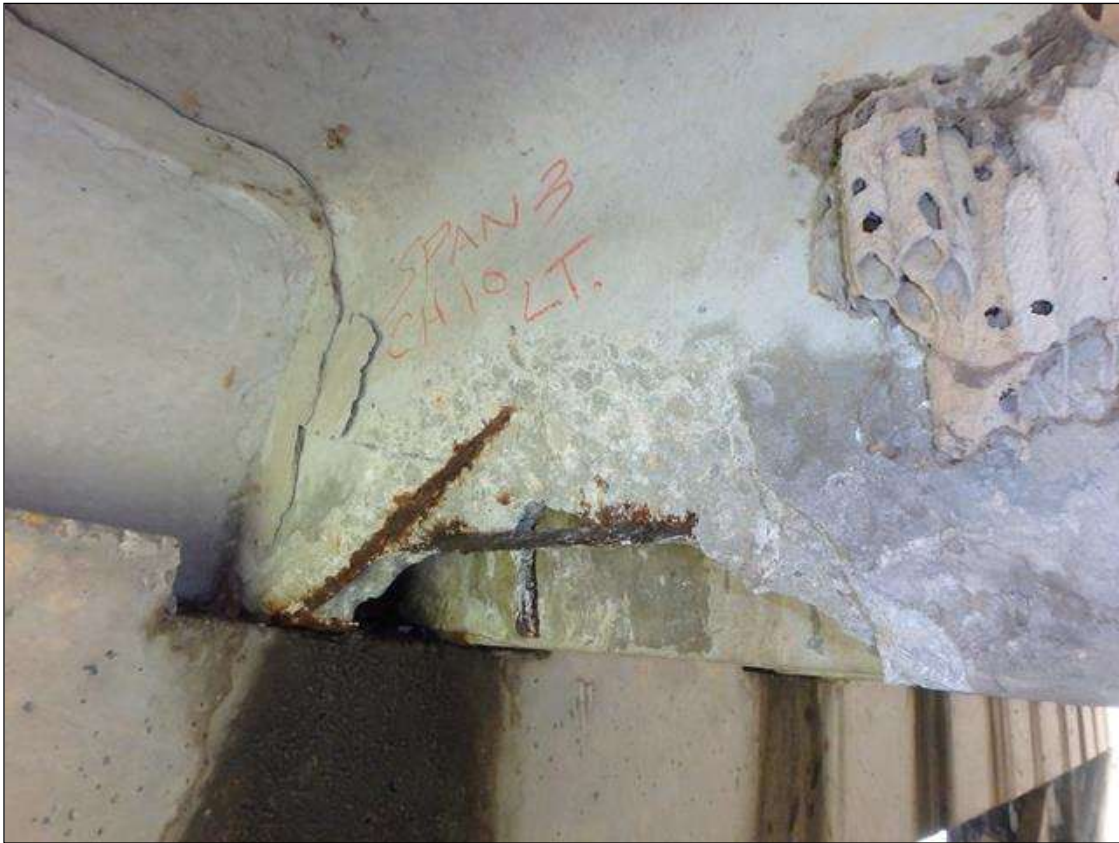
SPAN 3 CHANNEL 10 AT BENT LT. LEG SPALL WITH EXPOSED STEEL 6IN. H X 18IN. LONG. STRANDS HAVE RUST & SCALE. PRIORITY MAINTENANCE

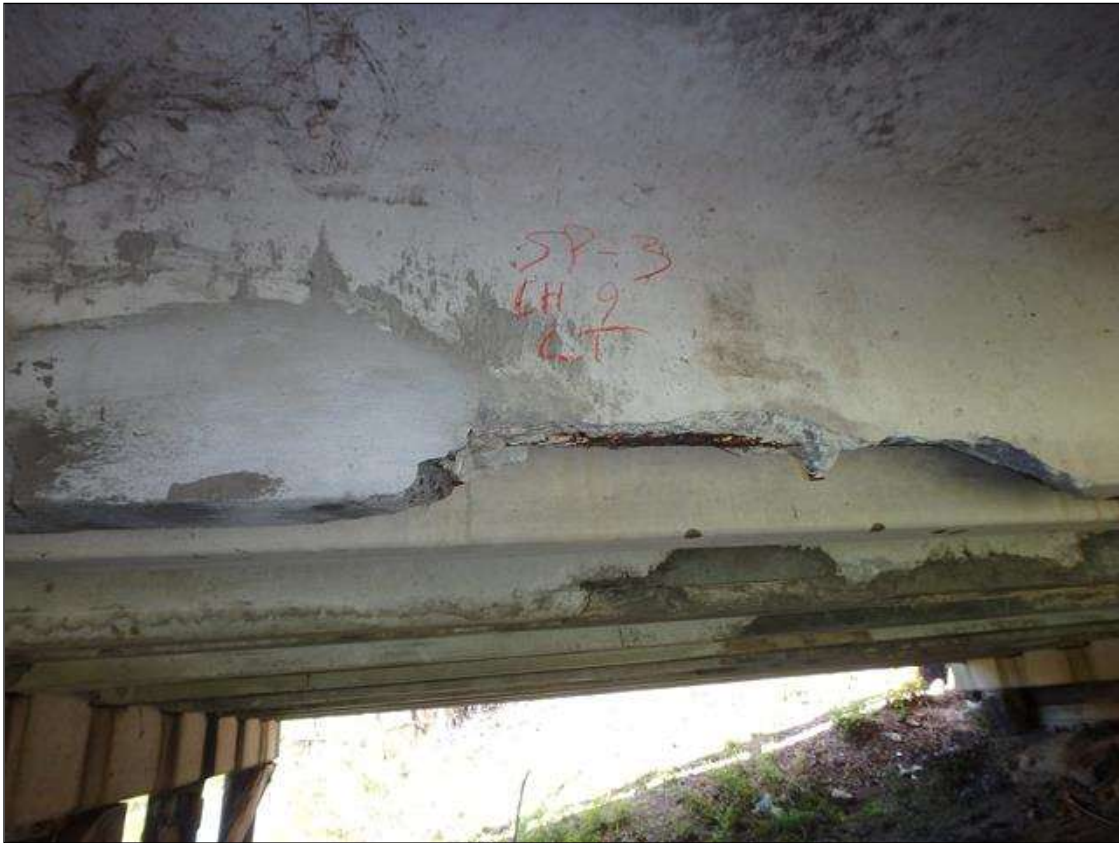
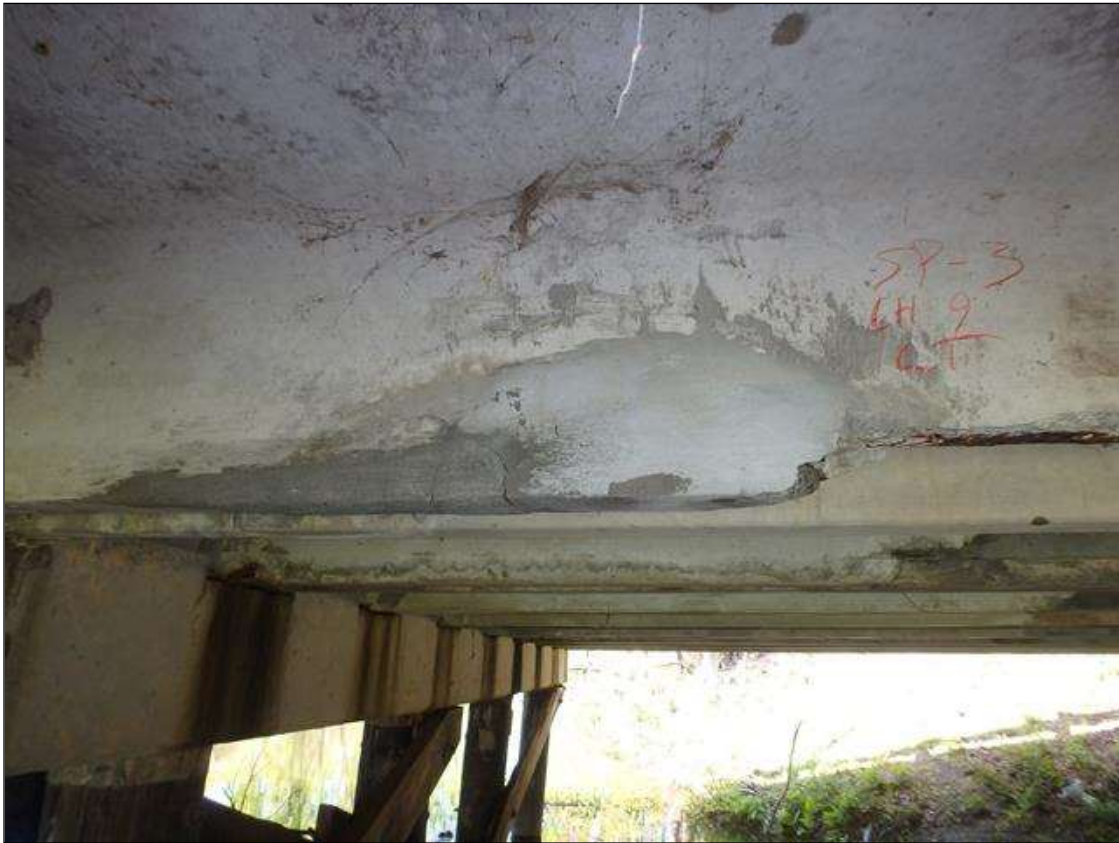
SPAN 3 CHANNEL 9 BOTTOM LT. LEG NEAR BENT PATCH W/ DELAMINATION 3IN. H X 30IN. L & SPALL WITH EXPOSED STEEL 3IN. H X 20IN. LONG. PRIORITY MAINTENANCE

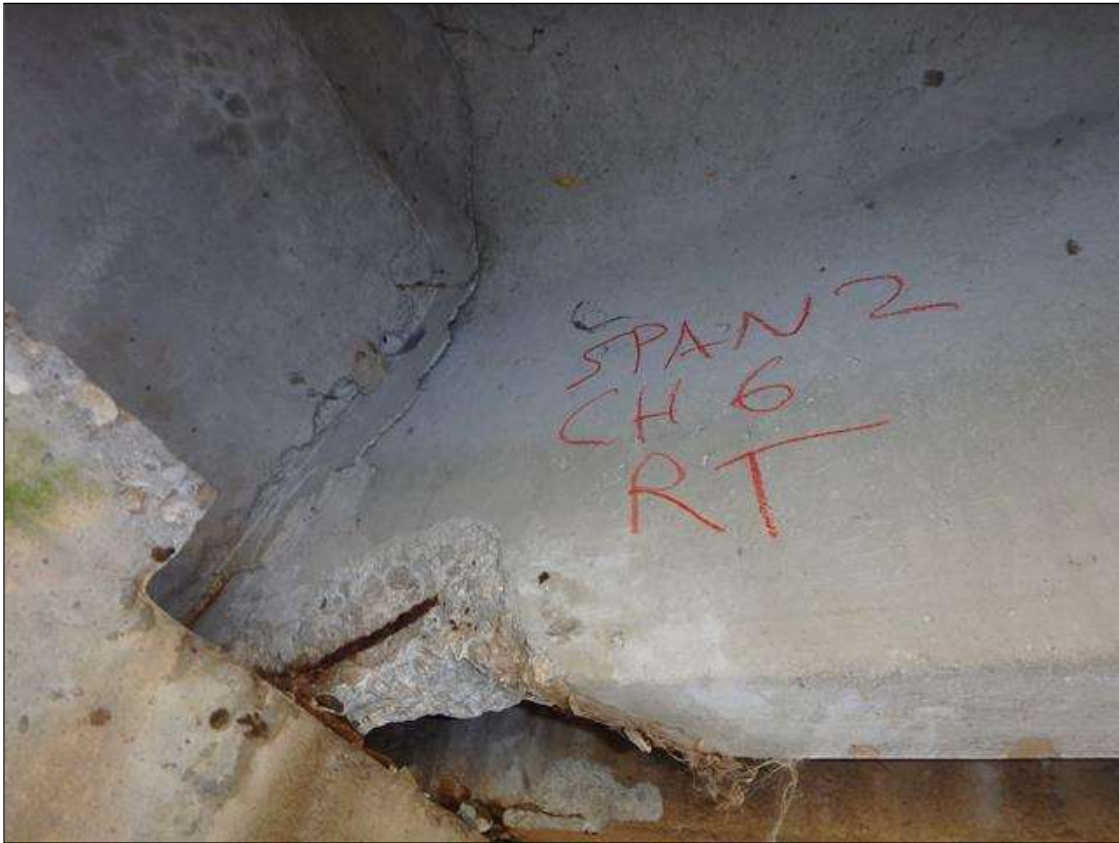
SPAN 2 CHANNEL 6 AT BENT 2 RT. LEG SPALL WITH EXPOSED STEEL 6IN. L X 3IN. HIGH. PRIORITY MAINTENANCE

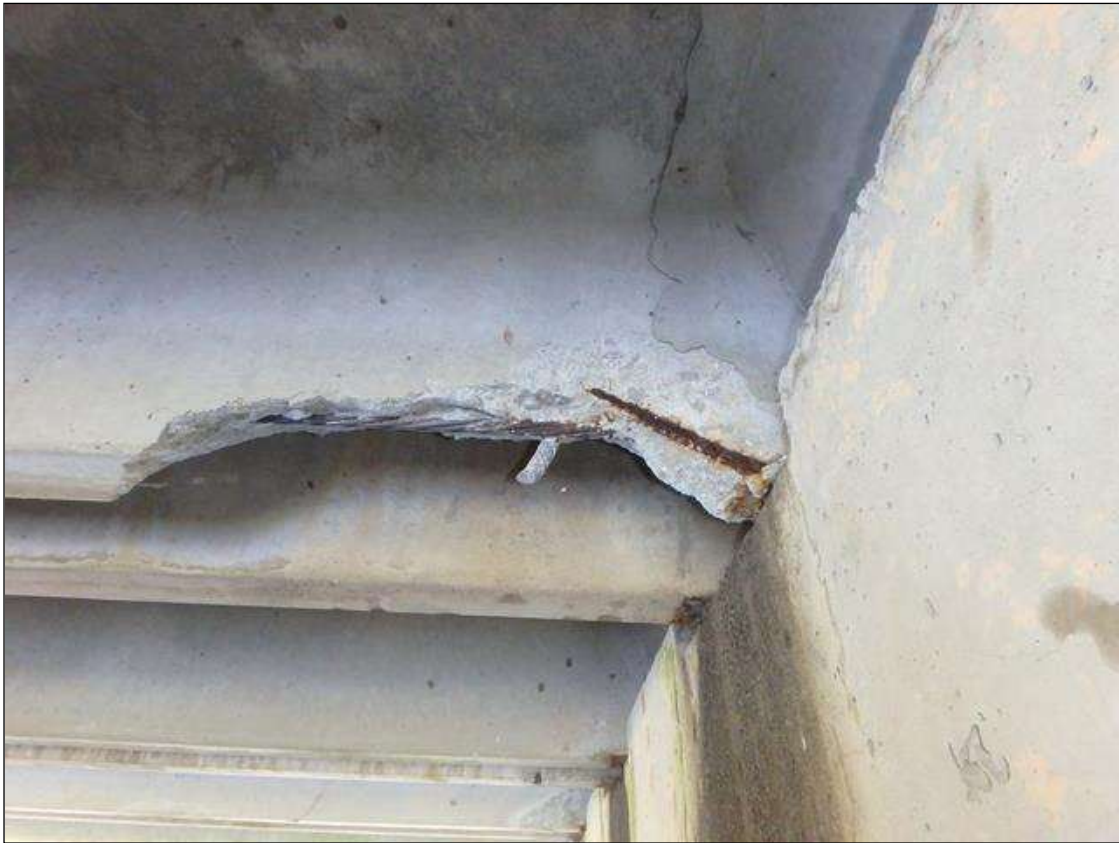
SPAN 2 CHANNEL 4 AT BENT 2 BOTTOM LT. LEG SPALL WITH EXPOSED STEEL 18IN. L X 4IN. HIGH. PRIORITY MAINTENANCE
