NC DEPARTMENT OF TRANSPORTATION  
DIVISION OF HIGHWAYS  
STRUCTURE MANAGEMENT UNIT

## Structure Safety Report

### Routine Element Inspection - Contract

COUNTY: ROBESON STRUCTURE NUMBER: 770434 FREQUENCY: 24 MONTHS

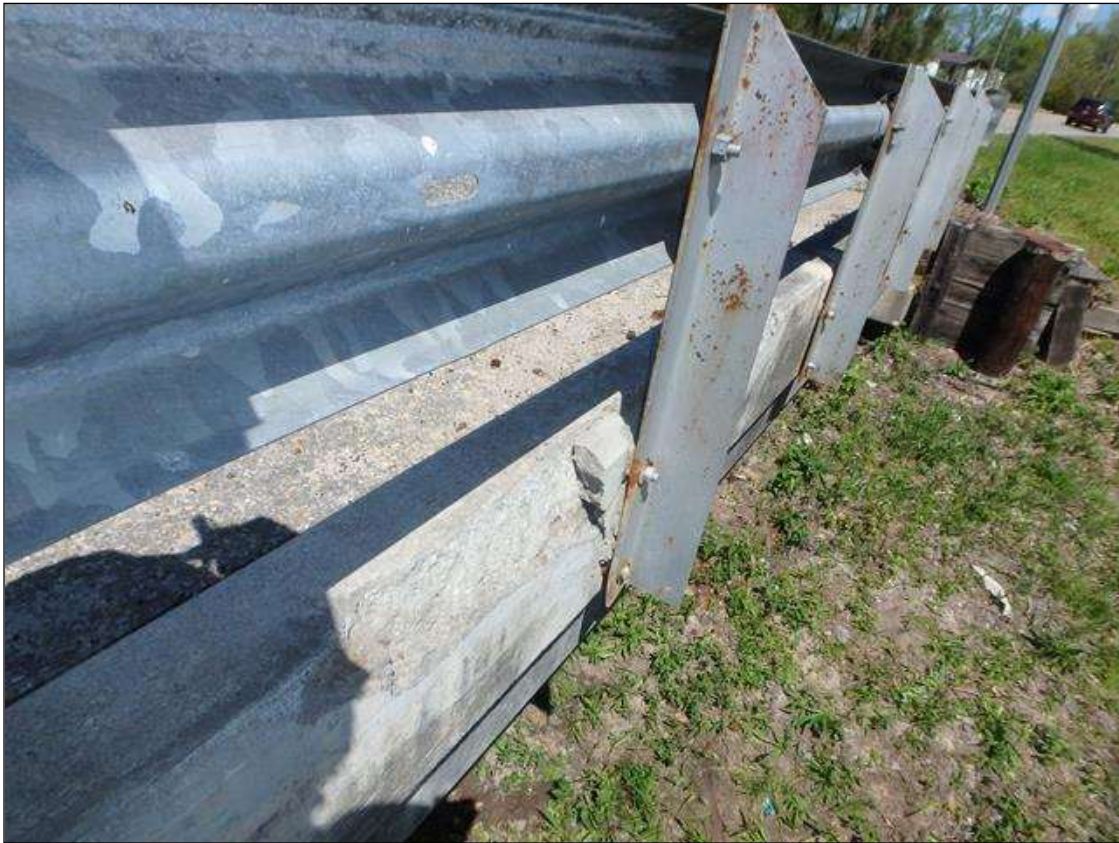
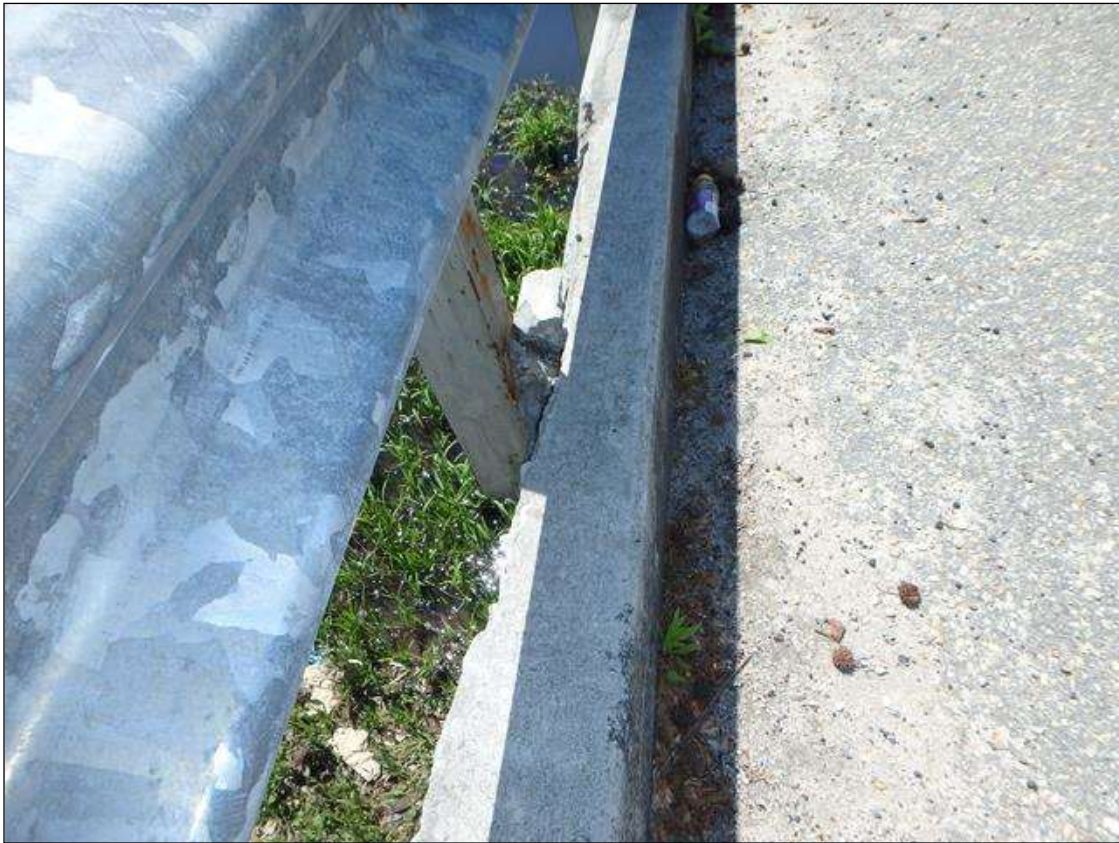
SPAN 3 RT. STEEL RAIL 4TH POST FROM ABUT 2 CONNECTION LOOSE DUE TO SPALL IN CURB 5FT. LONG X 3IN. D X 4IN. HIGH. PRIORITY MAINTENANCE
