NC DEPARTMENT OF TRANSPORTATION  
DIVISION OF HIGHWAYS  
STRUCTURE MANAGEMENT UNIT

## Structure Safety Report

### Routine Element Inspection

COUNTY: ASHE STRUCTURE NUMBER: 040023 FREQUENCY: 24 MONTHS  
FACILITY CARRIED: NC194 MILE POST: \_\_\_\_\_  
LOCATION: 100 FT.S.JCT.SR1353  
FEATURE INTERSECTED: OLD FIELD BRANCH  
LATITUDE: 36° 29' 56.6" LONGITUDE: 81° 30' 39.72"  
SUPERSTRUCTURE: STEEL PLANK FLOOR ON I-BEAMS  
SUBSTRUCTURE: REINFORCED CONCRETE ABUTMENTS  
SPANS: 1@ 33'-5"  
☐ FRACTURE CRITICAL ☐ TEMPORARY SHORING ☐ SCOUR CRITICAL ☐ SCOUR PLAN OF ACTION  
PRESENT CONDITION: Poor INSPECTION DATE: 05/12/2016  
POSTED SV: Not Posted POSTED TTST: Not Posted  
OTHER SIGNS PRESENT: NONE

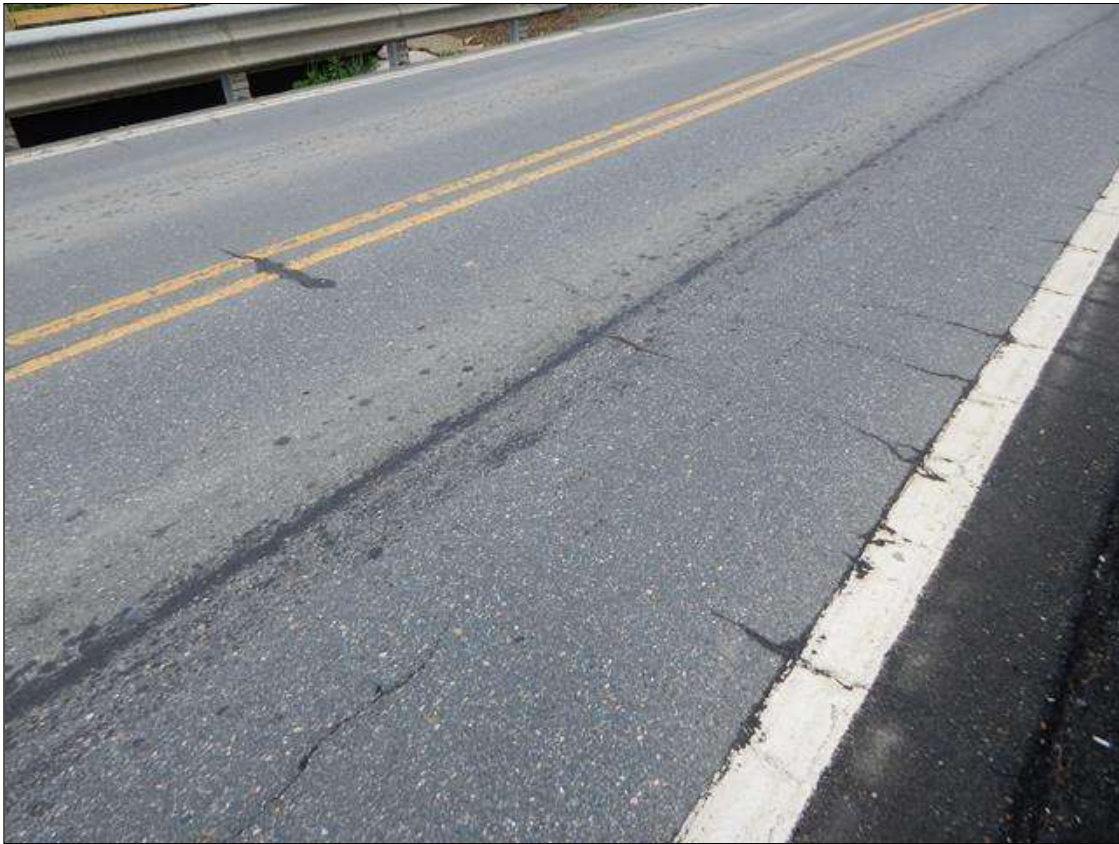
60 Square Feet of Crack (Wearing Surface): Width of more than 0.05 in. or spacing of less than 1.0 ft. TRANSVERSE CRACKS ALONG EACH ABUT. AND THROUGHOUT WEARING SURFACE

Span 1 Wearing Surface: 60 Square Feet of Crack (Wearing Surface): Width of more than 0.05 in. or spacing of less than 1.0 ft. TRANSVERSE CRACKS ALONG EACH ABUT. AND THROUGHOUT WEARING SURFACE

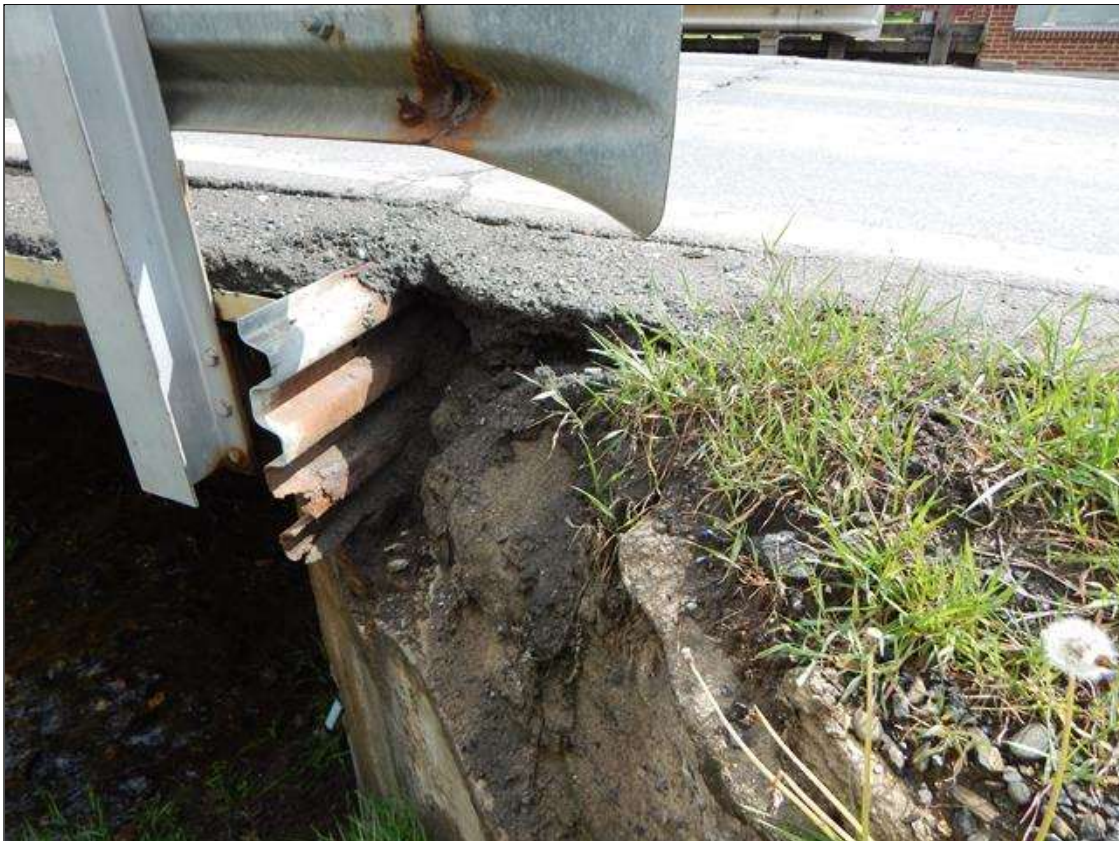
EROSION ALONG LEFT END ABUT. (A) SHOULDER (+/- 5' L X 2' H X 2' D) AND EXTENDS (+/- 6") UNDER EDGE OF WEARING SURFACE

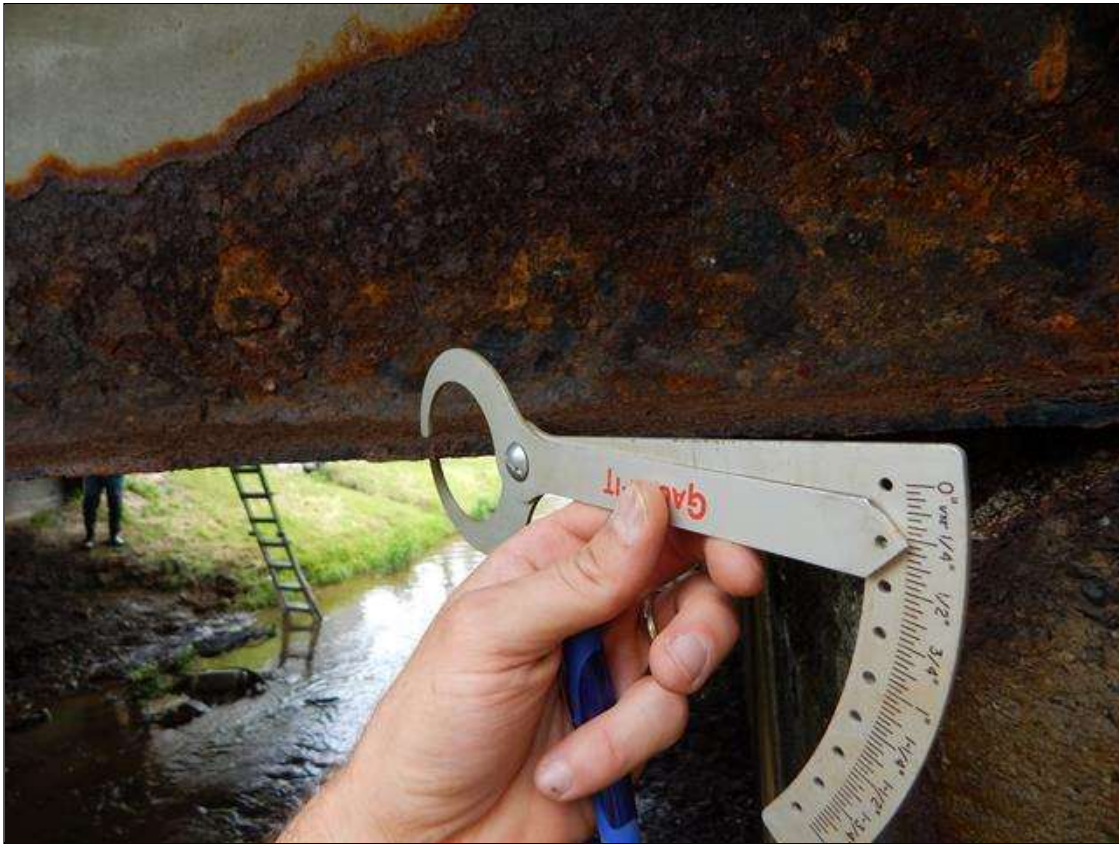
34 Feet of Corrosion: Section loss is evident or pack rust is present but does not warrant structural review. BEAM (1) CORROSION F/L ALONG TOP AND BOTTOM FLANGES WITH (1/4") AVG REMAINING AND (1/4") LOSS OF SECTION. EXTENDS INTO LOWER PORTION OF WEB (+/- 8" H) WITH (+/- 1/16") LOSS

68 Square Feet of Effectiveness (Steel Protective Coatings): Failed; no protection of the underlying metal. BEAM (1) CORROSION F/L ALONG TOP AND BOTTOM FLANGES WITH (1/4") AVG REMAINING AND (1/4") LOSS OF SECTION. EXTENDS INTO LOWER PORTION OF WEB (+/- 8" H) WITH (+/- 1/16") LOSS

Span 1 Beam 1: 34 Feet of Corrosion: Section loss is evident or pack rust is present but does not warrant structural review. BEAM (1) CORROSION F/L ALONG TOP AND BOTTOM FLANGES WITH (1/4") AVG REMAINING AND (1/4") LOSS OF SECTION. EXTENDS INTO LOWER PORTION OF WEB (+/- 8" H) WITH (+/- 1/16") LOSS

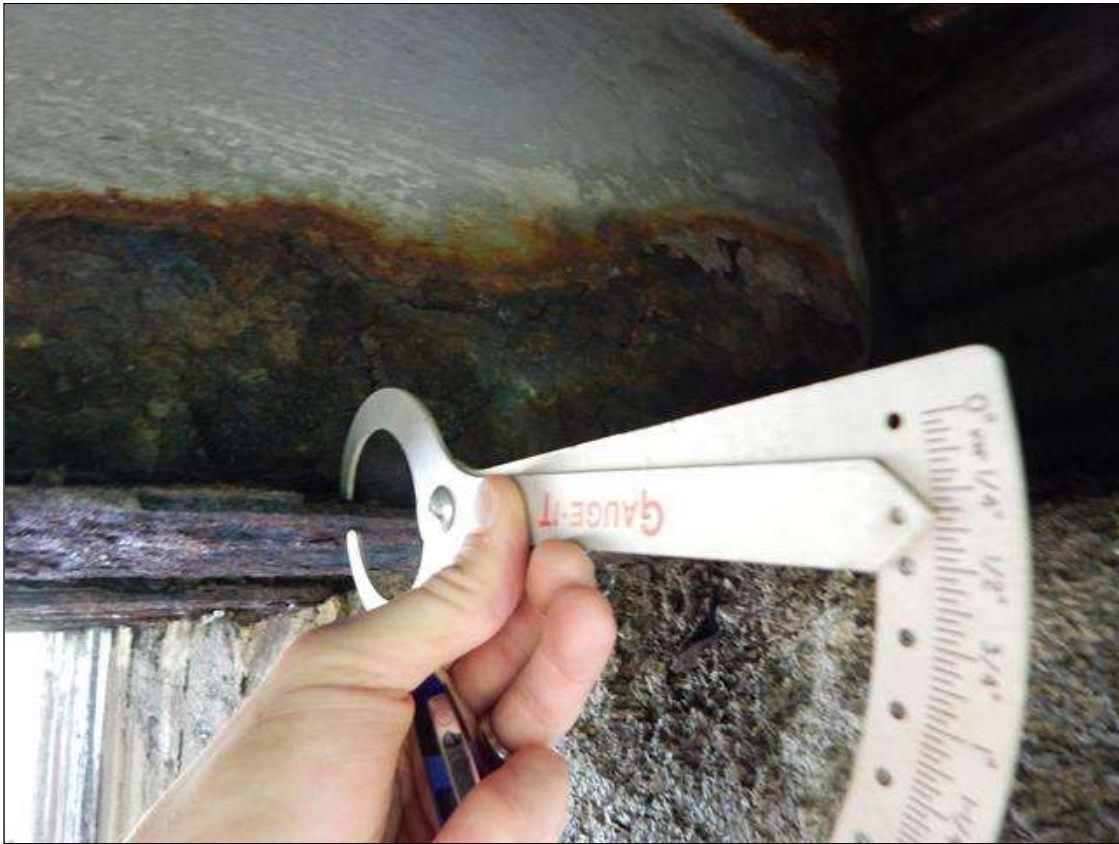
11 Feet of Corrosion: Section loss is evident or pack rust is present but does not warrant structural review. BEAM (2) CORROSION AT ABUT. (A) BEAM END (+/- 11 LF) ALONG TOP AND BOTTOM FLANGES WITH (5/16") AVG REMAINING AND (3/8") LOSS OF SECTION. EXTENDS INTO LOWER PORTION OF WEB (+/- 6" H) WITH (+/- 1/16") LOSS

11 Square Feet of Effectiveness (Steel Protective Coatings): Failed; no protection of the underlying metal. BEAM (2) CORROSION AT ABUT. (A) BEAM END (+/- 11 LF) ALONG TOP AND BOTTOM FLANGES WITH (5/16") AVG REMAINING AND (3/8") LOSS OF SECTION. EXTENDS INTO LOWER PORTION OF WEB (+/- 6" H) WITH (+/- 1/16") LOSS

Span 1 Beam 2: 11 Feet of Corrosion: Section loss is evident or pack rust is present but does not warrant structural review. BEAM (2) CORROSION AT ABUT. (A) BEAM END (+/- 11 LF) ALONG TOP AND BOTTOM FLANGES WITH (5/16") AVG REMAINING AND (3/8") LOSS OF SECTION. EXTENDS INTO LOWER PORTION OF WEB (+/- 6" H) WITH (+/- 1/16") LOSS

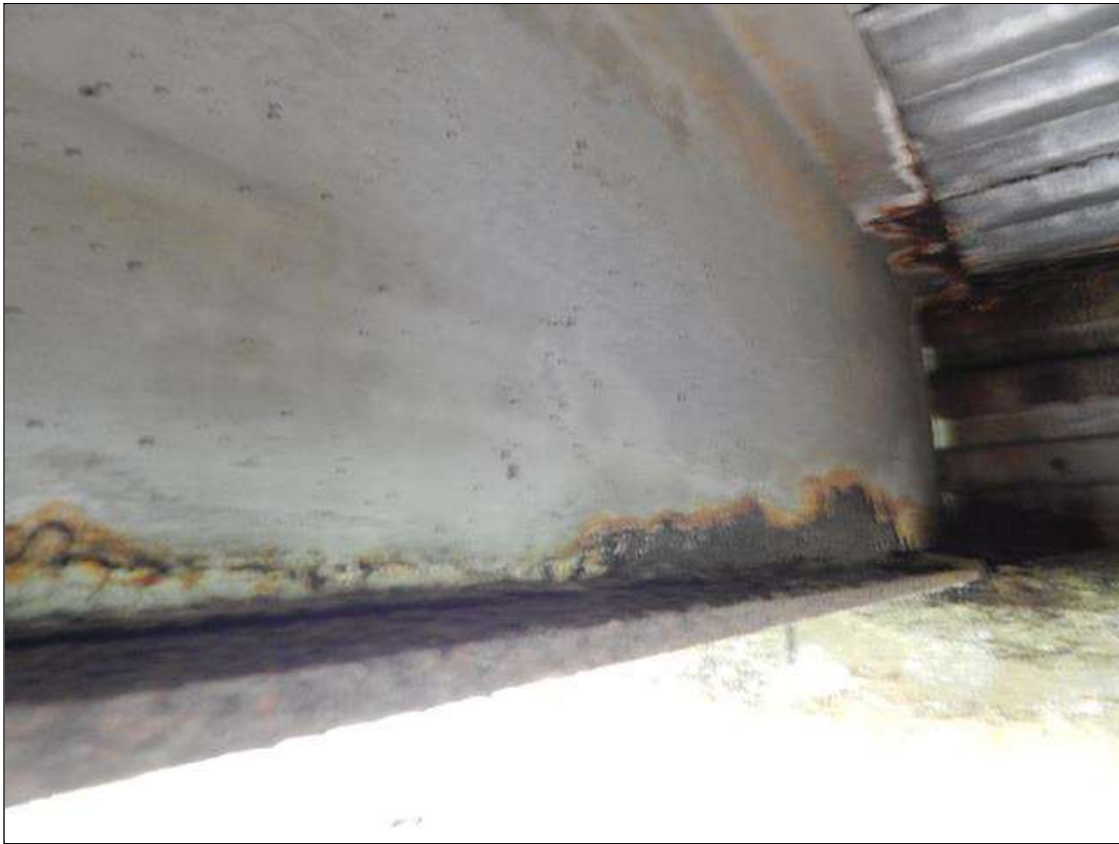
6 Feet of Corrosion: Section loss is evident or pack rust is present but does not warrant structural review. CORROSION (+/- 6 LF) AT ABUT. (B) BEAM END ALONG TOP AND BOTTOM FLANGES WITH NO MEASURABLE SECTION LOSS AT THIS TIME.

6 Square Feet of Effectiveness (Steel Protective Coatings): Failed; no protection of the underlying metal. CORROSION (+/- 6 LF) AT ABUT. (B) BEAM END ALONG TOP AND BOTTOM FLANGES WITH NO MEASURABLE SECTION LOSS AT THIS TIME.

Span 1 Beam 2: 6 Feet of Corrosion: Section loss is evident or pack rust is present but does not warrant structural review. CORROSION (+/- 6 LF) AT ABUT. (B) BEAM END ALONG TOP AND BOTTOM FLANGES WITH NO MEASURABLE SECTION LOSS AT THIS TIME.

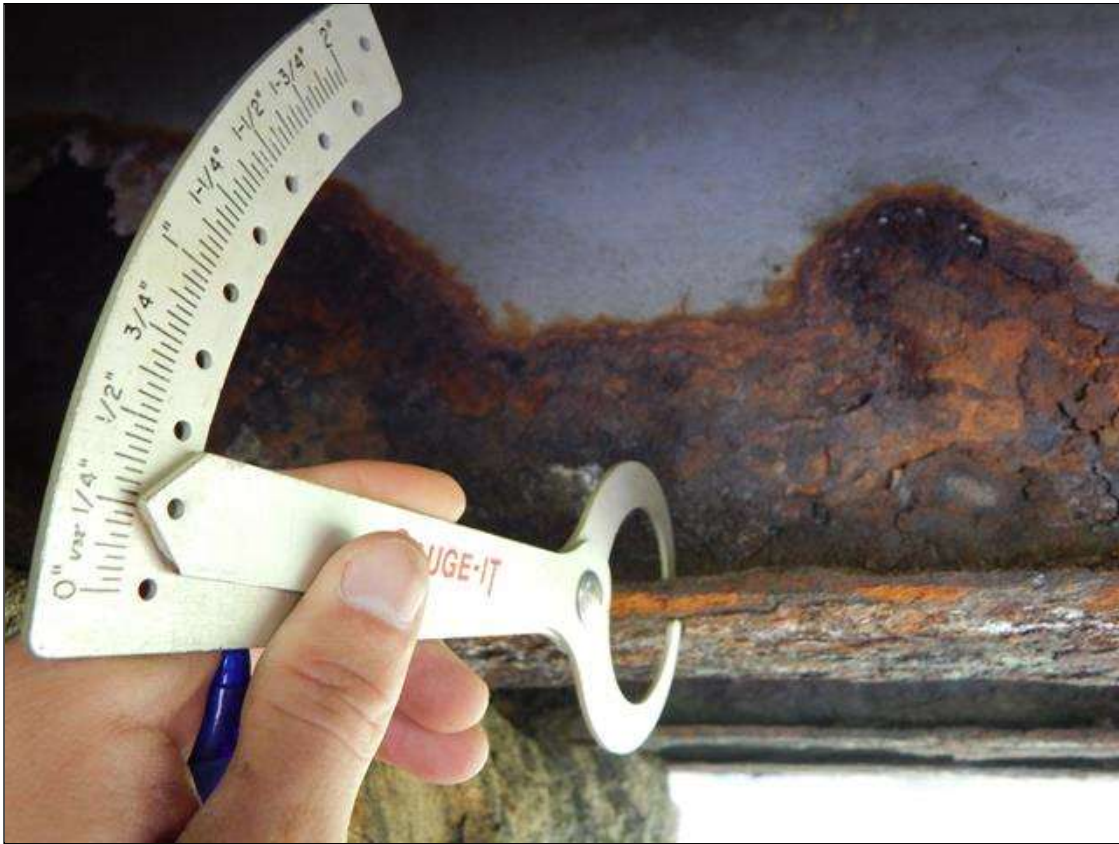
Span 1 Beam 3: 11 Feet of Corrosion: Section loss is evident or pack rust is present but does not warrant structural review. BEAM (3) CORROSION AT ABUT. (A) BEAM END (+/- 11 LF) ALONG TOP AND BOTTOM FLANGES WITH (1/4") AVG REMAINING AND (1/4") LOSS OF SECTION. EXTENDS INTO LOWER PORTION OF WEB (+/- 6" H) WITH (+/- 1/16") LOSS

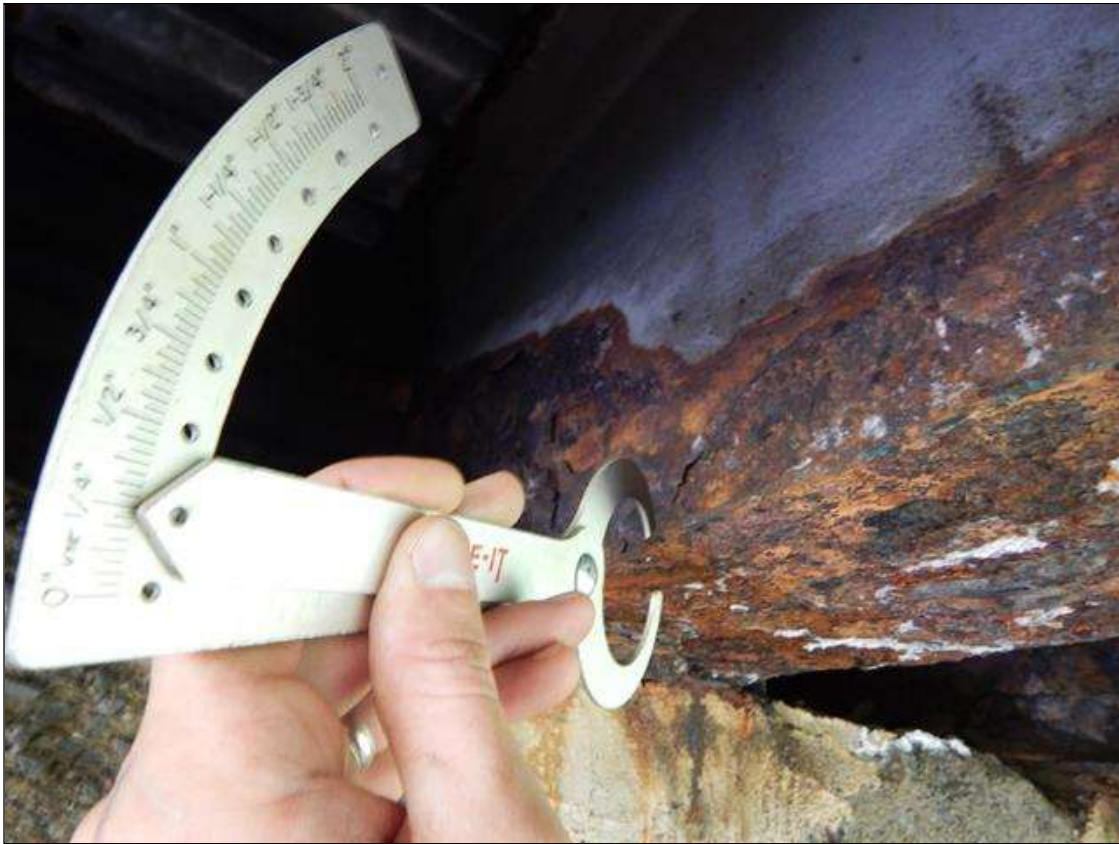
Span 1 Beam 4: 10 Feet of Corrosion: Section loss is evident or pack rust is present but does not warrant structural review. BEAM (4) CORROSION AT ABUT. (A) BEAM END (+/- 10 LF) ALONG TOP AND BOTTOM FLANGES WITH (1/4") AVG REMAINING AND (1/4") LOSS OF SECTION. EXTENDS INTO LOWER PORTION OF WEB (+/- 8" H) WITH (+/- 1/16") LOSS

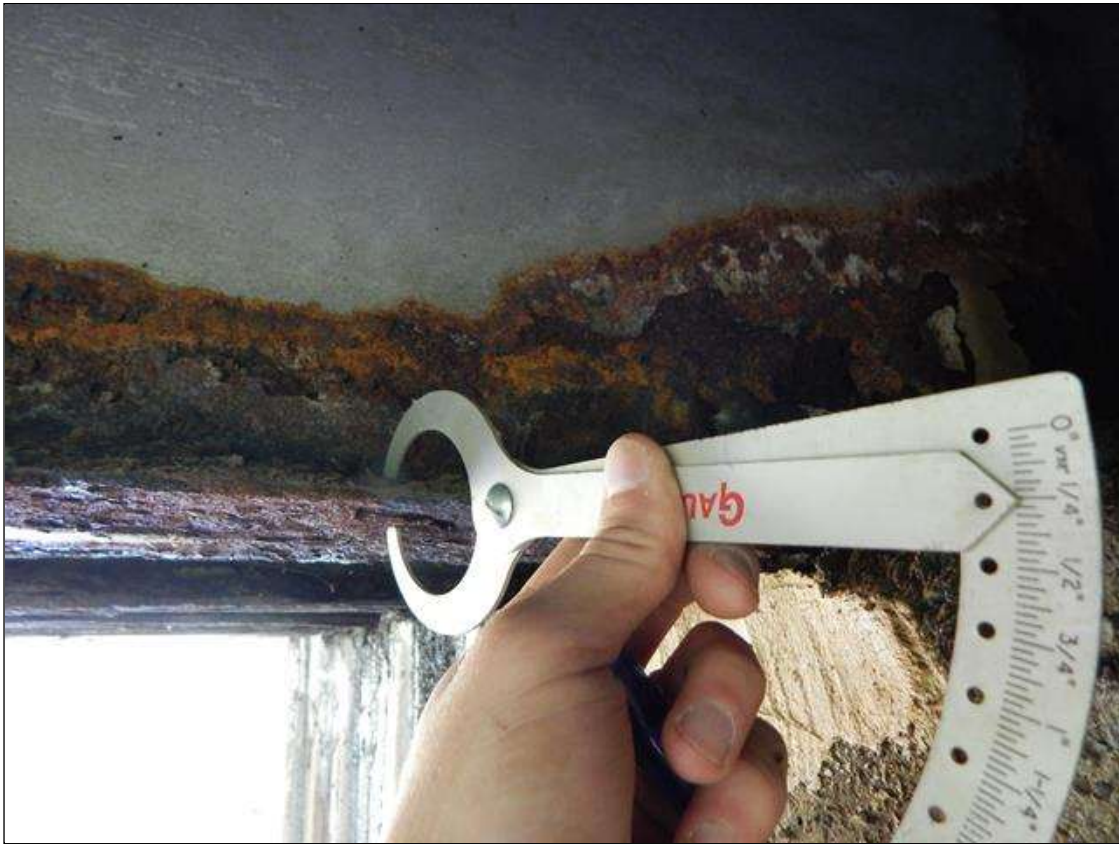
Span 1 Beam 5: 15 Feet of Corrosion: Section loss is evident or pack rust is present but does not warrant structural review. BEAM (5) CORROSION AT ABUT. (A) BEAM END (+/- 15 LF) ALONG TOP AND BOTTOM FLANGES WITH (1/4") AVG REMAINING AND (1/4") LOSS OF SECTION. EXTENDS INTO LOWER PORTION OF WEB (+/- 5" H) WITH (+/- 1/16") LOSS

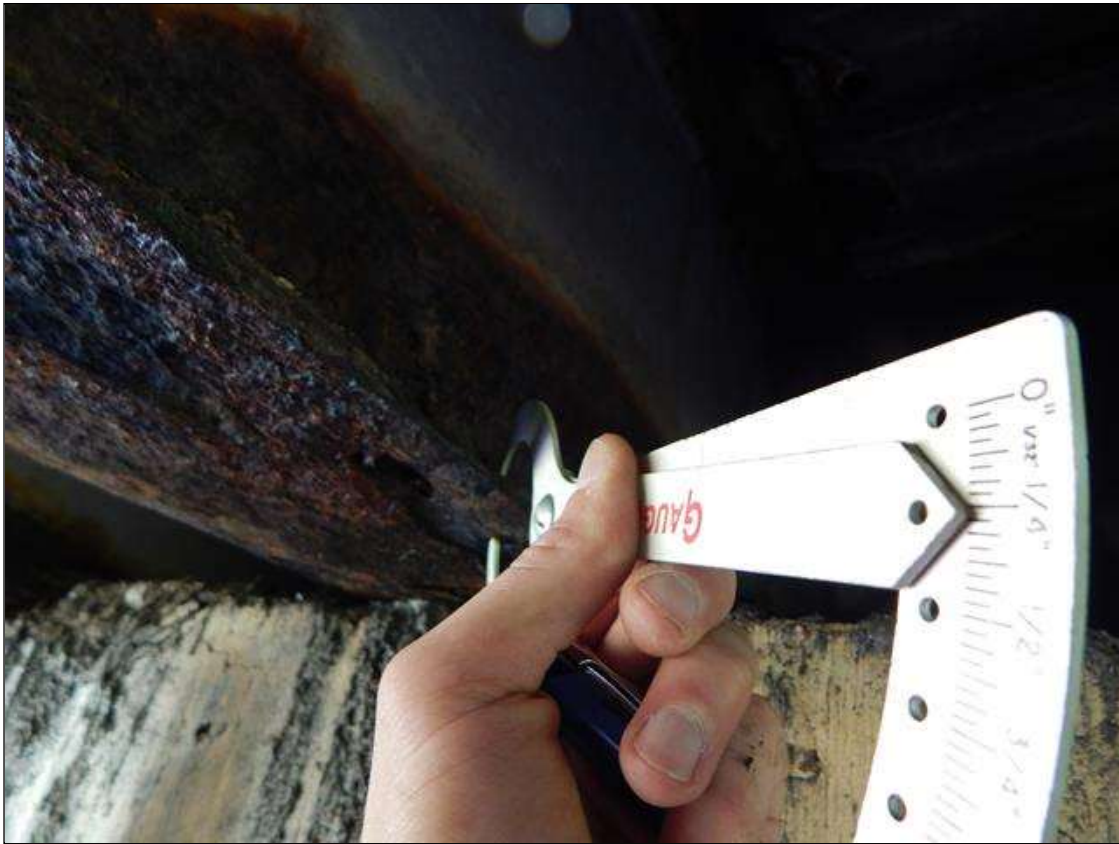
Span 1 Beam 6: 9 Feet of Corrosion: Section loss is evident or pack rust is present but does not warrant structural review. BEAM (6) CORROSION AT ABUT. (A) BEAM END (+/- 9 LF) ALONG TOP AND BOTTOM FLANGES WITH (1/4") AVG REMAINING AND (1/4") LOSS OF SECTION. EXTENDS INTO LOWER PORTION OF WEB (+/- 5" H) WITH (+/- 1/16") LOSS. WITH (2") DIA. HOLE IN LEFT SIDE BOTTOM FLANGE

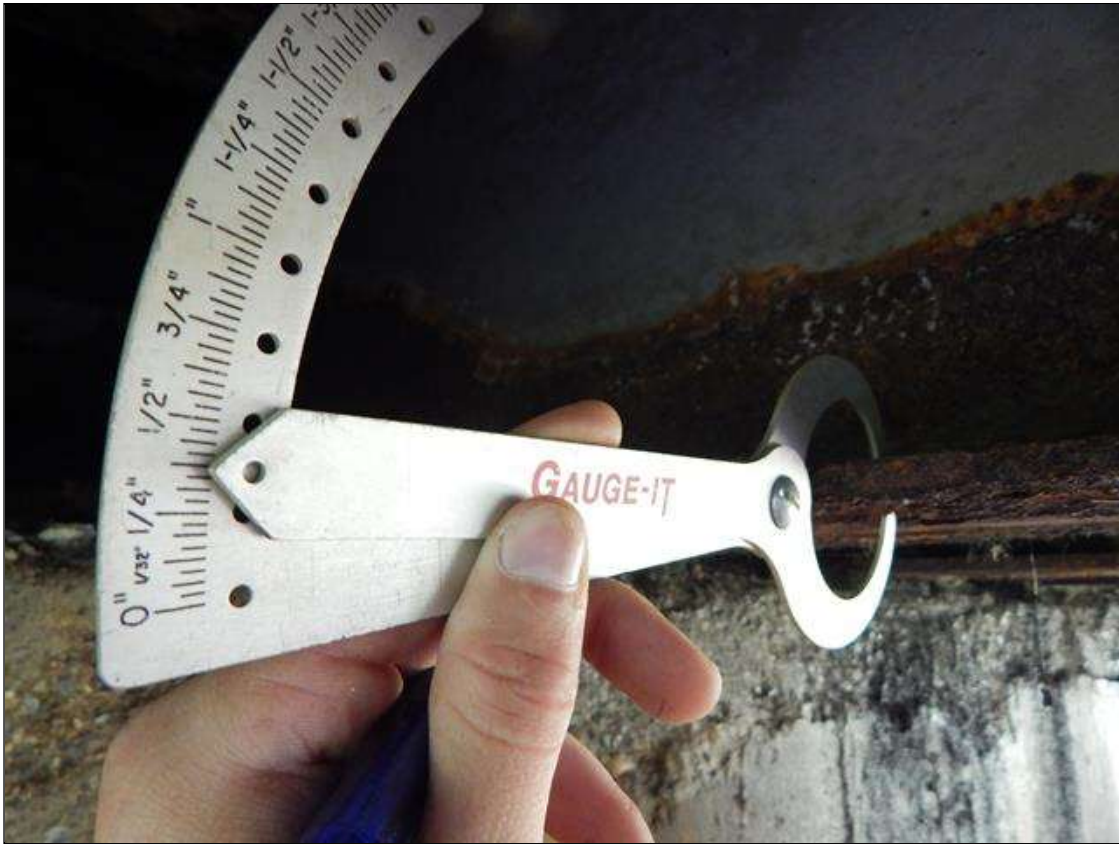
Span 1 Beam 6: 6 Feet of Corrosion: Section loss is evident or pack rust is present but does not warrant structural review. BEAM (6) CORROSION AT ABUT. (B) BEAM END (+/- 6 LF) ALONG TOP AND BOTTOM FLANGES WITH (3/8") AVG REMAINING AND (1/8") LOSS OF SECTION. EXTENDS INTO LOWER PORTION OF WEB (+/- 5" H) WITH (+/- 1/16") LOSS.

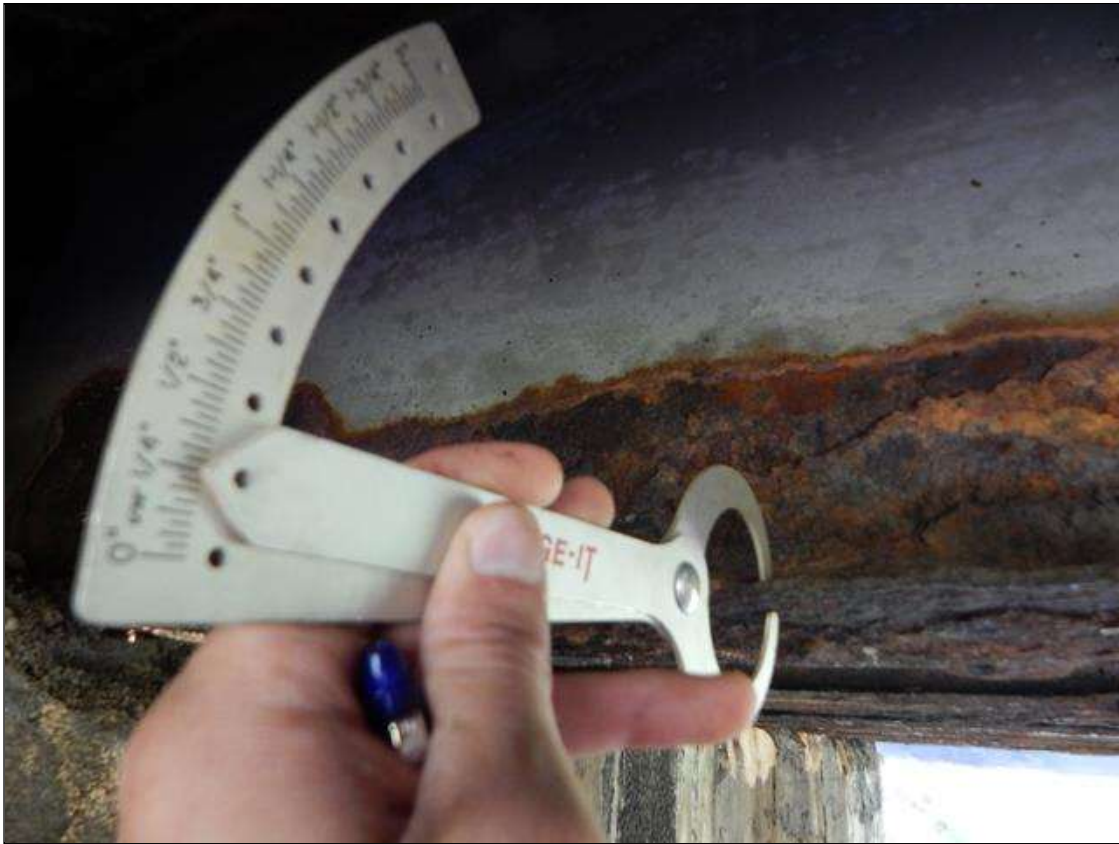
Span 1 Beam 7: 9 Feet of Corrosion: Section loss is evident or pack rust is present but does not warrant structural review. BEAM (7) CORROSION AT ABUT. (A) BEAM END (+/- 9 LF) ALONG TOP AND BOTTOM FLANGES WITH (1/4") AVG REMAINING AND (1/4") LOSS OF SECTION. EXTENDS INTO LOWER PORTION OF WEB (+/- 5" H) WITH (+/- 1/16") LOSS.

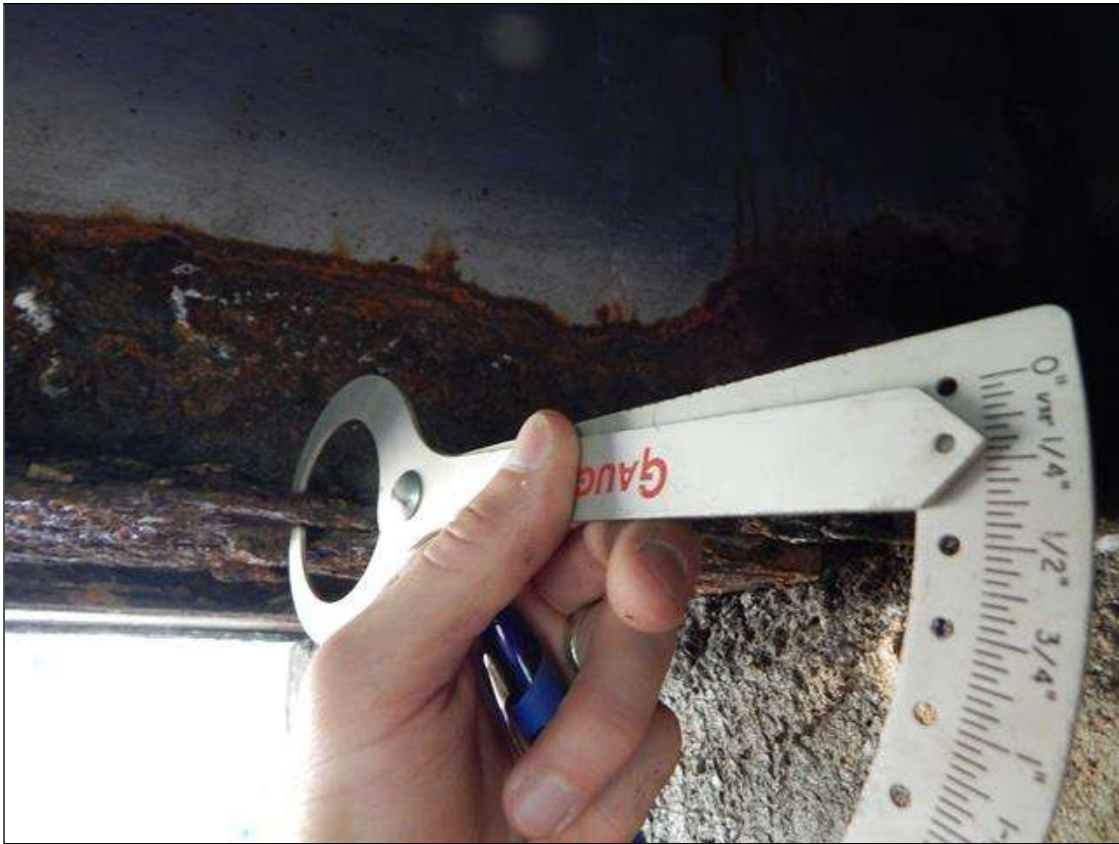
Span 1 Beam 8: 15 Feet of Corrosion: Section loss is evident or pack rust is present but does not warrant structural review. BEAM (8) CORROSION AT ABUT. (A) BEAM END (+/- 15 LF) ALONG TOP AND BOTTOM FLANGES WITH (3/16") AVG REMAINING AND (5/16") LOSS OF SECTION. EXTENDS INTO LOWER PORTION OF WEB (+/- 6" H) WITH (+/- 1/16") LOSS.

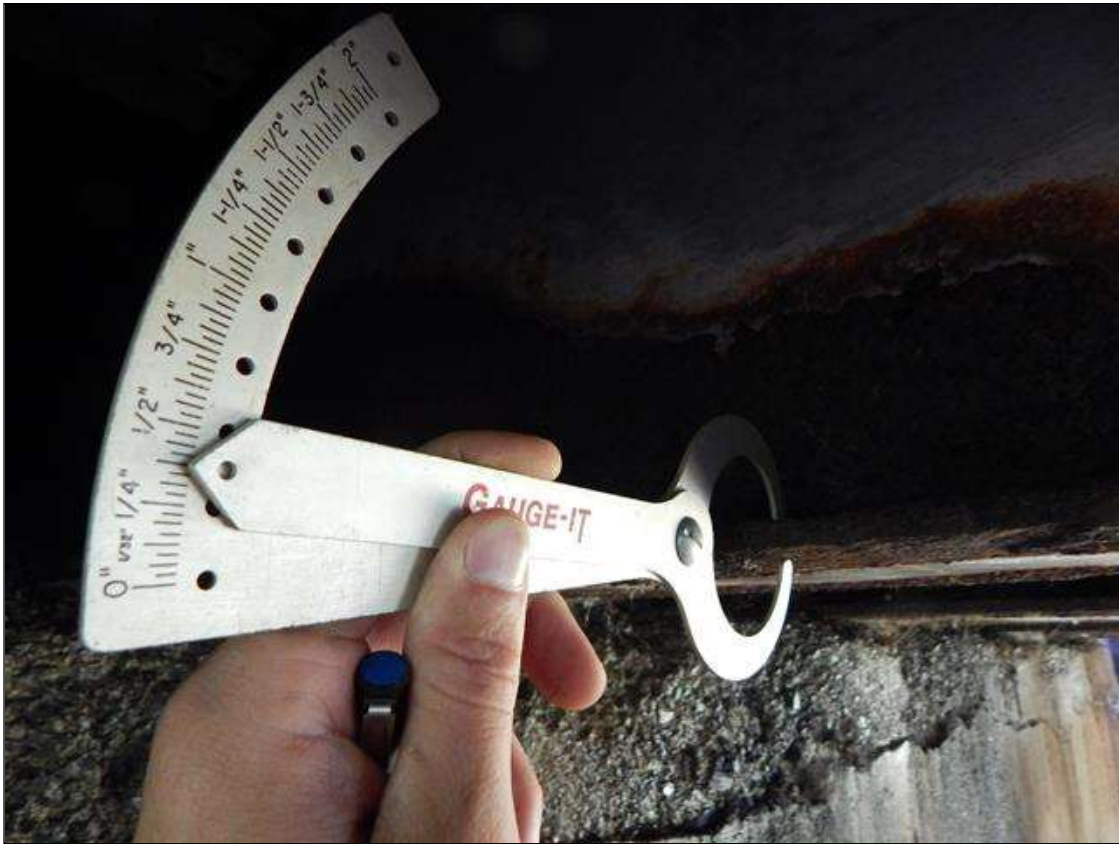
Span 1 Beam 8: 7 Feet of Corrosion: Section loss is evident or pack rust is present but does not warrant structural review. BEAM (8) CORROSION AT ABUT. (B) BEAM END (+/- 7 LF) ALONG TOP AND BOTTOM FLANGES WITH (3/8") AVG REMAINING AND (1/8") LOSS OF SECTION. EXTENDS INTO LOWER PORTION OF WEB (+/- 7" H) WITH (+/- 1/16") LOSS.

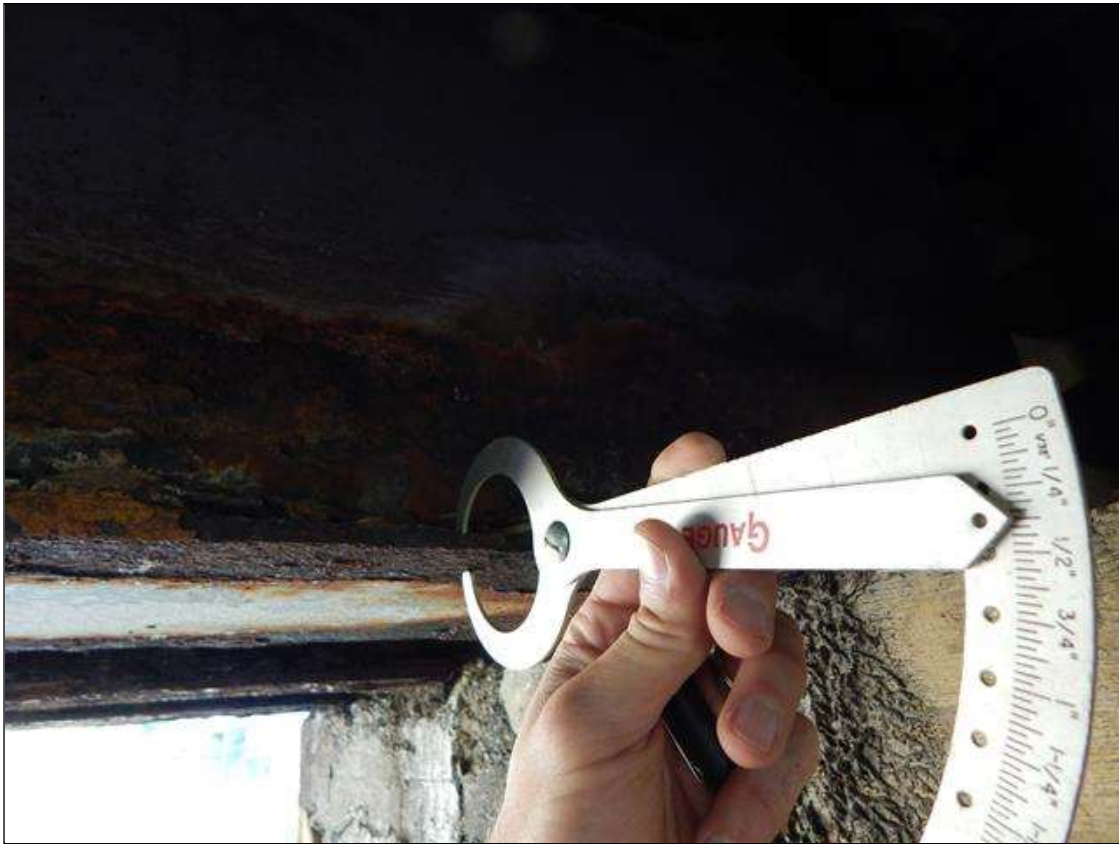
Span 1 Beam 9: 12 Feet of Corrosion: Section loss is evident or pack rust is present but does not warrant structural review. BEAM (9) CORROSION AT ABUT. (A) BEAM END (+/- 12 LF) ALONG TOP AND BOTTOM FLANGES WITH (3/8") AVG REMAINING AND (1/8") LOSS OF SECTION. EXTENDS INTO LOWER PORTION OF WEB (+/- 6" H) WITH (+/- 1/16") LOSS.

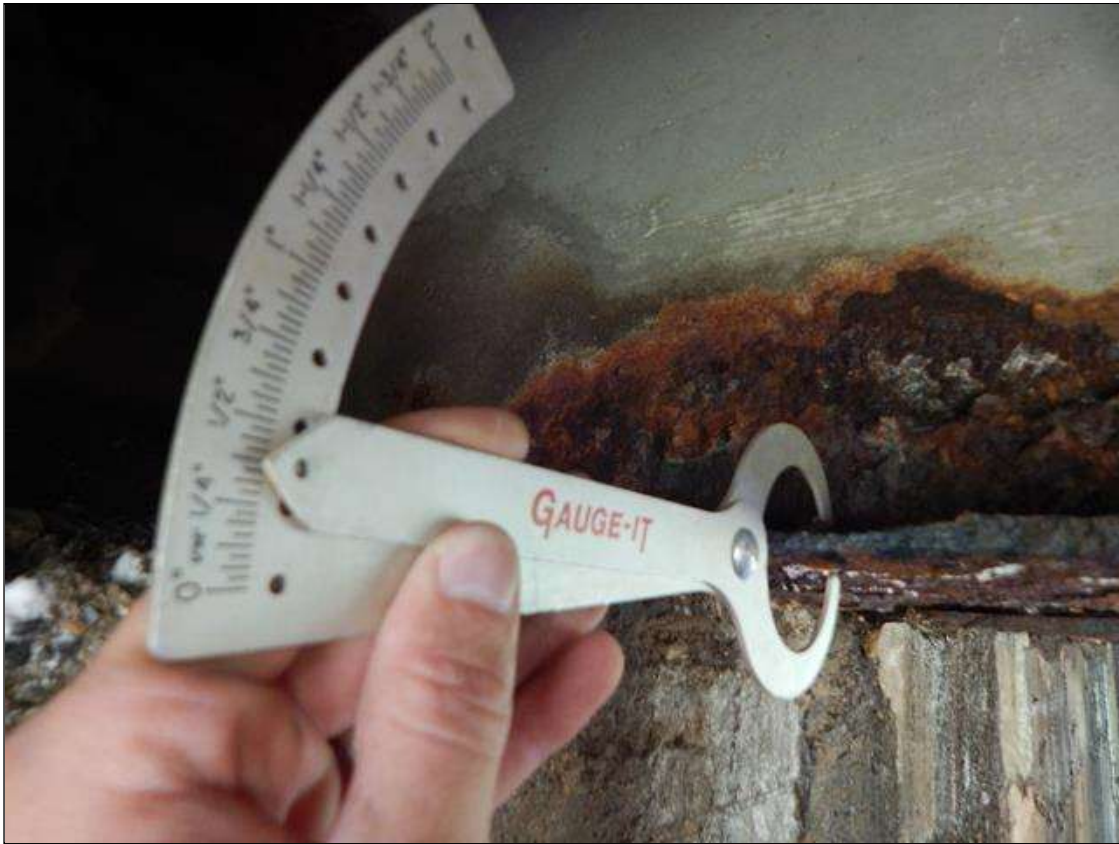
Span 1 Beam 10: 34 Feet of Corrosion: Section loss is evident or pack rust is present but does not warrant structural review. BEAM (10) CORROSION F/L ALONG TOP AND BOTTOM FLANGES WITH (3/8") AVG REMAINING AND (1/8") LOSS OF SECTION. EXTENDS INTO LOWER PORTION OF WEB (+/- 4" H) WITH (+/- 1/16") LOSS

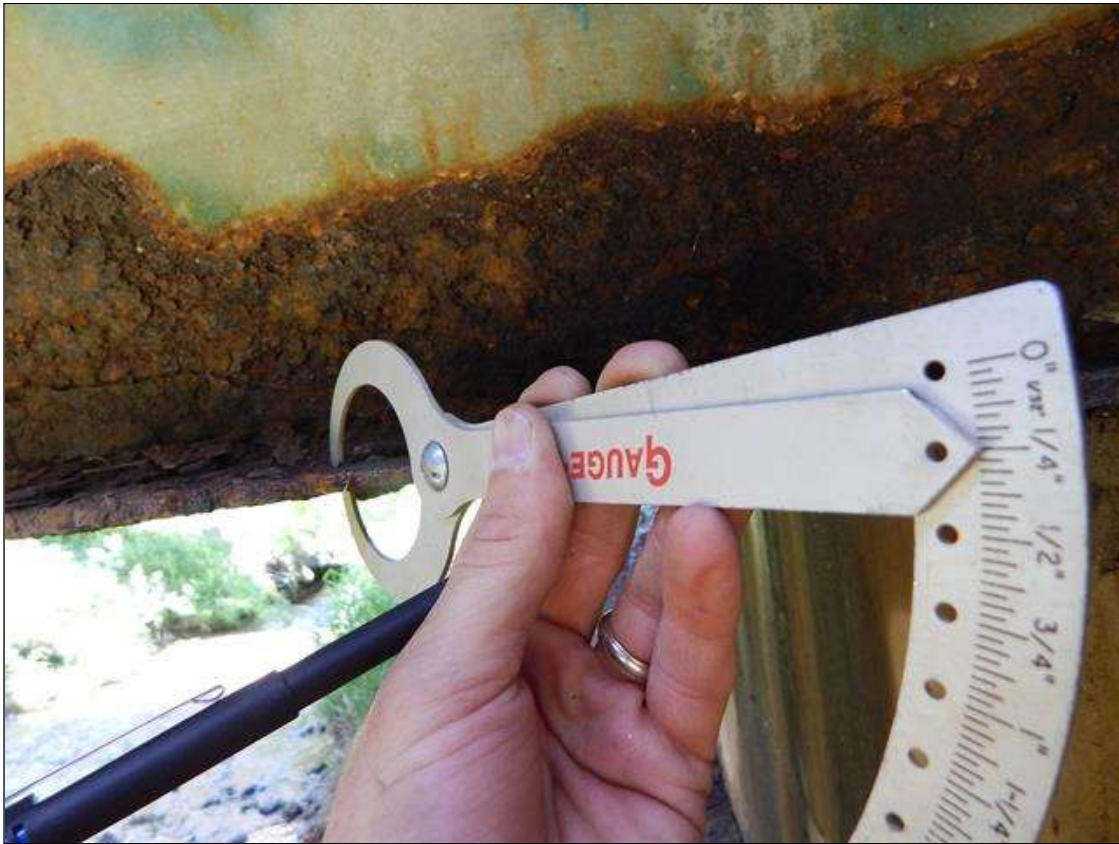
Span 1 Beam 11: 34 Feet of Corrosion: Section loss is evident or pack rust is present but does not warrant structural review. BEAM (11) CORROSION F/L ALONG TOP AND BOTTOM FLANGES WITH (1/4") AVG REMAINING AND (1/4") LOSS OF SECTION. EXTENDS INTO LOWER PORTION OF WEB (+/- 5" H) WITH (+/- 1/16") LOSS

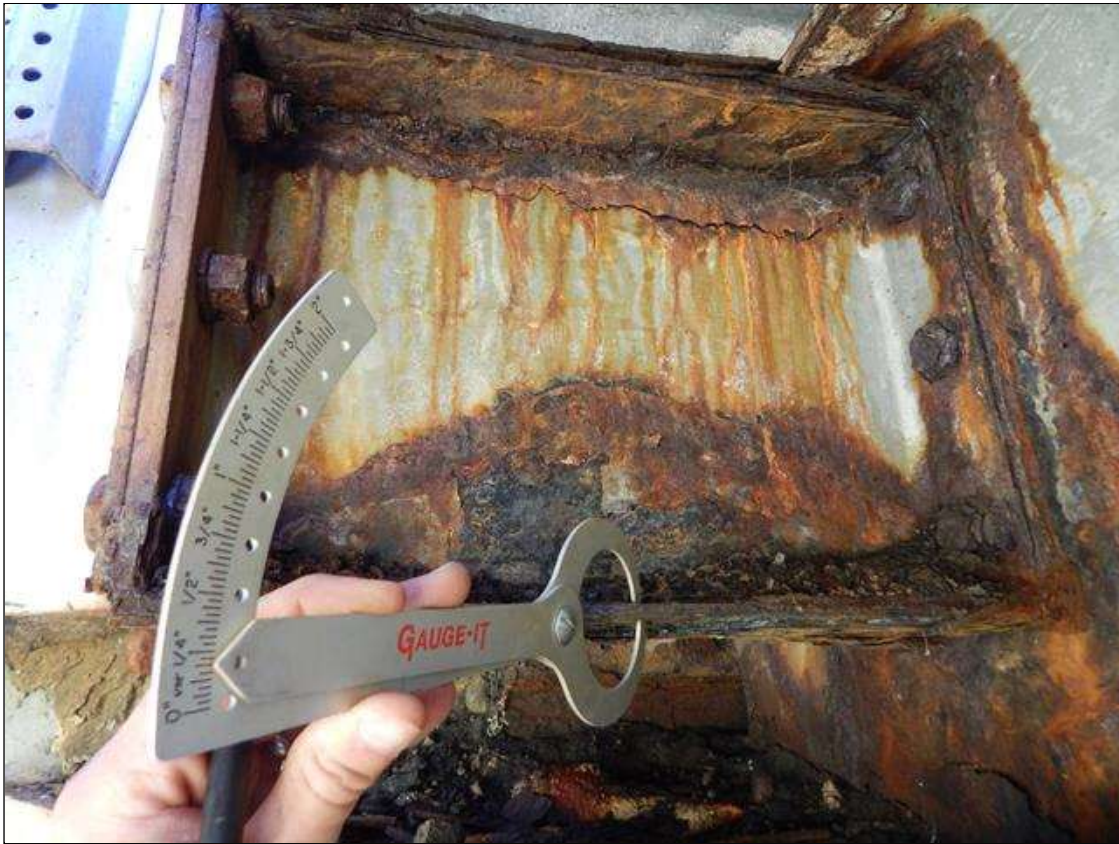
1 Square Feet of Corrosion: Section loss is evident or pack rust is present but does not warrant structural review. RIGHT RAIL POST BLOCK (1) CORROSION TO TOP AND BOTTOM FLANGES WITH (3/16") AVG REMAINING AND (3/16") LOSS OF SECTION. CORROSION TO WEB WITH (1/16") LOSS

1 Square Feet of Effectiveness (Steel Protective Coatings): Failed; no protection of the underlying metal. RIGHT RAIL POST BLOCK (1) CORROSION TO TOP AND BOTTOM FLANGES WITH (3/16") AVG REMAINING AND (3/16") LOSS OF SECTION. CORROSION TO WEB WITH (1/16") LOSS

Span 1 Right Bridge Rail: 1 Square Feet of Corrosion: Section loss is evident or pack rust is present but does not warrant structural review. RIGHT RAIL POST BLOCK (1) CORROSION TO TOP AND BOTTOM FLANGES WITH (3/16") AVG REMAINING AND (3/16") LOSS OF SECTION. CORROSION TO WEB WITH (1/16") LOSS

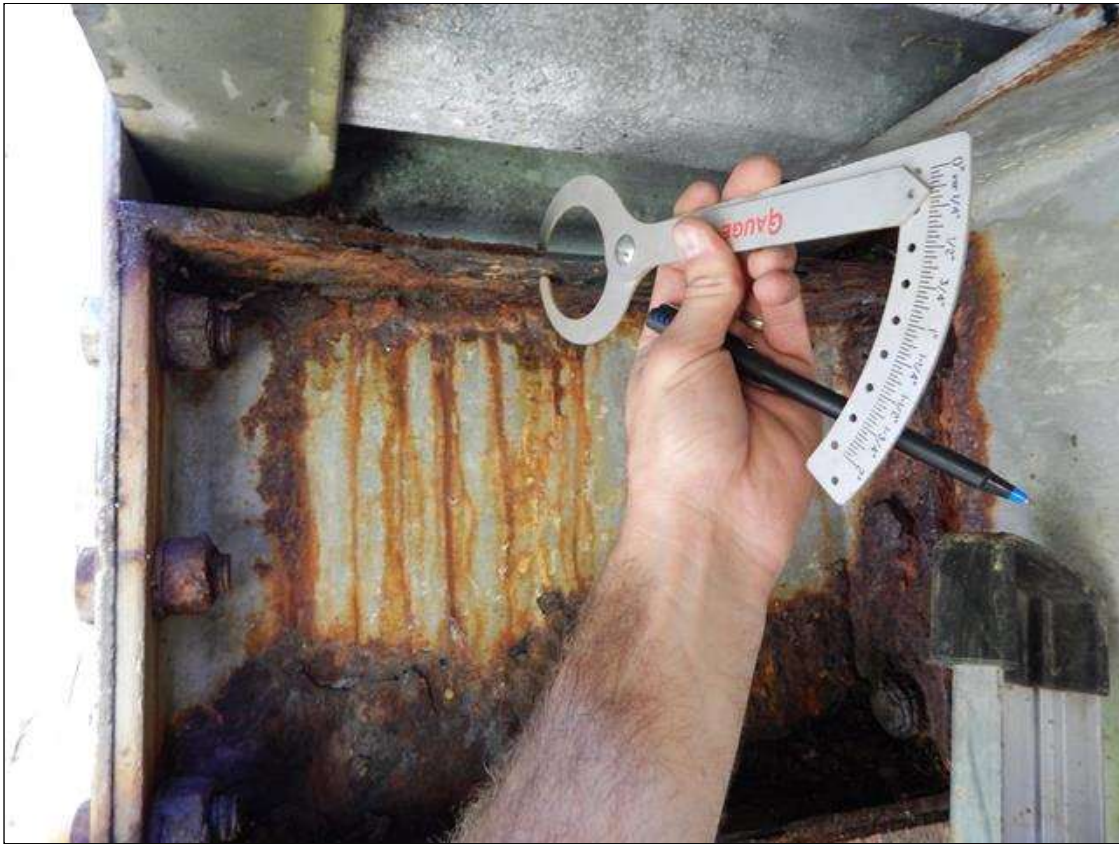
1 Square Feet of Corrosion: Section loss is evident or pack rust is present but does not warrant structural review. RIGHT RAIL POST BLOCK (2) CORROSION TO TOP AND BOTTOM FLANGES WITH (1/8") AVG REMAINING AND (1/4") LOSS OF SECTION. CORROSION TO WEB WITH (1/16") LOSS

1 Square Feet of Effectiveness (Steel Protective Coatings): Failed; no protection of the underlying metal. RIGHT RAIL POST

BLOCK (2) CORROSION TO TOP AND BOTTOM FLANGES WITH (1/8") AVG REMAINING AND (1/4") LOSS OF SECTION.  
CORROSION TO WEB WITH (1/16") LOSS

Span 1 Right Bridge Rail: 1 Square Feet of Corrosion: Section loss is evident or pack rust is present but does not warrant structural review. RIGHT RAIL POST BLOCK (2) CORROSION TO TOP AND BOTTOM FLANGES WITH (1/8") AVG REMAINING AND (1/4") LOSS OF SECTION. CORROSION TO WEB WITH (1/16") LOSS

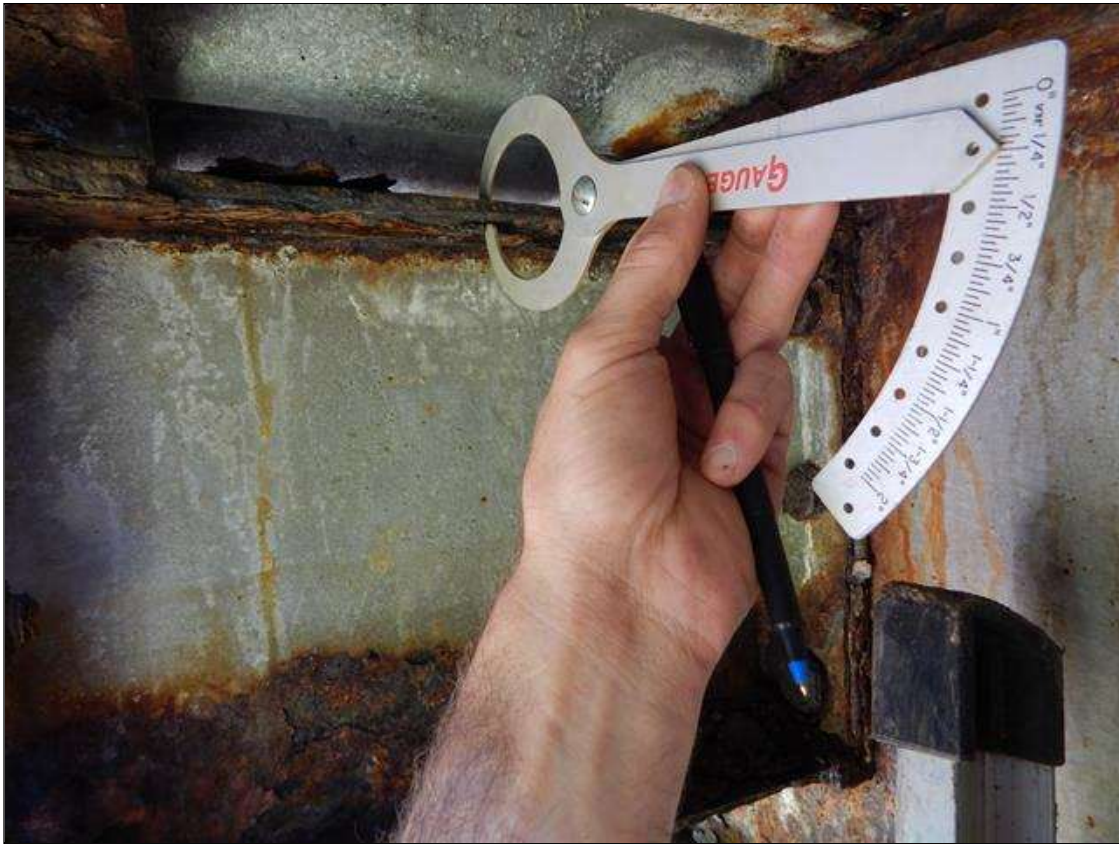
1 Square Feet of Corrosion: Section loss is evident or pack rust is present but does not warrant structural review. RIGHT RAIL POST BLOCK (3) CORROSION TO TOP AND BOTTOM FLANGES WITH (1/4") AVG REMAINING AND (1/8") LOSS OF SECTION. CORROSION TO WEB WITH (1/16") LOSS

1 Square Feet of Effectiveness (Steel Protective Coatings): Failed; no protection of the underlying metal. RIGHT RAIL POST BLOCK (3) CORROSION TO TOP AND BOTTOM FLANGES WITH (1/4") AVG REMAINING AND (1/8") LOSS OF SECTION. CORROSION TO WEB WITH (1/16") LOSS

Span 1 Right Bridge Rail: 1 Square Feet of Corrosion: Section loss is evident or pack rust is present but does not warrant structural review. RIGHT RAIL POST BLOCK (3) CORROSION TO TOP AND BOTTOM FLANGES WITH (1/4") AVG REMAINING AND (1/8") LOSS OF SECTION. CORROSION TO WEB WITH (1/16") LOSS

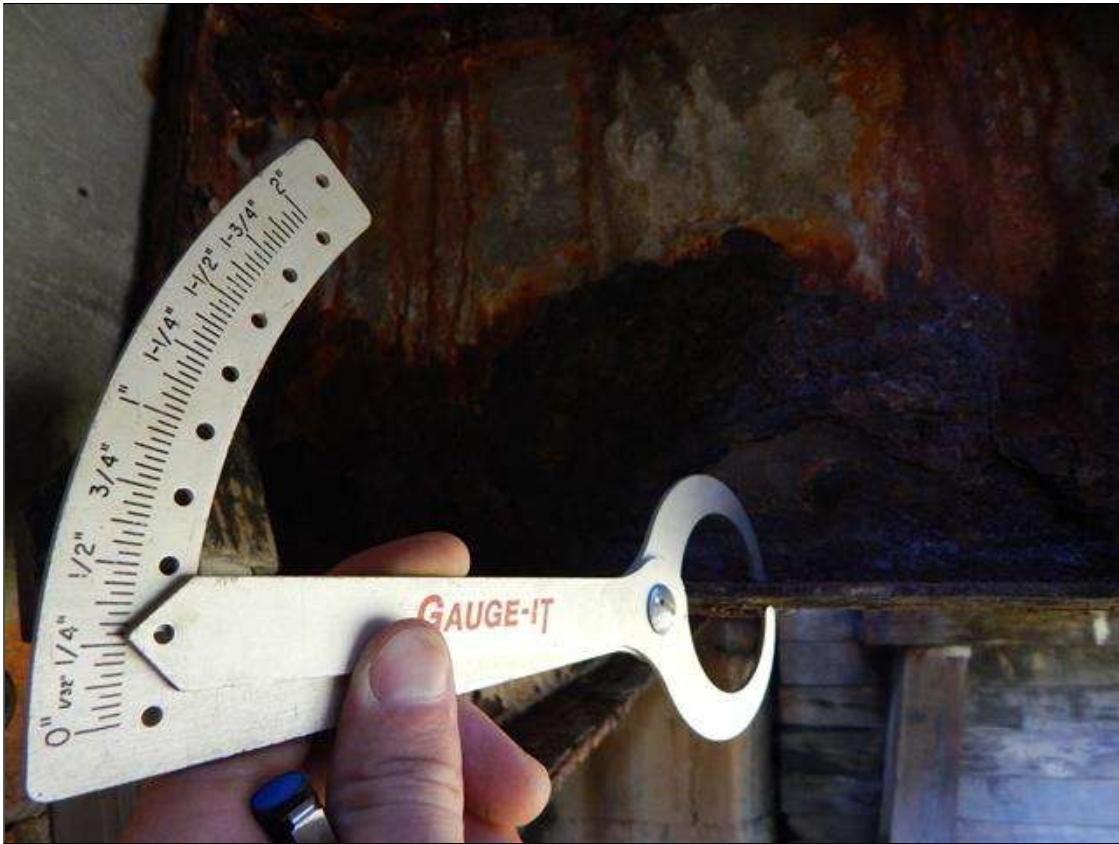
1 Square Feet of Corrosion: Section loss is evident or pack rust is present but does not warrant structural review. RIGHT RAIL POST BLOCK (4) CORROSION TO TOP AND BOTTOM FLANGES WITH (1/4") AVG REMAINING AND (1/8") LOSS OF SECTION. CORROSION TO WEB WITH (1/16") LOSS

1 Square Feet of Effectiveness (Steel Protective Coatings): Failed; no protection of the underlying metal. RIGHT RAIL POST BLOCK (4) CORROSION TO TOP AND BOTTOM FLANGES WITH (1/4") AVG REMAINING AND (1/8") LOSS OF SECTION. CORROSION TO WEB WITH (1/16") LOSS

Span 1 Right Bridge Rail: 1 Square Feet of Corrosion: Section loss is evident or pack rust is present but does not warrant structural review. RIGHT RAIL POST BLOCK (4) CORROSION TO TOP AND BOTTOM FLANGES WITH (1/4") AVG REMAINING AND (1/8") LOSS OF SECTION. CORROSION TO WEB WITH (1/16") LOSS

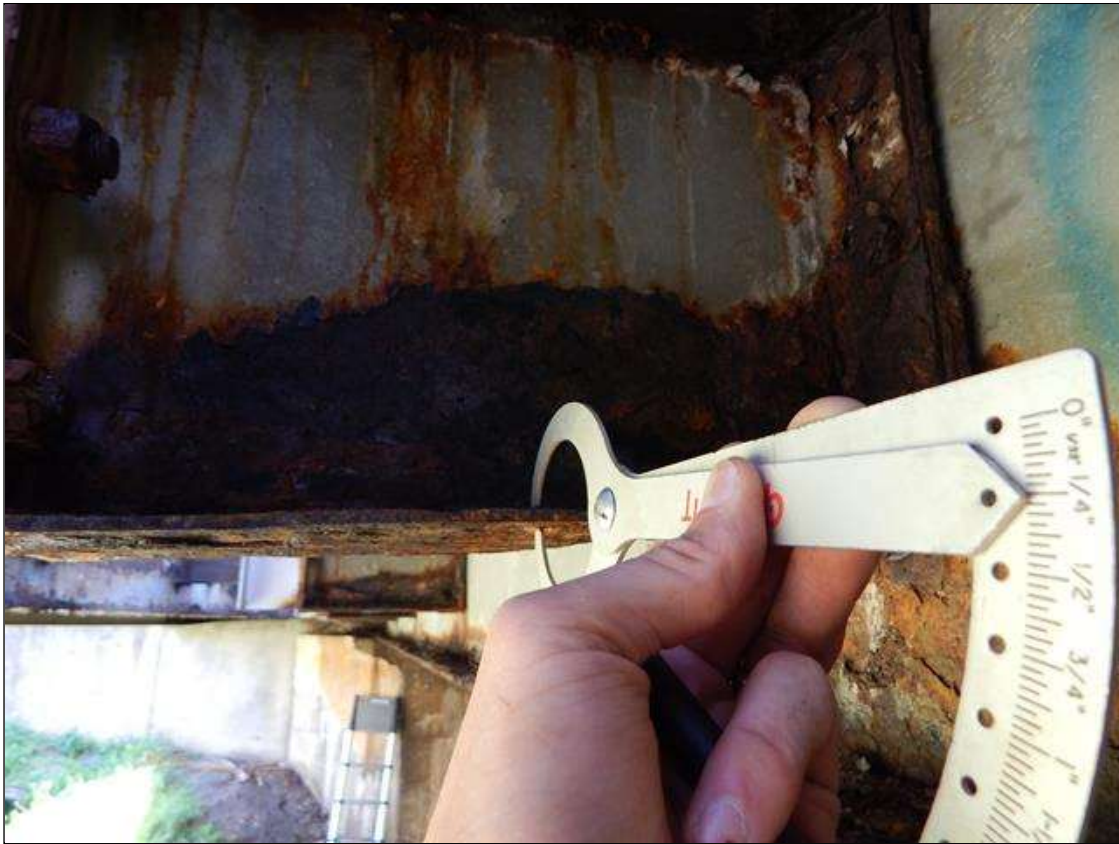
1 Square Feet of Corrosion: Section loss is evident or pack rust is present but does not warrant structural review. RIGHT RAIL POST BLOCK (5) CORROSION TO TOP AND BOTTOM FLANGES WITH (1/4") AVG REMAINING AND (1/8") LOSS OF SECTION. CORROSION TO WEB WITH (1/16") LOSS

1 Square Feet of Effectiveness (Steel Protective Coatings): Failed; no protection of the underlying metal. RIGHT RAIL POST BLOCK (5) CORROSION TO TOP AND BOTTOM FLANGES WITH (1/4") AVG REMAINING AND (1/8") LOSS OF SECTION. CORROSION TO WEB WITH (1/16") LOSS

Span 1 Right Bridge Rail: 1 Square Feet of Corrosion: Section loss is evident or pack rust is present but does not warrant structural review. RIGHT RAIL POST BLOCK (5) CORROSION TO TOP AND BOTTOM FLANGES WITH (1/4") AVG REMAINING AND (1/8") LOSS OF SECTION. CORROSION TO WEB WITH (1/16") LOSS
