NC DEPARTMENT OF TRANSPORTATION  
DIVISION OF HIGHWAYS  
STRUCTURE MANAGEMENT UNIT

## Structure Safety Report

### Routine Element Inspection

COUNTY: ASHE STRUCTURE NUMBER: 040023 FREQUENCY: 24 MONTHS  
FACILITY CARRIED: NC194 MILE POST: \_\_\_\_\_  
LOCATION: 100 FT.S.JCT.SR1353  
FEATURE INTERSECTED: OLD FIELD BRANCH  
LATITUDE: 36° 29' 56.6" LONGITUDE: 81° 30' 39.72"  
SUPERSTRUCTURE: STEEL PLANK FLOOR ON I-BEAMS  
SUBSTRUCTURE: REINFORCED CONCRETE ABUTMENTS  
SPANS: 1@ 33'-5"  
☐ FRACTURE CRITICAL ☐ TEMPORARY SHORING ☐ SCOUR CRITICAL ☐ SCOUR PLAN OF ACTION  
PRESENT CONDITION: Poor INSPECTION DATE: 05/12/2016  
POSTED SV: Not Posted POSTED TTST: Not Posted  
OTHER SIGNS PRESENT: NONE

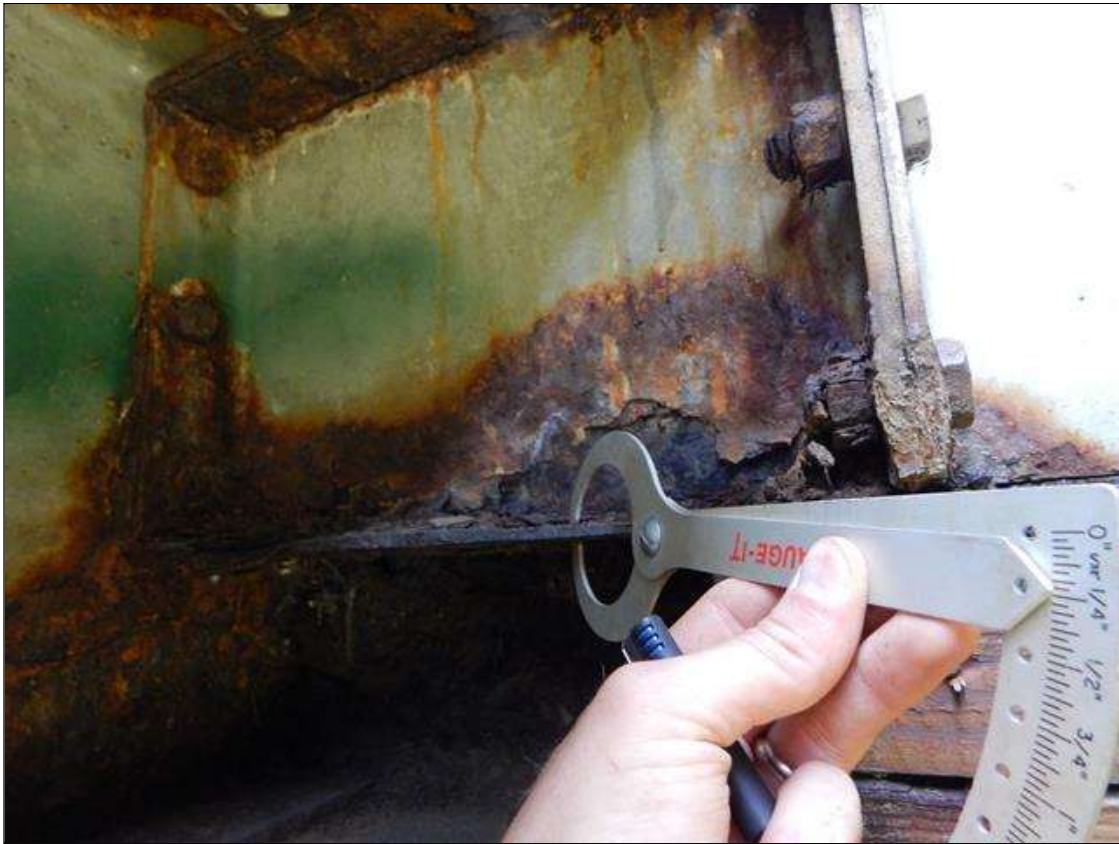
1 Square Feet of Corrosion: Section loss is evident or pack rust is present but does not warrant structural review. RIGHT RAIL POST BLOCK (6) CORROSION TO TOP AND BOTTOM FLANGES WITH (1/4") AVG REMAINING AND (1/8") LOSS OF SECTION. CORROSION TO WEB WITH (1/16") LOSS

1 Square Feet of Effectiveness (Steel Protective Coatings): Failed; no protection of the underlying metal. RIGHT RAIL POST BLOCK (6) CORROSION TO TOP AND BOTTOM FLANGES WITH (1/4") AVG REMAINING AND (1/8") LOSS OF SECTION. CORROSION TO WEB WITH (1/16") LOSS

Span 1 Right Bridge Rail: 1 Square Feet of Corrosion: Section loss is evident or pack rust is present but does not warrant structural review. RIGHT RAIL POST BLOCK (6) CORROSION TO TOP AND BOTTOM FLANGES WITH (1/4") AVG REMAINING AND (1/8") LOSS OF SECTION. CORROSION TO WEB WITH (1/16") LOSS

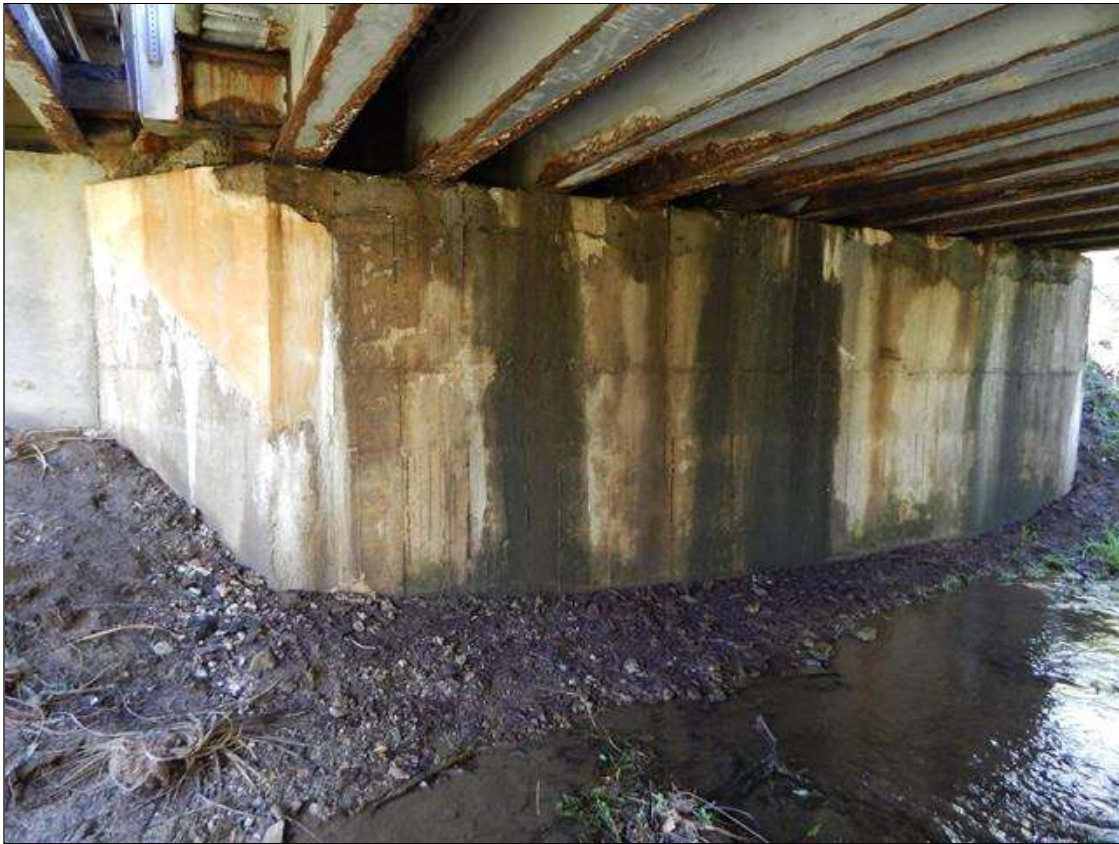
End Bent 1 Abutment/Backwall : 7 Feet of Delamination/Spall/Patched Area: Delaminated. Spall 1 in. or less deep or 6 in. or less in diameter. Patched area that is sound. TEMP. REPAIR TO SOUTH EAST ABUT. (A) AND UNDER BEAMS (6 & 9) GOOD AT THIS TIME.

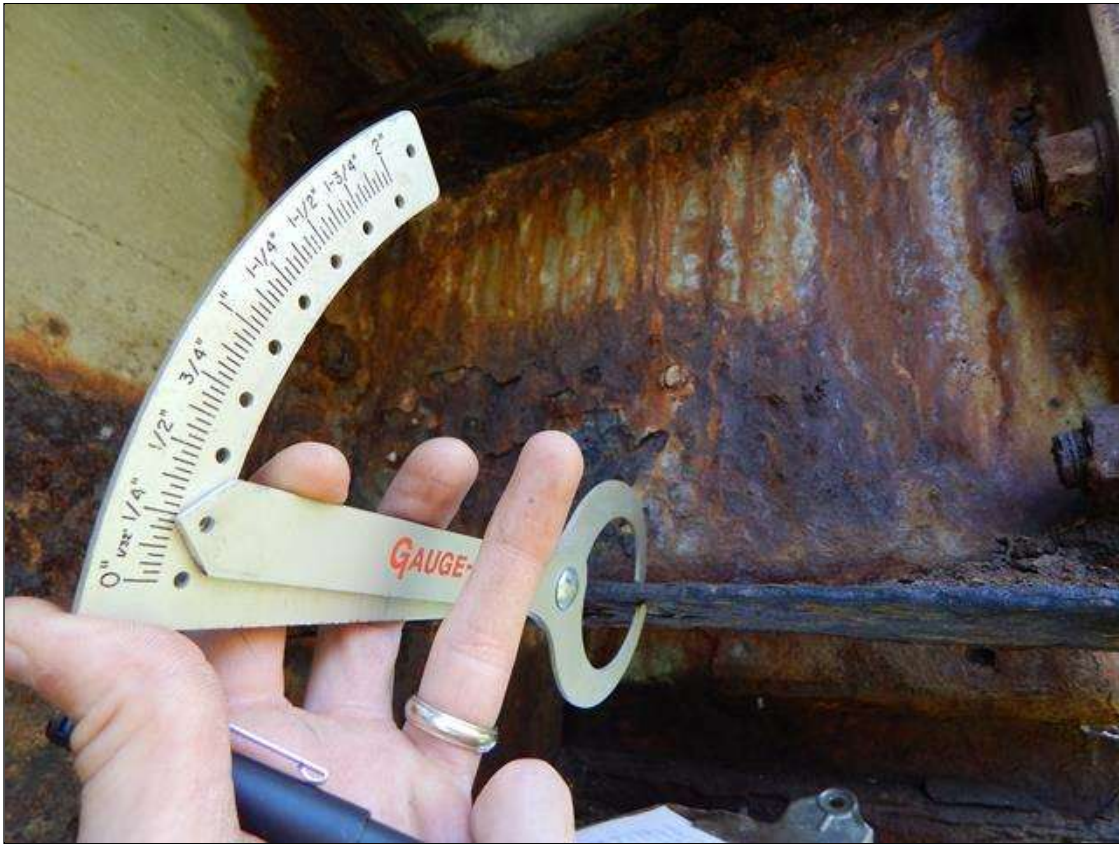
1 Square Feet of Corrosion: Section loss is evident or pack rust is present but does not warrant structural review. LEFT RAIL POST BLOCK (1) CORROSION TO TOP AND BOTTOM FLANGES WITH (1/4") AVG REMAINING AND (1/8") LOSS OF SECTION. CORROSION TO WEB WITH (1/16") LOSS

1 Square Feet of Effectiveness (Steel Protective Coatings): Failed; no protection of the underlying metal. LEFT RAIL POST BLOCK (1) CORROSION TO TOP AND BOTTOM FLANGES WITH (1/4") AVG REMAINING AND (1/8") LOSS OF SECTION. CORROSION TO WEB WITH (1/16") LOSS

Span 1 Left Bridge Rail: 1 Square Feet of Corrosion: Section loss is evident or pack rust is present but does not warrant structural review. LEFT RAIL POST BLOCK (1) CORROSION TO TOP AND BOTTOM FLANGES WITH (1/4") AVG REMAINING AND (1/8") LOSS OF SECTION. CORROSION TO WEB WITH (1/16") LOSS

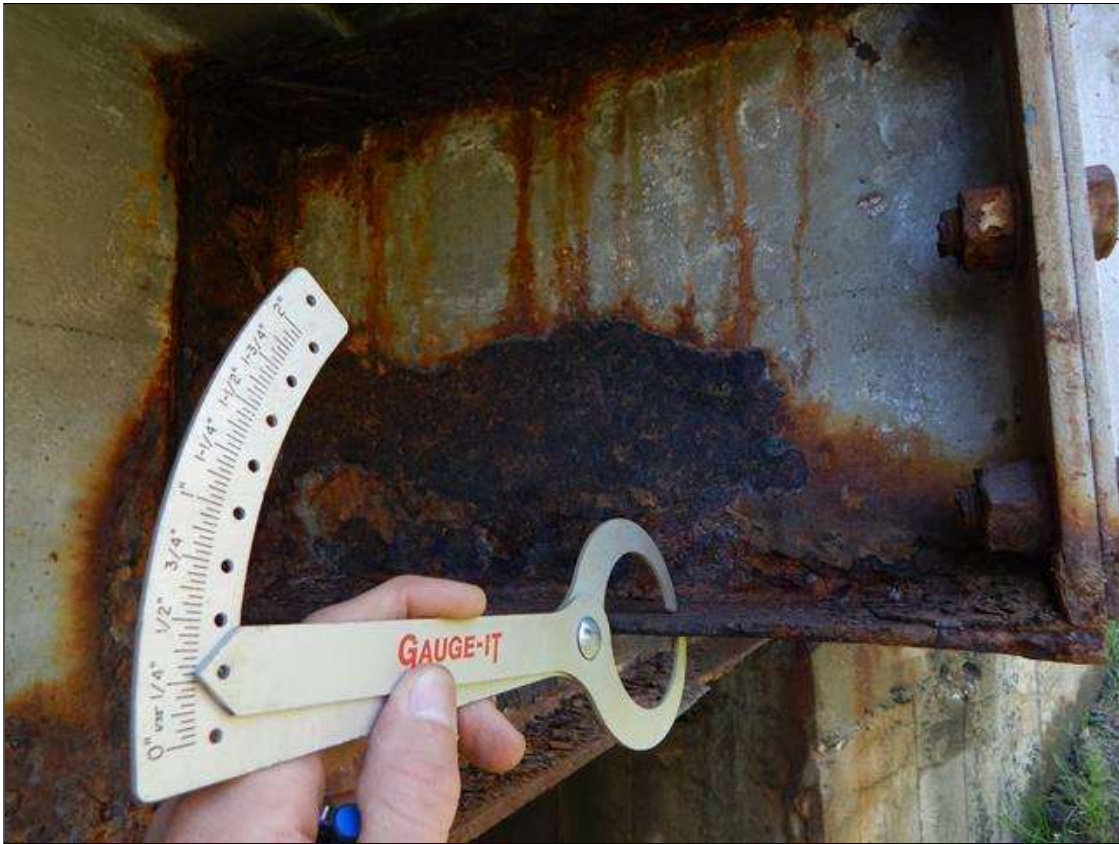
1 Square Feet of Corrosion: Section loss is evident or pack rust is present but does not warrant structural review. LEFT RAIL POST BLOCK (2) CORROSION TO TOP AND BOTTOM FLANGES WITH (1/4") AVG REMAINING AND (1/8") LOSS OF SECTION. CORROSION TO WEB WITH (1/16") LOSS

1 Square Feet of Effectiveness (Steel Protective Coatings): Failed; no protection of the underlying metal. LEFT RAIL POST BLOCK (2) CORROSION TO TOP AND BOTTOM FLANGES WITH (1/4") AVG REMAINING AND (1/8") LOSS OF SECTION. CORROSION TO WEB WITH (1/16") LOSS

Span 1 Left Bridge Rail: 1 Square Feet of Corrosion: Section loss is evident or pack rust is present but does not warrant structural review. LEFT RAIL POST BLOCK (2) CORROSION TO TOP AND BOTTOM FLANGES WITH (1/4") AVG REMAINING AND (1/8") LOSS OF SECTION. CORROSION TO WEB WITH (1/16") LOSS

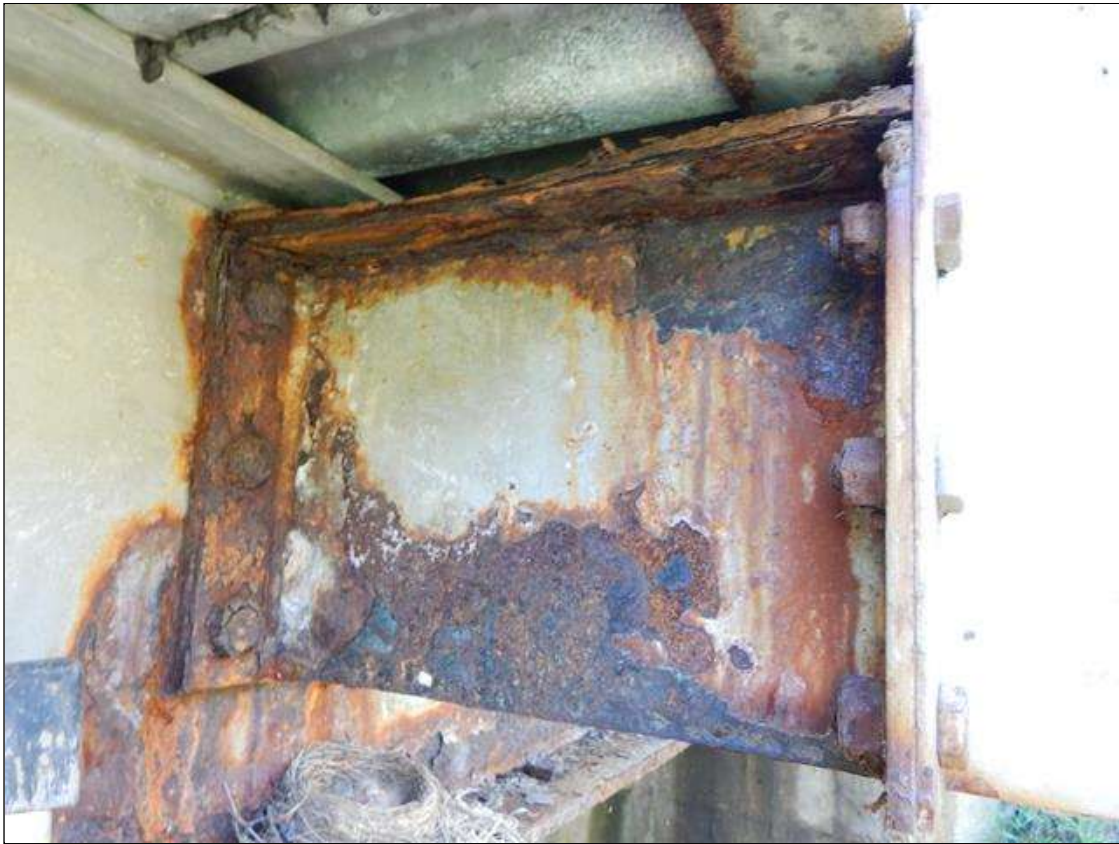
1 Square Feet of Corrosion: Section loss is evident or pack rust is present but does not warrant structural review. LEFT RAIL POST BLOCK (3) CORROSION TO TOP AND BOTTOM FLANGES WITH (1/4") AVG REMAINING AND (1/8") LOSS OF SECTION. CORROSION TO WEB WITH (1/16") LOSS

1 Square Feet of Effectiveness (Steel Protective Coatings): Failed; no protection of the underlying metal. LEFT RAIL POST BLOCK (3) CORROSION TO TOP AND BOTTOM FLANGES WITH (1/4") AVG REMAINING AND (1/8") LOSS OF SECTION. CORROSION TO WEB WITH (1/16") LOSS

Span 1 Left Bridge Rail: 1 Square Feet of Corrosion: Section loss is evident or pack rust is present but does not warrant structural review. LEFT RAIL POST BLOCK (3) CORROSION TO TOP AND BOTTOM FLANGES WITH (1/4") AVG REMAINING AND (1/8") LOSS OF SECTION. CORROSION TO WEB WITH (1/16") LOSS

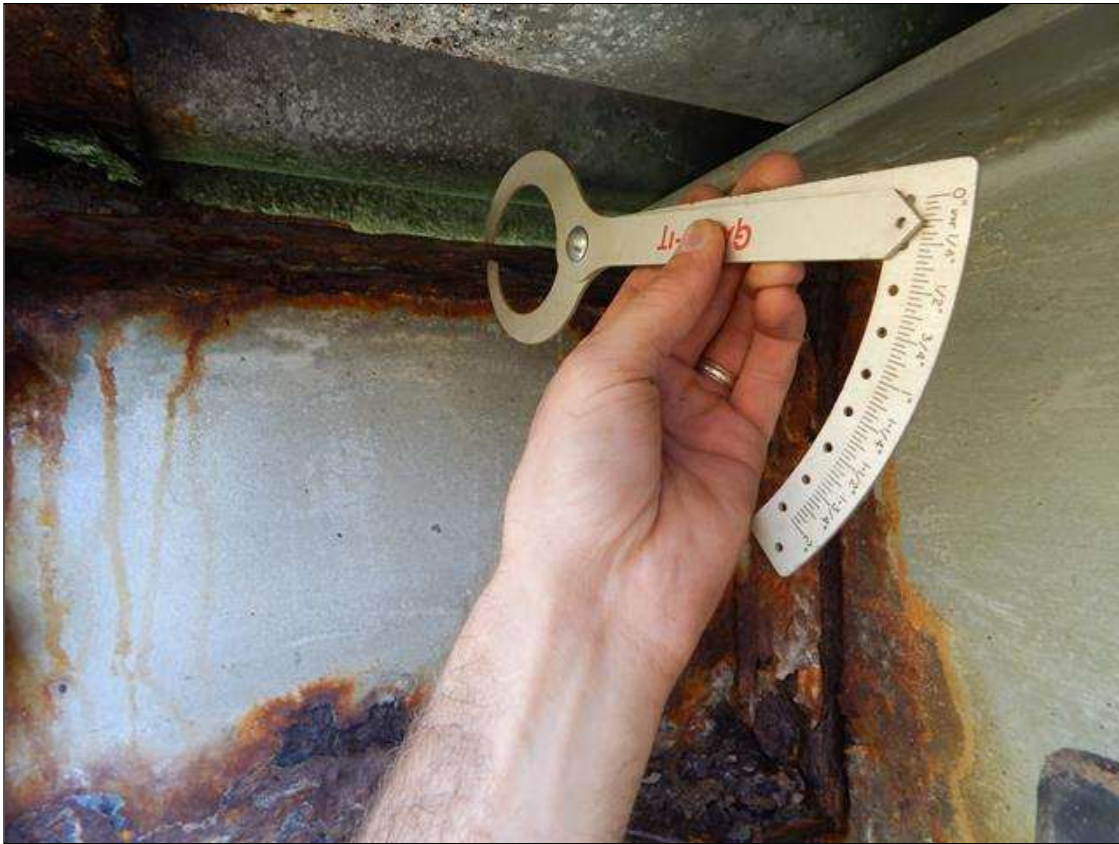
1 Square Feet of Corrosion: Section loss is evident or pack rust is present but does not warrant structural review. LEFT RAIL POST BLOCK (4) CORROSION TO TOP AND BOTTOM FLANGES WITH (1/8") AVG REMAINING AND (1/4") LOSS OF SECTION. CORROSION TO WEB WITH (1/16") LOSS

1 Square Feet of Effectiveness (Steel Protective Coatings): Failed; no protection of the underlying metal. LEFT RAIL POST BLOCK (4) CORROSION TO TOP AND BOTTOM FLANGES WITH (1/8") AVG REMAINING AND (1/4") LOSS OF SECTION. CORROSION TO WEB WITH (1/16") LOSS

Span 1 Left Bridge Rail: 1 Square Feet of Corrosion: Section loss is evident or pack rust is present but does not warrant structural review. LEFT RAIL POST BLOCK (4) CORROSION TO TOP AND BOTTOM FLANGES WITH (1/8") AVG REMAINING AND (1/4") LOSS OF SECTION. CORROSION TO WEB WITH (1/16") LOSS

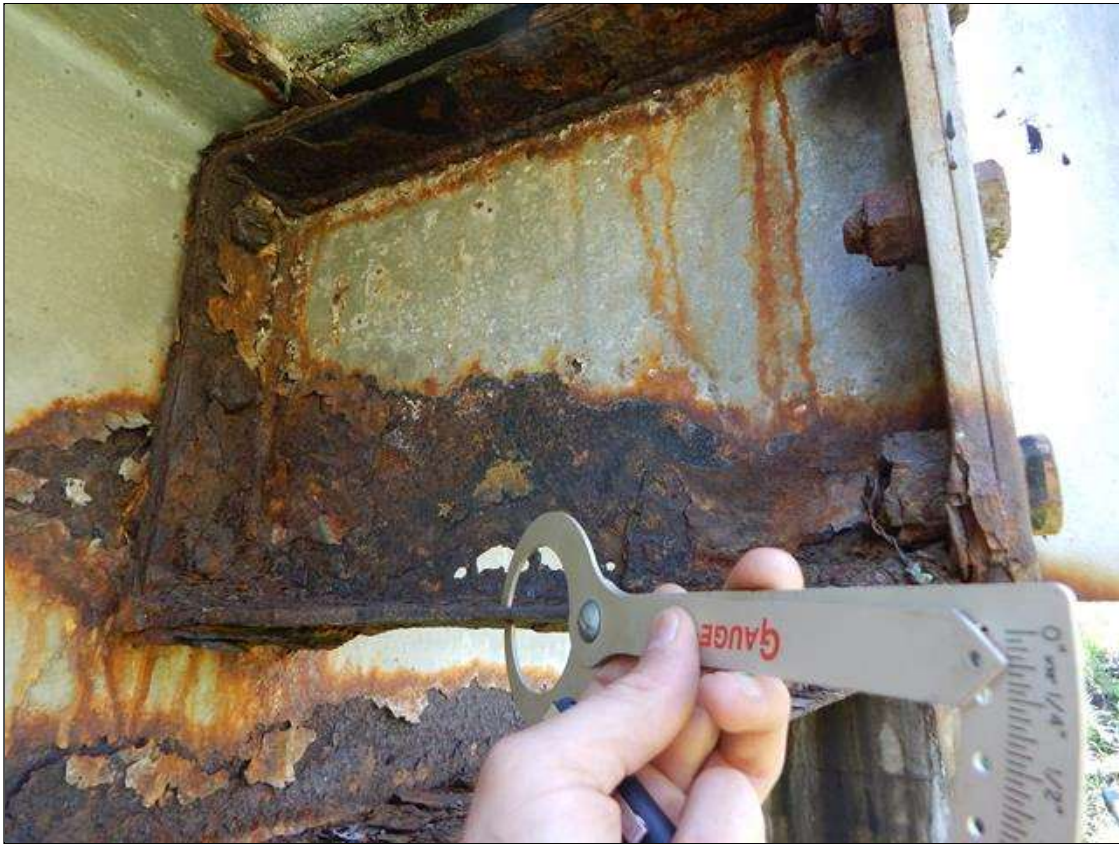
1 Square Feet of Corrosion: Section loss is evident or pack rust is present but does not warrant structural review. LEFT RAIL POST BLOCK (5) CORROSION TO TOP AND BOTTOM FLANGES WITH (1/8") AVG REMAINING AND (1/4") LOSS OF SECTION. CORROSION TO WEB WITH (1/16") LOSS. (3") DIA. HOLE IN WEB

1 Square Feet of Effectiveness (Steel Protective Coatings): Failed; no protection of the underlying metal. LEFT RAIL POST BLOCK (5) CORROSION TO TOP AND BOTTOM FLANGES WITH (1/8") AVG REMAINING AND (1/4") LOSS OF SECTION. CORROSION TO WEB WITH (1/16") LOSS. (3") DIA. HOLE IN WEB

Span 1 Left Bridge Rail: 1 Square Feet of Corrosion: Section loss is evident or pack rust is present but does not warrant structural review. LEFT RAIL POST BLOCK (5) CORROSION TO TOP AND BOTTOM FLANGES WITH (1/8") AVG REMAINING AND (1/4") LOSS OF SECTION. CORROSION TO WEB WITH (1/16") LOSS. (3") DIA. HOLE IN WEB

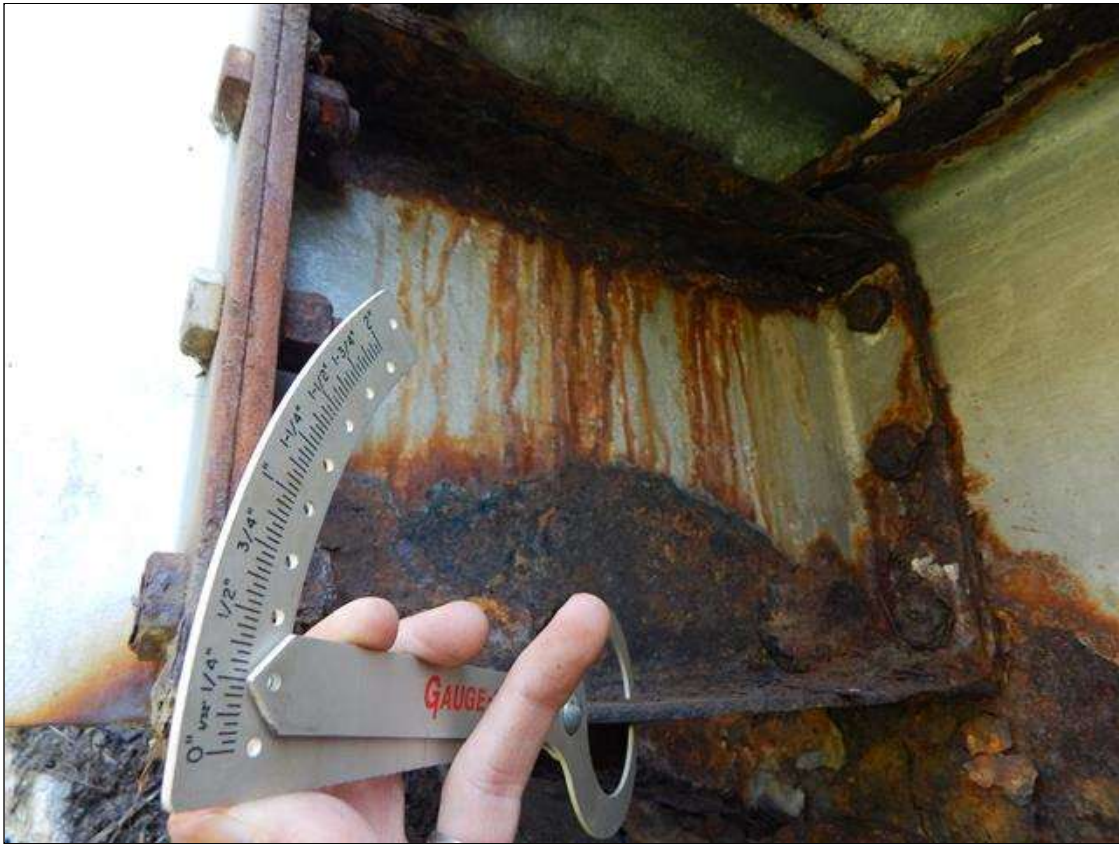
1 Square Feet of Corrosion: Section loss is evident or pack rust is present but does not warrant structural review. LEFT RAIL POST BLOCK (6) CORROSION TO TOP AND BOTTOM FLANGES WITH (1/4") AVG REMAINING AND (1/8") LOSS OF SECTION. CORROSION TO WEB WITH (1/16") LOSS

1 Square Feet of Effectiveness (Steel Protective Coatings): Failed; no protection of the underlying metal. LEFT RAIL POST BLOCK (6) CORROSION TO TOP AND BOTTOM FLANGES WITH (1/4") AVG REMAINING AND (1/8") LOSS OF SECTION. CORROSION TO WEB WITH (1/16") LOSS

Span 1 Left Bridge Rail: 1 Square Feet of Corrosion: Section loss is evident or pack rust is present but does not warrant structural review. LEFT RAIL POST BLOCK (6) CORROSION TO TOP AND BOTTOM FLANGES WITH (1/4") AVG REMAINING AND (1/8") LOSS OF SECTION. CORROSION TO WEB WITH (1/16") LOSS

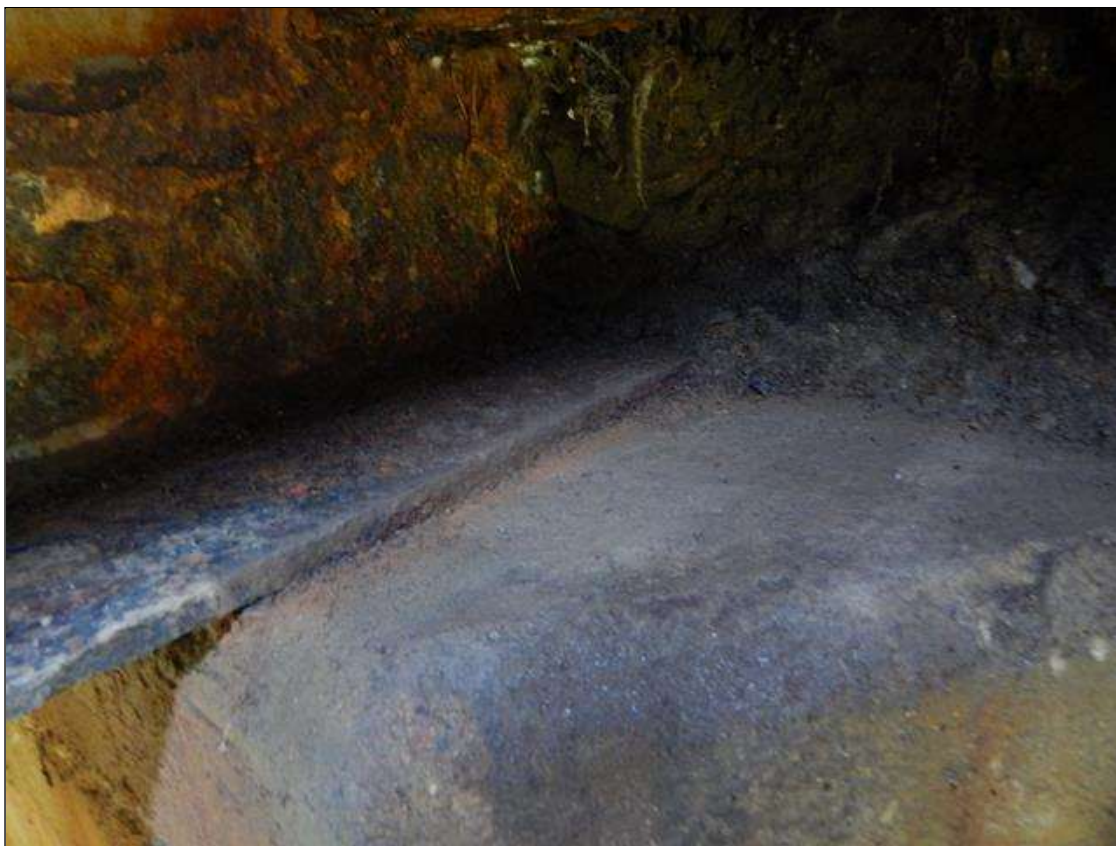
NO BEARING, ALL SIMILAR

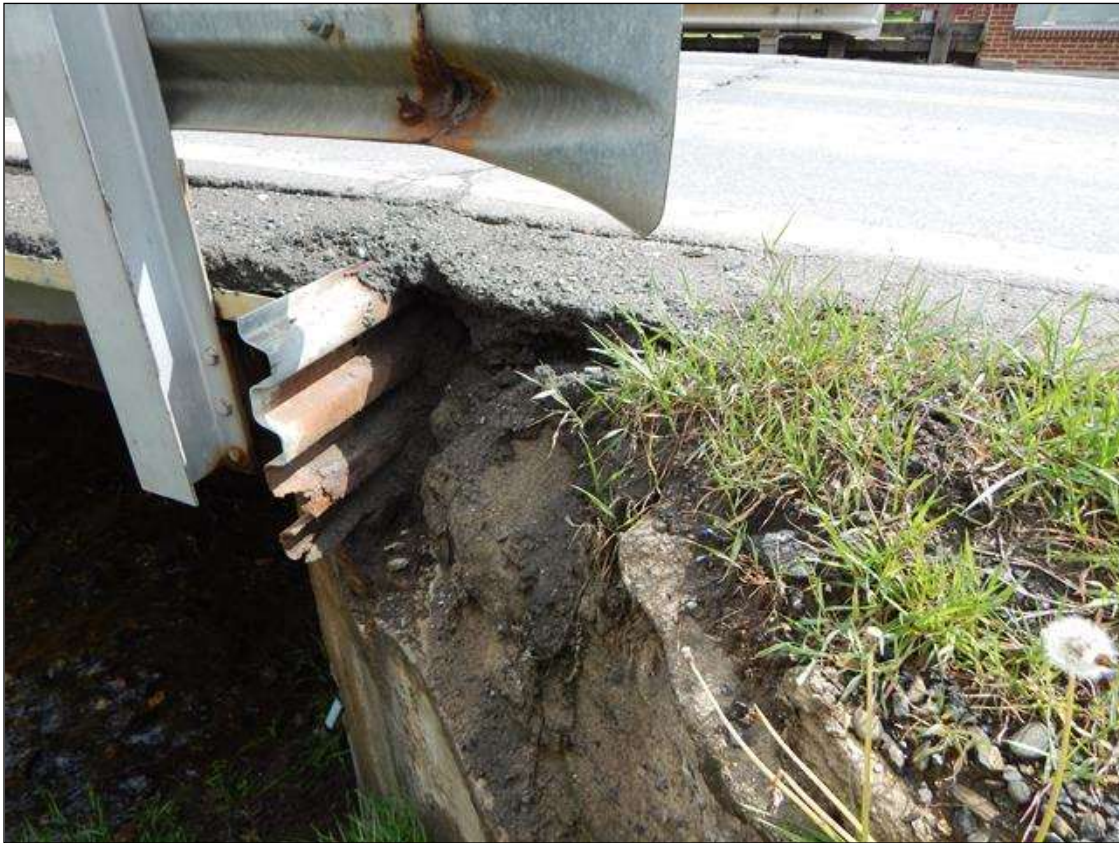
EROSION ALONG LEFT END ABUT. (A) SHOULDER (+/- 5' L X 2' H X 2' D) AND EXTENDS (+/- 6") UNDER EDGE OF WEARING SURFACE

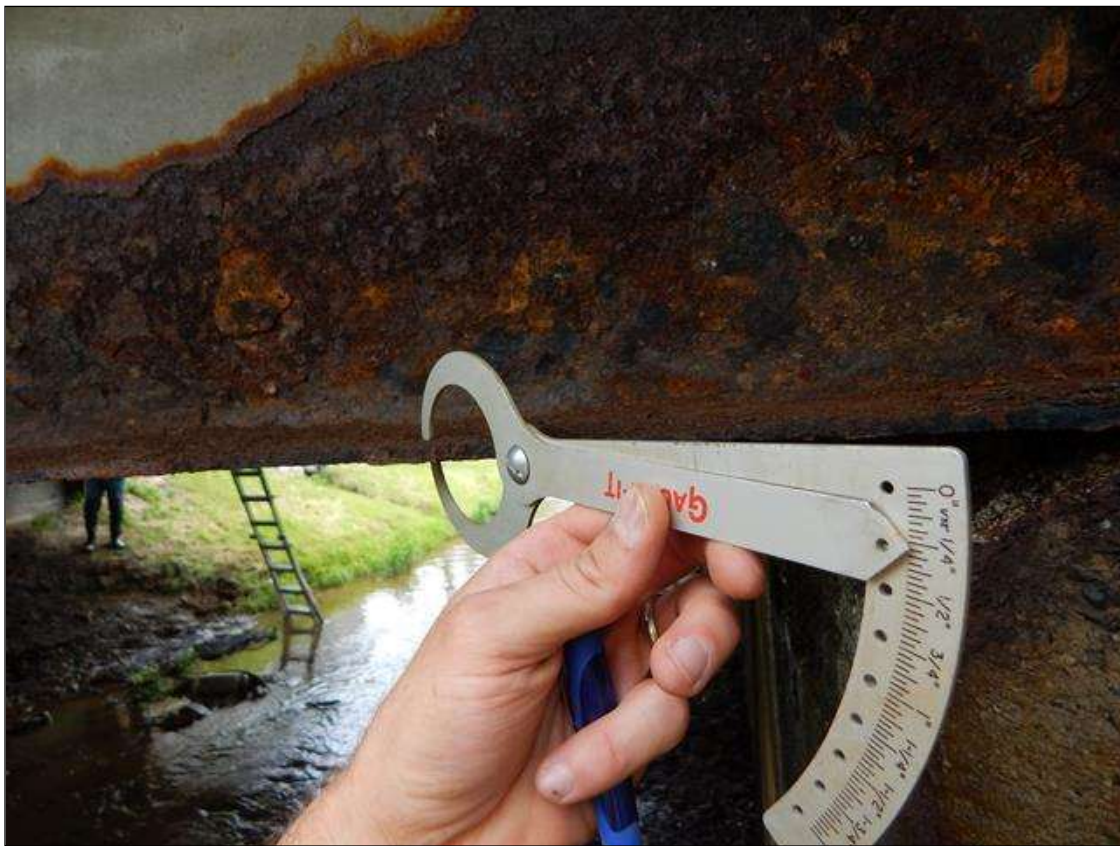
BEAM (1) CORROSION F/L ALONG TOP AND BOTTOM FLANGES WITH (1/4") AVG REMAINING AND (1/4") LOSS OF SECTION. EXTENDS INTO LOWER PORTION OF WEB (+/- 8" H)

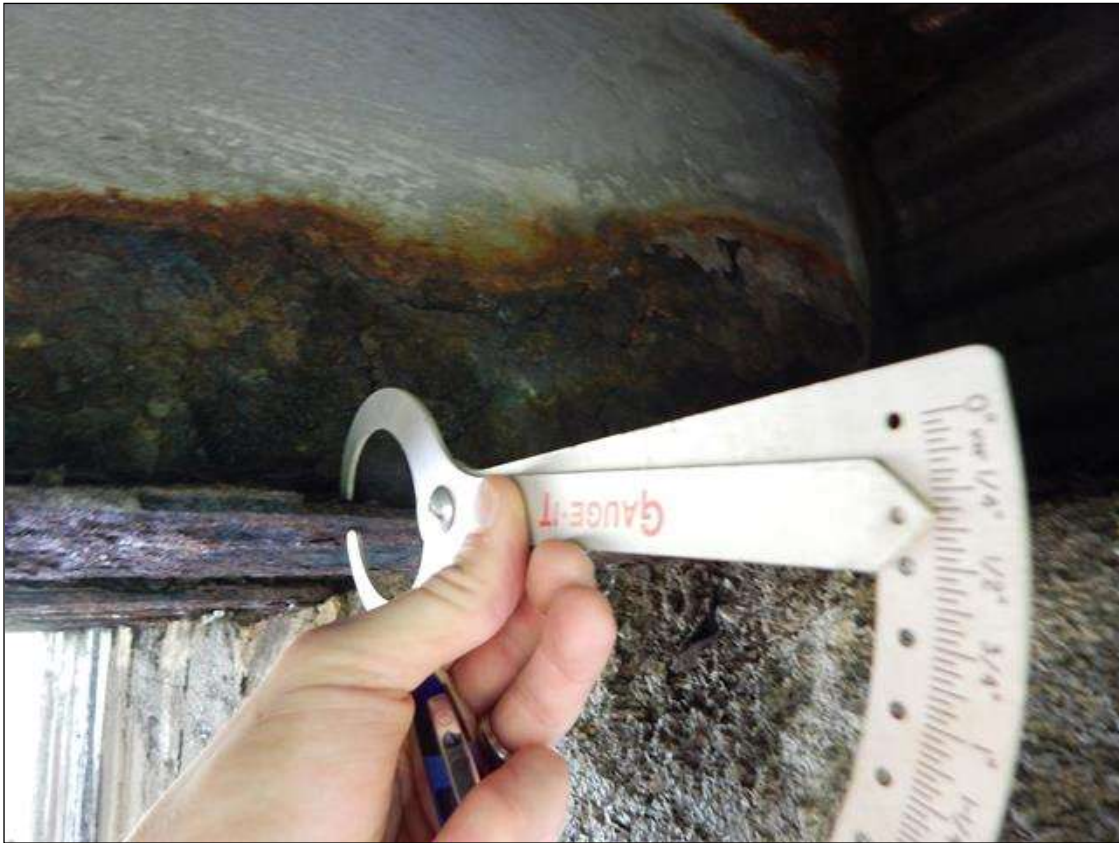
BEAM (2) CORROSION AT ABUT. (A) BEAM END (+/- 11 LF) ALONG TOP AND BOTTOM FLANGES WITH (5/16") AVG REMAINING AND (3/8") LOSS OF SECTION.

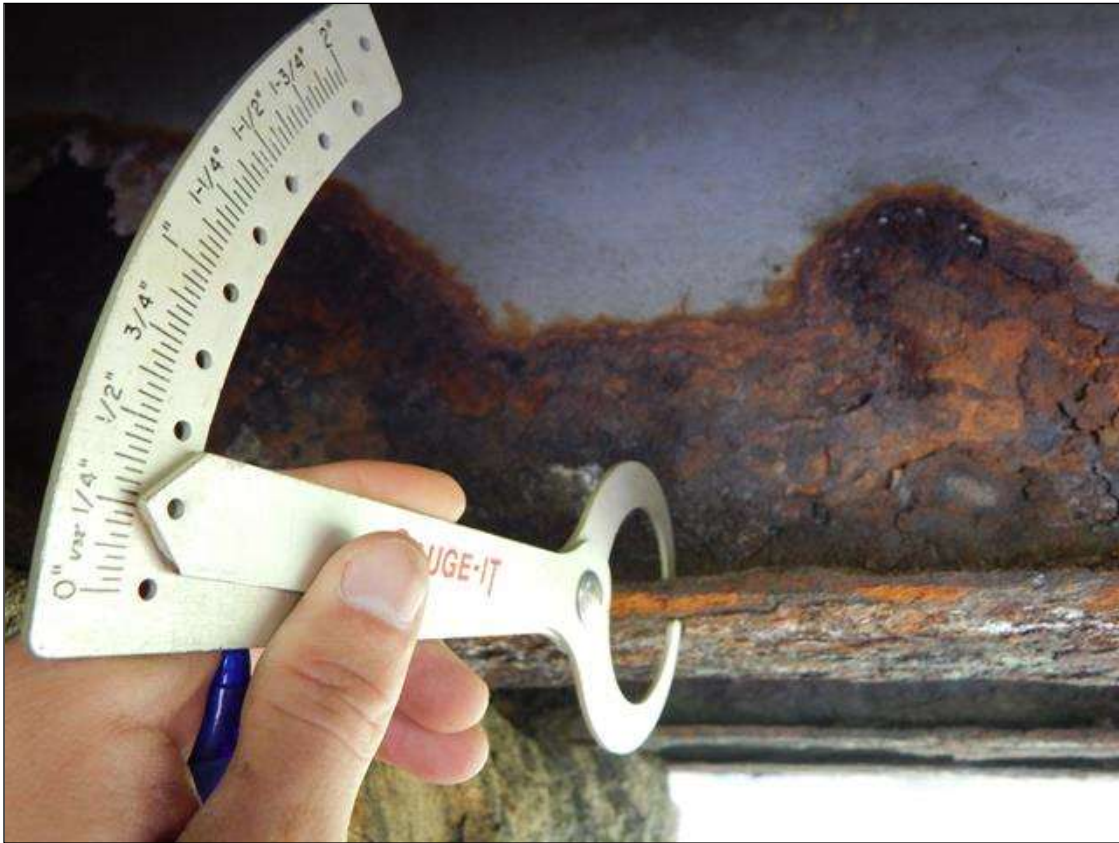
BEAM (3) CORROSION AT ABUT. (A) BEAM END (+/- 11 LF) ALONG TOP AND BOTTOM FLANGES WITH (1/4") AVG REMAINING AND (1/4") LOSS OF SECTION.

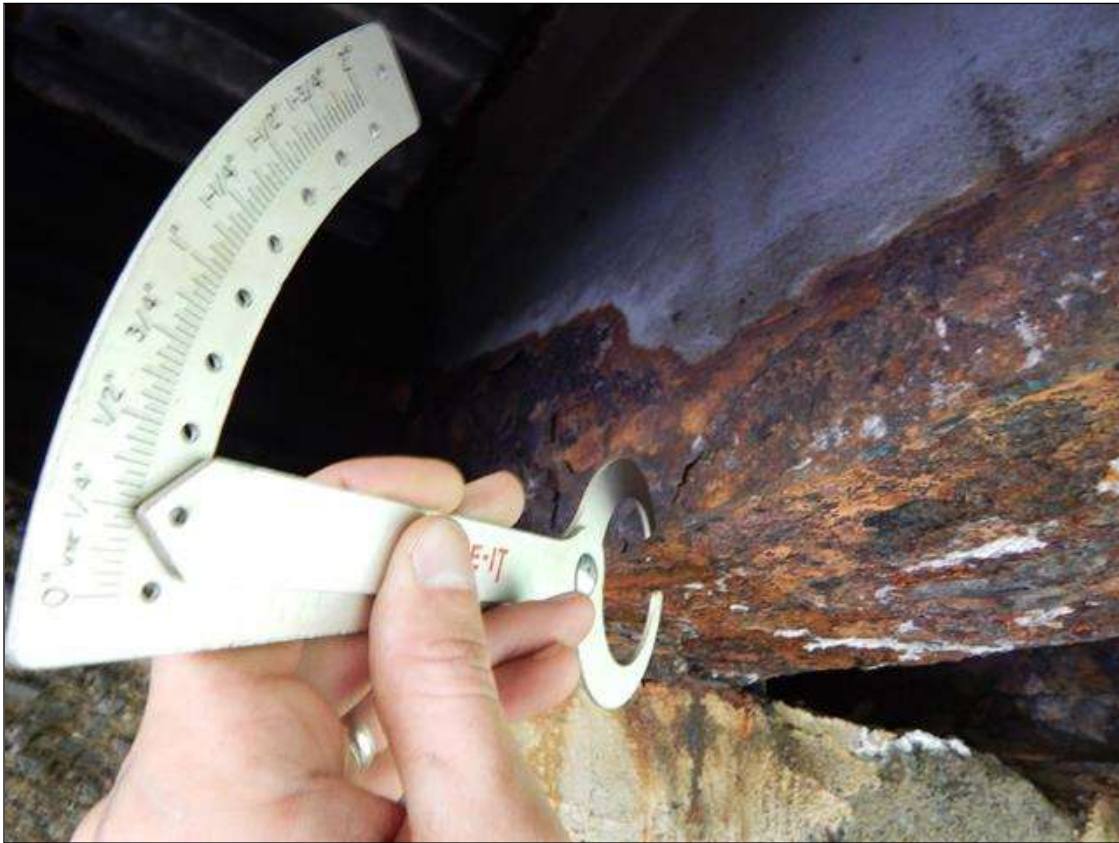
BEAM (4) CORROSION AT ABUT. (A) BEAM END (+/- 10 LF) ALONG TOP AND BOTTOM FLANGES WITH (1/4") AVG REMAINING AND (1/4") LOSS OF SECTION.

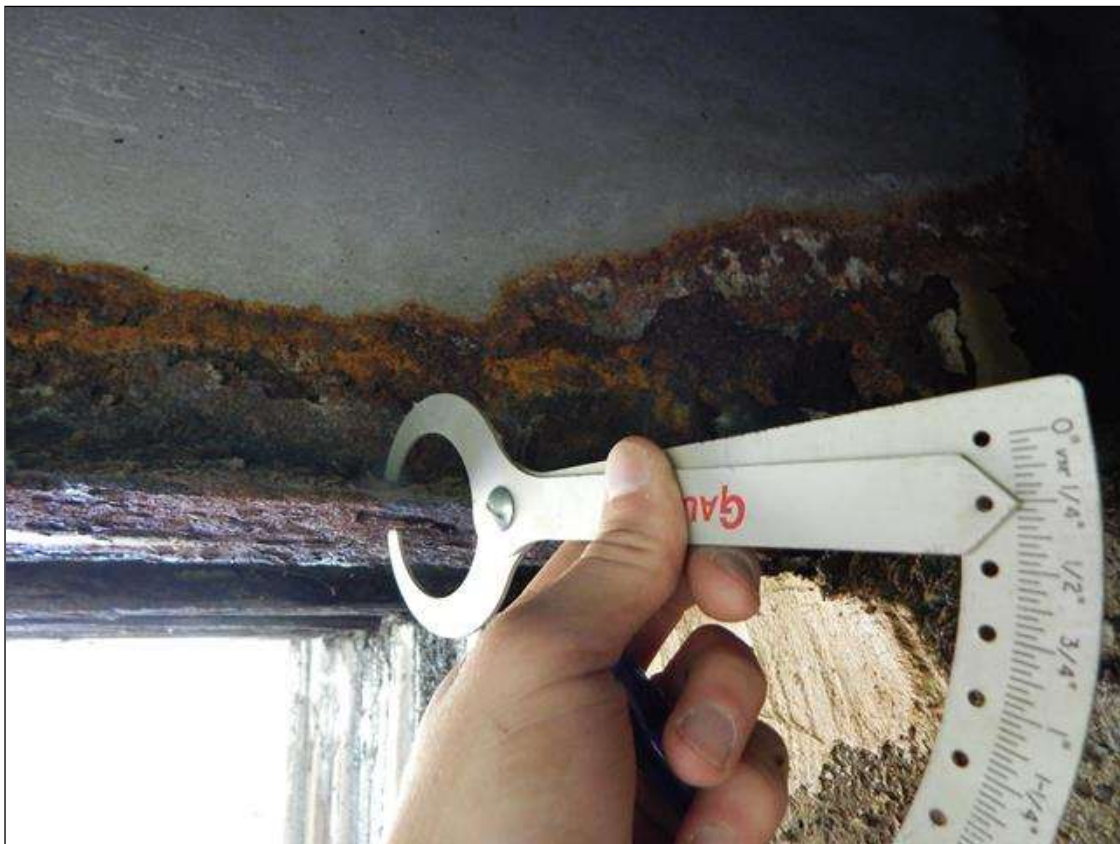
BEAM (5) CORROSION AT ABUT. (A) BEAM END (+/- 15 LF) ALONG TOP AND BOTTOM FLANGES WITH (1/4") AVG REMAINING AND (1/4") LOSS OF SECTION.

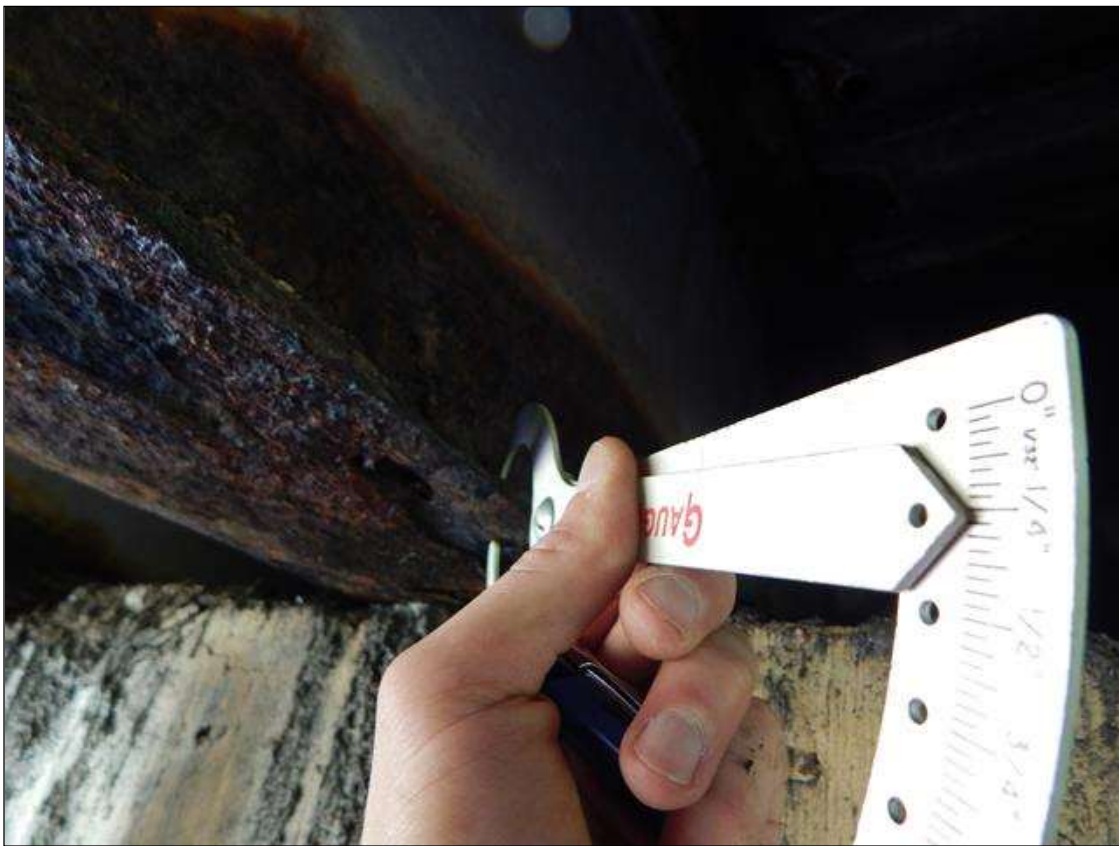
BEAM (6) CORROSION AT ABUT. (A) BEAM END (+/- 9 LF) ALONG TOP AND BOTTOM FLANGES WITH (1/4") AVG REMAINING AND (1/4") LOSS OF SECTION.

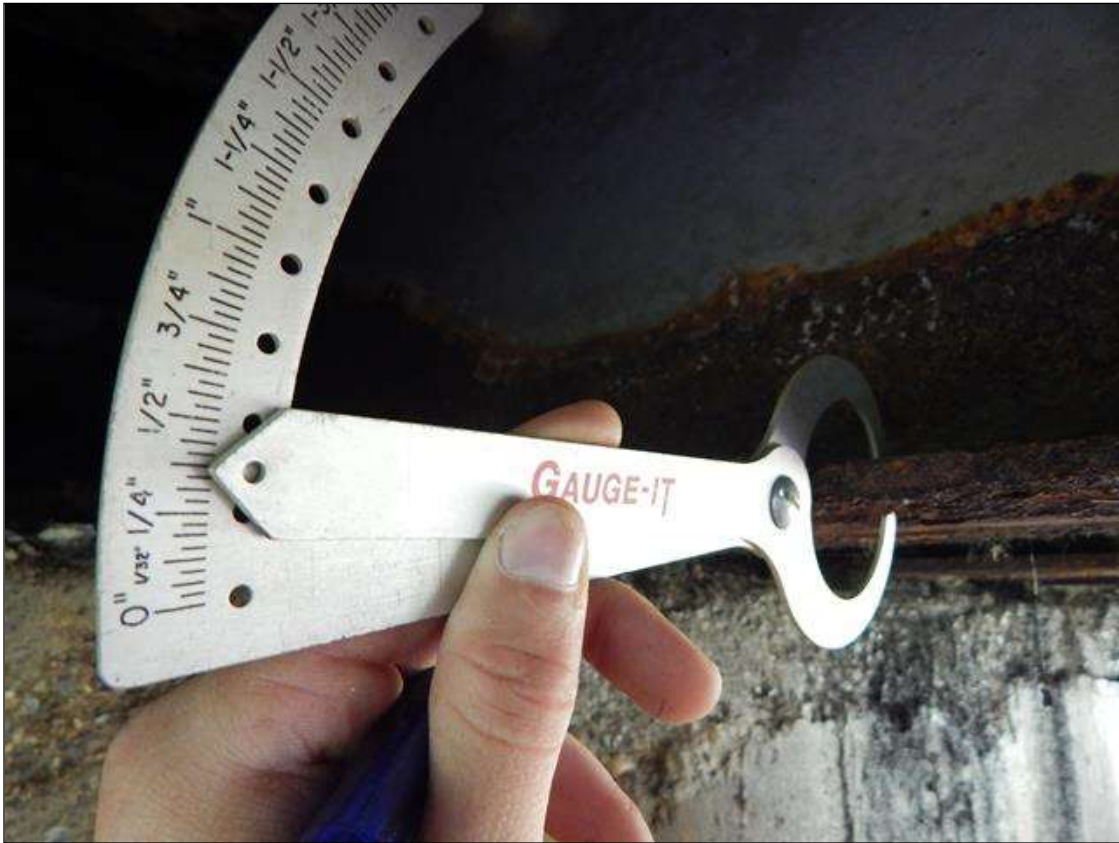
BEAM (6) CORROSION AT ABUT. (B) BEAM END (+/- 6 LF) ALONG TOP AND BOTTOM FLANGES WITH (3/8") AVG REMAINING AND (1/8") LOSS OF SECTION.

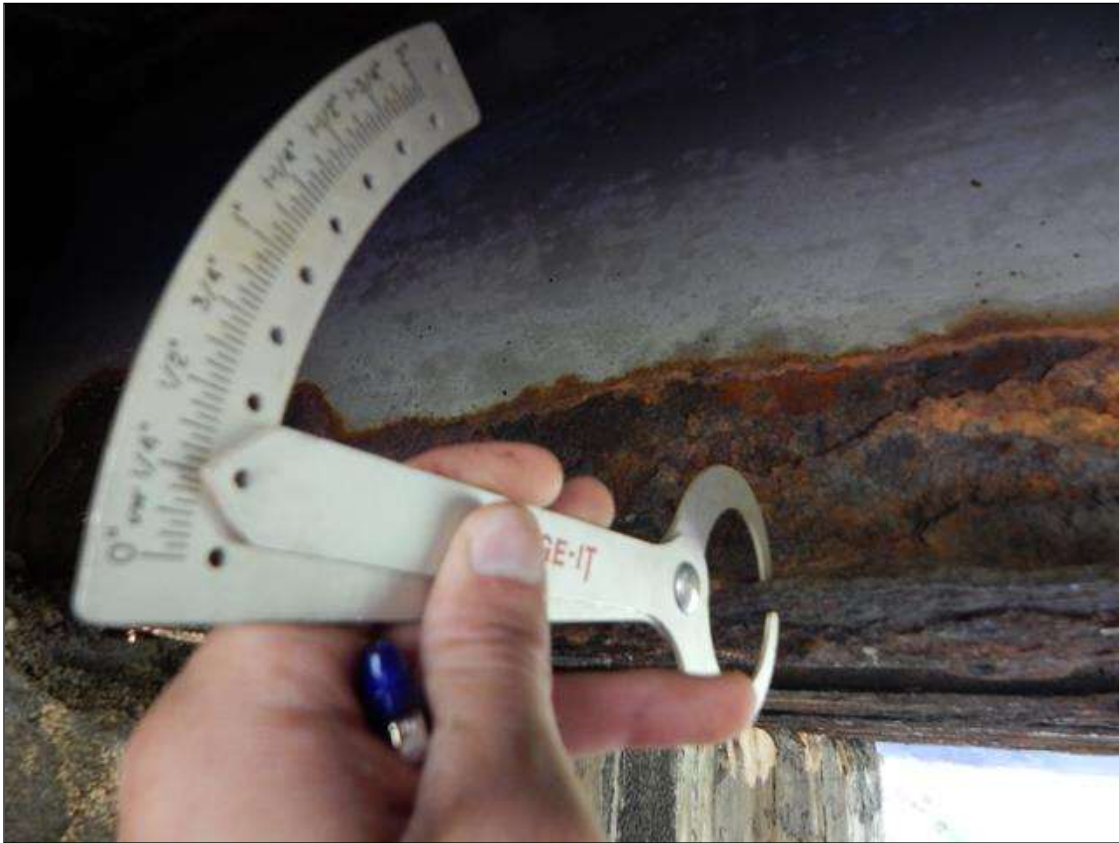
BEAM (7) CORROSION AT ABUT. (A) BEAM END (+/- 9 LF) ALONG TOP AND BOTTOM FLANGES WITH (1/4") AVG REMAINING AND (1/4") LOSS OF SECTION.

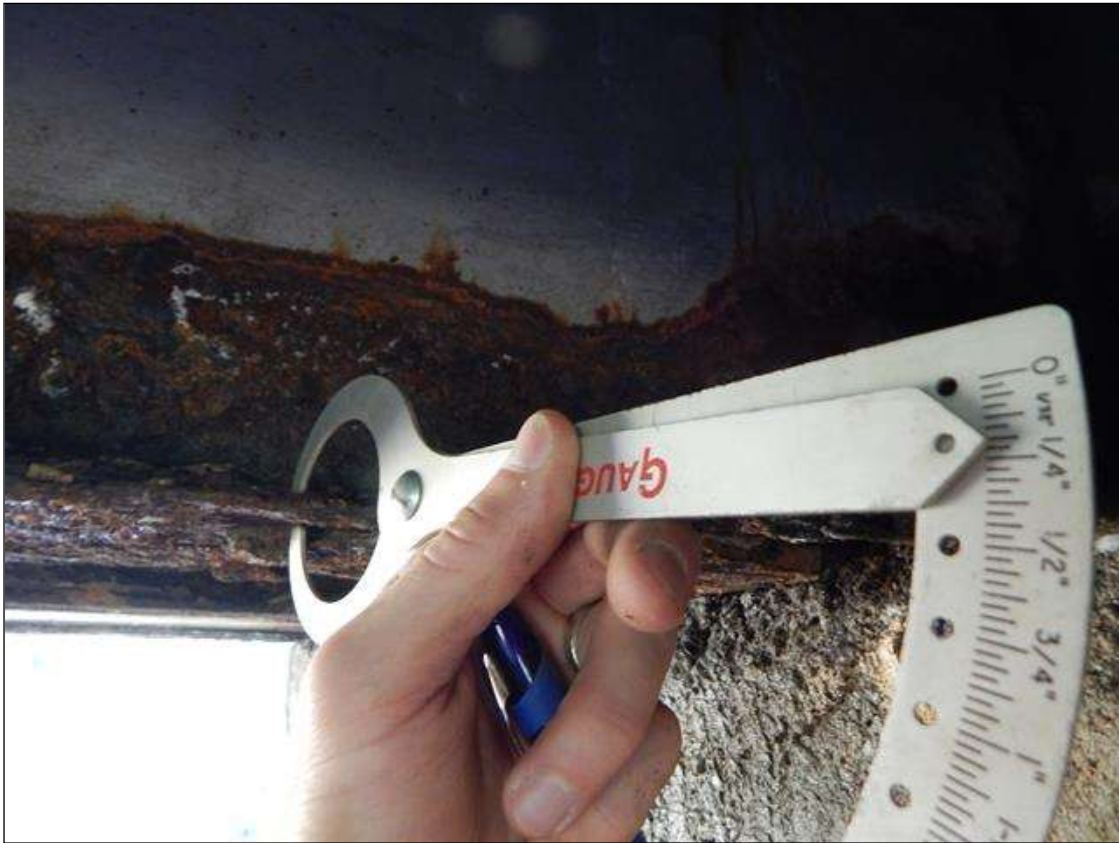
BEAM (8) CORROSION AT ABUT. (A) BEAM END (+/- 15 LF) ALONG TOP AND BOTTOM FLANGES WITH (3/16") AVG REMAINING AND (5/16") LOSS OF SECTION.

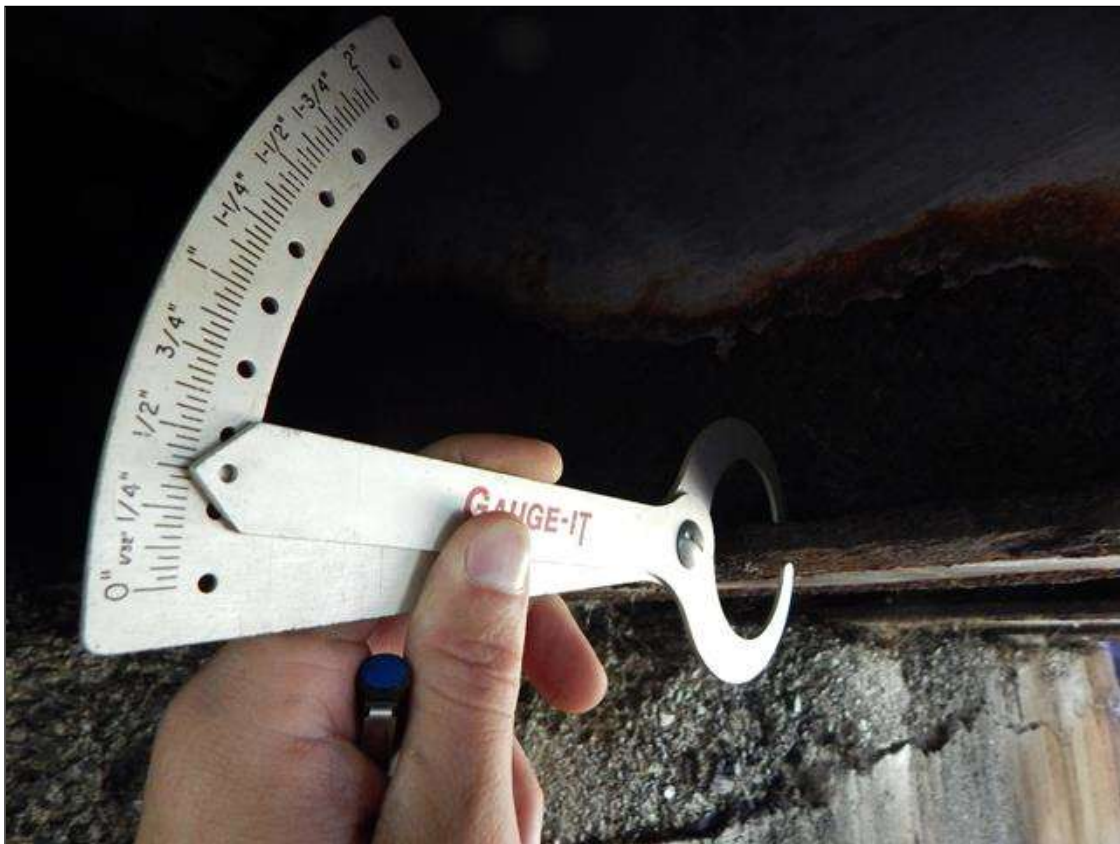
BEAM (8) CORROSION AT ABUT. (B) BEAM END (+/- 7 LF) ALONG TOP AND BOTTOM FLANGES WITH (3/8") AVG REMAINING AND (1/8") LOSS OF SECTION.

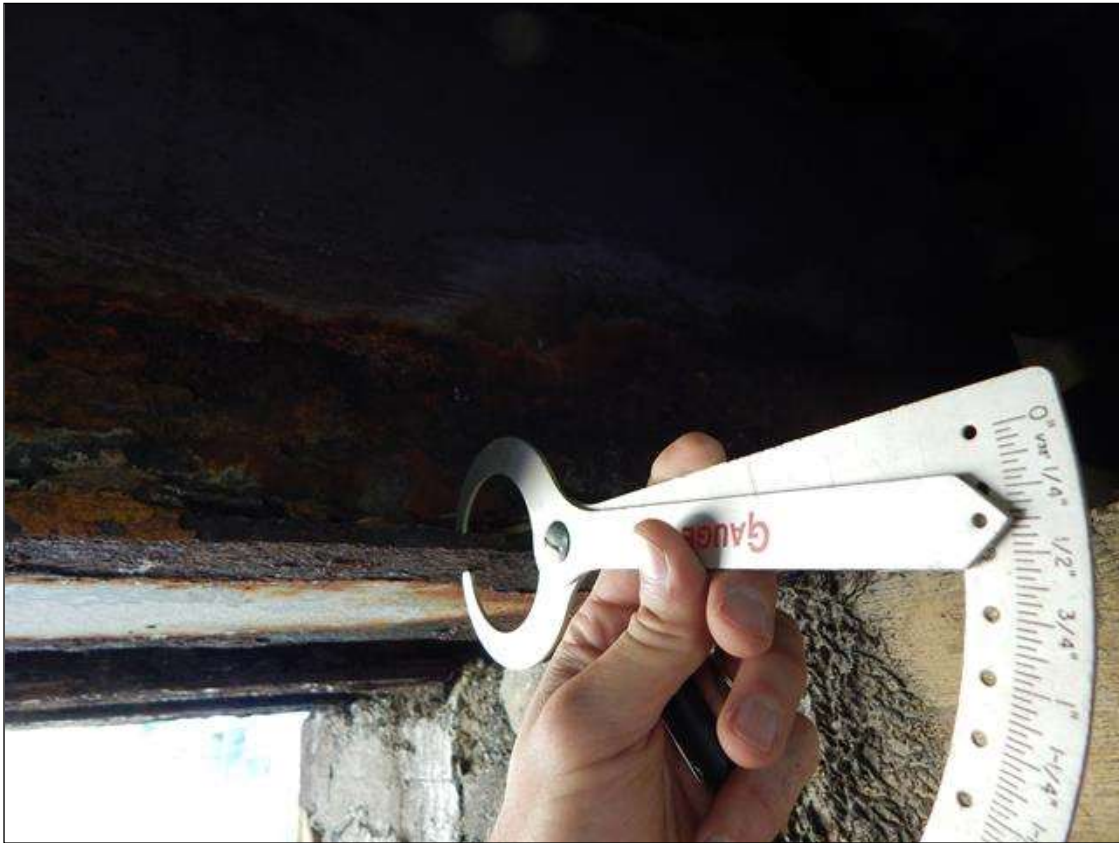
BEAM (9) CORROSION AT ABUT. (A) BEAM END (+/- 12 LF) ALONG TOP AND BOTTOM FLANGES WITH (3/8") AVG REMAINING AND (1/8") LOSS OF SECTION.

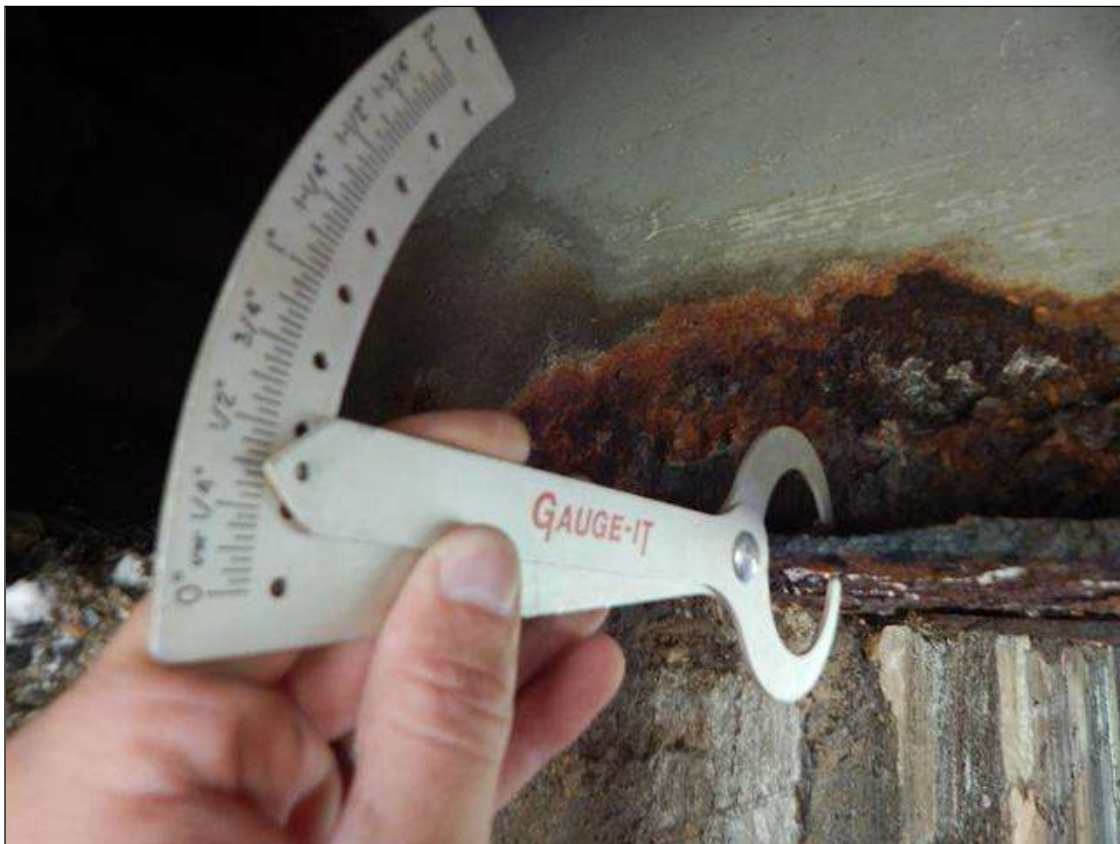
BEAM (10) CORROSION F/L ALONG TOP AND BOTTOM FLANGES WITH (3/8") AVG REMAINING AND (1/8") LOSS OF SECTION.
