NC DEPARTMENT OF TRANSPORTATION  
DIVISION OF HIGHWAYS  
STRUCTURE MANAGEMENT UNIT

## Structure Safety Report

### Routine Element Inspection

COUNTY: ASHE STRUCTURE NUMBER: 040023 FREQUENCY: 24 MONTHS  
FACILITY CARRIED: NC194 MILE POST: \_\_\_\_\_  
LOCATION: 100 FT.S.JCT.SR1353  
FEATURE INTERSECTED: OLD FIELD BRANCH  
LATITUDE: 36° 29' 56.6" LONGITUDE: 81° 30' 39.72"  
SUPERSTRUCTURE: STEEL PLANK FLOOR ON I-BEAMS  
SUBSTRUCTURE: REINFORCED CONCRETE ABUTMENTS  
SPANS: 1@ 33'-5"  
☐ FRACTURE CRITICAL ☐ TEMPORARY SHORING ☐ SCOUR CRITICAL ☐ SCOUR PLAN OF ACTION  
PRESENT CONDITION: Poor INSPECTION DATE: 05/12/2016  
POSTED SV: Not Posted POSTED TTST: Not Posted  
OTHER SIGNS PRESENT: NONE

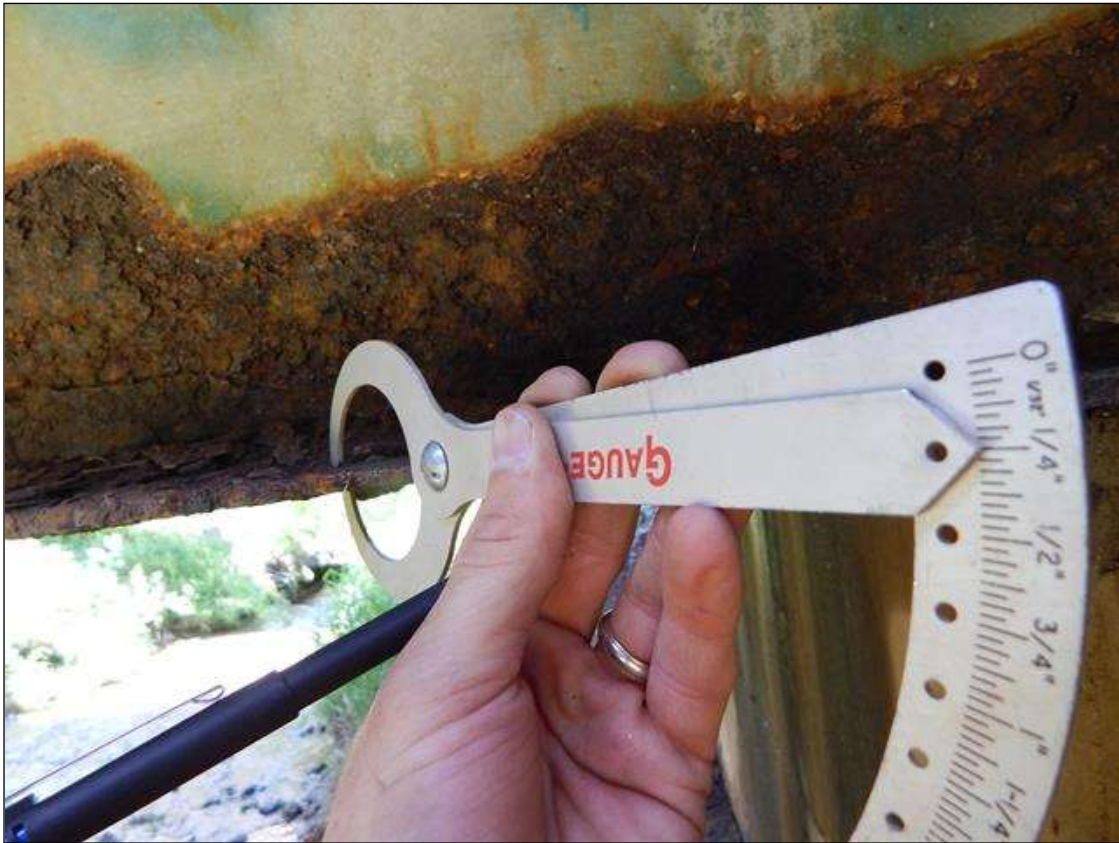
BEAM (11) CORROSION F/L ALONG TOP AND BOTTOM FLANGES WITH (1/4") AVG REMAINING AND (1/4") LOSS OF SECTION.

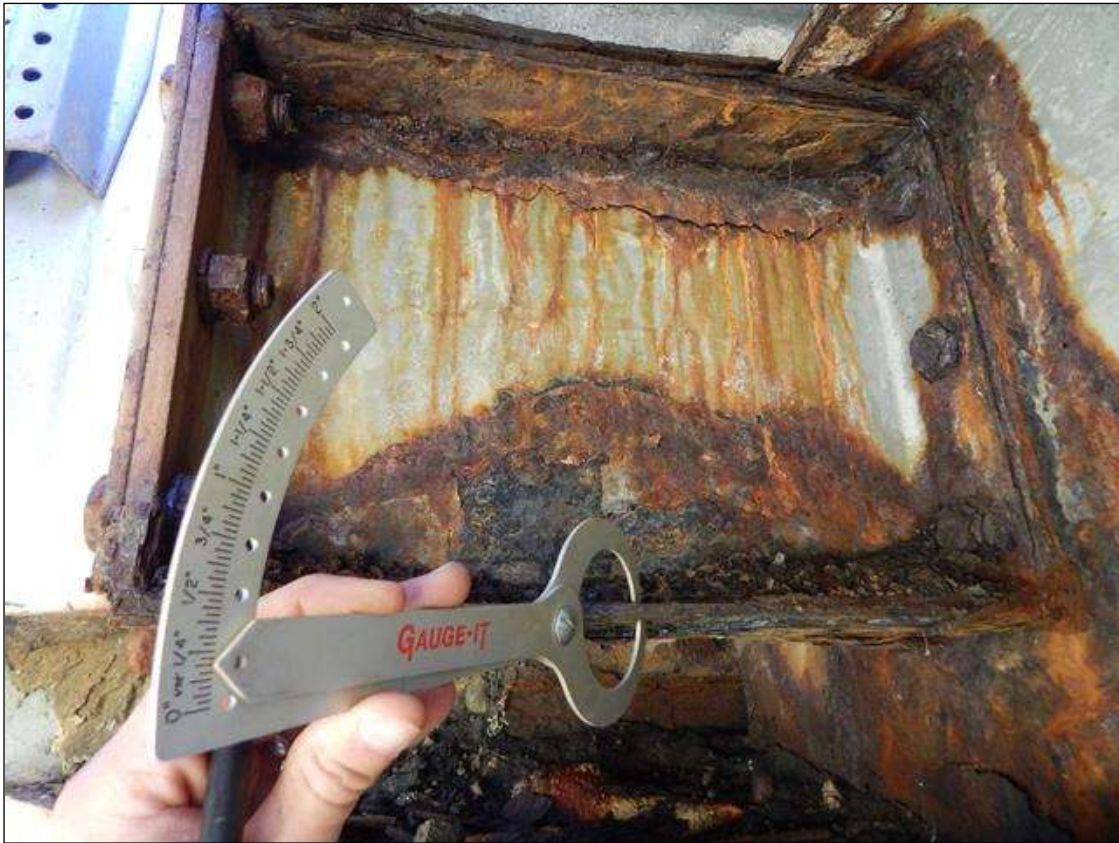
RIGHT RAIL POST BLOCK (1) CORROSION TO TOP AND BOTTOM FLANGES WITH (3/16") AVG REMAINING AND (3/16") LOSS OF SECTION.

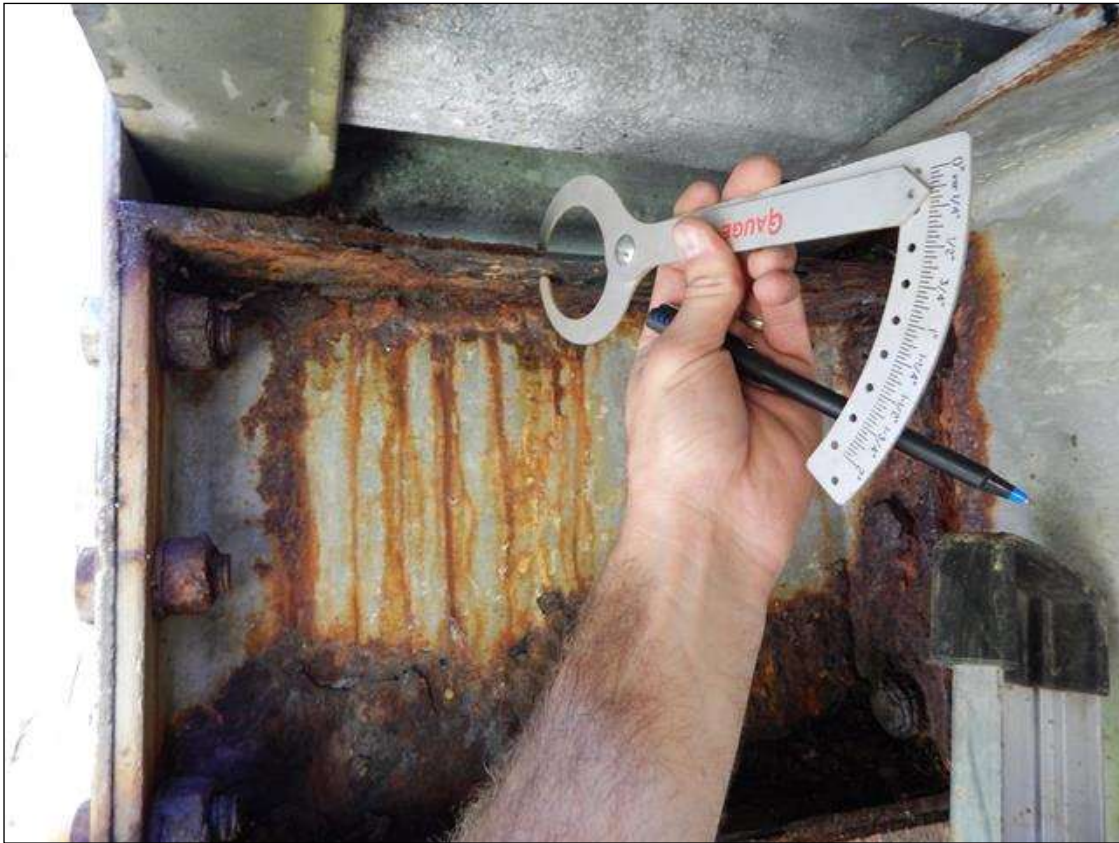
RIGHT RAIL POST BLOCK (2) CORROSION TO TOP AND BOTTOM FLANGES WITH (1/8") AVG REMAINING AND (1/4") LOSS OF SECTION. CORROSION TO WEB WITH (1/16") LOSS

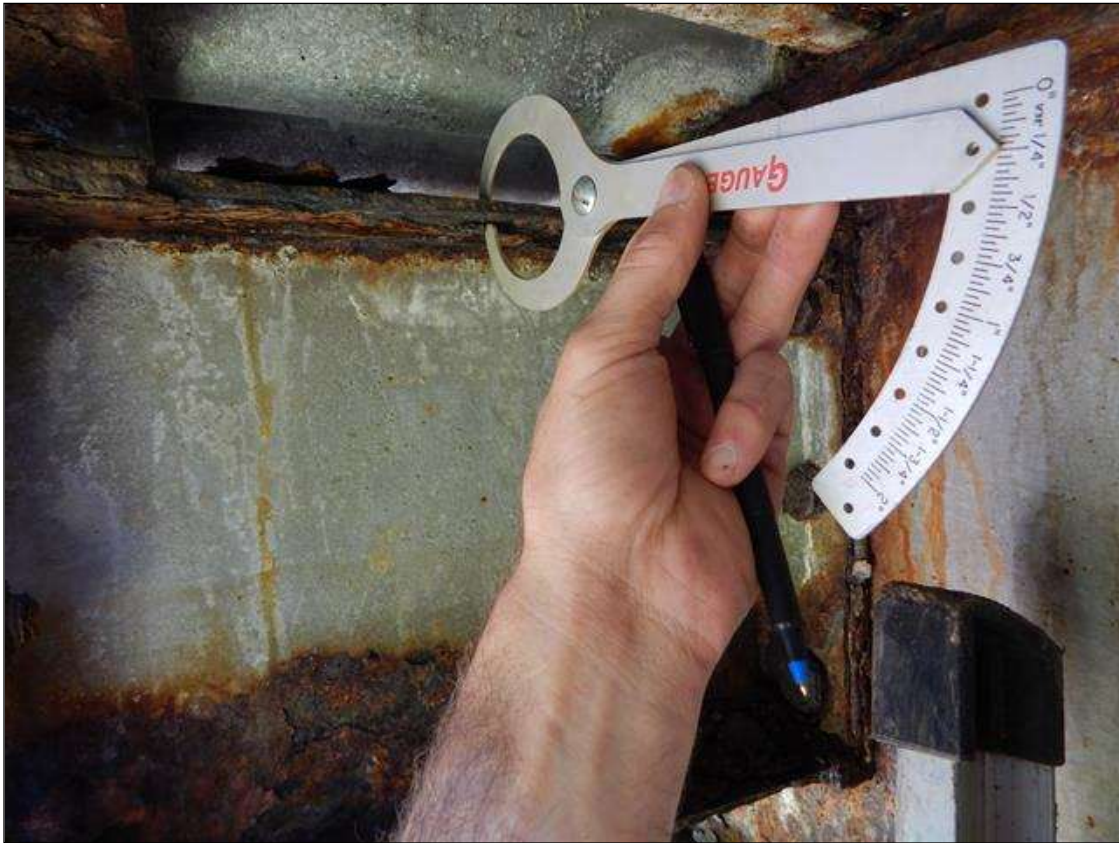
RIGHT RAIL POST BLOCK (3) CORROSION TO TOP AND BOTTOM FLANGES WITH (1/4") AVG REMAINING AND (1/8") LOSS OF SECTION. CORROSION TO WEB WITH (1/16") LOSS

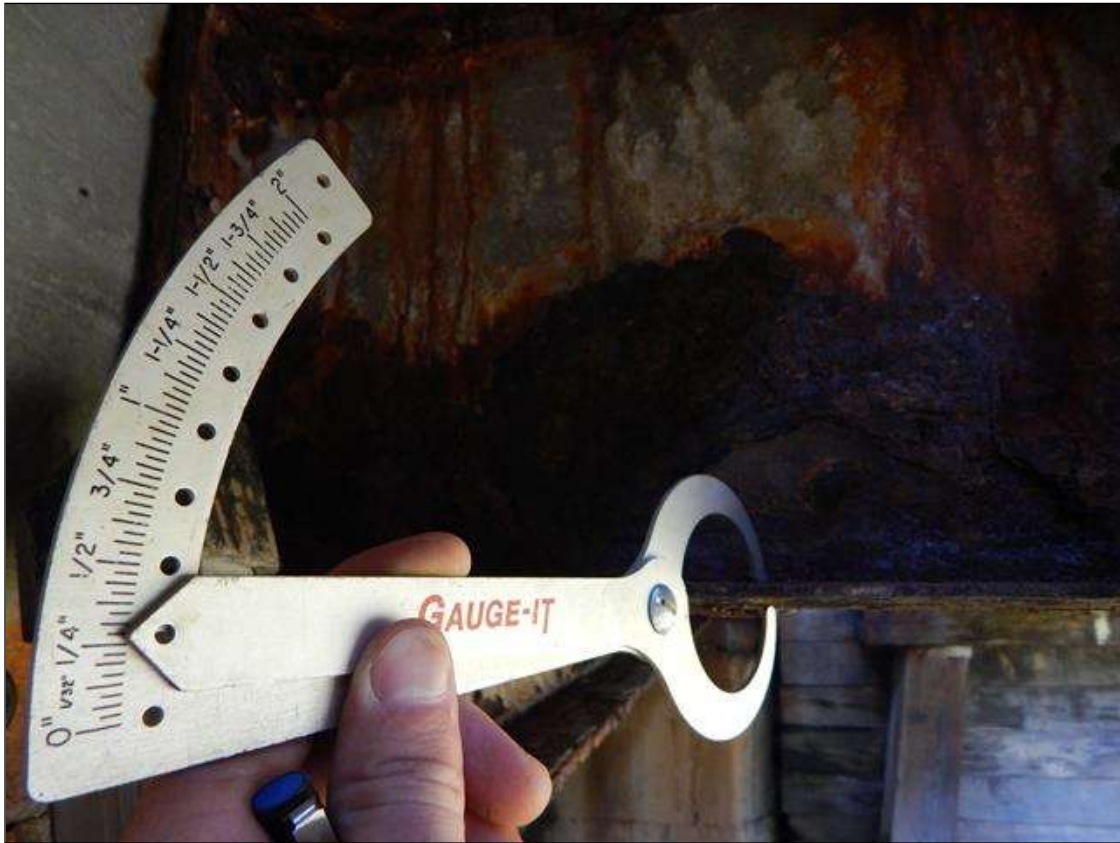
RIGHT RAIL POST BLOCK (4) CORROSION TO TOP AND BOTTOM FLANGES WITH (1/4") AVG REMAINING AND (1/8") LOSS OF SECTION. CORROSION TO WEB WITH (1/16") LOSS

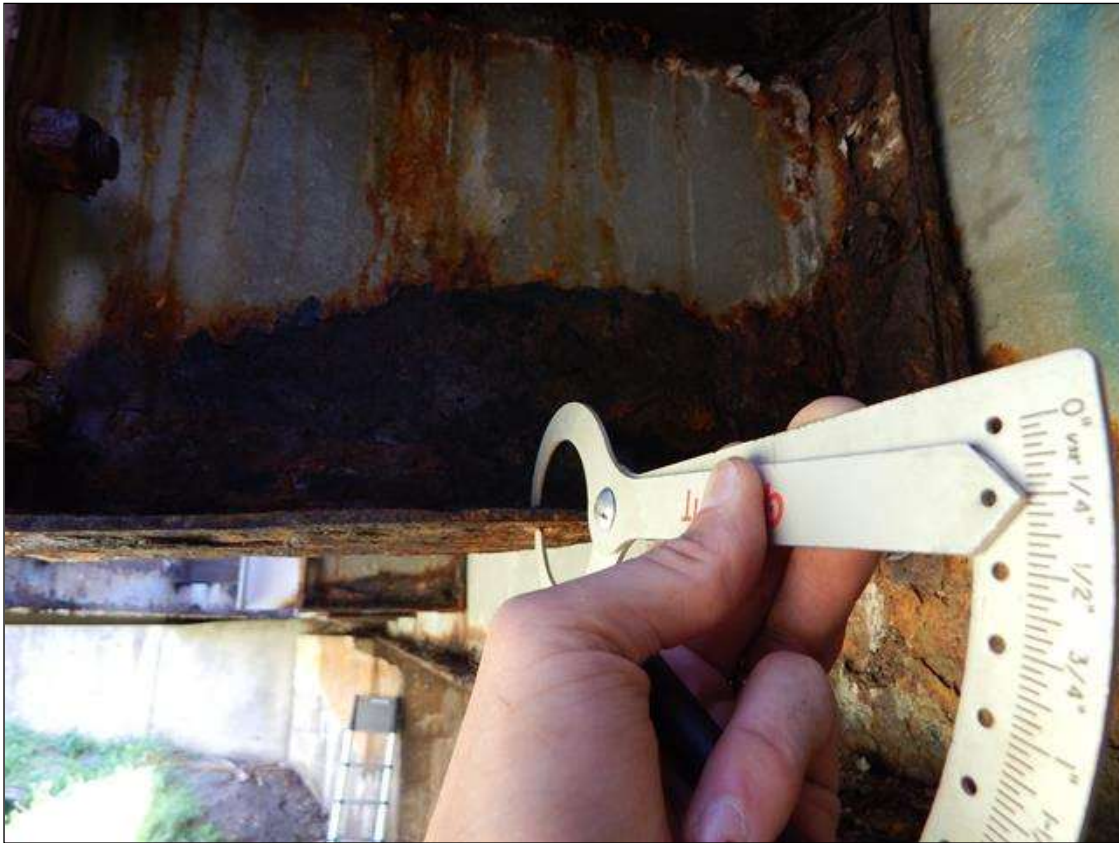
RIGHT RAIL POST BLOCK (5) CORROSION TO TOP AND BOTTOM FLANGES WITH (1/4") AVG REMAINING AND (1/8") LOSS OF SECTION. CORROSION TO WEB WITH (1/16") LOSS

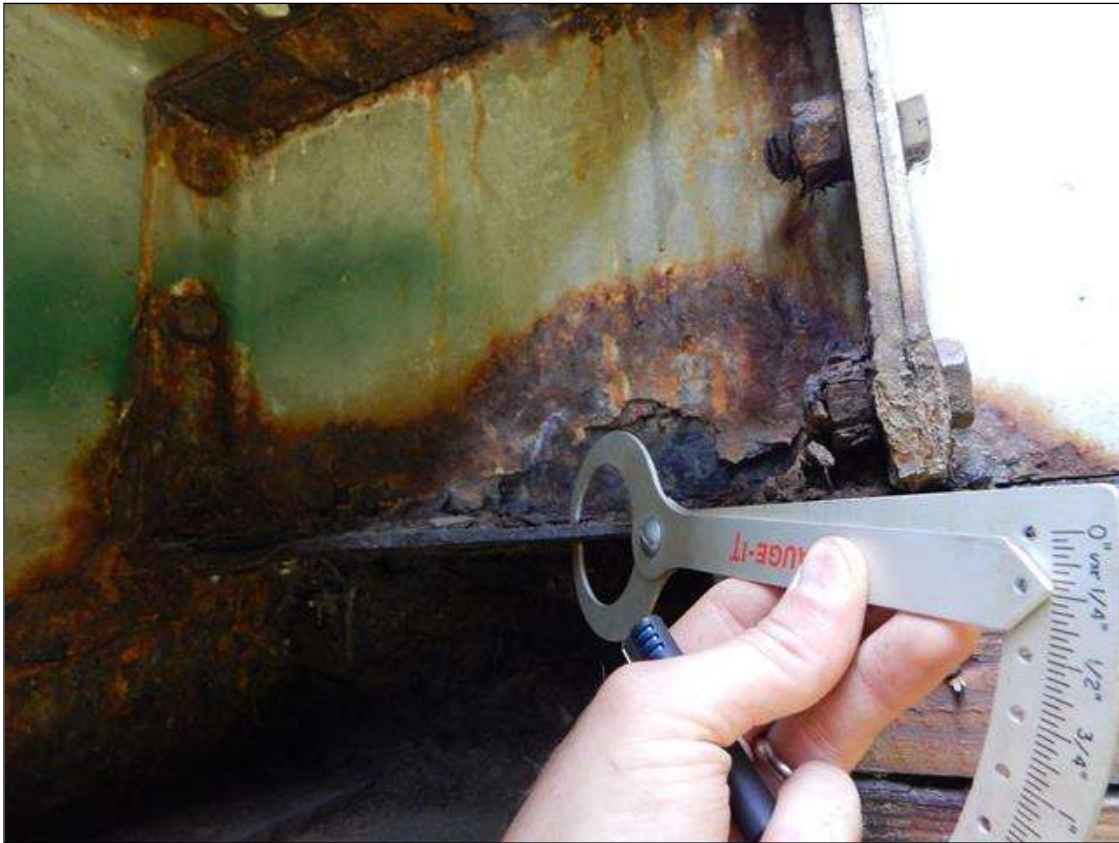
RIGHT RAIL POST BLOCK (6) CORROSION TO TOP AND BOTTOM FLANGES WITH (1/4") AVG REMAINING AND (1/8") LOSS OF SECTION. CORROSION TO WEB WITH (1/16") LOSS

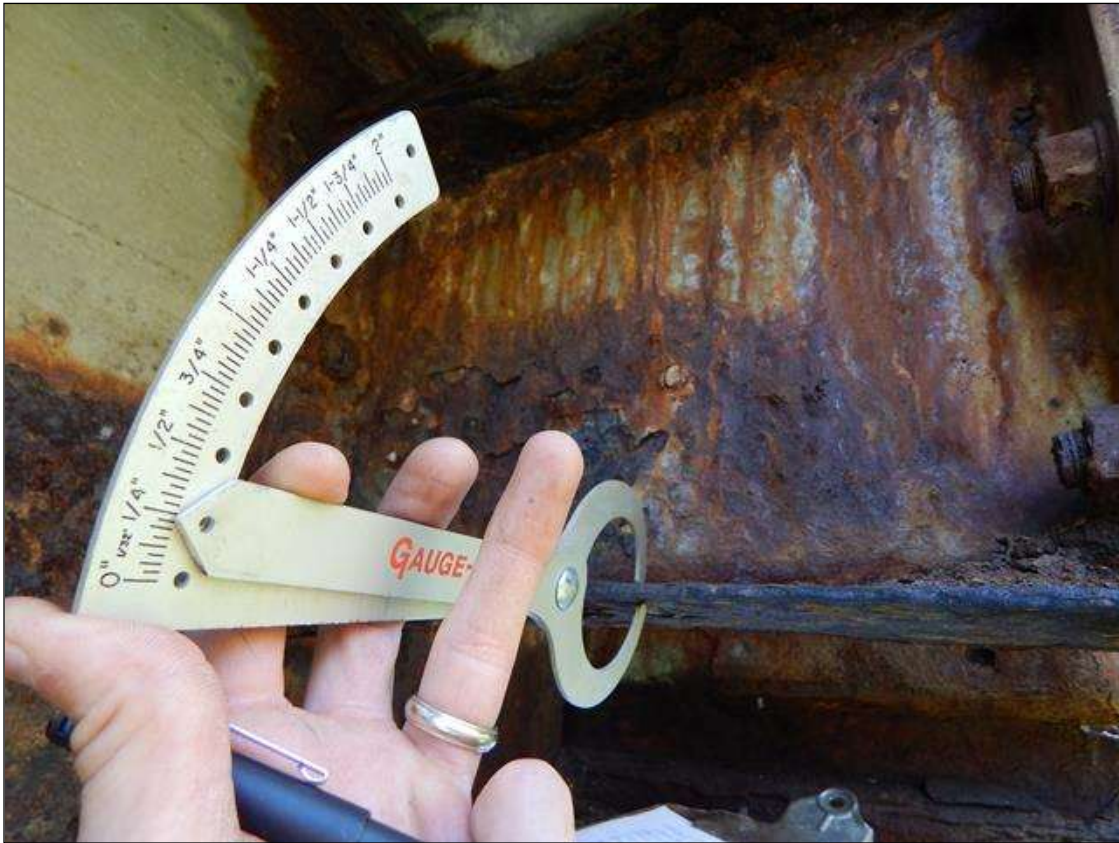
LEFT RAIL POST BLOCK (1) CORROSION TO TOP AND BOTTOM FLANGES WITH (1/4") AVG REMAINING AND (1/8") LOSS OF SECTION. CORROSION TO WEB WITH (1/16") LOSS

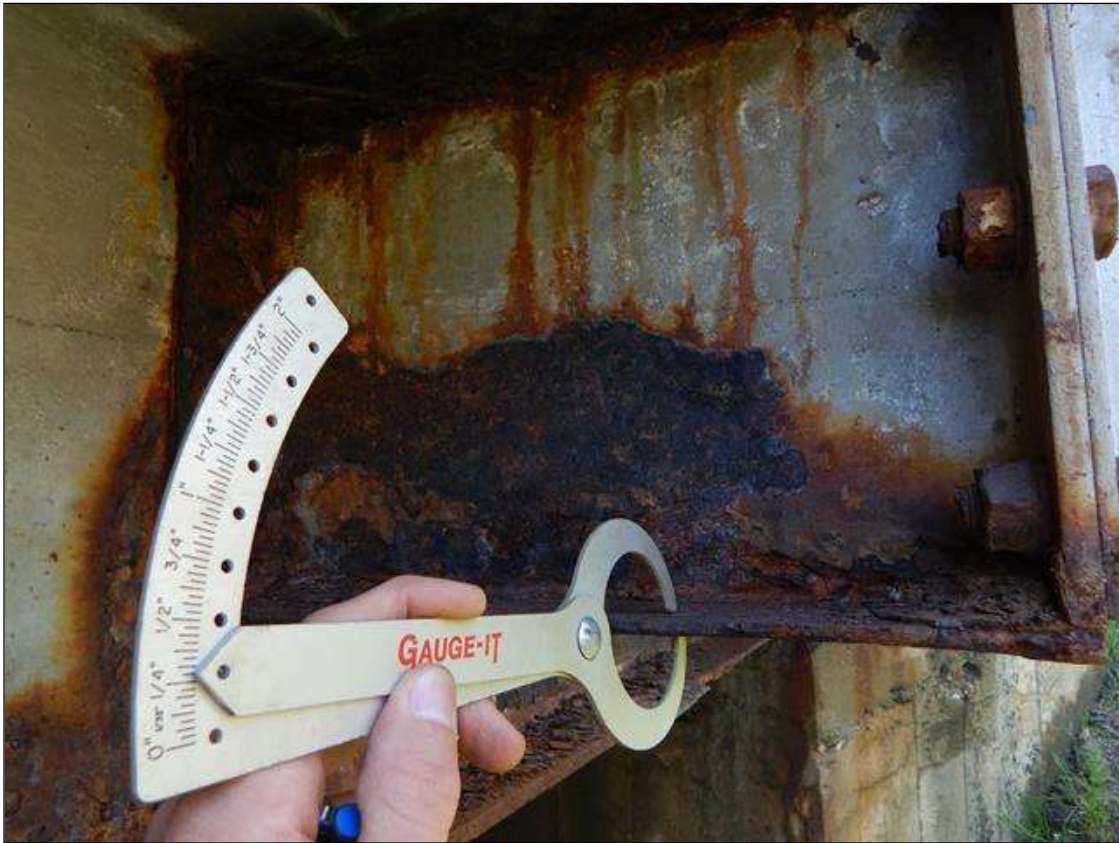
LEFT RAIL POST BLOCK (2) CORROSION TO TOP AND BOTTOM FLANGES WITH (1/4") AVG REMAINING AND (1/8") LOSS OF SECTION. CORROSION TO WEB WITH (1/16") LOSS

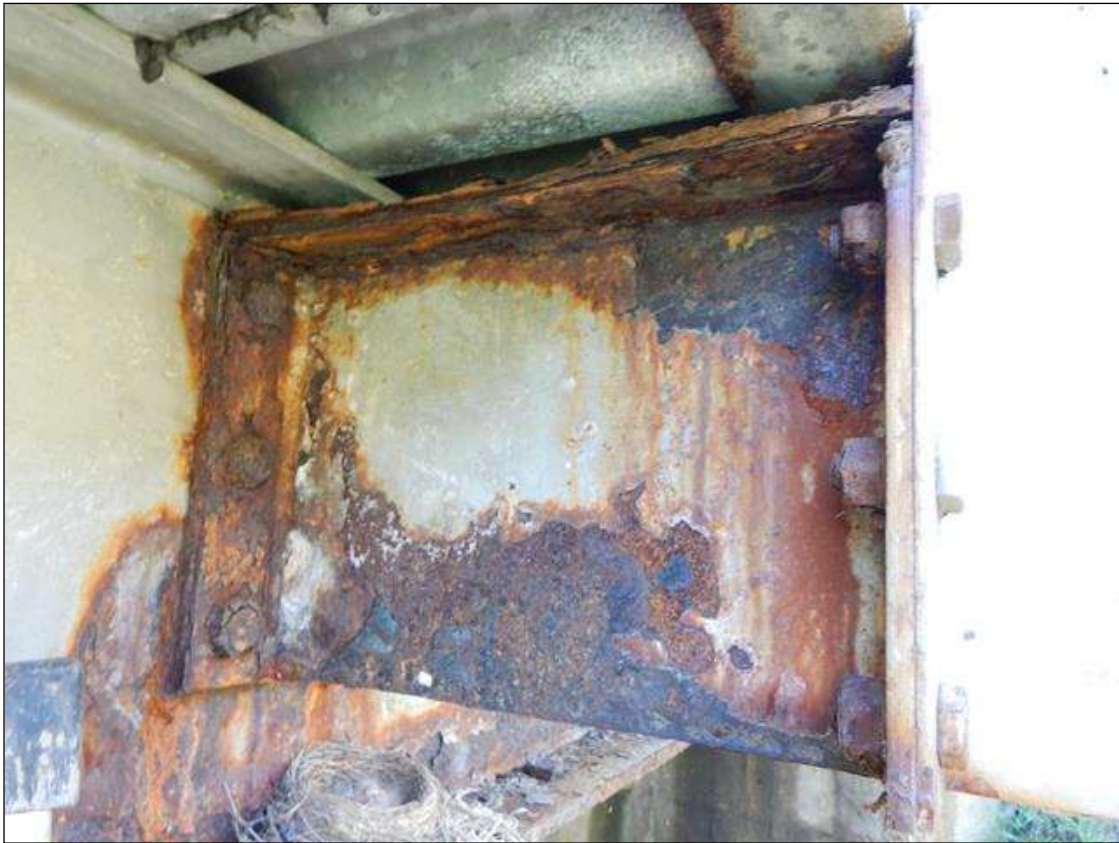
LEFT RAIL POST BLOCK (3) CORROSION TO TOP FLANGES WITH (1/4") AVG REMAINING AND (1/8") LOSS OF SECTION. CORROSION TO WEB WITH (1/16") LOSS

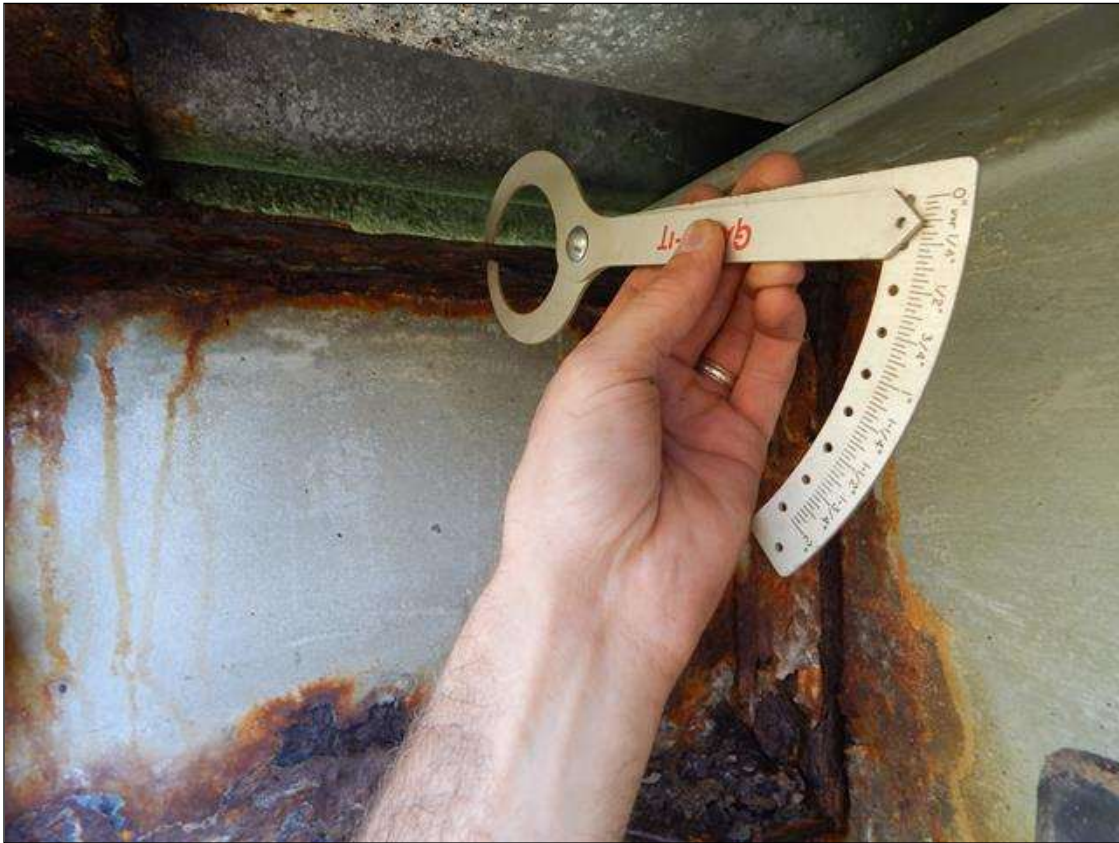
LEFT RAIL POST BLOCK (4) CORROSION TO TOP AND BOTTOM FLANGES WITH (1/8") AVG REMAINING AND (1/4") LOSS OF SECTION. CORROSION TO WEB WITH (1/16") LOSS

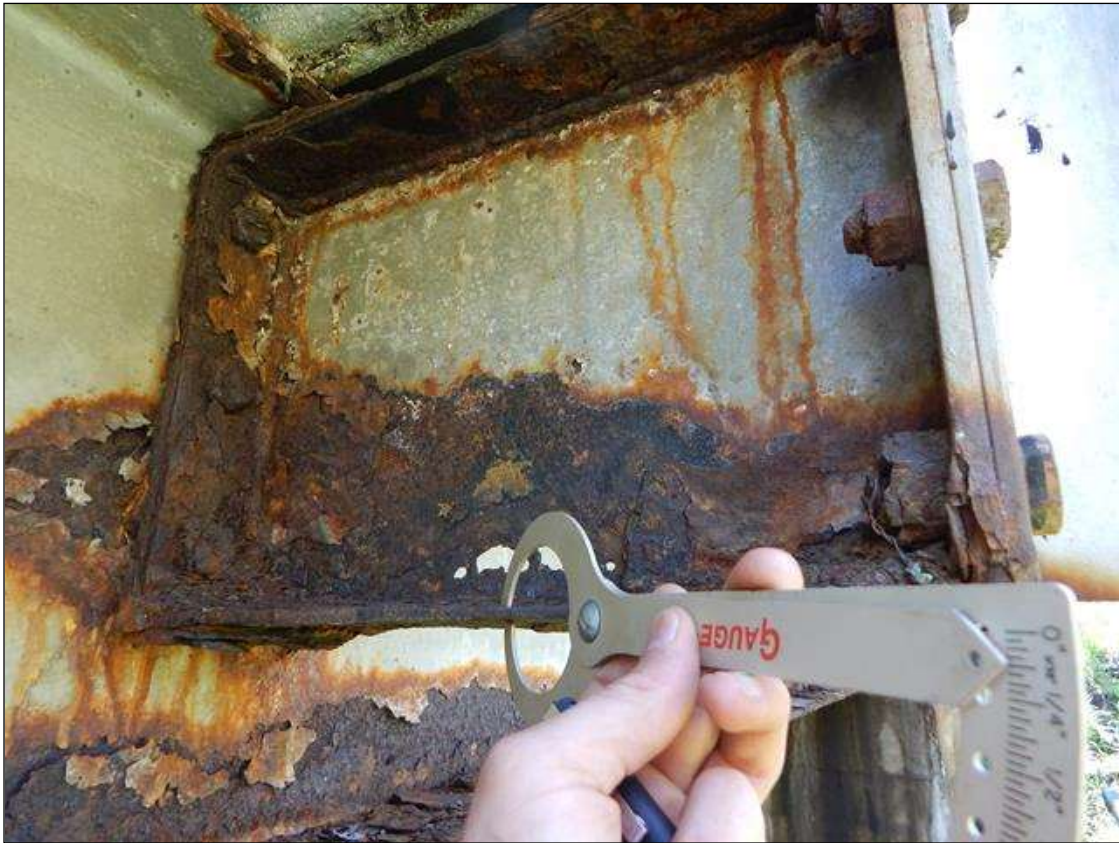
LEFT RAIL POST BLOCK (5) CORROSION TO TOP AND BOTTOM FLANGES WITH (1/8") AVG REMAINING AND (1/4") LOSS OF SECTION. CORROSION TO WEB WITH (1/16") LOSS.

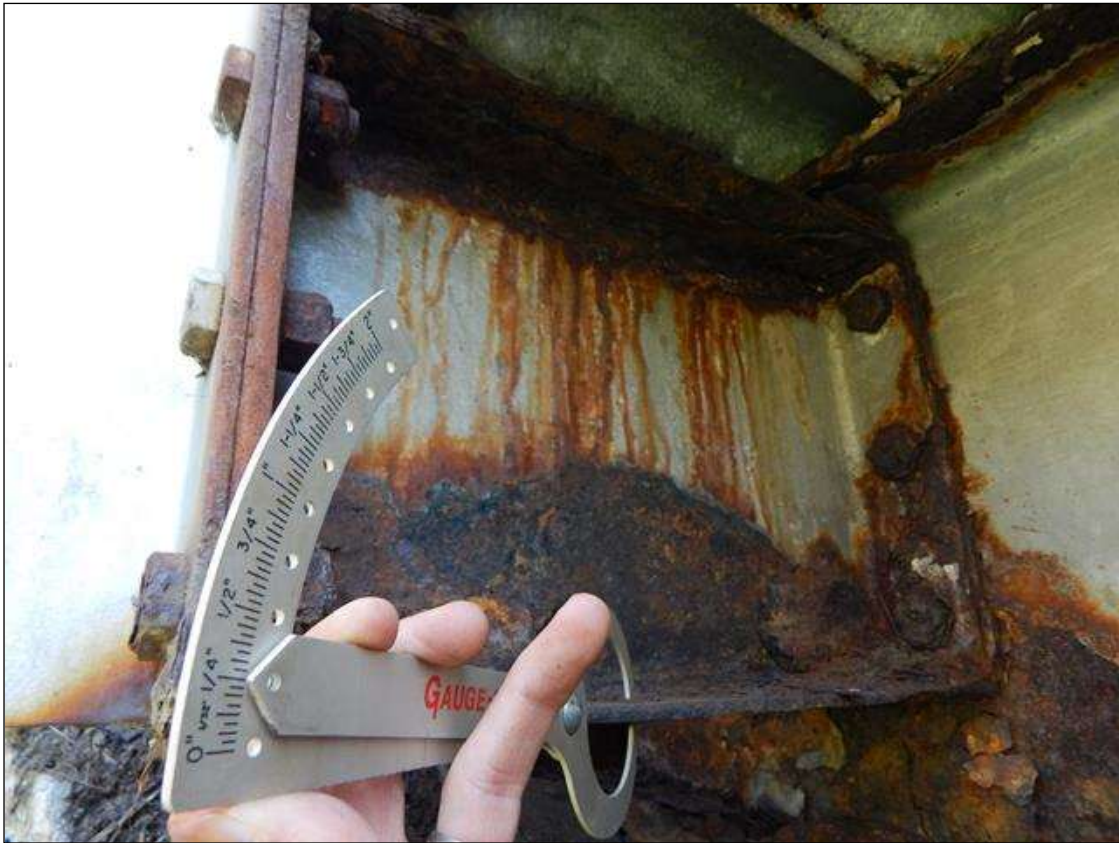
LEFT RAIL POST BLOCK (6) CORROSION TO TOP AND BOTTOM FLANGES WITH (1/4") AVG REMAINING AND (1/8") LOSS OF SECTION. CORROSION TO WEB WITH (1/16") LOSS
