NC DEPARTMENT OF TRANSPORTATION  
DIVISION OF HIGHWAYS  
STRUCTURE MANAGEMENT UNIT

## Structure Safety Report

### Routine Element Inspection

COUNTY: WATAUGA STRUCTURE NUMBER: 940278 FREQUENCY: 24 MONTHS  
FACILITY CARRIED: SR1540 MILE POST: \_\_\_\_\_  
LOCATION: 25 FT.W.JCT.US221,321  
FEATURE INTERSECTED: CREEK  
LATITUDE: 36° 10' 9.1" LONGITUDE: 81° 38' 47.88"  
SUPERSTRUCTURE: TIMBER FLOOR ON I-BEAMS

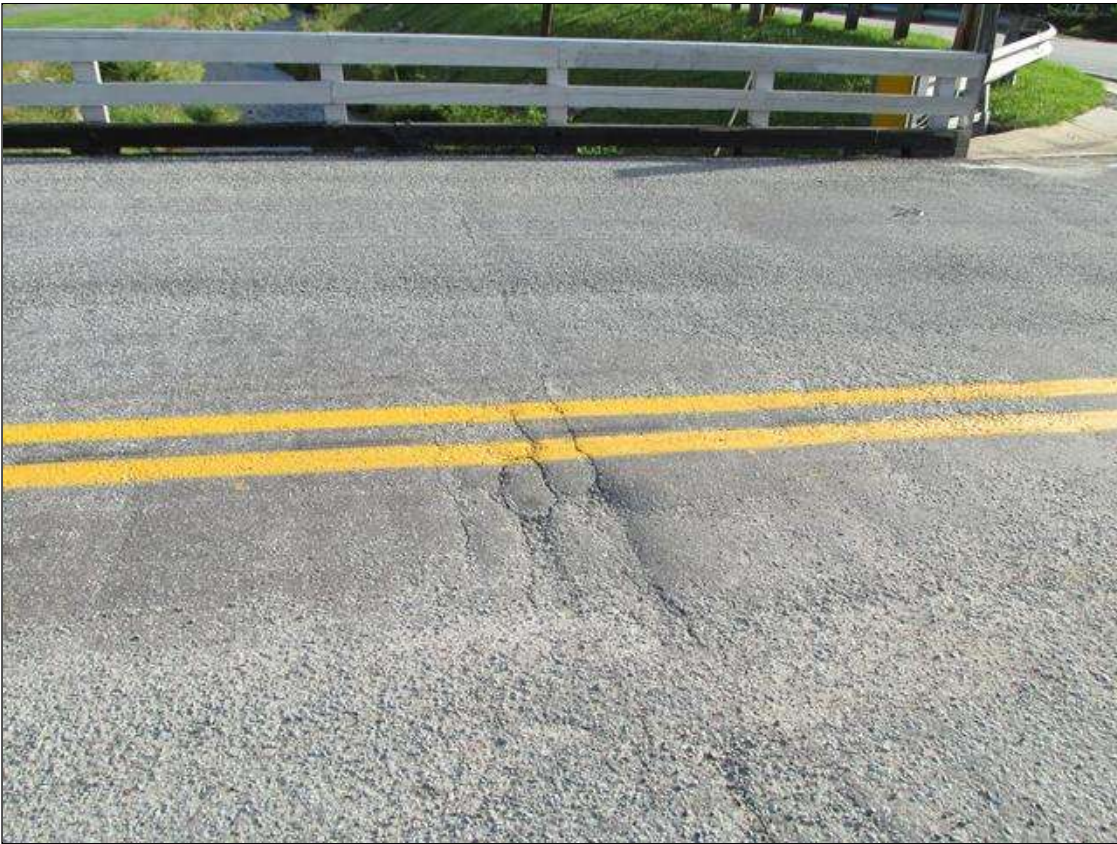
672 Square Feet of Crack (Wearing Surface): Width of more than 0.05 in. or spacing of less than 1.0 ft. TRANSVERSE CRACKS ALONG DECK BOARDS

Span 1 Wearing Surface: 672 Square Feet of Crack (Wearing Surface): Width of more than 0.05 in. or spacing of less than 1.0 ft. TRANSVERSE CRACKS ALONG DECK BOARDS

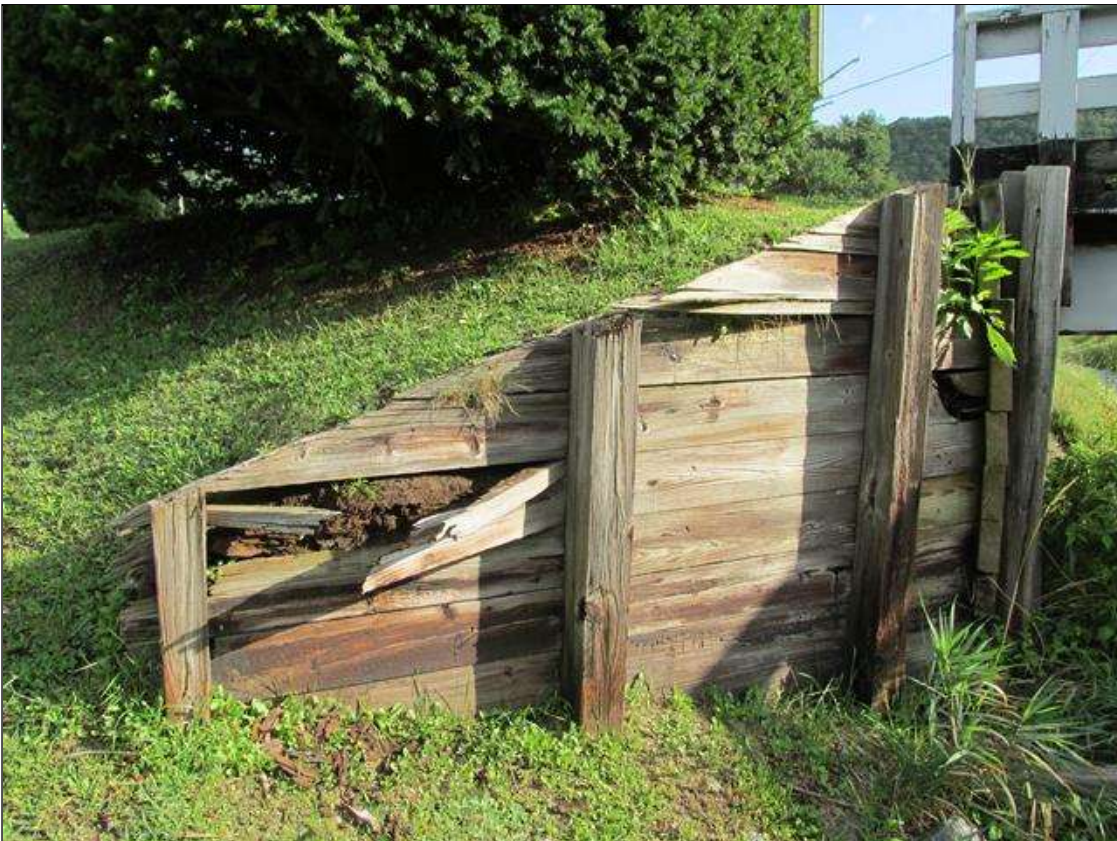
SOUTH WEST WING (5) BOARDS DECAYED WITH LOSS OF FILL (+/- 50 SF)

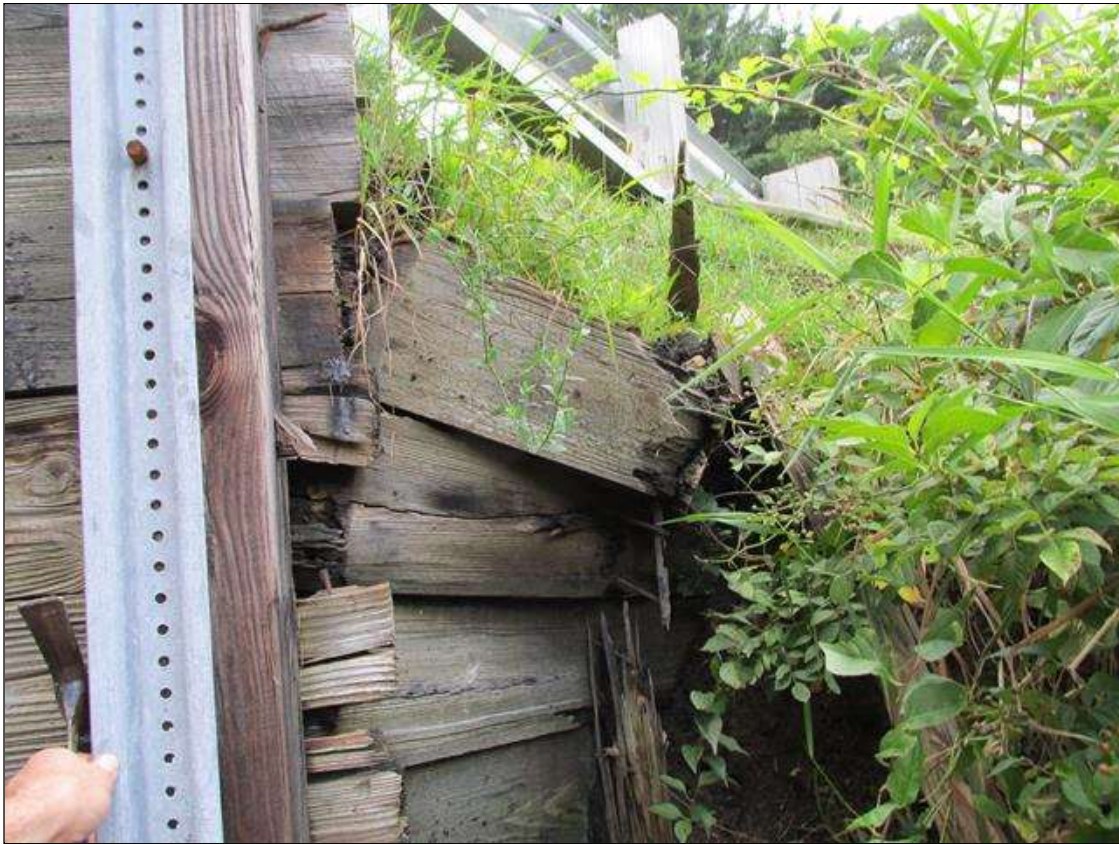
SOUTH EAST WING (5) BOARDS AND RETAINING POST DECAYED WITH LOSS OF FILL (+/- 50 SF)

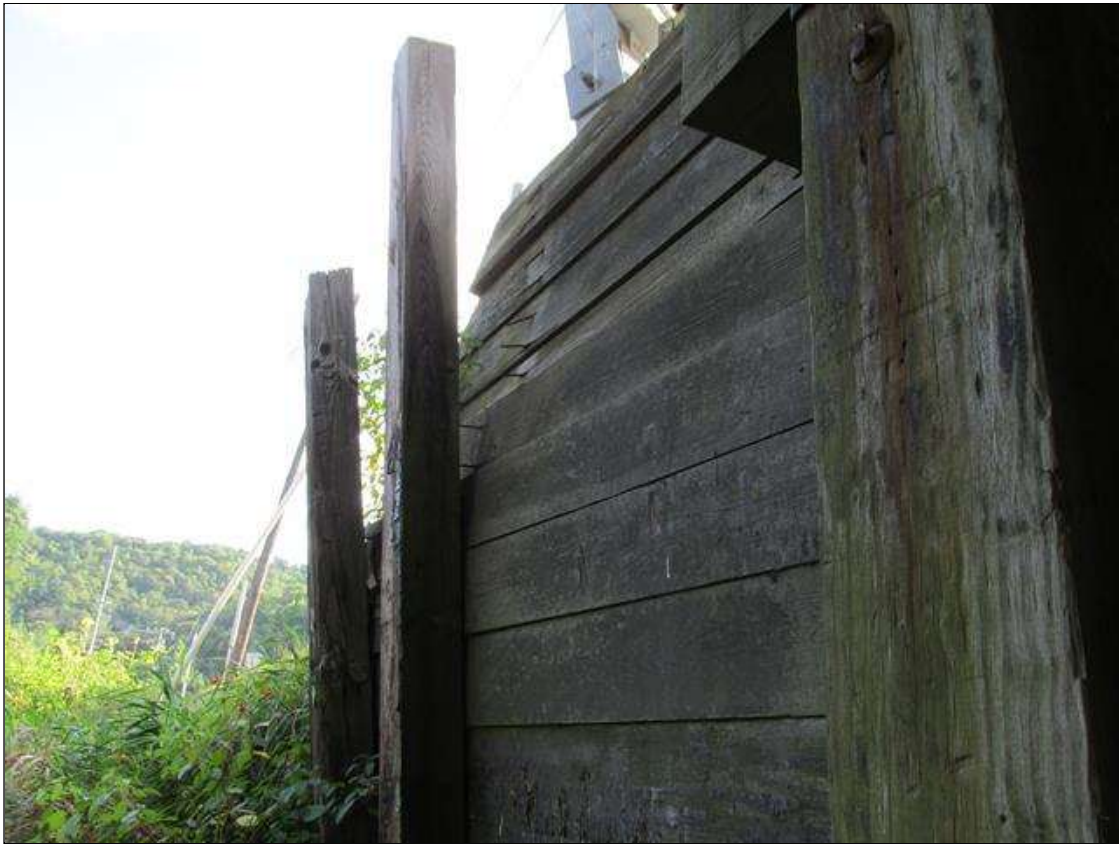
5 Feet of Decay/Section Loss: The condition warrants a structural review to determine the effect on strength or serviceability of the element or bridge; OR a structural review has been completed and the defects impact strength or serviceability of the element or bridge. LEFT END ABUT. (B) BULKHEAD (2) RETAINING POST BROKEN, DISTORTED AND PULLED AWAY FROM BULKHEAD FULL HEIGHT X 5' L.

End Bent 2 Abutment/Backwall : 5 Feet of Decay/Section Loss: The condition warrants a structural review to determine the effect on strength or serviceability of the element or bridge; OR a structural review has been completed and the defects impact strength or serviceability of the element or bridge. LEFT END ABUT. (B) BULKHEAD (2) RETAINING POST BROKEN, DISTORTED AND PULLED AWAY FROM BULKHEAD FULL HEIGHT X 5' L.

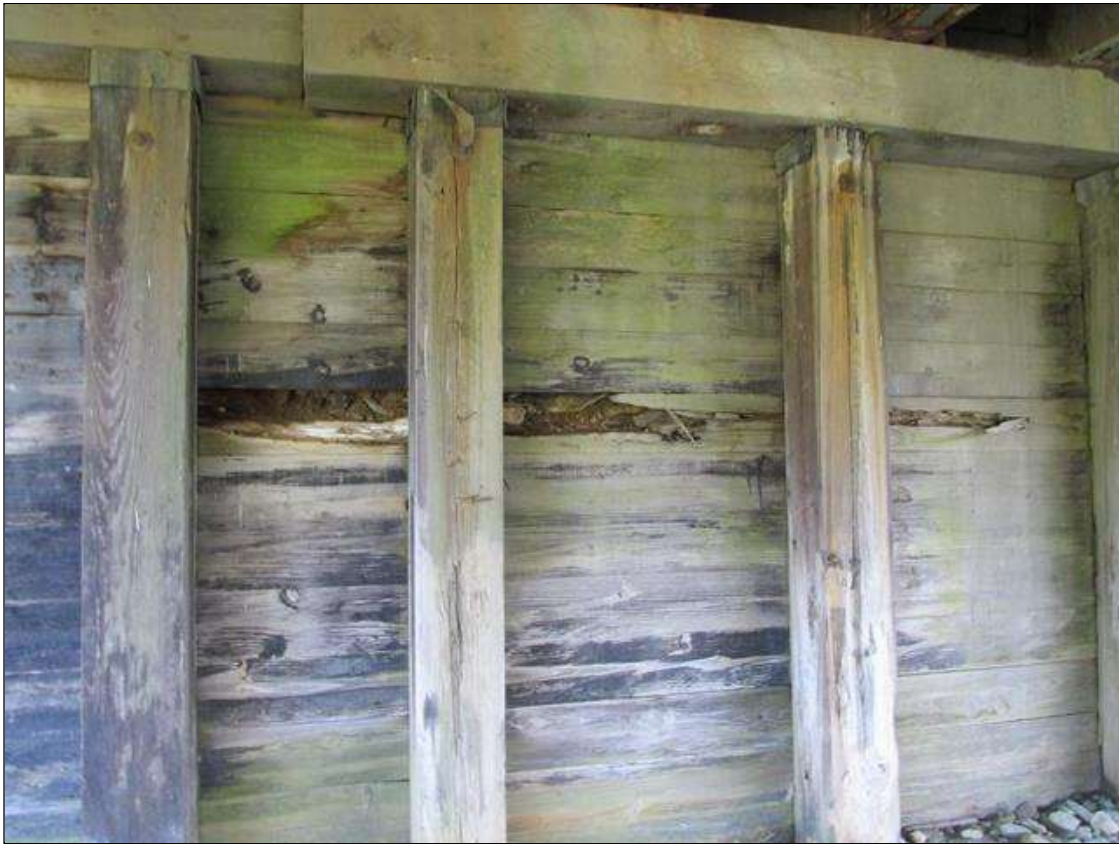
End Bent 2 Abutment/Backwall : 12 Feet of Decay/Section Loss: Affects 10% or more of the member but does not warrant structural review. ABUT. (B) (1) BOARD DECAYED (+/- 12 LF) WITH LOSS OF FILL, DECAY EXTENDS FROM POST (3 - 6)

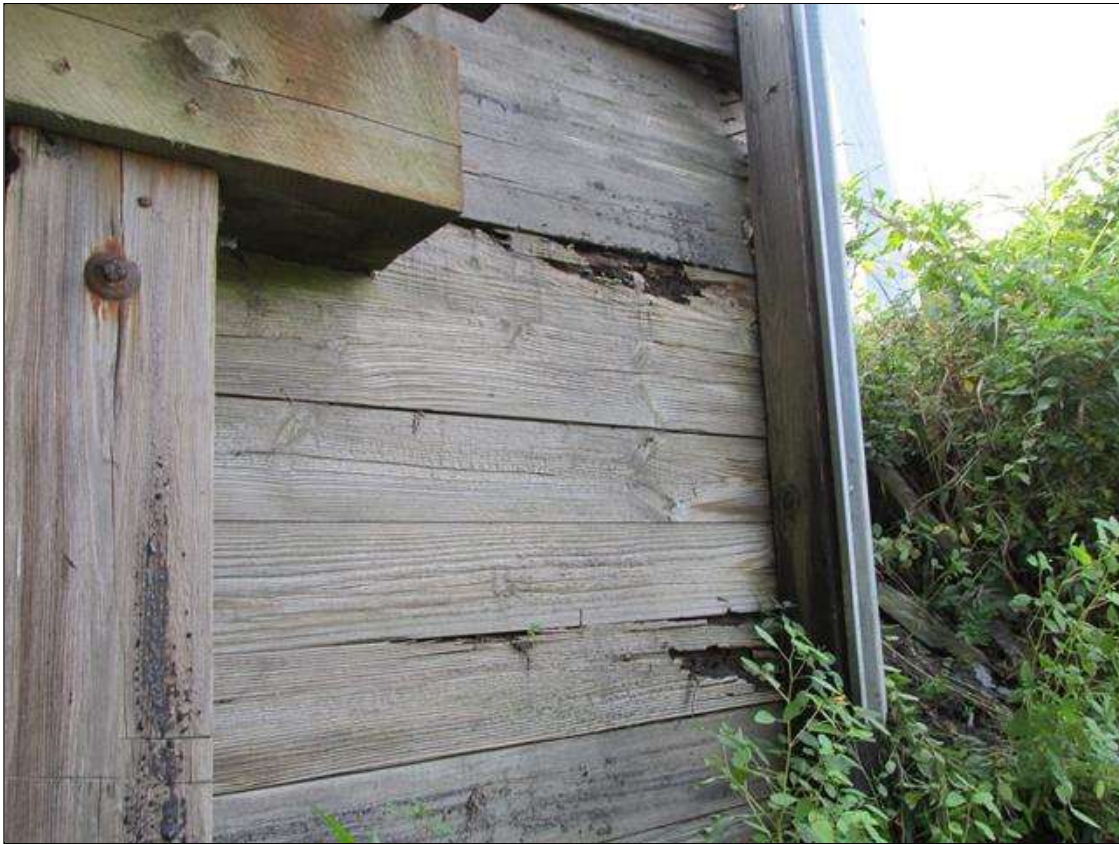
End Bent 2 Abutment/Backwall : 5 Feet of Decay/Section Loss: Affects 10% or more of the member but does not warrant structural review. RIGHT END ABUT. (B) (3) BOARDS DECAYED (+/- 5 LF)

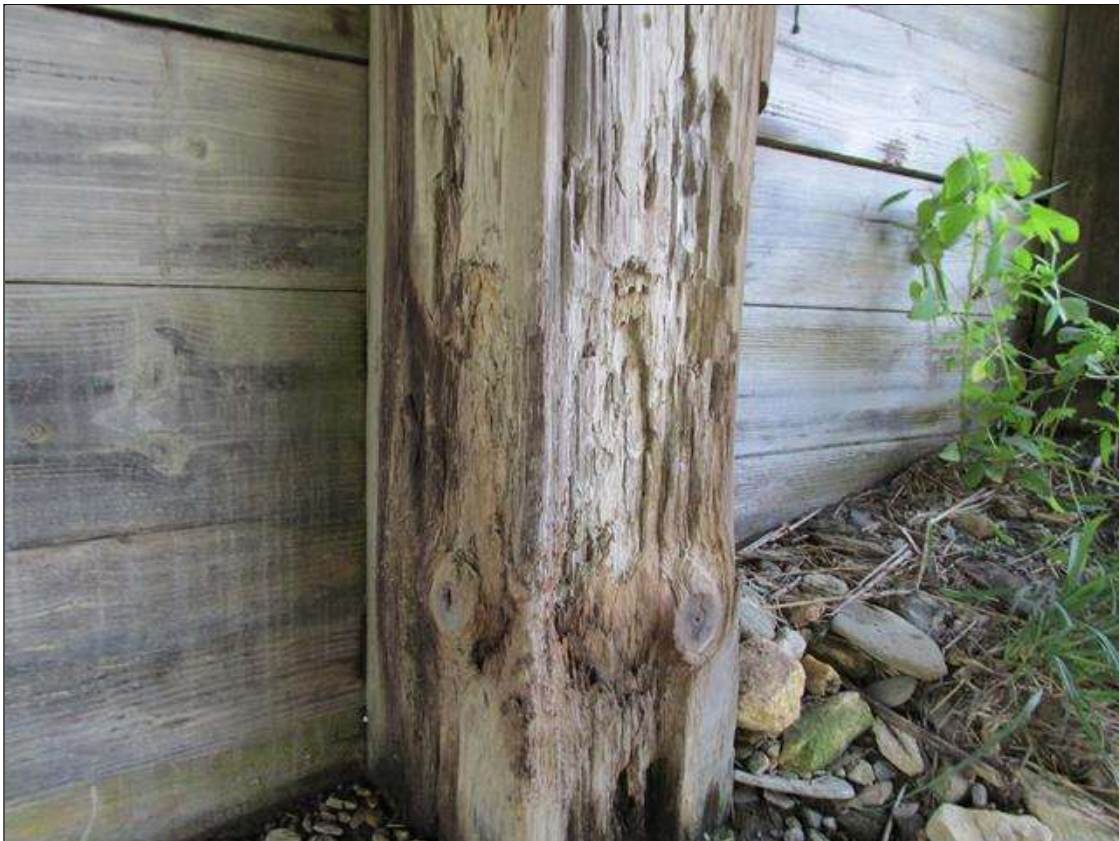
End Bent 2 Pile 7: 1 Each of Decay/Section Loss: Affects 10% or more of the member but does not warrant structural review. ABUT. (B) POST (7) DECAYED FULL HEIGHT (+/- 8' H X 3" D)

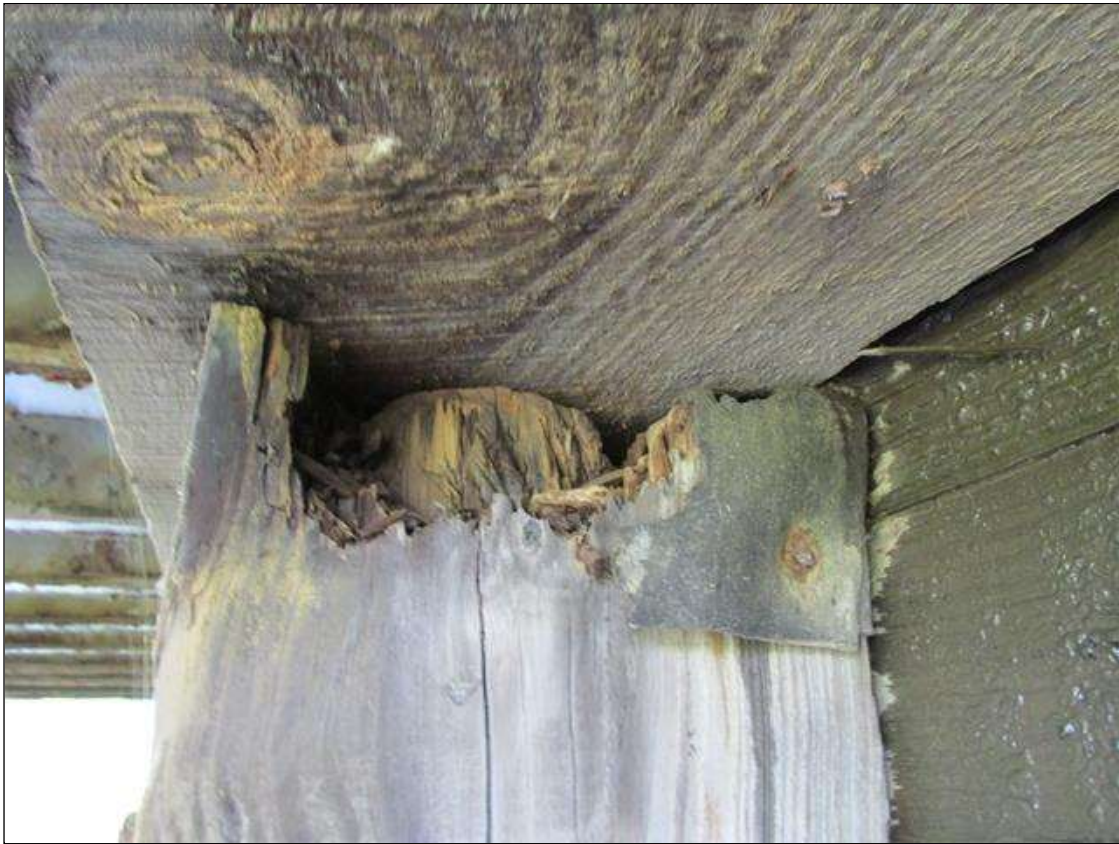
End Bent 2 Pile 7: 1 Each of Decay/Section Loss: Affects 10% or more of the member but does not warrant structural review. ABUT. (B) POST (7) DECAYED FULL HEIGHT (+/- 8' H X 3" D)

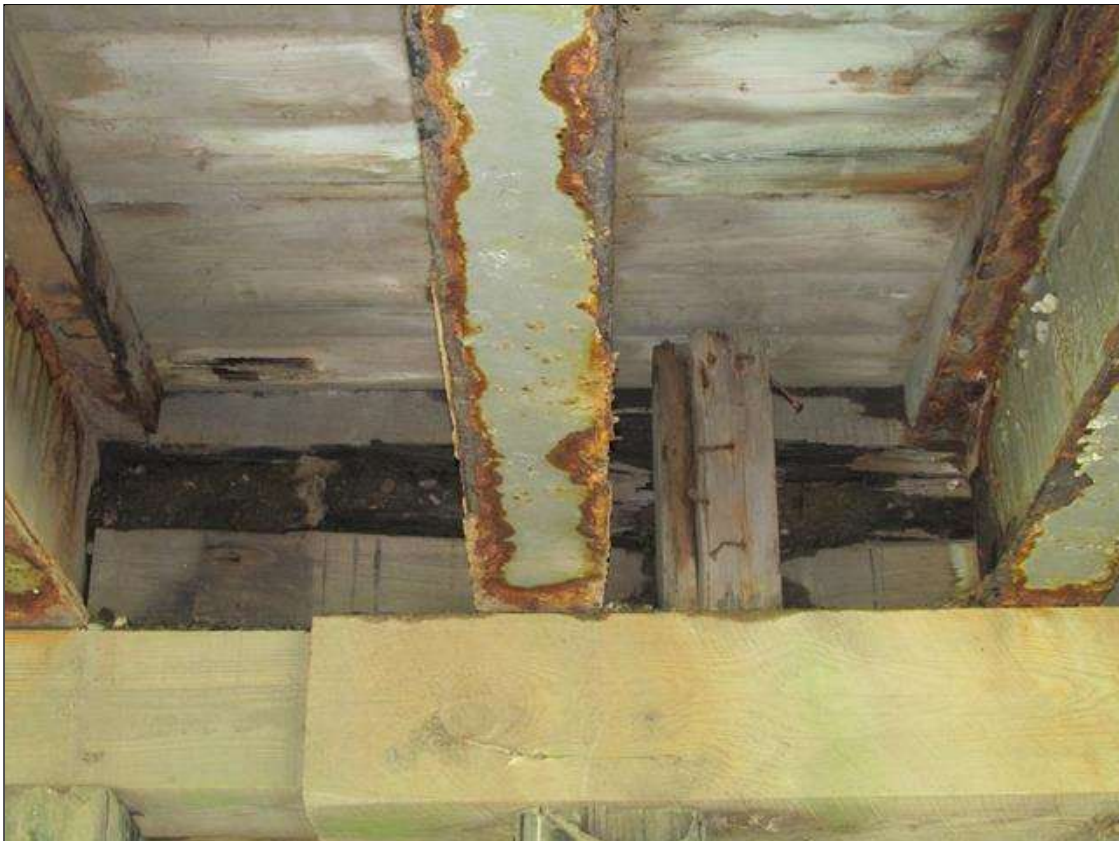
End Bent 2 Abutment/Backwall : 6 Feet of Decay/Section Loss: Affects 10% or more of the member but does not warrant structural review. ABUT. (B) BAYS (4 & 5) (1) BOARD DECAYED WITH LOSS OF FILL (+/- 6 LF)

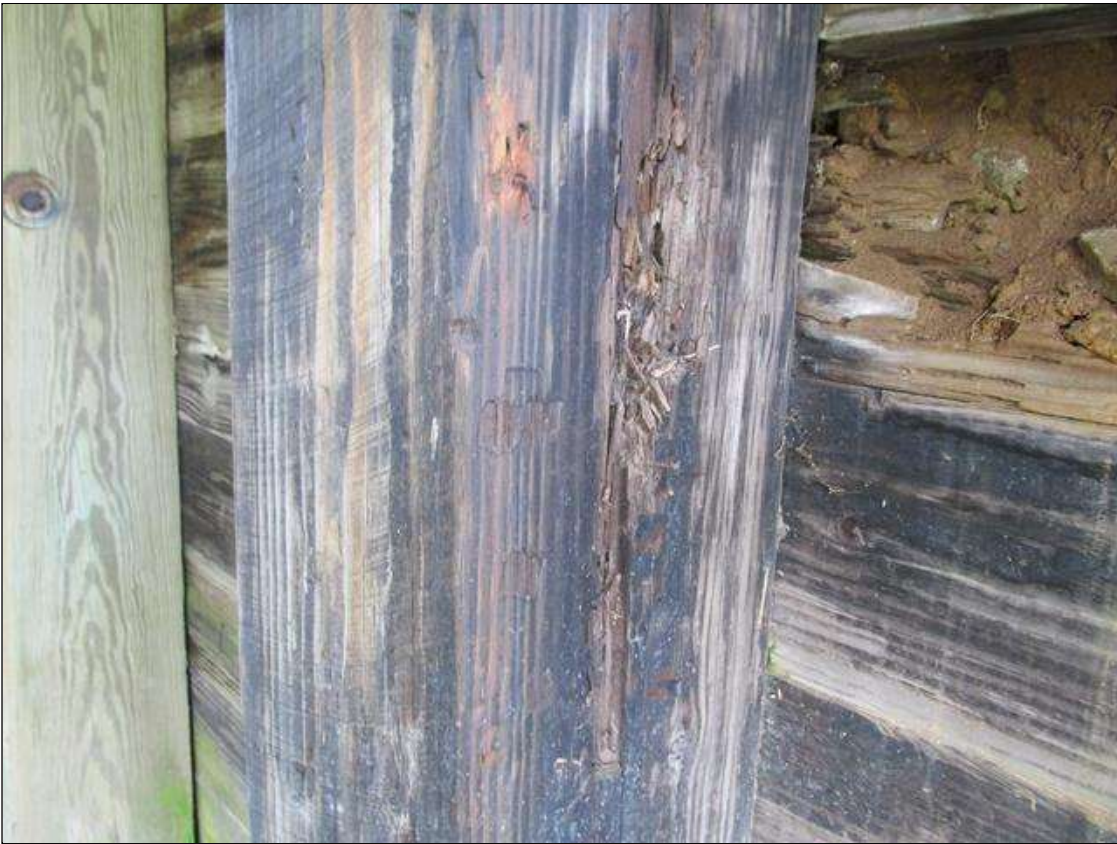
1 Each of Decay/Section Loss: Affects 10% or more of the member but does not warrant structural review. ABUT. (A) POST (4) NORTH FACE DECAYED (+/- 3') FROM G/L AND EXTENDS (+/- 2' H X 3" D)

End Bent 1 Pile 4: 1 Each of Decay/Section Loss: Affects 10% or more of the member but does not warrant structural review. ABUT. (A) POST (4) NORTH FACE DECAYED (+/- 3') FROM G/L AND EXTENDS (+/- 2' H X 3" D)

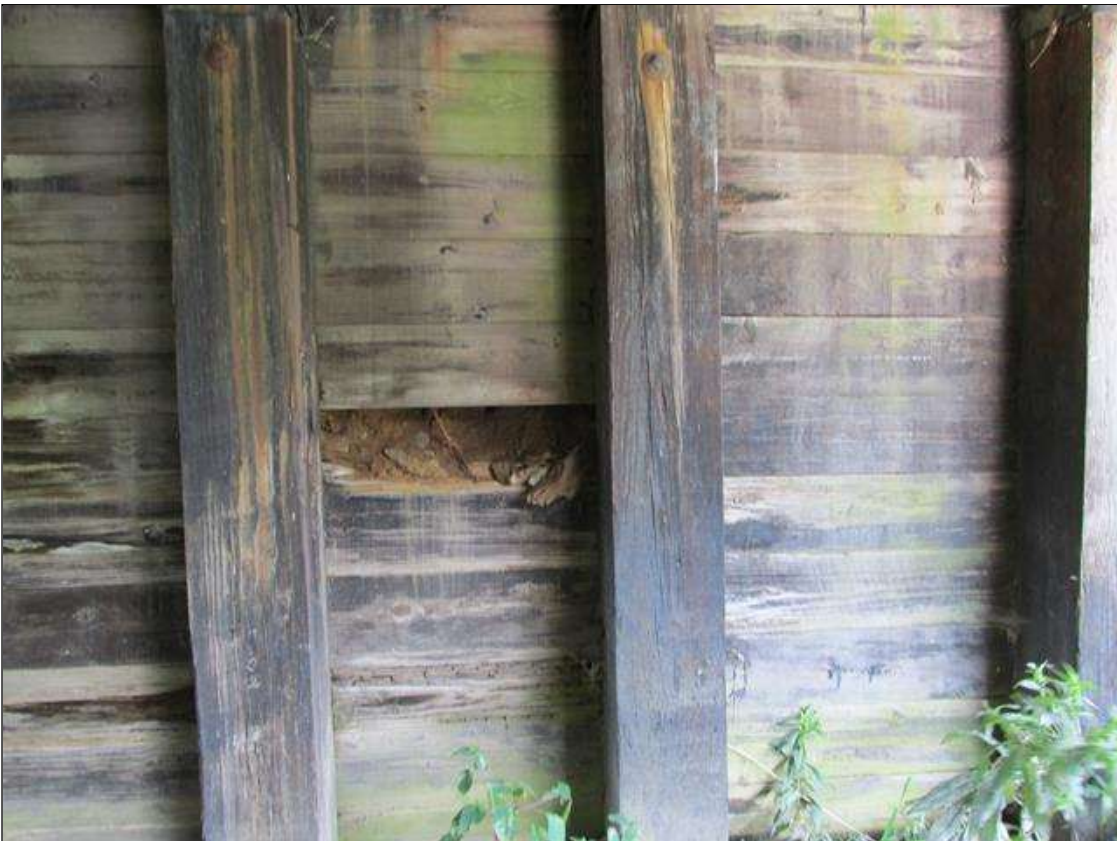
3 Feet of Decay/Section Loss: Affects 10% or more of the member but does not warrant structural review. ABUT. (A) (1) BOARD DECAYED WITH LOSS OF FILL (+/- 3 LF) BETWEEN POST (3 & 4)

End Bent 1 Abutment/Backwall : 3 Feet of Decay/Section Loss: Affects 10% or more of the member but does not warrant structural review. ABUT. (A) (1) BOARD DECAYED WITH LOSS OF FILL (+/- 3 LF) BETWEEN POST (3 & 4)

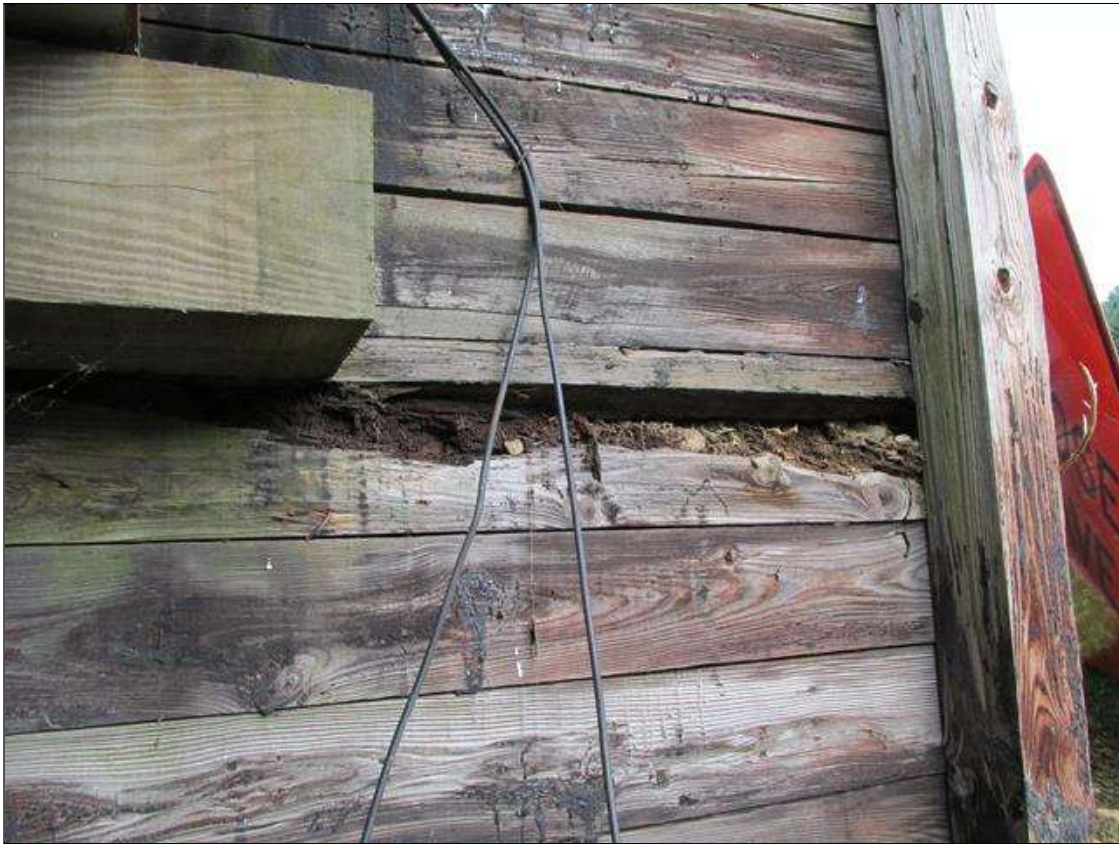
5 Feet of Decay/Section Loss: Affects 10% or more of the member but does not warrant structural review. LEFT END ABUT. (A) (1) BOARD DECAYED WITH LOSS OF FILL (+/- 5 LF)

End Bent 1 Abutment/Backwall : 5 Feet of Decay/Section Loss: Affects 10% or more of the member but does not warrant structural review. LEFT END ABUT. (A) (1) BOARD DECAYED WITH LOSS OF FILL (+/- 5 LF)

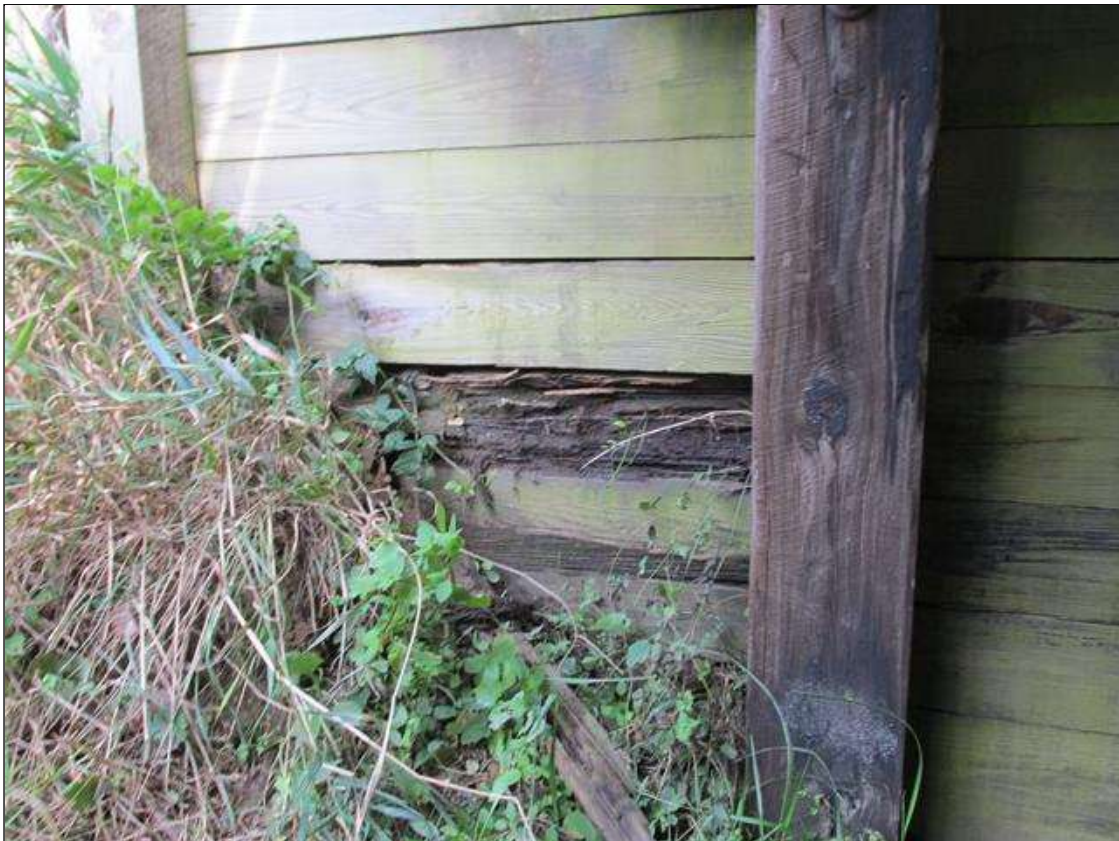
6 Feet of Decay/Section Loss: Affects 10% or more of the member but does not warrant structural review. RIGHT END ABUT. (A) (2) BOARDS DECAYED WITH LOSS OF FILL (+/- 6 LF)

End Bent 1 Abutment/Backwall : 6 Feet of Decay/Section Loss: Affects 10% or more of the member but does not warrant structural review. RIGHT END ABUT. (A) (2) BOARDS DECAYED WITH LOSS OF FILL (+/- 6 LF)

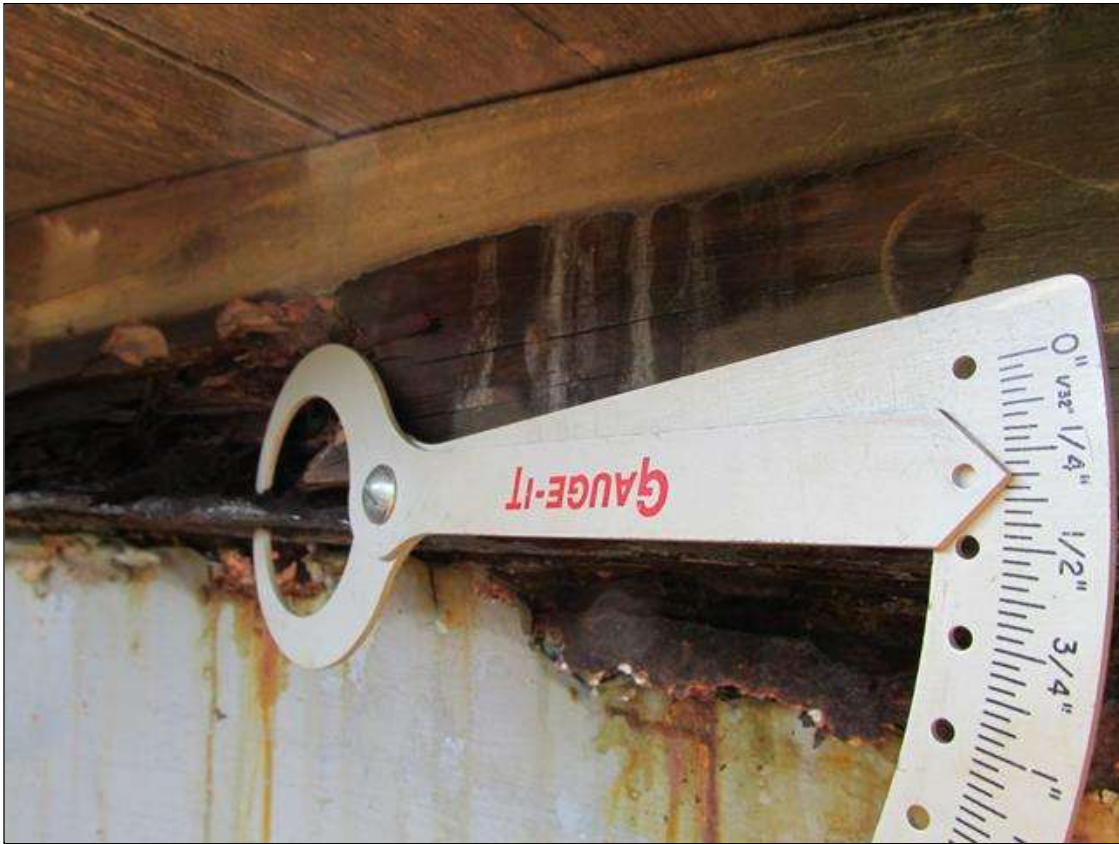
45 Feet of Corrosion: Section loss is evident or pack rust is present but does not warrant structural review. BEAM (1) CORROSION F/L ALONG TOP AND BOTTOM FLANGES WITH (+/- 1/4") LOSS OF SECTION AND A REMAINING SECTION (+/- 5/16") . CORROSION EXTENDS INTO BOTTOM PORTION OF WEB (+/- 4" H) WITH (+/- 1/16") LOSS OF SECTION

Span 1 Beam 1: 45 Feet of Corrosion: Section loss is evident or pack rust is present but does not warrant structural review. CORROSION F/L ALONG TOP AND BOTTOM FLANGES WITH (+/- 1/4") LOSS OF SECTION AND A REMAINING SECTION (+/- 5/16") . CORROSION EXTENDS INTO BOTTOM PORTION OF WEB (+/- 4" H) WITH (+/- 1/16") LOSS OF SECTION

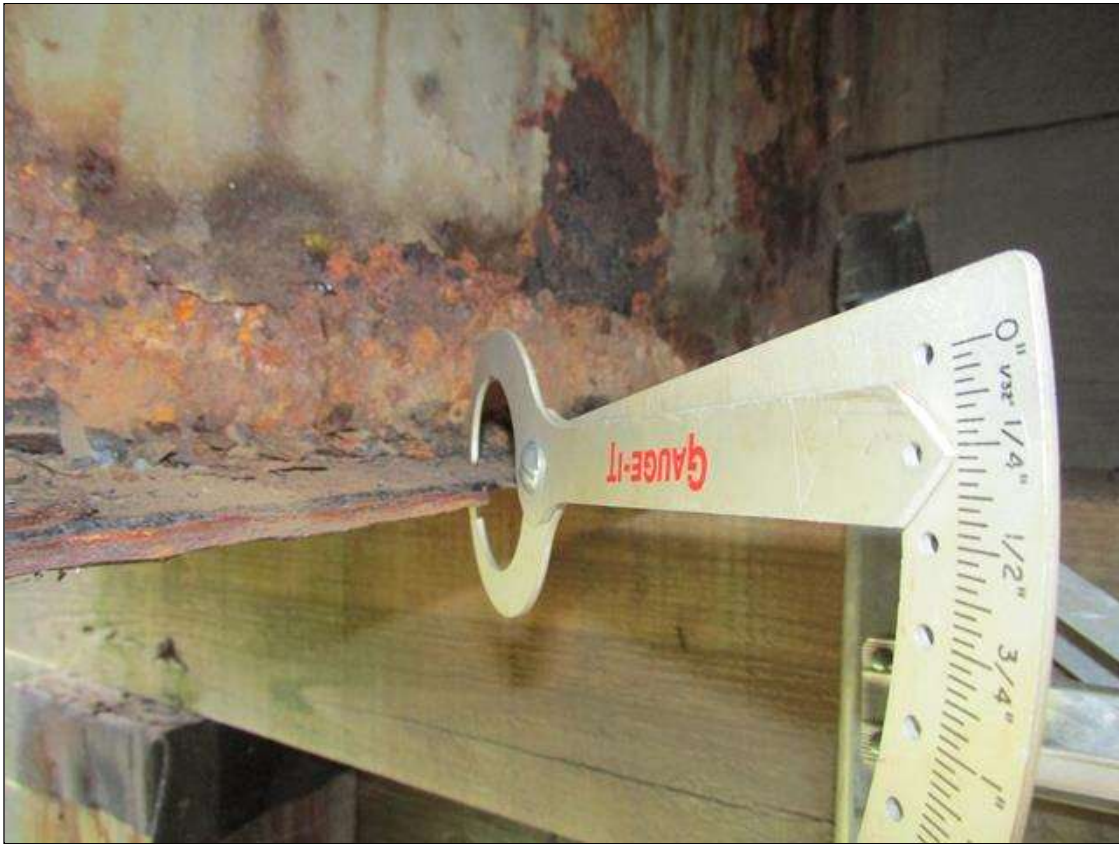
45 Feet of Corrosion: Section loss is evident or pack rust is present but does not warrant structural review. BEAM (2) CORROSION F/L ALONG TOP AND BOTTOM FLANGES WITH (+/- 5/16 ") LOSS OF SECTION AND A REMAINING SECTION (+/- 1/4") . CORROSION EXTENDS INTO WEB FULL HEIGHT WITH (+/- 1/16") LOSS OF SECTION

Span 1 Beam 2: 45 Feet of Corrosion: Section loss is evident or pack rust is present but does not warrant structural review. BEAM (2) CORROSION F/L ALONG TOP AND BOTTOM FLANGES WITH (+/- 5/16 ") LOSS OF SECTION AND A REMAINING SECTION (+/- 1/4") . CORROSION EXTENDS INTO WEB FULL HEIGHT WITH (+/- 1/16") LOSS OF SECTION

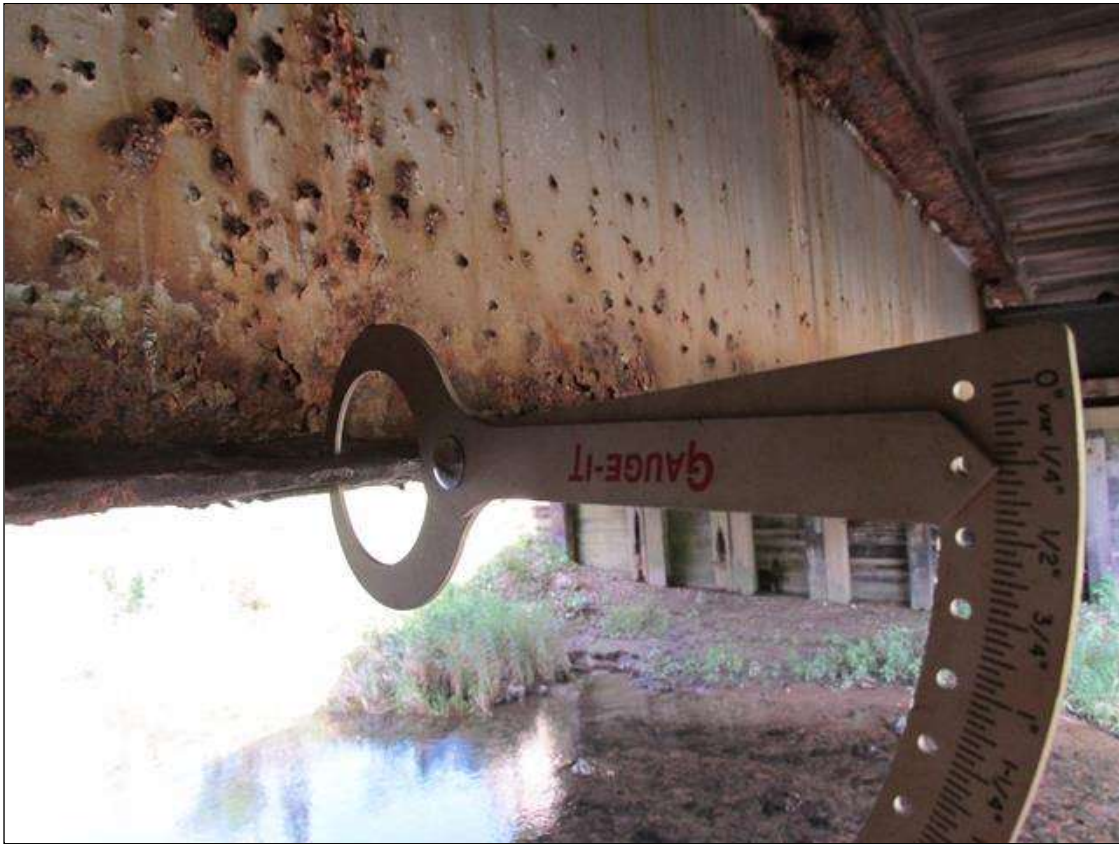
45 Feet of Corrosion: Section loss is evident or pack rust is present but does not warrant structural review. BEAM (3) CORROSION F/L ALONG TOP AND BOTTOM FLANGES WITH (+/- 5/16 ") LOSS OF SECTION AND A REMAINING SECTION (+/- 1/4") . CORROSION EXTENDS INTO BOTTOM PORTION OF WEB (+/- 3") WITH (+/- 1/16") LOSS OF SECTION

Span 1 Beam 3: 45 Feet of Corrosion: Section loss is evident or pack rust is present but does not warrant structural review. BEAM (3) CORROSION F/L ALONG TOP AND BOTTOM FLANGES WITH (+/- 5/16 ") LOSS OF SECTION AND A REMAINING SECTION (+/- 1/4") . CORROSION EXTENDS INTO BOTTOM PORTION OF WEB (+/- 3") WITH (+/- 1/16") LOSS OF SECTION

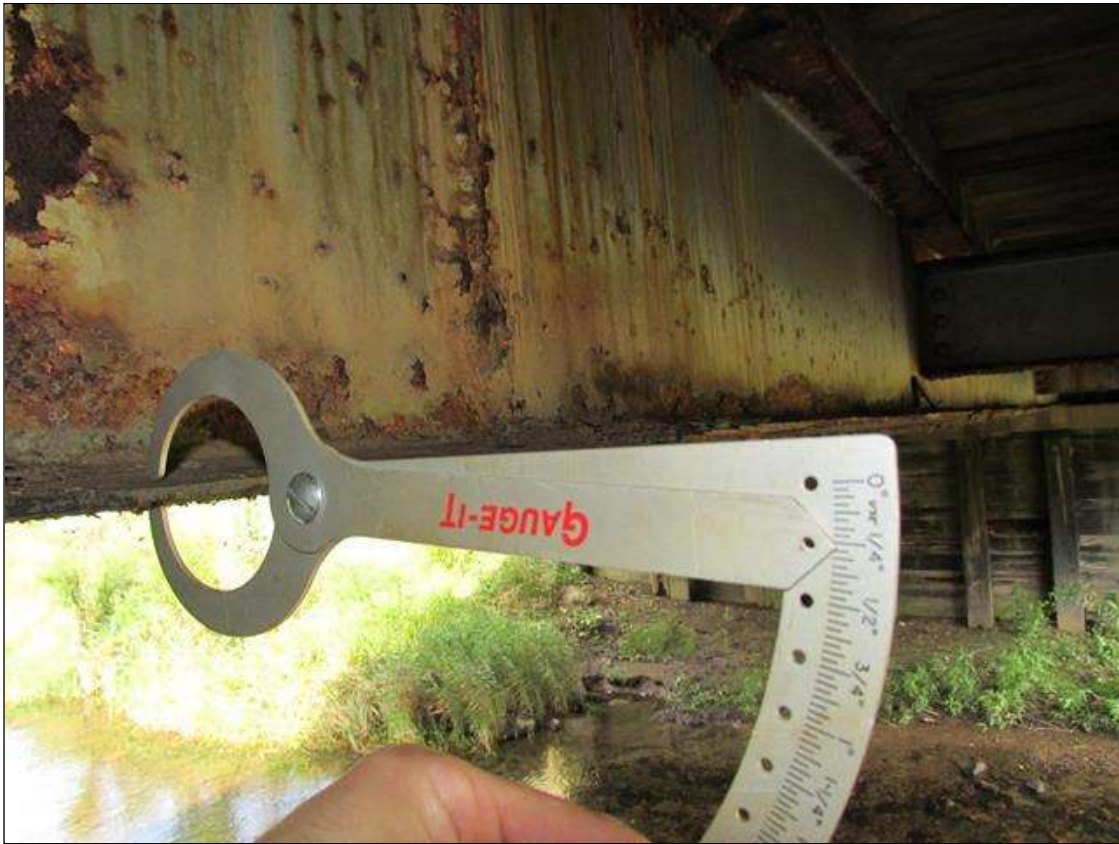
45 Feet of Corrosion: Section loss is evident or pack rust is present but does not warrant structural review. BEAM (4) CORROSION F/L ALONG TOP AND BOTTOM FLANGES WITH (+/- 5/16 ") LOSS OF SECTION AND A REMAINING SECTION (+/- 1/4") . CORROSION EXTENDS INTO BOTTOM PORTION OF WEB (+/- 3") WITH (+/- 1/16") LOSS OF SECTION

Span 1 Beam 4: 45 Feet of Corrosion: Section loss is evident or pack rust is present but does not warrant structural review. BEAM (4) CORROSION F/L ALONG TOP AND BOTTOM FLANGES WITH (+/- 5/16 ") LOSS OF SECTION AND A REMAINING SECTION (+/- 1/4") . CORROSION EXTENDS INTO BOTTOM PORTION OF WEB (+/- 3") WITH (+/- 1/16") LOSS OF SECTION

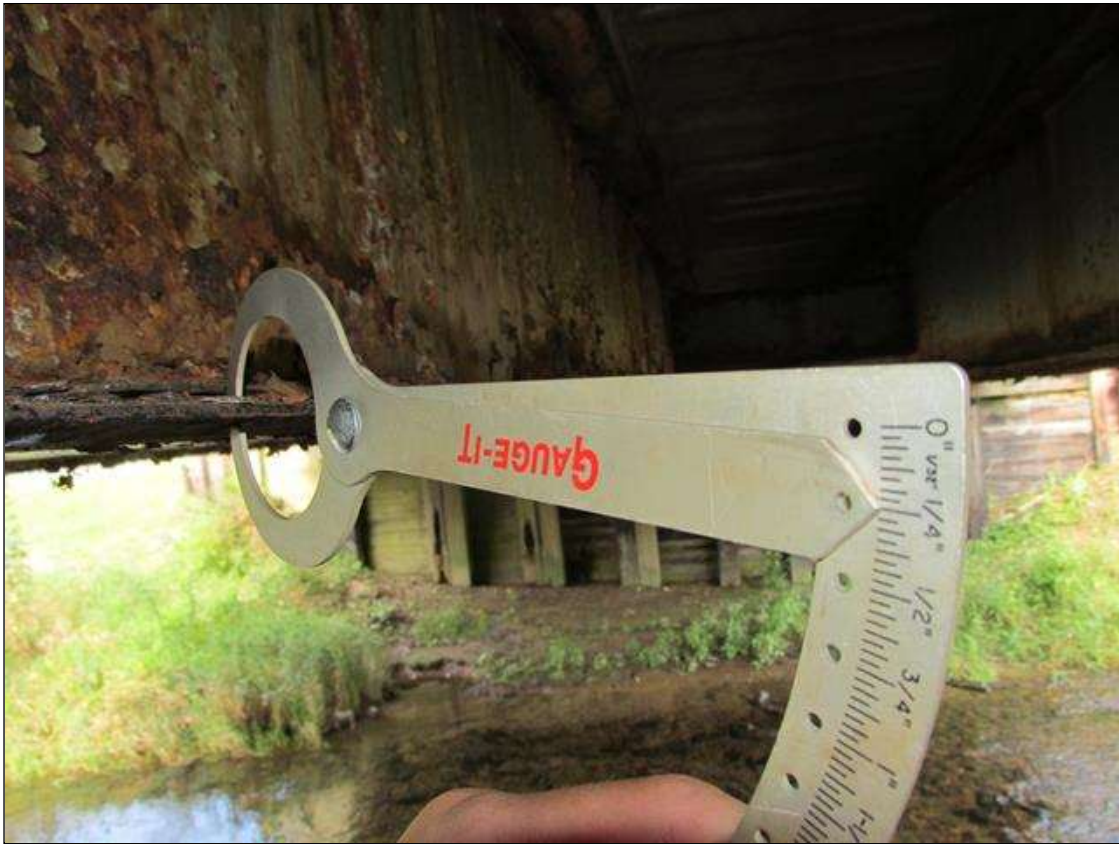
45 Feet of Corrosion: Section loss is evident or pack rust is present but does not warrant structural review. BEAM (5)  
CORROSION F/L ALONG TOP AND BOTTOM FLANGES WITH (+/- 5/16 ") LOSS OF SECTION AND A REMAINING  
SECTION (+/- 1/4") . CORROSION EXTENDS INTO BOTTOM PORTION OF WEB (+/- 4") WITH (+/- 1/16") LOSS OF  
SECTION

Span 1 Beam 5: 45 Feet of Corrosion: Section loss is evident or pack rust is present but does not warrant structural review. BEAM (5) CORROSION F/L ALONG TOP AND BOTTOM FLANGES WITH (+/- 5/16 ") LOSS OF SECTION AND A REMAINING SECTION (+/- 1/4") . CORROSION EXTENDS INTO BOTTOM PORTION OF WEB (+/- 4") WITH (+/- 1/16") LOSS OF SECTION

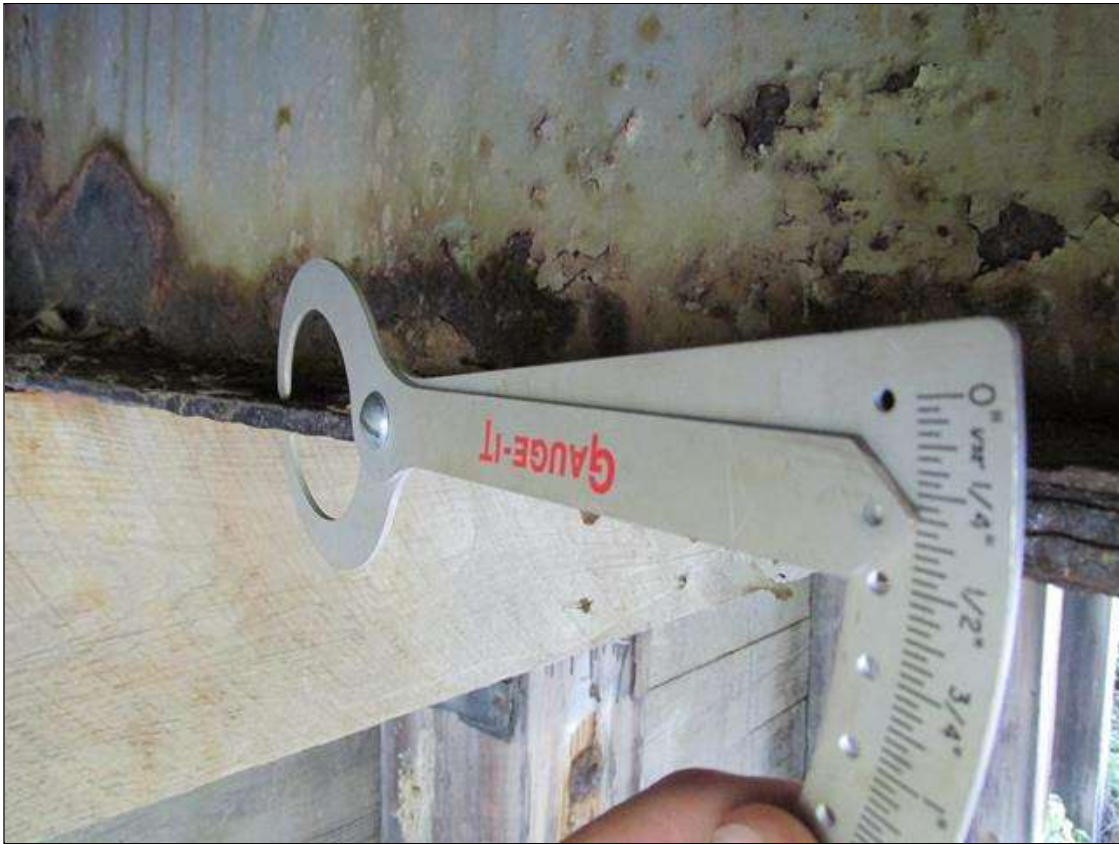
45 Feet of Corrosion: Section loss is evident or pack rust is present but does not warrant structural review. BEAM (6)  
CORROSION F/L ALONG TOP AND BOTTOM FLANGES WITH (+/- 1/4") LOSS OF SECTION AND A REMAINING SECTION  
(+/- 5/16") . CORROSION EXTENDS INTO BOTTOM PORTION OF WEB (+/- 4" H) WITH (+/ 1/16") LOSS OF SECTION

Span 1 Beam 6: 45 Feet of Corrosion: Section loss is evident or pack rust is present but does not warrant structural review. BEAM (6) CORROSION F/L ALONG TOP AND BOTTOM FLANGES WITH (+/- 1/4") LOSS OF SECTION AND A REMAINING SECTION (+/- 5/16") . CORROSION EXTENDS INTO BOTTOM PORTION OF WEB (+/- 4" H) WITH (+/- 1/16") LOSS OF SECTION

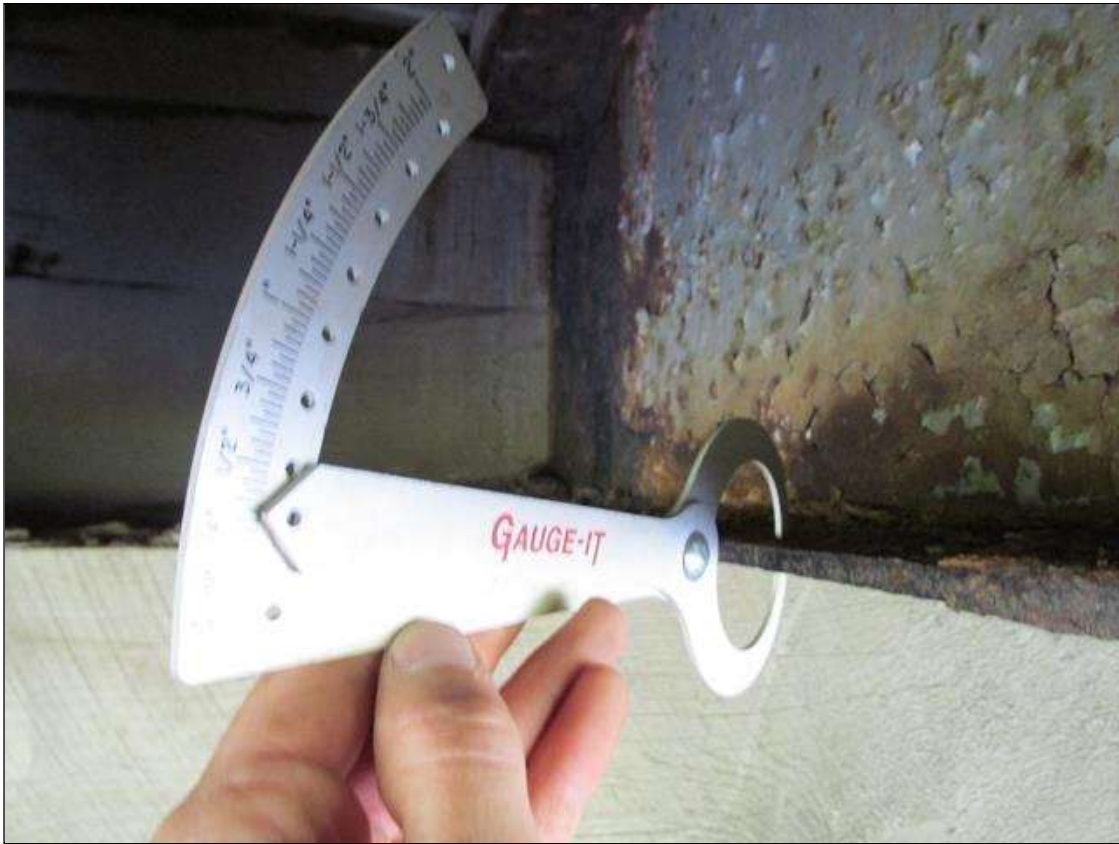
45 Feet of Corrosion: Section loss is evident or pack rust is present but does not warrant structural review. BEAM (7)  
CORROSION F/L ALONG TOP AND BOTTOM FLANGES WITH (+/- 1/4") LOSS OF SECTION AND A REMAINING SECTION  
(+/- 5/16") . CORROSION EXTENDS INTO BOTTOM PORTION OF WEB (+/- 4" H) WITH (+/ 1/16") LOSS OF SECTION

Span 1 Beam 7: 45 Feet of Corrosion: Section loss is evident or pack rust is present but does not warrant structural review. BEAM (7) CORROSION F/L ALONG TOP AND BOTTOM FLANGES WITH (+/- 1/4") LOSS OF SECTION AND A REMAINING SECTION (+/- 5/16") . CORROSION EXTENDS INTO BOTTOM PORTION OF WEB (+/- 4" H) WITH (+/- 1/16") LOSS OF SECTION

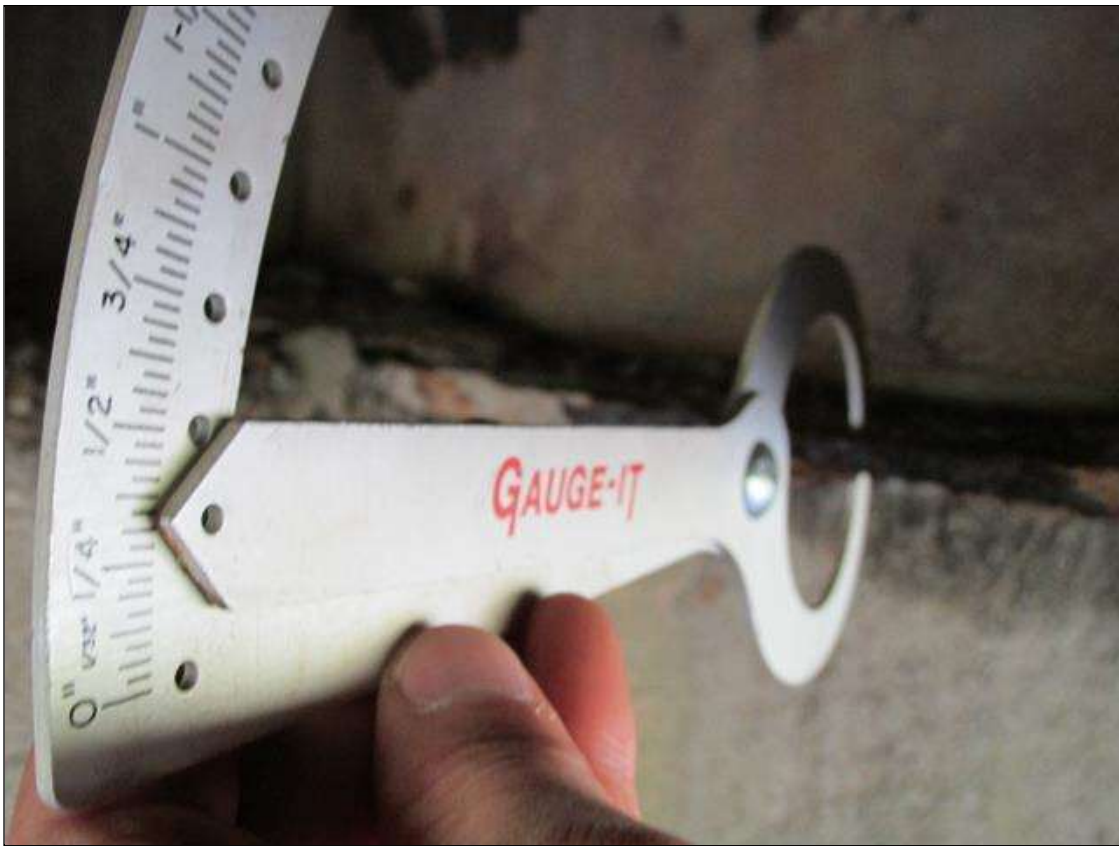
45 Feet of Corrosion: Section loss is evident or pack rust is present but does not warrant structural review. BEAM (8)  
CORROSION F/L ALONG TOP AND BOTTOM FLANGES WITH (+/- 1/4") LOSS OF SECTION AND A REMAINING SECTION  
(+/- 5/16") . CORROSION EXTENDS INTO BOTTOM PORTION OF WEB (+/- 2" H) WITH (+/ 1/16") LOSS OF SECTION

Span 1 Beam 8: 45 Feet of Corrosion: Section loss is evident or pack rust is present but does not warrant structural review. BEAM (8) CORROSION F/L ALONG TOP AND BOTTOM FLANGES WITH (+/- 1/4") LOSS OF SECTION AND A REMAINING SECTION (+/- 5/16") . CORROSION EXTENDS INTO BOTTOM PORTION OF WEB (+/- 2" H) WITH (+/- 1/16") LOSS OF SECTION
