NC DEPARTMENT OF TRANSPORTATION  
DIVISION OF HIGHWAYS  
STRUCTURE MANAGEMENT UNIT

## Structure Safety Report

### Routine Element Inspection

COUNTY: WATAUGA STRUCTURE NUMBER: 940278 FREQUENCY: 24 MONTHS  
FACILITY CARRIED: SR1540 MILE POST: \_\_\_\_\_  
LOCATION: 25 FT.W.JCT.US221,321  
FEATURE INTERSECTED: CREEK  
LATITUDE: 36° 10' 9.1" LONGITUDE: 81° 38' 47.88"  
SUPERSTRUCTURE: TIMBER FLOOR ON I-BEAMS

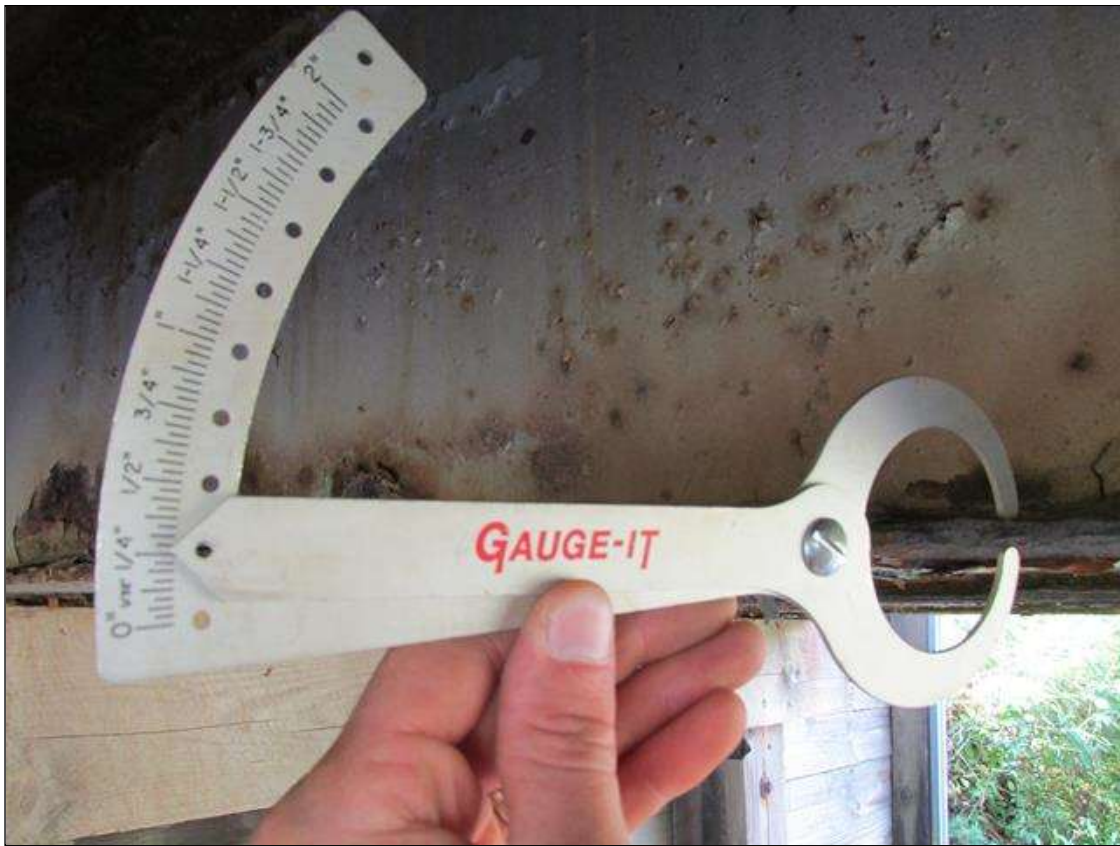
45 Feet of Corrosion: Section loss is evident or pack rust is present but does not warrant structural review. BEAM (9)  
CORROSION F/L ALONG TOP AND BOTTOM FLANGES WITH (+/- 5/16 ") LOSS OF SECTION AND A REMAINING  
SECTION (+/- 1/4") . CORROSION EXTENDS INTO BOTTOM PORTION OF WEB (+/- 3") WITH (+/- 1/16") LOSS OF  
SECTION

Span 1 Beam 9: 45 Feet of Corrosion: Section loss is evident or pack rust is present but does not warrant structural review. BEAM (9) CORROSION F/L ALONG TOP AND BOTTOM FLANGES WITH (+/- 5/16 ") LOSS OF SECTION AND A REMAINING SECTION (+/- 1/4") . CORROSION EXTENDS INTO BOTTOM PORTION OF WEB (+/- 3") WITH (+/- 1/16") LOSS OF SECTION

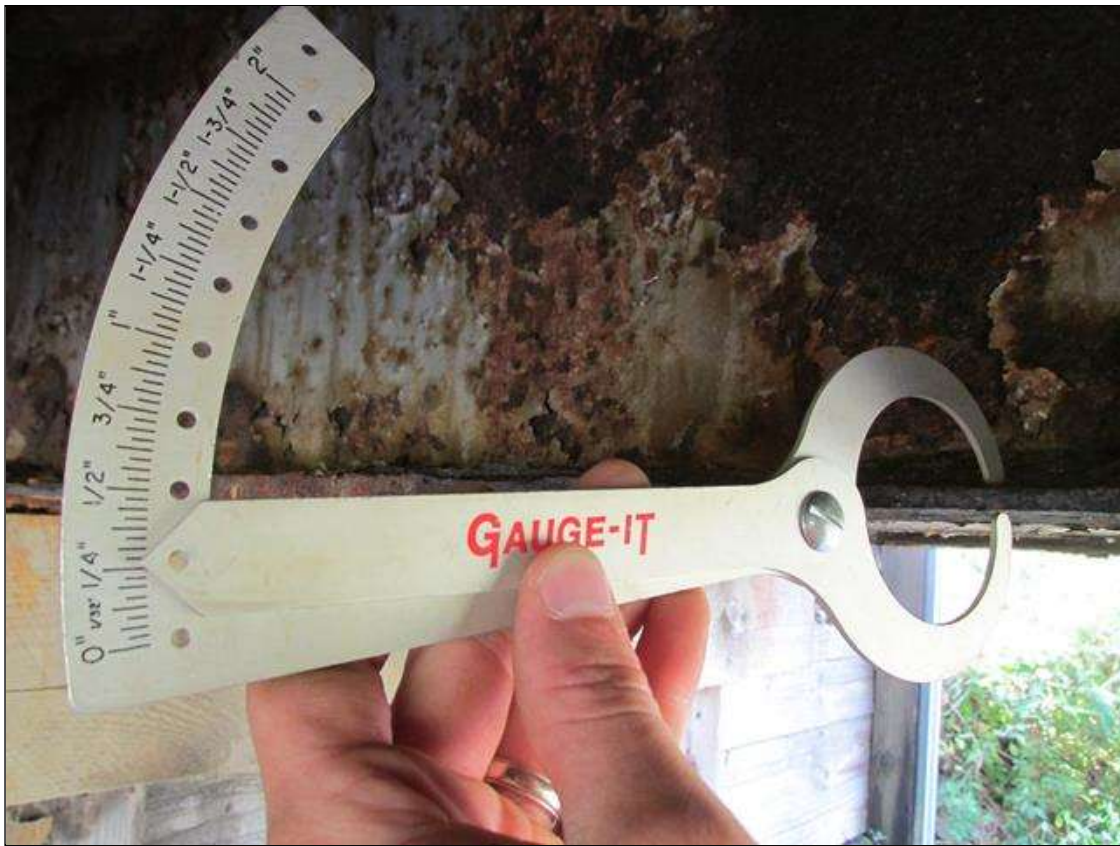
45 Feet of Corrosion: Section loss is evident or pack rust is present but does not warrant structural review. BEAM (10) CORROSION F/L ALONG TOP AND BOTTOM FLANGES WITH (+/- 5/16 ") LOSS OF SECTION AND A REMAINING SECTION (+/- 1/4") . CORROSION EXTENDS INTO BOTTOM PORTION OF WEB (+/- 8") WITH (+/- 1/16") LOSS OF SECTION

Span 1 Beam 10: 45 Feet of Corrosion: Section loss is evident or pack rust is present but does not warrant structural review. BEAM (10) CORROSION F/L ALONG TOP AND BOTTOM FLANGES WITH (+/- 5/16 ") LOSS OF SECTION AND A REMAINING SECTION (+/- 1/4") . CORROSION EXTENDS INTO BOTTOM PORTION OF WEB (+/- 8") WITH (+/- 1/16") LOSS OF SECTION

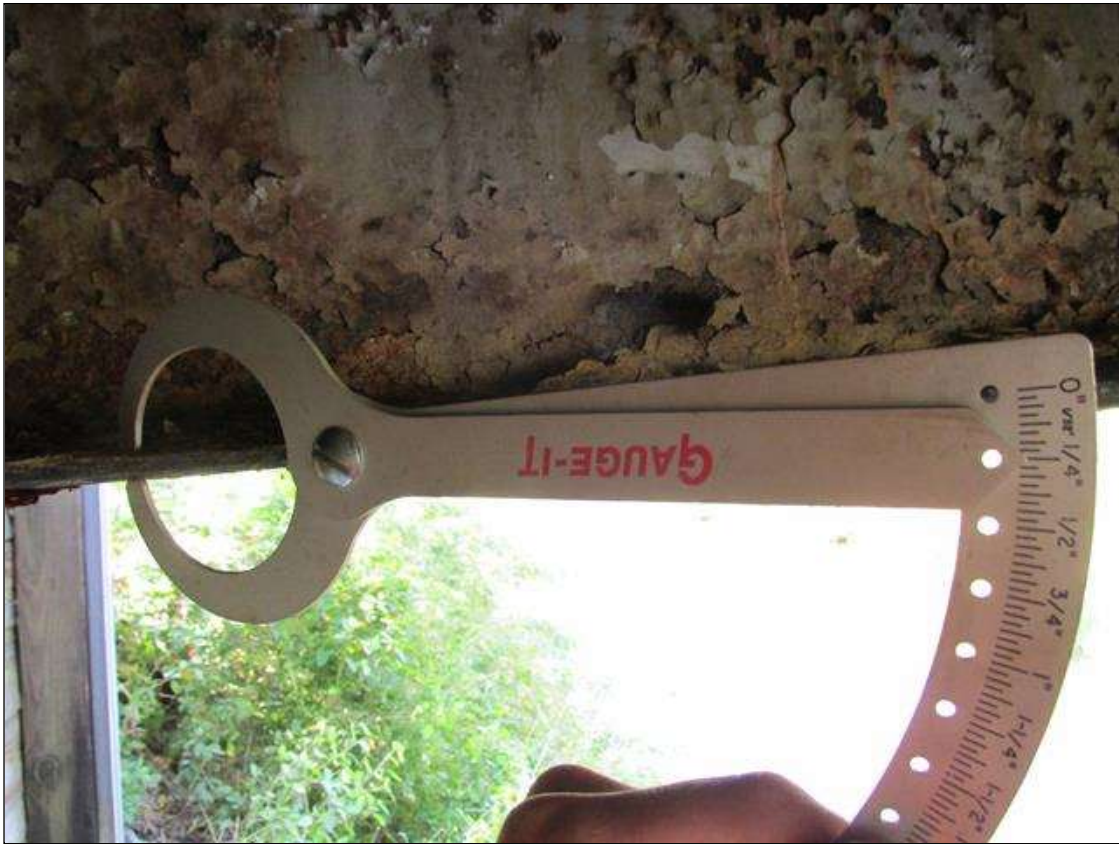
45 Feet of Corrosion: Section loss is evident or pack rust is present but does not warrant structural review. BEAM (11) CORROSION F/L ALONG TOP AND BOTTOM FLANGES WITH (+/- 5/16 ") LOSS OF SECTION AND A REMAINING SECTION (+/- 1/4") . CORROSION EXTENDS INTO BOTTOM PORTION OF WEB (+/- 8") WITH (+/- 1/16") LOSS OF SECTION

Span 1 Beam 11: 45 Feet of Corrosion: Section loss is evident or pack rust is present but does not warrant structural review. BEAM (11) CORROSION F/L ALONG TOP AND BOTTOM FLANGES WITH (+/- 5/16 ") LOSS OF SECTION AND A REMAINING SECTION (+/- 1/4") . CORROSION EXTENDS INTO BOTTOM PORTION OF WEB (+/- 8") WITH (+/- 1/16") LOSS OF SECTION

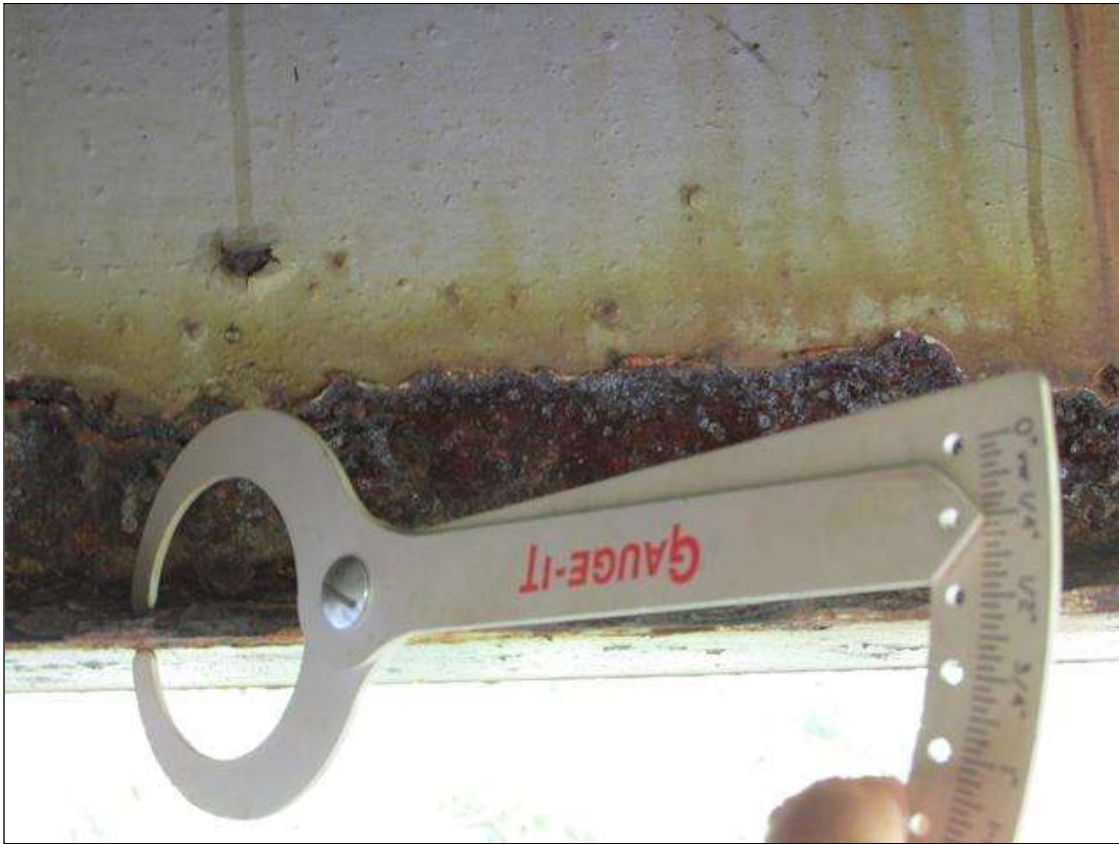
45 Feet of Corrosion: Section loss is evident or pack rust is present but does not warrant structural review. BEAM (12) CORROSION F/L ALONG TOP AND BOTTOM FLANGES WITH (+/- 5/16 ") LOSS OF SECTION AND A REMAINING SECTION (+/- 1/4") . CORROSION EXTENDS INTO BOTTOM PORTION OF WEB (+/- 3") WITH (+/- 1/16") LOSS OF SECTION

Span 1 Beam 12: 45 Feet of Corrosion: Section loss is evident or pack rust is present but does not warrant structural review. BEAM (12) CORROSION F/L ALONG TOP AND BOTTOM FLANGES WITH (+/- 5/16 ") LOSS OF SECTION AND A REMAINING SECTION (+/- 1/4") . CORROSION EXTENDS INTO BOTTOM PORTION OF WEB (+/- 3") WITH (+/- 1/16") LOSS OF SECTION

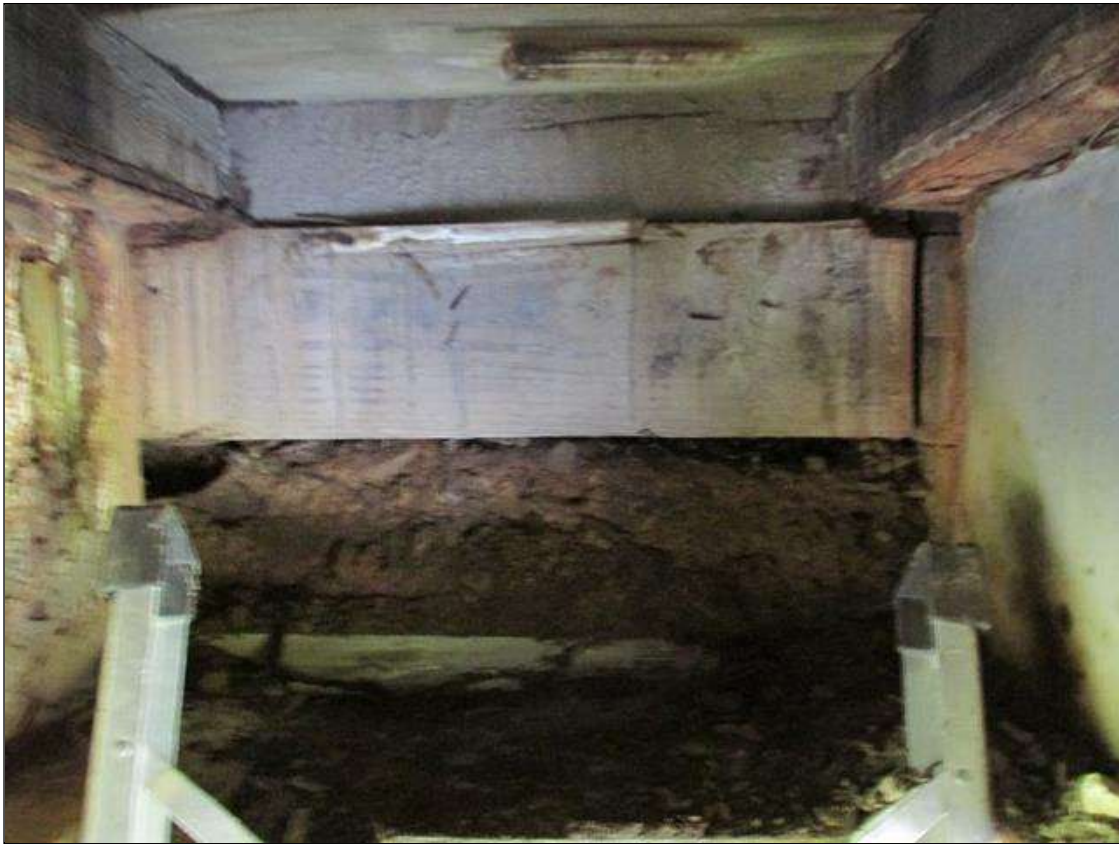
6 Feet of Decay/Section Loss: Affects 10% or more of the member but does not warrant structural review. ABUT. (A) BULKHEAD BAYS (4 & 5) (2) BOARDS DECAYED WITH LOSS OF FILL (+/- 6 LF)

End Bent 1 Abutment/Backwall : 6 Feet of Decay/Section Loss: Affects 10% or more of the member but does not warrant structural review. ABUT. (A) BULKHEAD BAYS (4 & 5) (2) BOARDS DECAYED WITH LOSS OF FILL (+/- 6 LF)

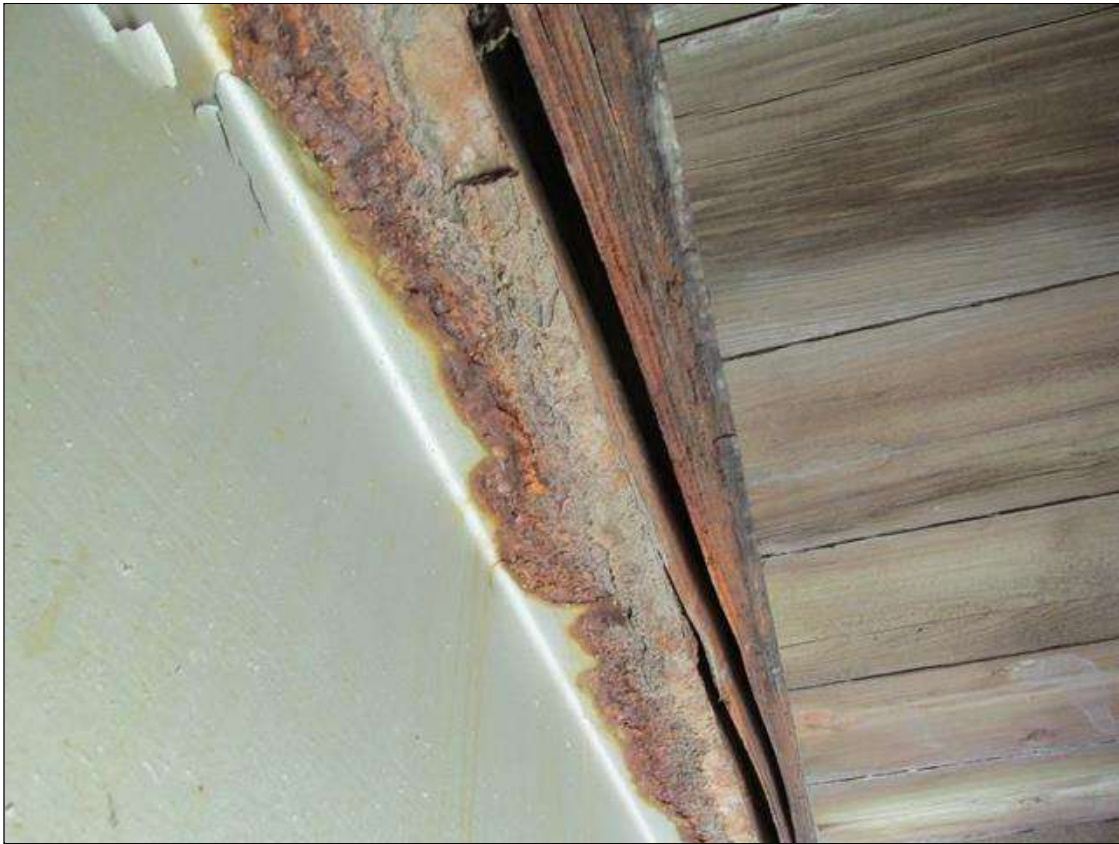
180 Square Feet of Decay/Section Loss: Affects 10% or more of the member but does not warrant structural review. BEAM (10) TIMBER NAILER, SPLIT AND DECAYED FULL LENGTH ALONG TOP OF BEAM (+/- 45 SF) SIMILAR AT BEAM NAILERS (9, 11 & 12) FULL LENGTH

Span 1 Deck: 180 Square Feet of Decay/Section Loss: Affects 10% or more of the member but does not warrant structural review. BEAM (10) TIMBER NAILER, SPLIT AND DECAYED FULL LENGTH ALONG TOP OF BEAM (+/- 45 SF) SIMILAR AT BEAM NAILERS (9, 11 & 12) FULL LENGTH

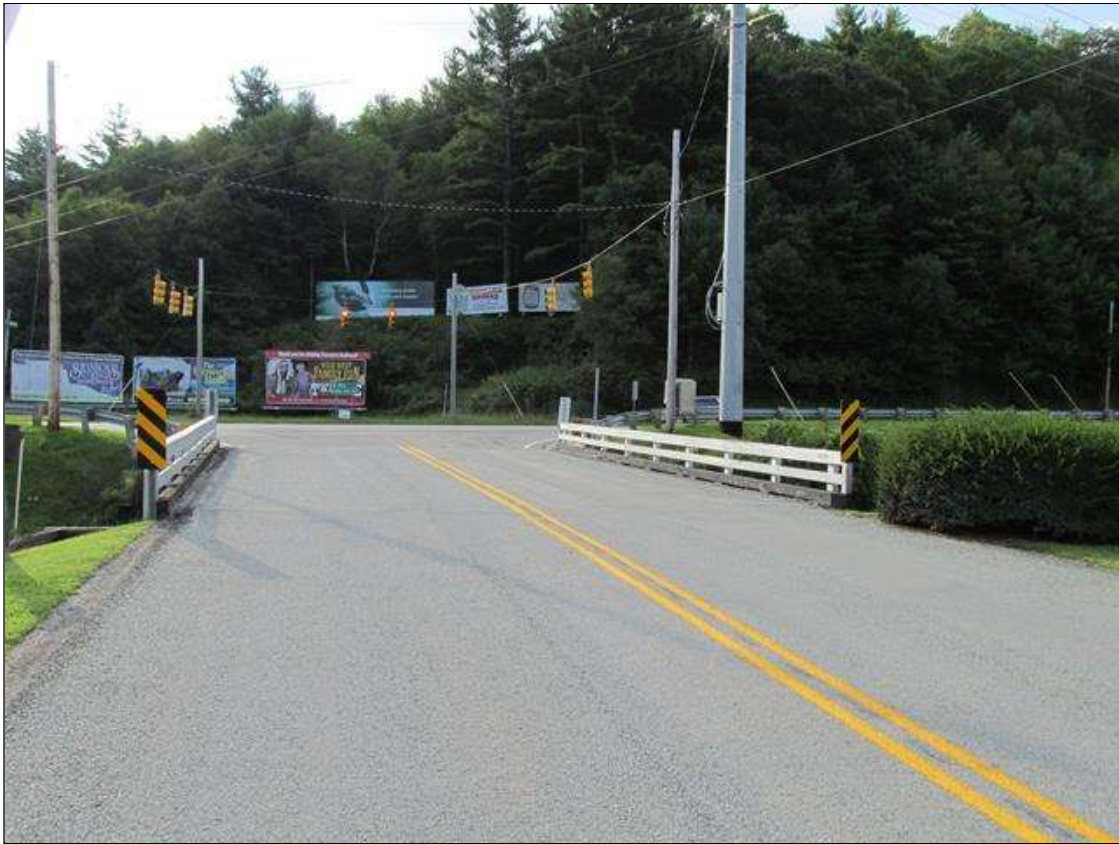
ATTENTION: **CRITICAL FIND (2) WEIGHT LIMIT SIGNS MISSING,  
PMN'S ISSUED FOR SUBSTRUCTURE,  
SUPERSTRUCTURE...**

MISSING (2) WEIGHT LIMIT SIGNS...

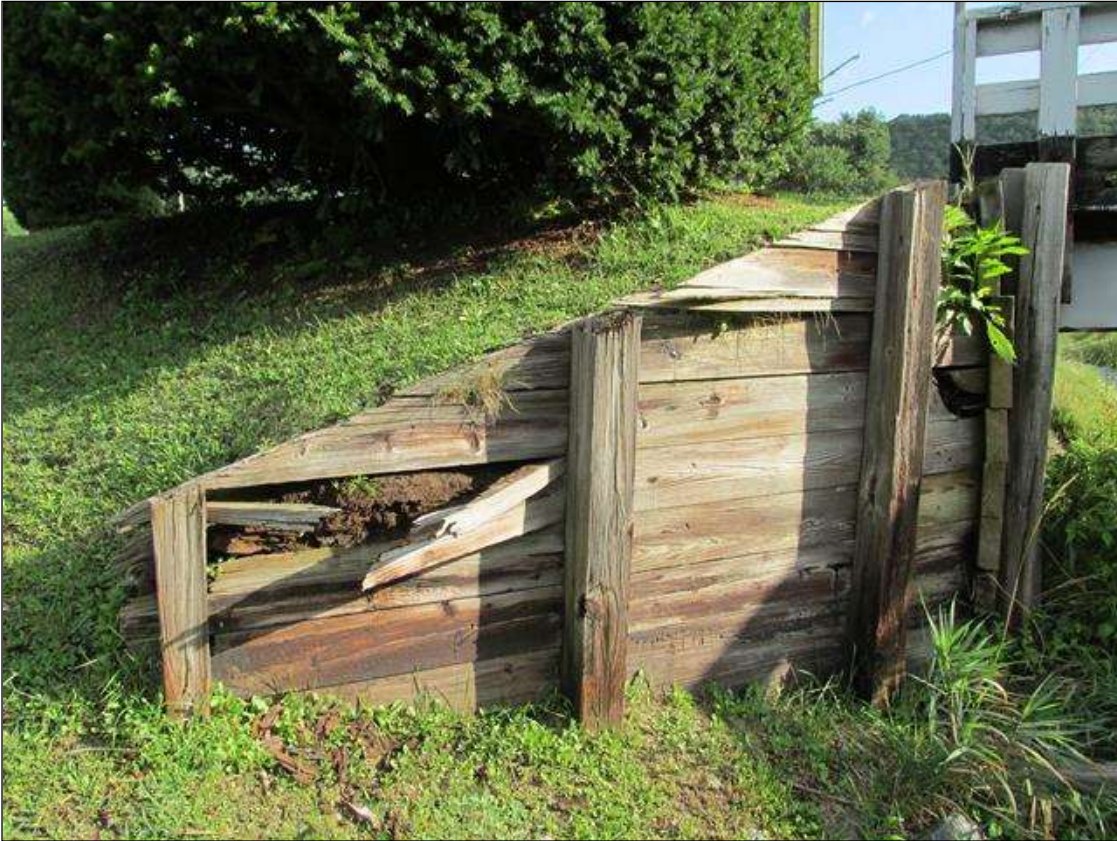
SOUTH WEST WING (5) BOARDS DECAYED WITH LOSS OF FILL (+/- 50 SF)

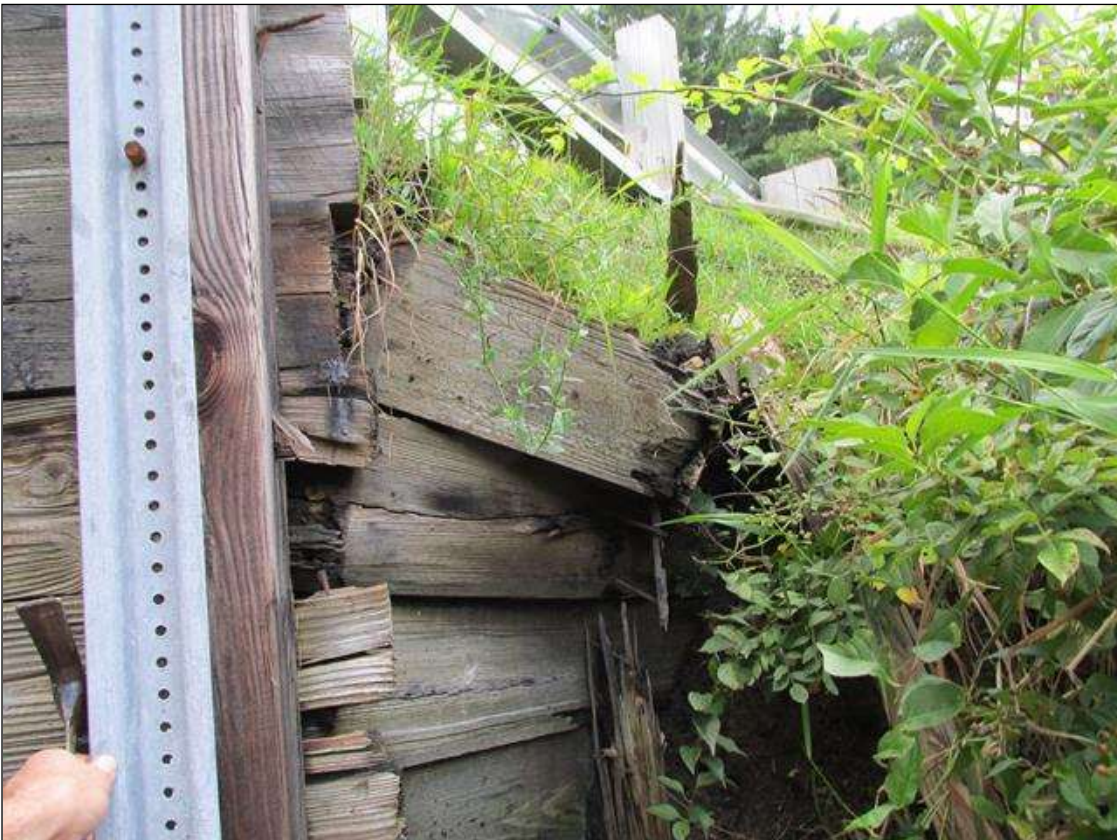
SOUTH EAST WING (5) BOARDS AND RETAINING POST DECAYED WITH LOSS OF FILL (+/- 50 SF)

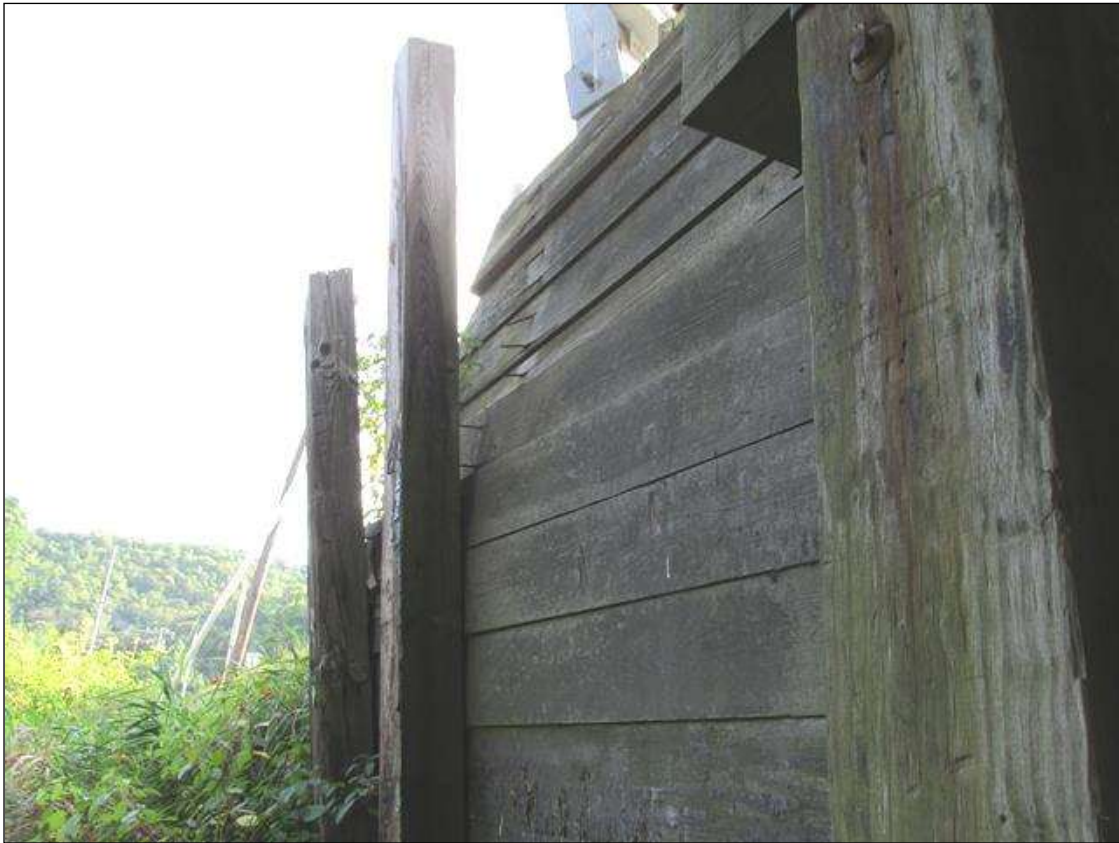
LEFT END ABUT. (B) BULKHEAD (2) RETAINING POST BROKEN, DISTORTED AND PULLED AWAY FROM BULKHEAD FULL HEIGHT X 5' L.

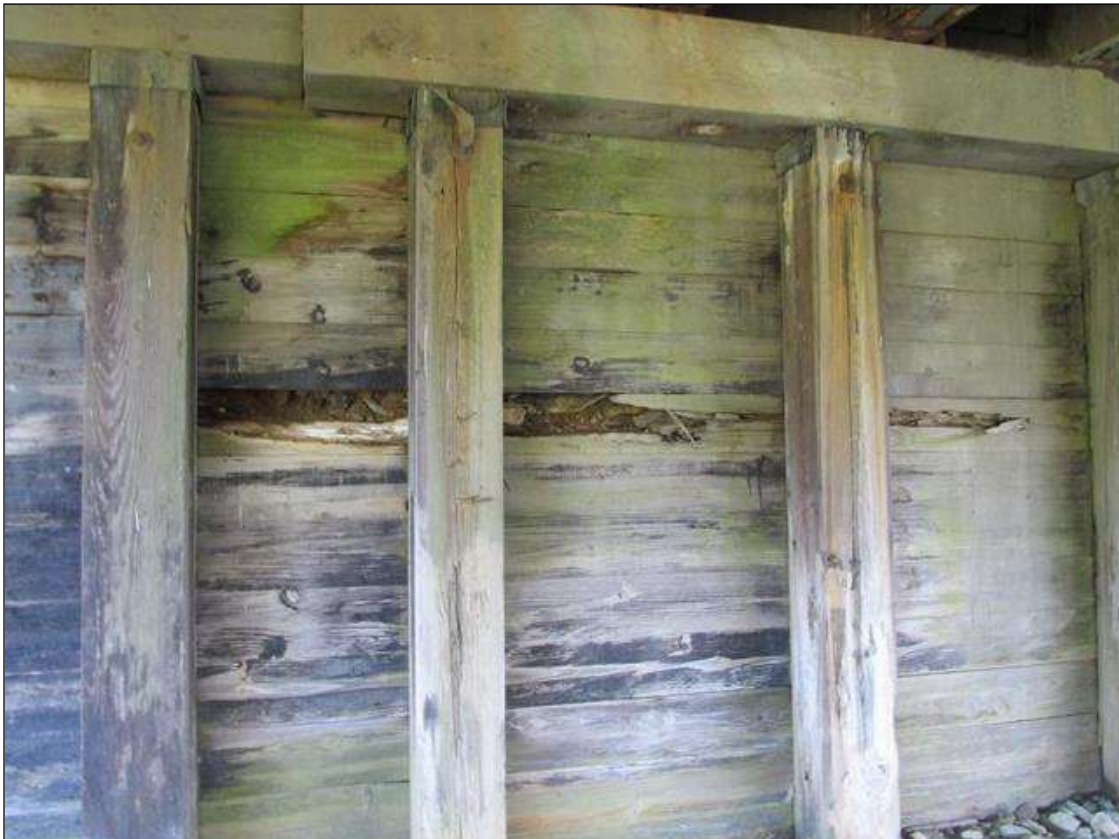
ABUT. (B) (1) BOARD DECAYED (+/- 12 LF) WITH LOSS OF FILL, DECAY EXTENDS FROM POST (3 - 6)

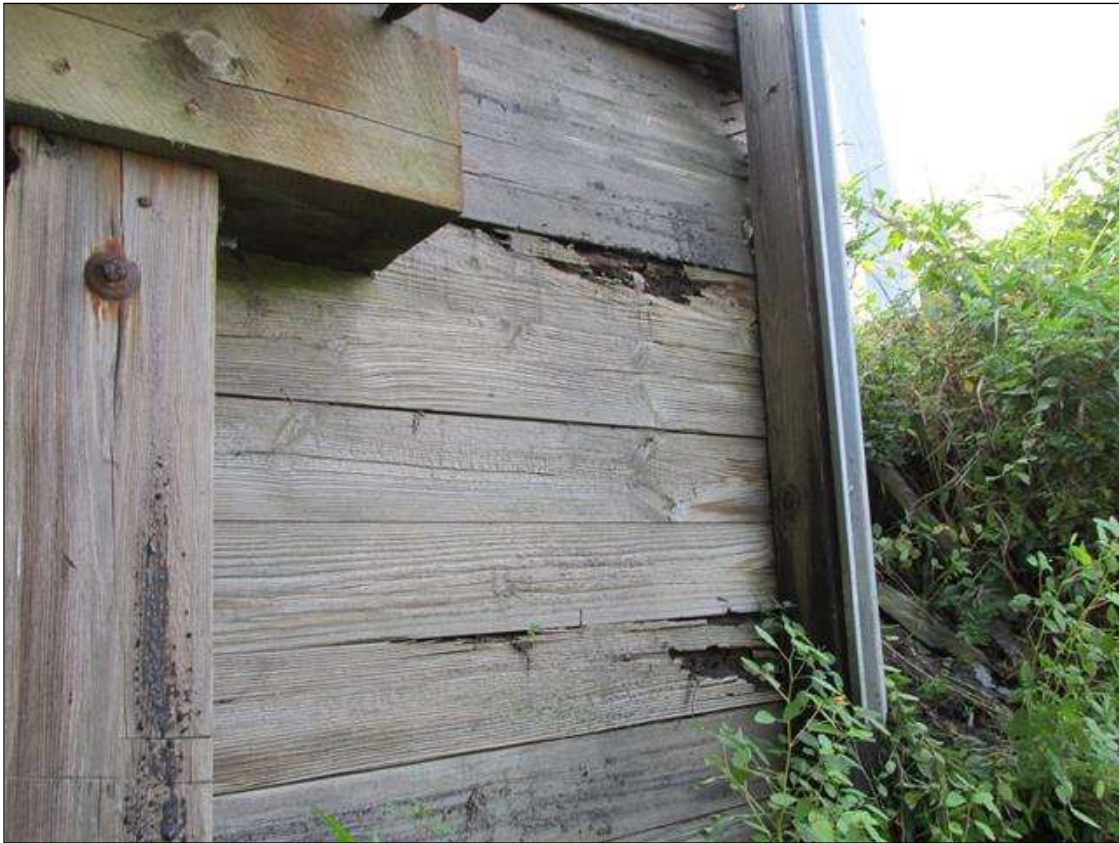
RIGHT END ABUT. (B) (3) BOARDS DECAYED (+/- 5 LF)

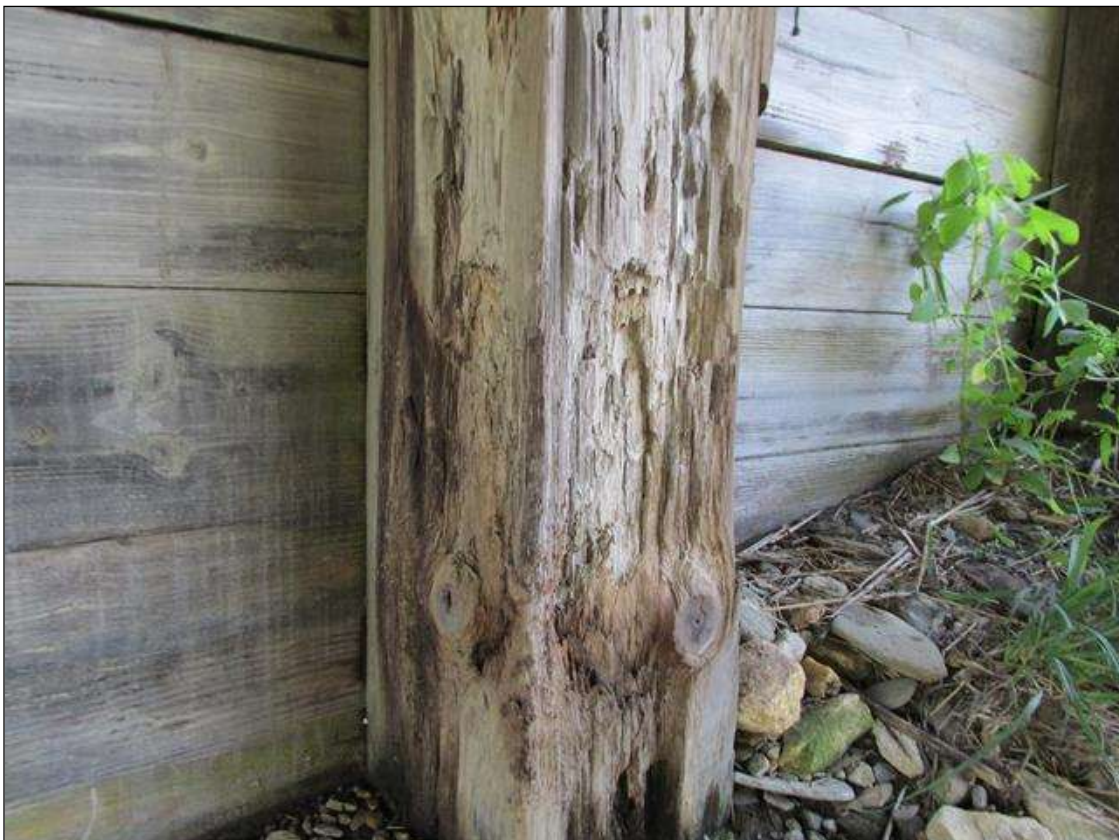
ABUT. (B) POST (7) DECAYED FULL HEIGHT (+/- 8' H X 3" D)

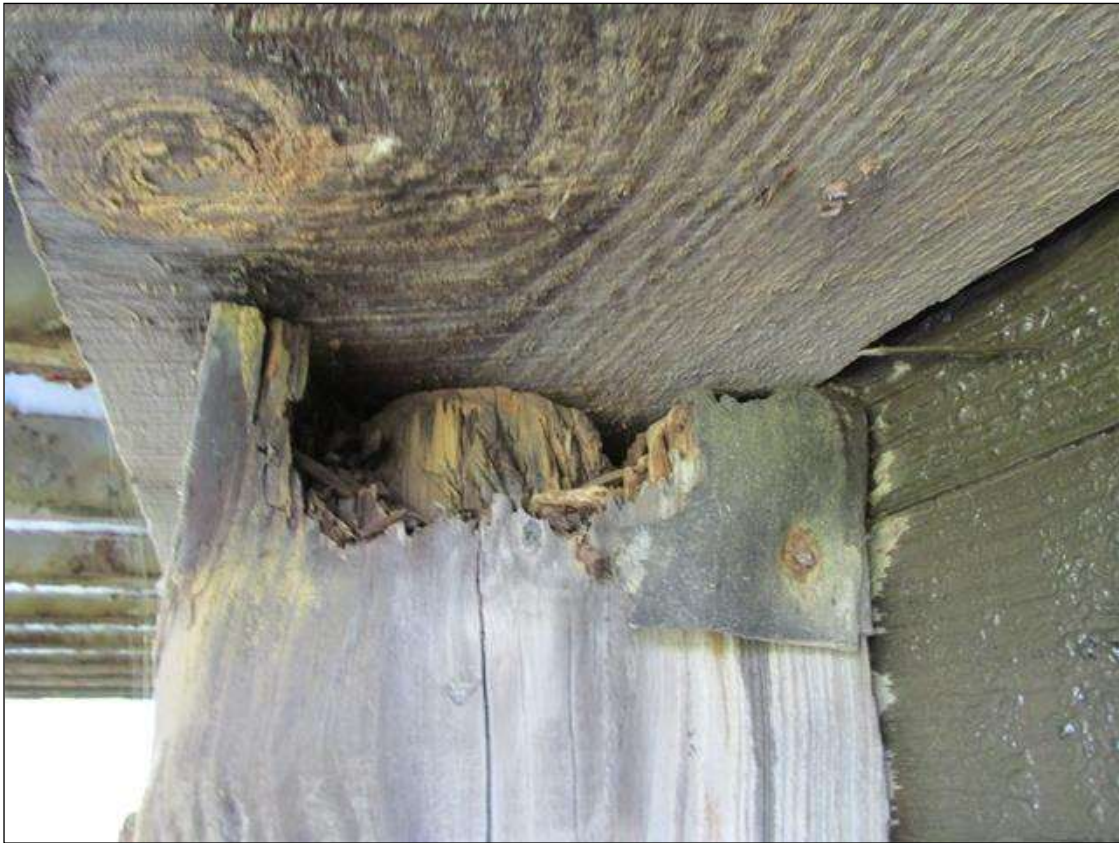
ABUT. (B) POST (7) DECAYED FULL HEIGHT (+/- 8' H X 3" D)

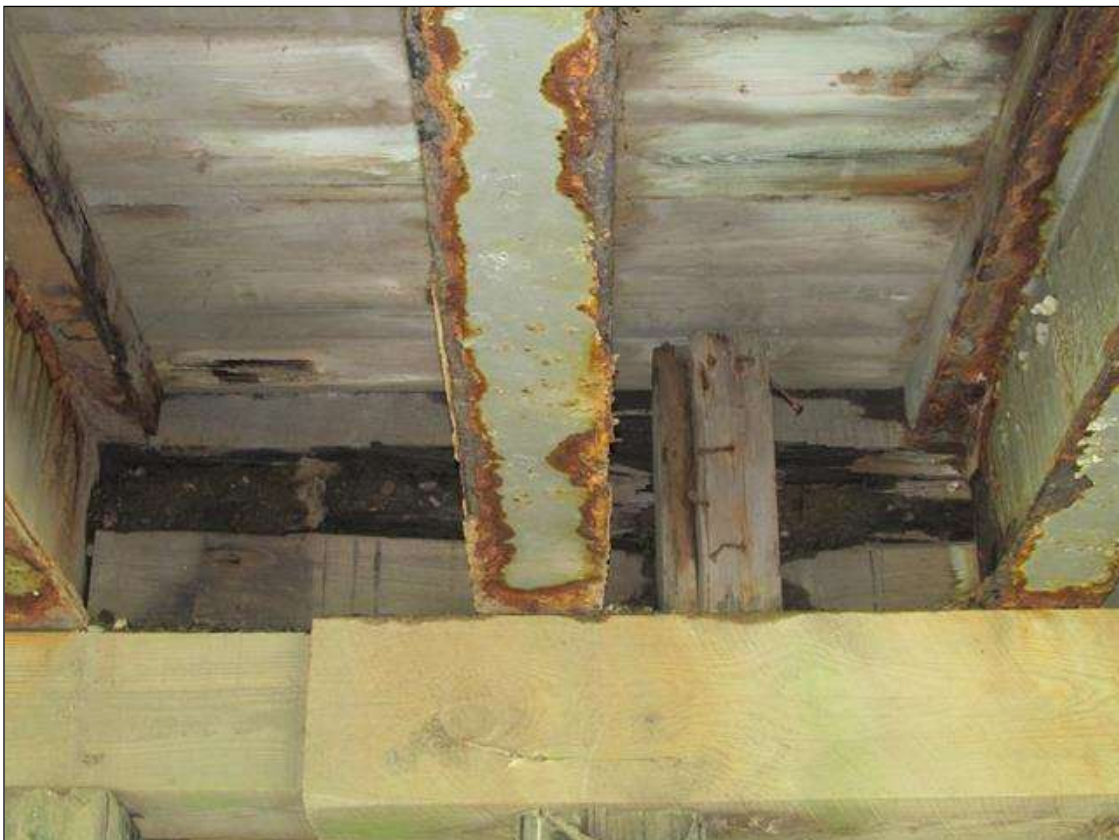
ABUT. (B) BAYS (4 & 5) (1) BOARD DECAYED WITH LOSS OF FILL (+/- 6 LF)

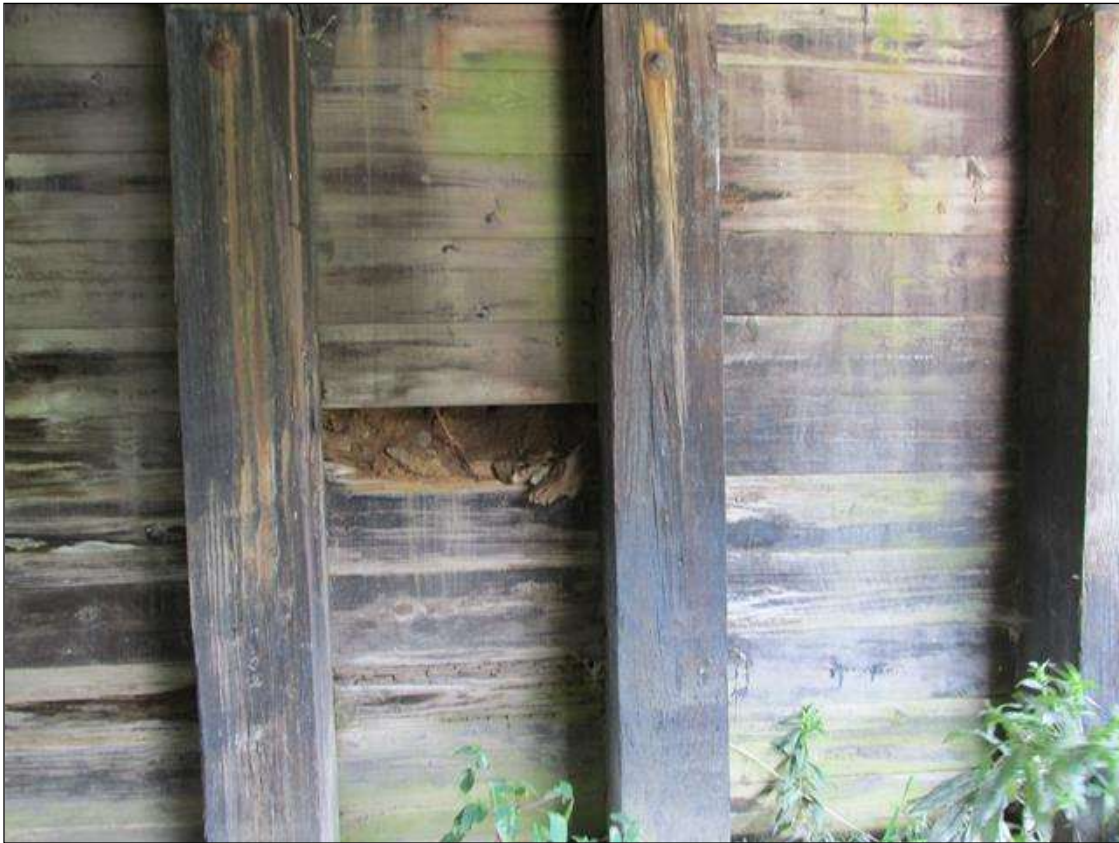
ABUT. (A) (1) BOARD DECAYED WITH LOSS OF FILL (+/- 3 LF) BETWEEN POST (3 & 4)

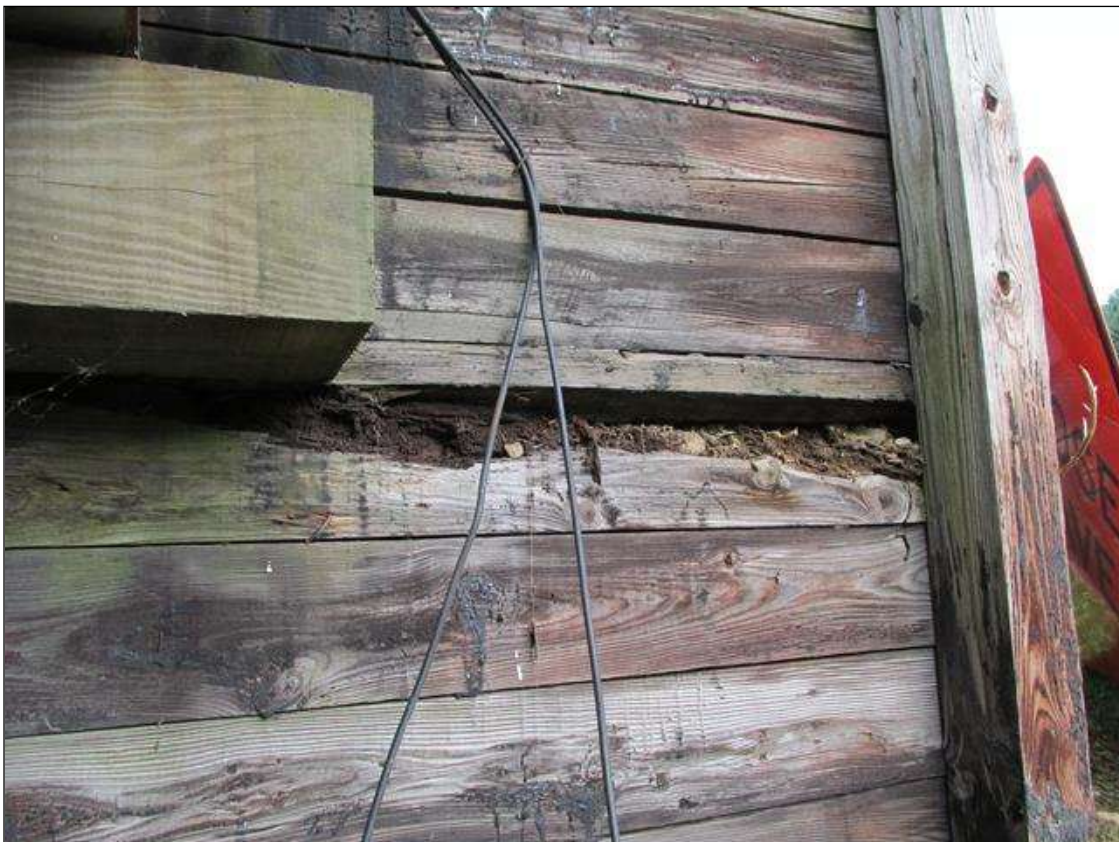
LEFT END ABUT. (A) (1) BOARD DECAYED WITH LOSS OF FILL (+/- 5 LF)

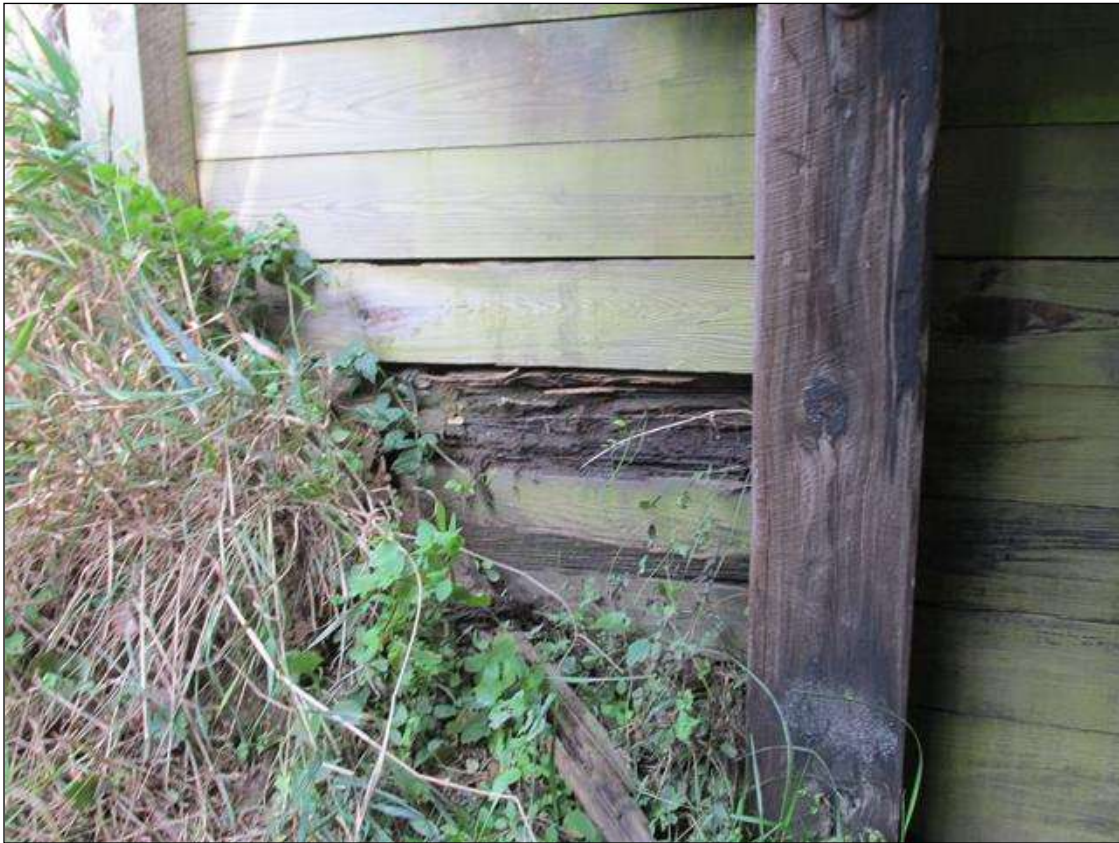
RIGHT END ABUT. (A) (2) BOARDS DECAYED WITH LOSS OF FILL (+/- 6 LF)

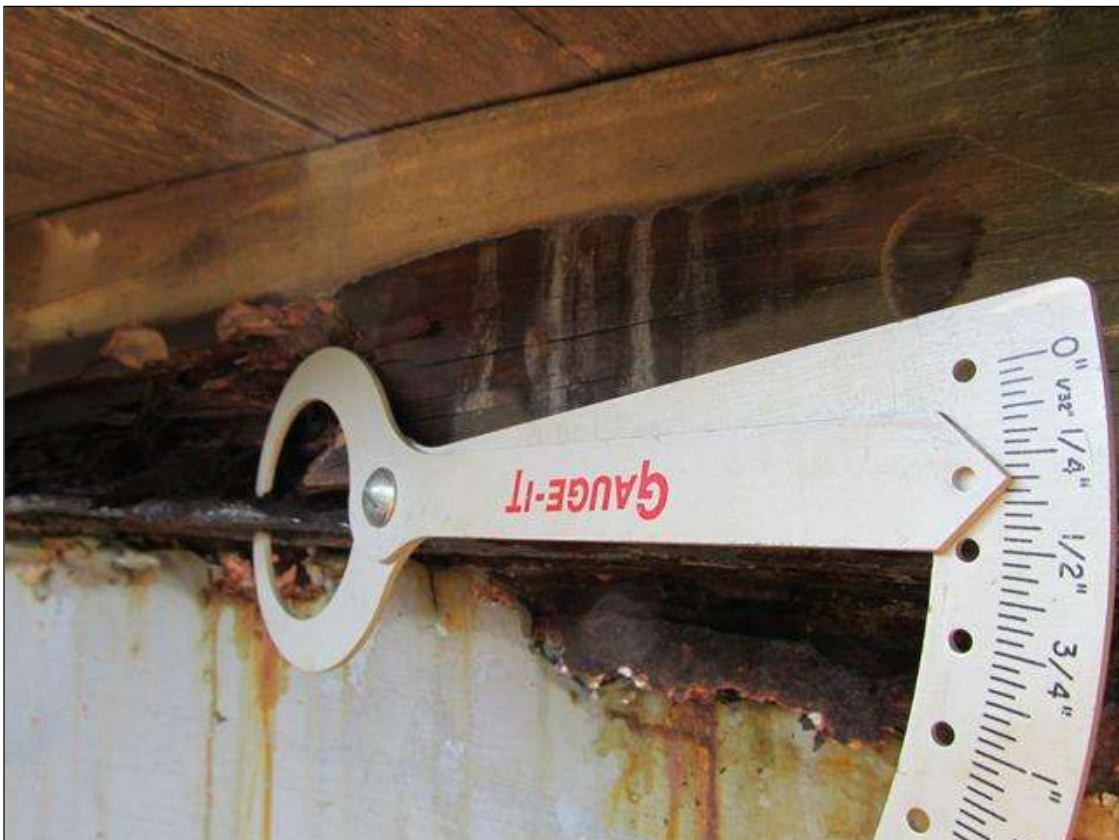
BEAM (1) CORROSION F/L ALONG TOP AND BOTTOM FLANGES WITH (+/- 1/4") LOSS OF SECTION AND A REMAINING SECTION (+/- 5/16") .

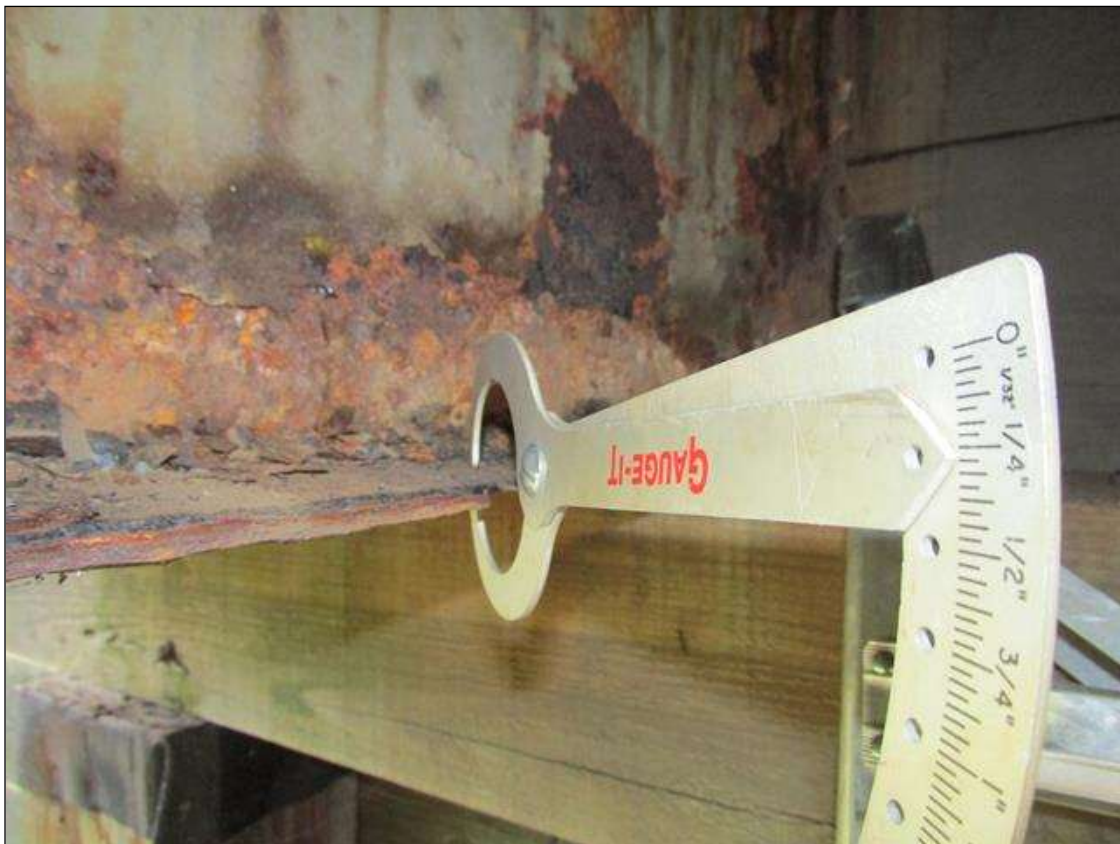
BEAM (2) CORROSION F/L ALONG TOP AND BOTTOM FLANGES WITH (+/- 5/16 ") LOSS OF SECTION AND A REMAINING SECTION (+/- 1/4")

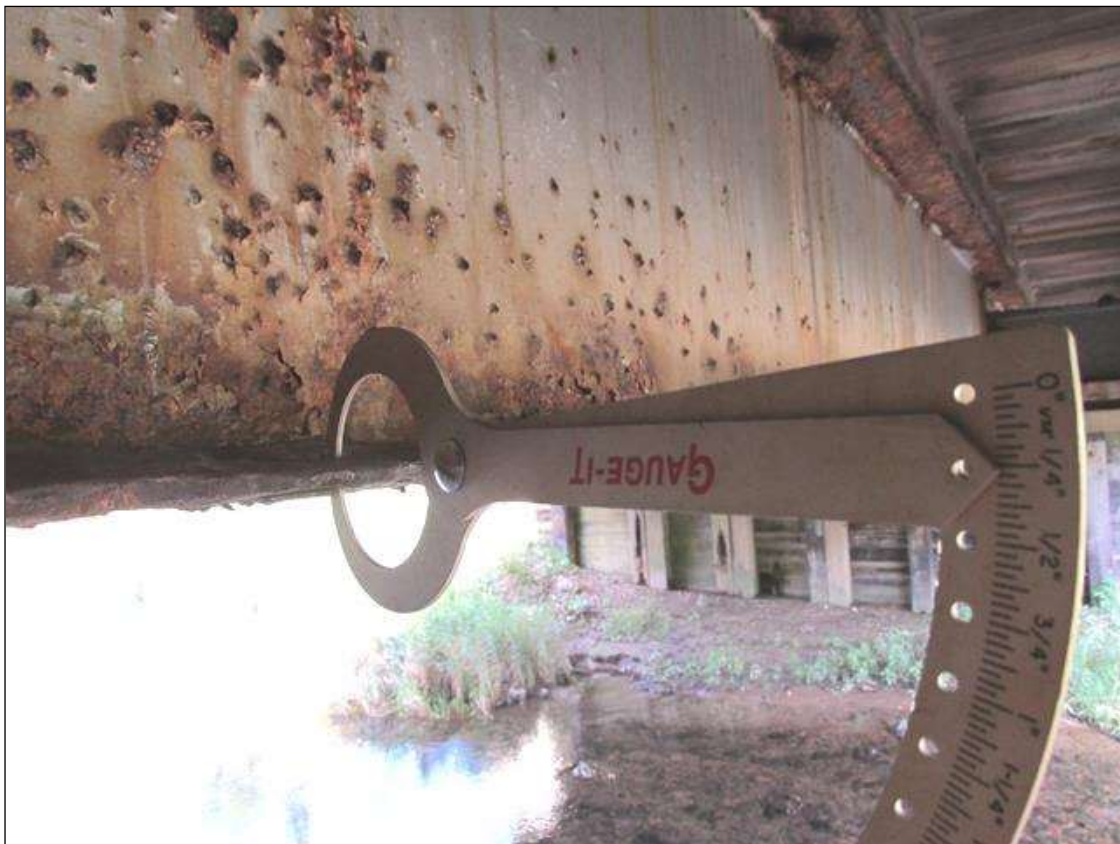
BEAM (3) CORROSION F/L ALONG TOP AND BOTTOM FLANGES WITH (+/- 5/16 ") LOSS OF SECTION AND A REMAINING SECTION (+/- 1/4")

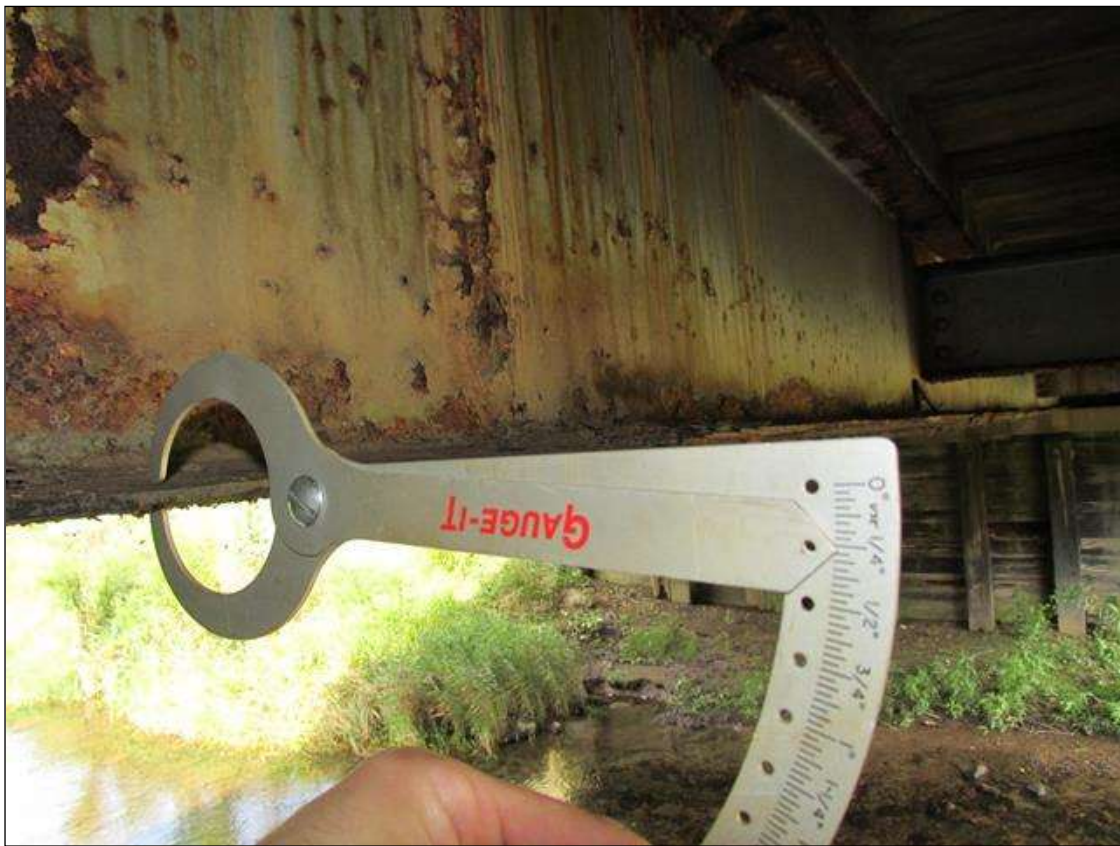
BEAM (4) CORROSION F/L ALONG TOP AND BOTTOM FLANGES WITH (+/- 5/16 ") LOSS OF SECTION AND A REMAINING SECTION (+/- 1/4")

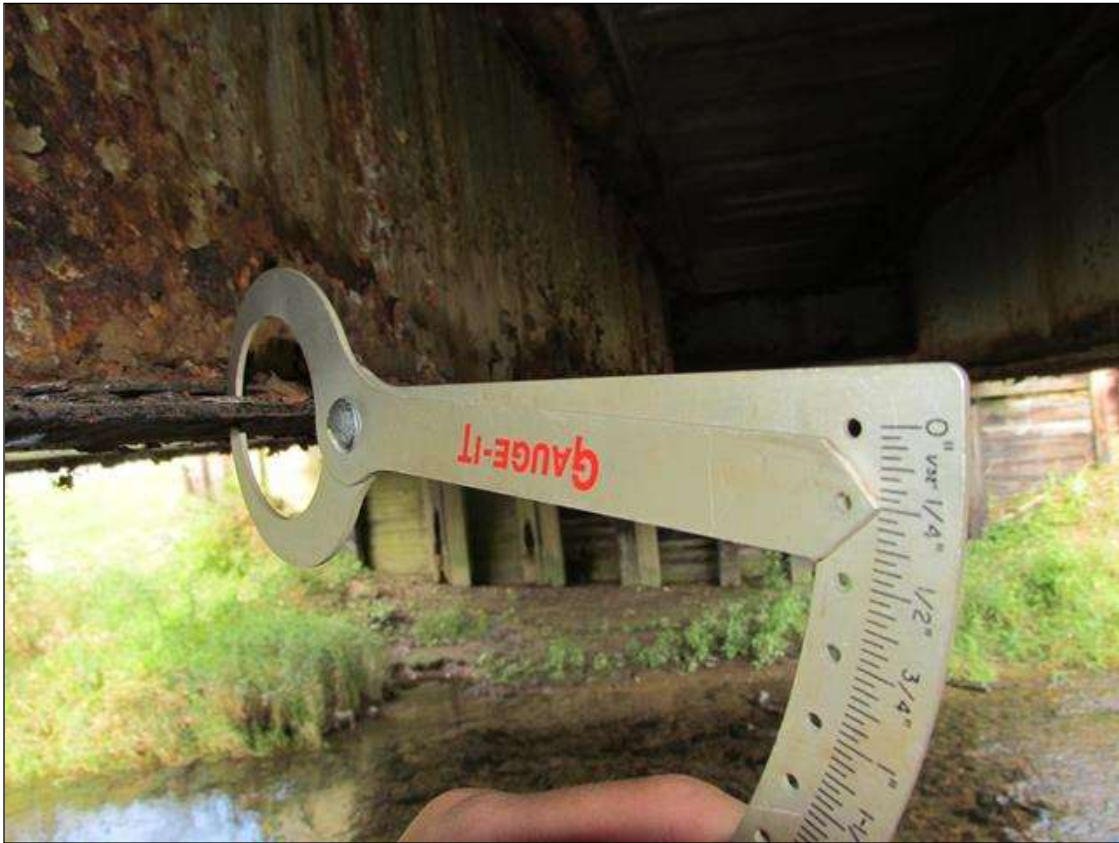
BEAM (5) CORROSION F/L ALONG TOP AND BOTTOM FLANGES WITH (+/- 5/16 ") LOSS OF SECTION AND A REMAINING SECTION (+/- 1/4")
