NC DEPARTMENT OF TRANSPORTATION  
DIVISION OF HIGHWAYS  
STRUCTURE MANAGEMENT UNIT

## Structure Safety Report

### Routine Element Inspection

COUNTY: WATAUGA STRUCTURE NUMBER: 940278 FREQUENCY: 24 MONTHS  
FACILITY CARRIED: SR1540 MILE POST: \_\_\_\_\_  
LOCATION: 25 FT.W.JCT.US221,321  
FEATURE INTERSECTED: CREEK  
LATITUDE: 36° 10' 9.1" LONGITUDE: 81° 38' 47.88"  
SUPERSTRUCTURE: TIMBER FLOOR ON I-BEAMS

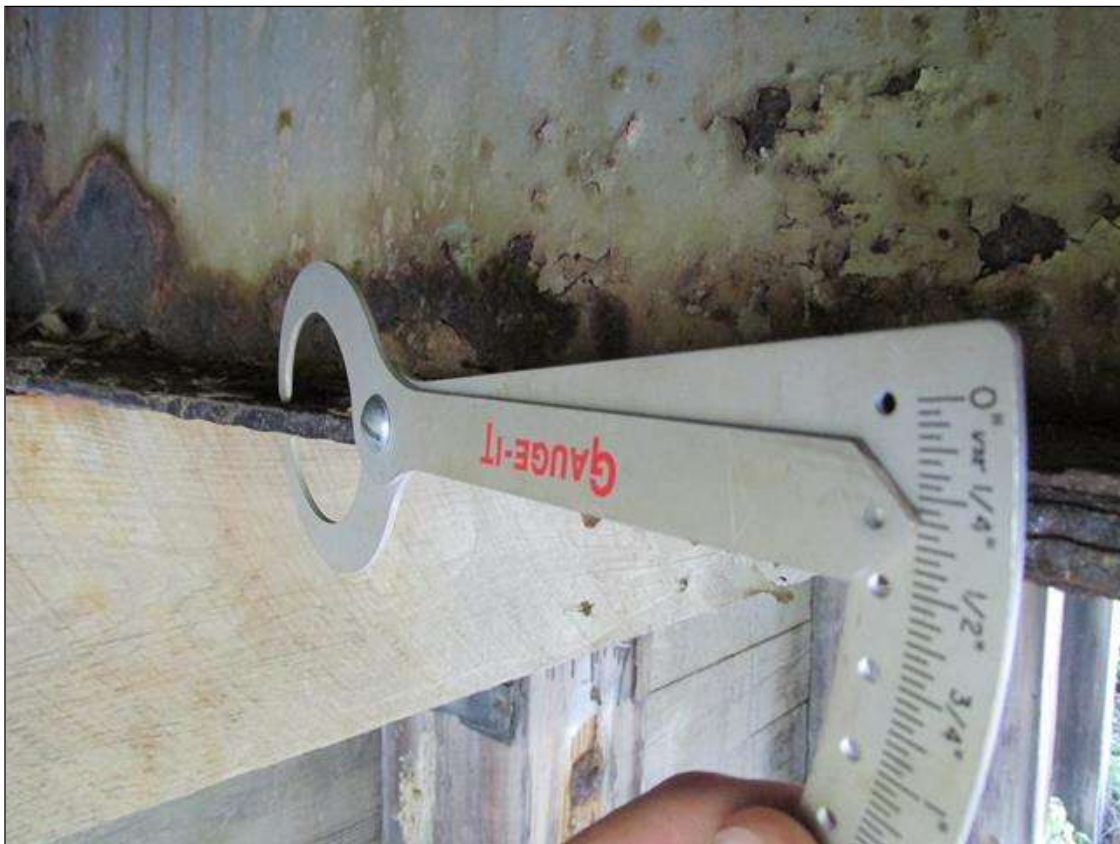
BEAM (6) CORROSION F/L ALONG TOP AND BOTTOM FLANGES WITH (+/- 1/4") LOSS OF SECTION AND A REMAINING SECTION (+/- 5/16")

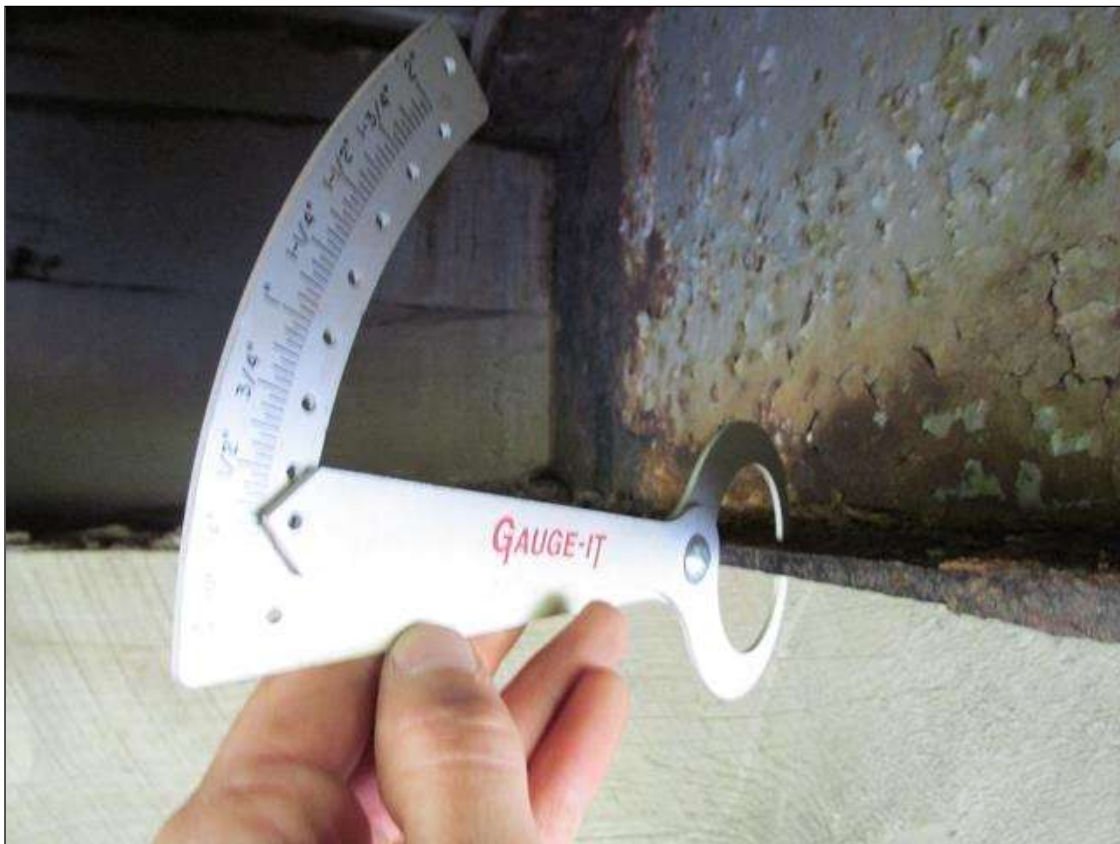
BEAM (7) CORROSION F/L ALONG TOP AND BOTTOM FLANGES WITH (+/- 1/4") LOSS OF SECTION AND A REMAINING SECTION (+/- 5/16")

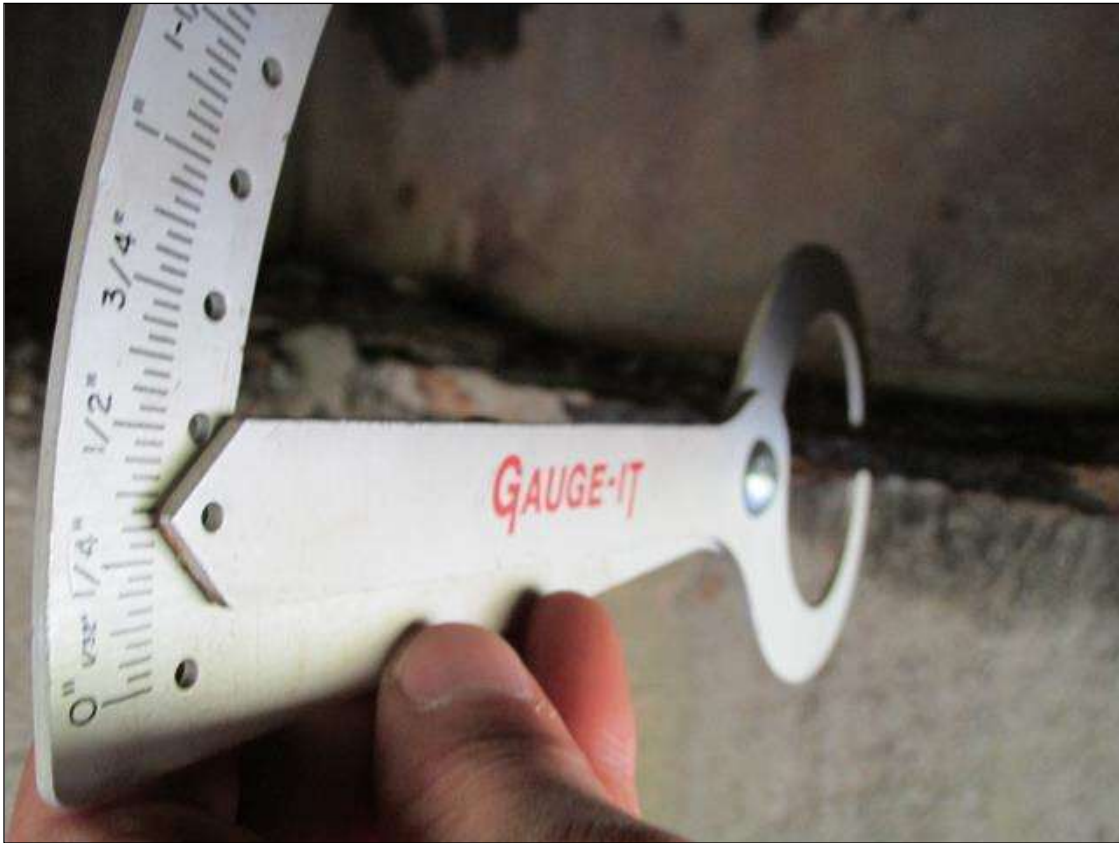
BEAM (8) CORROSION F/L ALONG TOP AND BOTTOM FLANGES WITH (+/- 1/4") LOSS OF SECTION AND A REMAINING SECTION (+/- 5/16")

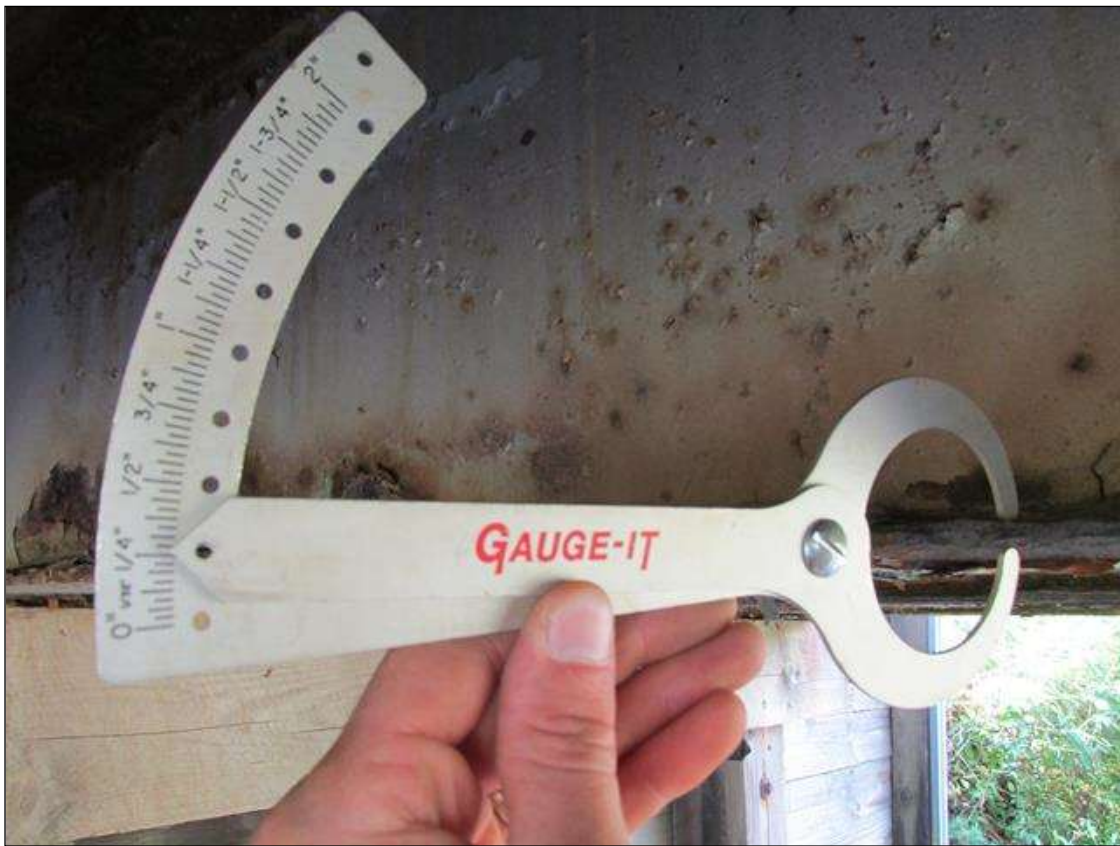
BEAM (9) CORROSION F/L ALONG TOP AND BOTTOM FLANGES WITH (+/- 5/16 ") LOSS OF SECTION AND A REMAINING SECTION (+/- 1/4")

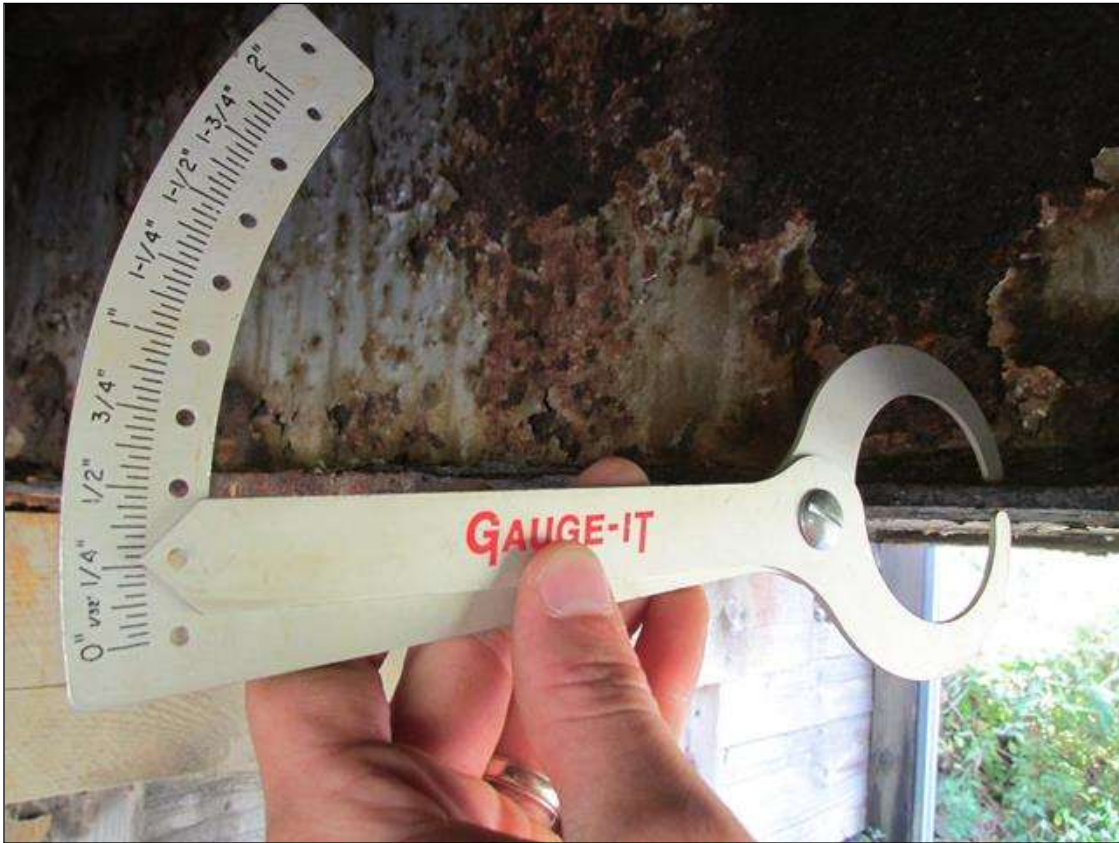
BEAM (10) CORROSION F/L ALONG TOP AND BOTTOM FLANGES WITH (+/- 5/16 ") LOSS OF SECTION AND A REMAINING SECTION (+/- 1/4")

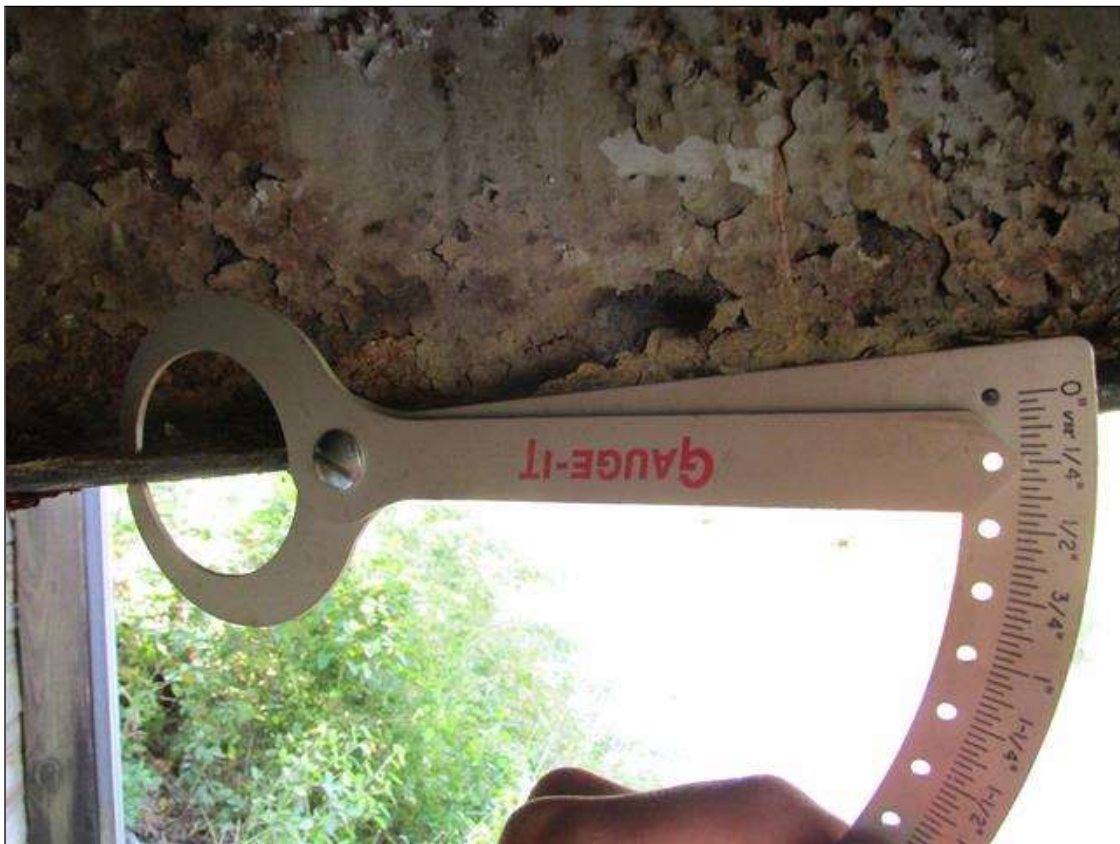
BEAM (11) CORROSION F/L ALONG TOP AND BOTTOM FLANGES WITH (+/- 5/16 ") LOSS OF SECTION AND A REMAINING SECTION (+/- 1/4")

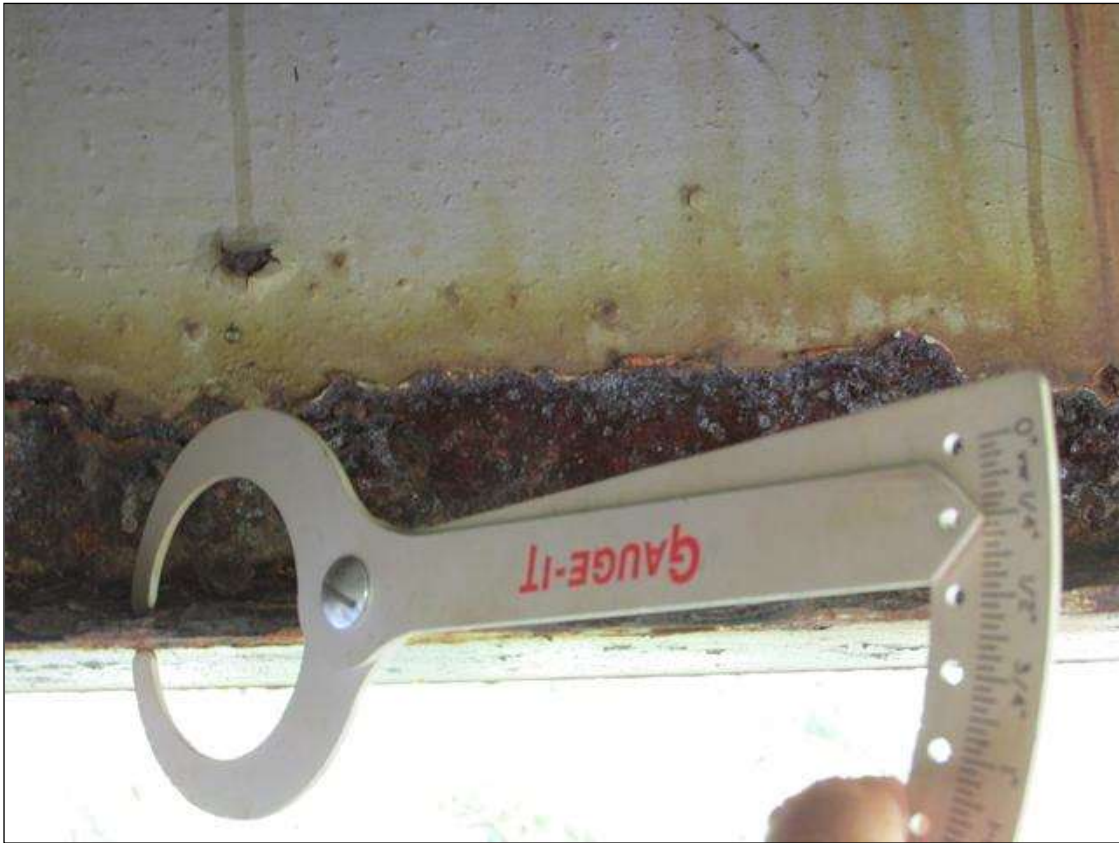
BEAM (12) CORROSION F/L ALONG TOP AND BOTTOM FLANGES WITH (+/- 5/16 ") LOSS OF SECTION AND A REMAINING SECTION (+/- 1/4")

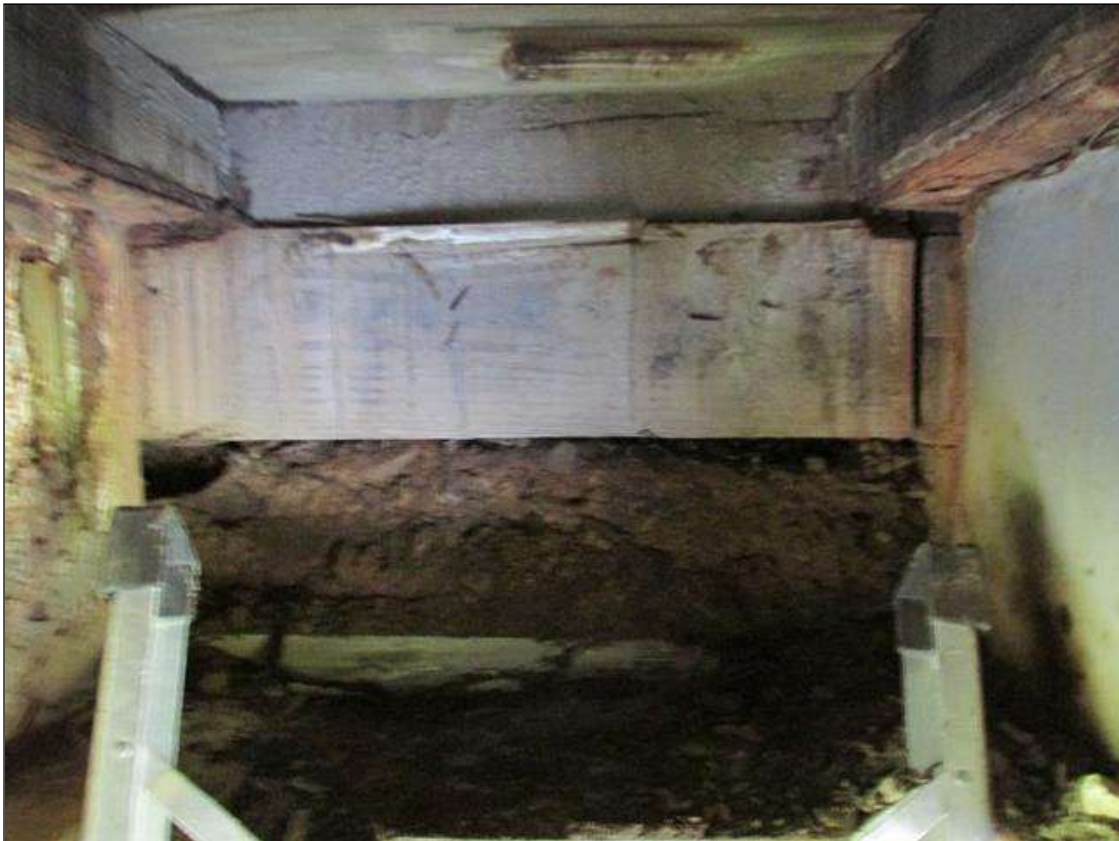
ABUT. (A) BULKHEAD BAYS (4 & 5) (2) BOARDS DECAYED WITH LOSS OF FILL (+/- 6 LF)

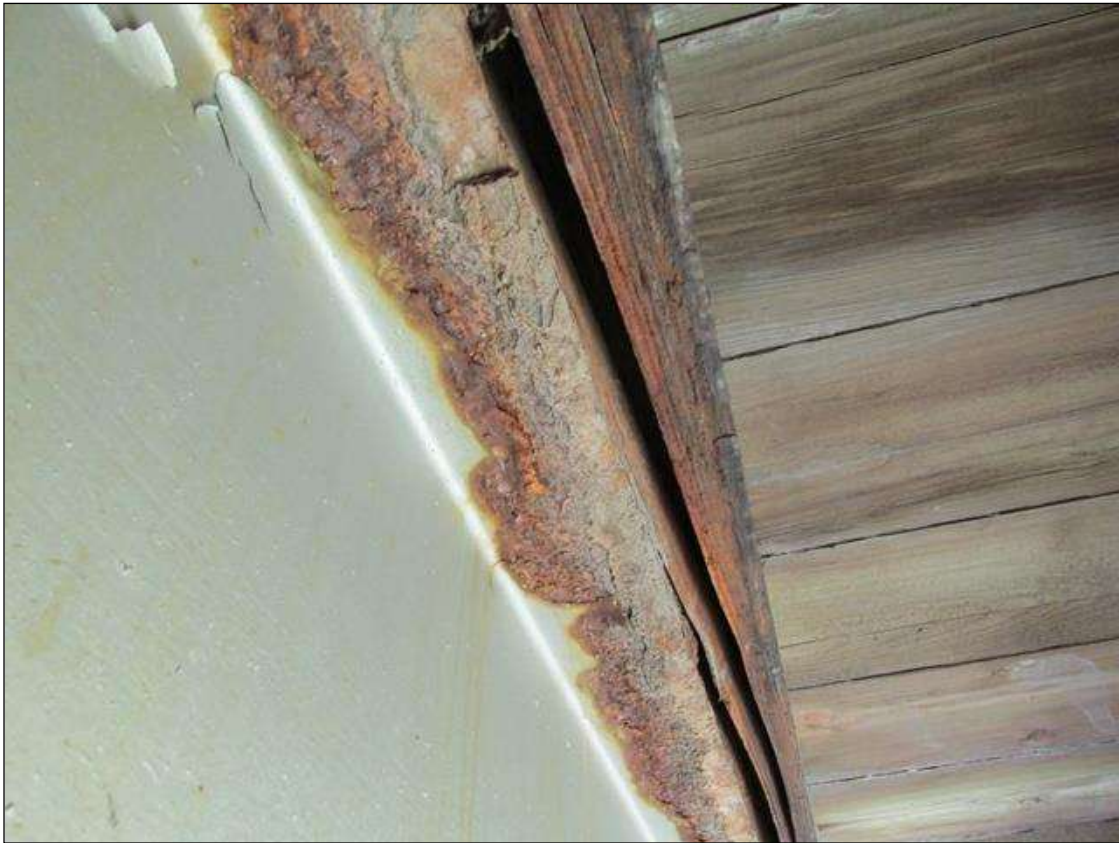
BEAM (10) TIMBER NAILER, SPLIT AND DECAYED FULL LENGTH ALONG TOP OF BEAM (+/- 45 SF) SIMILAR AT BEAM NAILERS (9, 11 & 12) F/L (+/- 180 SF) TOTAL

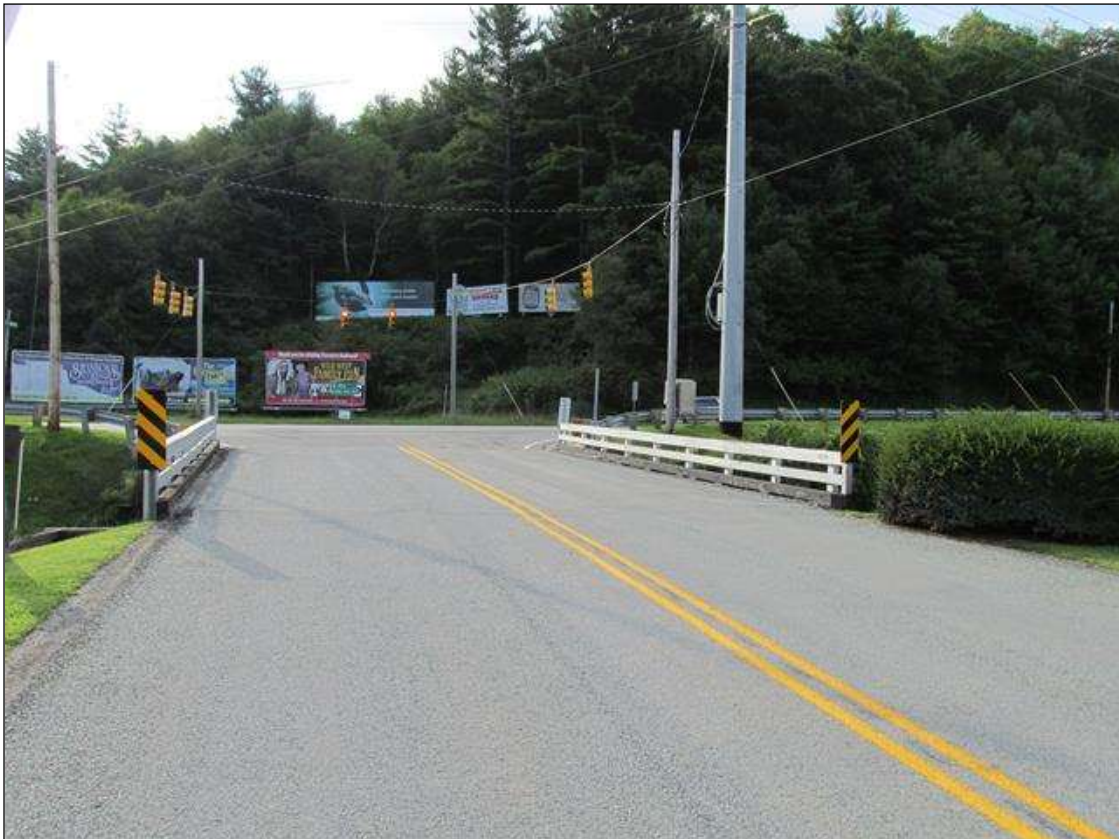
MISSING (2) WEIGHT LIMIT SIGNS...
