NC DEPARTMENT OF TRANSPORTATION  
DIVISION OF HIGHWAYS  
STRUCTURE MANAGEMENT UNIT

## Structure Safety Report

### Routine Element Inspection - Contract

DIVISION: 6 COUNTY: CUMBERLAND STRUCTURE NUMBER: 250043 FREQUENCY: 24 MONTHS

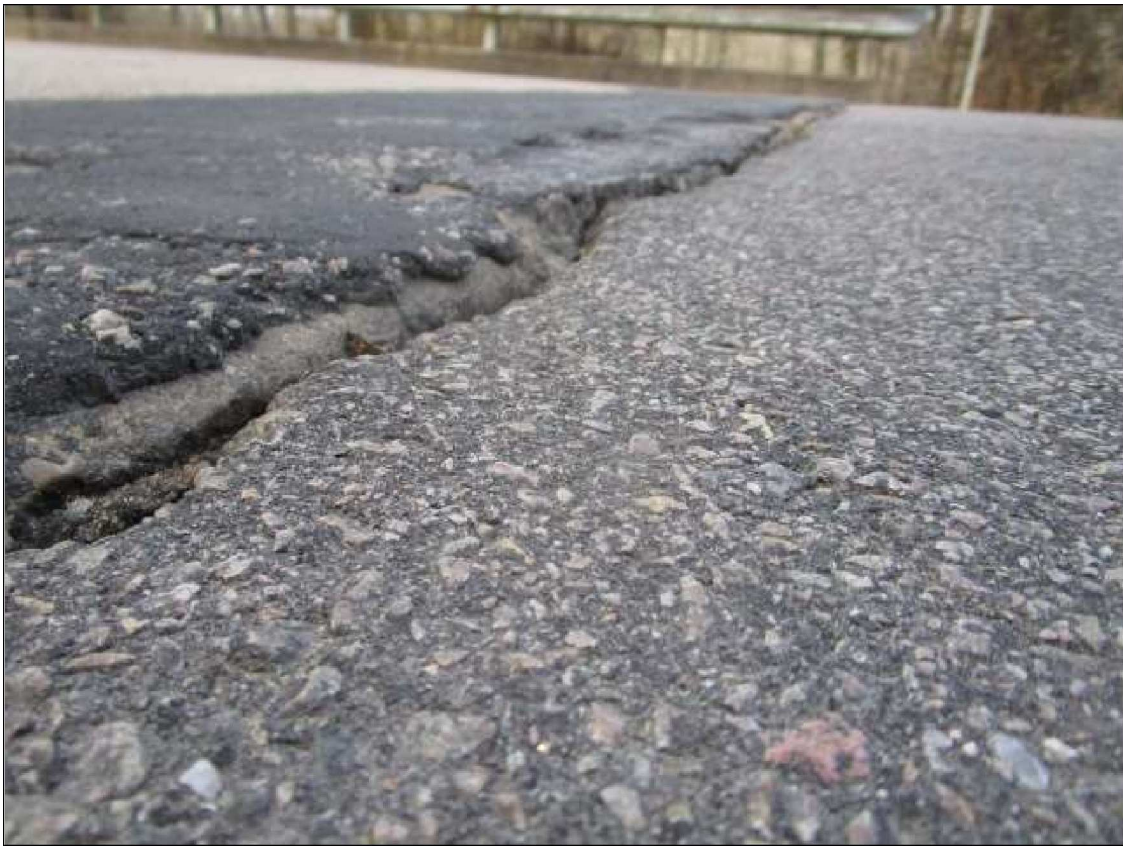
1/2" SETTLEMENT IN NORTH APPROACH

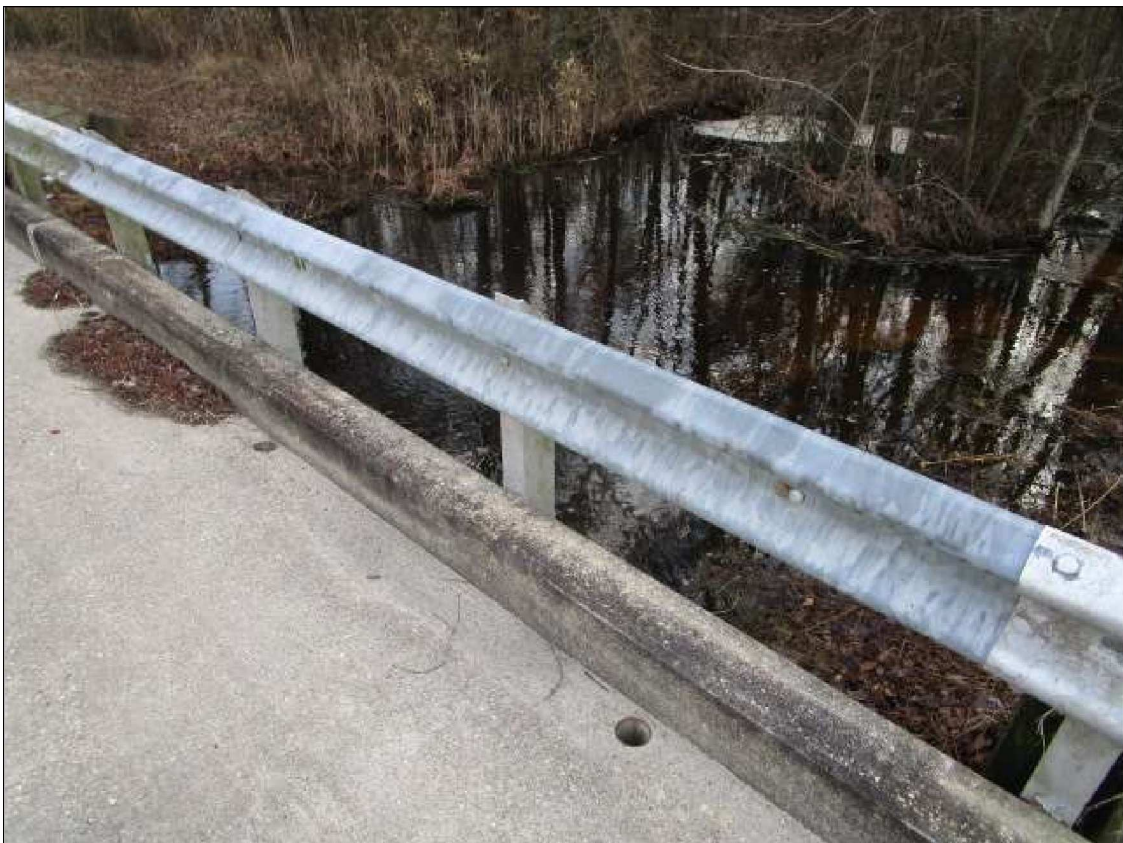
REPAIRED SPAN 1 RIGHT RAIL SECTION

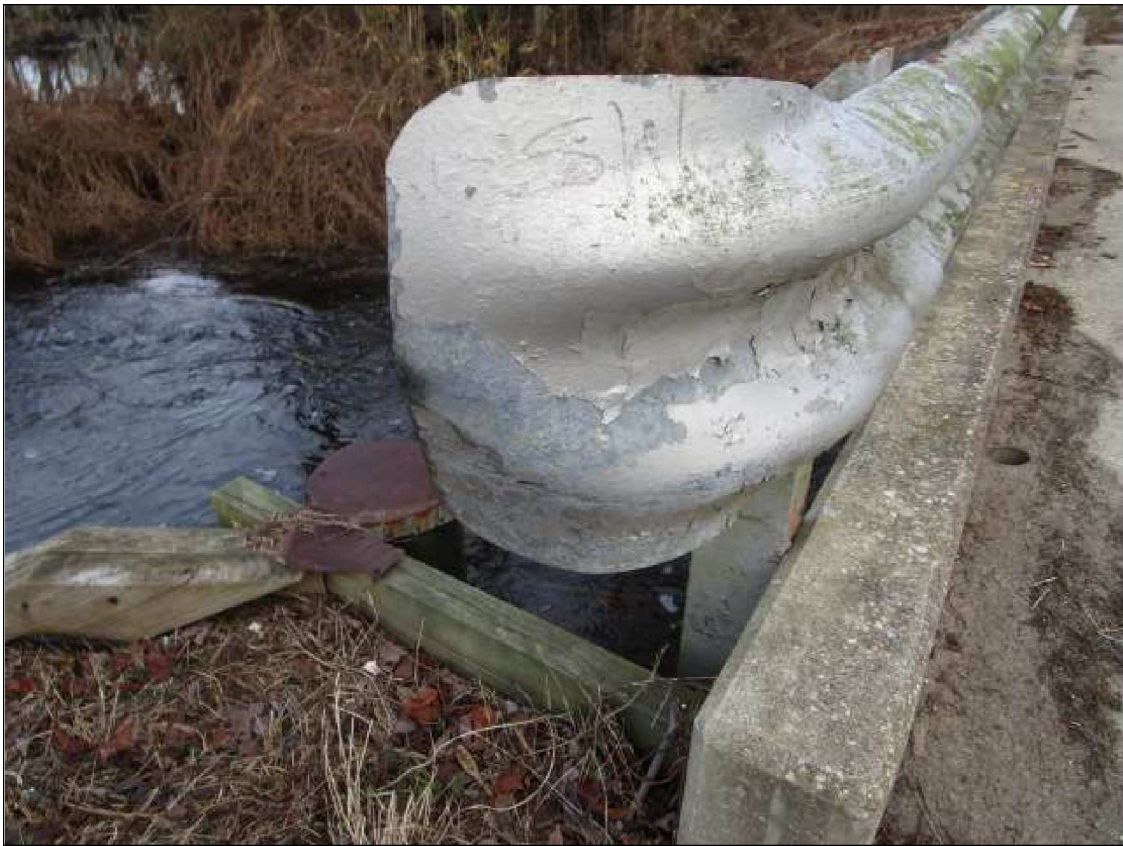
| Element Number | Defect Type | Defect Description | CS | CS Qty | Maint Qty | |
|---|---|---|---|---|---|---|
| 330 | Damage | DAMAGED RAIL END AT END BENT 1 | 2 | 1 | 1 | Feet |

Span 1 Left Bridge Rail: DAMAGED RAIL END AT END BENT 1

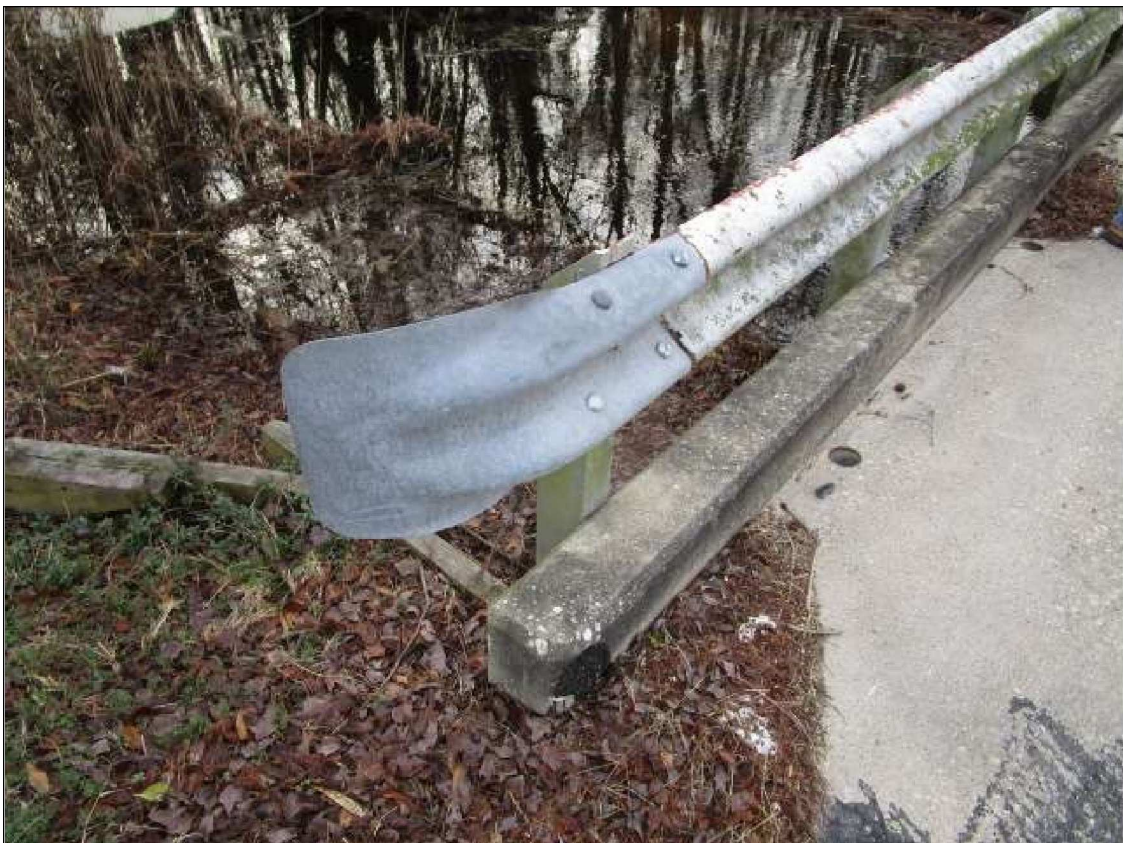
REPLACED NORTHEAST CORNER OF RAIL

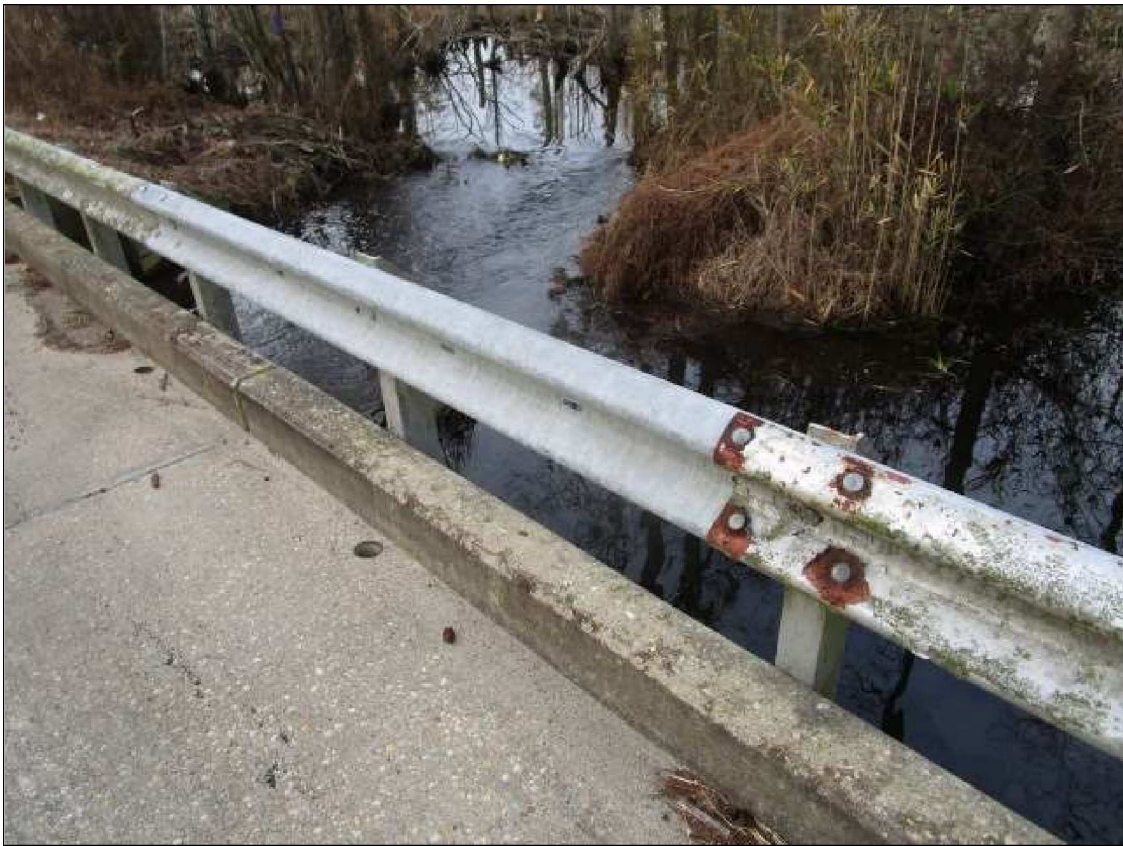
REPLACED LEFT RAIL SECTION OVER BENT 1

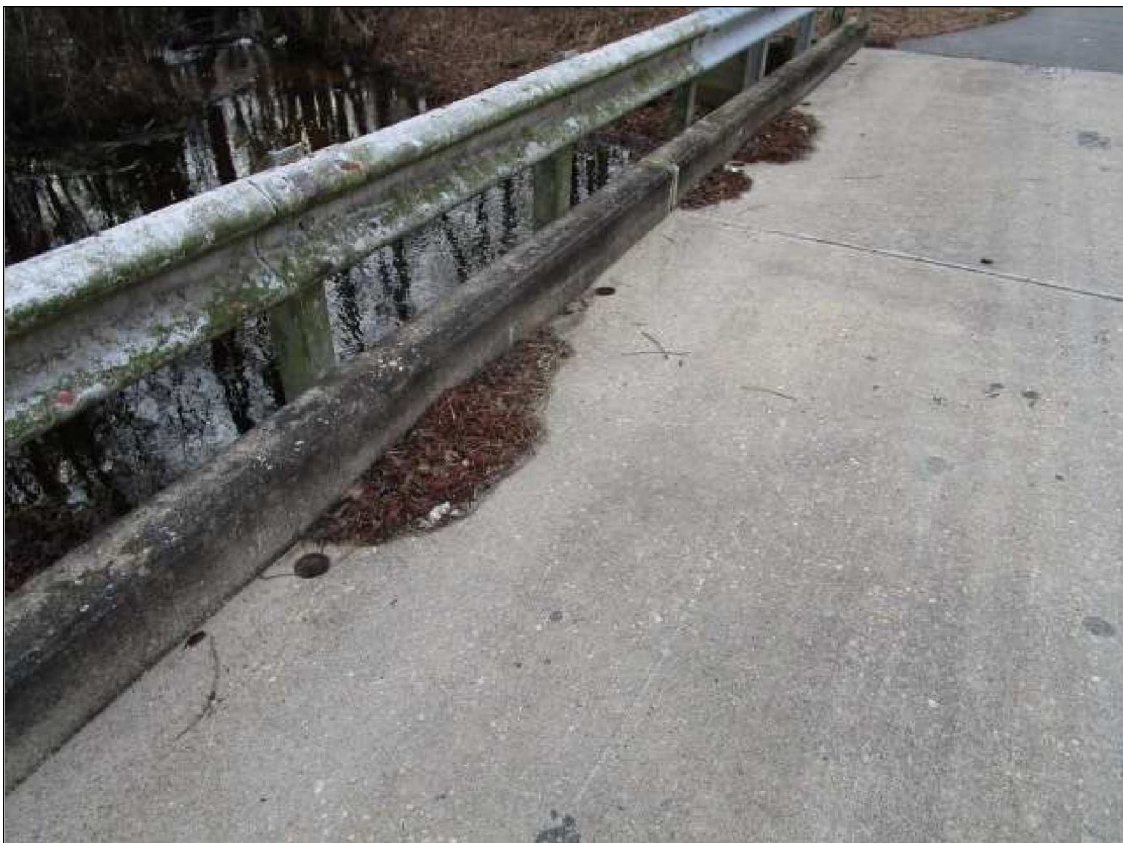
| Details | DEBRIS ALONG BOTH RAILS | | | | | | |

DEBRIS ALONG RAILS

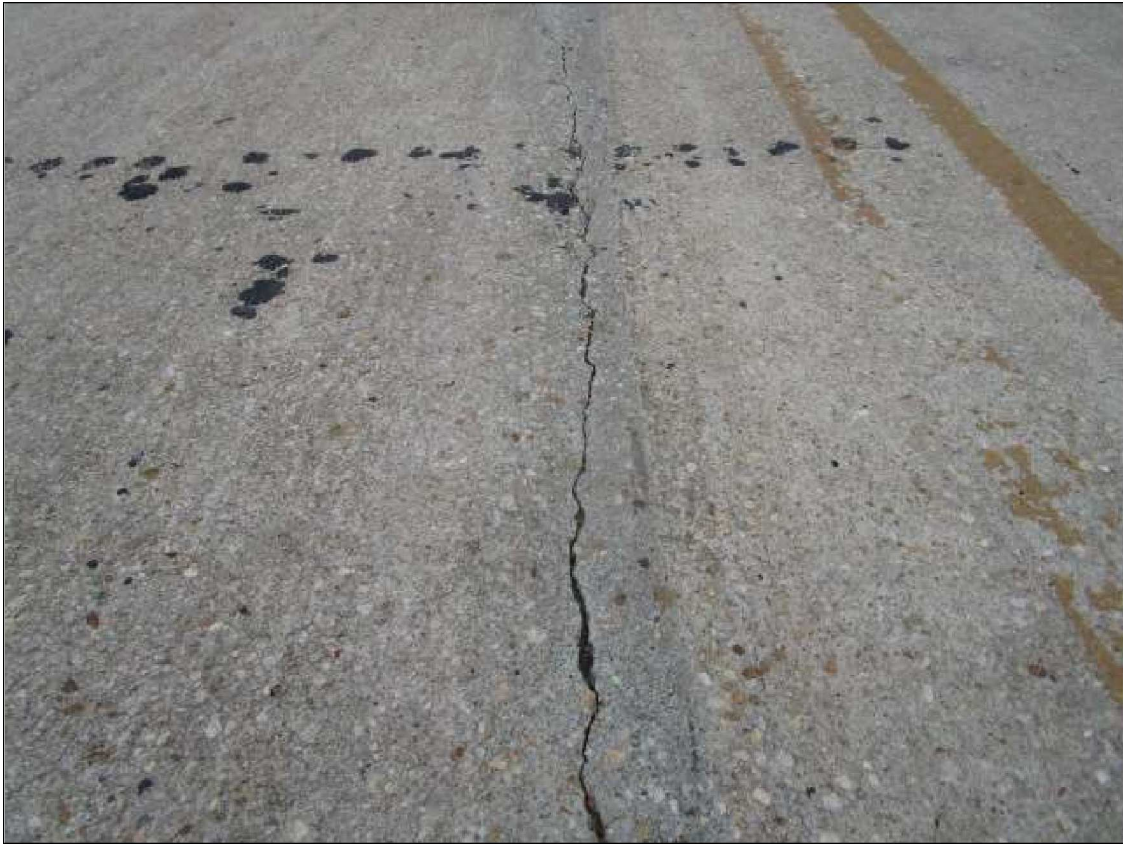
| Element Number | Defect Type | Defect Description | CS | CS Qty | Maint Qty | |
|---|---|---|---|---|---|---|
| 12 | Cracking (RC and Other) | 1/8" LONGITUDINAL CRACK IN SOUTH BOUND LANE | 3 | 18 | 18 | Square Feet |

Span 1 Deck: 1/8" LONGITUDINAL CRACK IN SOUTH BOUND LANE

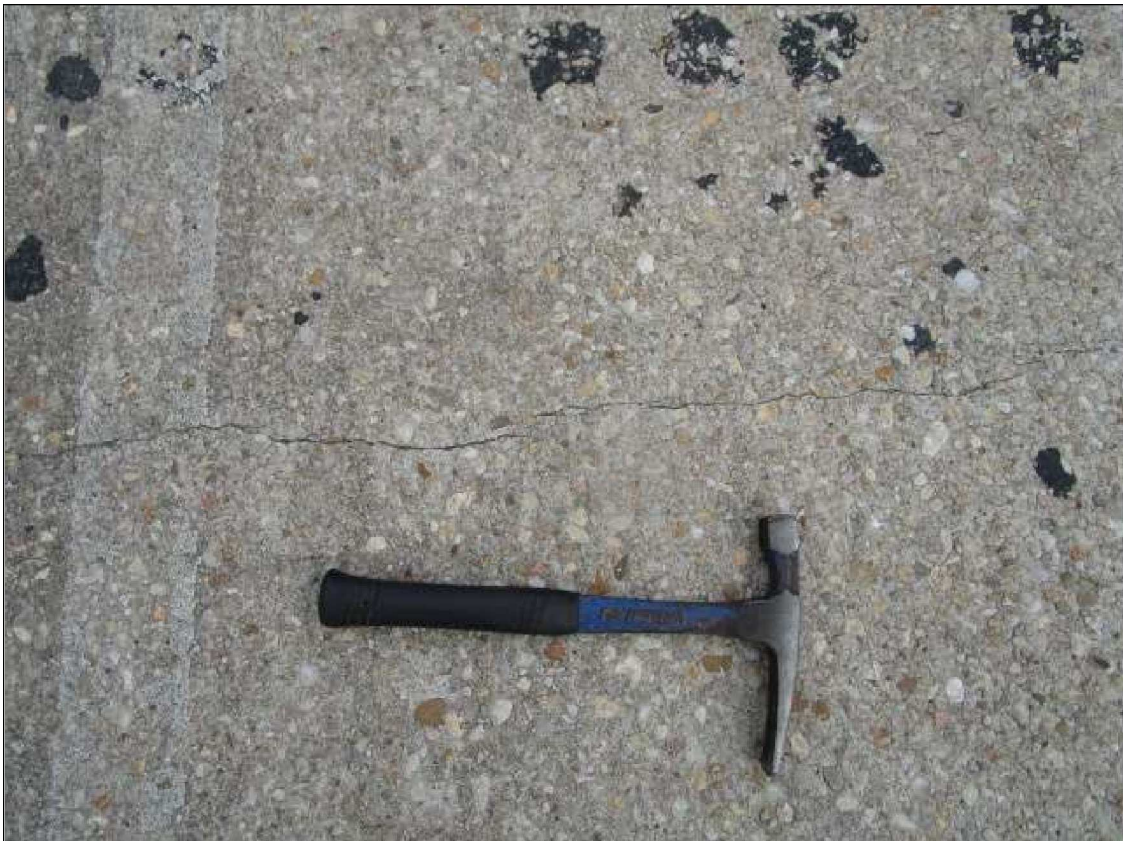
| Element Number | Defect Type | Defect Description | CS | CS Qty | Maint Qty | |
|---|---|---|---|---|---|---|
| 12 | Cracking (RC and Other) | 1/16" TRANSVERSE CRACKING | 2 | 50 | 50 | Square Feet |

Span 1 Deck: 1/16" TRANSVERSE CRACKING

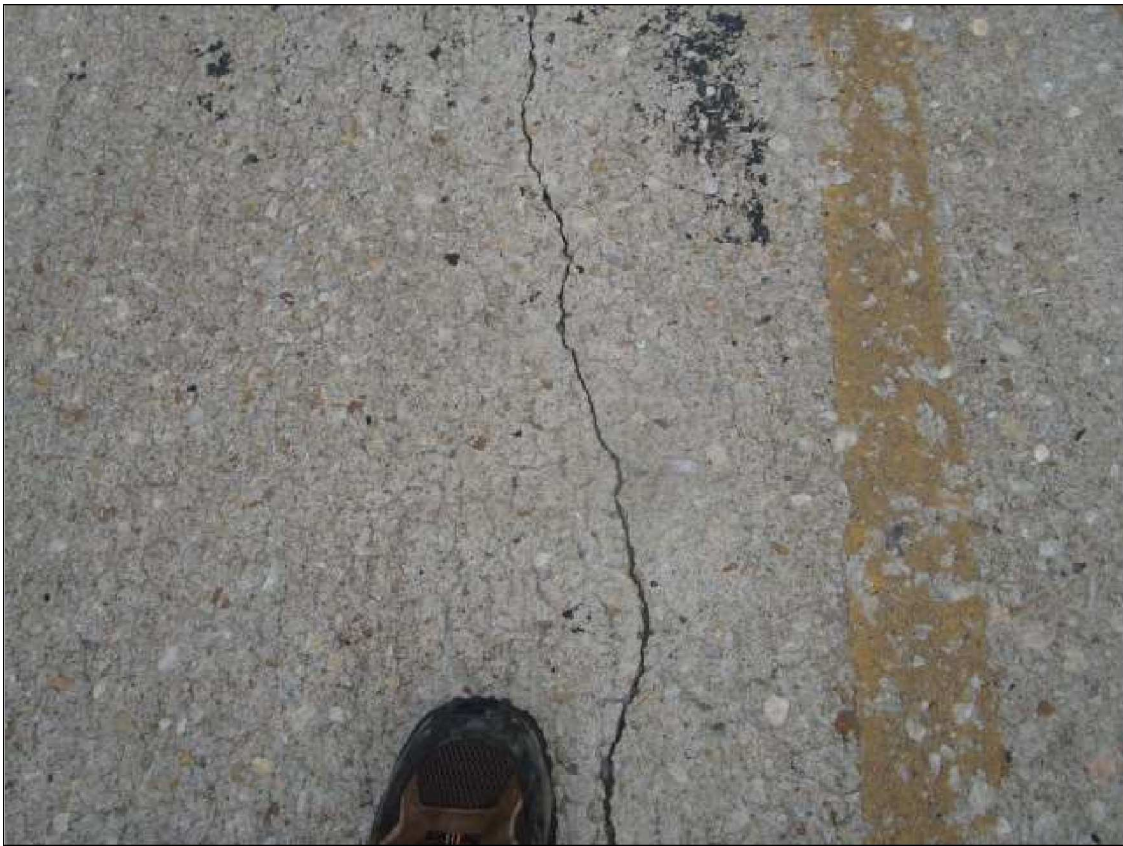
| Element Number | Defect Type | Defect Description | CS | CS Qty | Maint Qty |
|---|---|---|---|---|---|
| 12 | Cracking (RC and Other) | 1/8" LONGITUDINAL CRACK IN SOUTH BOUND LANE | 3 | 18 | 18 Square Feet |

Span 2 Deck: 1/8" LONGITUDINAL CRACK IN SOUTH BOUND LANE

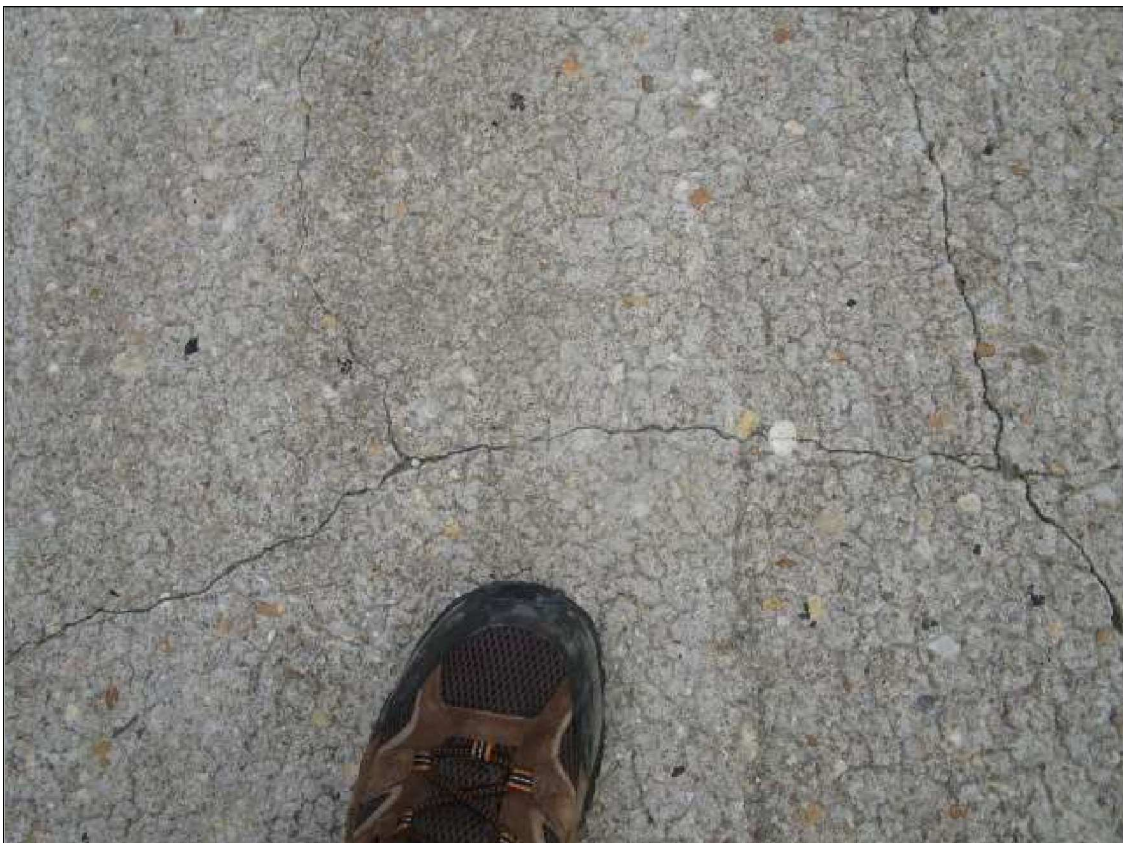
| Element Number | Defect Type | Defect Description | CS | CS Qty | Maint Qty |
|---|---|---|---|---|---|
| 12 | Cracking (RC and Other) | 1/16" TRANSVERSE AND LONGITUDINAL CRACKING | 2 | 93 | 93 Square Feet |

Span 2 Deck: 1/16" TRANSVERSE AND LONGITUDINAL CRACKING

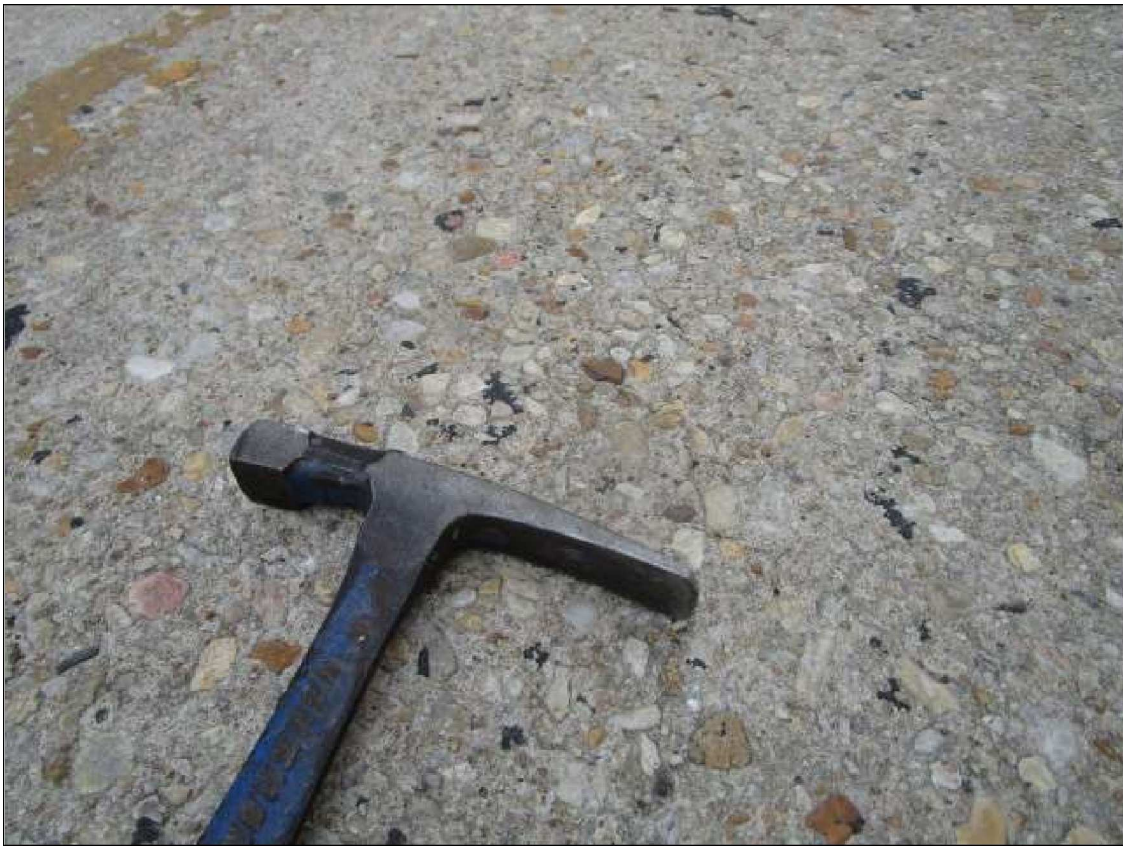
| Element Number | Defect Type | Defect Description | CS | CS Qty | Maint Qty |
|---|---|---|---|---|---|
| 12 | Abrasion/Wear (PSC/RC) | SCALING WITH 1/64" MAP CRACKING THROUGHOUT | 2 | 413 | Square Feet |

Span 2 Deck: SCALING WITH 1/64" MAP CRACKING THROUGHOUT

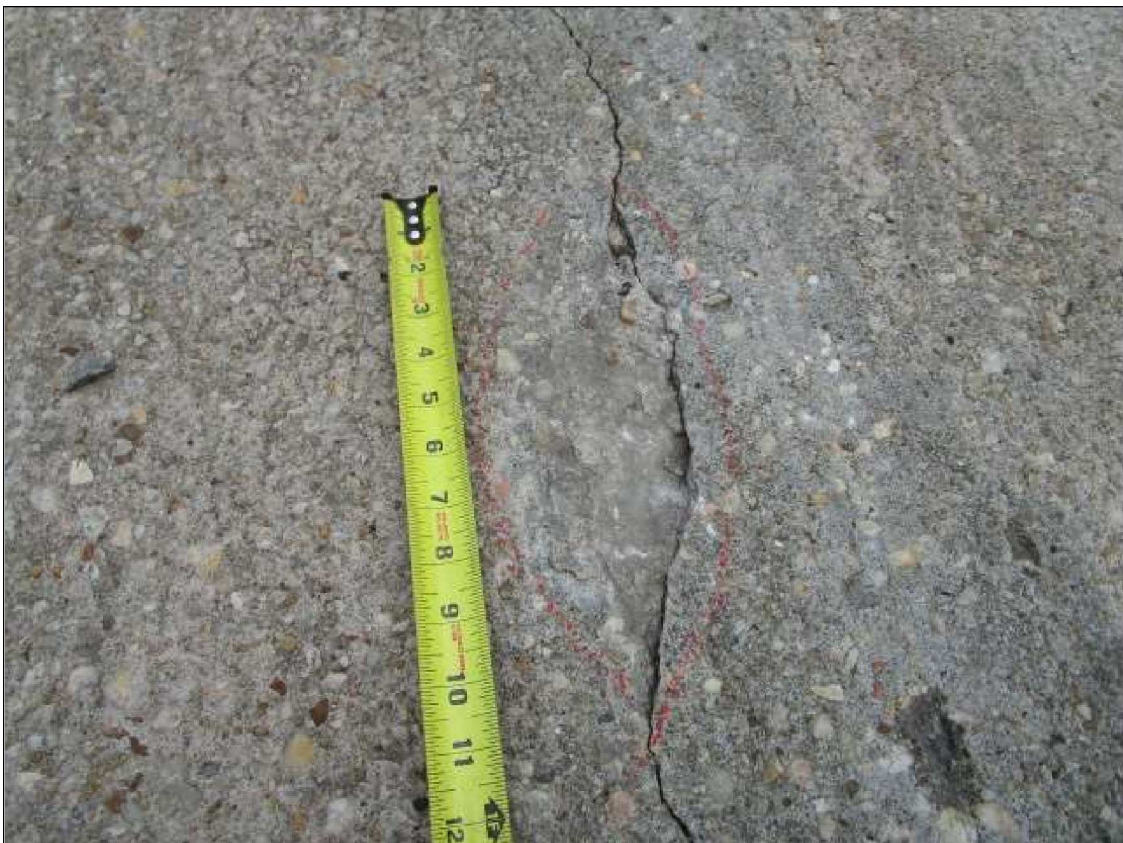
| Element Number | Defect Type | Defect Description | CS | CS Qty | Maint Qty | |
|---|---|---|---|---|---|---|
| 12 | Delamination/Spall | 11" X 4" X 3/8" DEEP POPOUT IN SOUTH BOUND LANE AT 2' FROM BENT 1 JOINT AND 11' FROM LEFT CURB | 3 | 1 | 1 | Square Feet |

Span 1 Deck: 11" X 4" X 3/8" DEEP POPOUT IN SOUTH BOUND LANE AT 2' FROM BENT 1 JOINT AND 11' FROM LEFT CURB

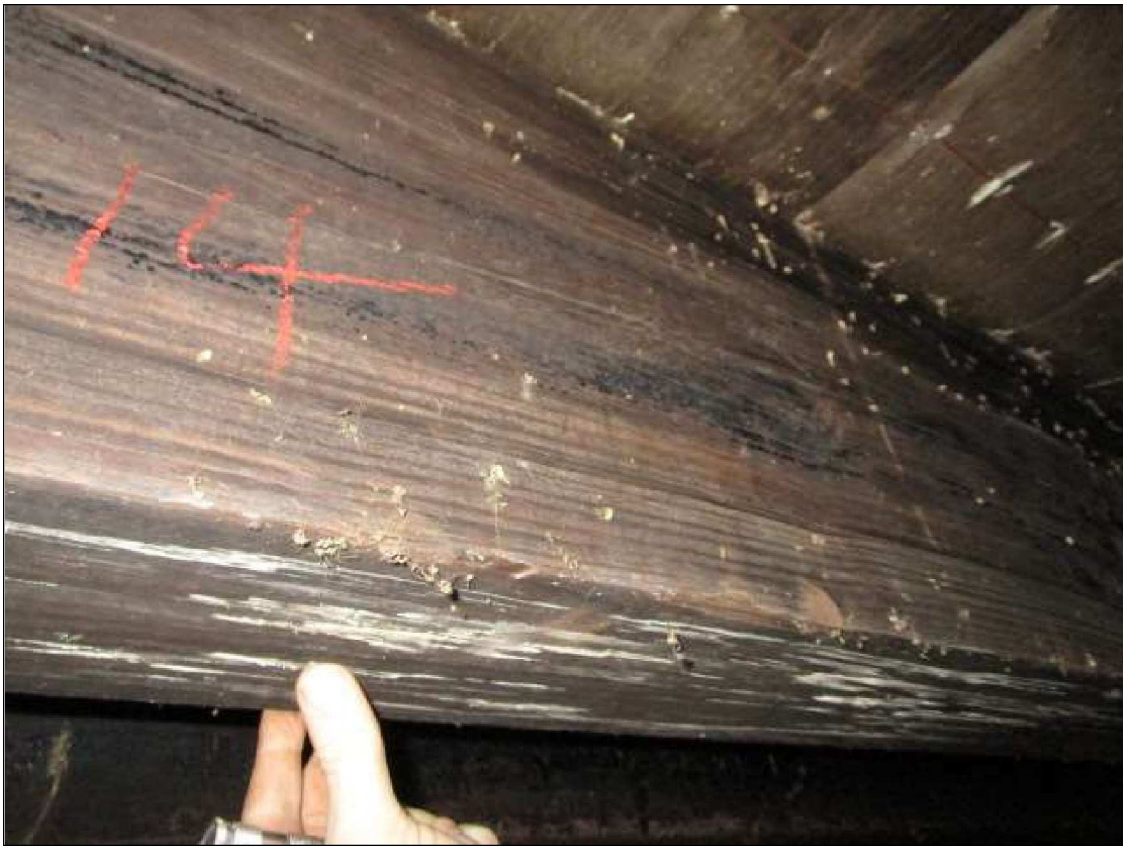
| Element Number | Defect Type | Defect Description | CS | CS Qty | Maint Qty |
|---|---|---|---|---|---|
| 111 | Check/Shake | 1/8" CHECKING WITH WHITE MOLD THROUGHOUT | 2 | 16 | Feet |

Span 1 Beam 14: 1/8" CHECKING WITH WHITE MOLD THROUGHOUT

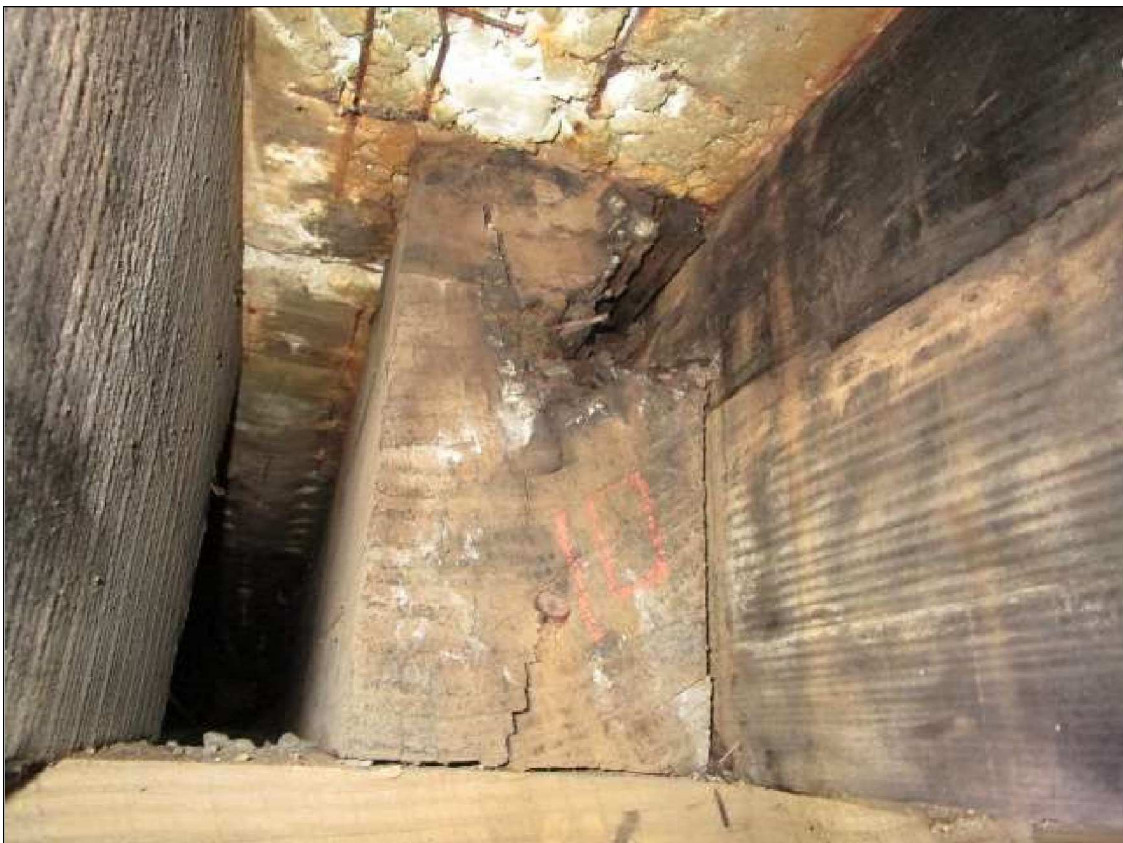
| Element Number | Defect Type | Defect Description | CS | CS Qty | Maint Qty |
|---|---|---|---|---|---|
| 111 | Decay/Section Loss | 5" X 5" X 4" DEEP DECAY IN TOP OF BEAM END OVER BENT 1 | 3 | 1 | 1 Feet |

Span 2 Beam 10: 5" X 5" X 4" DEEP DECAY IN TOP OF BEAM END OVER BENT 1

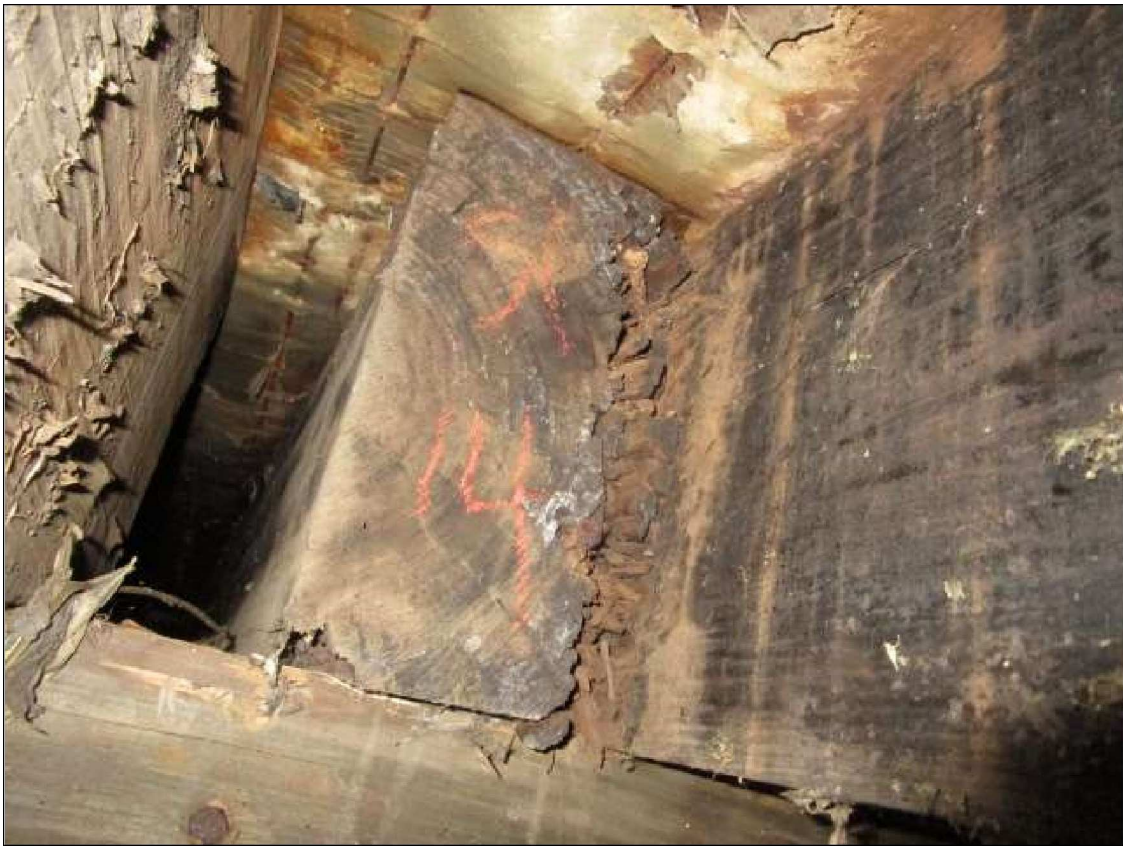
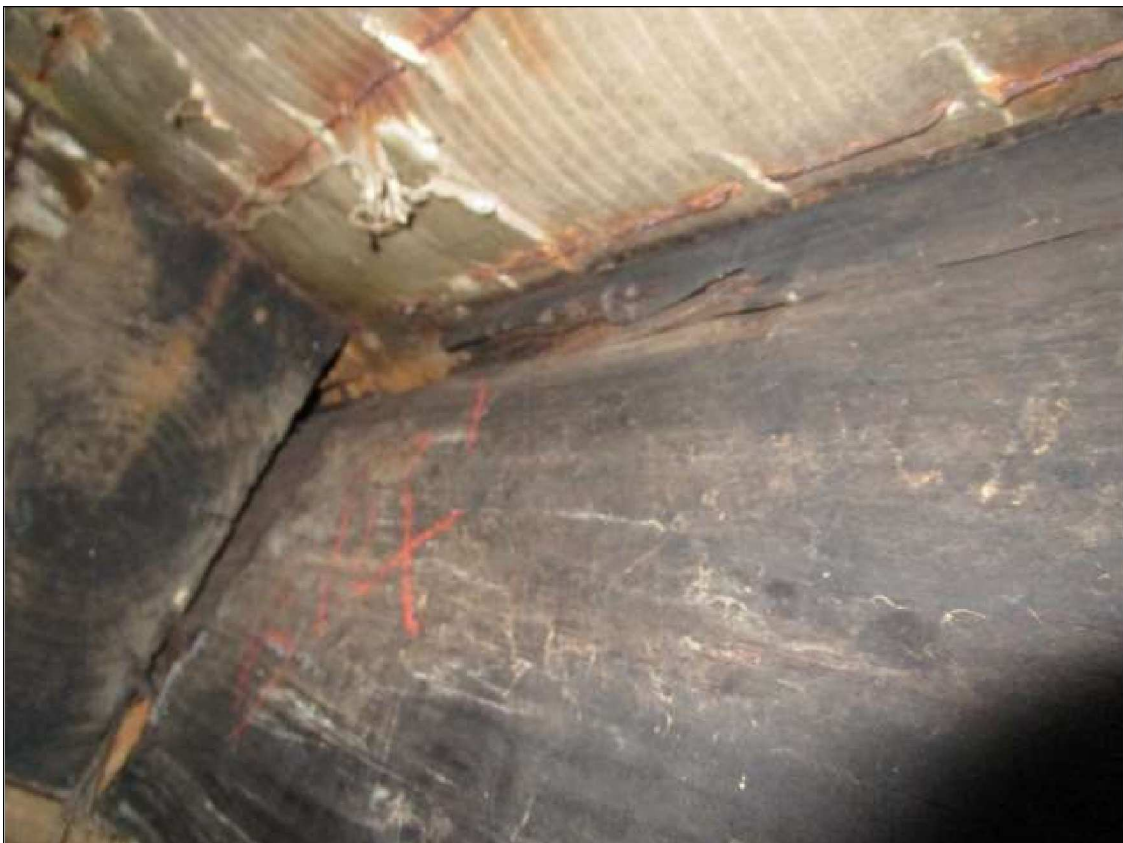
| Element Number | Defect Type | Defect Description | CS | CS Qty | Maint Qty |
|---|---|---|---|---|---|
| 111 | Decay/Section Loss | 2" X 2" X 2' LONG DECAY IN TOP OF BEAM END OVER BENT 1 | 3 | 2 | 2 Feet |

Span 1 Beam 14: 2" X 2" X 2' LONG DECAY IN TOP OF BEAM END OVER BENT 1

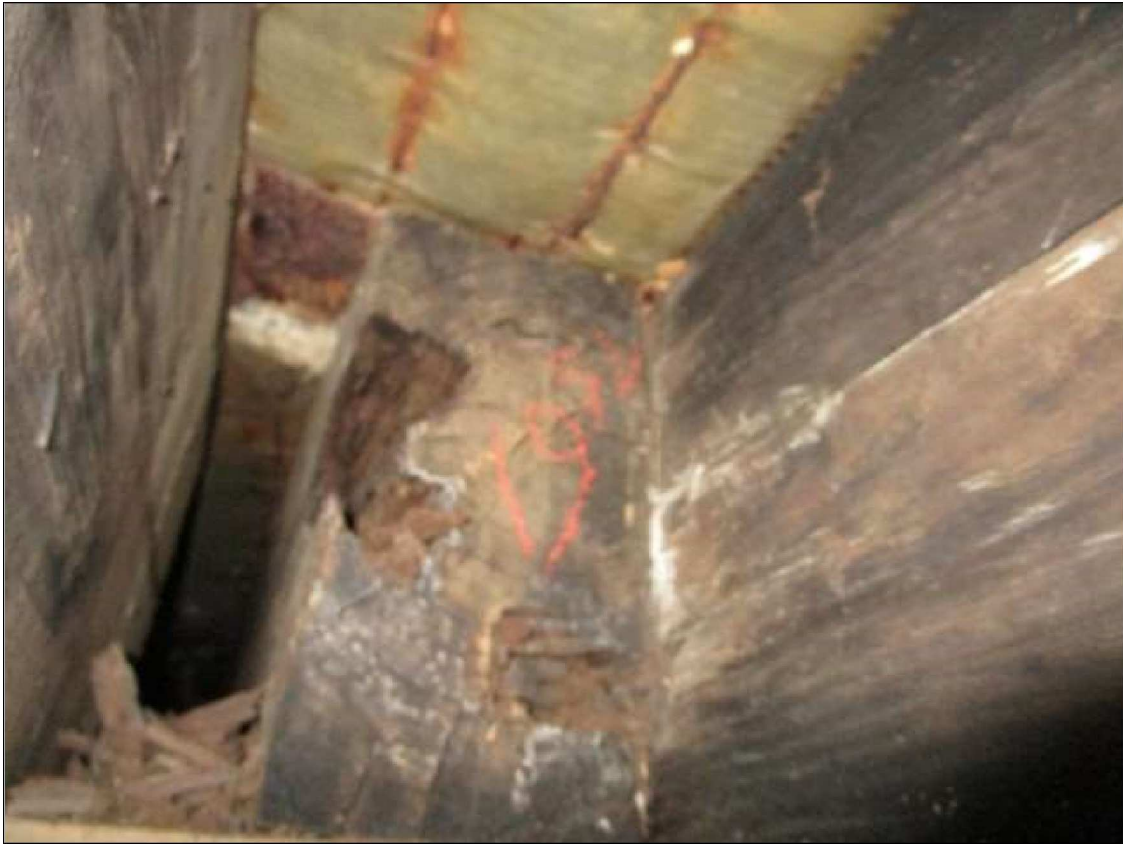
| Element Number | Defect Type | Defect Description | CS | CS Qty | Maint Qty |
|---|---|---|---|---|---|
| 111 | Decay/Section Loss | 6" TALL X 2" WIDE X 1' LONG DECAY ON BEAM END STARTING 2" DOWN FROM TOP ON LEFT SIDE AND 2" TALL X 3" WIDE X 2" LONG DECAY ON BEAM END ON RIGHT SIDE OVER BENT 1 AND SOUNDS HOLLOW ON TOP 2" FOR ADDITIONAL 4' | 3 | 1 | 1 Feet |

Span 2 Beam 19: 6" TALL X 2" WIDE X 1' LONG DECAY ON BEAM END STARTING 2" DOWN FROM TOP ON LEFT SIDE AND 2" TALL X 3" WIDE X 2" LONG DECAY ON BEAM END ON RIGHT SIDE OVER BENT 1 AND SOUNDS HOLLOW ON TOP 2" FOR ADDITIONAL 4'

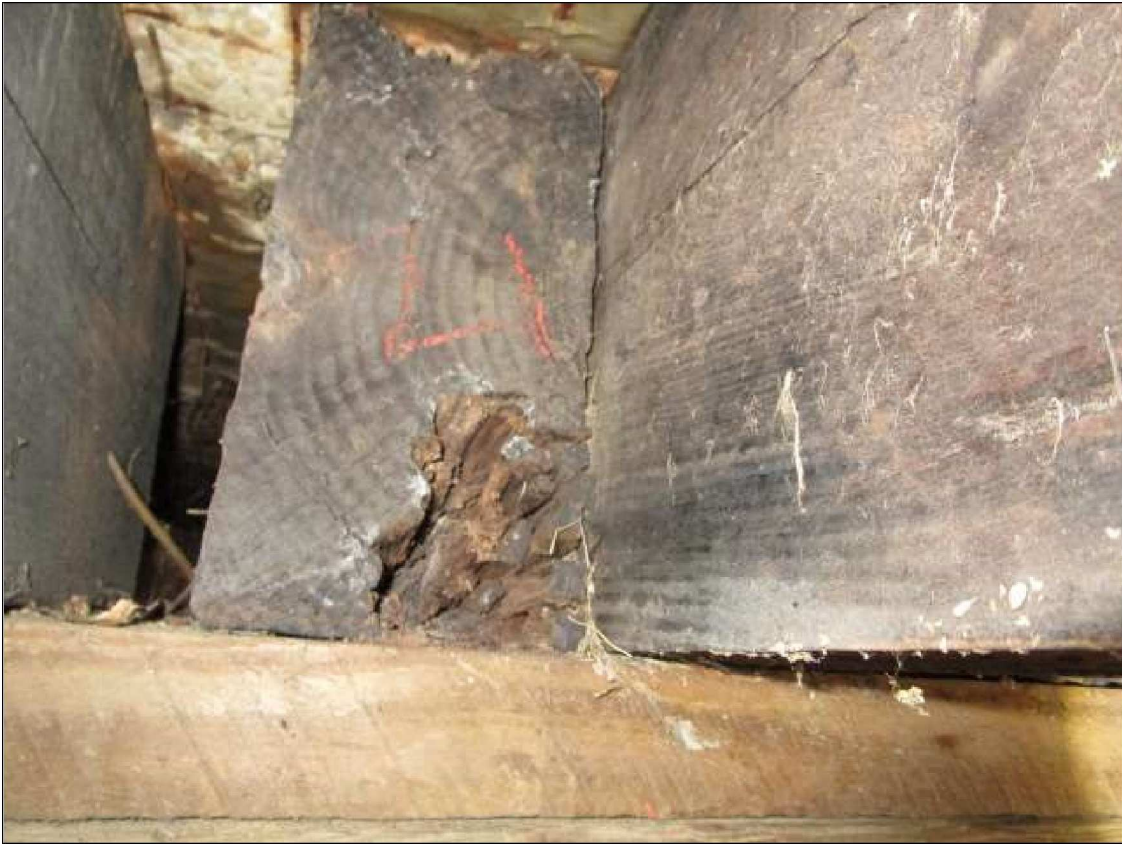
| Element Number | Defect Type | Defect Description | CS | CS Qty | Maint Qty |
|---|---|---|---|---|---|
| 111 | Decay/Section Loss | 4" X 4" X 4" DEEP DECAY ON BOTTOM RIGHT OF BEAM<br>END OVER BENT 1 | 3 | 1 | 1 Feet |

Span 2 Beam 21: 4" X 4" X 4" DEEP DECAY ON BOTTOM RIGHT OF BEAM END OVER BENT 1

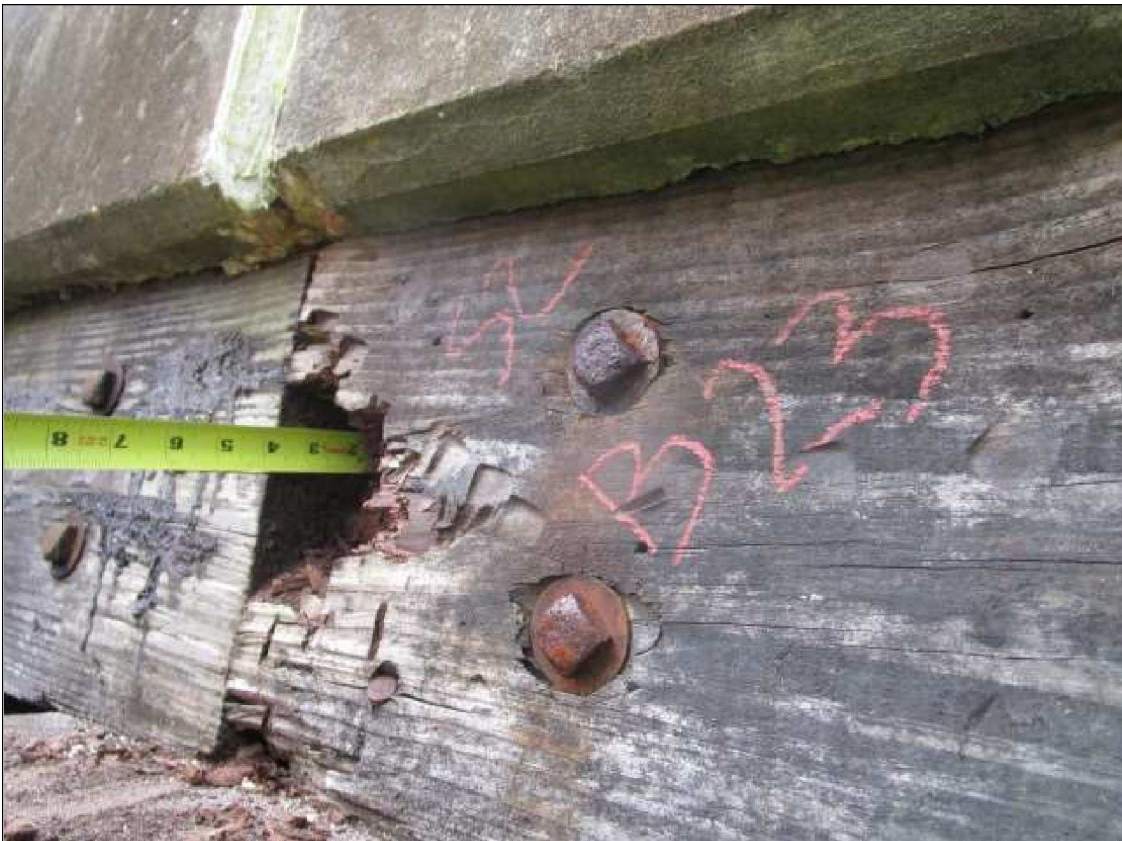
| Element Number | Defect Type | Defect Description | CS | CS Qty | Maint Qty |
|---|---|---|---|---|---|
| 111 | Decay/Section Loss | 4" X 6" X 4" DEEP DECAY ON RIGHT SIDE OF BEAM END<br>OVER BENT 1 | 3 | 1 | 1 Feet |

Span 2 Beam 23: 4" X 6" X 4" DEEP DECAY ON RIGHT SIDE OF BEAM END OVER BENT 1

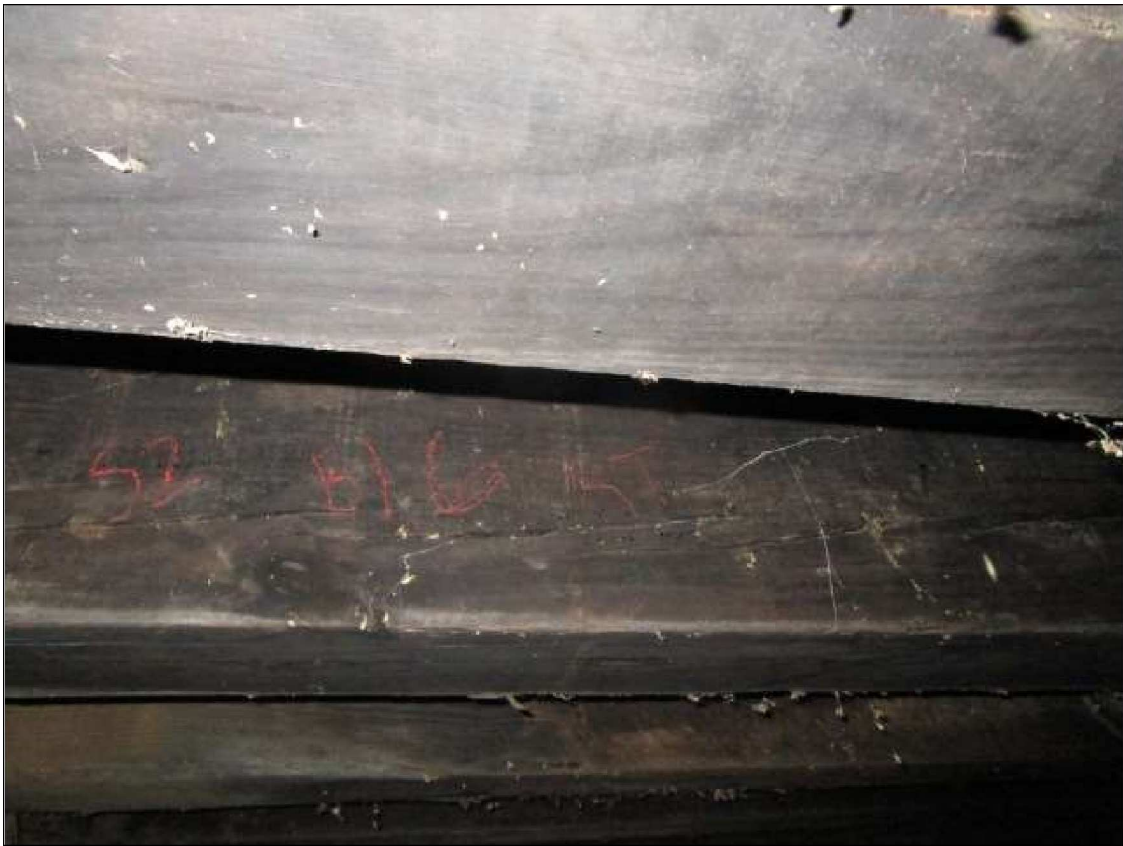
| Element Number | Defect Type | Defect Description | CS | CS Qty | Maint Qty |
|---|---|---|---|---|---|
| 111 | Check/Shake | 3/16" WIDE DIAGONAL CHECKING STARTING AT BOTTOM OF JOIST AND MOVING TOWARDS THE CENTERLINE FOR 6' STARTING AT BENT 1 | 2 | 6 | Feet |

Span 2 Beam 16: 3/16" WIDE DIAGONAL CHECKING STARTING AT BOTTOM OF JOIST AND MOVING TOWARDS THE CENTERLINE FOR 6' STARTING AT BENT 1

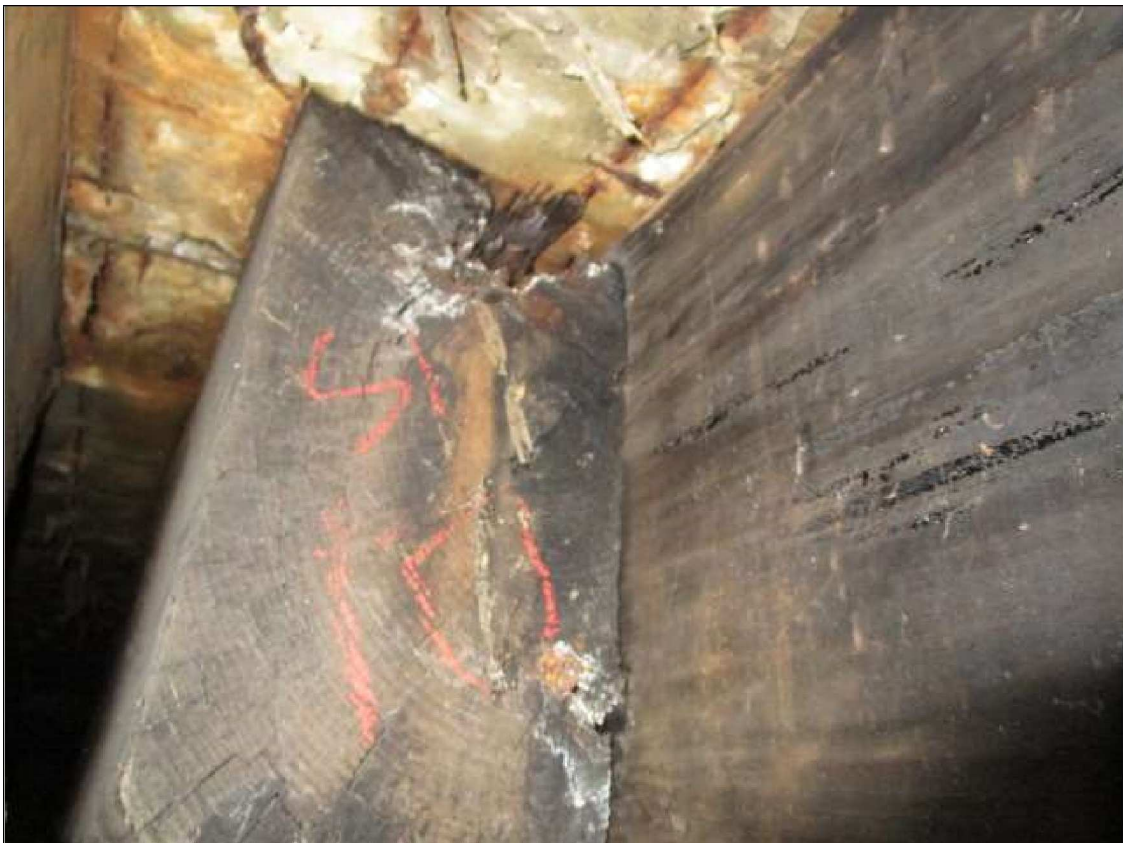
| Element Number | Defect Type | Defect Description | CS | CS Qty | Maint Qty |
|---|---|---|---|---|---|
| 111 | Decay/Section Loss | 4" X 3" X 2" DEEP DECAY ON TOP LEFT OF BEAM END OVER BENT 1 | 3 | 1 | 1 Feet |

Span 1 Beam 10: 4" X 3" X 2" DEEP DECAY ON TOP LEFT OF BEAM END OVER BENT 1

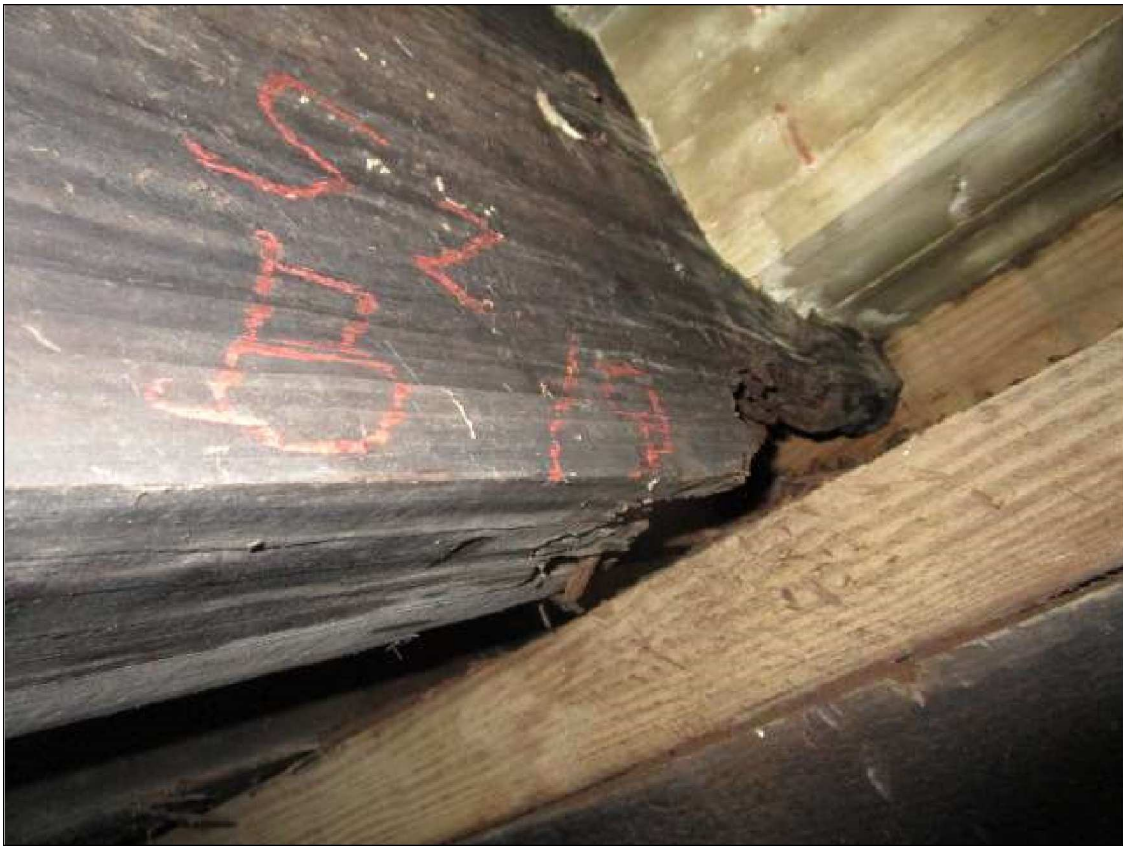
| Element Number | Defect Type | Defect Description | CS | CS Qty | Maint Qty |
|---|---|---|---|---|---|
| 111 | Decay/Section Loss | 4" TALL X FULL WIDTH X 20" LONG DECAY ALONG ENTIRE BOTTOM OF JOIST AT END BENT 2 | 4 | 2 | 2 Feet |

| Details | THERE ARE SEVERAL BEAMS (8) WITH ADVANCED DECAY PARTICULARLY OVER BENT 1 SPAN 2 BEAM 19 IS HEAVILY DECAYED AND IS NOT BEARING AT ALL ON END BENT 2 | | | | | | |

Span 2 Beam 19: 4" TALL X FULL WIDTH X 20" LONG DECAY ALONG ENTIRE BOTTOM OF JOIST AT END BENT
