NC DEPARTMENT OF TRANSPORTATION  
DIVISION OF HIGHWAYS  
STRUCTURE MANAGEMENT UNIT

## Structure Safety Report

### Routine Element Inspection - Contract

DIVISION: 6 COUNTY: CUMBERLAND STRUCTURE NUMBER: 250044 FREQUENCY: 24 MONTHS

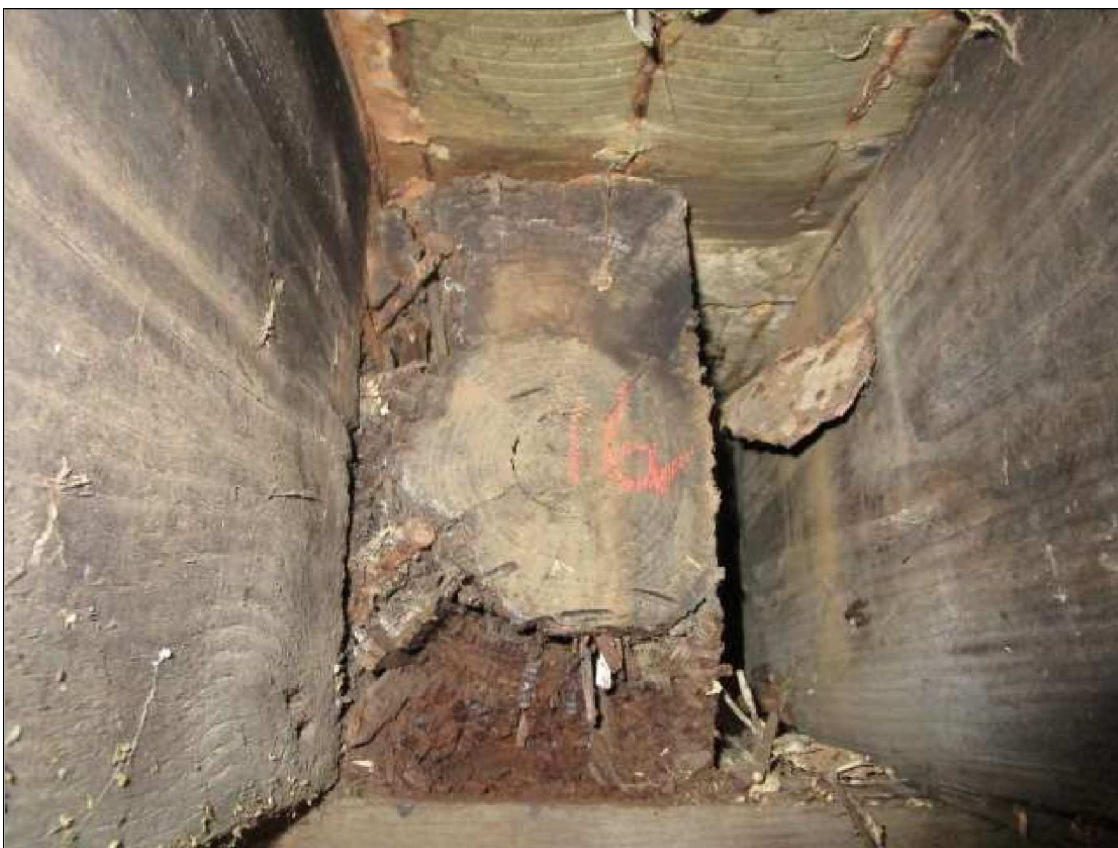
| Element Number | Defect Type | Defect Description | CS | CS Qty | Maint Qty |
|---|---|---|---|---|---|
| 111 | Decay/Section Loss | 3" TALL AT BOTTOM X 2" WIDE AT TOP DECAY IN AN "L" SHAPE ON LEFT SIDE OF BEAM END OVER BENT 1 THAT IS 15" DEEP | 3 | 2 | 2 Feet |

Span 1 Beam 16: 3" TALL AT BOTTOM X 2" WIDE AT TOP DECAY IN AN "L" SHAPE ON LEFT SIDE OF BEAM END OVER BENT 1 THAT IS 15" DEEP

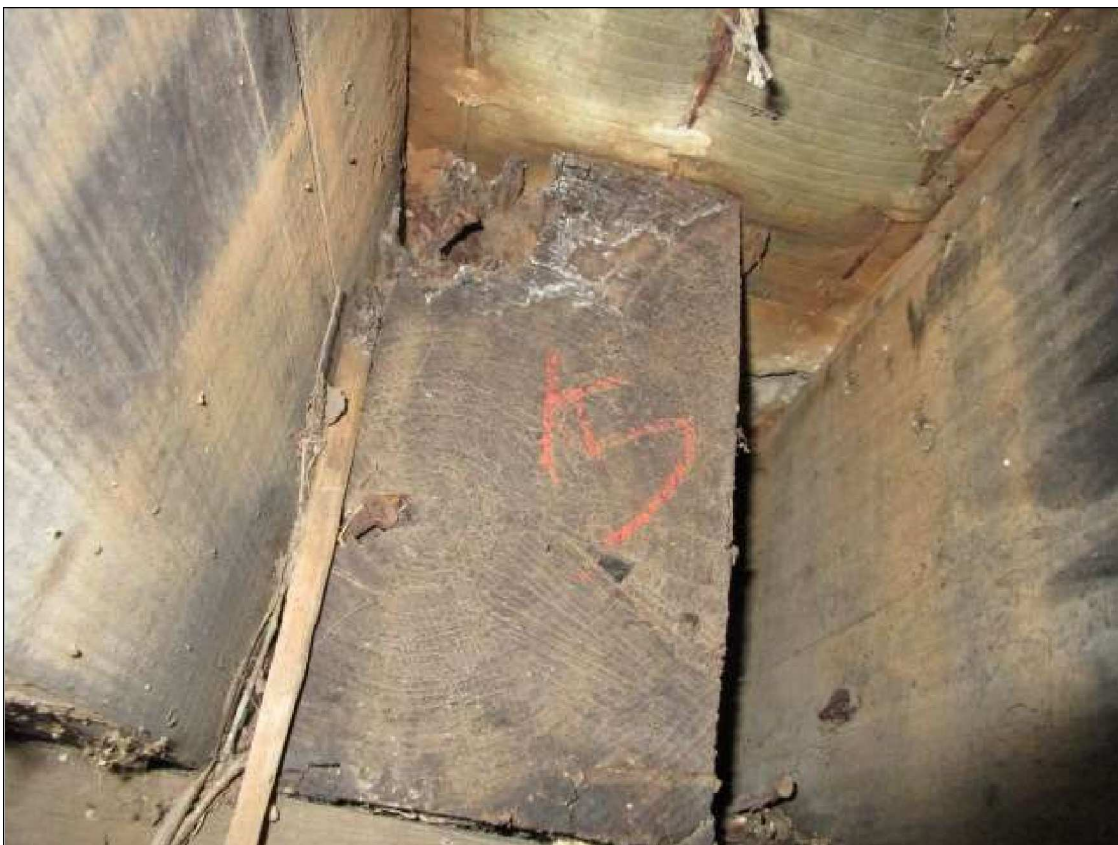
| Element Number | Defect Type | Defect Description | CS | CS Qty | Maint Qty |
|---|---|---|---|---|---|
| 111 | Decay/Section Loss | 2 1/2" X 4" X 3" DEEP DECAY ON TOP RIGHT OF BEAM END OVER BENT 1 | 3 | 1 | 1 Feet |

Span 1 Beam 15: 2 1/2" X 4" X 3" DEEP DECAY ON TOP RIGHT OF BEAM END OVER BENT 1

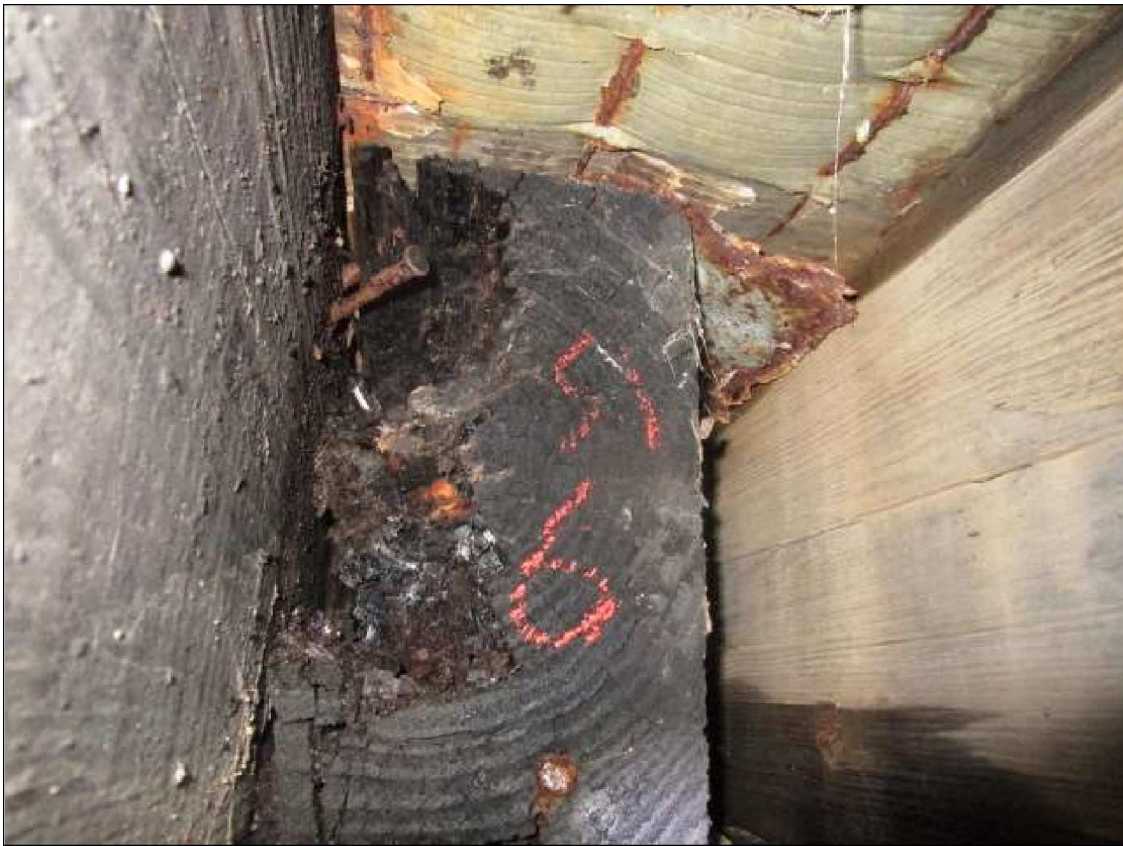
| Element Number | Defect Type | Defect Description | CS | CS Qty | Maint Qty |
|---|---|---|---|---|---|
| 111 | Decay/Section Loss | 10" X 3" X 6" DEEP DECAY ON TOP RIGHT OF BEAM END OVER BENT 1 | 3 | 1 | 1 Feet |

Span 1 Beam 6: 10" X 3" X 6" DEEP DECAY ON TOP RIGHT OF BEAM END OVER BENT 1

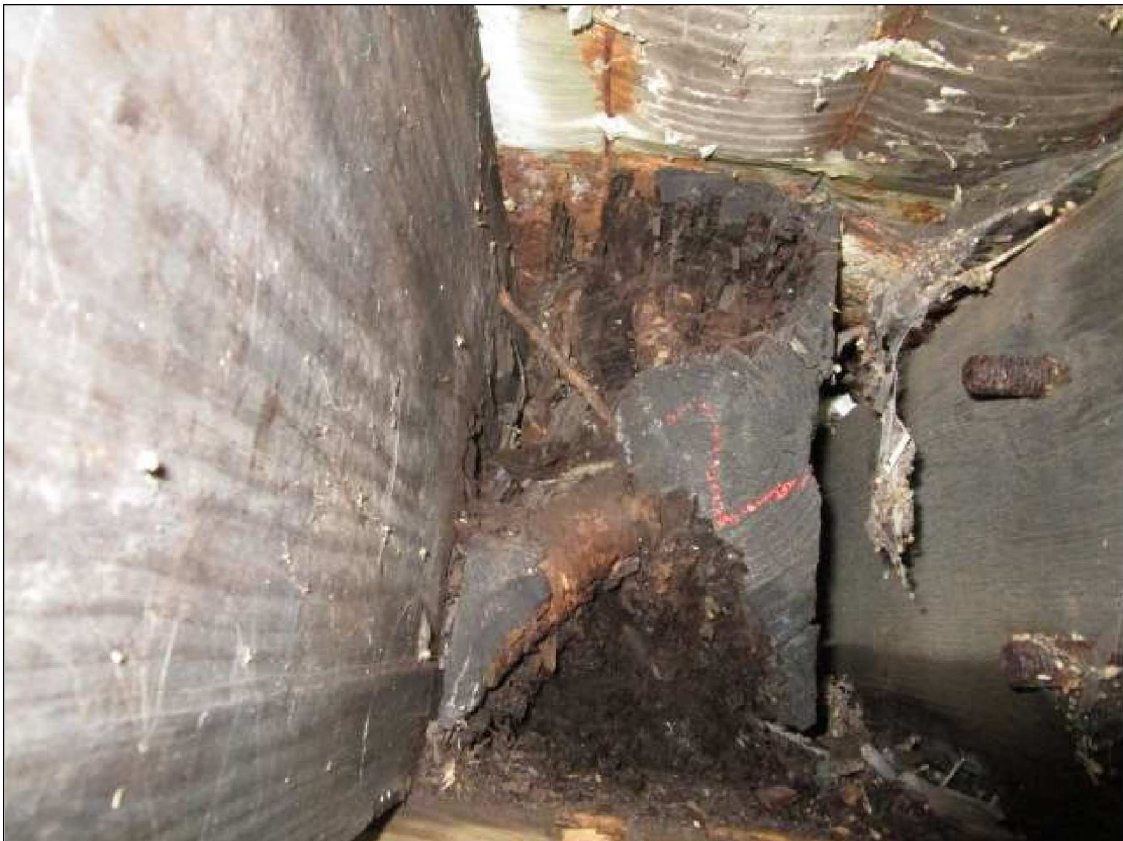
| Element Number | Defect Type | Defect Description | CS | CS Qty | Maint Qty |
|---|---|---|---|---|---|
| 111 | Decay/Section Loss | FULL HEIGHT X FULL WIDTH X 15" DEEP DECAY ON BEAM END OVER BENT 1 | 3 | 2 | 2 Feet |

Span 1 Beam 2: FULL HEIGHT X FULL WIDTH X 15" DEEP DECAY ON BEAM END OVER BENT 1

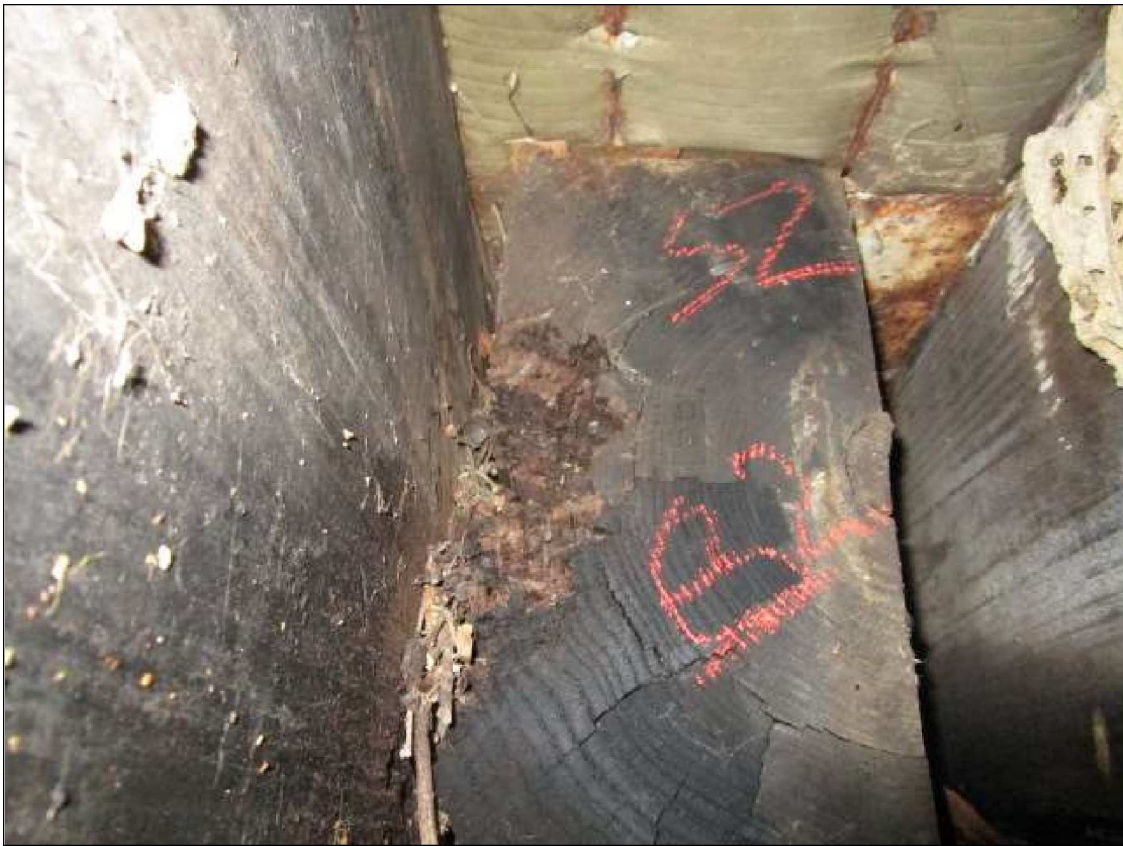
| Element Number | Defect Type | Defect Description | CS | CS Qty | Maint Qty |
|---|---|---|---|---|---|
| 111 | Decay/Section Loss | 6" X 2 1/2" X 3" DEEP DECAY ON LEFT SIDE OF BEAM END OVER BENT 1 | 3 | 1 | 1 Feet |

Span 2 Beam 2: 6" X 2 1/2" X 3" DEEP DECAY ON LEFT SIDE OF BEAM END OVER BENT 1

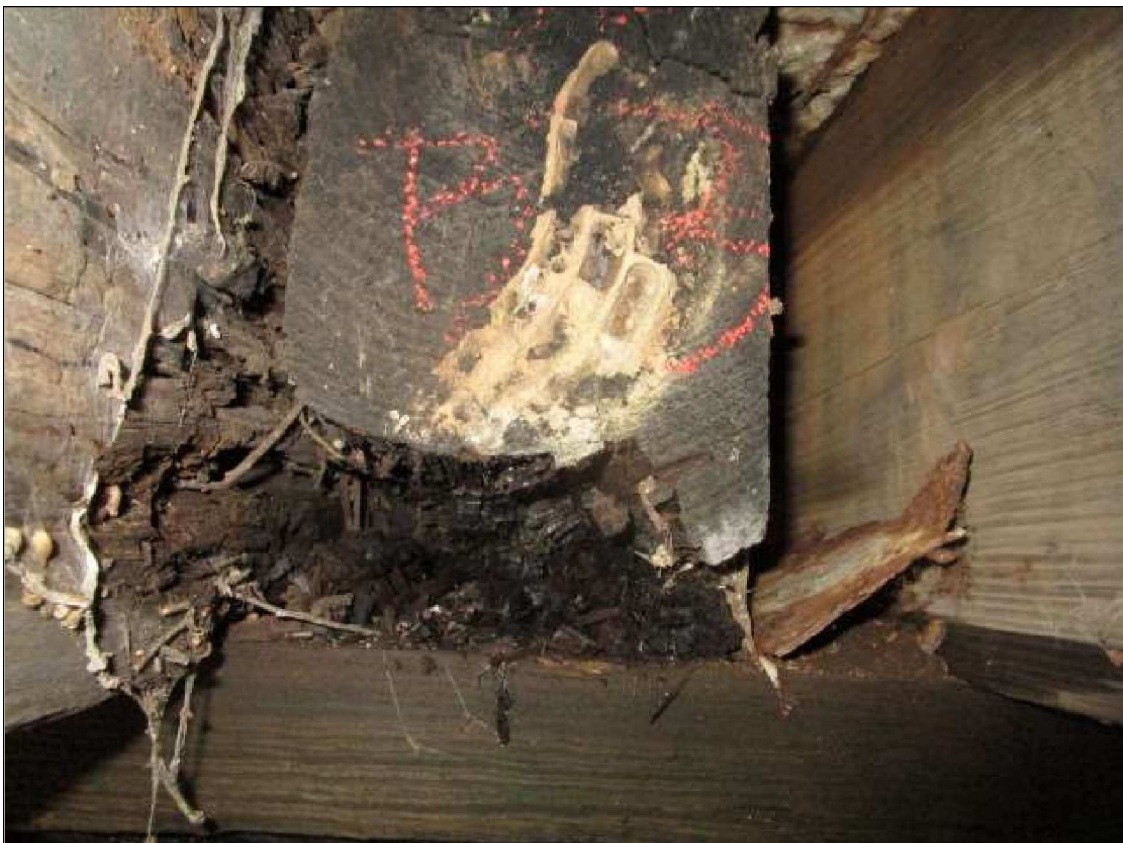
| Element Number | Defect Type | Defect Description | CS | CS Qty | Maint Qty |
|---|---|---|---|---|---|
| 111 | Decay/Section Loss | 3" X FULL WIDTH X 12" DEEP DECAY ON LEFT SIDE OF BEAM END OVER BENT 1 | 3 | 1 | 1 Feet |

Span 2 Beam 3: 3" X FULL WIDTH X 12" DEEP DECAY ON LEFT SIDE OF BEAM END OVER BENT 1

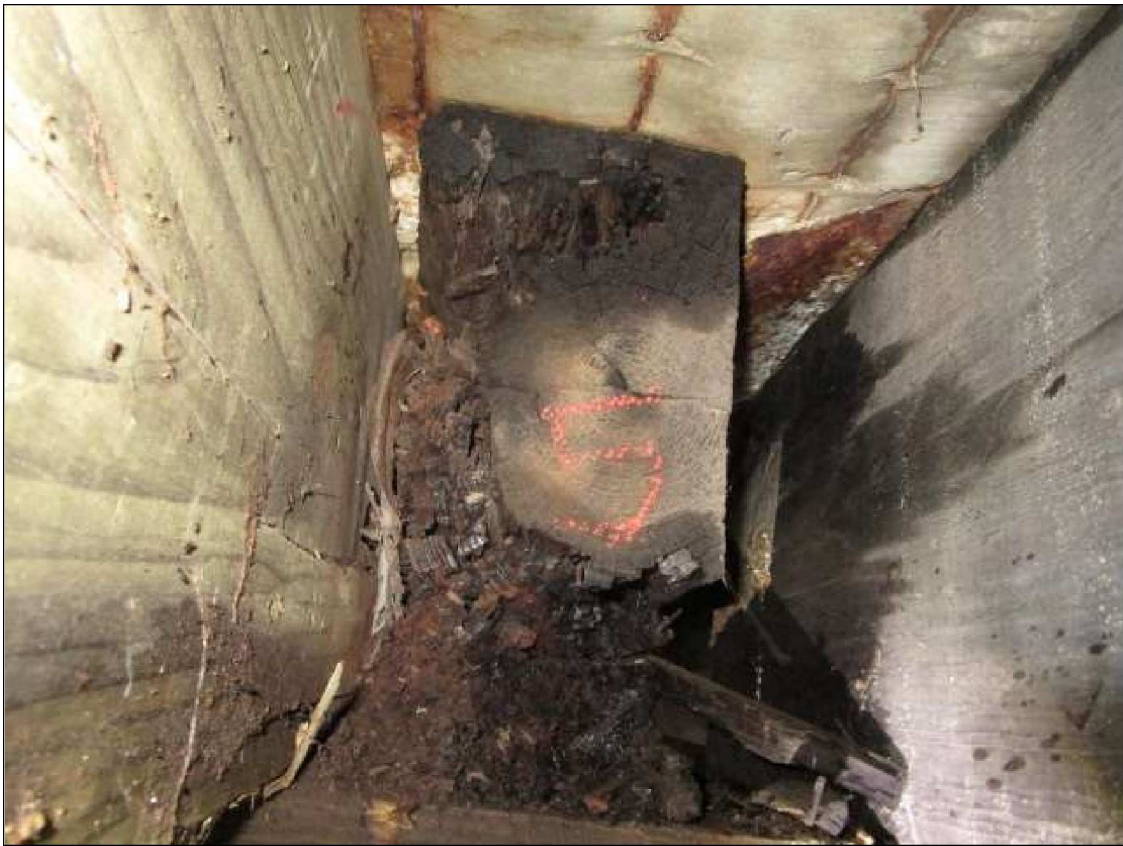
| Element Number | Defect Type | Defect Description | CS | CS Qty | Maint Qty |
|---|---|---|---|---|---|
| 111 | Decay/Section Loss | 4" CORE REMAINS ON LAST 8" OF BEAM END OVER BENT 1 | 3 | 1 | 1 Feet |

Span 2 Beam 5: 4" CORE REMAINS ON LAST 8" OF BEAM END OVER BENT 1

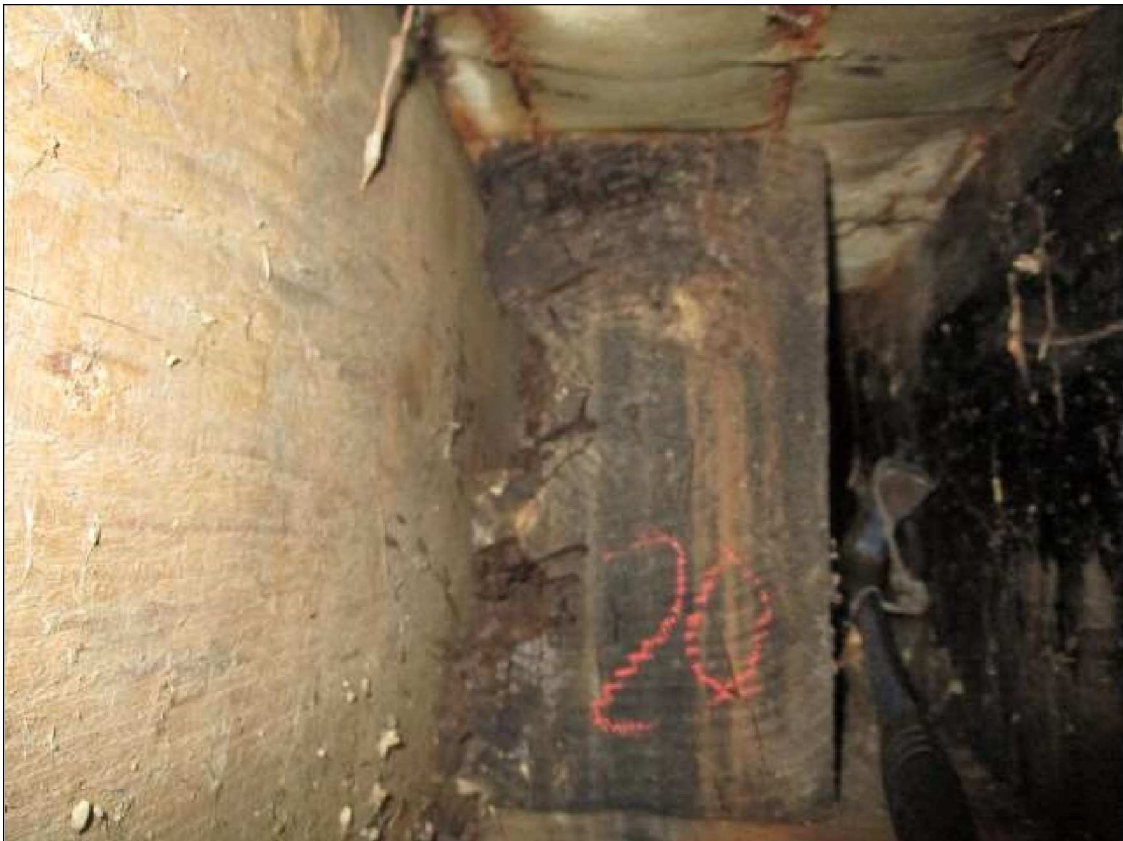
| Element Number | Defect Type | Defect Description | CS | CS Qty | Maint Qty |
|---|---|---|---|---|---|
| 111 | Decay/Section Loss | 2" X 12" X 6" DEEP DECAY ON BEAM END OVER BENT 1 | 3 | 1 | 1 Feet |

Span 2 Beam 20: 2" X 12" X 6" DEEP DECAY ON BEAM END OVER BENT 1

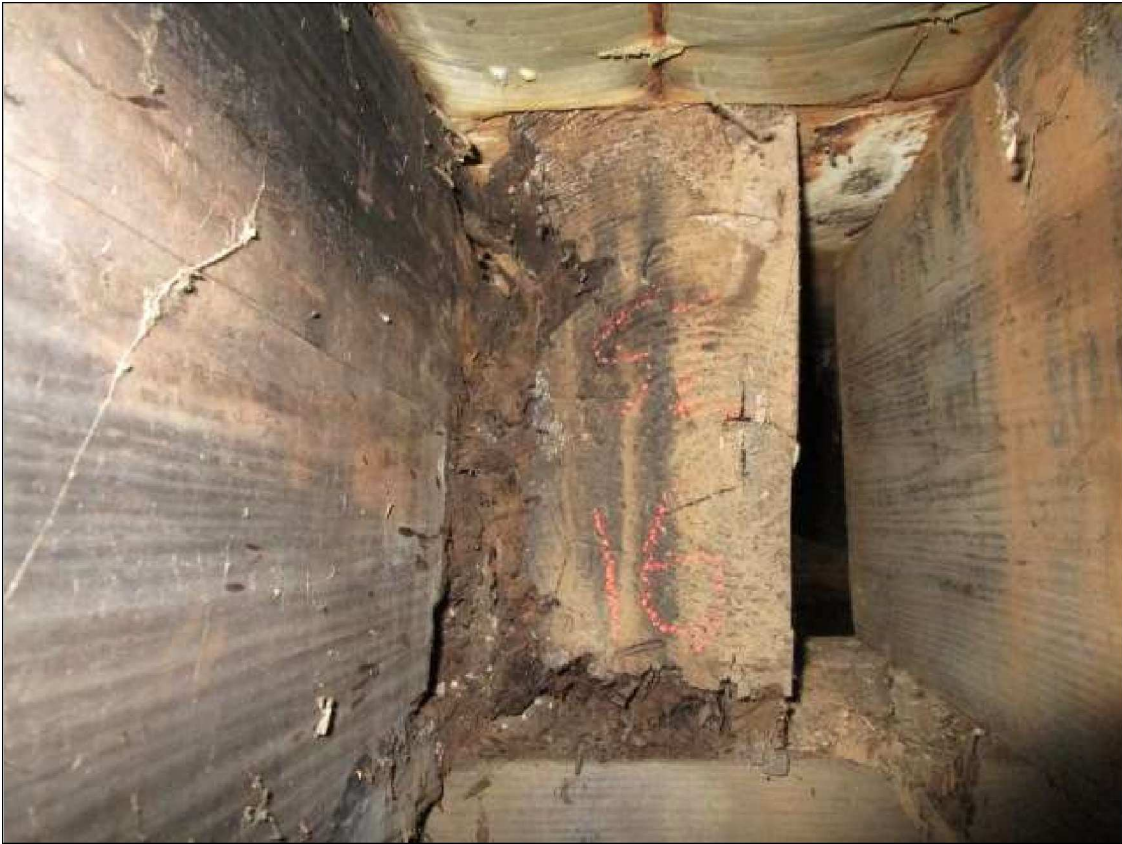
| Element Number | Defect Type | Defect Description | CS | CS Qty | Maint Qty |
|---|---|---|---|---|---|
| 111 | Decay/Section Loss | 2" WIDE AT TOP AND 2" TALL AT BOTTOM DECAY IN AN "L" SHAPE FOR 6" DEEP AT BEAM END OVER BENT 1 | 3 | 1 | 1 Feet |

Span 2 Beam 16: 2" WIDE AT TOP AND 2" TALL AT BOTTOM DECAY IN AN "L" SHAPE FOR 6" DEEP AT BEAM END OVER BENT 1

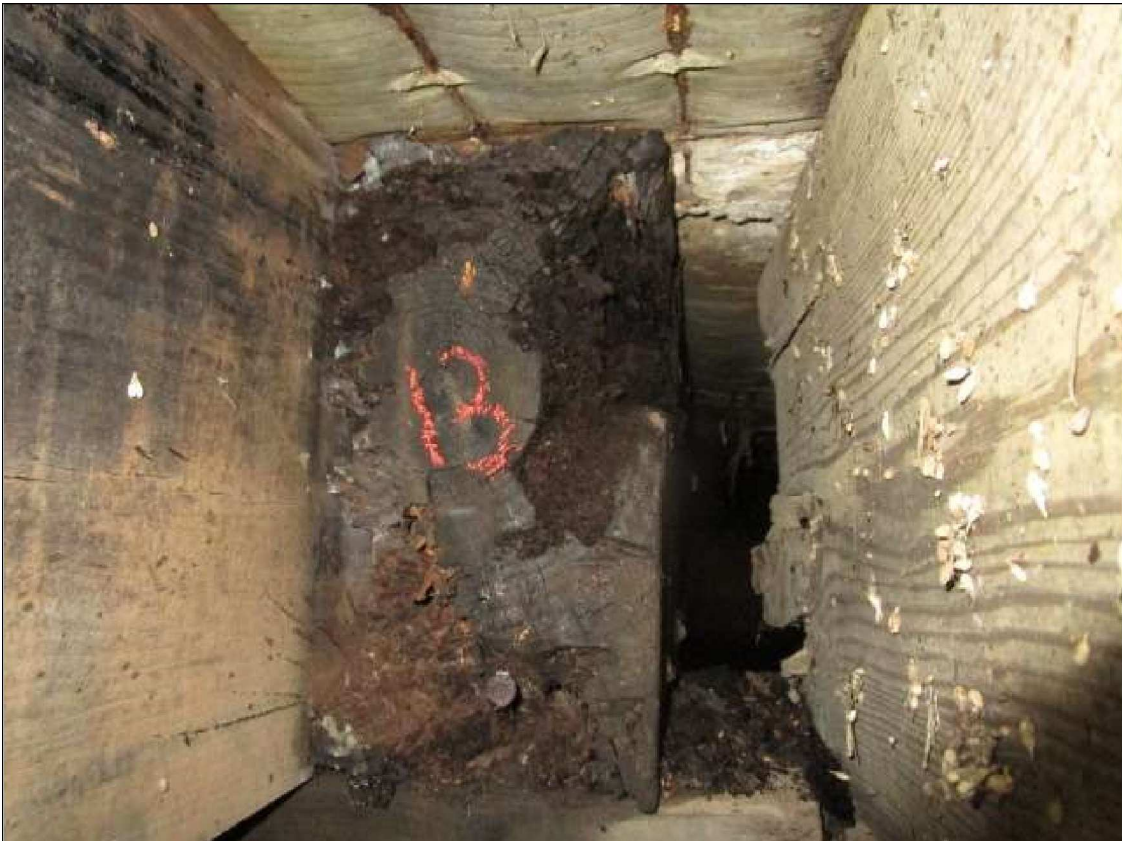
| Element Number | Defect Type | Defect Description | CS | CS Qty | Maint Qty |
|---|---|---|---|---|---|
| 111 | Decay/Section Loss | 3" CORE REMAINS FOR LAST 10" OF BEAM END OVER BENT 1 | 3 | 1 | 1 Feet |

Span 2 Beam 13: 3" CORE REMAINS FOR LAST 10" OF BEAM END OVER BENT 1

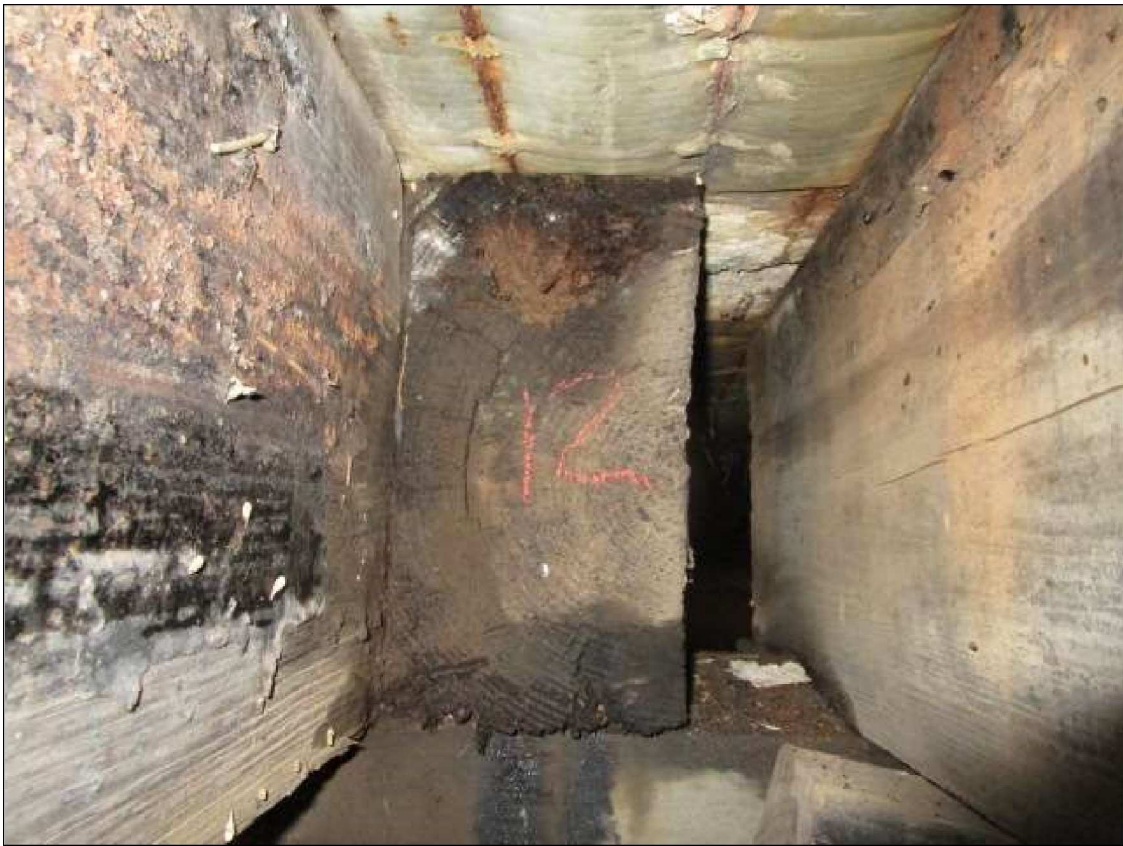
| Element Number | Defect Type | Defect Description | CS | CS Qty | Maint Qty |
|---|---|---|---|---|---|
| 111 | Decay/Section Loss | 3" X FULL WIDTH X 3" DEEP DECAY ON TOP OF BEAM END OVER BENT 1 | 3 | 1 | 1 Feet |

Span 2 Beam 12: 3" X FULL WIDTH X 3" DEEP DECAY ON TOP OF BEAM END OVER BENT 1

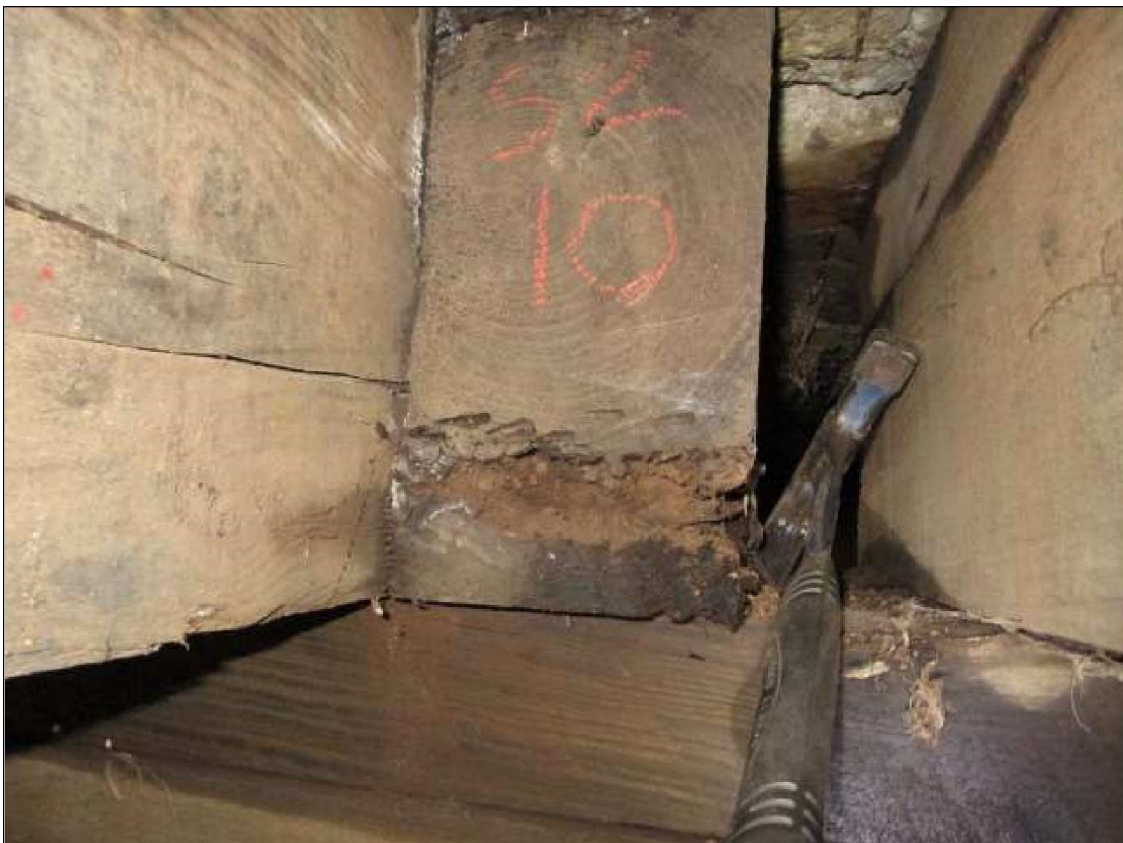
| Element Number | Defect Type | Defect Description | CS | CS Qty | Maint Qty |
|---|---|---|---|---|---|
| 111 | Decay/Section Loss | 3" X FULL WIDTH X 3" DEEP DECAY IN BOTTOM OF BEAM END OVER BENT 1 | 3 | 1 | 1 Feet |

Span 2 Beam 10: 3" X FULL WIDTH X 3" DEEP DECAY IN BOTTOM OF BEAM END OVER BENT 1

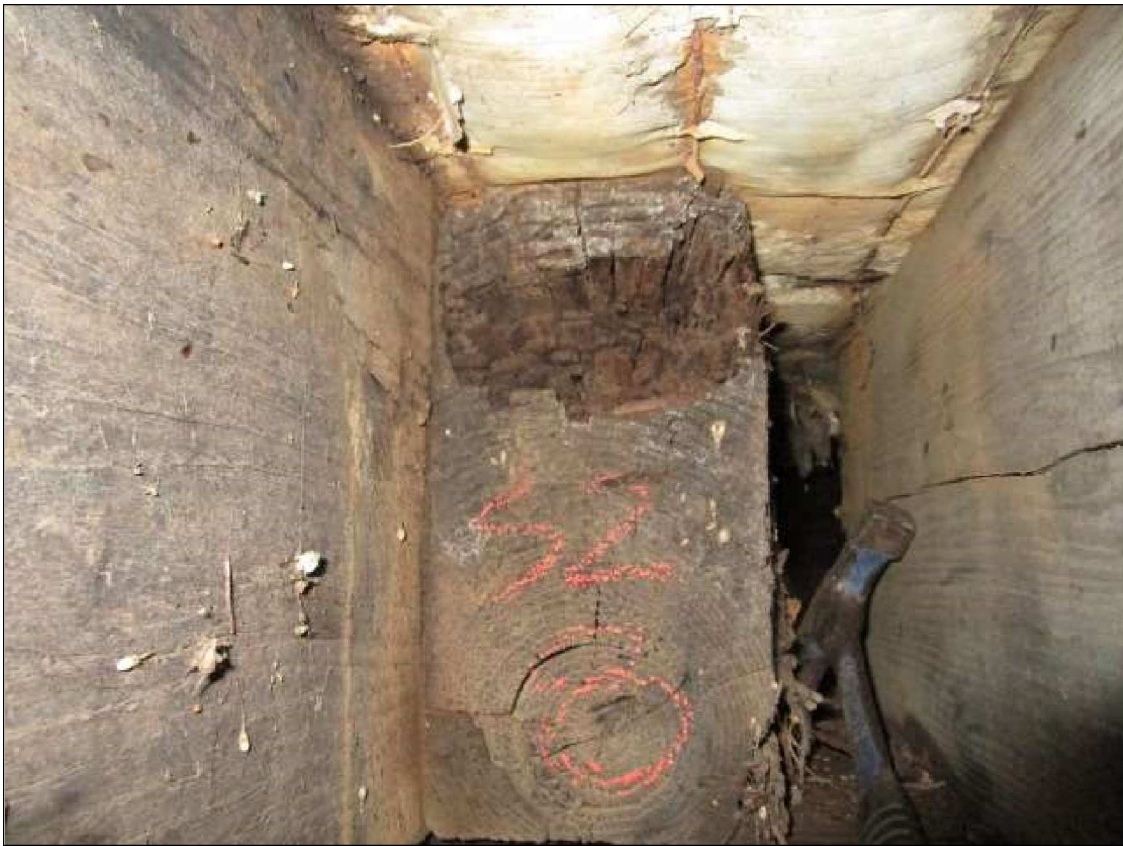
| Element Number | Defect Type | Defect Description | CS | CS Qty | Maint Qty |
|---|---|---|---|---|---|
| 111 | Decay/Section Loss | 4 1/2" X FULL WIDTH X 4" DEEP DECAY IN TOP OF BEAM END OVER BENT 1 | 3 | 1 | 1 Feet |

Span 2 Beam 8: 4 1/2" X FULL WIDTH X 4" DEEP DECAY IN TOP OF BEAM END OVER BENT 1

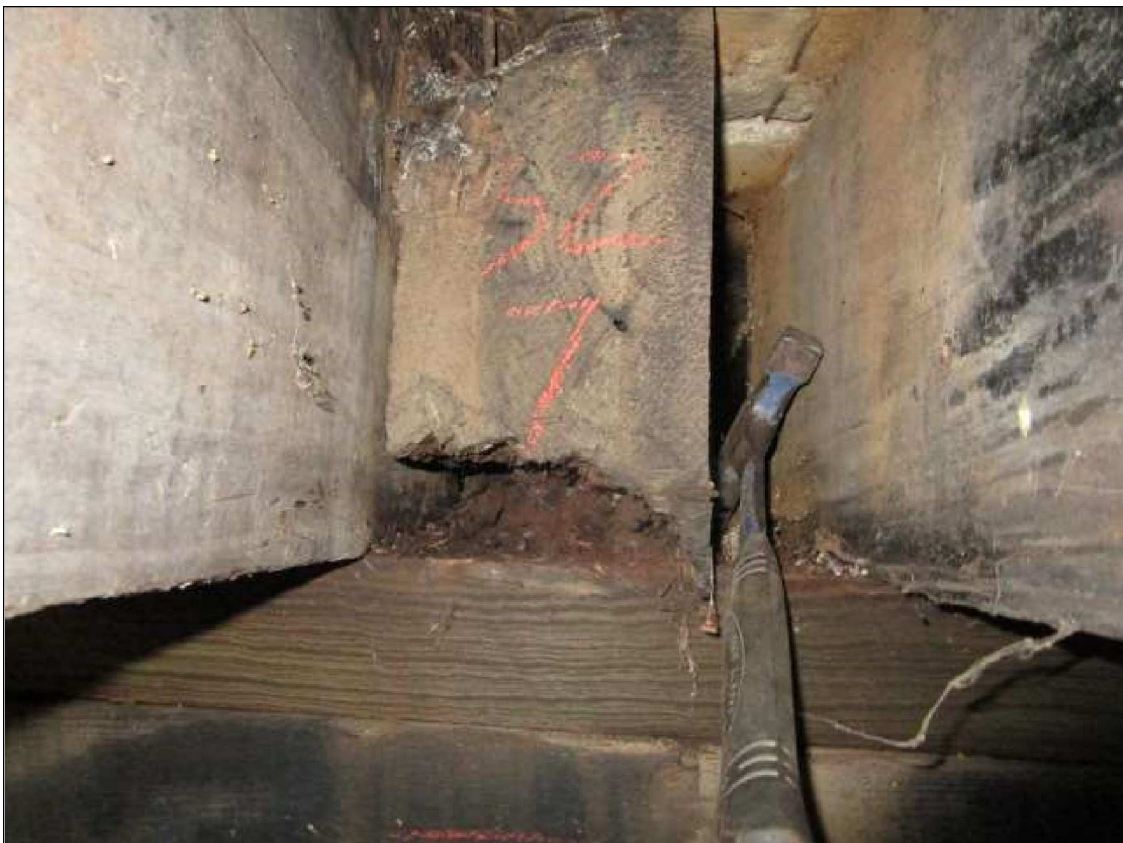
| 111 | Decay/Section Loss | 2 1/2" X FULL WIDTH X 1' DEEP DECAY ON BOTTOM OF BEAM END OVER BENT 1 | 3 | 1 | 1 Feet |

Span 2 Beam 7: 2 1/2" X FULL WIDTH X 1' DEEP DECAY ON BOTTOM OF BEAM END OVER BENT 1

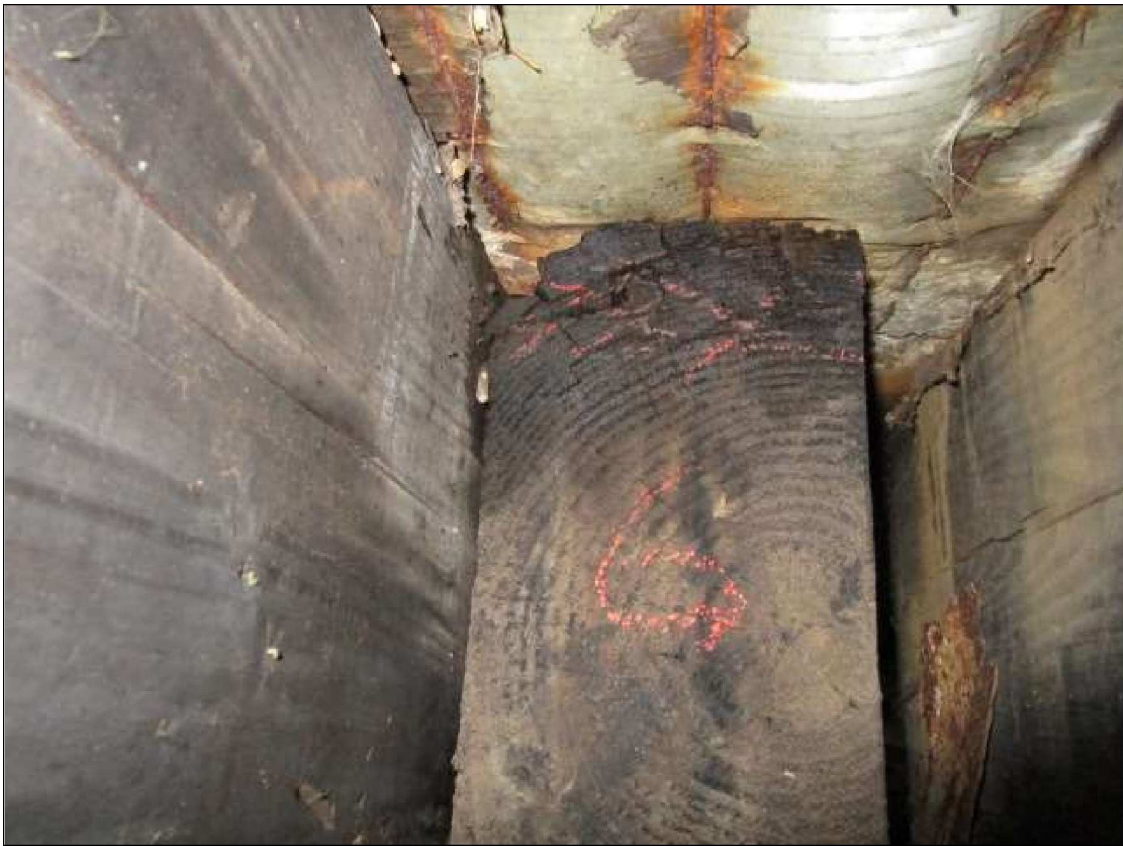
| Element Number | Defect Type | Defect Description | CS | CS Qty | Maint Qty |
|---|---|---|---|---|---|
| 111 | Decay/Section Loss | 2" X FULL WIDTH X 2" DEEP DECAY ON TOP OF BEAM END OVER BENT 1 | 3 | 1 | 1 Feet |

Span 2 Beam 6: 2" X FULL WIDTH X 2" DEEP DECAY ON TOP OF BEAM END OVER BENT 1

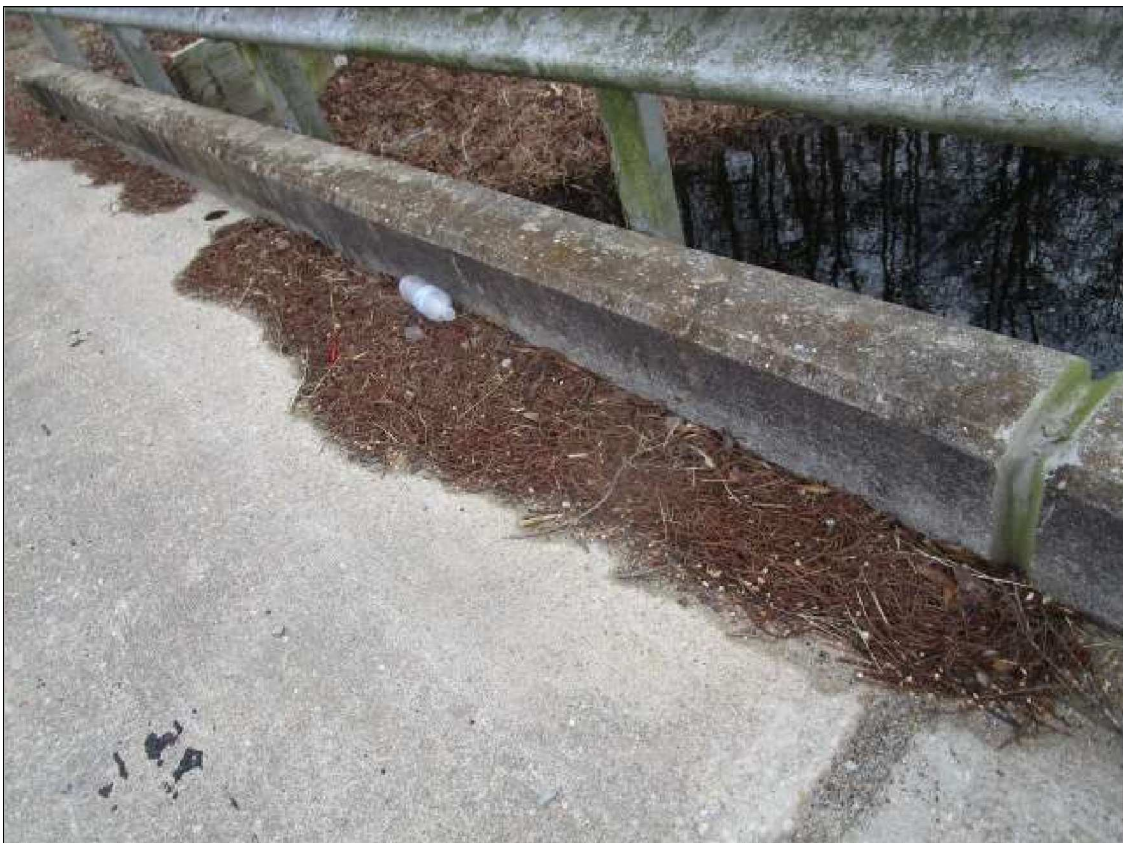
| <b>Details</b> | DEBRIS ALONG RAILS | | | | | | |

DEBRIS ALONG RAILS

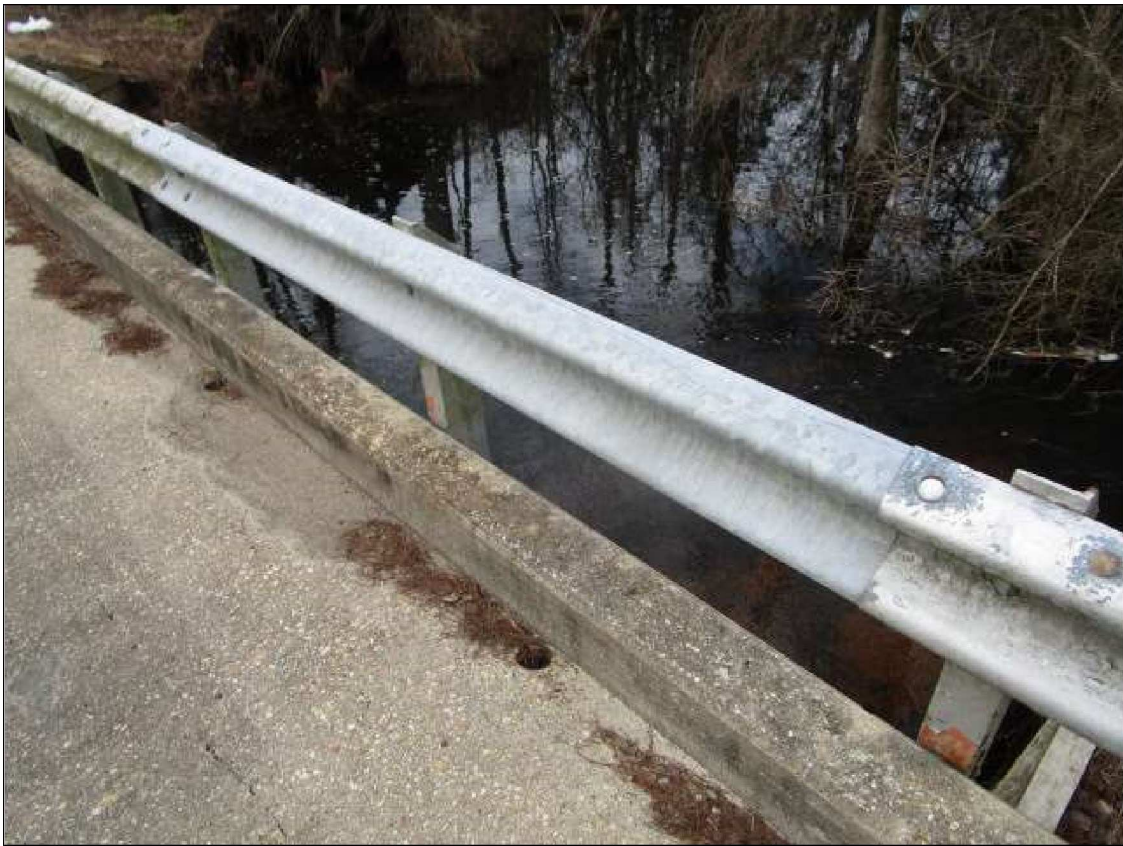
REPLACED SPAN 2 LEFT RAIL SECTION

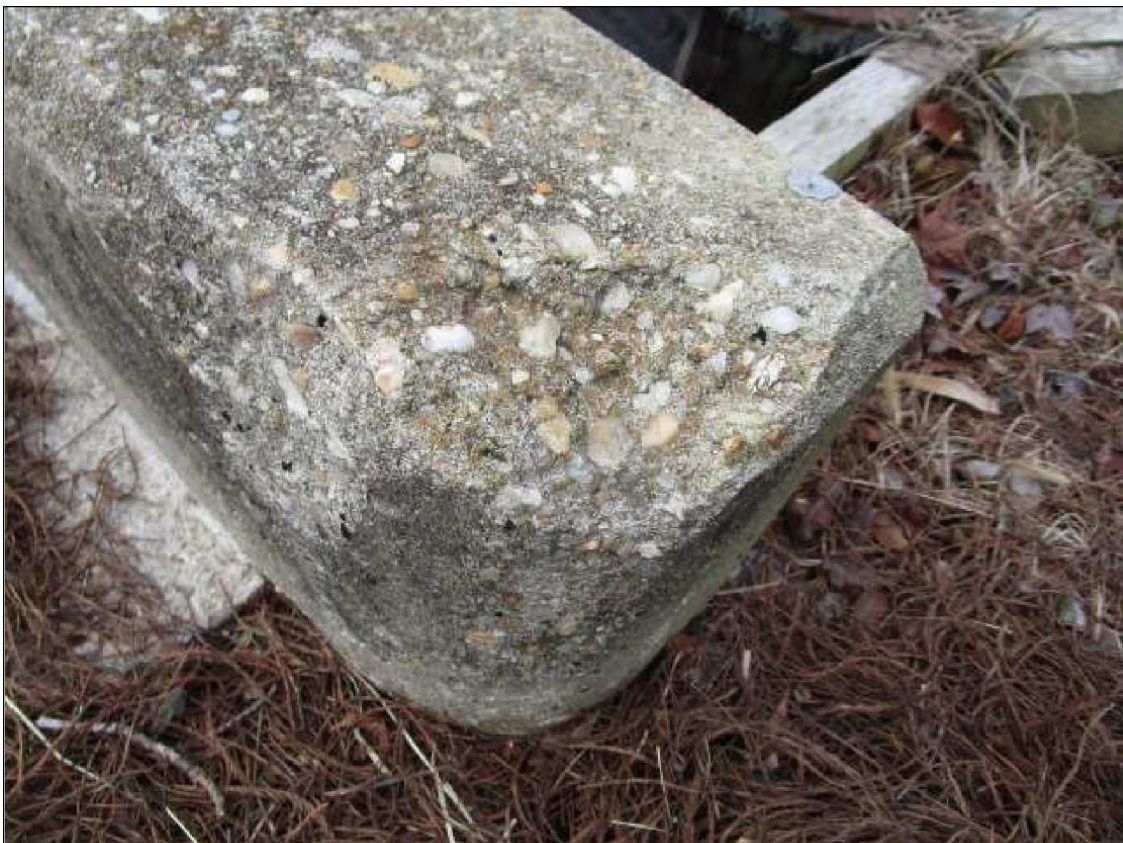
6" DIAMETER X 1/2" DEEP SPALL ON SPAN 2 LEFT CURB AT END BENT 2

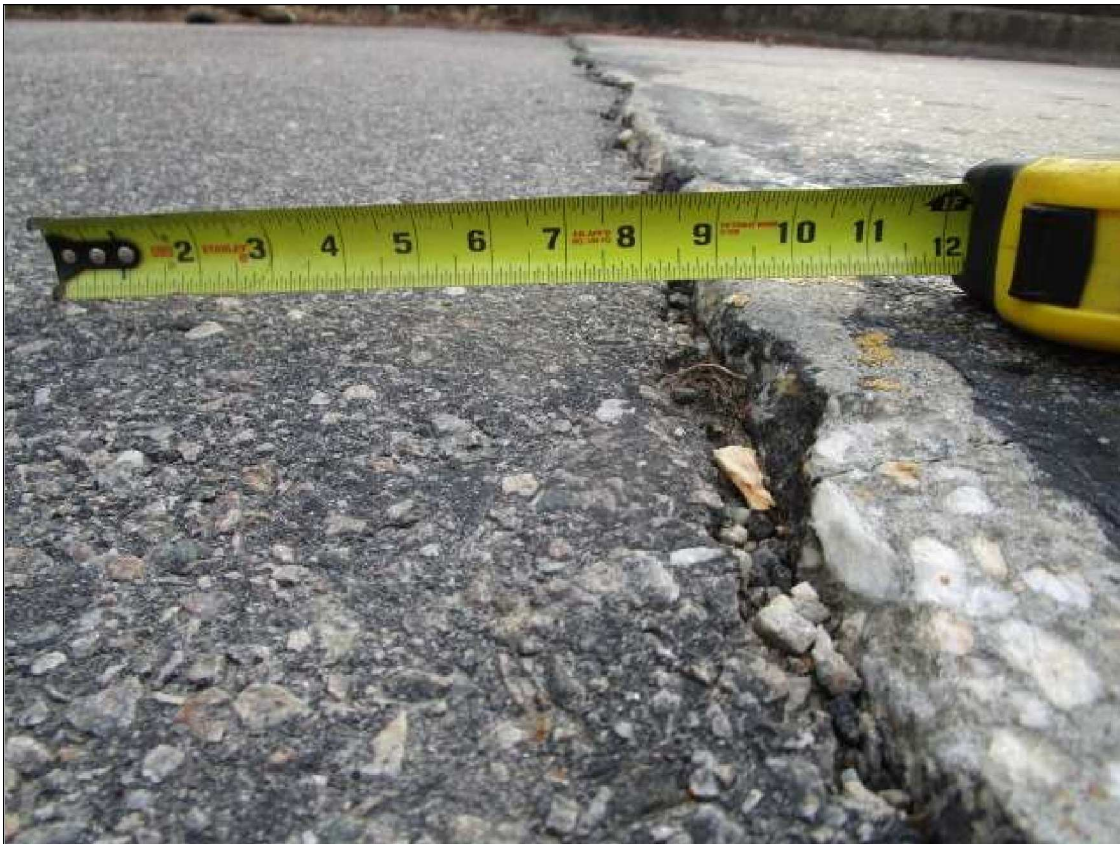
1" DEEP SETTLEMENT IN NORTH APPROACH

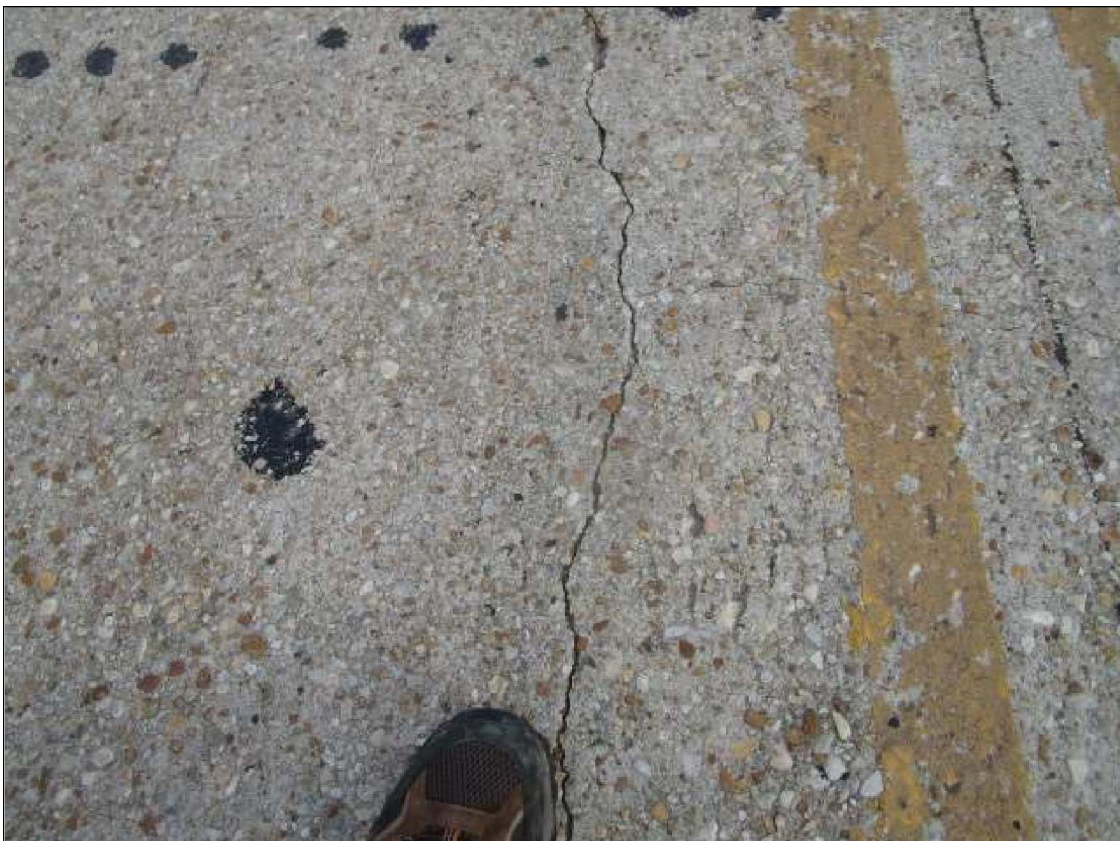
| Element Number | Defect Type | Defect Description | CS | CS Qty | Maint Qty |
|---|---|---|---|---|---|
| 12 | Cracking (RC and Other) | 1/8" LONGITUDINAL CRACK IN SOUTH BOUND LANE | 3 | 18 | 18 Square Feet |

Span 1 Deck: 1/8" LONGITUDINAL CRACK IN SOUTH BOUND LANE

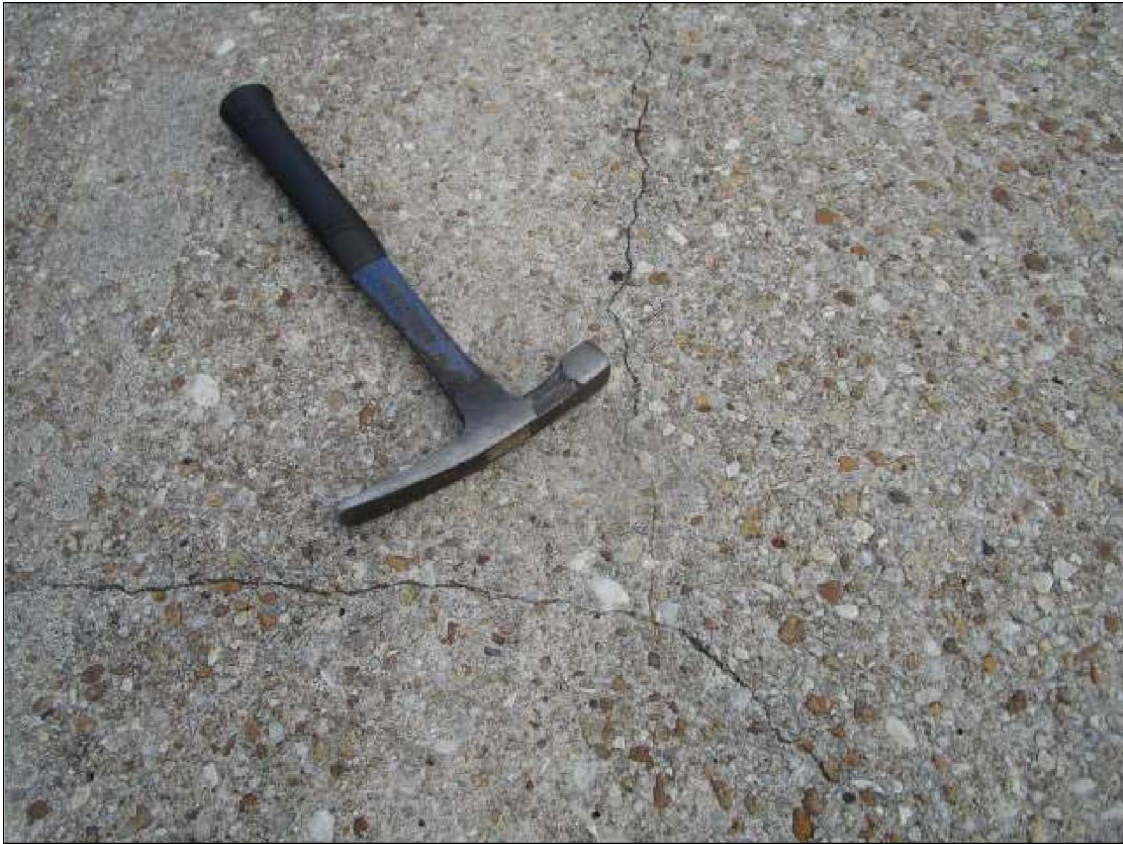
| 12 | Cracking (RC and Other) | 1/16" TRANSVERSE AND LONGITUDINAL CRACKING IN TOPSIDE | 2 | 100 | 100 | Square Feet |

Span 1 Deck: 1/16" TRANSVERSE AND LONGITUDINAL CRACKING IN TOPSIDE

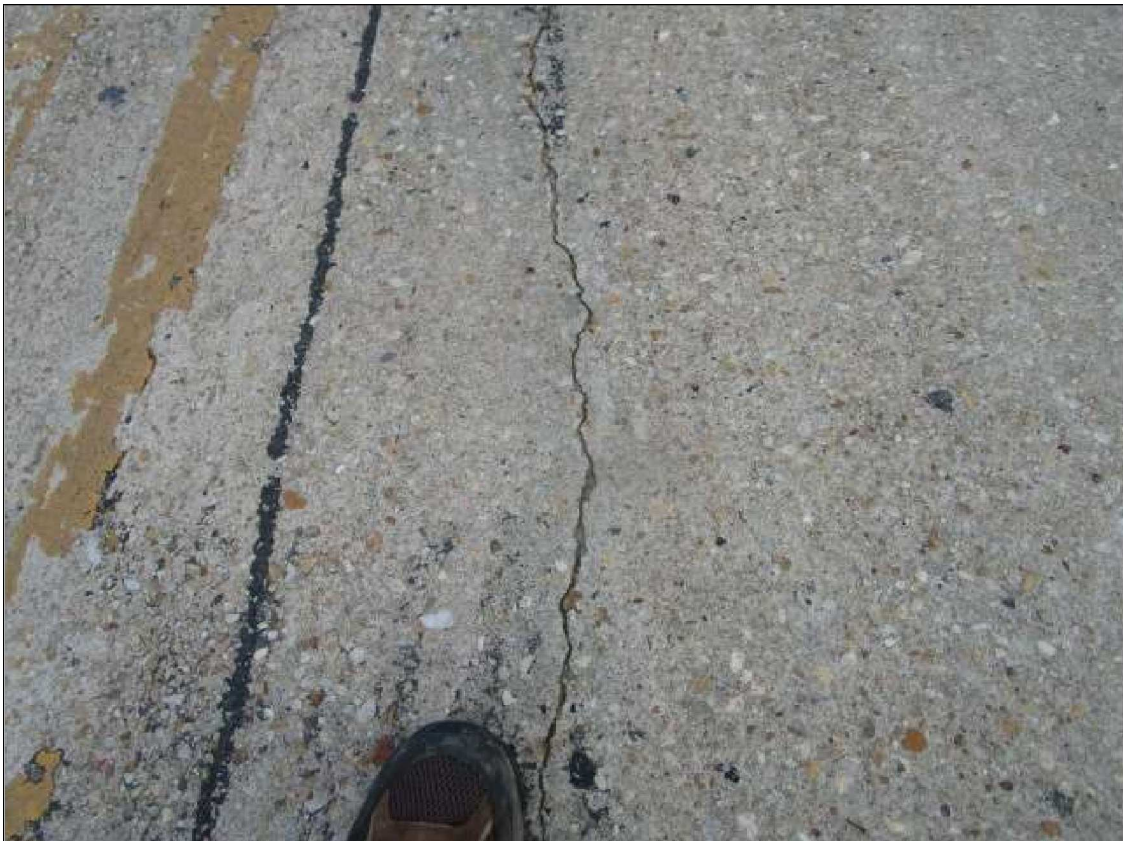
| Element Number | Defect Type | Defect Description | CS | CS Qty | Maint Qty |
|---|---|---|---|---|---|
| 12 | Cracking (RC and Other) | 1/8" LONGITUDINAL CRACK IN NORTH BOUND LANE | 3 | 18 | 18 Square Feet |

Span 2 Deck: 1/8" LONGITUDINAL CRACK IN NORTH BOUND LANE
