NC DEPARTMENT OF TRANSPORTATION  
DIVISION OF HIGHWAYS  
STRUCTURE MANAGEMENT UNIT

## Structure Safety Report

### Routine Element Inspection - Contract

DIVISION: 6 COUNTY: CUMBERLAND STRUCTURE NUMBER: 250044 FREQUENCY: 24 MONTHS

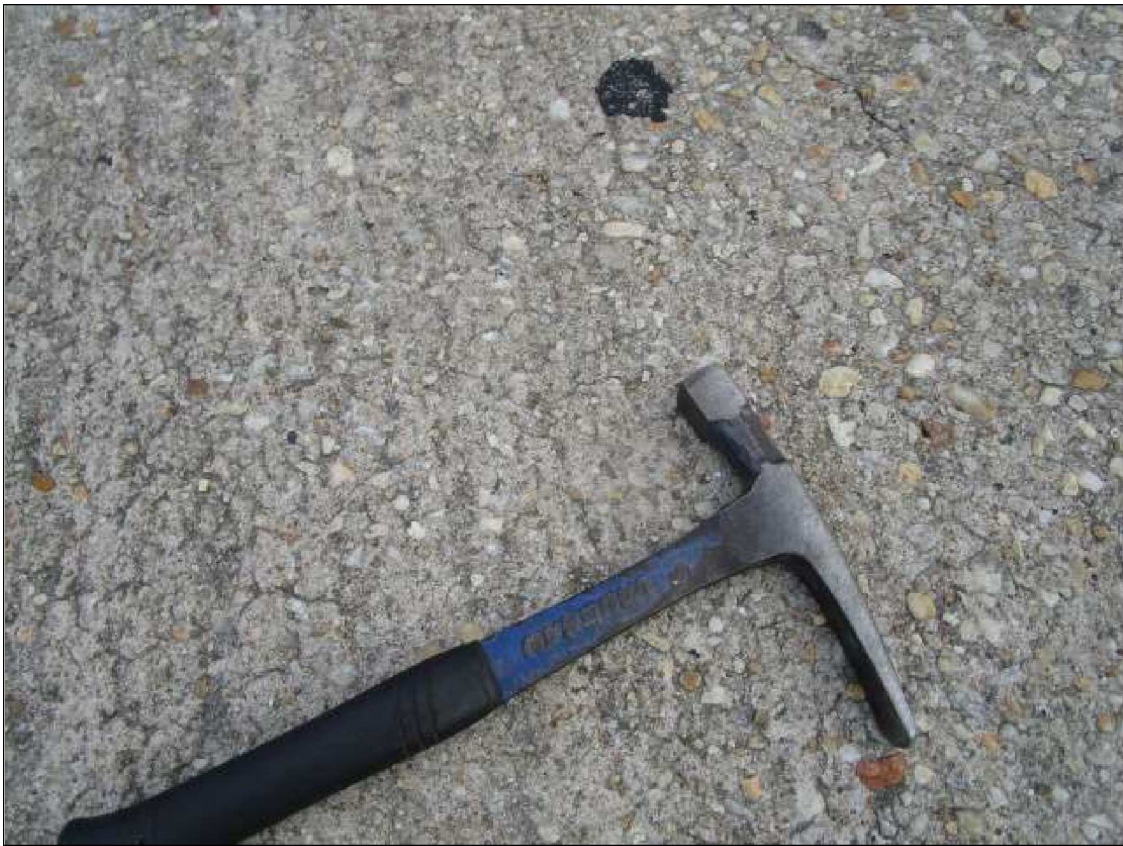
| Element Number | Defect Type | Defect Description | CS | CS Qty | Maint Qty |
|---|---|---|---|---|---|
| 12 | Abrasion/Wear (PSC/RC) | SCALING WITH 1/64" MAP CRACKING THROUGHOUT | 2 | 398 | Square Feet |

Span 2 Deck: SCALING WITH 1/64" MAP CRACKING THROUGHOUT

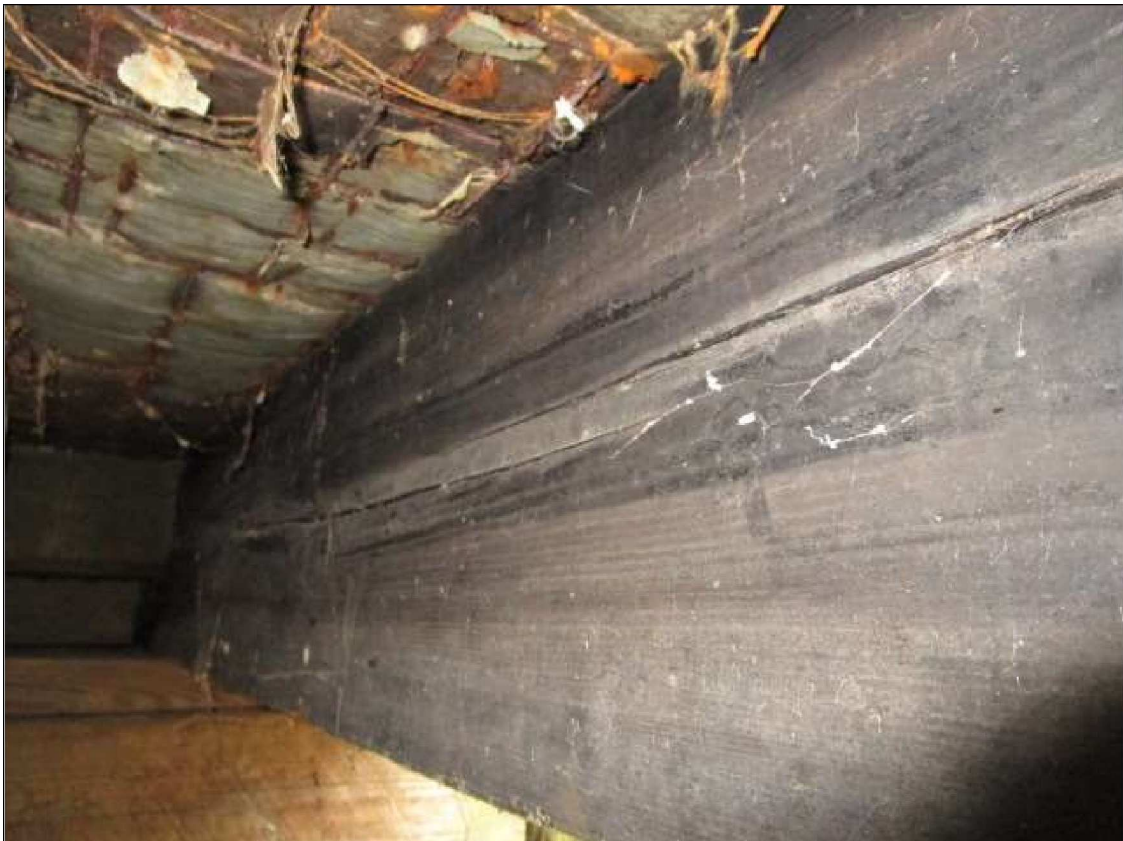
| Element Number | Defect Type | Defect Description | CS | CS Qty | Maint Qty |
|---|---|---|---|---|---|
| 111 | Check/Shake | HEAVY CHECKING THROUGHOUT | 2 | 19 | Feet |

Span 2 Beam 22: HEAVY CHECKING THROUGHOUT

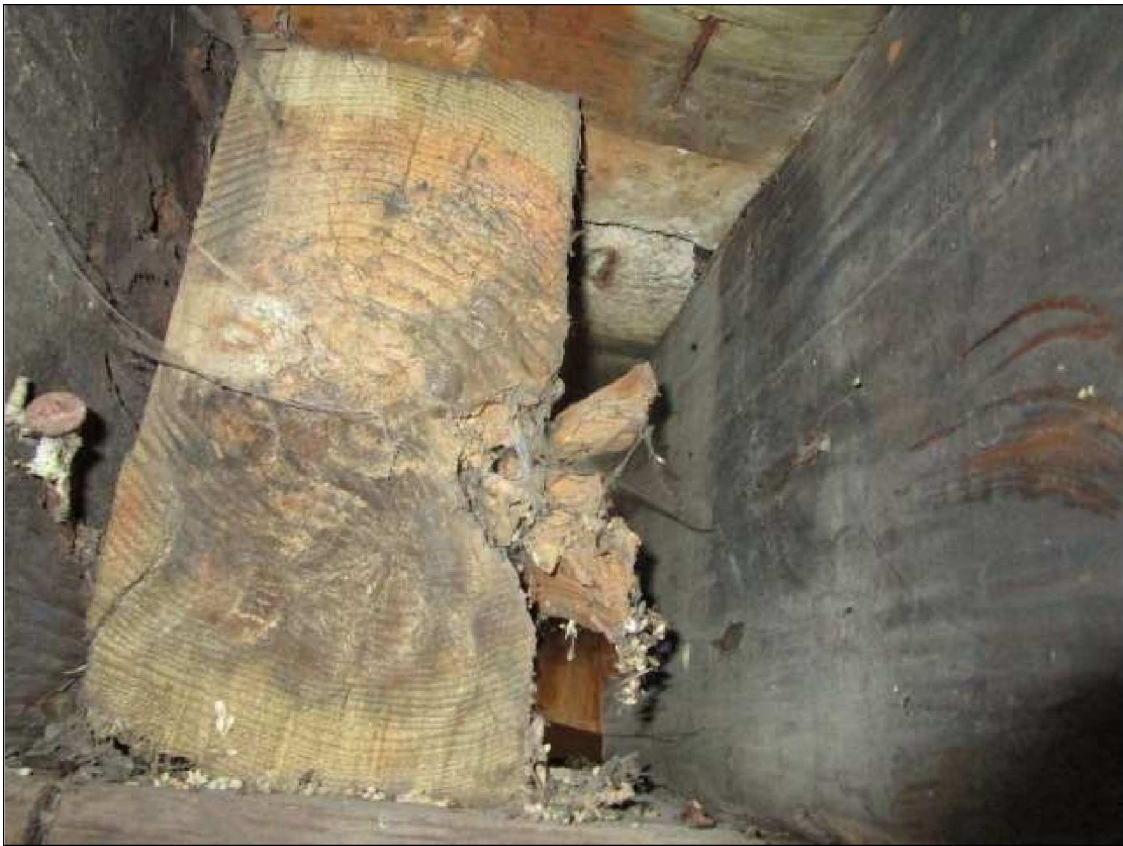
| Element Number | Defect Type | Defect Description | CS | CS Qty | Maint Qty |
|---|---|---|---|---|---|
| 111 | Damage | IMPACT DAMAGE TO BEAM END OVER BENT 1 | 2 | 1 | 1 Feet |

Span 1 Beam 20: IMPACT DAMAGE TO BEAM END OVER BENT 1

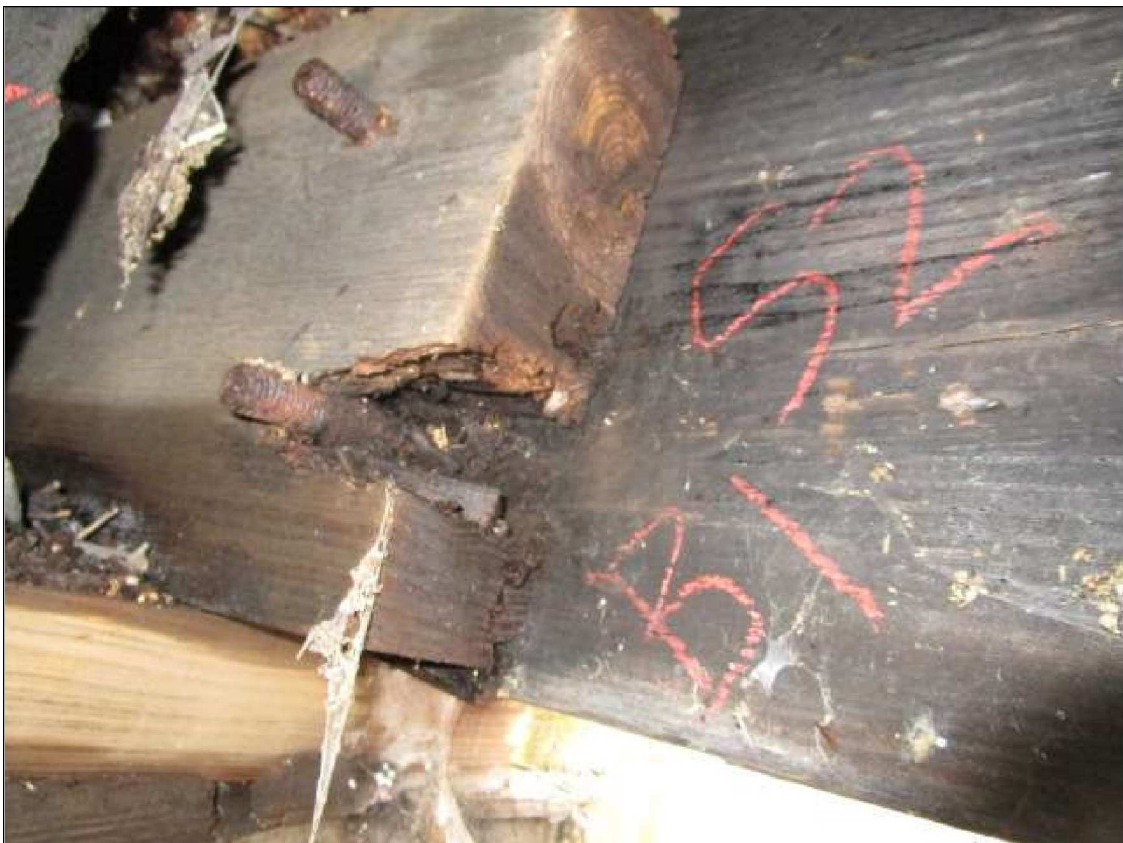
2 1/2" X 3" X 3" DEEP DECAY ON LEFT CONNECTOR PLATE OVER BENT 1
