NC DEPARTMENT OF TRANSPORTATION  
DIVISION OF HIGHWAYS  
STRUCTURE MANAGEMENT UNIT

## Structure Safety Report

### Routine Element Inspection - Contract

DIVISION: 6 COUNTY: HARNETT STRUCTURE NUMBER: 420234 FREQUENCY: 24 MONTHS

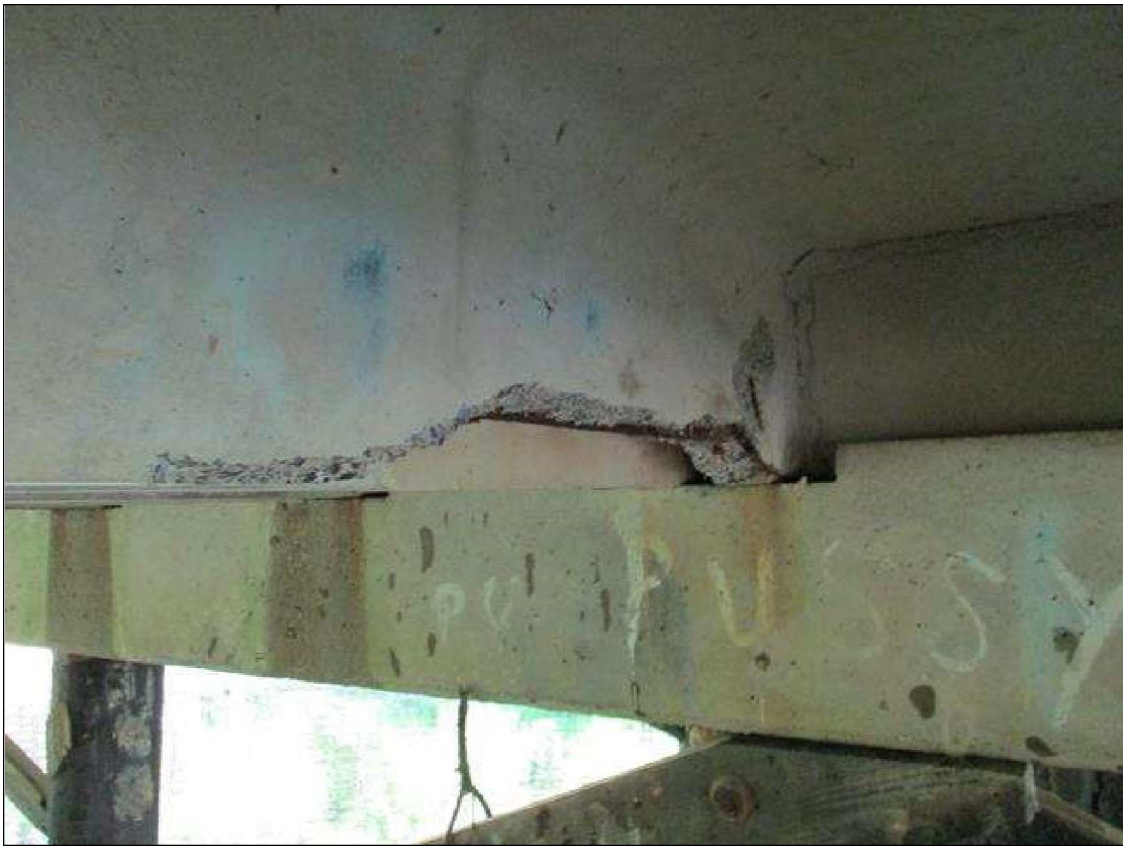
| Element Number | Defect Type | Defect Description | CS | CS Qty | Maint Qty |
|---|---|---|---|---|---|
| 109 | Delamination/Spall | SPALL LEFT LEG 37" LONG X 2-1/2" WIDE X 3-1/2" HIGH WITH CABLE EXPOSED WITH 10% SECTION LOSS AT EXPOSED STRANDS. (PRIORITY MAINTENANCE) | 4 | 3 | 3 Feet |

Span 1 Slab 6: SPALL LEFT LEG 37" LONG X 2-1/2" WIDE X 3-1/2" HIGH WITH CABLE EXPOSED WITH 10% SECTION LOSS AT EXPOSED STRANDS. (PRIORITY MAINTENANCE)

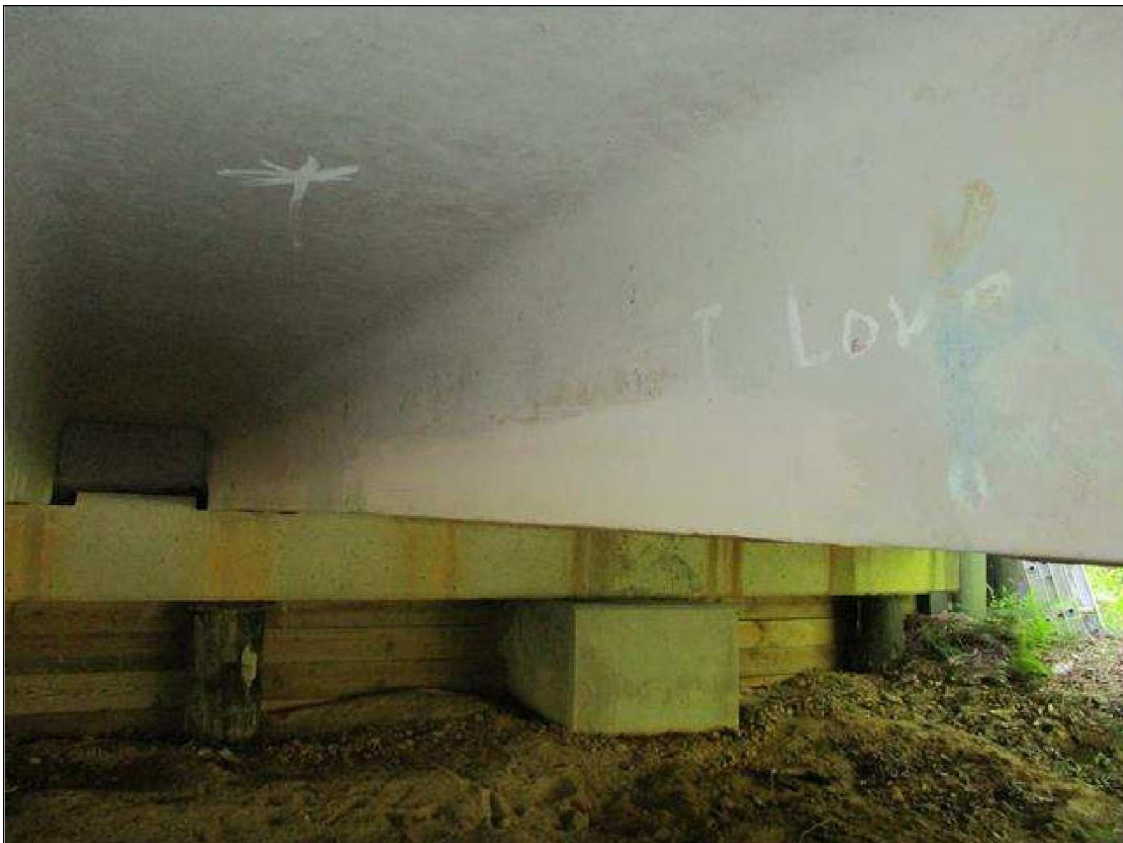
| Element Number | Defect Type | Defect Description | CS | CS Qty | Maint Qty |
|---|---|---|---|---|---|
| 109 | Patched Area | NEW REPAIR PATCH AT: 24" LONG X 3" HIGH X FULL WIDTH SPALL WITH EXPOSED STRAND LEFT LEG - 8' FROM END BENT 1 | 2 | 2 | Feet |

Span 1 Slab 6: NEW REPAIR PATCH AT: 24" LONG X 3" HIGH X FULL WIDTH SPALL WITH EXPOSED STRAND LEFT LEG - 8' FROM END BENT 1

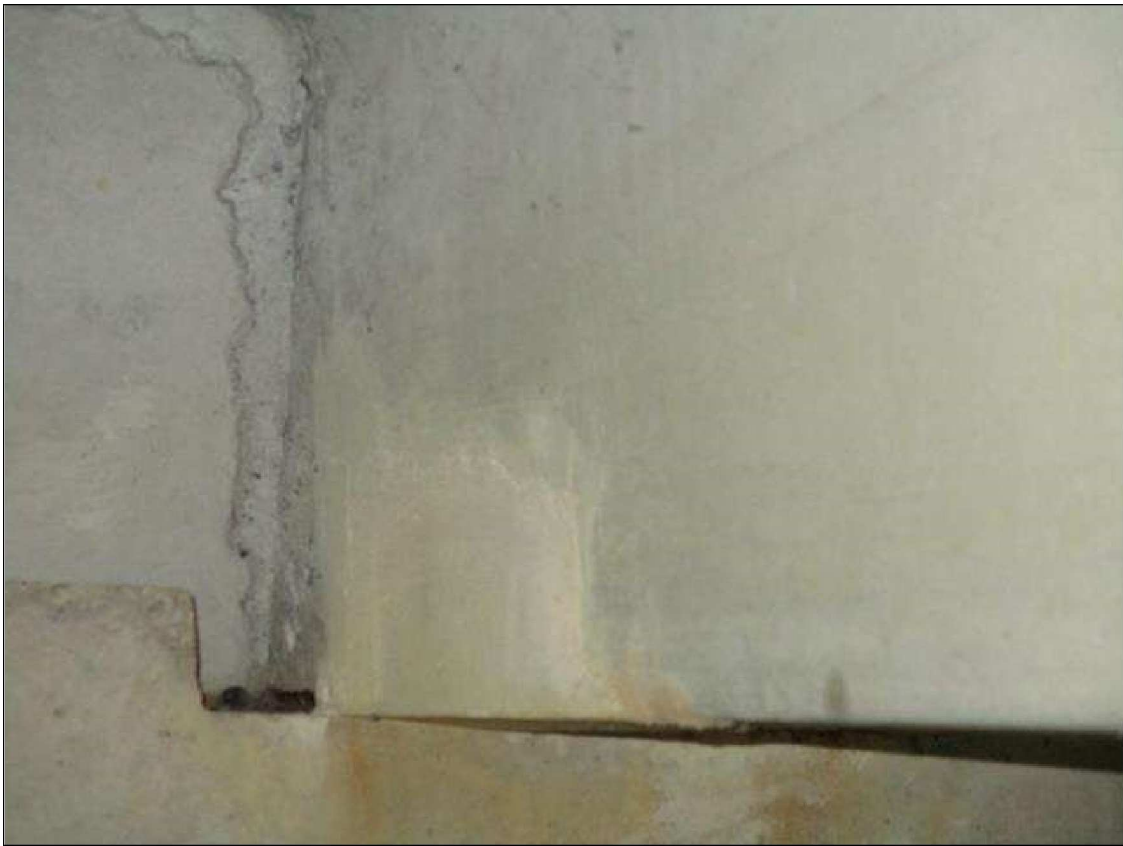
| Element Number | Defect Type | Defect Description | CS | CS Qty | Maint Qty |
|---|---|---|---|---|---|
| 109 | Patched Area | NEW PATCHED AREA AT: 6" LONG X 2" HIGH X 3/4" DEEP SPALL WITH EXPOSED REBAR LEFT SIDE RIGHT LEG AT BENT 1 | 2 | 1 | Feet |

Span 1 Slab 6: NEW PATCHED AREA AT: 6" LONG X 2" HIGH X 3/4" DEEP SPALL WITH EXPOSED REBAR LEFT SIDE RIGHT LEG AT BENT 1

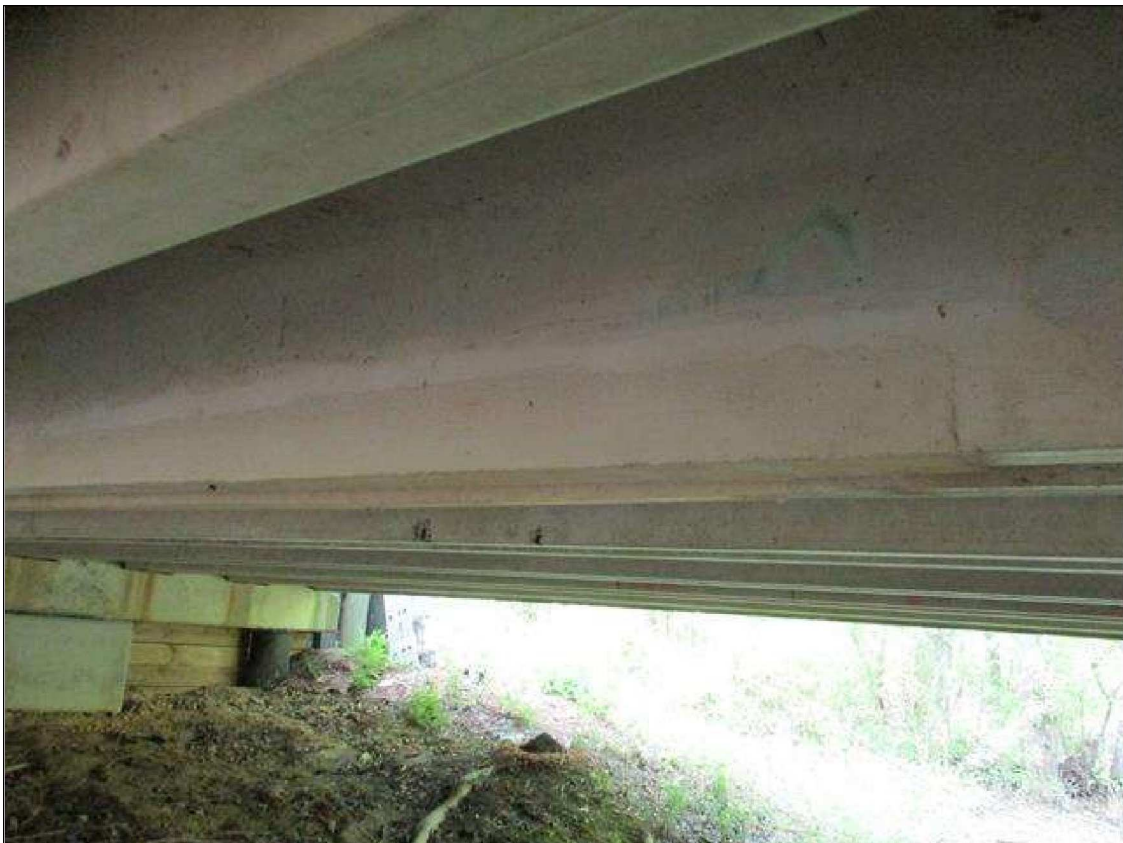
| Element Number | Defect Type | Defect Description | CS | CS Qty | Maint Qty |
|---|---|---|---|---|---|
| 109 | Patched Area | NEW REPAIR PATCH AT: 5' LONG X 3" HIGH FORMING SPALL ALONG LEFT LEG - 6' FROM BENT 1 | 2 | 5 | Feet |

Span 1 Slab 6: NEW REPAIR PATCH AT: 5' LONG X 3" HIGH FORMING SPALL ALONG LEFT LEG - 6' FROM BENT

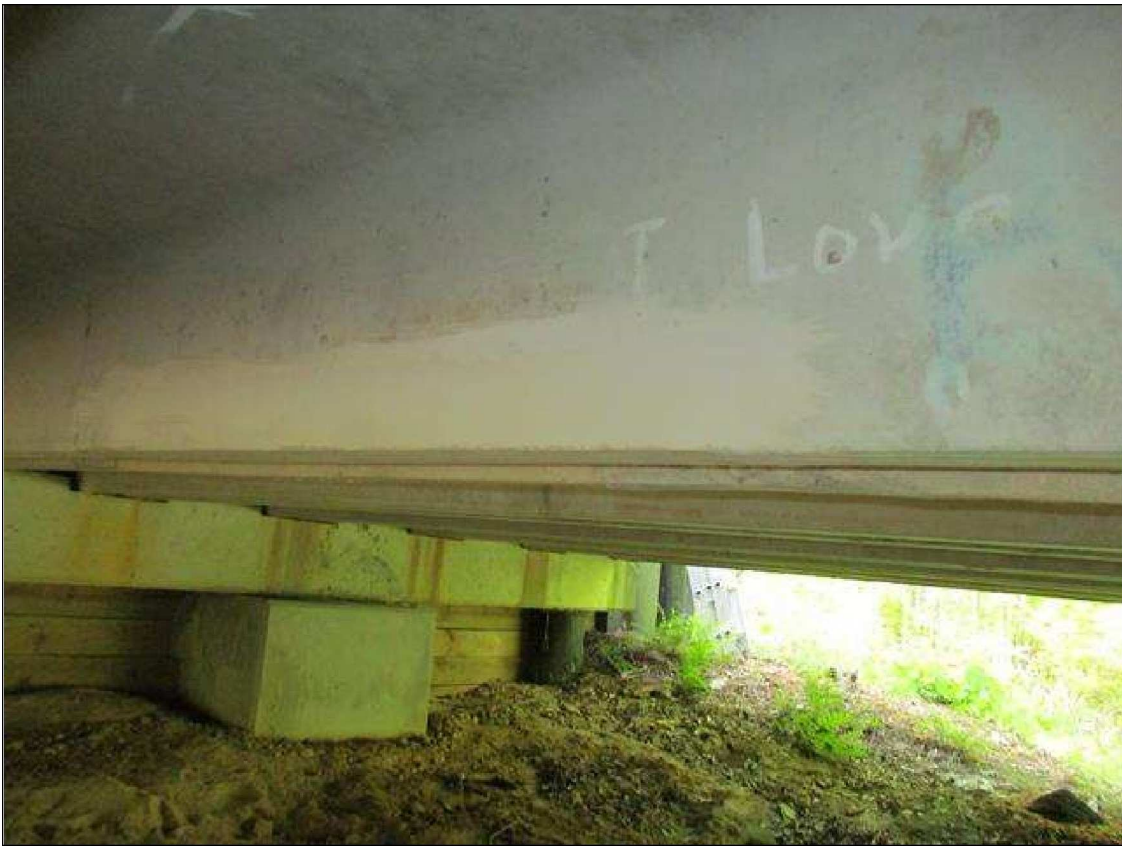
| Element Number | Defect Type | Defect Description | CS | CS Qty | Maint Qty |
|---|---|---|---|---|---|
| 109 | Patched Area | NEW PATCHED AREA AT: 8" LONG X 4" HIGH X FULL WIDTH SPALL WITH EXPOSED REBAR LEFT LEG AT END BENT 1 | 2 | 1 | Feet |

Span 1 Slab 6: NEW PATCHED AREA AT: 8" LONG X 4" HIGH X FULL WIDTH SPALL WITH EXPOSED REBAR  
LEFT LEG AT END BENT 1

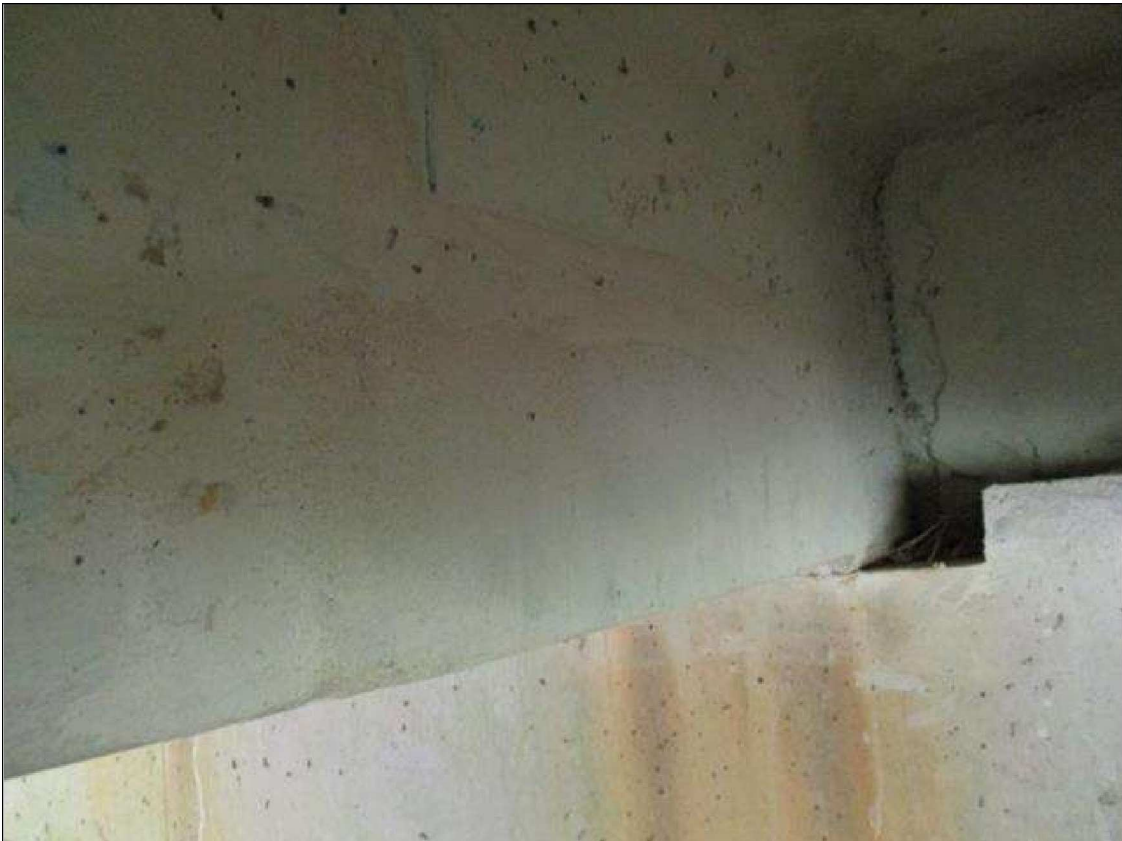
| Element Number | Defect Type | Defect Description | CS | CS Qty | Maint Qty |
|---|---|---|---|---|---|
| 109 | Patched Area | NEW REPAIR PATCH AT: 20" LONG X 4" HIGH X FULL WIDTH SPALL WITH EXPOSED STRAND RIGHT LEG AT END BENT 1 | 2 | 2 | Feet |

Span 1 Slab 6: NEW REPAIR PATCH AT: 20" LONG X 4" HIGH X FULL WIDTH SPALL WITH EXPOSED STRAND  
RIGHT LEG AT END BENT 1

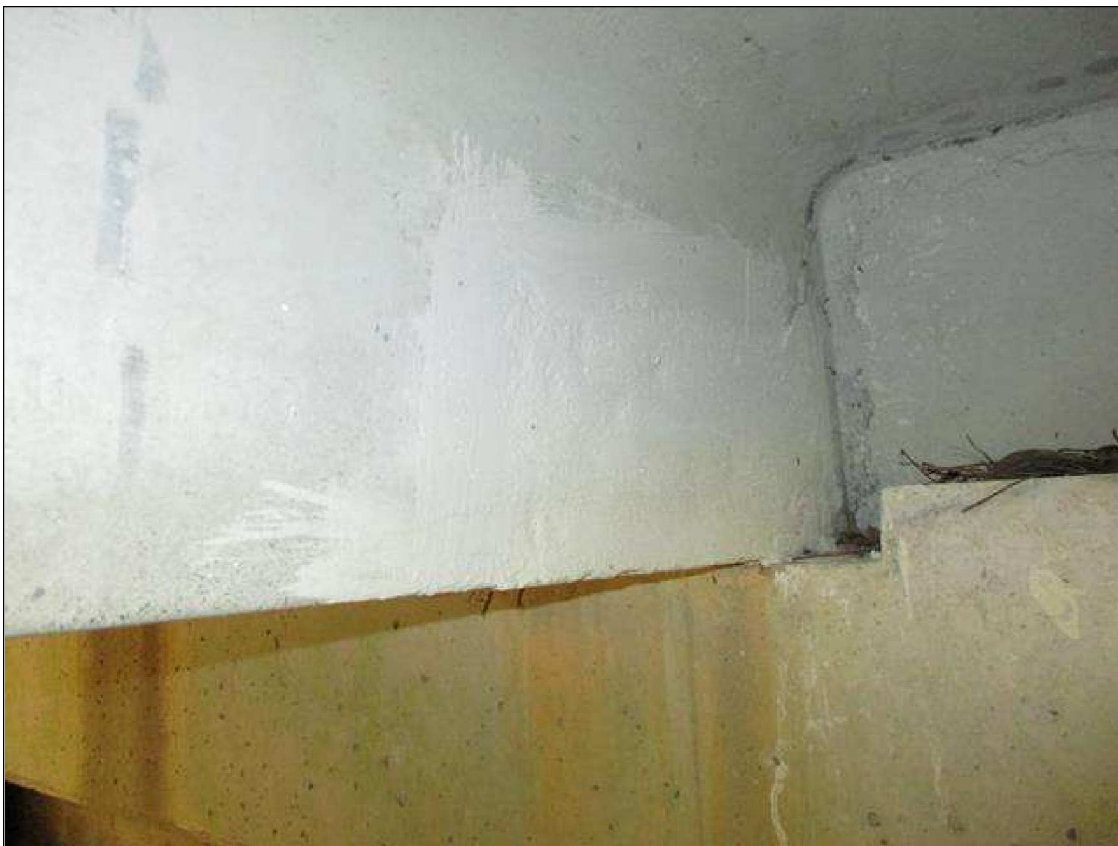
| Element Number | Defect Type | Defect Description | CS | CS Qty | Maint Qty |
|---|---|---|---|---|---|
| 109 | Patched Area | NEW REPAIR PATCH AT: 12" LONG X 3" HIGH X FULL WIDTH SPALL WITH EXPOSED REBAR RIGHT LEG AT END BENT 1 | 2 | 1 | Feet |

Span 1 Slab 7: NEW REPAIR PATCH AT: 12" LONG X 3" HIGH X FULL WIDTH SPALL WITH EXPOSED REBAR RIGHT LEG AT END BENT 1

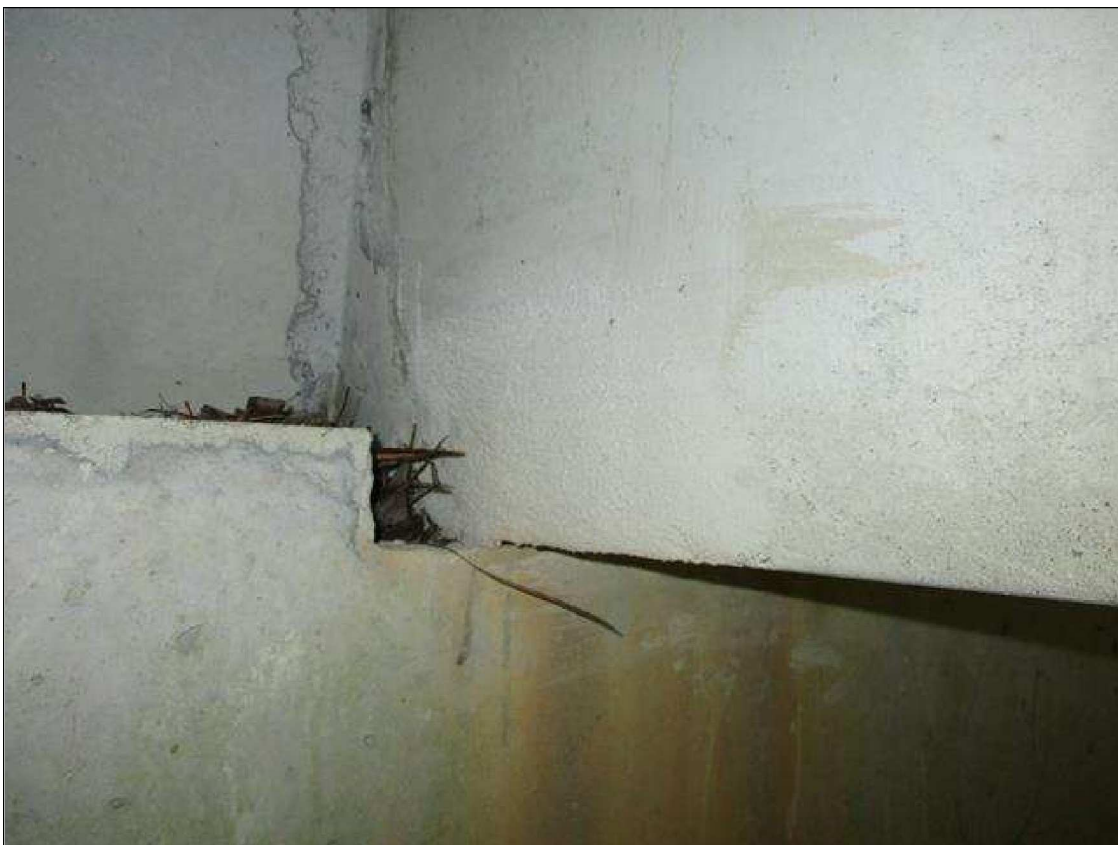
| Element Number | Defect Type | Defect Description | CS | CS Qty | Maint Qty |
|---|---|---|---|---|---|
| 109 | Patched Area | NEW REPAIR PATCH AT: 4" DIAMETER X 1/2" DEEP SPALL WITH EXPOSED REBAR LEFT LEG RIGHT SIDE AT END BENT 1 | 2 | 1 | Feet |

Span 1 Slab 7: NEW REPAIR PATCH AT: 4" DIAMETER X 1/2" DEEP SPALL WITH EXPOSED REBAR LEFT LEG RIGHT SIDE AT END BENT 1

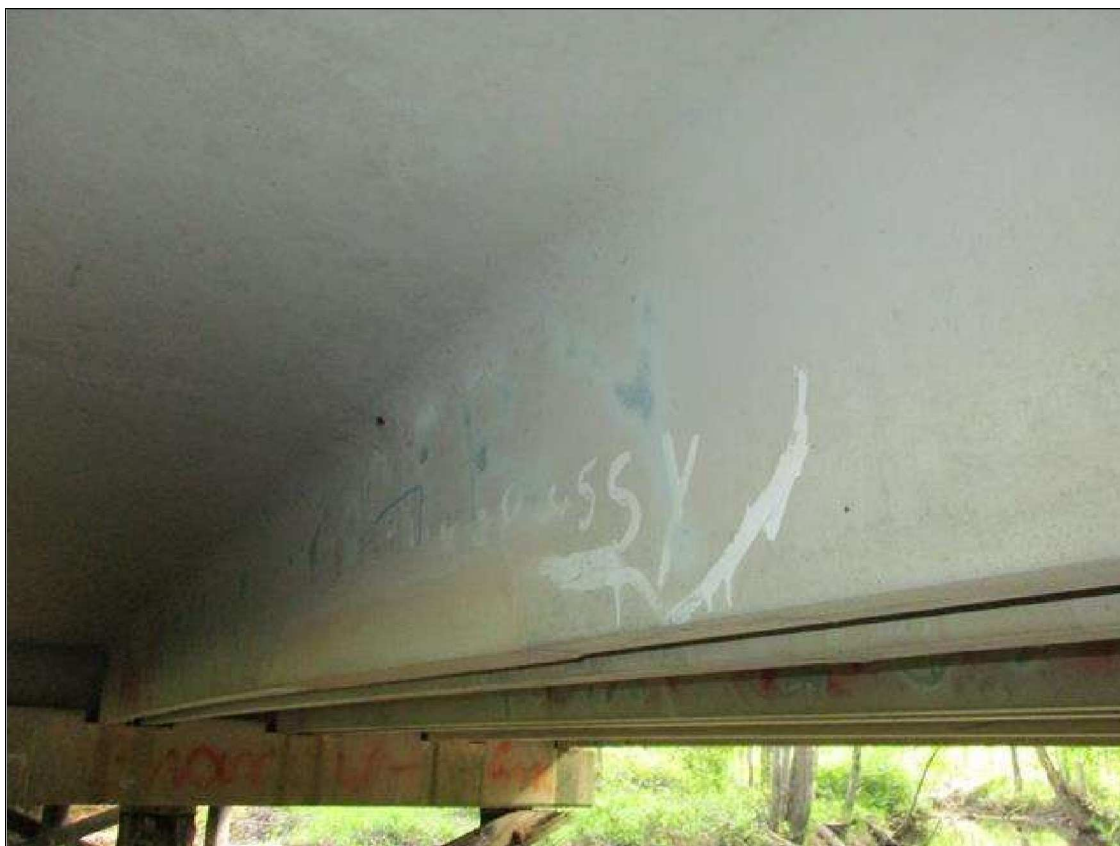
| Element Number | Defect Type | Defect Description | CS | CS Qty | Maint Qty |
|---|---|---|---|---|---|
| 109 | Patched Area | NEW REPAIR PATCH AT: 28" LONG X 3" HIGH X FULL WIDTH SPALL WITH EXPOSED STRAND RIGHT LEG - 12' FROM BENT 1 | 2 | 2 | Feet |

Span 1 Slab 7: NEW REPAIR PATCH AT: 28" LONG X 3" HIGH X FULL WIDTH SPALL WITH EXPOSED STRAND  
RIGHT LEG - 12' FROM BENT 1

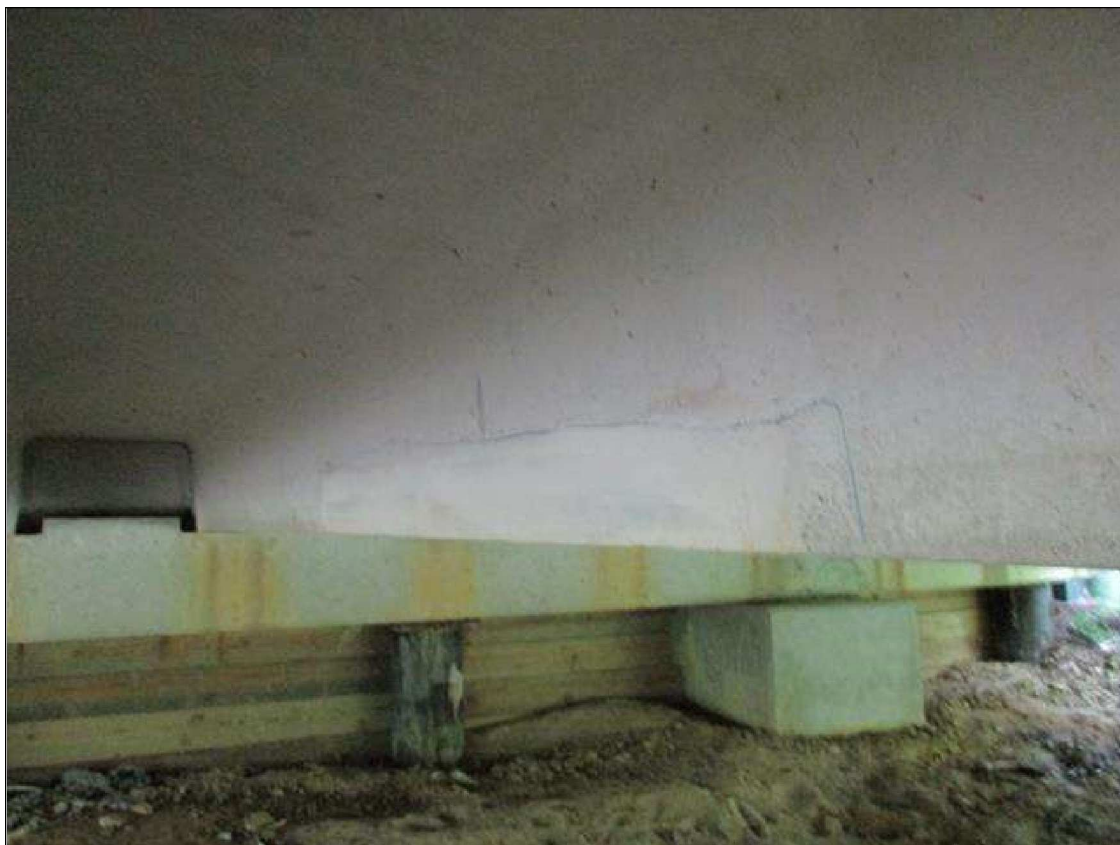
| Element Number | Defect Type | Defect Description | CS | CS Qty | Maint Qty |
|---|---|---|---|---|---|
| 109 | Patched Area | NEW REPAIR PATCH AT: 36" LONG X 3" HIGH X FULL WIDTH SPALL WITH EXPOSED STRAND LEFT LEG - 8' FROM END BENT 1 | 2 | 3 | Feet |

Span 1 Slab 7: NEW REPAIR PATCH AT: 36" LONG X 3" HIGH X FULL WIDTH SPALL WITH EXPOSED STRAND  
LEFT LEG - 8' FROM END BENT 1

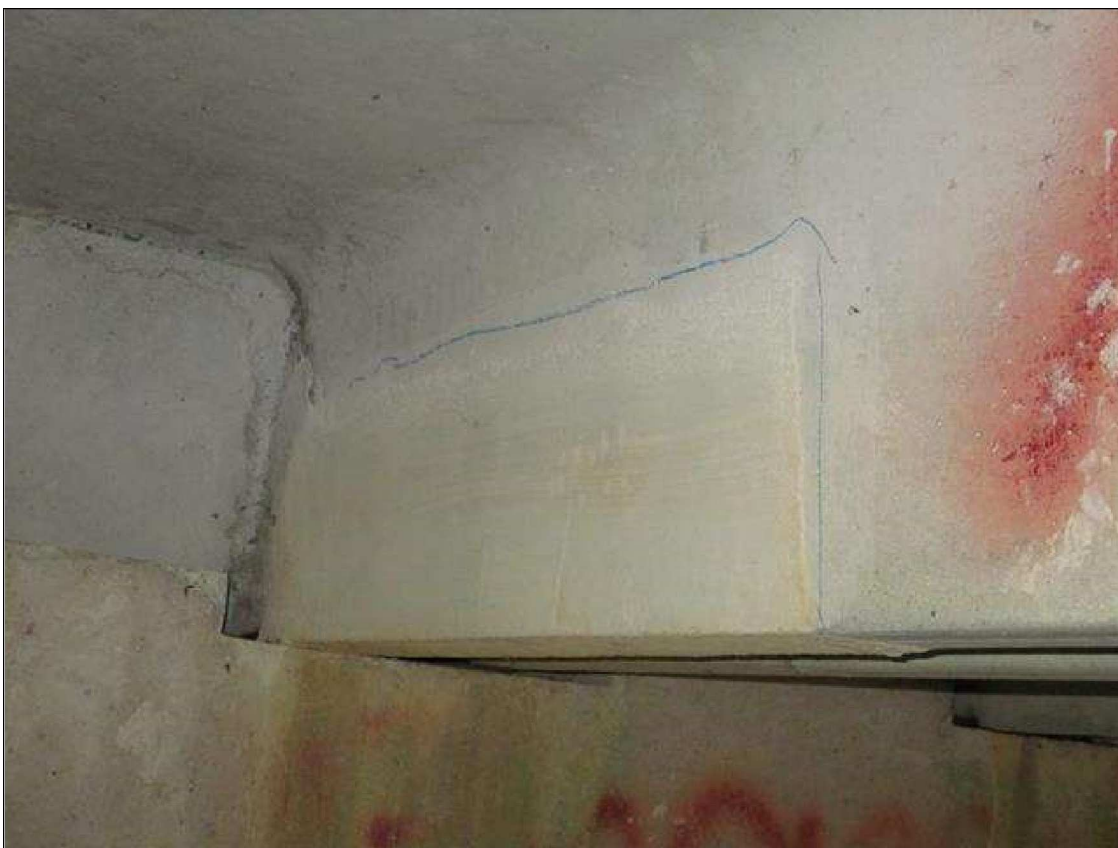
| Element Number | Defect Type | Defect Description | CS | CS Qty | Maint Qty |
|---|---|---|---|---|---|
| 109 | Patched Area | NEW REPAIR PATCH AT: 10" LONG X 5" HIGH X 1/4" DEEP SPALL WITH EXPOSED REBAR LEFT SIDE RIGHT LEG AT BENT 1 | 2 | 1 | Feet |

Span 1 Slab 7: NEW REPAIR PATCH AT: 10" LONG X 5" HIGH X 1/4" DEEP SPALL WITH EXPOSED REBAR LEFT SIDE RIGHT LEG AT BENT 1

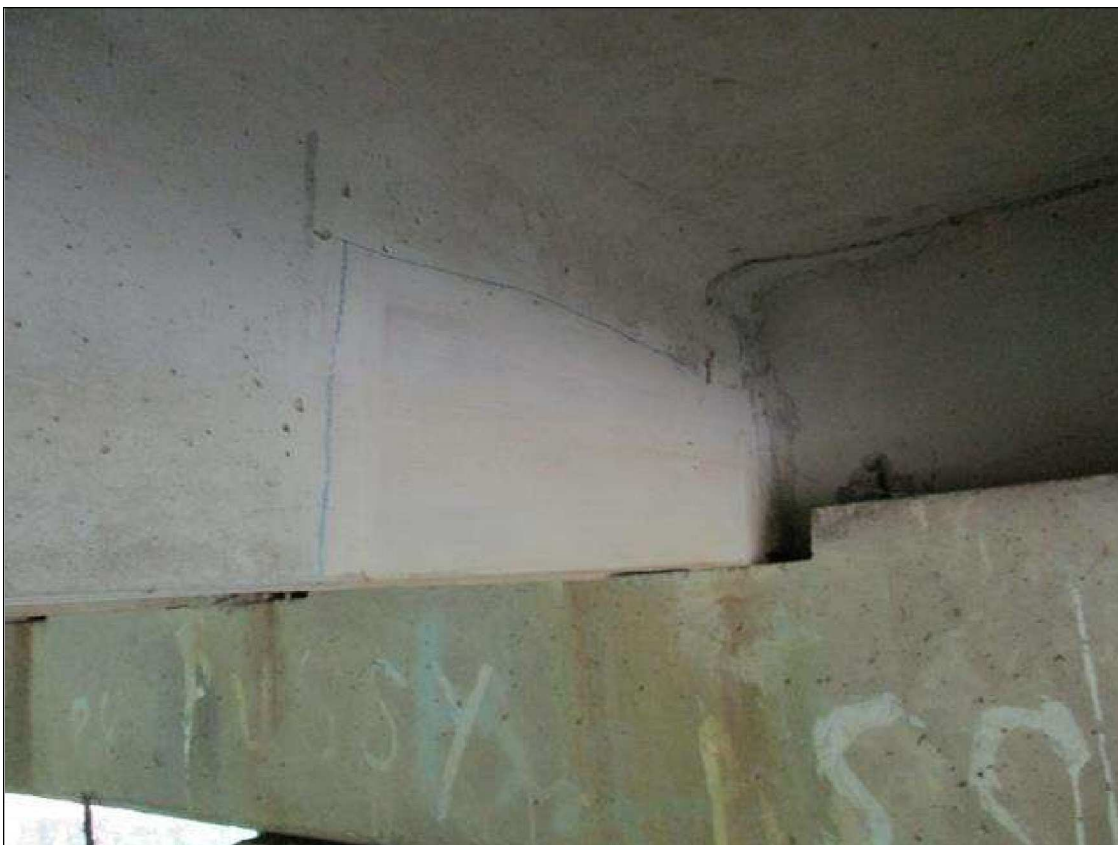
| Element Number | Defect Type | Defect Description | CS | CS Qty | Maint Qty |
|---|---|---|---|---|---|
| 109 | Patched Area | NEW PATCHED AREA AT: 10" LONG X 5" HIGH X 1/4" DEEP SPALL WITH EXPOSED REBAR RIGHT SIDE LEFT LEG AT BENT 1. | 2 | 1 | Feet |

Span 1 Slab 7: NEW PATCHED AREA AT: 10" LONG X 5" HIGH X 1/4" DEEP SPALL WITH EXPOSED REBAR RIGHT SIDE LEFT LEG AT BENT 1.

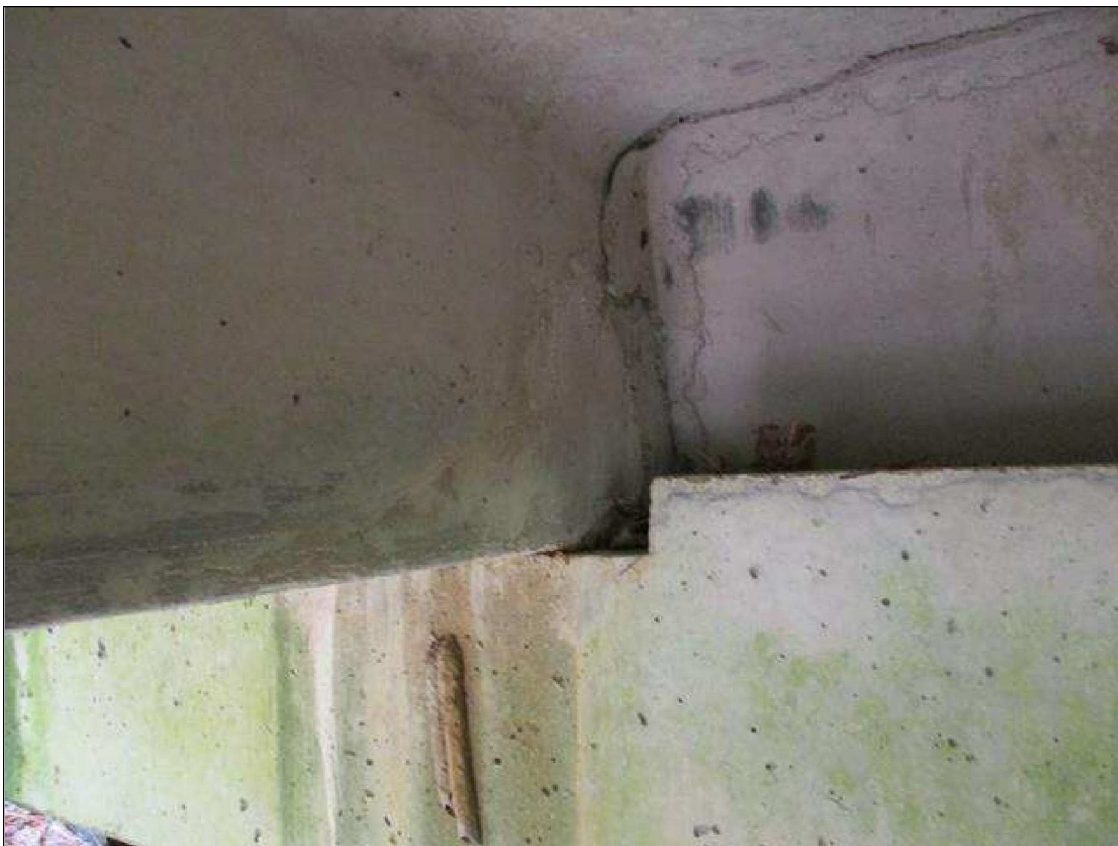
| Element Number | Defect Type | Defect Description | CS | CS Qty | Maint Qty |
|---|---|---|---|---|---|
| 109 | Patched Area | NEW REPAIR PATCH AT: 8" HIGH X 4" WIDE X 1/2" DEEP SPALL WITH EXPOSED REBAR RIGHT LEG LEFT SIDE AT END BENT 1 | 2 | 1 | Feet |

Span 1 Slab 9: NEW REPAIR PATCH AT: 8" HIGH X 4" WIDE X 1/2" DEEP SPALL WITH EXPOSED REBAR RIGHT LEG LEFT SIDE AT END BENT 1

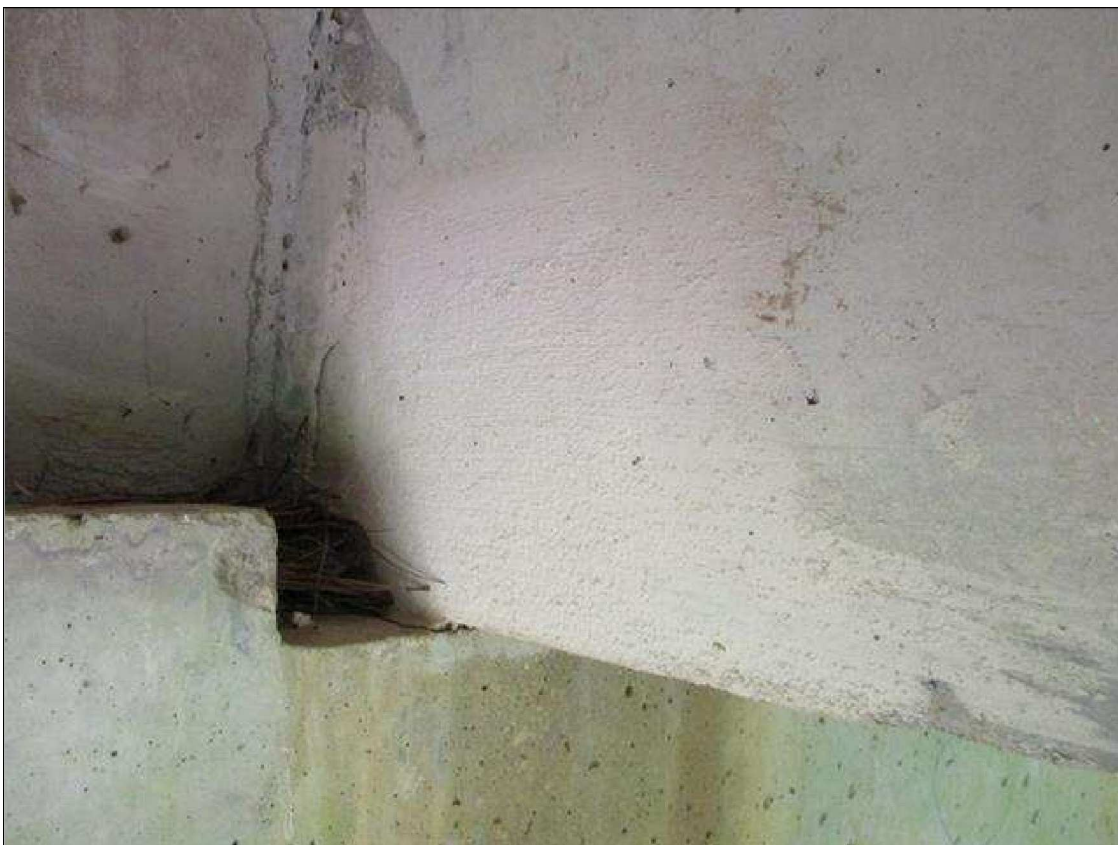
| Element Number | Defect Type | Defect Description | CS | CS Qty | Maint Qty |
|---|---|---|---|---|---|
| 109 | Patched Area | NEW REPAIR PATCH AT: 4" DIAMETER X 1/2" DEEP SPALL WITH EXPOSED REBAR LEFT LEG RIGHT SIDE AT END BENT 1. | 2 | 1 | Feet |

Span 1 Slab 9: NEW REPAIR PATCH AT: 4" DIAMETER X 1/2" DEEP SPALL WITH EXPOSED REBAR LEFT LEG RIGHT SIDE AT END BENT 1.

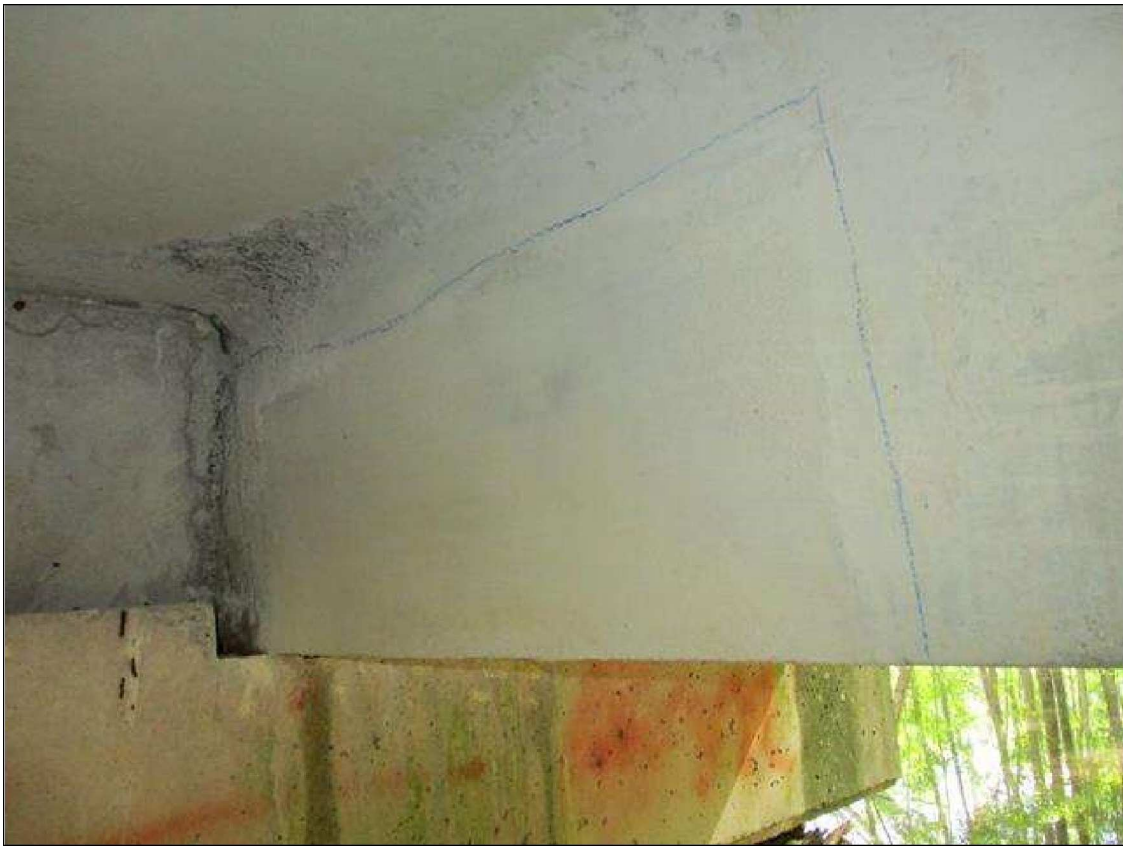
| Element Number | Defect Type | Defect Description | CS | CS Qty | Maint Qty |
|---|---|---|---|---|---|
| 109 | Patched Area | NEW REPAIR PATCH AT: 10" LONG X 5" HIGH X 1/4" DEEP SPALL WITH EXPOSED REBAR LEFT SIDE RIGHT LEG AT BENT 1. | 2 | 1 | Feet |

Span 1 Slab 9: NEW REPAIR PATCH AT: 10" LONG X 5" HIGH X 1/4" DEEP SPALL WITH EXPOSED REBAR LEFT SIDE RIGHT LEG AT BENT 1.

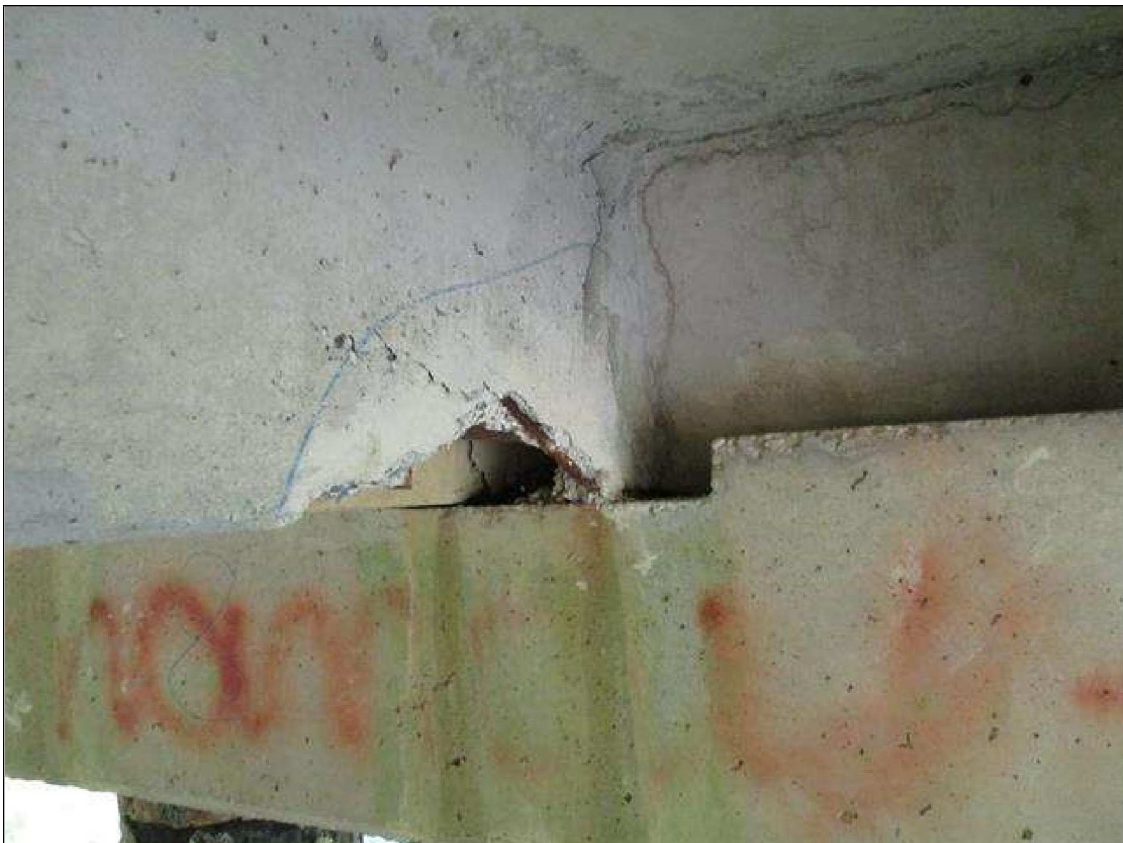
| Element Number | Defect Type | Defect Description | CS | CS Qty | Maint Qty |
|---|---|---|---|---|---|
| 109 | Exposed Rebar | SPALL 15" LONG X 3-1/2" HIGH X 2-1/2" WIDE WITH EXPOSED CABLE LEFT LEG AT BENT 1 END. (PRIORITY MAINTENANCE) | 3 | 2 | 2 Feet |

Span 1 Slab 9: SPALL 15" LONG X 3-1/2" HIGH X 2-1/2" WIDE WITH EXPOSED CABLE LEFT LEG AT BENT 1 END.  
(PRIORITY MAINTENANCE)

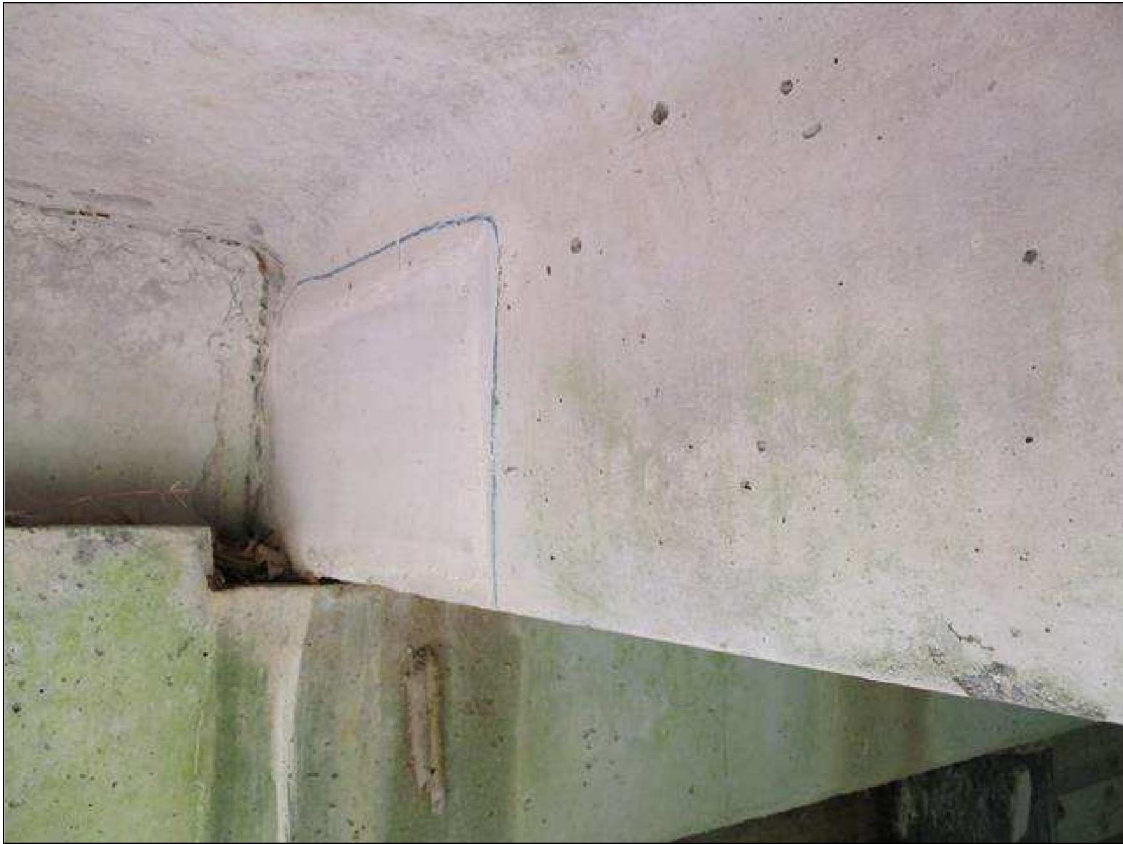
| Element Number | Defect Type | Defect Description | CS | CS Qty | Maint Qty |
|---|---|---|---|---|---|
| 109 | Patched Area | NEW PATCHED AREA: 6" DIAMETER X 1/4" DEEP SPALL WITH EXPOSED REBAR LEFT LEG RIGHT SIDE AT END BENT 1 | 2 | 1 | Feet |

Span 1 Slab 10: NEW PATCHED AREA: 6" DIAMETER X 1/4" DEEP SPALL WITH EXPOSED REBAR LEFT LEG  
RIGHT SIDE AT END BENT 1

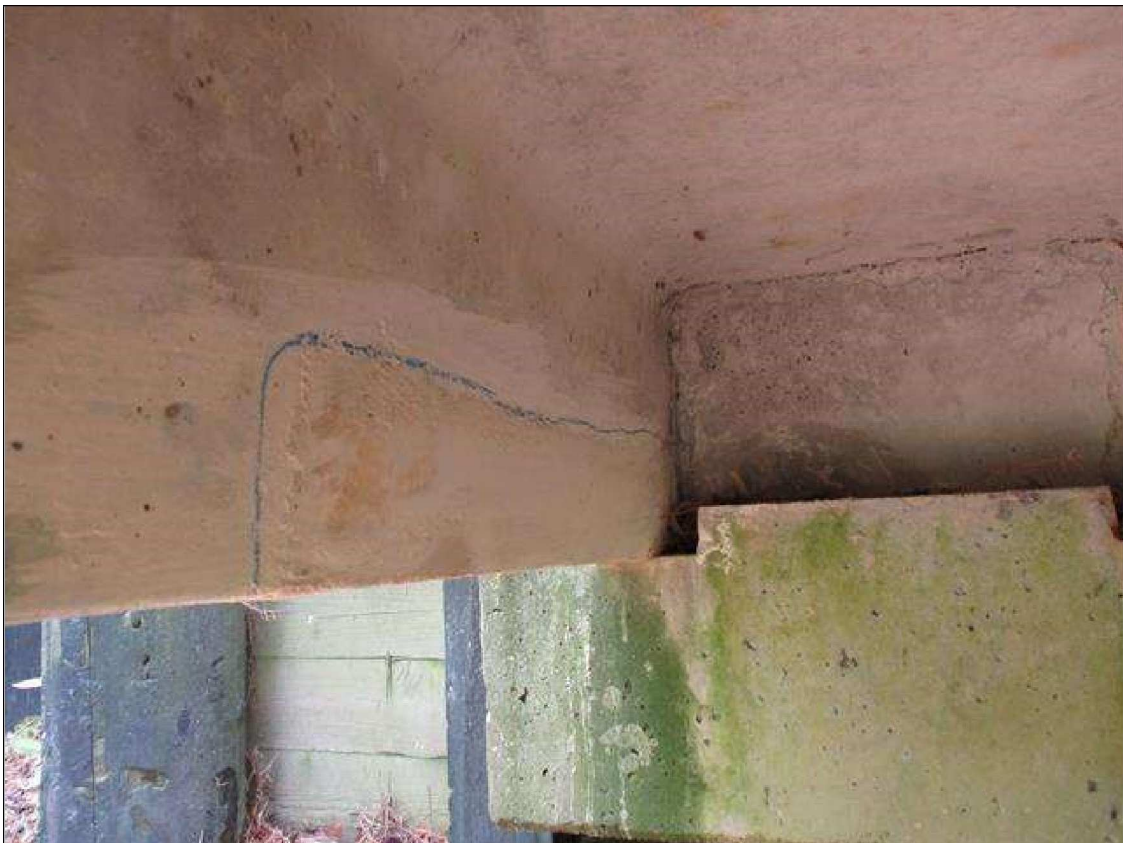
| Element Number | Defect Type | Defect Description | CS | CS Qty | Maint Qty |
|---|---|---|---|---|---|
| 109 | Patched Area | NEW PATCHED AREA: 4" LONG X 2" HIGH X 1" DEEP SPALL WITH EXPOSED REBAR RIGHT LEG LEFT SIDE AT END BENT 1 | 2 | 1 | Feet |

Span 1 Slab 10: NEW PATCHED AREA: 4" LONG X 2" HIGH X 1" DEEP SPALL WITH EXPOSED REBAR RIGHT  
LEG LEFT SIDE AT END BENT 1

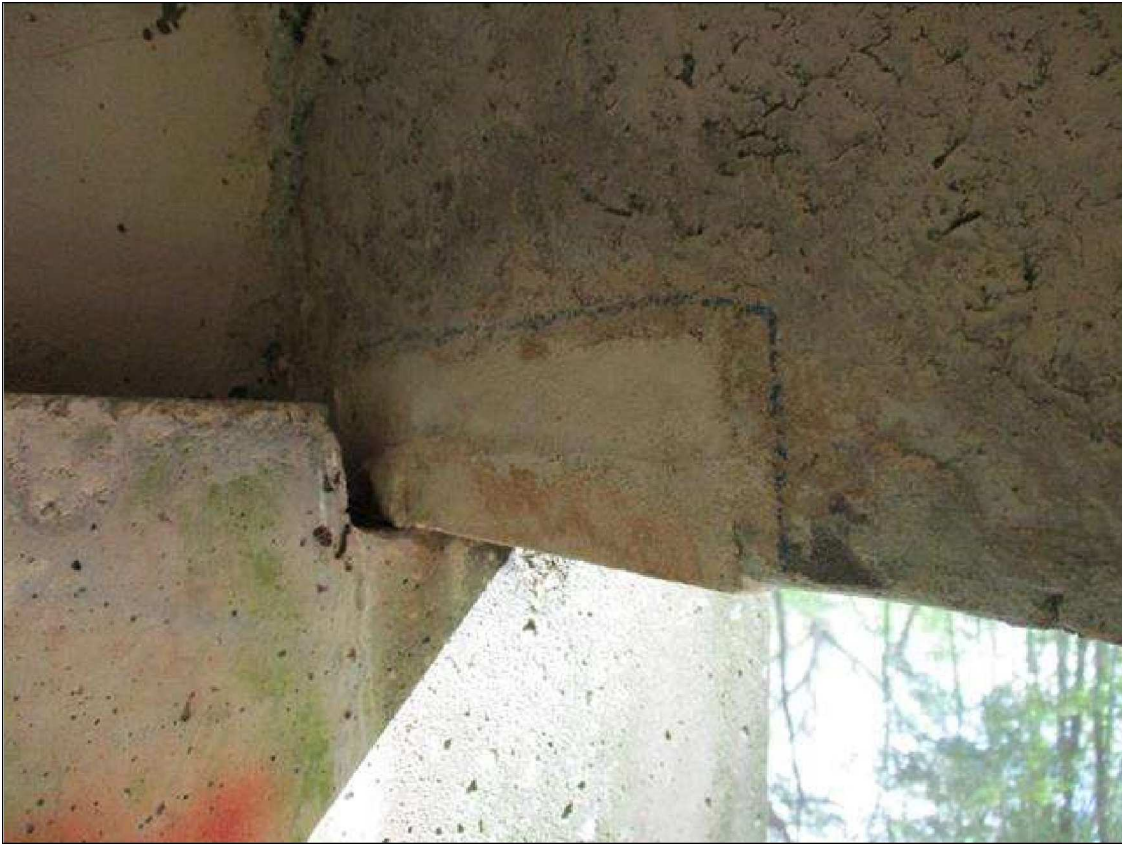
| Element Number | Defect Type | Defect Description | CS | CS Qty | Maint Qty |
|---|---|---|---|---|---|
| 109 | Patched Area | NEW PATCHED AREA: 6" LONG X 3" HIGH X FULL WIDTH SPALL WITH EXPOSED STRAND RIGHT LEG AT BENT 1 | 2 | 1 | Feet |

Span 1 Slab 10: NEW PATCHED AREA: 6" LONG X 3" HIGH X FULL WIDTH SPALL WITH EXPOSED STRAND RIGHT LEG AT BENT 1

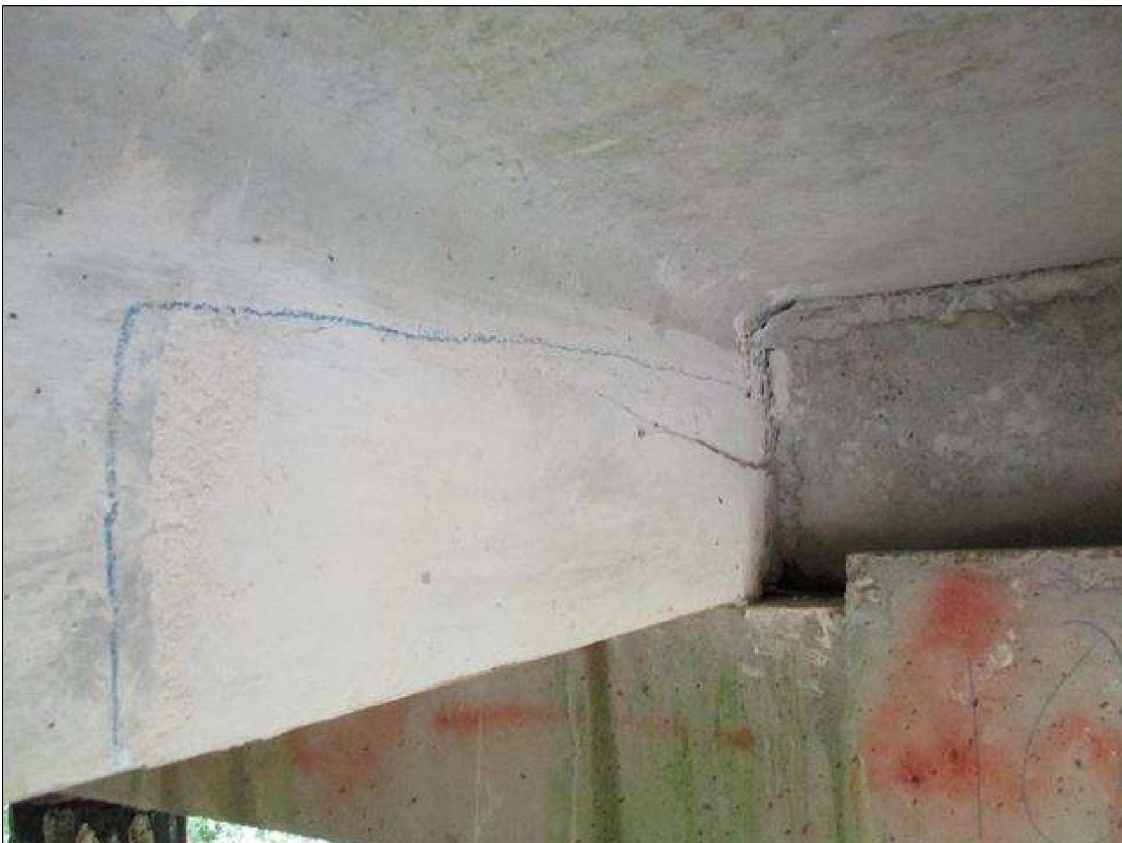
| Element Number | Defect Type | Defect Description | CS | CS Qty | Maint Qty |
|---|---|---|---|---|---|
| 109 | Patched Area | NEW PATCHED AREA AT: 8" LONG X 4" HIGH X 1/2" DEEP SPALL WITH EXPOSED REBAR RIGHT SIDE LEFT LEG AT BENT 1 | 2 | 1 | Feet |

Span 1 Slab 10: NEW PATCHED AREA AT: 8" LONG X 4" HIGH X 1/2" DEEP SPALL WITH EXPOSED REBAR RIGHT SIDE LEFT LEG AT BENT 1

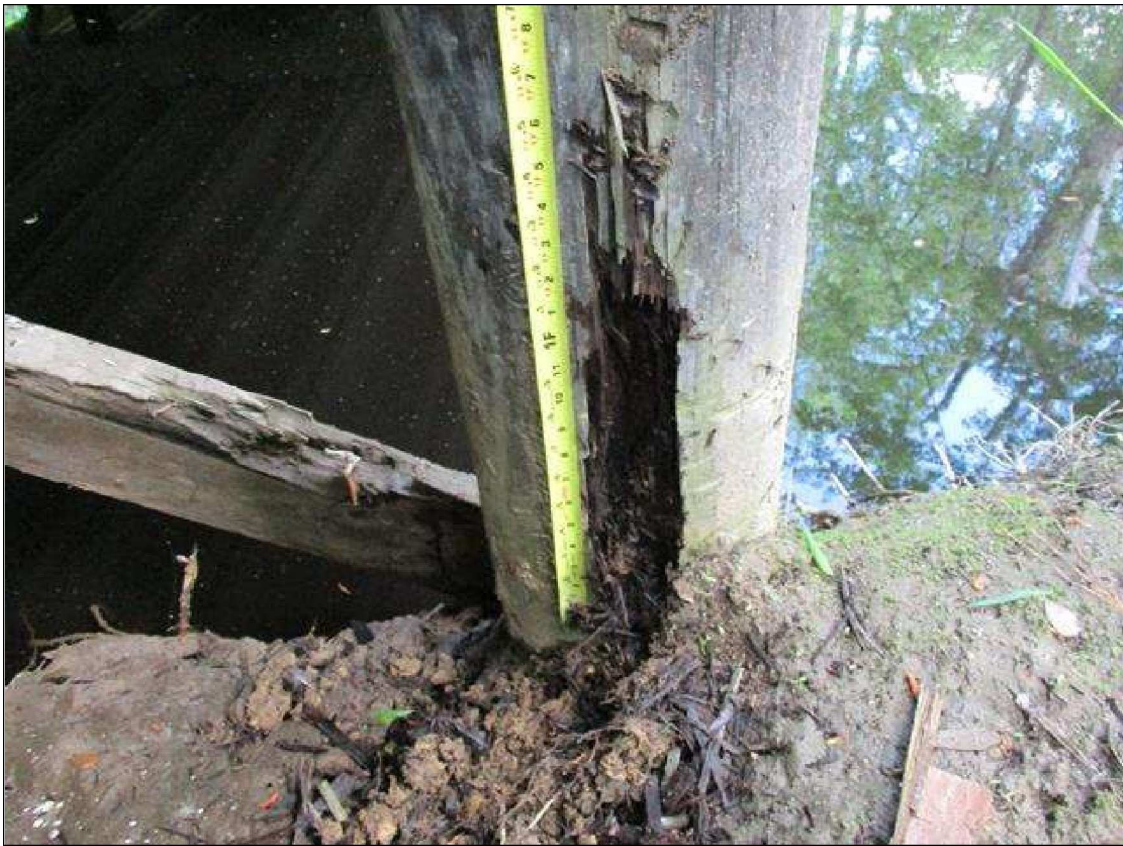
| Element Number | Defect Type | Defect Description | CS | CS Qty | Maint Qty | |
|---|---|---|---|---|---|---|
| 228 | Decay/Section Loss | DECAYED 3" WIDE X 14" HIGH X 1-1/2" DEEP ON SOUTH FACE AT GROUND-LINE, BEGINNING 35" BELOW BOTTOM OF CAP. | 2 | 1 | | Each |

Bent 1 Pile 5: DECAYED 3" WIDE X 14" HIGH X 1-1/2" DEEP ON SOUTH FACE AT GROUND-LINE, BEGINNING 35" BELOW BOTTOM OF CAP.

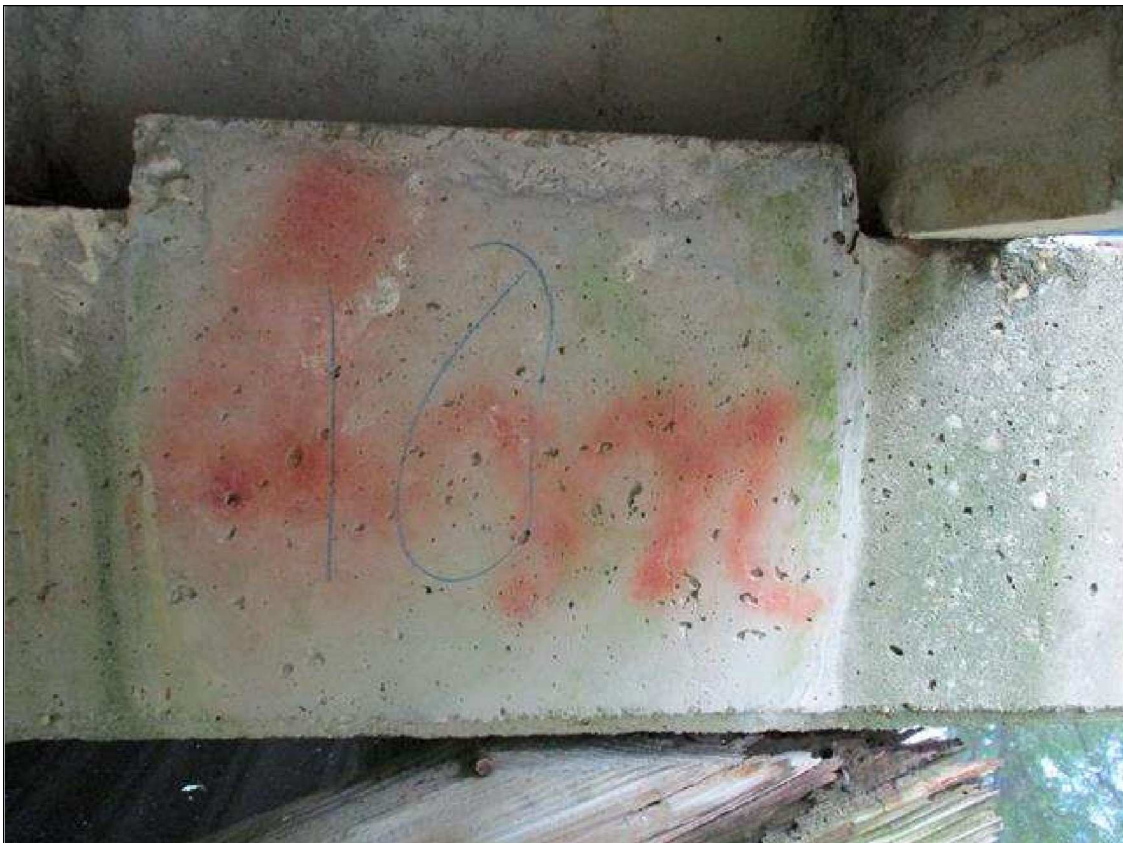
| Element Number | Defect Type | Defect Description | CS | CS Qty | Maint Qty |
|---|---|---|---|---|---|
| 233 | Delamination/Spall | SCATTERED HONEYCOMBING ON EACH FACE. | 2 | 10 | 10 Feet |

Bent 1 Cap 1: SCATTERED HONEYCOMBING ON EACH FACE.
