NC DEPARTMENT OF TRANSPORTATION  
DIVISION OF HIGHWAYS  
STRUCTURE MANAGEMENT UNIT

## Structure Safety Report

### Routine Element Inspection - Contract

DIVISION: 6 COUNTY: HARNETT STRUCTURE NUMBER: 420234 FREQUENCY: 24 MONTHS

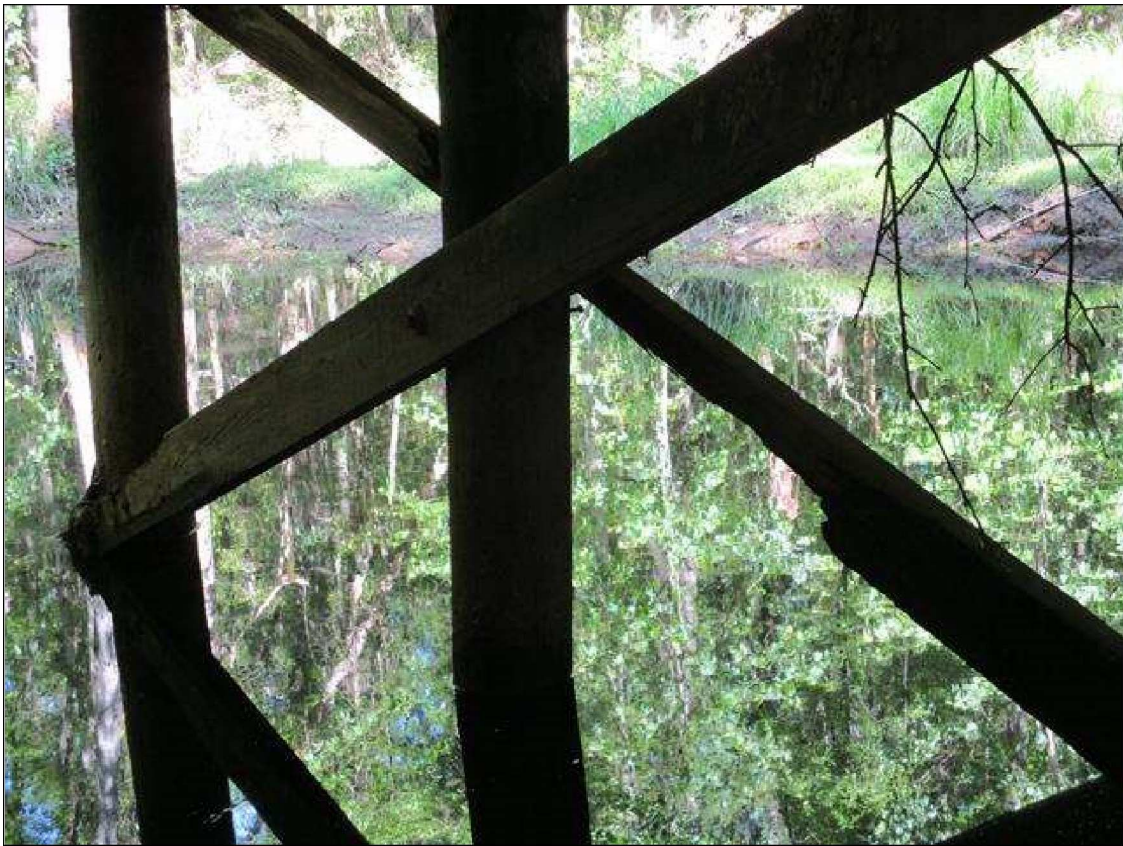
Details EACH CROSS-BRACING MEMBER AT BENT 1 IS DECAYED WITH UP TO 50% SECTION LOSS.

EACH CROSS-BRACING MEMBER AT BENT 1 IS DECAYED WITH UP TO 50% SECTION LOSS.

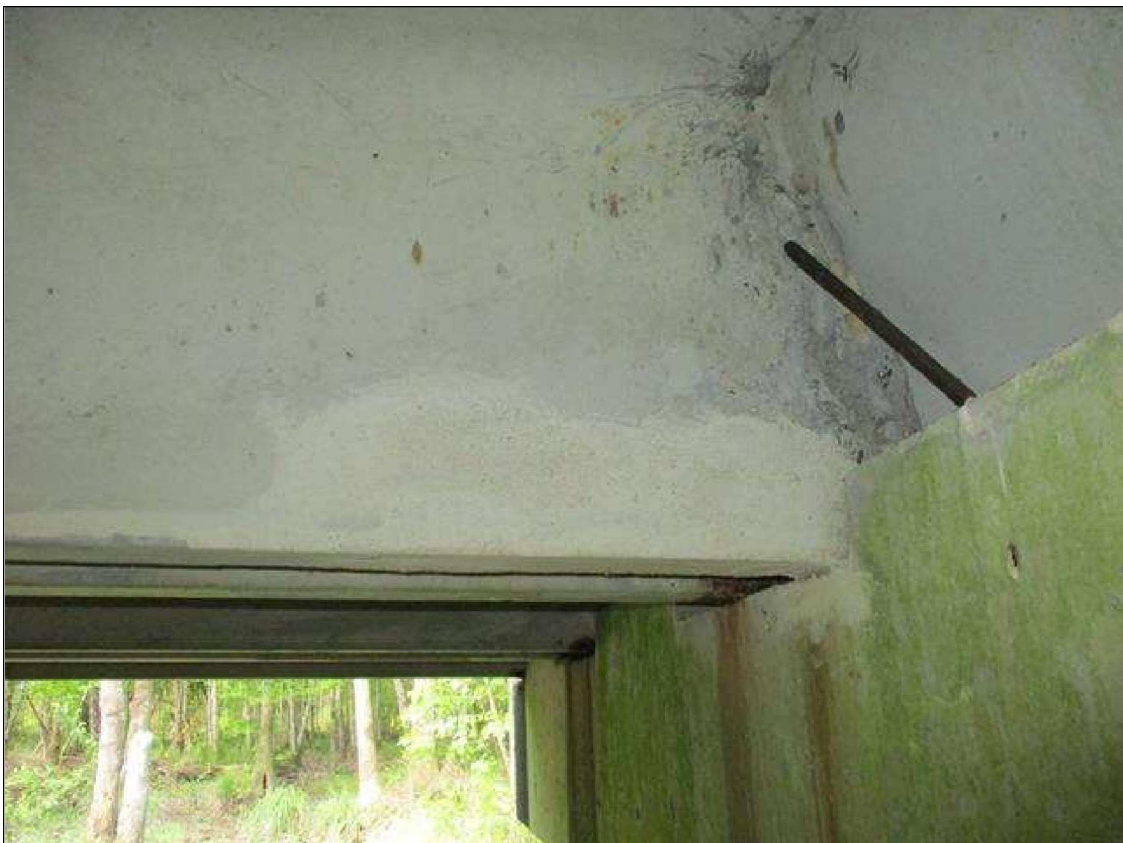
| Element Number | Defect Type | Defect Description | CS | CS Qty | Maint Qty | |
|---|---|---|---|---|---|---|
| 109 | Patched Area | NEW PATCHED AREA AT: 3" HIGH X 1" WIDE X 1/4" DEEP SPALL WITH EXPOSED REBAR LEFT LEG LEFT SIDE AT BENT 2 | 2 | 1 | | Feet |

Span 2 Slab 3: NEW PATCHED AREA AT: 3" HIGH X 1" WIDE X 1/4" DEEP SPALL WITH EXPOSED REBAR LEFT LEG LEFT SIDE AT BENT 2

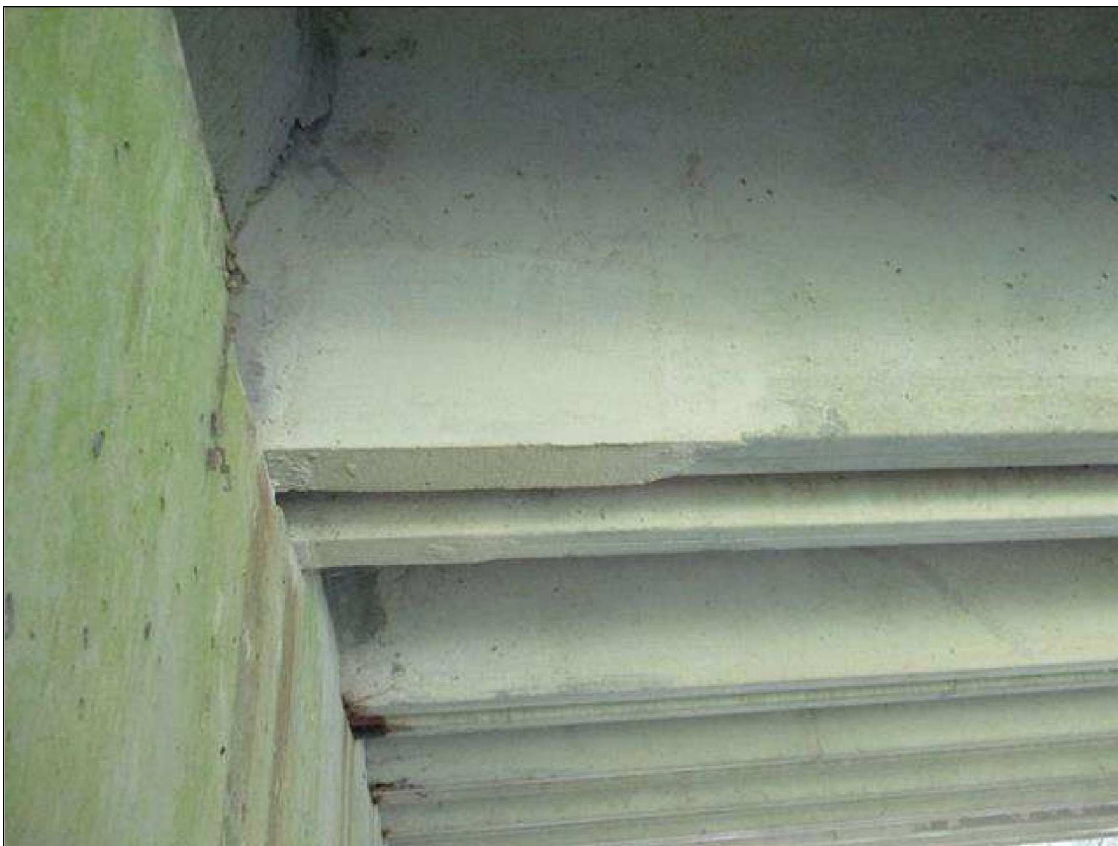
| Element Number | Defect Type | Defect Description | CS | CS Qty | Maint Qty | |
|---|---|---|---|---|---|---|
| 109 | Patched Area | NEW PATCHED AREA AT: 8" LONG X 4" HIGH X 1/2" DEEP SPALL WITH EXPOSED REBAR RIGHT LEG LEFT SIDE AT BENT 2 | 2 | 1 | | Feet |

Span 2 Slab 3: NEW PATCHED AREA AT: 8" LONG X 4" HIGH X 1/2" DEEP SPALL WITH EXPOSED REBAR RIGHT LEG LEFT SIDE AT BENT 2

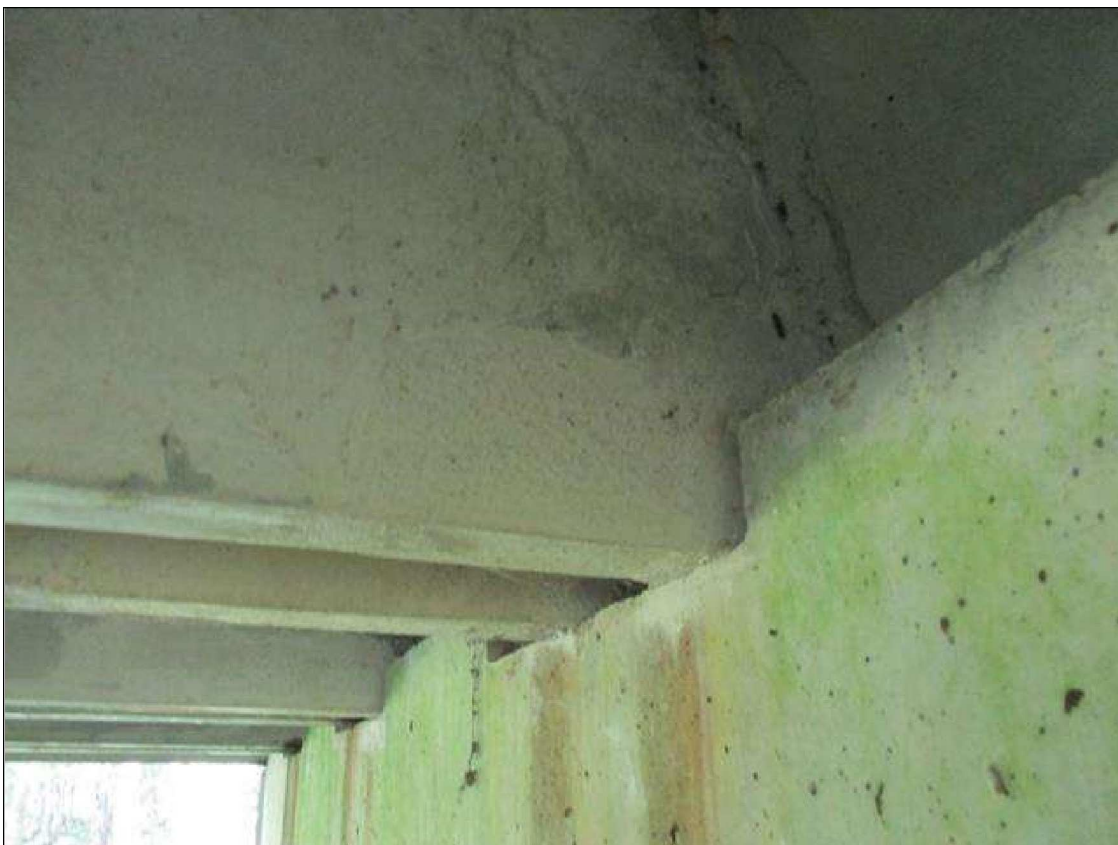
| Element Number | Defect Type | Defect Description | CS | CS Qty | Maint Qty | |
|---|---|---|---|---|---|---|
| 109 | Patched Area | NEW PATCHED AREA AT: 6" LONG X 2" HIGH X 1/2" DEEP SPALL WITH EXPOSED REBAR LEFT LEG RIGHT SIDE AT BENT 2 | 2 | 1 | | Feet |

Span 2 Slab 4: NEW PATCHED AREA AT: 6" LONG X 2" HIGH X 1/2" DEEP SPALL WITH EXPOSED REBAR LEFT LEG RIGHT SIDE AT BENT 2

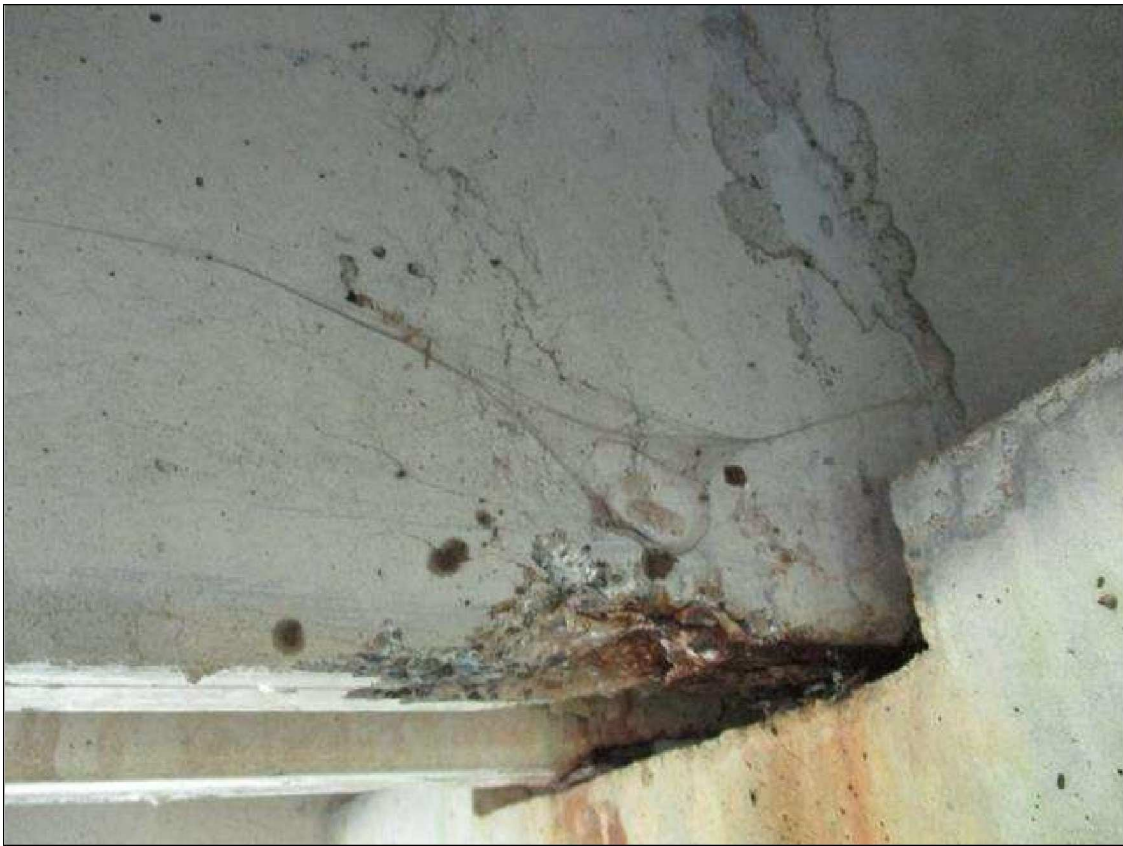
| Element Number | Defect Type | Defect Description | CS | CS Qty | Maint Qty | |
|---|---|---|---|---|---|---|
| 109 | Exposed Rebar | SPALL 4" LONG X 2-1/2" WIDE X 1/2" DEEP WITH REBAR EXPOSED LEFT LEG AT BENT 2 END. (PRIORITY MAINTENANCE) | 3 | 1 | 1 | Feet |

Span 2 Slab 5: SPALL 4" LONG X 2-1/2" WIDE X 1/2" DEEP WITH REBAR EXPOSED LEFT LEG AT BENT 2 END.  
(PRIORITY MAINTENANCE)

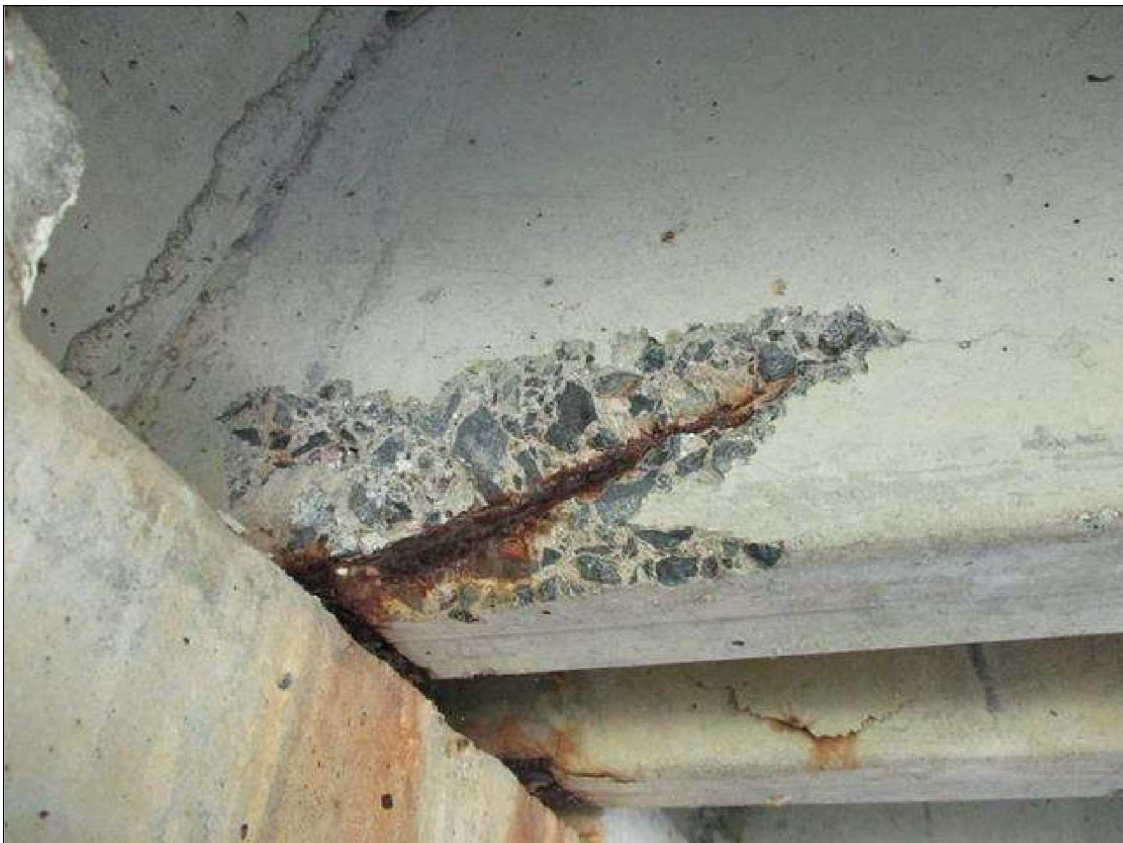
| Element Number | Defect Type | Defect Description | CS | CS Qty | Maint Qty | |
|---|---|---|---|---|---|---|
| 109 | Exposed Rebar | SPALL 6" LONG X 3" HIGH X 3/4" DEEP WITH REBAR EXPOSED ON RIGHT LEG AT BENT 2 END. (PRIORITY MAINTENANCE) | 3 | 1 | | Feet |

Span 2 Slab 5: SPALL 6" LONG X 3" HIGH X 3/4" DEEP WITH REBAR EXPOSED ON RIGHT LEG AT BENT 2 END.  
(PRIORITY MAINTENANCE)

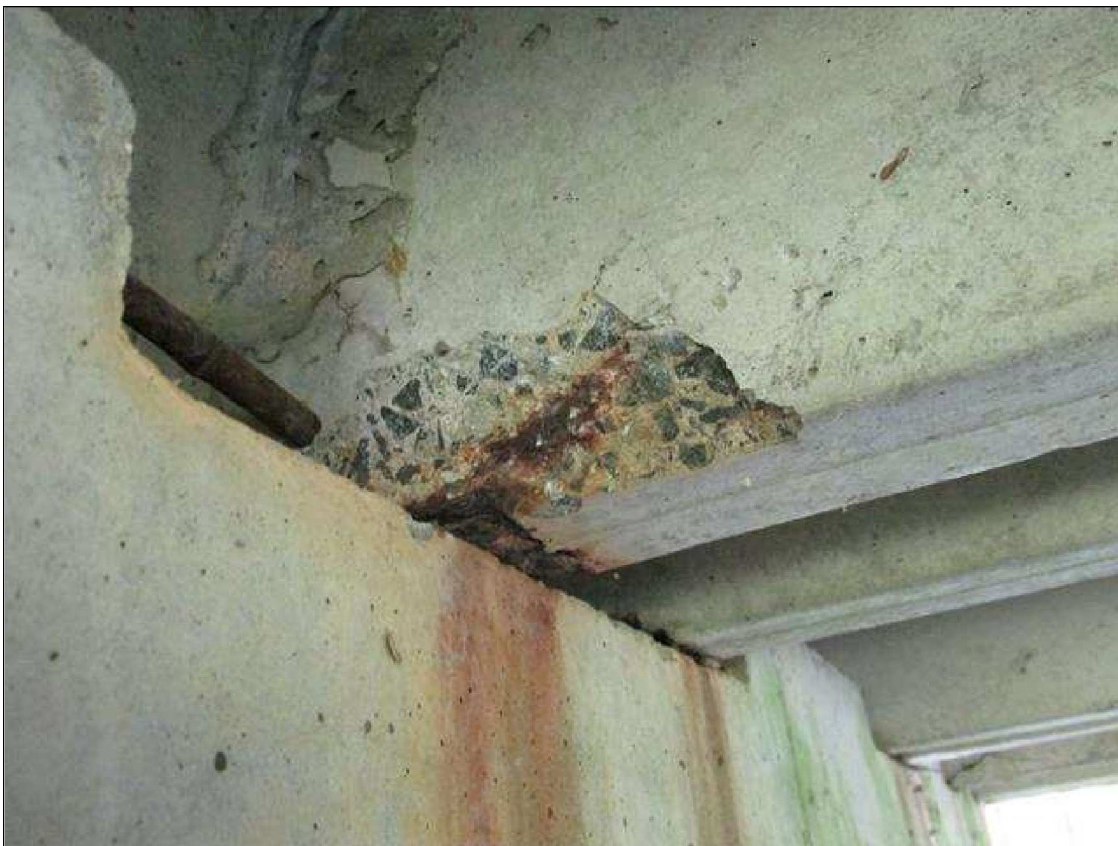
| Element Number | Element Name | Total Qty | CS1 Qty | CS2 Qty | CS3 Qty | CS4 Qty | |
|---|---|---|---|---|---|---|---|
| 109 | Exposed Rebar | SPALL 3" LONG X 2" HIGH X 1/2" DEEP WITH REBAR EXPOSED AT RIGHT LEG BENT 2 END. (PRIORITY MAINTENANCE) | 3 | 1 | 1 | Feet | |

Span 2 Slab 6: SPALL 3" LONG X 2" HIGH X 1/2" DEEP WITH REBAR EXPOSED AT RIGHT LEG BENT 2 END.  
(PRIORITY MAINTENANCE)

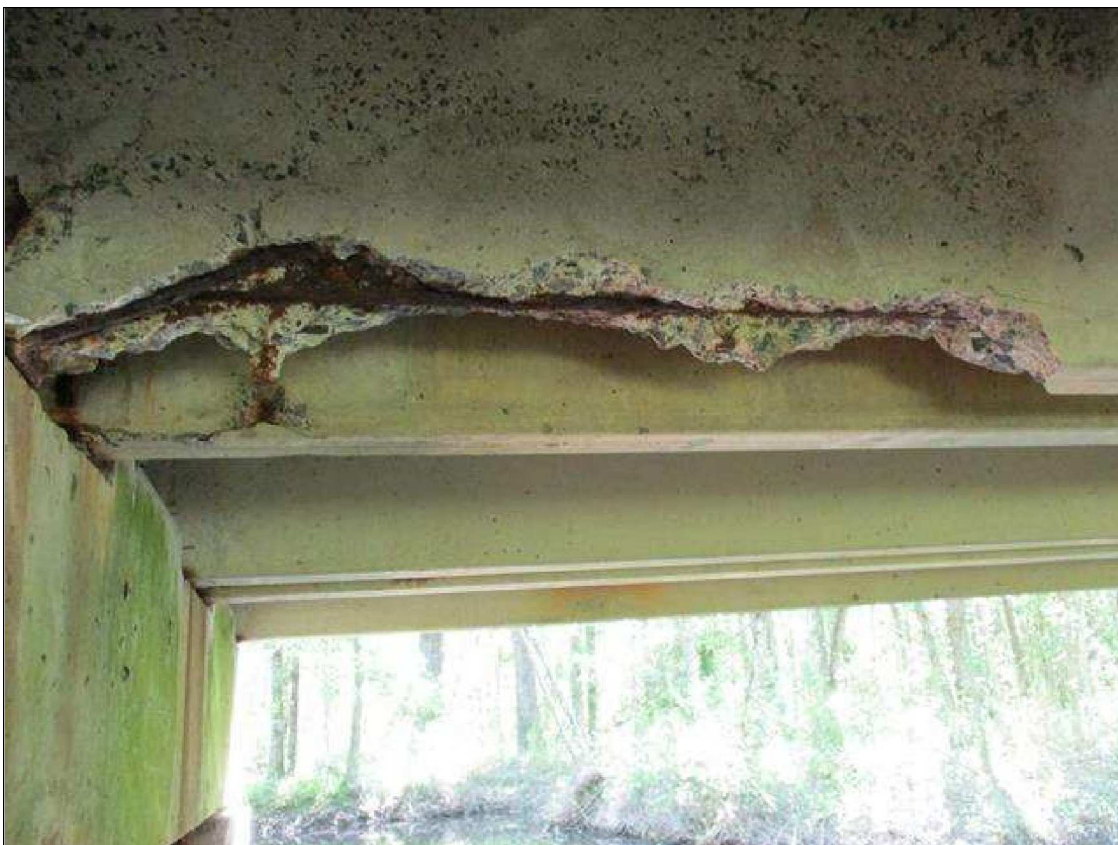
| Element Number | Element Name | Total Qty | CS1 Qty | CS2 Qty | CS3 Qty | CS4 Qty | |
|---|---|---|---|---|---|---|---|
| 109 | Exposed Rebar | SPALL 27" LONG X 2-1/2" WIDE X 4" HIGH WITH 10% SECTION LOSS ALONG EXPOSED CABLE STRANDS ON RIGHT LEG AT BENT 2 END. (PRIORITY MAINTENANCE) | 3 | 2 | 2 | Feet | |

Span 2 Slab 8: SPALL 27" LONG X 2-1/2" WIDE X 4" HIGH WITH 10% SECTION LOSS ALONG EXPOSED CABLE STRANDS ON RIGHT LEG AT BENT 2 END.

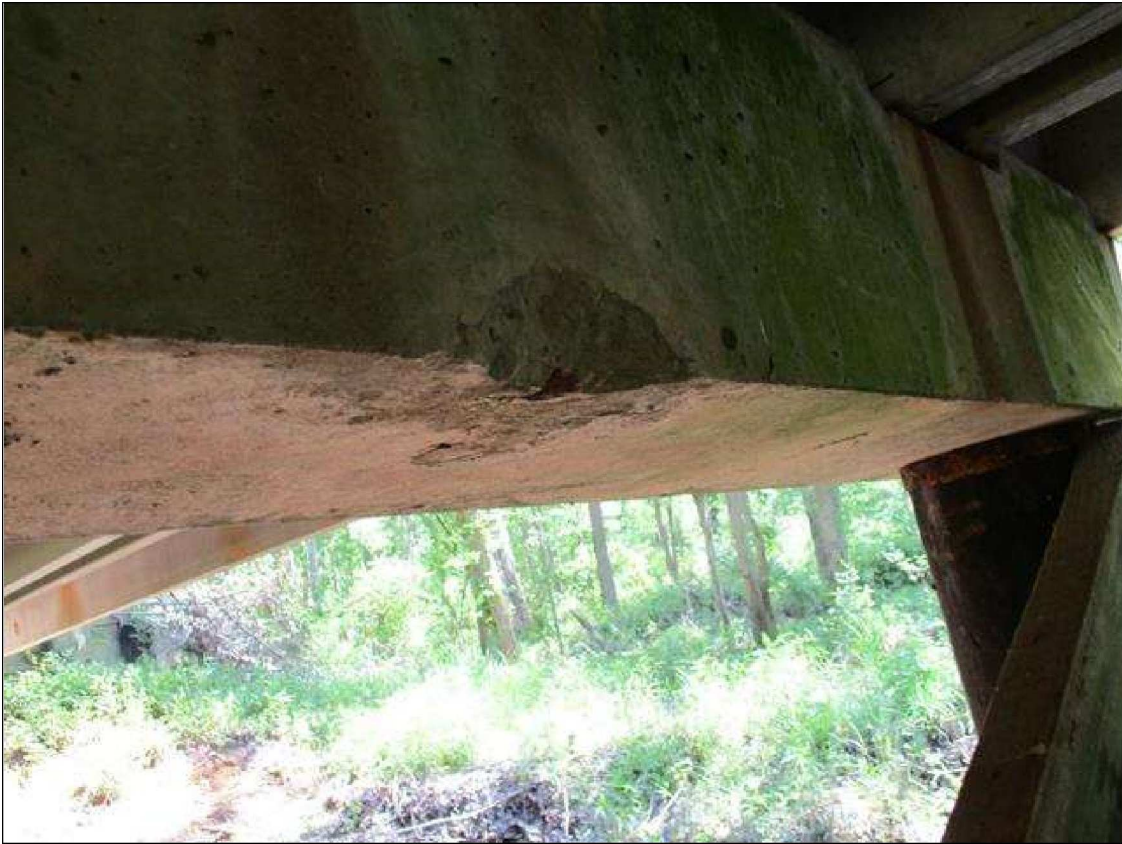
| Element Number | Defect Type | Defect Description | CS | CS Qty | Maint Qty | |
|---|---|---|---|---|---|---|
| 233 | Cracking (PSC) | SPALL 6" LONG X 3" WIDE X 1" DEEP ON BOTTOM FACE, SOUTH EDGE BETWEEN PILES 4 AND 5. | 2 | 1 | 1 | Feet |

Bent 2 Cap 1: SPALL 6" LONG X 3" WIDE X 1" DEEP ON BOTTOM FACE, SOUTH EDGE BETWEEN PILES 4 AND 5.

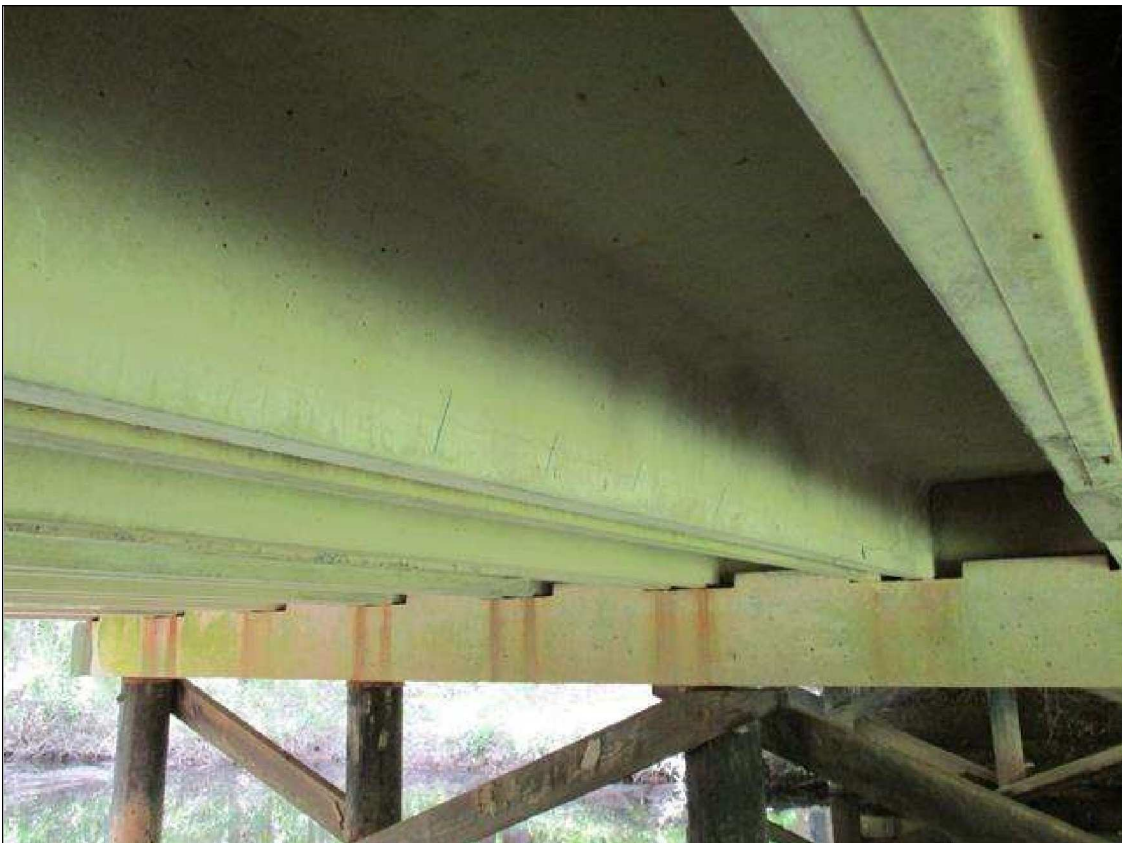
| Element Number | Element Name | Total Qty | CS1 Qty | CS2 Qty | CS3 Qty | CS4 Qty | |
|---|---|---|---|---|---|---|---|
| 109 | Cracking (PSC) | HORIZONTAL CRACK UP TO .125" OPEN ON RIGHT LEG 8' LONG BEGINNING AT BENT 2 END. (PRIORITY MAINTENANCE) | 3 | 8 | 8 | Feet | |

Span 3 Slab 4: HORIZONTAL CRACK UP TO .125" OPEN ON RIGHT LEG 8' LONG BEGINNING AT BENT 2 END.  
(PRIORITY MAINTENANCE)

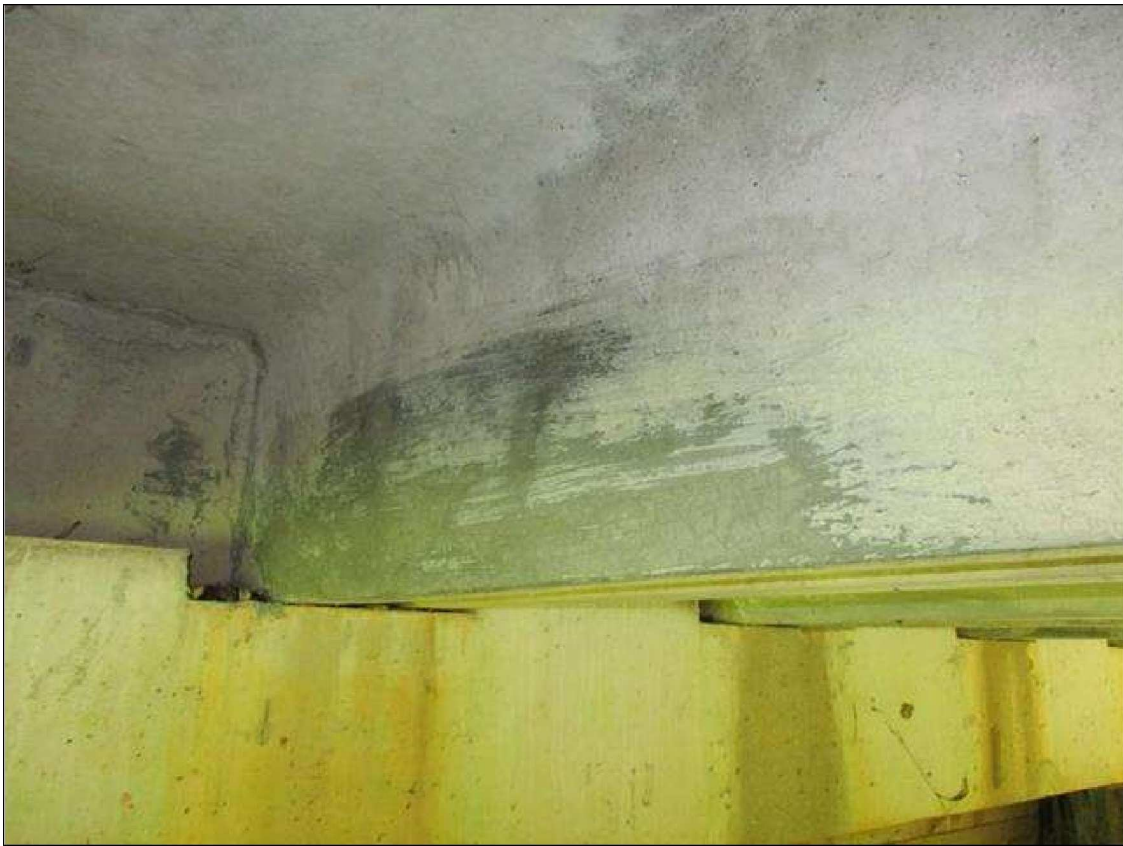
| 109 | Patched Area | REPAIR TO RIGHT LEG AT END BENT 2 | 2 | 1 | Feet |

Span 3 Slab 4: REPAIR TO RIGHT LEG AT END BENT 2

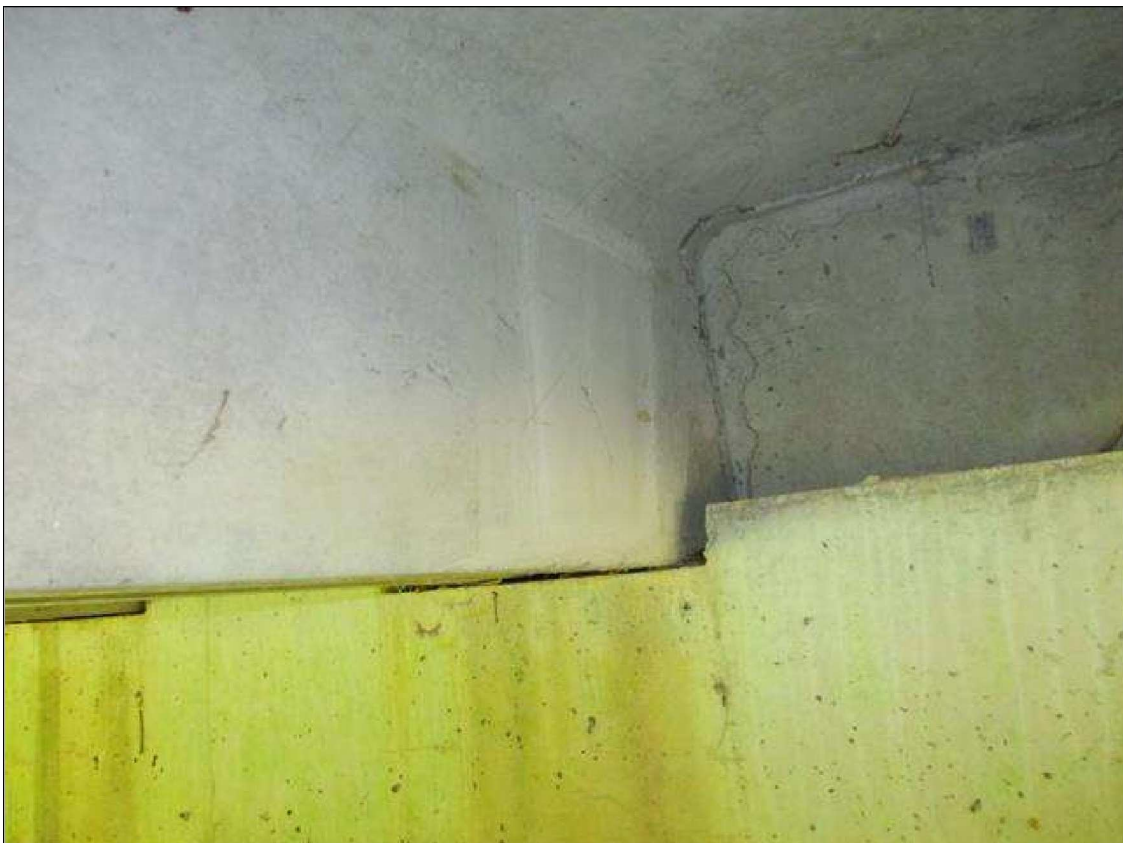
| 109 | Patched Area | NEW PATCHED AREA AT: 10" HIGH X 6" WIDE X 1/2" DEEP SPALL WITH EXPOSED REBAR LEFT LEG RIGHT SIDE AT END BENT 2 | 2 | 1 | Feet |

Span 3 Slab 4: NEW PATCHED AREA AT: 10" HIGH X 6" WIDE X 1/2" DEEP SPALL WITH EXPOSED REBAR LEFT LEG RIGHT SIDE AT END BENT 2

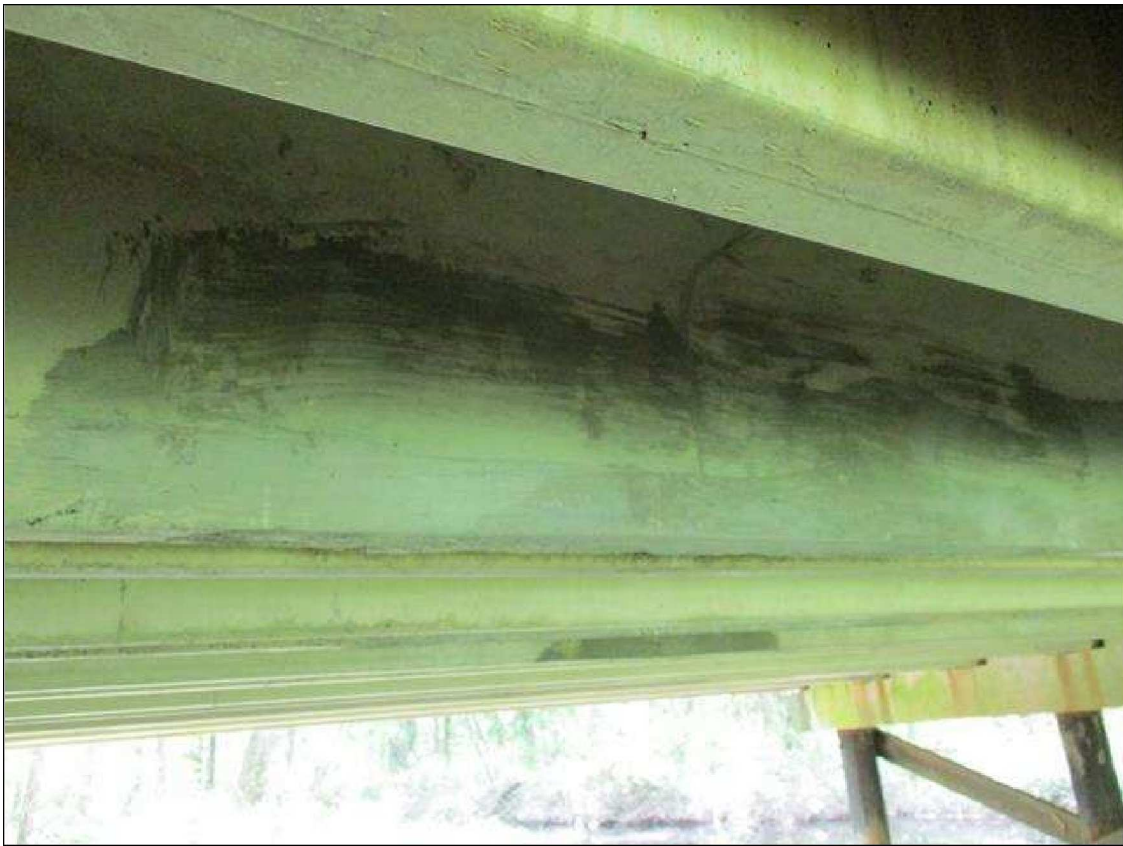
| 109 | Patched Area | REPAIR TO RIGHT LEG 10' FROM END BENT 2 | 2 | 1 | Feet |

Span 3 Slab 4: REPAIR TO RIGHT LEG 10' FROM END BENT 2

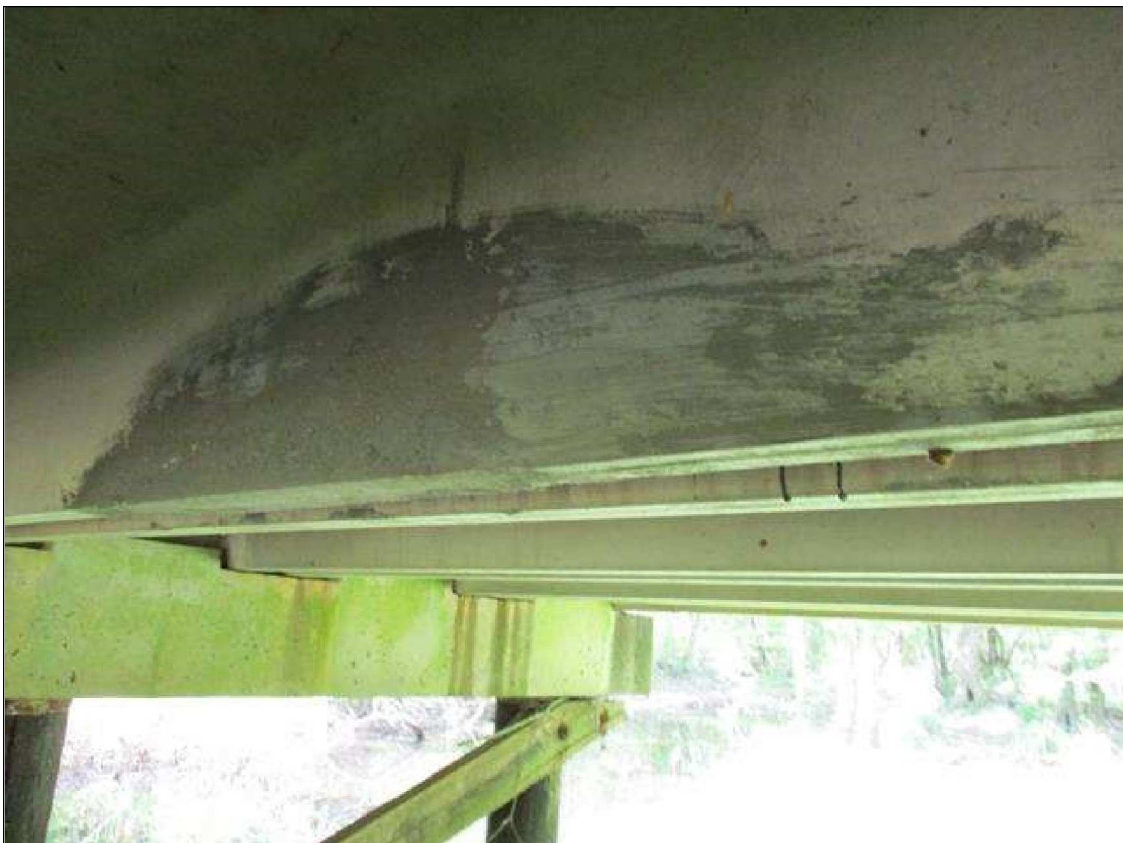
| 109 | Patched Area | REPAIR TO LEFT LEG 3' FROM BENT 2 | 2 | 1 | Feet |

Span 3 Slab 4: REPAIR TO LEFT LEG 3' FROM BENT 2

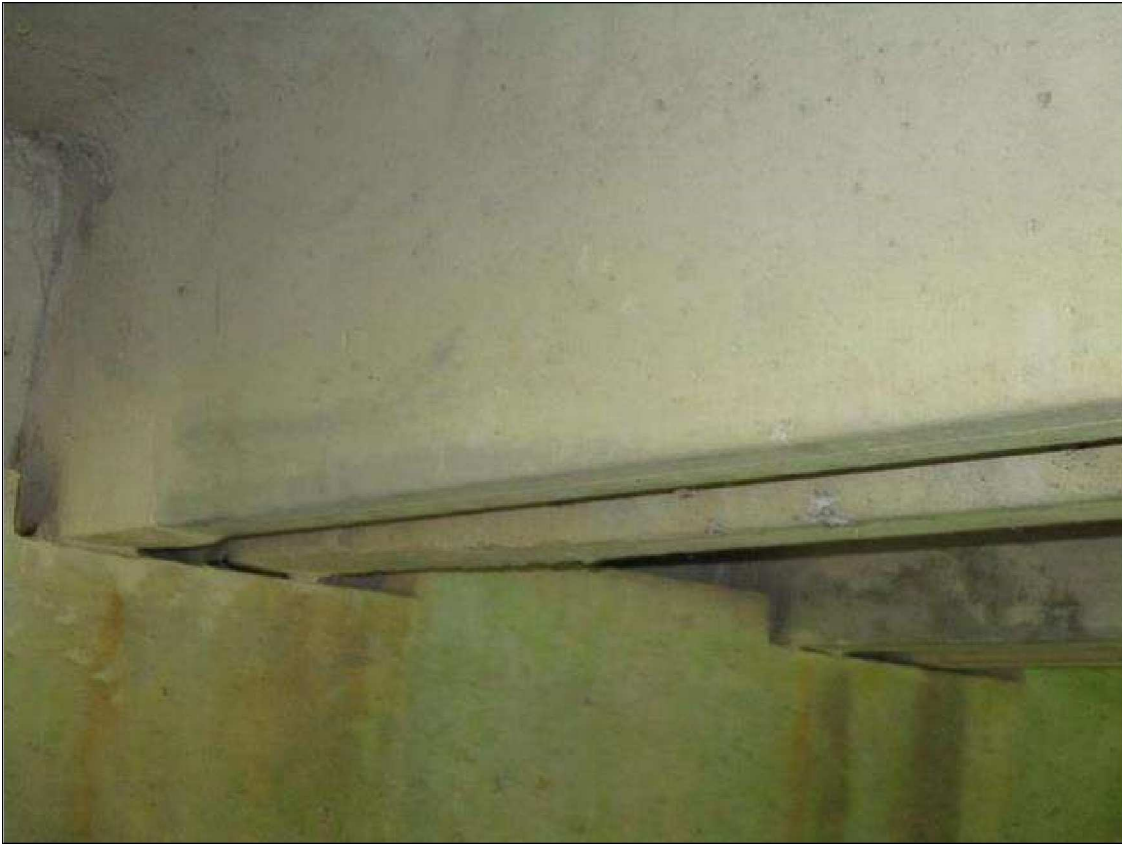
| Element Number | Defect Type | Defect Description | CS | CS Qty | Maint Qty |
|---|---|---|---|---|---|
| 109 | Patched Area | NEW PATCHED AREA AT: 3" LONG X 1/2" DEEP CORNER SPALL ALONG LEFT LEG RIGHT SIDE AT BENT 2 | 2 | 1 | Feet |

Span 3 Slab 5: NEW PATCHED AREA AT: 3" LONG X 1/2" DEEP CORNER SPALL ALONG LEFT LEG RIGHT SIDE AT BENT 2

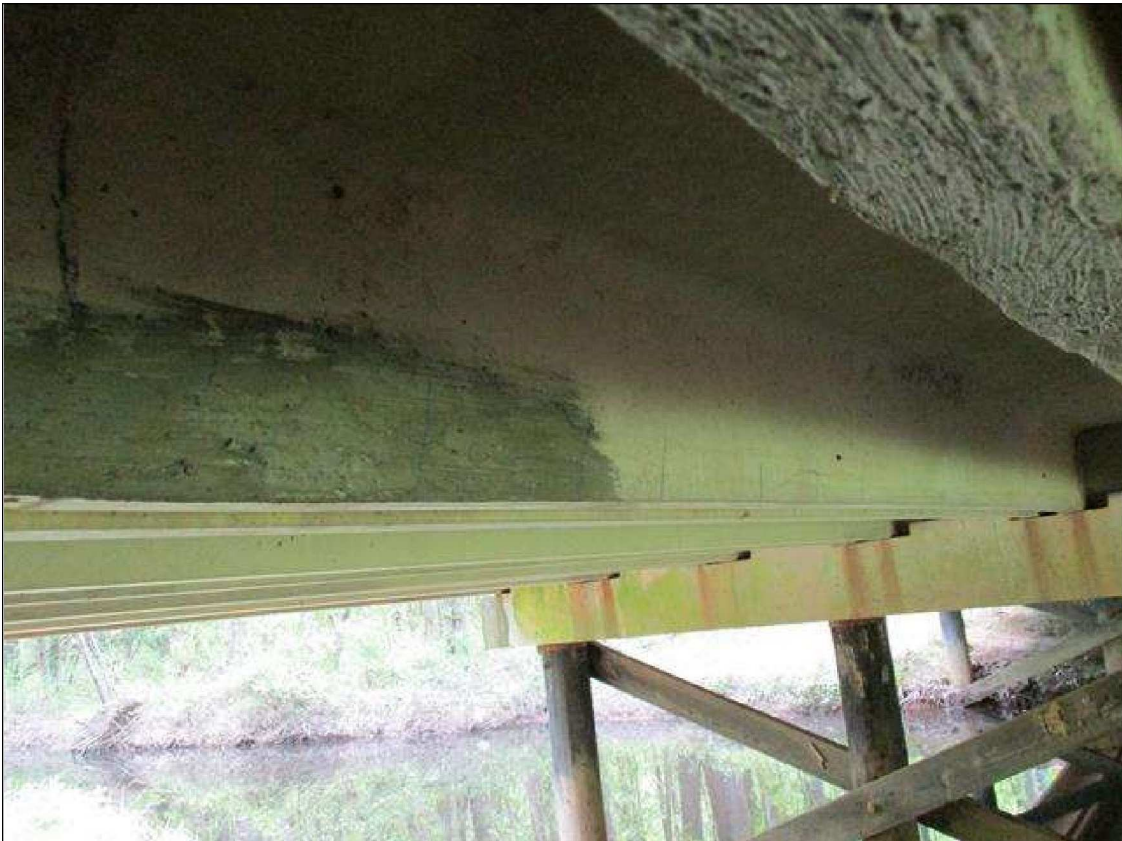
| Element Number | Defect Type | Defect Description | CS | CS Qty | Maint Qty |
|---|---|---|---|---|---|
| 109 | Cracking (PSC) | HORIZONTAL CRACK UP TO .09" OPEN, RIGHT LEG, BEGINNING 3' FROM BENT 2 END. (PRIORITY MAINTENANCE) | 3 | 9 | 9 Feet |

Span 3 Slab 6: HORIZONTAL CRACK UP TO .09" OPEN, RIGHT LEG, BEGINNING 3' FROM BENT 2 END.  
(PRIORITY MAINTENANCE)

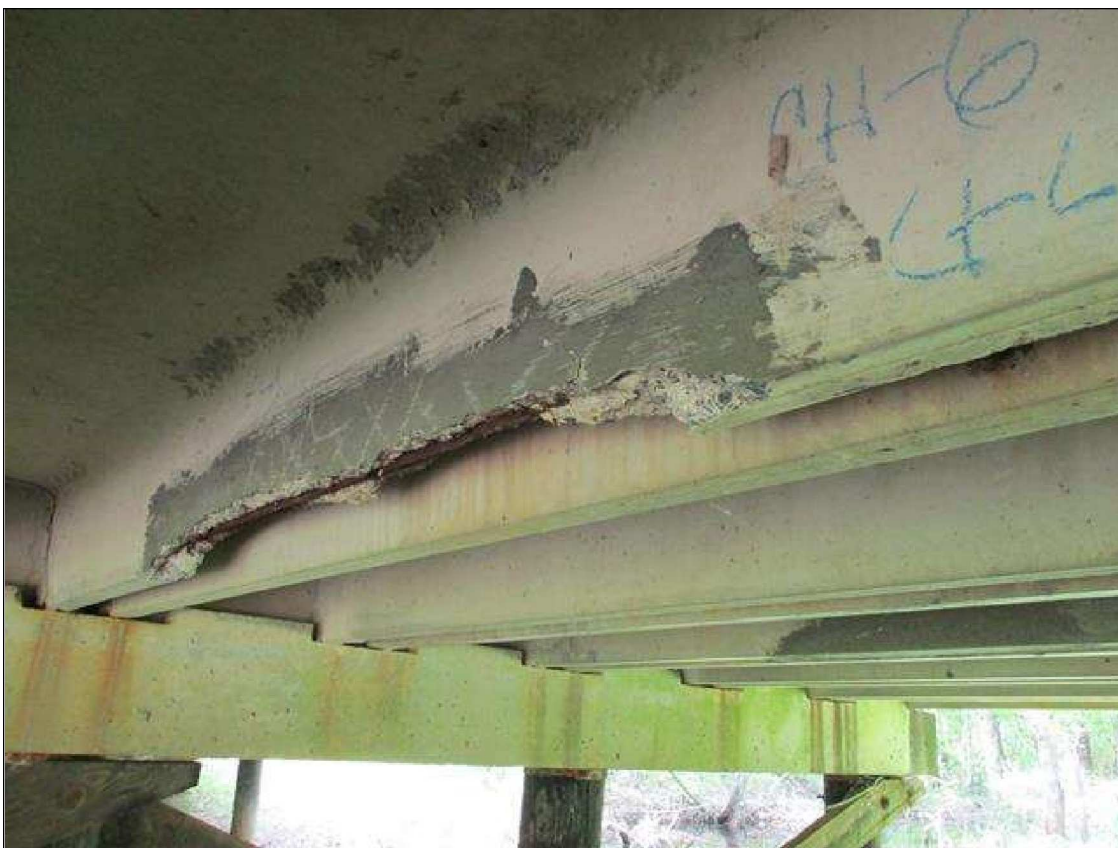
| Element Number | Defect Type | Defect Description | CS | CS Qty | Maint Qty |
|---|---|---|---|---|---|
| 109 | Exposed Rebar | SPALL 57" LONG X 2-1/2" WIDE X 3" HIGH, LEFT LEG, WITH 10% LOSS OF SECTION ON EXPOSED CABLE STRANDS BEGINNING TO SEPARATE. SPALL BEGINS 3' FROM BENT 2 END. (PRIORITY MAINTENANCE) | 3 | 5 | 5 Feet |

Span 3 Slab 6: SPALL 57" LONG X 2-1/2" WIDE X 3" HIGH, LEFT LEG, WITH 10% LOSS OF SECTION ON EXPOSED CABLE STRANDS BEGINNING TO SEPARATE. SPALL BEGINS 3' FROM BENT 2 END.

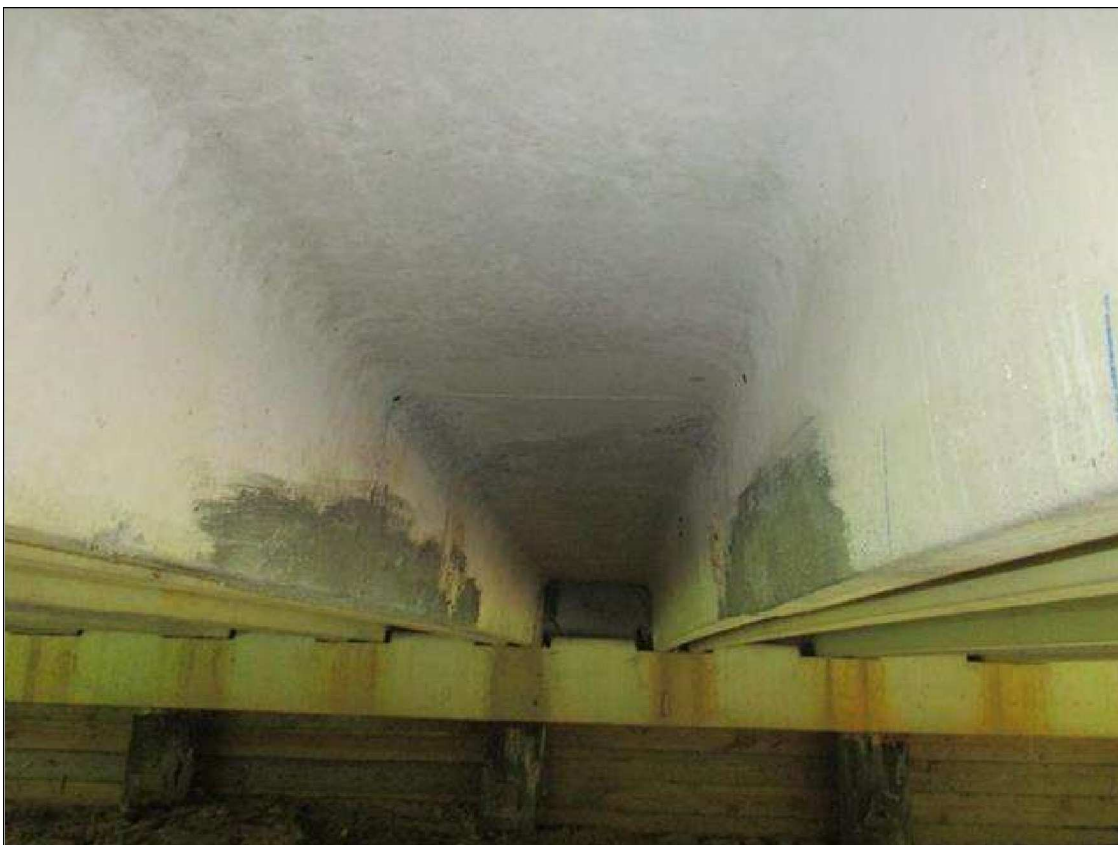
| Element Number | Defect Type | Defect Description | CS | CS Qty | Maint Qty |
|---|---|---|---|---|---|
| 109 | Patched Area | REPAIRS IN LEFT AND RIGHT LEGS AT MID-SPAN. | 2 | 1 | Feet |

Span 3 Slab 6: REPAIRS IN LEFT AND RIGHT LEGS AT MID-SPAN

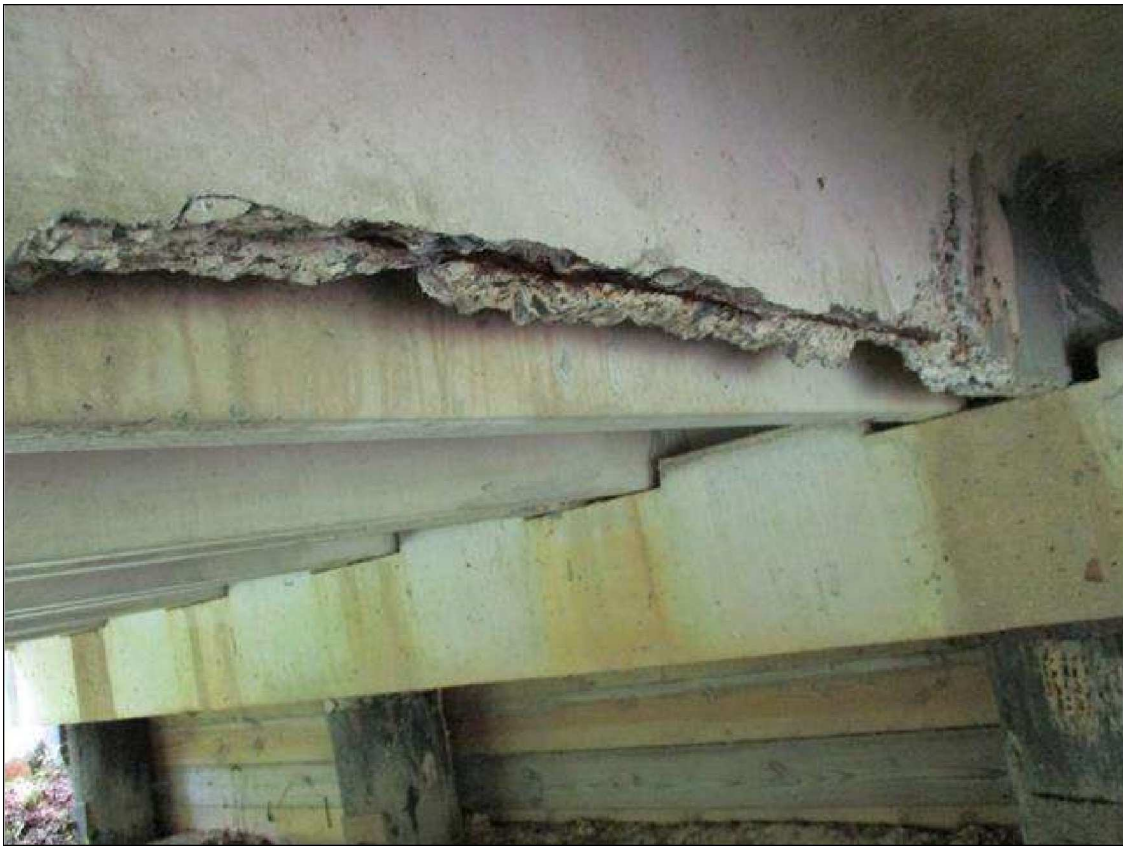
| Element Number | Defect Type | Defect Description | CS | CS Qty | Maint Qty |
|---|---|---|---|---|---|
| 109 | Exposed Rebar | SPALL 46" LONG X 2-1/2" WIDE X 2" HIGH, LEFT LEG, WITH 10% SECTION LOSS AT EXPOSED CABLE 2' FROM END BENT 2 END. (PRIORITY MAINTENANCE) | 3 | 4 | 4 Feet |

Span 3 Slab 6: SPALL 46" LONG X 2-1/2" WIDE X 2" HIGH, LEFT LEG, WITH 10% SECTION LOSS AT EXPOSED CABLE 2' FROM END BENT 2 END.

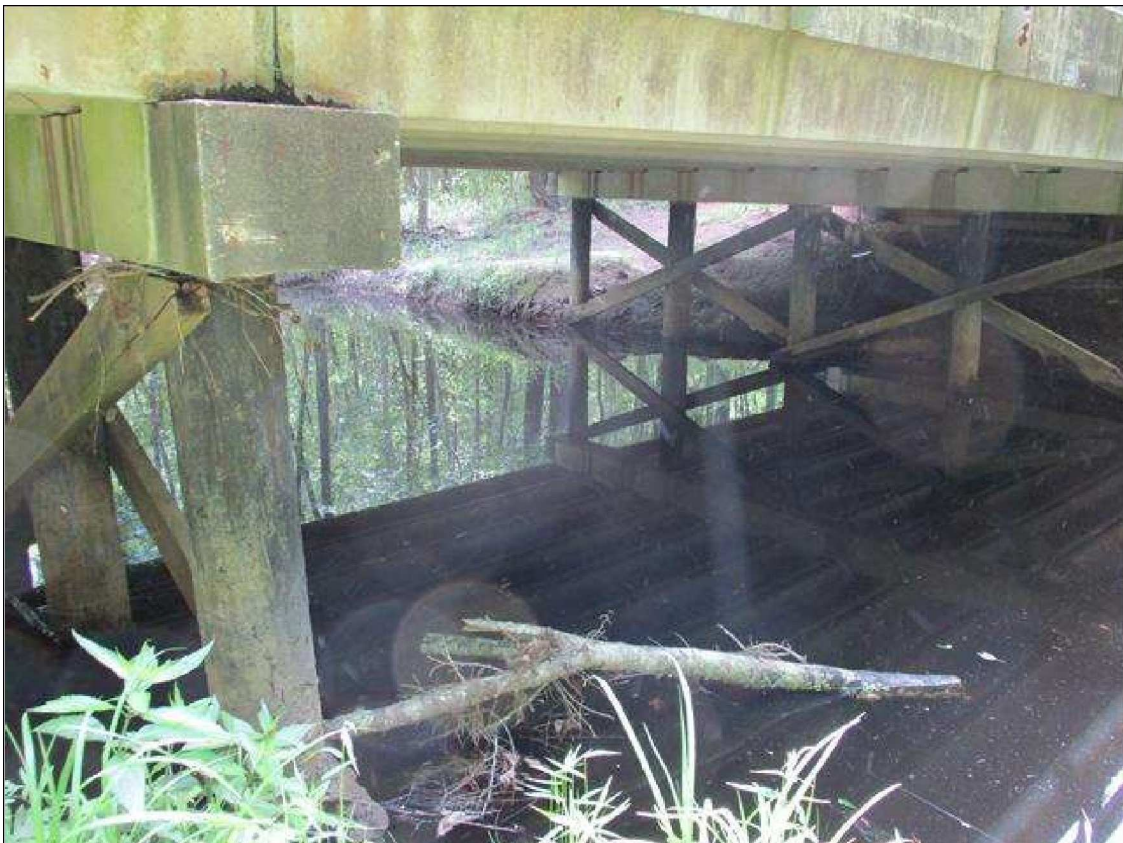
DRIFT AT BENT 2 UPSTREAM END.

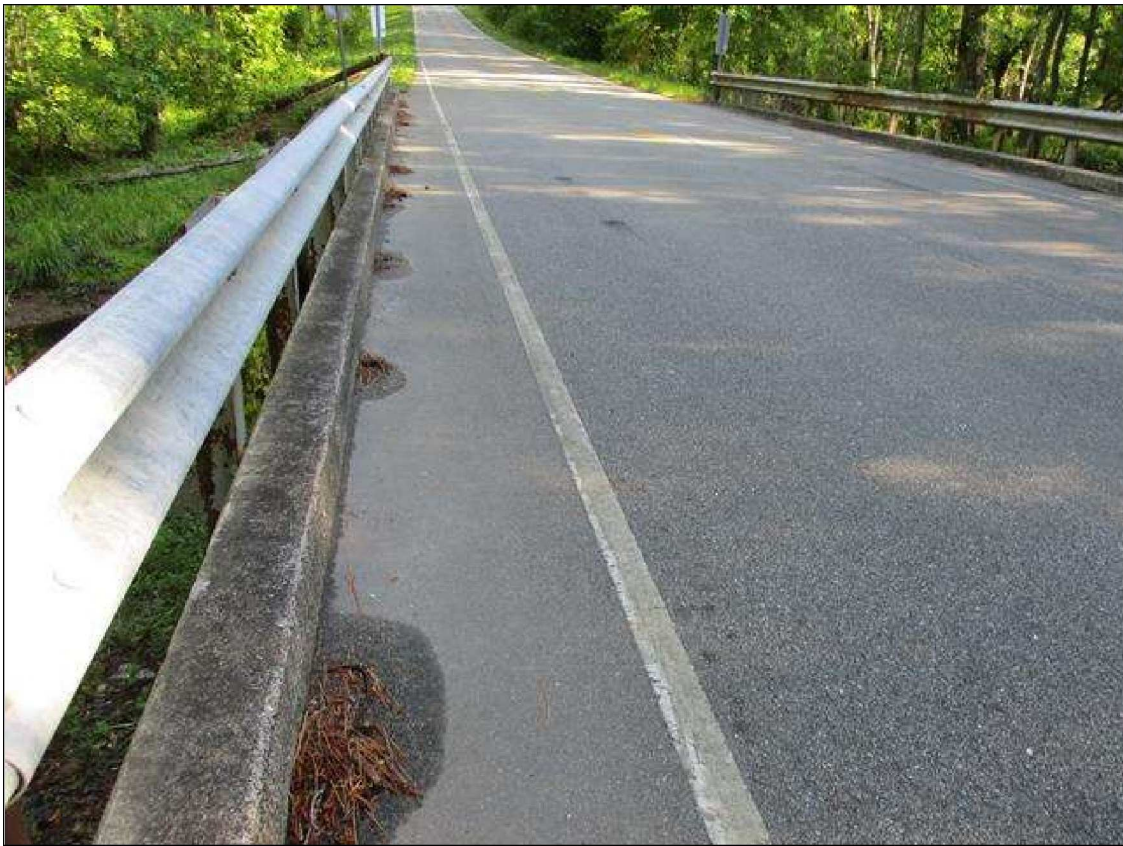
DECK DEBRIS ALONG CURB-LINE

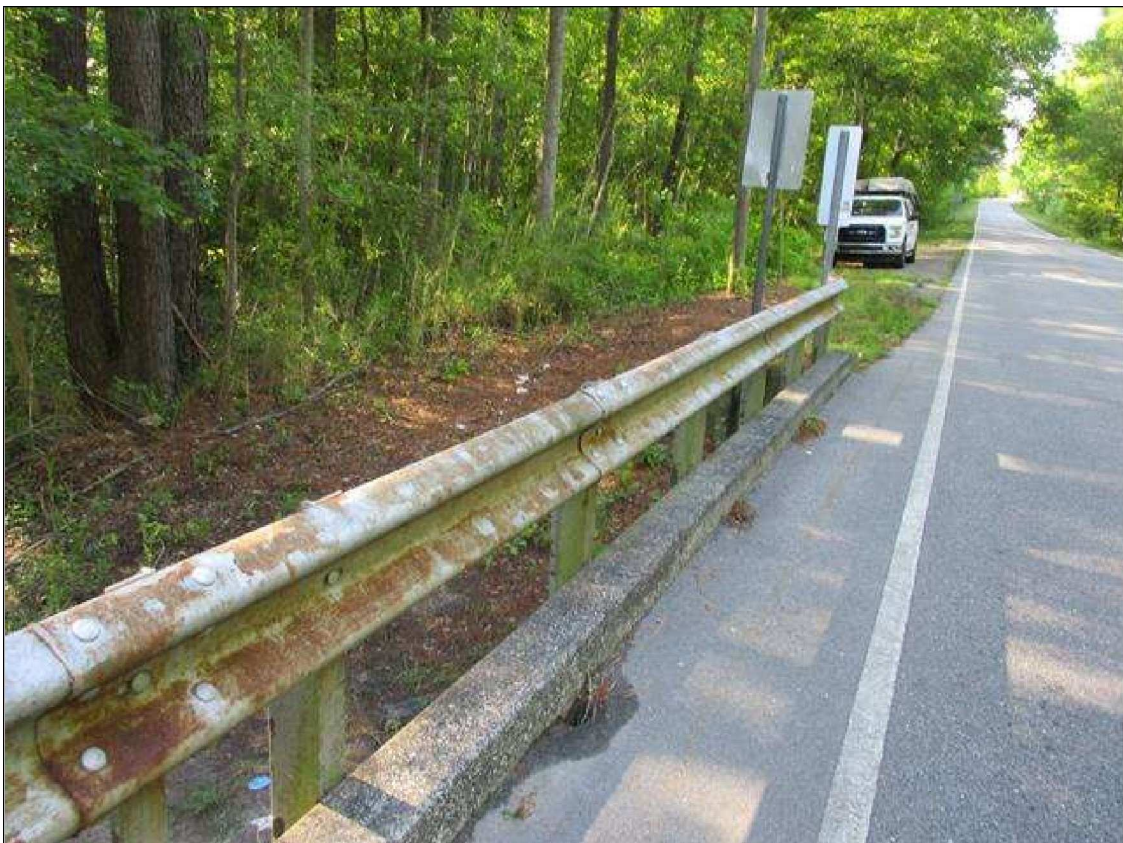
Span 1 Right Bridge Rail: FRECKLE SURFACE RUST ON RAIL SURFACES.
