NC DEPARTMENT OF TRANSPORTATION  
DIVISION OF HIGHWAYS  
STRUCTURE MANAGEMENT UNIT

## Structure Safety Report

### Routine Element Inspection - Contract

DIVISION: 6 COUNTY: HARNETT STRUCTURE NUMBER: 420234 FREQUENCY: 24 MONTHS

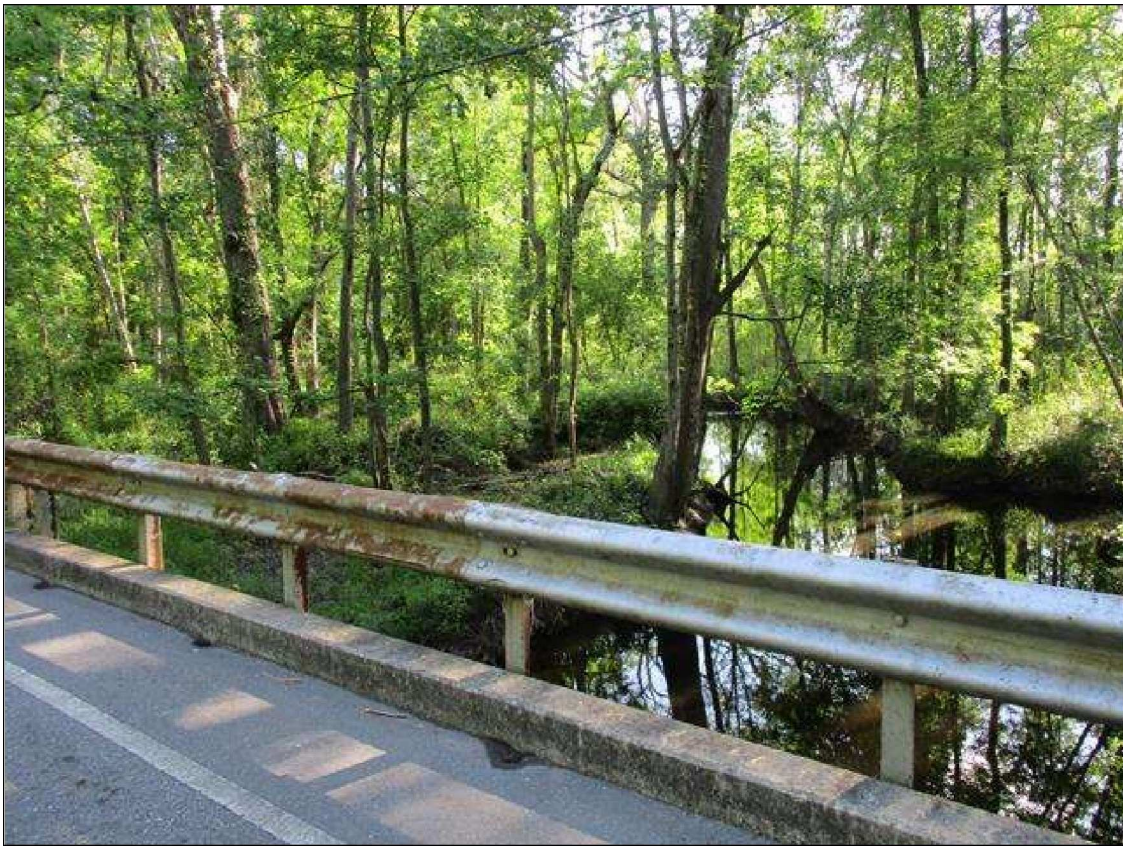
Span 2 Right Bridge Rail: FRECKLE SURFACE RUST ON RAIL SURFACES.

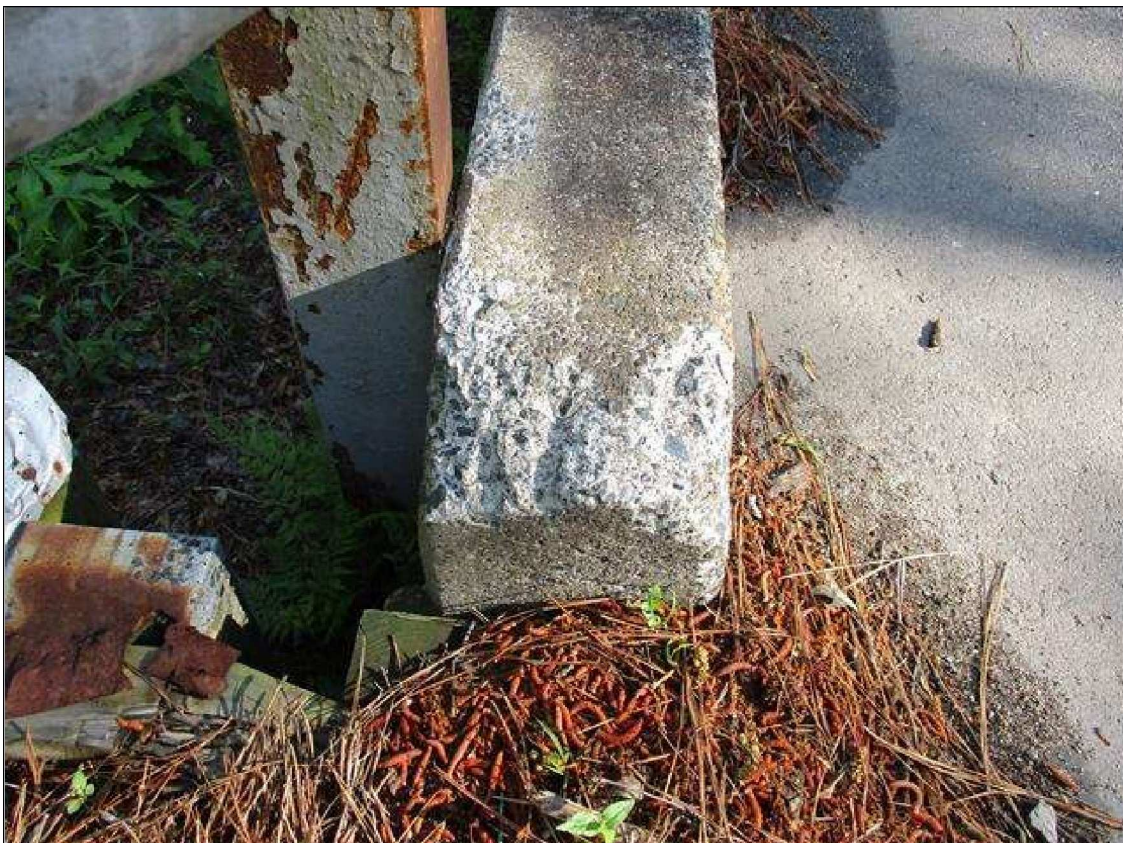
CORNER SPALL 8" X 8" X 1-1/2" DEEP AT END BENT 1 END AT LEFT CURB

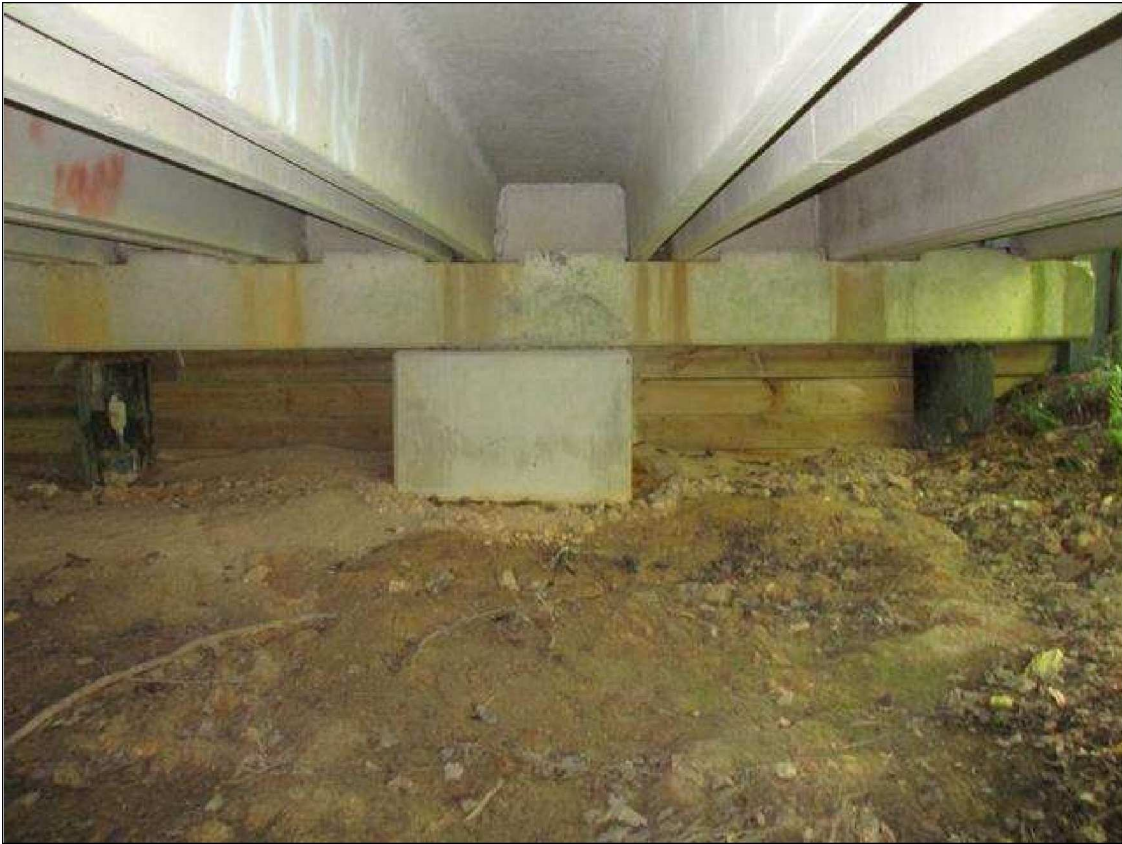
| Element Number | Element Name | Total Qty | CS1 Qty | CS2 Qty | CS3 Qty | CS4 Qty | |
|---|---|---|---|---|---|---|---|
| 228 | Decay/Section Loss | RECENT REPAIR WITH CONCRETE ENCASEMENT. | 2 | 1 | | | Each |

End Bent 1 Pile 2: RECENT REPAIR WITH CONCRETE ENCASEMENT.

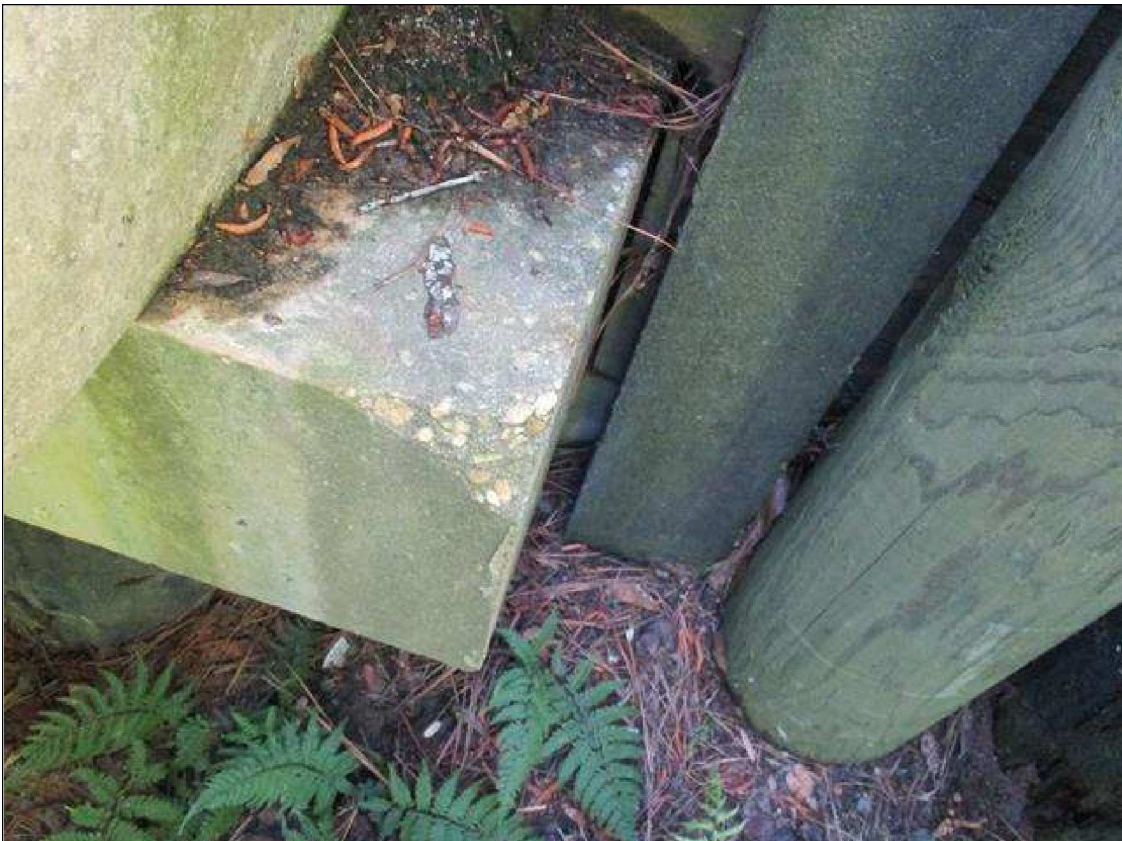
| Element Number | Defect Type | Defect Description | CS | CS Qty | Maint Qty |
|---|---|---|---|---|---|
| 233 | Delamination/Spall | CORNER SPALL 3-1/2" WIDE X 2" HIGH X 3/4" DEEP ON LEFT END. | 2 | 1 | 1 Feet |

End Bent 1 Cap 1: CORNER SPALL 3-1/2" WIDE X 2" HIGH X 3/4" DEEP ON LEFT END.

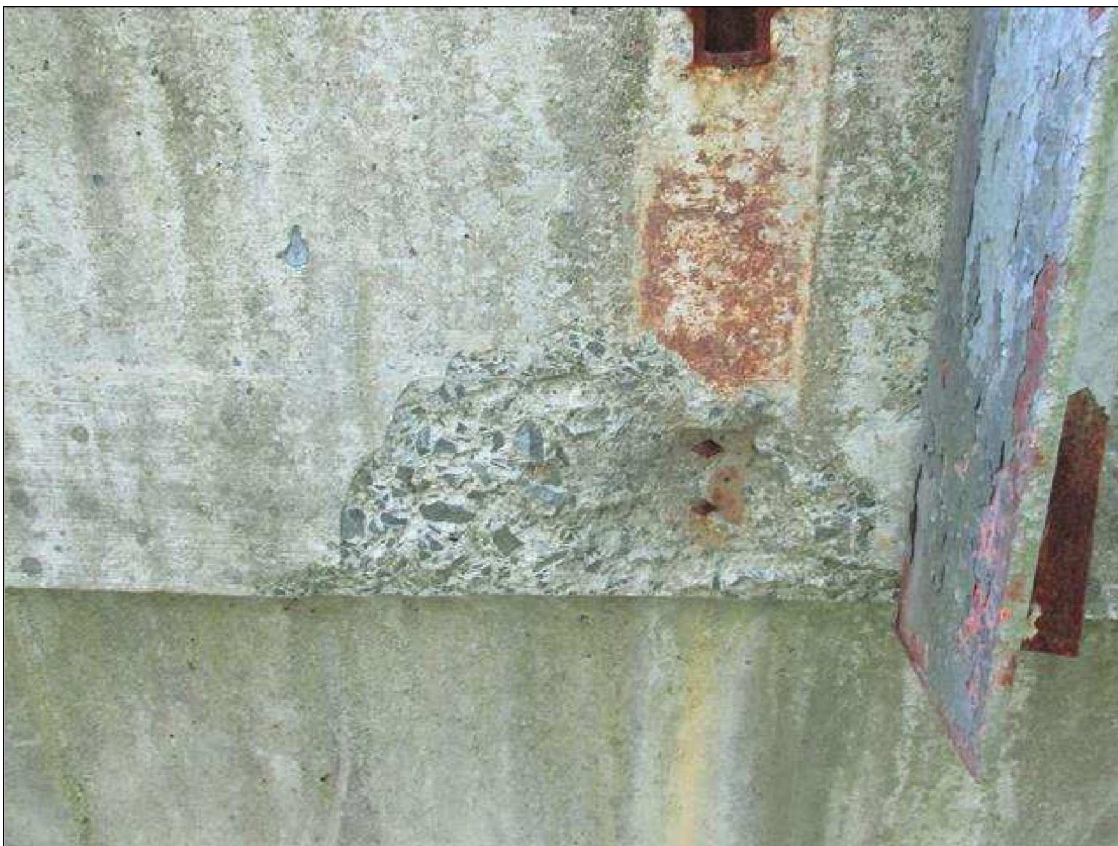
SPALL 11-1/2" WIDE X 7-1/4" HIGH X 1" DEEP WITH REBAR EXPOSED AT POST 3 IN CONCRETE CURB SECTION.

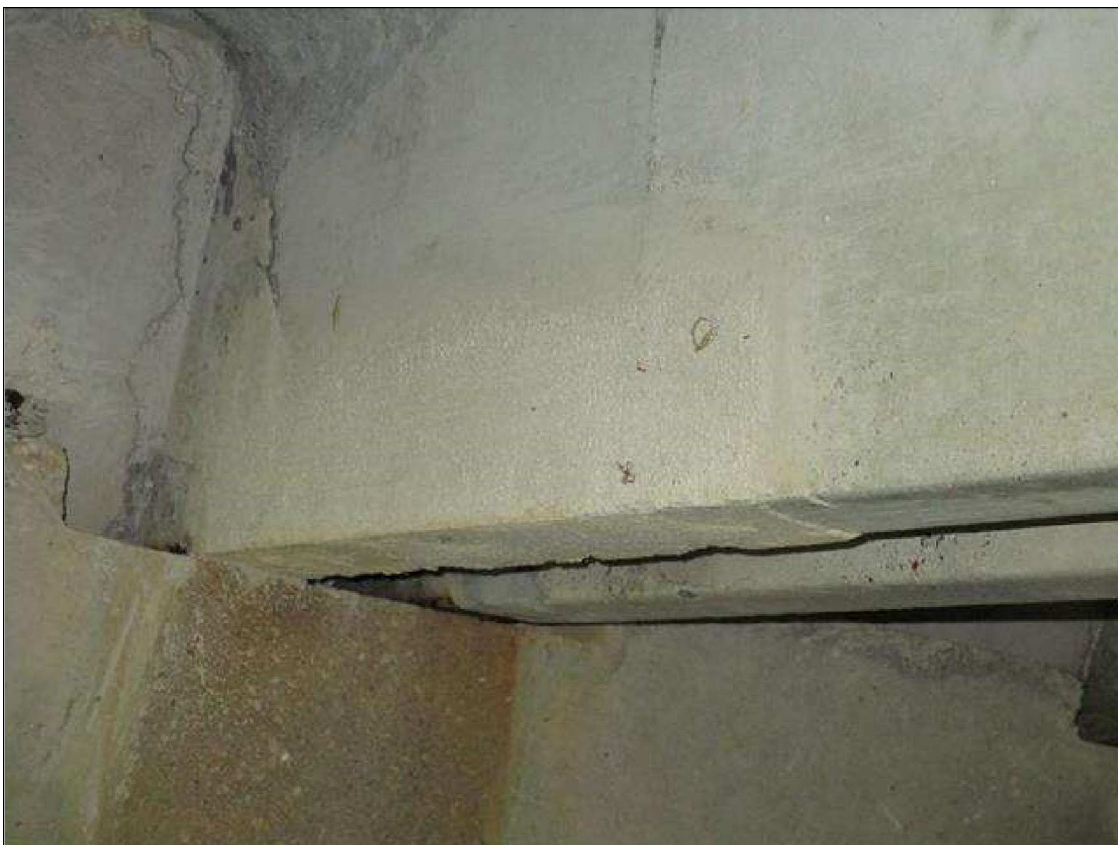
| Element Number | Defect Type | Defect Description | CS | CS Qty | Maint Qty | |
|---|---|---|---|---|---|---|
| 109 | Patched Area | NEW REPAIR PATCH AT: 20" LONG X 3" HIGH X FULL WIDTH SPALL WITH EXPOSED STRAND RIGHT LEG AT BENT 1 | 2 | 2 | | Feet |

Span 1 Slab 4: NEW REPAIR PATCH AT: 20" LONG X 3" HIGH X FULL WIDTH SPALL WITH EXPOSED STRAND RIGHT LEG AT BENT 1

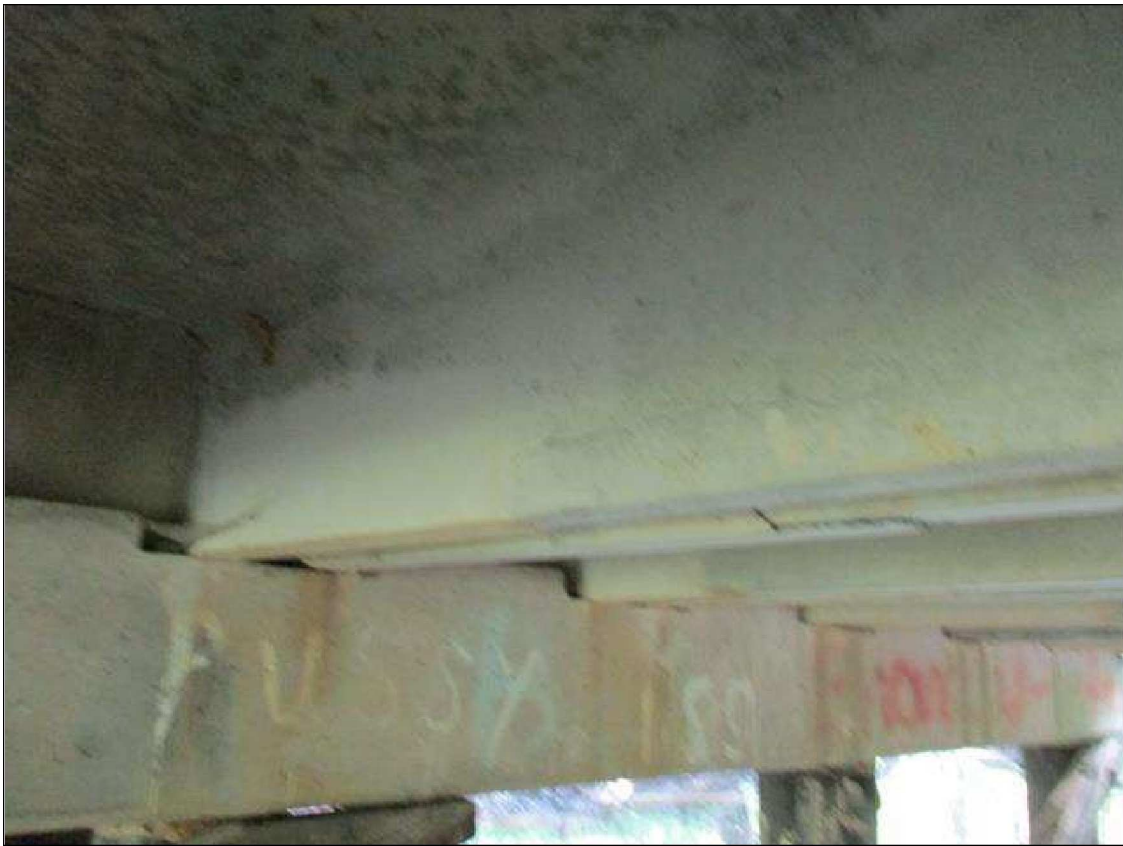
| Element Number | Defect Type | Defect Description | CS | CS Qty | Maint Qty | |
|---|---|---|---|---|---|---|
| 109 | Patched Area | NEW REPAIR PATCH AT: 10" LONG X 5" HIGH X 1/4" DEEP SPALL WITH EXPOSED REBAR LEFT SIDE RIGHT LEG AT BENT 1 | 2 | 1 | | Feet |

Span 1 Slab 5: NEW REPAIR PATCH AT: 10" LONG X 5" HIGH X 1/4" DEEP SPALL WITH EXPOSED REBAR LEFT SIDE RIGHT LEG AT BENT 1

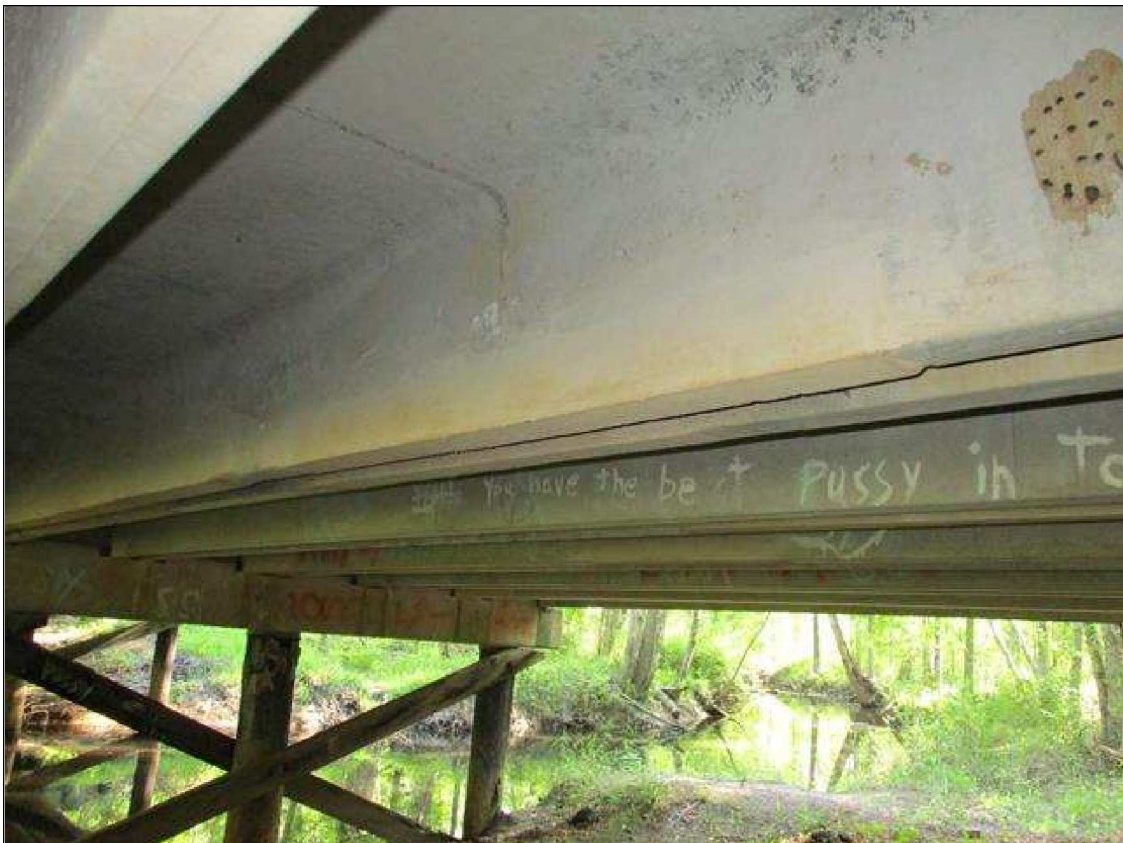
| Element Number | Defect Type | Defect Description | CS | CS Qty | Maint Qty | |
|---|---|---|---|---|---|---|
| 109 | Patched Area | NEW PATCHED AREA AT: 5' LONG X 3" HIGH FORMING SPALL ALONG RIGHT LEG - 10' FROM END BENT 1 | 2 | 5 | | Feet |

Span 1 Slab 5: NEW PATCHED AREA AT: 5' LONG X 3" HIGH FORMING SPALL ALONG RIGHT LEG - 10' FROM END BENT 1

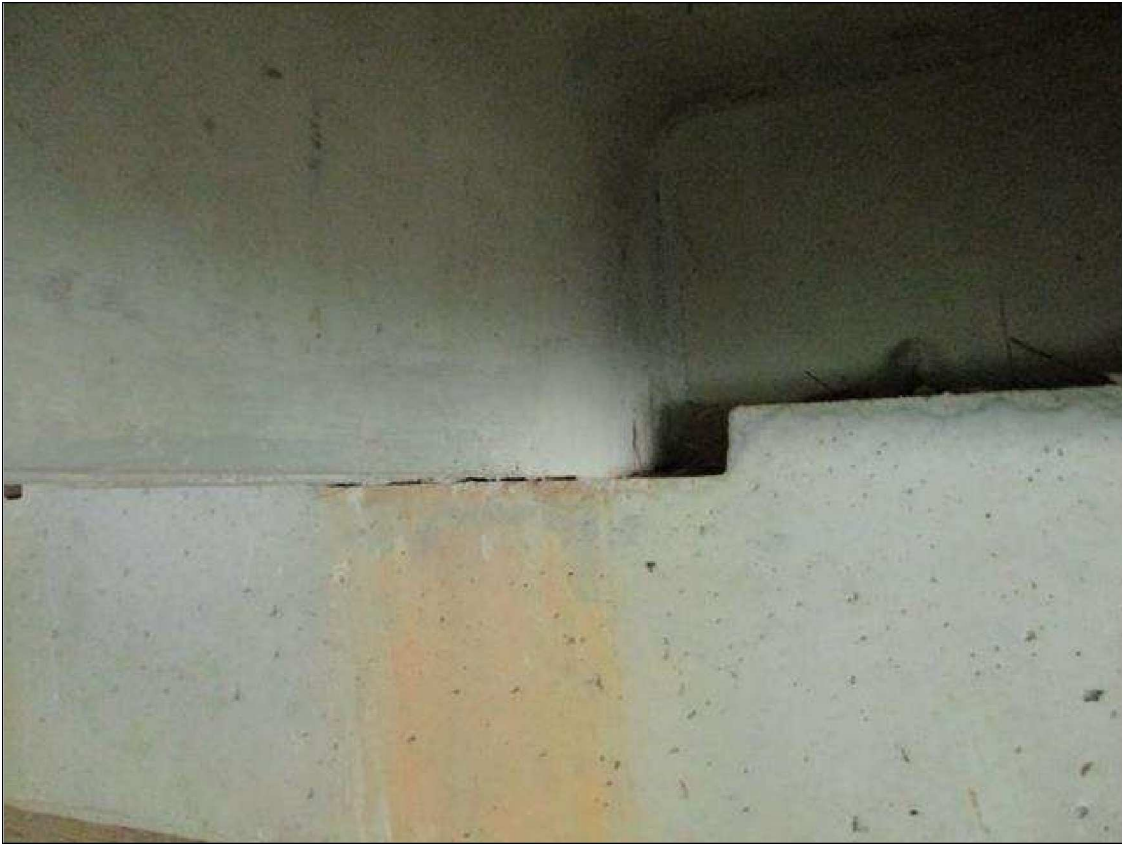
| Element Number | Defect Type | Defect Description | CS | CS Qty | Maint Qty | |
|---|---|---|---|---|---|---|
| 109 | Patched Area | NEW PATCHED AREA AT: 4" DIAMETER X 1/2" DEEP SPALL WITH EXPOSED REBAR RIGHT LEG LEFT SIDE AT END BENT 1 | 2 | 1 | | Feet |

Span 1 Slab 5: NEW PATCHED AREA AT: 4" DIAMETER X 1/2" DEEP SPALL WITH EXPOSED REBAR RIGHT LEG LEFT SIDE AT END BENT 1

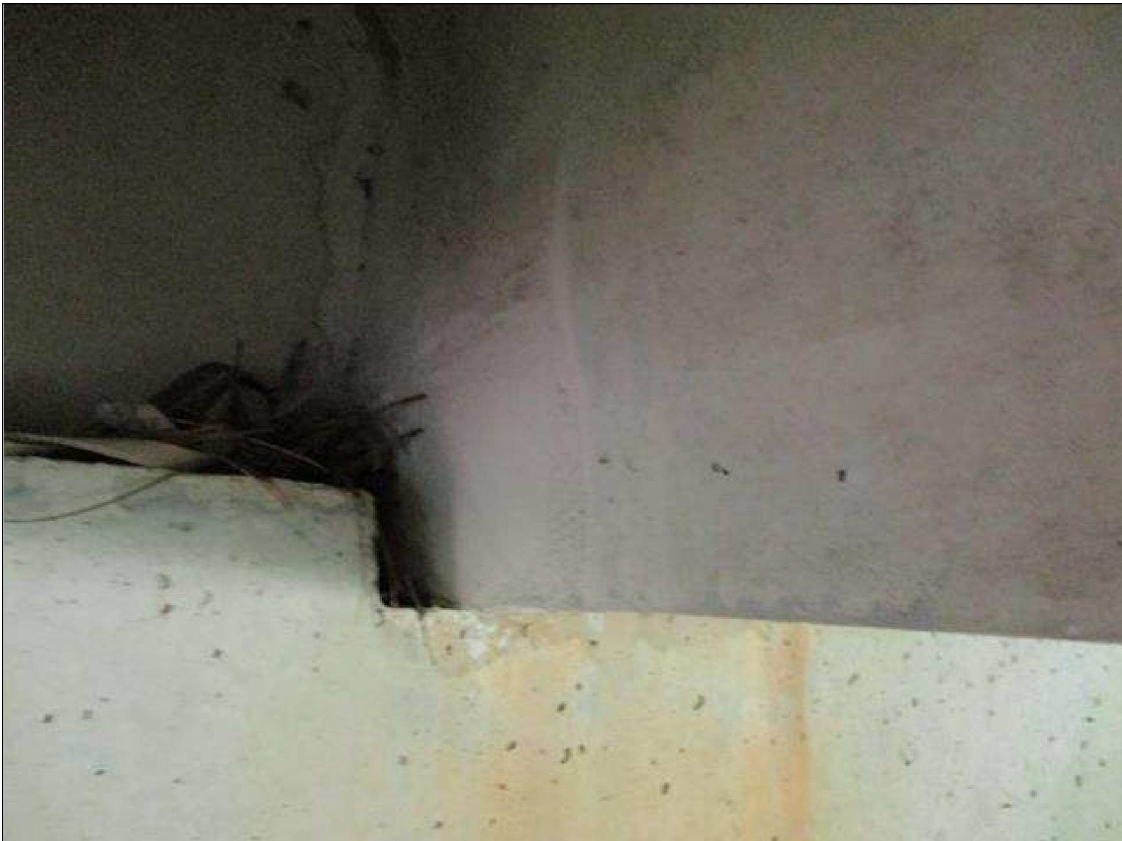
| Element Number | Defect Type | Defect Description | CS | CS Qty | Maint Qty | |
|---|---|---|---|---|---|---|
| 109 | Patched Area | NEW PATCHED AREA AT: 4" DIAMETER X 1/2" DEEP SPALL WITH EXPOSED REBAR LEFT LEG RIGHT SIDE AT END BENT 1 | 2 | 1 | | Feet |

Span 1 Slab 5: NEW PATCHED AREA AT: 4" DIAMETER X 1/2" DEEP SPALL WITH EXPOSED REBAR LEFT LEG RIGHT SIDE AT END BENT 1
