NC DEPARTMENT OF TRANSPORTATION  
DIVISION OF HIGHWAYS  
STRUCTURE MANAGEMENT UNIT

## Structure Safety Report

### Routine Element Inspection - Contract

DIVISION: 6 COUNTY: BLADEN STRUCTURE NUMBER: 080197 FREQUENCY: 24 MONTHS

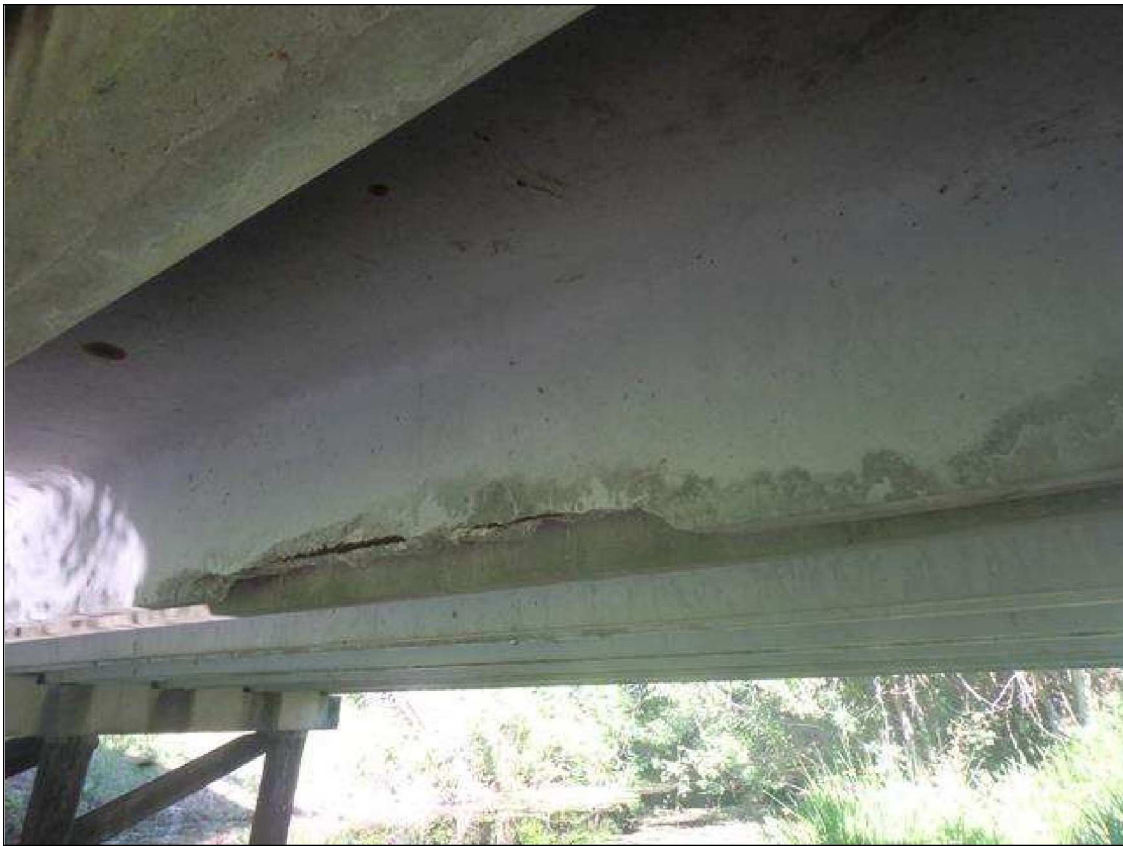
Span 2 Slab 6: 6'-2" LONG DELAMINATED AREA AND 3'-2" LONG X FULL WIDTH X 3-1/2" HIGH SPALLED AREA WITH EXPOSED PRESTRESSING STRAND ALONG THE LEFT LEG NEAR MID SPAN (PRIORITY MAINTENANCE)

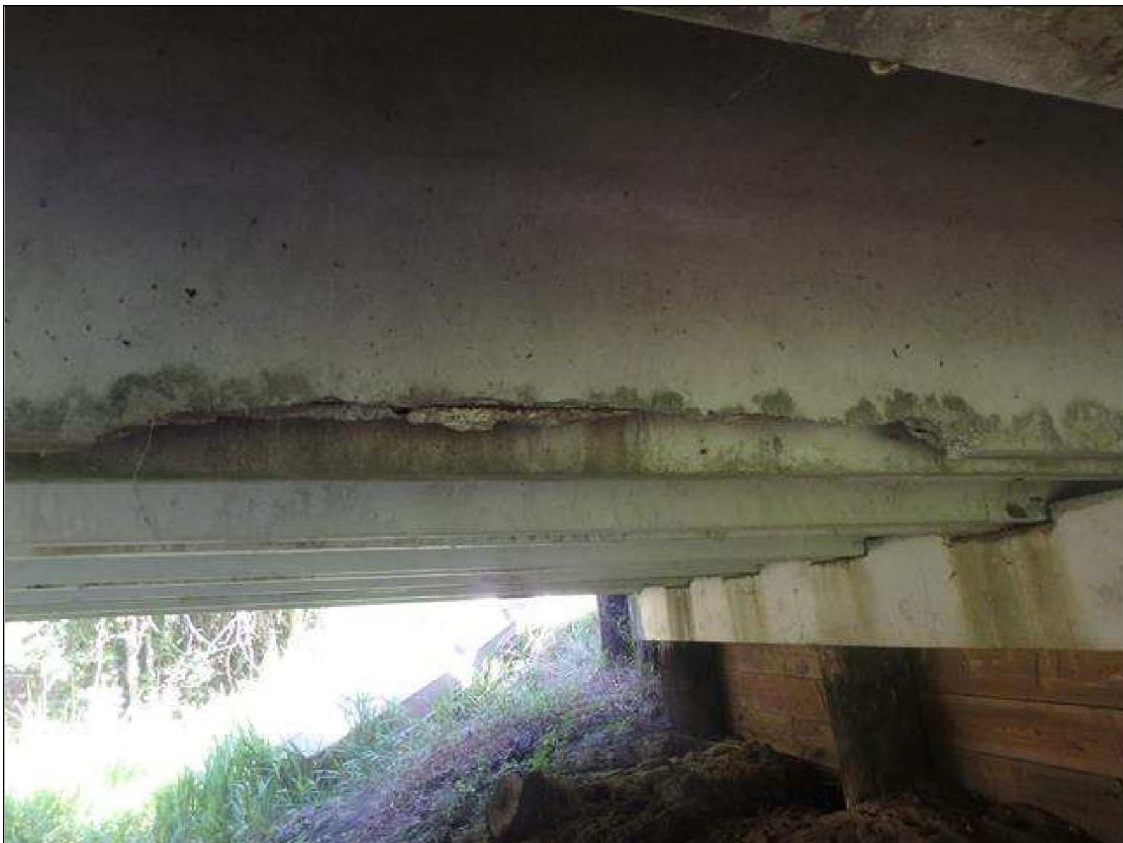
Span 2 Slab 6: 3'-4" LONG X FULL WIDTH X 3" HIGH SPALLED AREA WITH EXPOSED PRESTRESSING STRAND ALONG THE LEFT LEG 3'-4" FROM END BENT 2 (PRIORITY MAINTENANCE)

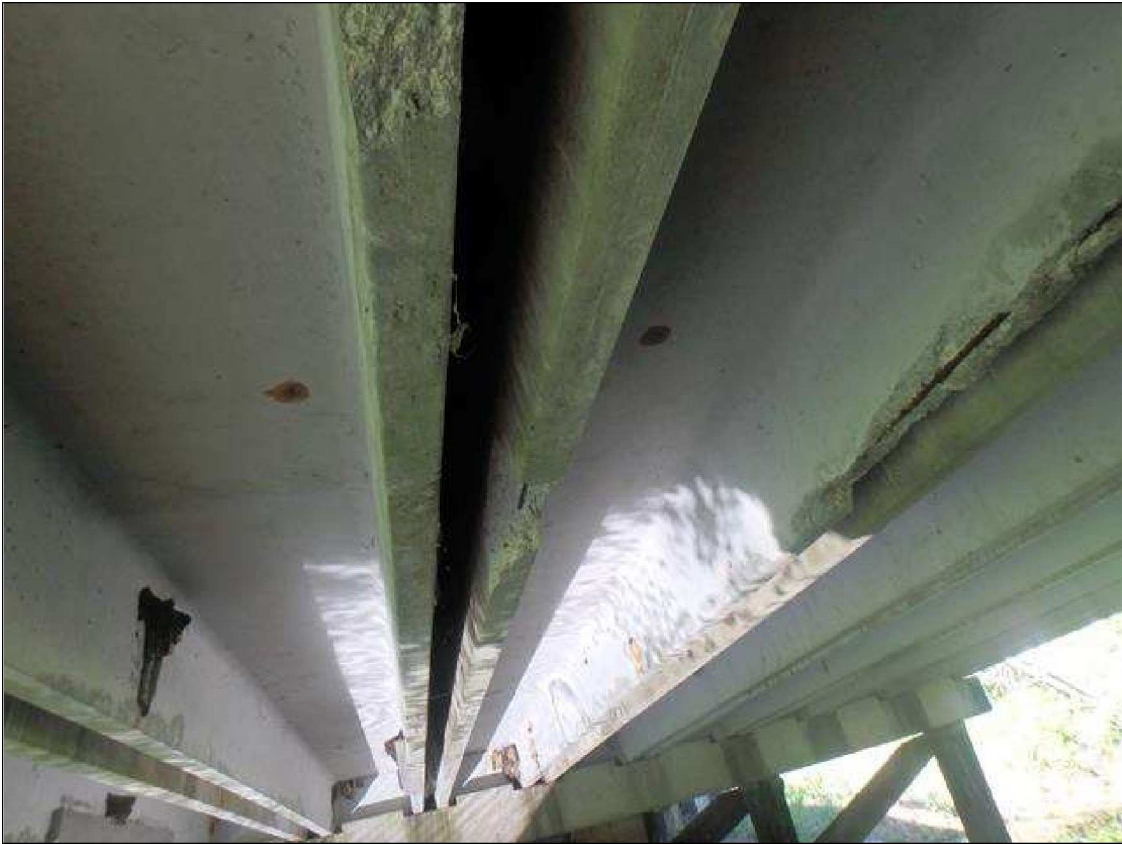
Span 2 Slab 6: 1' LONG X FULL WIDTH X 4" HIGH SPALLED AREA WITH EXPOSED PRESTRESSING STRAND ALONG THE RIGHT LEG AT MIDSPAN (PRIORITY MAINTENANCE)

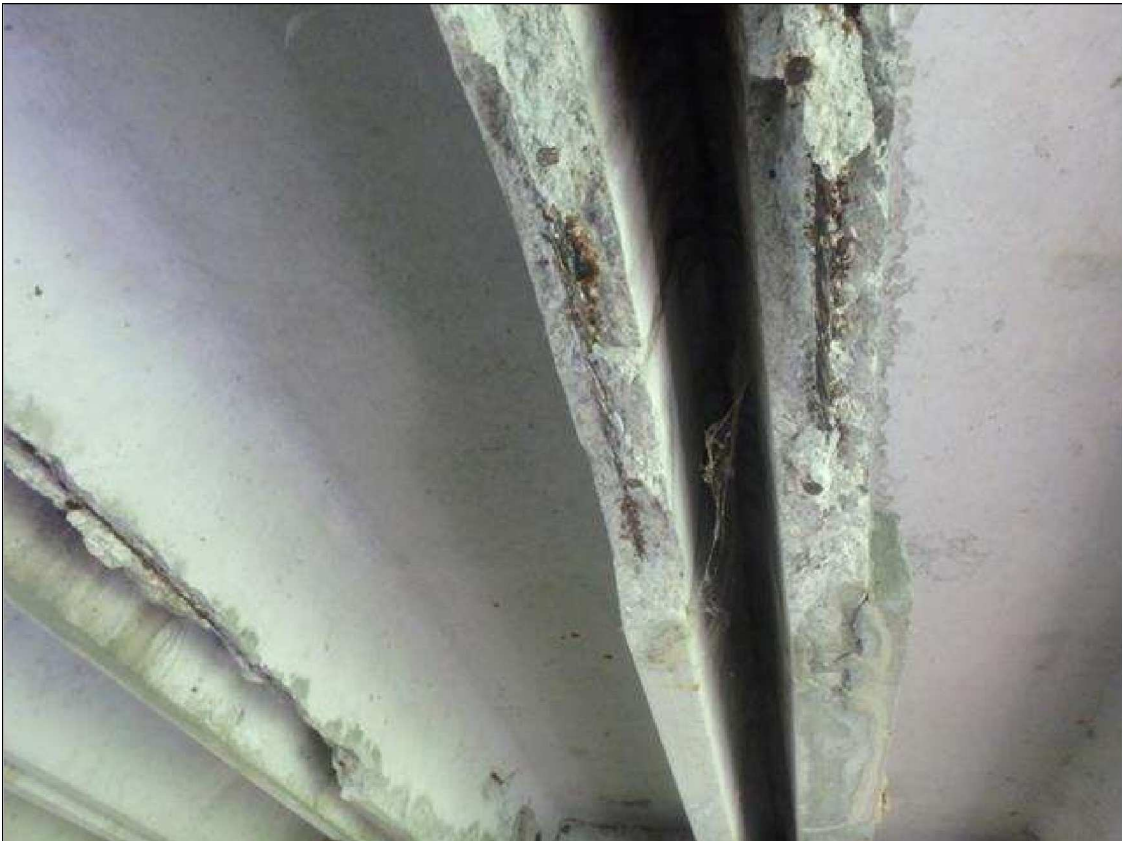
Span 2 Slab 6: 25' LONG X FULL WIDTH X 3-1/2" HIGH SPALLED AREA WITH EXPOSED PRESTRESSING STRAND ALONG THE RIGHT LEG, 5'-5" FROM END BENT 2 (PRIORITY MAINTENANCE)

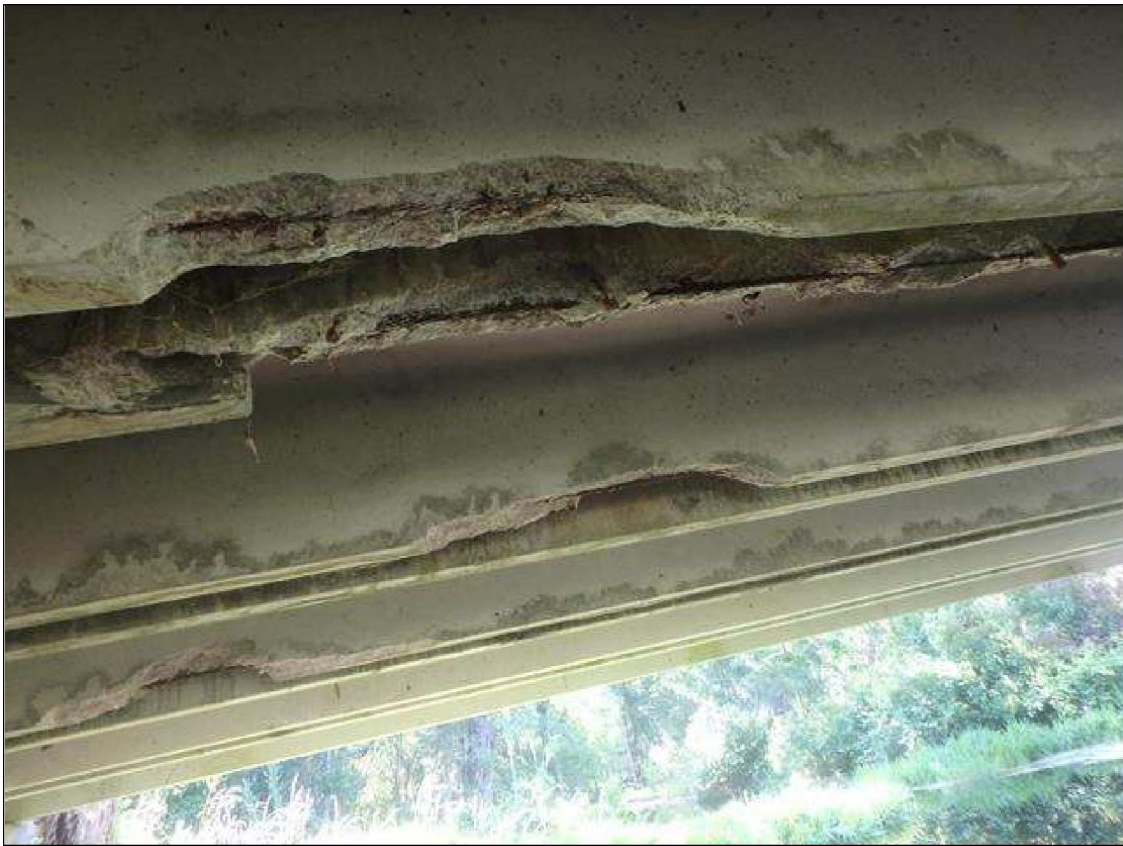
| Element Number | Defect Type | Defect Description | CS | CS Qty | Maint Qty |
|---|---|---|---|---|---|
| 109 | Delamination/Spall | 5'-10" LONG X FULL WIDTH X 4" HIGH SPALLED AREA WITH EXPOSED PRESTRESSING STRAND ALONG THE LEFT LEG, 4'-11" FROM END BENT 2 (PRIORITY MAINTENANCE) | 3 | 6 | 6 Feet |

Span 2 Slab 7: 5'-10" LONG X FULL WIDTH X 4" HIGH SPALLED AREA WITH EXPOSED PRESTRESSING STRAND ALONG THE LEFT LEG, 4'-11" FROM END BENT 2 (PRIORITY MAINTENANCE)

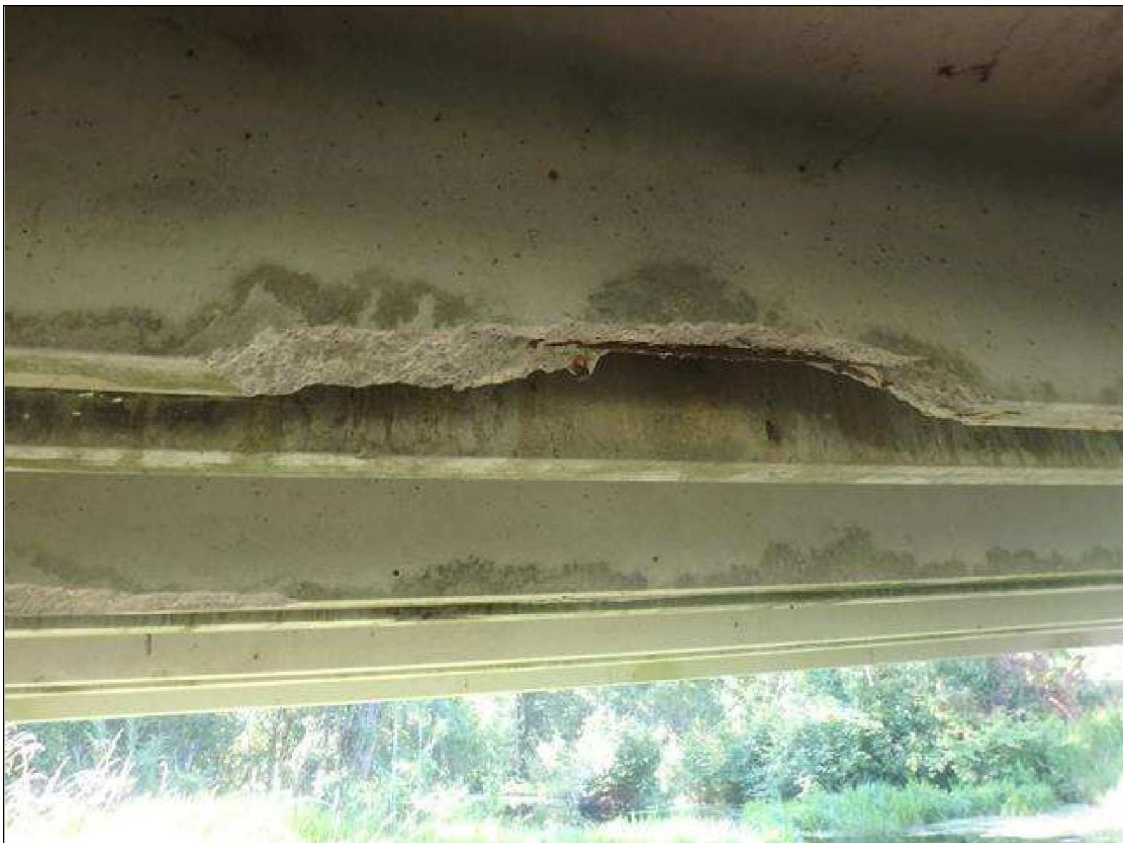
| Element Number | Defect Type | Defect Description | CS | CS Qty | Maint Qty |
|---|---|---|---|---|---|
| 109 | Delamination/Spall | 2'-6" LONG X FULL WIDTH X 4" HIGH SPALLED AREA WITH EXPOSED PRESTRESSING STRAND ALONG THE RIGHT LEG, 5'-11" FROM END BENT 2 (PRIORITY MAINTENANCE) | 3 | | 3 Feet |

Span 2 Slab 7: 2'-6" LONG X FULL WIDTH X 4" HIGH SPALLED AREA WITH EXPOSED PRESTRESSING STRAND ALONG THE RIGHT LEG, 5'-11" FROM END BENT 2 (PRIORITY MAINTENANCE)

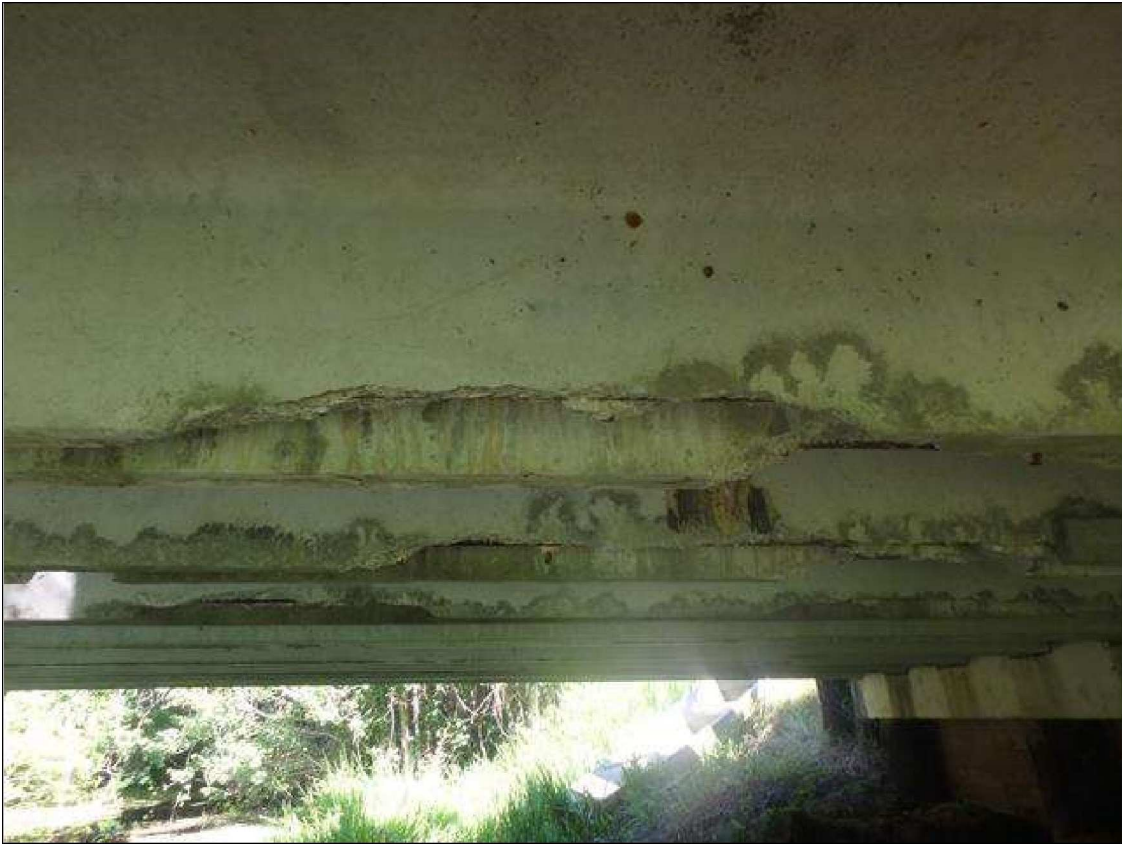
| Element Number | Defect Type | Defect Description | CS | CS Qty | Maint Qty |
|---|---|---|---|---|---|
| 109 | Delamination/Spall | 2'-8" LONG X FULL WIDTH X 4" HIGH SPALLED AREA WITH EXPOSED PRESTRESSING STRAND ALONG THE LEFT LEG, 7'-10" FROM END BENT 2 (PRIORITY MAINTENANCE) | 3 | 3 | 3 Feet |

Span 2 Slab 8: 2'-8" LONG X FULL WIDTH X 4" HIGH SPALLED AREA WITH EXPOSED PRESTRESSING STRAND ALONG THE LEFT LEG, 7'-10" FROM END BENT 2 (PRIORITY MAINTENANCE)

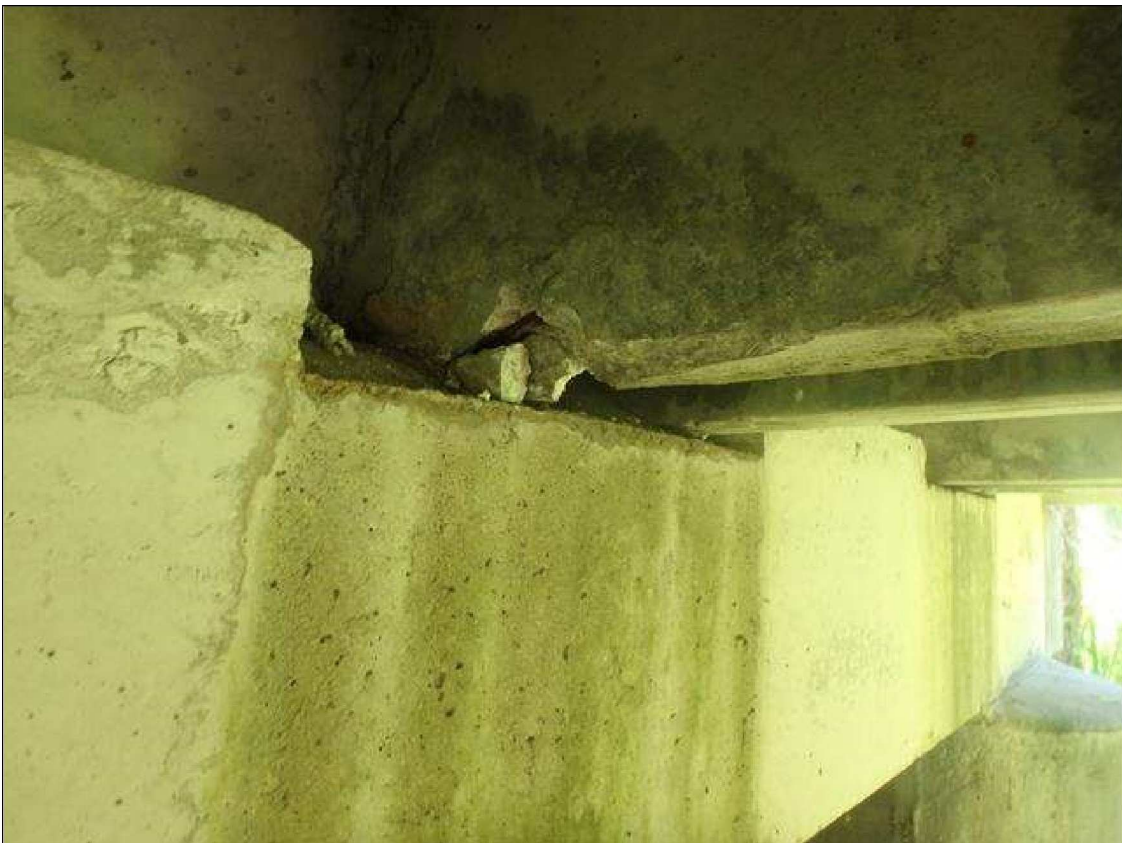
| Element Number | Defect Type | Defect Description | CS | CS Qty | Maint Qty |
|---|---|---|---|---|---|
| 109 | Delamination/Spall | 5" LONG X FULL WIDTH X 2" HIGH SPALLED AREA WITH EXPOSED PRESTRESSING STRAND ALONG THE RIGHT LEG AT END BENT 2 (PRIORITY MAINTENANCE) | 3 | 1 | 1 Feet |

Span 2 Slab 8: 5" LONG X FULL WIDTH X 2" HIGH SPALLED AREA WITH EXPOSED PRESTRESSING STRAND ALONG THE RIGHT LEG AT END BENT 2 (PRIORITY MAINTENANCE)

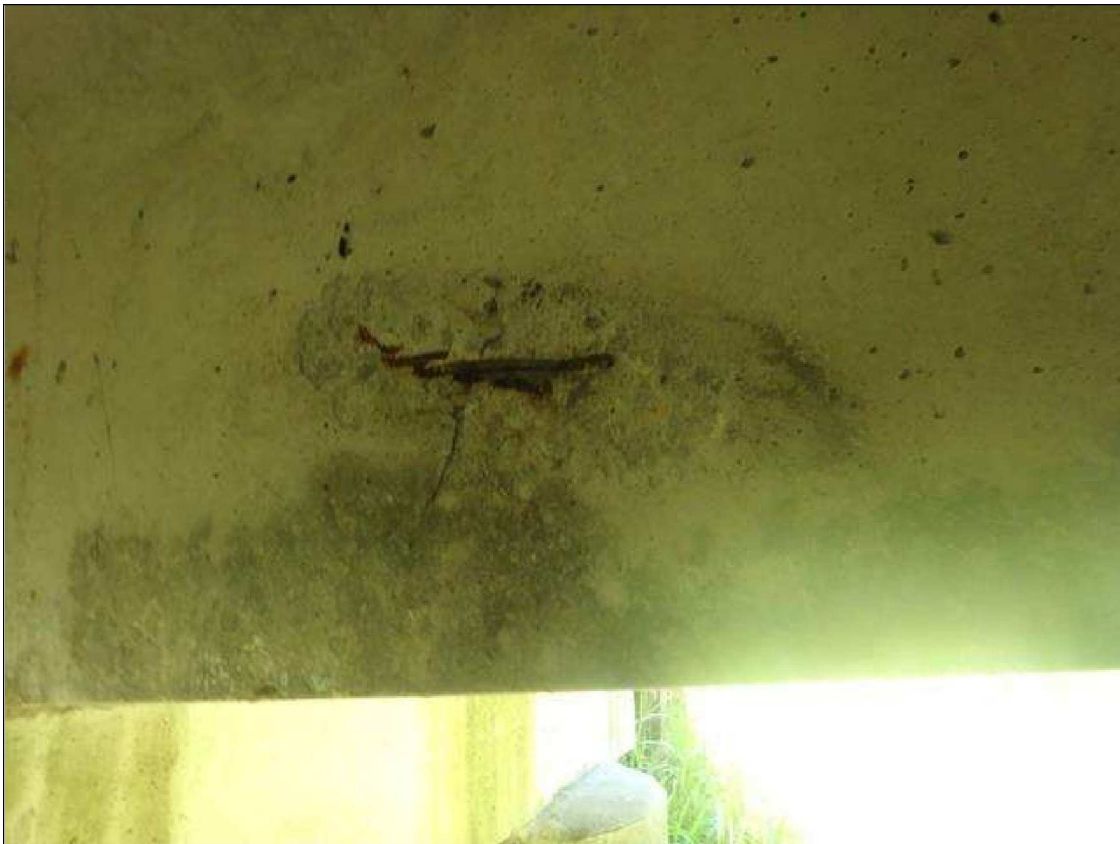
| Element Number | Defect Type | Defect Description | CS | CS Qty | Maint Qty |
|---|---|---|---|---|---|
| 109 | Delamination/Spall | 7" LONG X 2" HIGH SPALLED AREA WITH EXPOSED PRESTRESSING STRAND ALONG WEST FACE OF THE RIGHT LEG, 1'-2" FROM END BENT 2 (PRIORITY MAINTENANCE) | 3 | 1 | 1 Feet |

Span 2 Slab 8: 7" LONG X 2" HIGH SPALLED AREA WITH EXPOSED PRESTRESSING STRAND ALONG WEST FACE OF THE RIGHT LEG, 1'-2" FROM END BENT 2 (PRIORITY MAINTENANCE)

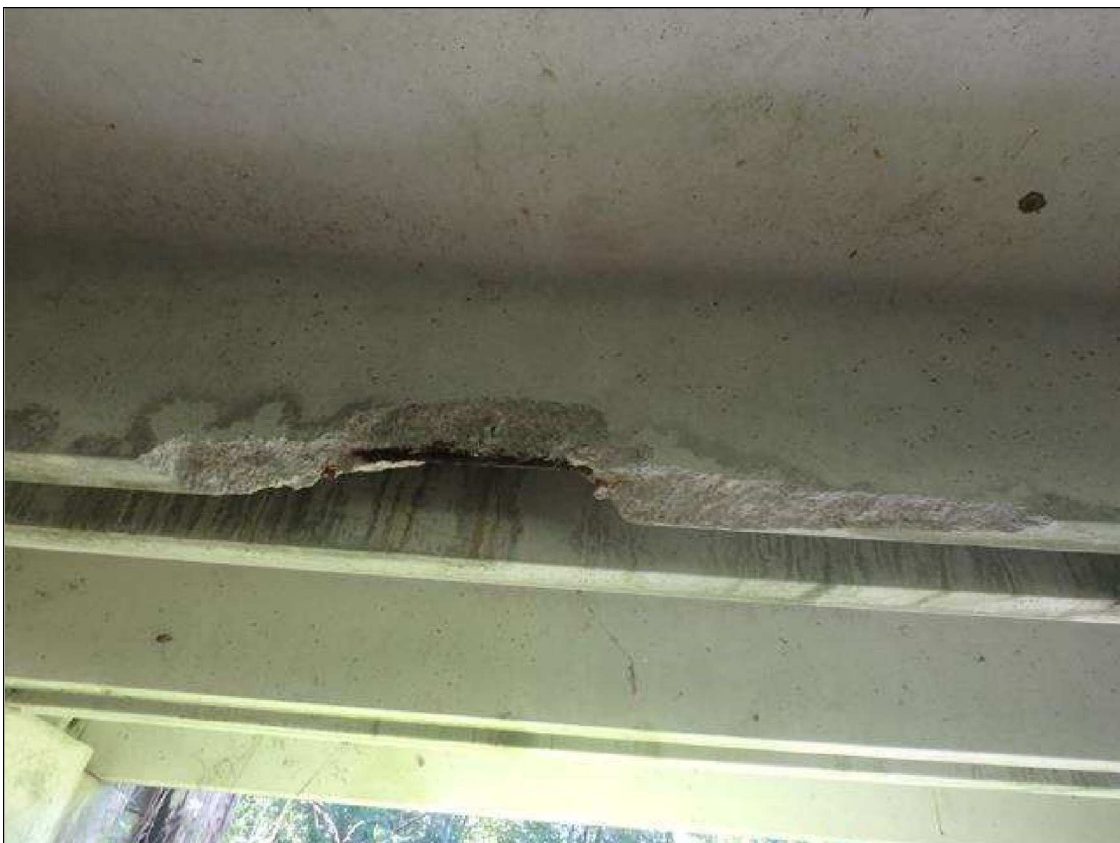
| Element Number | Defect Type | Defect Description | CS | CS Qty | Maint Qty |
|---|---|---|---|---|---|
| 109 | Delamination/Spall | 3'-3" LONG X FULL WIDTH X 5" HIGH SPALLED AREA WITH EXPOSED PRESTRESSING STRAND ALONG THE RIGHT LEG, 2'-8" FROM END BENT 2 (PRIORITY MAINTENANCE) | 3 | 4 | 4 Feet |

Span 2 Slab 8: 3'-3" LONG X FULL WIDTH X 5" HIGH SPALLED AREA WITH EXPOSED PRESTRESSING STRAND ALONG THE RIGHT LEG, 2'-8" FROM END BENT 2 (PRIORITY MAINTENANCE)

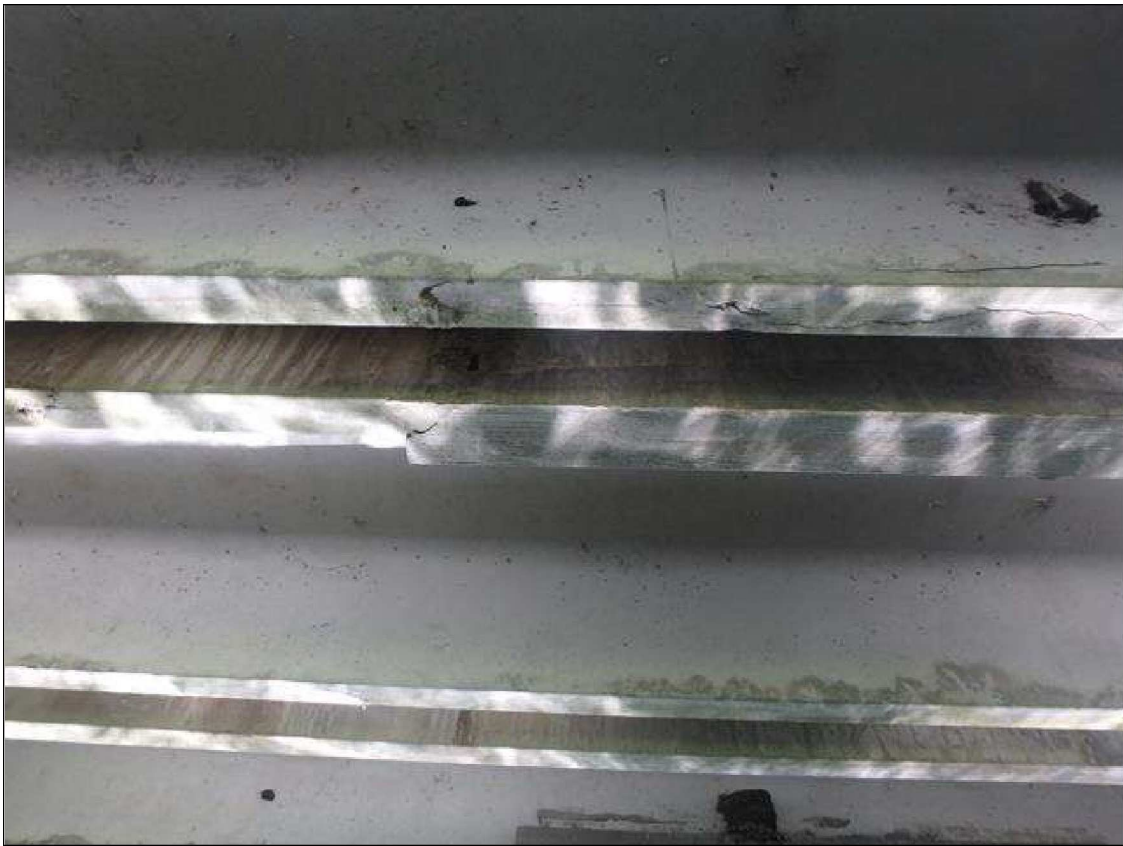
| Element Number | Defect Type | Defect Description | CS | CS Qty | Maint Qty |
|---|---|---|---|---|---|
| 109 | Delamination/Spall | 2" DIAMETER X 1" DEEP POP OUT SPALL WITH EXPOSED PRESTRESSING STRAND ALONG THE WEST FACE OF THE LEFT LEG, 7' FROM BENT 1 (PRIORITY MAINTENANCE) | 2 | 1 | 1 Feet |

Span 2 Slab 7: 2" DIAMETER X 1" DEEP SPALLED AREA WITH EXPOSED PRESTRESSING STRAND ALONG THE WEST FACE OF THE LEFT LEG, 7' FROM BENT 1 (PRIORITY MAINTENANCE)

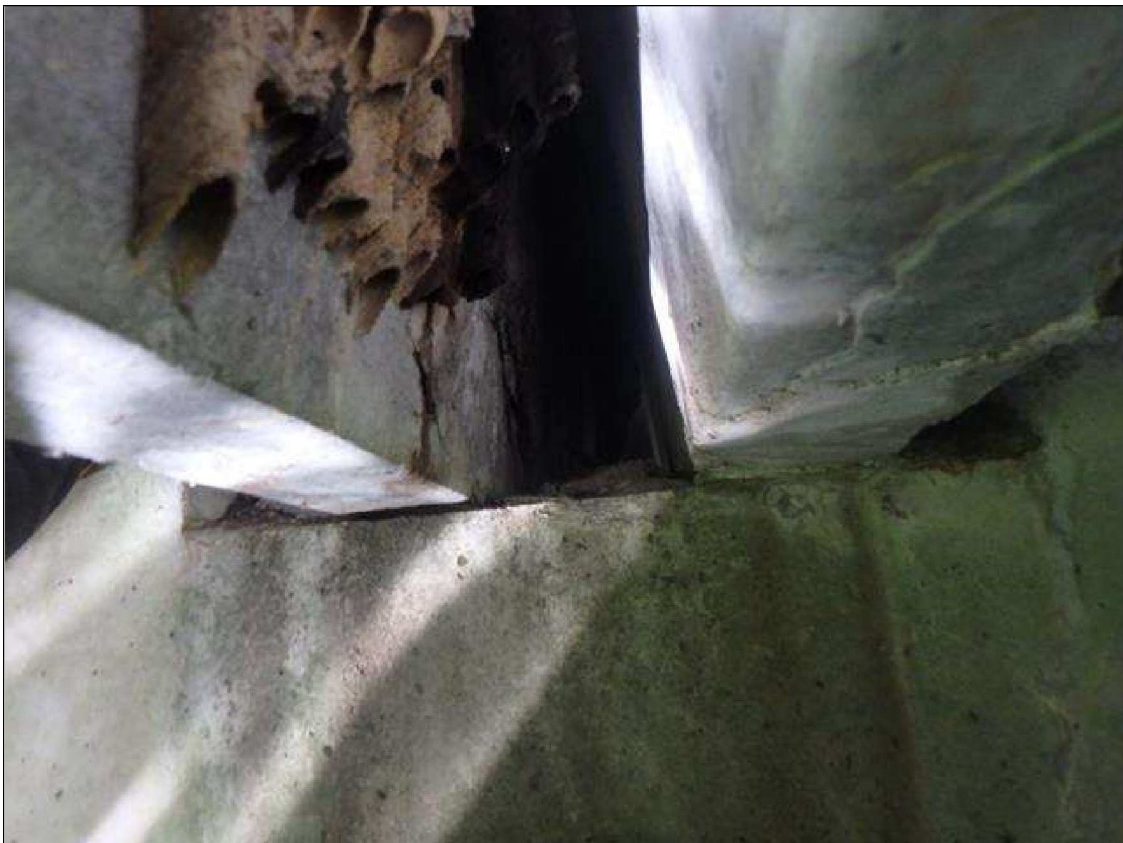
| Element Number | Defect Type | Defect Description | CS | CS Qty | Maint Qty |
|---|---|---|---|---|---|
| 109 | Delamination/Spall | 5" DIAMETER X 1/4" DEEP SPALLED AREA WITH EXPOSED PRESTRESSING STRAND ALONG THE WEST FACE OF THE LEFT LEG AT BENT 1 (PRIORITY MAINTENANCE) | 2 | 1 | 1 Feet |

Span 2 Slab 7: 5" DIAMETER X 1/4" DEEP SPALLED AREA WITH EXPOSED PRESTRESSING STRAND ALONG THE WEST FACE OF THE LEFT LEG AT BENT 1 (PRIORITY MAINTENANCE)

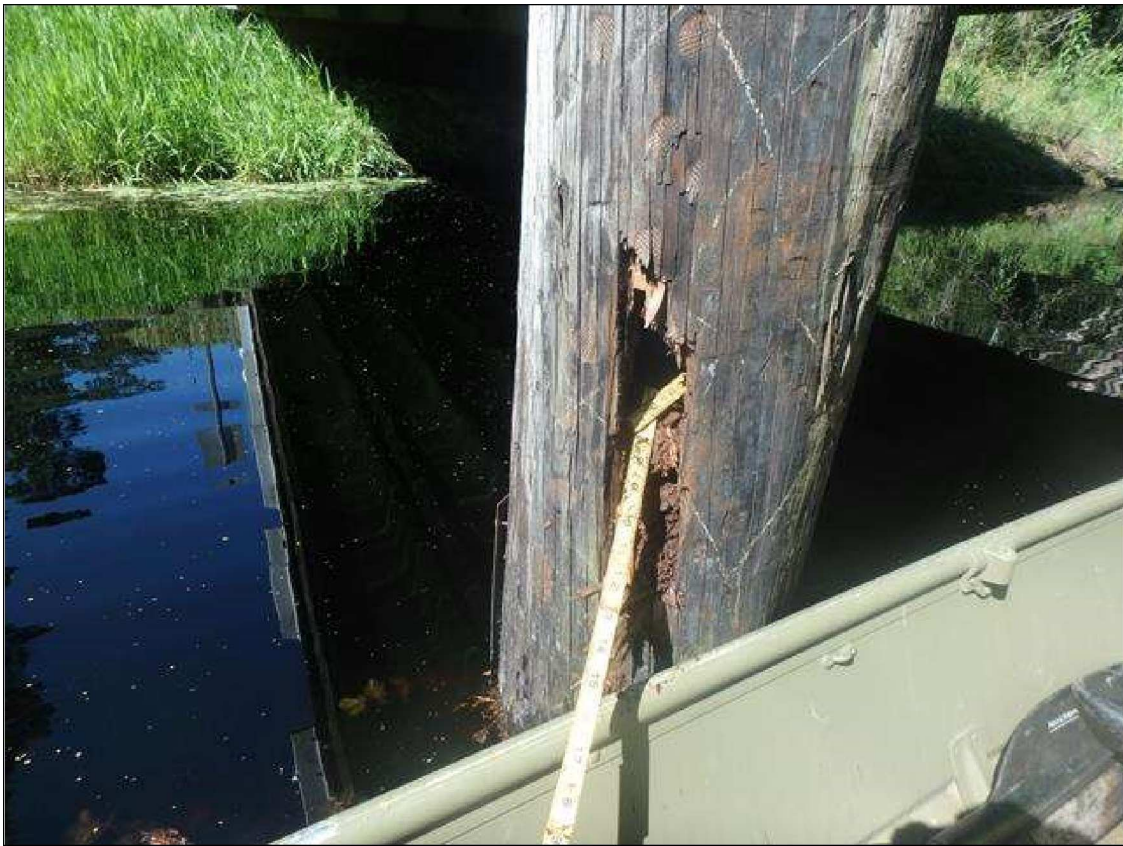
Bent 2 Pile 5: 4'-7" HIGH X FULL WIDTH X FULL CIRCUMFERENCE X UP TO 8" DEEP DECAY WITH A 10" HIGH X 1'-6" DEEP HOLE ALONG THE NORTH FACE, 11" ABOVE THE WATER LINE (PRIORITY MAINTENANCE)

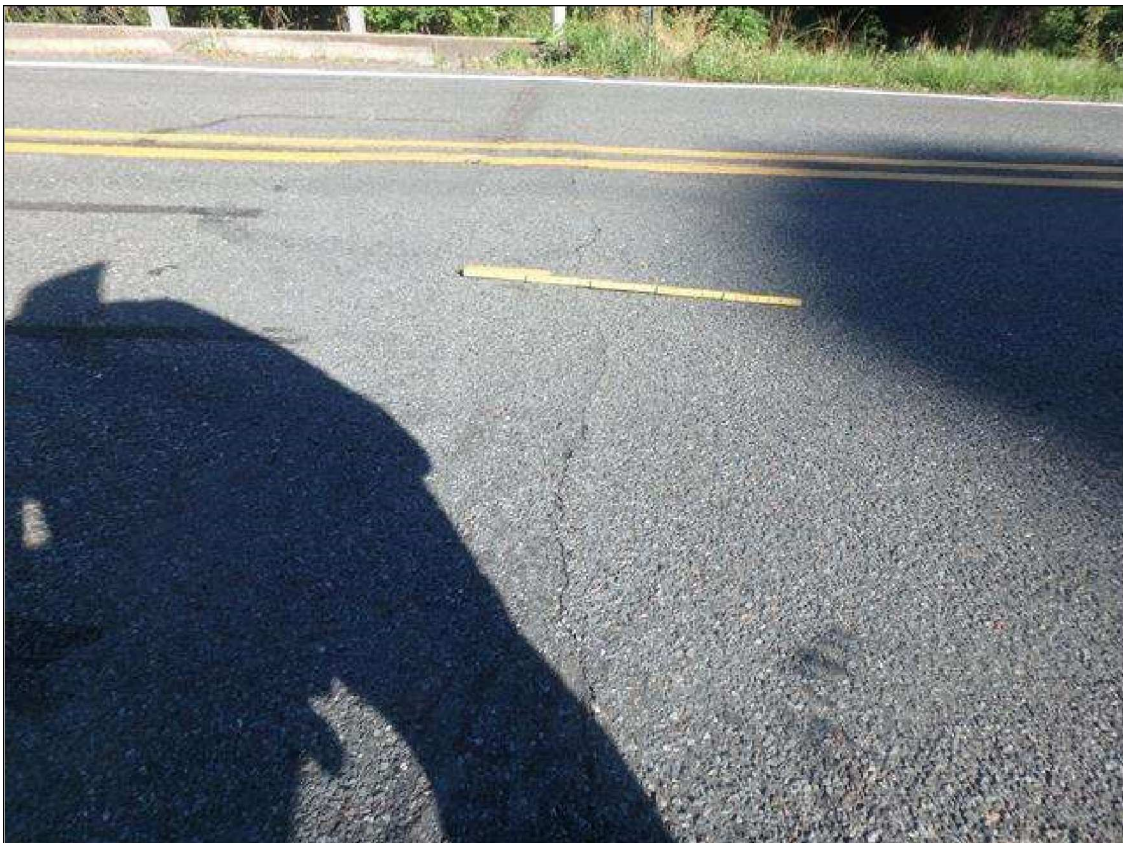
Approach: 9' LONG X 1/8" WIDE X UP TO 1/2" WIDE TRANSVERSE CRACK IN THE NORTHBOUND LANE AT THE NORTH APPROACH, 1' FROM END BENT 2 (SOUTH SIMILAR)

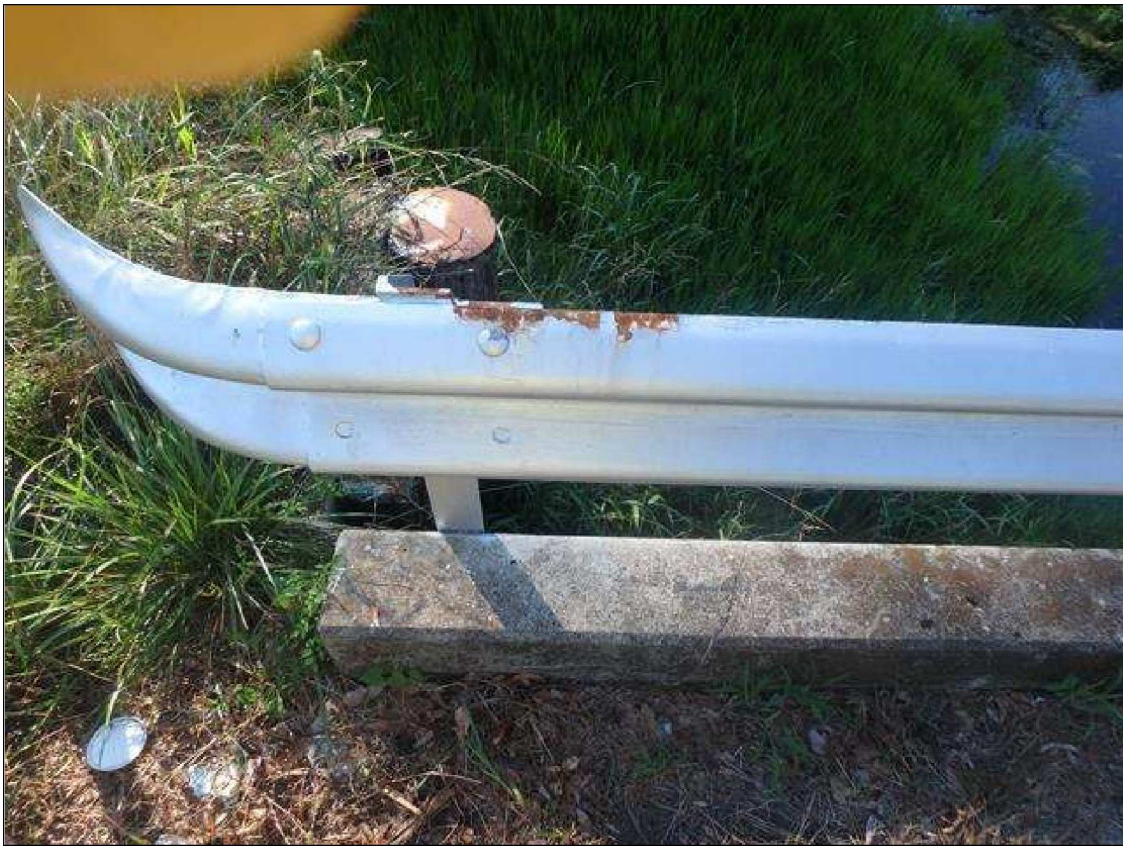
Span 2 Right Bridge Rail: 1' LONG X 2" WIDE PEELING PAINT, 1' FROM END BENT 2

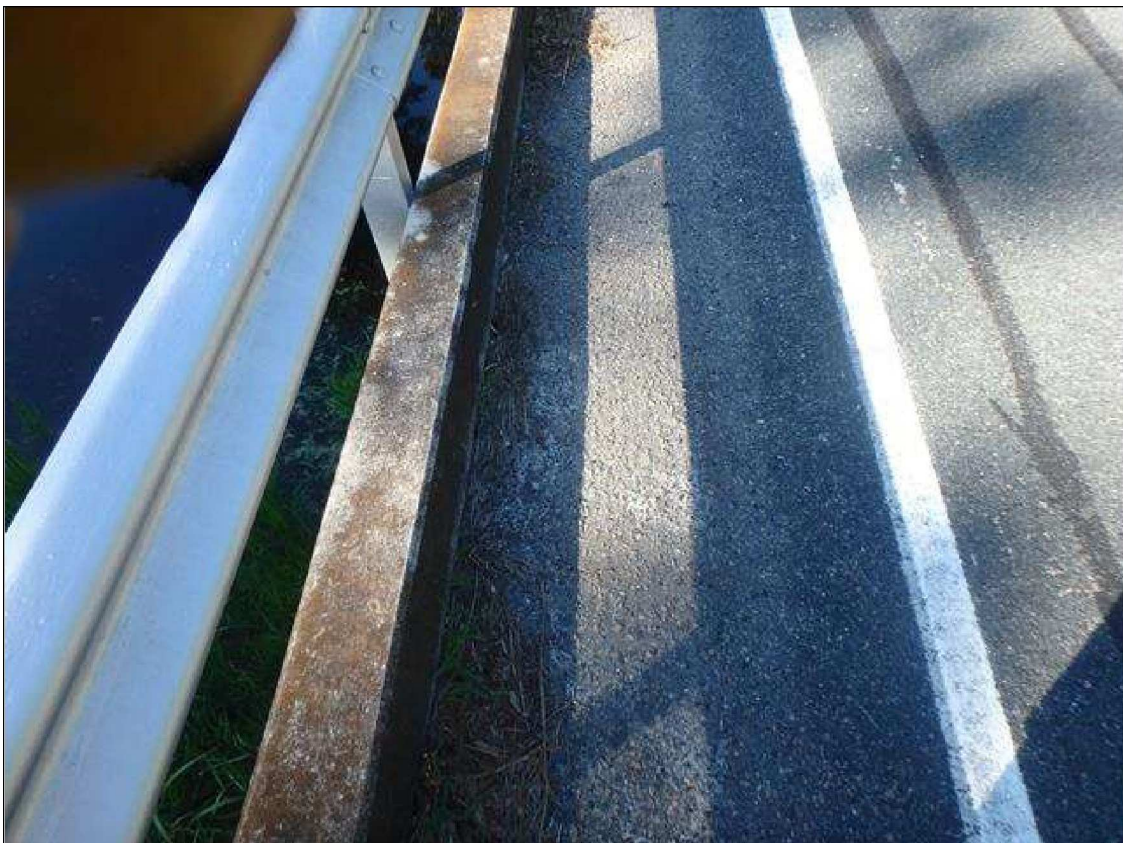
Deck Debris: INTERMITTENT FULL LENGTH X 2' WIDE DECK DEBRIS ALONG THE EAST BRIDGE RAIL (WEST SIMILAR)

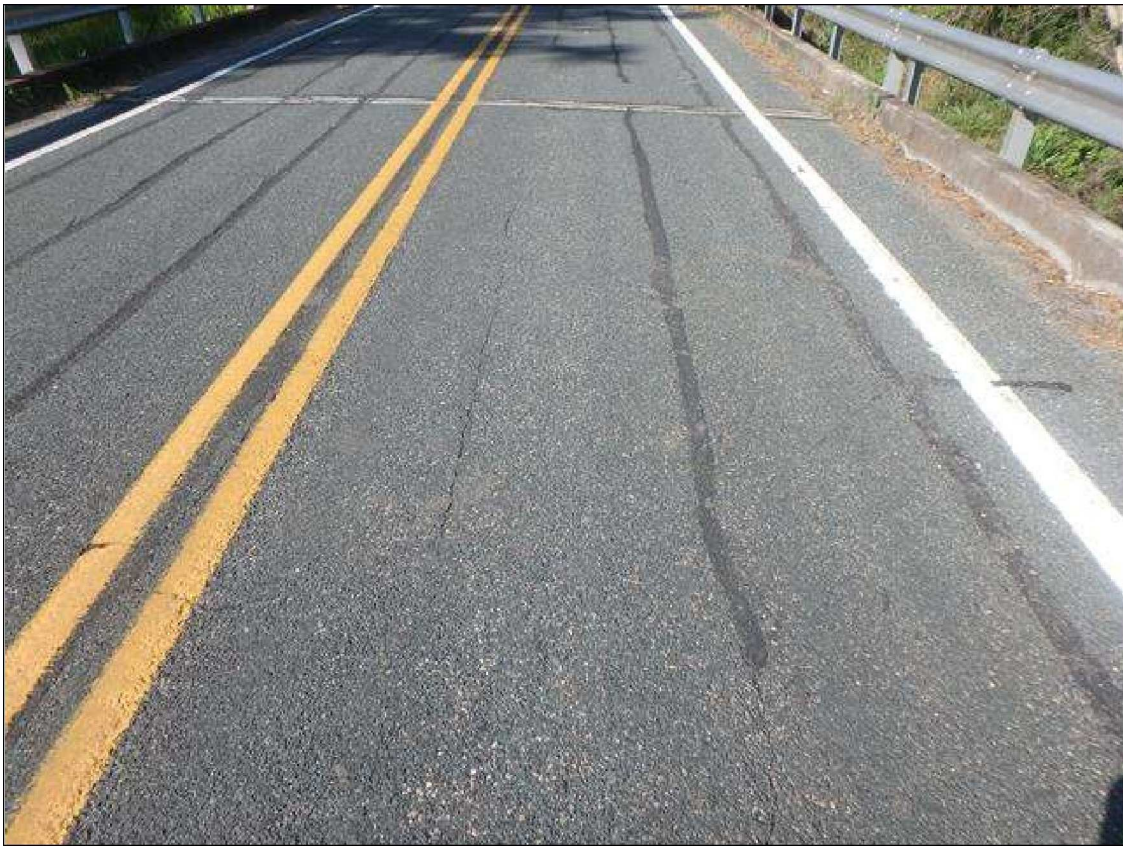
| Element Number | Defect Type | Defect Description | CS | CS Qty | Maint Qty |
|---|---|---|---|---|---|
| 510 | Crack (Wearing Surface) | INTERMITTENT FULL LENGTH X UP TO 1/4" WIDE SEALED LONGITUDINAL CRACKS WITH SOME EXTRUDED | 3 | 214 | 214 Square Feet |

Span 2 Wearing Surface: INTERMITTENT FULL LENGTH X UP TO 1/4" WIDE SEALED LONGITUDINAL CRACKS WITH SOME EXTRUDED (SPAN 1 SIMILAR)

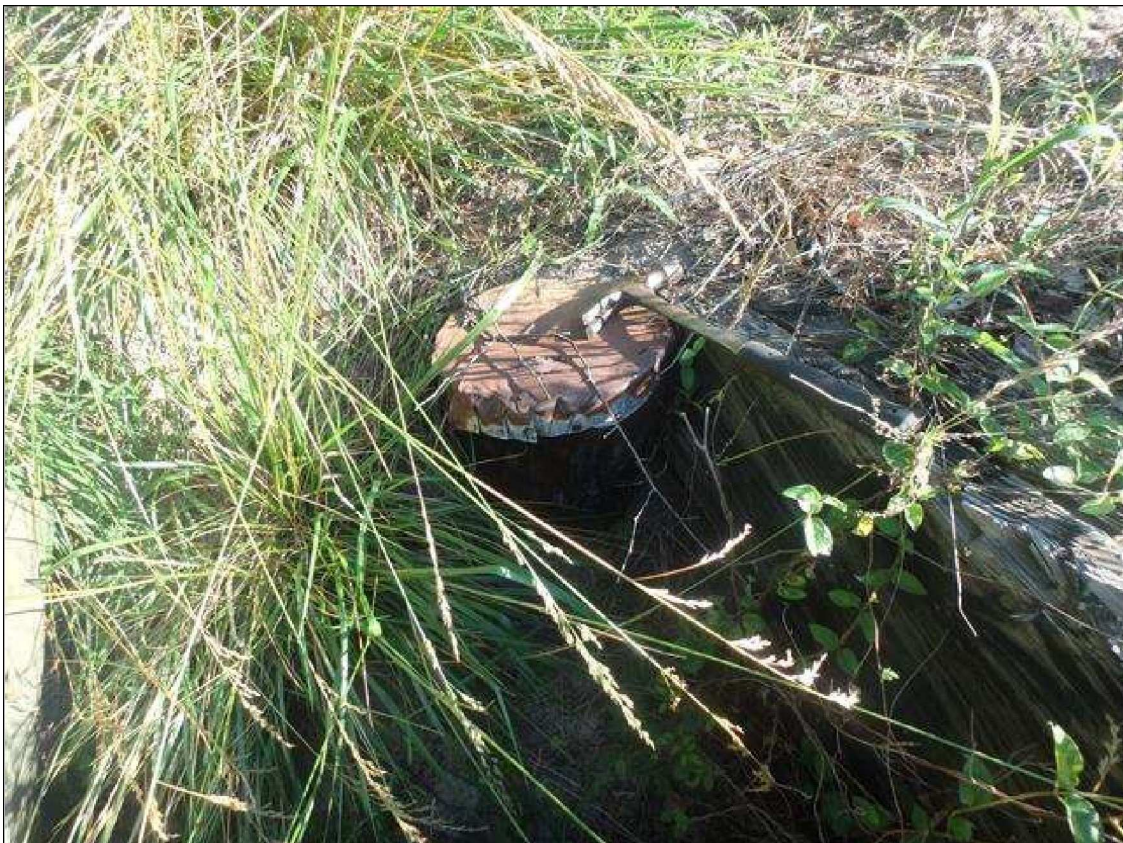
Wingwall: SUFACE RUST ALONG ALL OF THE WEST END SOLDIER PILE CAP ALONG THE NORTHWEST WINGWALL (OTHERS SIMILAR)

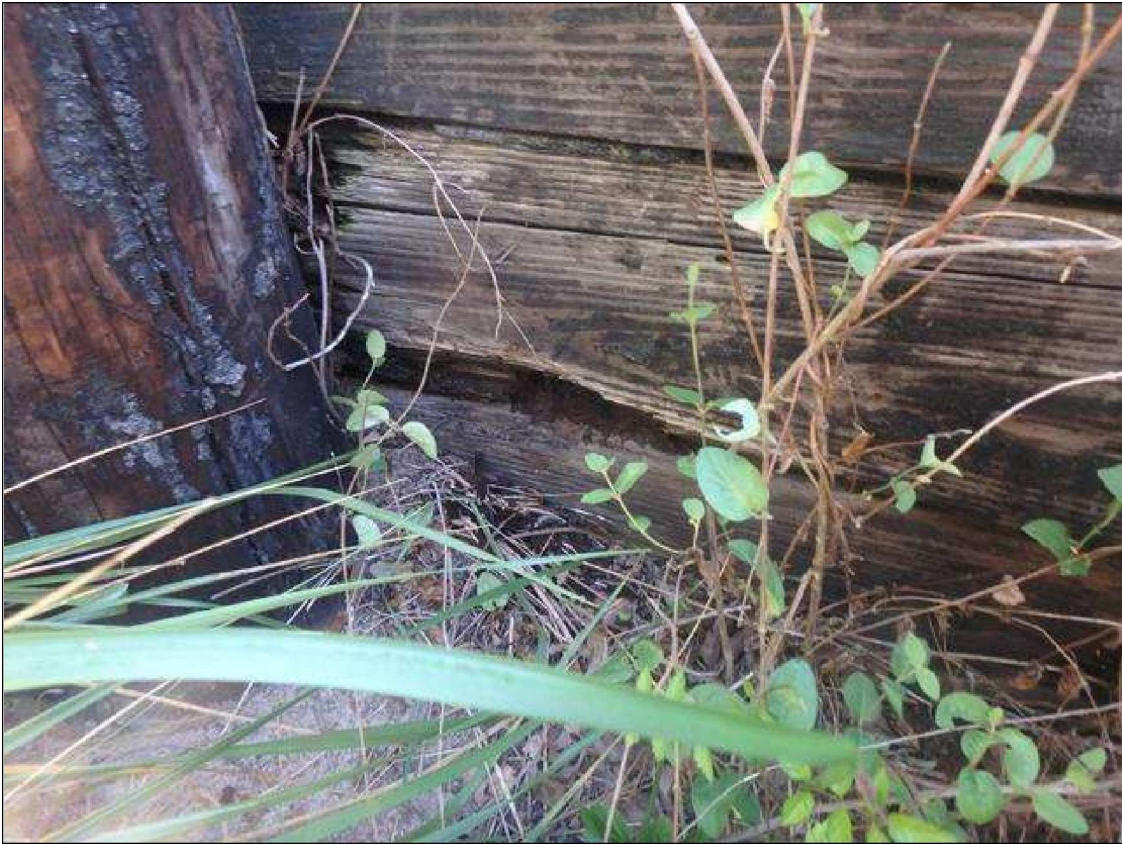
Wingwall: 1'-3" LONG X 2" HIGH X 2" DEEP DECAY ALONG THE NORTHWEST WINGWALL, ADJACENT TO PILE 1

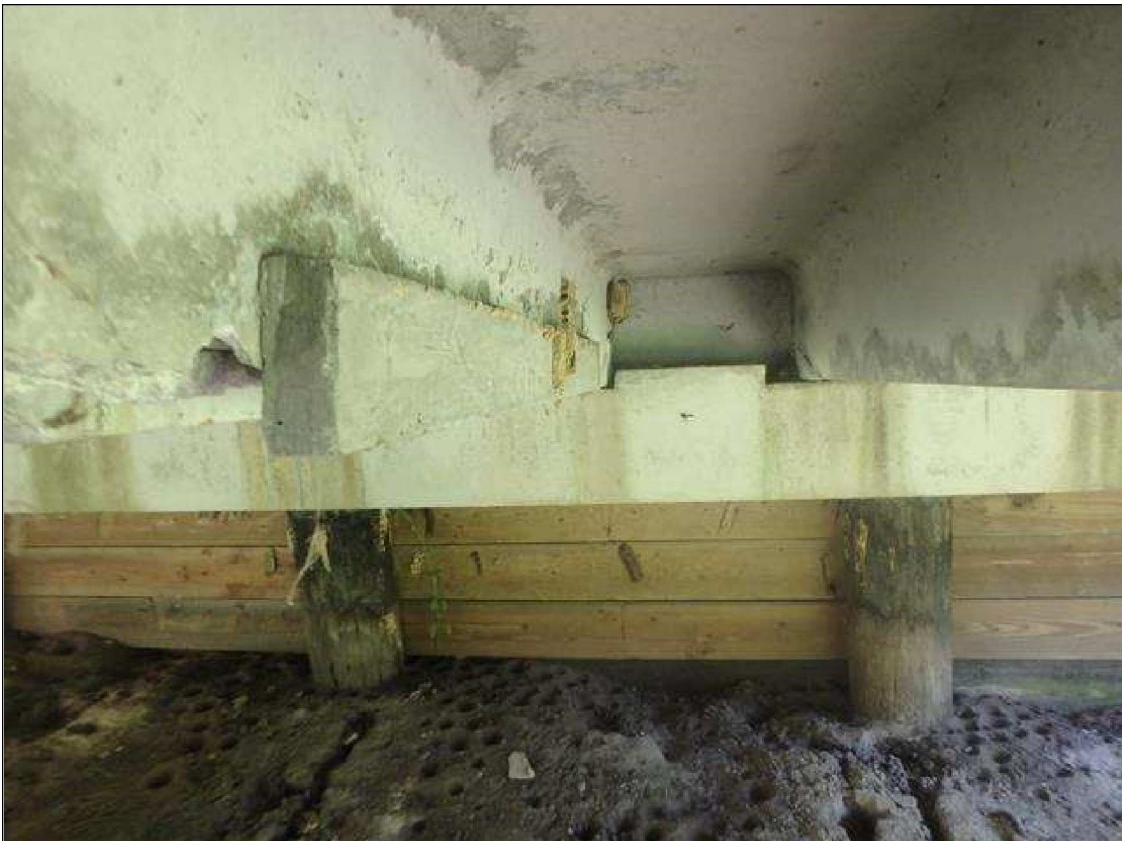
| Element Number | Defect Type | Defect Description | CS | CS Qty | Maint Qty |
|---|---|---|---|---|---|
| 109 | Patched Area | 3'-10" LONG X 4" HIGH X 2" WIDE CONCRETE REPAIR ALONG THE LEFT LEG, 1'-7" FROM END BENT 2 | 2 | 3 | Feet |

Span 2 Slab 7: 3'-10" LONG X 4" HIGH X 2" WIDE CONCRETE REPAIR ALONG THE LEFT LEG, 1'-7" FROM END BENT 2

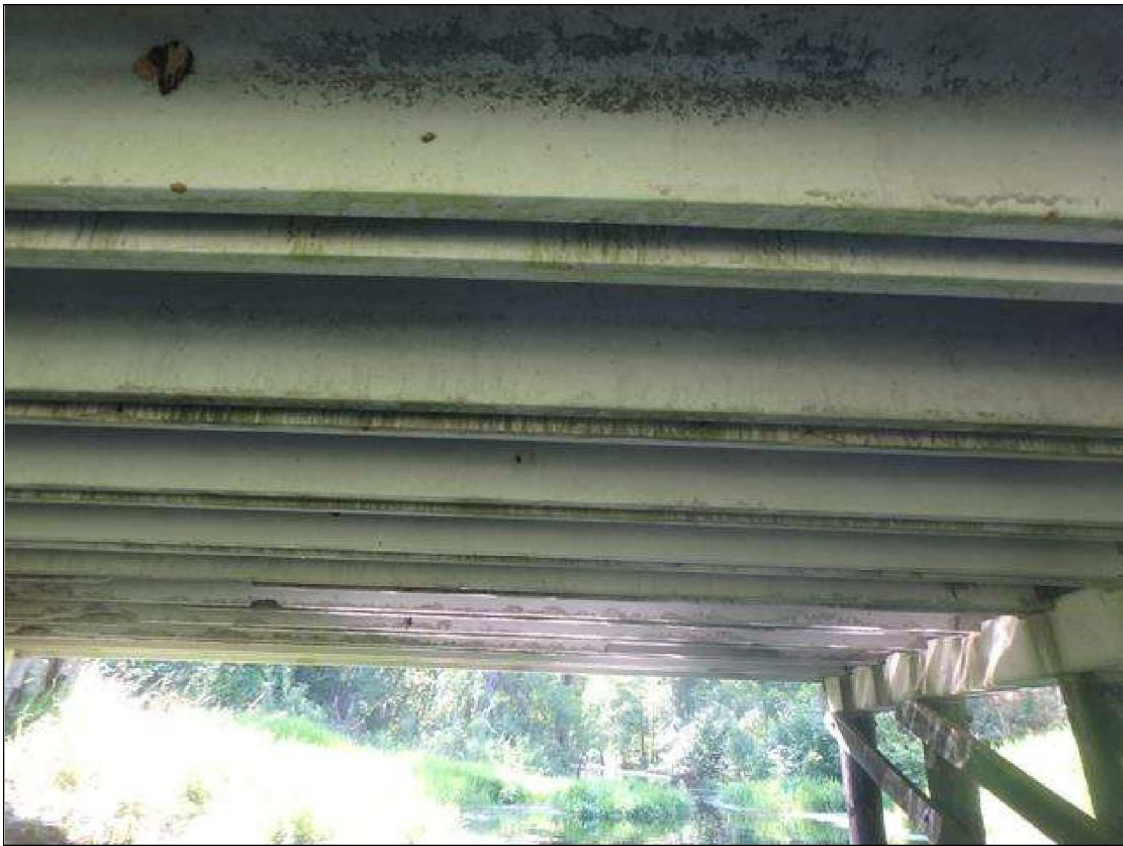
Span 2 Slab 3: (2) - 6" LONG X 2" HIGH X 1" WIDE SPALLED AREAS ALONG THE LEFT LEG AT MIDSPAN AND 7' FROM BENT 1

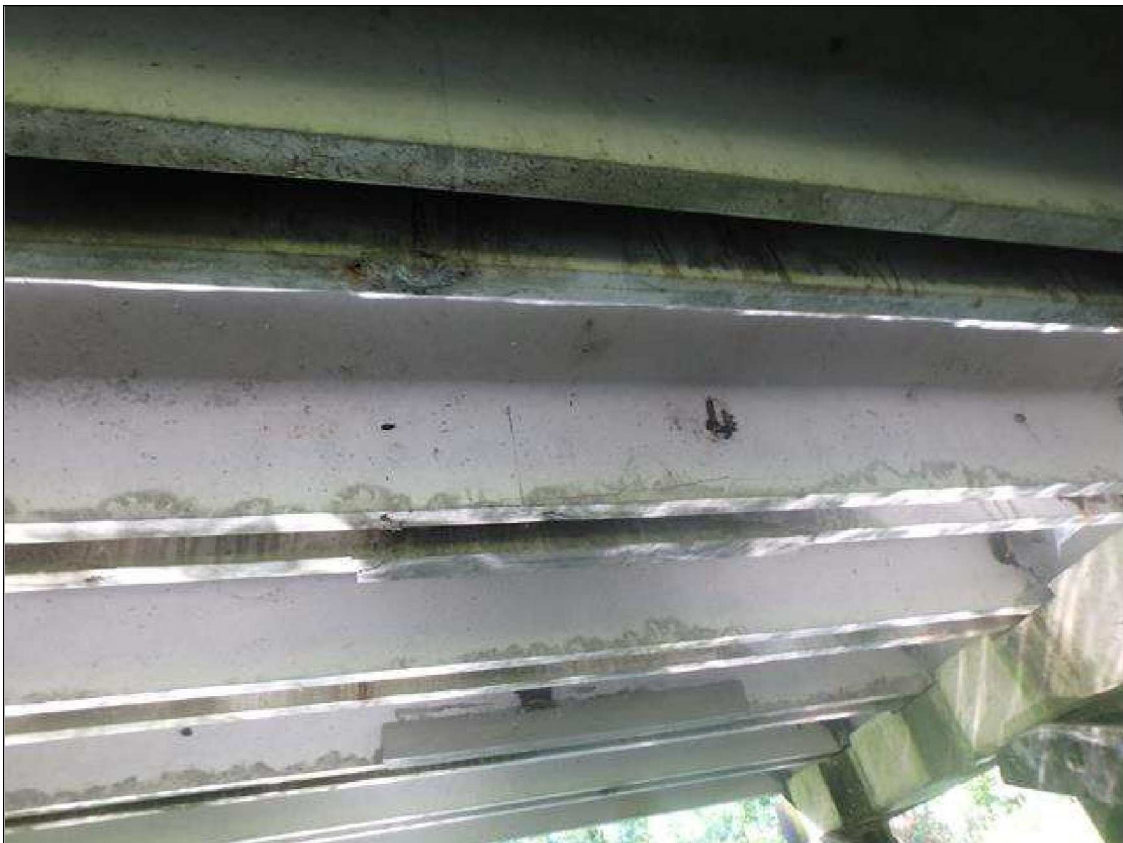
Span 2 Slab 6: 2' LONG X 2" HIGH X FULL WIDTH DELAMINATED AREA ALONG THE RIGHT LEG, 4'-8" FROM BENT 1
