NC DEPARTMENT OF TRANSPORTATION  
DIVISION OF HIGHWAYS  
STRUCTURE MANAGEMENT UNIT

## Structure Safety Report

### Routine Element Inspection - Contract

DIVISION: 6 COUNTY: BLADEN STRUCTURE NUMBER: 080197 FREQUENCY: 24 MONTHS

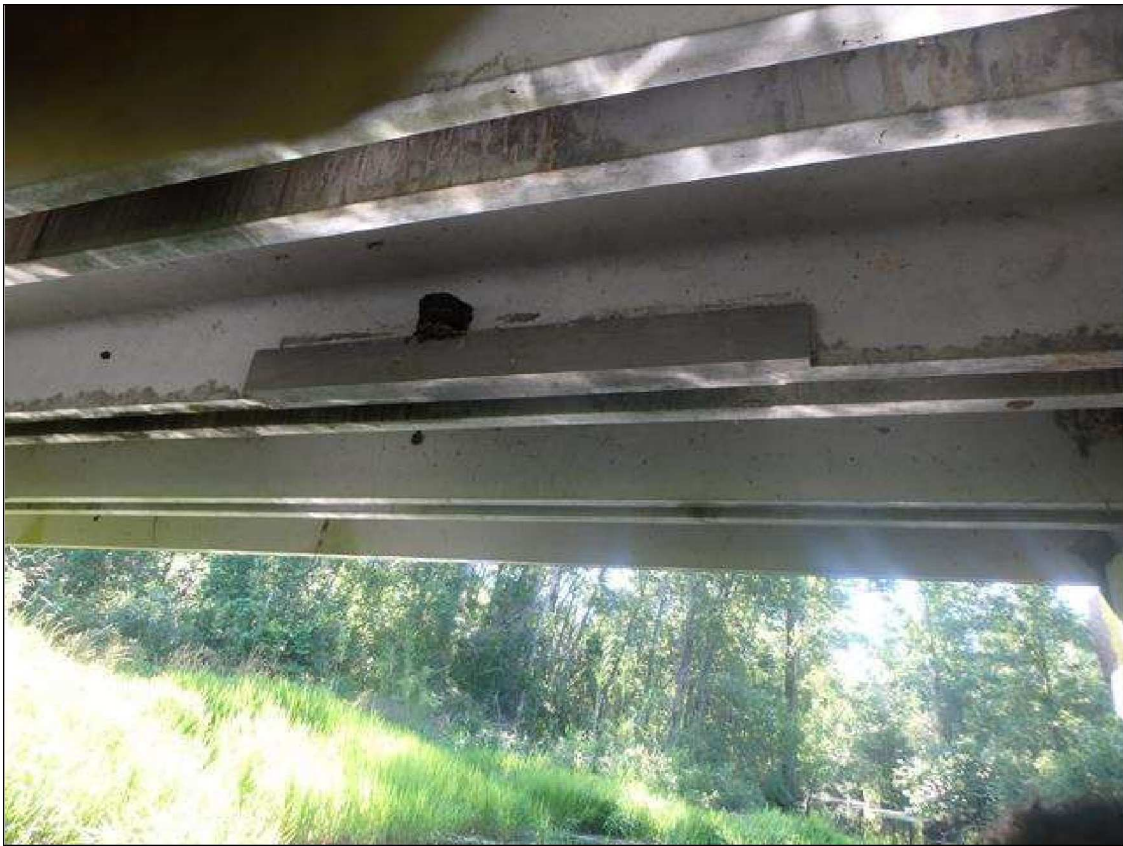
| Element Number | Defect Type | Defect Description | CS | CS Qty | Maint Qty |
|---|---|---|---|---|---|
| 109 | Patched Area | 3'-6" LONG X 4" HIGH X FULL WIDTH CONCRETE REPAIR ALONG THE RIGHT LEG, 2'-6" FROM BENT 1 | 2 | 4 | Feet |

Span 2 Slab 8: 3'-6" LONG X 4" HIGH X FULL WIDTH CONCRETE REPAIR ALONG THE RIGHT LEG, 2'-6" FROM BENT 1

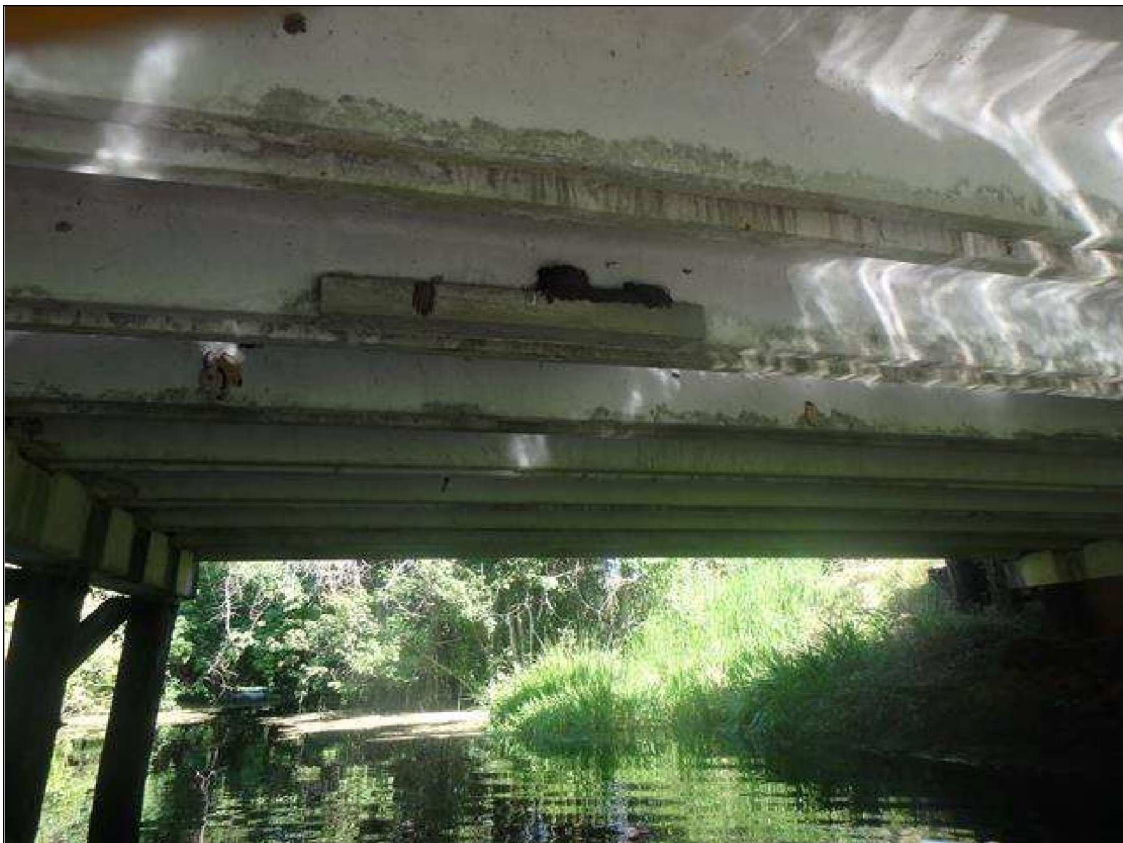
| Element Number | Defect Type | Defect Description | CS | CS Qty | Maint Qty |
|---|---|---|---|---|---|
| 109 | Patched Area | 3' LONG X 4" HIGH X FULL WIDTH CONCRETE REPAIR ALONG THE LEFT LEG, 4'-6" FROM BENT 1 | 2 | 3 | Feet |

Span 2 Slab 7: 3' LONG X 4" HIGH X FULL WIDTH CONCRETE REPAIR ALONG THE LEFT LEG, 4'-6" FROM BENT 1

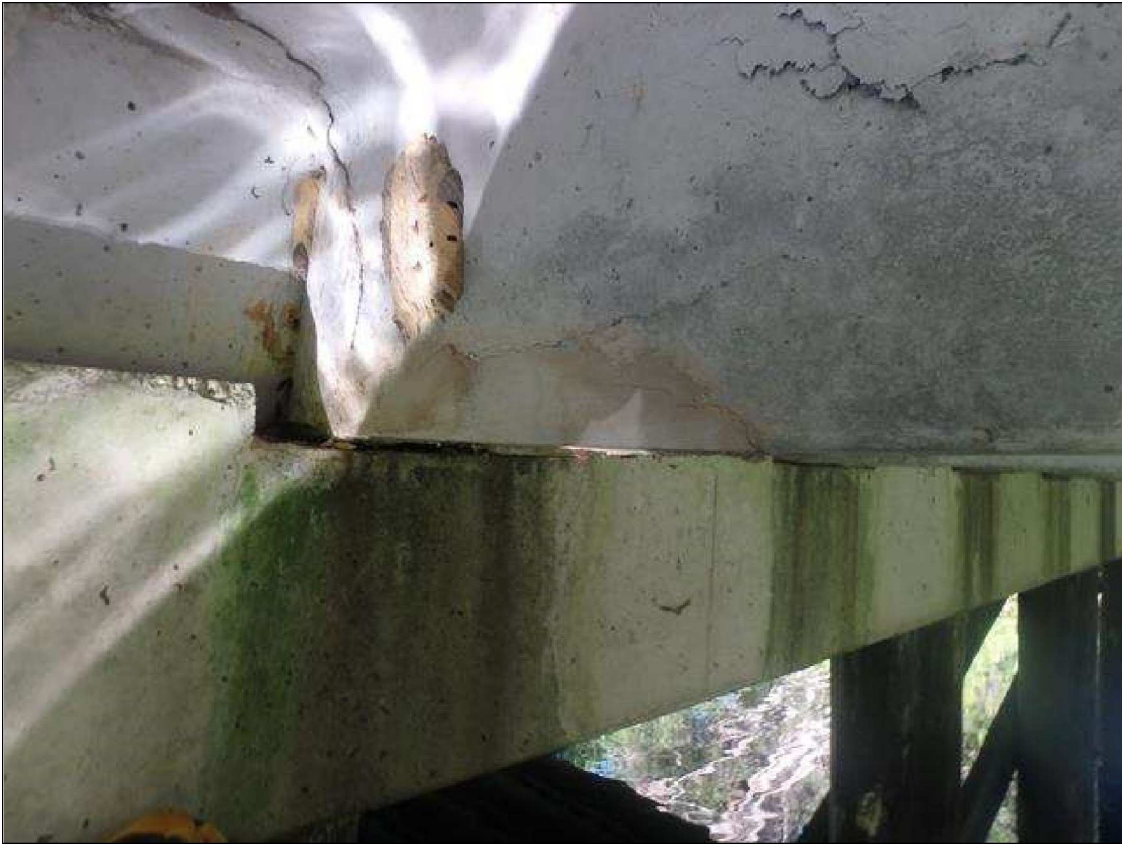
| Element Number | Defect Type | Defect Description | CS | CS Qty | Maint Qty |
|---|---|---|---|---|---|
| 109 | Patched Area | 1'-9" LONG X 2-1/2" HIGH X FULL WIDTH CONCRETE REPAIR ALONG THE RIGHT LEG AT BENT 1 | 2 | | Feet |

Span 2 Slab 8: 1'-9" LONG X 2-1/2" HIGH X FULL WIDTH CONCRETE REPAIR ALONG THE RIGHT LEG AT BENT 1

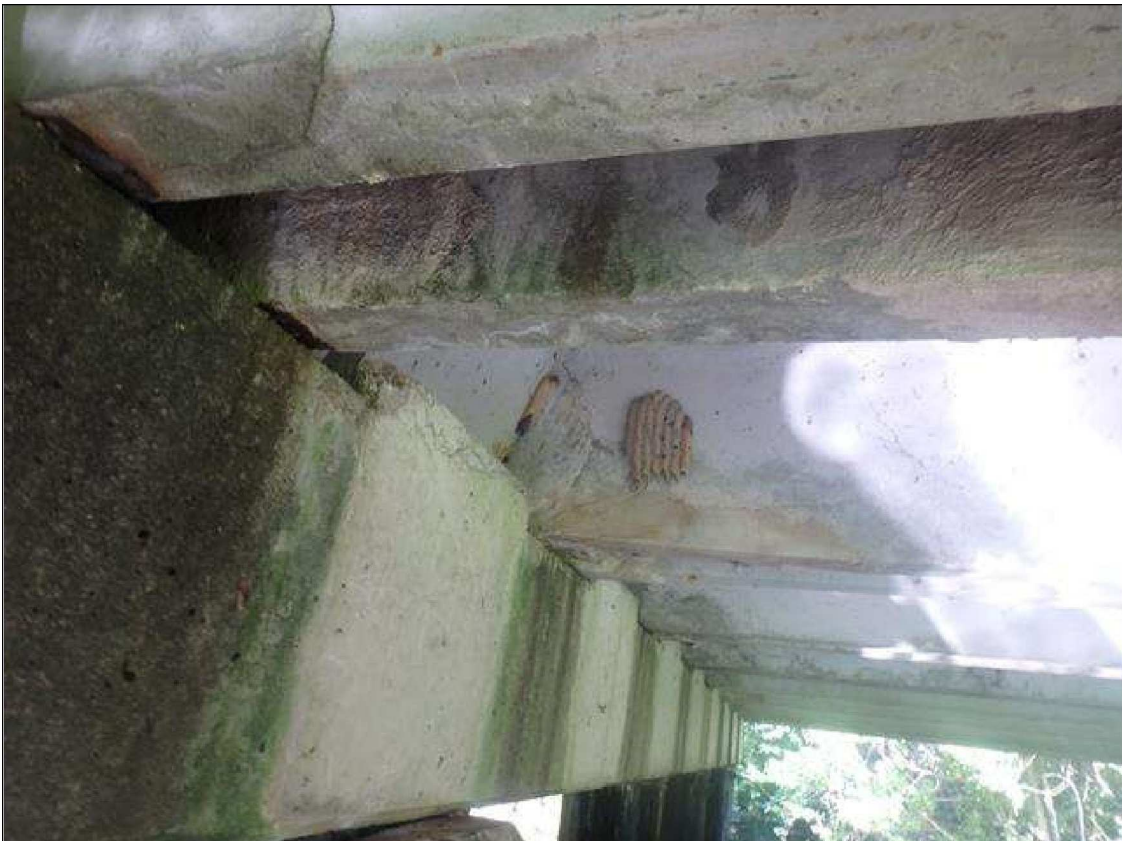
| Element Number | Defect Type | Defect Description | CS | CS Qty | Maint Qty |
|---|---|---|---|---|---|
| 109 | Patched Area | 1' LONG X 6" HIGH X FULL WIDTH CONCRETE REPAIR ALONG THE LEFT LEG AT BENT 1 | 2 | 1 | Feet |

Span 2 Slab 8: 1' LONG X 6" HIGH X FULL WIDTH CONCRETE REPAIR ALONG THE LEFT LEG AT BENT 1

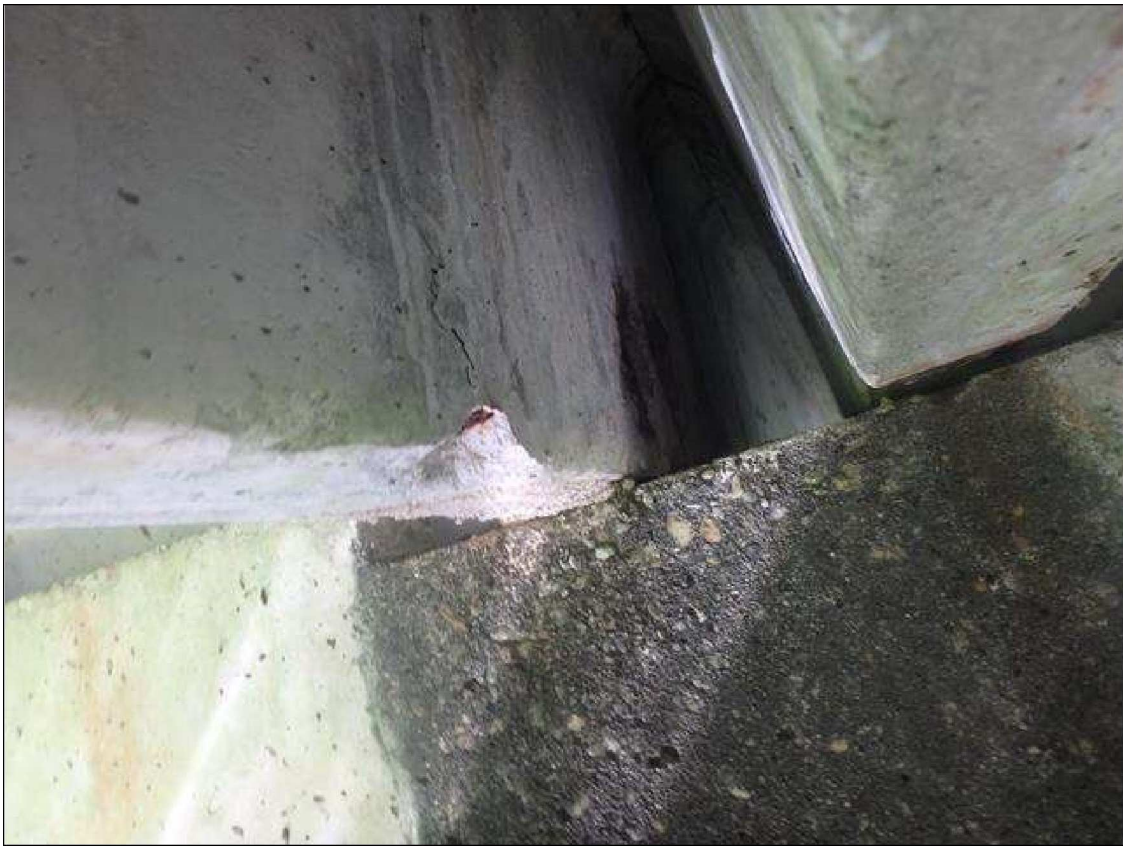
| Element Number | Defect Type | Defect Description | CS | CS Qty | Maint Qty | |
|---|---|---|---|---|---|---|
| 109 | Delamination/Spall | 11" LONG X 5" HIGH X 1/4" DEEP SPALLED AREA WITH EXPOSED REINFORCEMENT ALONG WEST FACE OF THE RIGHT LEG | 3 | 1 | 1 | Feet |

Span 2 Slab 10: 11" LONG X 5" HIGH X 1/4" DEEP SPALLED AREA WITH EXPOSED REINFORCEMENT ALONG WEST FACE OF THE RIGHT LEG

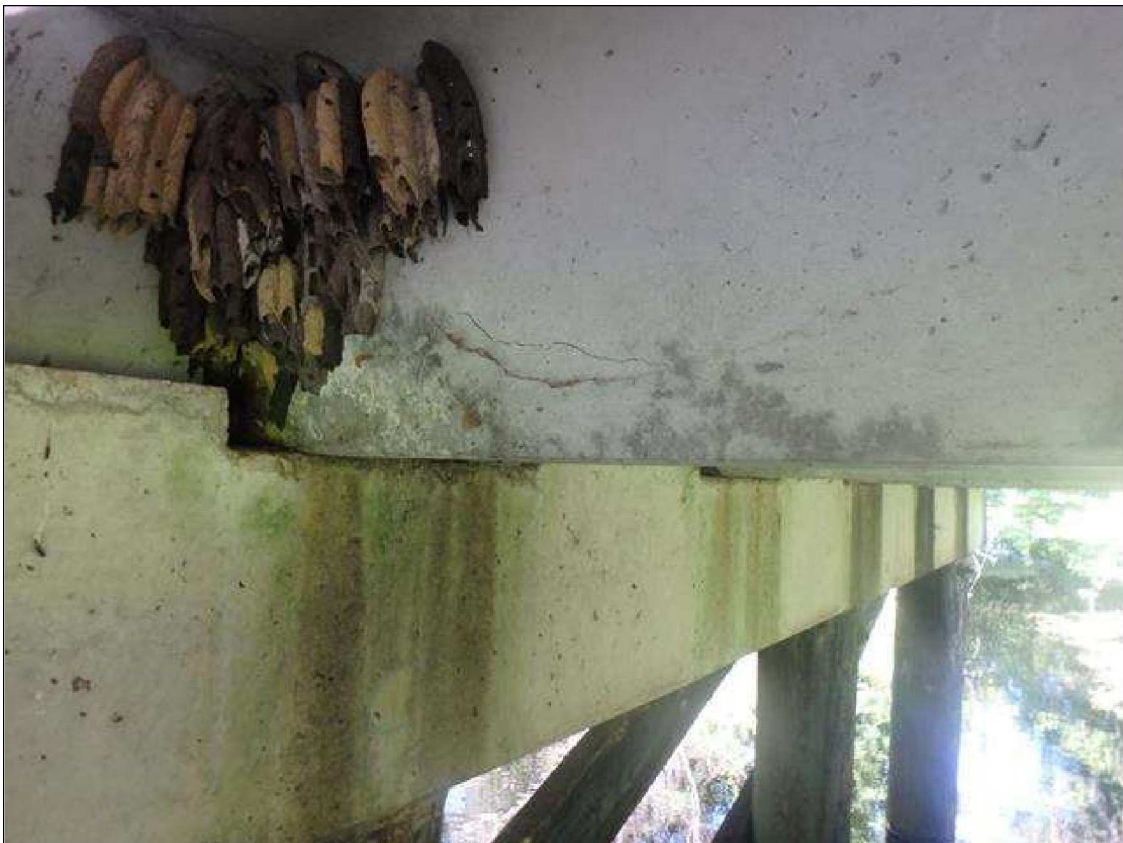
Span 2 Slab 6: 1'-4" LONG X 4" HIGH X FULL WIDTH DELAMINATED AREA ALONG THE LEFT LEG AT BENT 1

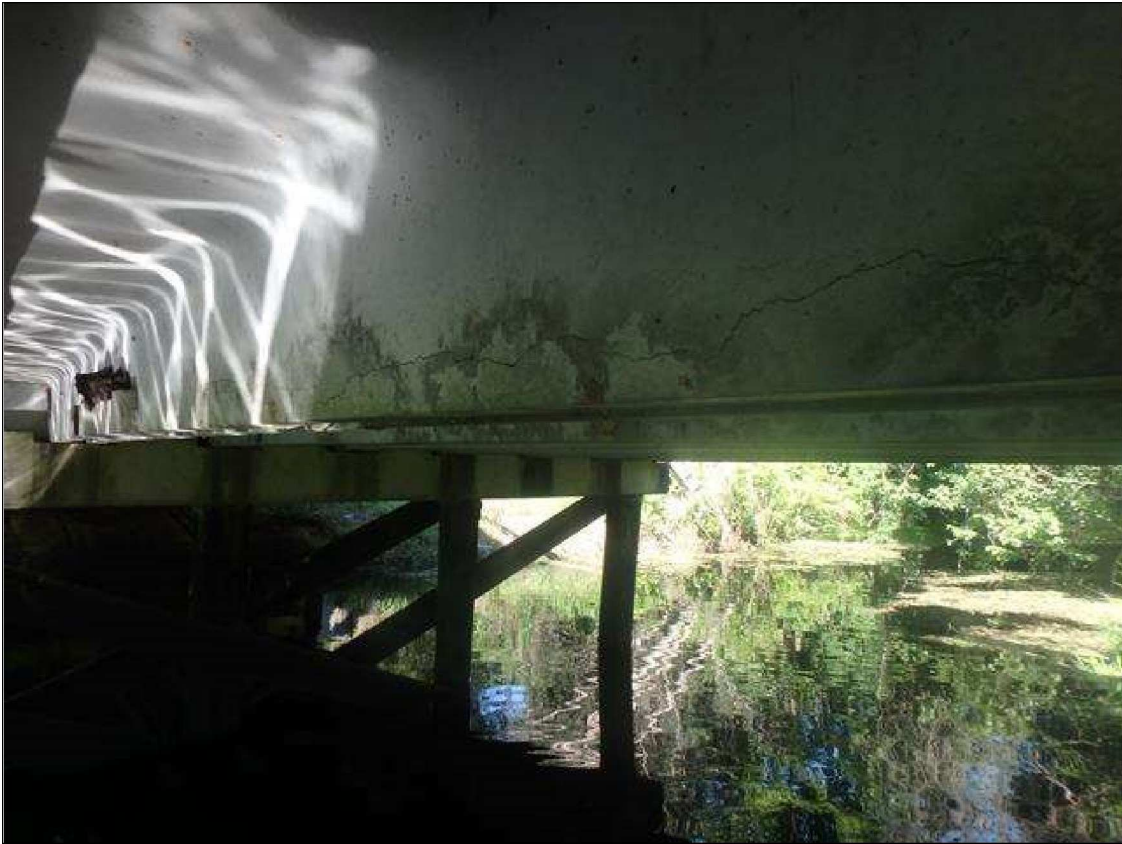
| Element Number | Defect Type | Defect Description | CS | CS Qty | Maint Qty |
|---|---|---|---|---|---|
| 109 | Delamination/Spall | 5'-3" LONG X 3" HIGH X FULL WIDTH DELAMINATED AREA ALONG THE EAST FACE OF THE RIGHT LEG AT MIDSPAN | 2 | 6 | Feet |

Span 2 Slab 7: 5'-3" LONG X 3" HIGH X FULL WIDTH DELAMINATED AREA ALONG THE EAST FACE OF THE RIGHT LEG AT MIDSPAN

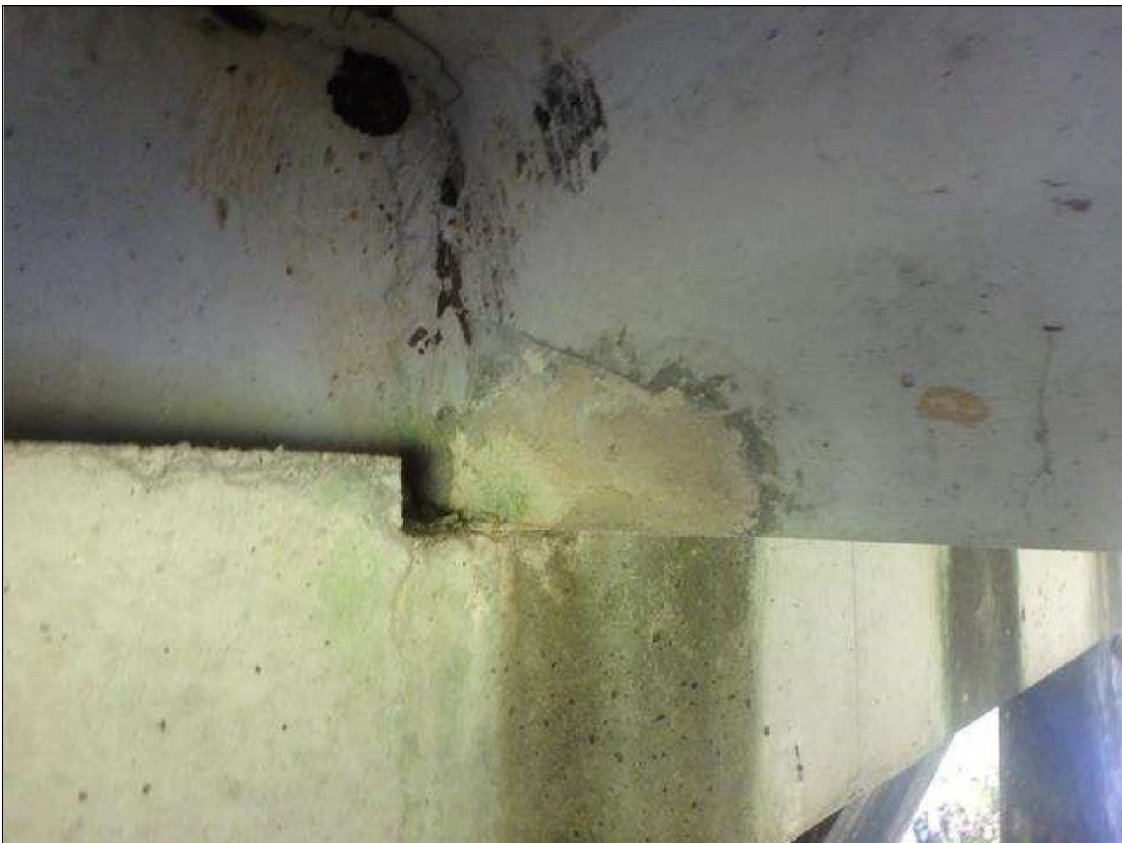
Span 2 Slab 4: 1' LONG X 5" HIGH X FULL WIDTH CONCRETE REPAIR ALONG THE EAST FACE OF THE RIGHT LEG AT BENT 1

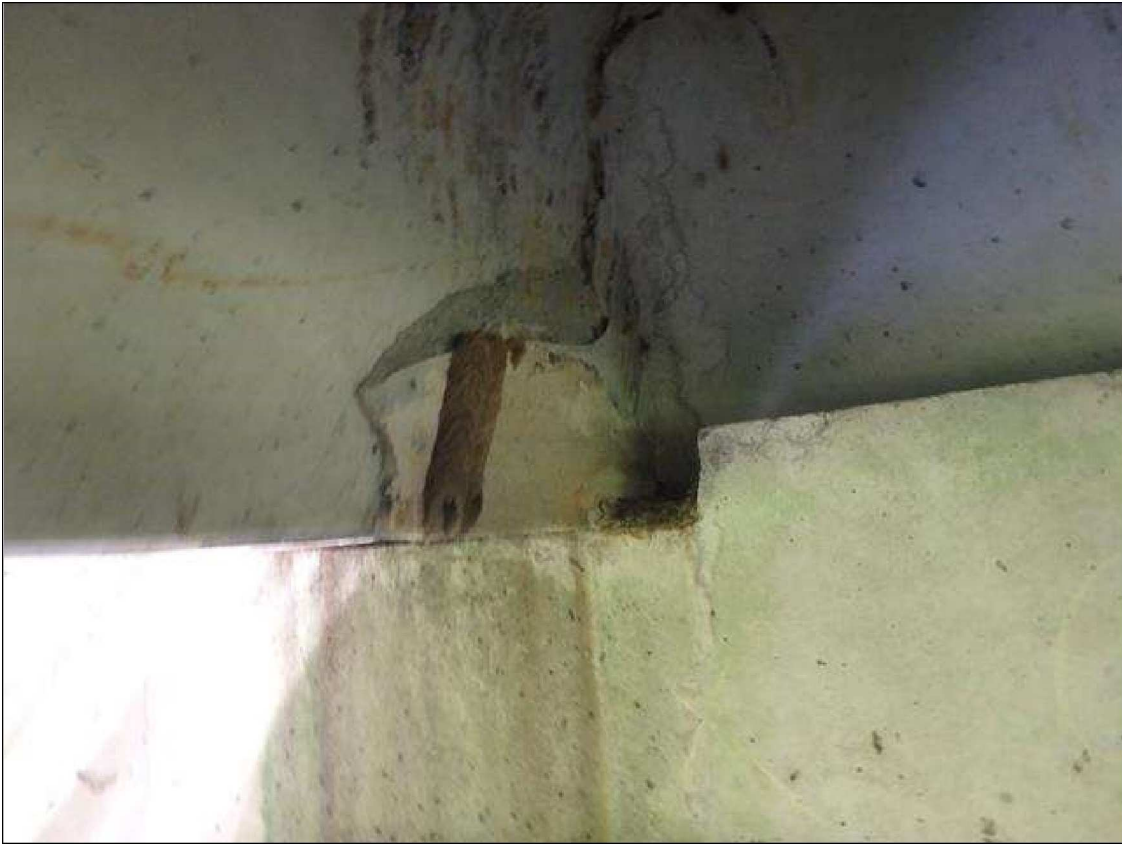
Span 2 Slab 6: 1' LONG X 4" HIGH X FULL WIDTH CONCRETE REPAIR ALONG THE WEST FACE OF THE RIGHT LEG AT BENT 1

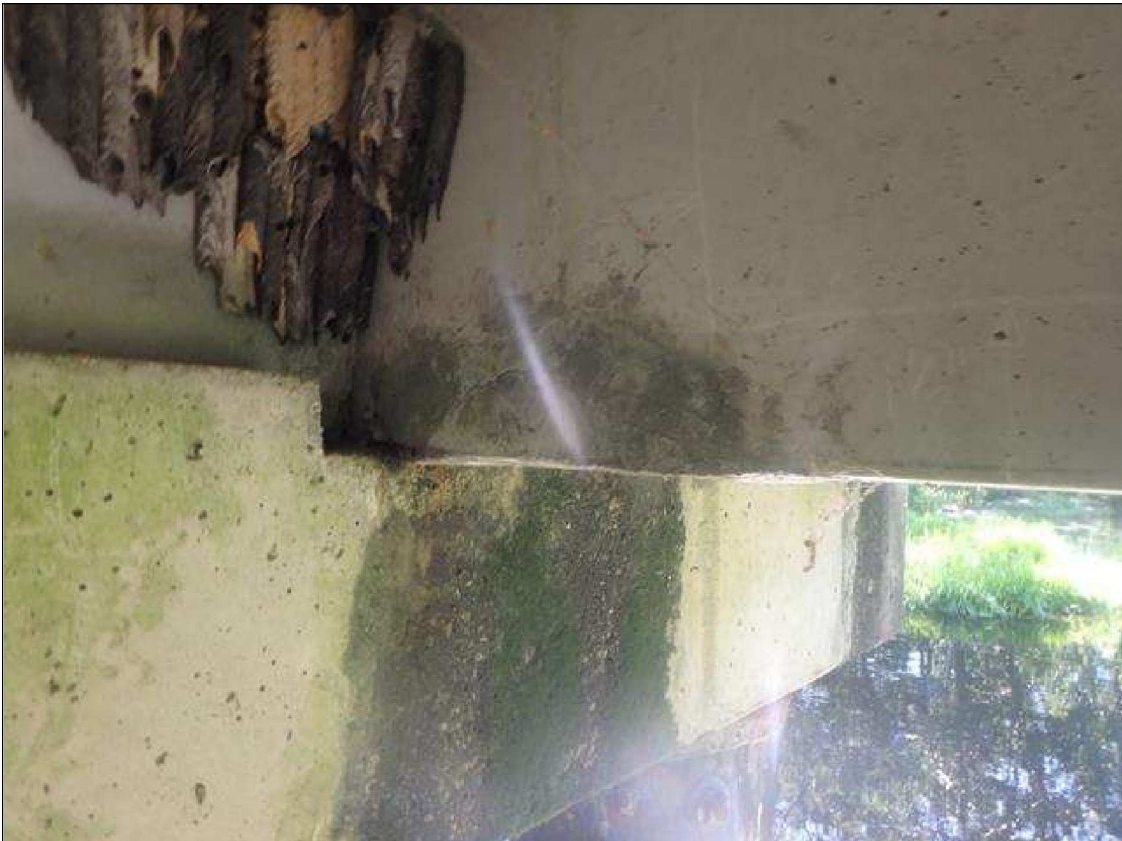
| Element Number | Defect Type | Defect Description | CS | CS Qty | Maint Qty |
|---|---|---|---|---|---|
| 109 | Patched Area | 1' LONG X FULL WIDTH FAILED PATCH AREA WITH A LONGITUDINAL CRACK 9" LONG X 1/32" WIDE ALONG THE WEST FACE OF THE RIGHT LEG AT BENT 1 | 3 | 1 | 1 Feet |

Span 1 Slab 9: 1' LONG X FULL WIDTH FAILED PATCH AREA WITH A LONGITUDINAL CRACK 9" LONG X 1/32" WIDE ALONG THE WEST FACE OF THE RIGHT LEG AT BENT 1

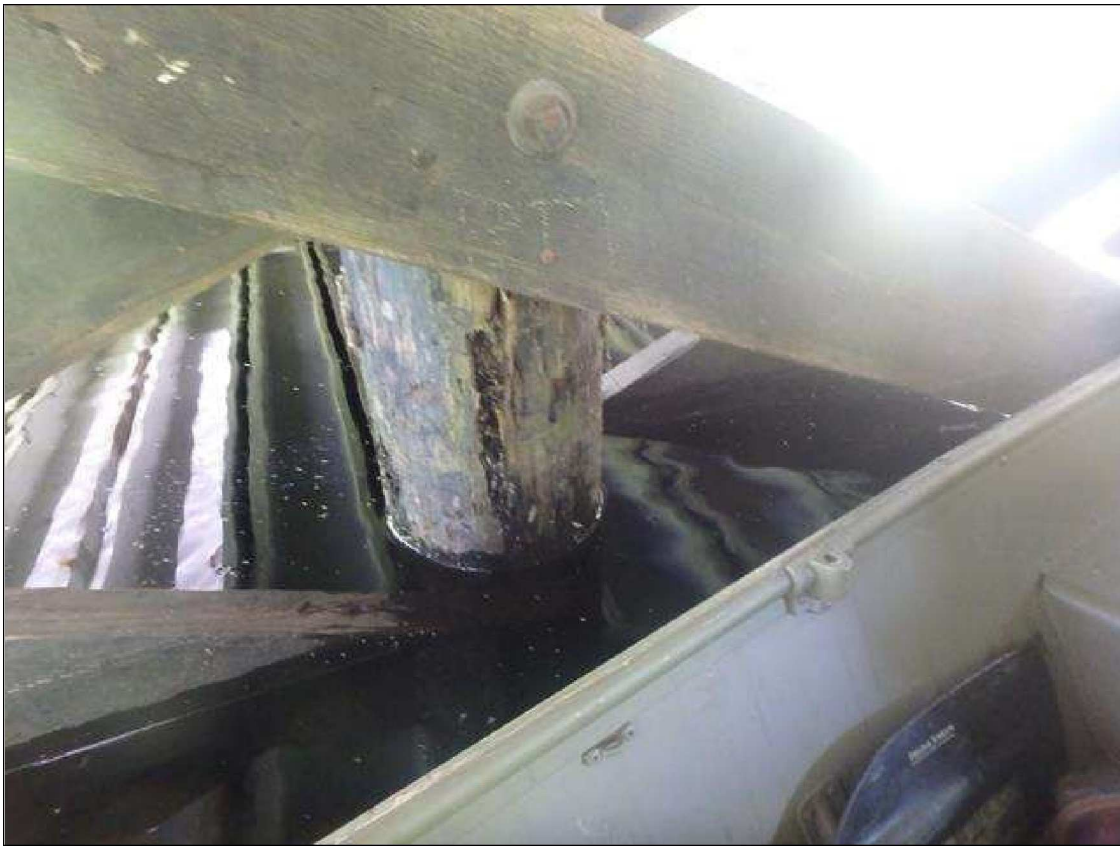
| Element Number | Defect Type | Defect Description | CS | CS Qty | Maint Qty | |
|---|---|---|---|---|---|---|
| 228 | Decay/Section Loss | 1'-4" HIGH X 4" WIDE X 1" DEEP DECAYED AREA ALONG THE NORTH FACE WITH 1" DEEP DECAYED AREA ALONG THE SOUTH FACE (PRIORITY MAINTENANCE) | 3 | 1 | 2 | Each |

Bent 1 Pile 3: 1'-4" HIGH X 4" WIDE X 1" DEEP DECAYED AREA ALONG THE NORTH FACE WITH 1" DEEP DECAYED AREA ALONG THE SOUTH FACE (PRIORITY MAINTENANCE)

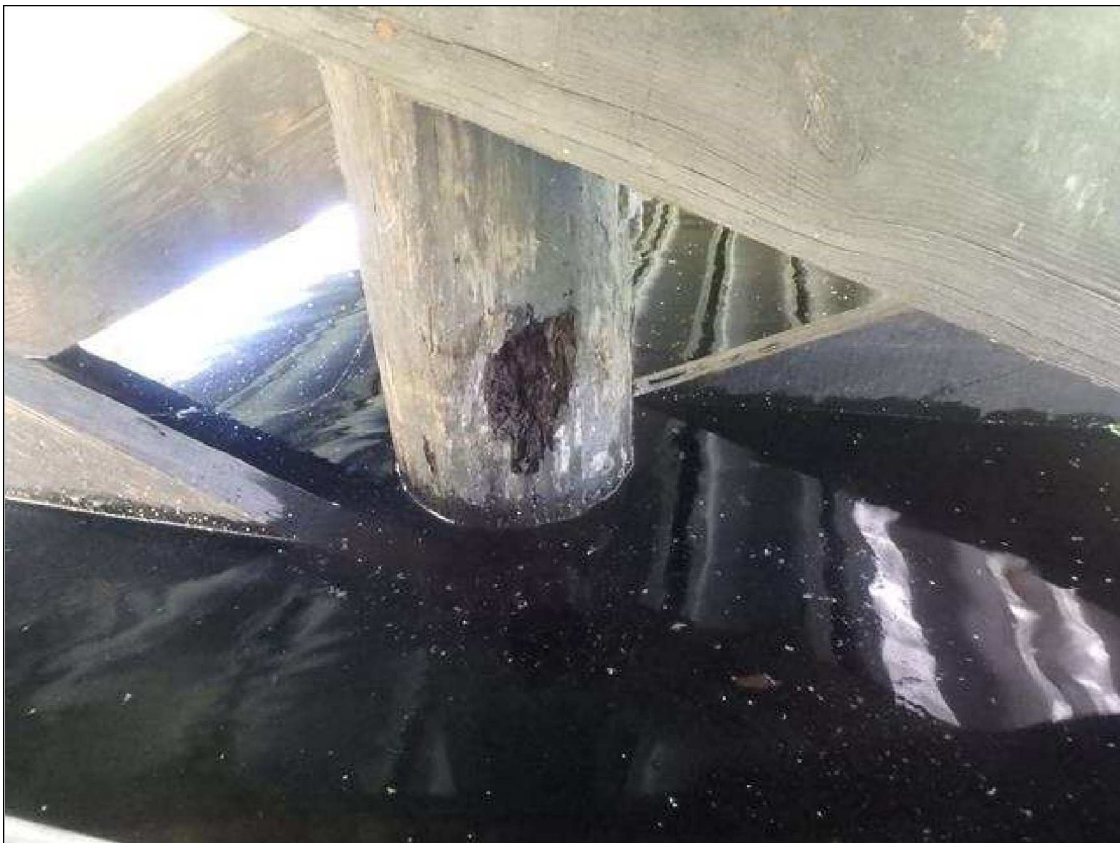
| Element Number | Defect Type | Defect Description | CS | CS Qty | Maint Qty | |
|---|---|---|---|---|---|---|
| 228 | Decay/Section Loss | 4" WIDE X 7" HIGH X 2" DEEP DECAYED AREA ALONG THE SOUTH FACE, 4" ABOVE THE WATER LINE (PRIORITY MAINTENANCE) | 3 | | 1 | Each |

Bent 1 Pile 3: 4" WIDE X 7" HIGH X 2" DEEP DECAYED AREA ALONG THE SOUTH FACE, 4" ABOVE THE WATER LINE (PRIORITY MAINTENANCE)

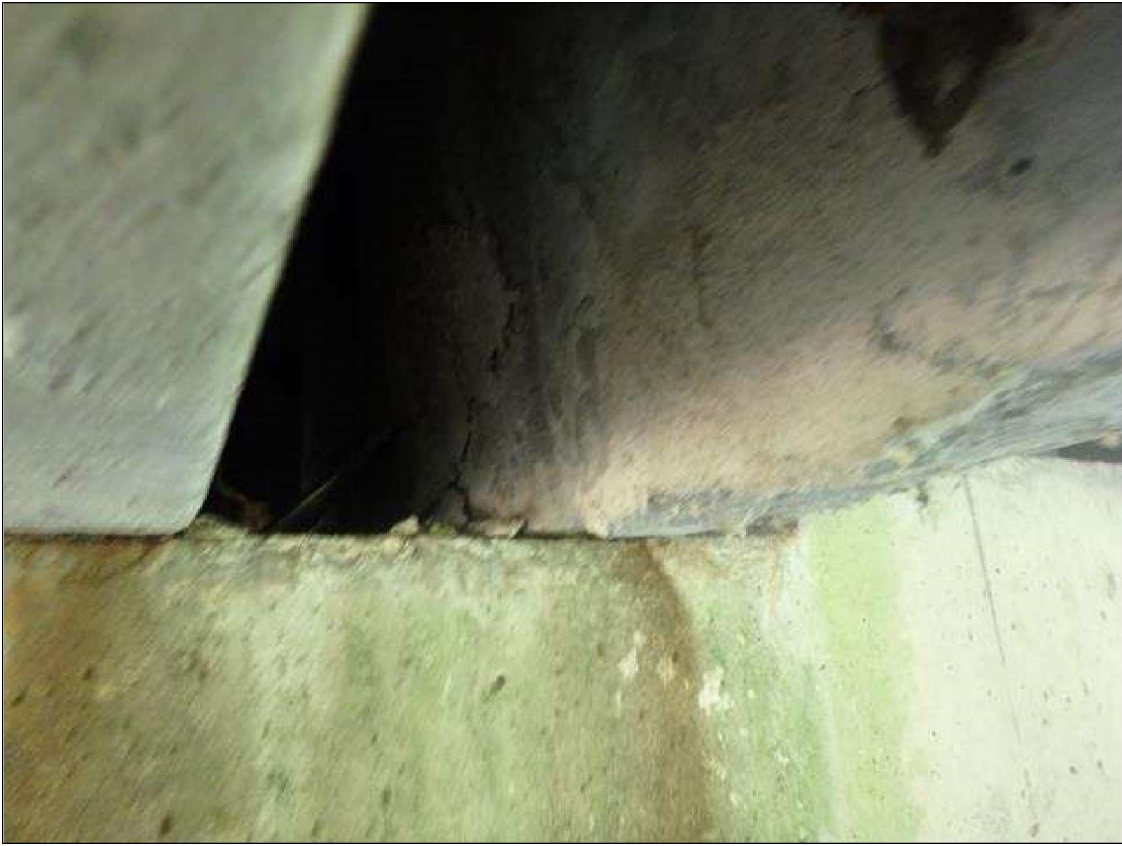
| Element Number | Defect Type | Defect Description | CS | CS Qty | Maint Qty | |
|---|---|---|---|---|---|---|
| 109 | Patched Area | 1' LONG X 6" HIGH CRACKED PATCH AREA ALONG THE WEST FACE OF THE RIGHT LEG AT BENT 1 | 3 | 1 | 1 | Feet |

Span 1 Slab 7: 1' LONG X 6" HIGH CRACKED PATCH AREA ALONG THE WEST FACE OF THE RIGHT LEG AT BENT 1

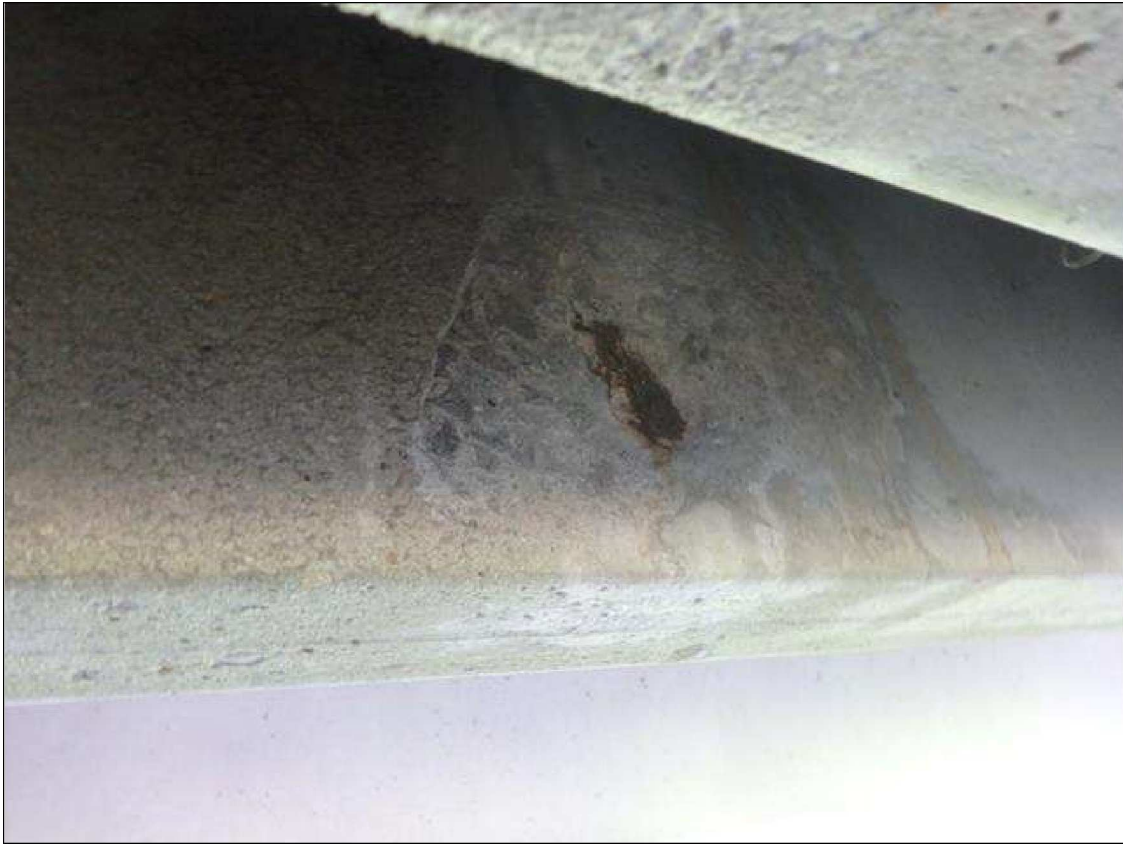
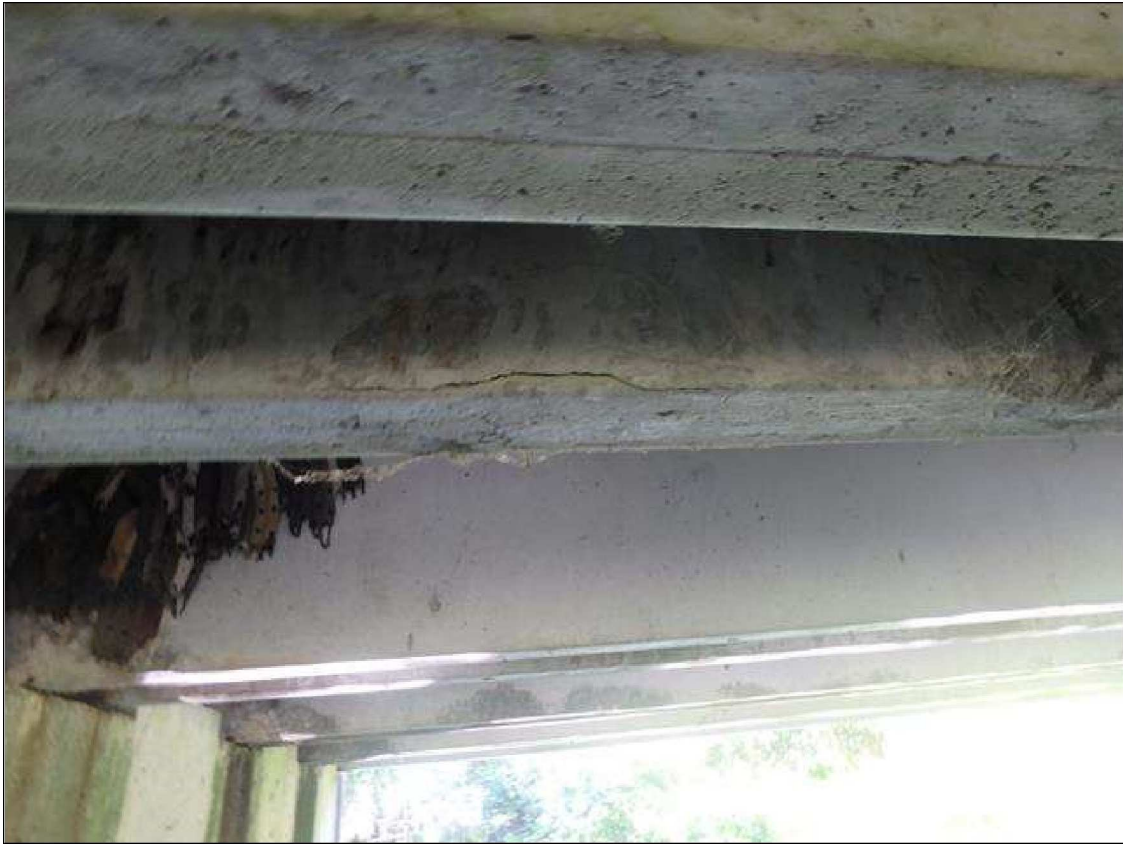
| Element Number | Defect Type | Defect Description | CS | CS Qty | Maint Qty | |
|---|---|---|---|---|---|---|
| 109 | Delamination/Spall | (2) - 6" DIAMETER SPALLED AREAS WITH A HAIRLINE HORIZONTAL CRACK UP TO 9" LONG AND EXPOSED REINFORCEMENT ALONG THE WEST FACE OF THE LEFT LEG, 1'-4" FROM BENT 1 (PRIORITY MAINTENANCE) | 2 | 2 | | Feet |

Span 1 Slab 7: (2) - 6" DIAMETER SPALLED AREAS WITH A HAIRLINE HORIZONTAL CRACK UP TO 9" LONG AND EXPOSED REINFORCEMENT ALONG THE WEST FACE OF THE LEFT LEG, 1'-4" FROM BENT 1 (PRIORITY MAINTENANCE)

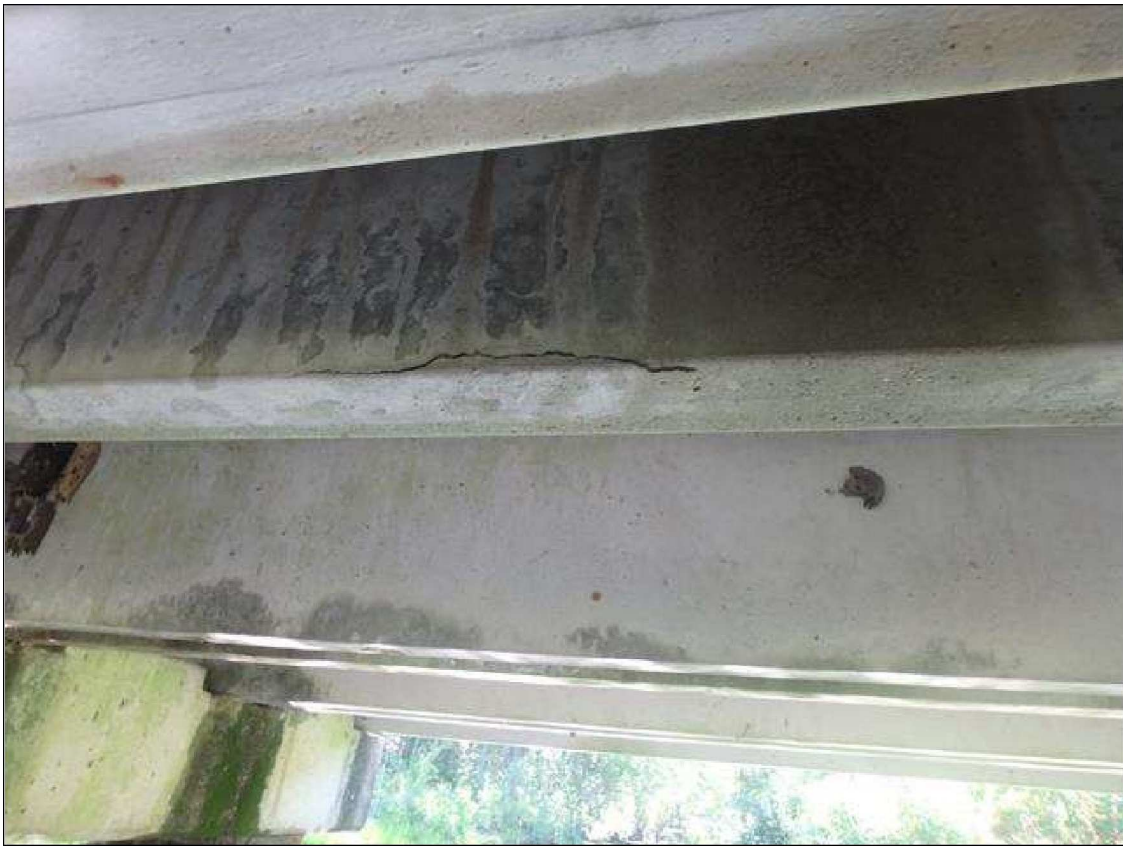
| Element Number | Defect Type | Defect Description | CS | CS Qty | Maint Qty |
|---|---|---|---|---|---|
| 109 | Delamination/Spall | (2) - 6" DIAMETER SPALLED AREAS WITH A HAIRLINE HORIZONTAL CRACK UP TO 9" LONG ALONG THE WEST FACE OF THE LEFT LEG, 4' FROM BENT 1 | 2 | 2 | Feet |

Span 1 Slab 8: (2) - 6" DIAMETER SPALLED AREAS WITH A HAIRLINE HORIZONTAL CRACK UP TO 9" LONG ALONG THE WEST FACE OF THE LEFT LEG, 4' FROM BENT 1

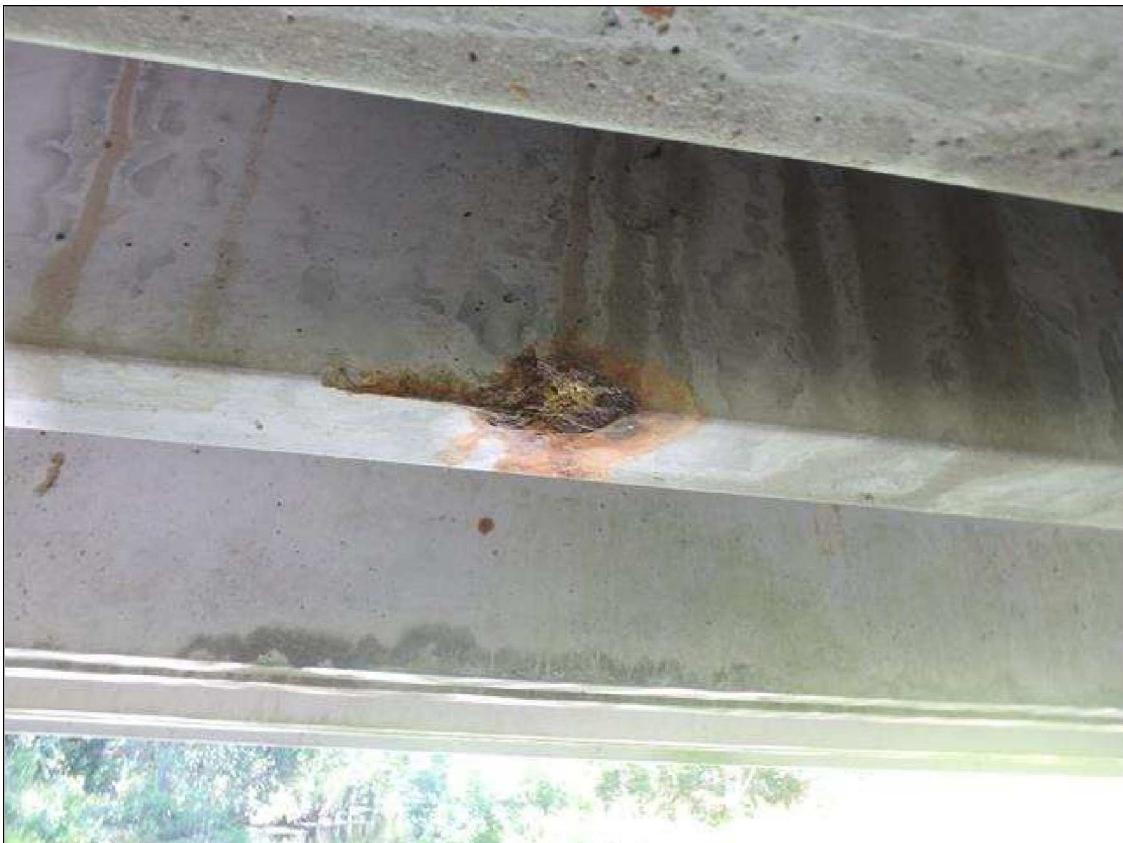
| Element Number | Defect Type | Defect Description | CS | CS Qty | Maint Qty |
|---|---|---|---|---|---|
| 109 | Delamination/Spall | 6" LONG X 1" HIGH X 2" WIDE SPALLED AREA ALONG THE WEST CORNER OF LEFT LEG, 6' FROM BENT 1 (PRIORITY MAINTENANCE) | 3 | 1 | 1 Feet |

Span 1 Slab 8: 6" LONG X 1" HIGH X 2" WIDE SPALLED AREA ALONG THE WEST CORNER OF LEFT LEG, 6' FROM BENT 1 (PRIORITY MAINTENANCE)

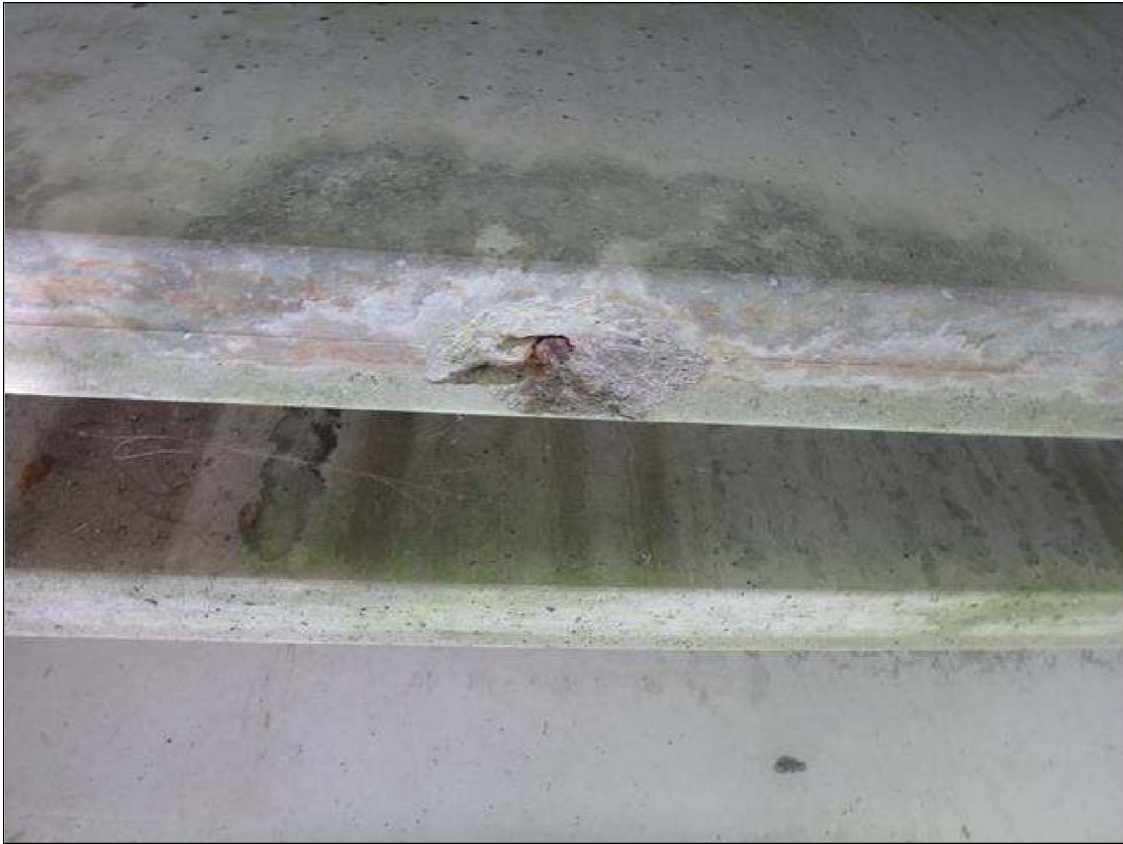
| Element Number | Defect Type | Defect Description | CS | CS Qty | Maint Qty |
|---|---|---|---|---|---|
| 109 | Delamination/Spall | 2" DIAMETER SPALLED AREA WITH EXPOSED REINFORCEMENT ALONG THE BOTTOM OF THE RIGHT LEG, 2'-6" FROM BENT 1 (PRIORITY MAINTENANCE) | 2 | 1 | 1 Feet |

Span 1 Slab 8: 2" DIAMETER SPALLED AREA WITH EXPOSED REINFORCEMENT ALONG THE BOTTOM OF THE RIGHT LEG, 2'-6" FROM BENT 1 (PRIORITY MAINTENANCE)

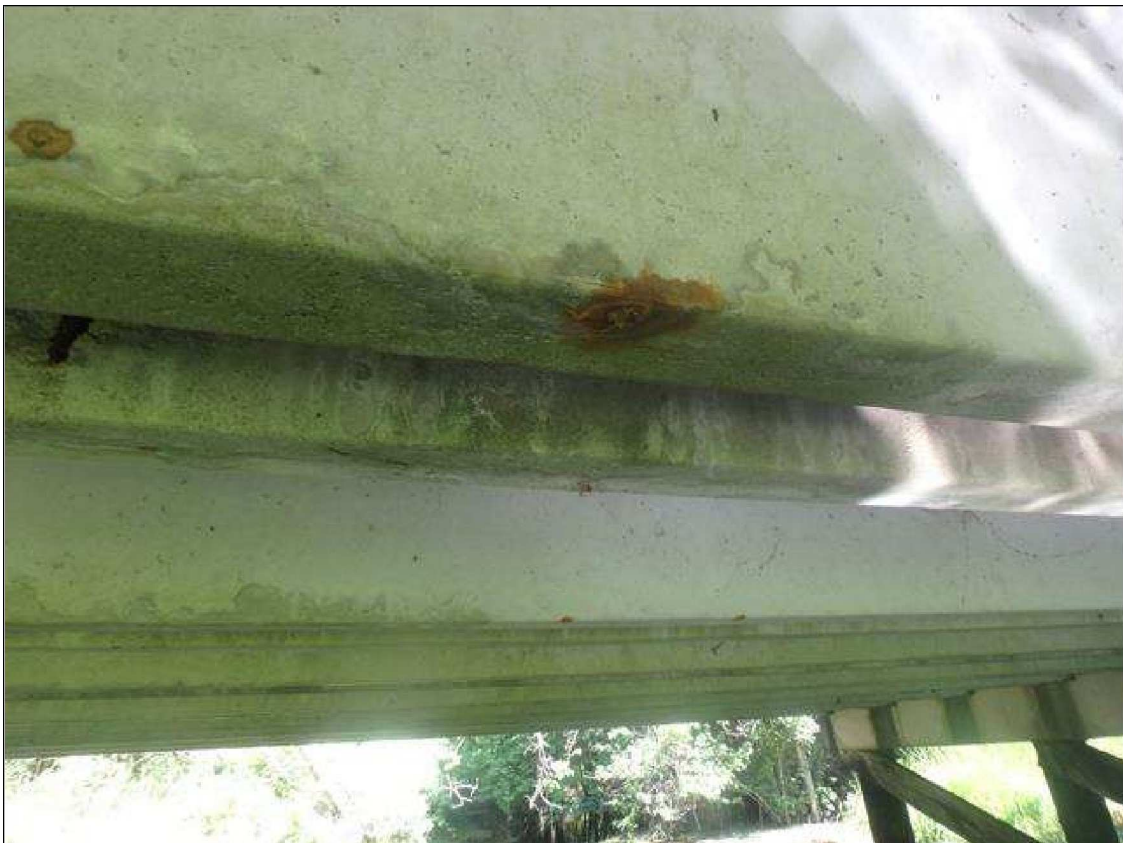
| Element Number | Defect Type | Defect Description | CS | CS Qty | Maint Qty |
|---|---|---|---|---|---|
| 109 | Delamination/Spall | 1" DIAMETER SPALLED AREA WITH EXPOSED REINFORCEMENT ALONG THE BOTTOM OF THE LEFT LEG AT MIDSPAN (PRIORITY MAINTENANCE) | 2 | 1 | 1 Feet |

Span 1 Slab 8: 1" DIAMETER SPALLED AREA WITH EXPOSED REINFORCEMENT ALONG THE BOTTOM OF THE LEFT LEG AT MIDSPAN (PRIORITY MAINTENANCE)

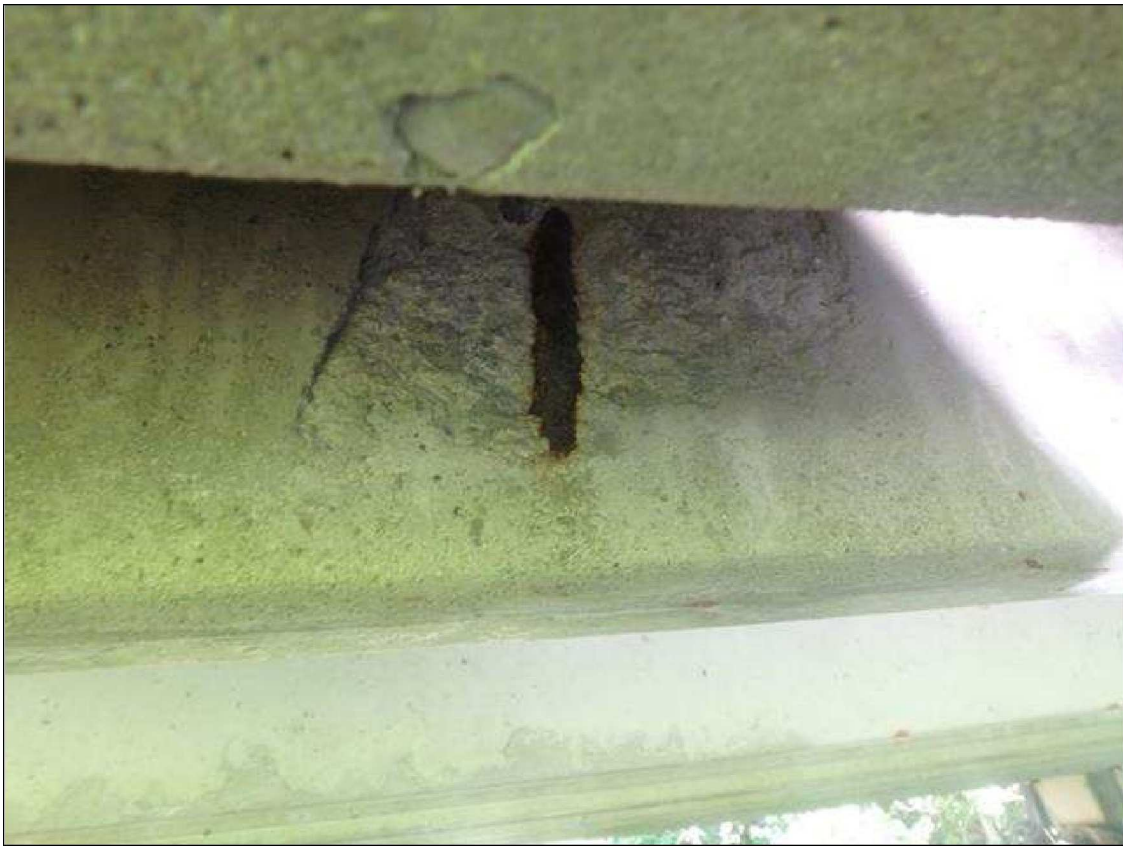
| Element Number | Defect Type | Defect Description | CS | CS Qty | Maint Qty | |
|---|---|---|---|---|---|---|
| 109 | Delamination/Spall | 6" LONG X 4" HIGH X 1/4" DEEP SPALLED AREA WITH EXPOSED REINFORCEMENT ALONG THE EAST FACE OF THE RIGHT LEG AT MIDSPAN (PRIORITY MAINTENANCE) | 2 | 1 | 1 | Feet |

Span 1 Slab 7: 6" LONG X 4" HIGH X 1/4" DEEP SPALLED AREA WITH EXPOSED REINFORCEMENT ALONG THE EAST FACE OF THE RIGHT LEG AT MIDSPAN (PRIORITY MAINTENANCE)

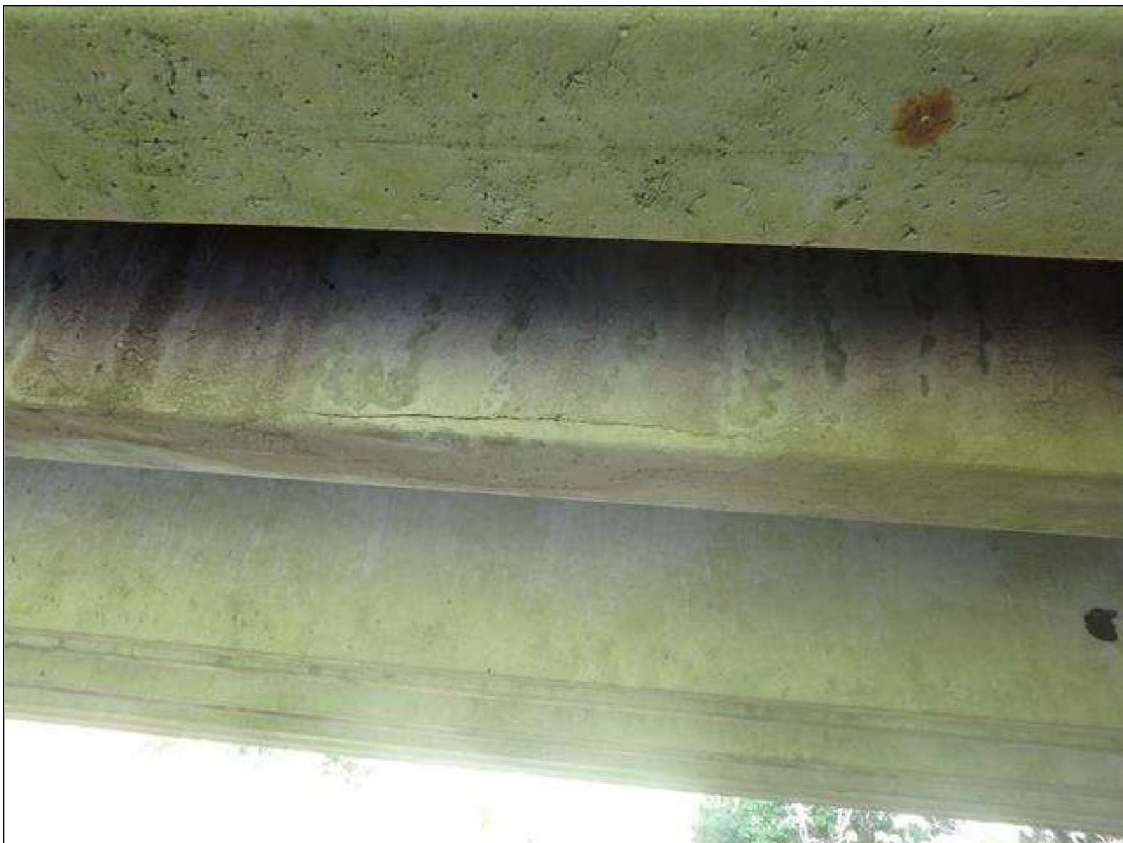
| Element Number | Defect Type | Defect Description | CS | CS Qty | Maint Qty | |
|---|---|---|---|---|---|---|
| 109 | Cracking (PSC) | 8" LONG X 1/32" WIDE HORIZONTAL CRACK ALONG THE EAST FACE OF THE RIGHT LEG AT MIDSPAN | 3 | 1 | | Feet |

Span 1 Slab 5: 8" LONG X 1/32" WIDE HORIZONTAL CRACK ALONG THE EAST FACE OF THE RIGHT LEG AT MIDSPAN

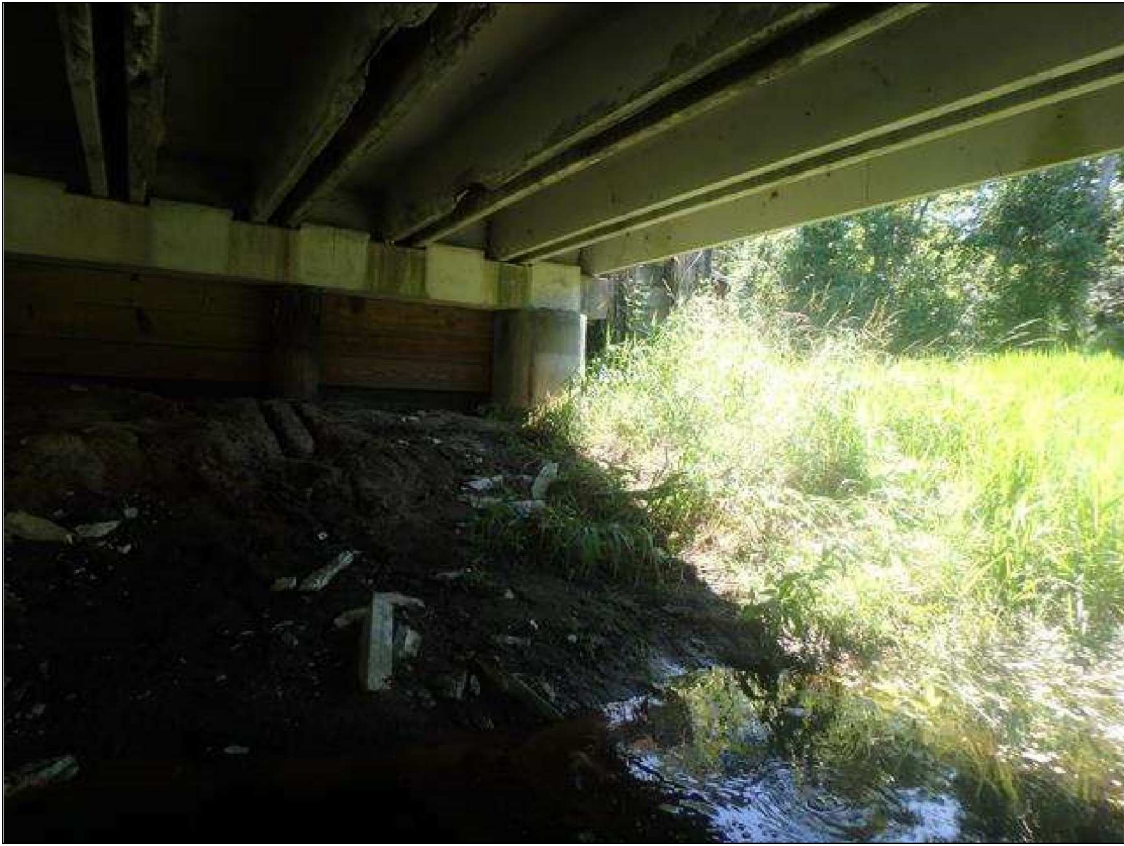
CONCRETE COLLAR REPAIR FOR PILE 5 AT END BENT 2
