NC DEPARTMENT OF TRANSPORTATION  
DIVISION OF HIGHWAYS  
STRUCTURE MANAGEMENT UNIT

## Structure Safety Report

### Routine Element Inspection - Contract

COUNTY: BLADEN STRUCTURE NUMBER: 080198 FREQUENCY: 24 MONTHS  
FACILITY CARRIED: SR1536 MILE POST: \_\_\_\_\_  
LOCATION: 1.0 MI N. OF JCT NC53  
FEATURE INTERSECTED: KELLY CREEK  
LATITUDE: 34° 29' 8.76" LONGITUDE: 78° 19' 16.61"  
SUPERSTRUCTURE: TIMBER FLOOR ON TIMBER JOISTS  
SUBSTRUCTURE: EBTS&IBTS:TIMBER CAP/TIMBER PILES @ VAR.CTS.  
SPANS: 1@17'8,1@17'1;1@16'8  
☐ FRACTURE CRITICAL ☒ TEMPORARY SHORING ☐ SCOUR CRITICAL ☐ SCOUR PLAN OF ACTION  
PRESENT CONDITION: Fair INSPECTION DATE: 06/16/2016  
POSTED SV: 15 POSTED TTST: 22  
OTHER SIGNS PRESENT: 4 DELINEATORS

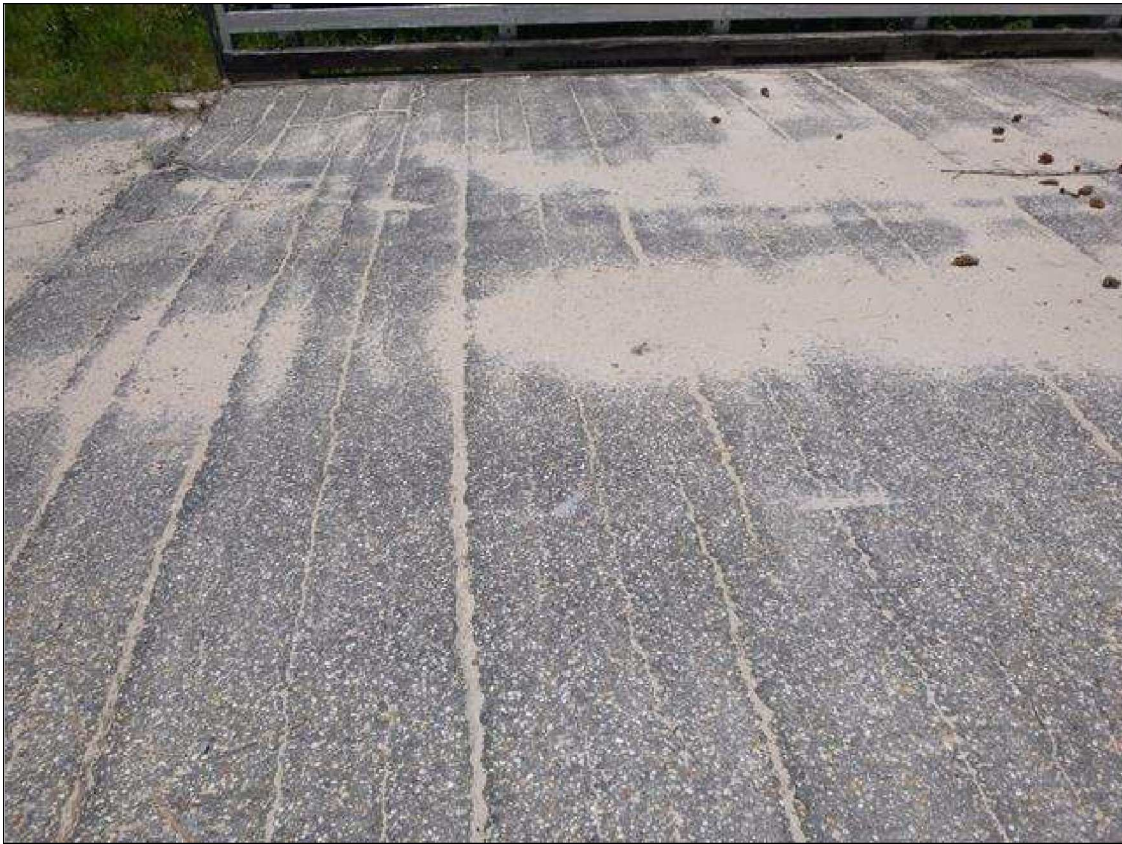
| Element Number | Element Name | Total Qty | CS1 Qty | CS2 Qty | CS3 Qty | CS4 Qty | |
|---|---|---|---|---|---|---|---|
| 510 | Crack (Wearing Surface) | TRANSVERSE CRACKS UP TO 1" OPEN ALONG FLOOR BOARDS JOINTS, 8" TO 16" APART. | 3 | 350 | 350 | | Square Feet |

Span 1 Wearing Surface: TRANSVERSE CRACKS UP TO 1" OPEN ALONG FLOOR BOARDS JOINTS, 8" TO 16" APART.

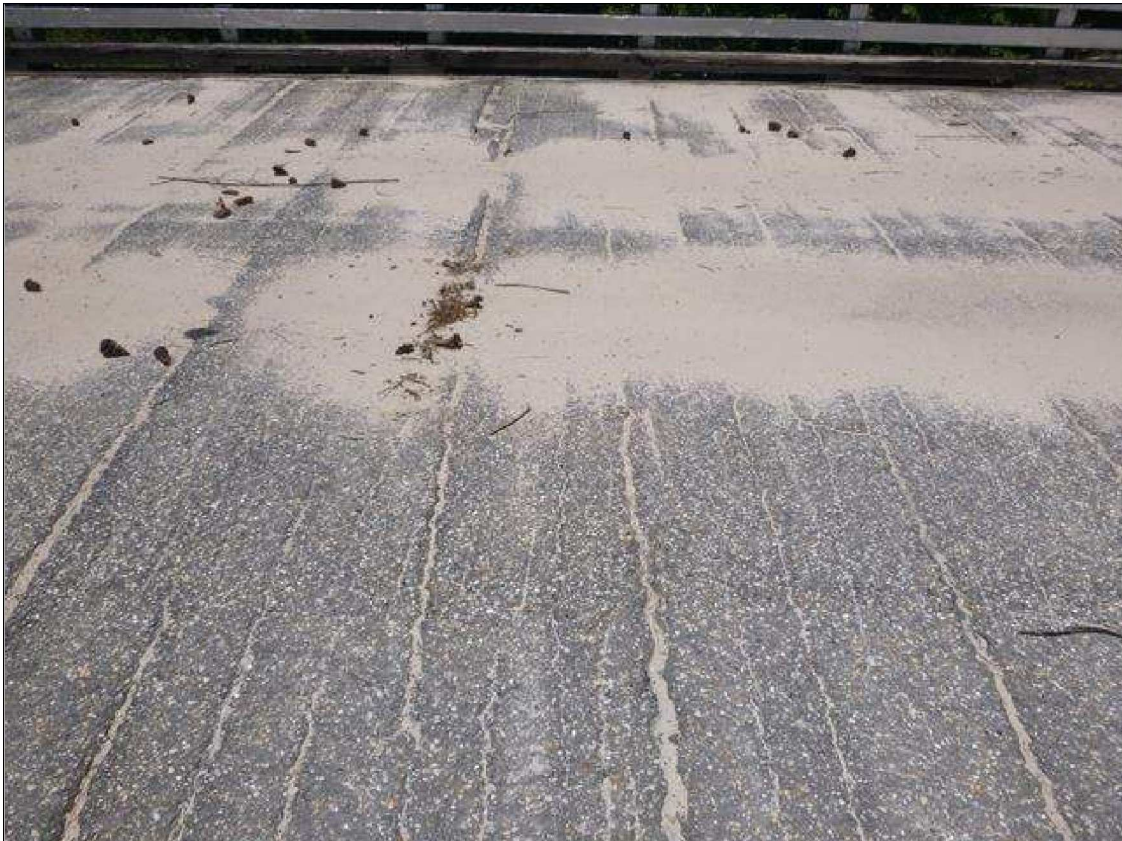
| Element Number | Defect Type | Defect Description | CS | CS Qty | Maint Qty | |
|---|---|---|---|---|---|---|
| 510 | Crack (Wearing Surface) | TRANSVERSE CRACKS UP TO 1" OPEN, 8" TO 16" APART ALONG FLOOR BOARD JOINTS. | 3 | 350 | 350 | Square Feet |

Span 2 Wearing Surface: TRANSVERSE CRACKS UP TO 1" OPEN, 8" TO 16" APART ALONG FLOOR BOARD JOINTS.

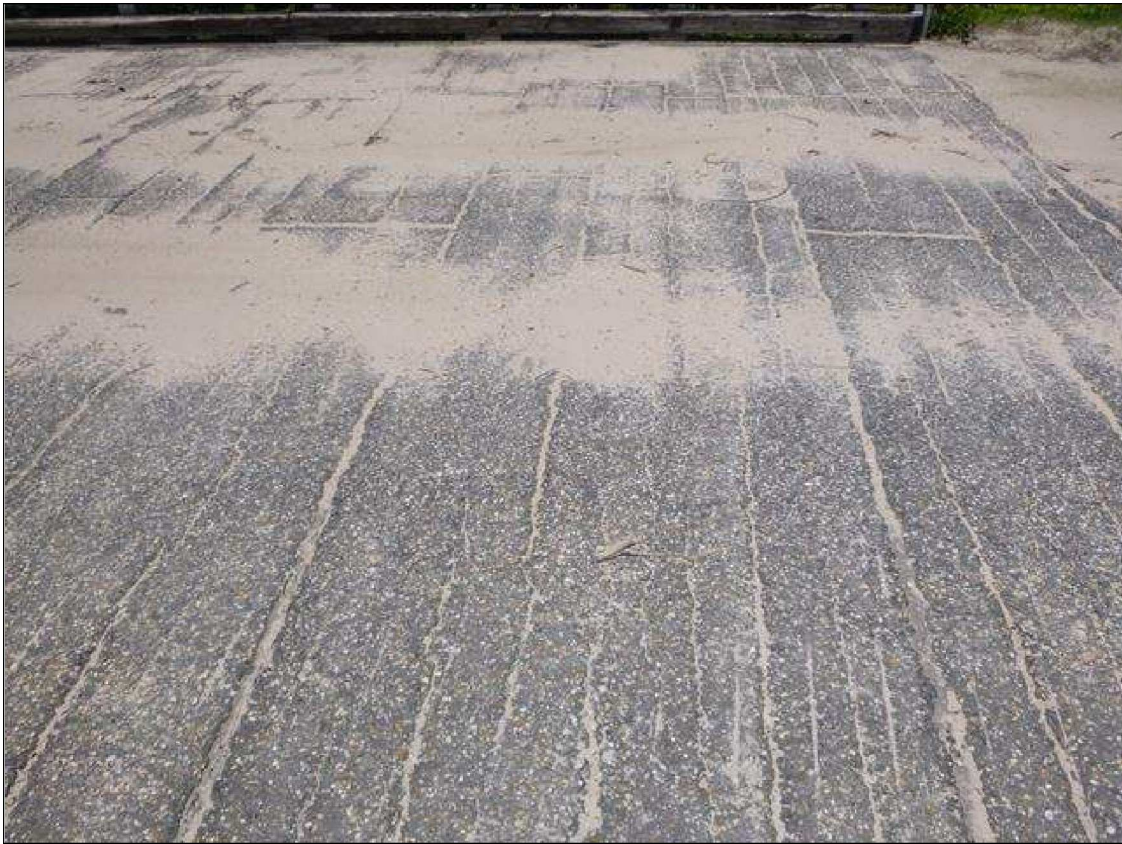
| 510 | Crack (Wearing Surface) | TRANSVERSE CRACKS UP TO 1" OPEN, 8" TO 16" APART ALONG FLOOR BOARD JOINTS. | 3 | 350 | 350 | Square Feet |

Span 3 Wearing Surface: TRANSVERSE CRACKS UP TO 1" OPEN, 8" TO 16" APART ALONG FLOOR BOARD JOINTS.

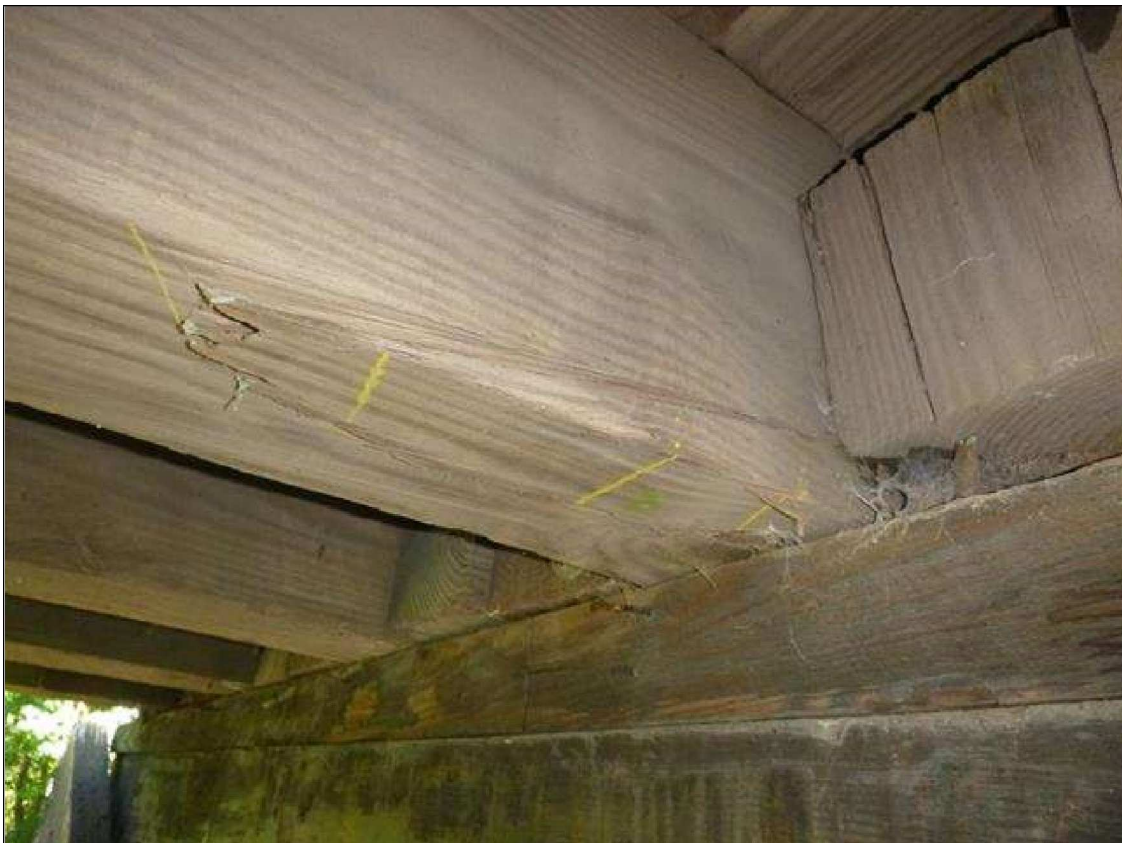
Span 2 Beam 4: SPLINTER 3" X 12" X 1-3/8" DEEP IN SEAT AREA AT BENT 2 END.

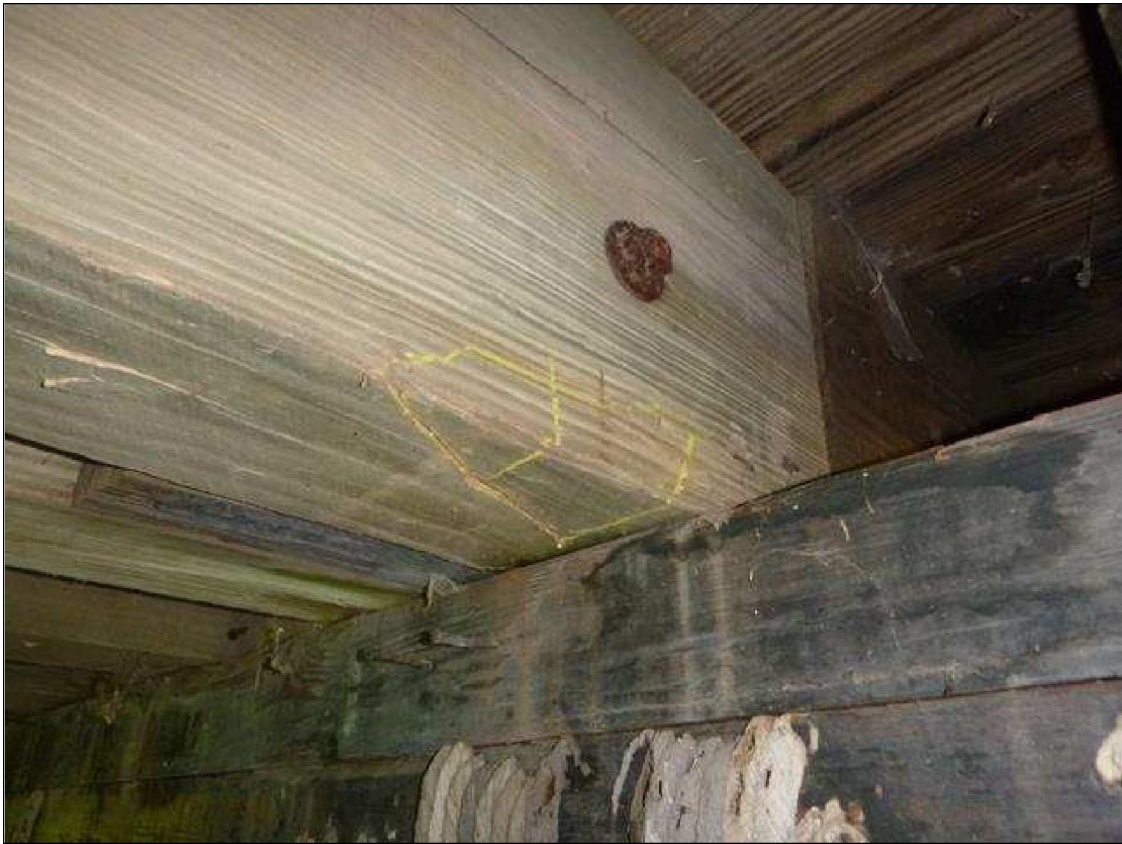
Span 2 Beam 13: SPLINTER SECTION 3" X 9" X 1-1/4" DEEP IN SEAT AREA AT BENT 2 END.

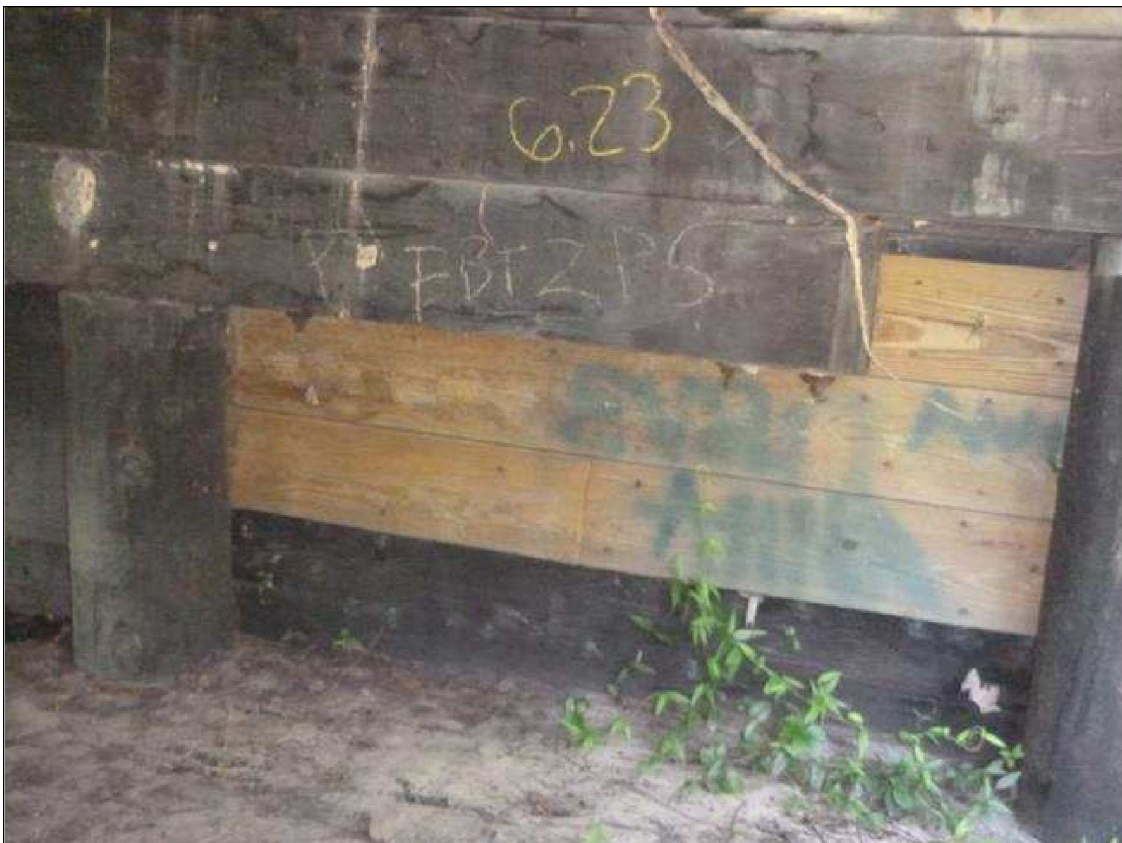
| Element Number | Defect Type | Defect Description | CS | CS Qty | Maint Qty |
|---|---|---|---|---|---|
| 216 | Decay/Section Loss | TEMPORARY PATCHWORK BETWEEN PILES 4 AND 5. | 2 | 6 | 6 Feet |

End Bent 2 Abutment/Backwall : TEMPORARY PATCHWORK BETWEEN PILES 4 AND 5.
