# Structure Safety Report

## 2 Year Complete Topside and Underwater Element Inspection

COUNTY: COLUMBUS STRUCTURE NUMBER: 230313 FREQUENCY: 24 MONTHSFACILITY CARRIED: SR1159 MILE POST: LOCATION: 1.1 MI.N. OF JCT.SR1158FEATURE INTERSECTED: BOGGY BRANCHLATITUDE: 34° 11' 18.99" LONGITUDE: 78° 41' 56.08"SUPERSTRUCTURE: REINF.CONC.FLOOR ON I-BEAMSSUBSTRUCTURE: E.BTS&INT.BTS:RC CAPS/TIMBER PILES@VAR.CTS.SPANS: 1@18.25'; 2@18.33'; 1@18.42'☐ FRACTURE CRITICAL ☐ TEMPORARY SHORING ☐ SCOUR CRITICAL ☐ SCOUR PLAN OF ACTIONPRESENT CONDITION: Fair INSPECTION DATE: 01/10/2017POSTED SV: Not Posted POSTED TTST: Not PostedOTHER SIGNS PRESENT: 4 DELINEATORS

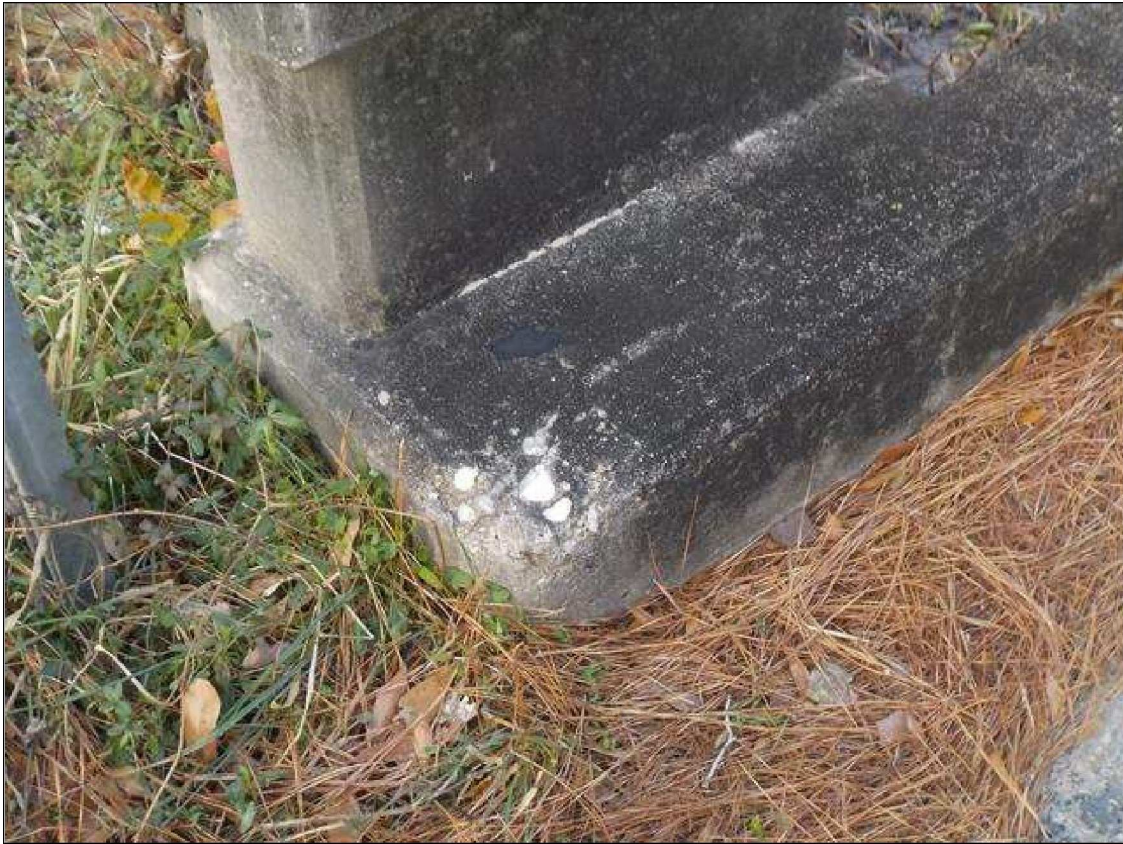
SOUTH END - SPALL 6" DIAMETER X 3/4" DEEP

SPALL, SPAN 1, LEFT RAIL, SOUTH END

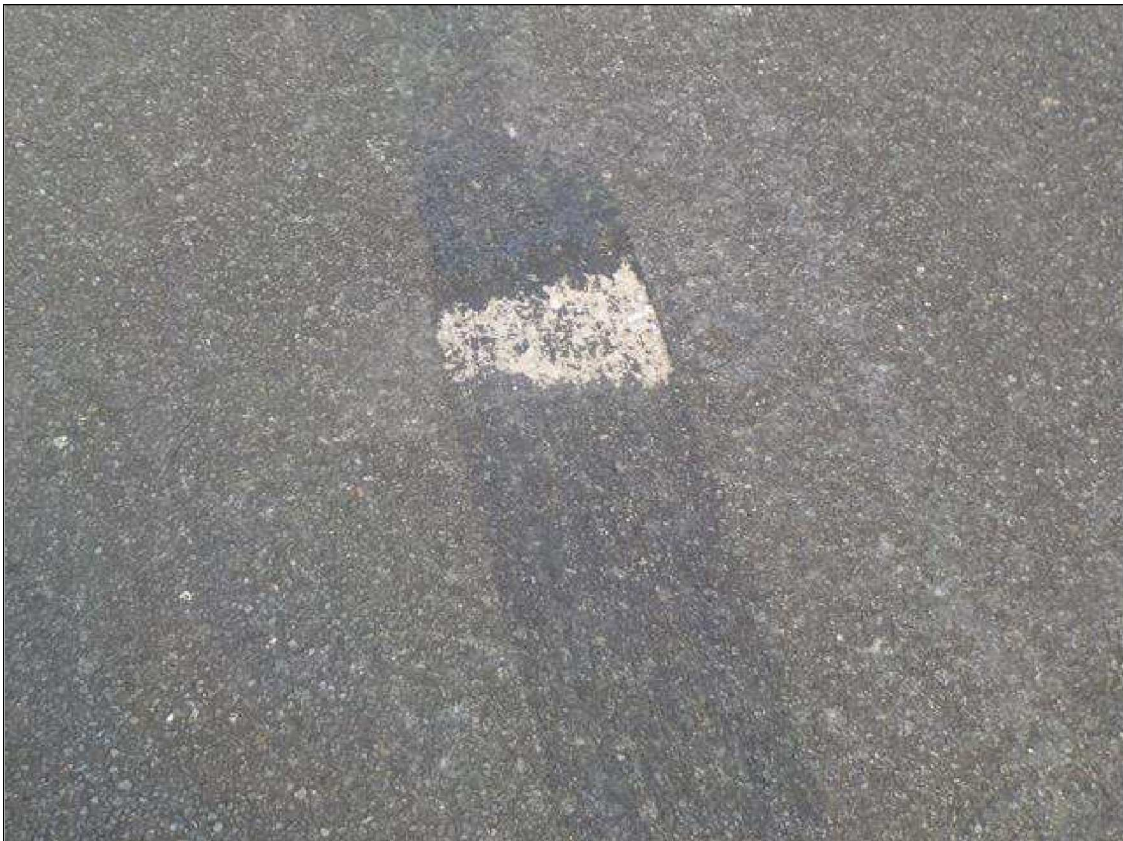
AWS WORN AWAY EXPOSING DECK

AWS WORN EXPOSING DECK, SPAN 1

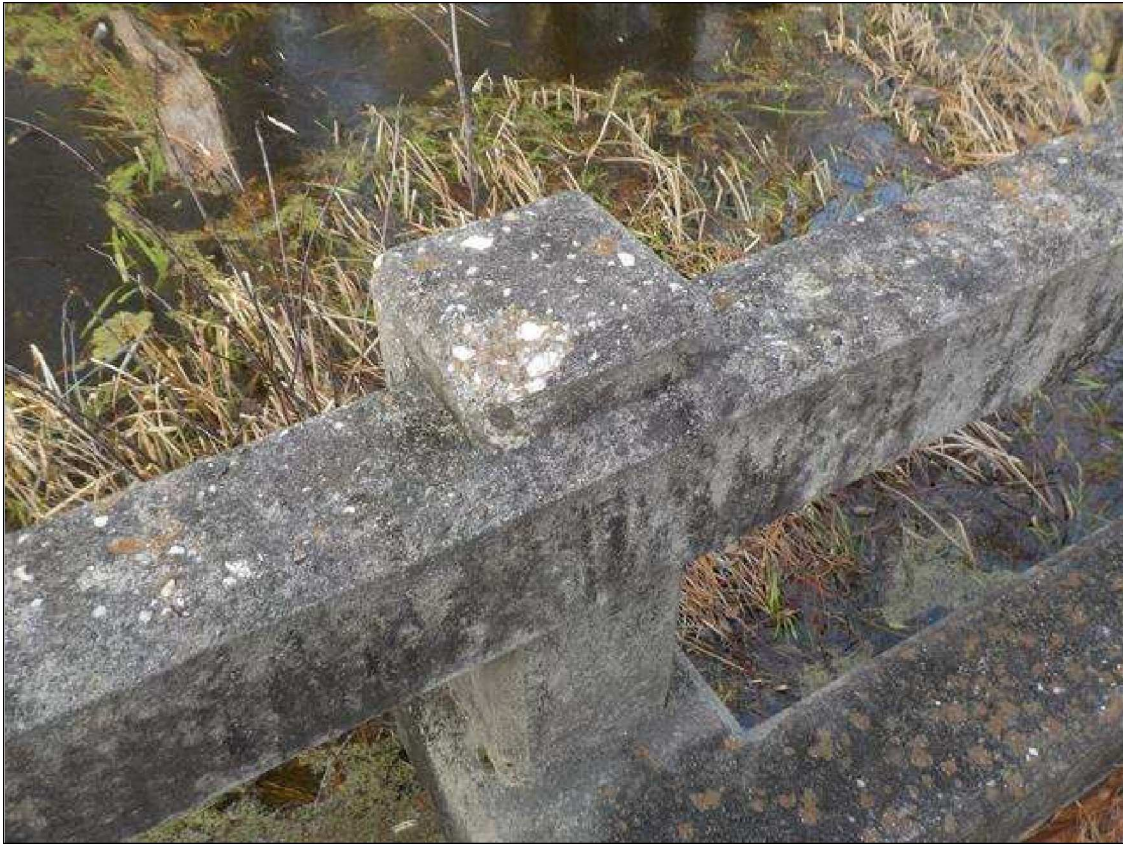
POST 3 - SPALL 3" DIAMETER X 1/2" DEEP

SPALL SPAN 3, POST 3, LEFT RAIL

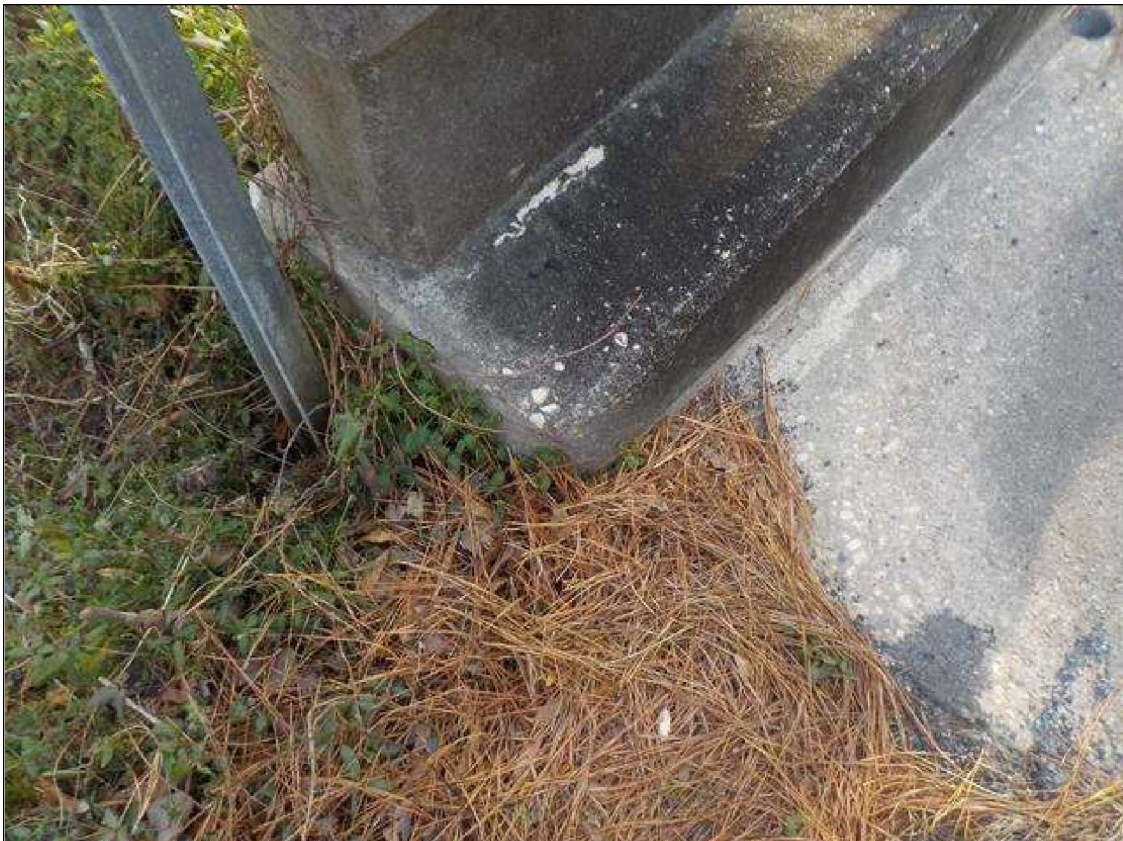
SPALL IN SPAN 4, RIGHT RAIL NORTH END

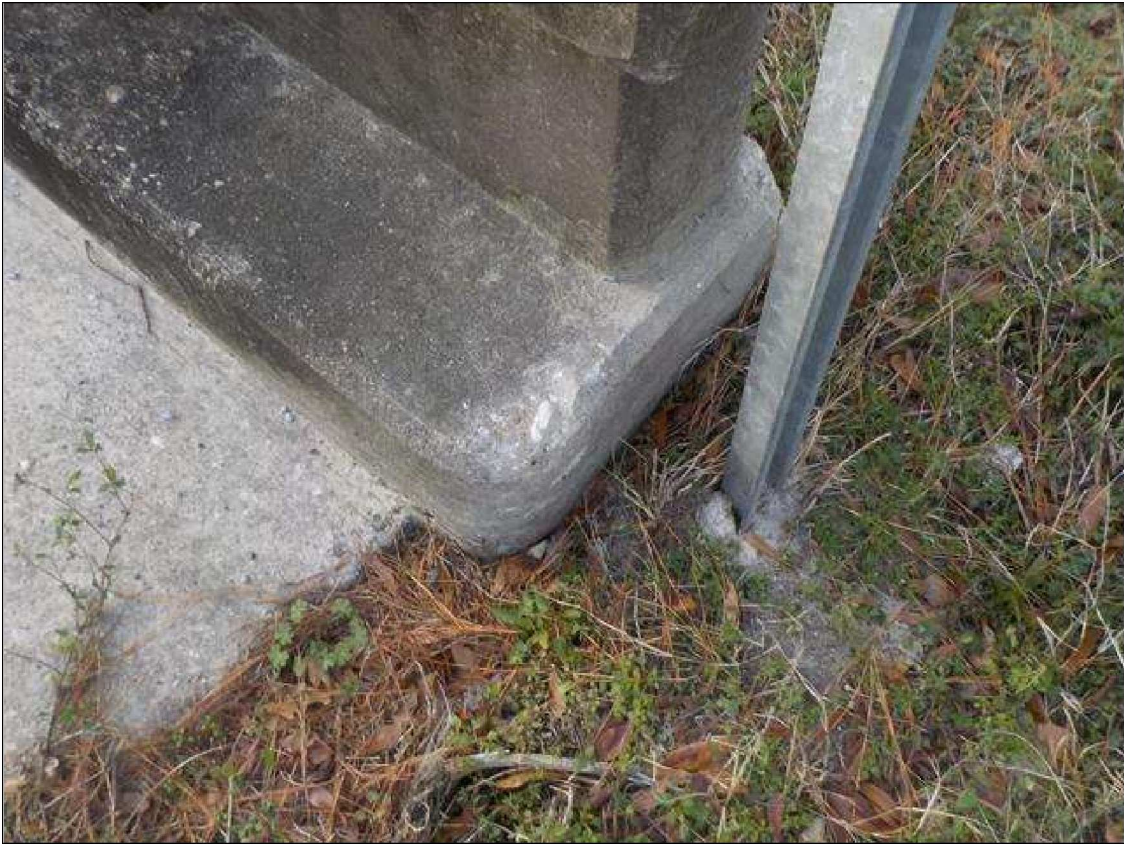
SPALL, SPAN 4, NORTH END LEFT RAIL

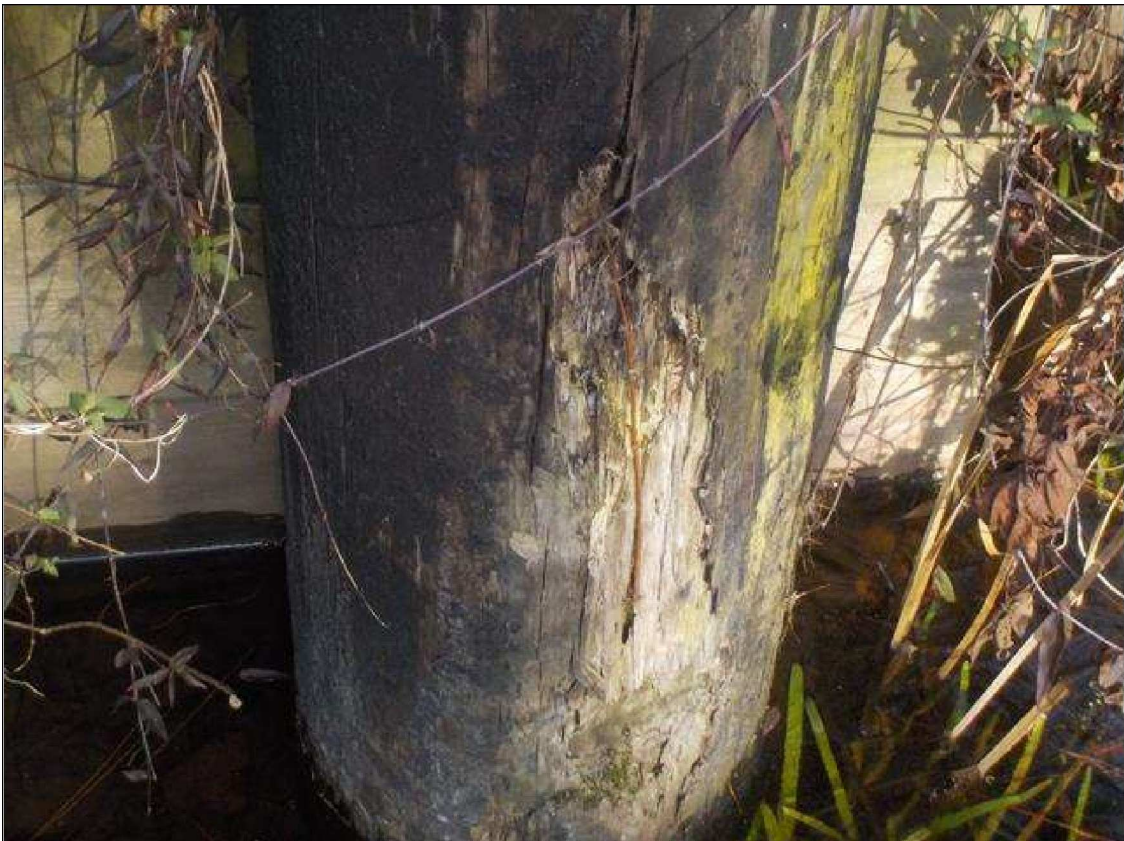
DECAY AT N.E. TURNPILE

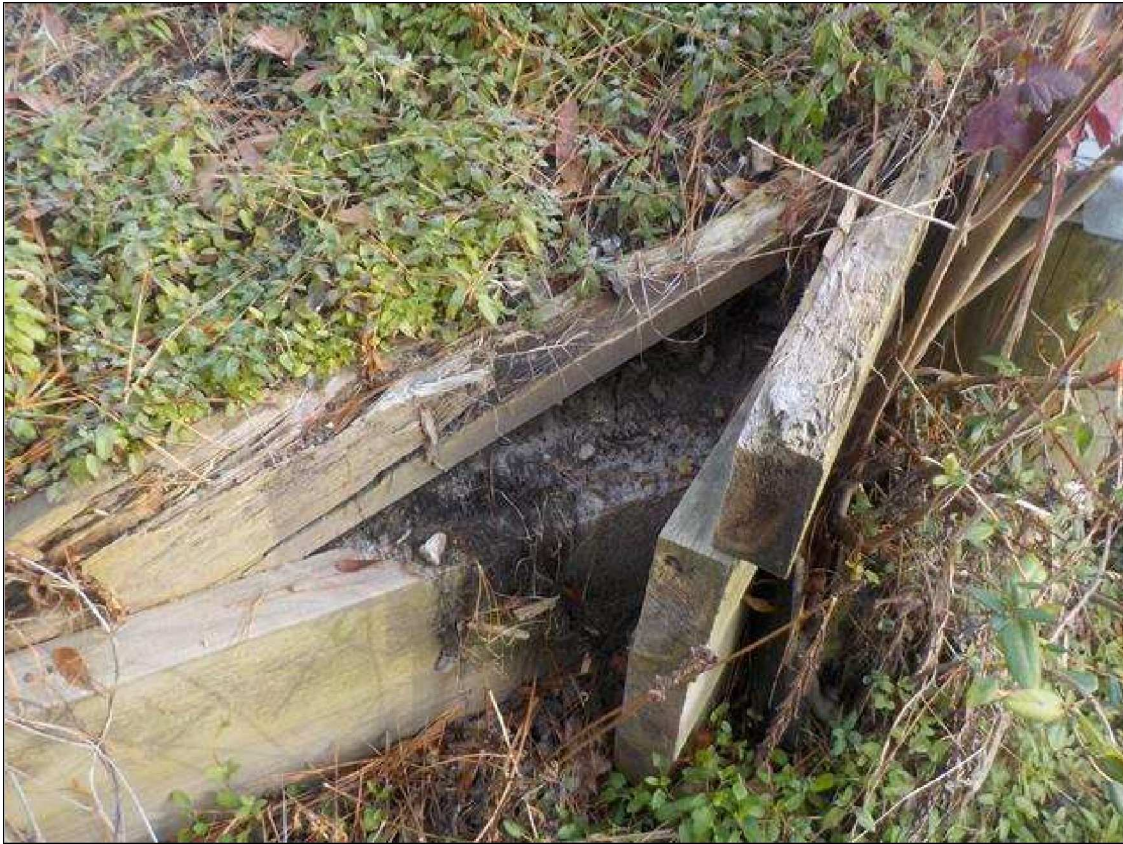
N.W. WING, TOP BOARD DECAYED AND DISPLACED

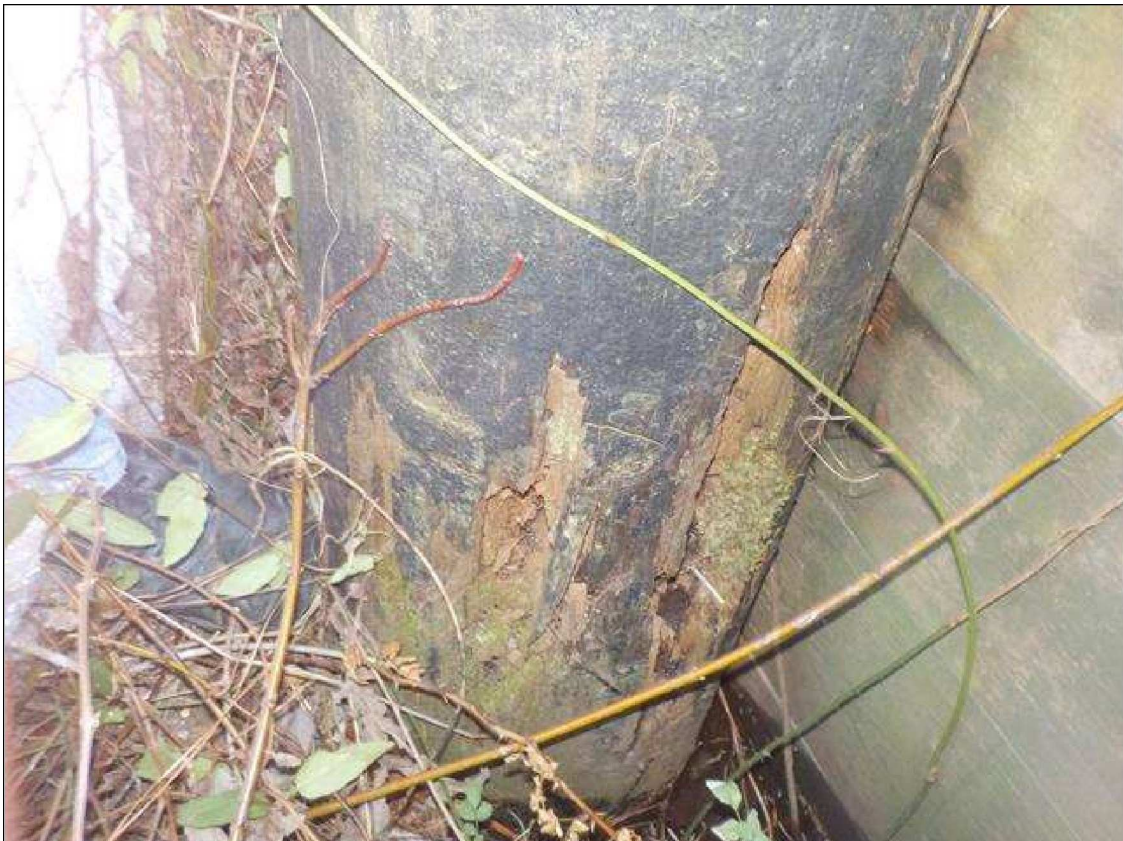
S.E. TURNPILE DECAY

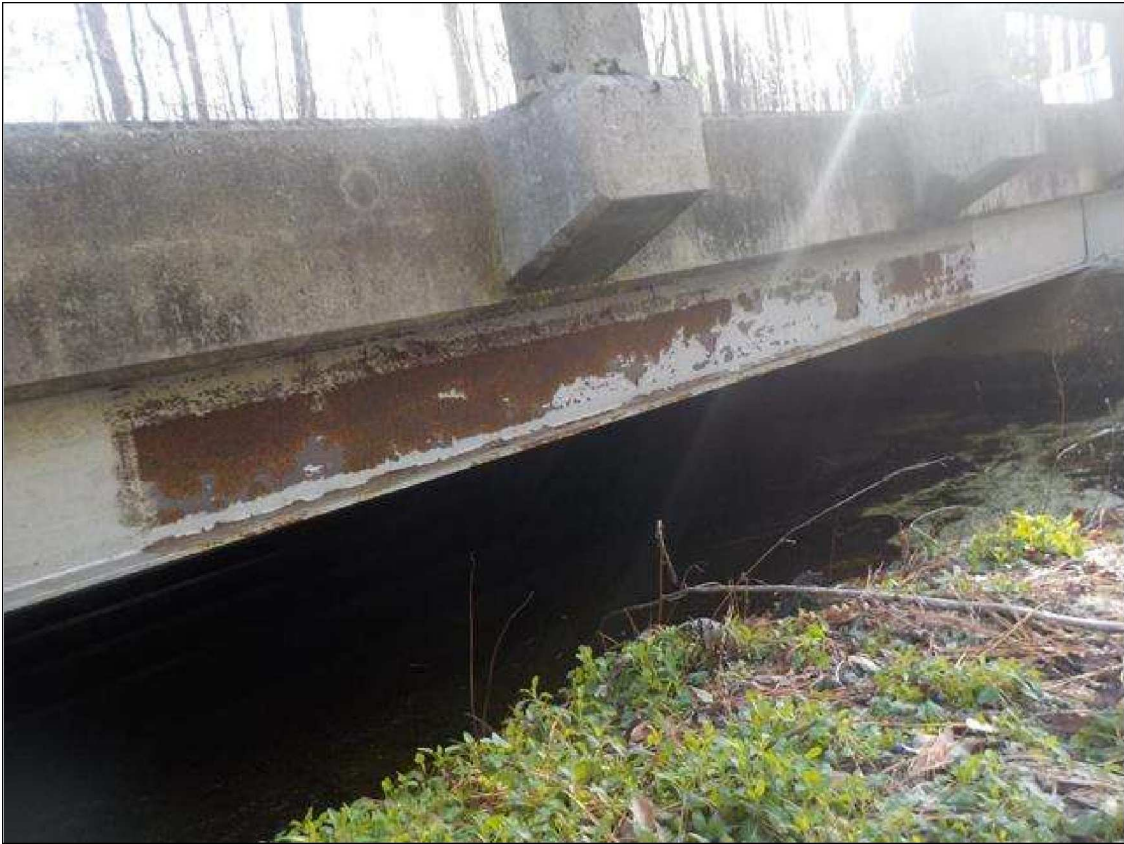
RUST WHERE PAINT MISSING ON BEAM 1, SPAN 4

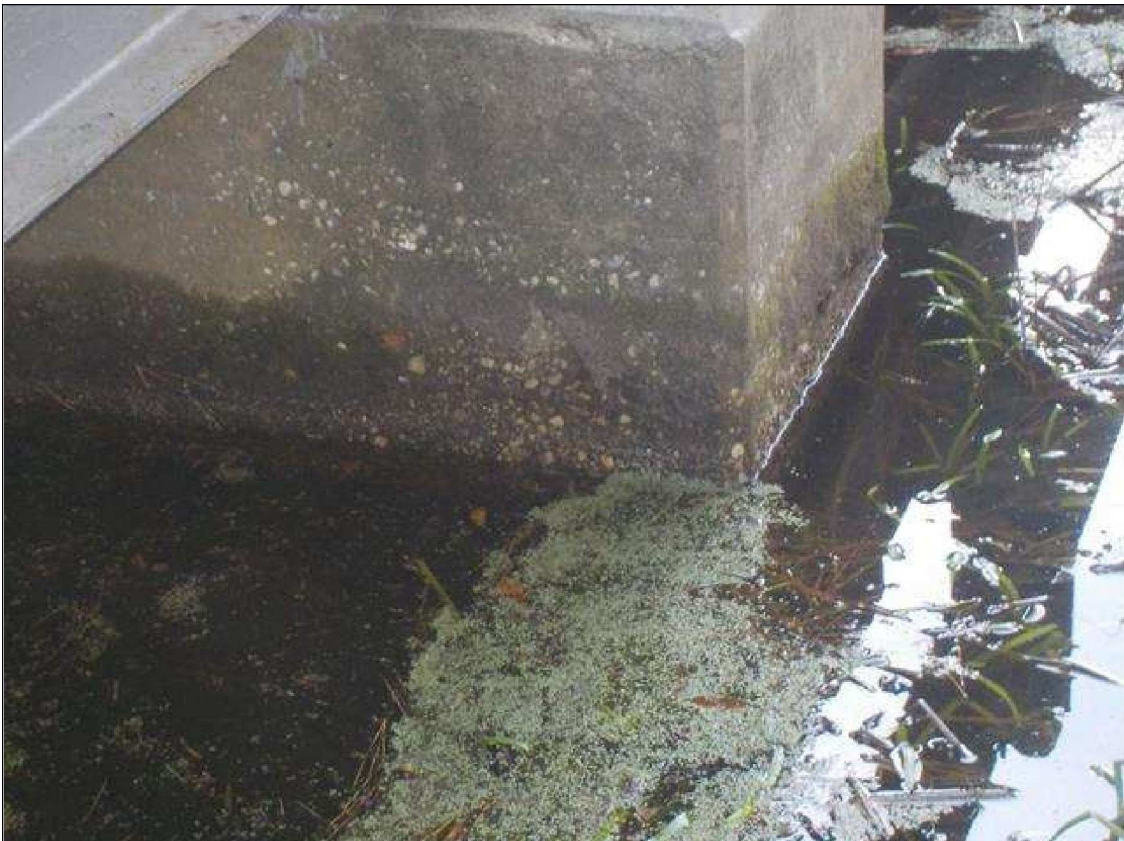
COARSE AGGREGATE EXPOSED ON CAPS

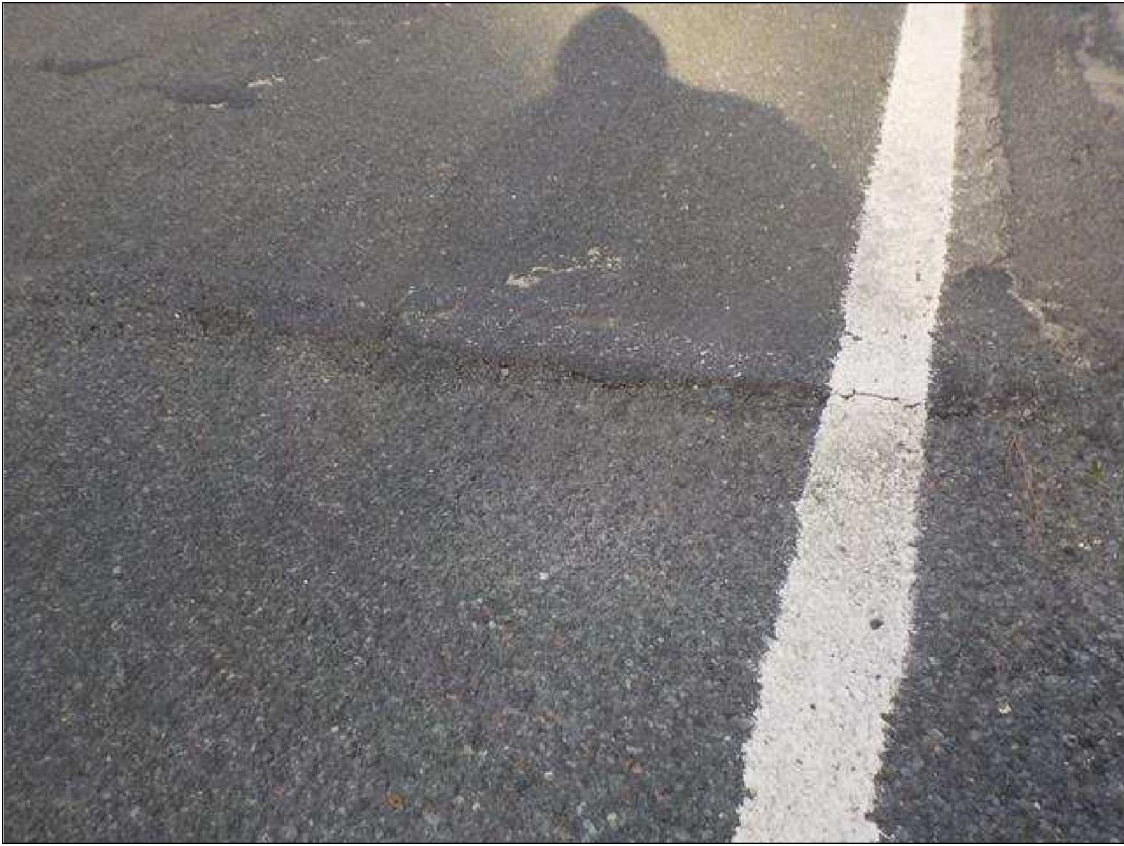
CRACKED TO 1" WIDE(MAX.)  
SBL SETTLED 1"  
NBL SETTLED 3/4"

SOUTH TRANSITION CRACKED AND SETTLED

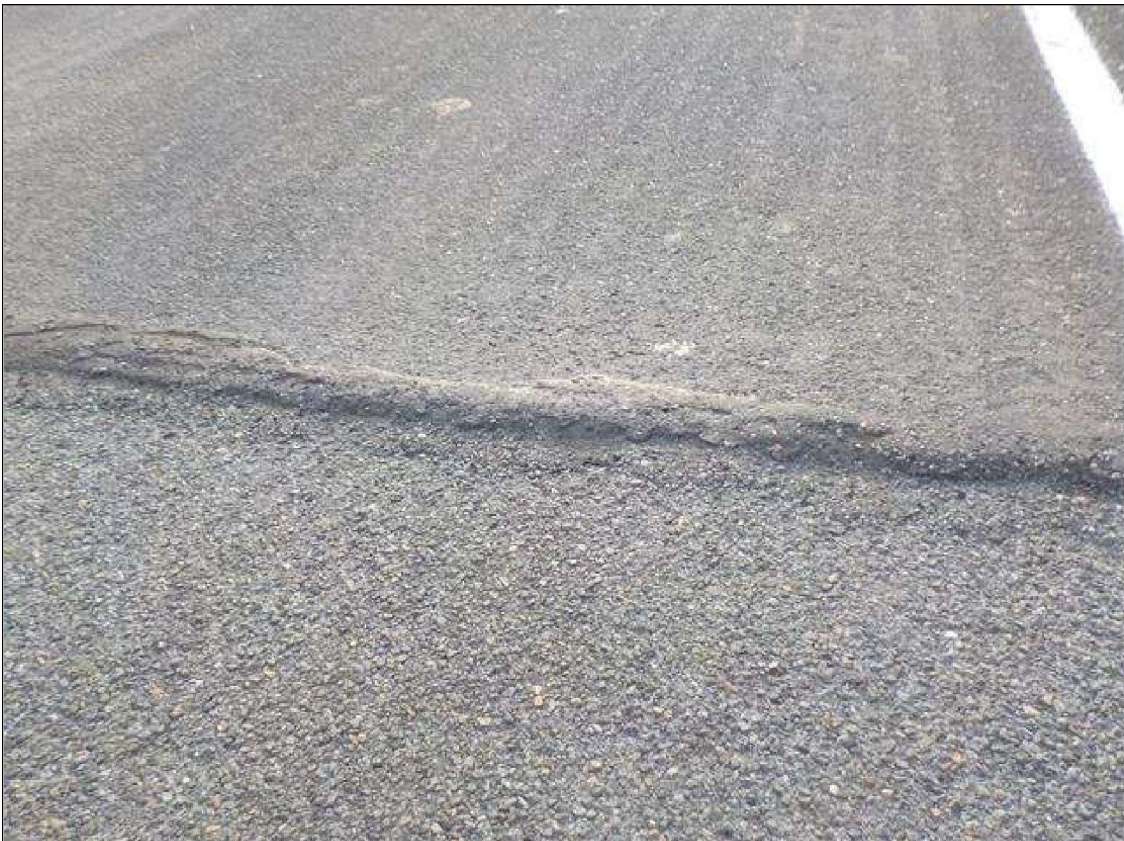
NORTH TRANSITION CRACKED AND SETTLED

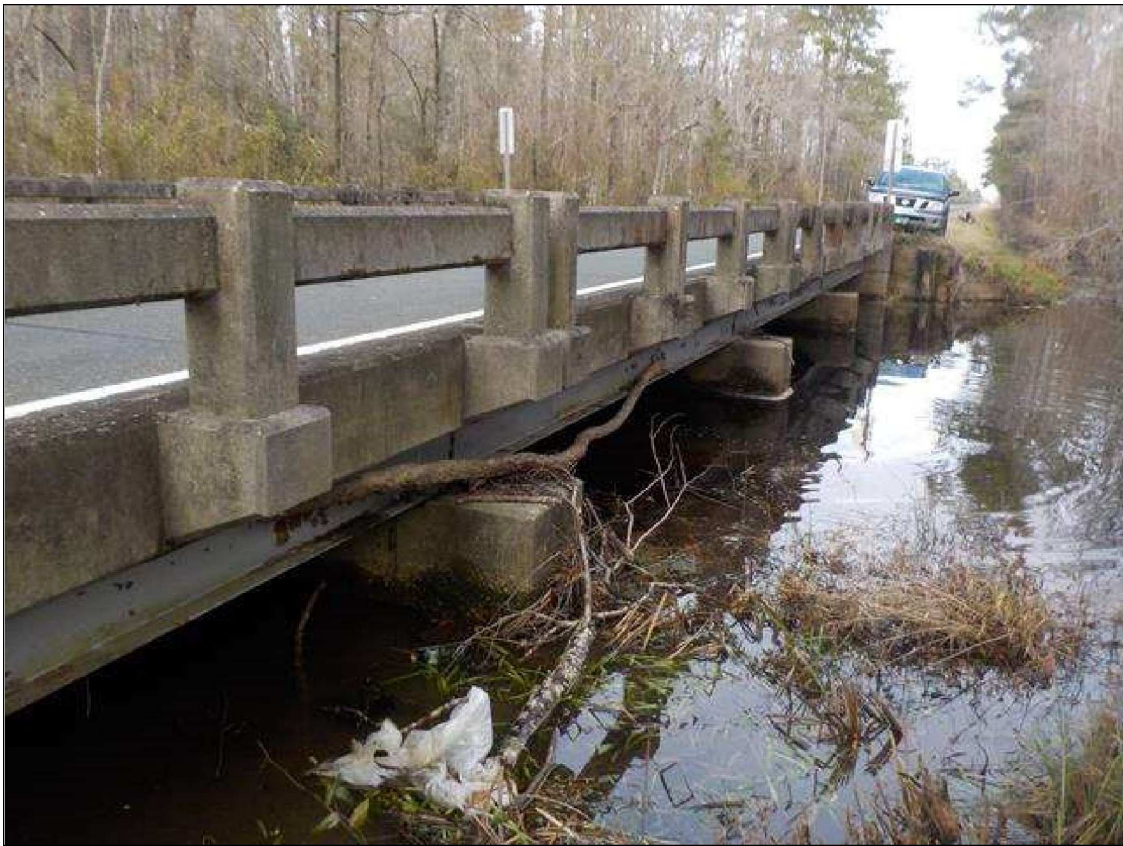
DRIFT ON BENT 1 UPSTREAM END

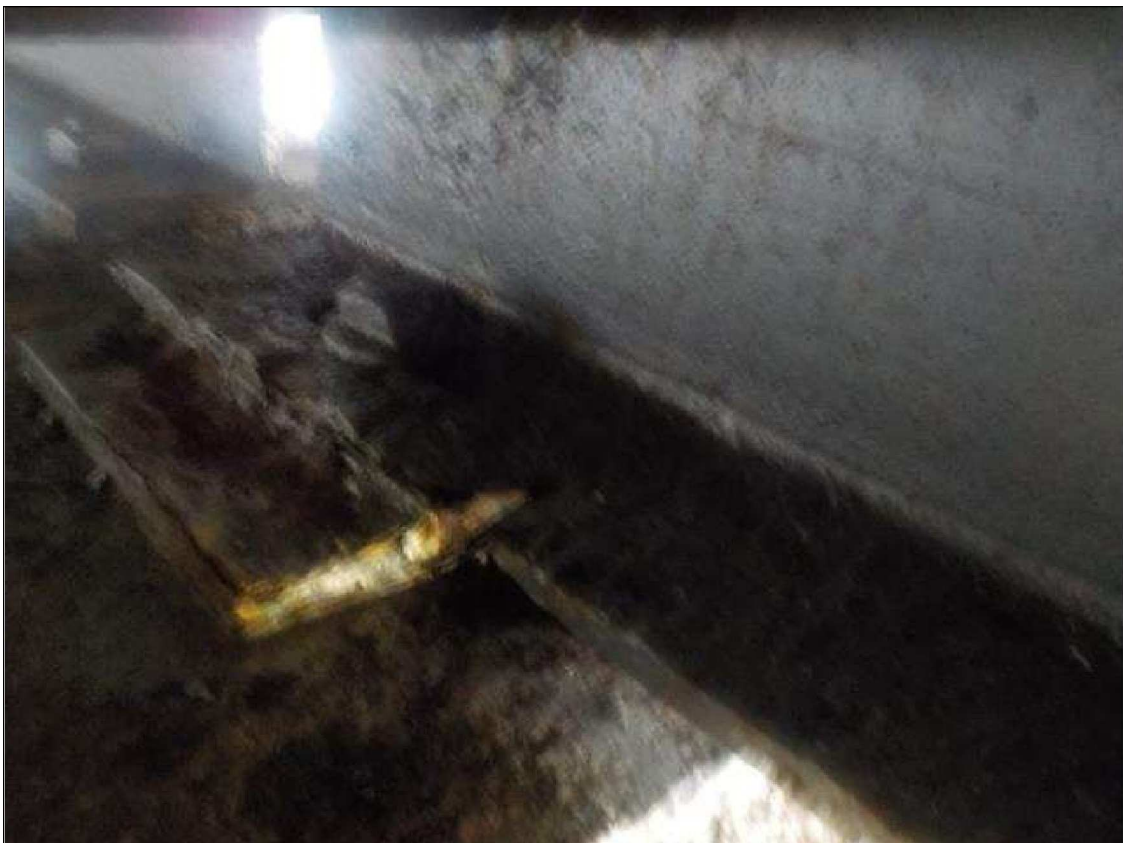
SECTION LOSS, BEAM 2, SPAN 4 OVER BENT 3, EAST FLANGE 1" WIDE X 1" TOWARD WEB

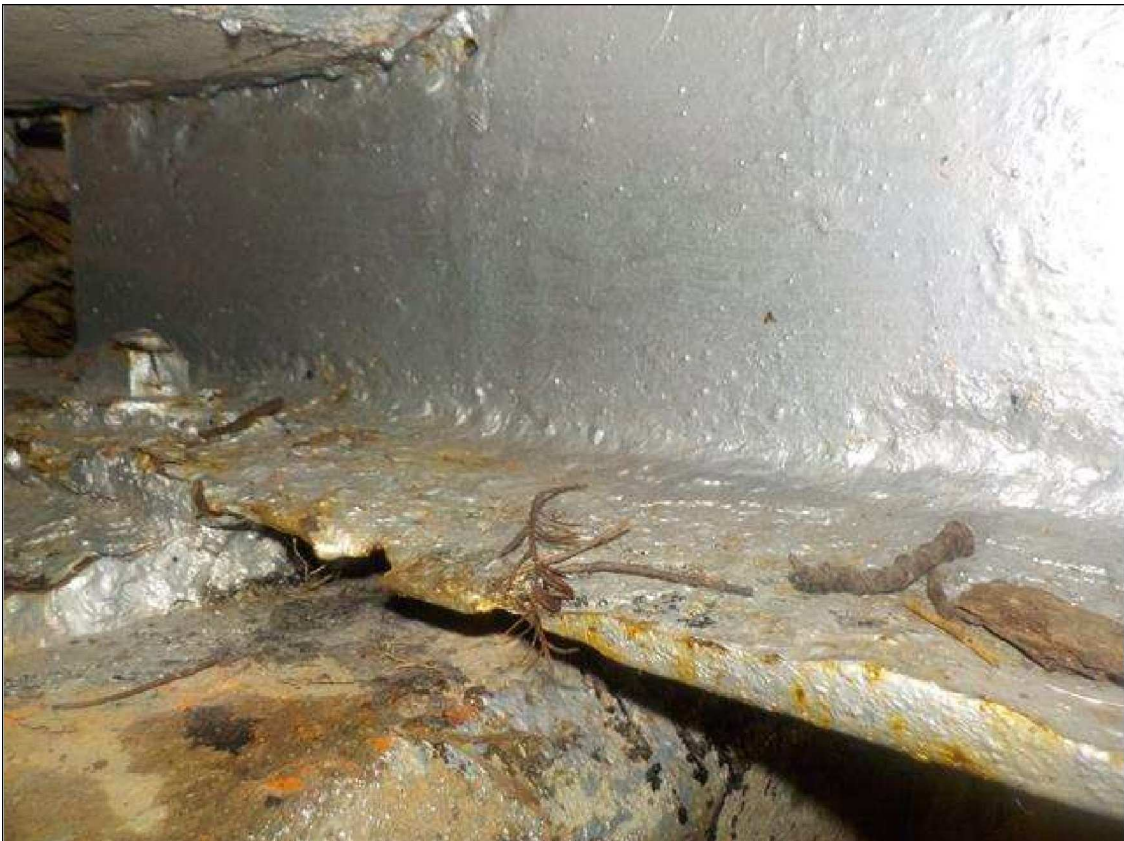
SECTION LOSS BEAM 10, SPAN 4 OVER BENT 3

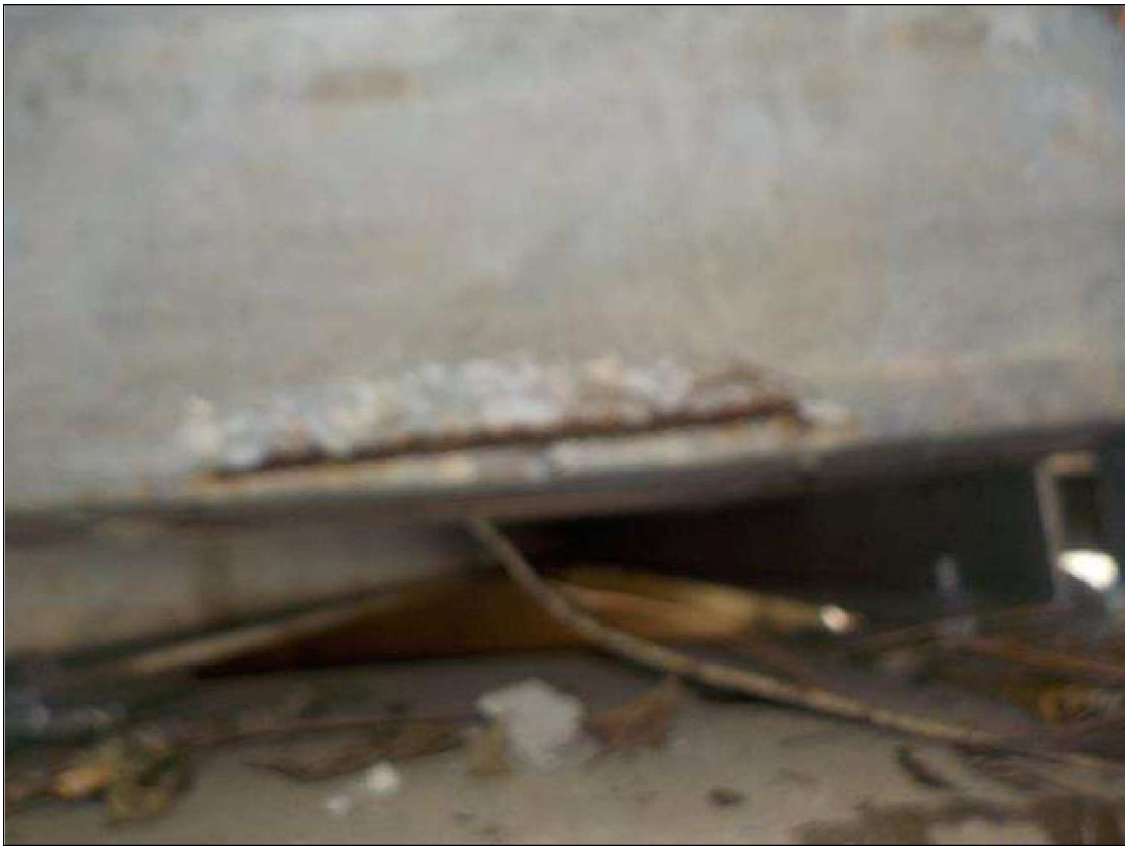
SPALL ON DIAPHRAM EXPOSING REBAR, SPAN 3, BAY 2 OVER BENT 2

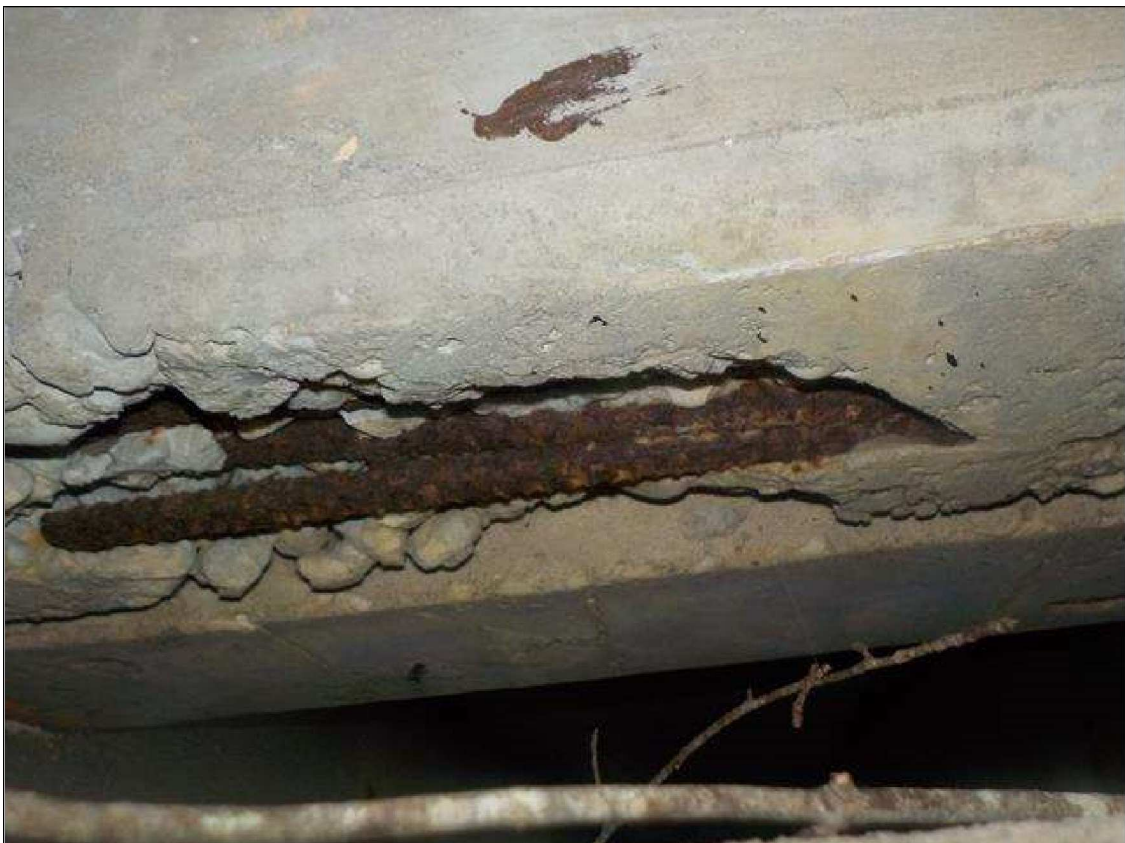
SPALL ON DIAPHRAM EXPOSING REBAR, SPAN 3, BAY 4 OVER BENT 2

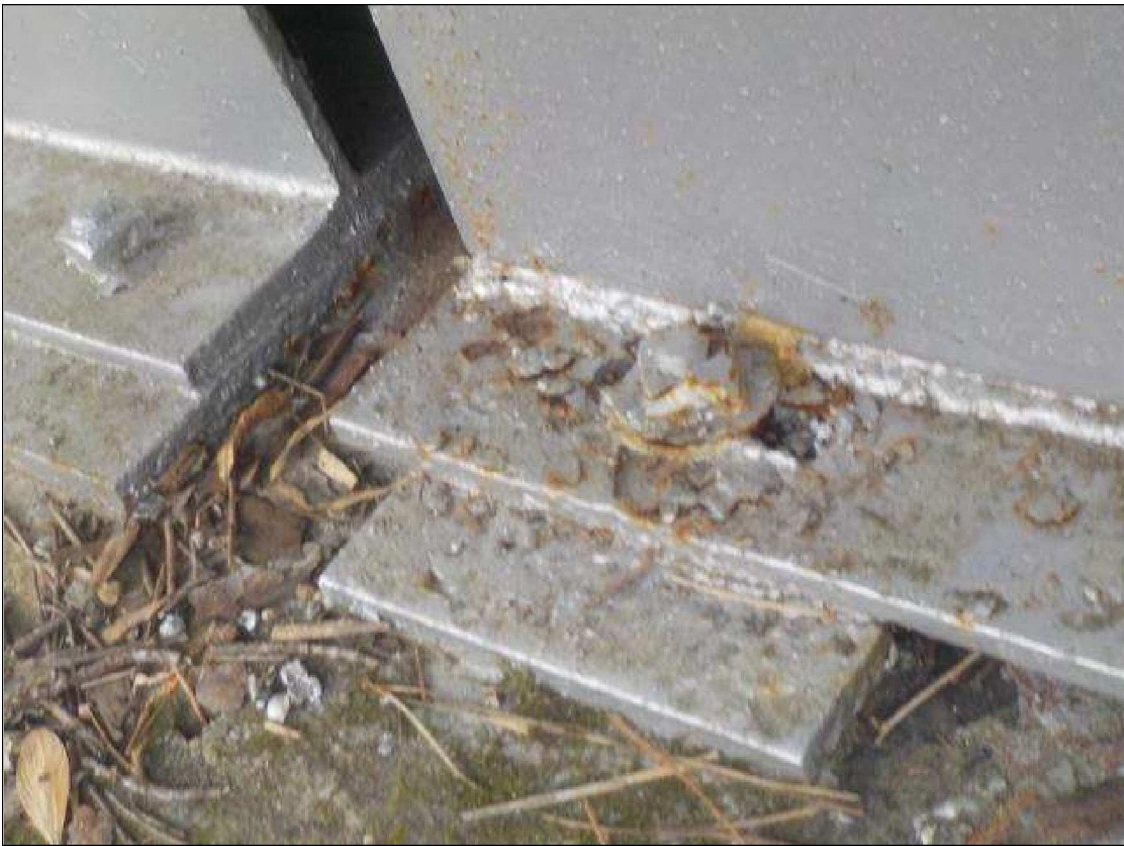
PITTING ON BEARING PLATE BEAM 11, OVER BENT 3 IN SPAN 4

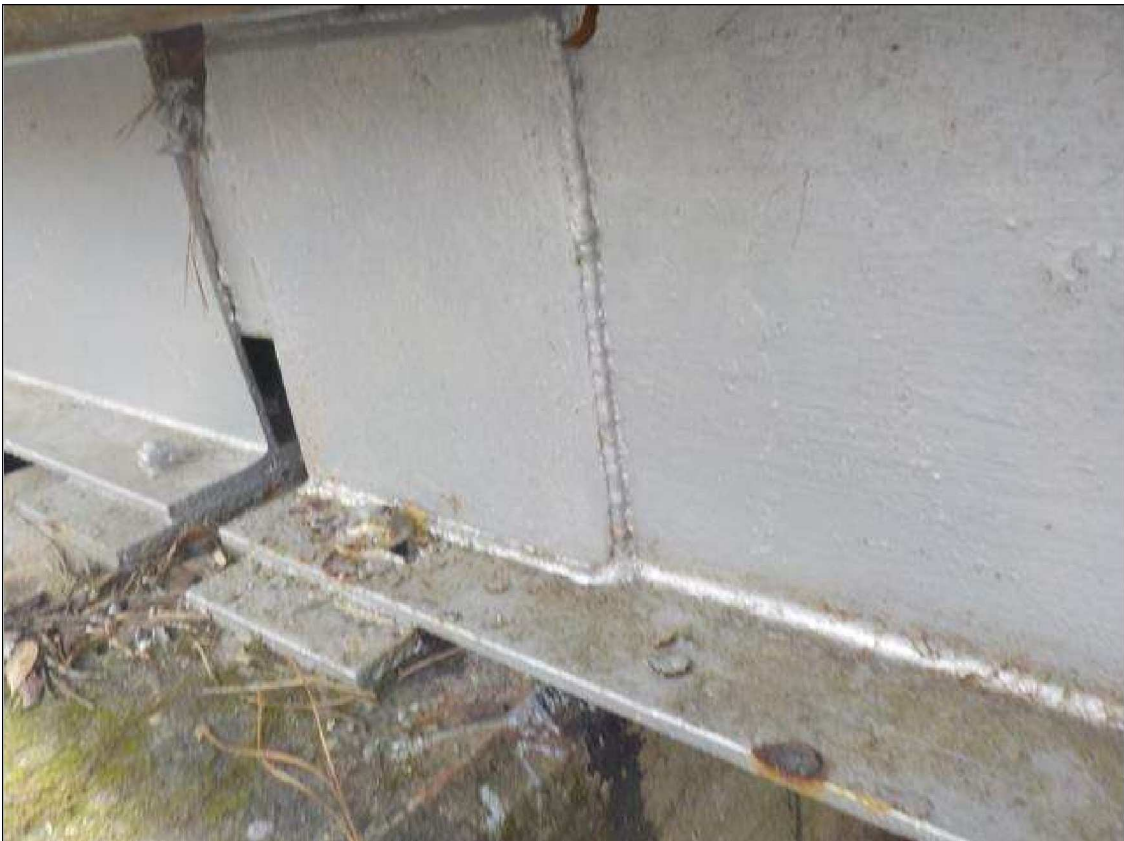
BEAM REPAIR
