NC DEPARTMENT OF TRANSPORTATION  
DIVISION OF HIGHWAYS  
STRUCTURE MANAGEMENT UNIT

# Structure Safety Report

## Routine Element Inspection

DIVISION: 6 COUNTY: ROBESON STRUCTURE NUMBER: 770108 FREQUENCY: 24 MONTHS

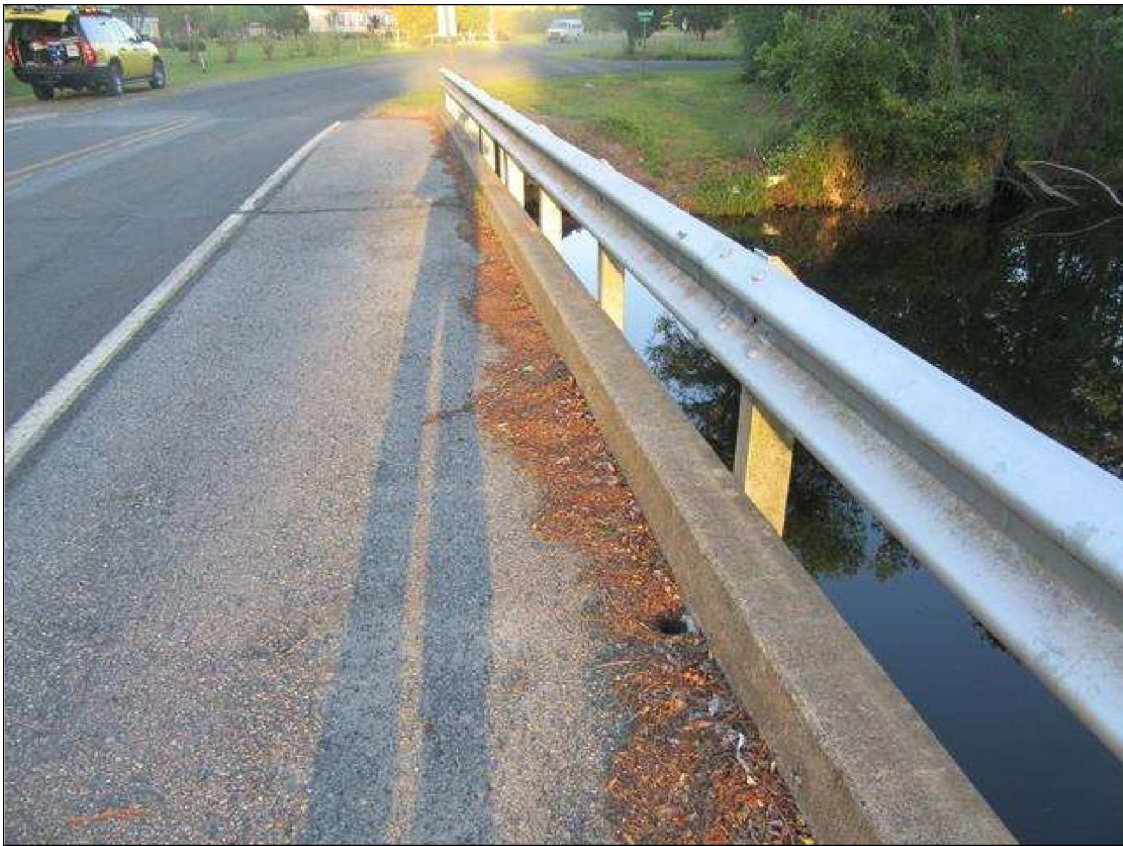
DEBRIS ALONG BOTH CURBS

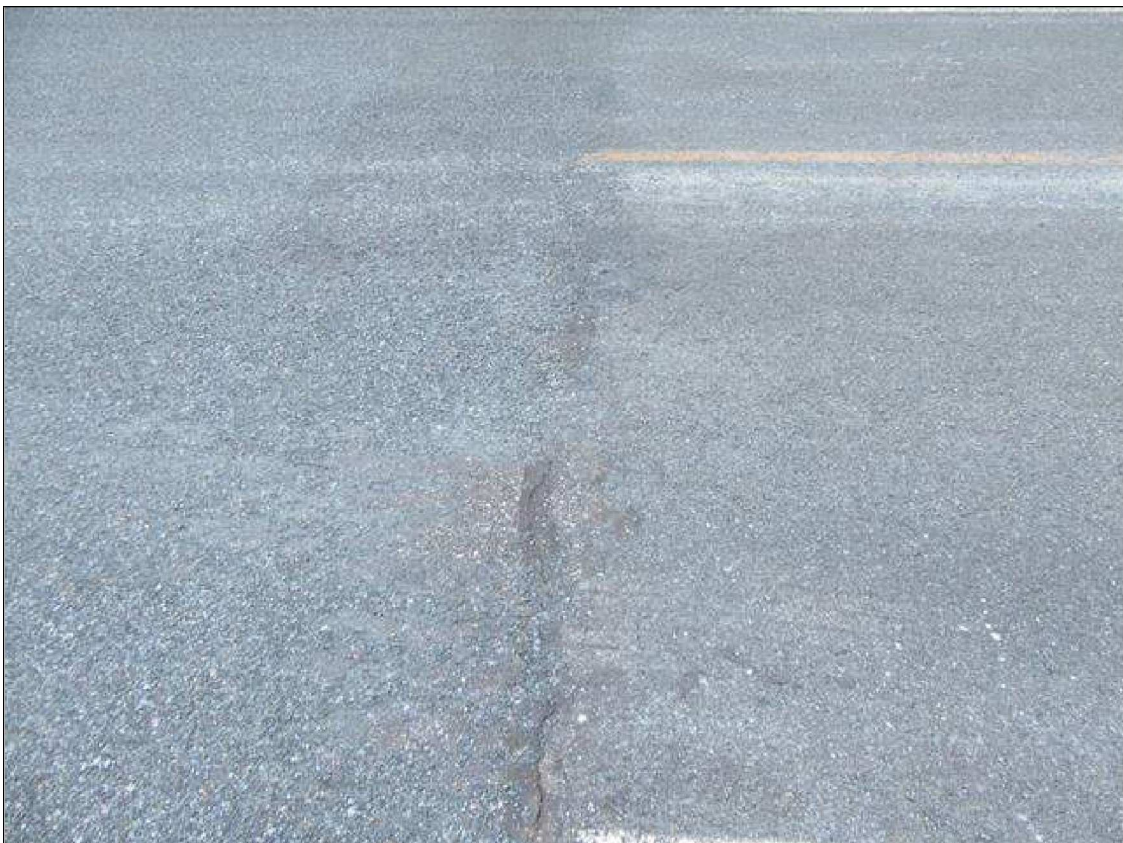
| Element Number | Defect Type | Defect Description | CS | CS Qty | Maint Qty |
|---|---|---|---|---|---|
| 510 | Crack (Wearing Surface) | 1/16" WIDE TRANSVERSE CRACK OVER END BENT 2 | 2 | 29 | 29 Square Feet |

Span 2 Wearing Surface: 1/16" WIDE TRANSVERSE CRACK OVER END BENT 2

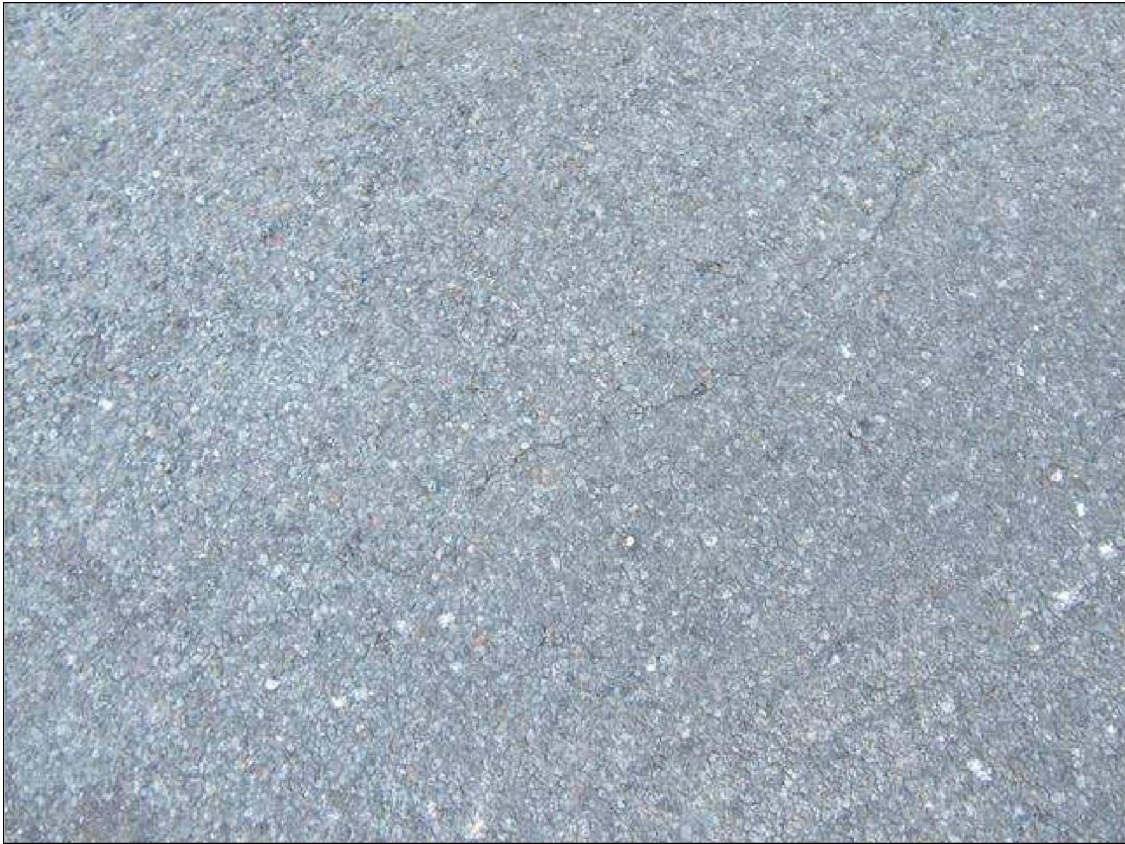
| Element Number | Defect Type | Defect Description | CS | CS Qty | Maint Qty |
|---|---|---|---|---|---|
| 510 | Crack (Wearing Surface) | 1/16 TO 1/8" WIDE LONGITUDINAL CRACKS | 3 | 15 | 15 Square Feet |

Span 2 Wearing Surface: 1/16 TO 1/8" WIDE LONGITUDINAL CRACKS

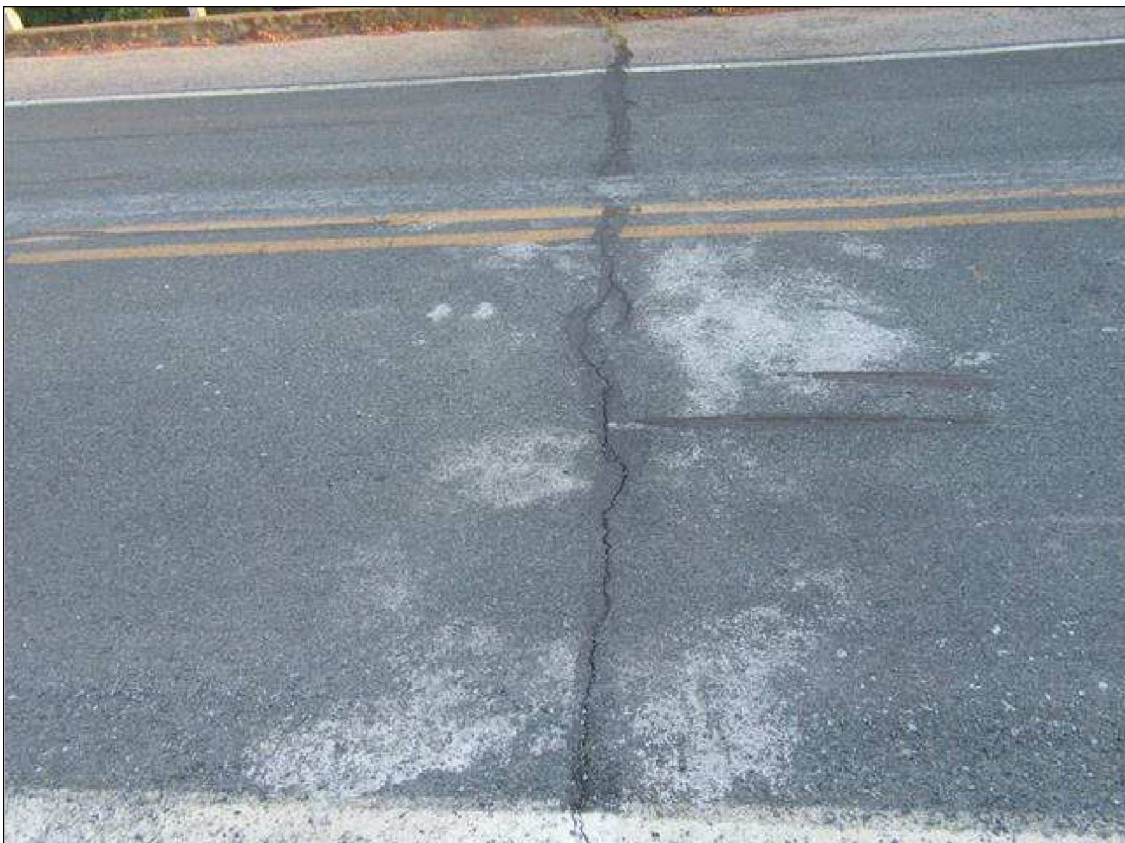
| Element Number | Defect Type | Defect Description | CS | CS Qty | Maint Qty |
|---|---|---|---|---|---|
| 510 | Crack (Wearing Surface) | 1/16" TO 1/8" WIDE TRANSVERSE CRACK OVER BENT 1 | 3 | 29 | 29 Square Feet |

Span 1 Wearing Surface: 1/16" TO 1/8" WIDE TRANSVERSE CRACK OVER BENT 1

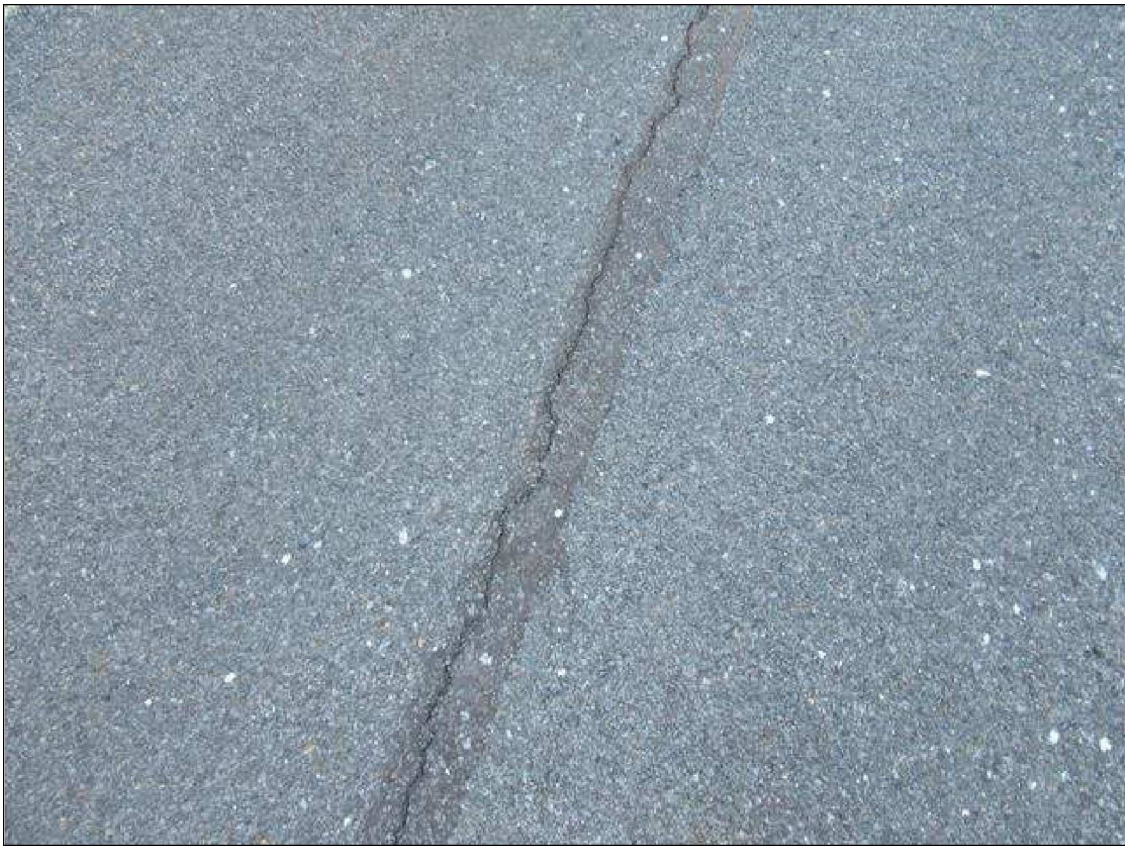
| Element Number | Defect Type | Defect Description | CS | CS Qty | Maint Qty |
|---|---|---|---|---|---|
| 510 | Patched Area/Pothole (Wearing Surface) | SEALED LONGITUDINAL CRACKS IN SPAN 1 | 2 | 70 | Square Feet |

Span 1 Wearing Surface: SEALED LONGITUDINAL CRACKS IN SPAN 1

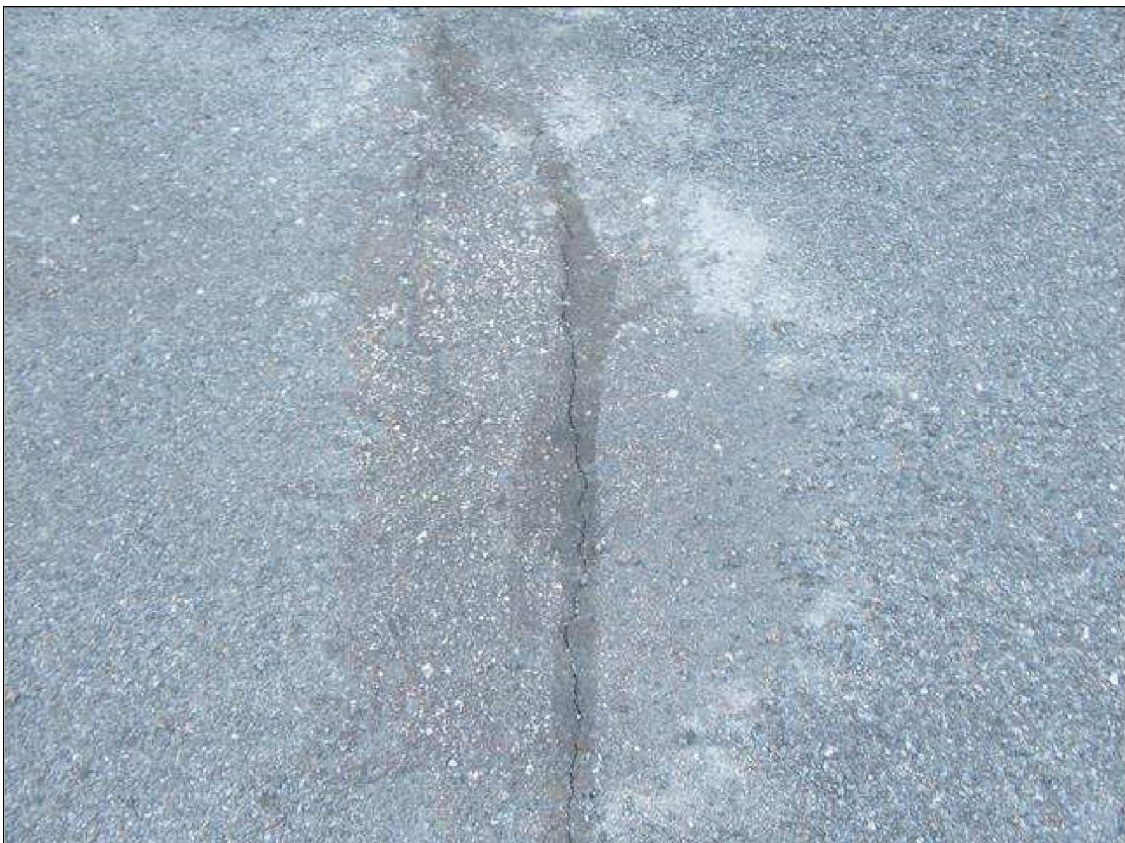
| Element Number | Defect Type | Defect Description | CS | CS Qty | Maint Qty |
|---|---|---|---|---|---|
| 510 | Crack (Wearing Surface) | 1/16" TO 1/8" WIDE TRANSVERSE CRACK OVER END BENT 1 | 3 | 29 | 29 Square Feet |

Span 1 Wearing Surface: 1/16" TO 1/8" WIDE TRANSVERSE CRACK OVER END BENT 1

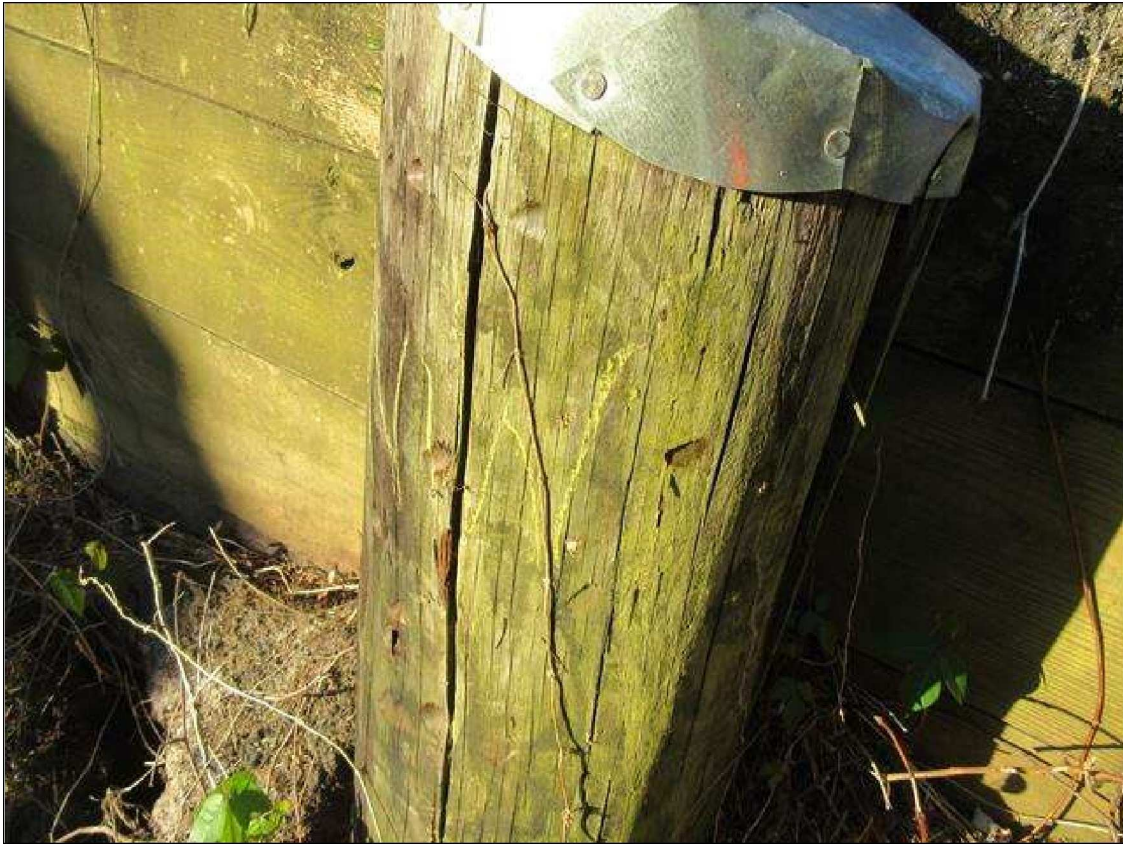
**Details** NWC WINGWALL PILE 1/4" WIDE VERTICAL CHECKS , HOLLOW

NWC WINGWALL PILE 1/4" WIDE VERTICAL CHECKS , HOLLOW

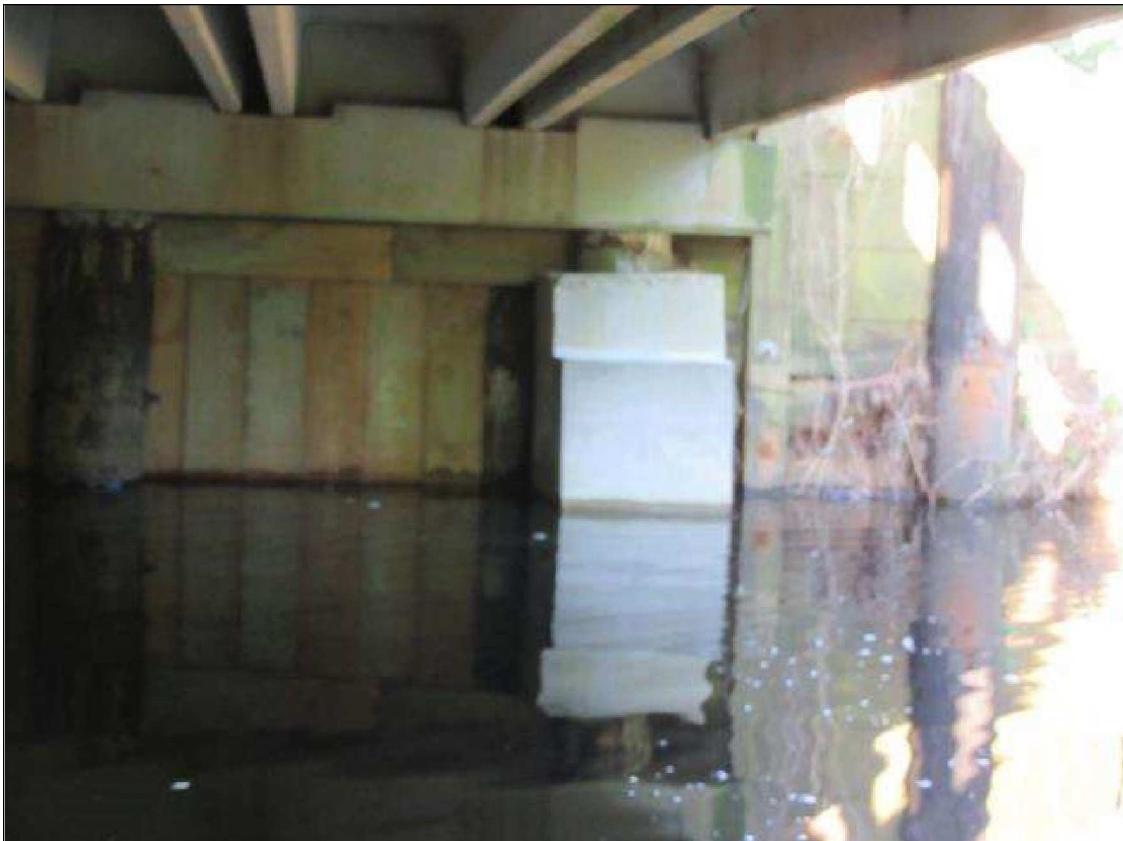
| Bent 1 | Pile 1 | TEMPORARY REPAIR: PILE HAS BEEN ENCASED WITH CONCRETE. |

END BENT 1 PILES 1 AND 6 ENCASED IN CONCRETE , TEMPORARY REPAIRS

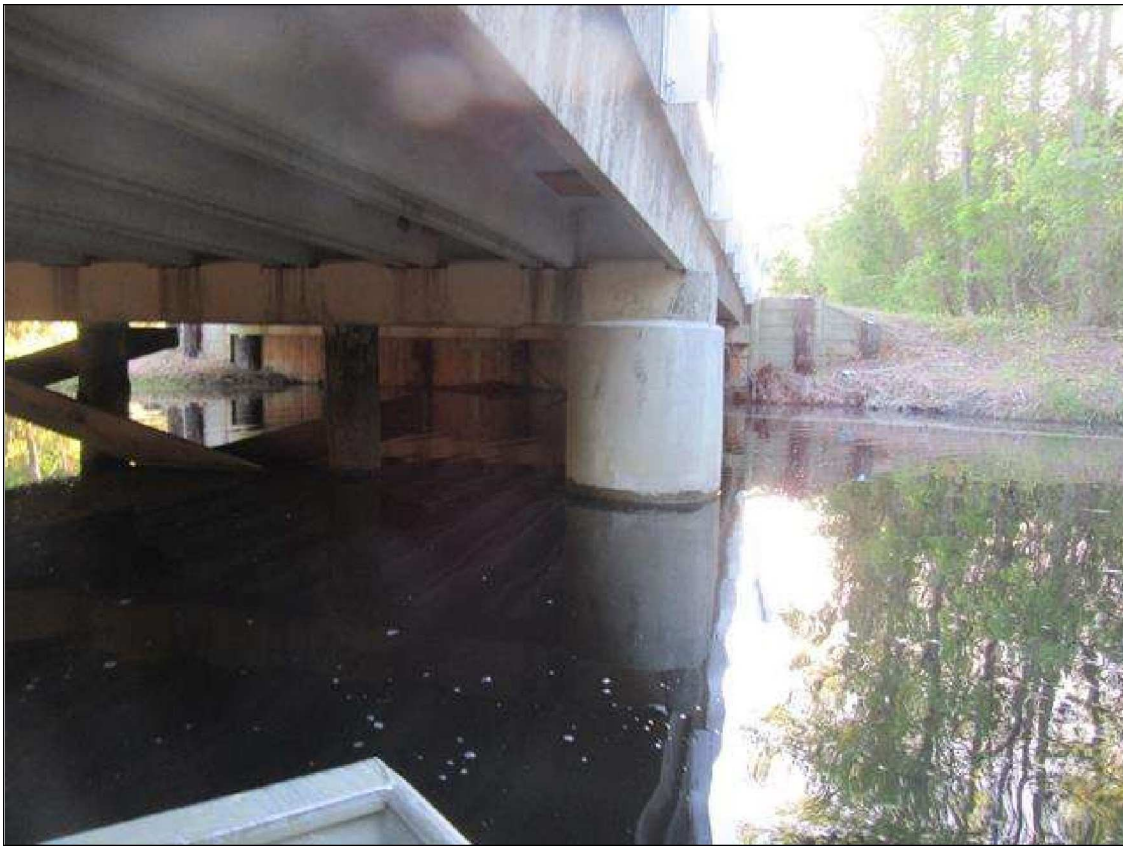
PILE 6 AT BENT 1 ENCASED IN CONCRETE, TEMPORARY REPAIR

| Bent 1 | Pile 6 | TEMPORARY REPAIR: PILE HAS BEEN ENCASED WITH CONCRETE.<br>1 Each of Decay/Section Loss: Affects 10% or more of the member but does not warrant structural review. |

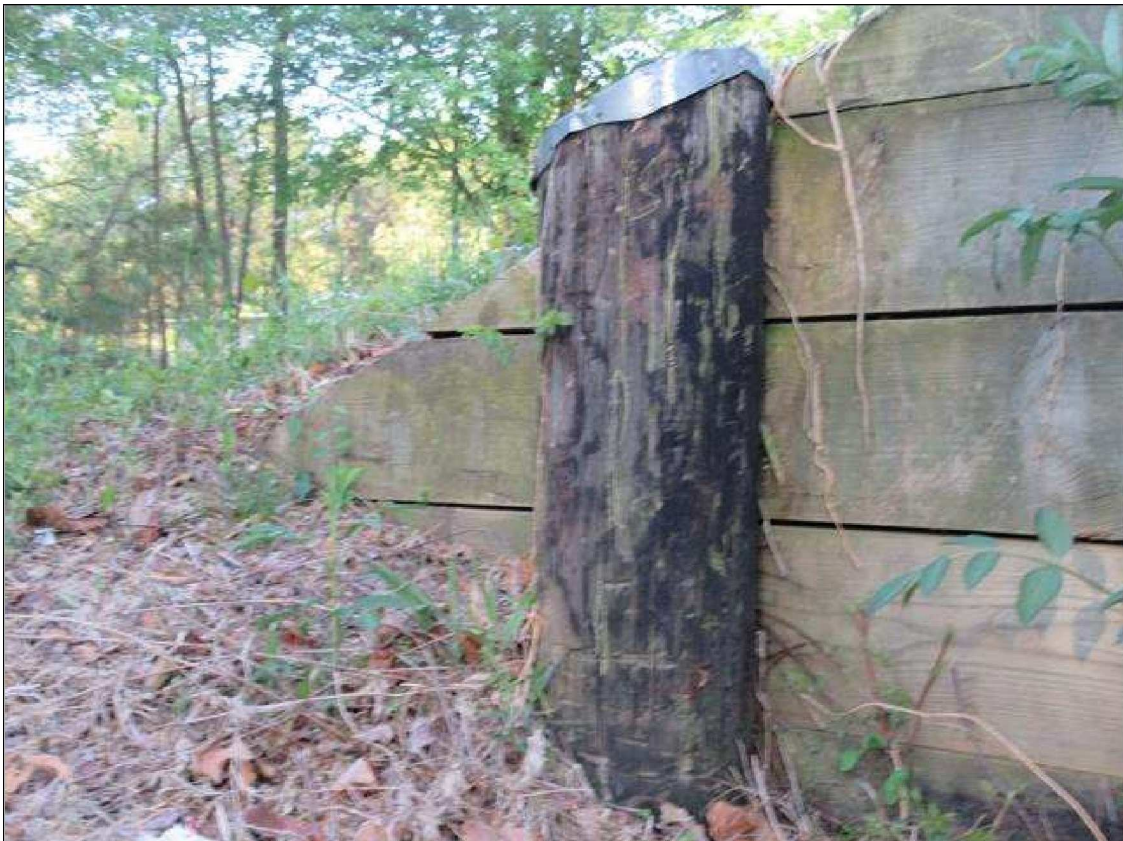
SWC WINGWALL PILE 1/8" WIDE X 4' HIGH VERTICAL CHECKS

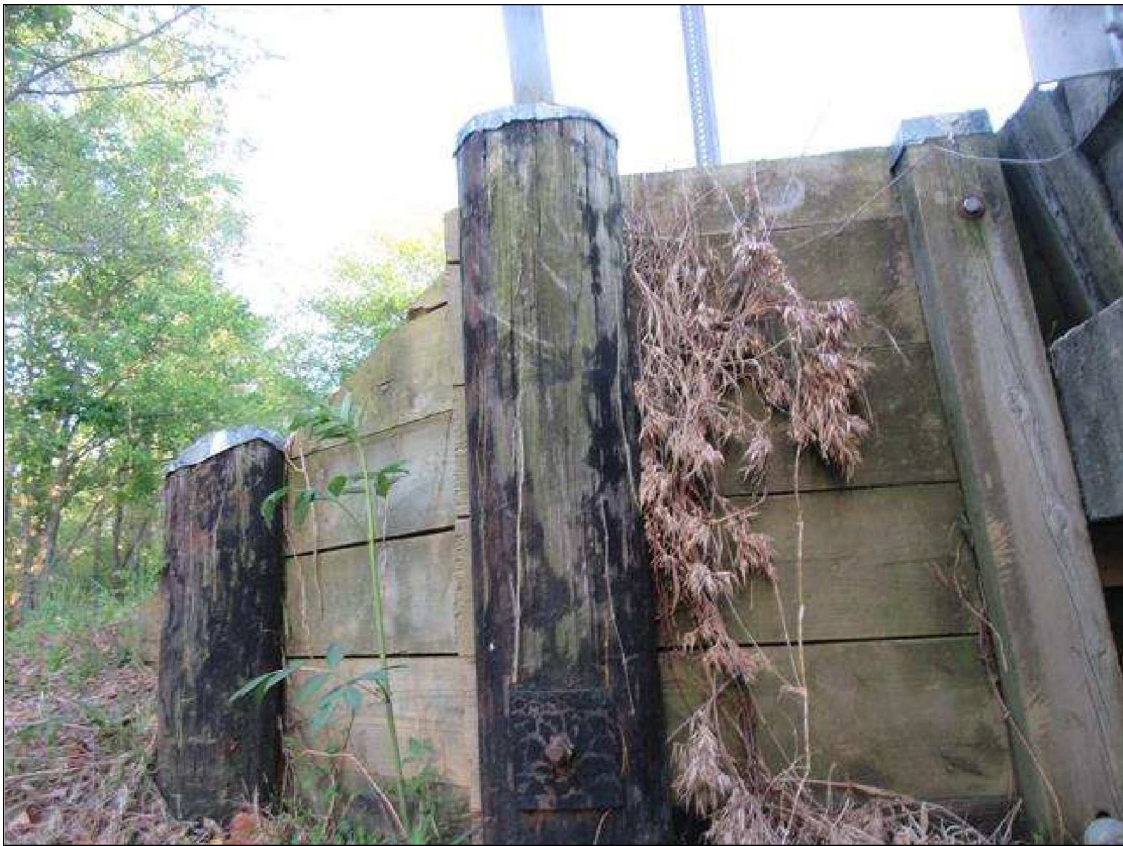
End Bent 1 Abutment/Backwall : 1/8" WIDE VERTICAL CHECKS IN TURNPILE AT SOUTHWEST CORNER

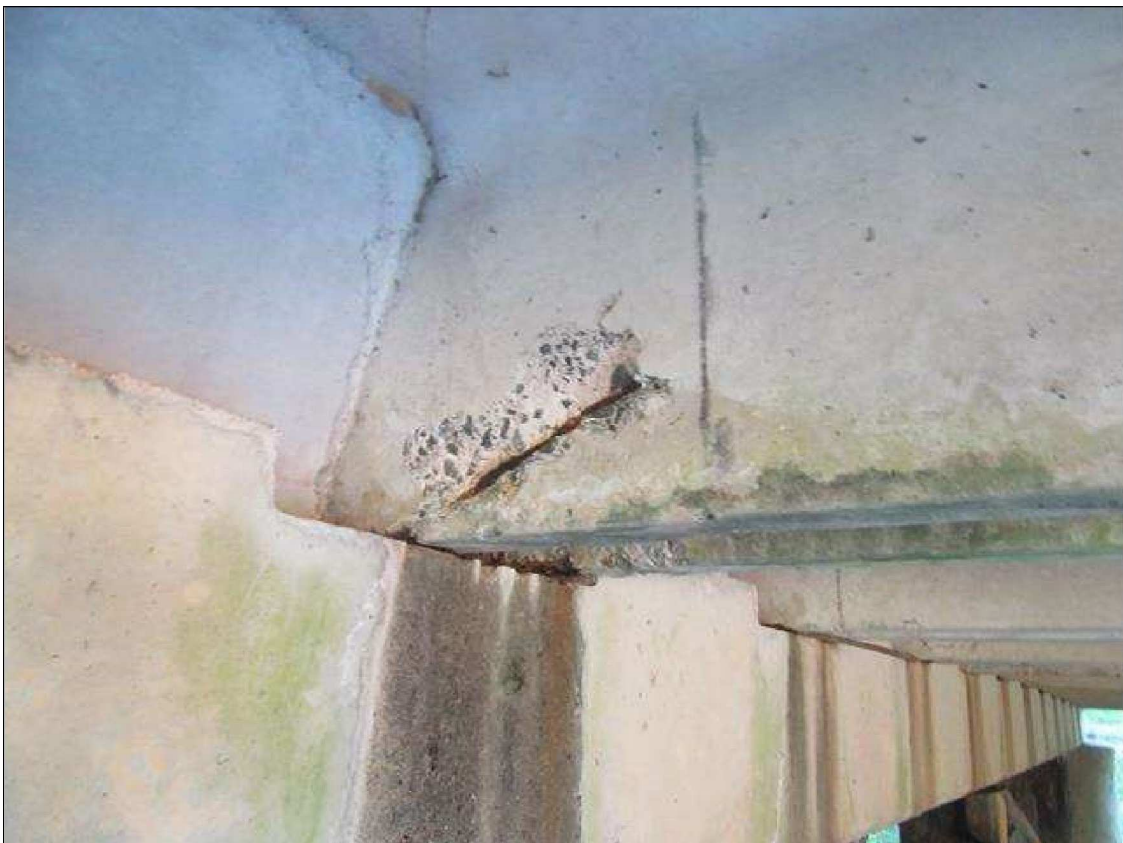
SPAN 1 CHANNEL 1 AT INT. BENT BOTH LEGS HAVE SPALLS WITH EXPOSED DIAGONAL REBAR: RT. LEG 8IN. LINE X 3IN. H X 1/2IN. DEEP, LT. LEG 4IN. LINE X 1/2IN. D X 2IN. HIGH.  
1 Feet of Delamination/Spall: Delaminated. Spall 1 in. or less deep or 6 in. or less in diameter.

Span 1 Slab 1: SPAN 1 CHANNEL 1 AT INT. BENT BOTH LEGS HAVE SPALLS WITH EXPOSED DIAGONAL REBAR: RT. LEG 8IN. LINE X 3IN. H X 1/2IN. DEEP, LT. LEG 4IN. LINE X 1/2IN. D X 2IN. HIGH.

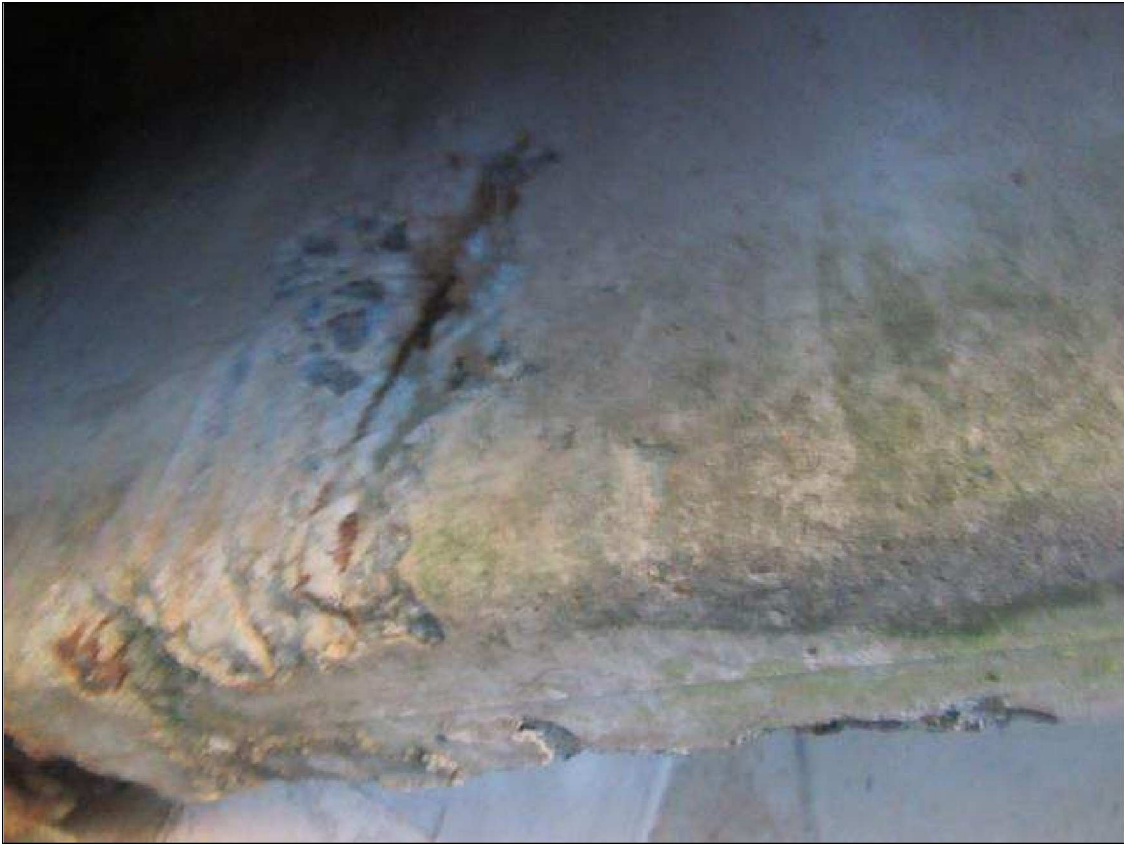
LT. LEG AT INT. BENT SPALL WITH EXPOSED VERTICAL REBAR 1/2IN. D X 4IN. H X 2IN. LONG.  
1 Feet of Delamination/Spall: Delaminated. Spall 1 in. or less deep or 6 in. or less in diameter.

Span 1 Slab 2: LT. LEG AT INT. BENT SPALL WITH EXPOSED VERTICAL REBAR 1/2IN. D X 4IN. H X 2IN. LONG.

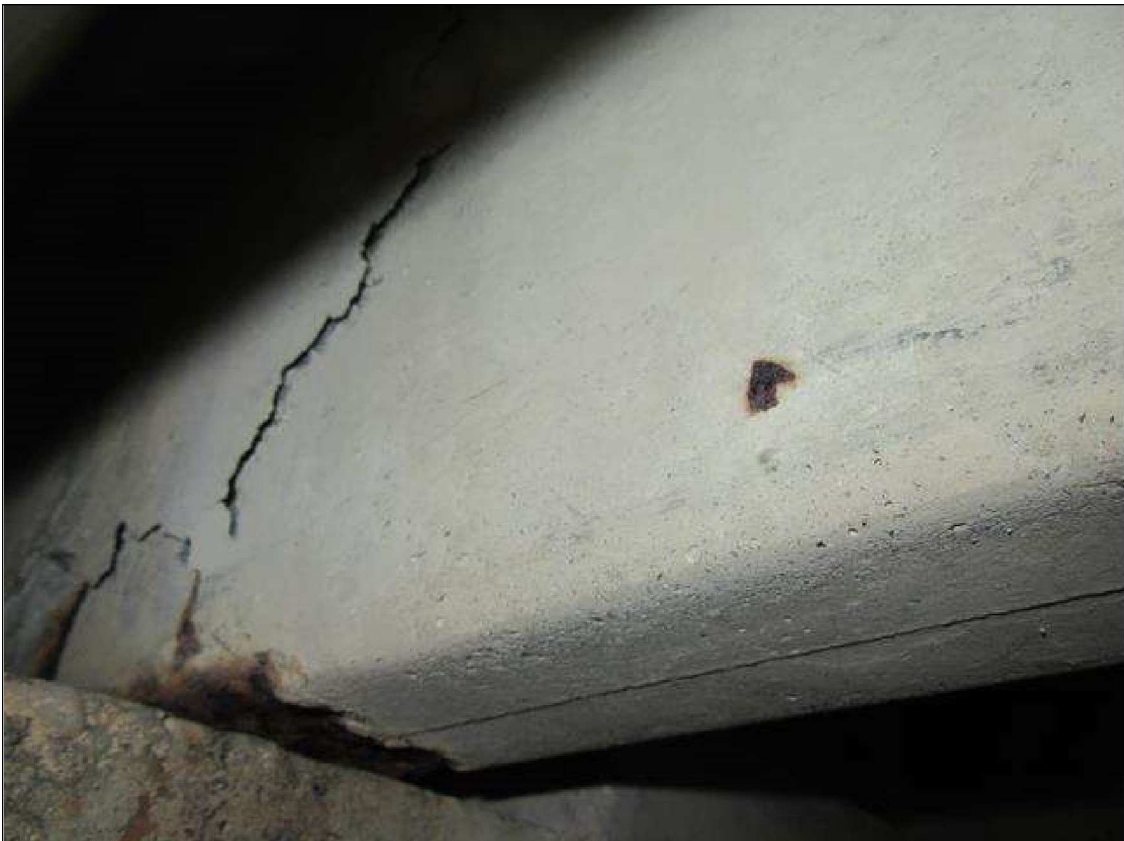
LT. LEG AT INT. BENT SPALL WITH EXPOSED DIAGONAL REBAR 1/2IN. D X 2IN. H X 4IN. LONG.  
1 Feet of Delamination/Spall: Delaminated. Spall 1 in. or less deep or 6 in. or less in diameter.

Span 1 Slab 8: LT. LEG AT INT. BENT SPALL WITH EXPOSED DIAGONAL REBAR 1/2IN. D X 2IN. H X 4IN. LONG.

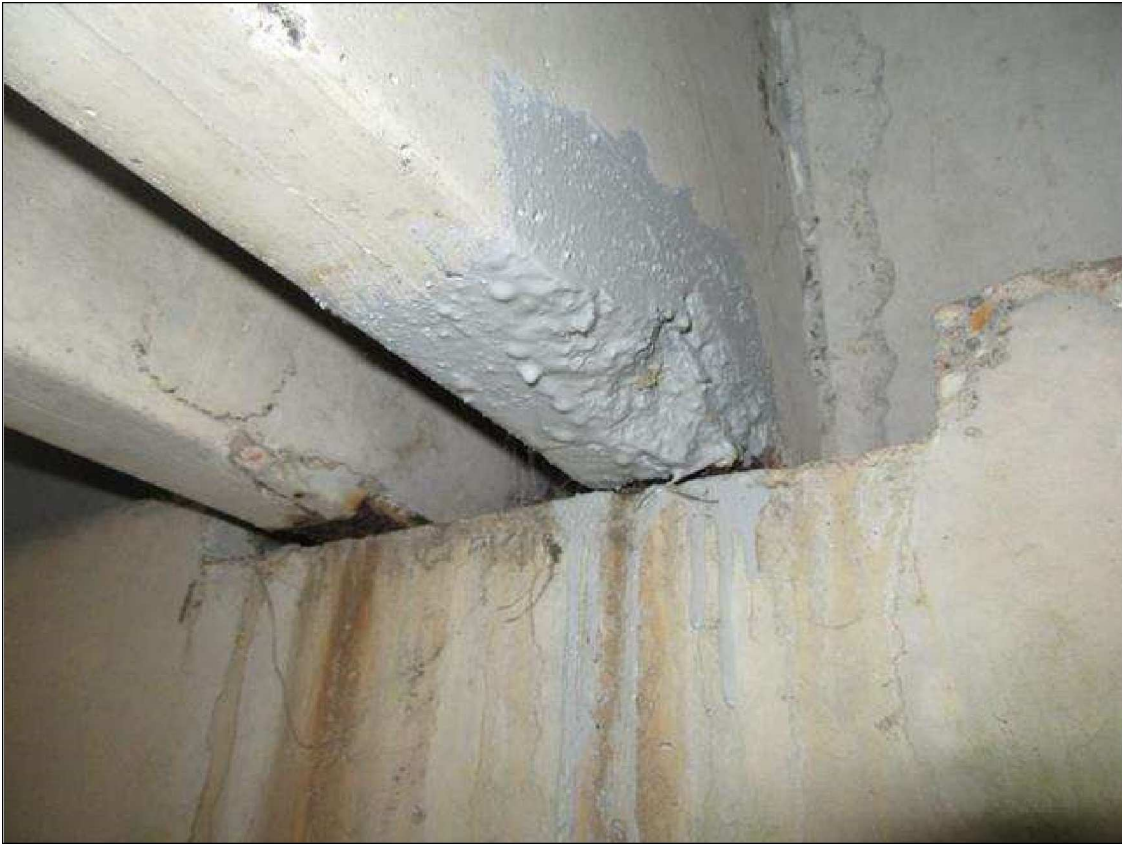
LT. LEG AT INT. BENT SPALL WITH EXPOSED DIAGONAL REBAR 1/2IN. D X 2IN. H X 4IN. LONG.  
1 Feet of Delamination/Spall: Delaminated. Spall 1 in. or less deep or 6 in. or less in diameter.

Span 1 Slab 10: LT. LEG AT INT. BENT SPALL WITH EXPOSED DIAGONAL REBAR 1/2IN. D X 2IN. H X 4IN. LONG.

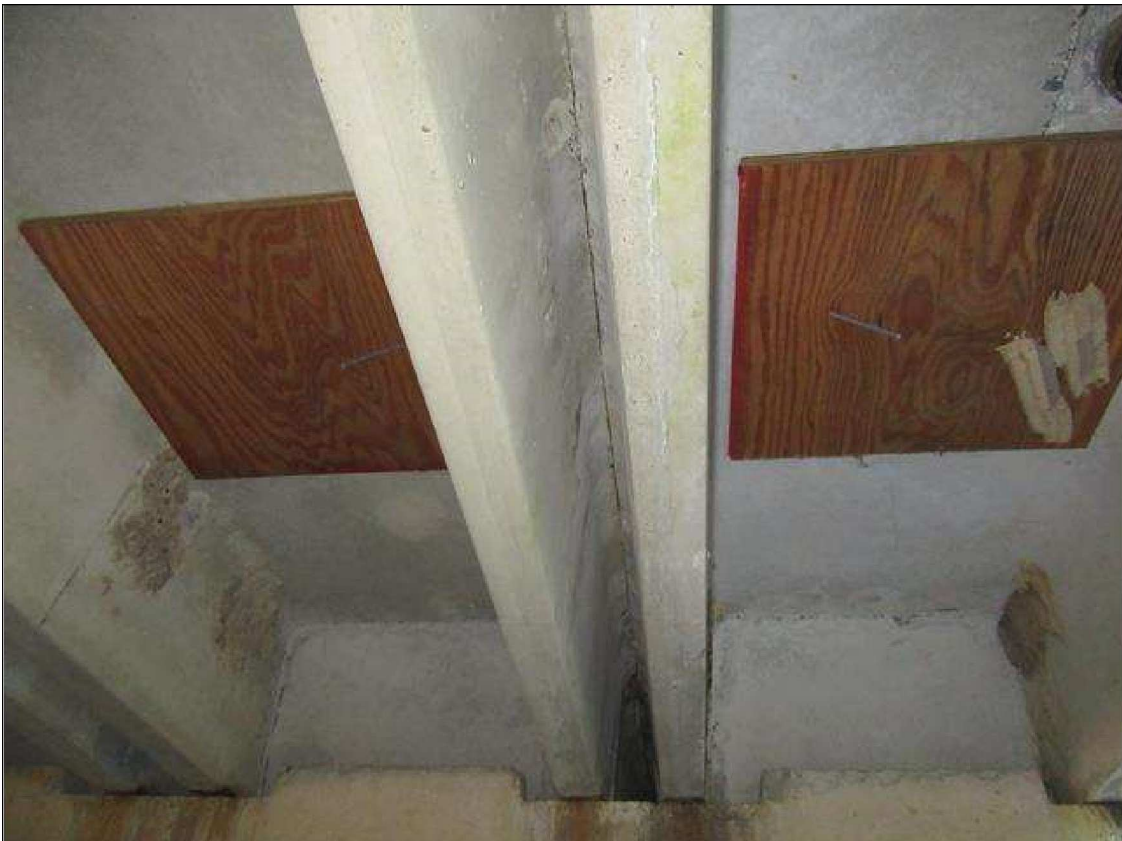
FORM BOARDS IN PLACE , BOTTOM OF TOP CHANNELS 11 AND 12 SPAN 1 NEAR BENT 1

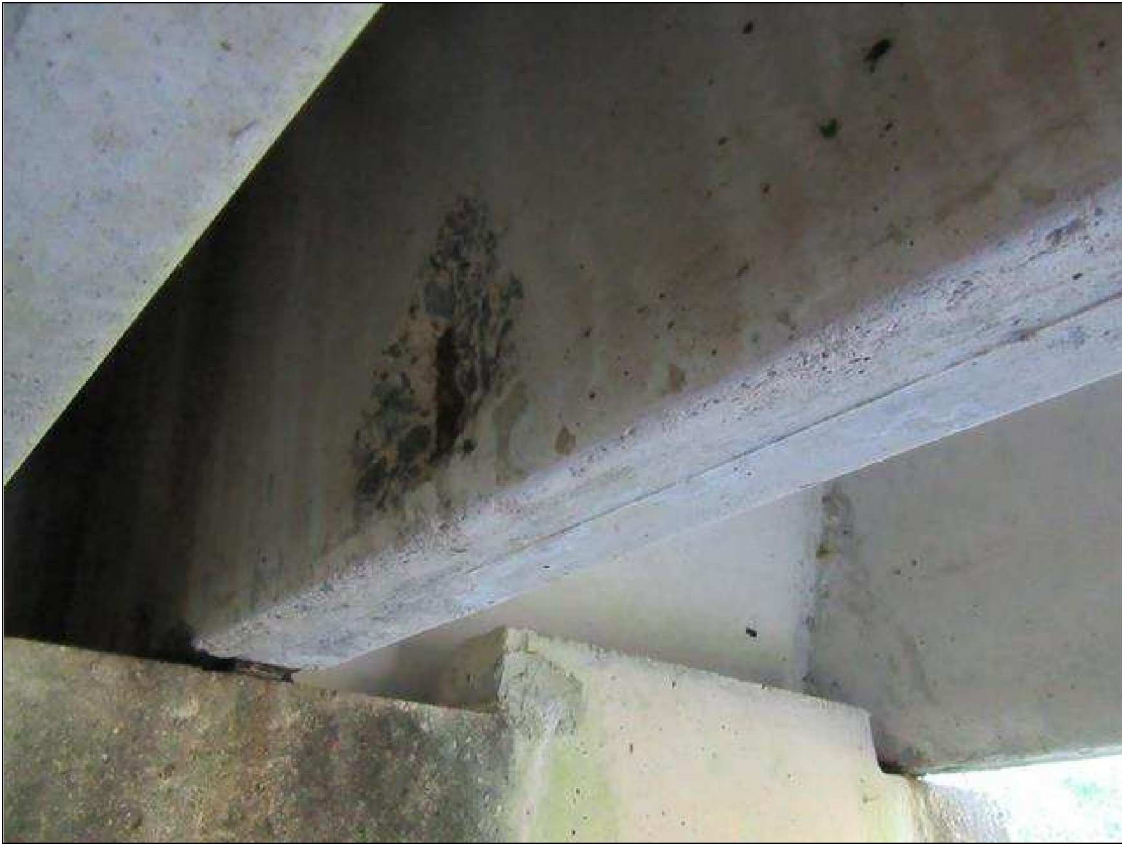
RT. LEG AT INT. BENT HAS SPALL WITH EXPOSED VERTICAL REBAR 2IN. DIA. X 1/2IN. DEEP.

1 Feet of Delamination/Spall: Delaminated. Spall 1 in. or less deep or 6 in. or less in diameter.

Span 2 Slab 1: RT. LEG AT INT. BENT HAS SPALL WITH EXPOSED VERTICAL REBAR 2IN. DIA. X 1/2IN. DEEP.

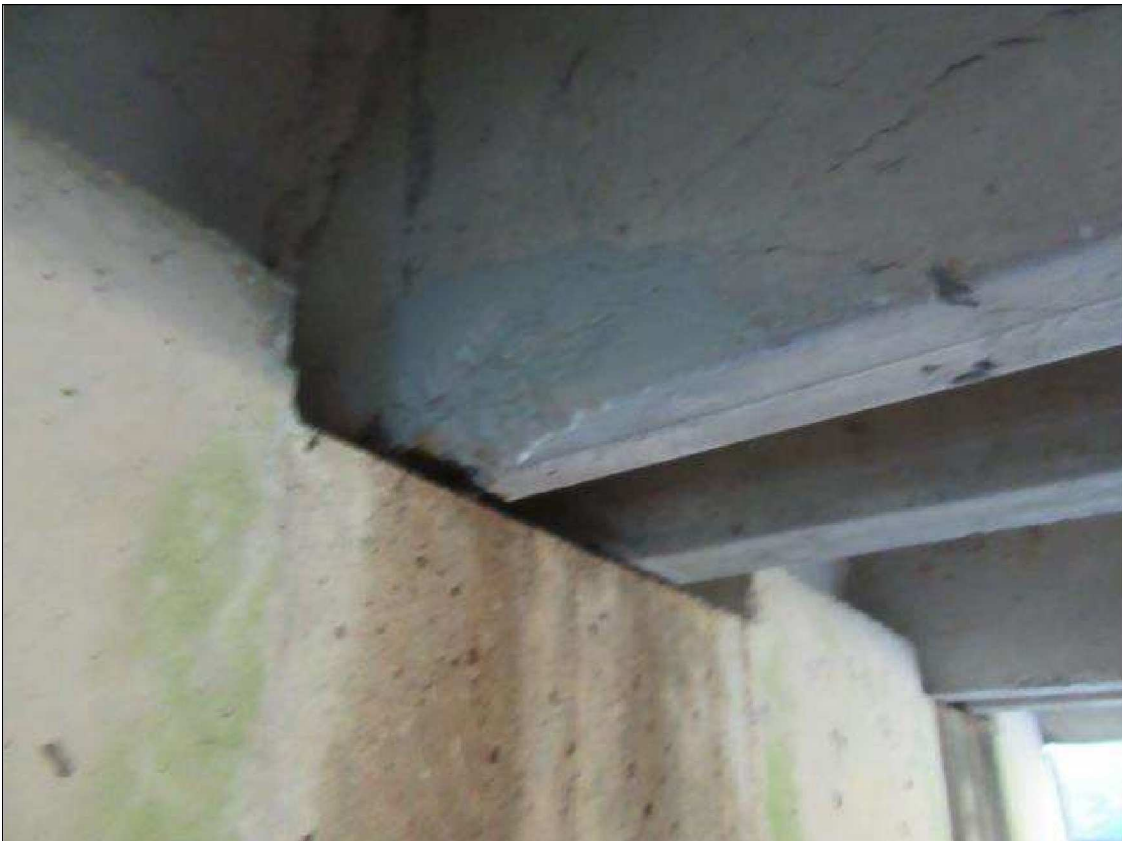
SPAN 2 CHANNEL 3 AT INT. BENT LT. LEG HAS SPALL WITH EXPOSED VERTICAL REBAR 3IN. LINE X 2IN. H X 1/2IN. DEEP.

1 Feet of Delamination/Spall: Delaminated. Spall 1 in. or less deep or 6 in. or less in diameter.

Span 2 Slab 3: LT. LEG HAS SPALL WITH EXPOSED VERTICAL REBAR 3IN. LINE X 2IN. H X 1/2IN. DEEP.

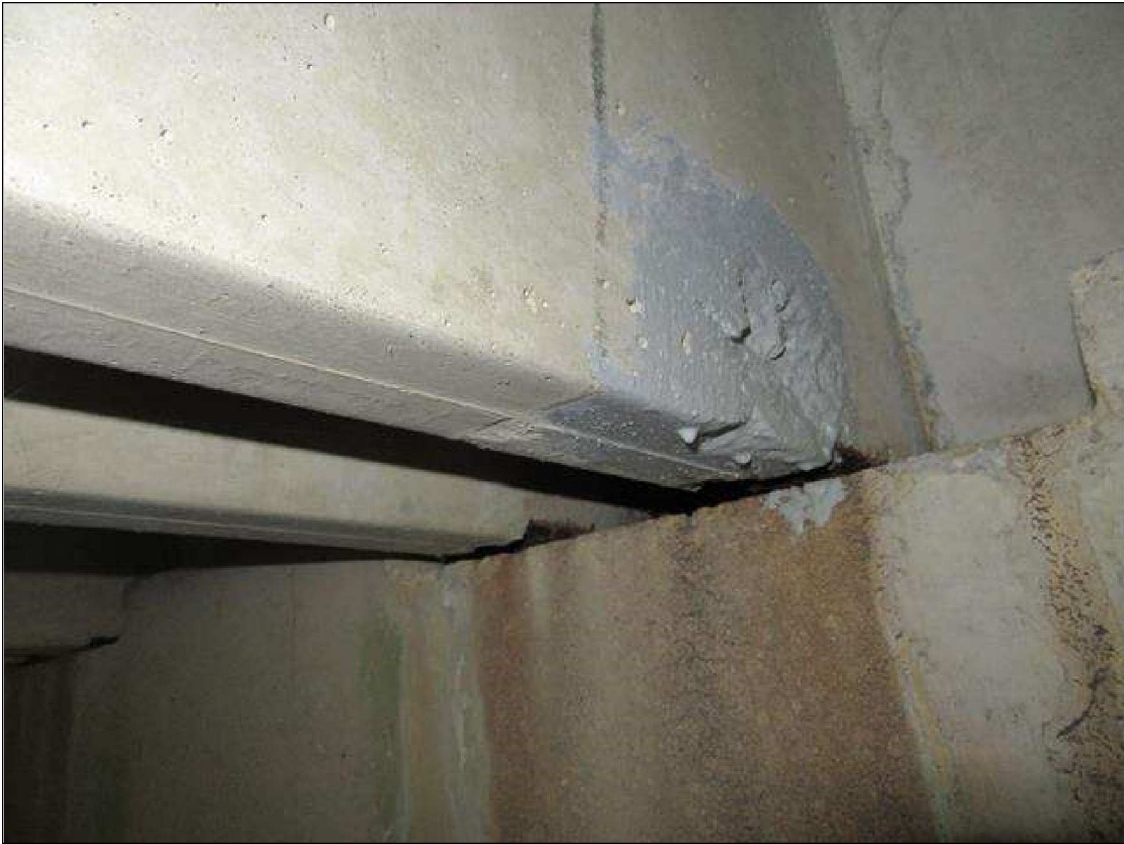
SPAN 2 CHANNEL 4 AT INT. BENT RT. LEG HAS SPALL WITH EXPOSED VERTICAL REBAR 3IN. H X 2IN. LINE X 1/2IN. DEEP.

1 Feet of Delamination/Spall: Delaminated. Spall 1 in. or less deep or 6 in. or less in diameter.

Span 2 Slab 4: RT. LEG HAS SPALL WITH EXPOSED VERTICAL REBAR 3IN. H X 2IN. LINE X 1/2IN. DEEP.

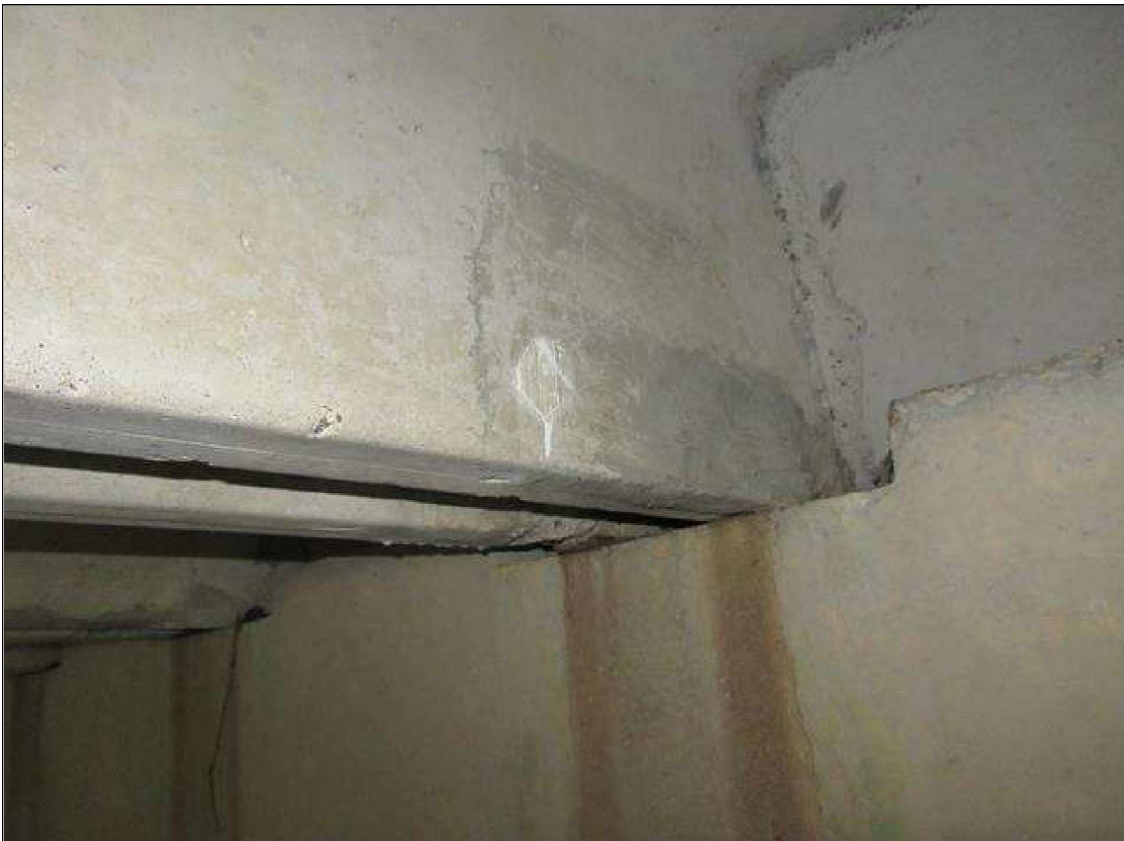
| Element Number | Defect Type | Defect Description | CS | CS Qty | Maint Qty |
|---|---|---|---|---|---|
| 109 | Delamination/Spall | BOTTOM RT. LEG HAS CONC. PATCH 6IN. LINE X 4IN. H X 2IN. WIDE. | 2 | 1 | 1 Feet |

Span 2 Slab 6: BOTTOM RT. LEG HAS CONC. PATCH 6IN. LINE X 4IN. H X 2IN. WIDE.

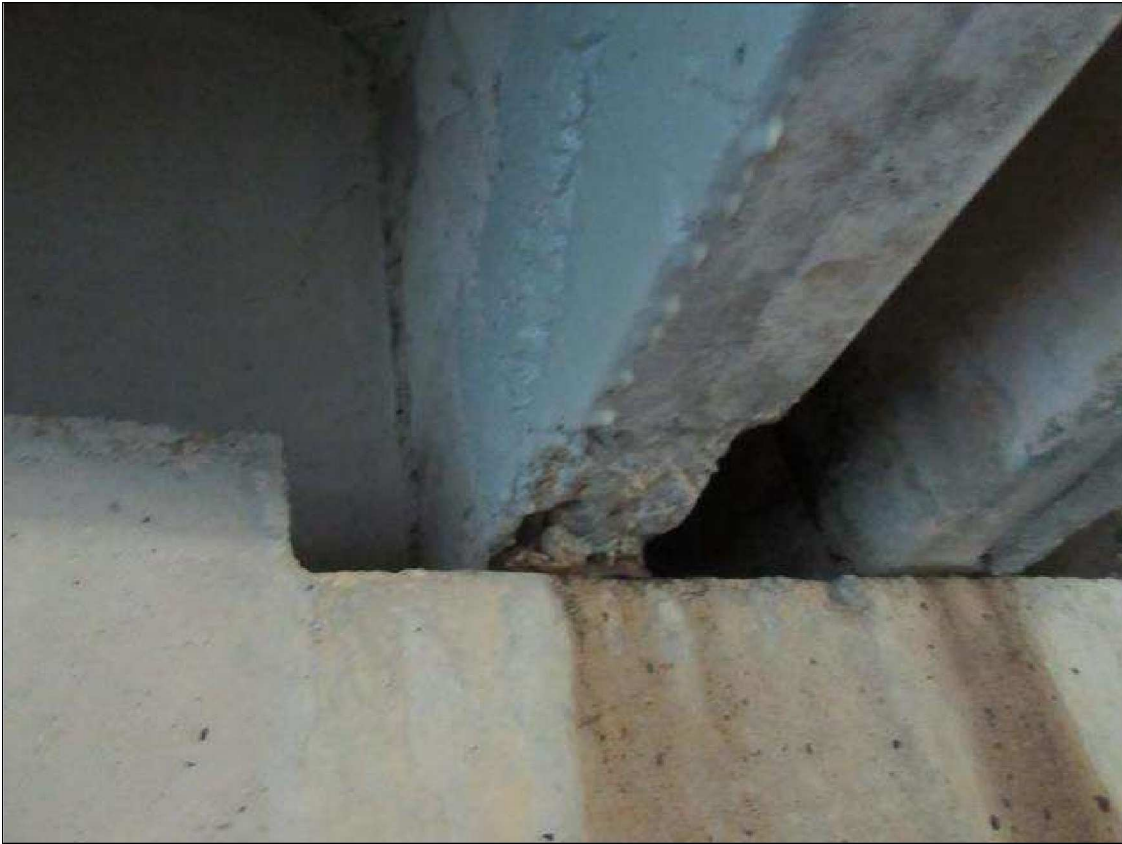
SPAN 2 CHANNEL 7 AT INT. BENT, LT. LEG INSIDE FACE HAS SPALL WITH EXPOSED DIAGONAL REBAR 4IN. LINE X 2IN. H X 1/2IN. DEEP AND HONEYCOMB 2IN. LINE ON UNDERSIDE OF LT. LEG. 1 Feet of Delamination/Spall: Delaminated. Spall 1 in. or less deep or 6 in. or less in diameter.

Span 2 Slab 7: LT. LEG INSIDE FACE HAS SPALL WITH EXPOSED DIAGONAL REBAR 4IN. LINE X 2IN. H X 1/2IN. DEEP AND HONEYCOMB 2IN. LINE ON UNDERSIDE OF LT. LEG. 1

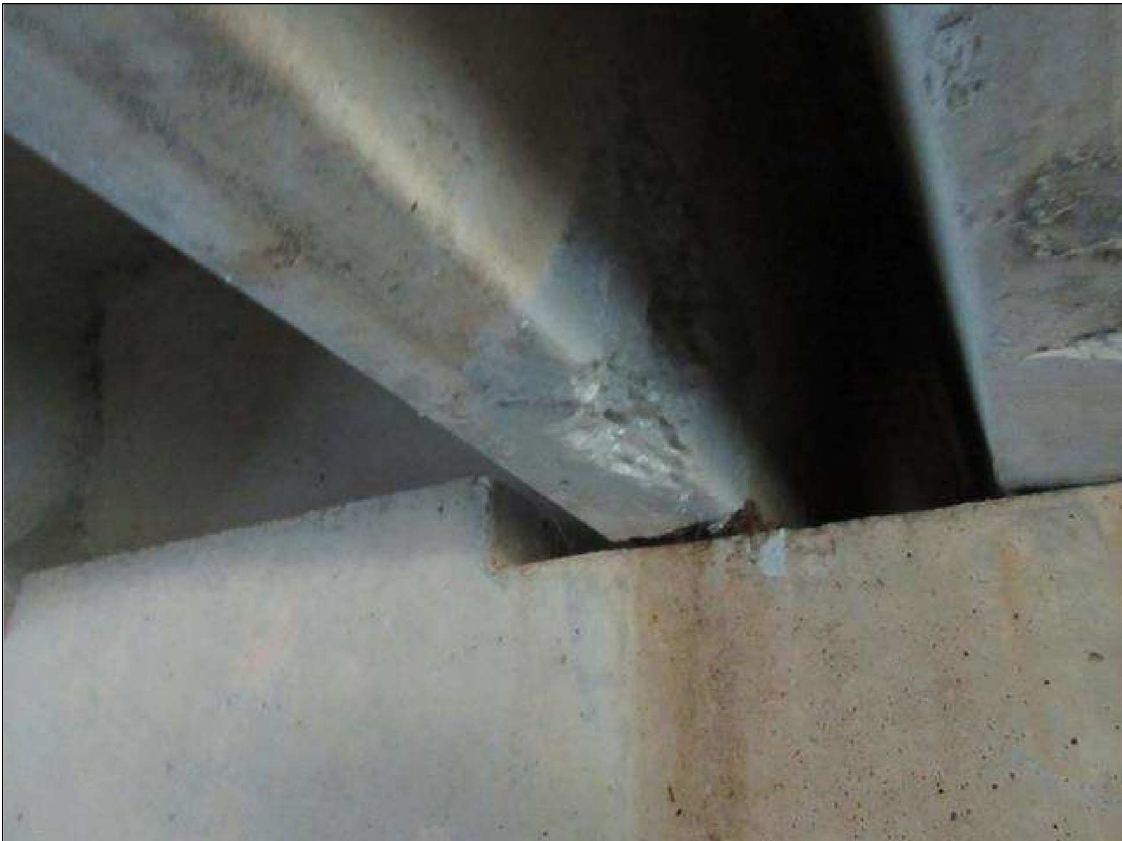
BOTTOM OF RT. LEG AT INT. BENT. HAS CONC. PATCH TO SPALL IN 9IN. LINE X UP TO 4IN. HIGH.  
1 Feet of Patched Area: Patched area that is sound

Span 2 Slab 8: RT. LEG AT INT. BENT. HAS CONC. PATCH TO SPALL IN 9IN. LINE X UP TO 4IN. HIGH.
