NC DEPARTMENT OF TRANSPORTATION  
DIVISION OF HIGHWAYS  
STRUCTURE MANAGEMENT UNIT

# Structure Safety Report

## Routine Element Inspection

DIVISION: 6 COUNTY: ROBESON STRUCTURE NUMBER: 770108 FREQUENCY: 24 MONTHS

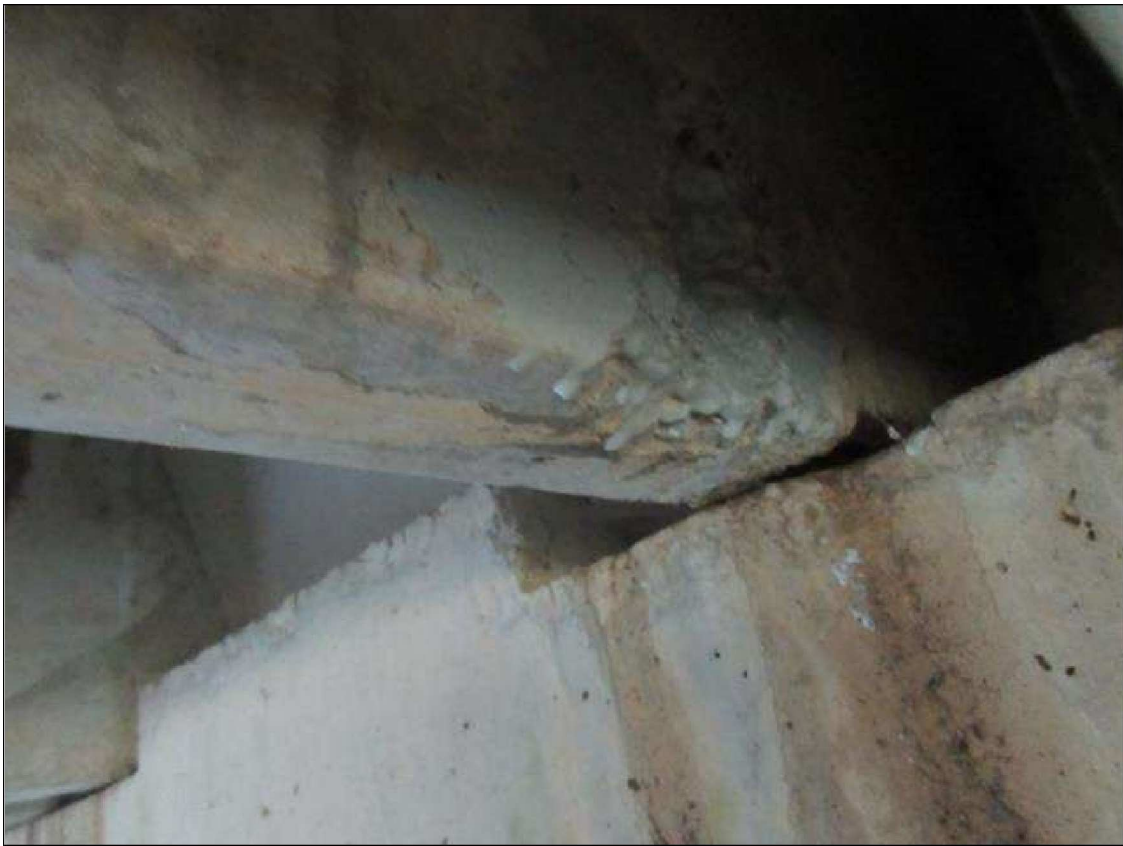
SPAN 2 CHANNEL 10 AT INT. BENT CAP BOTTOM LT. LEG SPALL WITH EXPOSED STEEL 1/2IN. D X 3IN. DIA.  
1 Feet of Delamination/Spall: Delaminated. Spall 1 in. or less deep or 6 in. or less in diameter.

Span 2 Slab 10: BOTTOM LT. LEG SPALL WITH EXPOSED STEEL 1/2IN. D X 3IN. DIA.

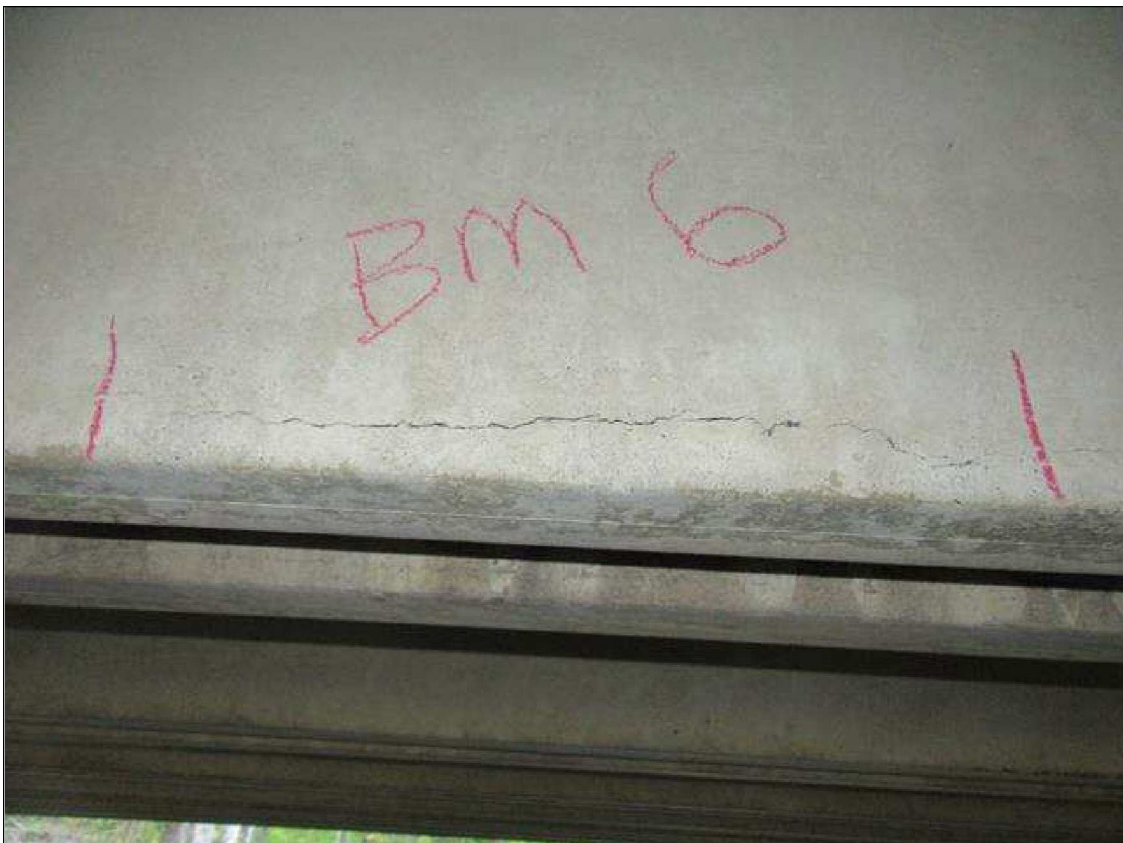
| Element Number | Defect Type | Defect Description | CS | CS Qty | Maint Qty |
|---|---|---|---|---|---|
| 109 | Cracking (PSC) | 1/16" WIDE X 1 FT. LONG HORIZONTAL CRACK IN RIGHT LEG AT MID SPAN | 2 | 1 | 1 Feet |

Span 2 Slab 6: 1/16" WIDE X 1 FT. LONG HORIZONTAL CRACK IN RIGHT LEG AT MID SPAN

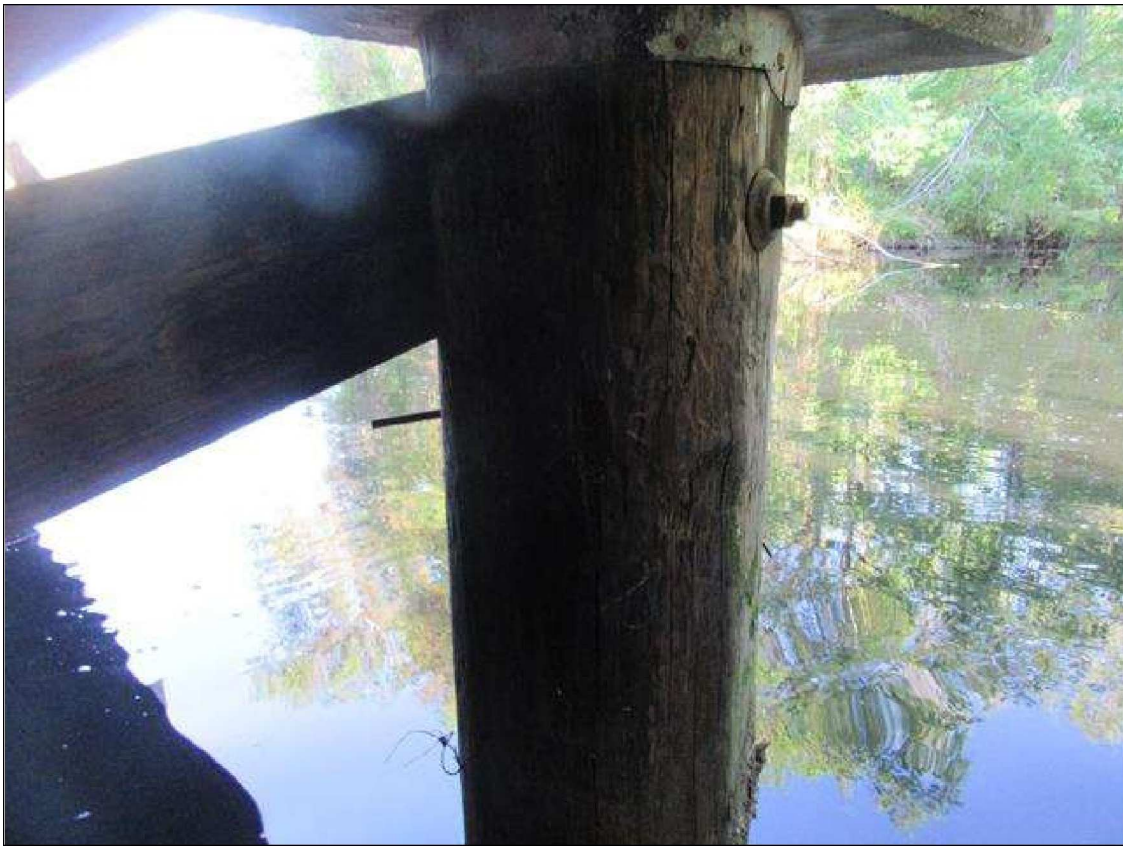
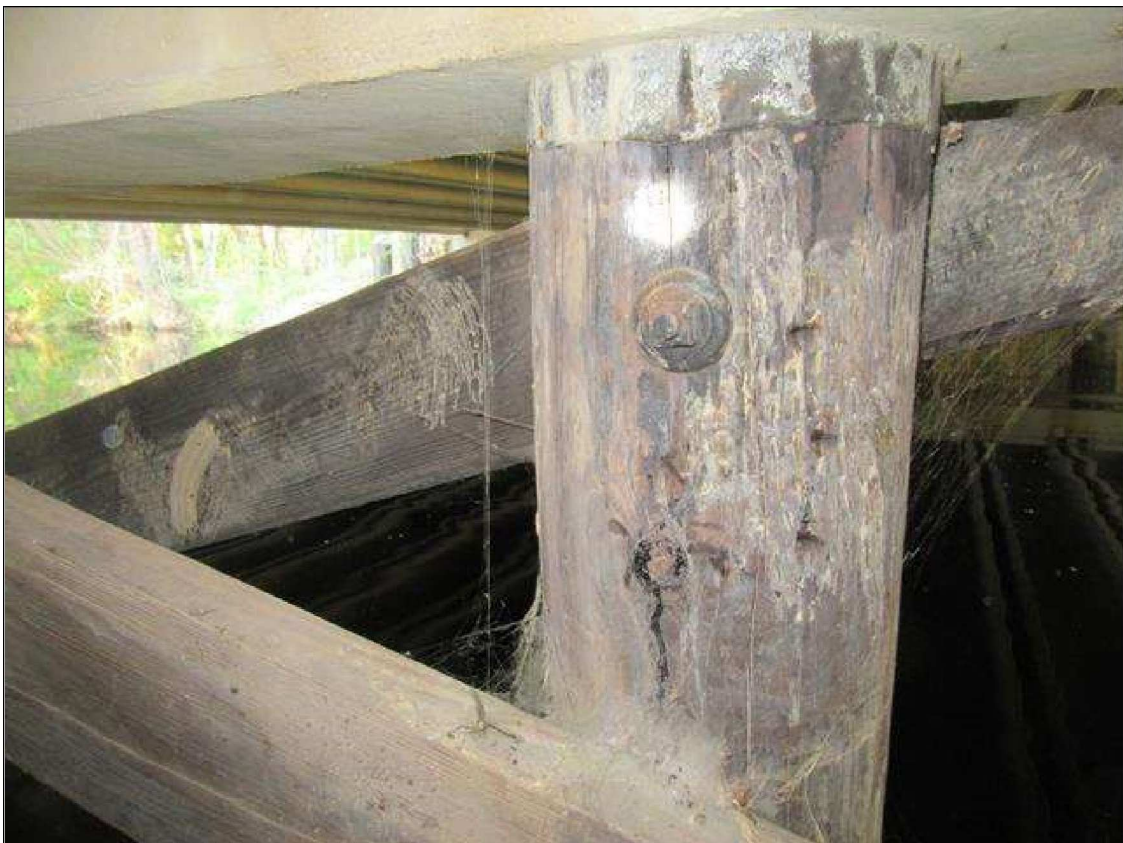
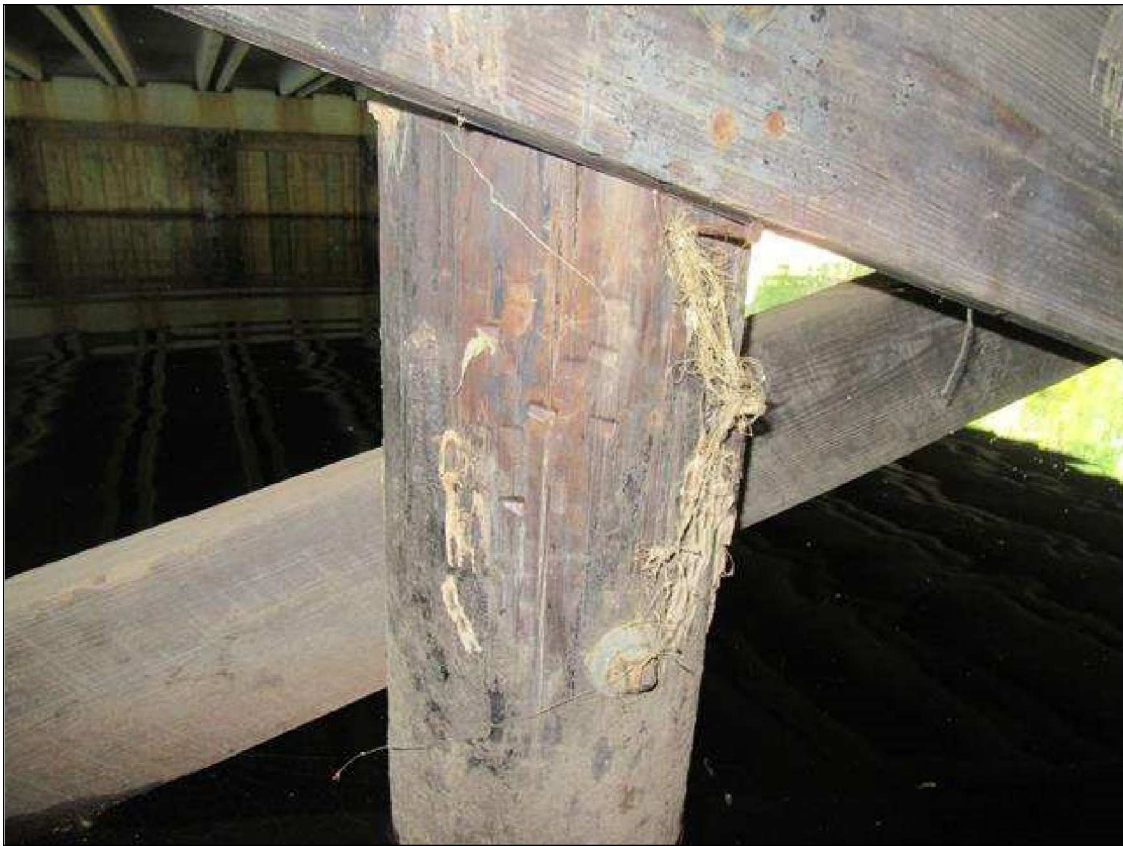
Bent 1 Pile 1: 1/16" TO 1/8" WIDE X 3 FT. HIGH X 1/2" DEEP VERTICAL CHECKS

1/16" TO 1/8" WIDE X 3 FT. HIGH X 1/2" DEEP VERTICAL CHECKS

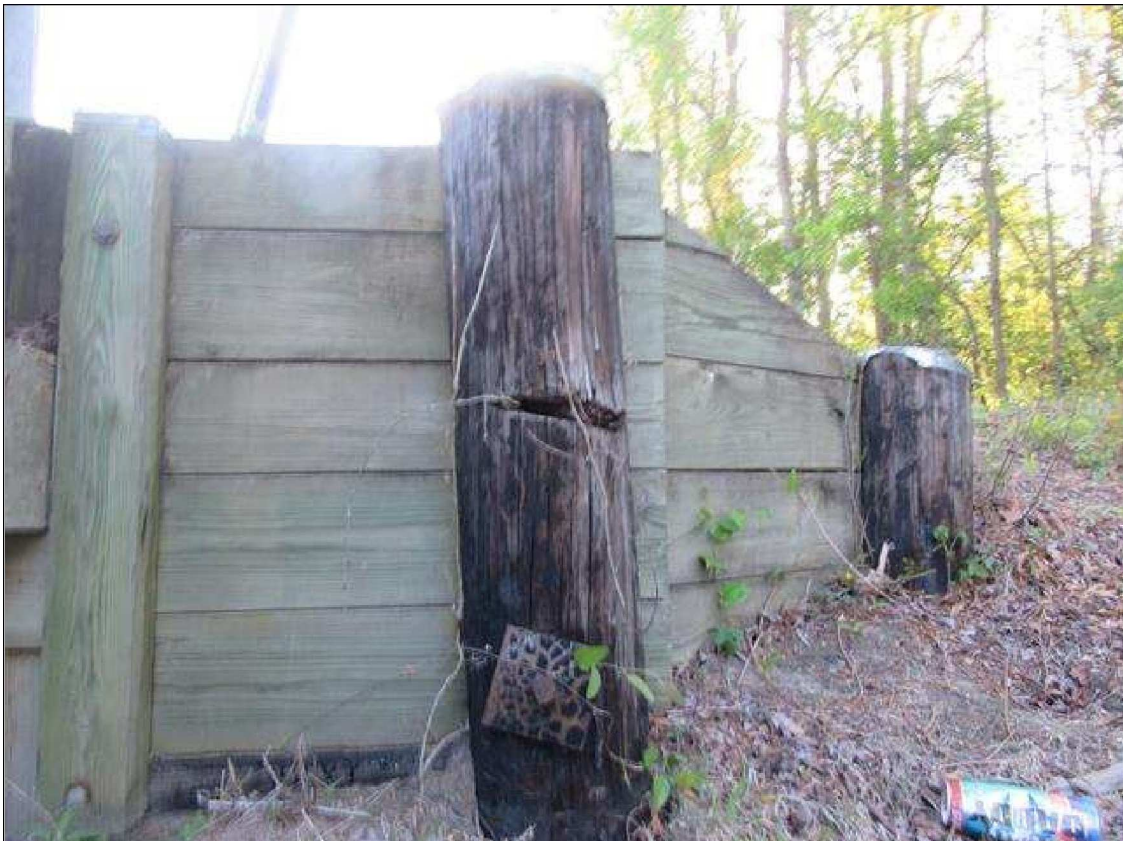
| Element Number | Defect Type | Defect Description | CS | CS Qty | Maint Qty |
|---|---|---|---|---|---|
| 216 | Decay/Section Loss | MOWER DAMAGE AND 1/16" WIDE VERTICAL CHECKS AT SOUTHEAST TURNPILE | 2 | 1 | Feet |

End Bent 2 Abutment/Backwall : MOWER DAMAGE AND 1/16" WIDE VERTICAL CHECKS AT SOUTHEAST TURNPILE

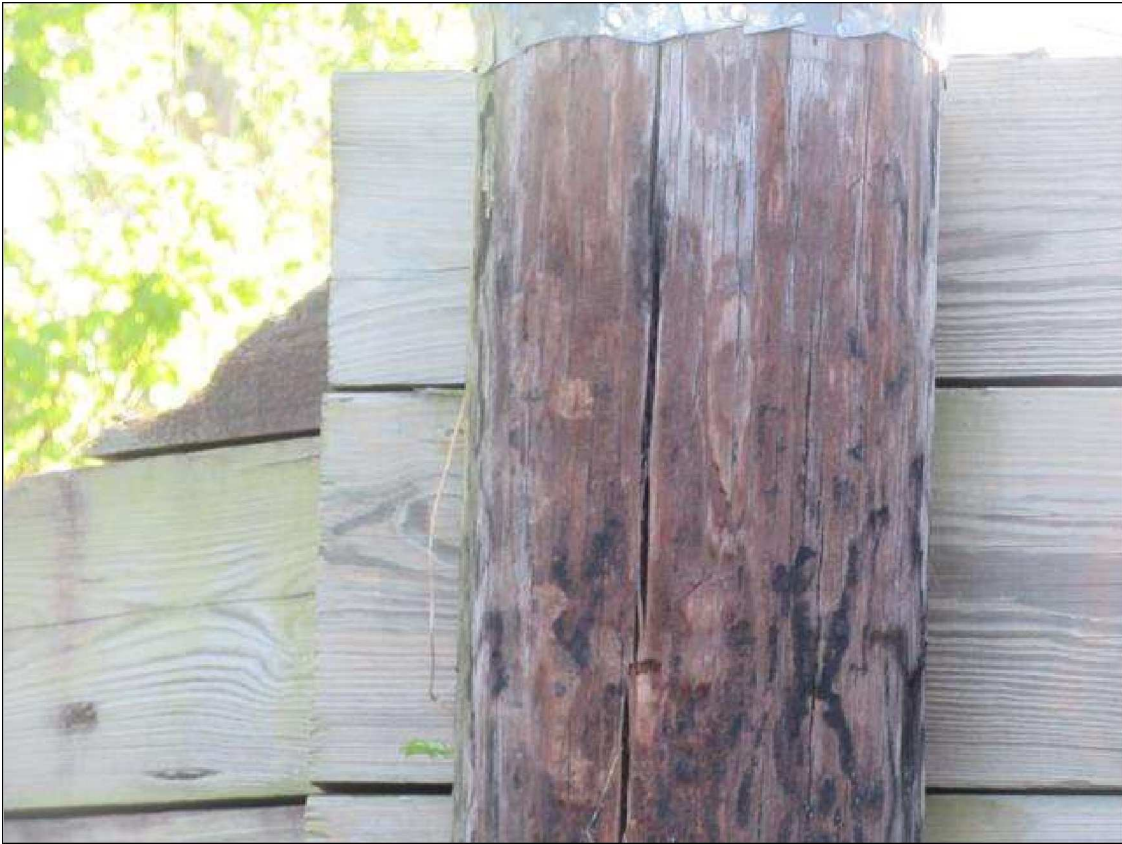
End Bent 2 Abutment/Backwall : 1/8" WIDE VERTICAL CHECKS TURNPILE AT NORTHEAST CORNER

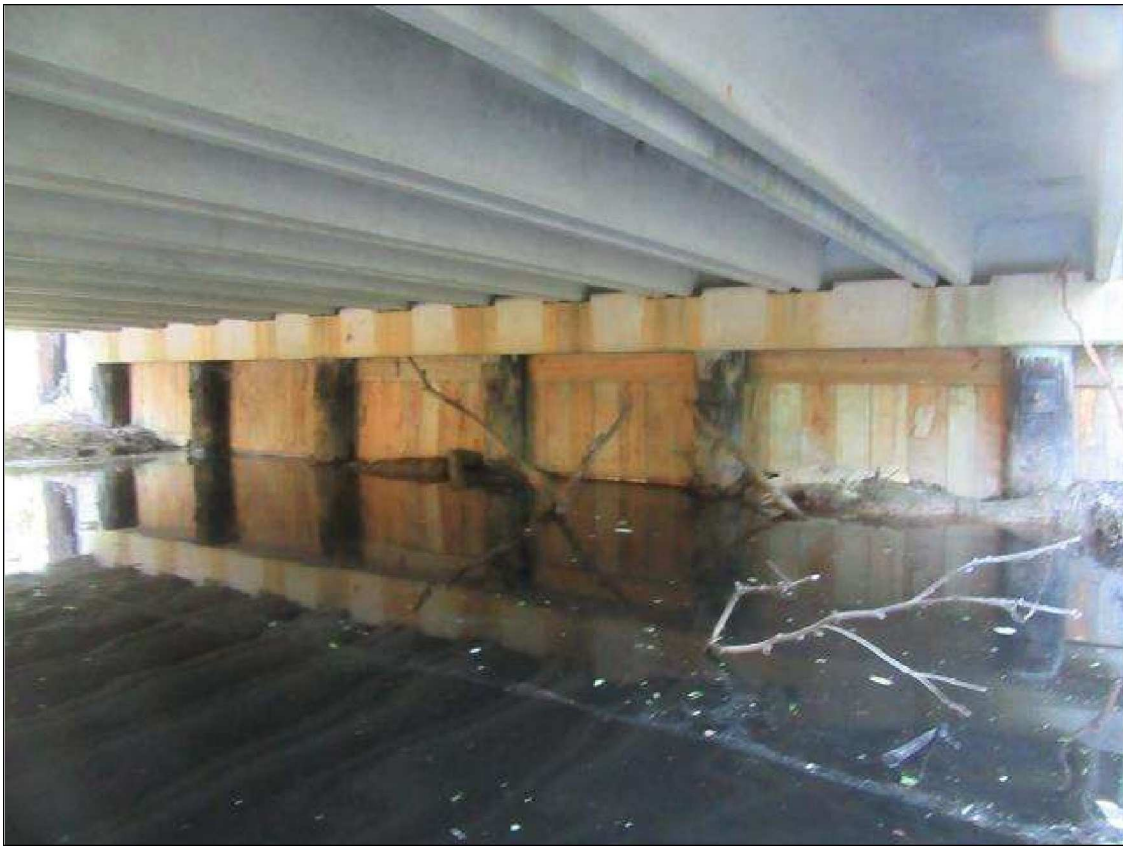
NEW BULKHEAD BOARDS AT END BENT 2, SIMILAR AT END BENT 1
