NC DEPARTMENT OF TRANSPORTATION  
DIVISION OF HIGHWAYS  
STRUCTURE MANAGEMENT UNIT

## Structure Safety Report

### Routine Element Inspection - Contract

COUNTY: BUNCOMBE STRUCTURE NUMBER: 100088 FREQUENCY: 24 MONTHS

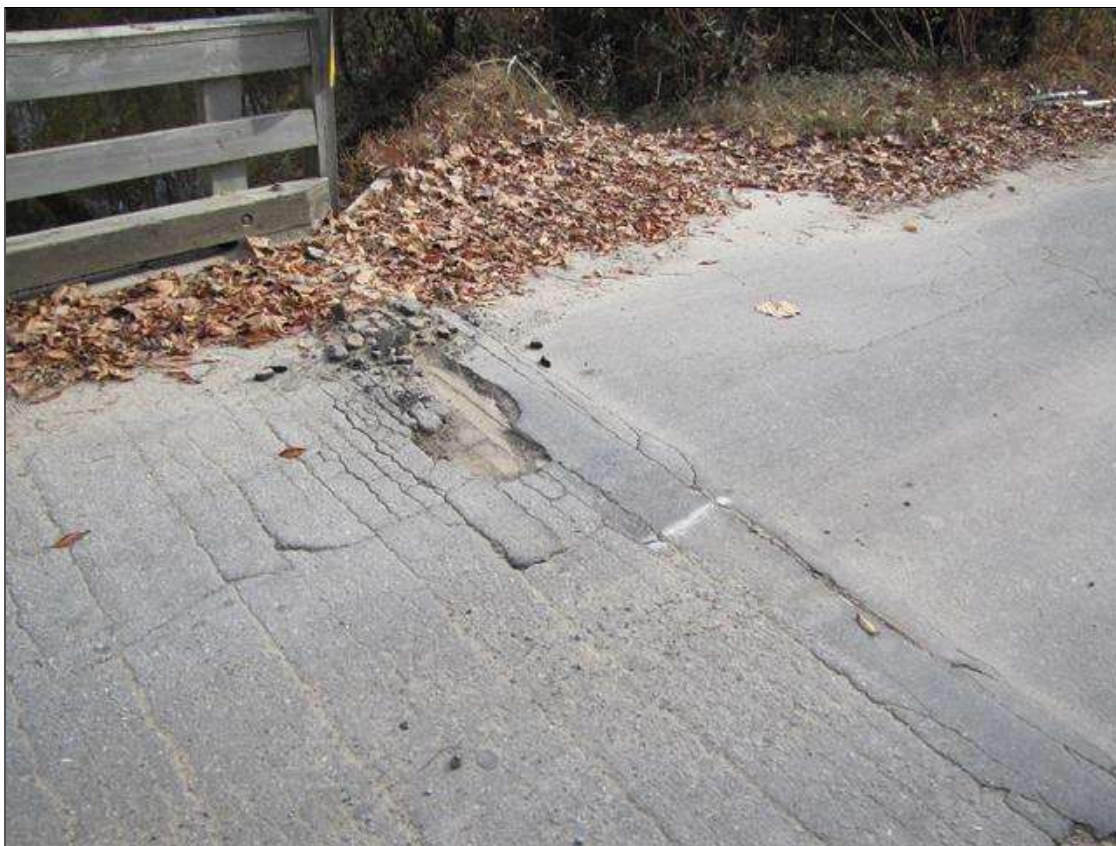
| Element Number | Element Name | Total Qty | CS1 Qty | CS2 Qty | CS3 Qty | CS4 Qty | |
|---|---|---|---|---|---|---|---|
| 510 | Damage | LOSS OF ASPHALT WEARING SURFACE AT SOUTHEAST CORNER | 4 | 3 | 3 | Square Feet | |

Span 1 Wearing Surface: LOSS OF ASPHALT WEARING SURFACE AT SOUTHEAST CORNER

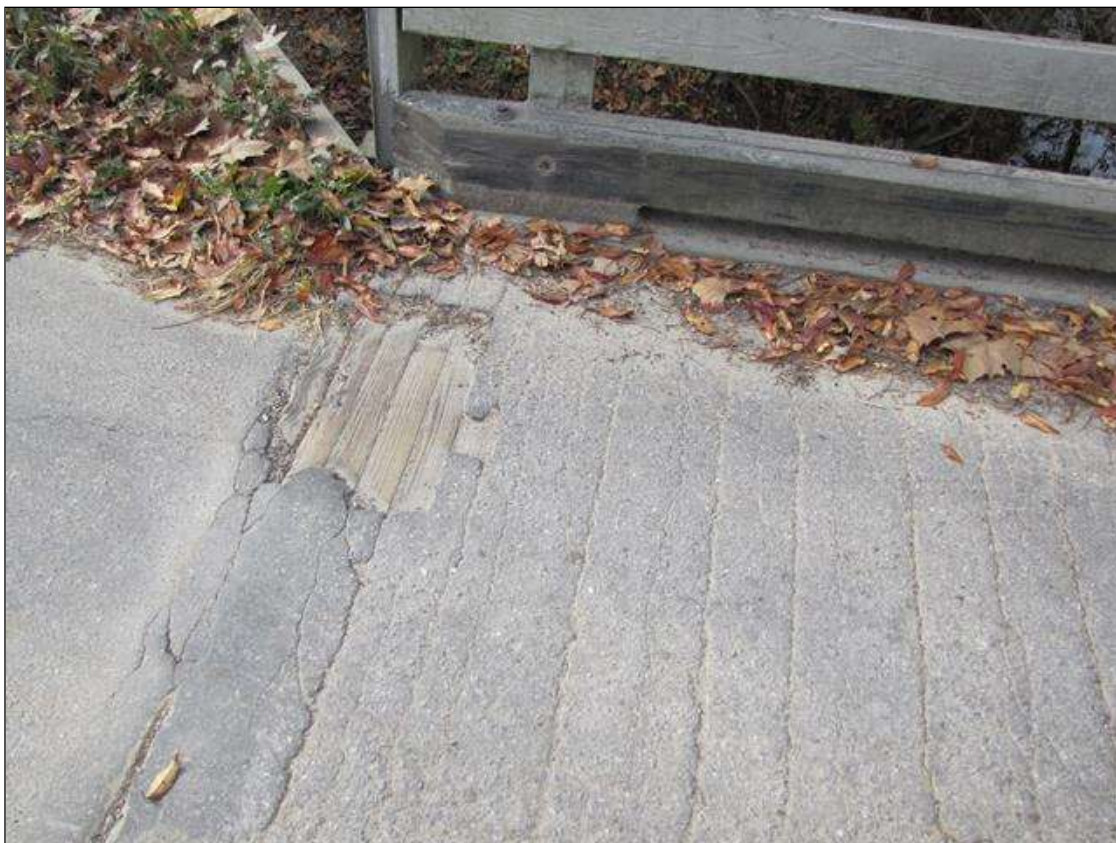
| Element Number | Element Name | Total Qty | CS1 Qty | CS2 Qty | CS3 Qty | CS4 Qty | |
|---|---|---|---|---|---|---|---|
| 510 | Damage | LOSS OF ASPHALT WEARING SURFACE AT SOUTHWEST | 4 | 2 | 2 | Square Feet | |

Span 1 Wearing Surface: LOSS OF ASPHALT WEARING SURFACE AT SOUTHWEST CORNER

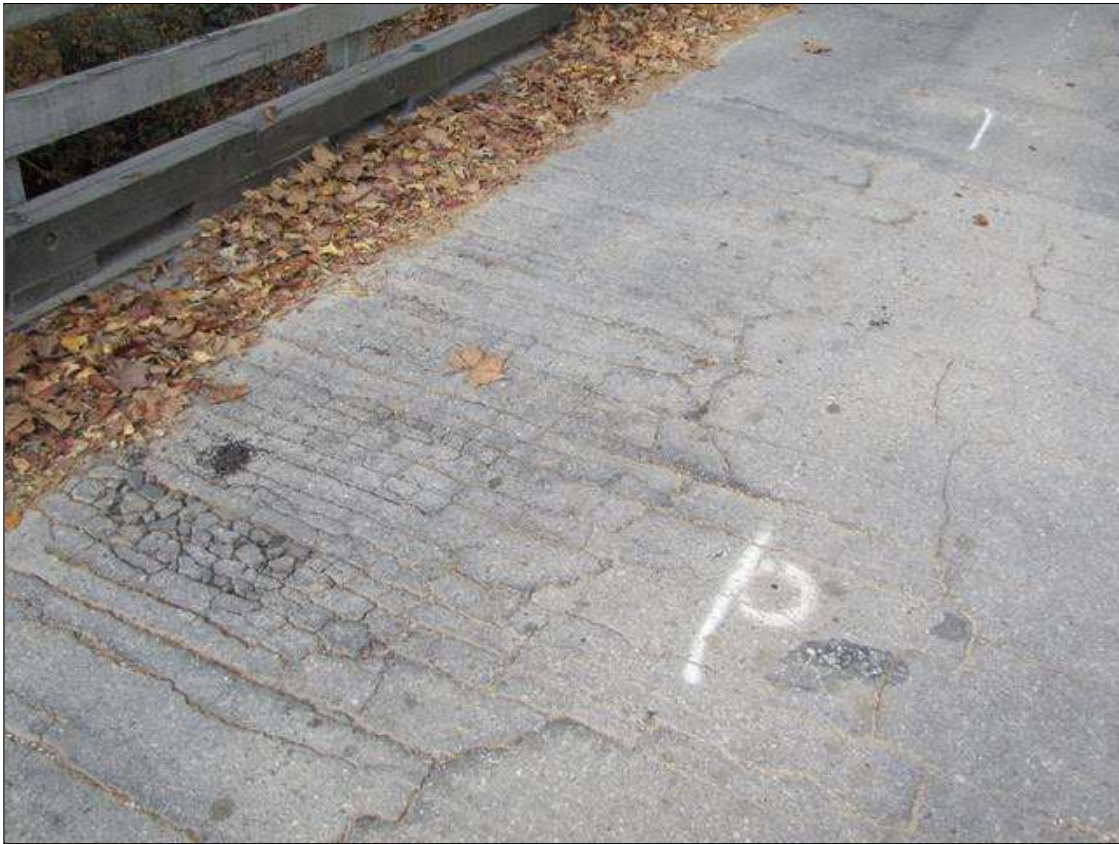
| 510 | Crack (Wearing Surface) | CORNER<br>TRANSVERSE REFLECTIVE CRACKING UP TO 1/2" WIDE<br>WITH RANDOM AREAS OF BROKEN PAVEMENT OVER<br>ENTIRE SURFACE | 3 | 636 | 636 Square Feet |

Span 1 Wearing Surface: TRANSVERSE REFLECTIVE CRACKING UP TO 1/2" WIDE WITH RANDOM AREAS OF BROKEN PAVEMENT OVER ENTIRE SURFACE

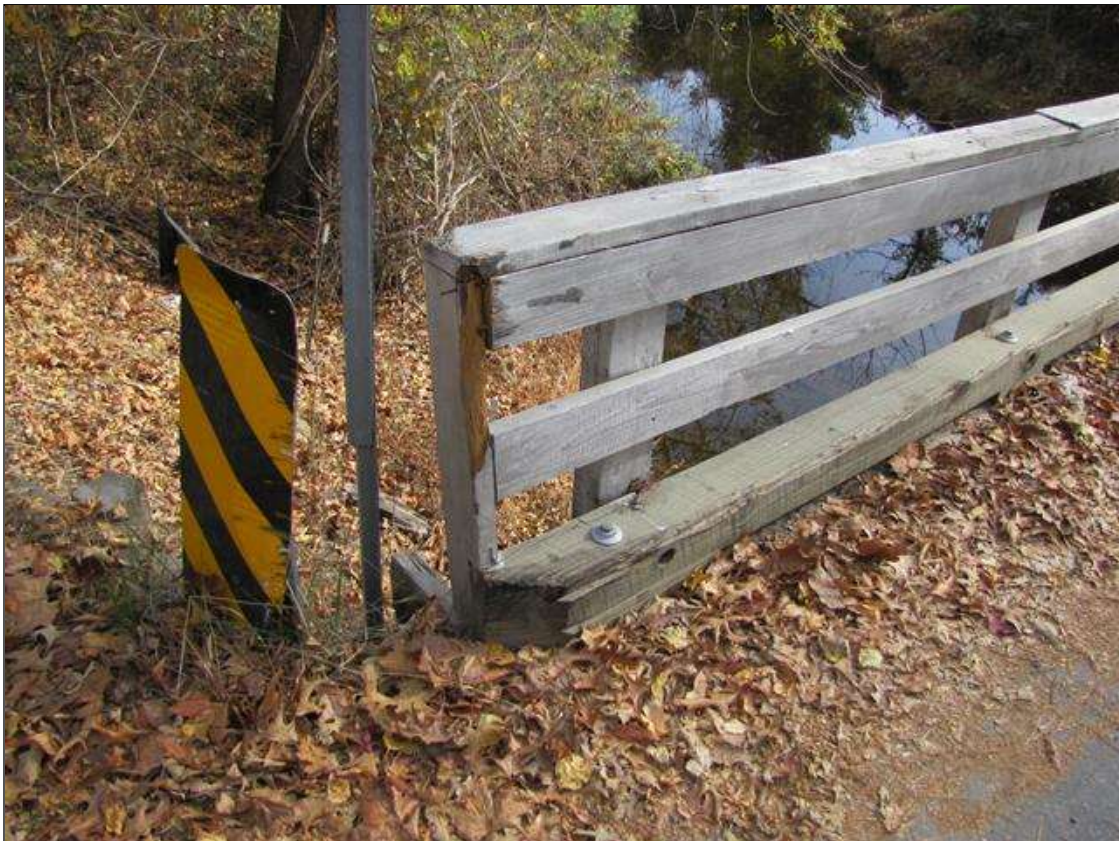
| Element Number | Defect Type | Defect Description | CS | CS Qty | Maint Qty |
|---|---|---|---|---|---|
| 332 | Damage | IMPACT DAMAGE TO END POST AT NORTHEAST CORNER | 2 | 1 | 1 Feet |

Span 1 Right Bridge Rail: IMPACT DAMAGE TO END POST AT NORTHEAST CORNER

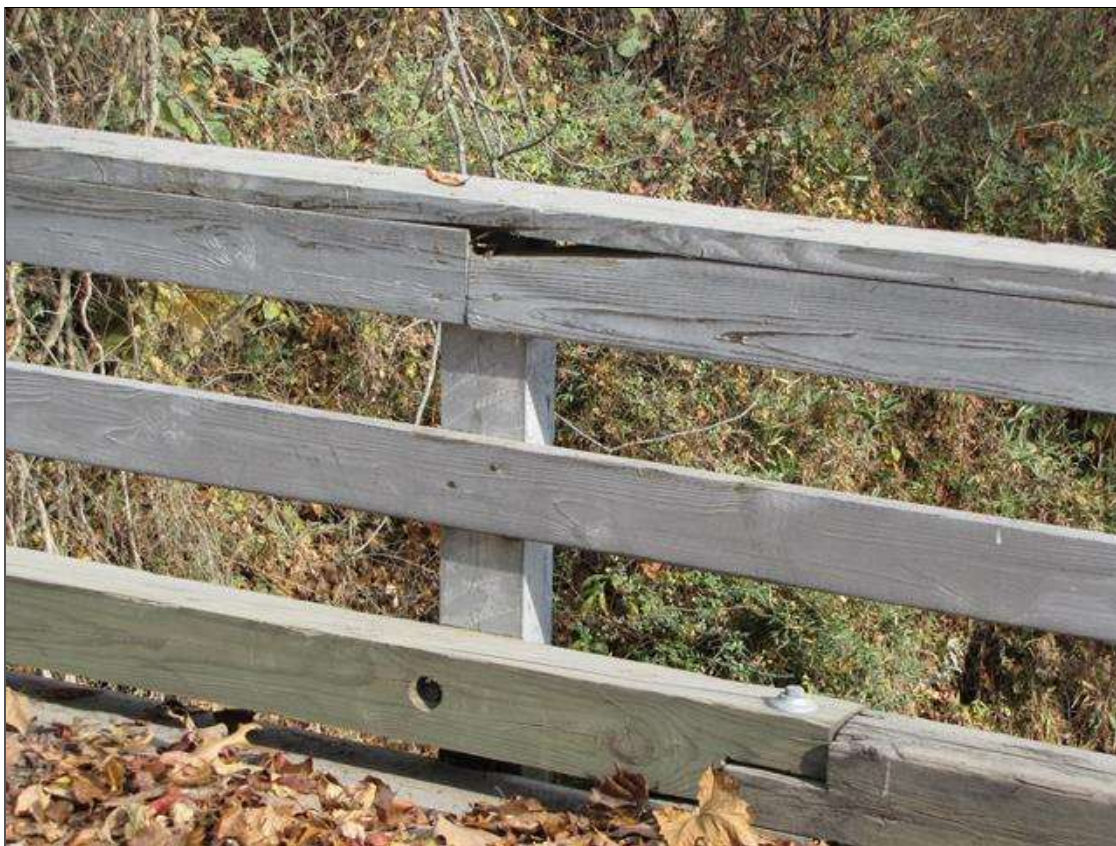
| Element Number | Defect Type | Defect Description | CS | CS Qty | Maint Qty |
|---|---|---|---|---|---|
| 332 | Split/Delamination (Timber) | SPLIT IN TOP RAIL AT RAIL POST #4 | 2 | 1 | 1 Feet |

Span 1 Right Bridge Rail: SPLIT IN TOP RAIL AT RAIL POST #4

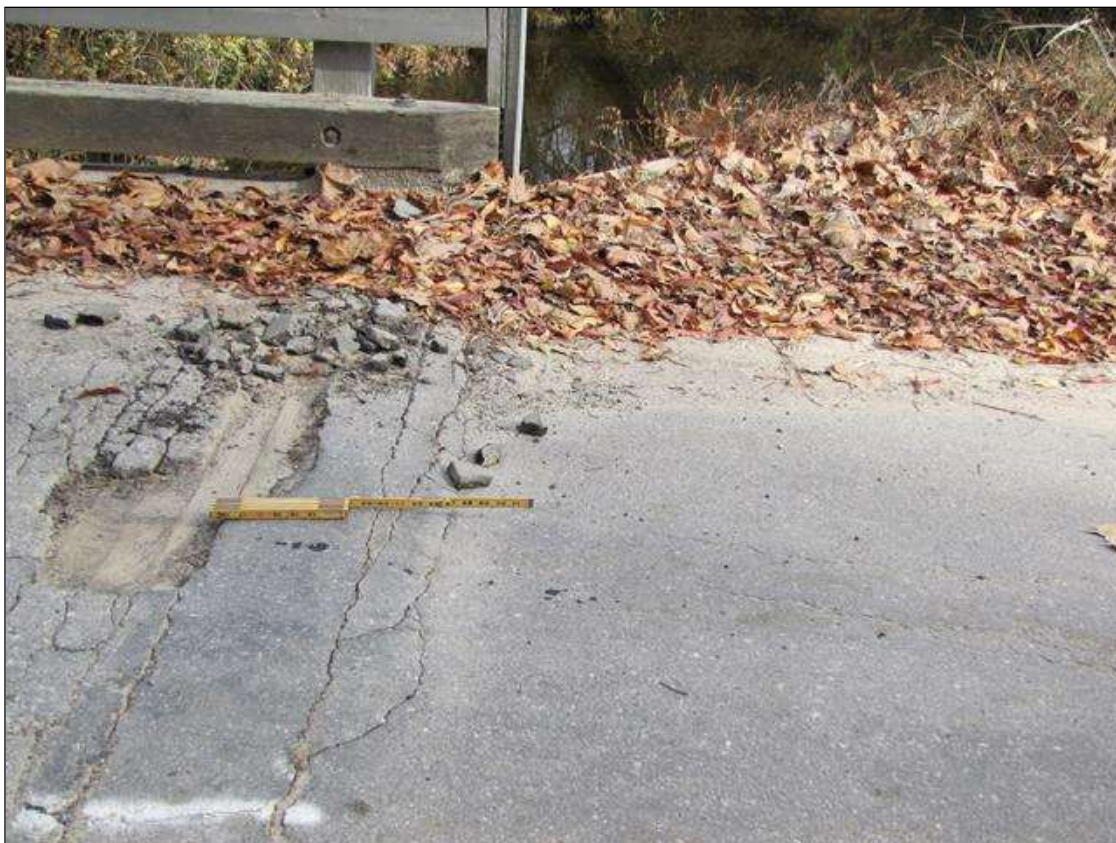
APPROACH ROADWAY: SOUTH APPROACH ROADWAY HAS SETTLED UP TO 2" AT THE SOUTHEAST CORNER

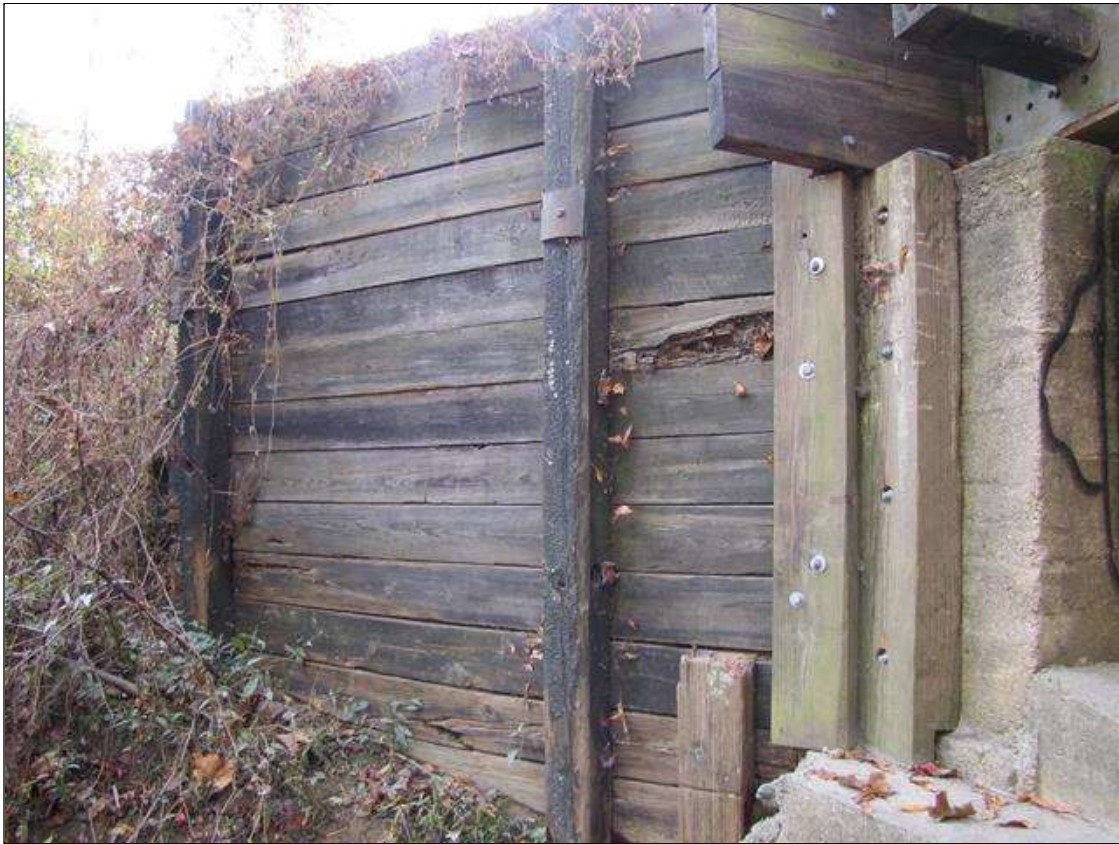
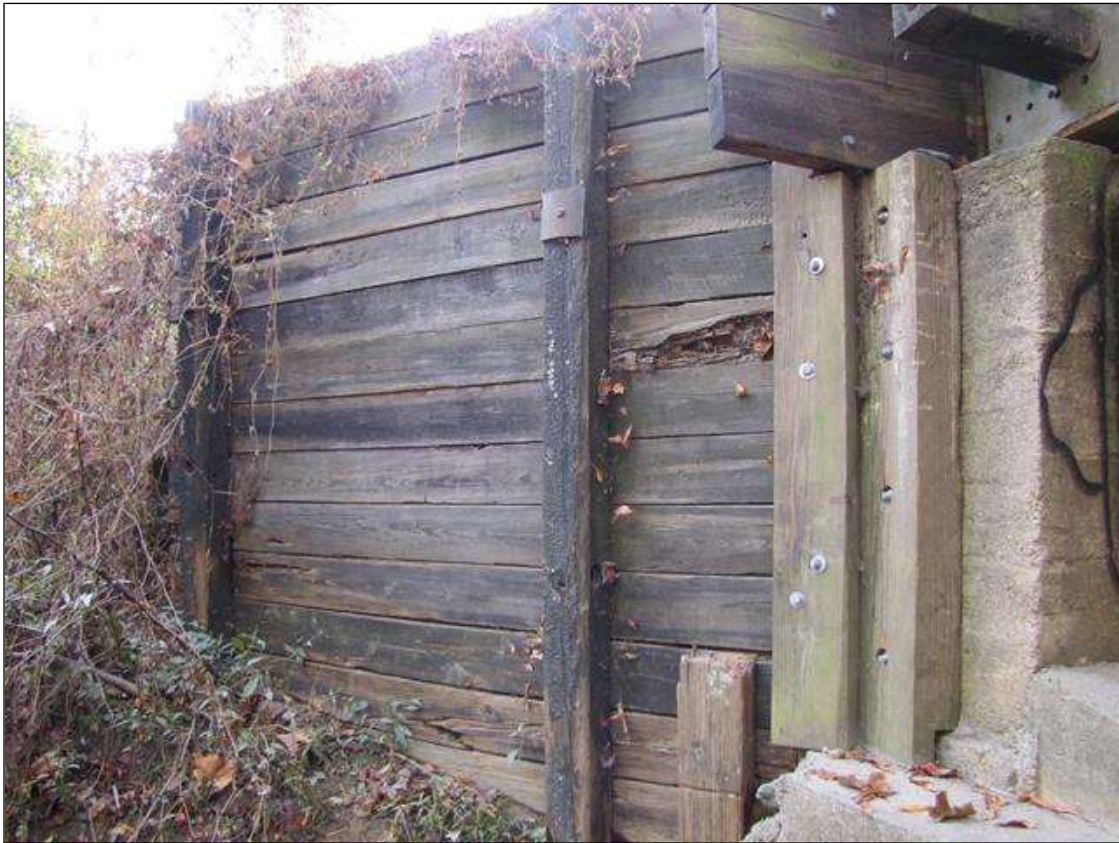
WINGWALLS: RANDOM AREAS OF DECAY OVER ENTIRE SURFACE OF SOUTHEAST WINGWALL WITH SEPARATION OF TIMBER BOARDS AND FILL SPILLAGE (PM)

| MMS Code | Description of Function | Unit | Quantity | Remarks | Est. Cost |
|---|---|---|---|---|---|
| 3344 | Repair / Replace Timber Substructure Components | LF | 15 | RANDOM AREAS OF DECAY OVER ENTIRE SURFACE OF SOUTHEAST WINGWALL WITH SEPARATION OF TIMBER BOARDS AND FILL SPILLAGE (PM) | |

| MMS Code | MMS Description | Quantity |
|---|---|---|
| RANDOM AREAS OF DECAY OVER ENTIRE SURFACE OF SOUTHEAST WINGWALL WITH SEPARATION OF TIMBER BOARDS AND FILL SPILLAGE (PM) | | |

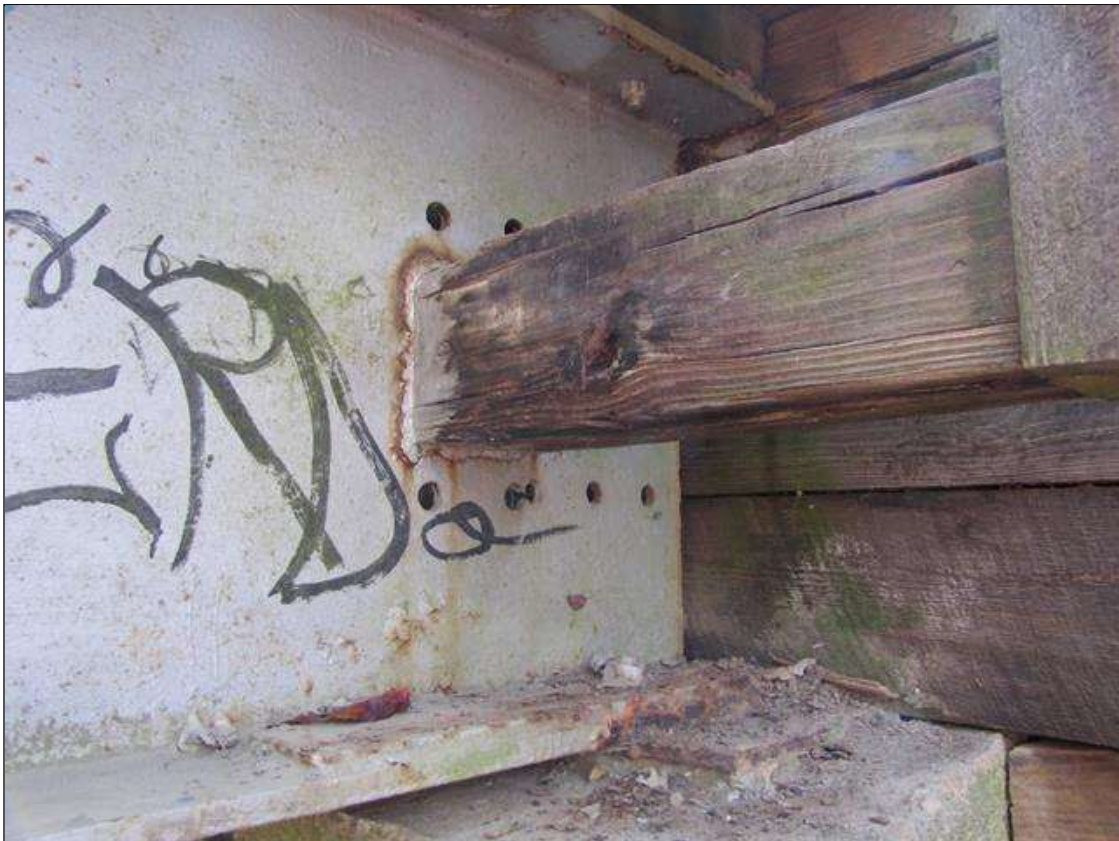
| Element Number | Defect Type | Defect Description | CS | CS Qty | Maint Qty | |
|---|---|---|---|---|---|---|
| 107 | Corrosion | SURFACE CORROSION ON BOTTOM FLANGE AT BEAM ENDS | 2 | 2 | | Feet |
| 515 | Effectiveness (Steel Protective Coatings) | PROTECTIVE COATING HAS LIMITED EFFECTIVENESS AT BOTTOM FLANGE AT ENDS | 3 | 4 | 4 | Square Feet |

Span 1 Beam 1: SURFACE CORROSION ON BOTTOM FLANGE AT BEAM ENDS

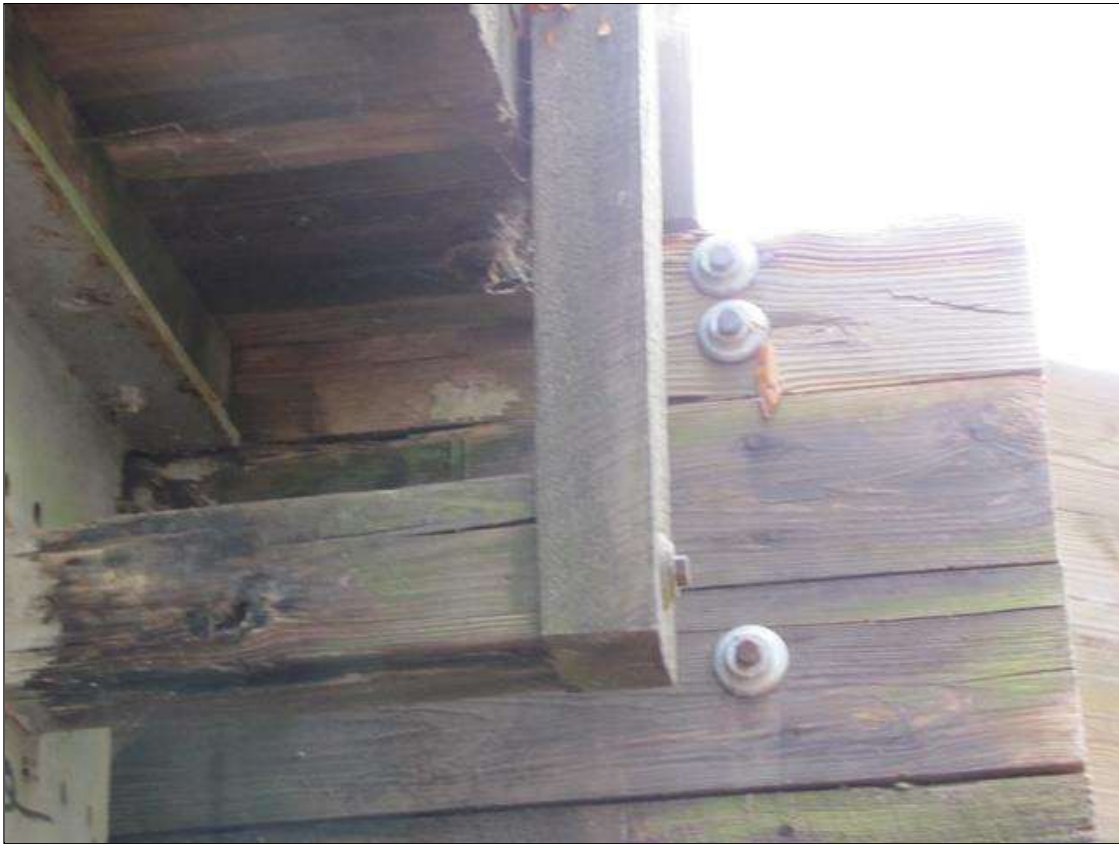
TOP OF ABUTMENT IS 4 TIMBER BOARDS. DECAY 3 FT LONG AT SOUTHWEST CORNER.

END BENT 1 BACKWALL: DECAY 3 FT LONG AT TOP BOARD OF TIMBER BACKWALL AT END BENT 1 SOUTHWEST CORNER.

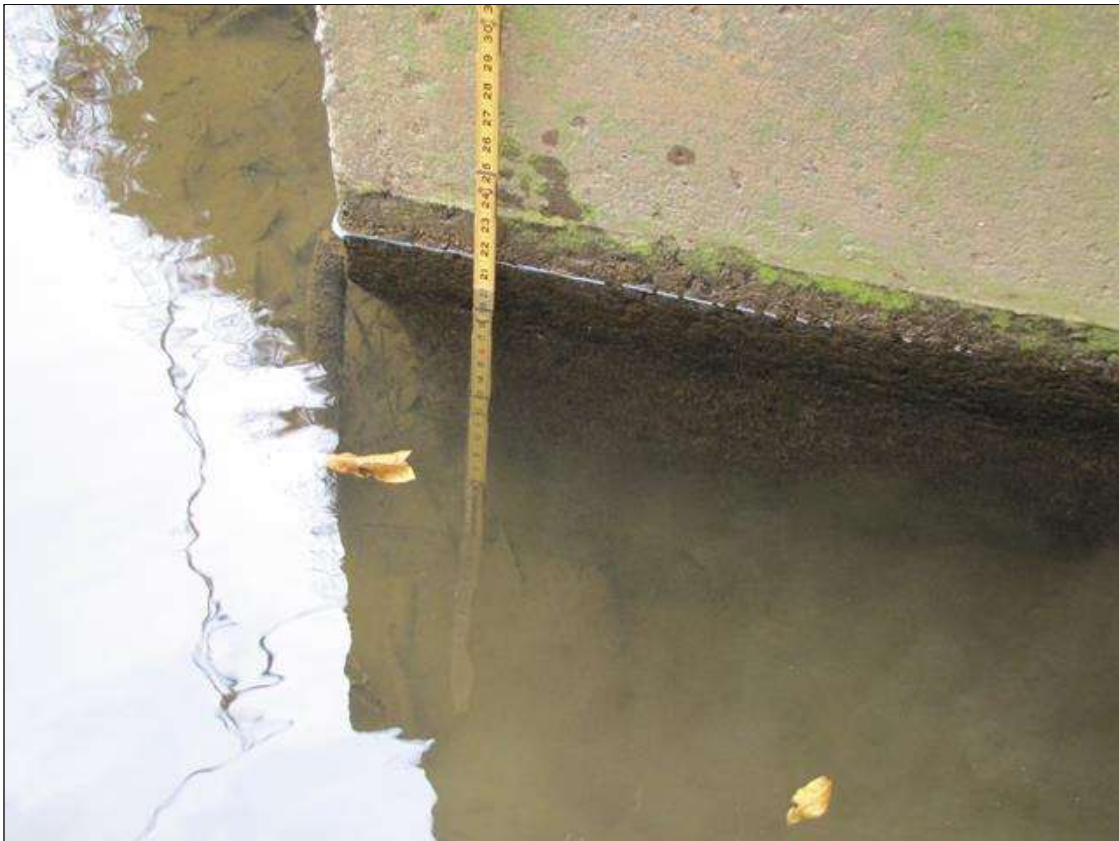
| Element Number | Defect Type | Defect Description | CS | CS Qty | Maint Qty | |
|---|---|---|---|---|---|---|
| 215 | Delamination/Spall | 4" LONG X 18" HIGH X 2" DEEP SPALL IN UPSTREAM END OF FOOTING (OVERLAP WITH SCOUR QUANTITY) | 2 | | 1 | Feet |

End Bent 1 Abutment/Backwall : SCOUR UP TO 6" DEEP BELOW BOTTOM OF FOOTING WITH UNDERMINING 9" BACK AT UPSTREAM END OF FOOTING

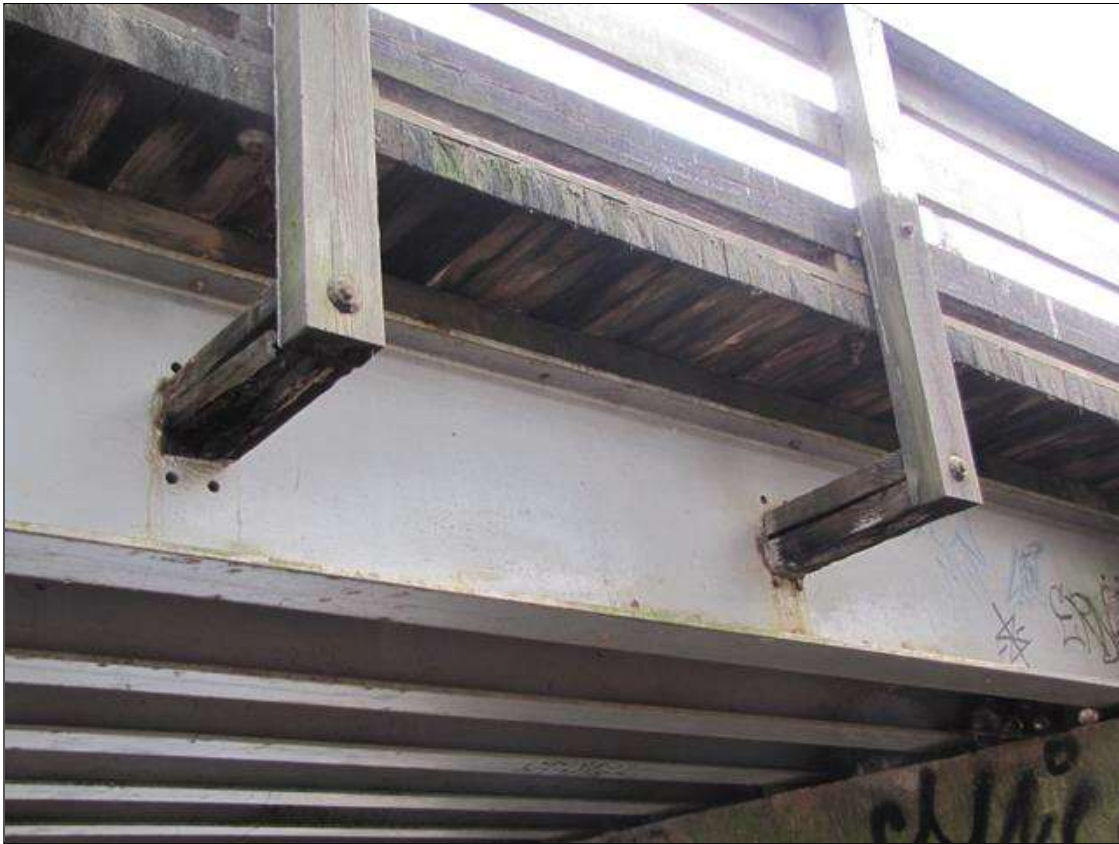
| Element Number | Defect Type | Defect Description | CS | CS Qty | Maint Qty |
|---|---|---|---|---|---|
| 332 | Connection | POST #2, #3, AND #6 HAVE DECAYED RAIL POST TO BEAM CONNECTION BLOCK | 3 | 3 | 3 Feet |

Span 1 Left Bridge Rail: POST #2 AND #3 HAVE DECAYED RAIL POST TO BEAM CONNECTION BLOCK

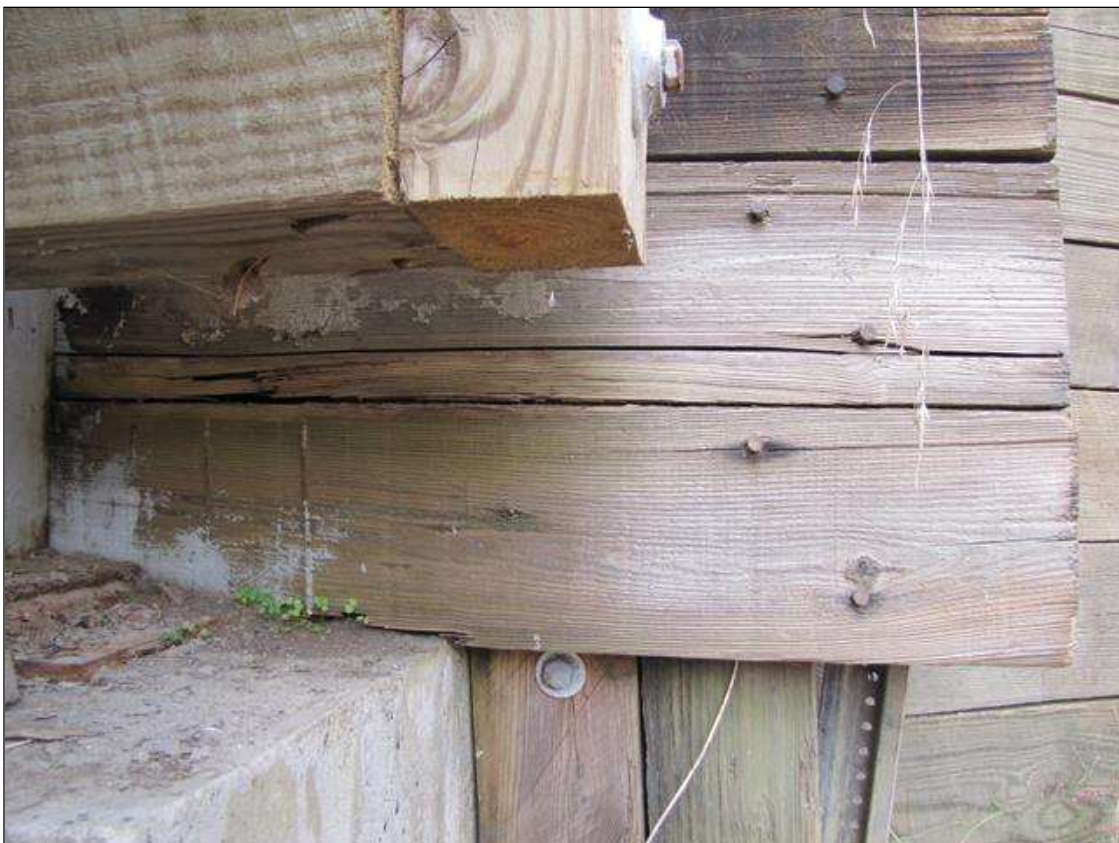
TOP OF ABUTMENT IS 4 TIMBER BOARDS, DECAY 3 FT LONG IN 2ND TIMBER FROM BOTTOM AT NORTHEAST CORNER

END BENT 2 BACKWALL: DECAY 3 FT LONG IN 2ND TIMBER FROM BOTTOM AT NORTHEAST CORNER

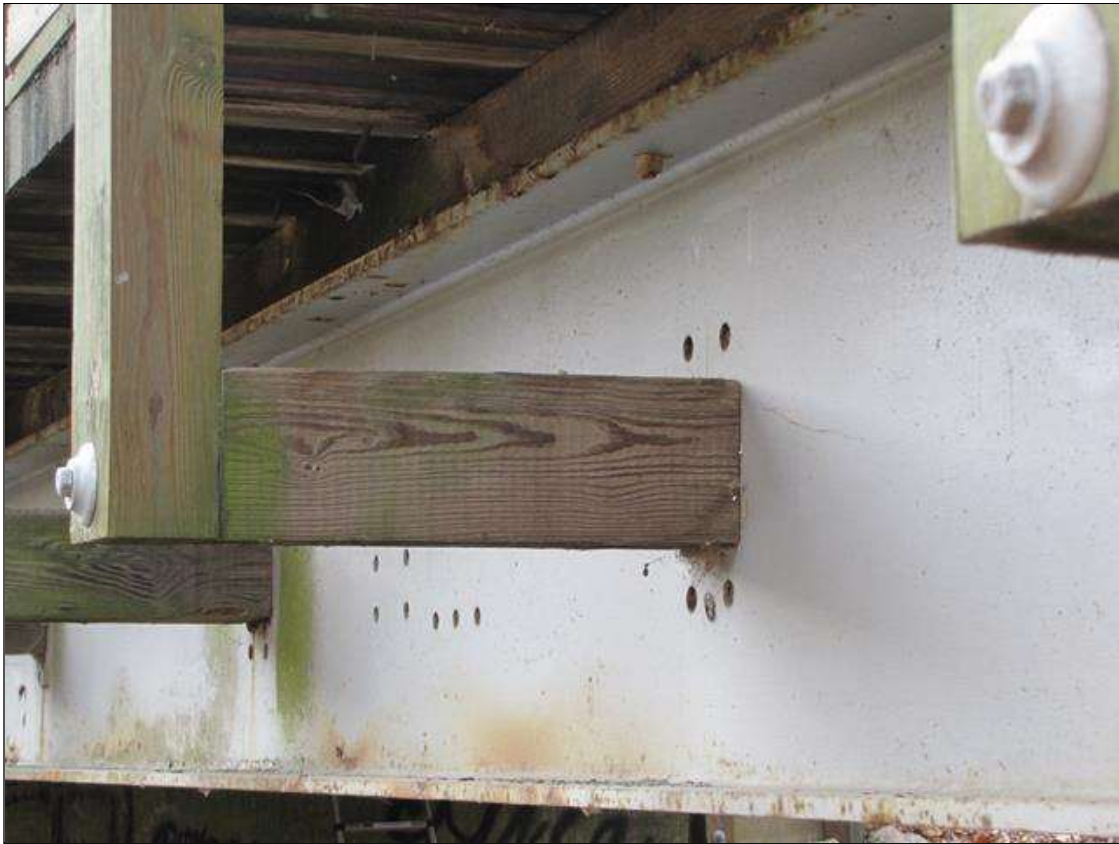
| Element Number | Element Name | Total Qty | CS1 Qty | CS2 Qty | CS3 Qty | CS4 Qty | |
|---|---|---|---|---|---|---|---|
| 515 | Effectiveness (Steel Protective Coatings) | PROTECTIVE COATING IS SUBSTANTIALLY EFFECTIVE, WITH RANDOM SPOTS OF SURFACE RUST ALONG EDGES OF TOP FLANGE | 2 | 30 | 30 | Square Feet | |

Span 1 Beam 6: PROTECTIVE COATING IS SUBSTANTIALLY EFFECTIVE, WITH RANDOM SPOTS OF SURFACE RUST ALONG EDGES OF TOP FLANGE

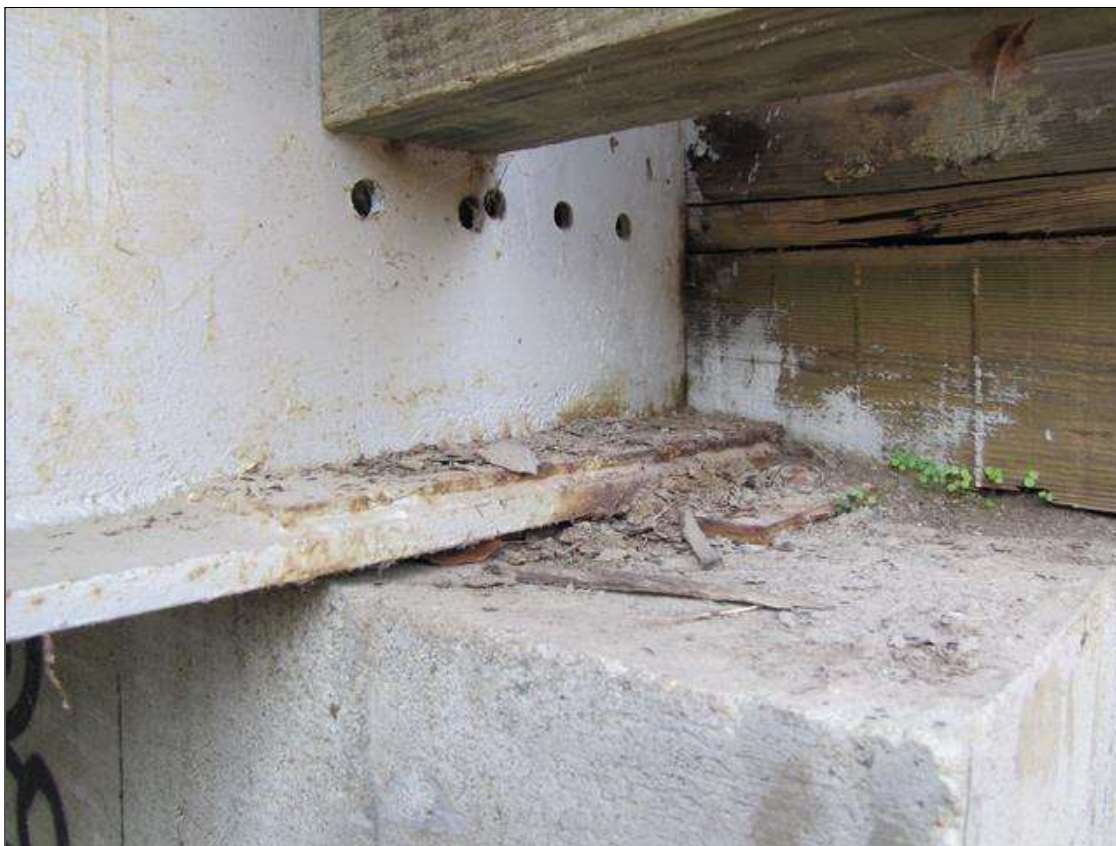
THERE IS TWO PLATES WELDED TO THE BOTTOM FLANGE AT BOTH ENDS 18" LONG X 4" WIDE

WELDED PLATE REPAIR AT BEAM 6 AT END BENT 2
