NC DEPARTMENT OF TRANSPORTATION  
DIVISION OF HIGHWAYS  
STRUCTURE MANAGEMENT UNIT

## Structure Safety Report

### Routine Element Inspection

COUNTY: BUNCOMBE STRUCTURE NUMBER: 100099 FREQUENCY: 24 MONTHS  
FACILITY CARRIED: SR2816 MILE POST: \_\_\_\_\_  
LOCATION: 0.5 MI.S.JCT.SR.2782  
FEATURE INTERSECTED: GARREN CREEK  
LATITUDE: 35° 32' 3.38" LONGITUDE: 82° 23' 24.75"

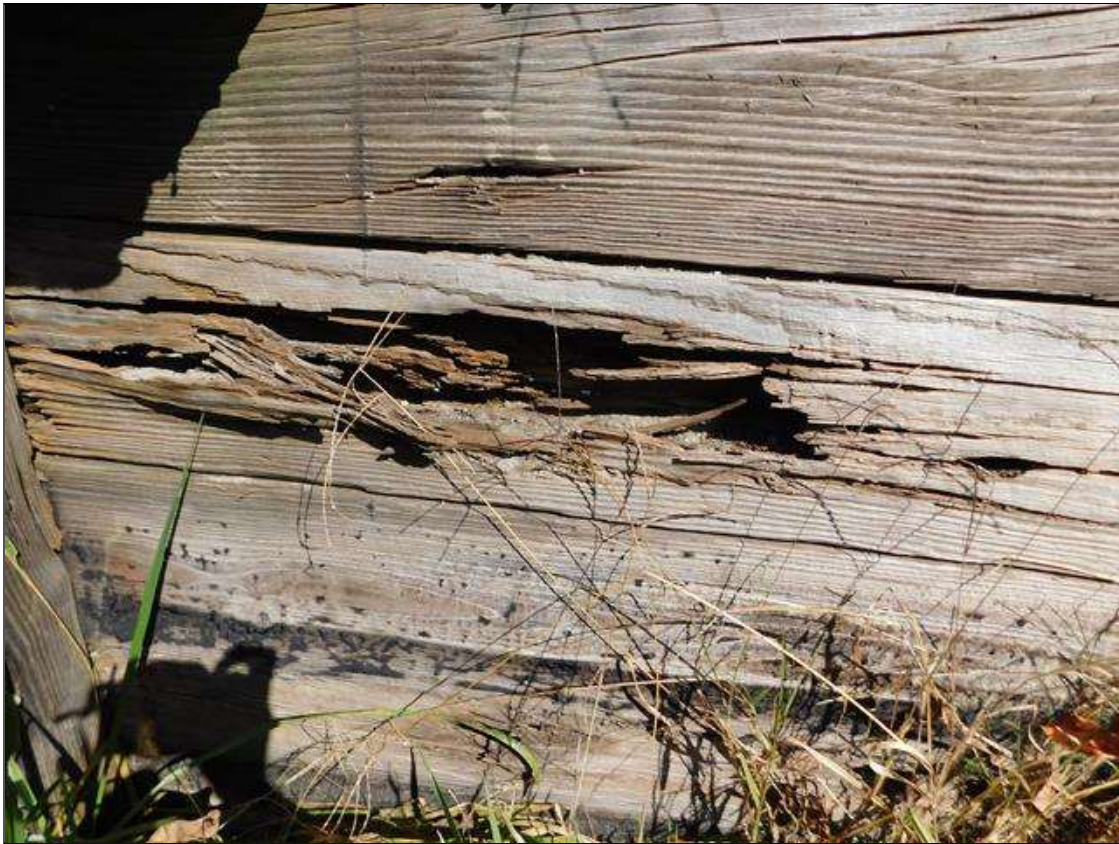
| End Bent 2 | | Timber Abutment 1 | | | | | |
|---|---|---|---|---|---|---|---|
| 216 | Decay/Section Loss | DECAY WITH FILL FALLING THROUGH TO ABUTMENT 2 / UPSTREAM AND DOWNSTREAM ENDS; AREA TOTALS 18 LF X 1' HIGH. (P.M.) UPSTREAM END MEASURES 6 LF X 1' HIGH. DOWNSTREAM END MEASURES 12 LF X 1' HIGH. | 3 | 18 | 18 | Feet | |

End Bent 2 Abutment/Backwall : DECAY WITH FILL FALLING THROUGH TO ABUTMENT 2 / UPSTREAM AND DOWNSTREAM ENDS; AREA TOTALS 18 LF X 1' HIGH. (P.M.) UPSTREAM END MEASURES 6 LF X 1' HIGH. DOWNSTREAM END MEASURES 12 LF X 1' HIGH.

| MMS Code | Description of Function | Unit | Quantity | Remarks | Est. Cost |
|---|---|---|---|---|---|
| 3346 | Repair / Maintain Timber Wings & Blkhds | SF | 18 | End Bent 2 Abutment/Backwall : DECAY WITH FILL FALLING THROUGH TO ABUTMENT 2 / UPSTREAM AND DOWNSTREAM ENDS; AREA TOTALS 18 LF X 1' HIGH. (P.M.) UPSTREAM END MEASURES 6 LF X 1' HIGH. DOWNSTREAM END MEASURES 12 LF X 1' HIGH. | |

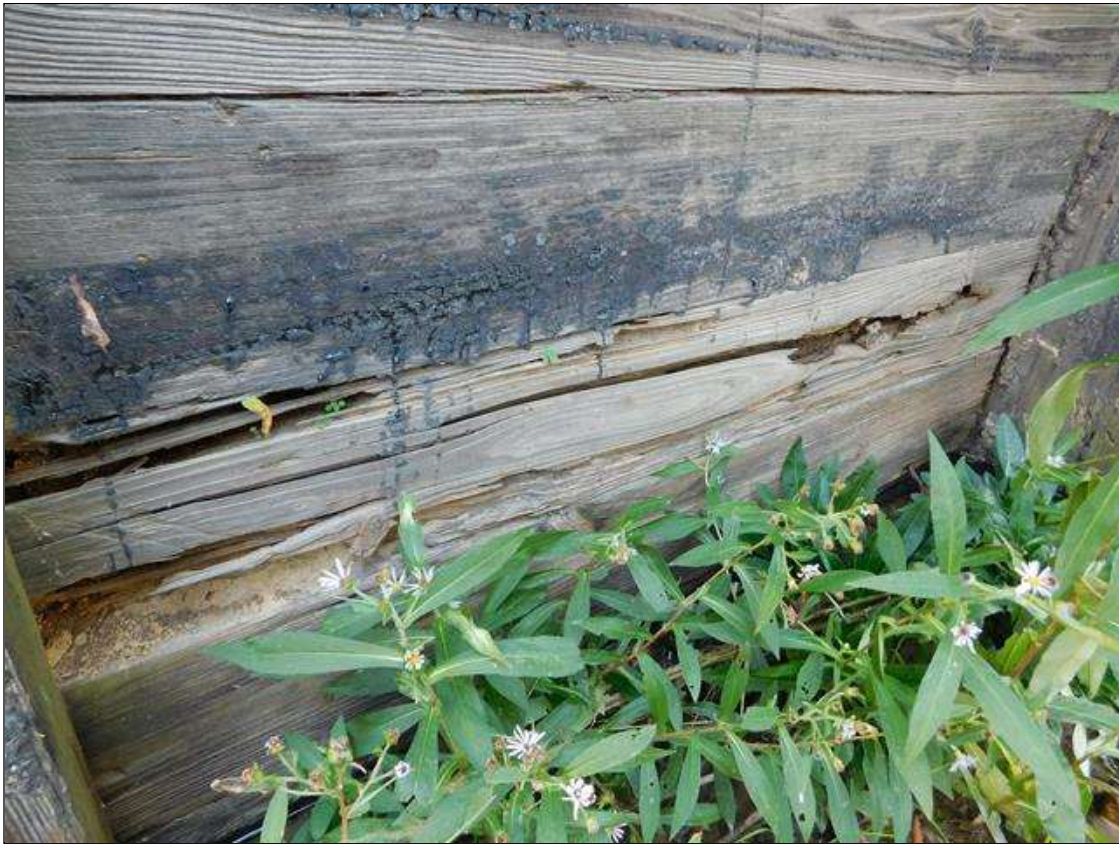
End Bent 2 Abutment/Backwall : DECAY WITH FILL FALLING THROUGH TO ABUTMENT 2 / UPSTREAM AND DOWNSTREAM ENDS; AREA TOTALS 18 LF X 1' HIGH. (P.M.) UPSTREAM END MEASURES 6 LF X 1' HIGH. DOWNSTREAM END MEASURES 12 LF X 1' HIGH.

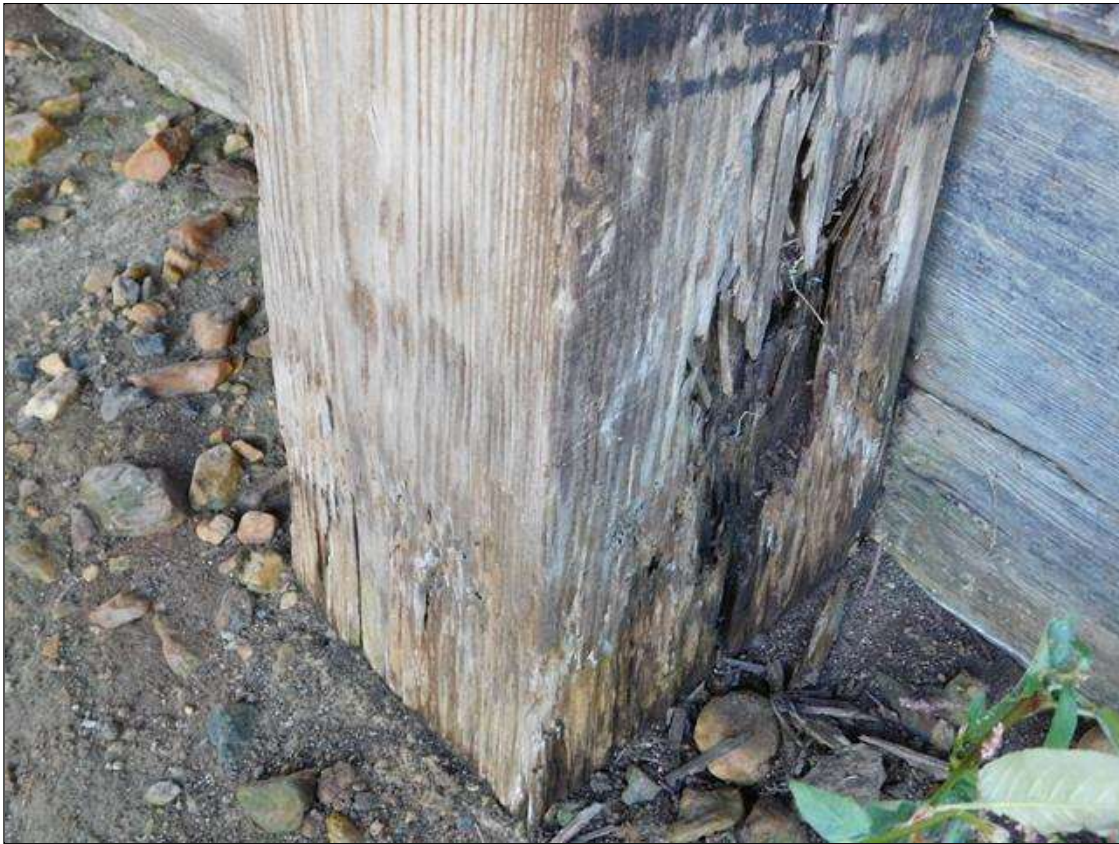
End Bent 1 Pile 2: DECAY TO PILE 2 / ABUTMENT 2; DECAY MEASURES 1' HIGH X 1' WIDE X 4" DEEP. (P.M.)

| MMS Code | Description of Function | Unit | Quantity | Remarks | Est. Cost |
|---|---|---|---|---|---|
| 3344 | Repair / Replace Timber Substructure Components | LF | 1 | End Bent 1 Pile 2: DECAY TO PILE 2 / ABUTMENT 2; DECAY MEASURES 1' HIGH X 1' WIDE X 4" DEEP. (P.M.) | |

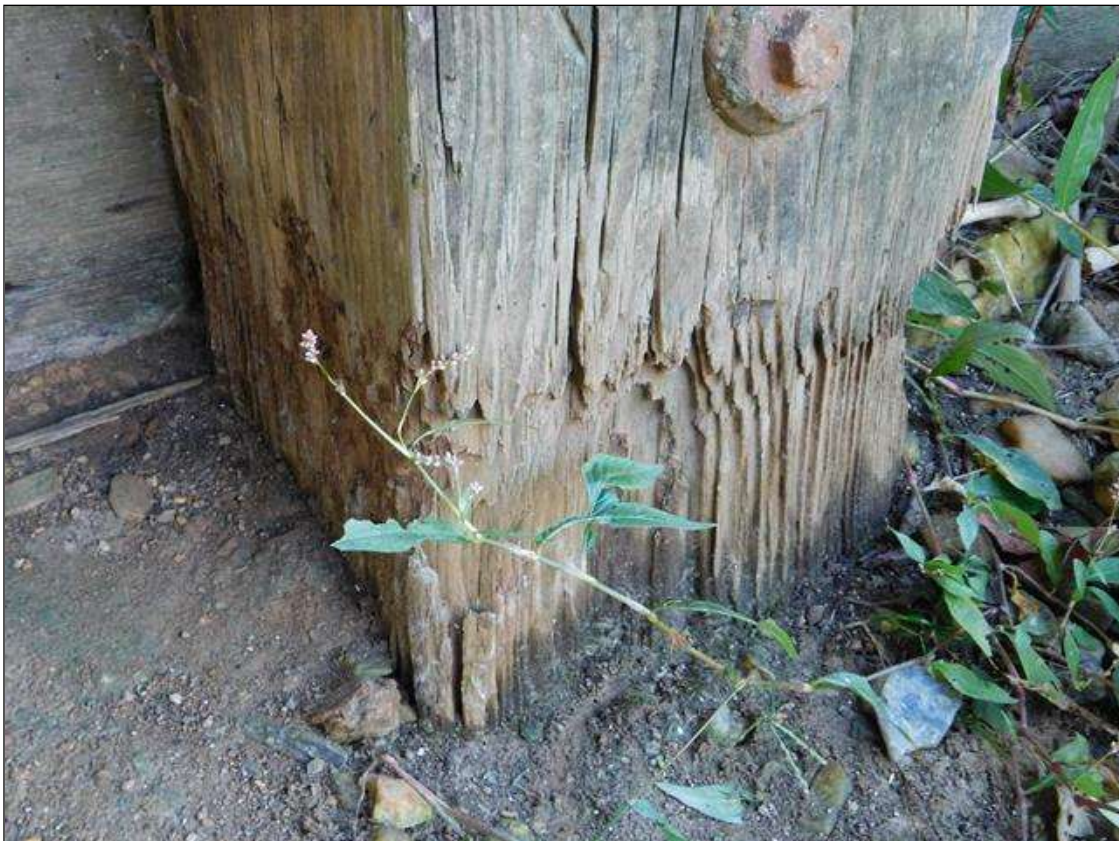
| End Bent 1 | | Timber Pile 1 | | | | | |
|---|---|---|---|---|---|---|---|
| 228 | Decay/Section Loss | DECAY TO PILE 1 / ABUTMENT 1 / AT GROUNDLINE. | | | 2 | 1 | 1 |

End Bent 1 Pile 1: DECAY TO PILE 1 / ABUTMENT 1 / AT GROUNDLINE.

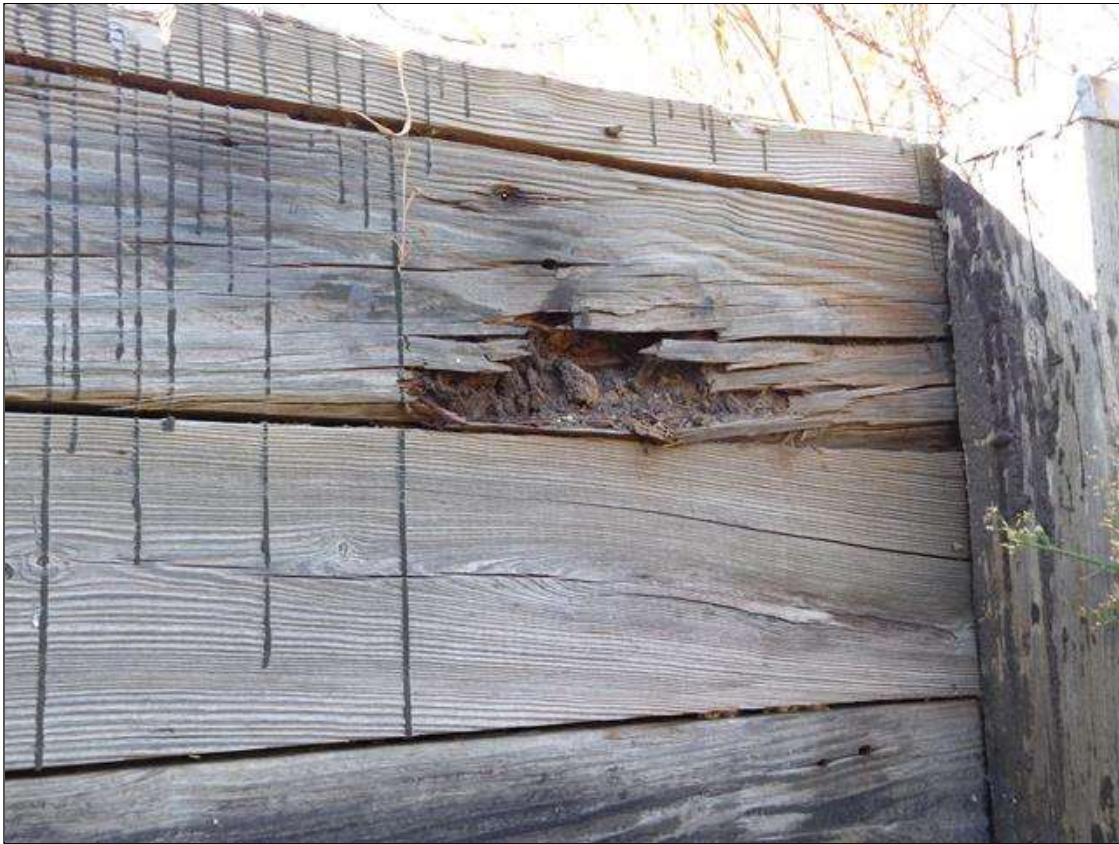
| Element Number | Element Name | Total Qty | CS1 Qty | CS2 Qty | CS3 Qty | CS4 Qty |
|---|---|---|---|---|---|---|
| 216 | Decay/Section Loss | DECAY WITH FILL FALLING THROUGH TO ABUTMENT 1 / UPSTREAM AND DOWNSTREAM ENDS; AREA TOTALS 4 LF X 1' HIGH. (P.M.) UPSTREAM END MEASURES 2 LF X 1' HIGH. DOWNSTREAM END MEASURES 2 LF X 1' HIGH. | 3 | 4 | 4 | Feet |

End Bent 1 Abutment/Backwall : DECAY WITH FILL FALLING THROUGH TO ABUTMENT 1 / UPSTREAM AND DOWNSTREAM ENDS; AREA TOTALS 4 LF X 1' HIGH. (P.M.) UPSTREAM END MEASURES 2 LF X 1' HIGH. DOWNSTREAM END MEASURES 2 LF X 1' HIGH.

| MMS Code | Description of Function | Unit | Quantity | Remarks | Est. Cost |
|---|---|---|---|---|---|
| 3346 | Repair / Maintain Timber Wings & Blkhds | SF | 4 | End Bent 1 Abutment/Backwall : DECAY WITH FILL FALLING THROUGH TO ABUTMENT 1 / UPSTREAM AND DOWNSTREAM ENDS; AREA TOTALS 4 LF X 1' HIGH. (P.M.) UPSTREAM END MEASURES 2 LF X 1' HIGH. DOWNSTREAM END MEASURES 2 LF X 1' HIGH. | |

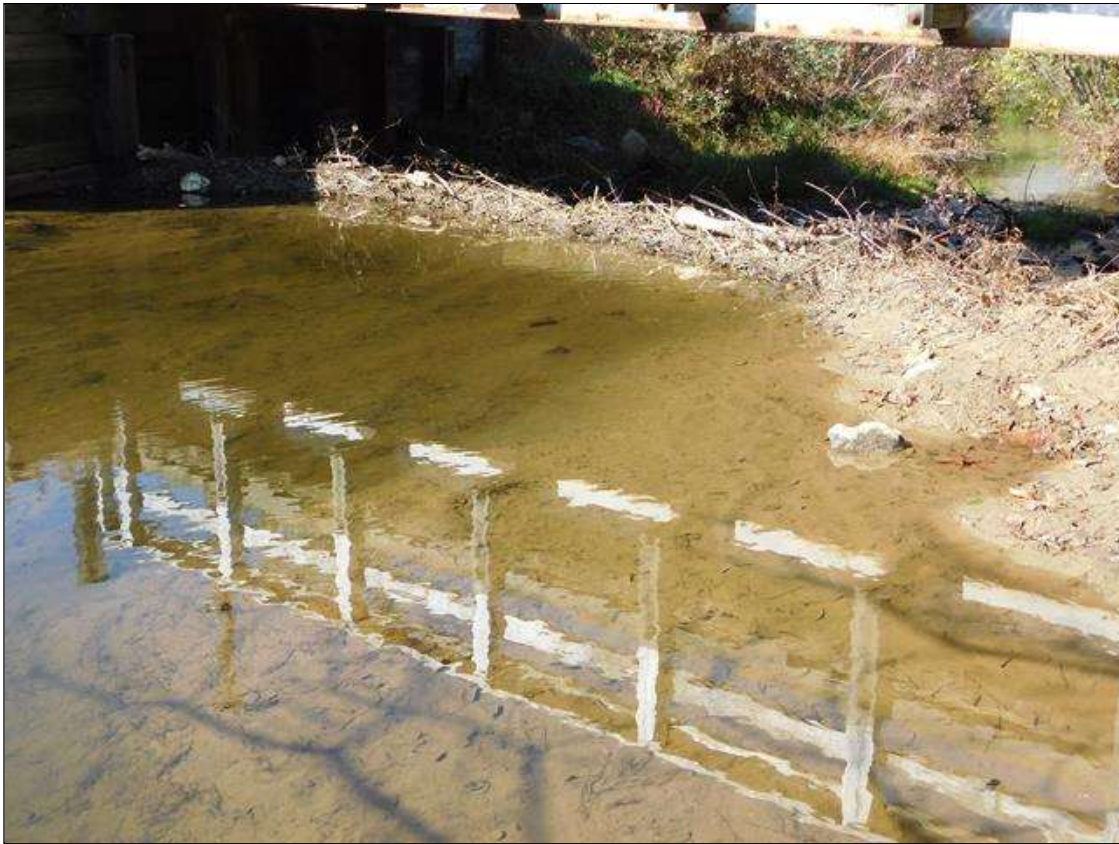
BEAVER DAM LOCATED BENEATH STRUCTURE; DRIFT MEASURES 30 LF X 3' HIGH. (P.M.)

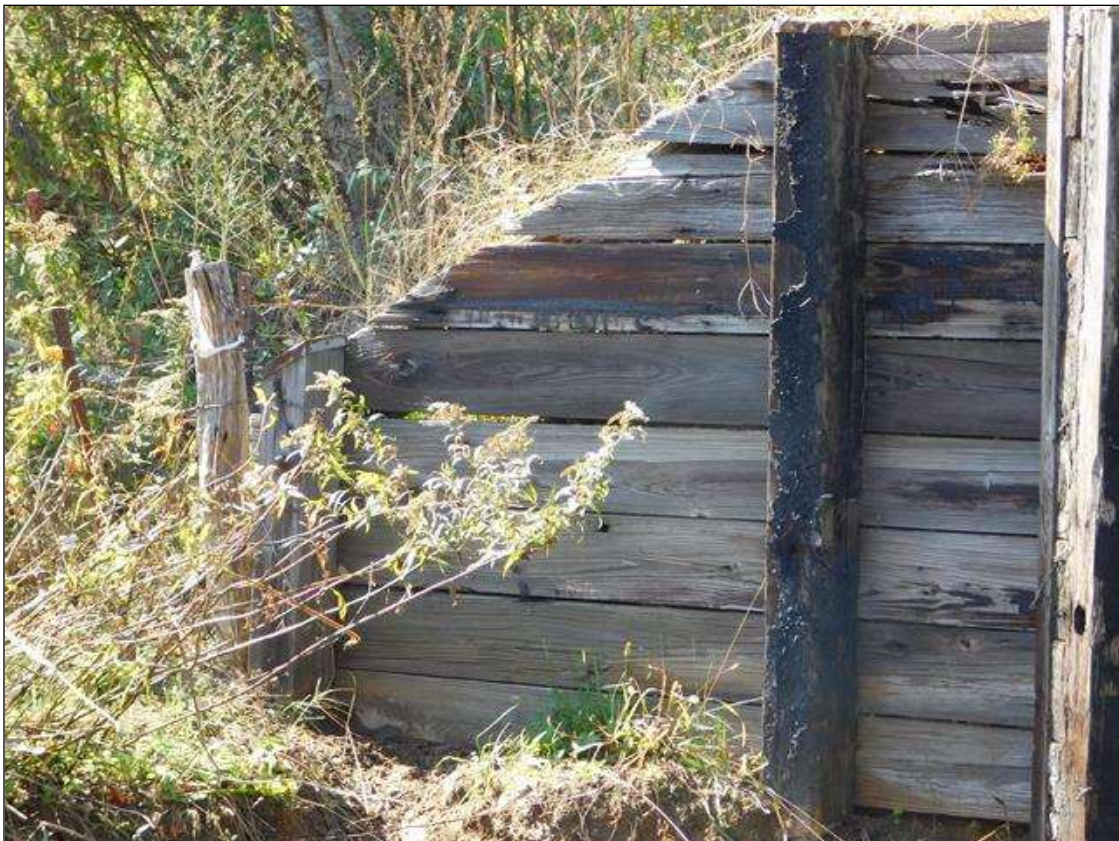
DECAY WITH FILL FALLING THROUGH TO SOUTH EAST WINGWALL; AREA MEASURES 6 LF X 2' HIGH. (P.M.)

| MMS Code | Description of Function | Unit | Quantity | Remarks | Est. Cost |
|---|---|---|---|---|---|
| 3346 | Repair / Maintain Timber Wings & Blkhds | SF | 12 | DECAY WITH FILL FALLING THROUGH TO SOUTHEAST WINGWALL; AREA MEASURES 6 LF X 2' HIGH. (P.M.) | |

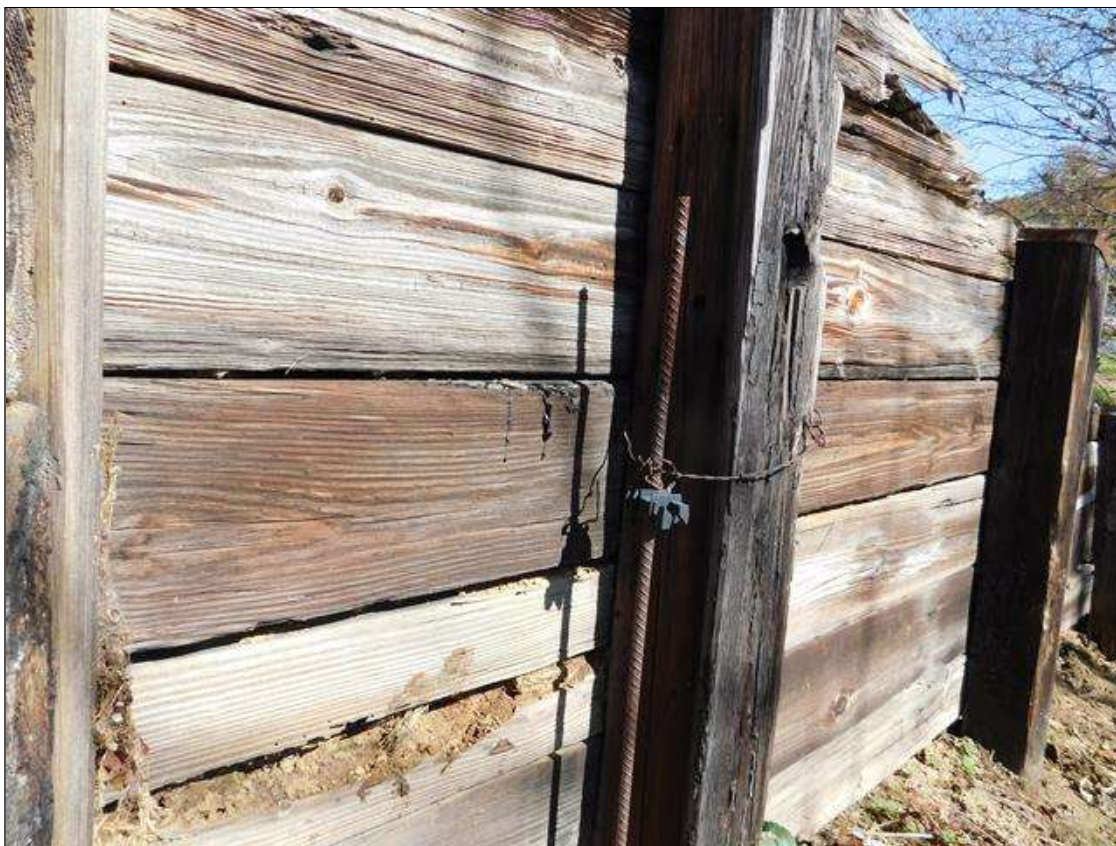
DECAY WITH FILL FALLING THROUGH TO NORTH EAST WINGWALL; AREA MEASURES 10 LF X 2' HIGH. (P.M.)

| MMS Code | Description of Function | Unit | Quantity | Remarks | Est. Cost |
|---|---|---|---|---|---|
| 3346 | Repair / Maintain Timber Wings & Blkhds | SF | 20 | DECAY WITH FILL FALLING THROUGH TO NORTHEAST WINGWALL; AREA MEASURES 10 LF X 2' HIGH. (P.M.) | |

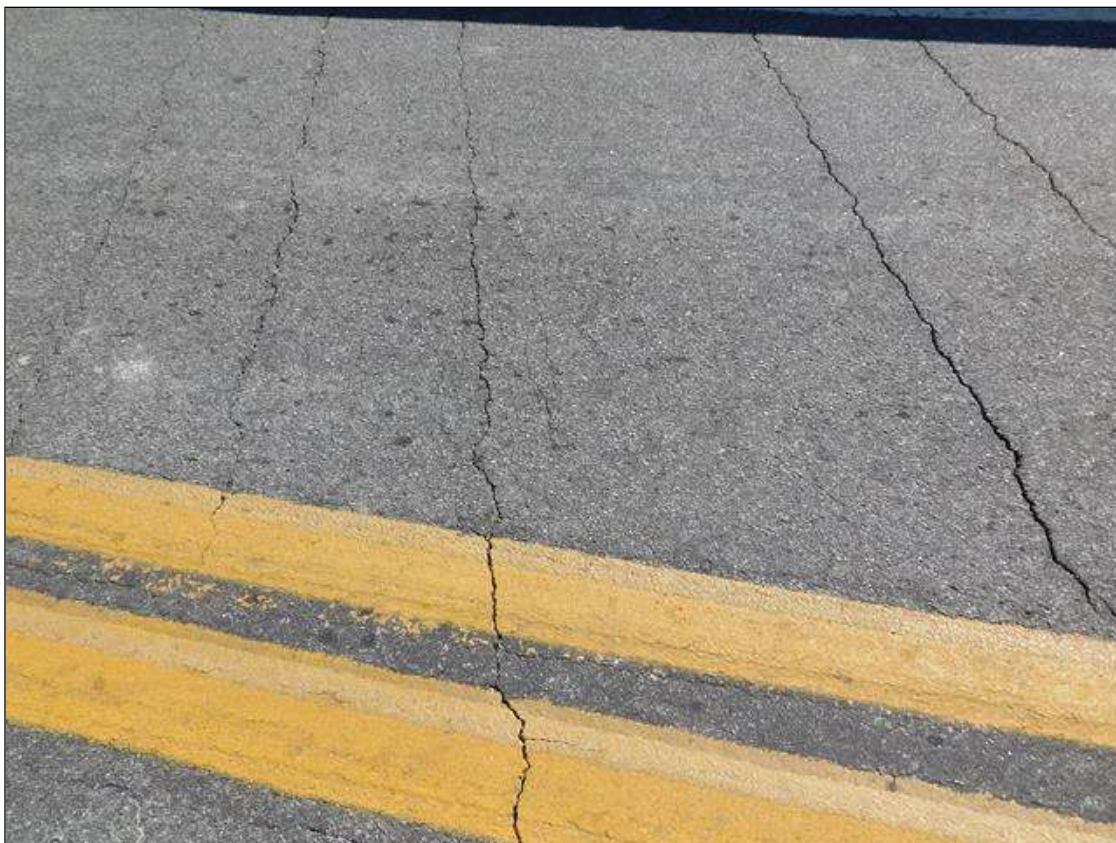
| Element Number | Defect Type | Defect Description | CS | CS Qty | Maint Qty | |
|---|---|---|---|---|---|---|
| 510 | Crack (Wearing Surface) | CRACKING TO WEARING SURFACE. | 2 | 80 | 80 | Square Feet |

REP OF CRACKING TO WEARING SURFACE

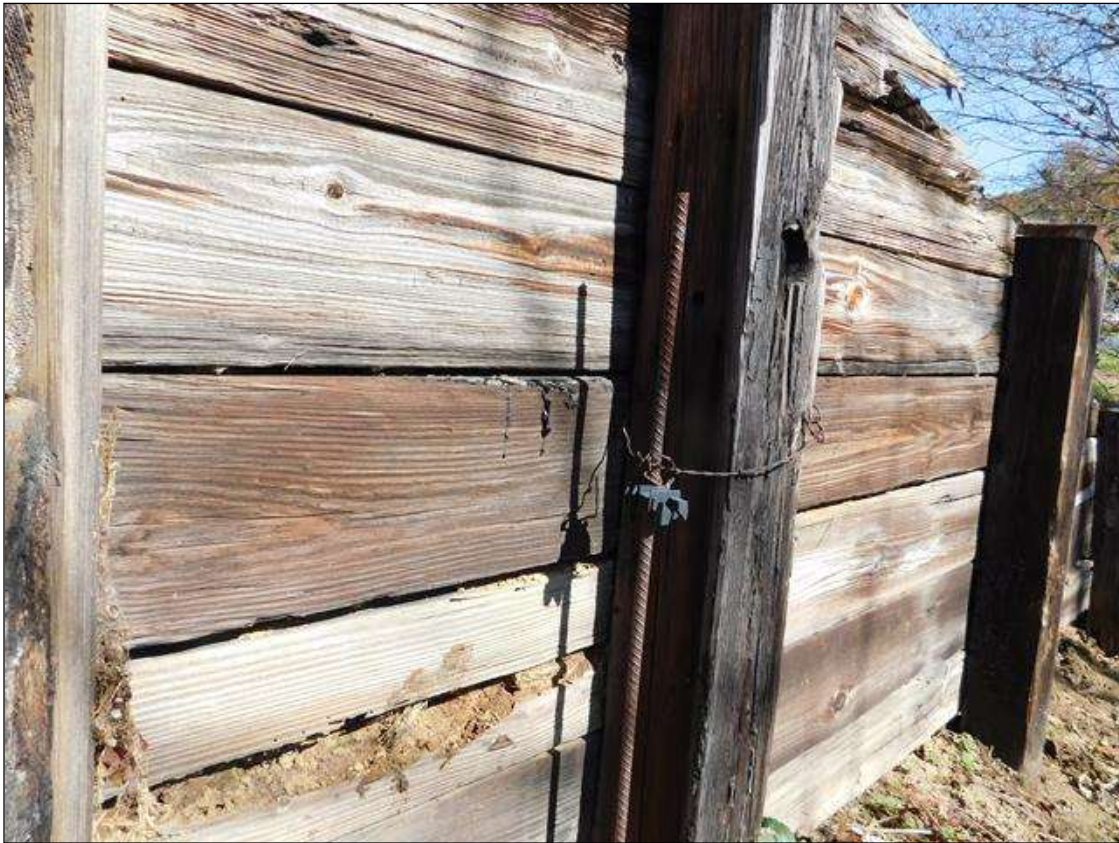
DECAY WITH FILL FALLING THROUGH TO NORTHEAST WINGWALL; AREA MEASURES 10 LF X 2' HIGH. (P.M.)

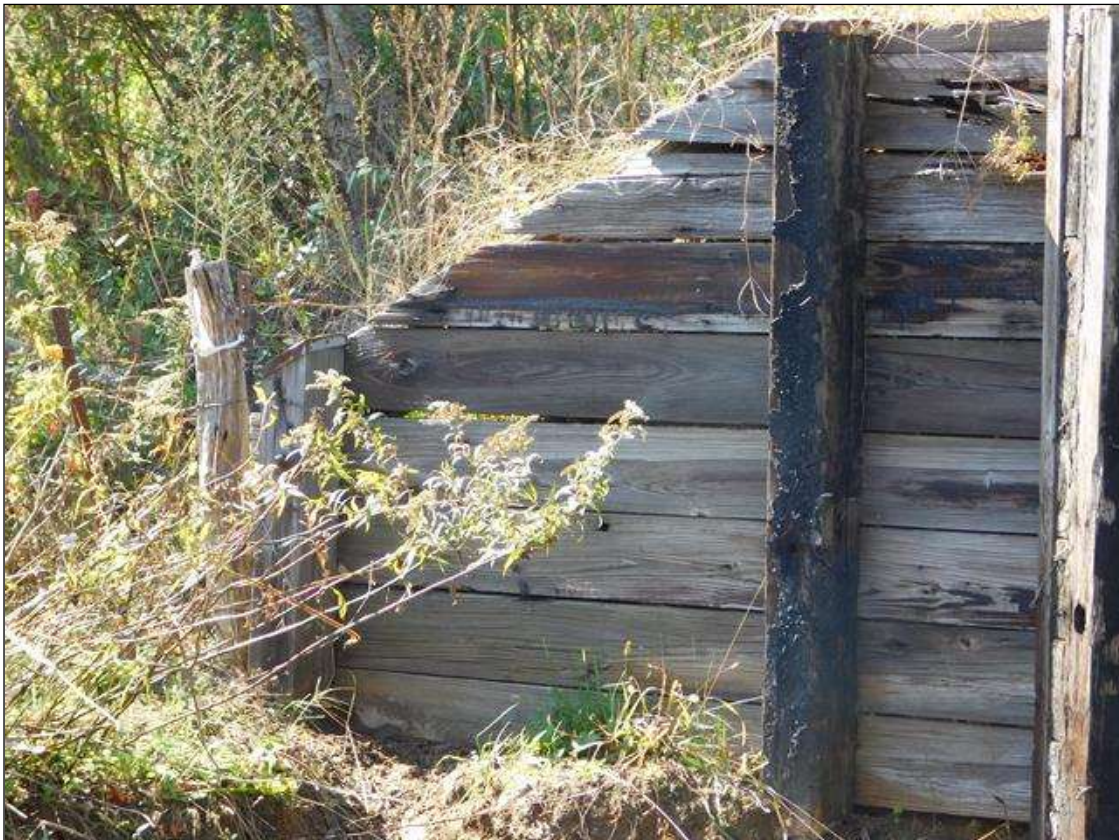
DECAY WITH FILL FALLING THROUGH TO SOUTHEAST WINGWALL; AREA MEASURES 6 LF X 2' HIGH. (P.M.)

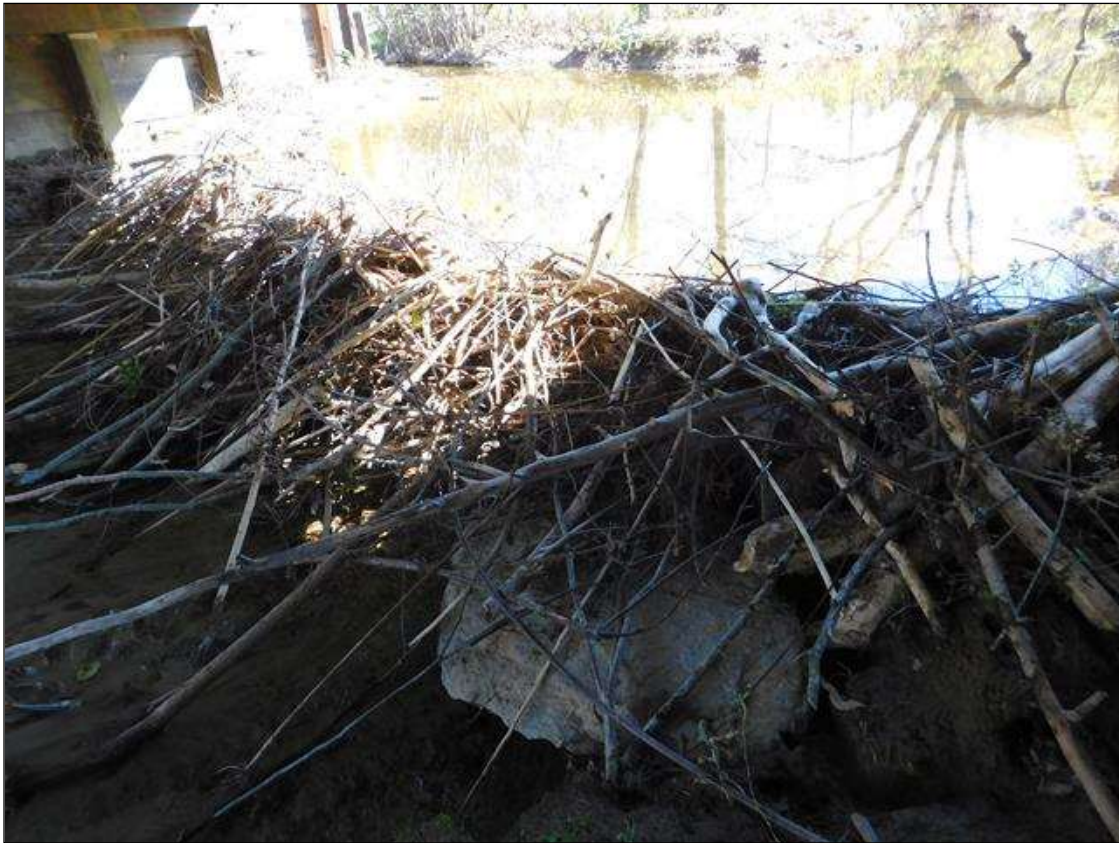
BEAVER DAM LOCATED BENEATH STRUCTURE; DRIFT MEASURES 30 LF X 3' HIGH. (P.M.)

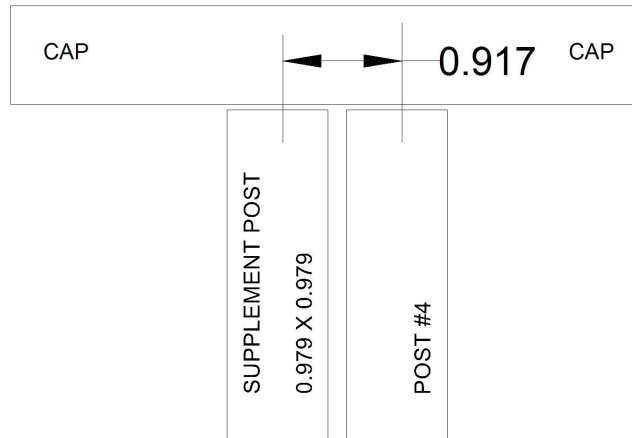
NOTE: THE PLACEMENT OF ALL SUPPLEMENT POSTS  
ARE TEMPORARY REPAIRS  
SUPPLEMENT POSTS ARE ATTACHED TO ORIGINAL POSTS  
WITH ONE (1) 5/8" DIAMETER BOLT

SUPPLEMENT POST PLACED AT ABUT. #1

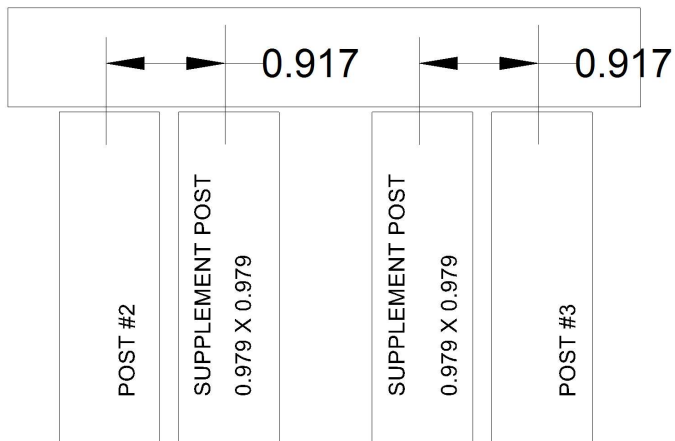
SUPPLEMENT POSTS PLACED AT ABUT. #2
