NC DEPARTMENT OF TRANSPORTATION  
DIVISION OF HIGHWAYS  
STRUCTURE MANAGEMENT UNIT

## Structure Safety Report

### Routine Element Inspection

COUNTY: BUNCOMBE STRUCTURE NUMBER: 100100 FREQUENCY: 24 MONTHS

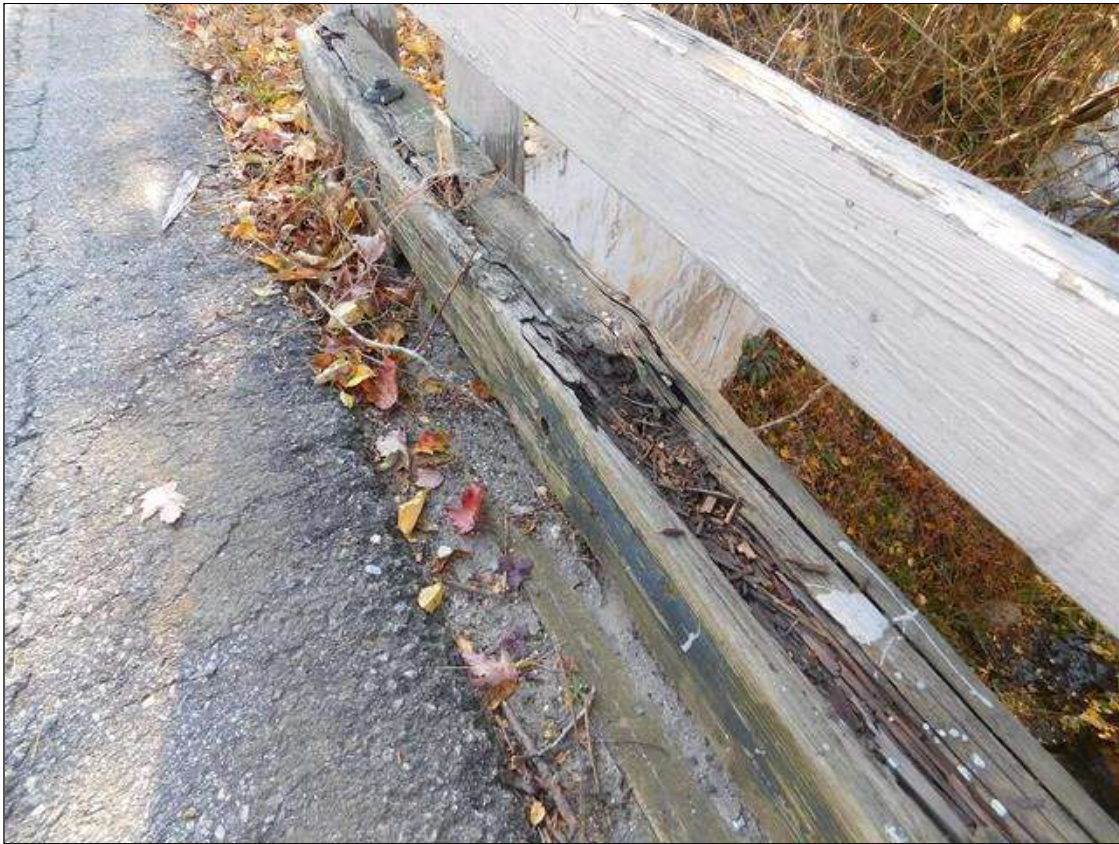
| Element Number | Defect Type | Defect Description | CS | CS Qty | Maint Qty | |
|---|---|---|---|---|---|---|
| 332 | Decay/Section Loss | UP TO 4" DEEP DECAY IN THE TIMBER WHEELGUARD AT THE EAST MOST END LENGTH 8'-8" | 3 | 8 | 8 | Feet |

Span 1 Right Bridge Rail: UP TO 4" DEEP DECAY IN THE TIMBER WHEELGUARD AT THE EAST MOST END  
LENGTH 8'-8" P/M

| MMS Code | Description of Function | Unit | Quantity | Remarks | Est. Cost |
|---|---|---|---|---|---|
| 3316 | Maint to Timber Handrail | LF | 8 | Span 1 Right Bridge Rail: UP TO 4" DEEP DECAY IN THE TIMBER WHEELGUARD AT THE EAST MOST END LENGTH 8'-8" | |

| MMS Code | MMS Description | Quantity |
|---|---|---|
| Span 1 Right Bridge Rail: UP TO 4" DEEP DECAY IN THE TIMBER WHEELGUARD AT THE EAST MOST END LENGTH 8'-8" | | |

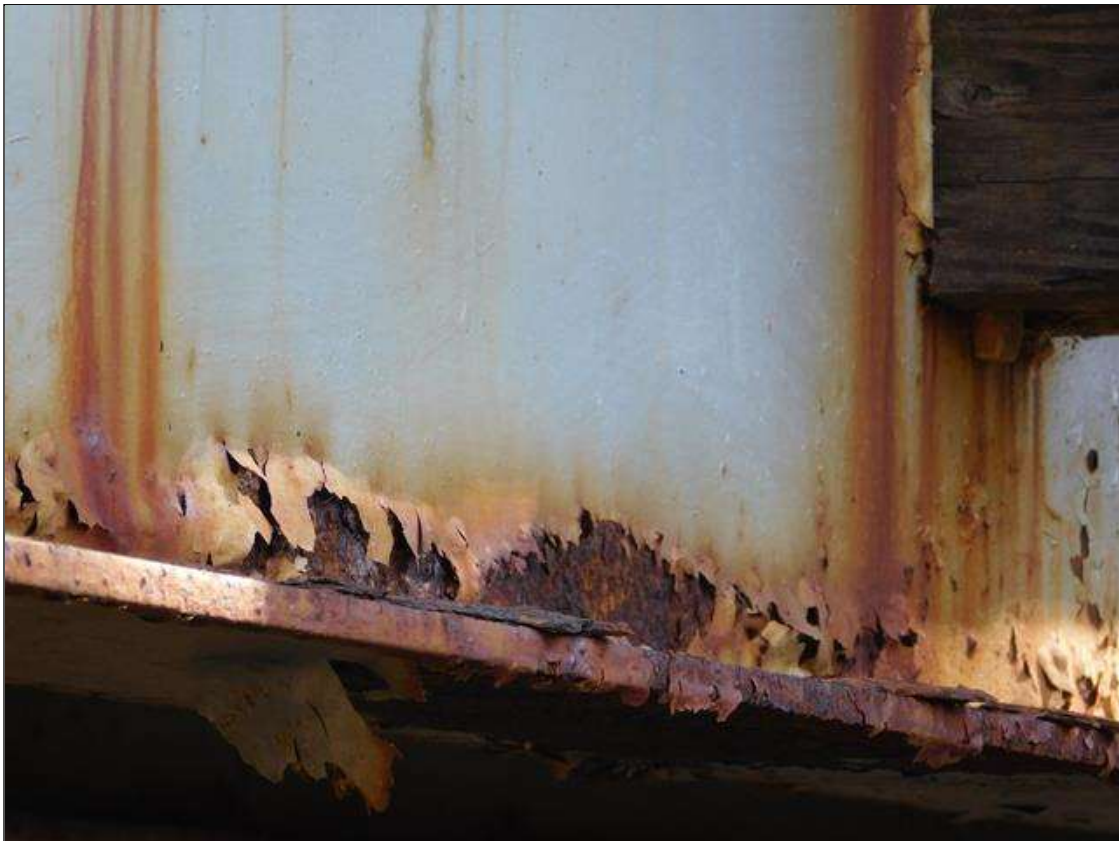
| Element Number | Defect Type | Defect Description | CS | CS Qty | Maint Qty |
|---|---|---|---|---|---|
| 107 | Cracking | 10' LONG X 2 HIGH SECTION OF 1/16" LOSS TO THE OUTSIDE FACE OF WEB BEAM 9 AT 12' OUT FROM ABUTMENT 1 | 3 | 10 | 10 Feet |

Span 1 Beam 8: 10' LONG X 2 HIGH SECTION OF 1/16" LOSS TO THE OUTSIDE FACE OF WEB BEAM 9 AT 12'  
OUT FROM ABUTMENT 1 P/M

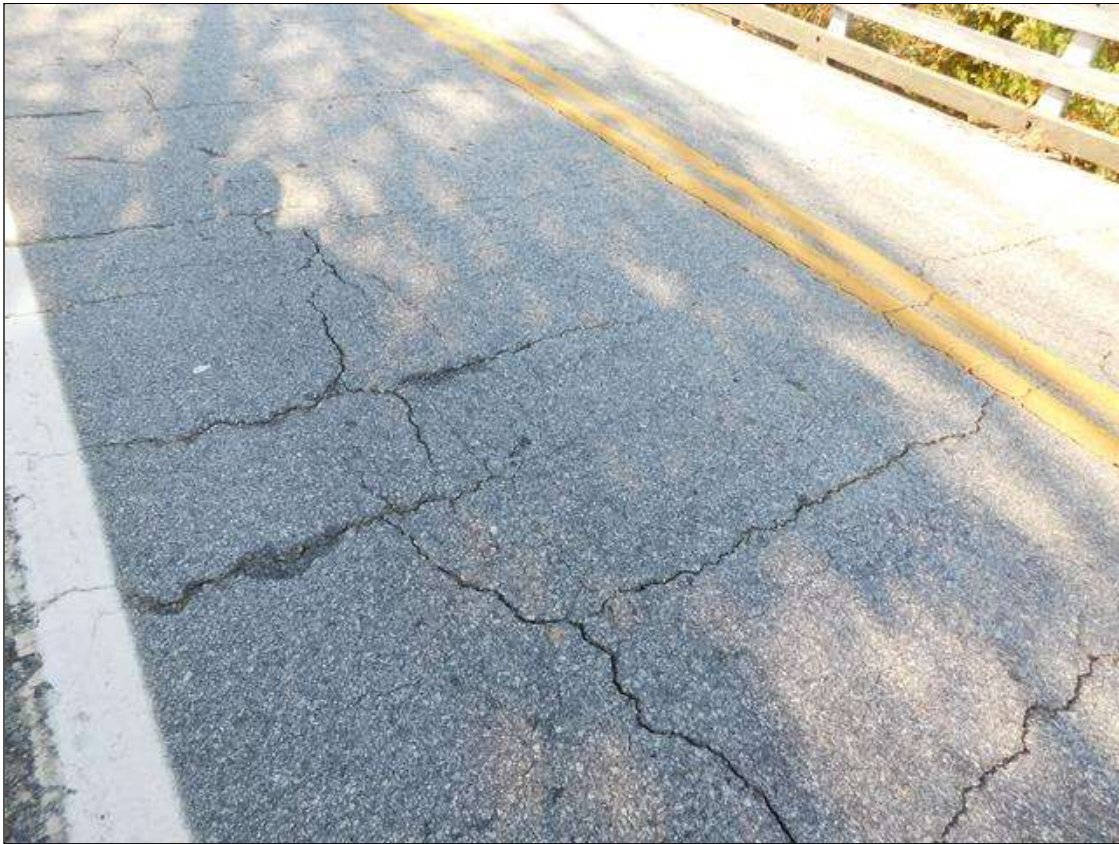
| Element Number | Defect Type | Defect Description | CS | CS Qty | Maint Qty |
|---|---|---|---|---|---|
| 510 | Crack (Wearing Surface) | SCATTERED CRACKING | 2 | 19 | 19 Square Feet |

CRACKING IN WEARING SURFACE

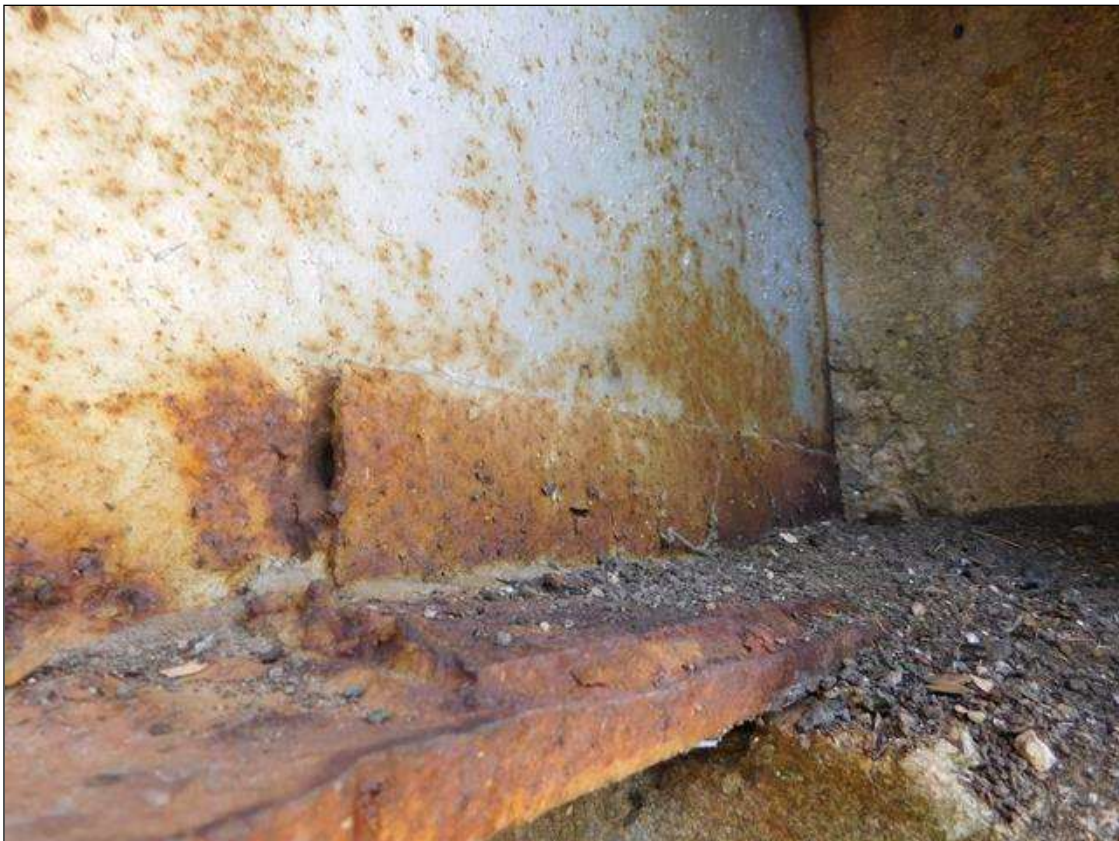
| Element Number | Defect Type | Defect Description | CS | CS Qty | Maint Qty |
|---|---|---|---|---|---|
| 107 | Connection | PLATE WELDED TO BOTTOM OF WEB AND LEFT FLANGE AT ABUTMENT 1 15" LONG X 2" WIDE | 2 | 1 | 1 Feet |

PLATE WELDED TO BEAM 1

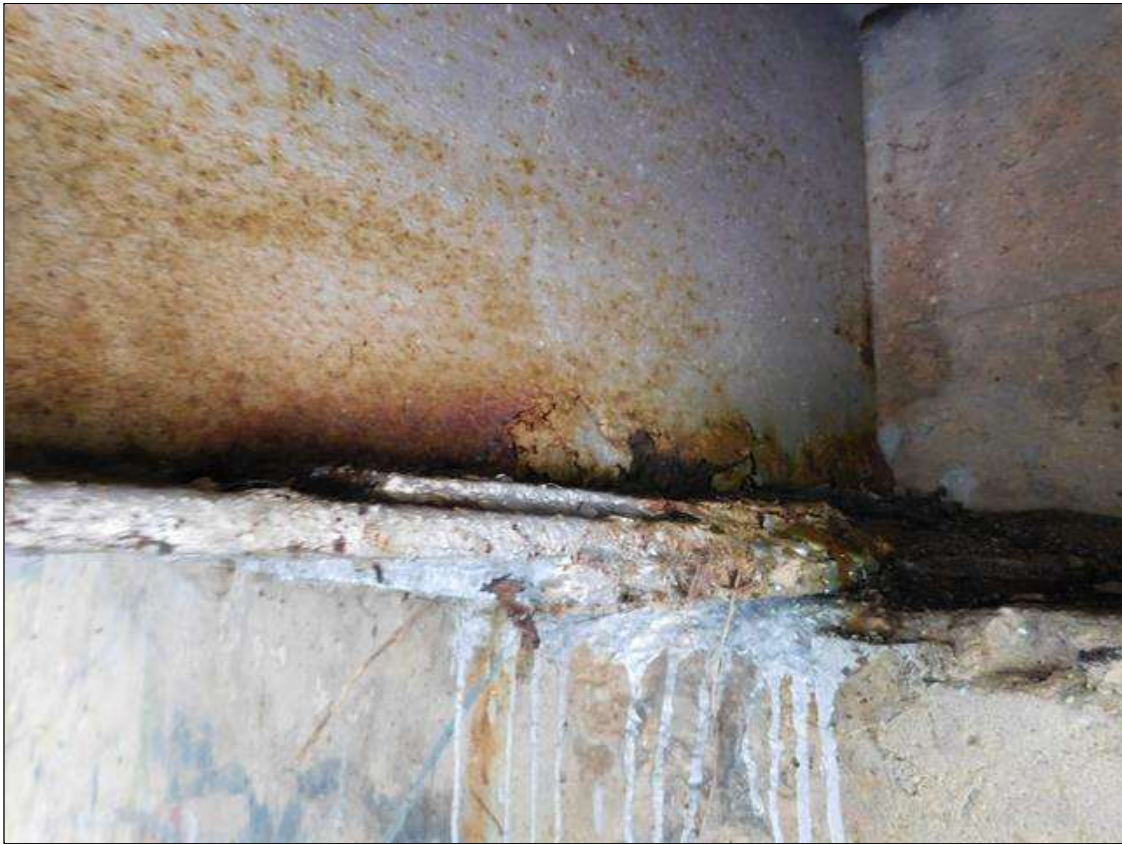
| Element Number | Defect Type | Defect Description | CS | CS Qty | Maint Qty |
|---|---|---|---|---|---|
| 107 | Connection | PLATE WELDED TO BOTTOM OF WEB AND LEFT FLANGE AT ABUTMENT 1/ 15" LONG X 2" WIDE FLANGE / WEB 8" LONG X 8" WIDE / | 2 | 1 | 1 Feet |

PLATE WELDED TO BEAM 2

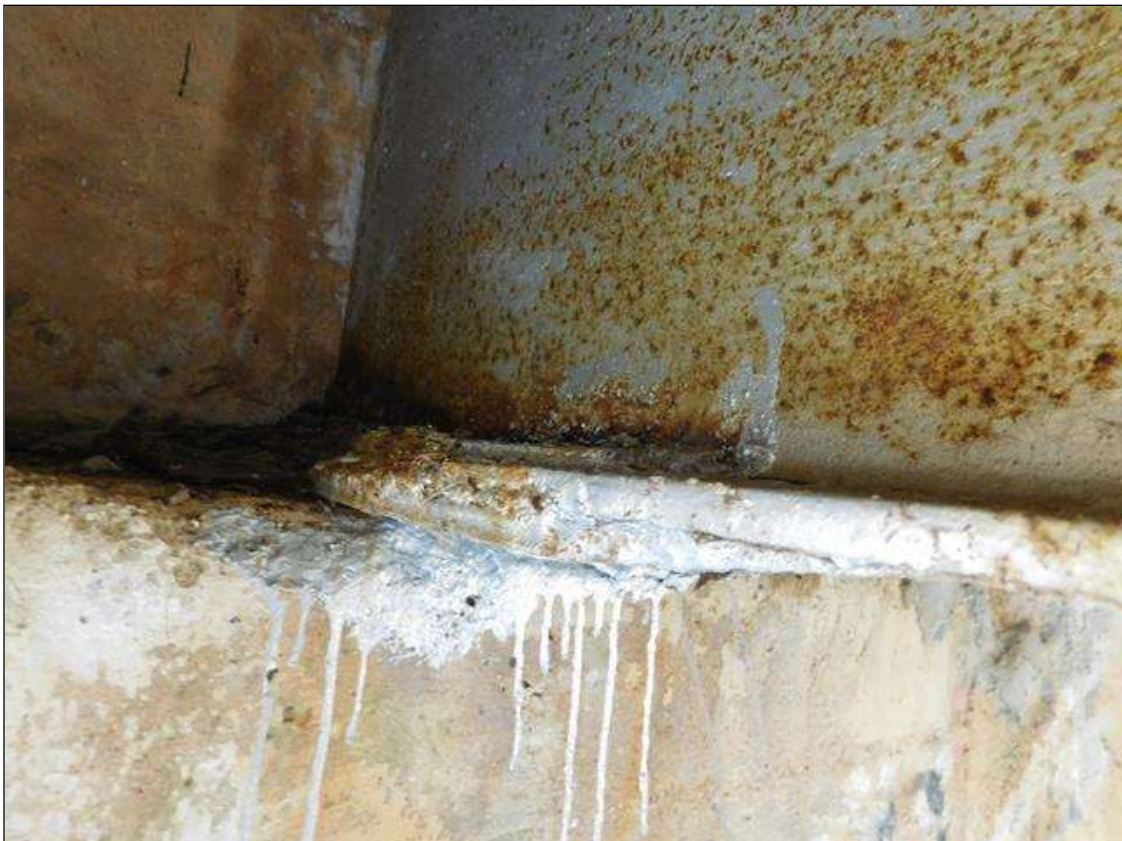
| Element Number | Defect Type | Defect Description | CS | CS Qty | Maint Qty |
|---|---|---|---|---|---|
| 107 | Connection | PLATE WELDED TO BOTTOM OF WEB AND RIGHT FLANGE AT ABUTMENT 1/ 15" LONG X 2" WIDE FLANGE / WEB 8" LONG X 8" WIDE | 2 | 1 | 1 Feet |

PLATE WELDED TO BEAM 8

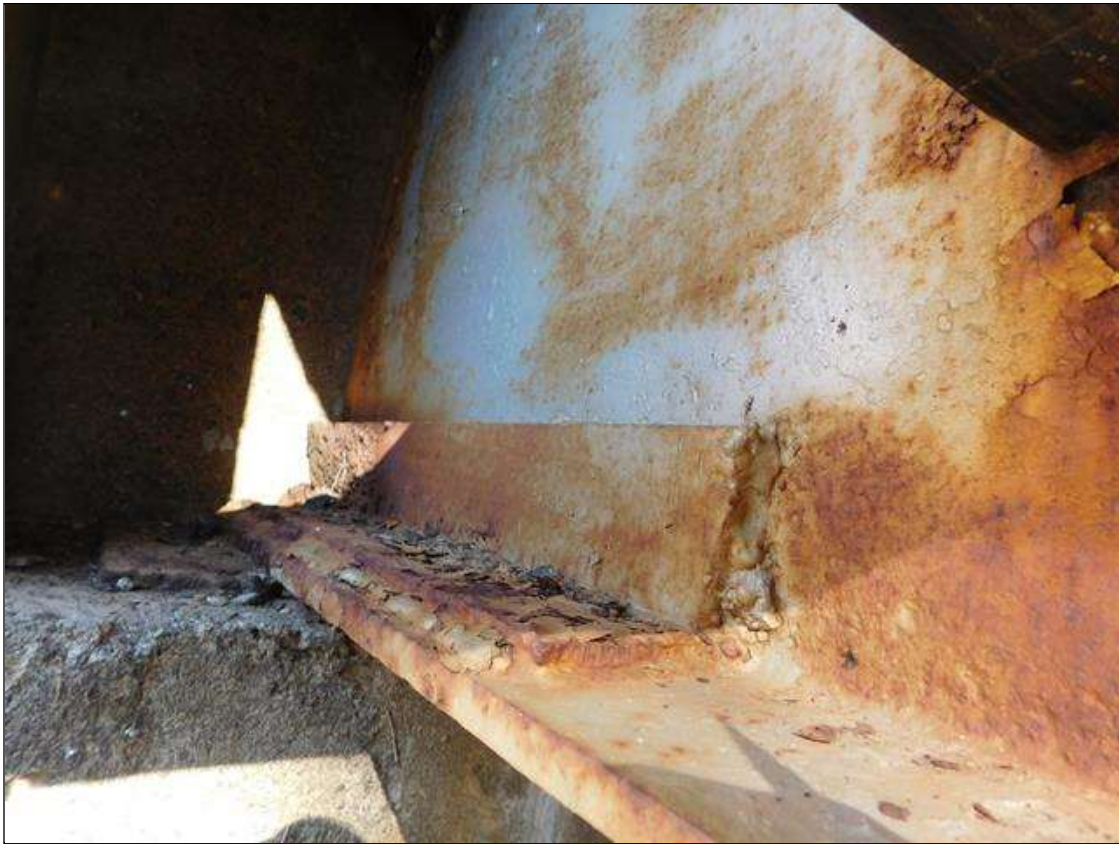
| Element Number | Defect Type | Defect Description | CS | CS Qty | Maint Qty |
|---|---|---|---|---|---|
| 107 | Connection | PLATE WELDED TO BOTTOM OF WEB AND RIGHT FLANGE AT ABUTMENT 1/ 15" LONG X 2" WIDE WEB AND FLANGE | 2 | 1 | 1 Feet |

PLATE WELDED TO BEAM 9

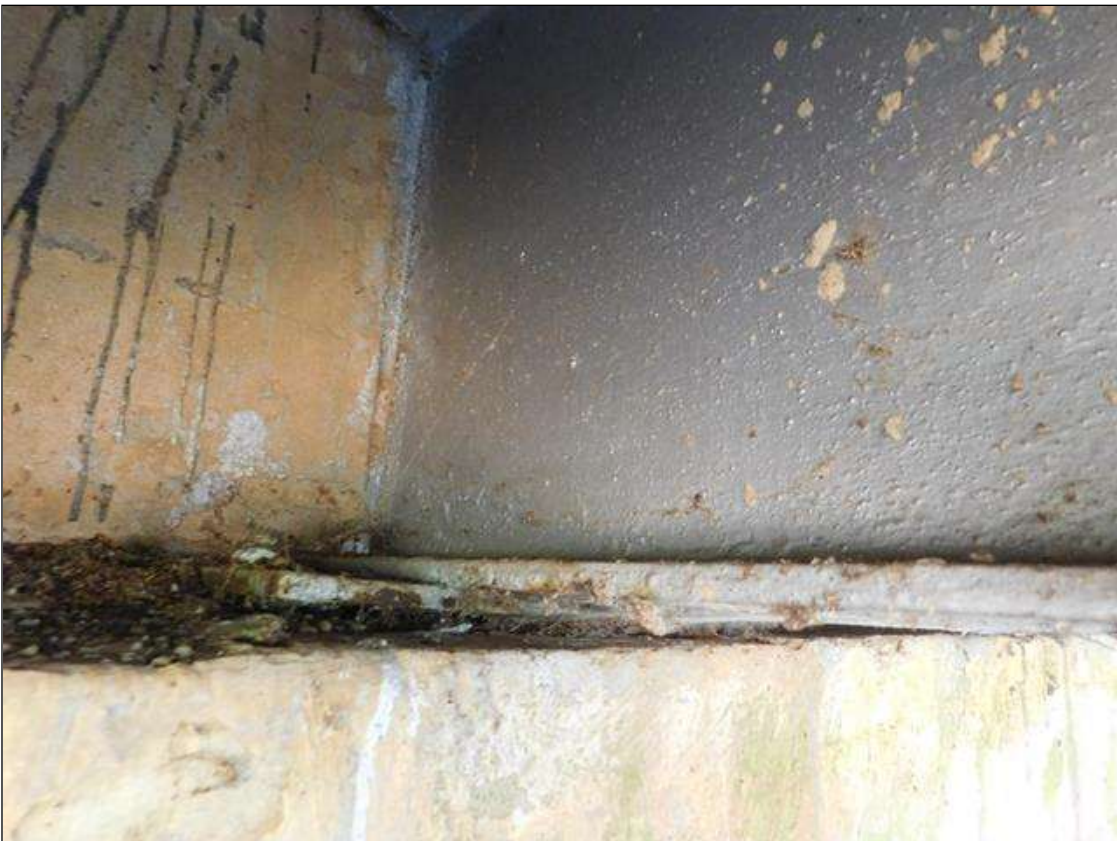
REP OF BEARINGS

| Element Number | Defect Type | Defect Description | CS | CS Qty | Maint Qty | |
|---|---|---|---|---|---|---|
| 313 | Corrosion | 1/16" LOSS | 2 | 1 | | Each |
