NC DEPARTMENT OF TRANSPORTATION  
DIVISION OF HIGHWAYS  
STRUCTURE MANAGEMENT UNIT

## Structure Safety Report

### Routine Element Inspection

COUNTY: MITCHELL STRUCTURE NUMBER: 600157 FREQUENCY: 24 MONTHS  
FACILITY CARRIED: SR1325 MILE POST: \_\_\_\_\_  
LOCATION: 1 MI.N.JCT.SR1328  
FEATURE INTERSECTED: BEANS CREEK  
LATITUDE: 36° 5' 8.29" LONGITUDE: 82° 13' 35.94"  
SUPERSTRUCTURE: TIMBER FLOOR ON TIMBER JOISTS

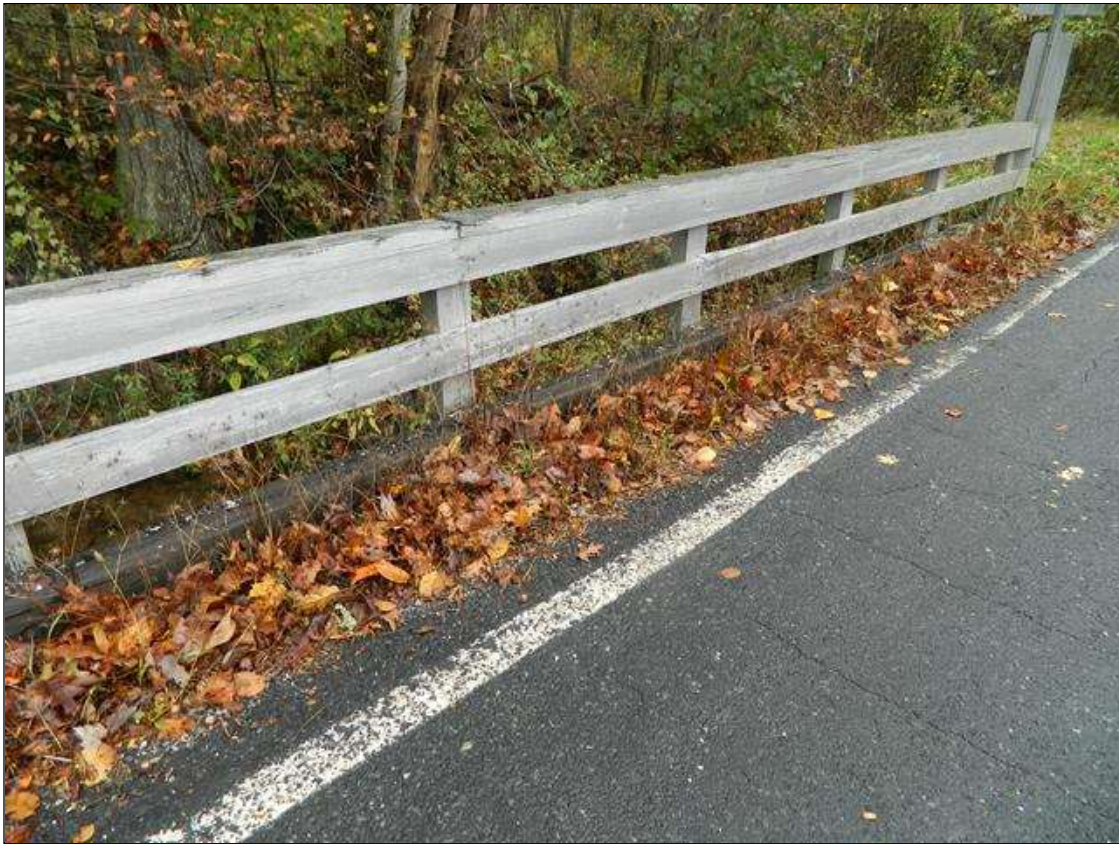
| <b>Details</b> | 1' WIDE X 2" DEEP DECK DEBRIS ALONG BOTH WHEELGUARDS. | | | | | | |

1' WIDE X 2" DEEP DEBRIS ALONG BOTH WHEELGUARDS.

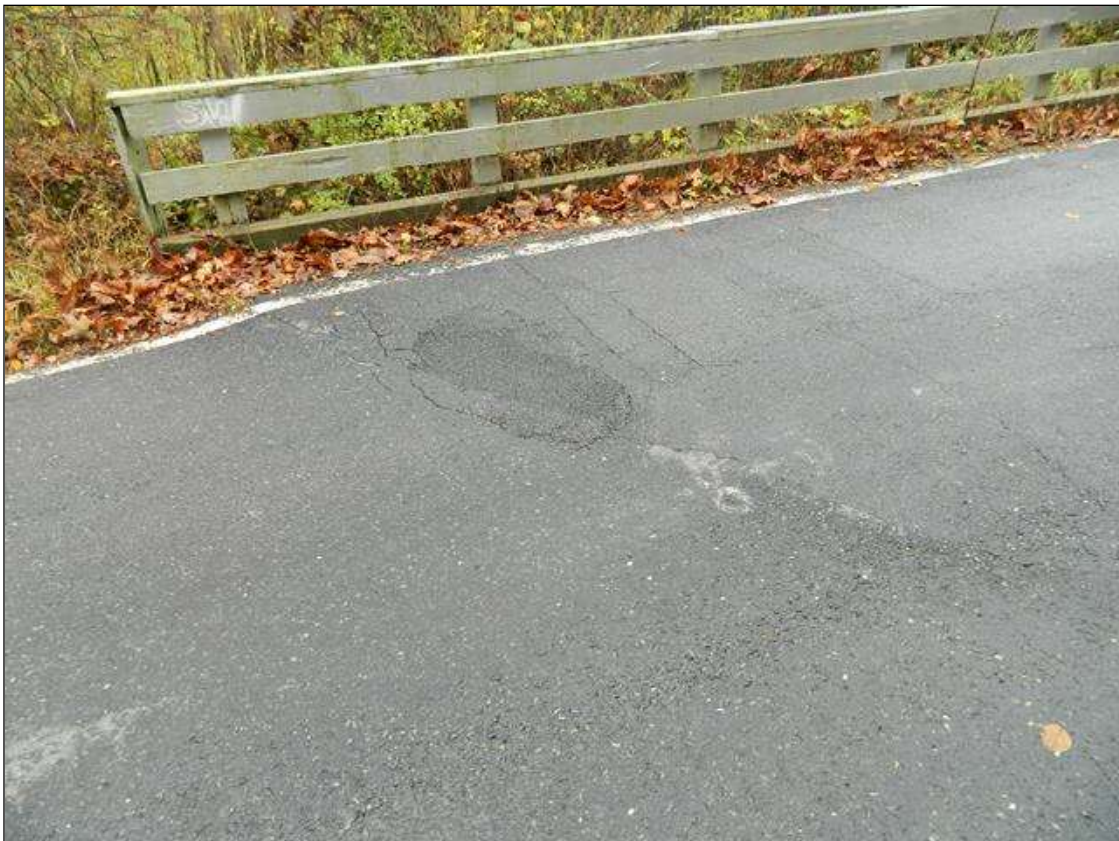
| <b>Details</b> | 8' WIDE X 3" DEEP SETTLEMENT BEHIND THE SOUTH APPROACH FILL FACE ON THE LEFT SIDE OF THE STRUCTURE. | | | | | | |

8' WIDE X 3" DEEP SETTLEMENT BEHIND THE SOUTH APPROACH FILL FACE ON THE LEFT SIDE OF THE STRUCTURE.

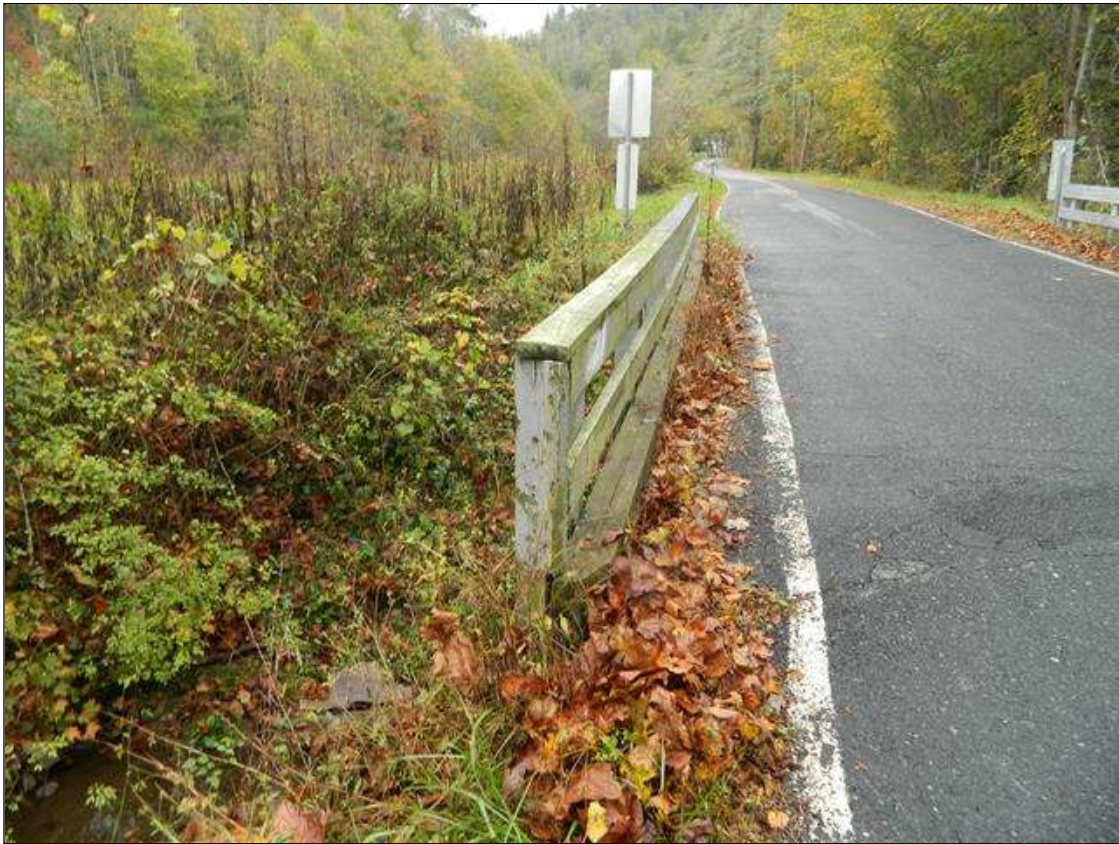
SOUTH WEST DELINEATOR IS MISSING. A SIGN NOTICE HAS BEEN ISSUED AND A PRIORITY MAINTENANCE IS REQUESTED.

| MMS Code | Description of Function | Unit | Quantity | Remarks | Est. Cost |
|---|---|---|---|---|---|
| 3250 | Install or Replace Ground Mounted Signs | SF | 3 | DELINEATOR AT THE SOUTH WEST CORNER MISSING. A SIGN NOTICE HAS BEEN ISSUED AND A PRIORITY MAINTENANCE IS REQUESTED. | |

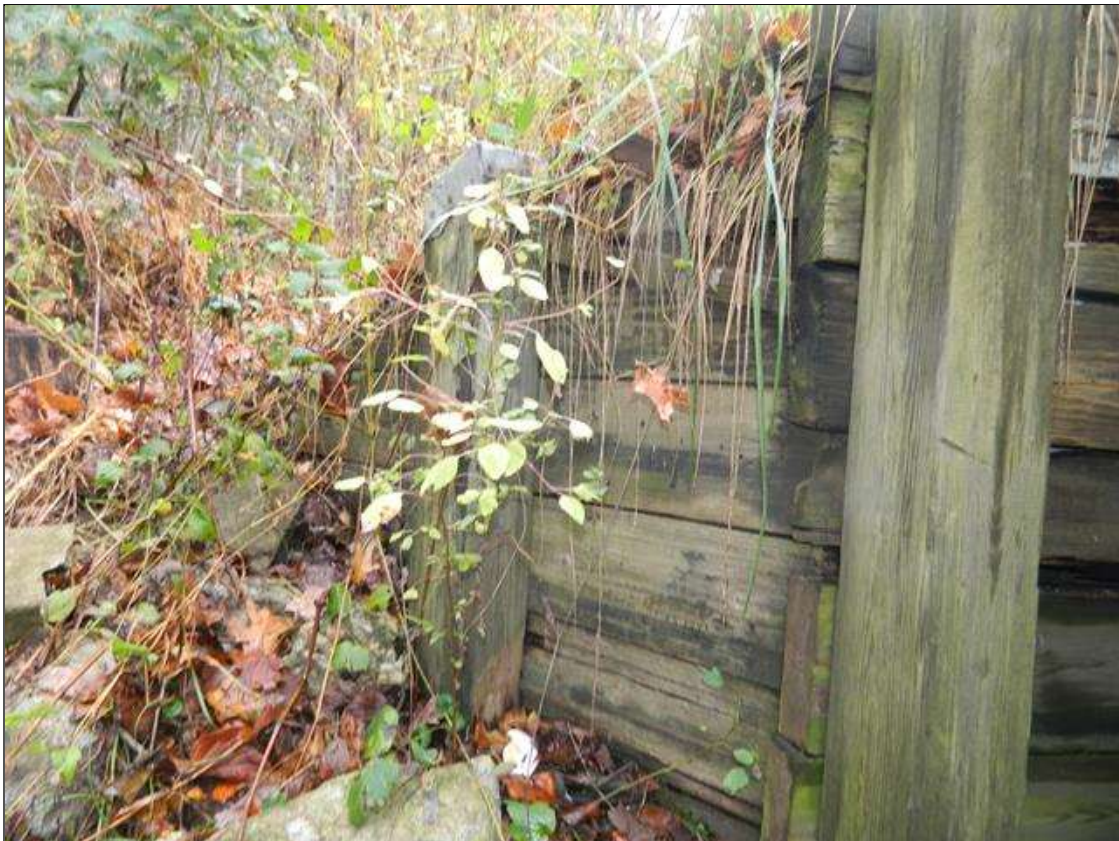
SOUTH EAST WINGWALL: ALL TIMBERS ARE SOFT WITH DECAYED AREAS UP TO 1/2" DEEP. RETAINING POST ALSO HAS DECAY UP TO 1" DEEP.

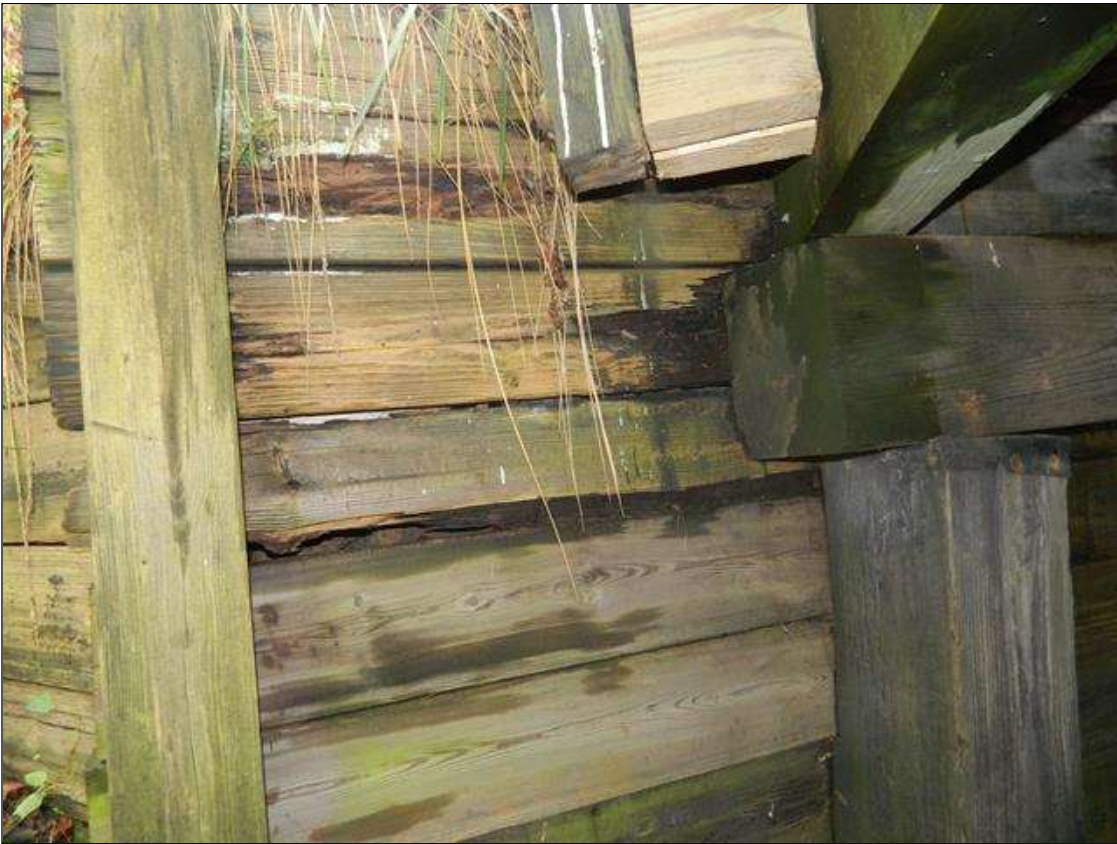
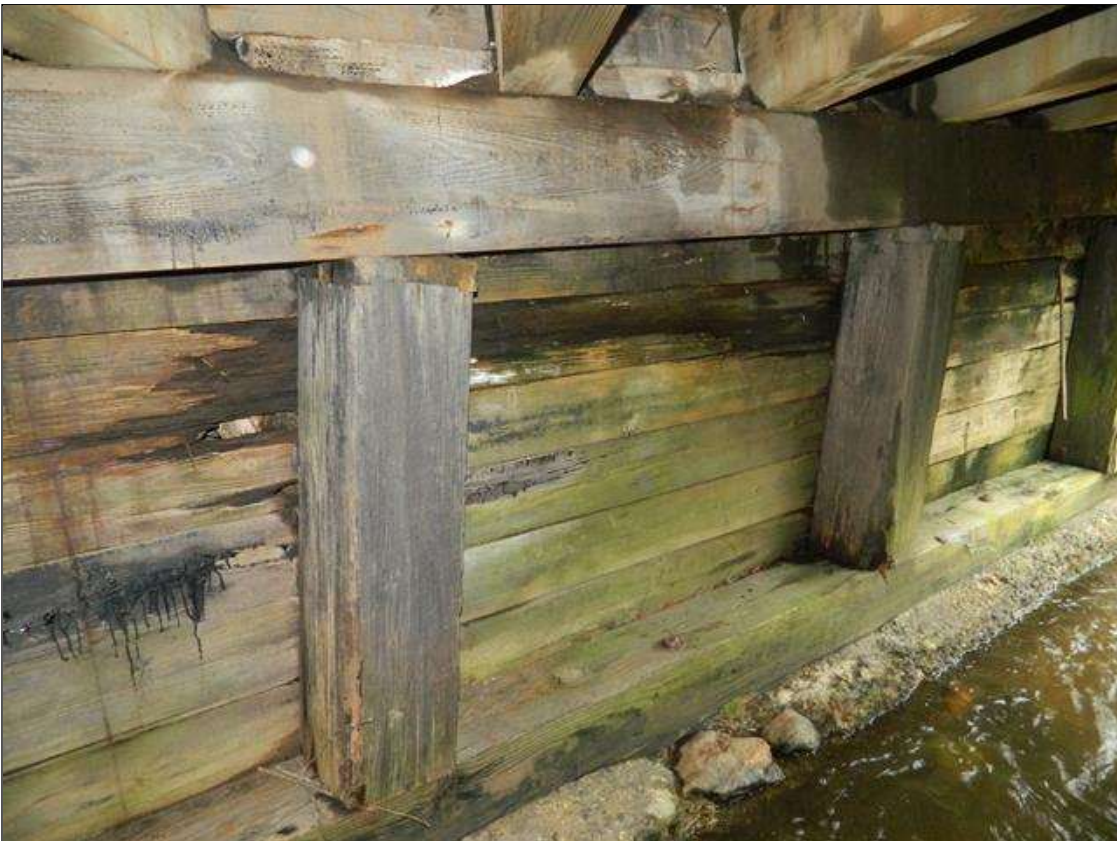
| Element Number | Defect Type | Defect Description | CS | CS Qty | Maint Qty | |
|---|---|---|---|---|---|---|
| 216 | Decay/Section Loss | TIMBERS ARE SOFT WITH AREAS OF DECAY UP TO 1/2" DEEP SCATTERED THROUGHOUT THE ABUTMENT. | 3 | 27 | 27 | Feet |

End Bent 1 Abutment/Backwall : TIMBERS ARE SOFT WITH AREAS OF DECAY UP TO 1/2" DEEP SCATTERED THROUGHOUT THE ABUTMENT.

| MMS Code | Element Name | Defect Name | Recommended Quantity |
|---|---|---|---|
| 3346 | Timber Abutment | Decay/Section Loss | 54 Feet |

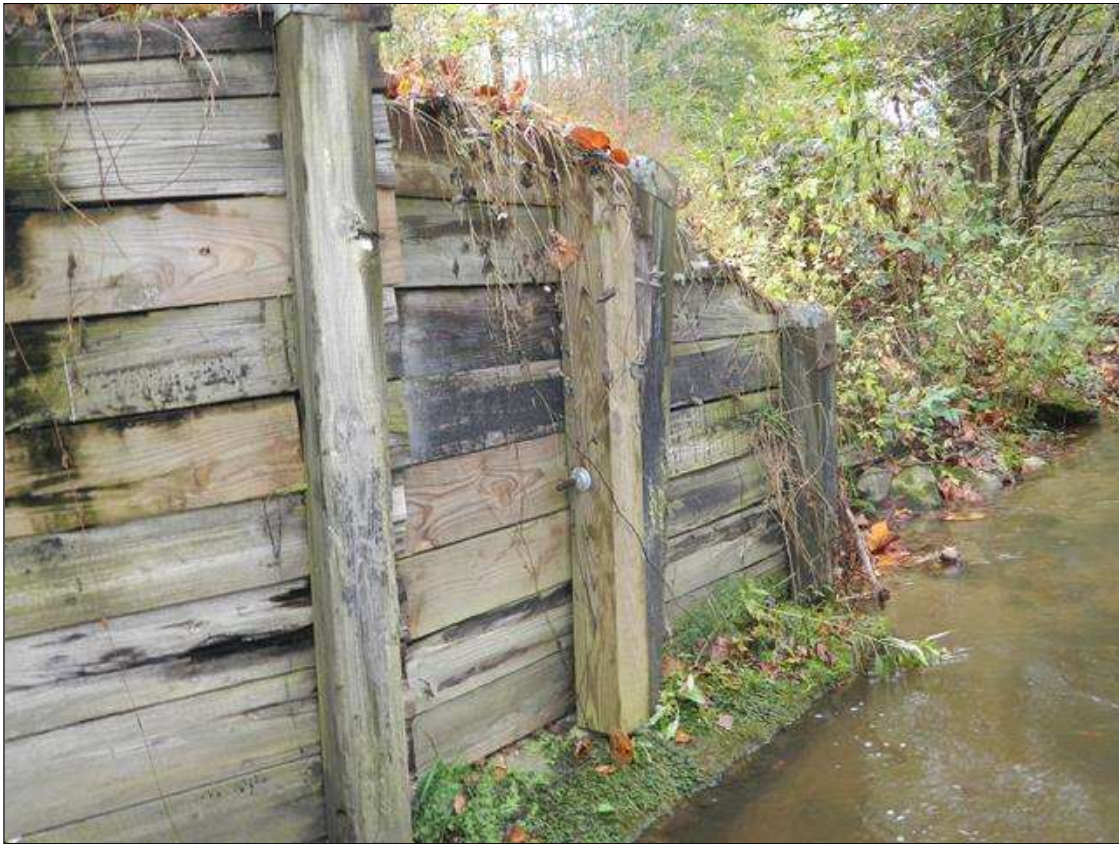
SOUTH WEST WINGWALL: THE RETAINING POST AT THE MIDDLE OF THE WING HAS BEEN SUPPLEMENTED. MULTIPLE BOARDS IN THE WING ARE SOFT WITH AREAS OF DECAY UP TO 1/2" DEEP.

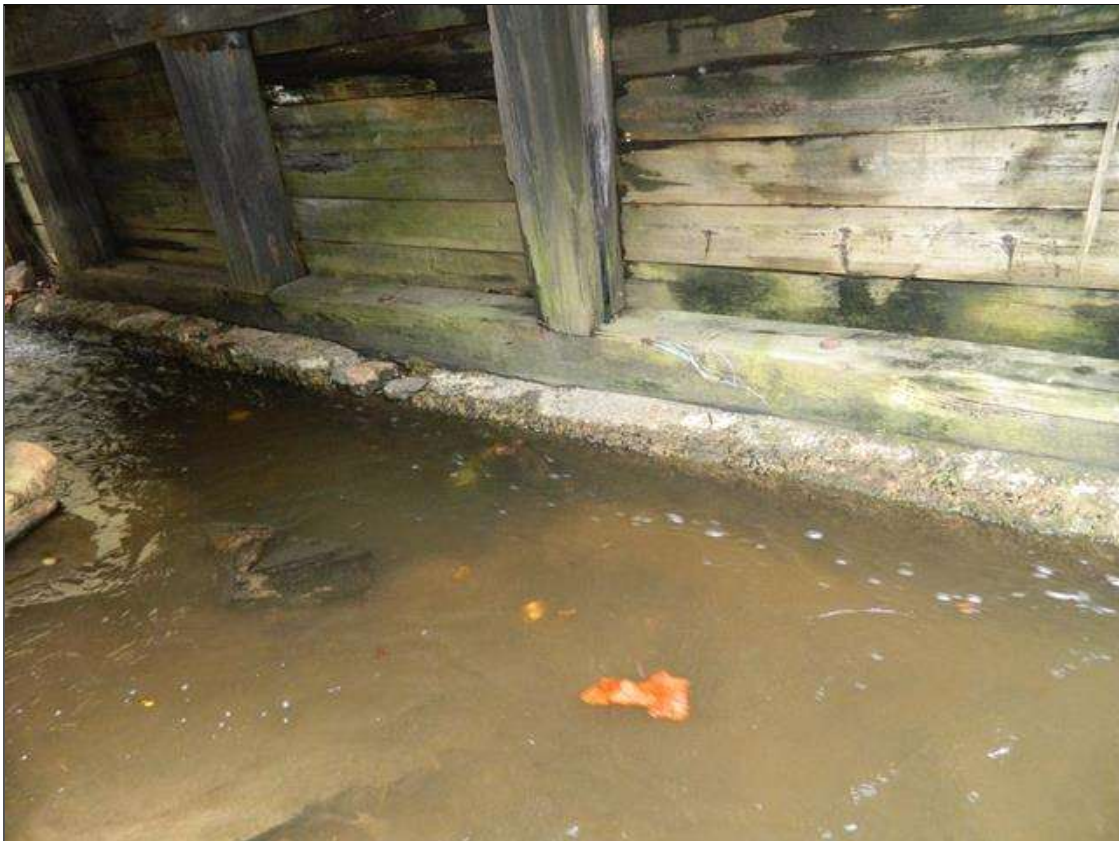
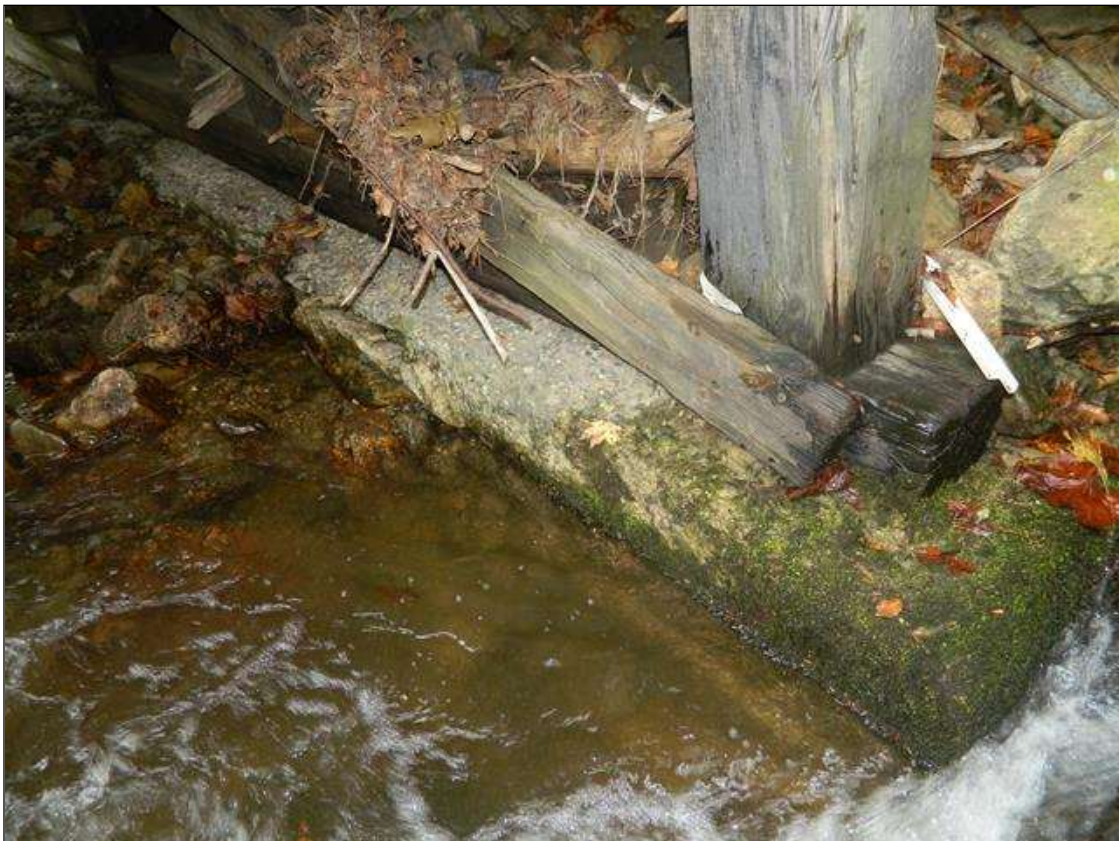
| Element Number | Defect Type | Defect Description | CS | CS Qty | Maint Qty |
|---|---|---|---|---|---|
| 220 | Abrasion/Wear (PSC/RC) | FULL LENGTH ABRASION UP TO 1/4" DEEP EXPOSING THE COARSE AGGREGATE. | 2 | 21 | Feet |

Bent 1 Footing: FULL LENGTH ABRASION UP TO 1/4" DEEP, EXPOSING THE COARSE AGGREGATE.

Bent 1 Footing: FULL LENGTH ABRASION UP TO 1/4" DEEP EXPOSING THE COARSE AGGREGATE.

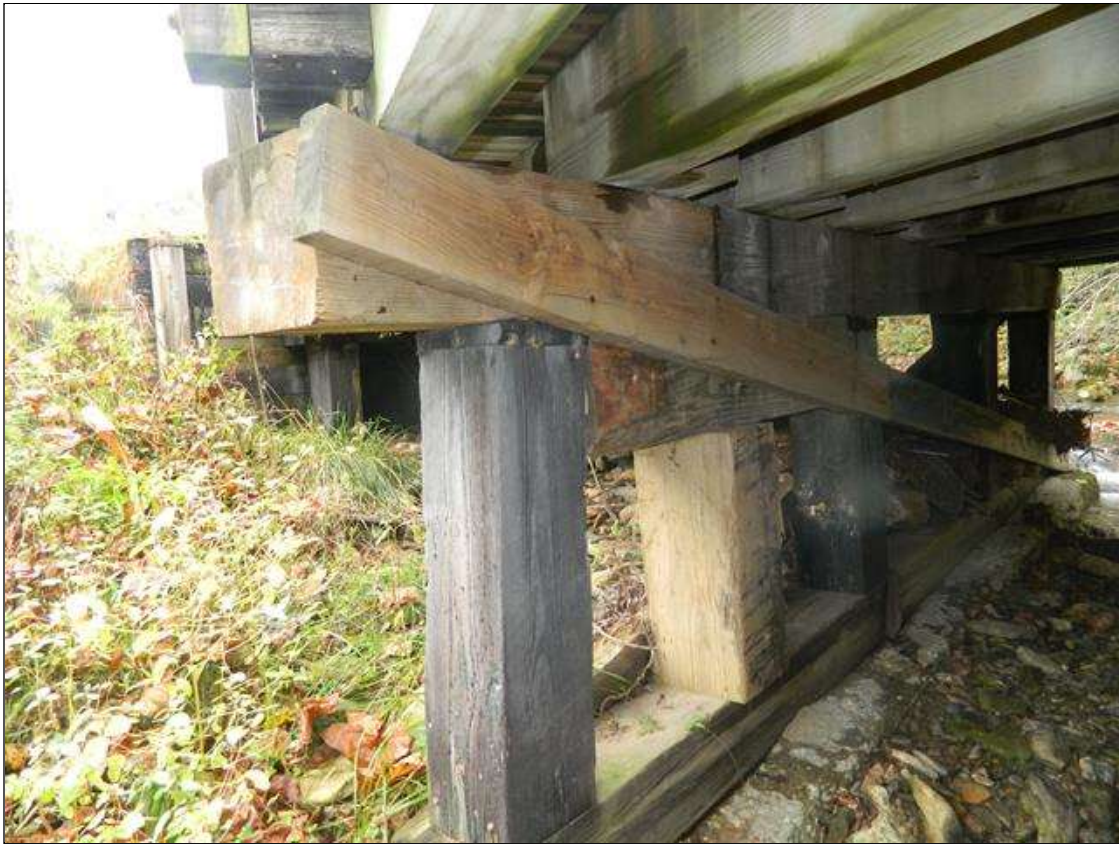
THIS IS A TEMPORARY REPAIR TO A PREVIOUS PRIORITY MAINTENANCE.

THIS IS PART OF A TEMPORARY REPAIR TO A PREVIOUS PRIORITY MAINTENANCE

TEMPORARY REPAIRS MADE TO BENT 1.

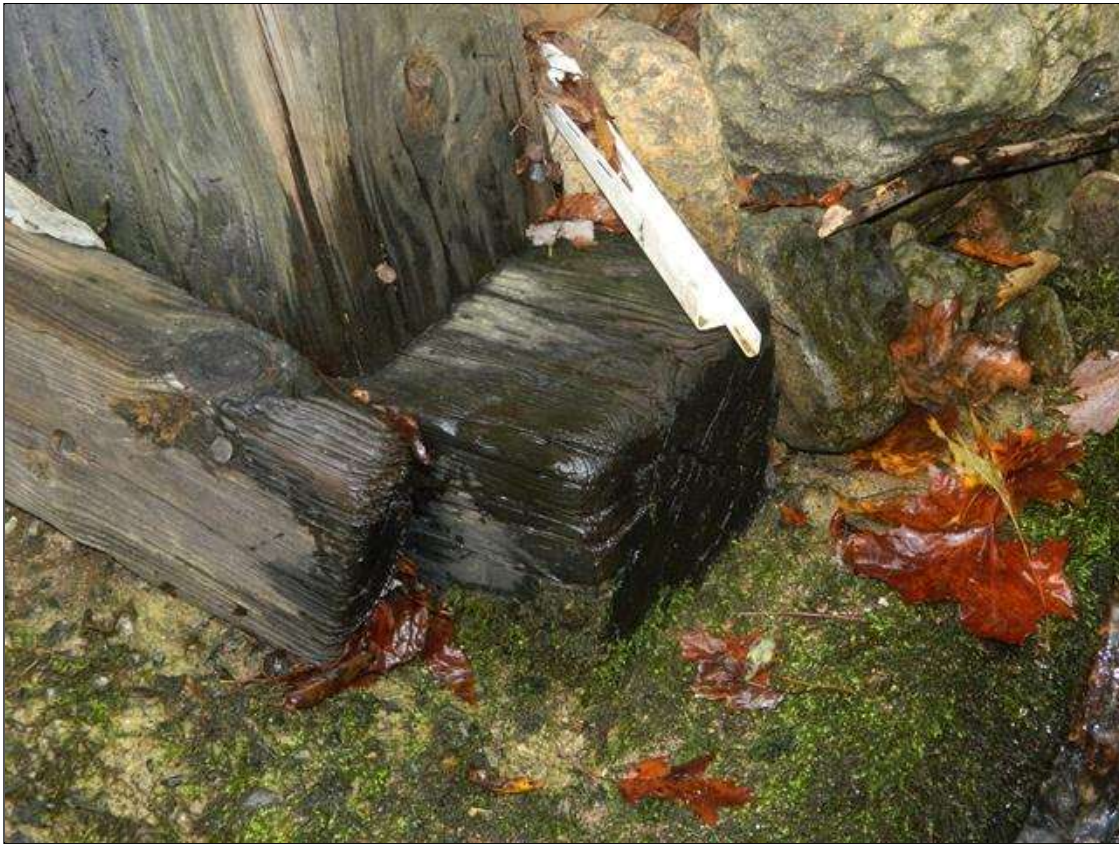
INTERIOR BENT SILL: THE UPSTREAM END OF THE SILL IS SATURATED AND SOFT WITH UP TO 1/2" DEEP DECAY TO THE TOP FACE AND THE UPSTREAM END.

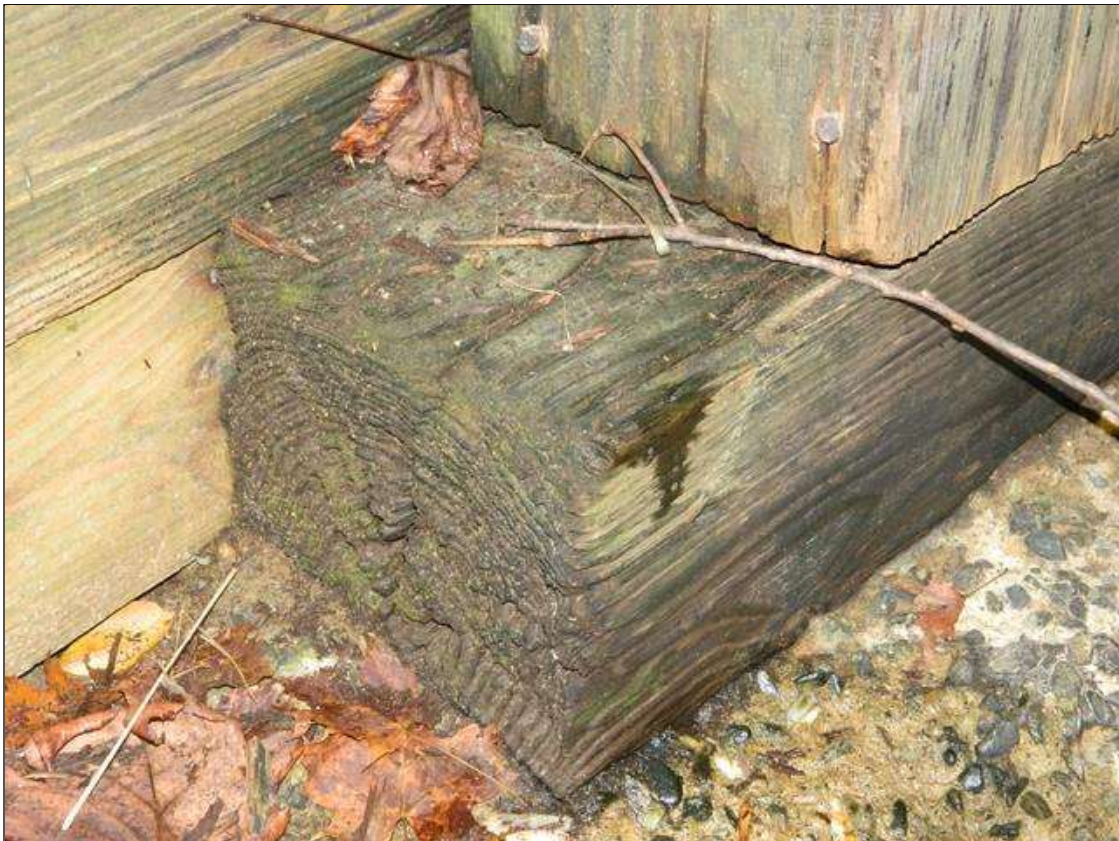
ENB BENT 1 SILL: THE UPSTREAM END OF THE SILL IS SATURATED AND SOFT WITH UP TO 1/2" DEEP DECAY TO THE TOP FACE AND THE UPSTREAM END.

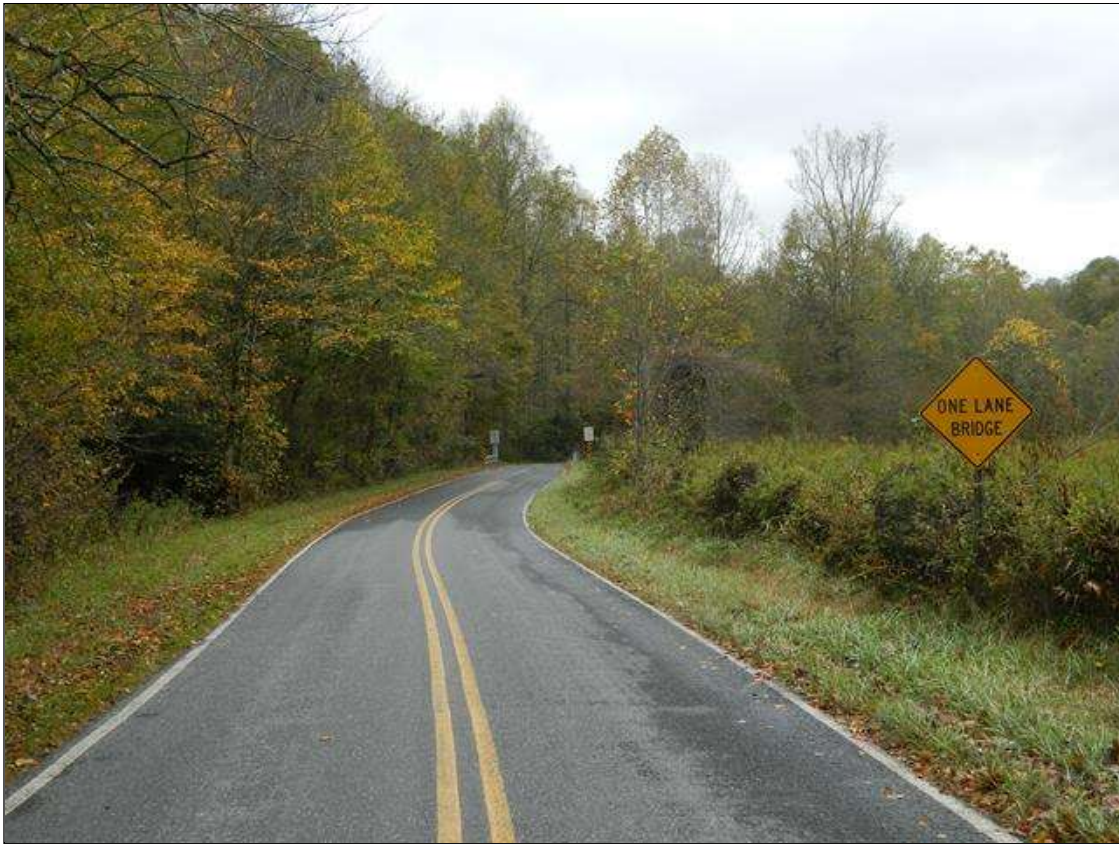
NORTH APPROACH ONE LANE BRIDGE AT 200' FROM THE BRIDGE END. THE SOUTH APPROACH SIGN IS ALSO AT 200'.

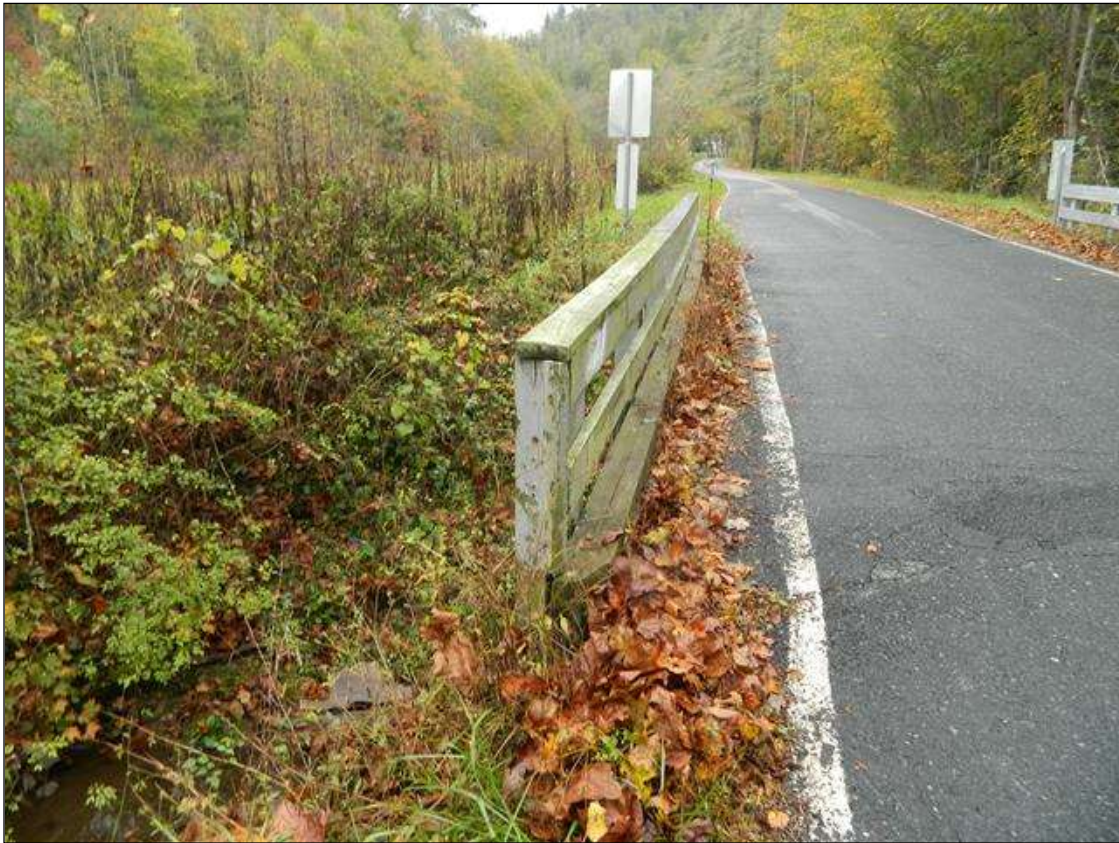
DELINEATOR AT THE SOUTH WEST CORNER MISSING. A SIGN NOTICE HAS BEEN ISSUED AND A PRIORITY MAINTENANCE IS REQUESTED.

| MMS Code | MMS Description | Quantity |
|---|---|---|
| 3250 | Install or Replace Ground Mounted Signs | 3              SF |
