NC DEPARTMENT OF TRANSPORTATION  
DIVISION OF HIGHWAYS  
STRUCTURE MANAGEMENT UNIT

## Structure Safety Report

### Routine Element Inspection

COUNTY: BUNCOMBE STRUCTURE NUMBER: 100142 FREQUENCY: 24 MONTHS

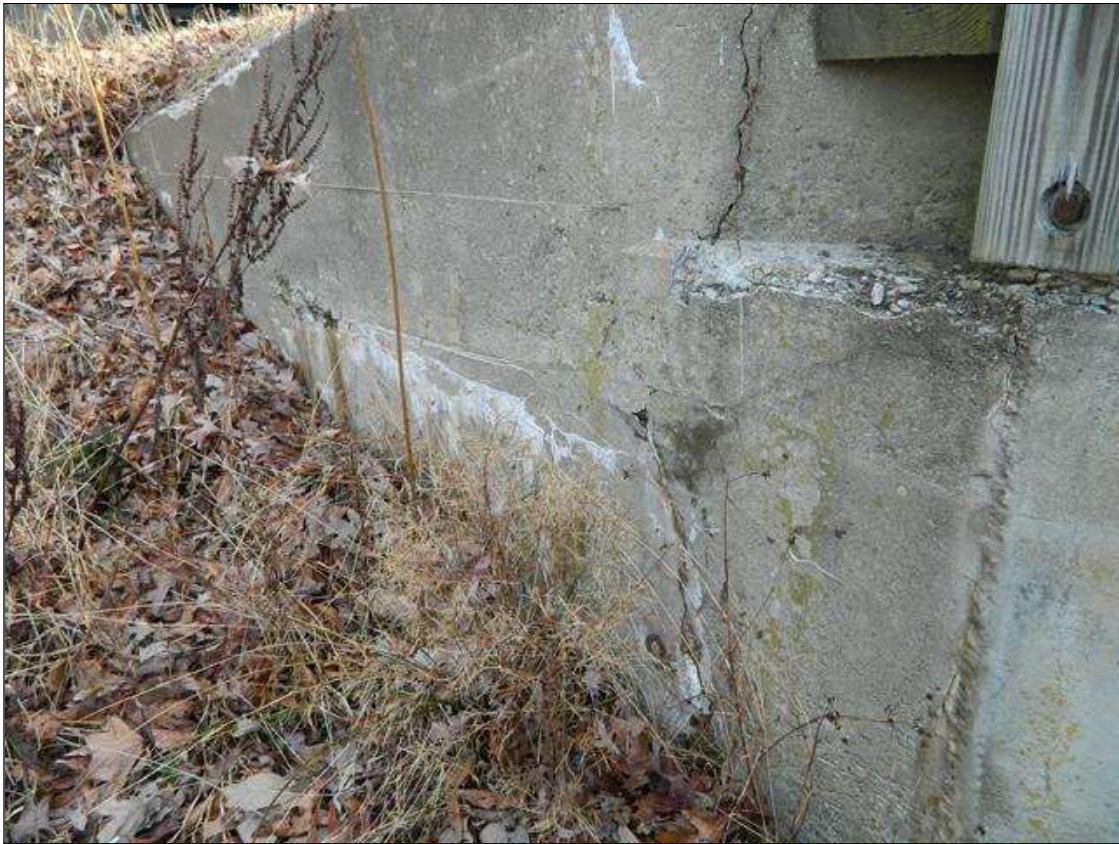
End Bent 2 Abutment/Backwall : 10' LONG X 5' HIGH AREA OF MAP CRACKING WITH HEAVY EFFLORESCENCE AND RUST STAINING ON THE LEFT END OF THE ABUTMENT.

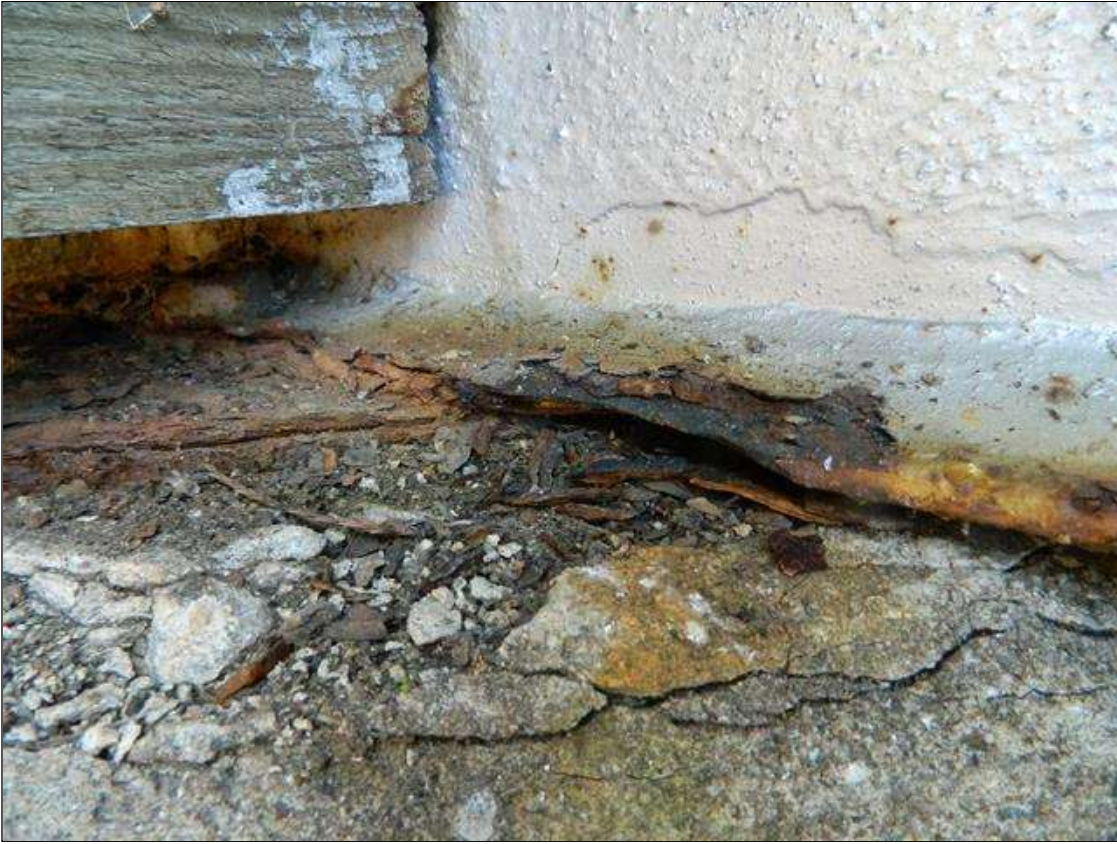
| Element Number | Defect Type | Defect Description | CS | CS Qty | Maint Qty | |
|---|---|---|---|---|---|---|
| 107 | Corrosion | CORROSION WITH THE FULL WIDTH OF THE BOTTOM FLANGE REDUCED TO 1/8" FOR 12" BEGINNING AT THE FAR END OF THE BEAM. THE ENTIRE LENGTH OF THE TOP FLANGE HAS CORROSION WITH REMAINING SECTION REDUCED TO 1/8" - 3/16". THE LOWER 4" OF THE WEB IS REDUCED TO 1/8" FOR 12" AT BEARINGS ON BOTH END BENTS. ORIGINAL 1/4" WEB AND 5/16" FLANGE THICKNESSES. FRECKLED/FLAKING RUST THROUGHOUT THE REMAINING AREA OF THE BEAM. A PRIORITY MAINTENANCE IS REQUESTED. | 4 | 21 | 21 | Feet |

Span 1 Beam 1: CORROSION WITH THE FULL WIDTH OF THE BOTTOM FLANGE REDUCED TO 1/8" FOR 12" BEGINNING AT THE FAR END OF THE BEAM. THE ENTIRE LENGTH OF THE TOP FLANGE HAS CORROSION WITH REMAINING SECTION REDUCED TO 1/8" - 3/16". THE LOWER 4" OF THE WEB IS REDUCED TO 1/8" FOR 12" AT BEARINGS ON BOTH END BENTS. ORIGINAL 1/4" WEB AND 5/16" FLANGE THICKNESSES. FRECKLED/FLAKING RUST THROUGHOUT THE REMAINING AREA OF THE BEAM. A PRIORITY MAINTENANCE IS REQUESTED.

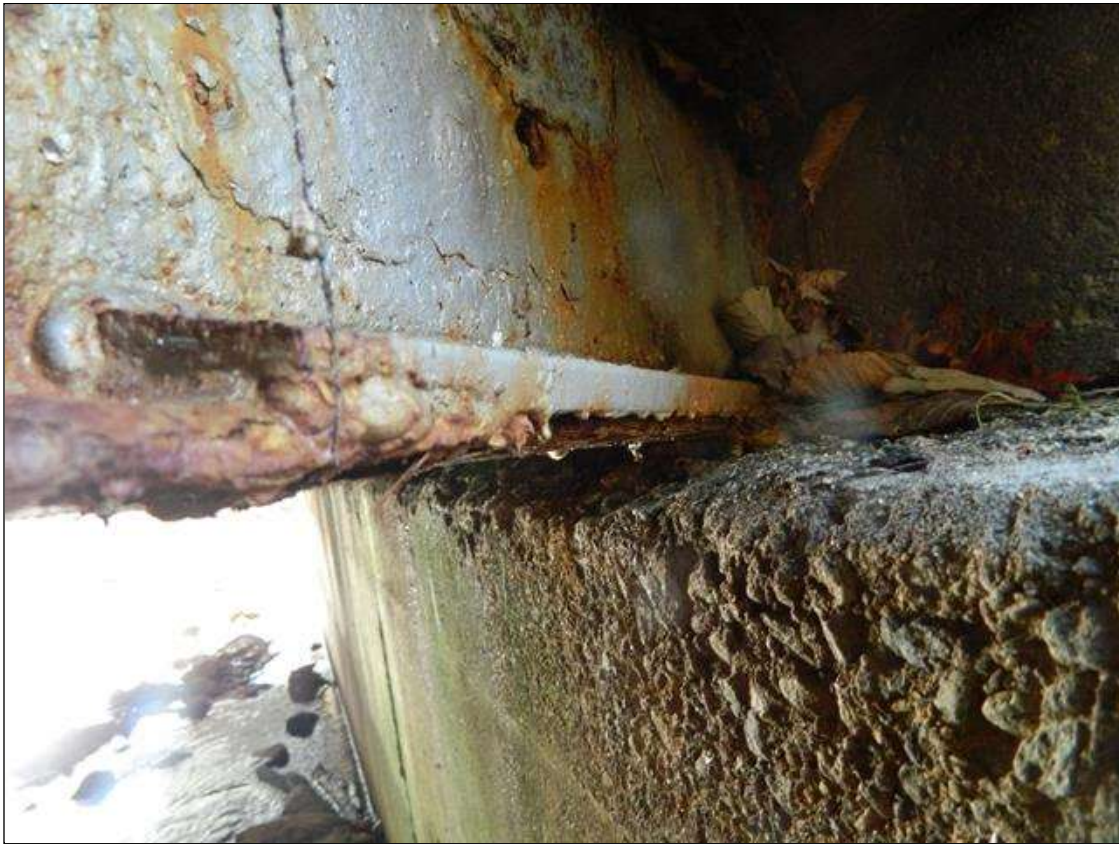
BEAM 1 REPAIR PLATES:  
 10" LONG X 2" WIDE X 1/2" THICK PLATE WELDED TO THE LEFT HALF OF THE BOTTOM FLANGE AT 12" FROM NEAR END.  
 6" LONG X 2" WIDE X 1/2" THICK PLATE WELDED TO THE RIGHT HALF OF THE BOTTOM FLANGE AT 10" FROM THE NEAR END.

BEAM 1 REPAIR PLATES: 10" LONG X 2" WIDE X 1/2" THICK PLATE WELDED TO THE LEFT HALF OF THE BOTTOM FLANGE AT 12" FROM NEAR END. 6" LONG X 2" WIDE X 1/2" THICK PLATE WELDED TO THE RIGHT HALF OF THE BOTTOM FLANGE AT 10" FROM THE NEAR END.

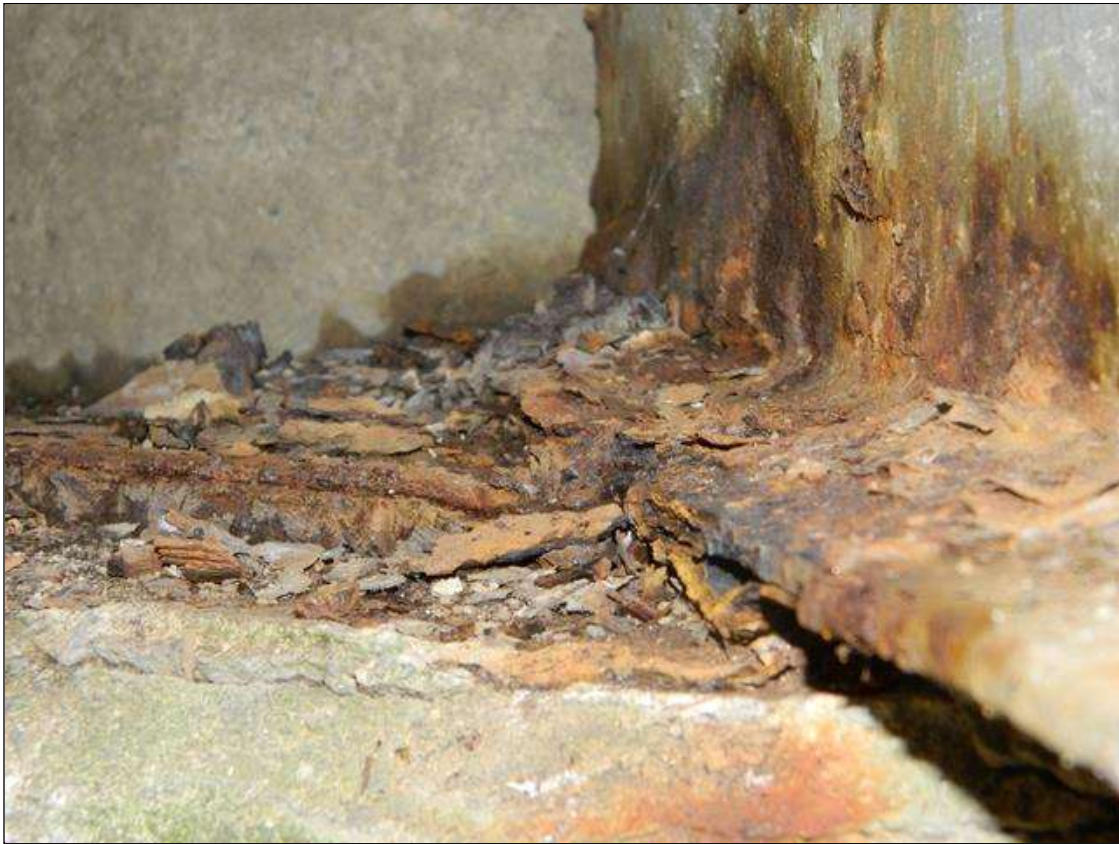
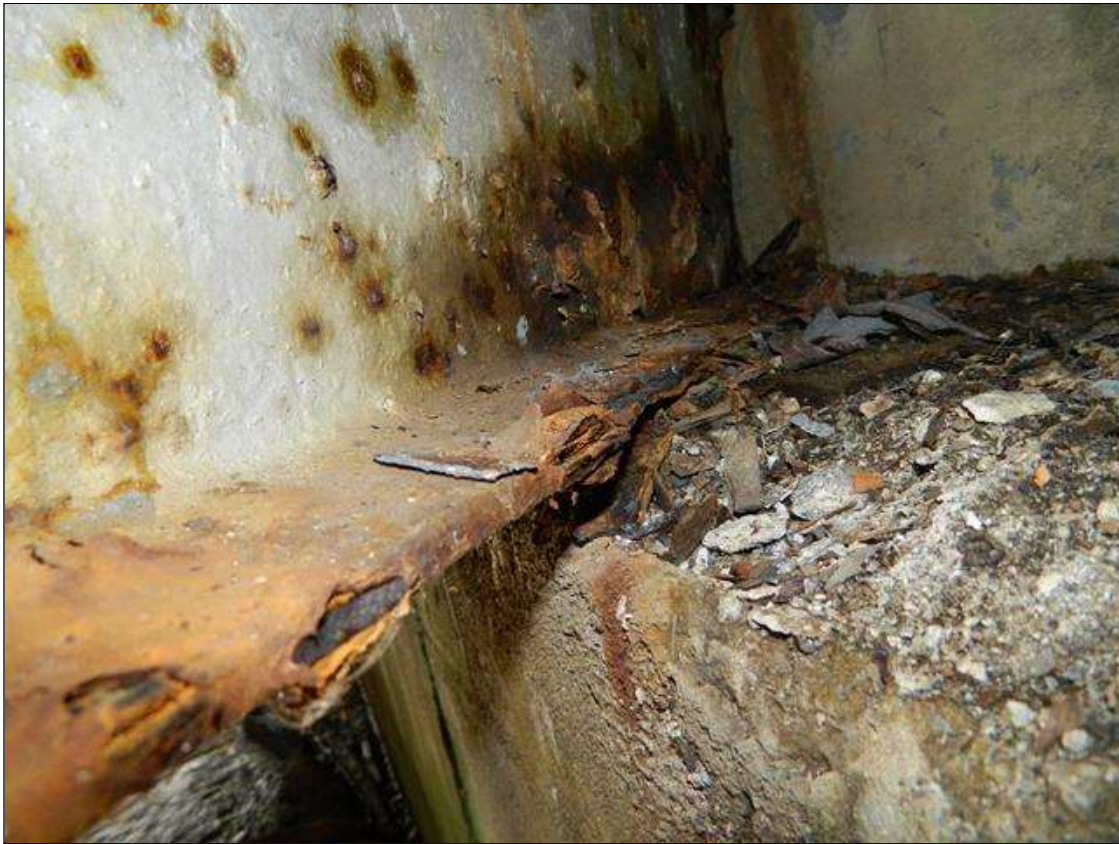
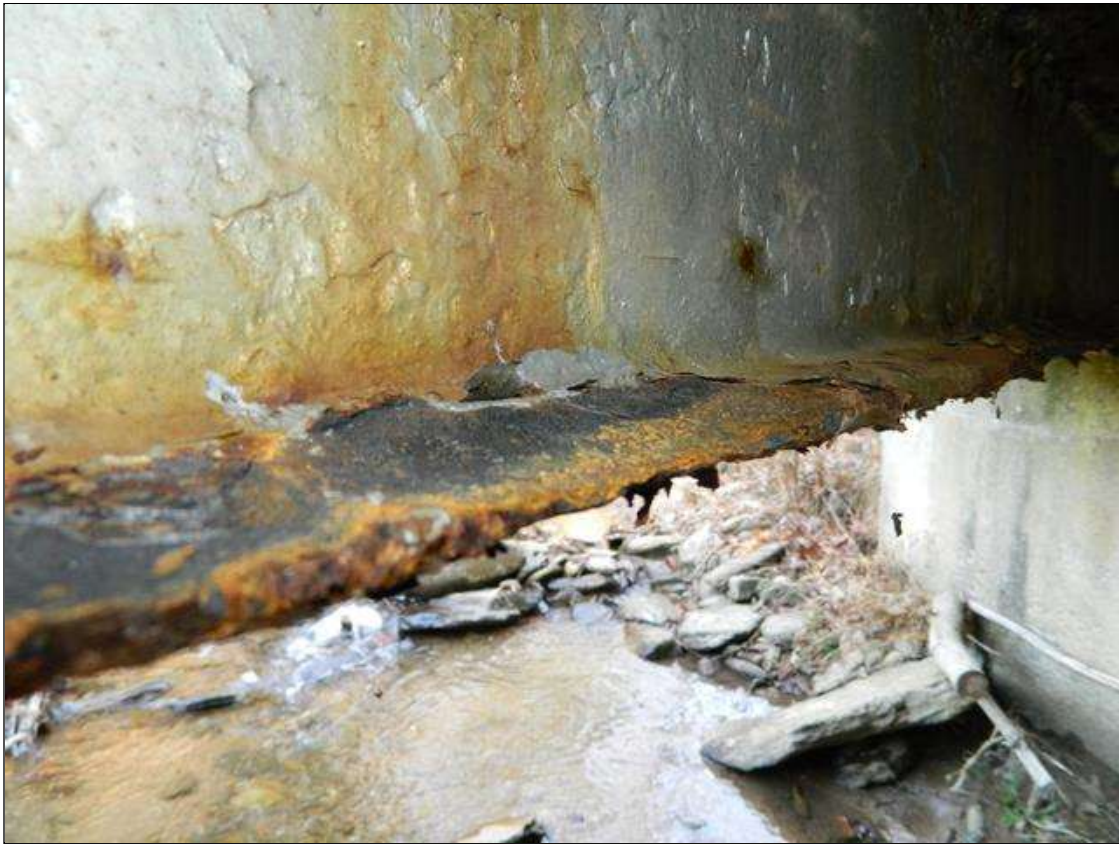
| Element Number | Defect Type | Defect Description | CS | CS Qty | Maint Qty | |
|---|---|---|---|---|---|---|
| 107 | Corrosion | CORROSION WITH THE FULL WIDTH OF THE BOTTOM FLANGE REDUCED TO A KNIFE EDGE TO 1/16" FOR 13" BEGINNING AT THE NEAR END OF THE BEAM. THE LEFT HALF OF THE FLANGE IS REDUCED TO 1/8" FOR 12" BEGINNING AT 10' AND 13' FROM THE NEAR END OF THE BEAM. THE FULL WIDTH OF THE BOTTOM FLANGE IS REDUCED TO 1/16" - 1/8" FOR 12" AT THE FAR END OF THE BEAM. THE ENTIRE LENGTH OF THE TOP FLANGE HAS CORROSION WITH REMAINING SECTION REDUCED TO 1/8" - 3/16". THE FULL HEIGHT OF THE WEB IS REDUCED TO 1/8" FOR 12" AT BEARINGS ON BOTH END BENTS. ORIGINAL 1/4" WEB AND 5/16" FLANGE THICKNESSES. FRECKLED/FLAKING RUST THROUGHOUT THE REMAINING AREA OF THE BEAM. A PRIORITY MAINTENANCE IS REQUESTED. | 4 | 21 | 21 | Feet |

Span 1 Beam 2: CORROSION WITH THE FULL WIDTH OF THE BOTTOM FLANGE REDUCED TO A KNIFE EDGE TO 1/16" FOR 13" BEGINNING AT THE NEAR END OF THE BEAM. THE LEFT HALF OF THE FLANGE IS REDUCECD TO 1/8" FOR 12" BEGINNING AT 10' AND 13' FROM THE NEAR END OF THE BEAM. THE FULL WIDTH OF THE BOTTOM FLANGE IS REDUCED TO 1/16" - 1/8" FOR 12" AT THE FAR END OF THE BEAM. THE ENTIRE LENGTH OF THE TOP FLANGE HAS CORROSION WITH REMAINING SECTION REDUCED TO 1/8" - 3/16". THE FULL HEIGHT OF THE WEB IS REDUCED TO 1/8" FOR 12" AT BEARINGS ON BOTH END BENTS. ORIGINAL 1/4" WEB AND 5/16" FLANGE THICKNESSES. FRECKLED/FLAKING RUST THROUGHOUT THE REMAINING AREA OF THE BEAM. A PRIORITY MAINTENANCE IS REQUESTED.

Span 1 Beam 2: CORROSION WITH THE FULL WIDTH OF THE BOTTOM FLANGE REDUCED TO A KNIFE EDGE TO 1/16" FOR 13' BEGINNING AT THE NEAR END OF THE BEAM. THE LEFT HALF OF THE FLANGE IS REDUCED TO 1/8" FOR 12' BEGINNING AT 10' AND 13' FROM THE NEAR END OF THE BEAM. THE FULL WIDTH OF THE BOTTOM FLANGE IS REDUCED TO 1/16" - 1/8" FOR 12" AT THE FAR END OF THE BEAM. THE ENTIRE LENGTH OF THE TOP FLANGE HAS CORROSION WITH REMAINING SECTION REDUCED TO 1/8" - 3/16". THE FULL HEIGHT OF THE WEB IS REDUCED TO 1/8" FOR 12" AT BEARINGS ON BOTH END BENTS. ORIGINAL 1/4" WEB AND 5/16" FLANGE THICKNESSES. FRECKLED/FLAKING RUST THROUGHOUT THE REMAINING AREA OF THE BEAM. A PRIORITY MAINTENANCE IS REQUESTED.

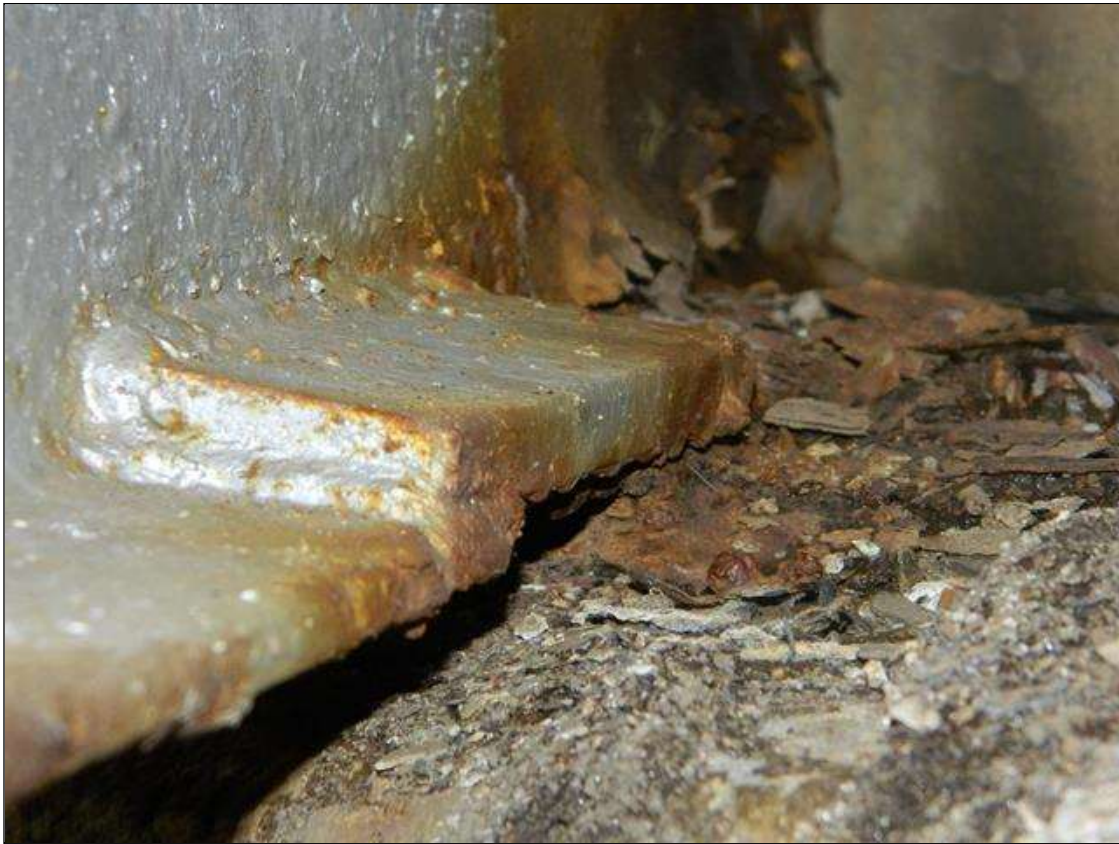
Span 1 Beam 3: REPAIR PLATES HAVE BEEN WELDED TO THE BOTTOM FLANGE AT 10" FROM THE NEAR END OF THE BEAM. THESE ARE PRIORITY MAINTENANCE REPAIRS. THE FULL LENGTH OF THE TOP FLANGE IS REDUCED TO 1/8" - 3/16" THE FULL LENGTH OF THE BEAM. FRECKLED AND FLAKING RUST ON THE WEB AND BOTTOM FLANGE.

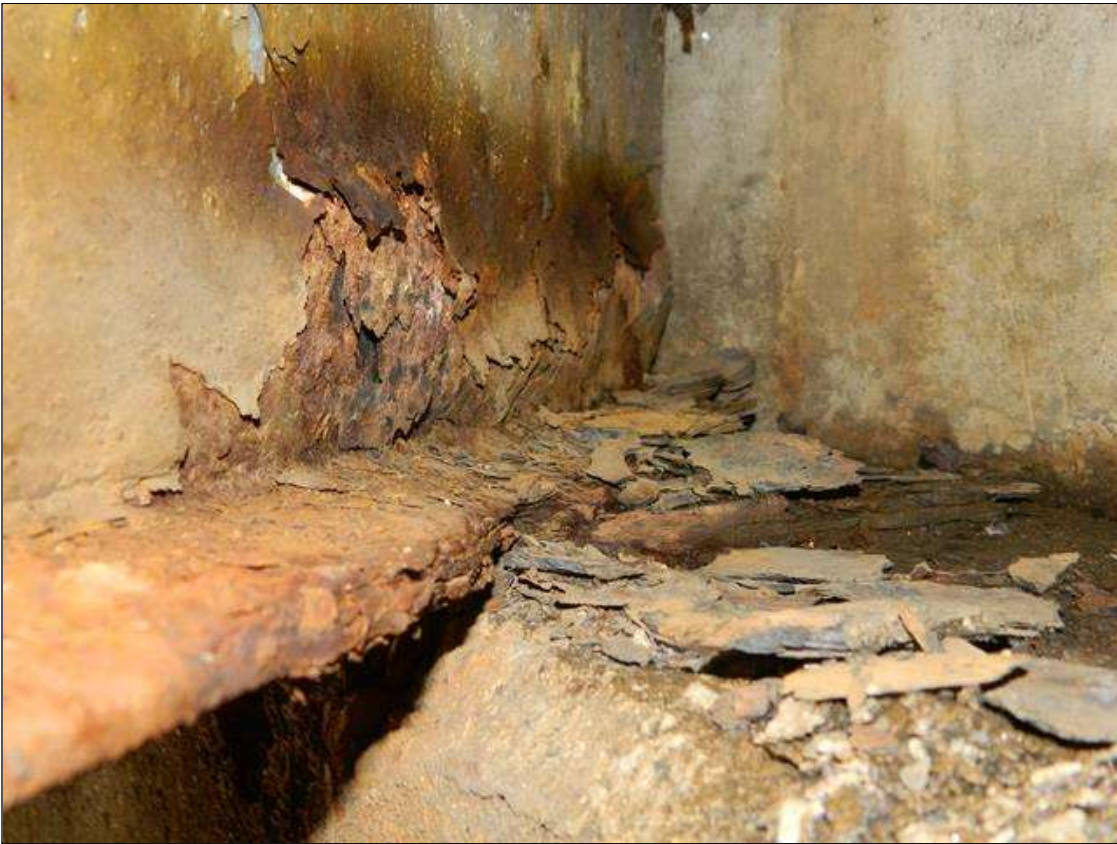
Span 1 Beam 5: CORROSION WITH THE LEFT HALF OF THE BOTTOM FLANGE REDUCED TO  $\frac{1}{16}$ " -  $\frac{1}{8}$ " FOR 15" BEGINNING AT THE NEAR END OF THE BEAM. THE RIGHT HALF OF THE BOTTOM FLANGE HAS A PLATE AT THE NEAR END OF THE BEAM. THE ENTIRE LENGTH OF THE TOP FLANGE HAS CORROSION WITH REMAINING SECTION REDUCED TO  $\frac{1}{8}$ " -  $\frac{3}{16}$ ". THE LOWER 3" OF THE WEB IS REDUCED TO  $\frac{1}{8}$ " FOR 12" AT BEARINGS ON BOTH END BENTS. ORIGINAL  $\frac{1}{4}$ " WEB AND  $\frac{5}{16}$ " FLANGE THICKNESSES. FRECKLED/FLAKING RUST THROUGHOUT THE REMAINING AREA OF THE BEAM. A PRIORITY MAINTENANCE IS REQUESTED.

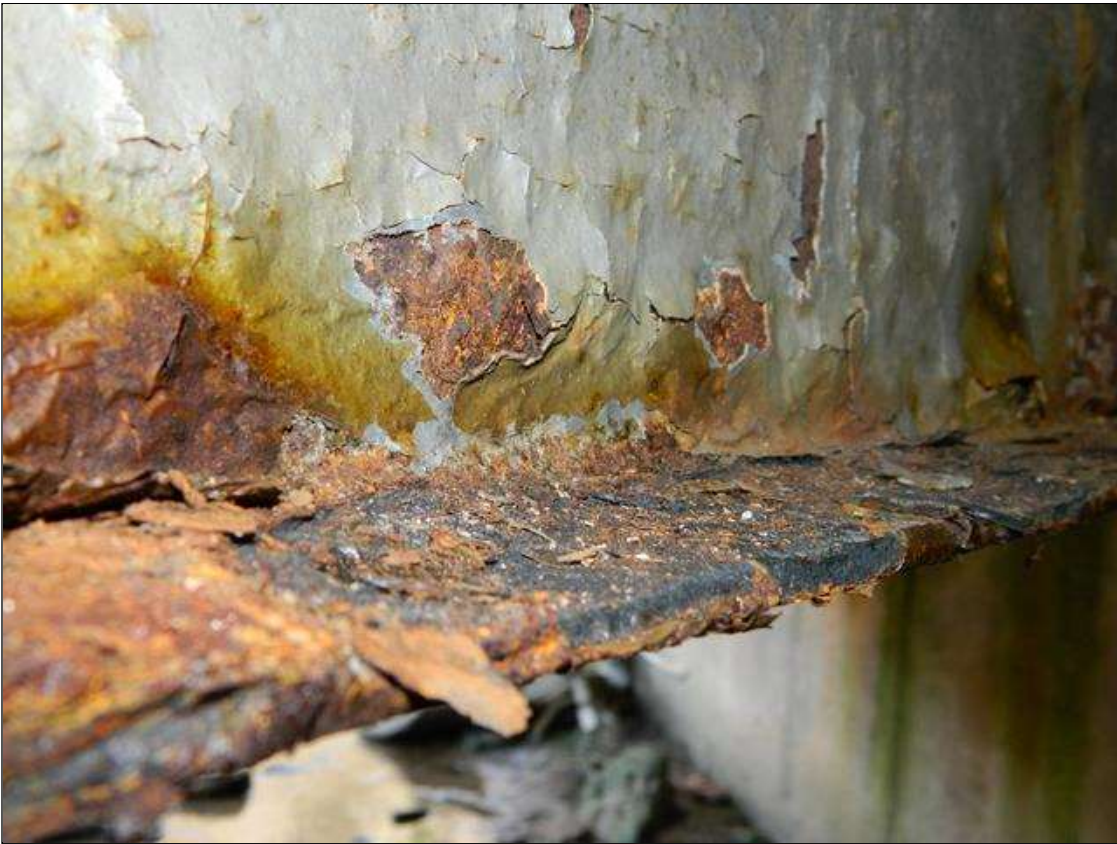
Span 1 Beam 6: CORROSION WITH THE RIGHT HALF OF THE BOTTOM FLANGE REDUCED TO  $\frac{1}{8}$ " FOR 4'-6" BEGINNING AT 8'-9" FROM THE NEAR END OF THE BEAM. THE ENTIRE LENGTH OF THE TOP FLANGE HAS CORROSION WITH REMAINING SECTION REDUCED TO  $\frac{1}{8}$ " -  $\frac{3}{16}$ ". THE FULL HEIGHT OF THE WEB IS REDUCED TO  $\frac{3}{16}$ " FOR 12" AT BEARINGS ON BOTH END BENTS. ORIGINAL  $\frac{1}{4}$ " WEB AND  $\frac{5}{16}$ " FLANGE THICKNESSES. FRECKLED/FLAKING RUST THROUGHOUT THE REMAINING AREA OF THE BEAM. A PRIORITY MAINTENANCE IS REQUESTED.

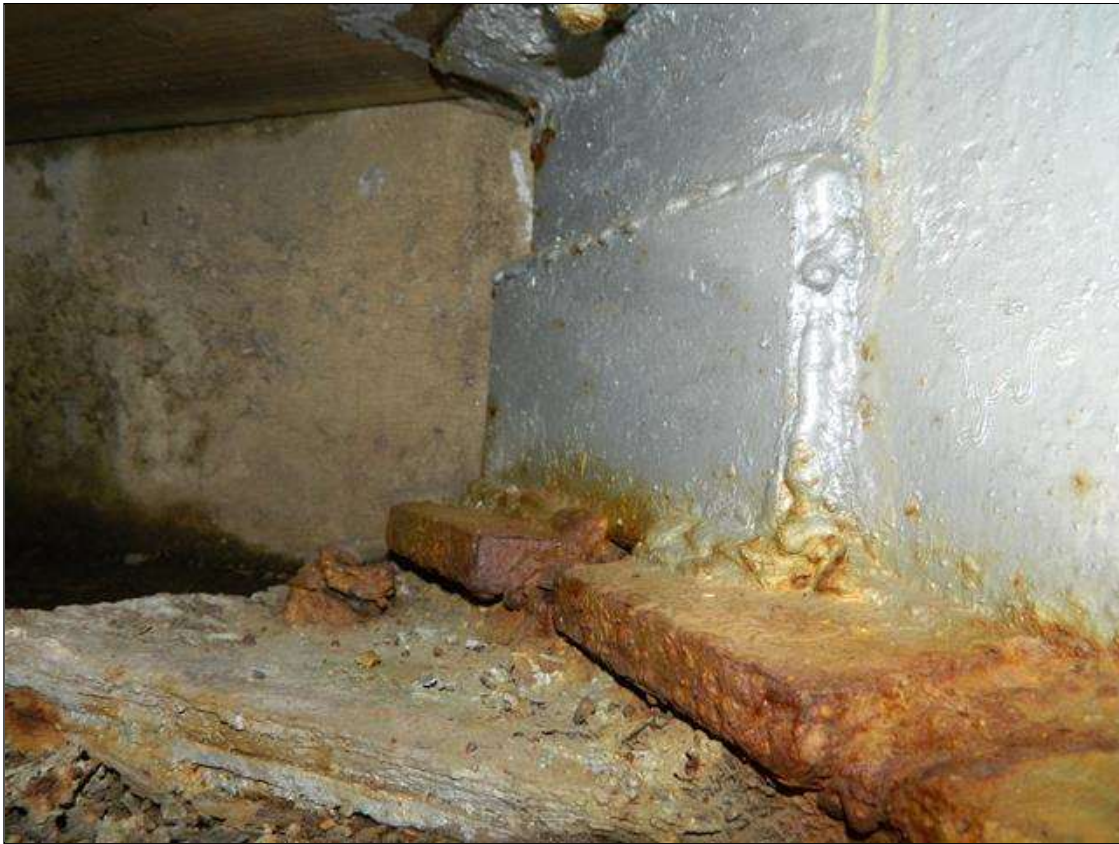
BEAM 6 REPAIR PLATES: 14" LONG X 2" WIDE X 1/2" THICK STEEL PLATE WELDED TO THE RIGHT HALF OF THE BOTTOM FLANGE AT THE NEAR END OF THE BEAM. 2" LONG X 2" WIDE X 1/2" THICK STEEL PLATE WELDED TO THE LEFT HALF OF THE BOTTOM FLANGE AT 12" FROM THE NEAR END. 8" LONG X 6" HIGH X 1/2" THICK STEEL PLATE WELDED TO THE RIGHT FACE OF THE WEB AT THE NEAR END. THESE ARE REPAIRS TO PREVIOUS PRIORITY MAINTENANCES.

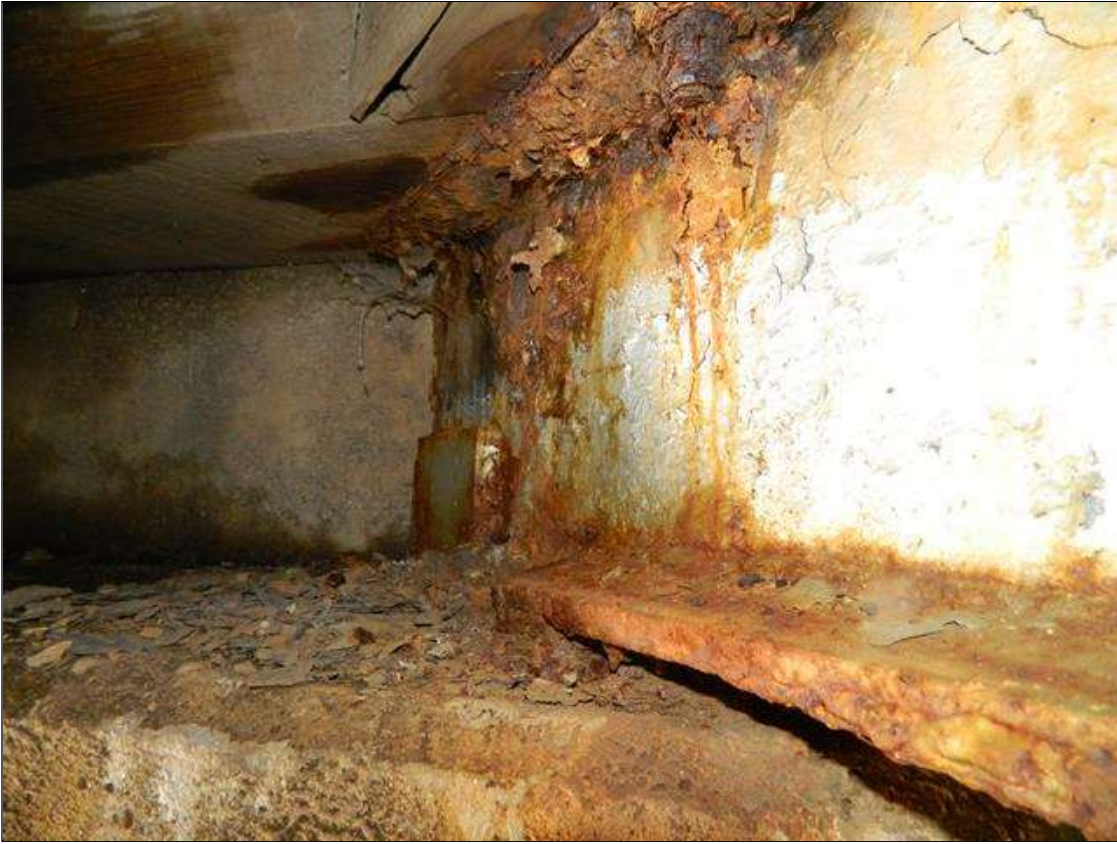
BEAM 7 REPAIR PLATES: 5" LONG X 2" WIDE X 1/2" THICK STEEL PLATES WELDED TO BOTH SIDES OF THE BOTTOM FLANGE AT 10" FROM THE NEAR END OF THE BEAM. 3" WIDE X 3" HIGH X 1/2" THICK STEEL PLATE WELDED TO THE RIGHT FACE OF THE WEB AT THE NEAR END.

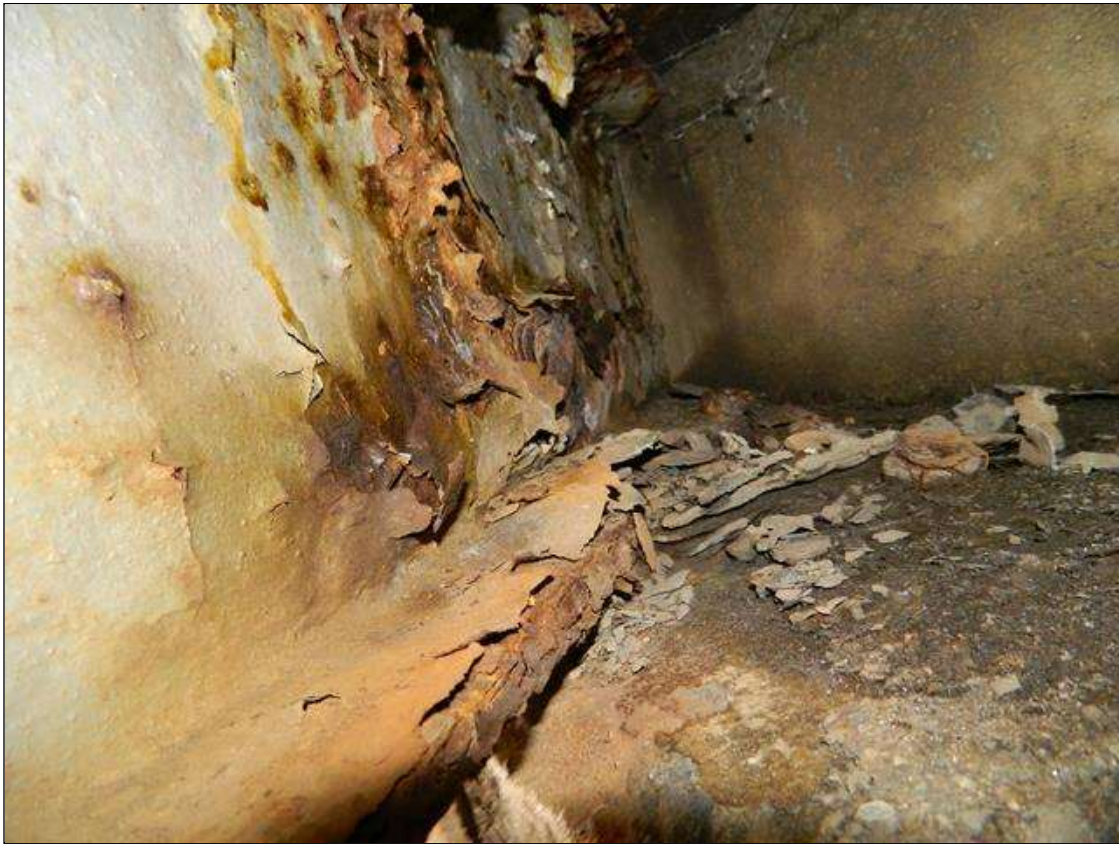
Span 1 Beam 8: CORROSION WITH THE FULL WIDTH OF THE BOTTOM FLANGE REDUCED TO 1/8" FOR 13" BEGINNING AT THE NEAR END OF THE BEAM. THE ENTIRE LENGTH OF THE TOP FLANGE HAS CORROSION WITH REMAINING SECTION REDUCED TO 1/8" - 3/16". THE FULL HEIGHT OF THE WEB IS REDUCED TO 1/8" FOR 12" AT BEARINGS ON BOTH END BENTS. ORIGINAL 1/4" WEB AND 5/16" FLANGE THICKNESSES. FRECKLED/FLAKING RUST THROUGHOUT THE REMAINING AREA OF THE BEAM. A PRIORITY MAINTENANCE IS REQUESTED.

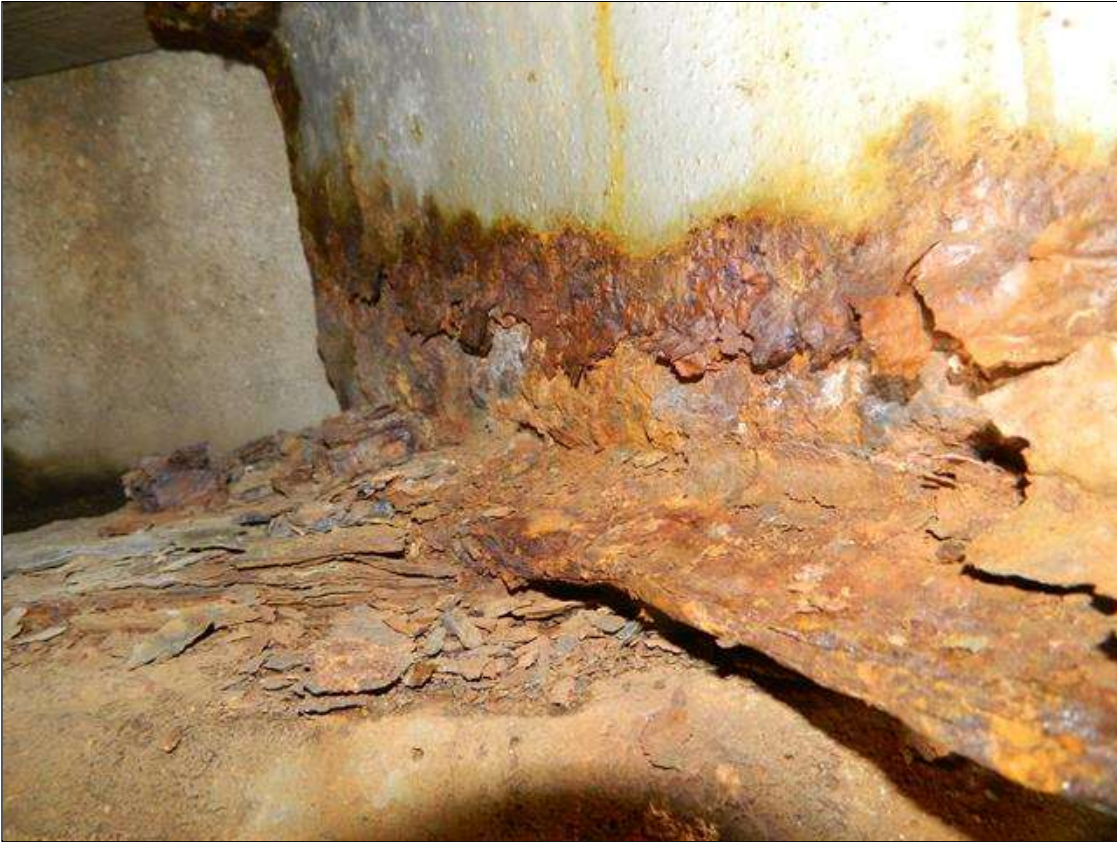
Span 1 Beam 9: CORROSION WITH THE FULL WIDTH OF THE BOTTOM FLANGE REDUCED TO 1/8" FOR 13" BEGINNING AT THE NEAR END OF THE BEAM. THE ENTIRE LENGTH OF THE TOP FLANGE HAS CORROSION WITH REMAINING SECTION REDUCED TO 1/8" - 3/16". THE LOWER 4" OF THE WEB IS REDUCED TO 1/8" FOR 12" AT BEARINGS ON BOTH END BENTS. ORIGINAL 1/4" WEB AND 5/16" FLANGE THICKNESSES. FRECKLED/FLAKING RUST THROUGHOUT THE REMAINING AREA OF THE BEAM. A PRIORITY MAINTENANCE IS REQUESTED.

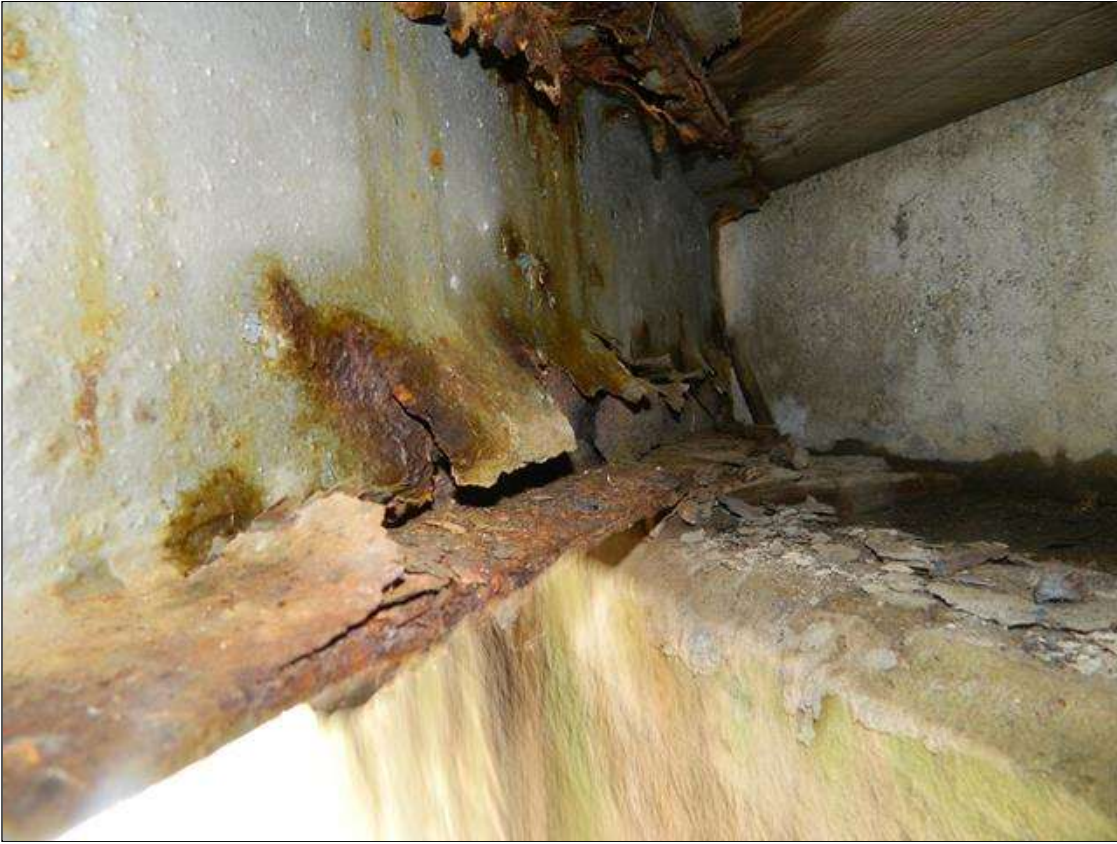
Span 1 Beam 10: CORROSION WITH THE FULL WIDTH OF THE BOTTOM FLANGE REDUCED TO 1/8" FOR 13" BEGINNING AT THE NEAR END OF THE BEAM. THE ENTIRE LENGTH OF THE TOP FLANGE HAS CORROSION WITH REMAINING SECTION REDUCED TO 1/8" - 3/16". THE LOWER 4" OF THE WEB IS REDUCED TO 1/8" FOR 12" AT BEARINGS ON BOTH END BENTS. ORIGINAL 1/4" WEB AND 5/16" FLANGE THICKNESSES. FRECKLED/FLAKING RUST THROUGHOUT THE REMAINING AREA OF THE BEAM. A PRIORITY MAINTENANCE IS REQUESTED.

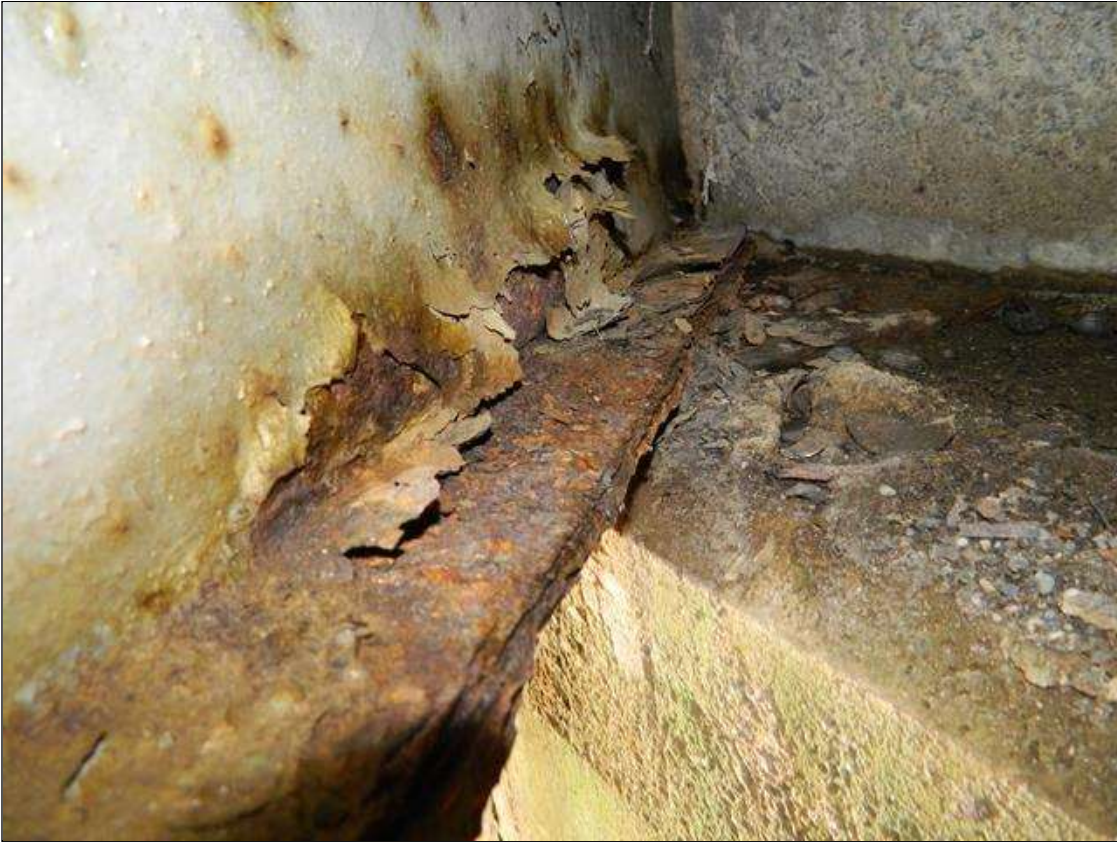
Span 1 Beam 11: CORROSION WITH THE LEFT HALF OF THE BOTTOM FLANGE REDUCED TO 1/8" FOR 14" BEGINNING AT THE NEAR END OF THE BEAM. THE ENTIRE LENGTH OF THE TOP FLANGE HAS CORROSION WITH REMAINING SECTION REDUCED TO 1/8" - 3/16". THE LOWER 4" OF THE WEB IS REDUCED TO 3/16" FOR 12" AT BEARINGS ON BOTH END BENTS. ORIGINAL 1/4" WEB AND 5/16" FLANGE THICKNESSES. FRECKLED/FLAKING RUST THROUGHOUT THE REMAINING AREA OF THE BEAM. A PRIORITY MAINTENANCE IS REQUESTED.

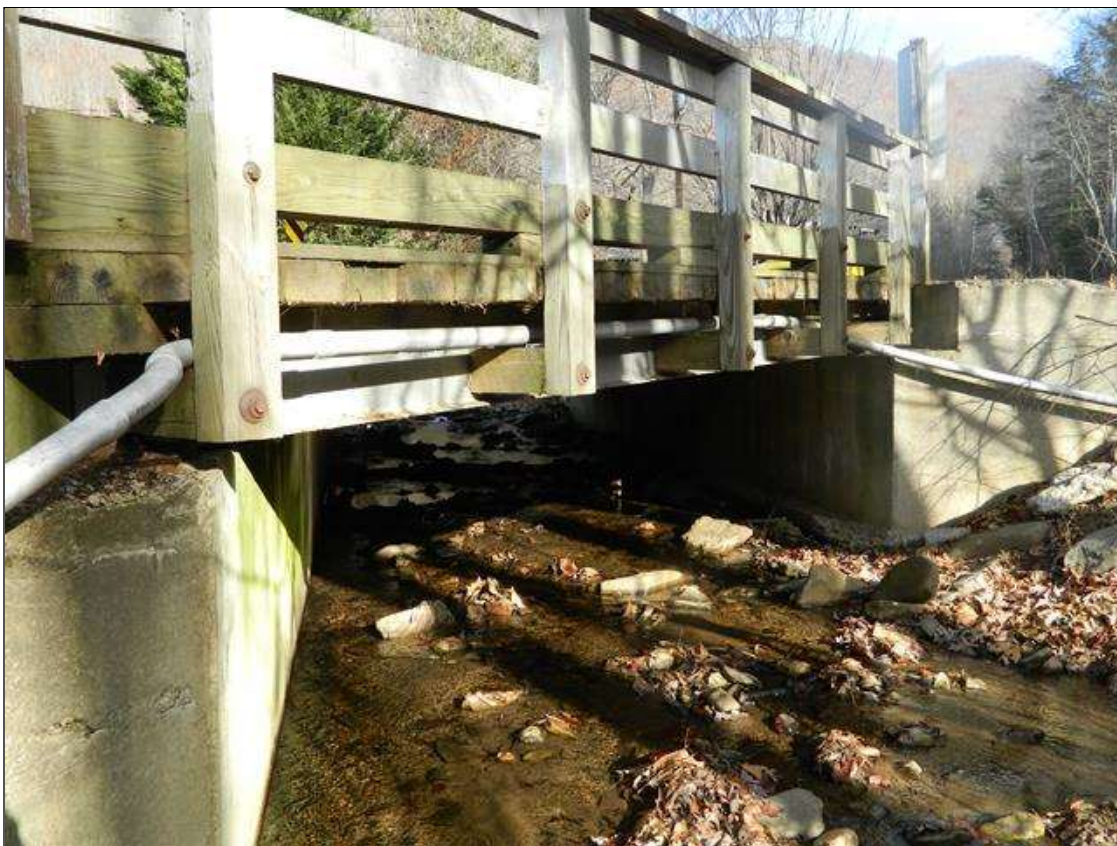
UTILITY LINE ON THE RIGHT SIDE OF THE BRIDGE.
