## Structure Safety Report

### Routine Element Inspection - Contract

COUNTY: BURKE STRUCTURE NUMBER: 110145 FREQUENCY: 24 MONTHS

FEATURE INTERSECTED: BRISTOL CREEK

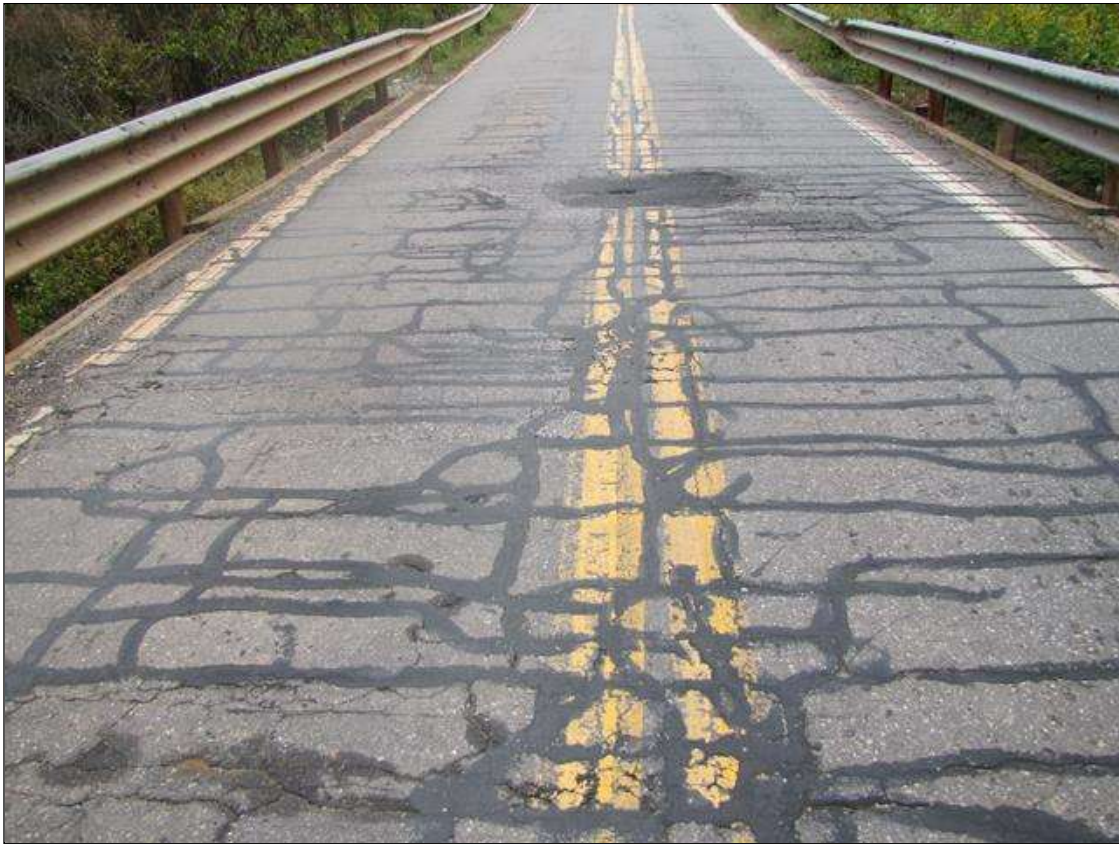
| Element Number | Defect Type | Defect Description | CS | CS Qty | Maint Qty | |
|---|---|---|---|---|---|---|
| 510 | Effectiveness (Wearing Surface) | REFLECTIVE TRANSVERSE CRACKS UP TO 1/4" WIDE THROUGHOUT | 3 | 747 | 747 | Square Feet |

Span 1 Wearing Surface: REFLECTIVE TRANSVERSE CRACKS THROUGHOUT

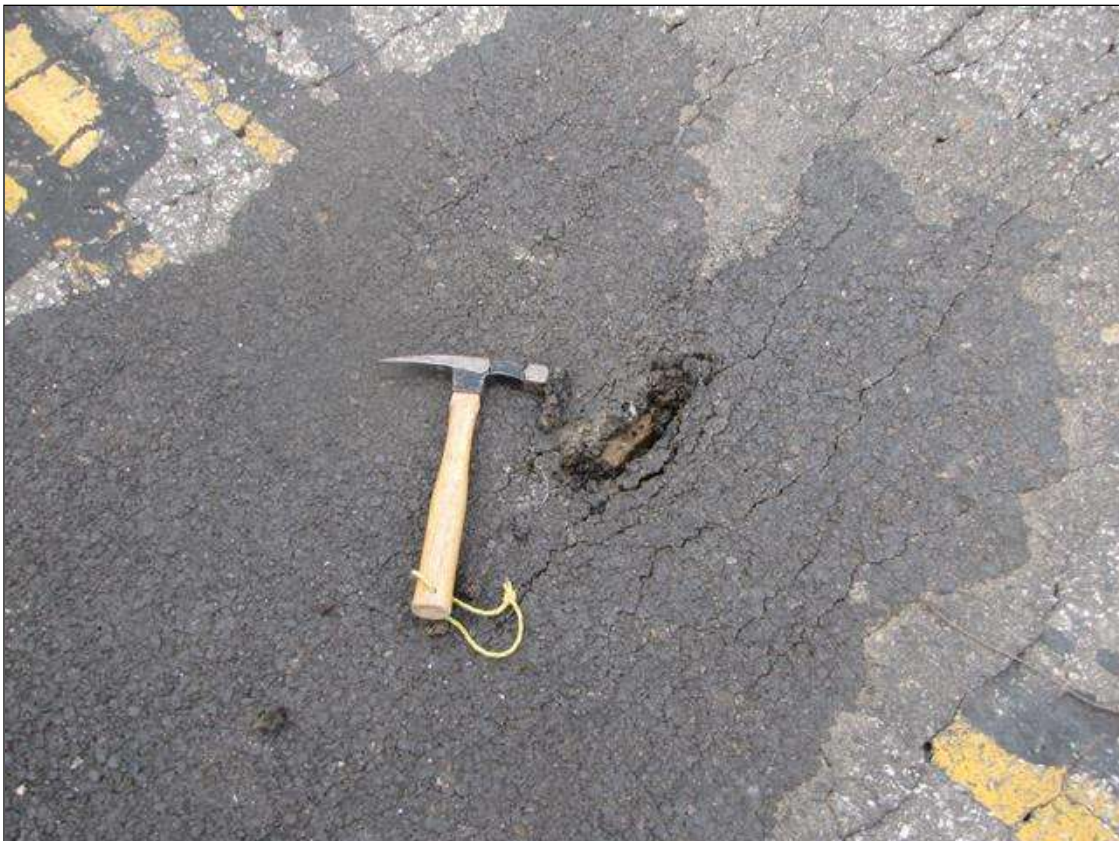
| Element Number | Defect Type | Defect Description | CS | CS Qty | Maint Qty | |
|---|---|---|---|---|---|---|
| 510 | Patched Area/Pothole (Wearing Surface) | 8" X 2" X 2" DEEP POT HOLE AT CENTERLINE BRIDGE AT MID SPAN WITH 4 FT X 5 FT ASPHALT PATCH | 3 | 20 | 20 | Square Feet |

Span 1 Wearing Surface: 8" X 2" X 2" DEEP POT HOLE AT CENTERLINE BRIDGE AT MID SPAN WITH 4 FT X 5 FT ASPHALT PATCH

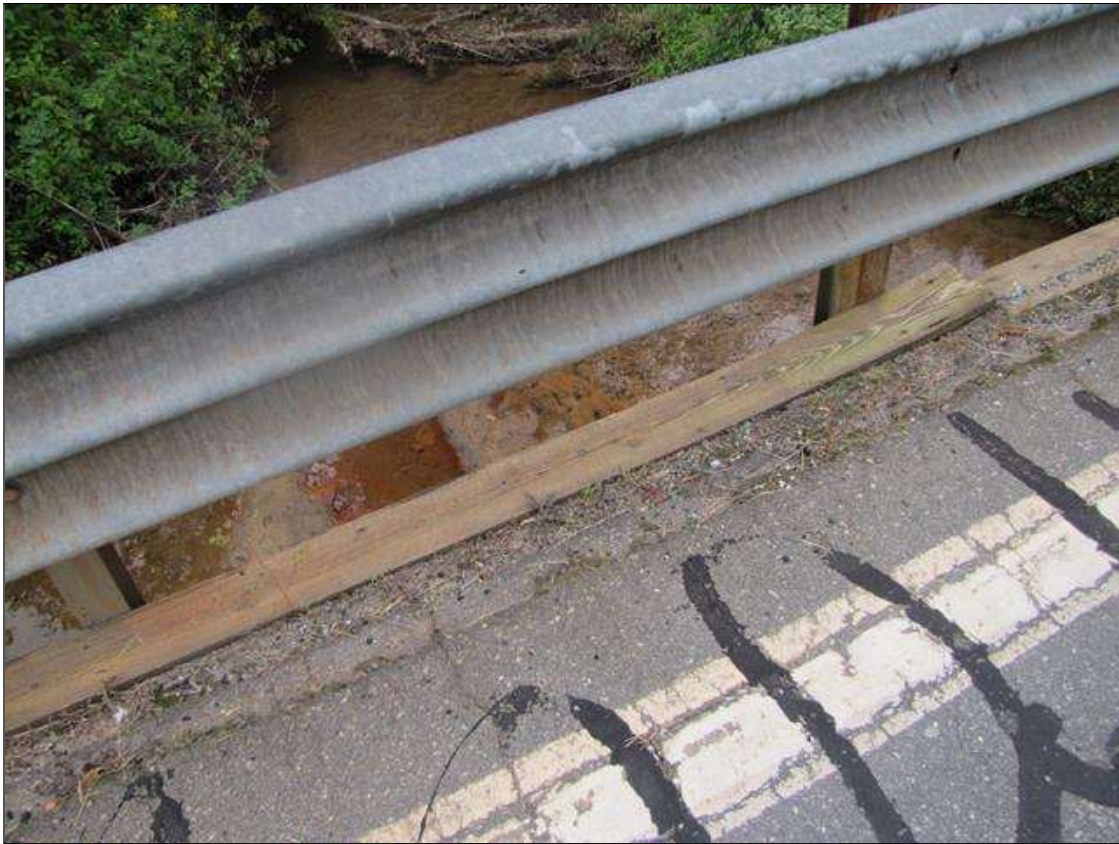
| Element Number | Defect Type | Defect Description | CS | CS Qty | Maint Qty |
|---|---|---|---|---|---|
| 31 | Connection | TIMBER EDGE BOARDS BOTH SIDES ARE LOOSE AND WARPED FULL LENGTH | 3 | 80 | 80 Square Feet |

Span 1 Deck: TIMBER EDGE BOARDS BOTH SIDES ARE LOOSE AND WARPED FULL LENGTH

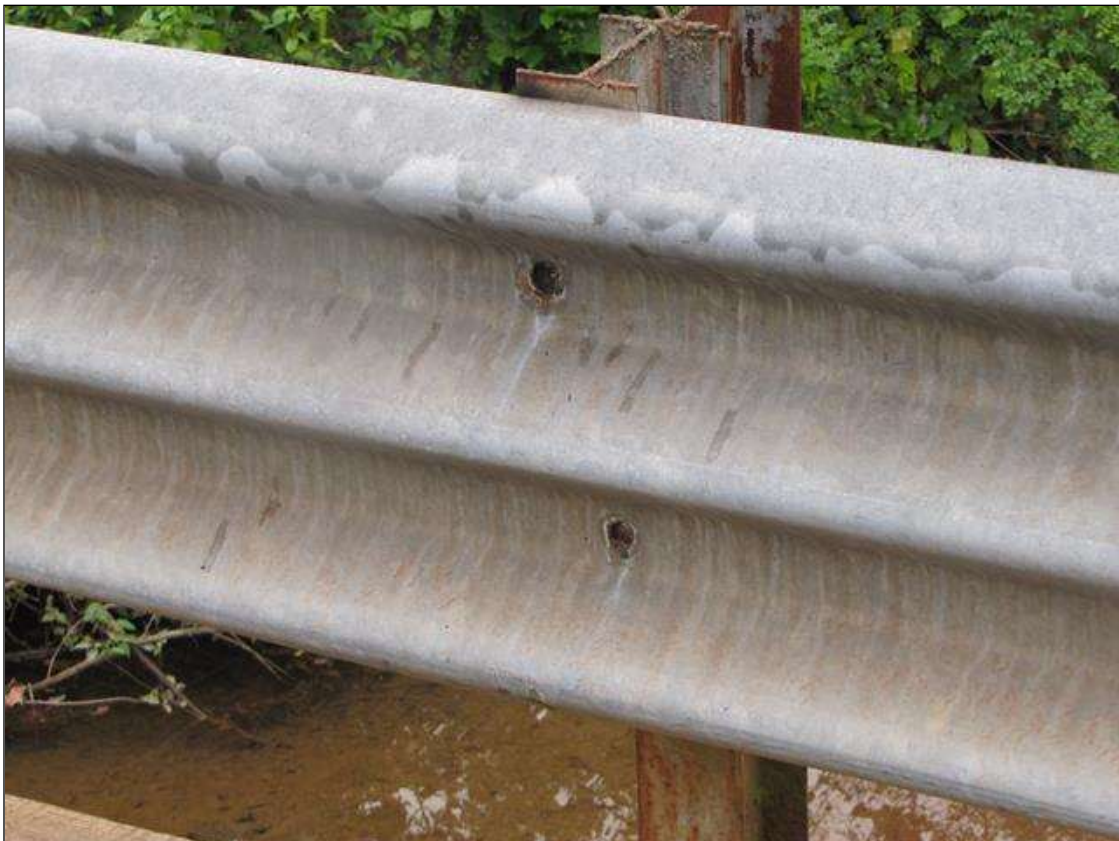
| Element Number | Defect Type | Defect Description | CS | CS Qty | Maint Qty | |
|---|---|---|---|---|---|---|
| 330 | Connection | MISSING BOLTS AT RAIL POST #3 | 3 | 1 | 1 | Feet |

Span 1 Right Bridge Rail: MISSING BOLTS AT RAIL POST #3

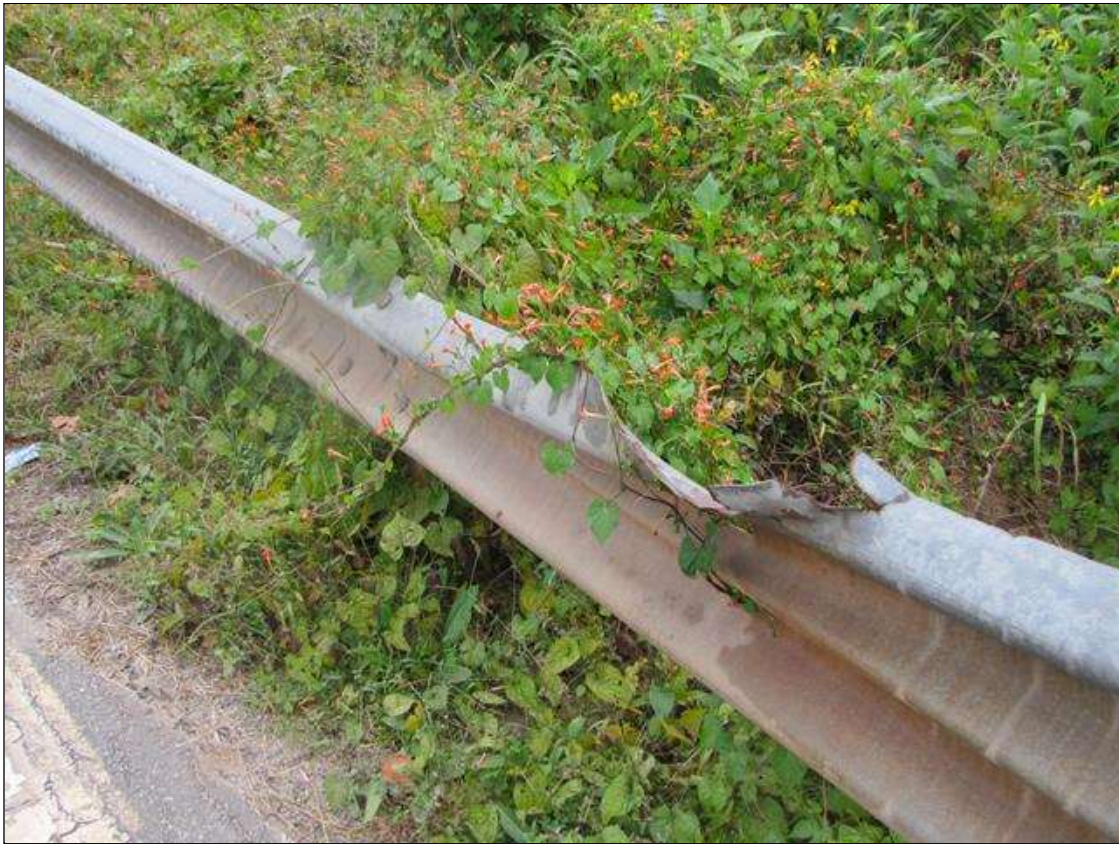
**Details** APPROACH ROADWAY: IMPACT DAMAGE TO APPROACH GUARDRAIL AT NORTHEAST CORNER 2 FT LONG  
POST SPACING AT APPROACH GUARDRAIL IS 12 FT

APPROACH ROADWAY: IMPACT DAMAGE TO APPROACH GUARDRAIL AT NORTHEAST CORNER 2 FT LONG

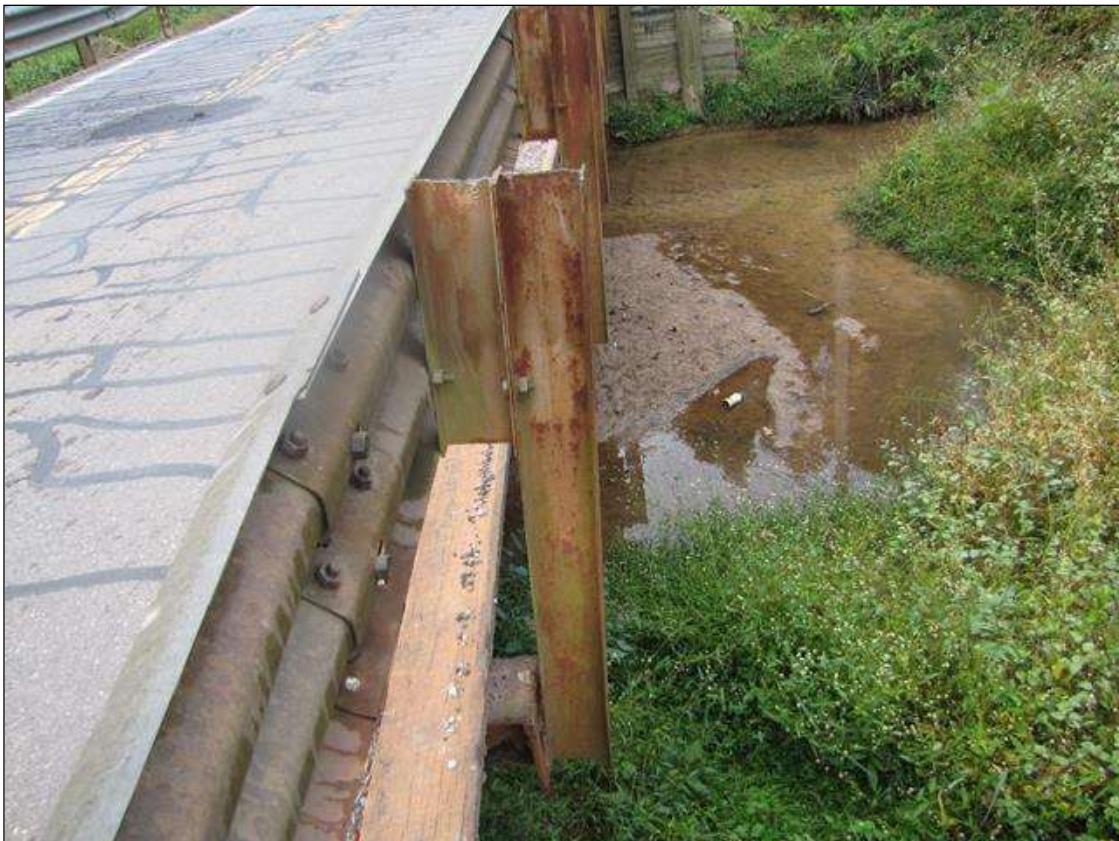
| Element Number | Defect Type | Defect Description | CS | CS Qty | Maint Qty | |
|---|---|---|---|---|---|---|
| 330 | Corrosion | SURFACE CORROSION ON ALL RAIL POSTS | 2 | 6 | | Square Feet |

Span 1 Left Bridge Rail: SURFACE CORROSION ON ALL RAIL POSTS

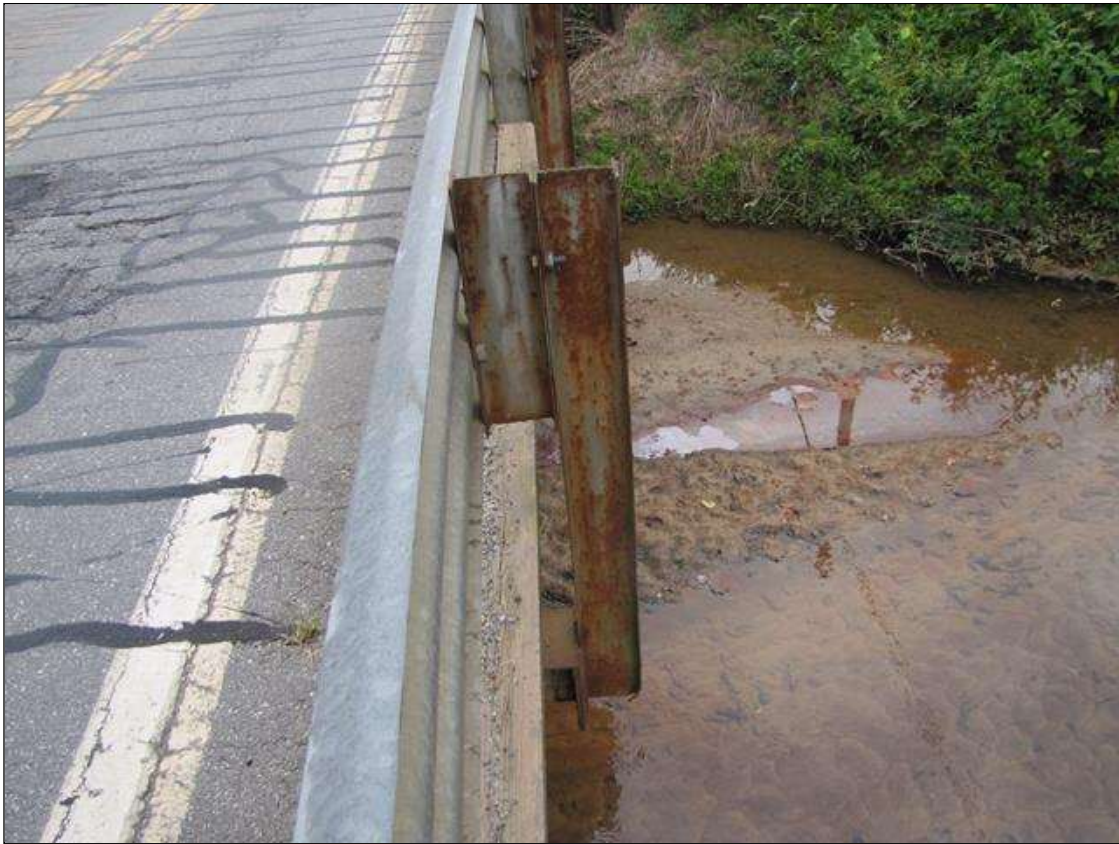
| Element Number | Defect Type | Defect Description | CS | CS Qty | Maint Qty | |
|---|---|---|---|---|---|---|
| 330 | Corrosion | SURFACE CORROSION AT ALL RAIL POSTS | 2 | 6 | | Square Feet |

Span 1 Right Bridge Rail: SURFACE CORROSION AT ALL RAIL POSTS

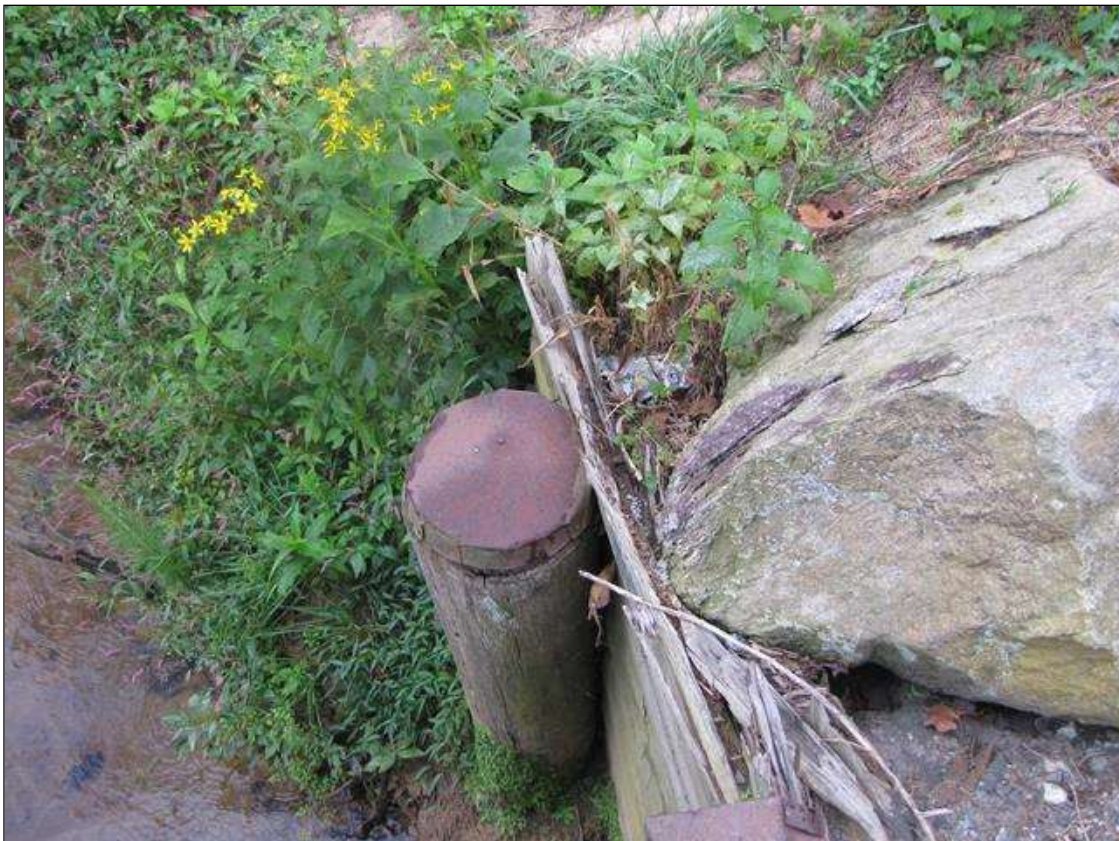
| Element Number | Defect Type | Defect Description | CS | CS Qty | Maint Qty |
|---|---|---|---|---|---|
| 216 | Decay/Section Loss | DECAY OF TOP BULKHEAD BOARD AT SOUTHEAST CORNER | 3 | 6 | 6 Feet |

End Bent 1 Abutment/Backwall : DECAY OF TOP BULKHEAD BOARD AT SOUTHEAST CORNER

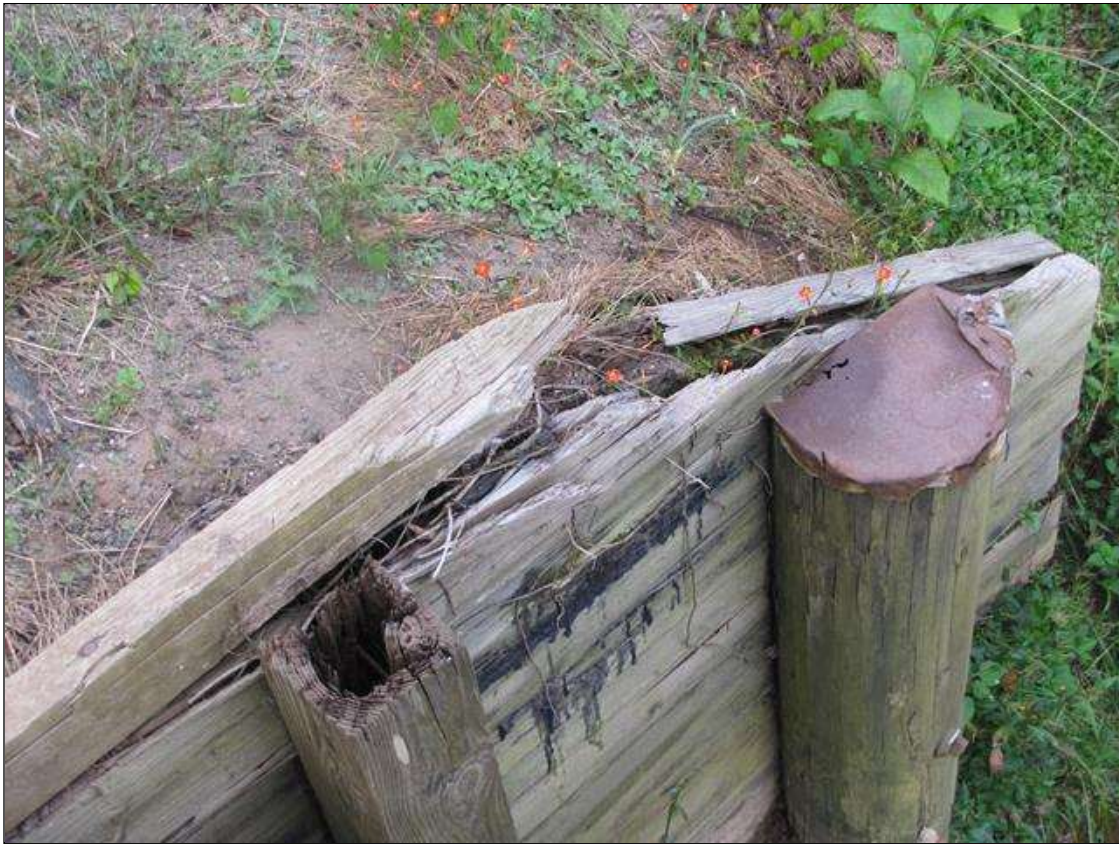
| Element Number | Defect Type | Defect Description | CS | CS Qty | Maint Qty |
|---|---|---|---|---|---|
| 216 | Decay/Section Loss | DECAY OF TOP BULKHEAD BOARD AT SOUTHWEST CORNER | 3 | 6 | 6 Feet |

End Bent 1 Abutment/Backwall : DECAY OF TOP BULKHEAD BOARD AT SOUTHWEST CORNER

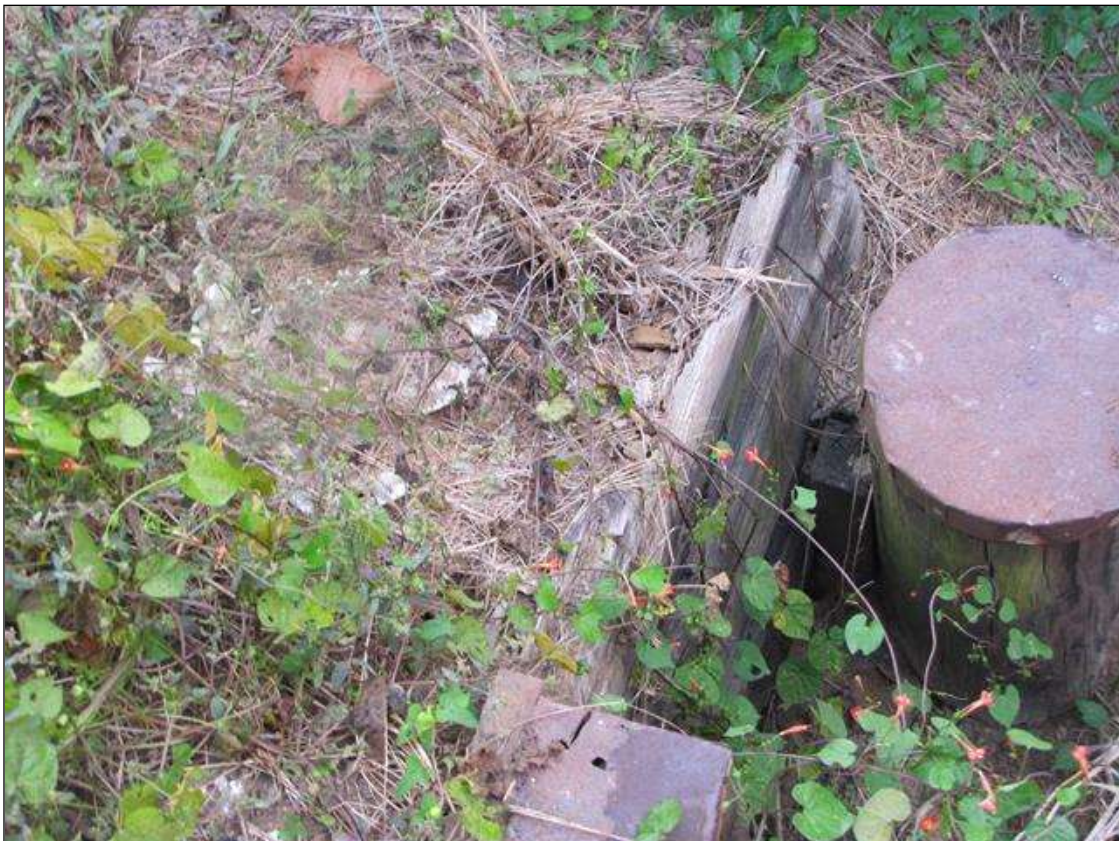
| Element Number | Defect Type | Defect Description | CS | CS Qty | Maint Qty |
|---|---|---|---|---|---|
| 216 | Decay/Section Loss | DECAY OF TOP BULKHEAD BOARD AT NORTHEAST CORNER | 3 | 6 | 6 Feet |

End Bent 2 Abutment/Backwall : DECAY OF TOP BULKHEAD BOARD AT NORTHEAST CORNER

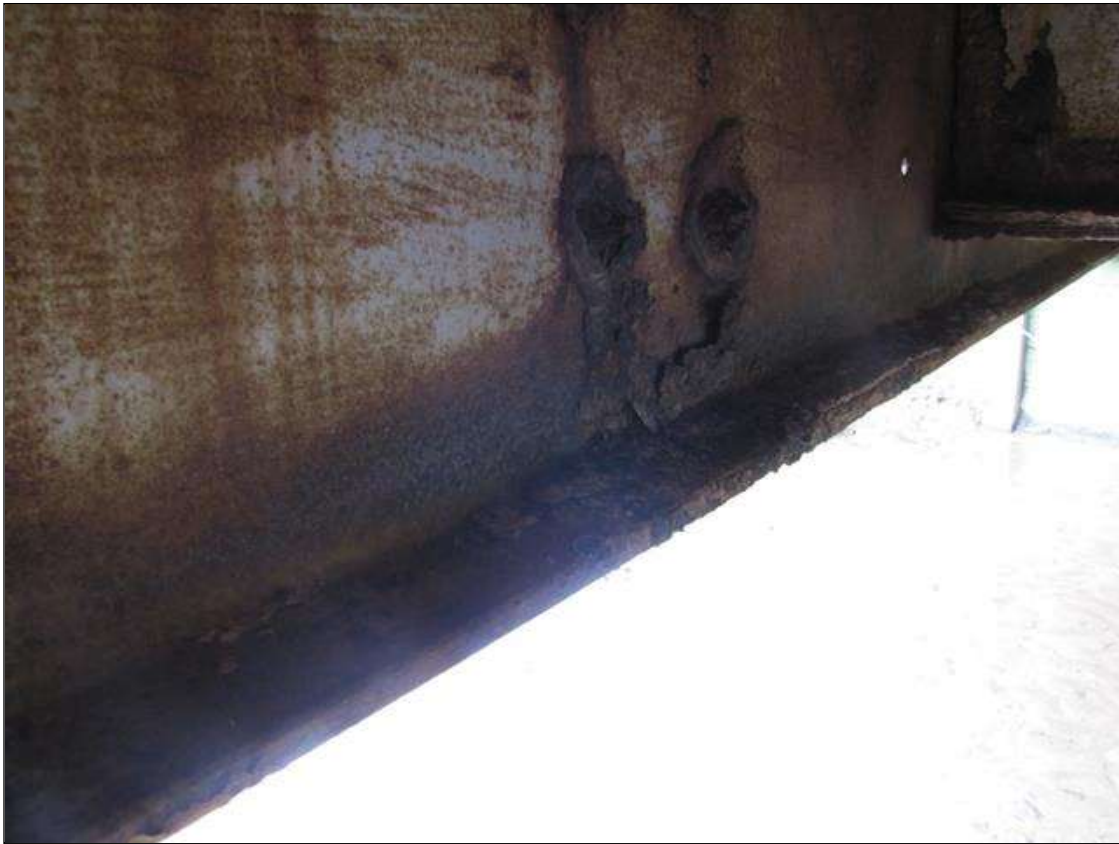
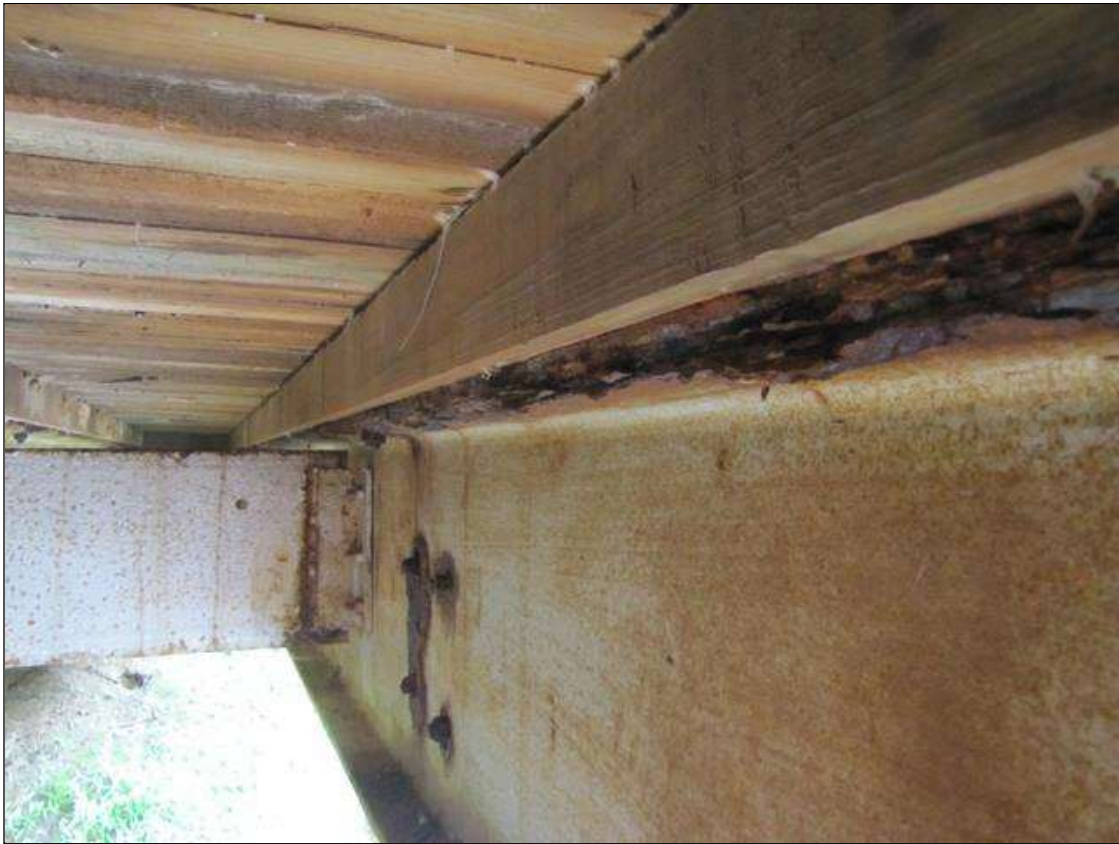
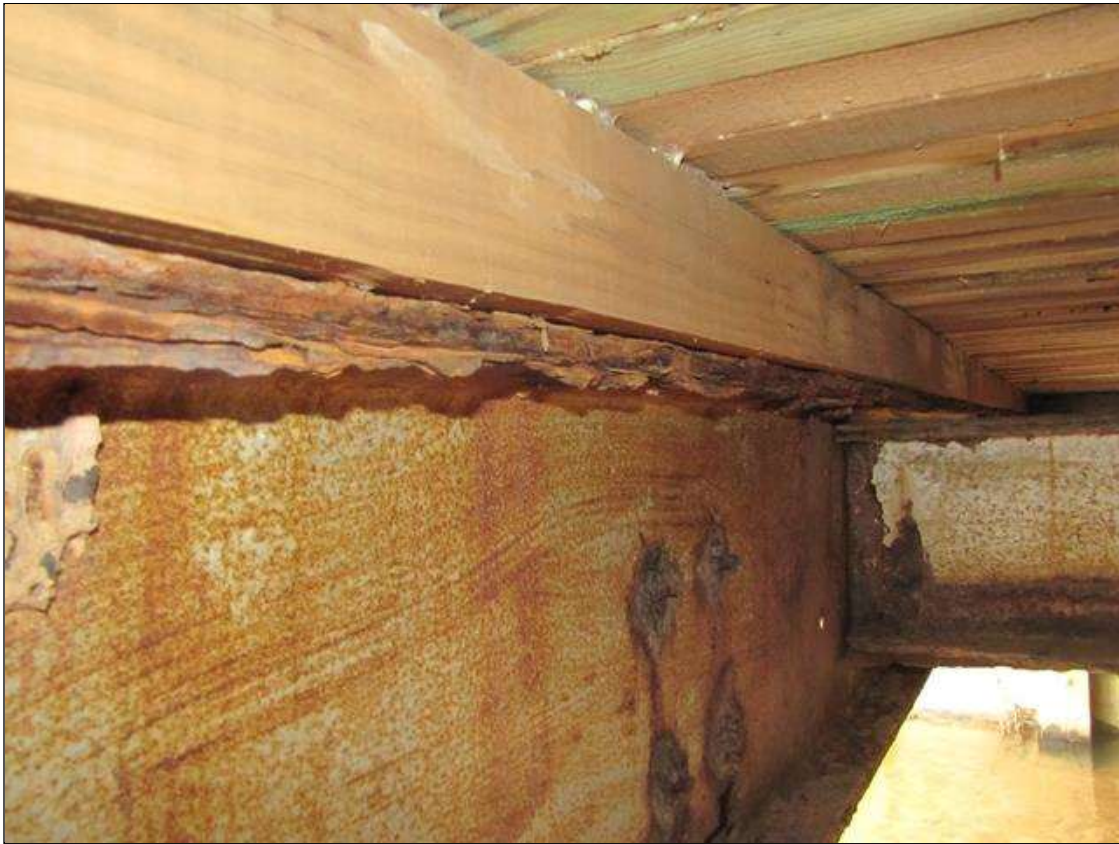
| Element Number | Defect Type | Defect Description | CS | CS Qty | Maint Qty |
|---|---|---|---|---|---|
| 107 | Corrosion | SEVERE CORROSION OF TOP FLANGE FULL LENGTH WITH FLAKING RUST AND SECTION LOSS. ALSO AT BOTTOM FLANGE FOR 10 FT AT MID SPAN AND 10 FT AT END BENT 2. REMAINING TOP FLANGE IS 1/4" X 5" THROUGHOUT. REMAINING BOTTOM FLANGE IS 7/16" X 5 7/8" AT MID SPAN. (PRIORITY MAINTENANCE) | 3 | 40 | 40 Feet |

Span 1 Beam 8: SEVERE CORROSION OF BOTTOM FLANGE FOR 10 FT AT MID SPAN AND 10 FT AT END BENT  
2. REMAINING BOTTOM FLANGE IS  $\frac{7}{16}$ " X  $5 \frac{7}{8}$ " AT MID SPAN. BOTTOM FLANGE SHOWN (PRIORITY MAINTENANCE)

Span 1 Beam 8: SEVERE CORROSION OF TOP FLANGE FULL LENGTH WITH FLAKING RUST AND SECTION LOSS. REMAINING TOP FLANGE IS 1/4" X 5" THROUGHOUT. NORTH SIDE TOP FLANGE SHOWN (PRIORITY MAINTENANCE)

Span 1 Beam 8: SEVERE CORROSION OF TOP FLANGE FULL LENGTH WITH FLAKING RUST AND SECTION LOSS. REMAINING TOP FLANGE IS 1/4" X 5" THROUGHOUT. SOUTH SIDE TOP FLANGE SHOWN (PRIORITY MAINTENANCE)

| MMS Code | Description of Function | Unit | Quantity | Remarks | Est. Cost |
|---|---|---|---|---|---|
| 3314 | Maintain Steel Superstructure Components | LF | 40 | Span 1 Beam 8: SEVERE CORROSION OF TOP FLANGE FULL LENGTH WITH FLAKING RUST AND SECTION LOSS. ALSO AT BOTTOM FLANGE FOR 10 FT AT MID SPAN AND 10 FT AT END BENT 2. REMAINING TOP FLANGE IS 1/4" X 5" THROUGHOUT. REMAINING BOTTOM FLANGE IS 7/16" X 5 7/8" AT MID SPAN. (PRIORITY MAINTENANCE) | |

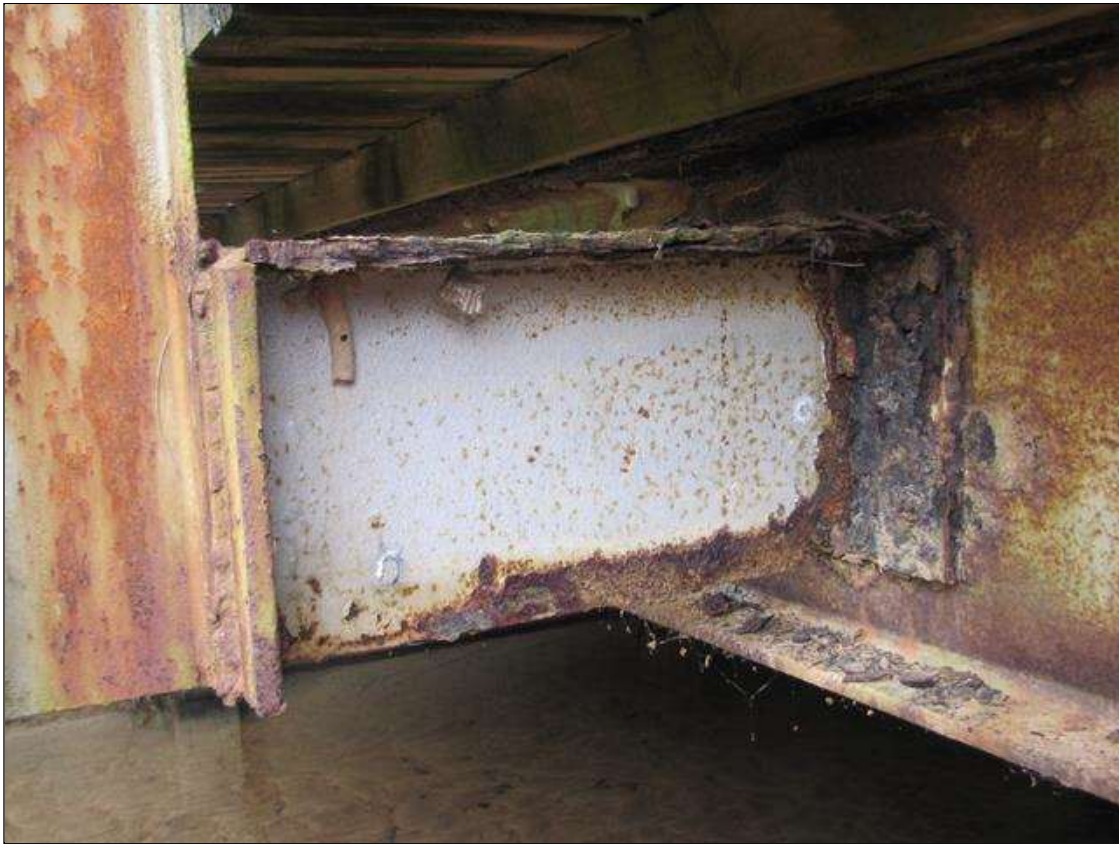
| Element Number | Defect Type | Defect Description | CS | CS Qty | Maint Qty | |
|---|---|---|---|---|---|---|
| 330 | Corrosion | HEAVY CORROSION OF POST OUTRIGGER AT ALL LOCATIONS WITH SECTION LOSS AT TOP FLANGE UP TO 50%. | 3 | | 12 | Square Feet |

Span 1 Right Bridge Rail: HEAVY CORROSION OF POST OUTRIGGER AT ALL LOCATIONS WITH SECTION LOSS AT TOP FLANGE UP TO 50%.

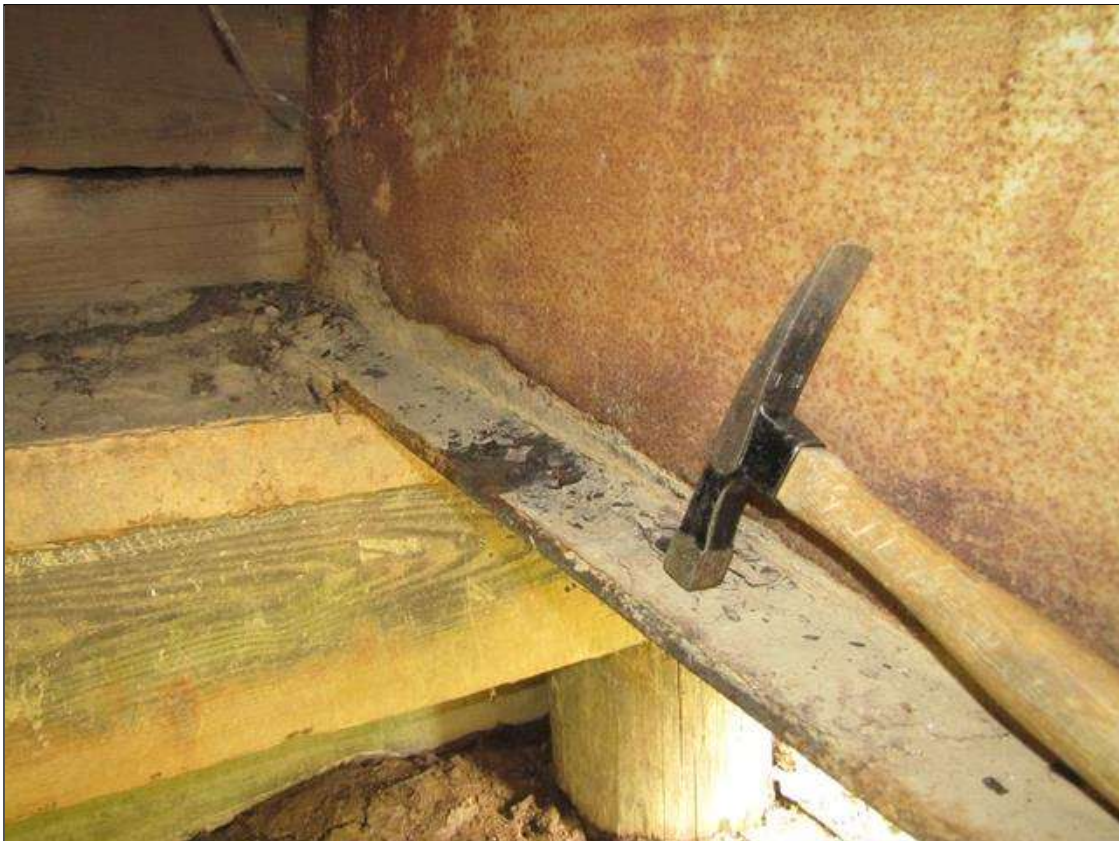
| Element Number | Defect Type | Defect Description | CS | CS Qty | Maint Qty |
|---|---|---|---|---|---|
| 107 | Corrosion | HEAVY CORROSION AT BOTTOM FLANGE AT END BENT 2 WITH FLAKING RUST AND SECTION LOSS 3 FT LONG X 7/16" X 5 7/8" REMAINING. (PRIORITY MAINTENANCE) | 3 | 3 | 3 Feet |

Span 1 Beam 7: HEAVY CORROSION AT BOTTOM FLANGE AT END BENT 2 WITH FLAKING RUST AND SECTION LOSS 3 FT LONG X 7/16" X 5 7/8" REMAINING. (PRIORITY MAINTENANCE)

| MMS Code | Description of Function | Unit | Quantity | Remarks | Est. Cost |
|---|---|---|---|---|---|
| 3314 | Maintain Steel Superstructure Components | LF | 3 | Span 1 Beam 7: HEAVY CORROSION AT BOTTOM FLANGE AT END BENT 2 WITH FLAKING RUST AND SECTION LOSS 3 FT LONG X 7/16" X 5 7/8" REMAINING. (PRIORITY MAINTENANCE) | |

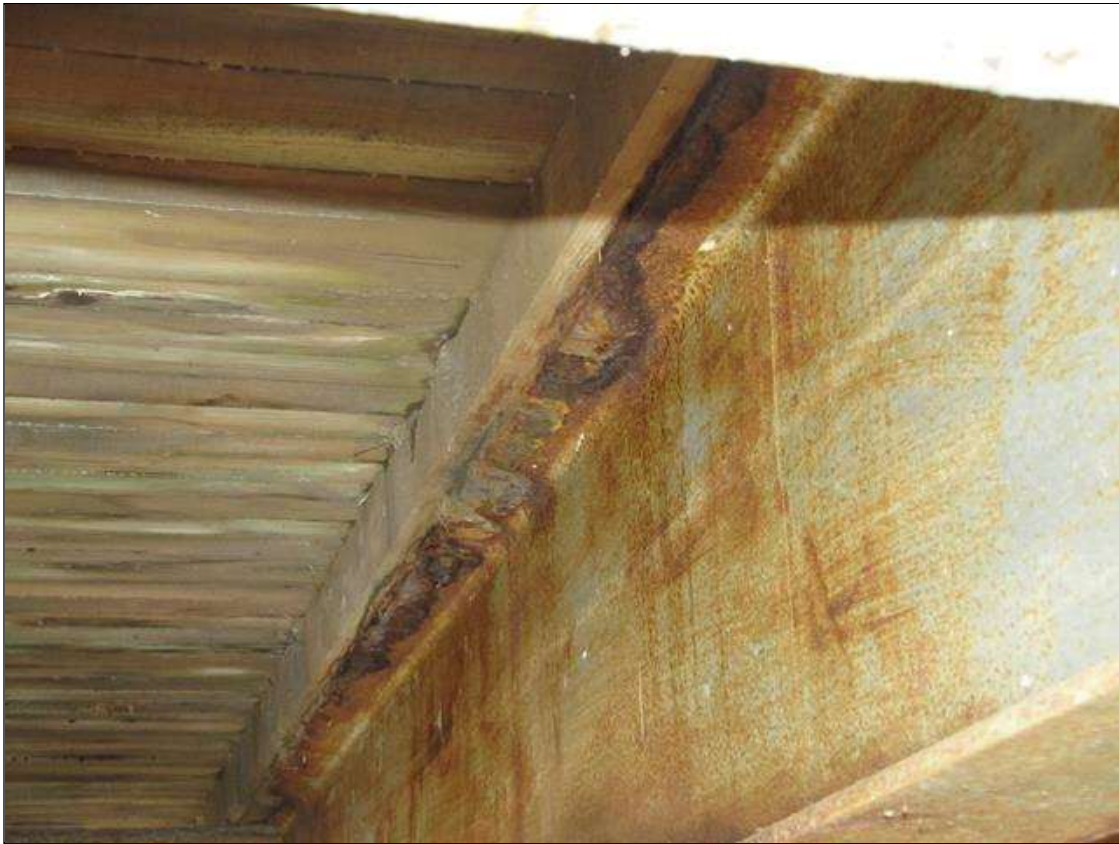
| Element Number | Defect Type | Defect Description | CS | CS Qty | Maint Qty |
|---|---|---|---|---|---|
| 107 | Corrosion | HEAVY CORROSION WITH FLAKING RUST AND SECTION LOSS AT TOP FLANGE AT MID SPAN 6 FT X 1/4" X 5" REMAINING (PRIORITY MAINTENANCE) | 3 | 6 | 6 Feet |

Span 1 Beam 7: HEAVY CORROSION WITH FLAKING RUST AND SECTION LOSS AT TOP FLANGE AT MID SPAN  
6 FT X 1/4" X 5" REMAINING (PRIORITY MAINTENANCE)

| MMS Code | Description of Function | Unit | Quantity | Remarks | Est. Cost |
|---|---|---|---|---|---|
| 3314 | Maintain Steel Superstructure Components | LF | 6 | Span 1 Beam 7: HEAVY CORROSION WITH FLAKING RUST AND SECTION LOSS AT TOP FLANGE AT MID SPAN 6 FT X 1/4" X 5" REMAINING (PRIORITY MAINTENANCE) | |

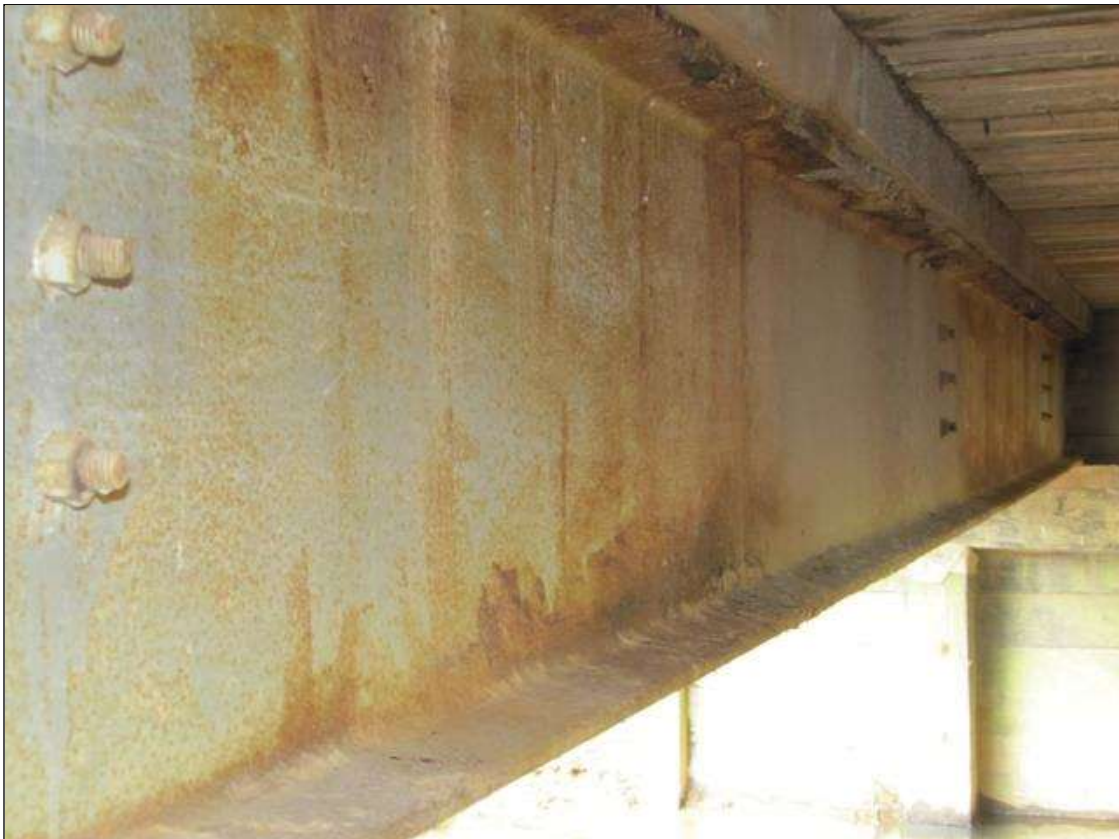
| Element Number | Defect Type | Defect Description | CS | CS Qty | Maint Qty |
|---|---|---|---|---|---|
| 107 | Corrosion | REMAINING LENGTH OF BEAM HAS SURFACE RUST ON BOTH FLANGES AND WEB FULL LENGTH | 2 | 31 | Feet |

Span 1 Beam 7: REMAINING LENGTH OF BEAM HAS SURFACE RUST ON BOTH FLANGES AND WEB FULL  
LENGTH

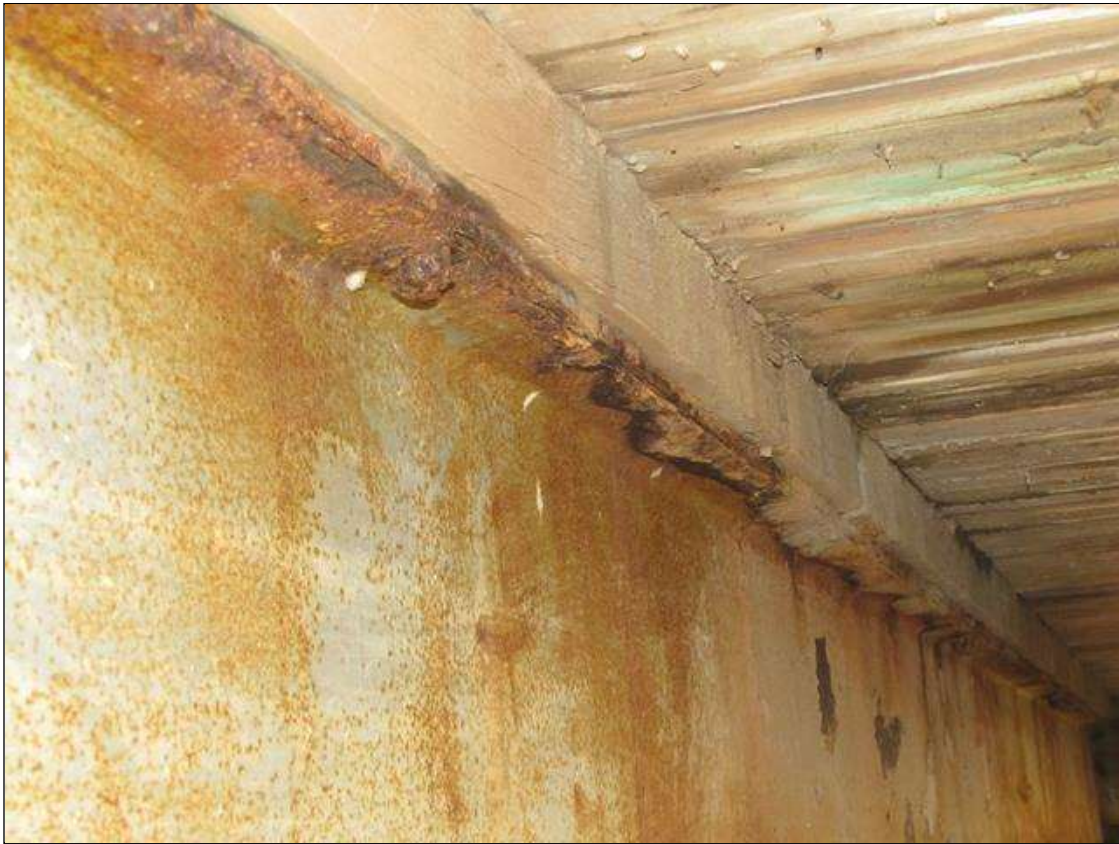
| Element Number | Defect Type | Defect Description | CS | CS Qty | Maint Qty |
|---|---|---|---|---|---|
| 107 | Corrosion | HEAVY CORROSION TOP FLANGE AT MID SPAN WITH FLAKING RUST AND SECTION LOSS WITH 8 FT X 3/8" X 5 1/2" REMAINING. (PRIORITY MAINTENANCE) | 3 | 8 | 8 Feet |

Span 1 Beam 6: HEAVY CORROSION TOP FLANGE AT MID SPAN WITH FLAKING RUST AND SECTION LOSS WITH 8 FT X 3/8" X 5 1/2" REMAINING. (PRIORITY MAINTENANCE)

| MMS Code | Description of Function | Unit | Quantity | Remarks | Est. Cost |
|---|---|---|---|---|---|
| 3314 | Maintain Steel Superstructure Components | LF | 8 | Span 1 Beam 6: HEAVY CORROSION TOP FLANGE AT MID SPAN WITH FLAKING RUST AND SECTION LOSS WITH 8 FT X 3/8" X 5 1/2" REMAINING. (PM) | |

| MMS Code | MMS Description | Quantity |
|---|---|---|
| Span 1 Beam 6: HEAVY CORROSION TOP FLANGE AT MID SPAN WITH FLAKING RUST AND SECTION LOSS WITH 8 FT X 3/8" X 5 1/2" REMAINING. (PM) | | |

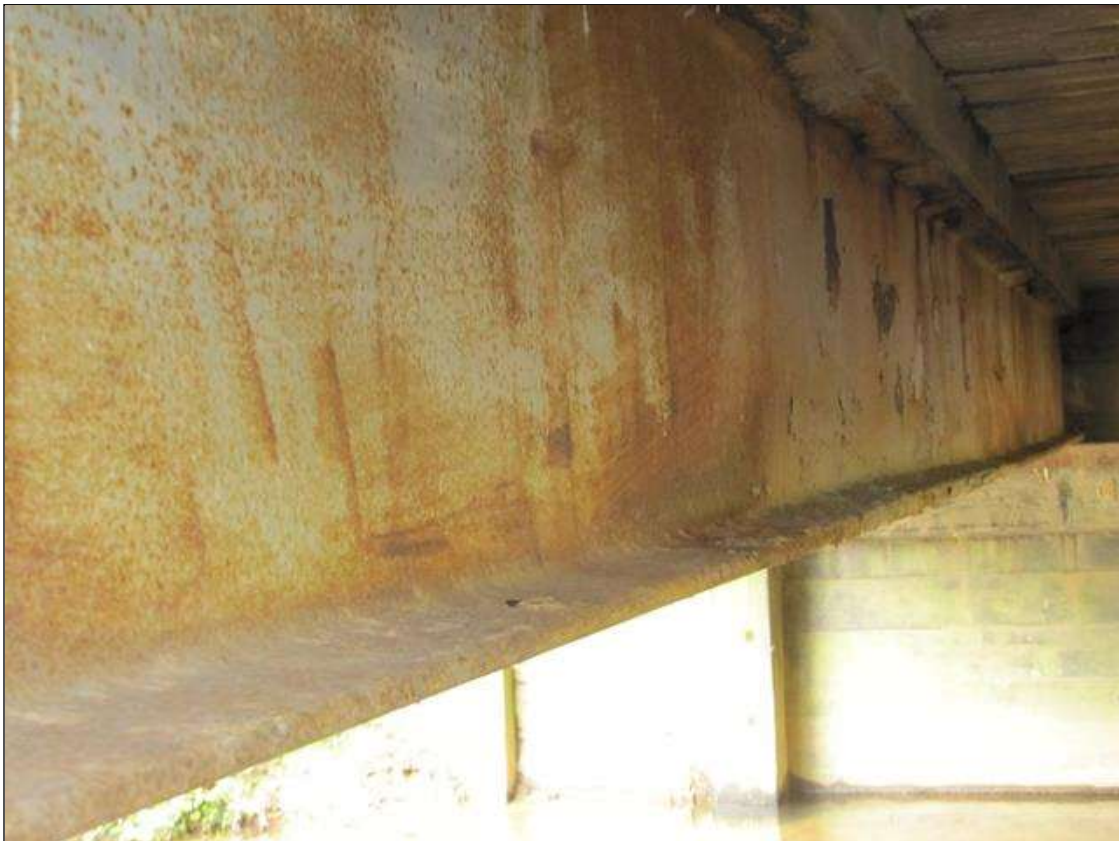
| Element Number | Defect Type | Defect Description | CS | CS Qty | Maint Qty |
|---|---|---|---|---|---|
| 107 | Corrosion | SURFACE RUST THROUGHOUT WEB AND BOTH FLANGES FULL LENGTH | 2 | 32 | Feet |

Span 1 Beam 6: SURFACE RUST THROUGHOUT WEB AND BOTH FLANGES FULL LENGTH

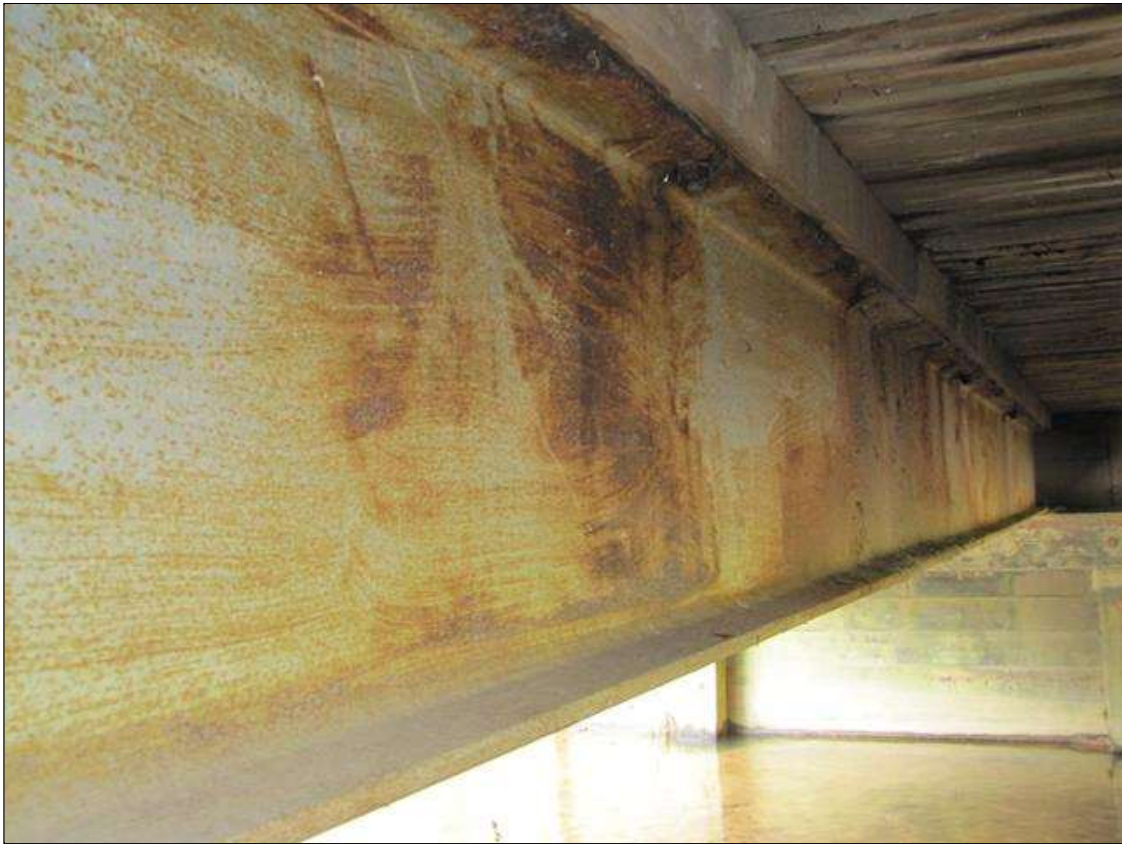
| Element Number | Defect Type | Defect Description | CS | CS Qty | Maint Qty | |
|---|---|---|---|---|---|---|
| 107 | Corrosion | SURFACE RUST THROUGHOUT WEB AND BOTH FLANGES WITH SOME RUST SCALE ON TOP FLANGE BUT NO SECTION LOSS | 2 | 40 | | Feet |

Span 1 Beam 5: SURFACE RUST THROUGHOUT WEB AND BOTH FLANGES WITH SOME RUST SCALE ON TOP FLANGE BUT NO SECTION LOSS

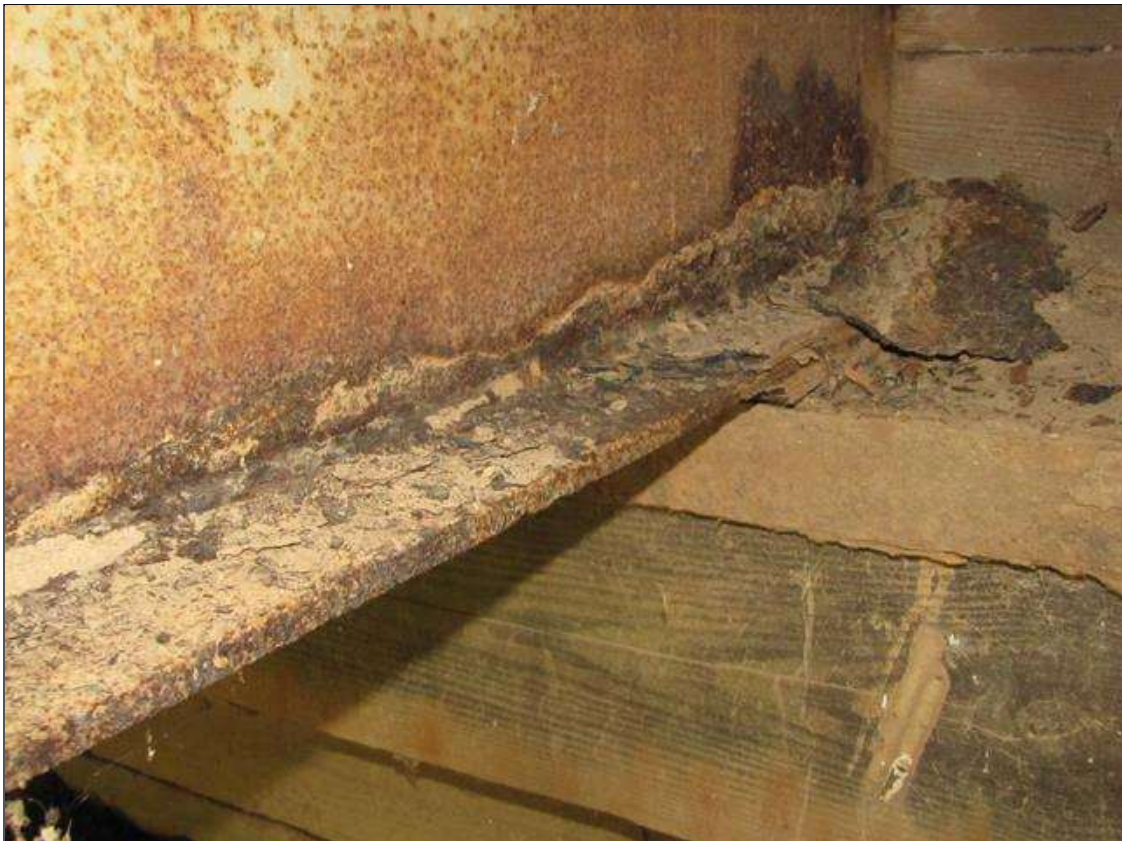
| Element Number | Defect Type | Defect Description | CS | CS Qty | Maint Qty | |
|---|---|---|---|---|---|---|
| 107 | Corrosion | HEAVY CORROSION OF BOTTOM FLANGE AT END BENT 2 WITH FLAKING RUST AND SECTION LOSS 2 FT X 3/8" X 5 7/8" REMAINING. (PRIORITY MAINTENANCE) | 3 | 2 | 2 | Feet |

Span 1 Beam 4: HEAVY CORROSION OF BOTTOM FLANGE AT END BENT 2 WITH FLAKING RUST AND SECTION LOSS 2 FT X 3/8" X 5 7/8" REMAINING. (PRIORITY MAINTENANCE)

| MMS Code | Description of Function | Unit | Quantity | Remarks | Est. Cost |
|---|---|---|---|---|---|
| 3314 | Maintain Steel Superstructure Components | LF | 2 | Span 1 Beam 4: HEAVY CORROSION OF BOTTOM FLANGE AT END BENT 2 WITH FLAKING RUST AND SECTION LOSS 2 FT X 3/8" X 5 7/8" REMAINING. (PM) | |

| MMS Code | MMS Description | Quantity |
|---|---|---|
| Span 1 Beam 4: HEAVY CORROSION OF BOTTOM FLANGE AT END BENT 2 WITH FLAKING RUST AND SECTION LOSS 2 FT X 3/8" X 5 7/8" REMAINING. (PM) | | |
