## Structure Safety Report

### Routine Element Inspection - Contract

COUNTY: BURKE STRUCTURE NUMBER: 110145 FREQUENCY: 24 MONTHS

FEATURE INTERSECTED: BRISTOL CREEK

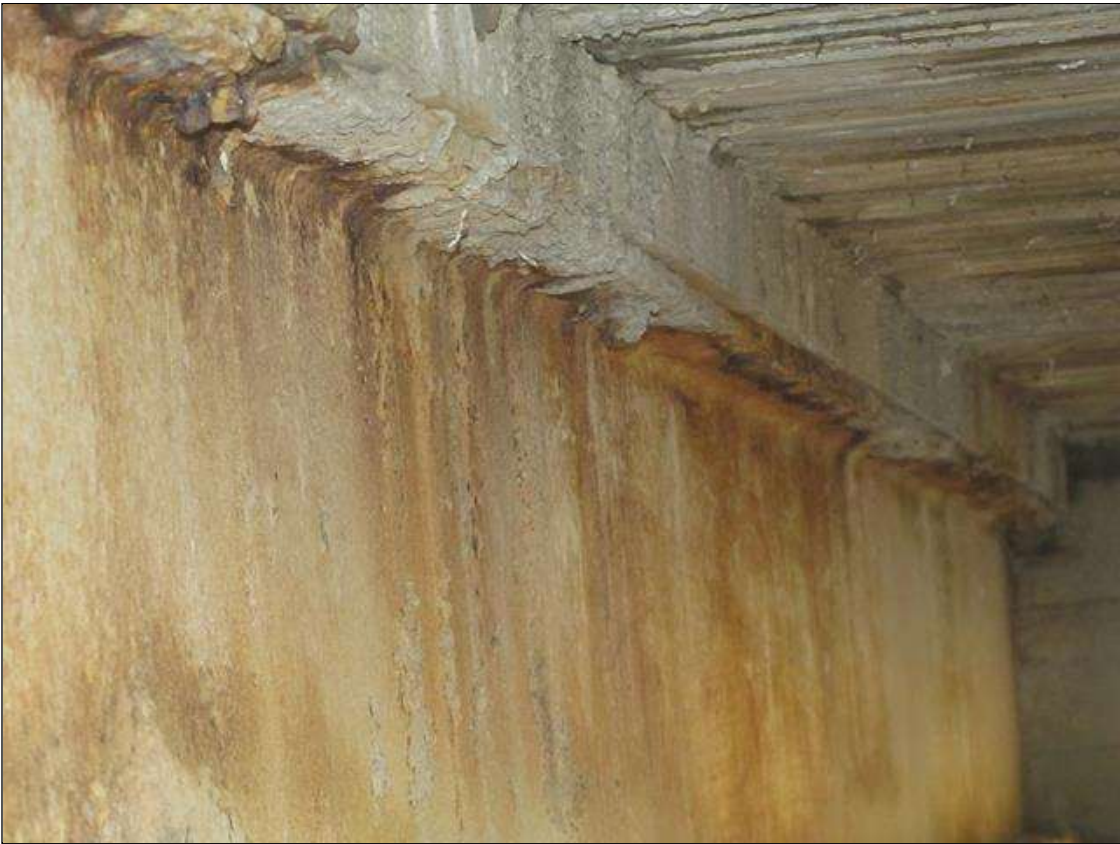
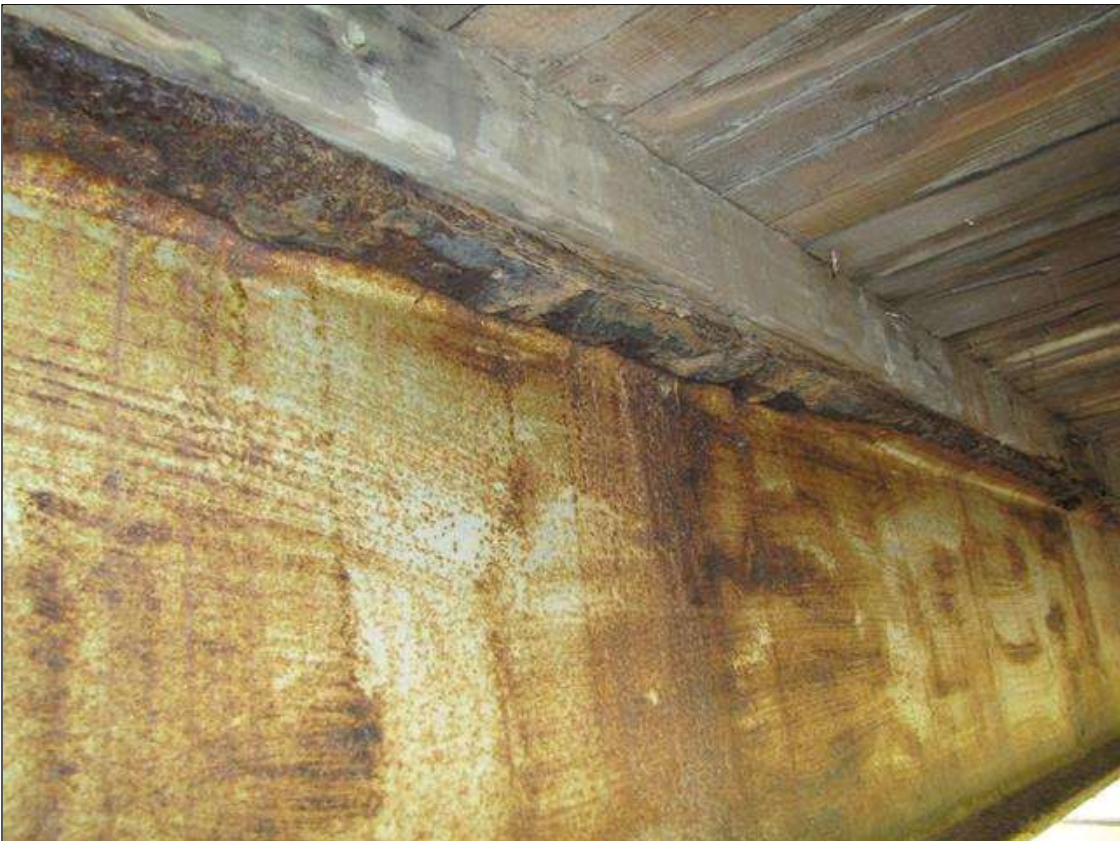
| Element Number | Defect Type | Defect Description | CS | CS Qty | Maint Qty | |
|---|---|---|---|---|---|---|
| 107 | Corrosion | HEAVY CORROSION OF TOP FLANGE WITH FLAKING RUST AND SECTION LOSS FULL LENGTH WITH 3/8" X 5 1/2" REMAINING (PRIORITY MAINTENANCE) | 3 | 38 | 38 | Feet |

Span 1 Beam 4: HEAVY CORROSION OF TOP FLANGE WITH FLAKING RUST AND SECTION LOSS FULL LENGTH WITH 3/8" X 5 1/2" REMAINING. SOUTH SIDE SHOWN (PRIORITY MAINTENANCE)

Span 1 Beam 4: HEAVY CORROSION OF TOP FLANGE WITH FLAKING RUST AND SECTION LOSS FULL LENGTH WITH 3/8" X 5 1/2" REMAINING. NORTH SIDE SHOWN (PRIORITY MAINTENANCE)

| MMS Code | Description of Function | Unit | Quantity | Remarks | Est. Cost |
|---|---|---|---|---|---|
| 3314 | Maintain Steel Superstructure Components | LF | 38 | Span 1 Beam 4: HEAVY CORROSION OF TOP FLANGE WITH FLAKING RUST AND SECTION LOSS FULL LENGTH WITH 3/8" X 5 1/2" REMAINING (PRIORITY MAINTENANCE) | |

| MMS Code | MMS Description | Quantity |
|---|---|---|
| Span 1 Beam 4: HEAVY CORROSION OF TOP FLANGE WITH FLAKING RUST AND SECTION LOSS FULL LENGTH WITH 3/8" X 5 1/2" REMAINING (PRIORITY MAINTENANCE) | | |

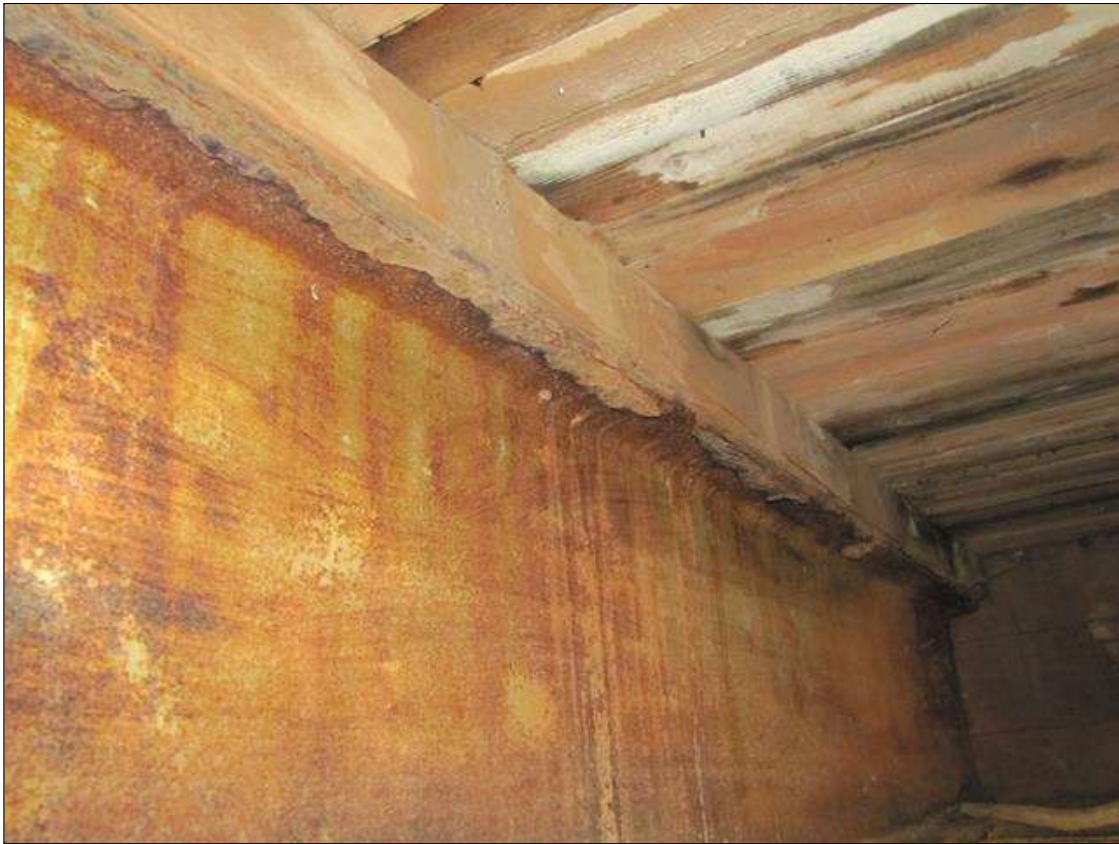
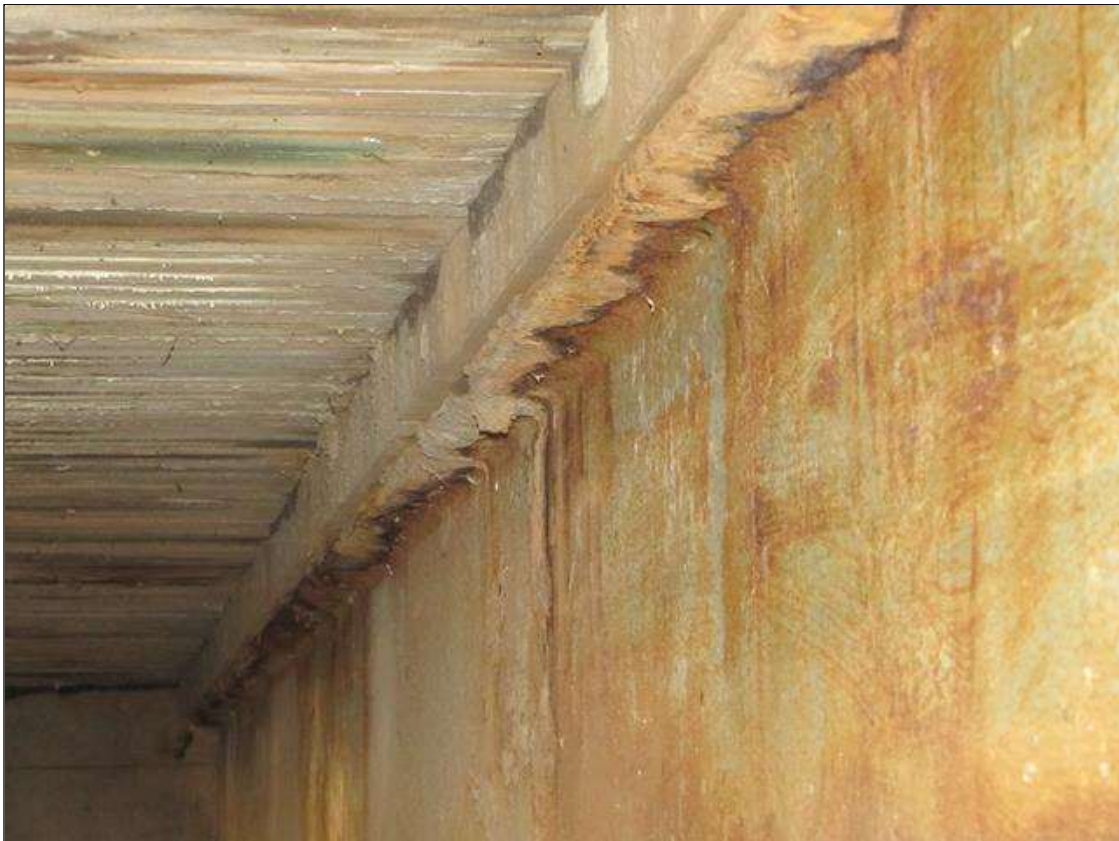
| Element Number | Defect Type | Defect Description | CS | CS Qty | Maint Qty | |
|---|---|---|---|---|---|---|
| 107 | Corrosion | HEAVY CORROSION OF TOP FLANGE FULL LENGTH WITH FLAKING RUST AND SECTION LOSS 3/8" X 5 1/2" REMAINING (PRIORITY MAINTENANCE) | 3 | 40 | 40 | Feet |

Span 1 Beam 3: HEAVY CORROSION OF TOP FLANGE FULL LENGTH WITH FLAKING RUST AND SECTION LOSS 3/8" X 5 1/2" REMAINING (PRIORITY MAINTENANCE)

| MMS Code | Description of Function | Unit | Quantity | Remarks | Est. Cost |
|---|---|---|---|---|---|
| 3314 | Maintain Steel Superstructure Components | LF | 40 | Span 1 Beam 3: HEAVY CORROSION OF TOP FLANGE FULL LENGTH WITH FLAKING RUST AND SECTION LOSS 3/8" X 5 1/2" REMAINING (PRIORITY MAINTENANCE) | |

| MMS Code | MMS Description | Quantity |
|---|---|---|
| Span 1 Beam 3: HEAVY CORROSION OF TOP FLANGE FULL LENGTH WITH FLAKING RUST AND SECTION LOSS 3/8" X 5 1/2" REMAINING (PRIORITY MAINTENANCE) | | |

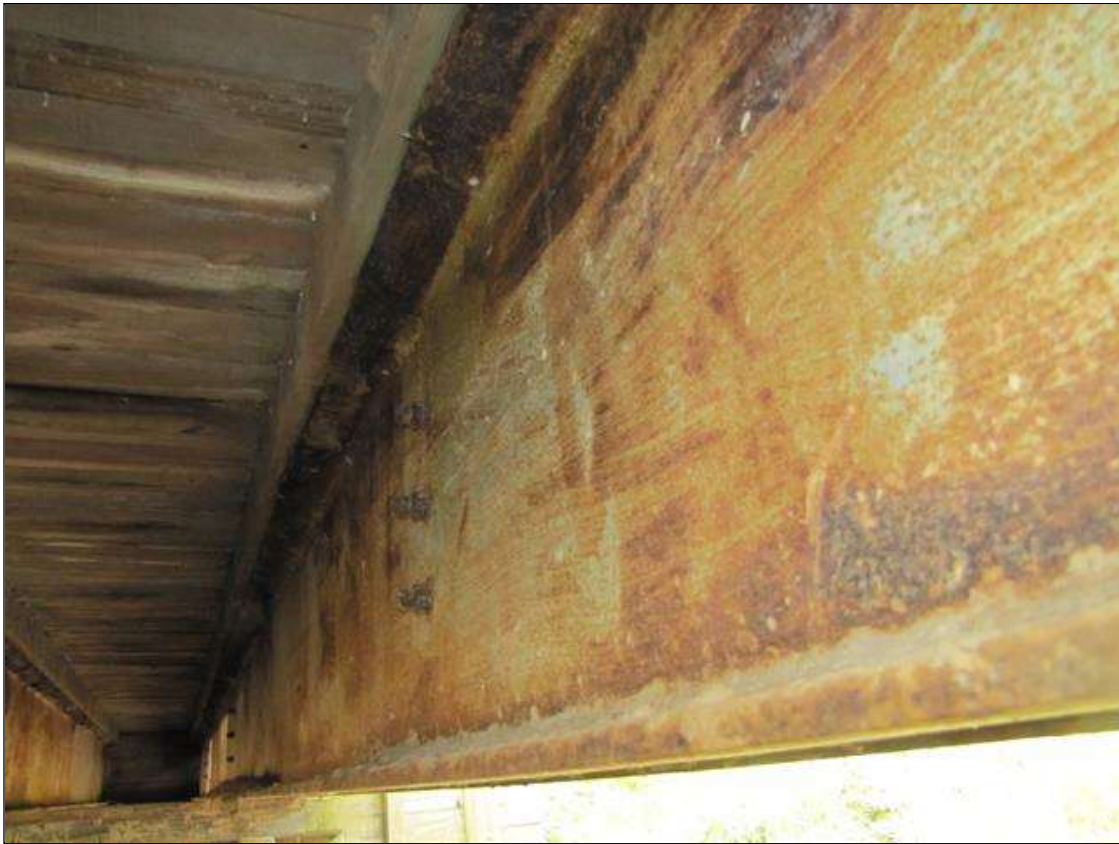
| Element Number | Defect Type | Defect Description | CS | CS Qty | Maint Qty |
|---|---|---|---|---|---|
| 107 | Corrosion | SURFACE CORROSION AND RUST SCALE FULL LENGTH AT TOP FLANGE AND SURFACE RUST OF WEB AND BOTTOM FLANGE | 2 | 40 | Feet |

Span 1 Beam 2: SURFACE CORROSION AND RUST SCALE FULL LENGTH AT TOP FLANGE AND SURFACE RUST OF WEB AND BOTTOM FLANGE

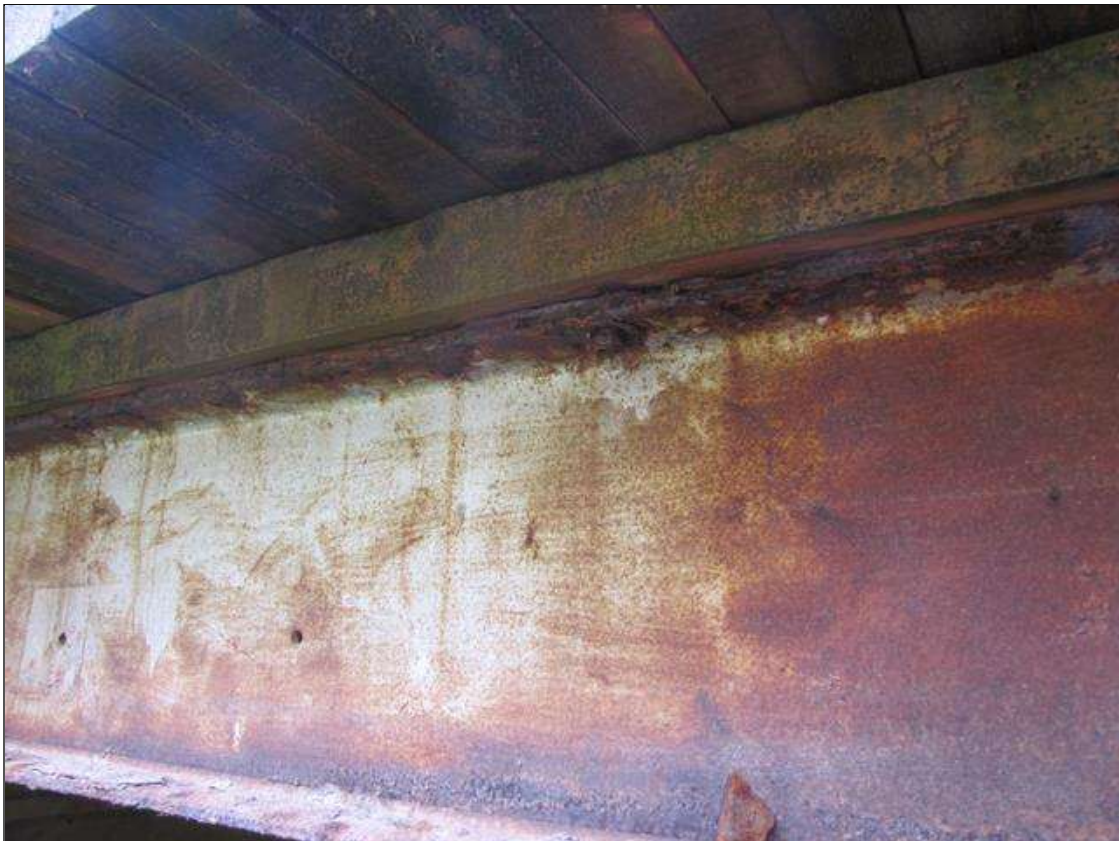
| Element Number | Defect Type | Defect Description | CS | CS Qty | Maint Qty |
|---|---|---|---|---|---|
| 107 | Corrosion | HEAVY CORROSION OF TOP FLANGE EXTENDING FROM END BENT 2 WITH FLAKING RUST AND SECTION LOSS WITH 6 FT X 7/16" X 5 1/2" REMAINING (PRIORITY MAINTENANCE) | 3 | 6 | 6 Feet |

Span 1 Beam 1: HEAVY CORROSION OF TOP FLANGE EXTENDING FROM END BENT 2 WITH FLAKING RUST AND SECTION LOSS WITH 6 FT X 7/16" X 5 1/2" REMAINING (PRIORITY MAINTENANCE)

| MMS Code | Description of Function | Unit | Quantity | Remarks | Est. Cost |
|---|---|---|---|---|---|
| 3314 | Maintain Steel Superstructure Components | LF | 6 | Span 1 Beam 1: HEAVY CORROSION OF TOP FLANGE EXTENDING FROM END BENT 2 WITH FLAKING RUST AND SECTION LOSS WITH 6 FT X 7/16" X 5 1/2" REMAINING (PRIORITY MAINTENANCE) | |

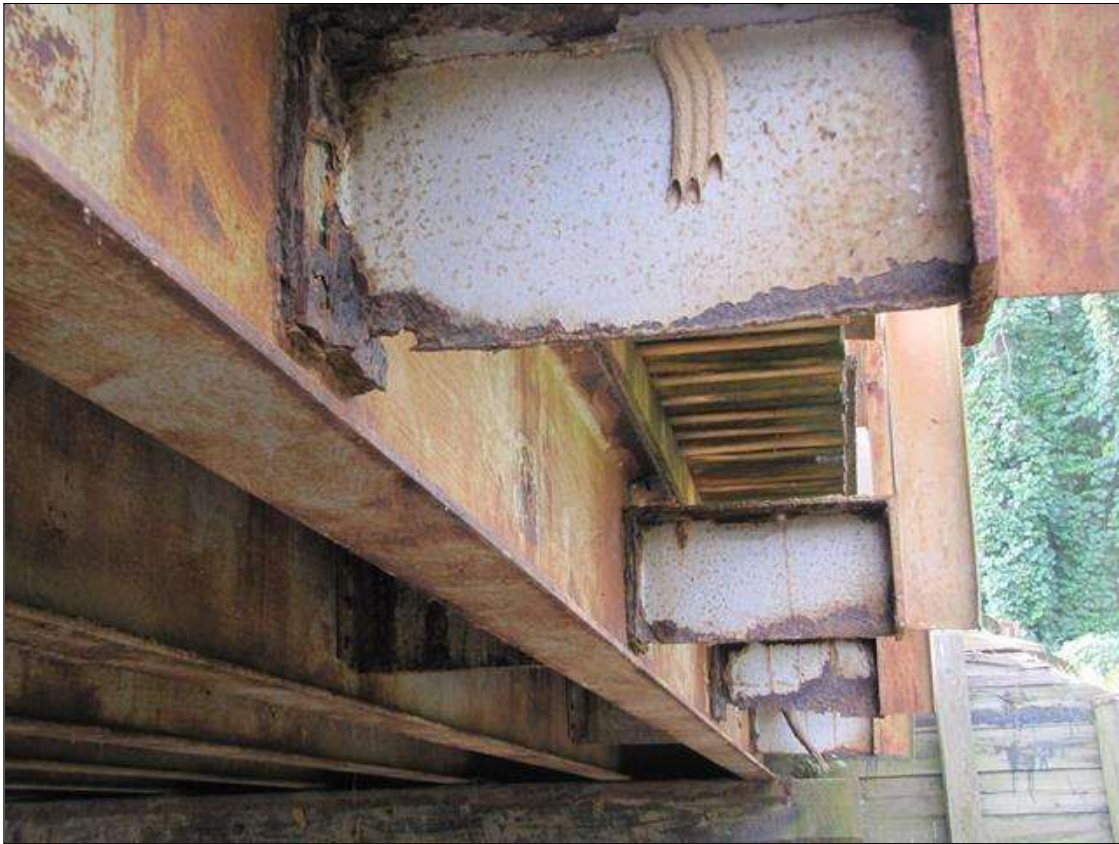
| Element Number | Defect Type | Defect Description | CS | CS Qty | Maint Qty |
|---|---|---|---|---|---|
| 107 | Corrosion | SURFACE CORROSION WITH SOME RUST SCALE FULL LENGTH BOTH FLANGES AND WEB | 2 | 34 | Feet |

Span 1 Beam 1: SURFACE CORROSION WITH SOME RUST SCALE FULL LENGTH BOTH FLANGES AND WEB

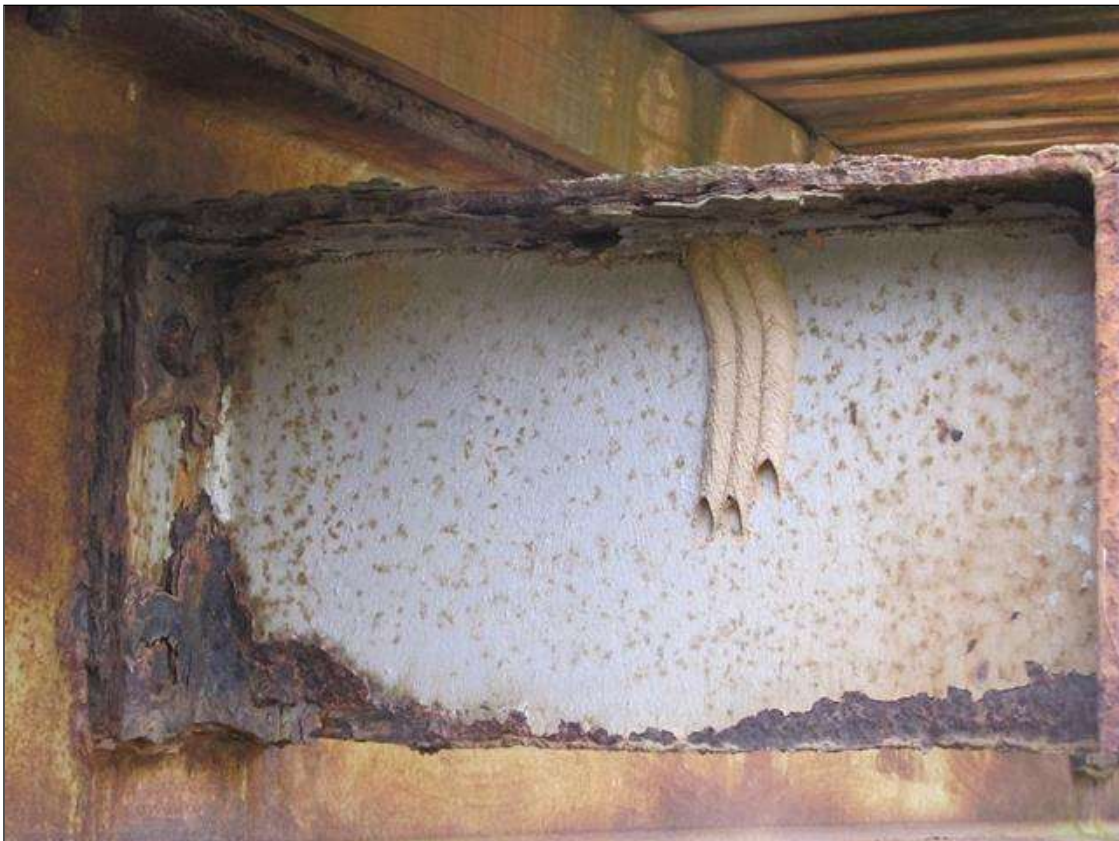
| Element Number | Defect Type | Defect Description | CS | CS Qty | Maint Qty | |
|---|---|---|---|---|---|---|
| 330 | Corrosion | RAIL POST OUTRIGGERS HAVE SEVERE CORROSION WITH SECTION LOSS OF TOP FLANGE AND WEB UP TO 50% AT ALL LOCATIONS | 3 | | 12 | Square Feet |

Span 1 Left Bridge Rail: RAIL POST OUTRIGGERS HAVE SEVERE CORROSION WITH SECTION LOSS OF TOP FLANGE AND WEB UP TO 50% AT ALL LOCATIONS

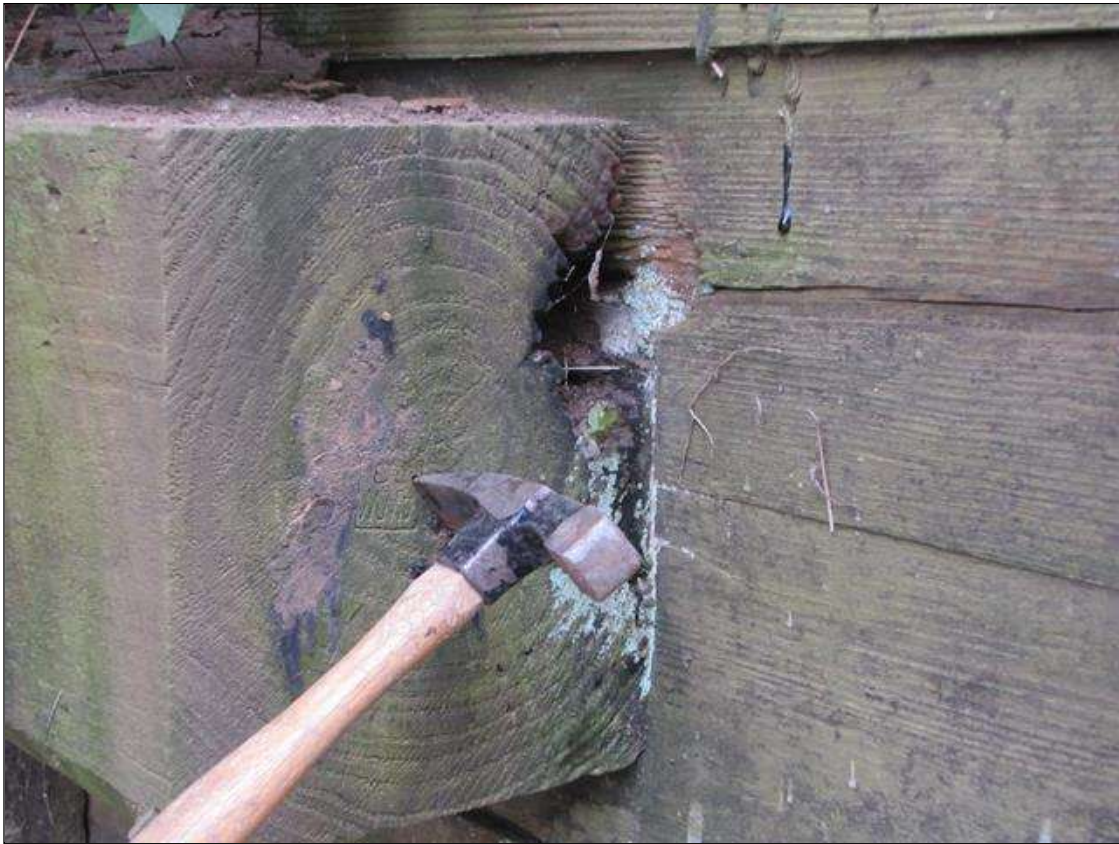
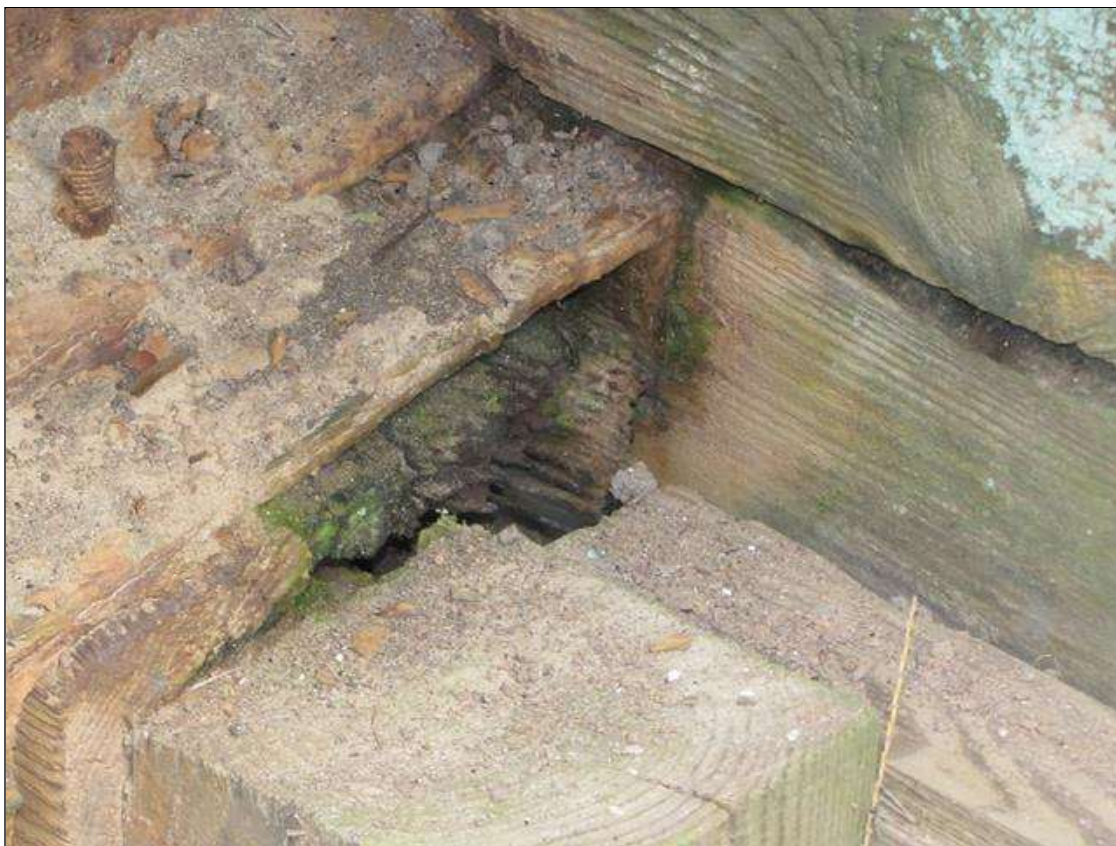
| Element Number | Defect Type | Defect Description | CS | CS Qty | Maint Qty | |
|---|---|---|---|---|---|---|
| 235 | Decay/Section Loss | 4" X 6" X 3" DECAY AT EAST END OF CAP | 3 | 1 | 1 | Feet |

End Bent 2 Cap 1: 4" X 6" DEEP DECAY AT EAST END OF CAP

End Bent 2 Cap 1: 4" X 6" X 3" DECAY AT EAST END OF CAP

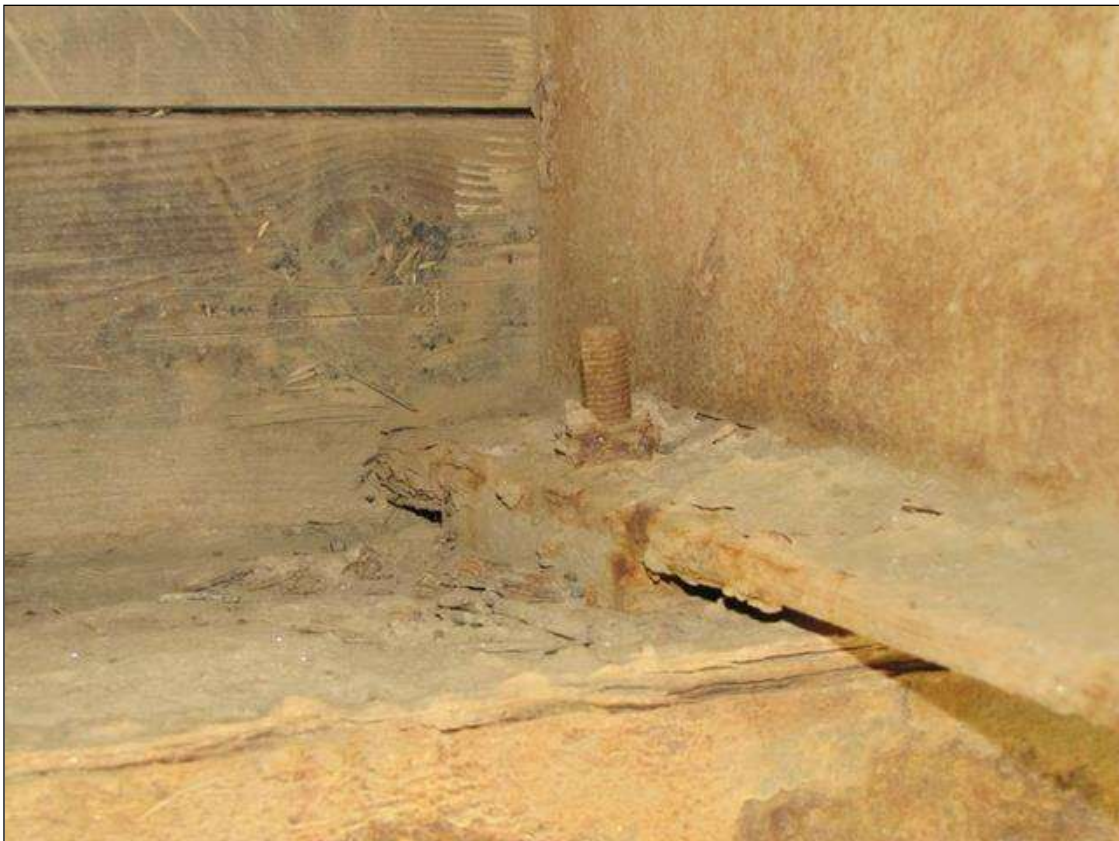
Span 1 Beam 3 Near Bearing 3: SEVERE CORROSION WITH FLAKING RUST

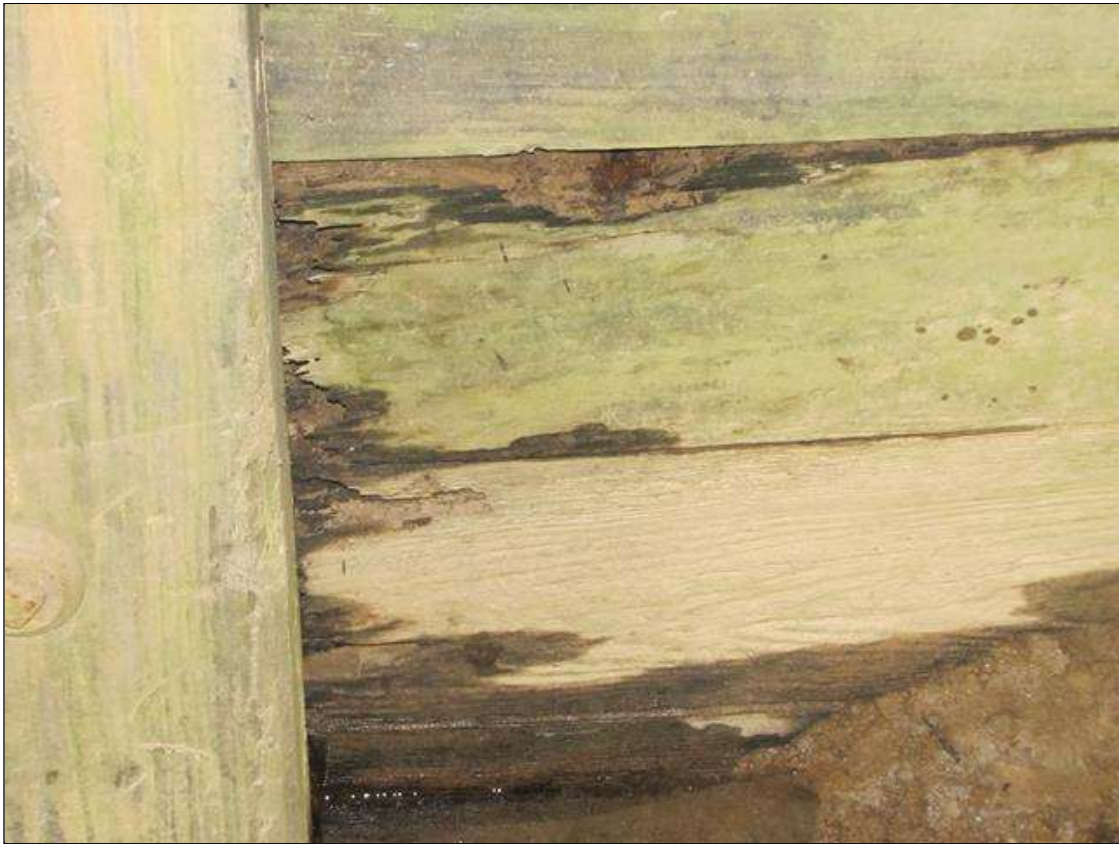
| Element Number | Defect Type | Defect Description | CS | CS Qty | Maint Qty |
|---|---|---|---|---|---|
| 216 | Decay/Section Loss | 2 FT X 2" X FULL DEPTH DECAY WITH SOIL SPILL THROUGH BETWEEN PILES 1 AND 2 (PRIORITY MAINTENANCE) | 3 | 2 | 2 Feet |

End Bent 1 Abutment/Backwall : 2 FT X 2" X FULL DEPTH DECAY WITH SOIL SPILL THROUGH BETWEEN PILES 1 AND 2 (PRIORITY MAINTENANCE)

| MMS Code | Description of Function | Unit | Quantity | Remarks | Est. Cost |
|---|---|---|---|---|---|
| 3346 | Repair / Maintain Timber Wings & Blkhds | SF | 2 | End Bent 1 Abutment/Backwall : 2 FT X 2" X FULL DEPTH DECAY WITH SOIL SPILL THROUGH BETWEEN PILES 1 AND 2 (PRIORITY MAINTENANCE) | |

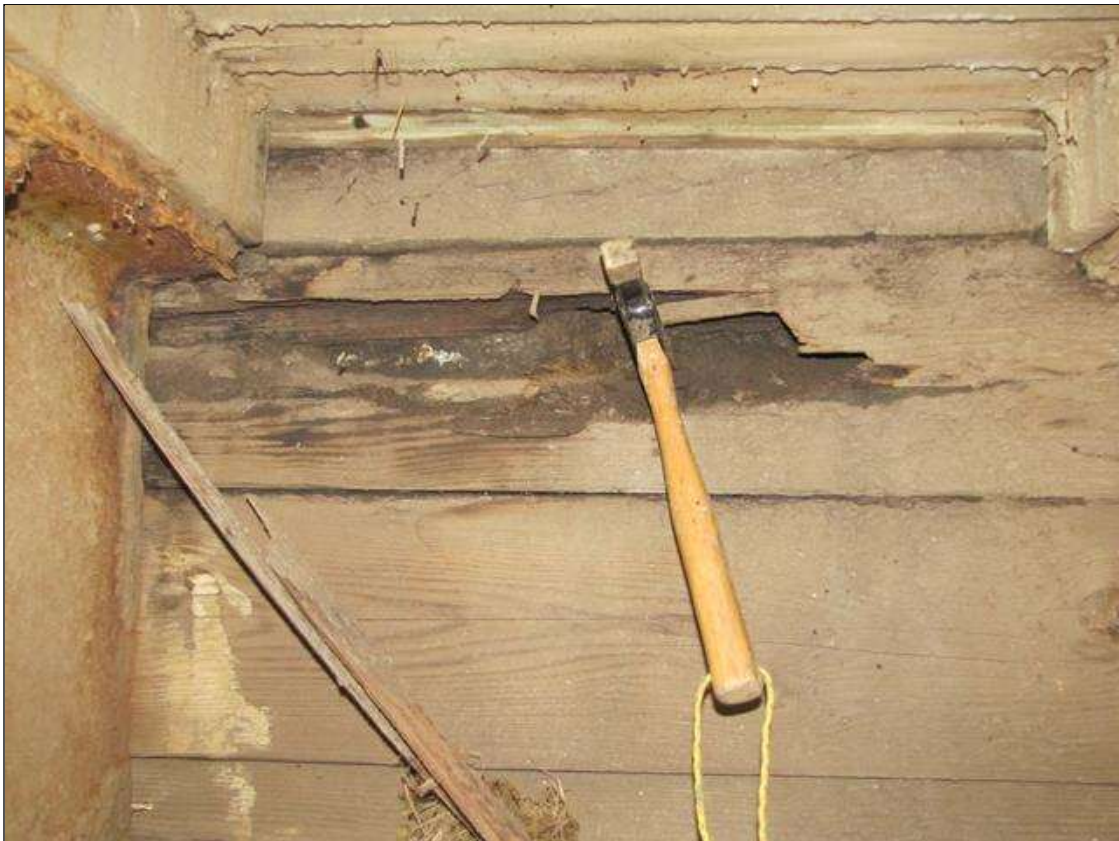
| Element Number | Defect Type | Defect Description | CS | CS Qty | Maint Qty |
|---|---|---|---|---|---|
| 216 | Decay/Section Loss | 2 FT X 4" X FULL DEPTH DECAY OF BULKHEAD BETWEEN BEAMS 5 AND 6 (PRIORITY MAINTENANCE) | 3 | 2 | 2 Feet |

End Bent 1 Abutment/Backwall : 2 FT X 4" X FULL DEPTH DECAY OF BULKHEAD BETWEEN BEAMS 5 AND 6 (PRIORITY MAINTENANCE)

| MMS Code | Description of Function | Unit | Quantity | Remarks | Est. Cost |
|---|---|---|---|---|---|
| 3346 | Repair / Maintain Timber Wings & Blkhds | SF | 2 | End Bent 1 Abutment/Backwall : 2 FT X 4" X FULL DEPTH DECAY OF BULKHEAD BETWEEN BEAMS 5 AND 6 (PRIORITY MAINTENANCE) | |
